Project Proposal

River Blyth

Humford, Bedlington

28th September 2015

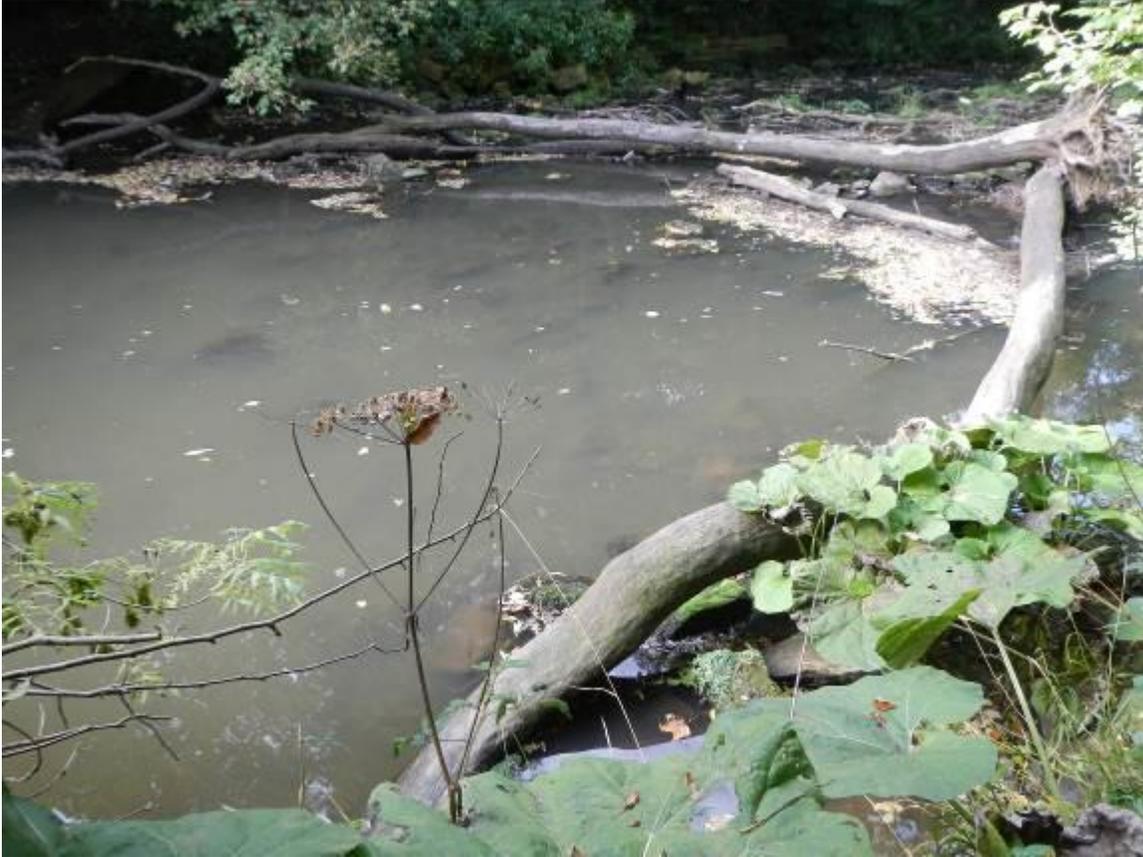
Figure 1. Natural woody material already present in the reach accumulating around shallower depositional areas.

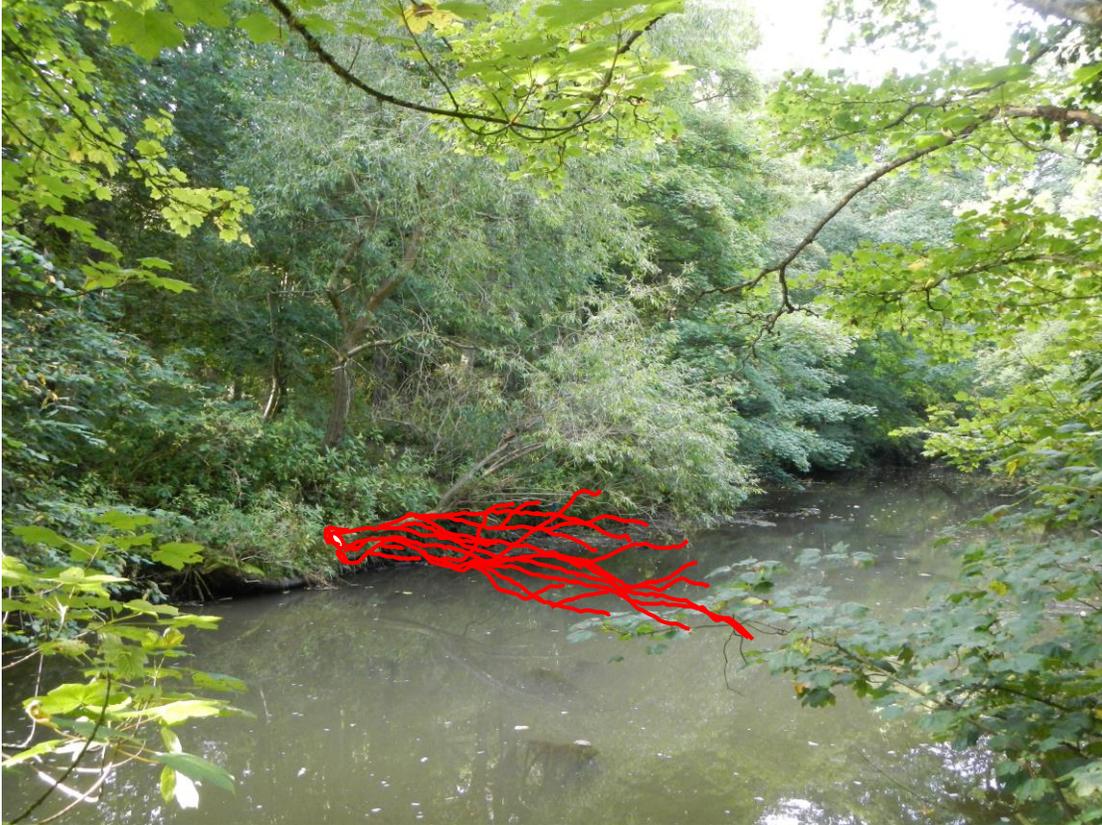
Figure 2. The red outline represents how the willow limb could be laid down into the river margin to enhance cover and fish holding habitat and, over time, encourage deposition and retention of substrate in that area.

The primary issues on this section of river are the uniform channel width and lack of variable bed structure and associated cover. The first proposal is to increase cover at strategic locations along the reach by hinging and laying the trunks and branches of suitable tree species (willow, hazel, elm etc.) into the margins (e.g. Fig. 2).

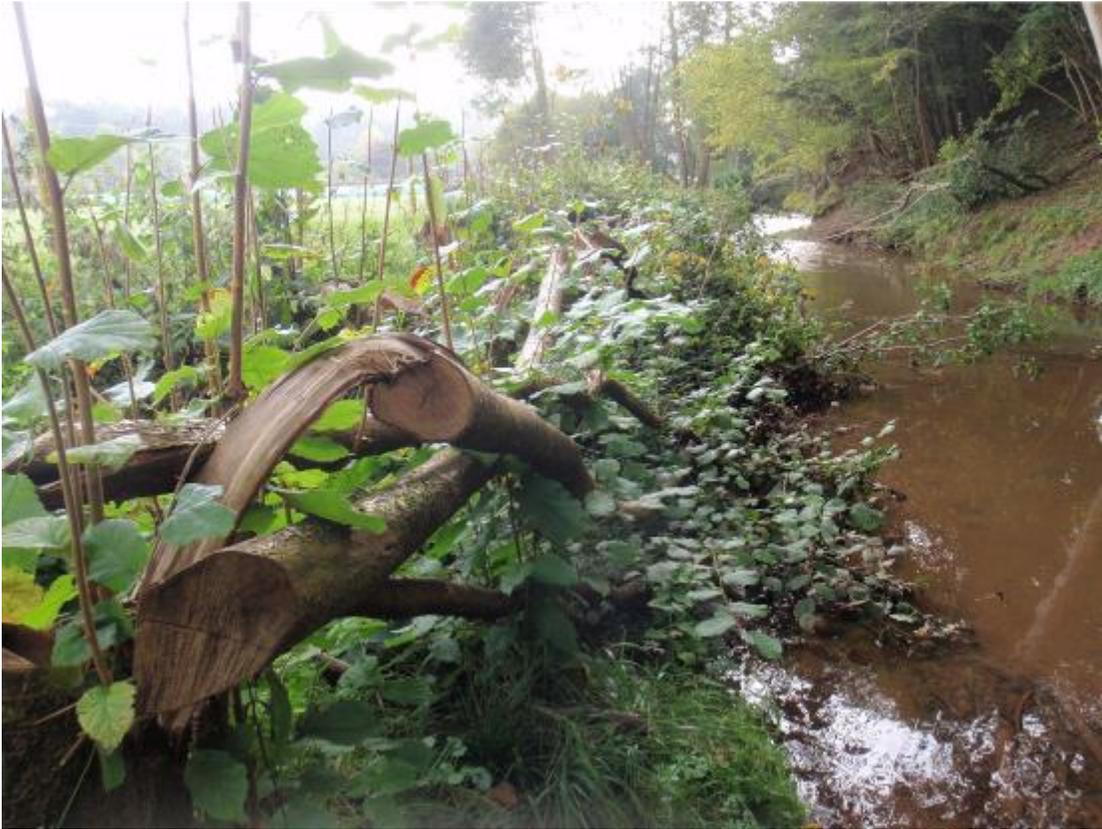
Figure 3. Small hazel limbs laid into the margin of a stream to increase cover and structure.

The process involves cutting part way through the stem/trunk, a little at a time (like laying a hedge), until it can be forced over into the channel (Figs. 3 & 4). The depth of the cut is limited to only that which is required to bend the limb over, to retain maximum strength in the hinge. This maintains the health of the tree/shrub and ensures that it is retained in place during high flow events. On smaller shrubs, simply cutting the stem/trunk at a very shallow angle and putting an axe blade into the cut and hitting it with a hammer can be sufficient to allow laying, while retaining a good strong hinge.

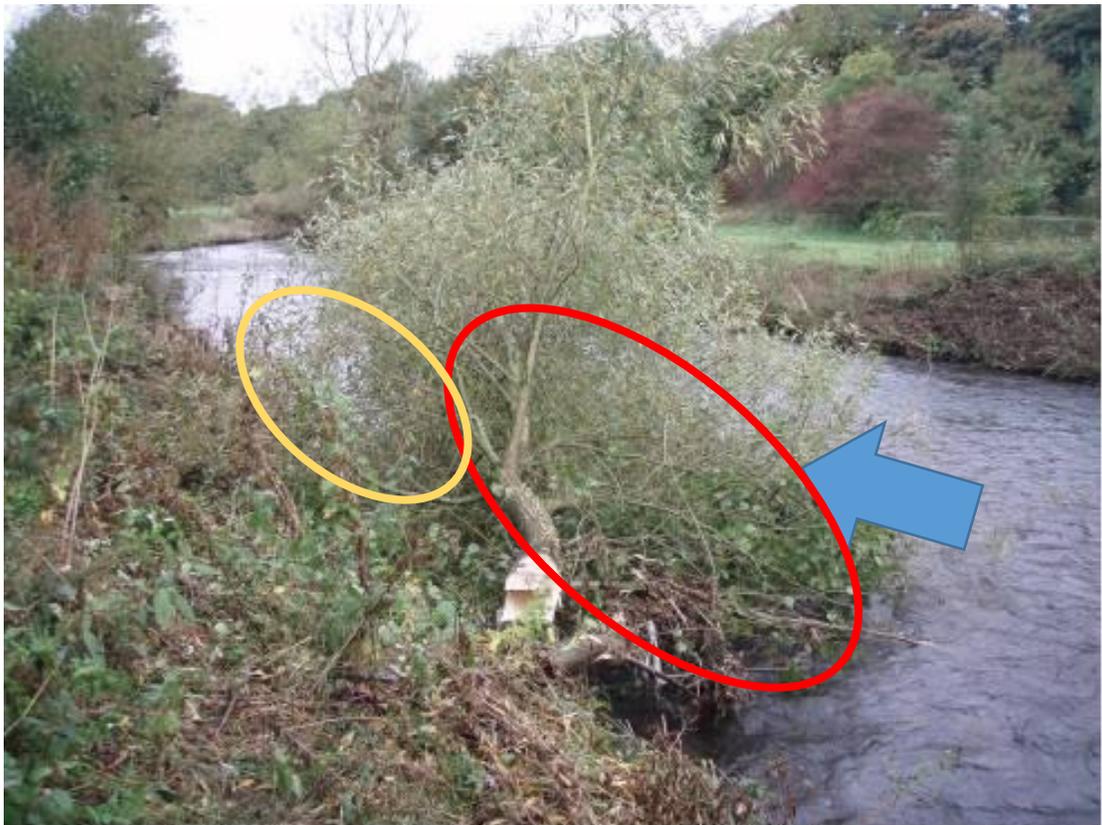
Figure 4. A large willow laid into the channel to focus flows into the centre of the channel (blue arrow), provide cover and structure in the river margin (red circle) and encourage deposition d/s (brown circle).

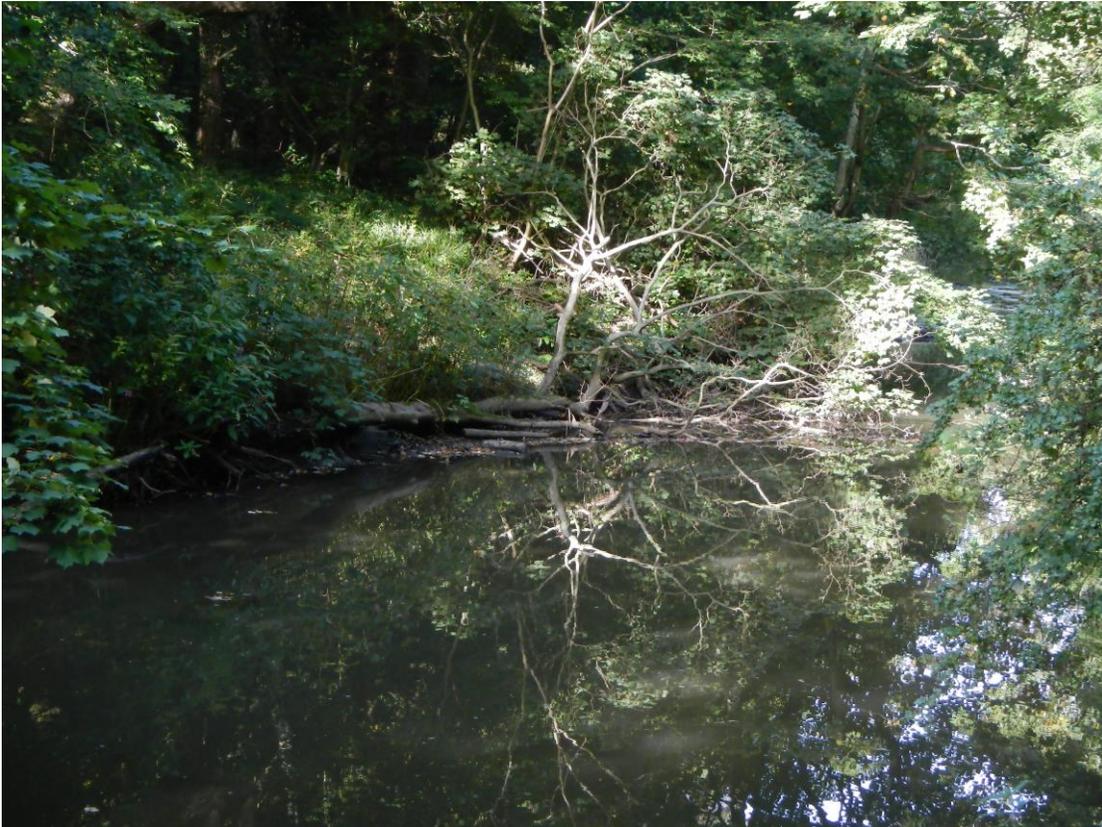
Figure 5. A natural fallen tree – the habitat that tree kickers closely mimic.

An alternative method, where greater intervention is required to reinstate active river erosional and depositional features, is to deploy tree kickers. Kickers offer an excellent way to rapidly increase the level of in-channel structure and create semi-natural pinch points that focus flows (centre of channel) and closely mimic the habitat provided by fallen trees already present in the reach (Fig. 5). They can be employed to encourage gravel deposition and retention within the margins of straight, uniform width channel sections, while promoting increased scour towards the centre of the channel that will help remove fine sediment from the bed.

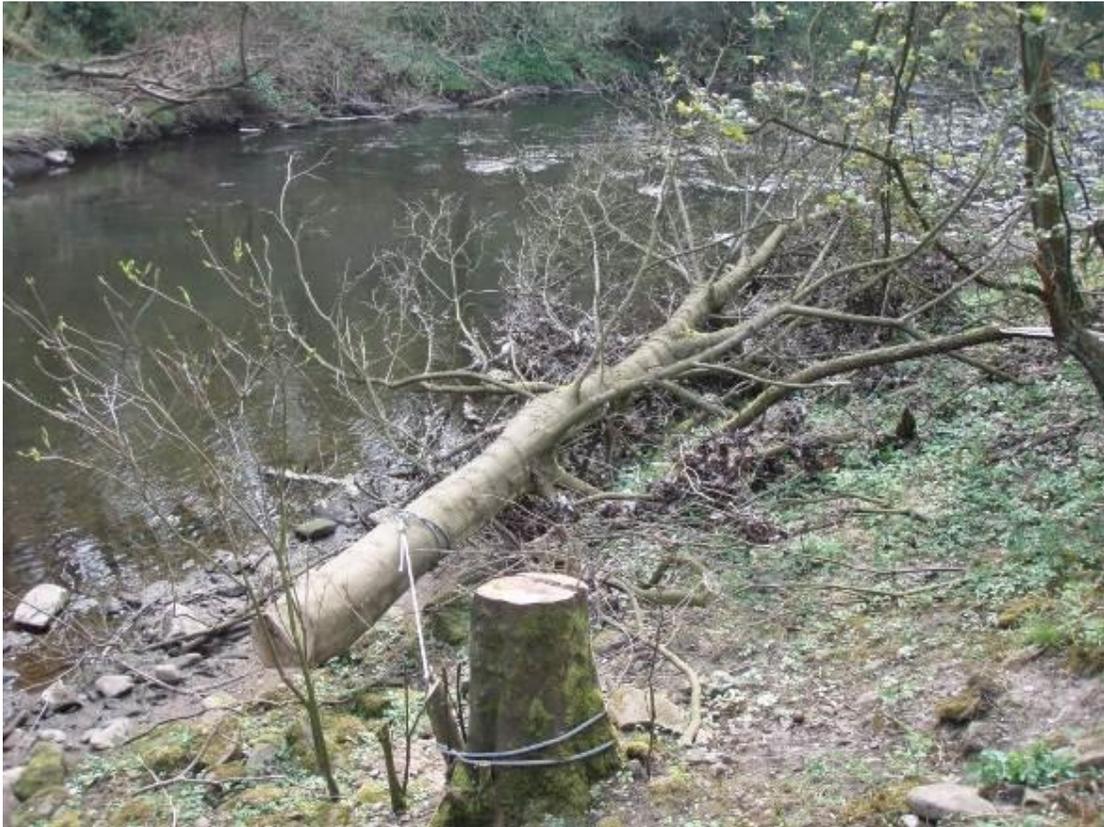
Figure 6. A tree kicker – a large sycamore tree that has been coppiced and cabled to its own trunk to provide structure within the river channel and facilitate deposition in the margin (see Fig. 7).

The installation of a tree kicker simply involves cutting a tree off at a low coppice and cabling the base of the tree to its stump with 7 x 19 wire strand core rope (rated to a minimum breaking load of 4,182 kg) (Fig. 6). Once in place and sediment accumulation occurs in and around the structure (Fig. 7), the limbs of the tree often become buried and trapped, further securing the structure in place naturally.

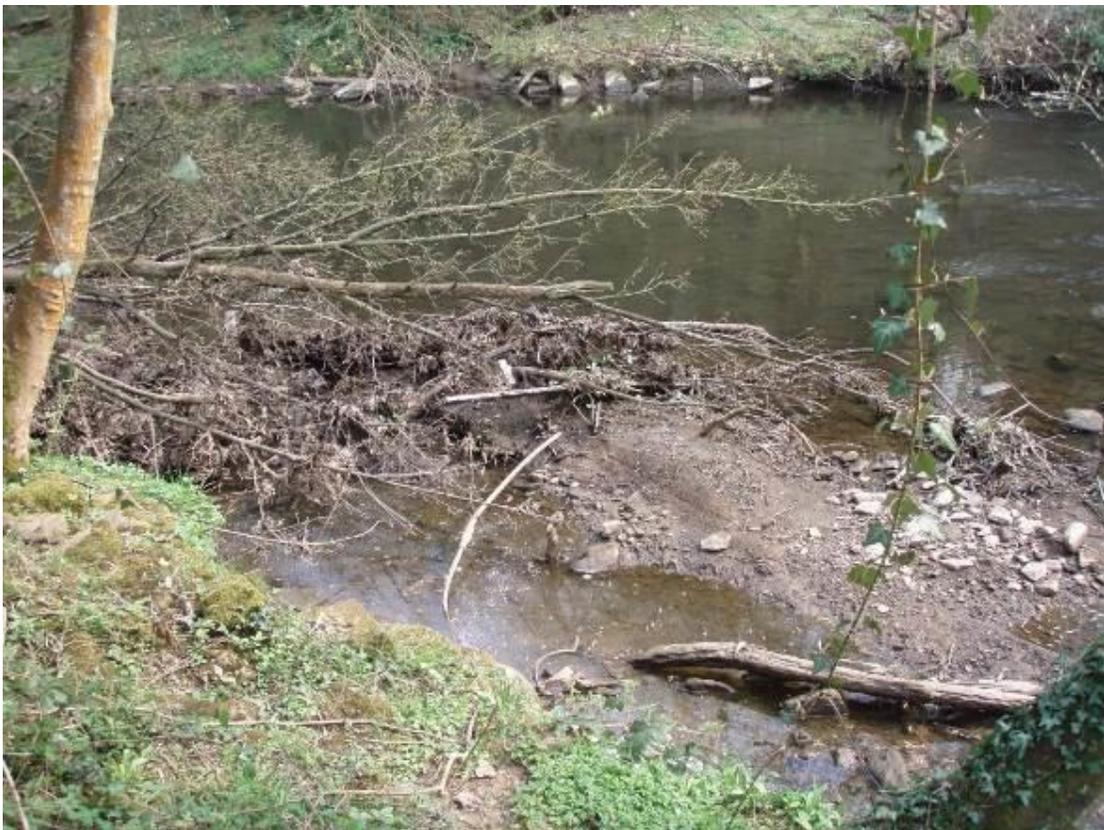
Figure 7. The d/s end of a tree kicker that has already accumulated a range of substrate sizes in its leys. This helps kick-start a natural narrowing process, retains substrate in channels where it is susceptible to high flows and introduces valuable width variation.
