**Advisory Visit**

**River Browney – River Wear**

**Co. Durham**

**21/02/15**

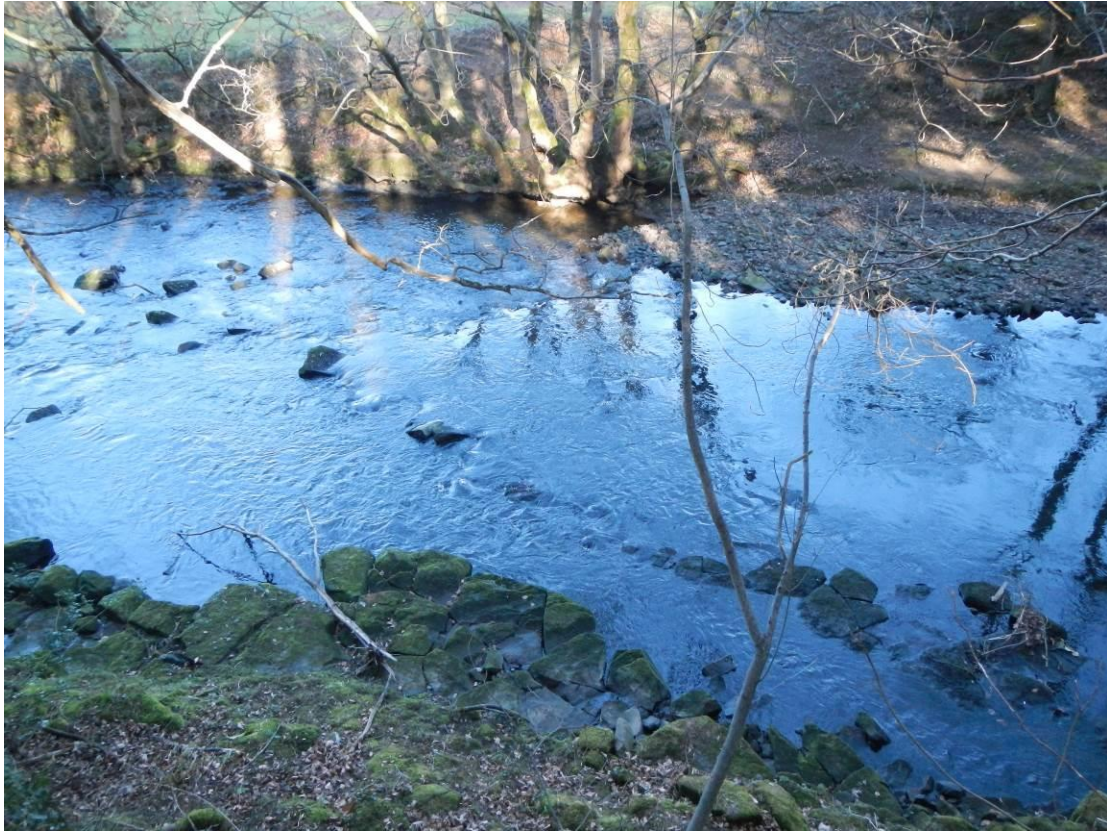
Bedrock is a prominent feature along the reach inspected, particularly in the lower third, where surface outcrops limit bed scour and, consequently, river depth. The shallow water areas created provide some good fry and parr habitat, although loose gravel on which fish can spawn is limited. Occasional gravel bars are present (Photo. 1) although they are often marginal features, exposed at normal flows (not viable spawning areas). Fissures and lower areas in the bedrock do provide areas of deeper water capable of holding adult trout, particularly on the bends.

**Photograph 1. Bedrock outcrop, limiting water depth and suitability as adult trout habitat, but providing good juvenile habitat in normal flows.**

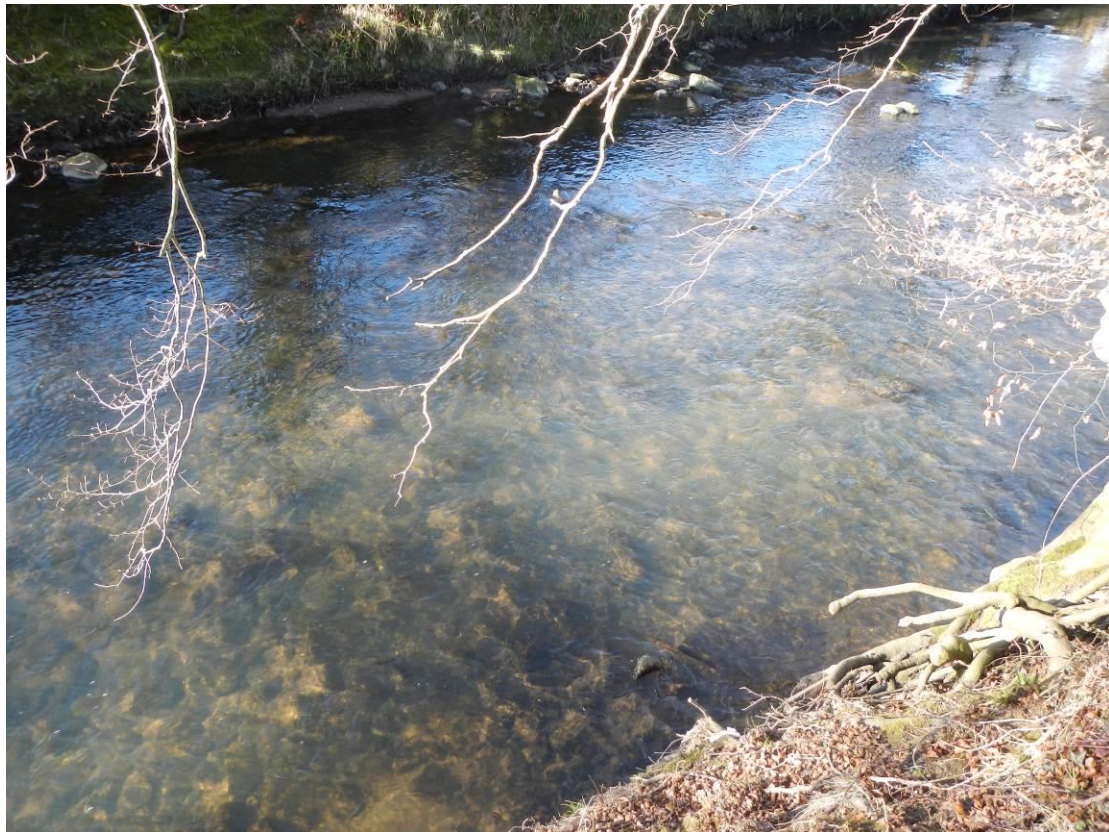
As suspected by the 'moderate' macrophytes and phytobenthos status, it does appear that sedimentation is an impact on the river, as seen in Photo 3, where spaces between the boulder substrate have trapped fine sand and silt. Such sedimentation can be an issue for juvenile salmonid survival as it smothers eggs laid within the gravel; the same applies to certain beneficial invertebrate species, as silt smothers their habitat. In-channel structure can play a part in improving the situation, as by constricting the channel in places, flows are accelerated at focal points, scouring the bed clean, while wider areas allow sediment deposition in the margins.

**Photograph 3. Reasonable juvenile salmonid habitat (a little lacking in cover/structure), but also note the significant sediment accumulation between the larger substrate particles.**

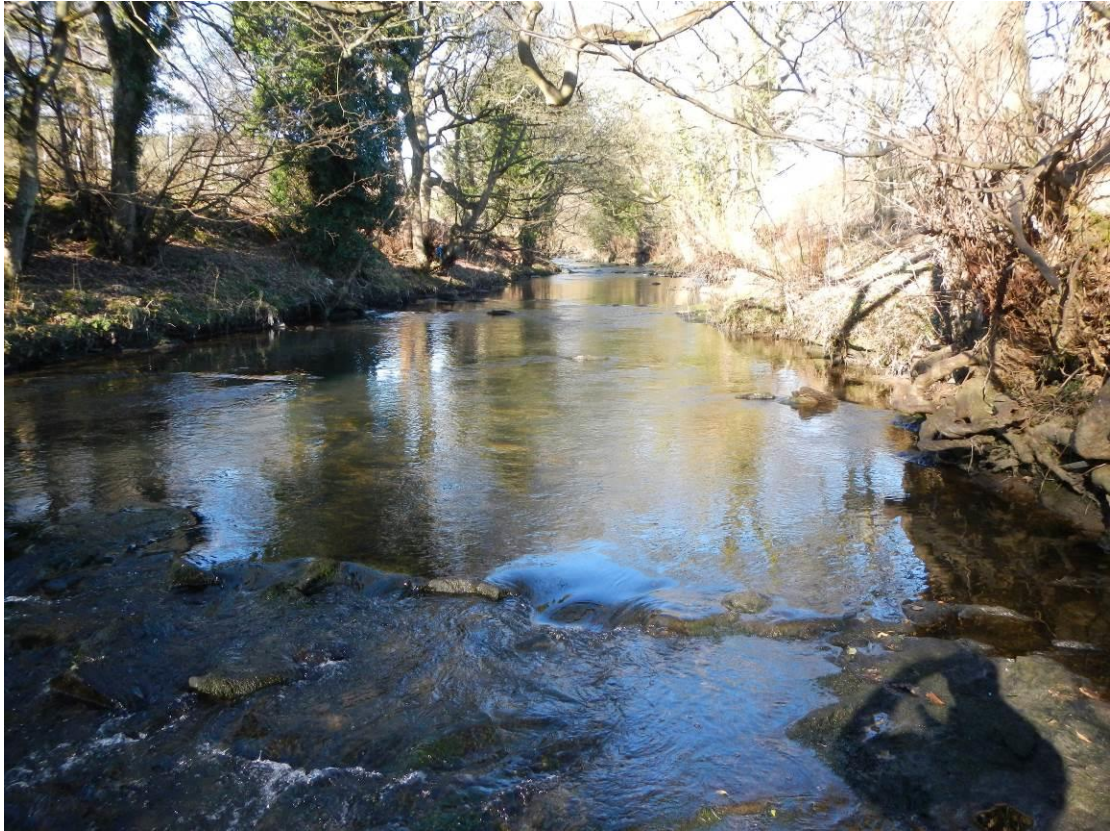
Trees alongside the river provide valuable shade and cover, although there was evidence that channel maintenance/tree pruning may have been undertaken in areas, as evident by a lack of low branches (Photo. 4), and by elm (*Ulmus minor var. vulgaris*) and hazel (*Corylus avellana*) stools where coppicing has taken place (Photo. 5). The tree shading and high banks along this reach may also be reducing macrophyte growth; however, the bedrock and boulder substrate is not conducive to significant growth of aquatic vegetation and tree shade and cover can act as a surrogate habitat type. For this reason, over pruning trees along such rugged channel types to improve macrophyte can be futile, and actually further denude habitat, as tree cover and shade is lost and significant growth of aquatic macrophytes is still unlikely.

**Photograph 4. Area with a lack of low-level cover and in-channel structure, possibly due to past maintenance.**

Habitat can, however, be significantly enhanced by simply laying some of the more pliable tree species such as hazel, elm, hawthorn (*Crataegus monogyna*), and particularly willows (*Salix spp.*), down into the channel. This creates instant, valuable low-level cover and trailing structure along the river margins, replicating the natural, fallen alder (*Alnus glutinosa*) habitat shown in Photo. 6. The coppice re-growth in Photo 5 and the small saplings in Photo. 7 would be ideally suited to this treatment, as would the hawthorn in Photo. 8.

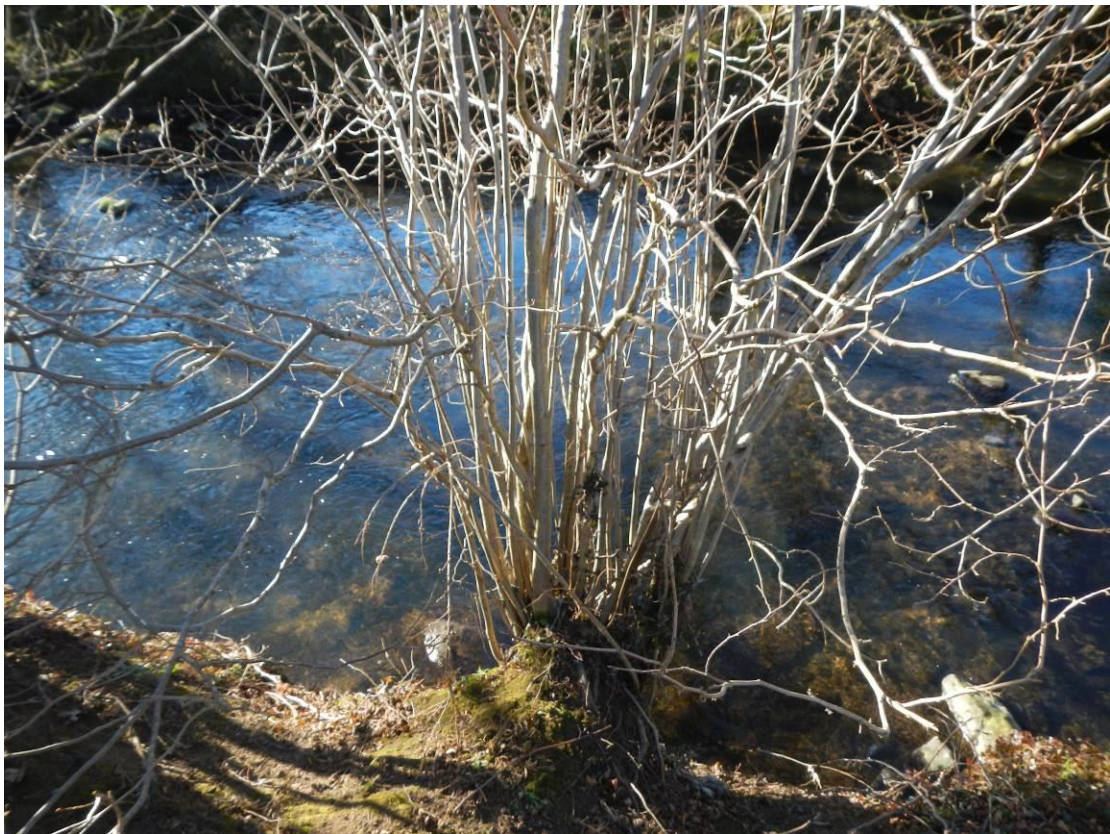
**Photograph 5. A coppiced stool, again suggesting historic channel maintenance.**

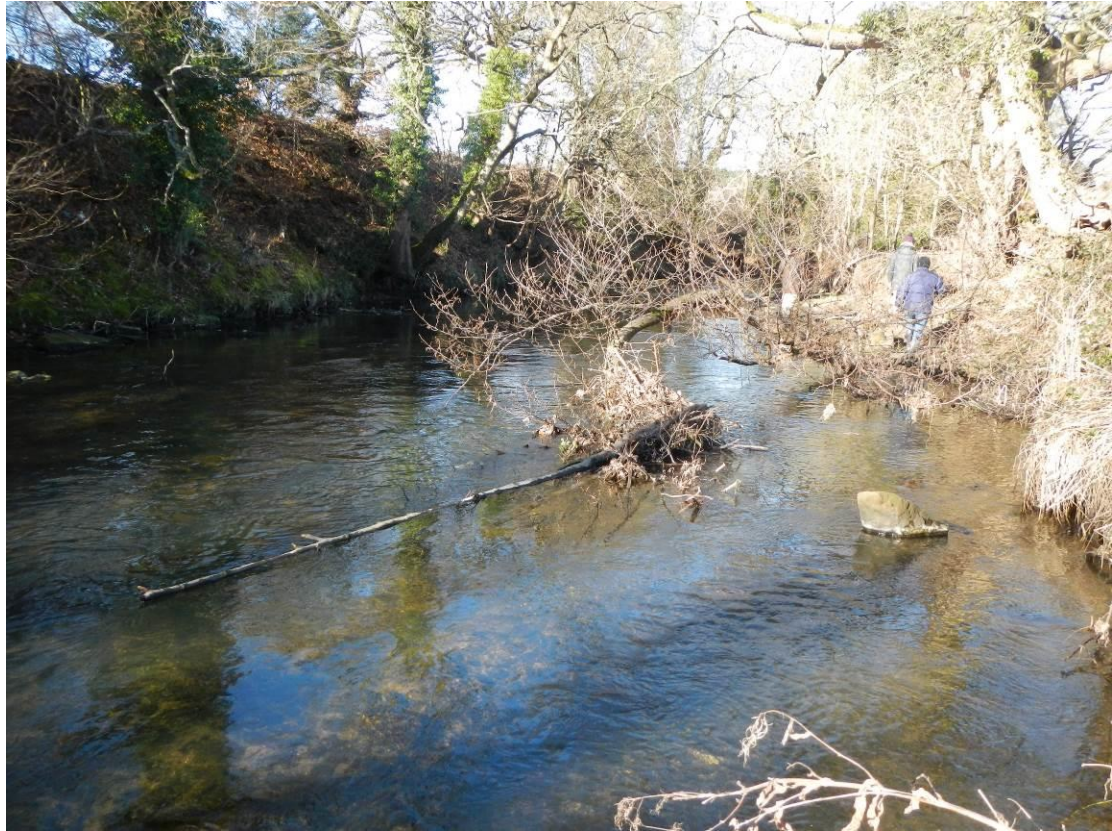
**Photograph 6. Valuable cover and structure provided by a fallen alder shrub.**

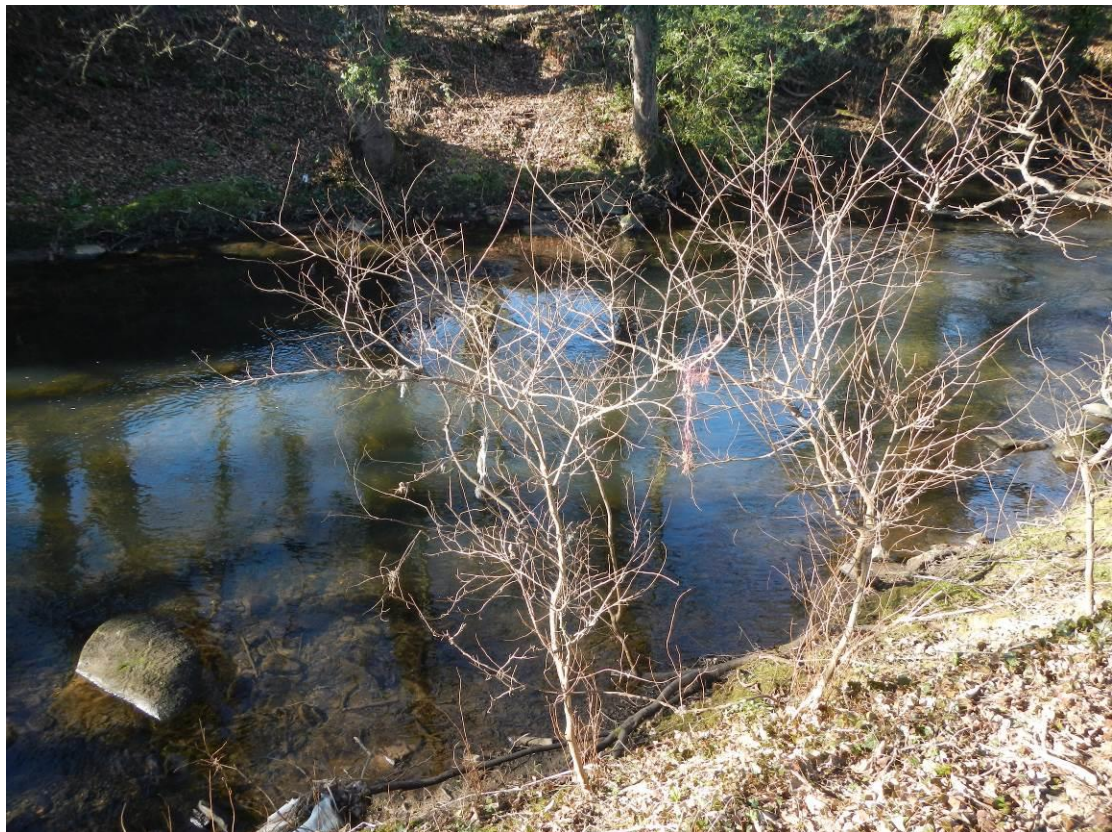
**Photograph 7. Small, pliable shrubs can be easily laid into the river channel/margin to enhance habitat.**

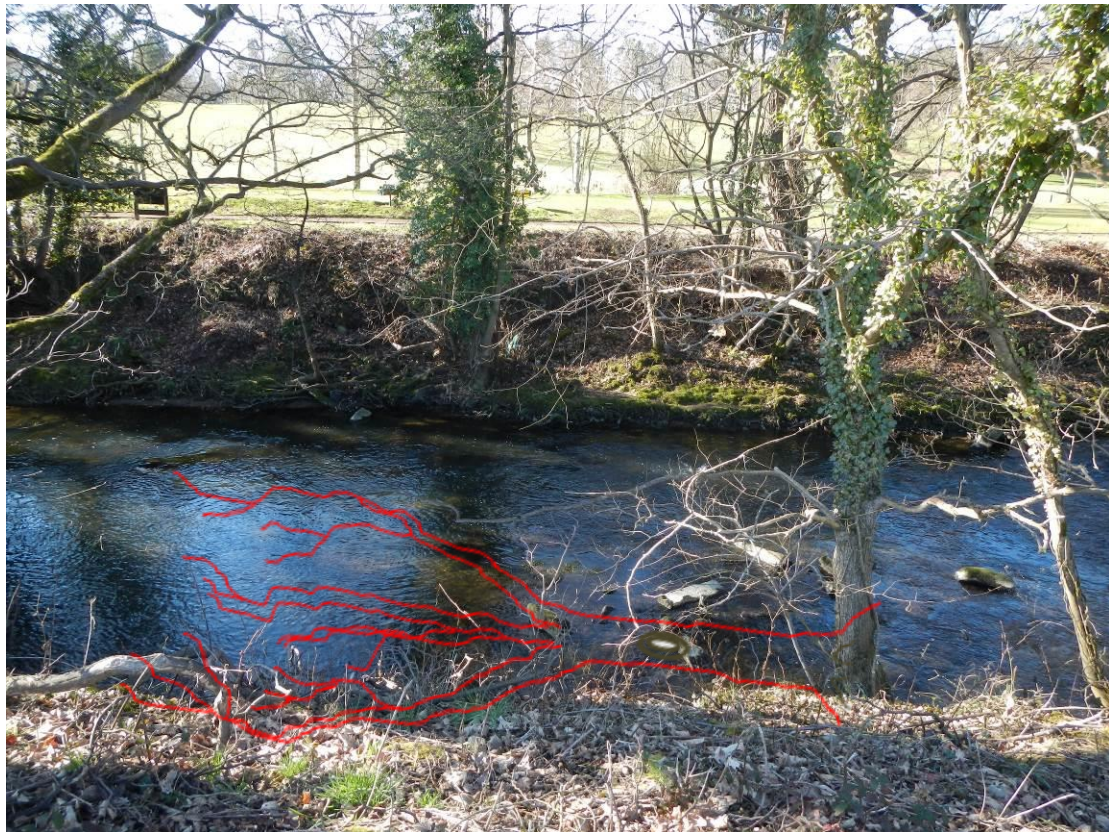
**Photograph 8. Even larger shrubs can be laid if they are a suitable species, like the hawthorn pictured above, which could be laid as per the red tree outline.**

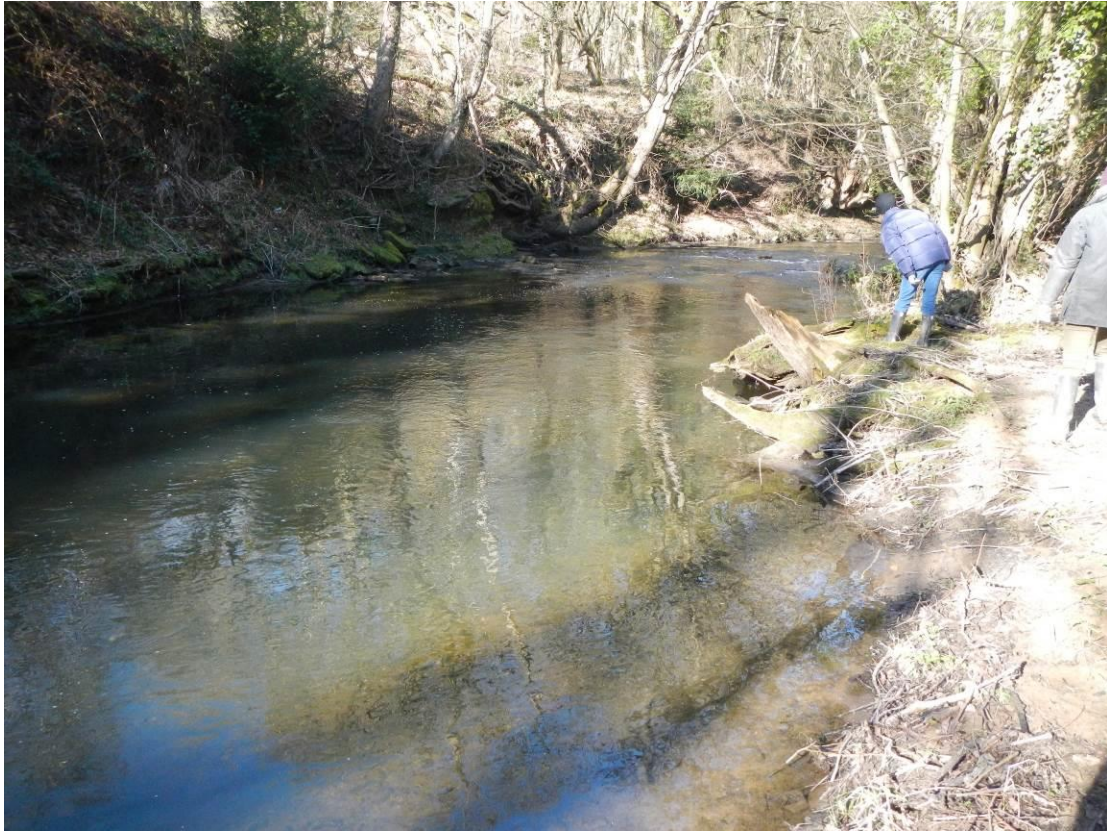
On a large bend, approximately mid-way through the reach visited a deeper pool providing excellent adult trout habitat was observed, with the remains of a big, old crack willow (*Salix fragilis*) protruding from the bank. The tree now appears to be dead, with only the roots remaining, but they do still provide valuable bank stabilisation. Planting of willow whips around this area would be beneficial to reinstate the cover that has been lost and help maintain the integrity of the bank. In the same area, the remains of a large stand of Himalayan balsam (*Impatiens glandulifera*) was also observed, the presence of which can also destabilise riverbanks, as the plant outcompetes native species before dying back for winter and leaving the banks devoid of any vegetation. Treating this issue by pulling the plants well before they have flowered, strimming them below the first node, or having them chemically treated by a user who is trained and licensed for use of herbicides near a watercourse.

**Photograph 9. Area of bank where a large crack willow has died. Planting of this area would be beneficial to consolidate depositional material on the inside of the bend and maintain bank stability.**

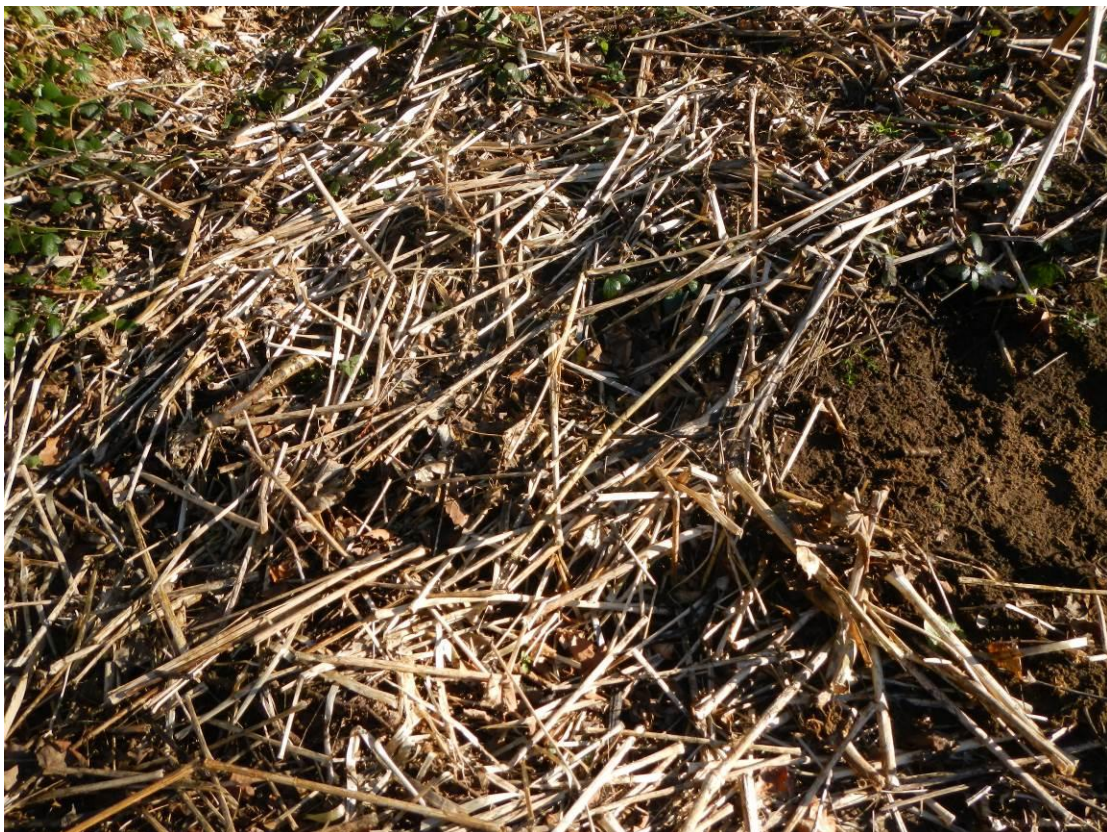
**Photograph 10. All that remains in areas of Himalayan balsam during the winter.**

The stand of balsam observed (Photo 10) should be treated (pulling, strimming or herbicide) if possible, which should help reduce issue. Local scale control (initial high effort – then a little ongoing weeding) can be extremely valuable to overall biodiversity, even when balsam is present in other areas of the catchment. The below link demonstrates how an urban volunteer group manage to maintain their small patch free of balsam despite massive stands upstream - <http://urbantrout.blogspot.co.uk/2014/07/volunteer-action-on-urban-river.html>.

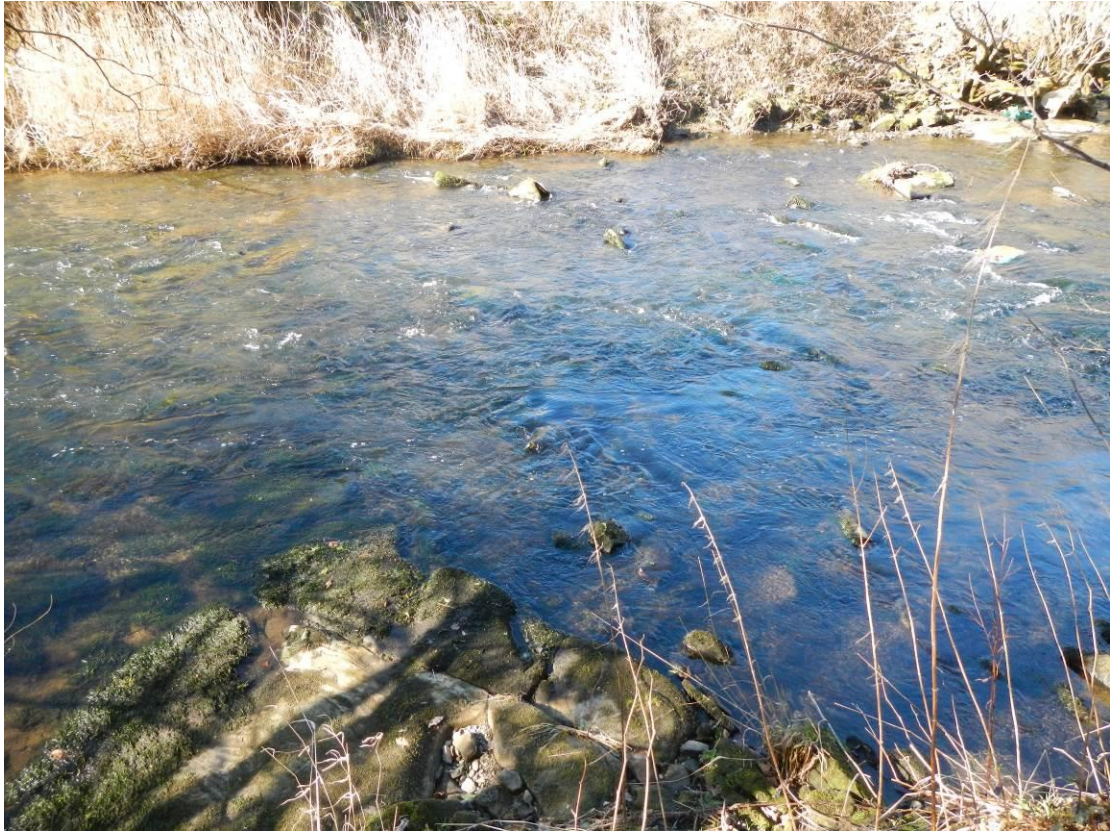
A short distance further upstream, a good range of habitat was also observed. Shallow riffles provide a range of micro-habitats for fry and parr (Photo. 11), with deeper runs and naturally overhanging willow cover also present to support larger adult fish (Photo. 12).

**Photograph 11. Fast and slow flow amongst variable substrate provides ideal habitat for a range of juvenile salmonid life stages.**

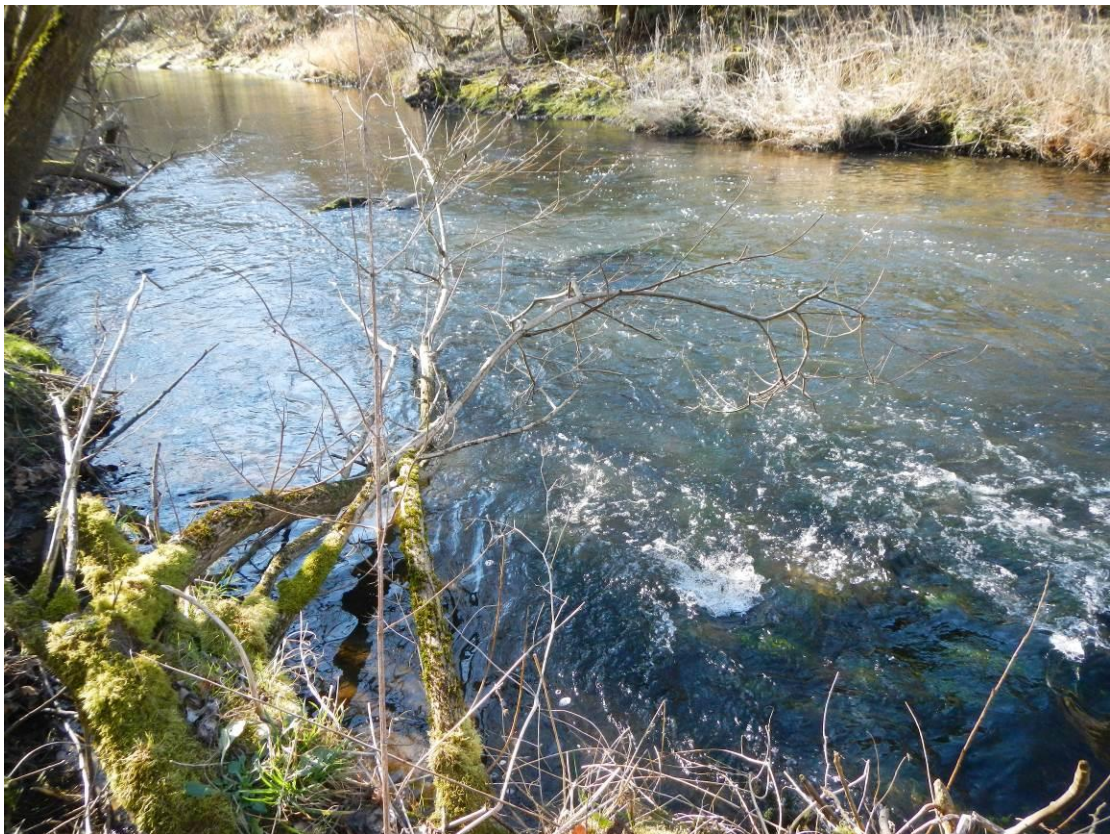
**Photograph 12. Deeper water with overhanging cover is ideal habitat for larger trout.**

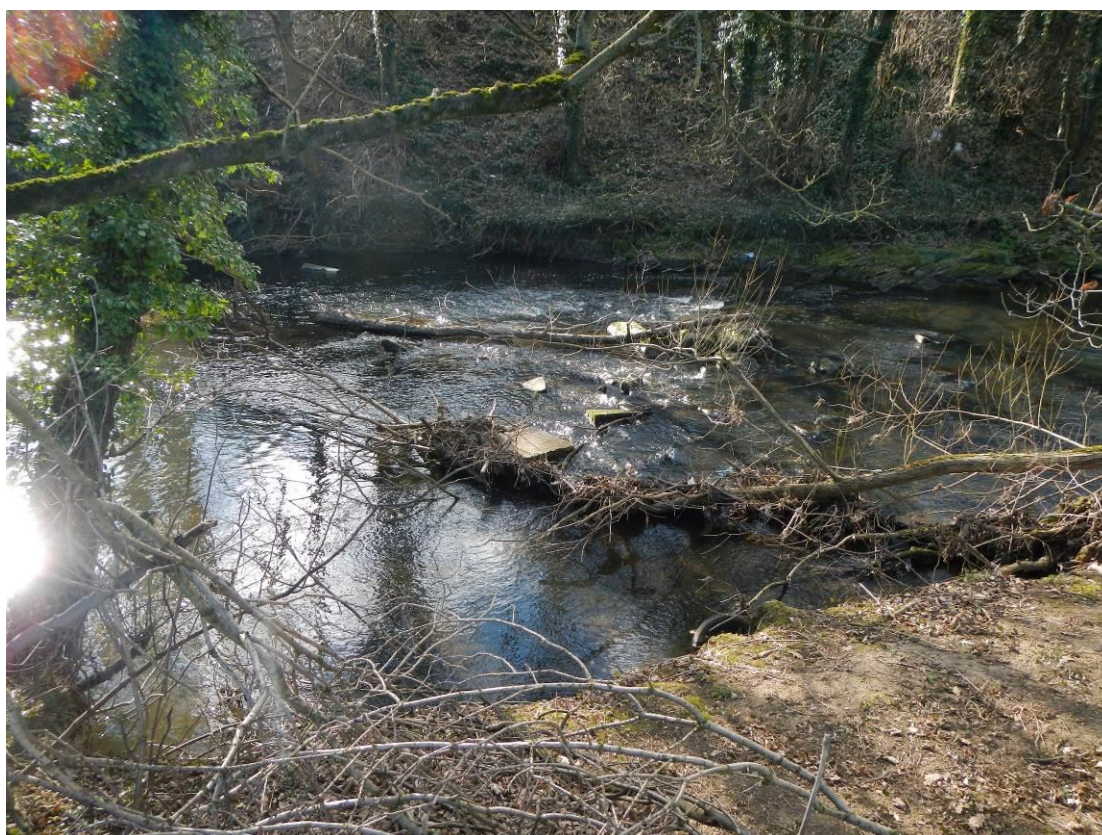
Large Woody Debris towards the upper end of the section provides valuable cover, flow disturbance and shelter, greatly enhancing habitat locally (Photo. 13). It can be understood why, historically, in-channel features such as these may have been removed (often as EA flood prevention measures), in an attempt to 'tidy' the river and remove blockages. However, where flooding is not an issue, the massive benefit to habitat far outweighs the unsightliness of a bit of debris and rubbish which may accumulate around the structure. Time and again, surveys have shown greatly increased numbers of fish and invertebrates inhabiting an area after the accumulation or installation of such structures.

**Photograph 13. Highly beneficial LWD provided by a naturally collapsed willow lying into the channel (foreground) and a log (background). Note the focussed, accelerated flow in the centre of the channel and slower sheltered water in the foreground.**

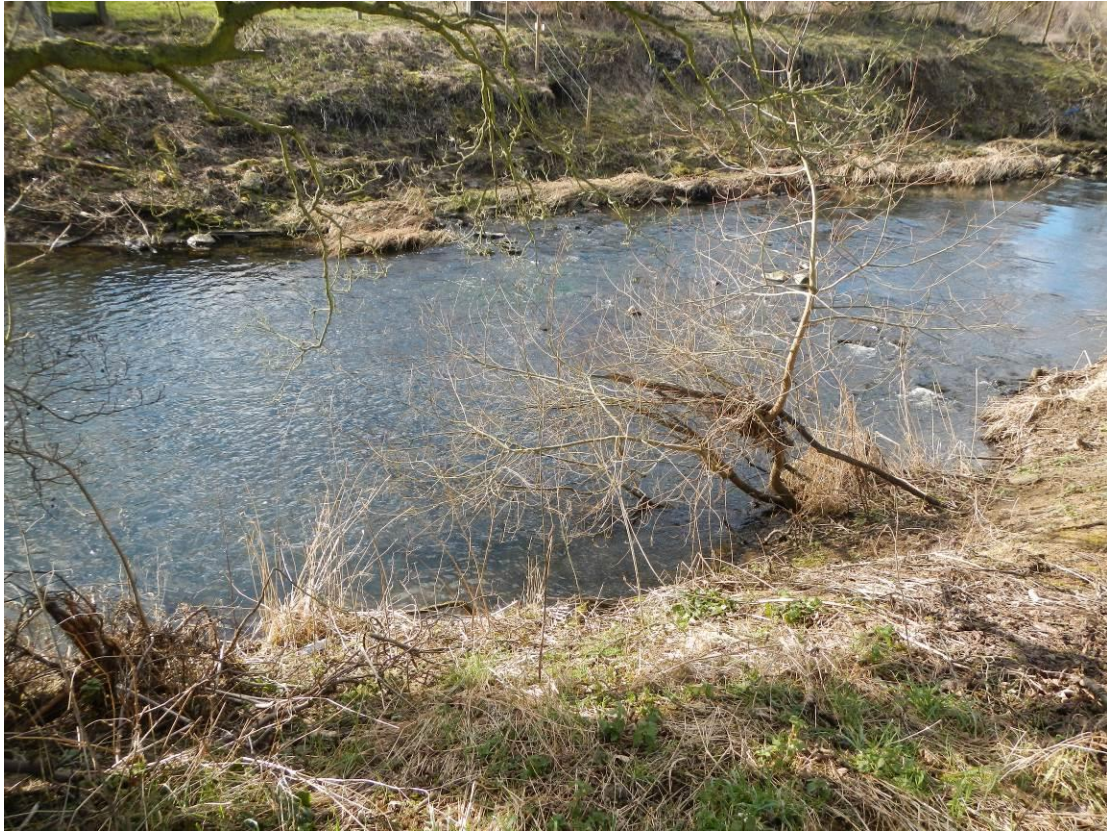
Small self-set willow shrubs also provide valuable, natural channel narrowing, as evident in Photo. 14, where accumulation and consolidation of sediment around the base is forming a new bankline. This will, again, increase flow velocities within the channel, cleaning and grading/sorting the substrate. The added cover and structure in the margin is also a great fish lie.

**Photograph 14. Self-set willow, encouraging natural channel narrowing. The extent of narrowing that will occur is dependent upon the river flows experienced, with high flows scouring and maintain the channel width required.**

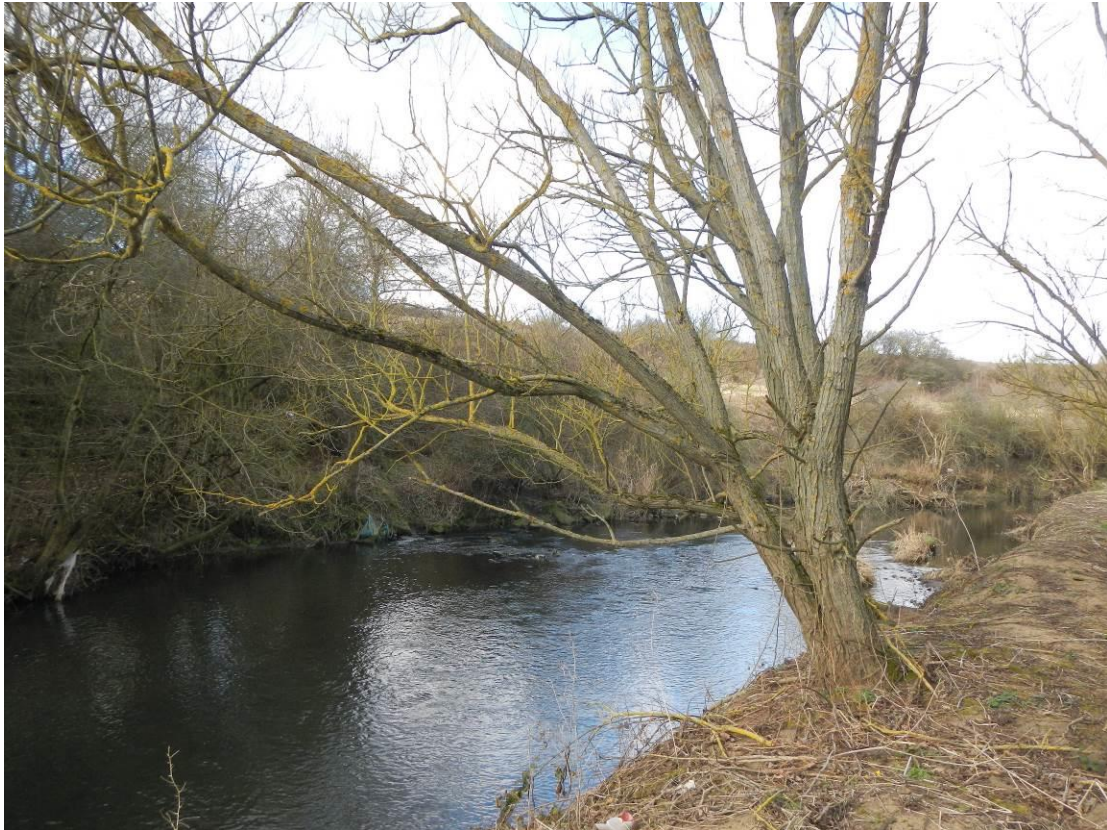
**Photograph 16. Medium-sized willow tree is ideally suited for laying into the river margin.**

The valuable LWD habitat and fallen willows can be easily replicated to optimise habitat within the reach and this treatment would be suitable in many locations observed during the visit, such as that in Photo 16. This tree could be easily laid into the river margin by hinging it within 400-500mm from its base. The limb could also be cabled to its stump for extra security, if required.

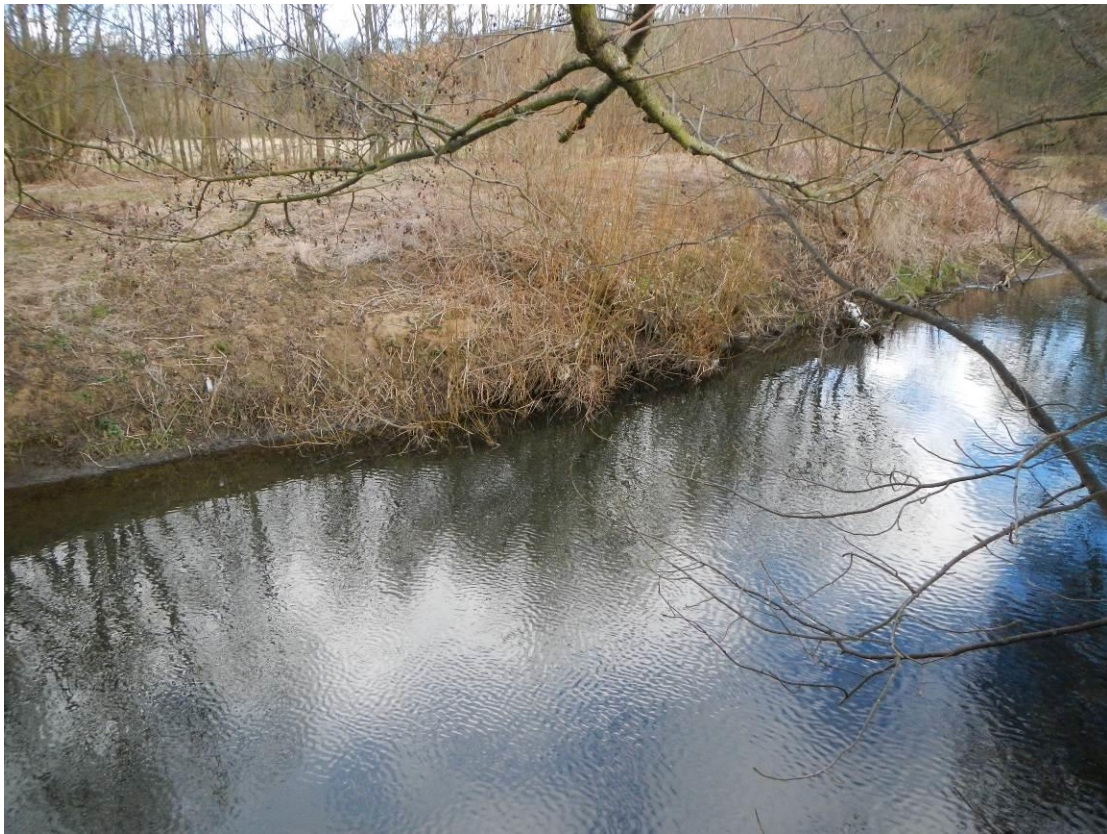
Towards the very upstream extent of the reach visited, a deep, straight channel section with slow flow provides some good adult trout and migratory salmonid holding water, but is generally lacking cover and flow diversity (Photo. 17). Small willow shrubs, sycamore (*Acer pseudoplatanus*) and alders along the margin do provide some enhancement.

**Photograph 17. Willow and other bankside trees provide some cover along a pool that is generally lacking in cover and flow diversity.**

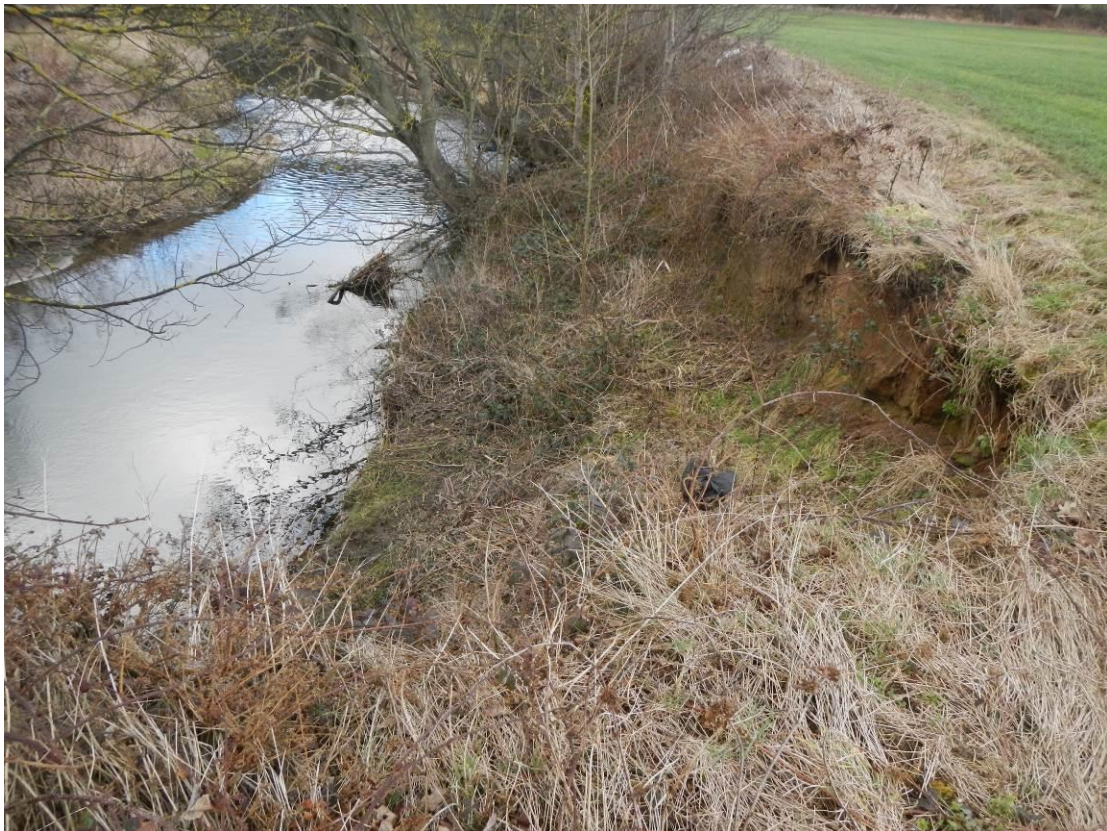
In this area, a large area of slumped riverbank was also observed (Photo. 18). This is likely to be the result of undercutting on the outside of the bend causing the bank to collapse. The slumped material appears to have remained relatively stable due to the vegetation cover and associated root matrix within the soil, and it should remain that way. The area could be further protected by planting willow whips within the slumped material to increase the root matrix within the soil.

**Photograph 18. Area of slumped bank that may benefit from willow whip planting to increase stability.**

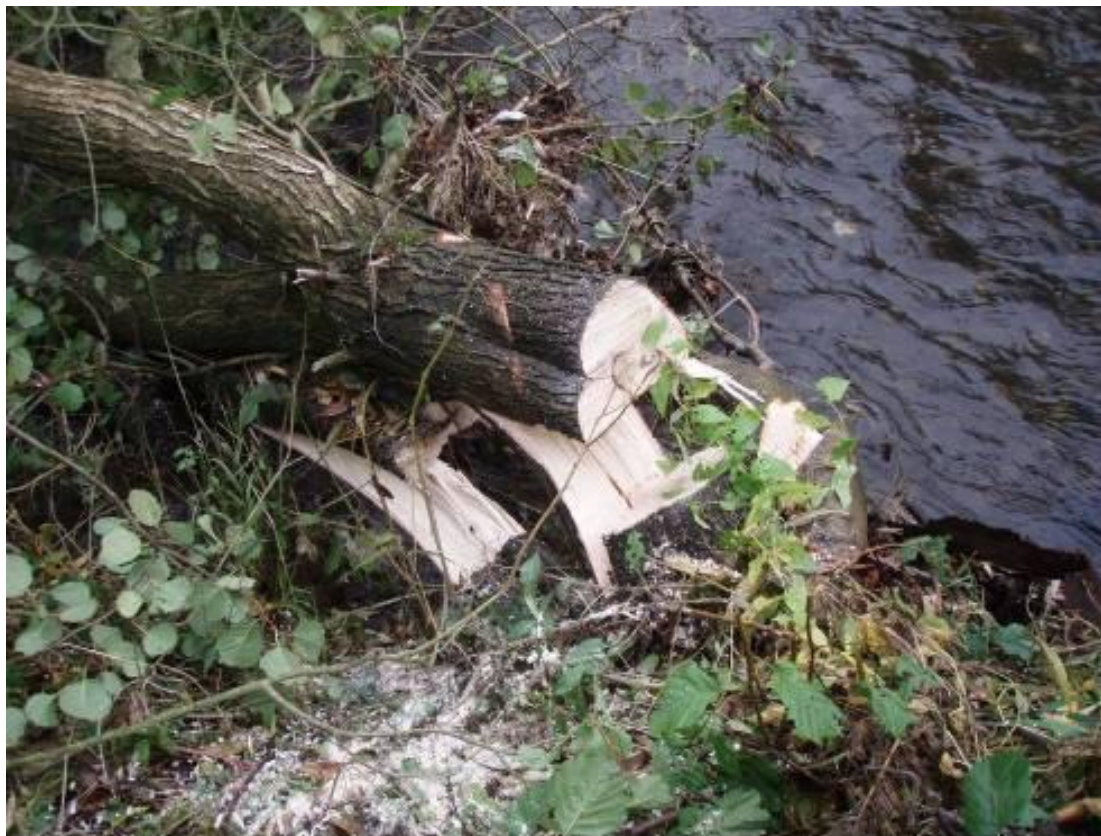
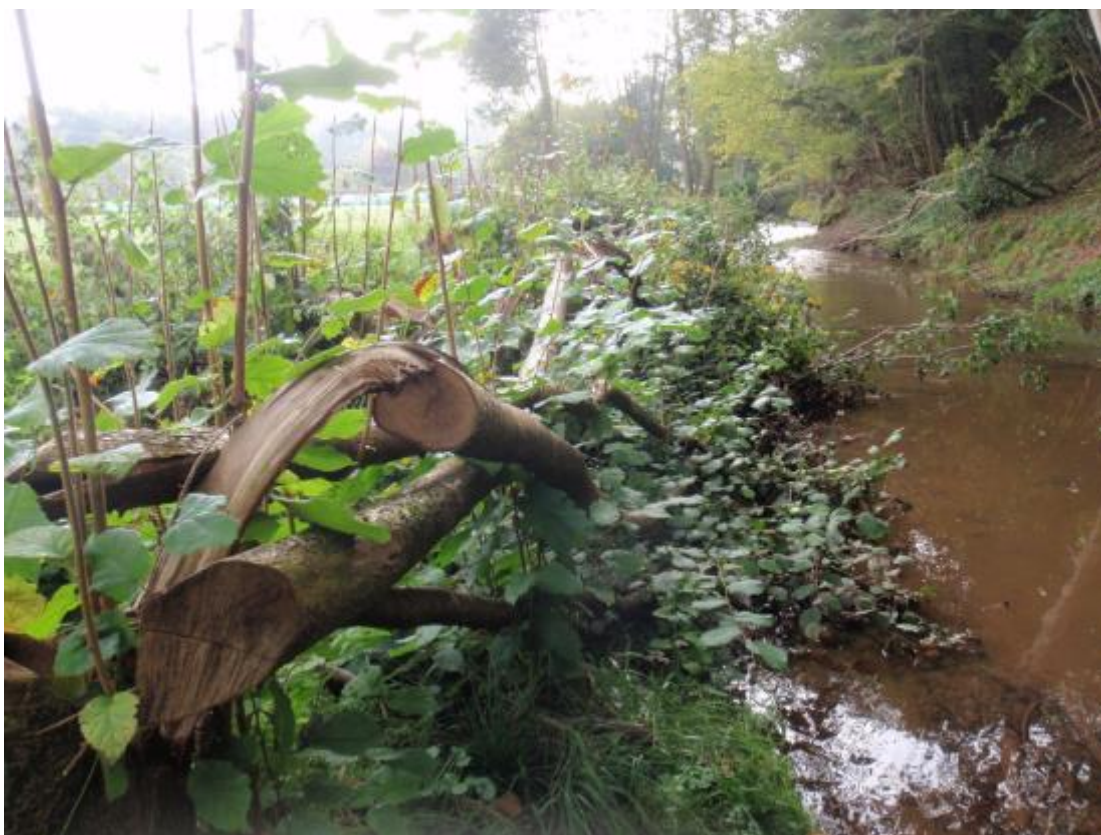
**Photograph 19. Hinged willow.**

**Photograph 20. Hinged hazel.**

The process involves cutting part way through the stem/trunk, a bit at a time (like laying a hawthorn hedge), until it can be forced over into the channel (Figures 19 & 20). The depth of the cut should be limited to that which is required to bend the limb over, to retain maximum strength and health of the tree/shrub.

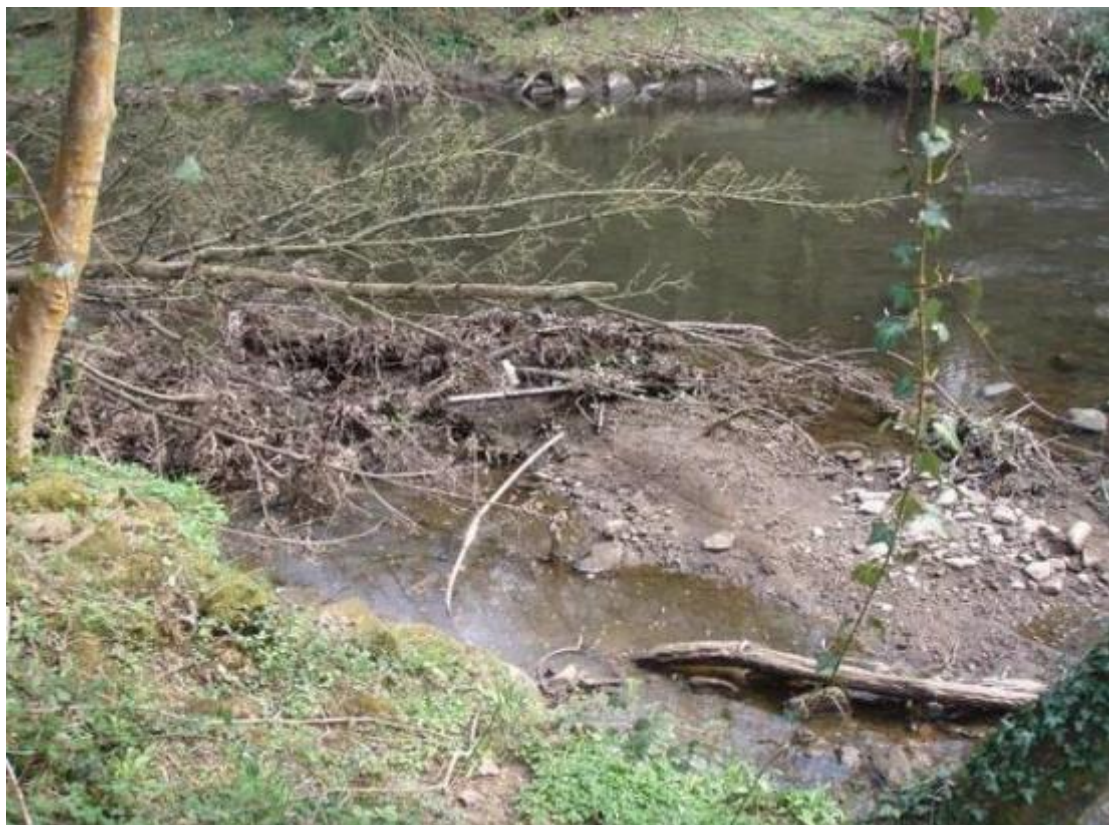
**Photograph 21. Note the narrowing effect through significant sediment accumulation (foreground centre and right of shot) in the sheltered area downstream of the tree kicker.**

The introduction of additional LWD and structures like tree kickers (live and dead) into the channel can also be used to encourage new areas of scour and deposition. Such structures can also help to concentrate flows in certain areas of the channel (usually towards the centre), and scour deeper pool habitat, while also creating slacker areas within the margins where deposition will increase (Photo. 21). The method simply involves cabling the trunk of a coppiced tree to its own stump (Photos. 22 & 23). (N.B. - This technique will require a Flood Defence Consent from the Environment Agency).

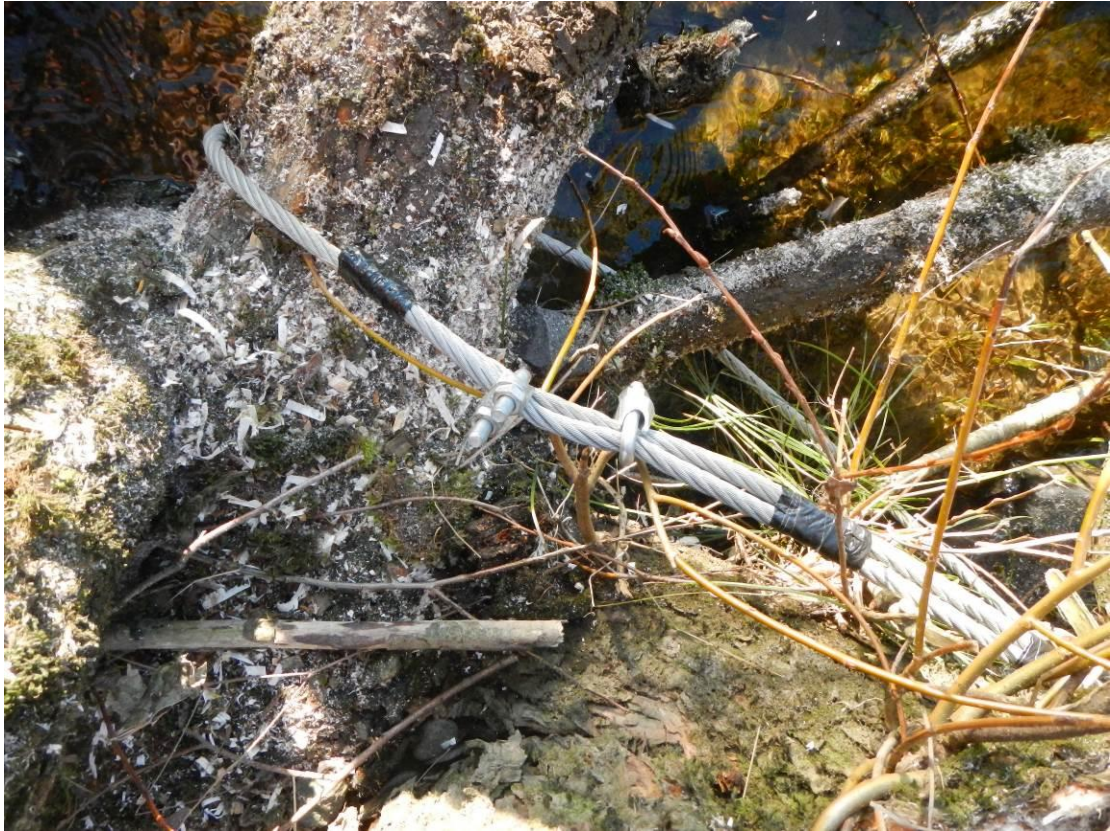
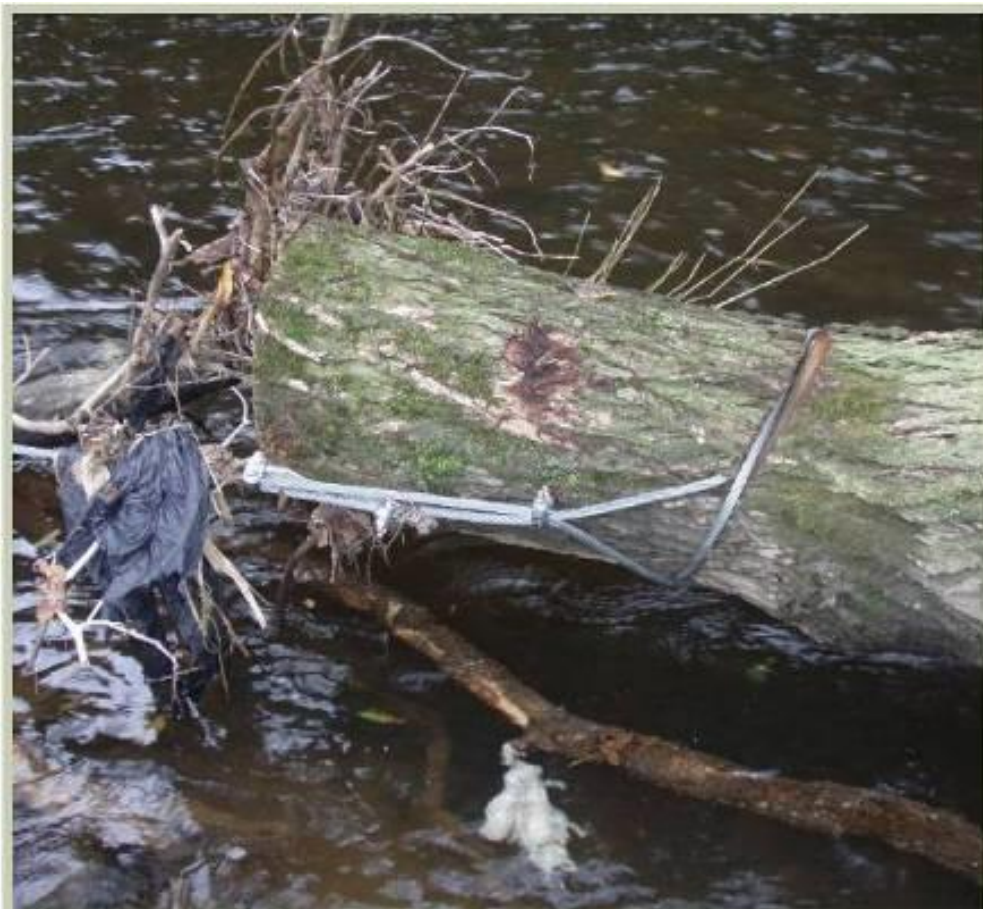
**Photograph 22. Stump cabling for a tree kicker.**

**Photograph 23. Trunk cabling for a tree kicker.**
