Advisory Visit to the River Cole, Sparkhill (Birmingham)

22nd November, 2014

1.0 Introduction

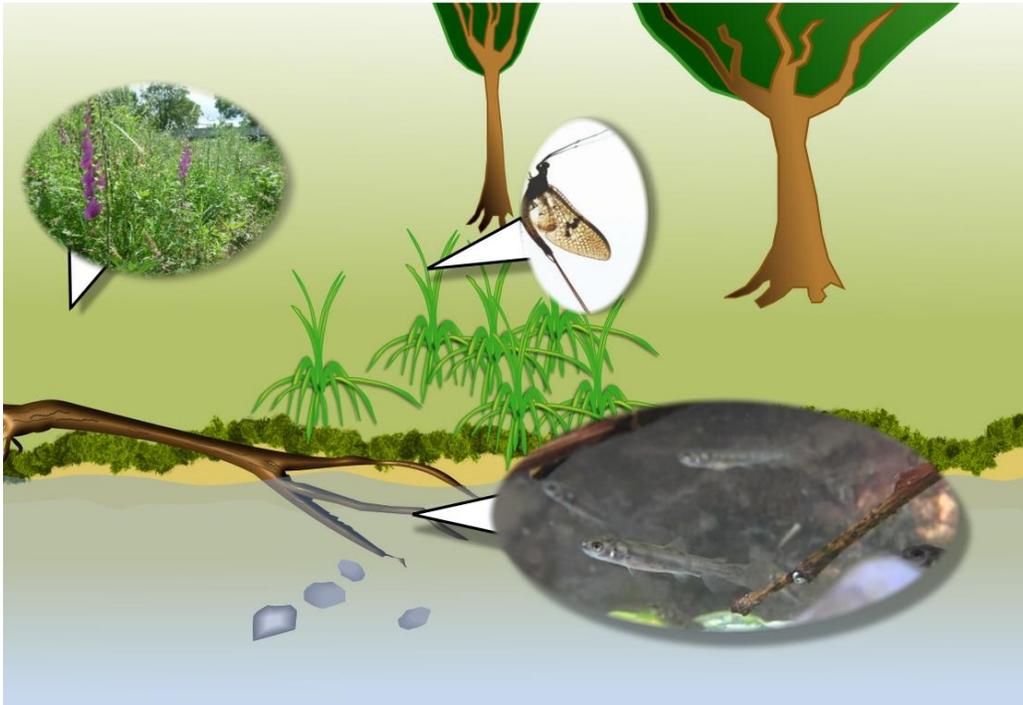
Figure 2: Larger cobbles and submerged “brashy” cover and/or exposed fronds of tree roots provide vital cover from predation and spate flows to tiny juvenile fish in shallower water (<30cm deep). Trailing overhanging vegetation also provides a similar function and diverse bank-side vegetation has many benefits for invertebrate populations (some of which will provide a ready food supply for the juvenile fish).

- In addition to cabled tree limbs/crowns, some areas (such as those pictured in Fig. 20) provide good opportunities to “lay” or “hinge” bankside sapling and scrub growth down so that it trails in the water – providing some of the ideal juvenile habitat illustrated in Figs. 2 & 21

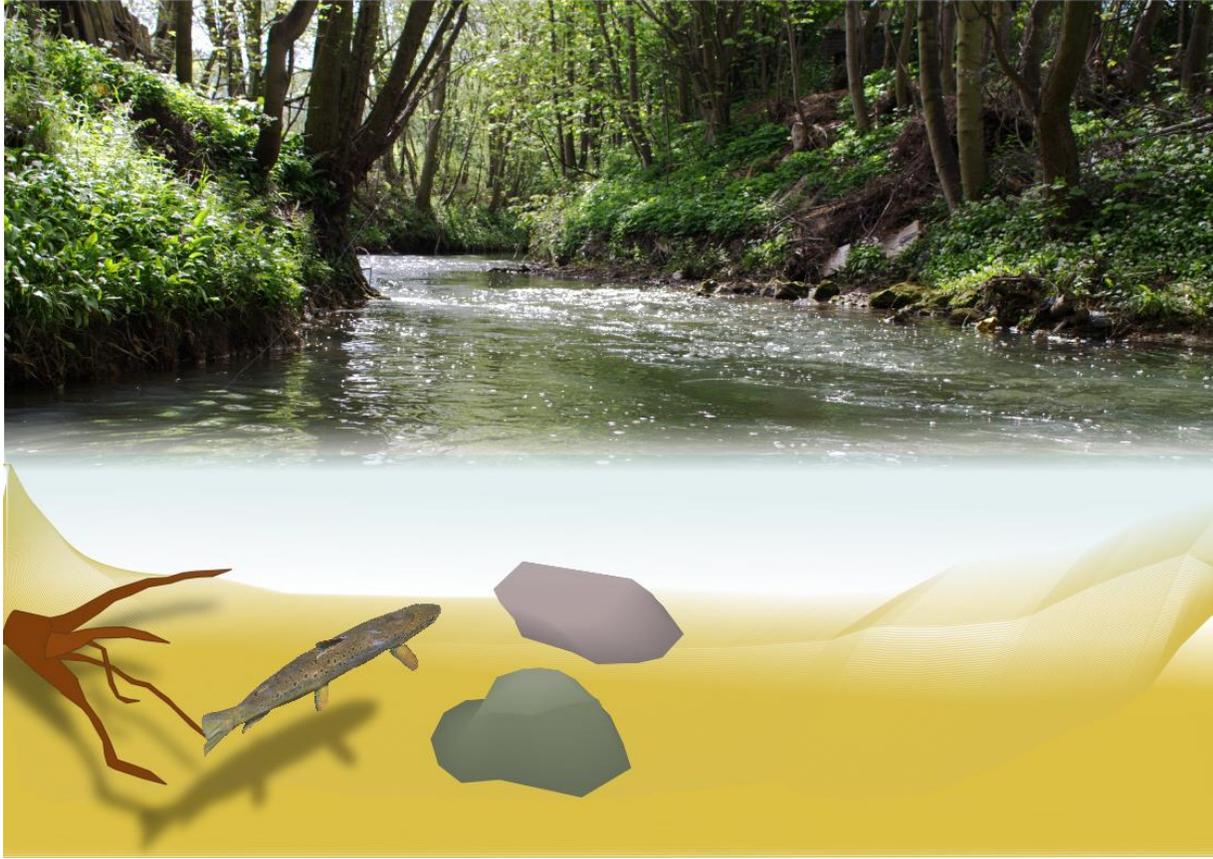
Figure 3: The availability of deeper water bolt holes (>30cm to several metres), low overhanging cover and larger submerged structures such as boulders, fallen trees, large root-wads etc. close to a good food supply (e.g. below a riffle in this case) are all strong components of adult trout habitat requirements.

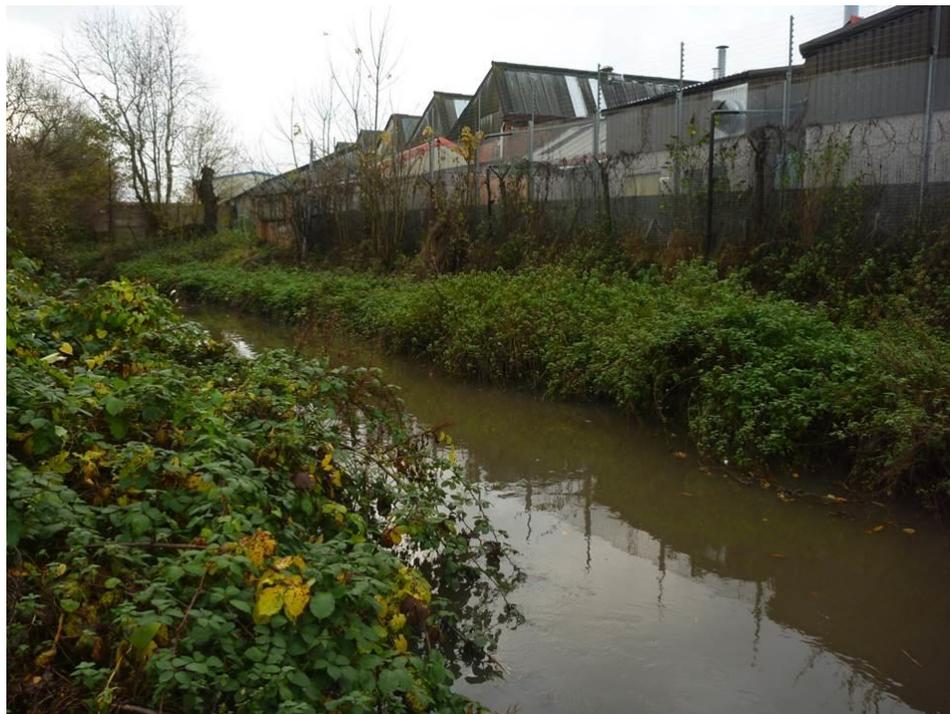
Progressing upstream from the lower limit visited on this occasion (National Grid Reference SP 09843 83663) the first observation to make is the notable artificial straightening of the channel (Fig. 5). Throughout the visit the river level was relatively high as a result of heavy prior rainfall, so some features of the riverbed were not possible to observe closely (although a previous Advisory Visit report, available on request, considering reaches of the Cole both up and downstream on the same river gives relevant clues).

There was quite good marginal overhead cover provided by the shaggy growth of bank-side plants (predominantly brambles) – but a general lack of diversity in flow depth and pace due to the straightened nature of the channel (Fig. 5). The overall value of the bank-side cover could possibly be

Figure 5: Artificially straight channel but with dense (low-level) overhead/trailing cover provided primarily by dense brambles. Submerged structural cover would increase the value of this section to adult fish and a more diverse flora would benefit associated invertebrate communities.

enhanced by some management of the bramble patches to allow other native species to also colonise.

- On a similar theme to above, maintaining a diverse “patchy” distribution of brambles by cutting back the centres of the thickest stands (if suitable equipment and operators are available)

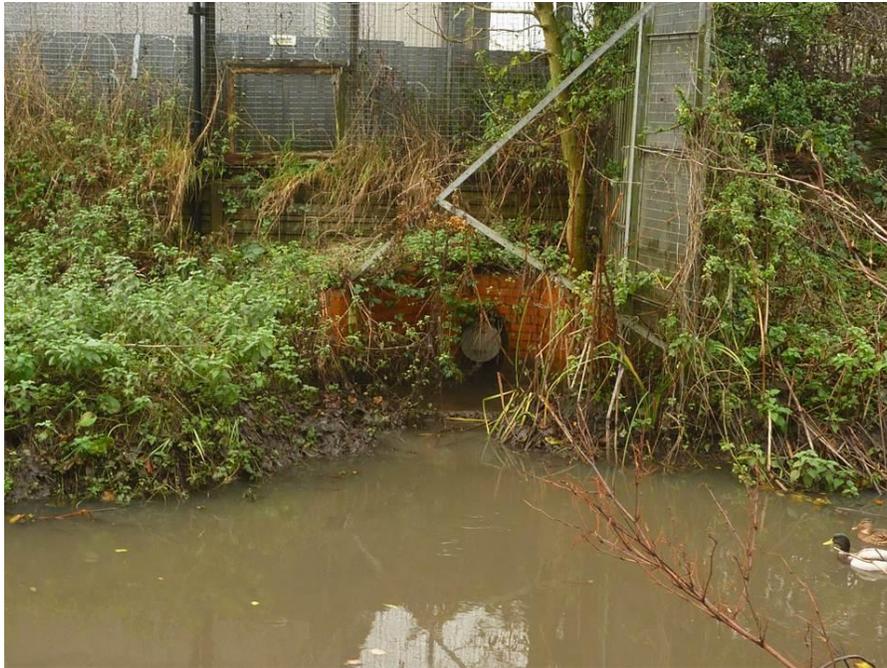
The presence of surface water drainage outfalls from a variety of apparently industrial properties (e.g. Fig. 6) provides a visual reminder of the ever-present risks to water quality due to accidental spillages of chemicals (or misconnections) in almost all urban watercourses (see <http://www.connectright.org.uk/> for more information). Consequently, there can be great benefit to undertaking monitoring of pollution-sensitive aquatic fauna as a means of detecting and tackling pollution (see section 4: Recommendations).

Figure 6: Surface water drainage outfall

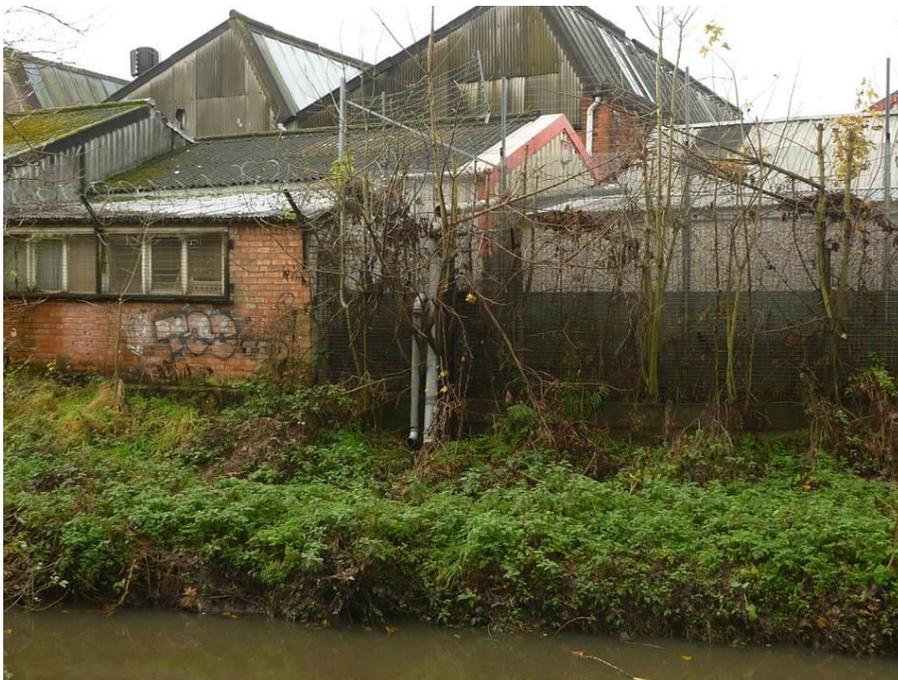
More difficult issues that arise from urban drainage arise from the large areas of pavement/relatively impervious surfaces that include roof drainage systems (e.g. Fig. 7). The lack of opportunity for rainfall to soak into the ground before percolating either to the groundwater or into river systems leads to extremely rapid rises in river levels. It also reduces the opportunities for pollution to be removed from that water before it enters a watercourse. This is a much broader issue to tackle than the main scope of this report – but there is additional information here and also a call for

Figure 7: Drain pipes at SP 09845 83636 funnelling roof drainage to a single discharge point onto the riverbank (which may provide at least some small opportunity for soakaway and/or removal of pollutants prior to entry into watercourse. This protective effect may be quite limited during heavy downpours.

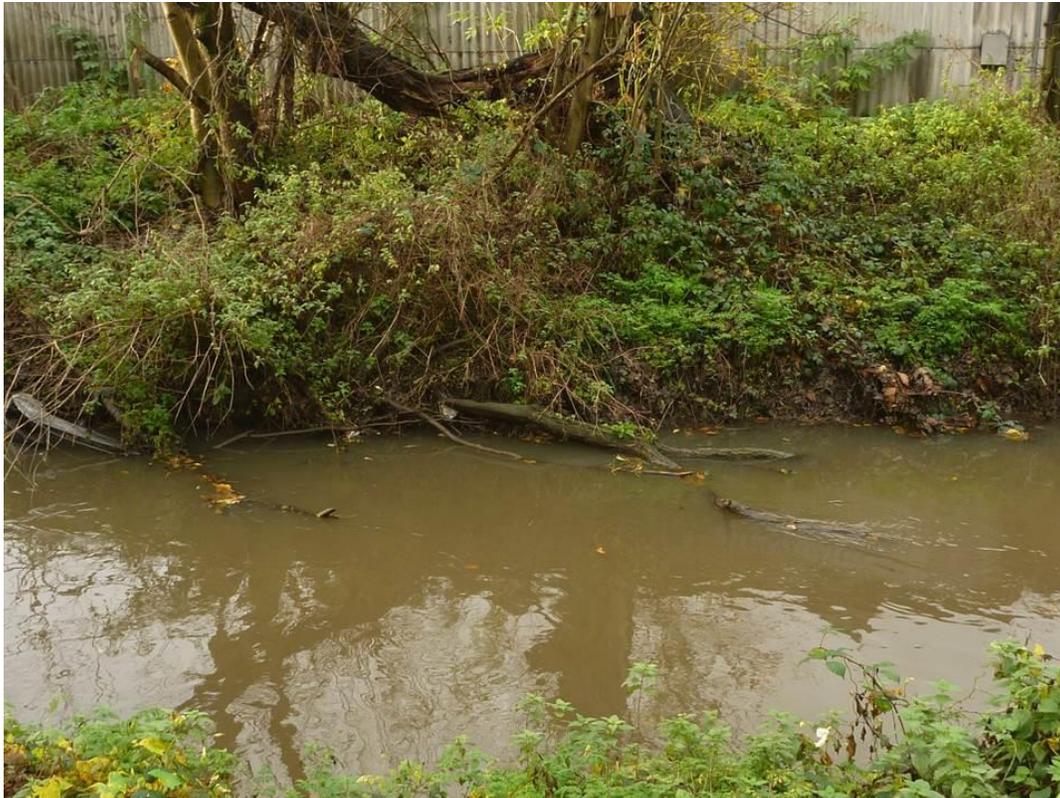
Approximately 10 m upstream of the photographed roof-drainage pipes there was a nice example of in-stream cover generated by fallen dead wood (Fig. 8).

Figure 8: Good quality submerged cover formed by fallen wood. This effect can be augmented by deliberate introduction of comparable woody material and using secure anchoring techniques to stabilise introduced material

- Where opportunities exist – to securely cable suitable woody debris to existing tree root masses in the margins of the river to increase available cover for juvenile and adult fish (an example is shown in the video on the following link – but note that these structures can be scaled to ensure that they are appropriately-sized to each individual river channel: <https://vimeo.com/72720550>).

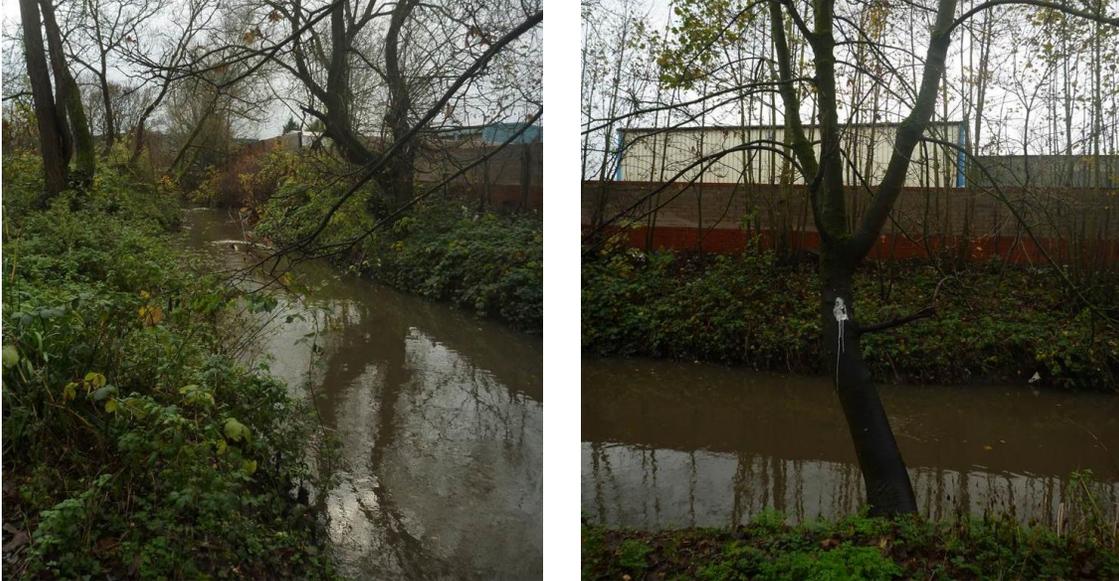
A section with greater variation in the riverbed profile was evident around SP 09860 83577 (Fig. 9) and also included the opportunity to use non-native sycamore as a source of securely-anchored submerged cover (Fig. 10). As well as the benefits of cover to adult fish, there is also potential for such material to help to “grade” gravels in the stream bed into mounds made up of particles suitable for trout spawning (as illustrated in Fig. 1).

Figure 9: Section with greater variation in understory vegetation species and more varied riverbed profile (left) as well as the opportunity to augment the currently very sparse in-stream woody material by using material arising from non-native sycamore (right). Photos both taken from SP 09860 83577

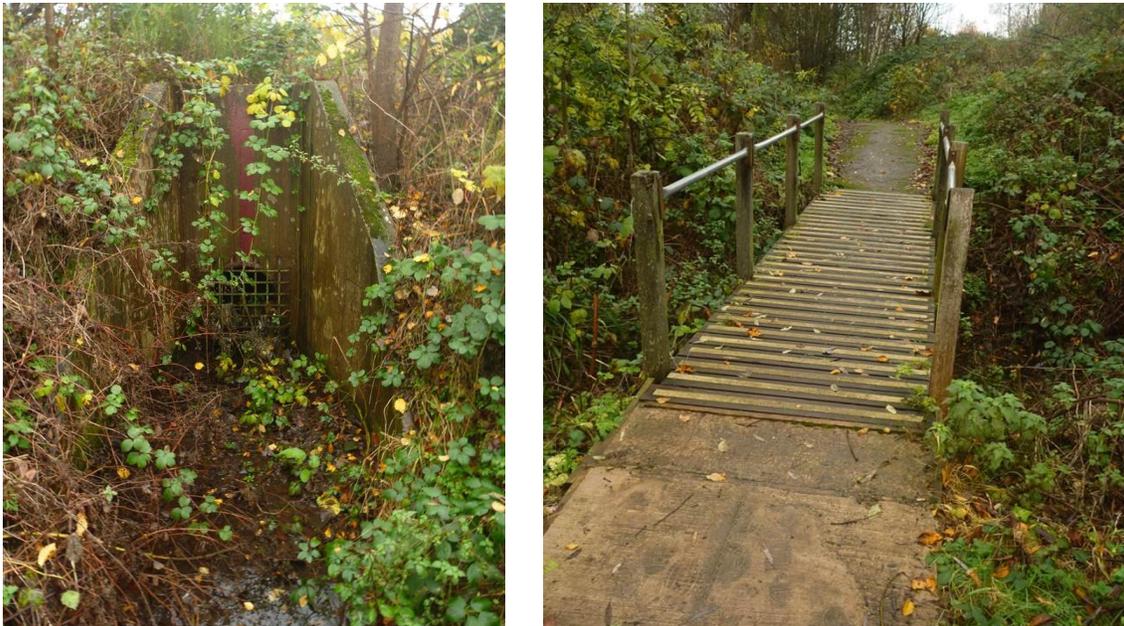
Just upstream at SP09858 83539 there was a combined sewer outfall (“CSO” which under normal conditions carries and discharges relatively clean surface water but also has the capacity for foul-sewer discharge under heavy rainfall). Depending on maintenance and also the proportion of misconnections to these systems, they can represent a significant source of pollution to surface watercourses (i.e. rivers and streams).

Figure 10: Combined Sewer Outfall (CSO) at SP 09858 83539 (left) sited beneath footbridge (right) that carries the river-side footpath

- Keep an eye on CSO discharges that could be misconnected – and report foul discharges that occur when the river is at low-flow levels. Both the Environment Agency (0800 80 70 60) and local Utilities company (Severn Trent: 024 7771 5000) should be informed of such incidents.

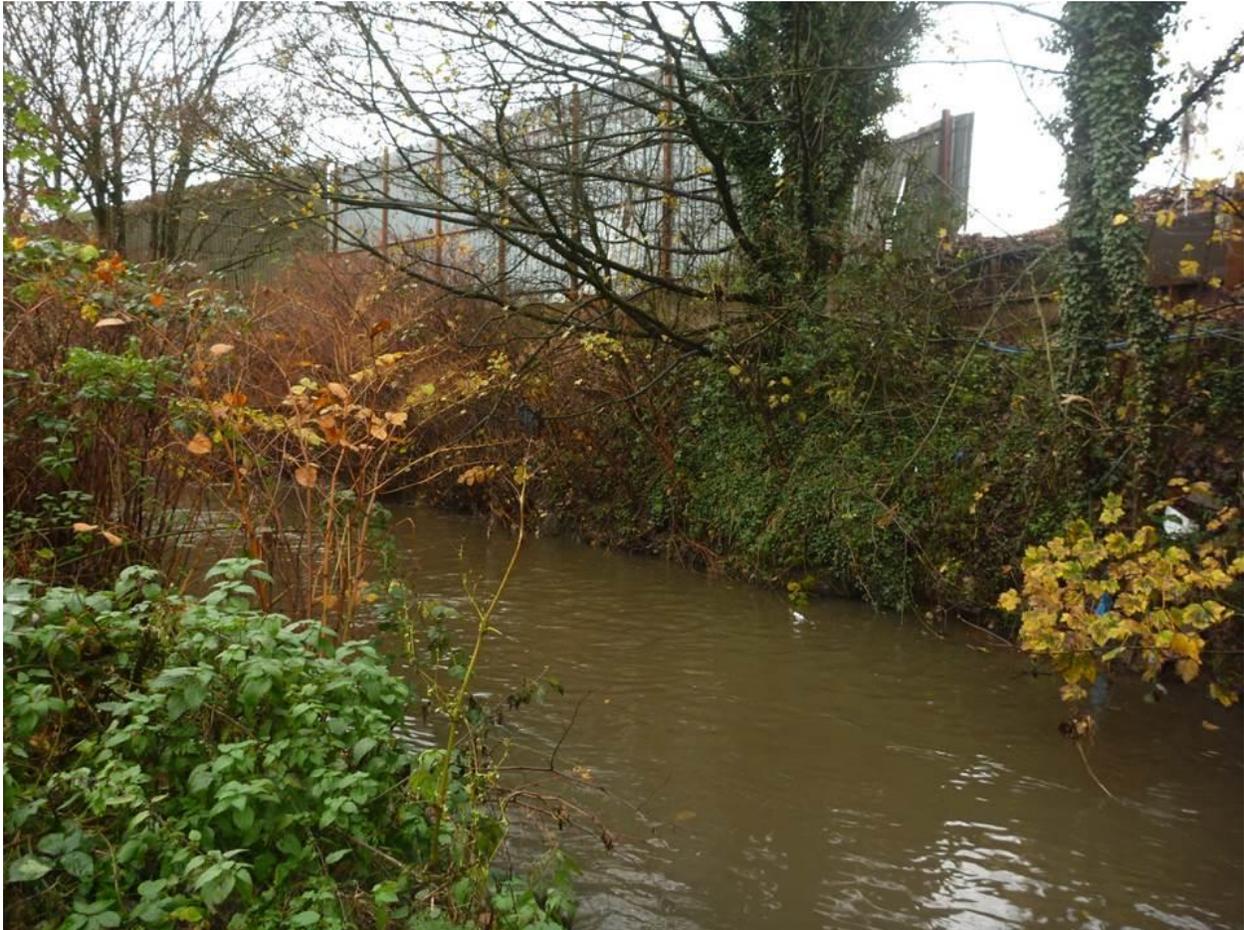
The steep banks evident in the reach photographed at SP 09856 83527 show a risk of unwelcome inputs into the channel from sources such as the rubble pile that is breaching the fencing at this location (Fig. 11). It would be desirable for local Council and Environment Agency representatives to help

Figure 11: Steep-sided opposite bank at SP 09856 83527 with fencing panels being breached by collapsing rubble pile (and associated litter inputs)

site operators/owners to establish better control of accidental collapse/release of materials from such sites.

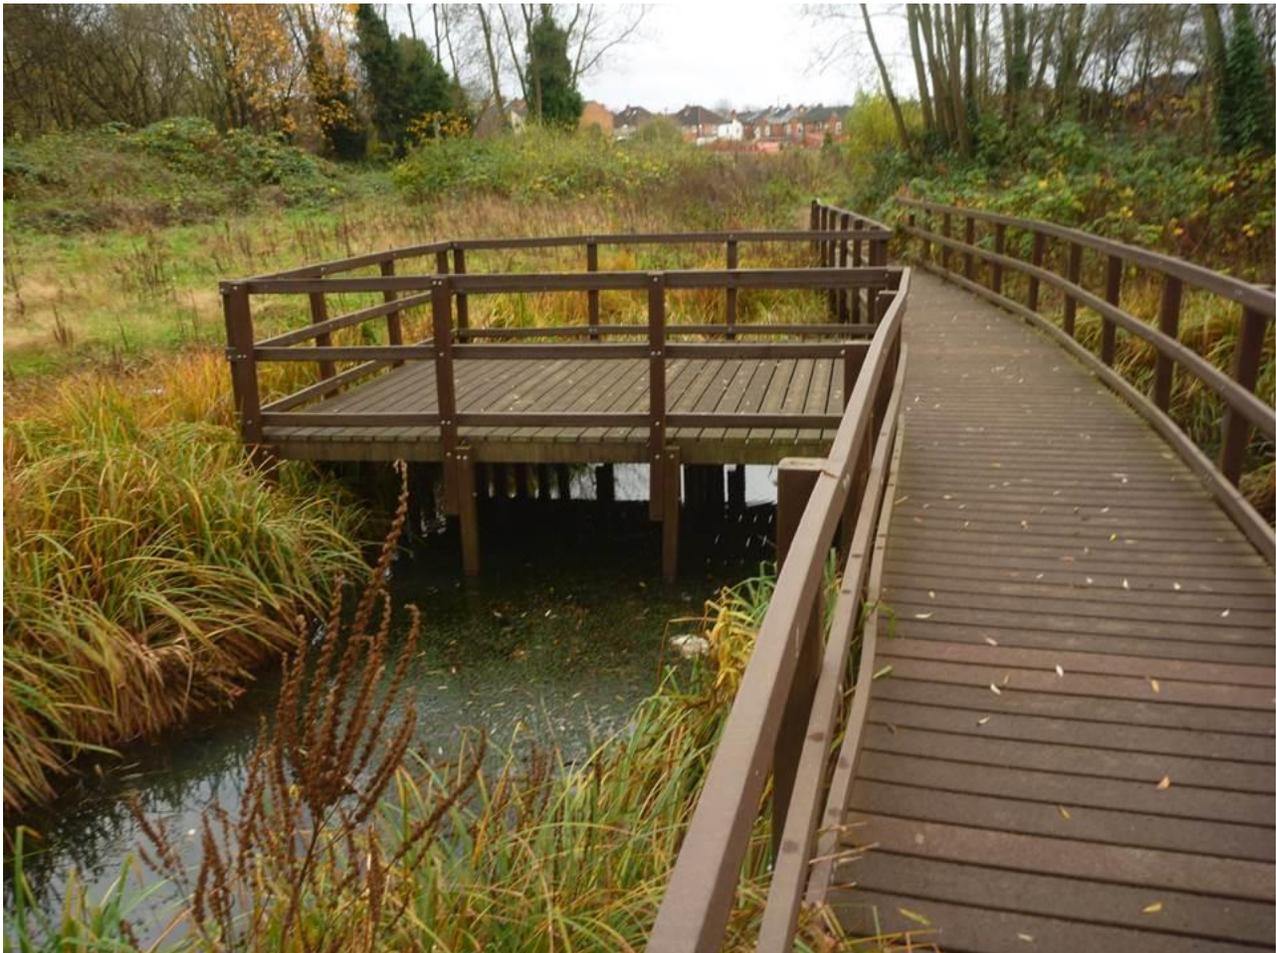
Although reported during the visit to be smaller than originally planned due to the line taken by a gas main through the site, there is a valuable wetland scrape that has been created and periodically connected at its upstream end (during high flows) to the main river channel (Figs. 12 and 13). Waterside Care members are concerned that the large growth of weed (and possibly algae) during summer months could be tackled by connecting the scrape at both upstream *and* downstream ends to provide a sweetening flow. This could, potentially be beneficial; although this will critically depend on the water in the river being “cleaner” than that which seeps into the scrape currently from the surrounding land (the likely source of the nutrients which support the vigorous aquatic plant growth especially during hot summer months). *Topographical surveys would also be required to determine*

Figure 12: Elevated walkway platforms giving sustainable access to the wetland scrape (and associated wetland plants). This is a valuable addition to biodiversity in the flood plain and also may provide a degree of flood water storage that could help to reduce potential flooding of properties and infrastructure downstream. It is currently uncertain whether increasing the ease and frequency of exchange of water between wetland and main river would result in benefits to flora and fauna in the wetland. If water quality was found to be good enough, there may be a benefit to increasing the ease with which fish can enter/exit the pond such that it functions as a refuge during spate-flow conditions in the main river.

whether there is sufficient vertical head difference between inlet and outlet to generate a flow through the pond. Currently the scrape is providing additional biodiversity benefits and a degree of increased flood water storage capacity. Adopting some invertebrate monitoring (see section 4: Recommendations) to try to understand the likely nutrient/pollution status of the main river would enable a better judgement of the possible costs/benefits of generating a sweetening flow through the pool (and to establish whether the end results would justify the expense of burying a connecting pipe beneath the footpath.

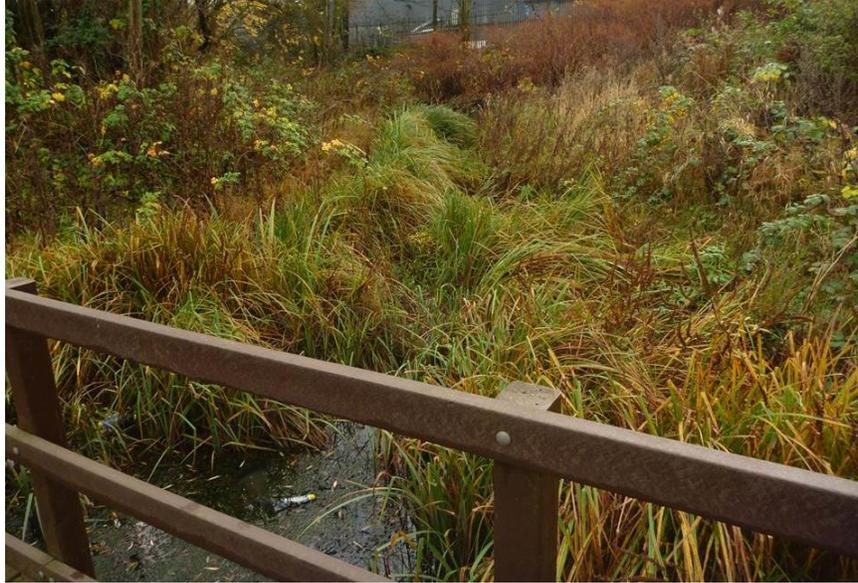
Figure 13: Ephemeral connecting channel between main river and the upstream side of the wetland scrape at SP 09891 83485

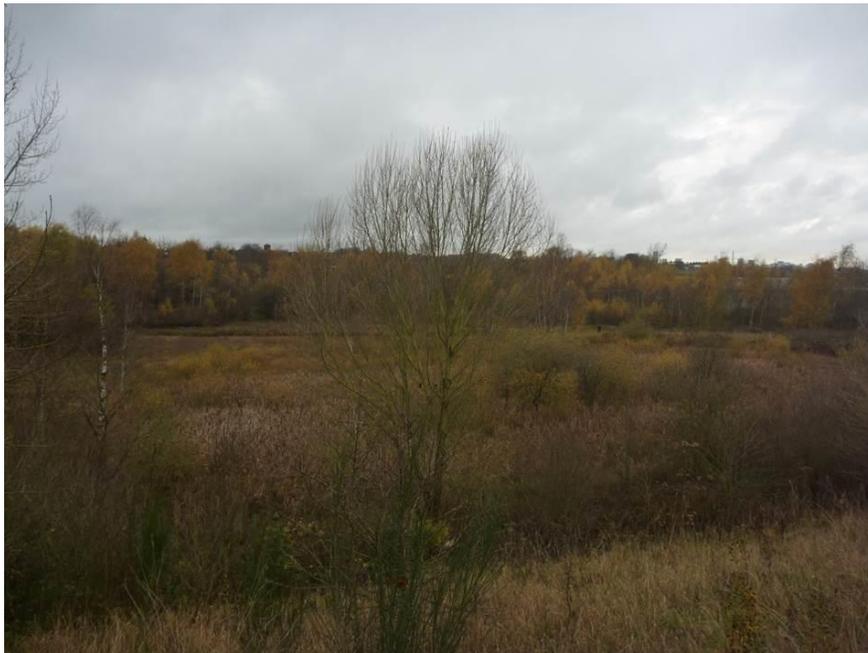
Figure 14: Extensive haven for birds, wetland flora and fauna in urban Birmingham (taken at SP 10032 83610)

Although sited in the middle of an extremely urbanised section of Birmingham, the sheer size of the historic brickworks site that has been reclaimed and re-vegetated has created an impressive nature reserve around the River Cole corridor at this location. An overview of the swamp/heath (Fig. 14) and methane vent for reclaimed buried site (Fig. 15) provide a context for other details and suggestions within this report.

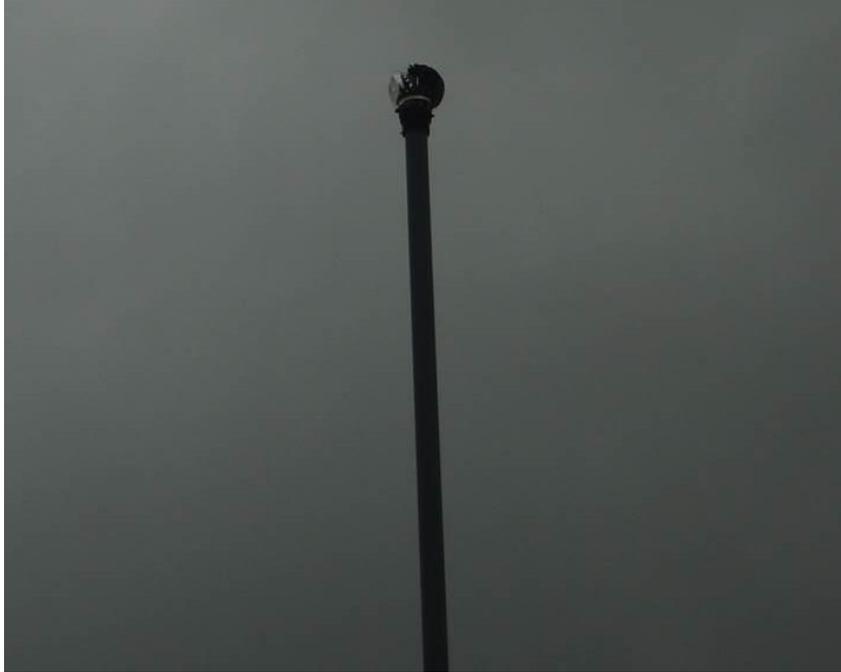
Figure 15: Vent to release gases from buried site standing above entrance to Shire Country Park at SP09959 83723

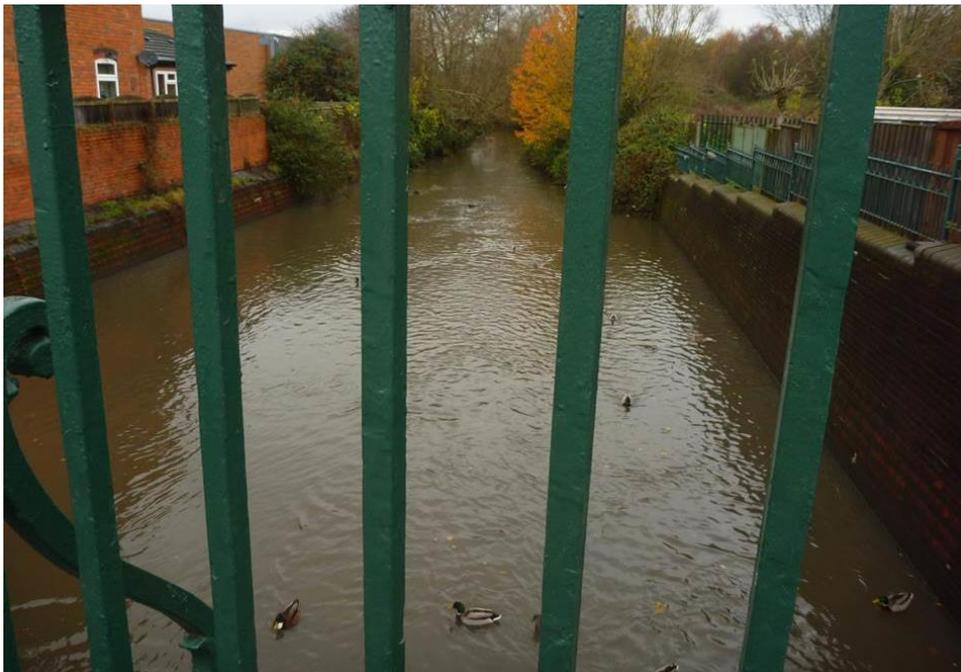
The Bridge on Formans Road is located at SP 09910 83358 (view facing downstream from this bridge; Fig. 16)

Figure 16: Walled channel directly downstream of bridge on Formans Road

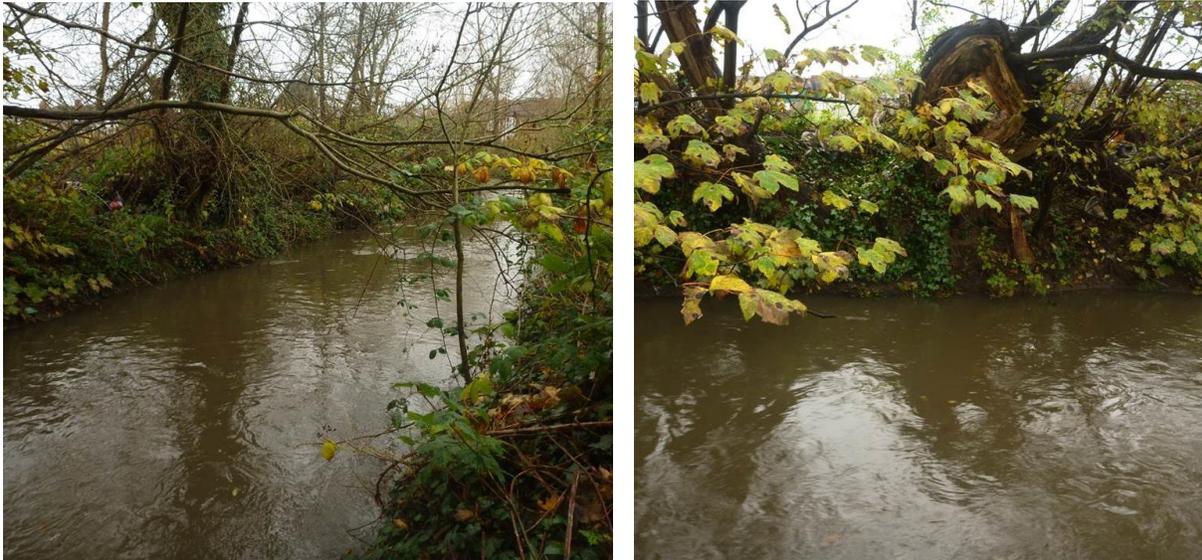
The channel on the Left Bank (LB) above the bridge is bordered by allotments and there are apparent litter problems associated with those that back directly onto the river (Fig. 17). Tree density along the riverbanks is generally greater in the reaches upstream of the bridge – providing ample potential material to be used for in-stream structural enhancements (Fig. 17).

Figure 17: Channel backing onto allotments at SP 09943 83264 - litter issues (L) and increased tree density (R) relative to the majority of the reach below the bridge

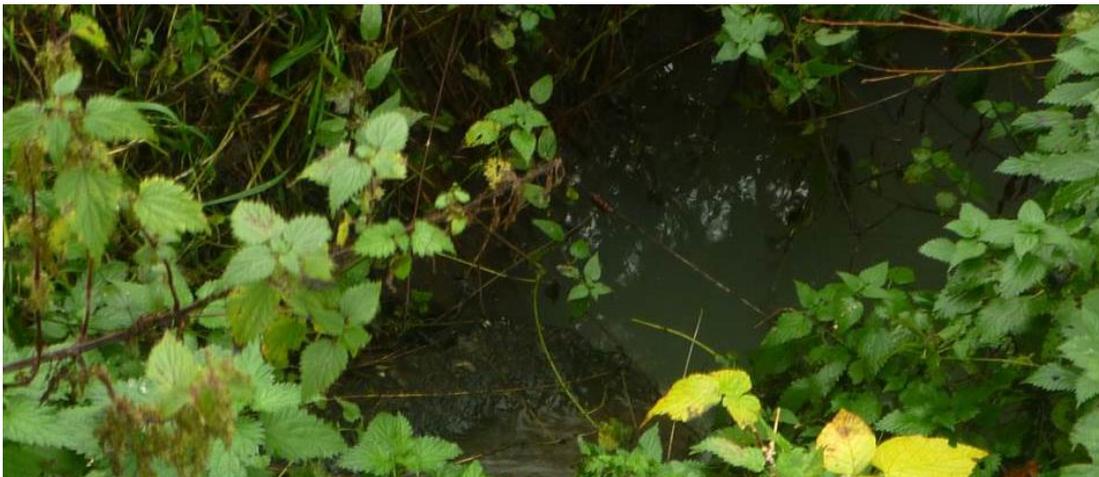
A further outfall at SP 09941 83222 (Fig. 18) may be worth inspecting for possible misconnections (Malcolm Beach reports that there is a 3 °C temperature difference in the reaches below this outfall compared to those above).

Figure 18: Small quantity of grey water issuing under low outfall discharge conditions at SP09941 83222 – a potential indication of blockage or misconnection in the system

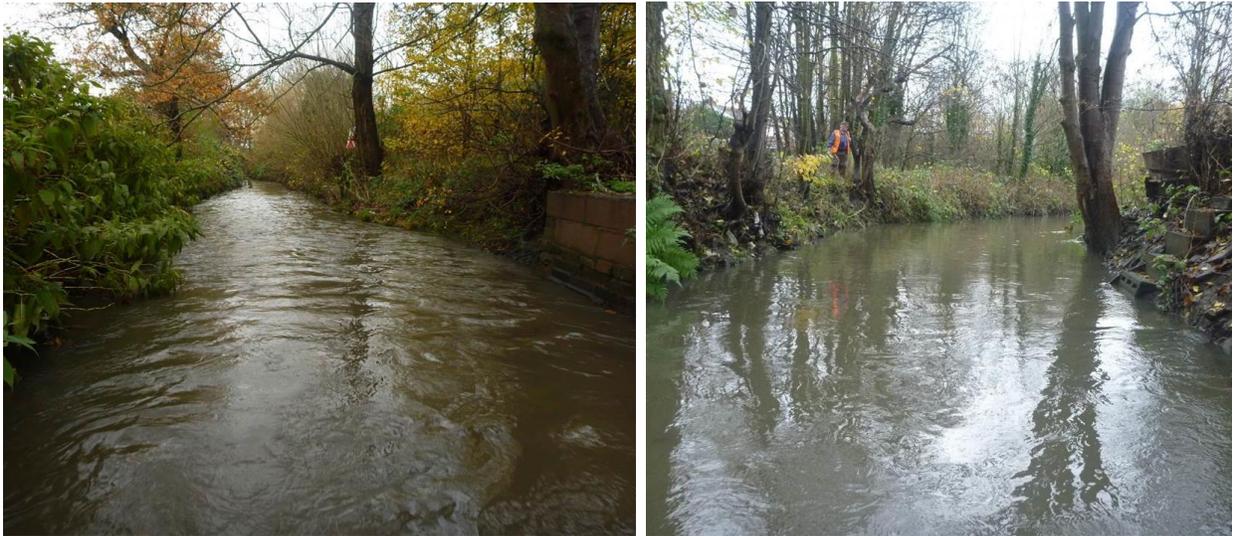
A riffle (gravel and cobble) formed at SP 09970 83097 (Fig.19) may (under future investigation with clearer water) offer an opportunity to improve prospective spawning success. Just upstream of the riffle (Fig. 19), secure installation of suitable woody structure may promote beneficial localised scour and sorting of spawning gravel as illustrated in Fig. 1.

Figure 19: Riffle (L) and the glide just above it (R) at SP 09970 83097 providing valuable variety to riverbed profile. Secure installation of a suitable woody debris structure towards the tail of the glide could significantly improve spawning success for gravel-spawning fish species.

- At suitable location/locations (for instance SP 09970 83097) secure installation of woody structures that would promote localised sorting of riverbed gravels (as illustrated in Fig. 1) could provide valuable opportunities for successful recruitment of gravel-spawning species such as trout. As an example, see structures outlined from 4 minutes and 13 seconds in this online video guide: <https://vimeo.com/32317564>)

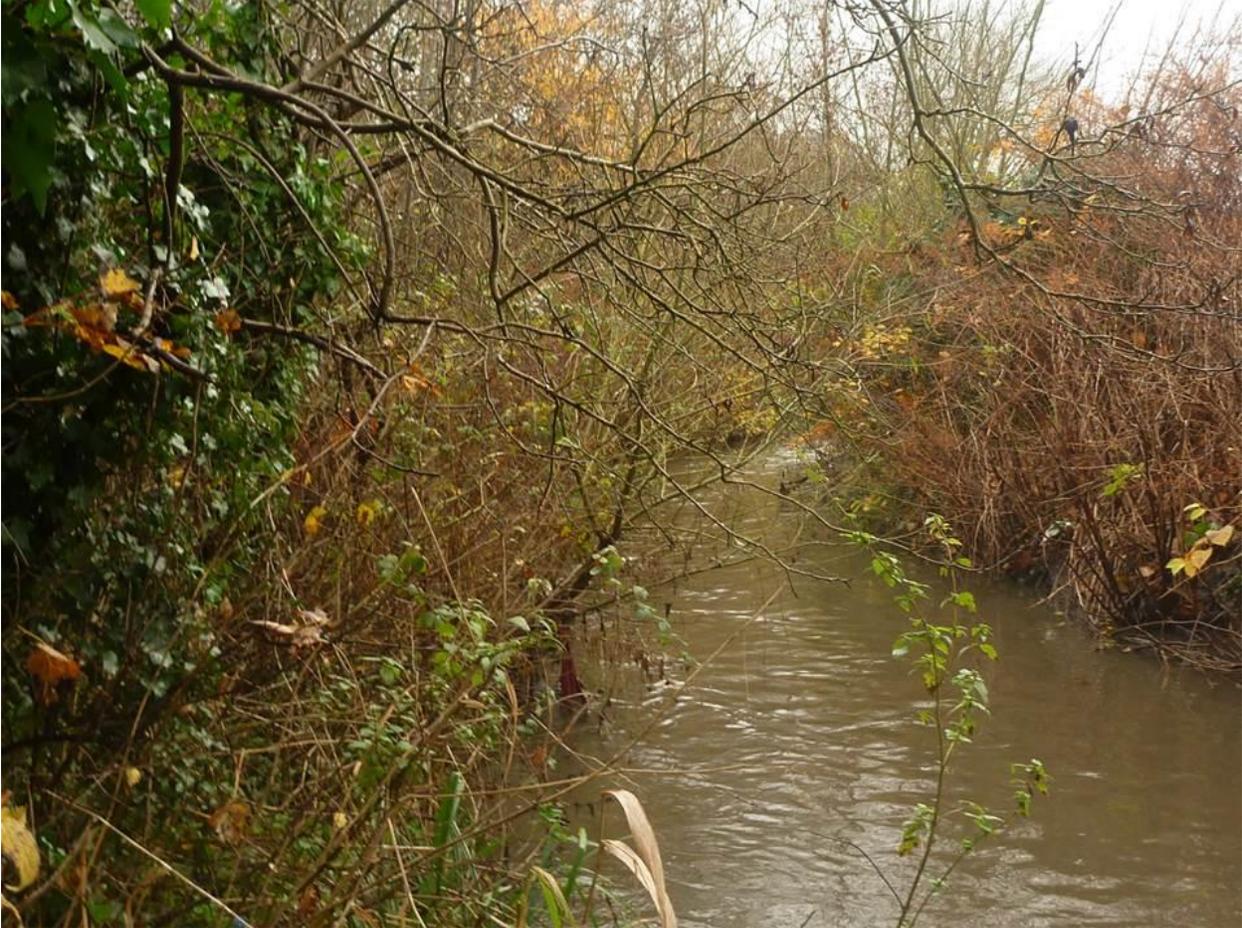
The upstream limit of the river observed around 10-m upstream of SP09976 83081 during this visit consisted of examples of good quality habitat associated with a meandering path of the channel (Fig. 20) as well as some useful cover provided by understory vegetation. The channel meandering was also associated with the formation of another riffle as well as valuable “scour pool” habitat formed as the river carved a deeper slot on the outside of the bend. It is likely that the secure introduction of some submerged, dense “brash” cover in this area of the river would substantially improve the survival prospects of juvenile fish – as well as aiding in the patchy retention of leaf-litter material (along with associated invertebrate communities). More detailed advice on specific measures is given in Section 4.

Figure 20: Probably the best quality river corridor habitat observed during the current visit. Greater structural variety around SP09976 83081 translates into more diverse opportunities for wildlife.

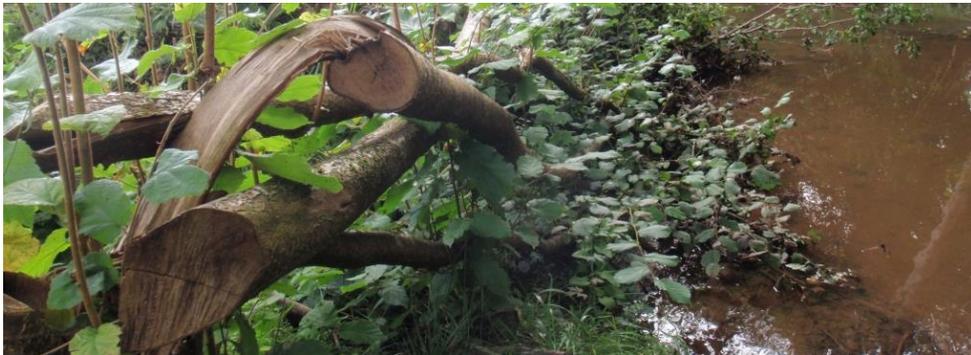
Figure 21: Hinged marginal brush creating cover for juvenile fish
