**Advisory Visit to the River Coquet**

**9<sup>th</sup> April, 2014**

This report is the output of a site visit undertaken by Gareth Pedley of the Wild Trout Trust to the River Coquet on 9<sup>th</sup> April, 2014, at the request of the Northumbrian Anglers Federation (NAF). Comments in this report are based on observations on the day of the site visit and discussions with Mike Dodds and Willy Farndale of the Northumbrian Anglers Federation.

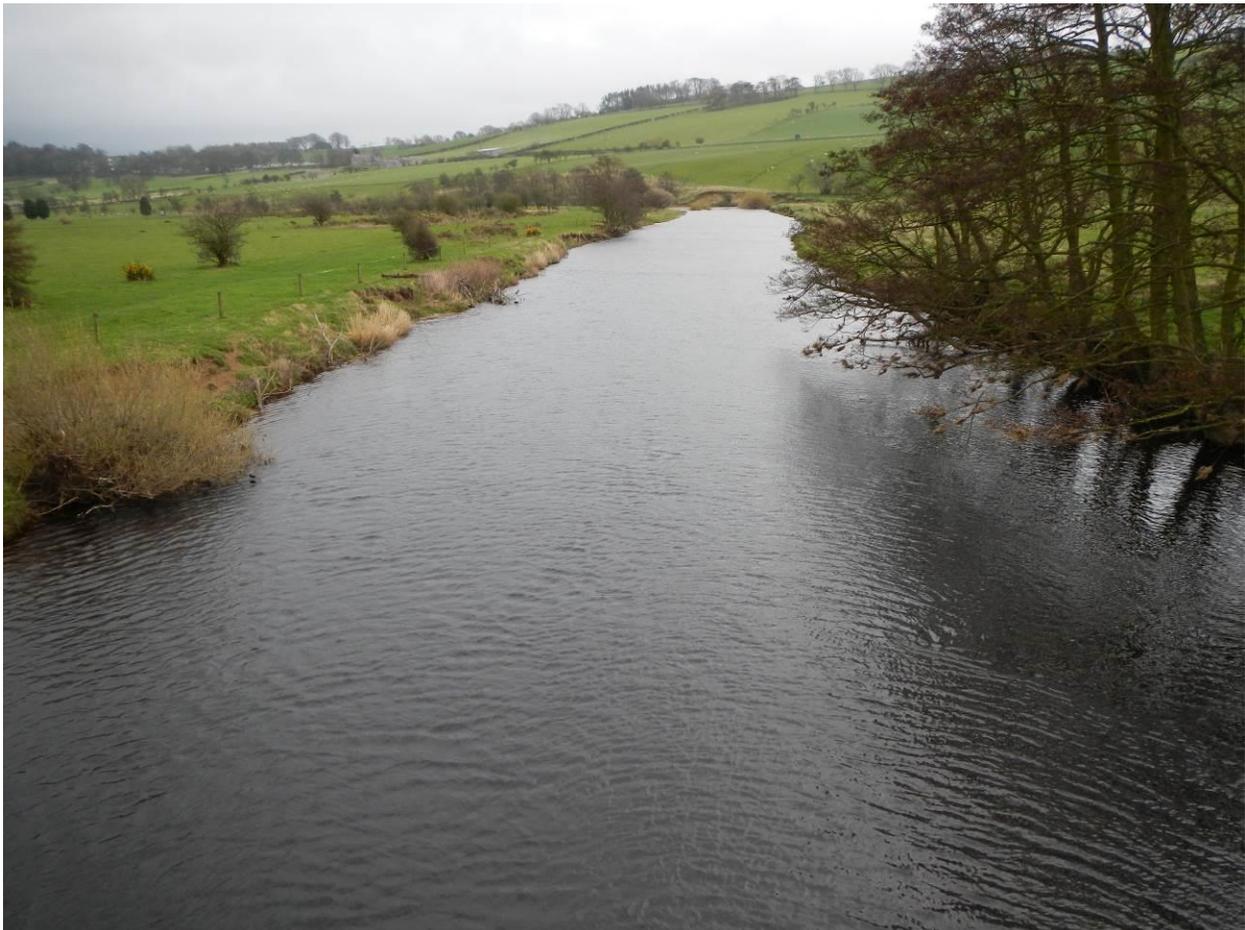
Upstream of Rothbury, several sections of the Coquet have been straightened, with new channels dredged out of the floodplain to realign the river away from its natural course to its current location. This creates an unnaturally straight, wide and deep channel with very little flow diversity, making such sections poor quality habitat for trout. Some adult trout and older parr may reside in the area, but in most cases they will be reliant upon the cover provided by overhanging and trailing willow (*Salix spp.*) and alder (*Alnus glutinosa*) branches (Figure 1).

**Figure 1. One of the realigned, straightened sections of the river where trout habitat is heavily reliant upon the bankside willow (left of shot) and alder trees (right of shot).**

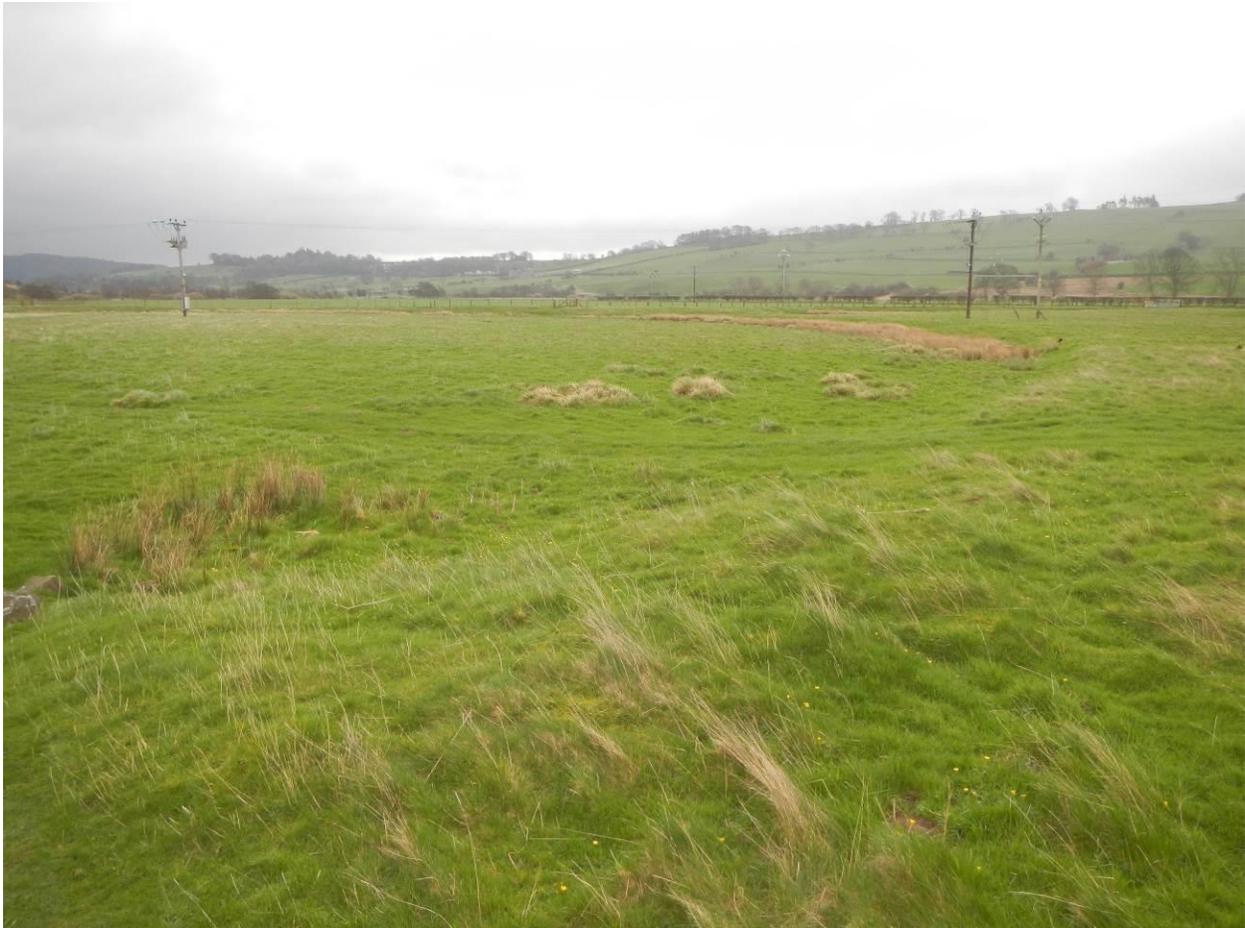
Figure 2 shows a redundant channel section from which the river has been realigned. The low area that arcs around to the left is an earlier, more meandering river course. This kind of action was often taken to divert the river away from prime land or buildings, or simply to create more manageable field parcels. Realignment was also sometimes undertaken to

reduce erosion on bends, however, grazing is often the underlying cause of excessive erosion in the first place, as natural, well vegetated banks greatly reduce erosion rates.

**Figure 2. The depression in the centre of shot shows one of the former river channels. Note the rushes (*Juncus effusus*) in the left of shot and background which demonstrates that it is still a damp area of the field.**

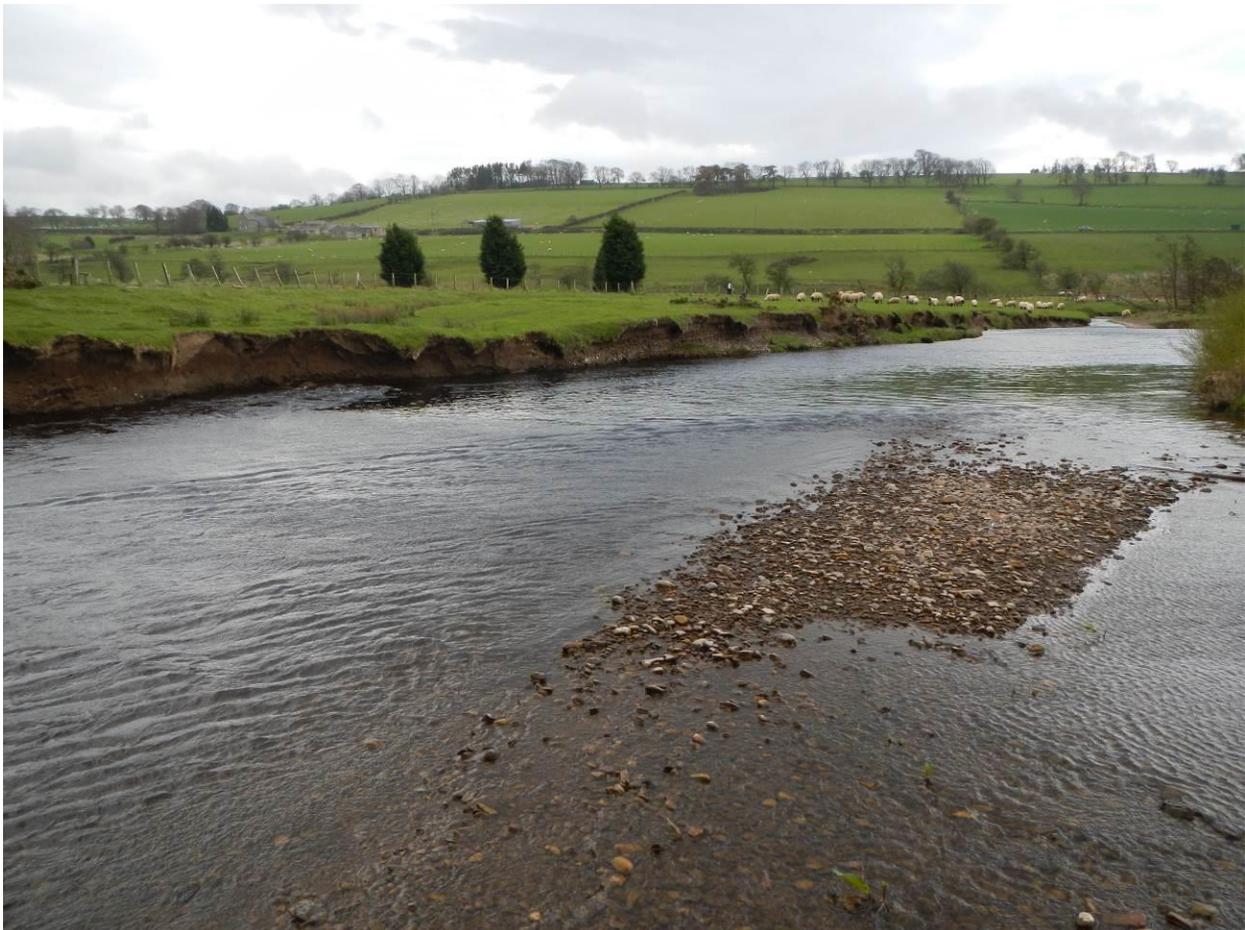
It has to be recognised that erosion of the river bed and bank is part of the river's natural process, but it can be massively accelerated by grazing, or by dredging/realignment that has lowered the bed to leave the banks perched, with erodible gravels and subsoil exposed (Figure 3).

A further consequence of grazing and the associated lack of root structure within the bank is that as the banks erode, the material that slumps breaks up and washes away more easily (Figures 3 & 4). Conversely, on better vegetated banks the root structure makes it less susceptible to wash-out and allows it to consolidate naturally re-grade the bank line (Figure 5).

A gravel bar present in Figure 3 demonstrates the availability of salmonid spawning substrate on the river, which was present throughout the sections walked. It would, however, be of a higher quality if the erosion and sedimentation were reduced, and if there were better vegetated stable margins with overhanging cover in which emerging fry could seek refuge.

**Figure 3. Section of bank erosion exacerbated by grazing pressure. Some material has slumped and been retained to the right of shot, but all of the material in the centre and left of shot has been washed out. Note how the river is now free to erode into the friable sub-soil.**

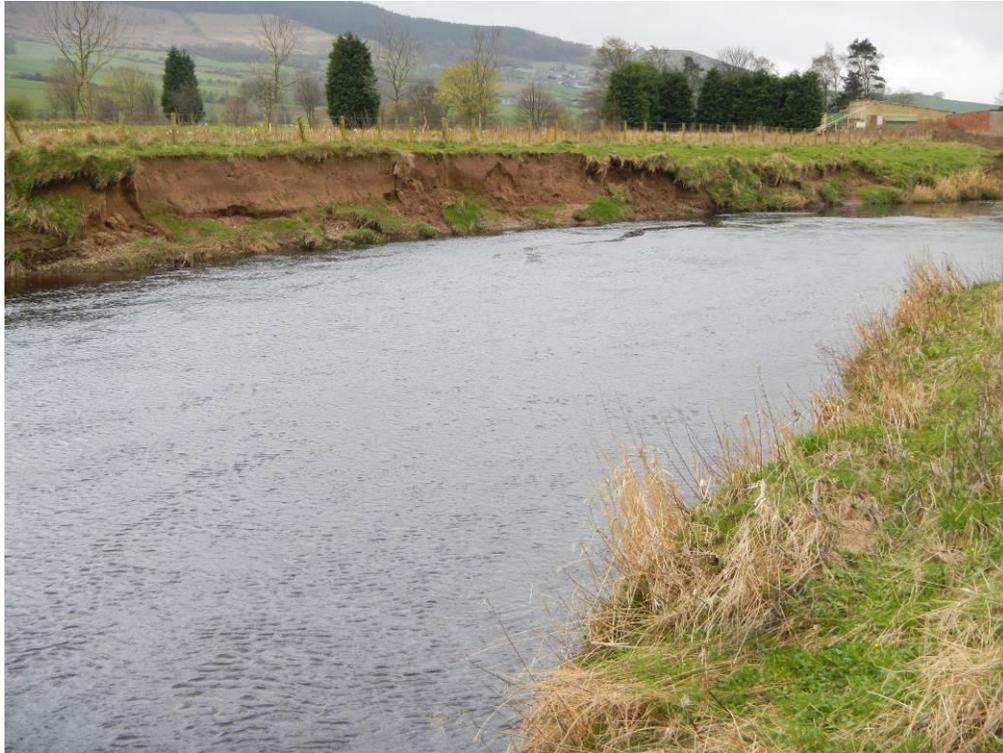
**Figure 4. Erosion on a grazed bank. Some material is retained but a large portion has been lost and the friable sub-soils remain exposed.**

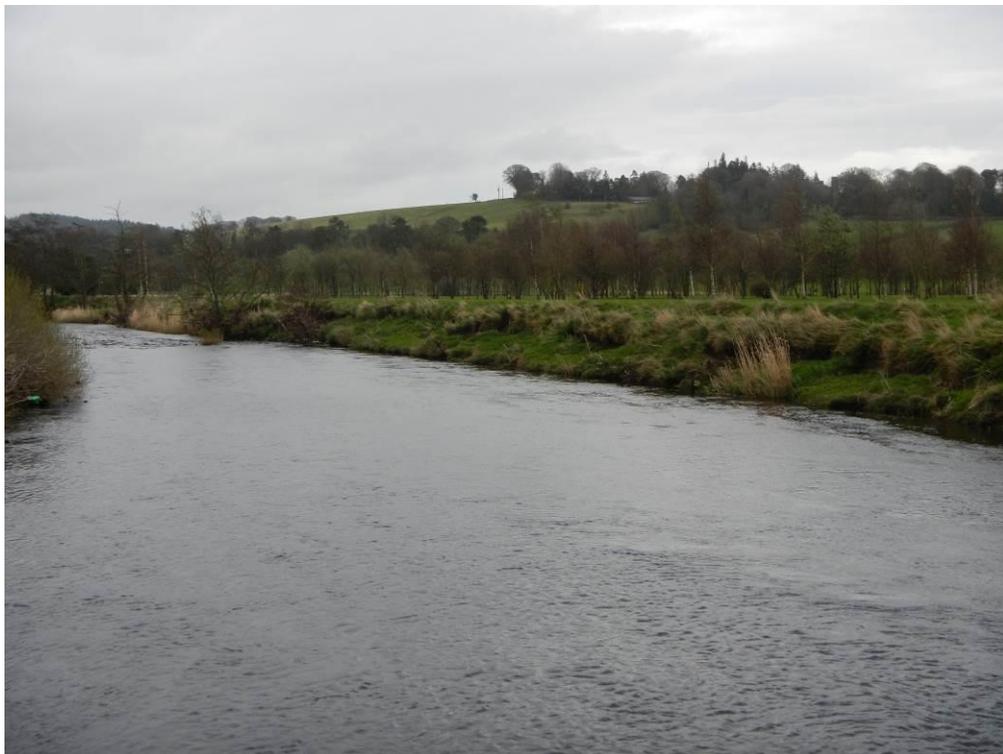
**Figure 5. Un-grazed section of bank directly downstream of Figure 4. Although erosion and slumping has occurred, the lack of grazing and increased vegetation has aided retention of bank material.**

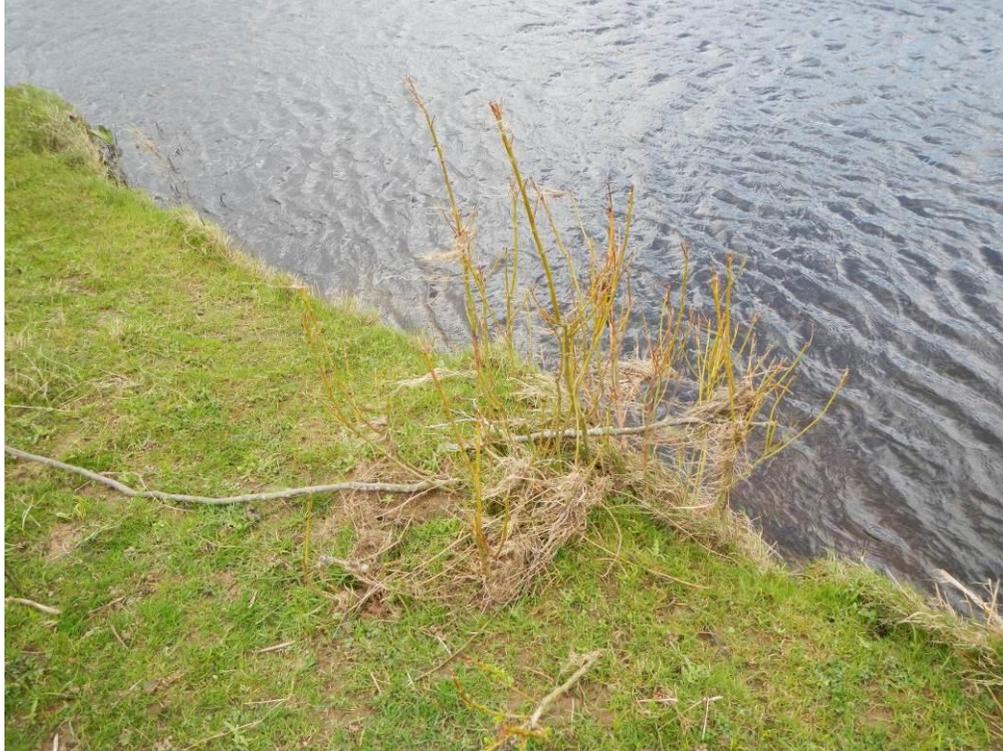
**Figure 6. Where livestock have access, the occasional willow or other saplings that do become established are heavily targeted and damaged, particularly by sheep.**

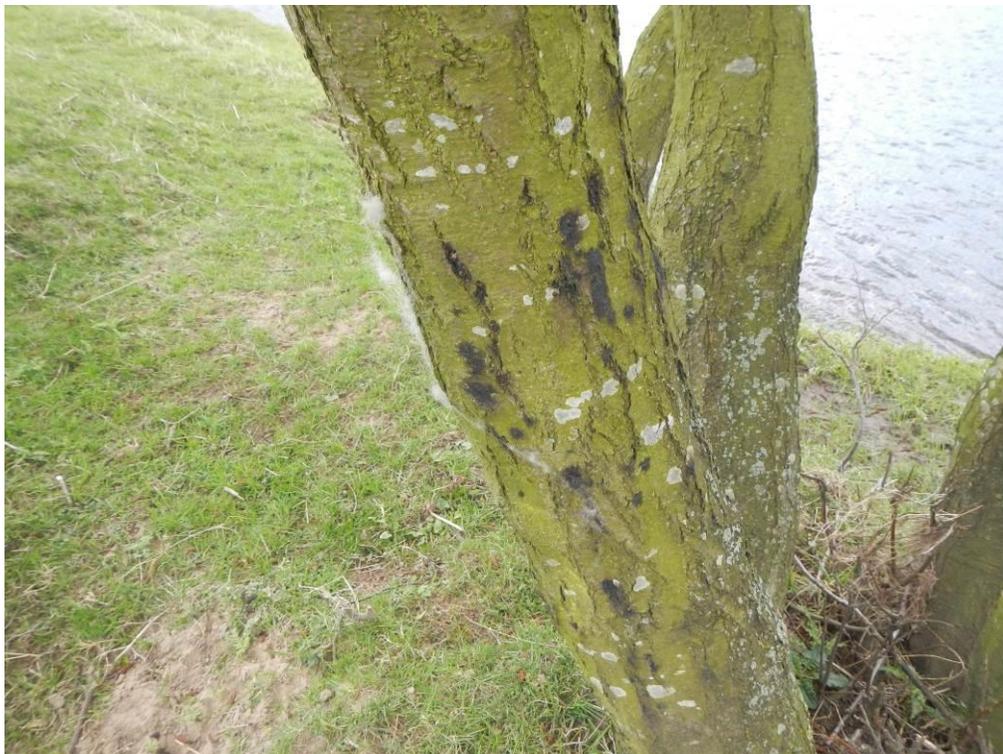
**Figure 7. Alder tree displaying likely signs of *Phytophthora*.**

N.B. There is some evidence to show that coppicing diseased alders can reinvigorate them and at least prolong their life.

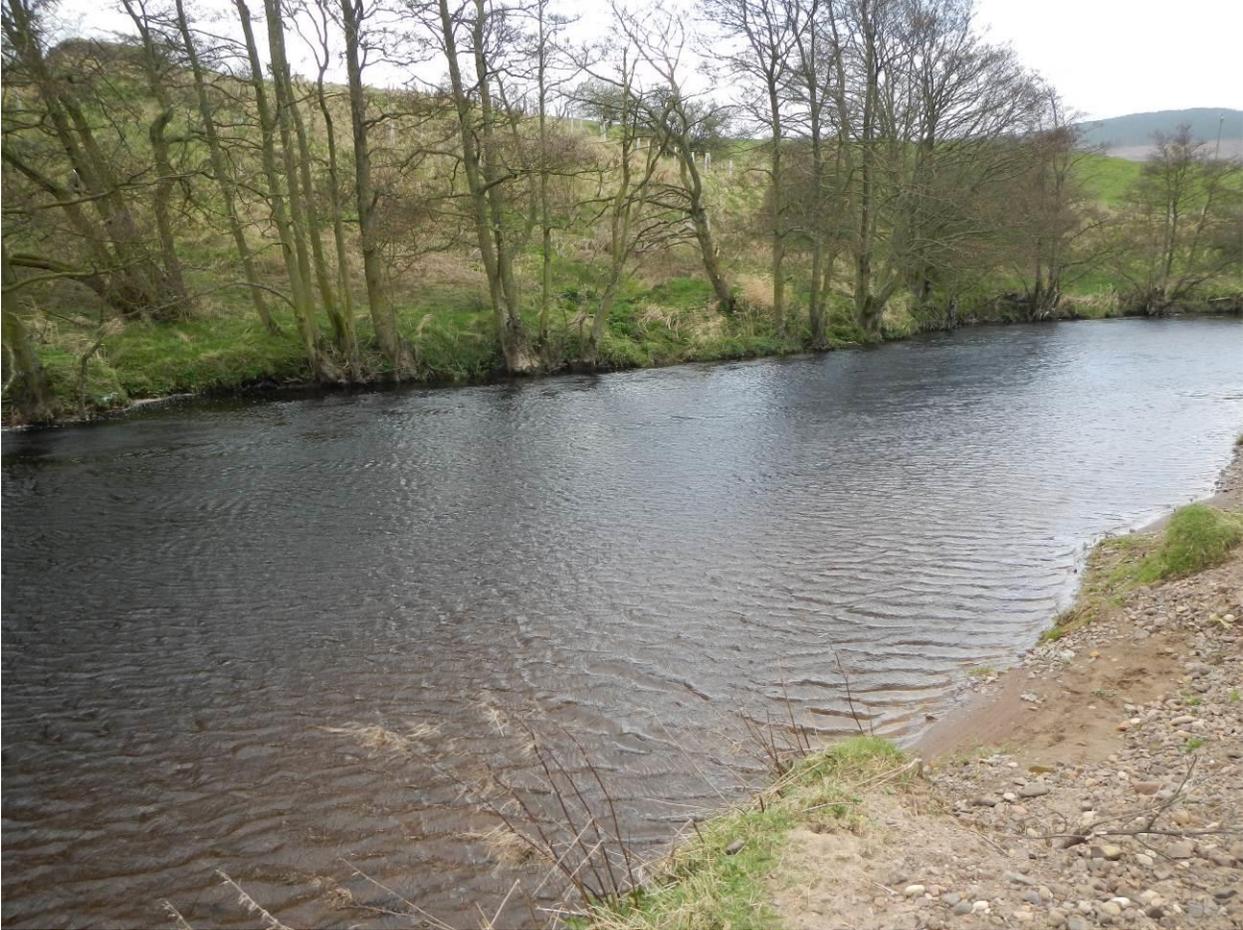
It is also noted that in areas where trees are present, the lower branches appear to have been removed. While this could occur through high flows breaking off the limbs, it is more likely that this has been done deliberately in a misguided attempt to aid casting to likely lies. In actual fact, removal of the branches will have greatly lowered the habitat quality in that area and reduced the size and number of fish that the area can support. It may be slightly easier to get a fly to the spot where the fish were holding, but will they still be there in such numbers, or will they have moved on to another area with better cover?

**Figure 8. A line of beneficial alders that are helping to protect the bank and providing some cover through their roots. The lack of low and trailing branches, however, greatly reduces their potential for providing low-level cover for trout.**

It is recommended that, if it has been undertaken in the past, any pruning of branches along the bankside trees be ceased in favour of promoting such features. Where low-lying branches are present, they can even be bent/trained down into the water to create additional lies. This may make

some casts more difficult, but the overall increase in habitat and fish holding capacity will far outweigh any inconvenience.

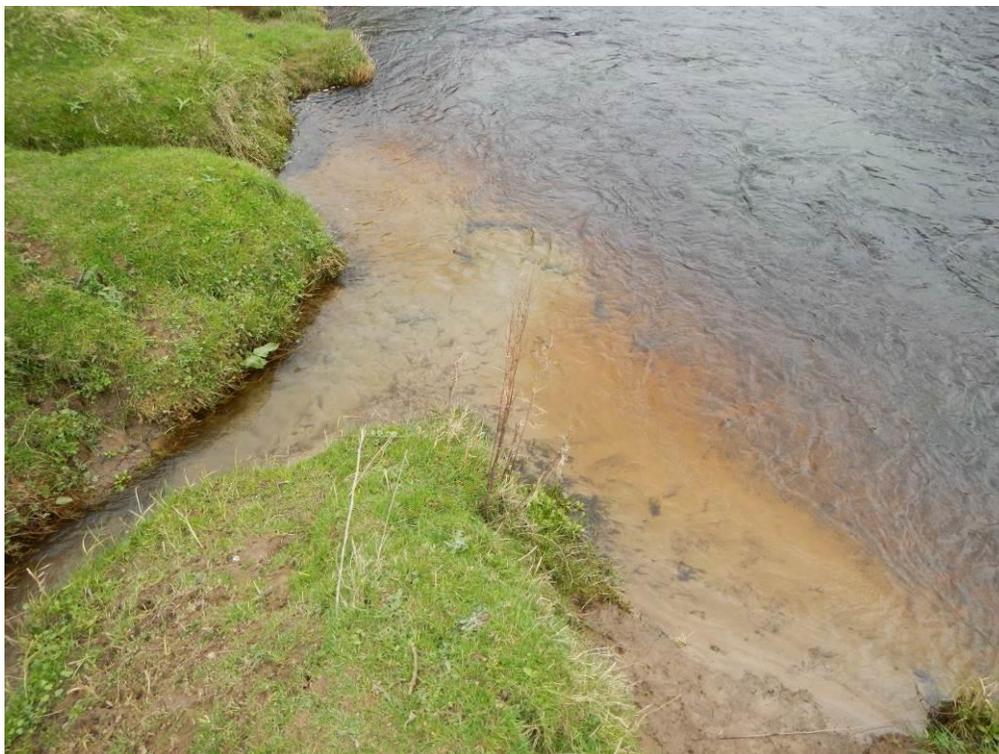
In the same way that grazing and the associated erosion issues deteriorate habitat and lead to increased erosion and sedimentation on the main river, the same is true for tributaries. Figure 9 shows how grazing and livestock poaching are greatly increasing the sediment input from the small tributary that enters the river c. 700m downstream of Lady's Bridge (opposite the golf course). Without this degradation, the tributary may possibly have been a potential spawning and juvenile area (Figure 10). The importance of even the smallest tributaries such as this for those purposes is only more recently being realised.

**Figure 9. Obvious signs of sedimentation where a small tributary discharges to the Coquet.**

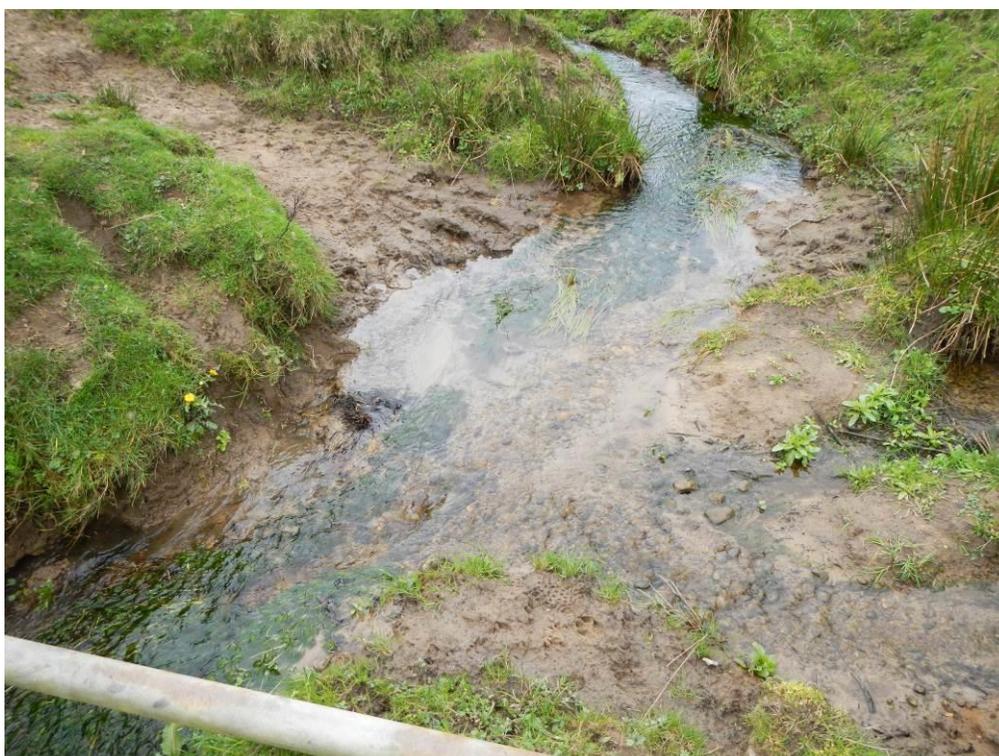
**Figure 10. Habitat in the tributary depicted in Figure 9 could have potential as a spawning and juvenile area if livestock were excluded.**

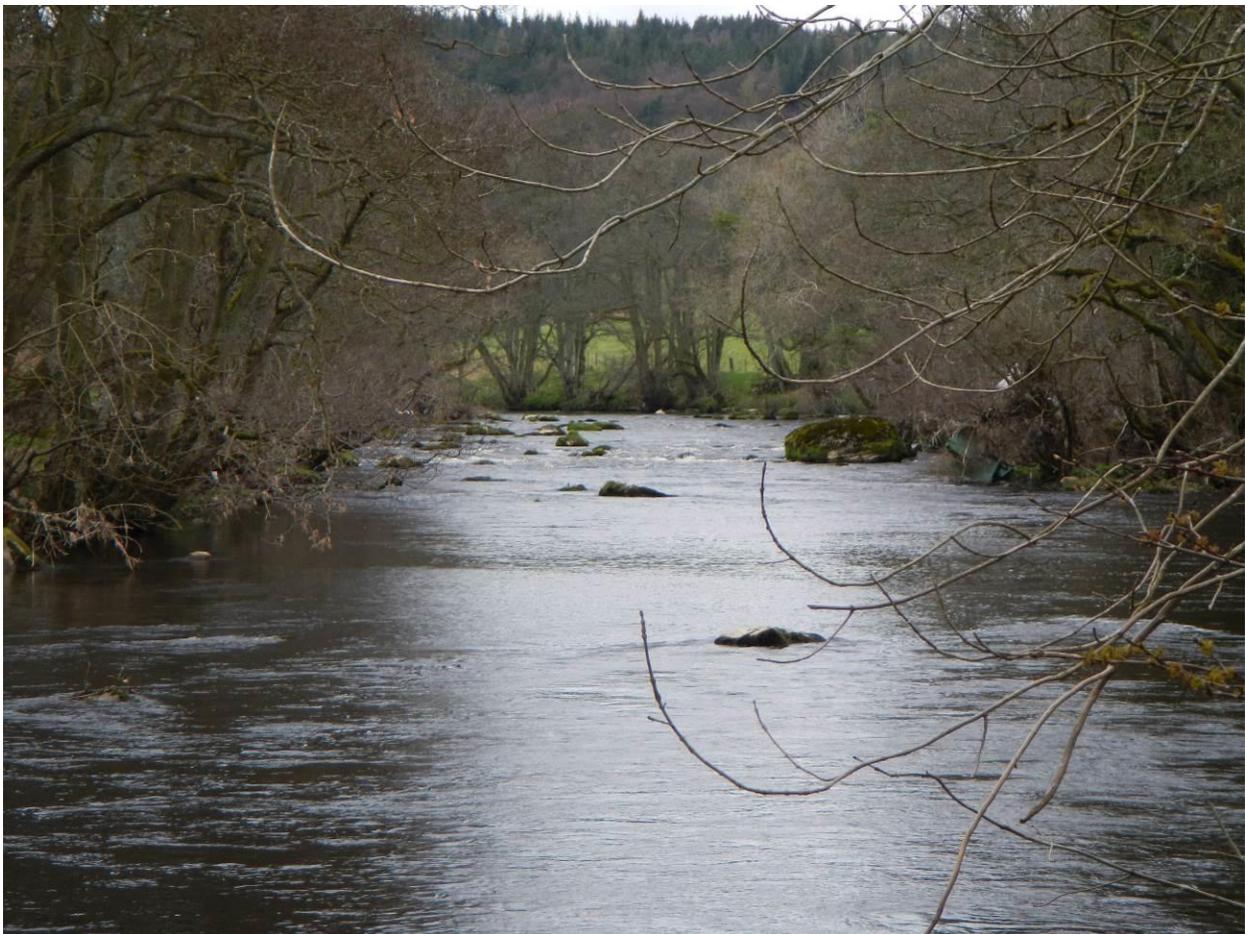
Immediately downstream of Rothbury, the river descends into a narrower, gorge-like section of valley, unlike the wider upper floodplain. Through this section, a combination of stock exclusion and reduced accessibility for stock allows a more naturally tree-lined section of river. Here the bankside trees provide shade to around 50% of the channel, while providing both low-level and trailing branches along the river. The steeper nature of the watercourse in this section also means that rather than the pool and riffle type habitat found upstream, much of the section is riffle and glide with the occasional pool, interspersed with large boulders that create excellent flow disturbance. This makes ideal habitat for wild fish, with a range of depths and flow characteristics that is poorly suited to stocked fish.

**Figure 11. Excellent habitat immediately downstream of Rothbury, ideal for wild trout.**

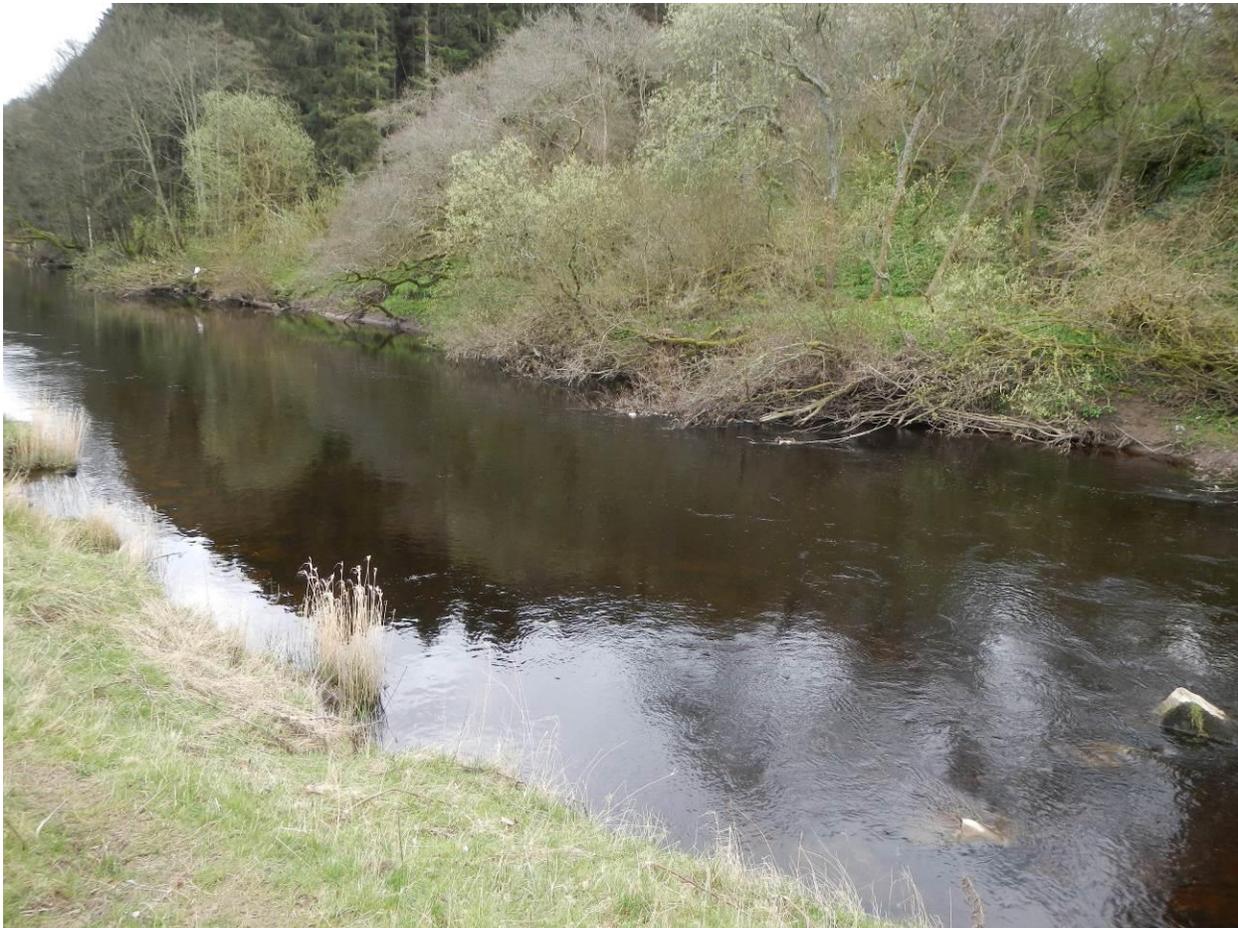
Although there were numerous large boulders downstream of Rothbury, in general, there was a lack of in-channel structure in the upper section; however, below the narrower gorge section, where the river valley opens out again in the fields upstream of Pauperhaugh, more trailing branches and large woody debris (LWD) were present (Figure 12 & 13). These greatly enhance the habitat by providing cover and flow disturbance, particularly in the slower deeper sections. This structure also provides massively increased protection from piscivorous birds such as herons (*Ardea cinerea*), merganser (*Mergus serrator*), goosander (*Mergus merganser*) and cormorants (*Phalacrocorax carbo*), as fish can much more easily negotiate the structure than the birds can.

**Figure 12. LWD on the far side of the channel providing great habitat and refuge from predators. The structure also provides valuable flow disruption in the slower sections.**

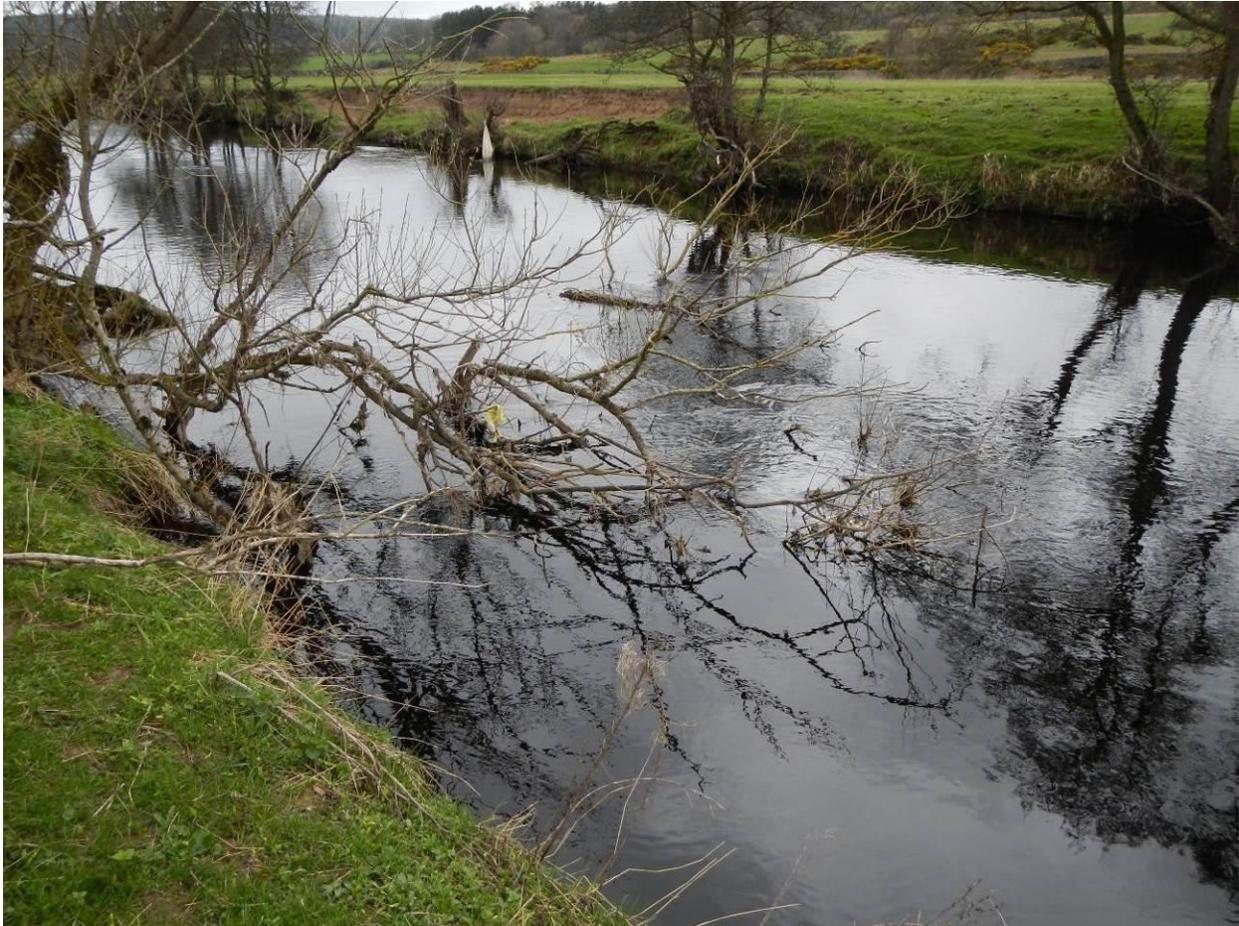
**Figure 13. Excellent trailing branch structure where some of the limbs of a willow tree have collapsed into the river. This is a vital fish holding feature in an otherwise deep and relatively featureless area. Once the leaf is on the tree the structure provided is guaranteed to hold fish and should be retained at all cost.**

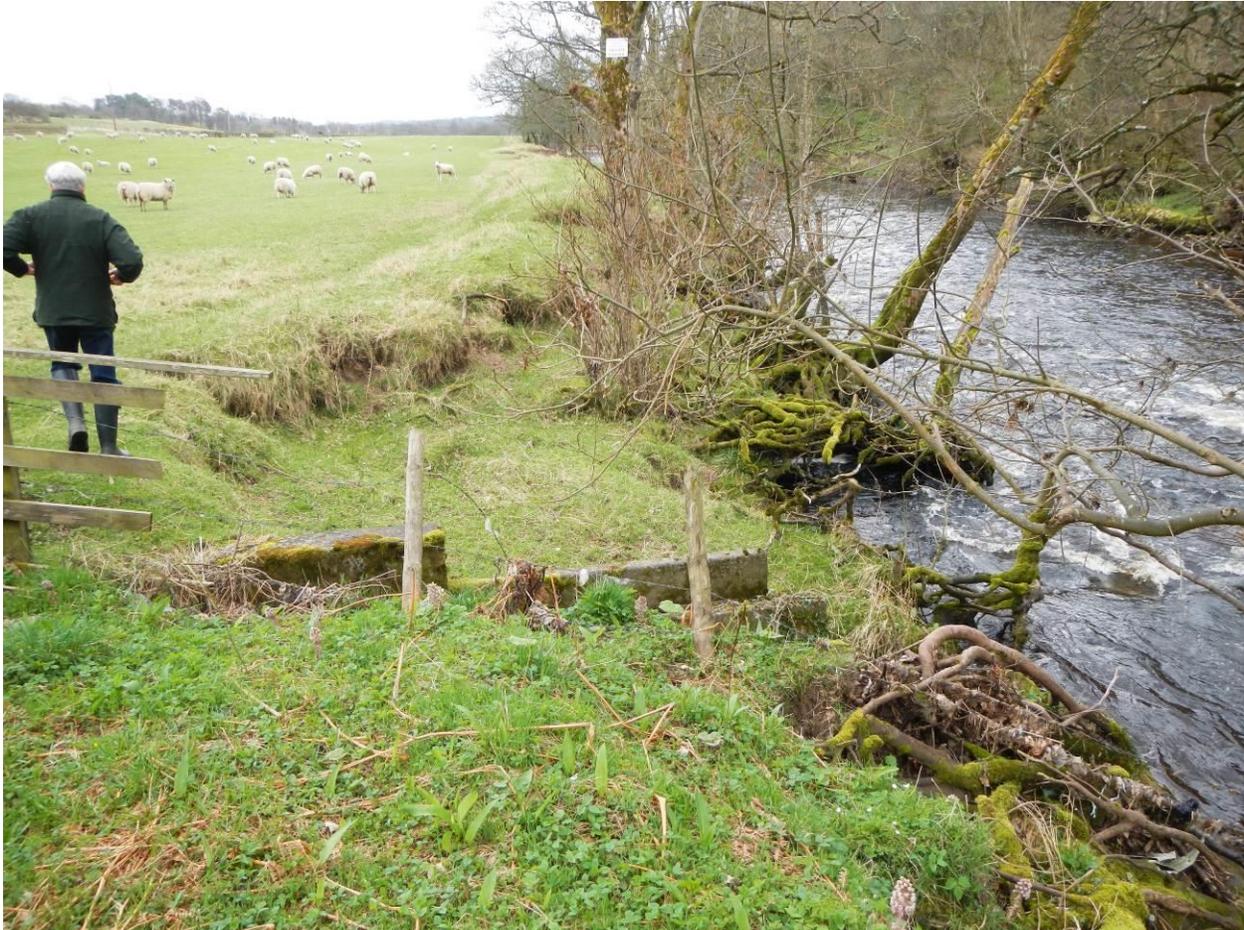
In the fields upstream of Pauperhaugh, the issues of sheep grazing again come to the fore, with obvious signs of accelerated erosion around the root-ball of many of the trees. This is because the shallower root systems of the grazed grass provide less protection to the banks, which are then more easily washed out in high flows. This eventually leads to the tree being out-flanked by the river and loss of the tree. Imagine these pools without the tree structure: they would be greatly lacking in features and much less capable of supporting healthy fish stocks.

**Figure 14. A perfect example of how sheep can kill or remove mature trees. Note how the trees to the right of shot are precariously hanging on to the bank and will likely be lost in future floods. Exclusion of livestock from the banks could have prevented the issue occurring and still could greatly reduce the extent of future tree loss.**

Possibly the single greatest improvement that could be made to habitat on the river would be to install buffer fencing that would allow development of a more diverse vegetation structure on the banks and allow regeneration of trees. The siting of this would be paramount, as a spatey river like the Coquet would have to be allowed a good buffer over which the erosion could stabilise, and the fence would have to be located out of the immediate risk of flooding.

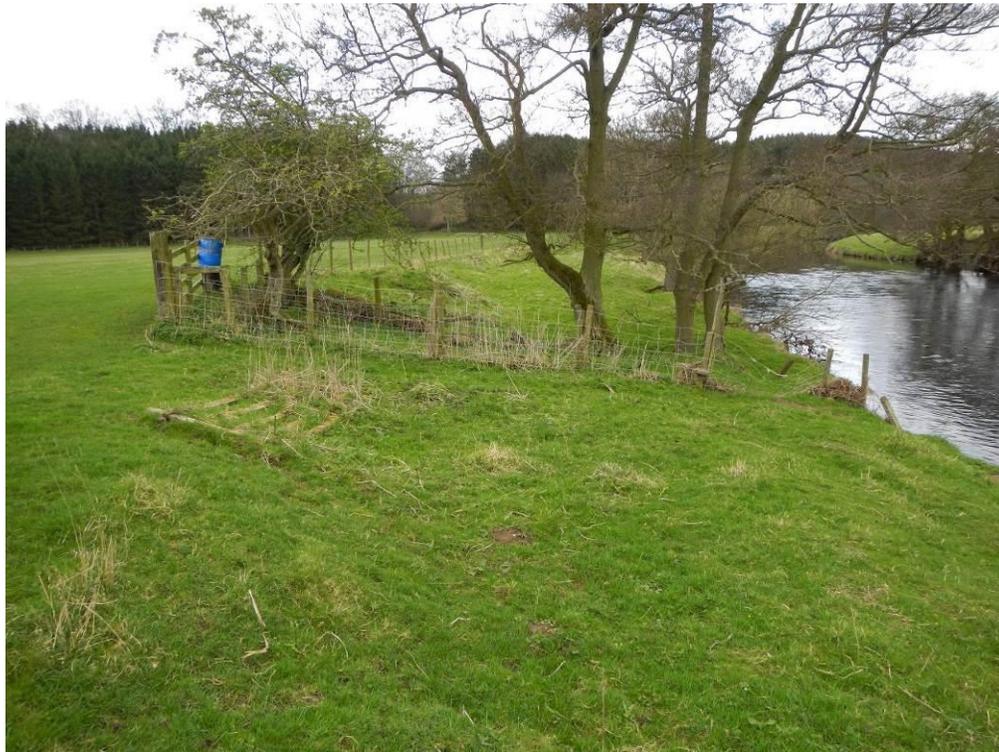
Areas currently fenced should also be inspected, as without maintenance they will become ineffective over time (Figure 15).

**Figure 15. Old buffer fencing that is no longer effective, upstream of Pauperhaugh Bridge on the RB.**

It is recommended that Natural England and the Environment Agency are both approached for assistance with any planned fencing work as it is highly likely to fit with their river management aspirations and they may be able to offer funding assistance and advice through programmes such as Catchment Sensitive Farming and/or Countryside Stewardship schemes.

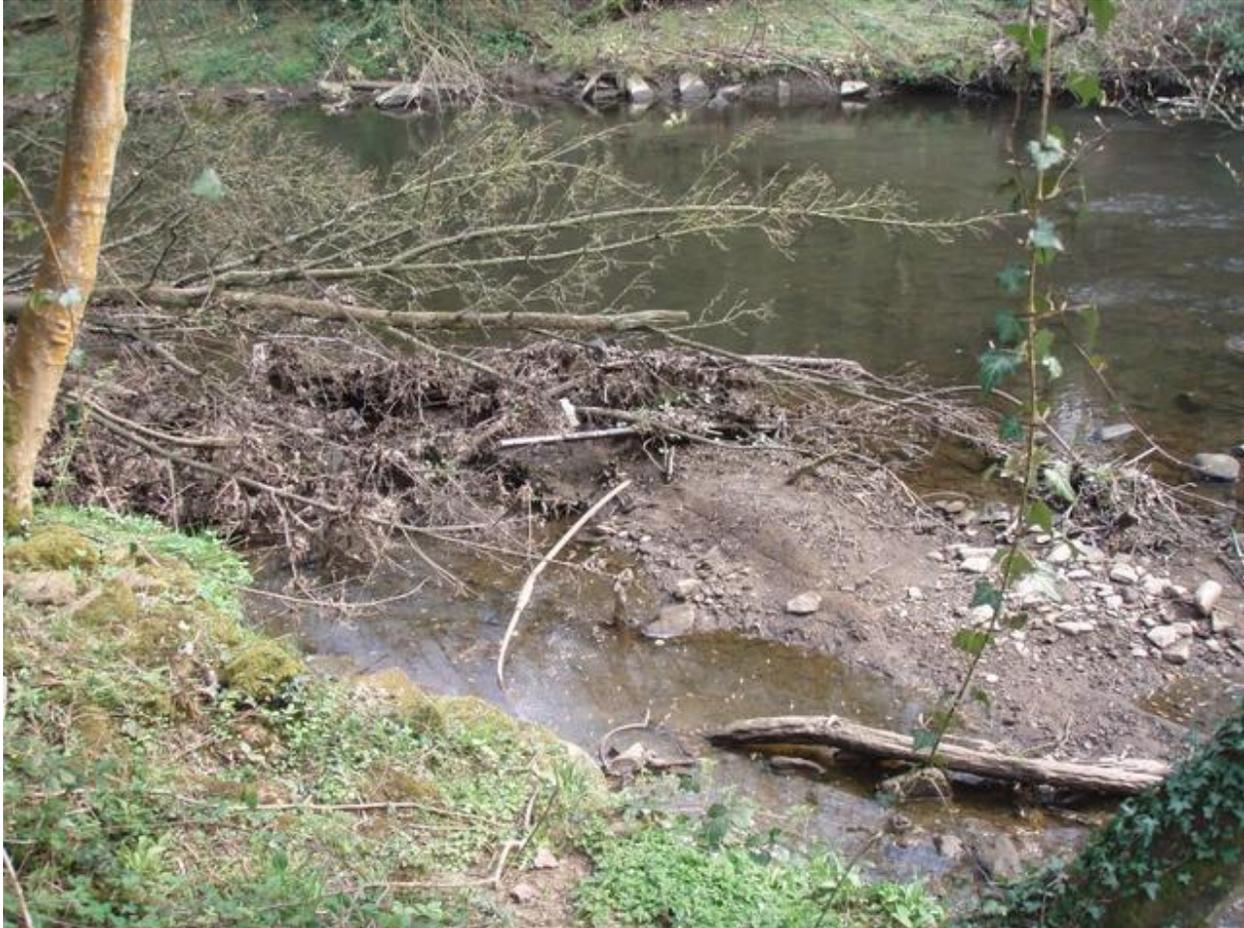
In many of the slower, deeper and featureless sections the trunks of the trees coppiced could be well employed as tree kickers (Figure 16), whereby the trunk is layed along the bank line and strongly cabled to its stump or another immovable anchor. This then provides the valuable cover and structure that is so often missing; furthermore, this can also assist in accumulating sediments downstream, behind the LWD and can facilitate narrowing of the channel to a more natural width, where required (e.g. the dredged, straightened sections).

**Figure 16. Tree Kicker employed on a shallow section of river, showing the accumulation of sediment downstream. This method would be equally applicable on deeper river sections.**

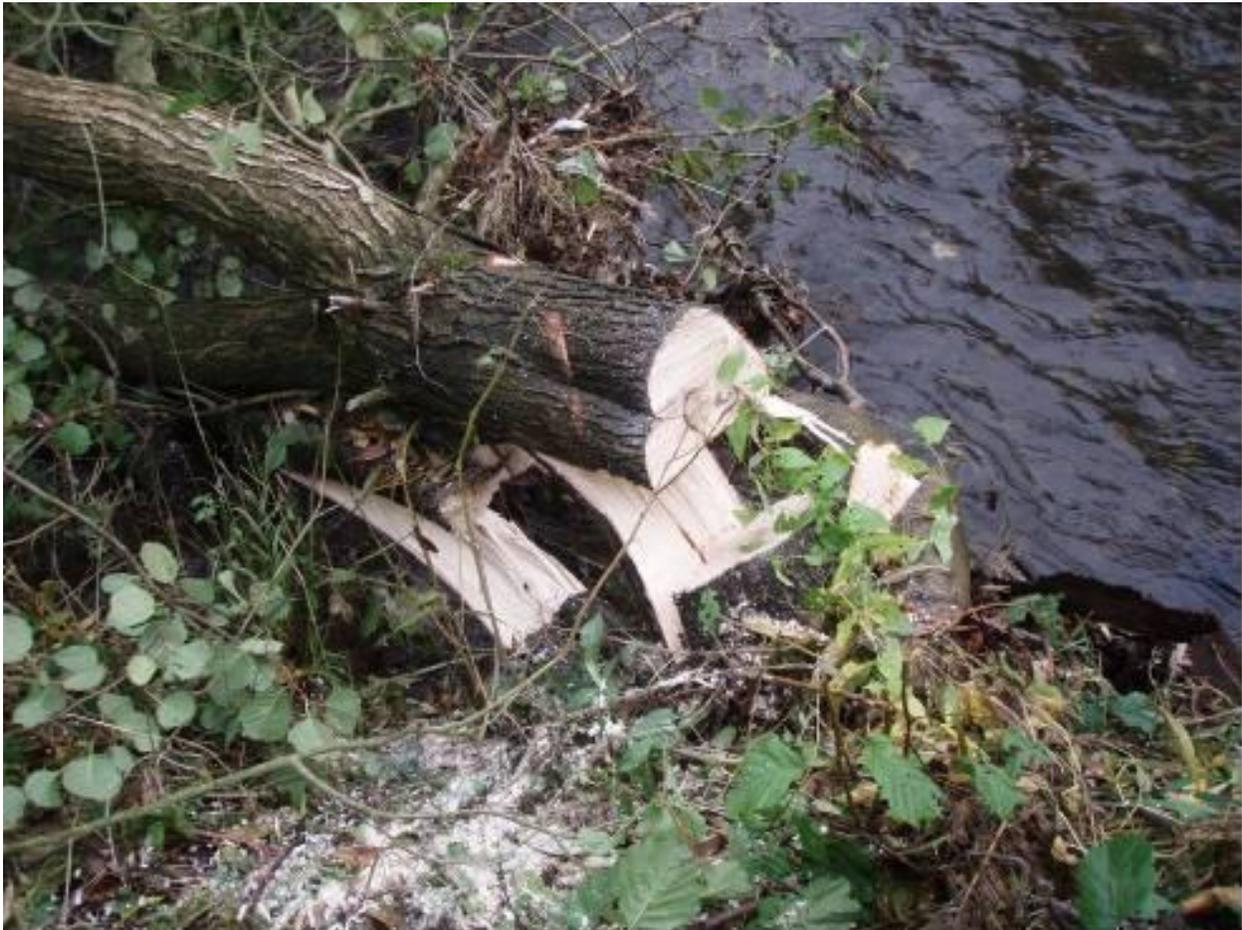
Figure 17. Hinged willow.

The process involves cutting part way through the stem/trunk (a bit at a time) until it can be forced over into the channel (Figure 17). Care should be taken to limit the depth of the cut to only that which is required to bend the limb over, thereby a substantial hinge is retained to provide maximum strength and health of the tree. This treatment can be an aspirational
