## **River Crane - Twickenham**

**An advisory visit carried out by the Wild Trout Trust – December 2012**

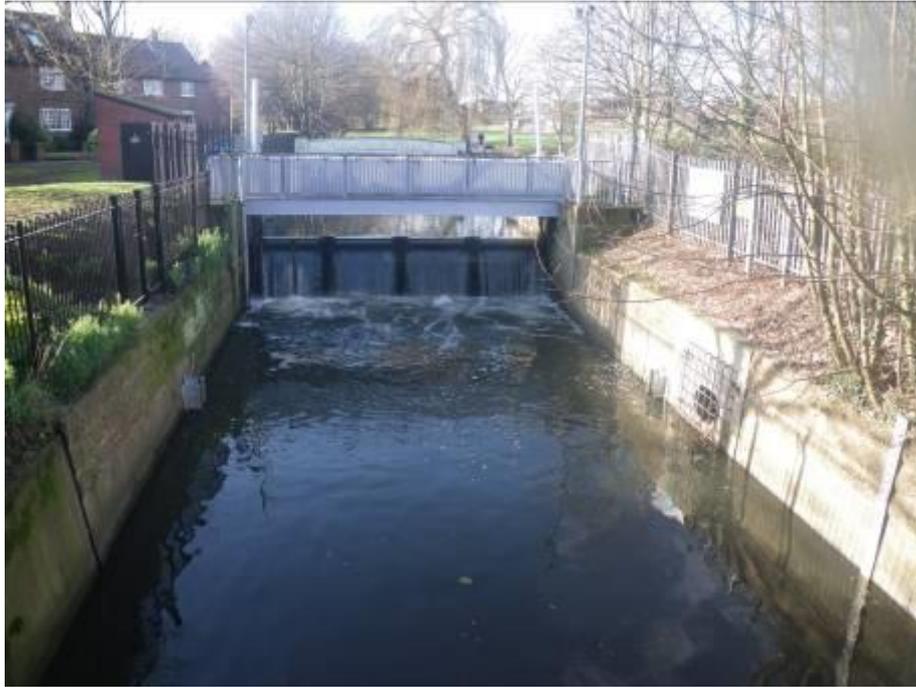
Photo1. The weir located on the Crane at the bottom of Knellor Gardens. The structure appears to block upstream fish migration via this route and is a serious impediment to habitat restoration in the reach immediately upstream. The headloss may be reduced when high spring tides coincide with strong fluvial flow.

These weirs seriously impact in-channel habitat quality by impounding the flow and slowing upstream water velocities. The downstream weir (photo 1) may, however, be essential for protecting local properties from the effects of tidal flooding. There may be more scope for modifying the weir upstream but a corresponding reduction in bed levels on the mill channel might be required to secure an acceptable flow split around the loop.

- Open up a dialogue with the EA over the possibility of lowering the height of the two weirs at either end of Knellor Park.
- Explore the idea of a large project within the park to re-profile the existing vertical revetment to create a low biologically valuable river margin.

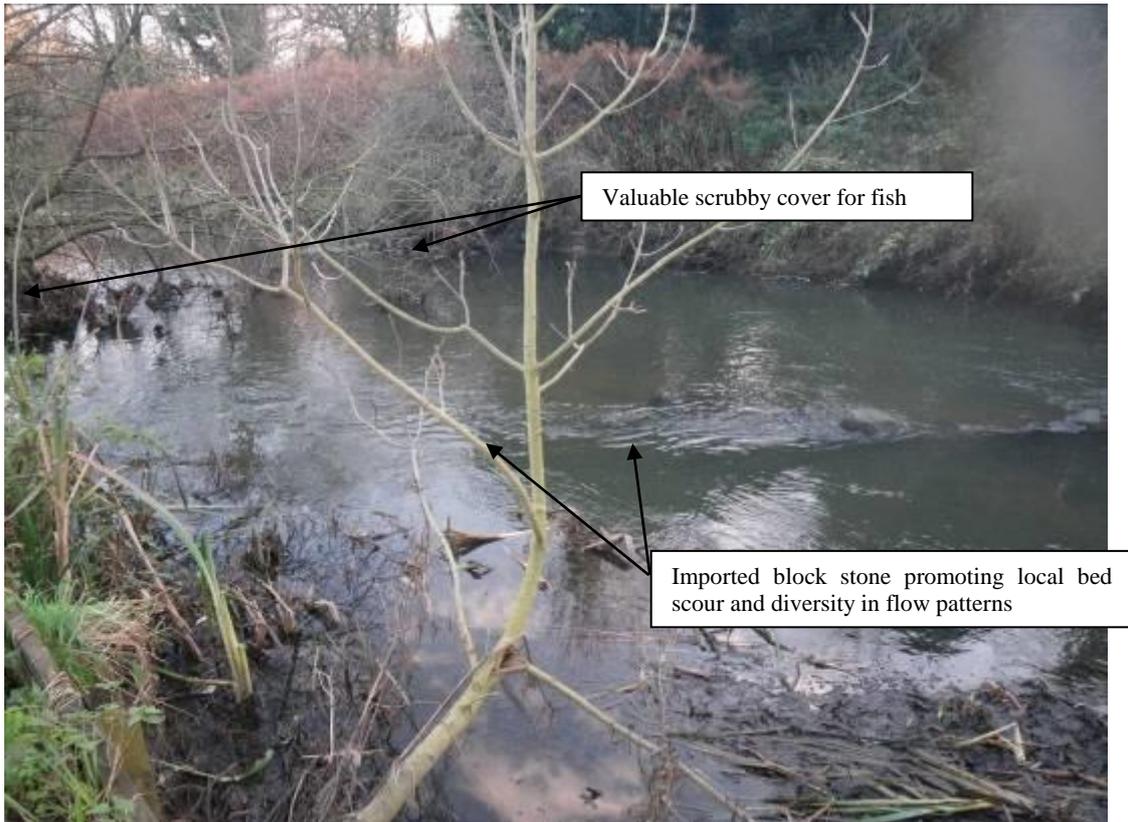
Photo 2. River Crane through Crane Park. A good example of varied in-channel habitat

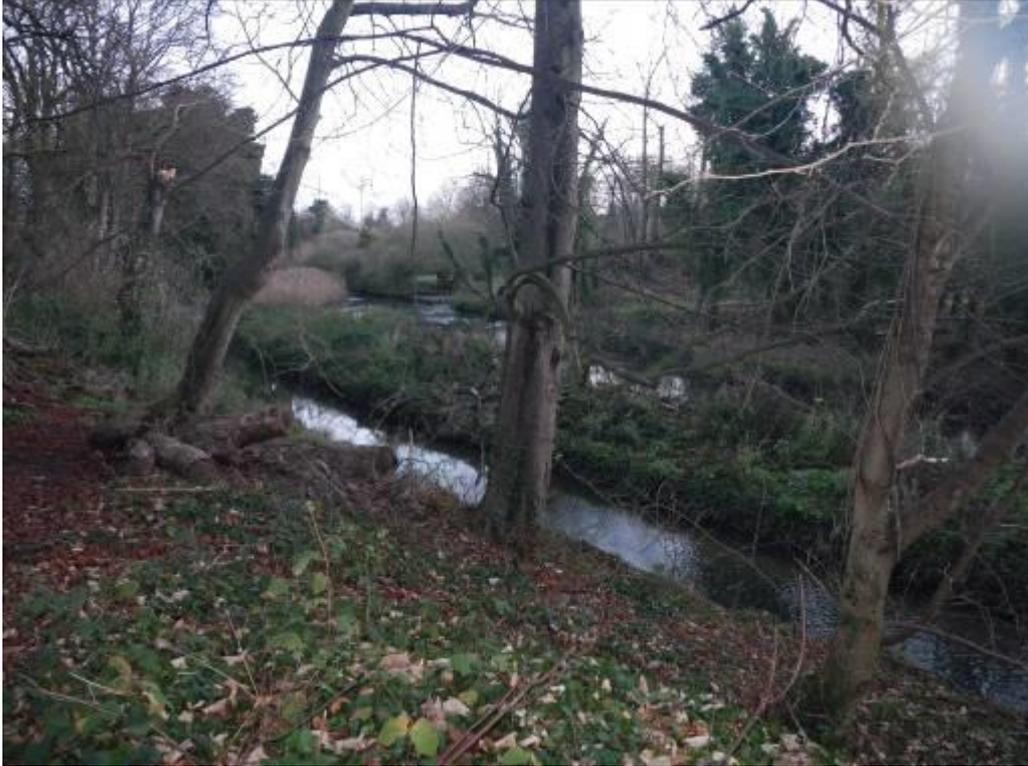
At the very upper reach inspected, the channel is split, with what looks to be an old high level milling leat (photo 4). This channel is a flat shallow glide with relatively few in-channel features. Some attempts to create improved habitat are underway. Improving this channel is important because it appears to link up well with the channel above. The lower level channel, although taking the bulk of the flow, appears to run through a long culvert upstream of the Pevensy Road Nature Reserve which may well limit fish passage.

Photo 4. Old high level milling leat in the foreground might be potentially important for upstream fish passage

- Carry out further assessments for fish migration on the upper mill leat. The outcome of this investigation will drive future actions for prioritising flow splits between the channels and the necessity, or otherwise, for improving access on the stepped structure lying at the downstream end of the two channels.

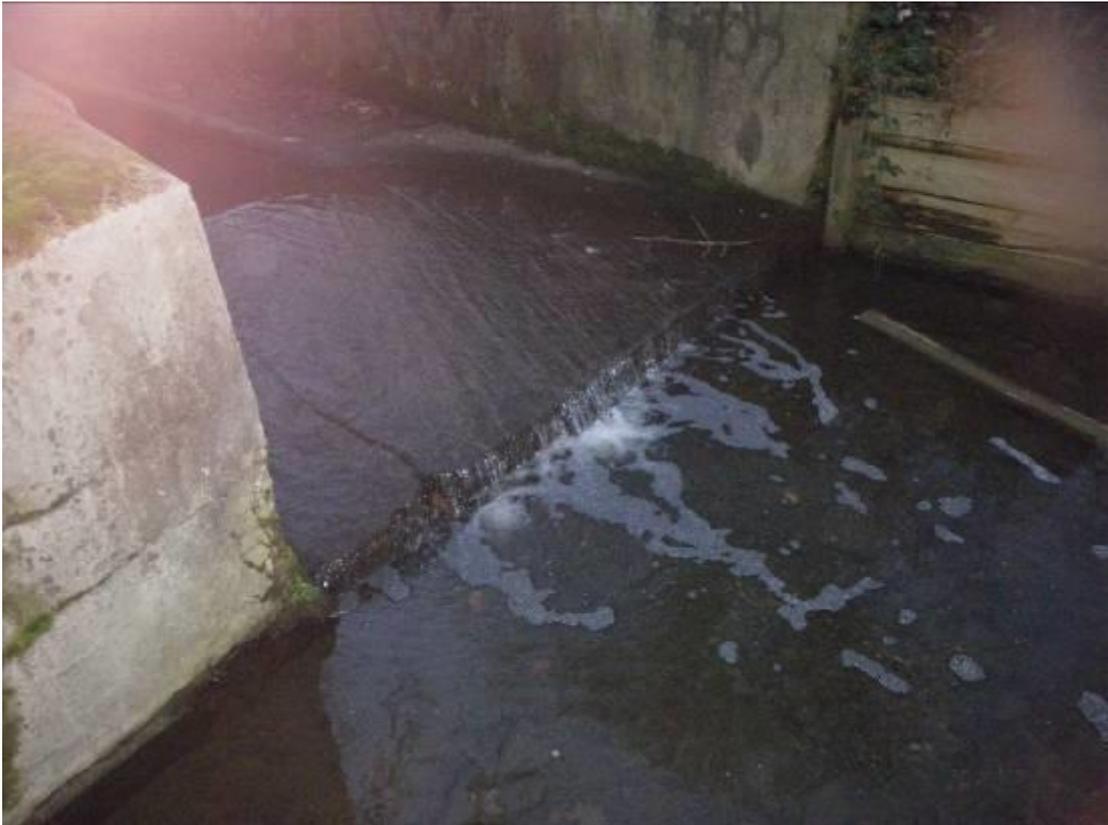
Photo 6. Another box section on the tail of this structure is required to enable fish to swim up to the next step.

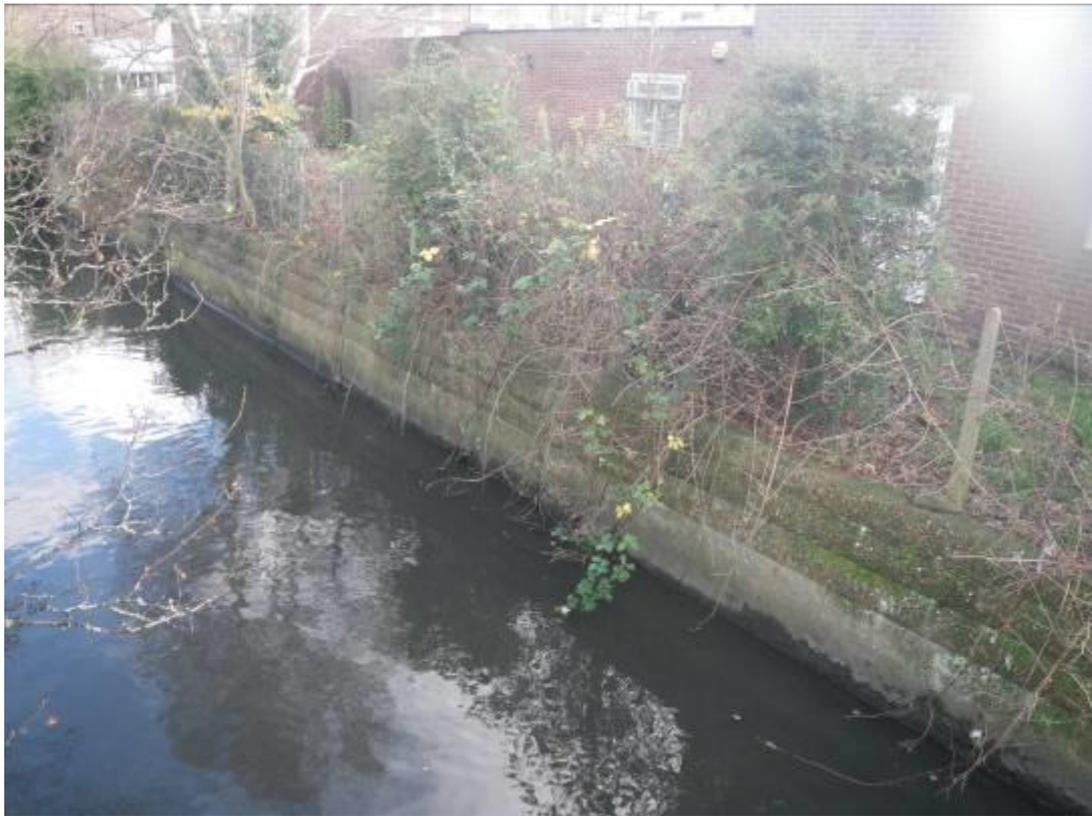
Downstream of the weir on the Crane and also downstream of the railway bridge on the DNR, the in-channel habitat is very poor. The vertical hard revetment and flat concrete river bed provides precious little habitat for plants, fish or invertebrates. Scope for improving this section of channel might be limited due to sensitivities over flooding adjacent property. There is some scope for providing some in-channel interest via the use of imported woody habitat that can be secured to the hard margins and allowed to float up during flood events. Whole 'brashy' tree sweepers such as thorns, or even complex conifers could be

Photo 7. The RB margin on the Crane downstream of the weir. A sterile river margin ripe for improvement.

secured by the lower butt with flexible galvanized cable to anchor points rag-bolted to the brick or concrete banks.

These tree sweepers provide vital cover for a range of species in what would be currently an extremely hostile environment. They are cheap and easy to install and represent an extremely low flood risk as they will rise up in spate conditions. Care must be taken to ensure the fixings are located in such a way that enables the sweepers to float up to the top of a bank full flood, but are sufficiently short so that they are not left high and dry on top of the bank when water levels recede. If trees of a suitable size cannot be procured, or if the physical conditions make it difficult to install large trees then smaller refuge areas can be constructed from brushings that are tightly lashed at the butts and fastened to the margins in similar fashion to the whole tree sweepers.

- Install tethered floating tree sweepers, or if deemed inappropriate smaller brash bundles to the margins of sections of hard vertical wall.
- Create some river bed roughness over the smooth shallow glides running down from below the bottom weir on the Crane and downstream of the railway line on the DNR.

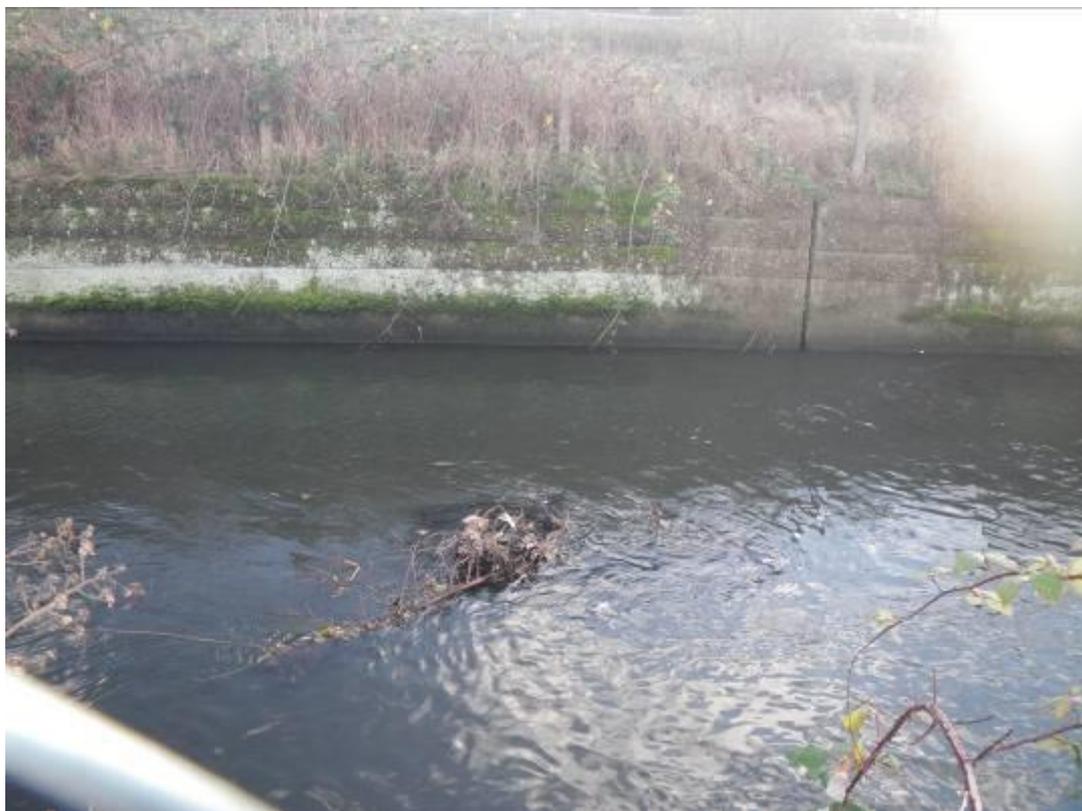
Photo 10. A little bit of central channel debris providing a micro habitat on the DNR below the railway line. Similar micro habitats can be easily installed and provide habitat for small fish.

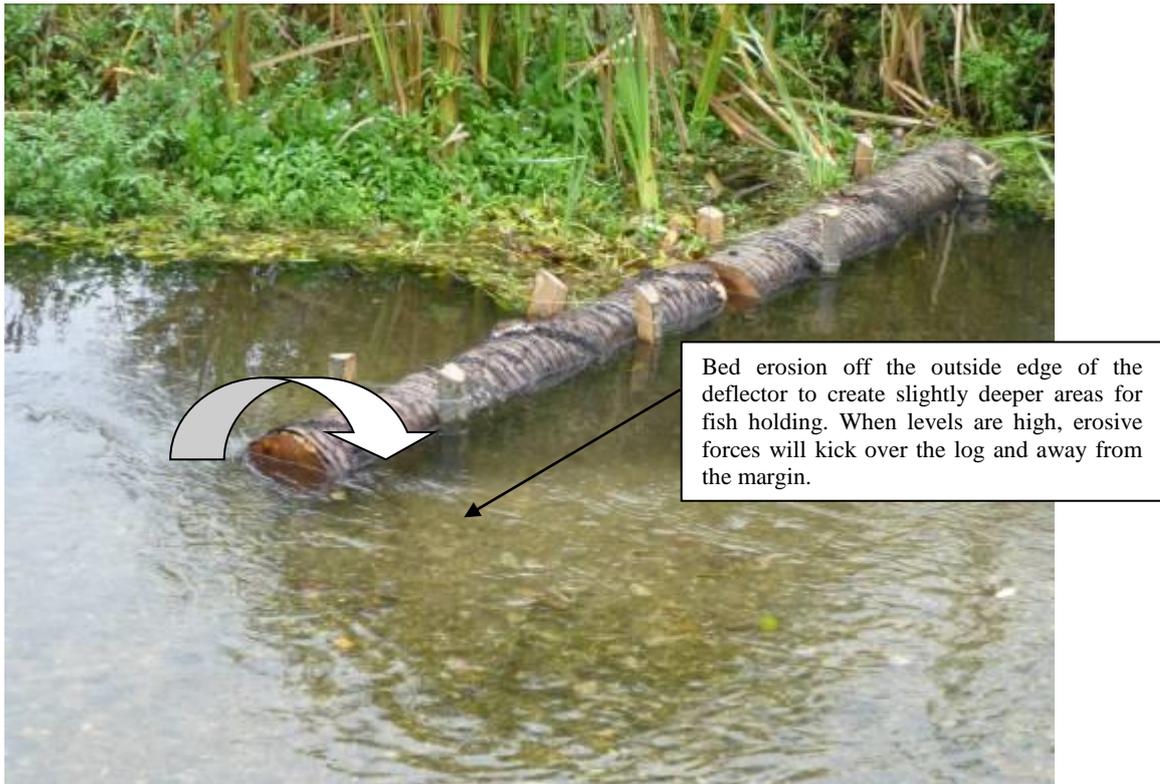
Photo 11

A single modular deflector designed to promote some scour off the out-side edge. These deflectors still work even when submerged by high water levels.

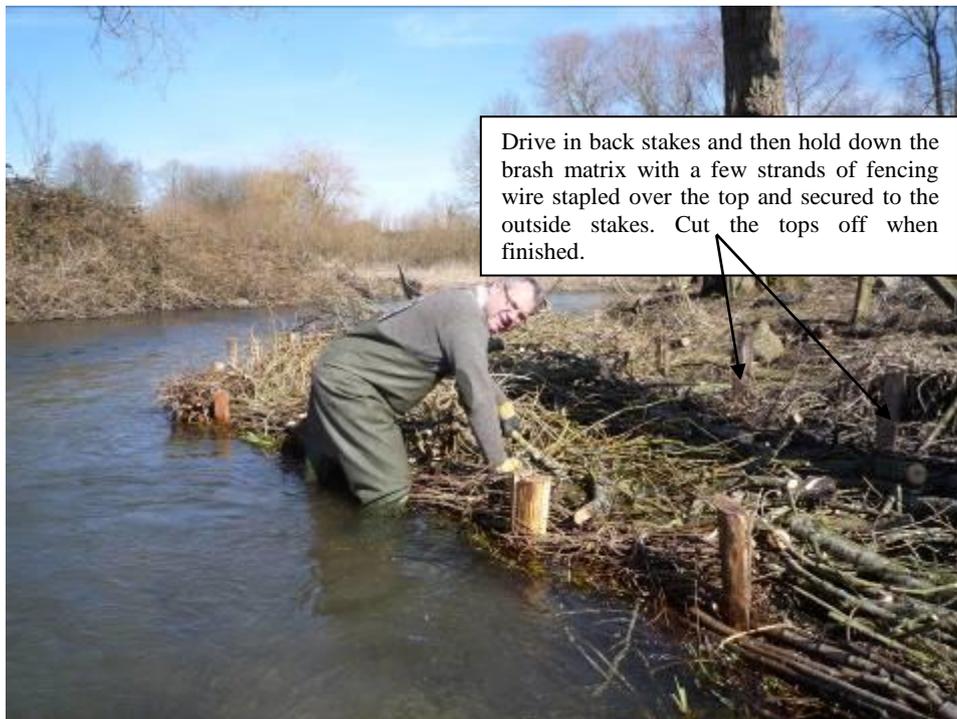
Photo 12 Packing a marginal shelf with lots of wood brushings to help collect sediments and provide a medium for marginal emergent plant growth.

If channel narrowing is to be undertaken using log revetment then ensure the area inside the logs is well packed with brush (photo 12).
