**Advisory Visit**  
**River Esk (North Yorkshire)**  
**13/06/2017**

**Undertaken by Gareth Pedley**

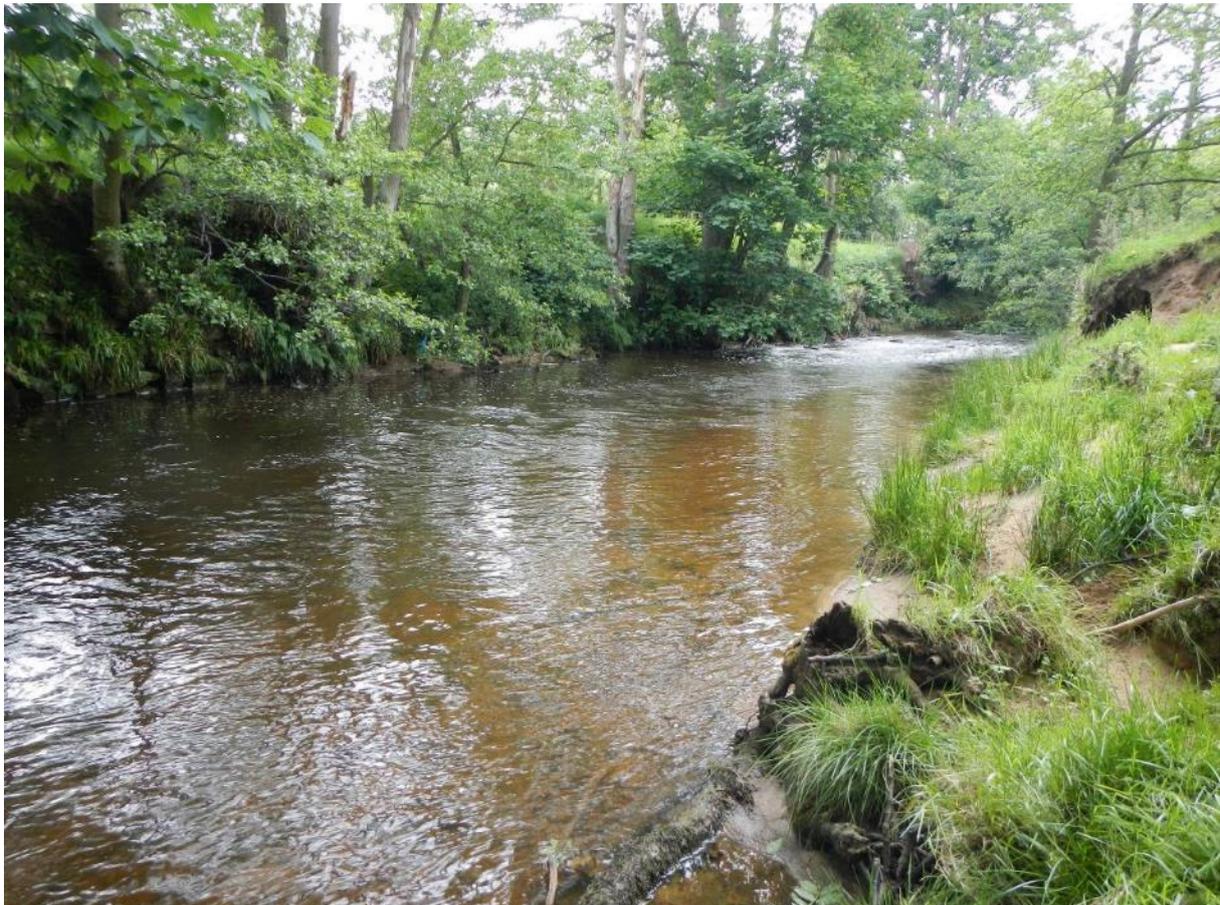
river, with fast, shallow riffles providing high quality juvenile habitat, some potential spawning areas for salmonids and deeper adult-holding water (Fig. 1). Much of the spawning habitat in this area is particularly suited to larger migratory fish owing to the relatively coarse size (c. 40-60mm +) of the substrate (Fig. 2). Smaller resident trout resident trout tend to require smaller substrate (10-40 mm dia. range), which was also present in the area but not as abundant, largely being transported through this higher energy section on high flows.

**Figure 1.** Good quality adult and juvenile salmonid habitat.

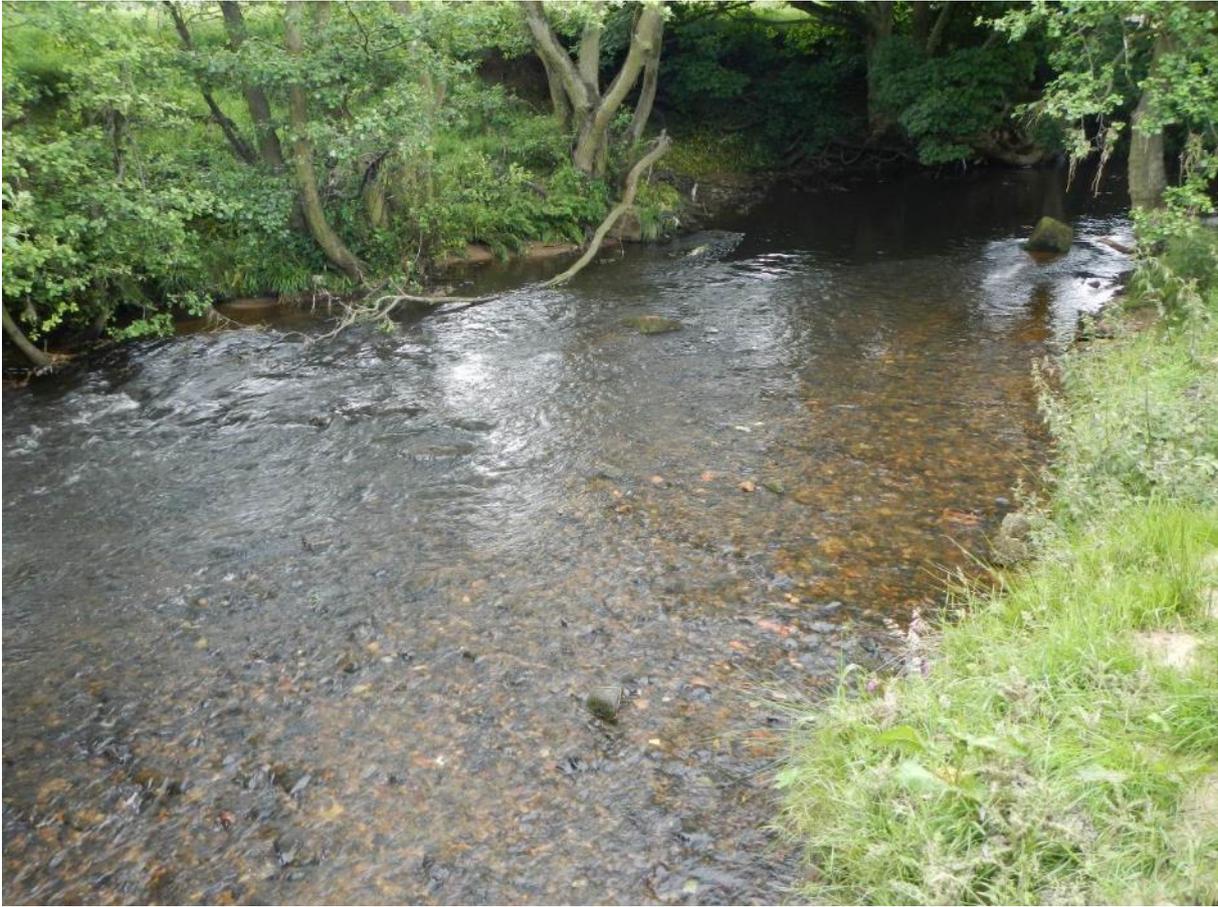
Large volumes of fine sediment were also noted in the river margins and slower-flowing areas indicating excess input from upstream. This finer material often becomes trapped among the coarse substrate, locking the bed together, reducing the availability and quality of habitat many invertebrate species, including pearl mussels. It also degrades potential salmonid spawning habitat by inhibiting the cutting or redds (fish nests) within the gravel and reducing the flow-through of water within the gravels that is required to oxygenate incubating eggs. Fine sediment input is already a recognised issue on the River Esk and something that the NYMNP have been working hard to address through buffer fencing schemes to protect the vital river bank vegetation from livestock.

**Figure 2.** Potential sea trout and salmon spawning habitat. However, the substrate also contains a large amount of finer material, somewhat reducing its quality.

Fine sediment input to the system is a known issue, although one that is already being addressed by organisations like the NYMNP, with already visible results. One of the most significant improvements to habitat would be achieved through further buffer fencing to exclude livestock from the river bank, wherever fencing is not already present. This would facilitate greater diversity of bankside vegetation and shrubs, providing improved habitat and bank stability and reducing erosion/fine sediment input, along with beneficial in-channel structure.

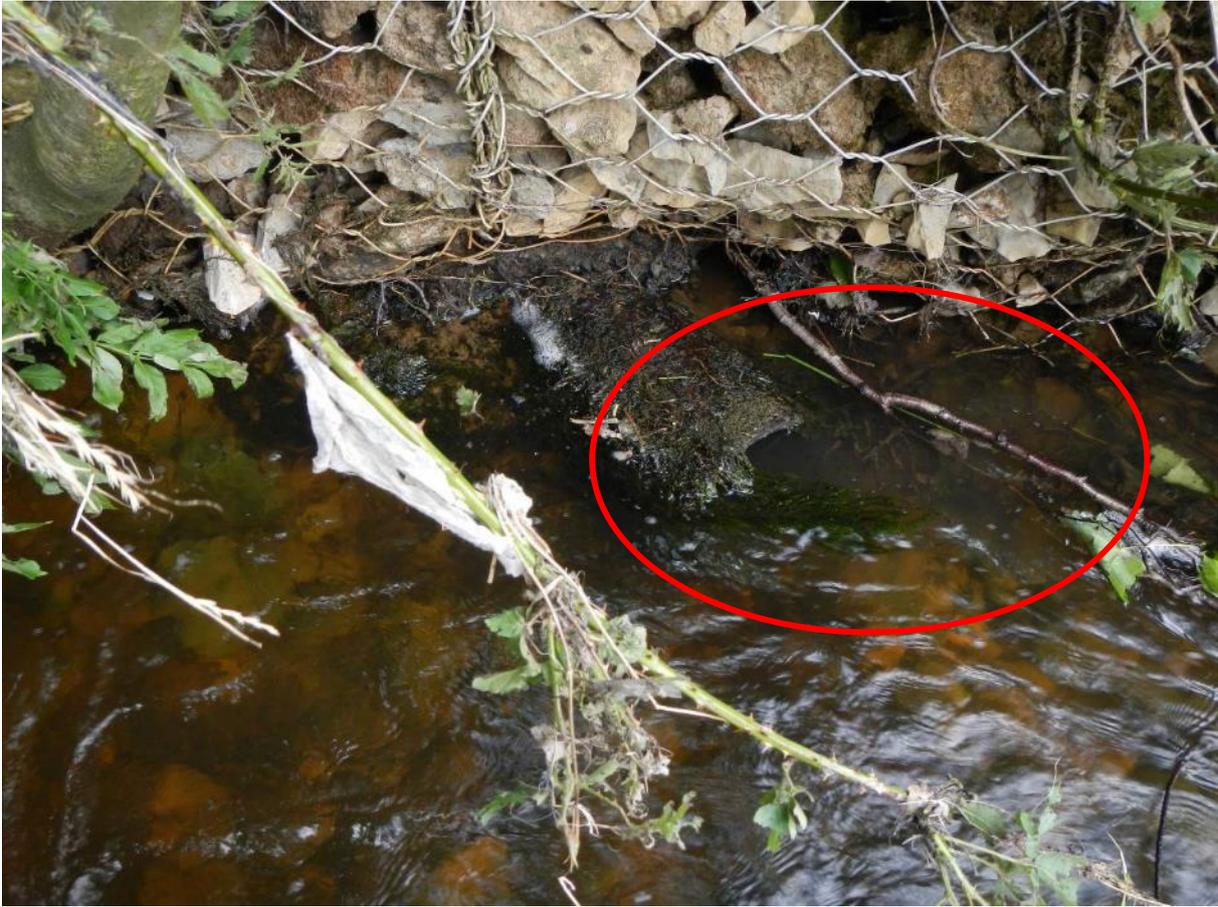
A medium sized sewage treatment works (STW) is located on the LB, which ultimately discharges to the river. While the discharge appeared to be of a low volume at the time of the visit, the water emanating from the plant had a definite greyish tinge, symptomatic of a high particulate loading and excess nutrients (Fig. 1). A smaller, presumed overflow pipe, also appeared to be discharging low volumes of high nutrient effluent to the river (Fig. 2), along with periodic flushes of sewage litter, as observed by remnants caught within vegetation around the outflow pipes.

**Figure 3.** Greyish water emanating from the STW discharge. Also note the sewage litter caught on the trailing vegetation.

Both of these discharge points should be monitored by the club and if any further elevation of turbidity or obvious eutrophication (increased algae or grey or brown biofilm/slime) is noted around the outfalls, the Environment Agency should be contacted on their Pollution Prevention Hotline - 0800 80 700 60. Likewise, sanitary litter should be screened from any discharge to the river and if such items are observed along the river, the water company should be contacted to undertake a litter pick-up.

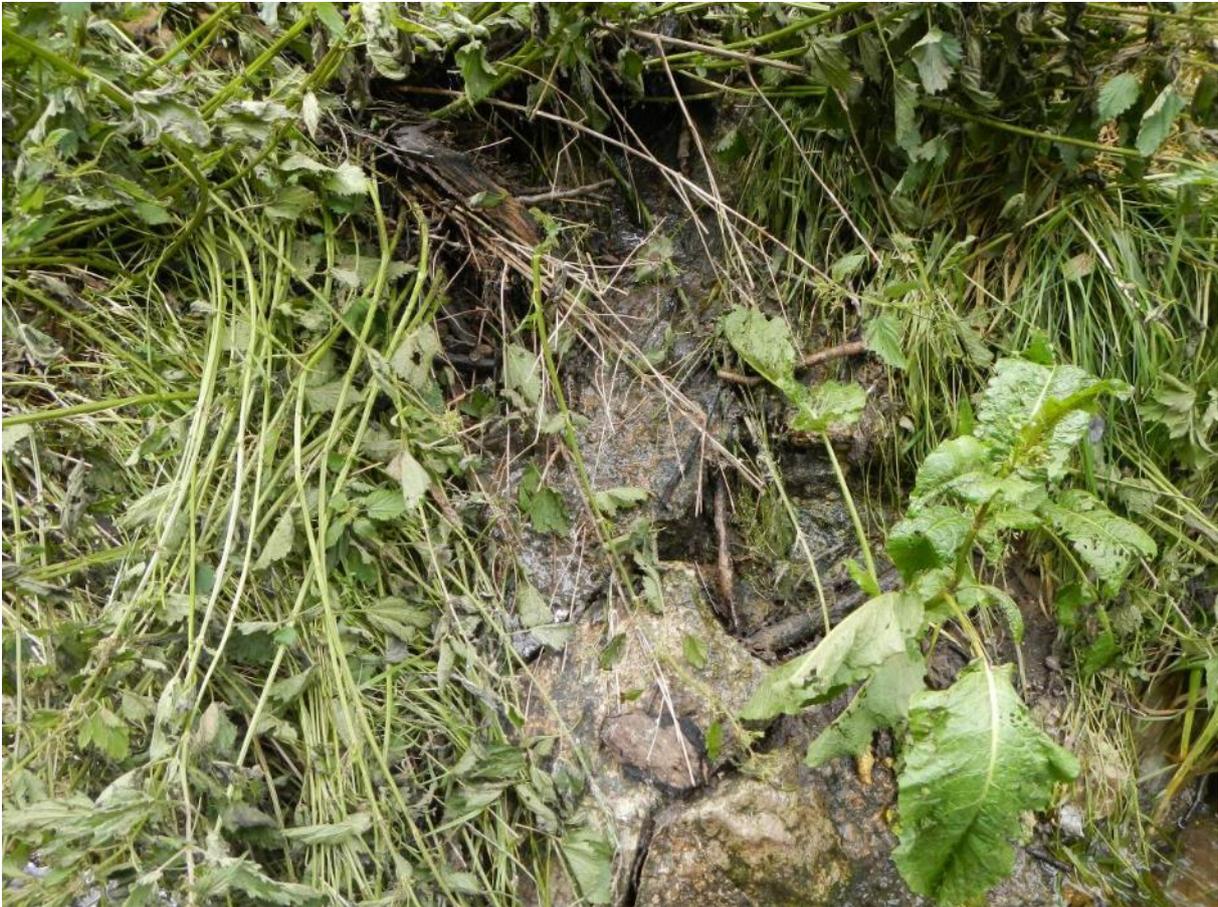
**Figure 4.** Increased biofilm growth around a suspected overflow pipe from the STW.

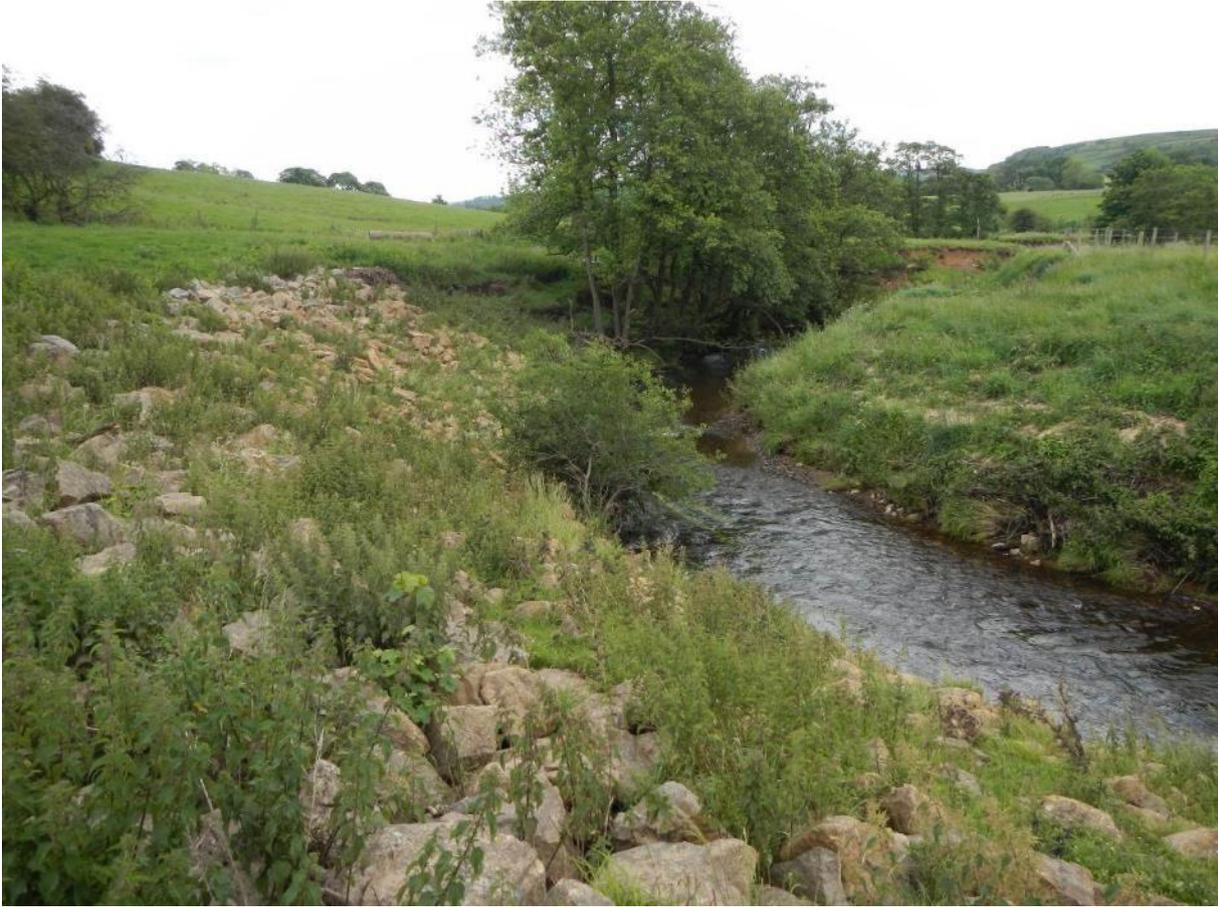
Immediately d/s of the STW a large area of bank armoring has been undertaken, presumably to protect the railway line (Fig. 5). Fortunately, the roughness of the armoring has trapped fine sediment at high flows, allowing vegetation to become established between the boulders and improving bankside habitat.

**Figure 5.** Rock armouring has trapped fine sediment in high flows and facilitated some revegetation of the area. A small willow shrub (*Salix sp.*) was also retained which enhances habitat in that area of bank (red circle).

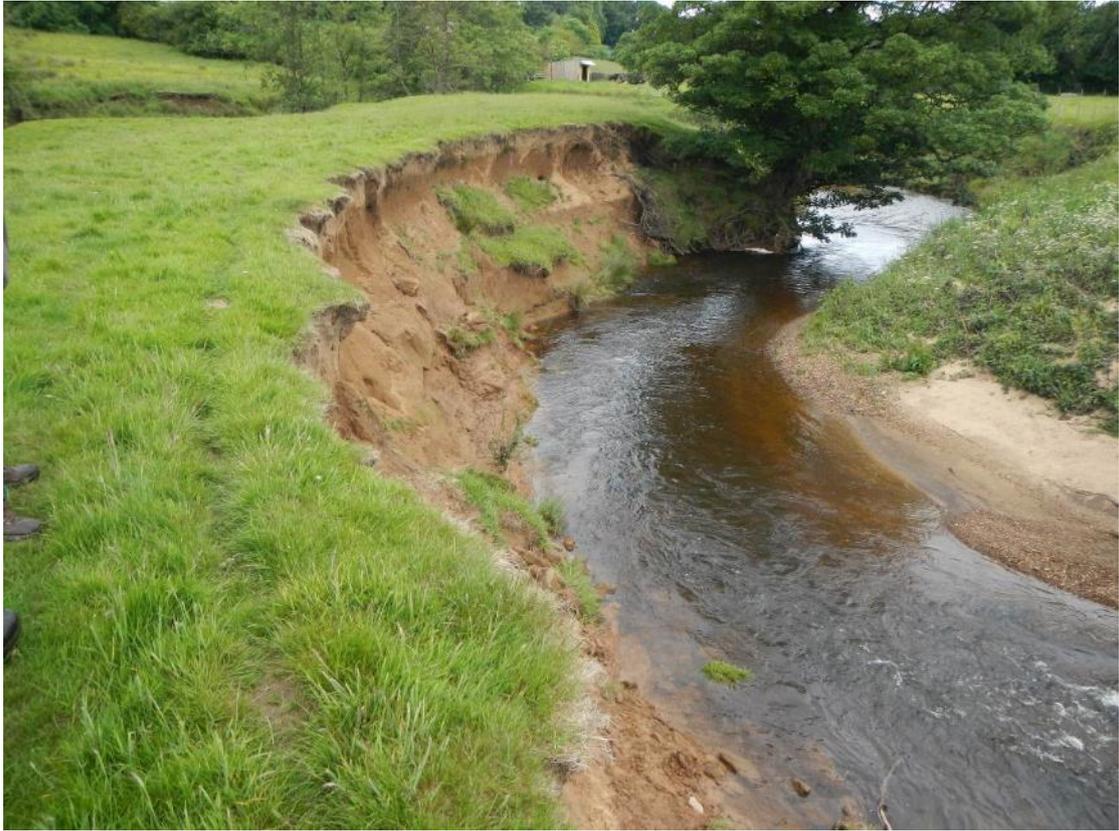
The River Esk will always be prone to adjusting its course owing to the very friable nature of soils within the catchment (Fig. 6). However, grazing pressure further exacerbates erosion, reducing the abundance and diversity of vegetation that would naturally stabilise the banks (grasses being one of the few species that can withstand regular grazing). With more growth expended upon replacing lost foliage than developing root stock, and a fewer root systems, less bank protection is provided. This reduces the capacity of the banks to naturally regrade as any slumped bank material is less consolidated and more easily disintegrates, often washing into the river (bad for habitat quality and for the landowner/tenant).

Livestock grazing also greatly inhibits natural tree regeneration and the bank protection that the trees would provide, as saplings are usually browsed before they can develop. This is bad news for bank stability but has knock-on impacts upon in-channel habitat, as trees provide vital cover and shelter for fish and invertebrates through their roots and trailing branches. The greater bank stability trees provide also deflects erosive flows downwards into the river bed, naturally creating and maintaining deeper pool areas, rather than allowing lateral erosion that would lead to an over-wide channel. Trees therefore often provide, create and maintain the main fish-holding features within a pool.

**Figure 6.** Where livestock have access to the river bank the reduction in vegetation leaves those areas at a far greater susceptibility to erosion. Note how shallow the roots of the grazed grasses are alone (c. 10 cm), in contrast to the diverse, extensive root matrices of ungrazed bank on another section of the River Esk depicted in Fig. 6 (below).

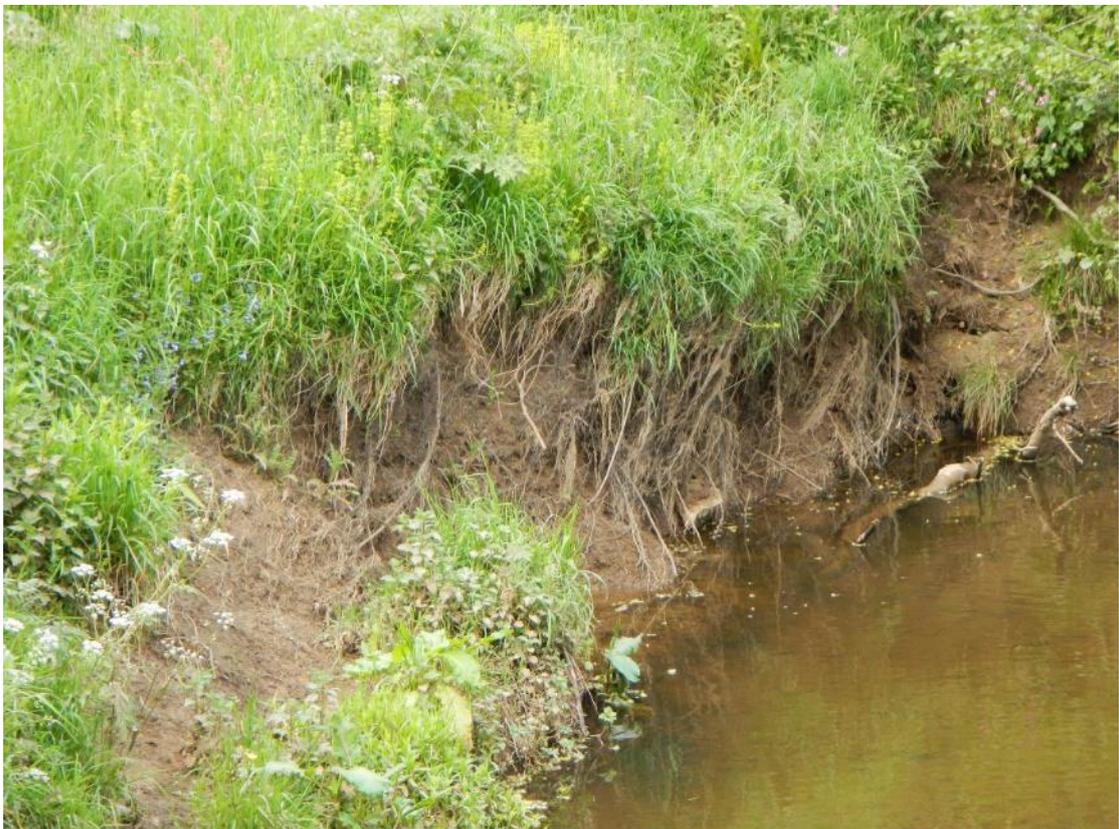
**Figure 7.** In the absence of grazing, the species composition and range of root systems is far more diverse, penetrate much more extensively into the ground and offering far greater bank protection (and habitat potential).

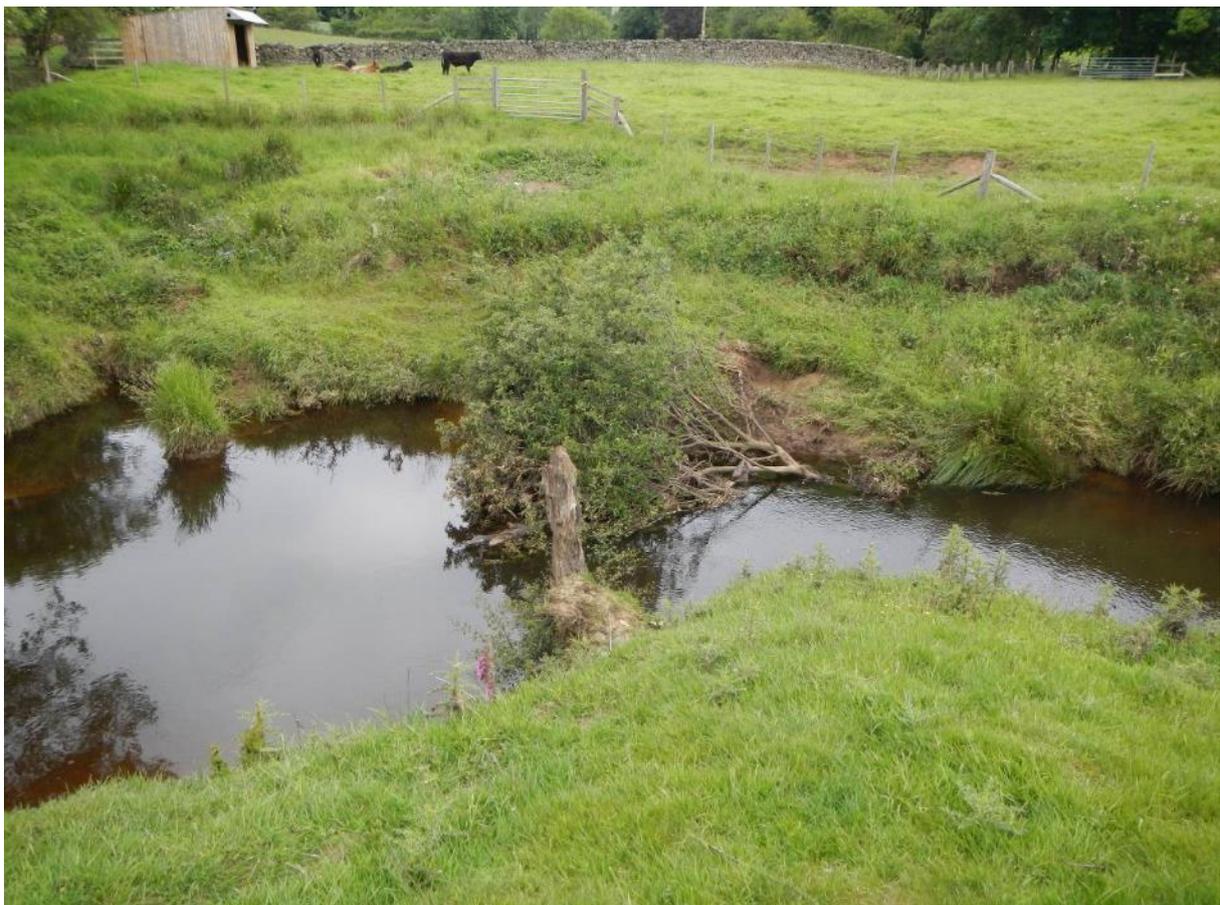
Woody material within the channel plays a vital role in creating and maintaining fish habitat. The localised flow pinching and scouring that it promotes helps to scour and maintain deeper pool habitat, while the structure and diversity of flow increases the range of habitat niches that are provided for both fish and invertebrates (Fig. 8). Structure provides vital refuge, allowing fish to shelter during floods and areas in which they can more effectively evade predators (Fig. 9). It is far easier for fish to swim amongst branches and obstacles than is for predators like goosanders (*Mergus merganser*), cormorants (*Phalacrocorax carbo*) etc., so fish will utilise such structures in evading whatever is chasing them.

**Figure 8.** Valuable in-channel structure provided where a willow tree has collapsed into the river. A great example of natural fish-holding habitat and refuge.

It is therefore vital to retain as much in-channel structure as possible. Doing so will not only increase the number of fish that the river can support (providing more fish habitat) but will also increase the survival rate of those fish. Structure also provides interesting features to cast to, making angling slightly more challenging in terms of accessing the fish but also better, as there will be more fish to target.

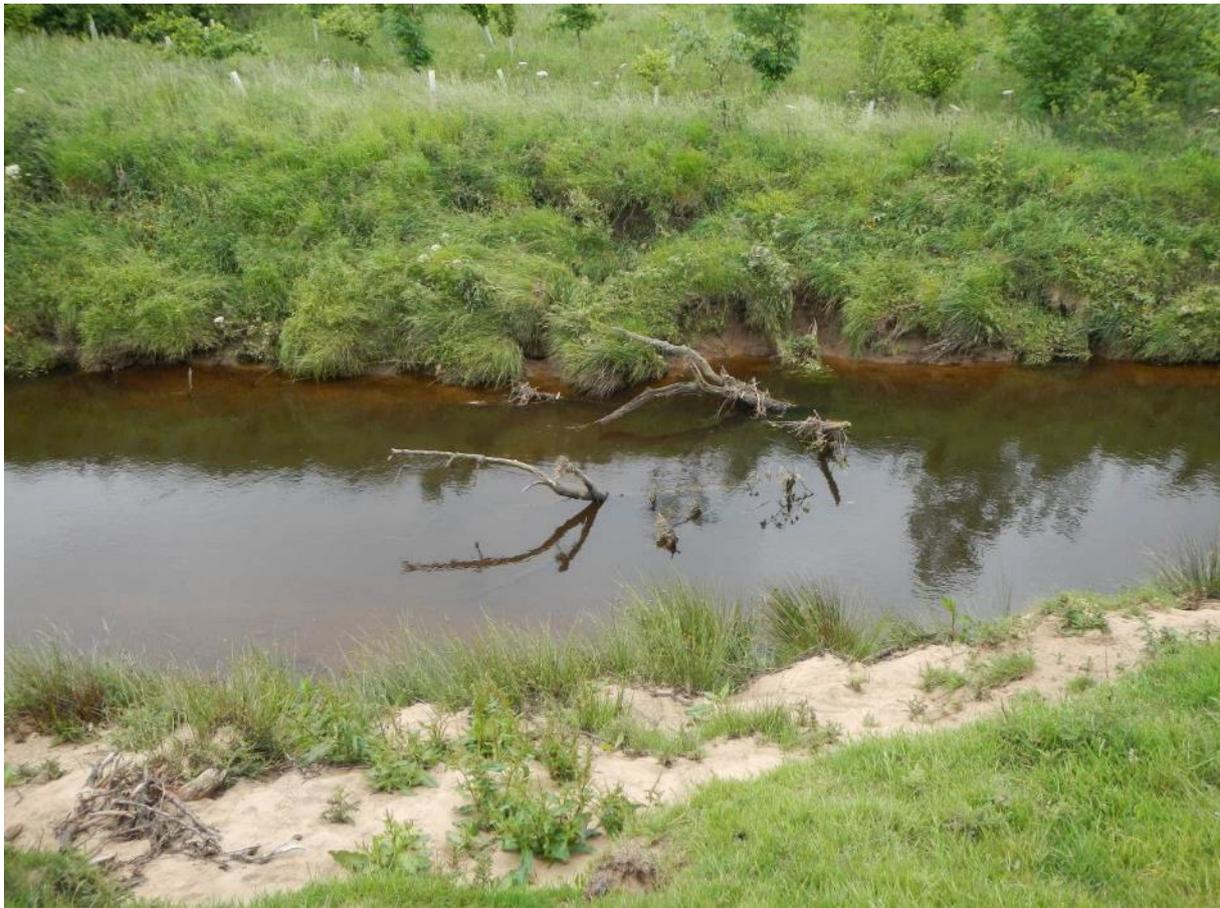
**Figure 9.** A seemingly worthless, dead tree; however, the this will not only provide additional habitat in what is a relatively featureless area but will also offer structure to assist fish in evading predators. Also note the fine sediment trapped along the near bank highlighting the excess fine material supplied form u/s and the benefit of rough vegetation along the banks to trap and consolidate this material into new bank.

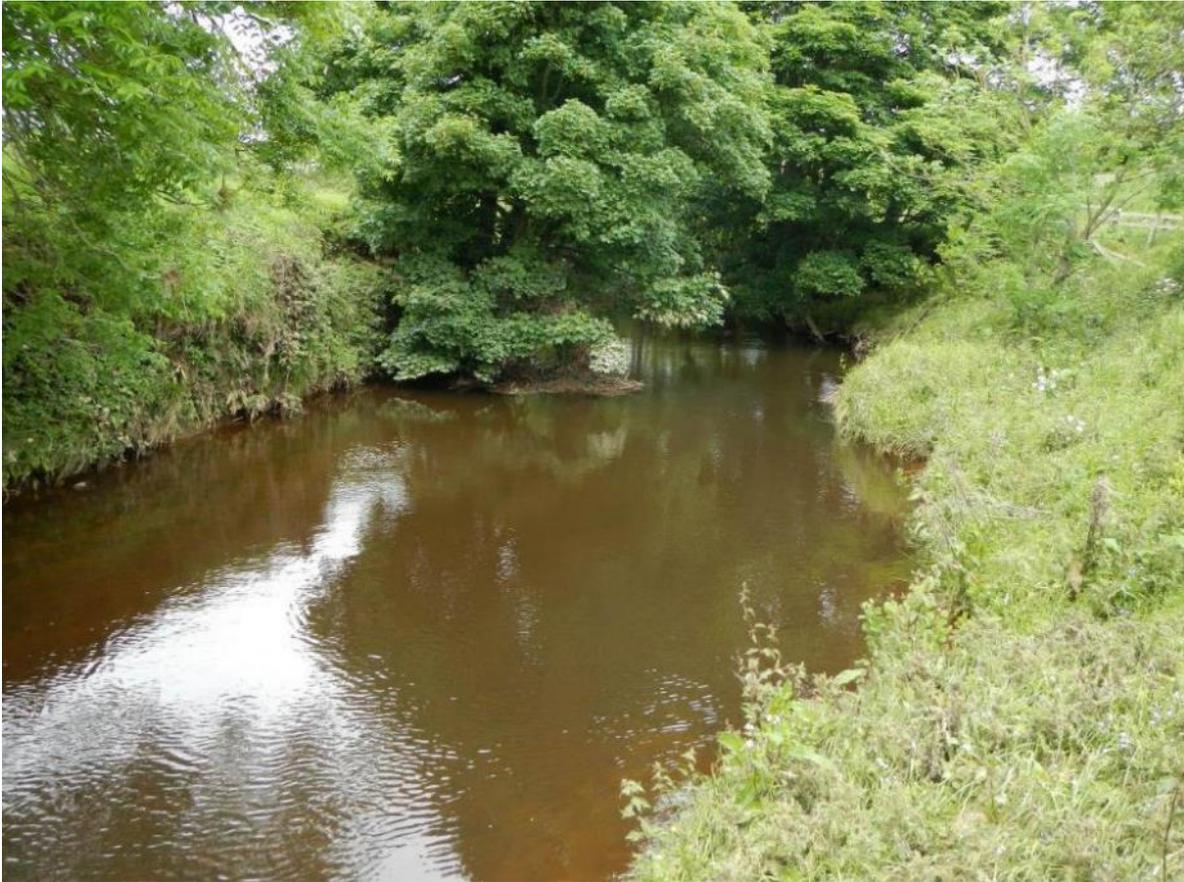
An interesting area of habitat was observed where large bankside trees have been left to encroach out over the channel and trailing branches from a sycamore (*Acer pseudoplatanus*) on the RB have accumulated a raft of debris (Fig. 10). This area may be tricky to access for traditional wet fly techniques but is exactly the kind of habitat that is vital for resident trout and will provide great features to fish to with a nymph or dry fly. Retaining some less accessible areas also creates locations in which larger river resident fish are likely to grow on.

**Figure 10.** Excellent shade and cover for resident trout that is likely to support some larger specimens. This area also provides holding water for migratory fish ascending the river.

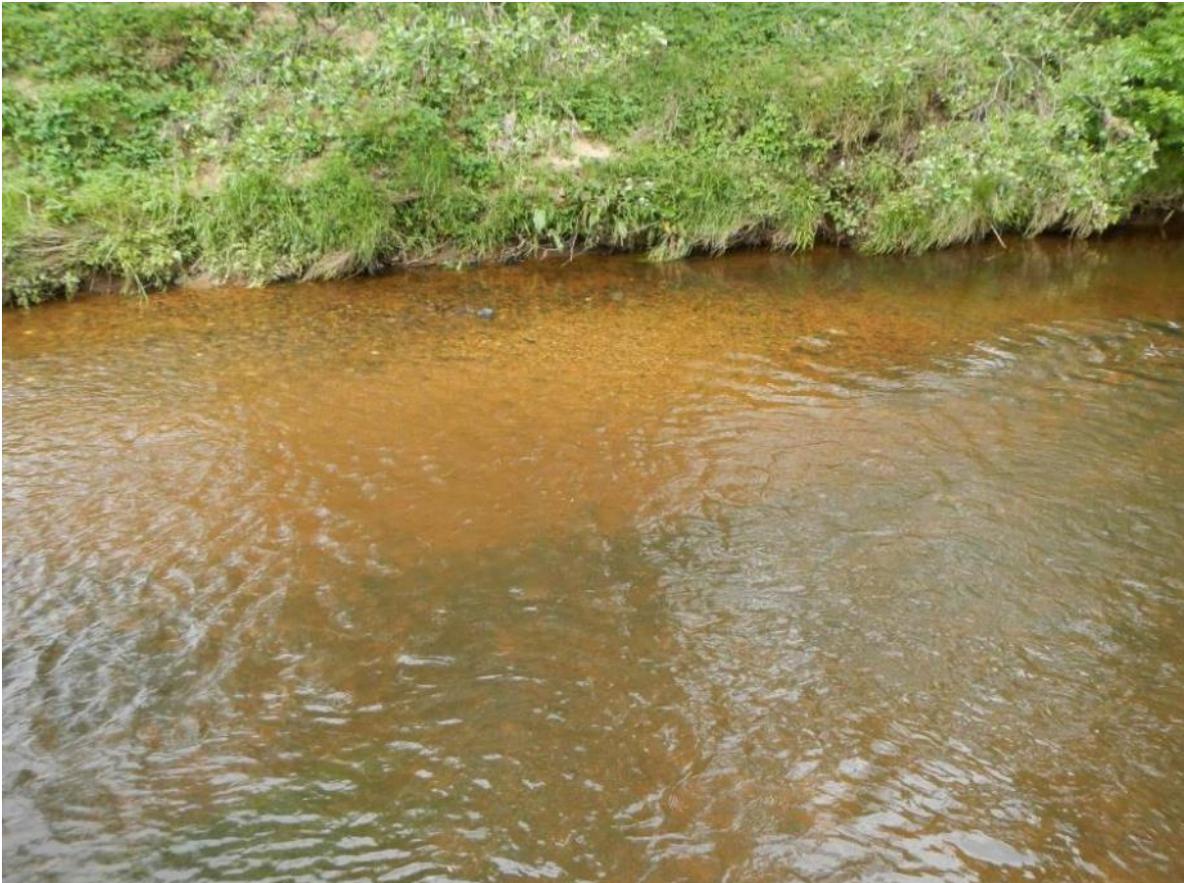
Recently scoured bed material (sorted by size and relatively free from fine sediment) at the bend d/s provides valuable trout and sea trout spawning habitat and demonstrates that main river spawning opportunities are available, even for resident trout (Fig. 11). Such riffles and substrate provide important habitat for many of the key invertebrate species that form part of the trout's diet and hatches fished by anglers.

**Figure 11.** Relatively silt free, size-sorted gravels, providing good potential salmonid spawning and invertebrate habitat.

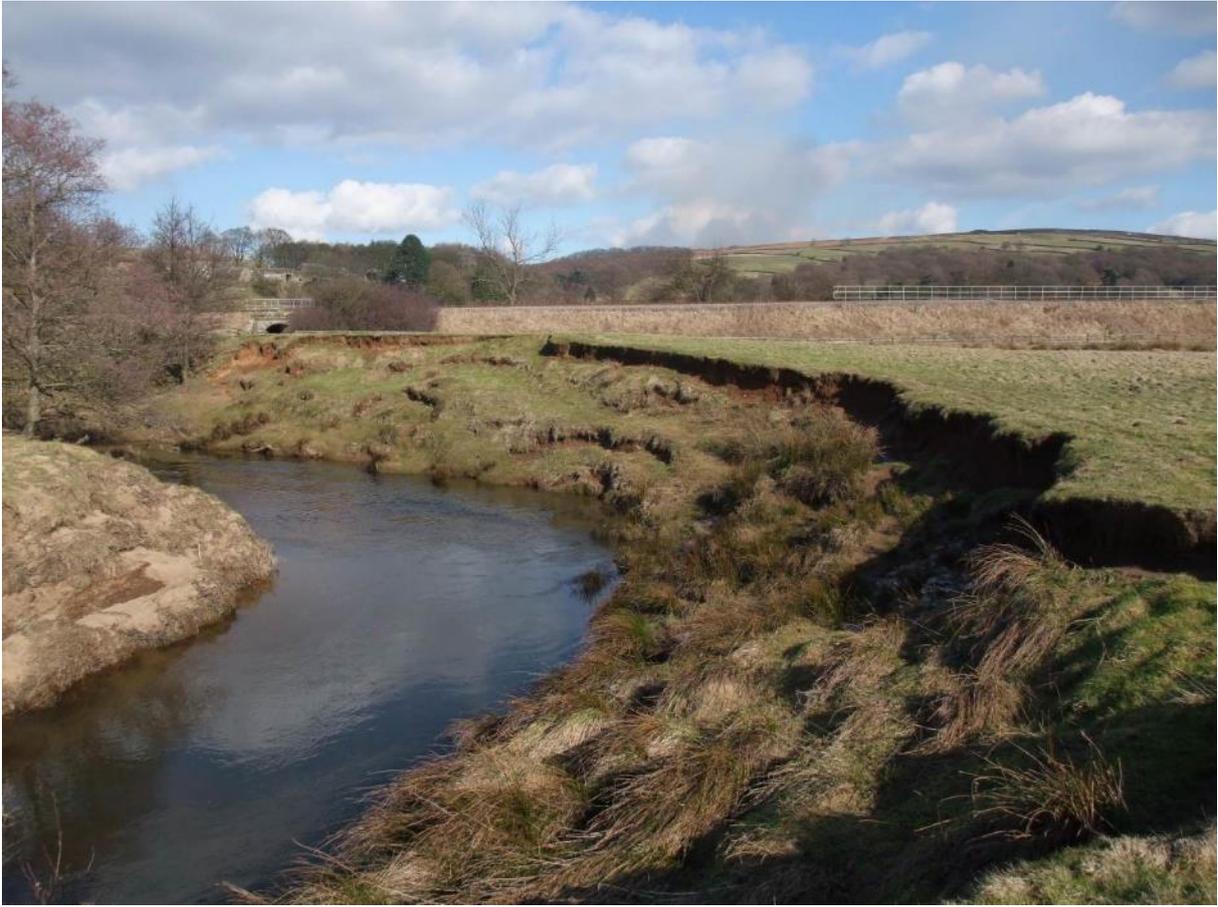
Figure 12 shows the condition of the next bend d/s before a fencing and tree planting scheme undertaken by the NYMNP. Figure 13 brilliantly demonstrates how easily the issue was addressed with the installation of a buffer fence to exclude livestock.

**Figure 12.** How the riverbank depicted in Figure 12 looked before livestock were excluded and planting was undertaken.

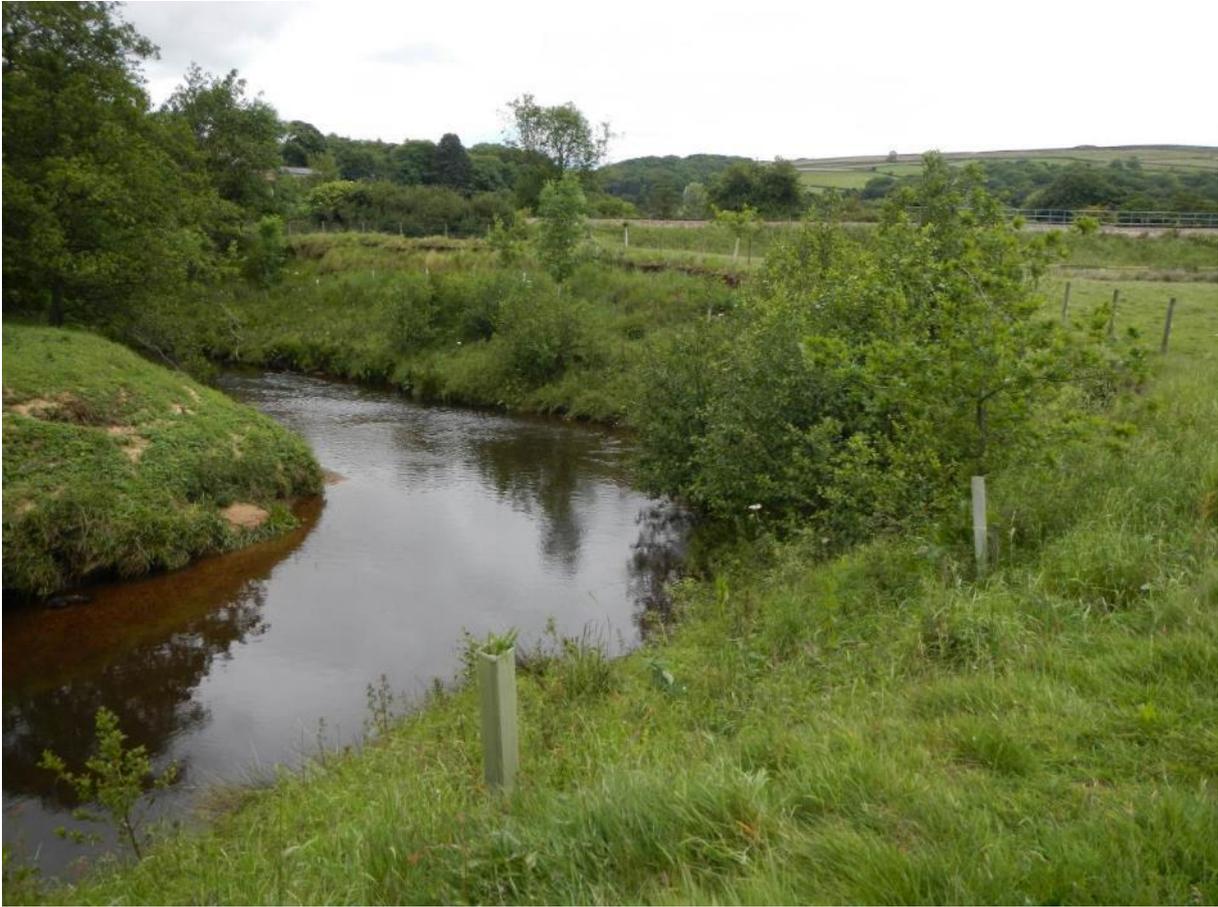
**Figure 13.** High quality habitat and stable river bank observed during the visit, following buffer fencing. Note the far greater diversity of vegetation achieved.

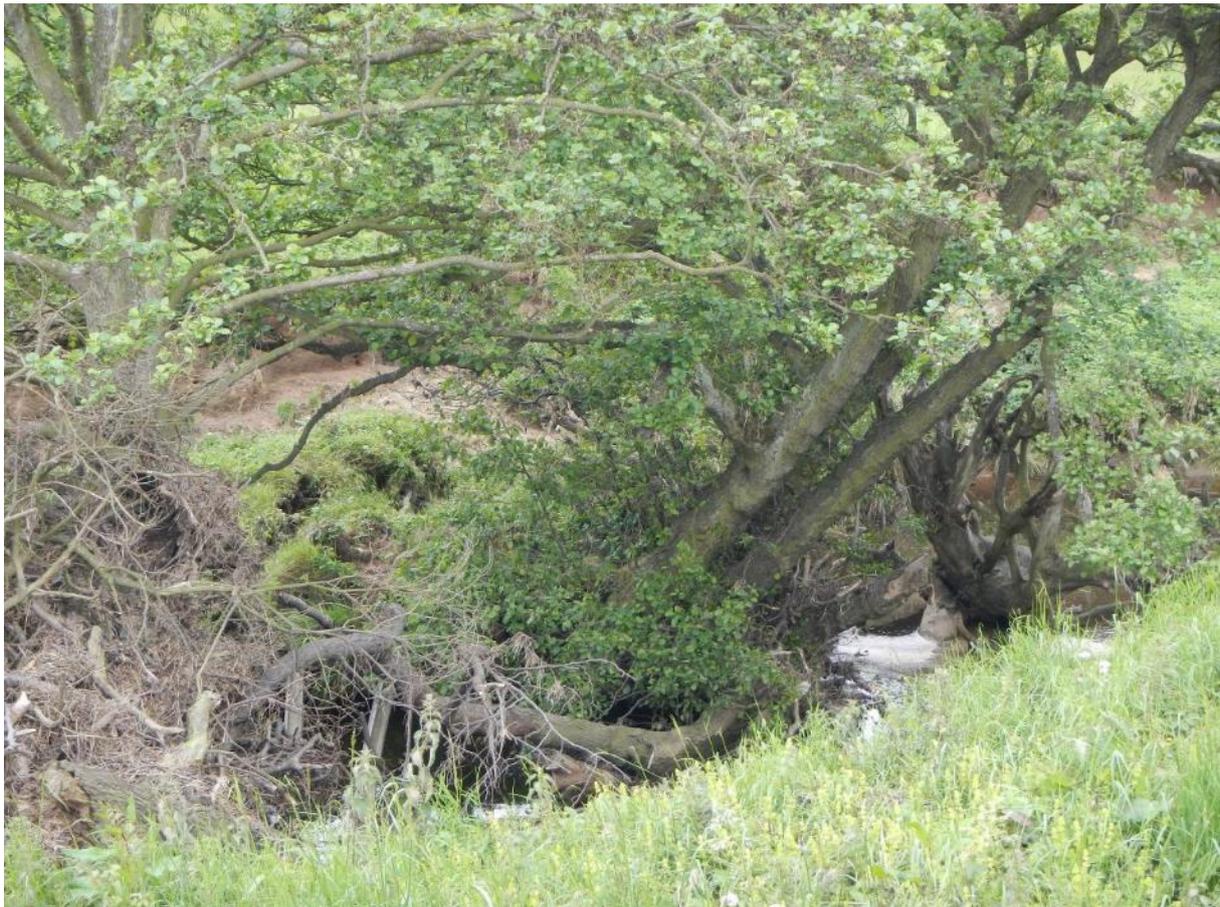
**Figure 14.** *A leaning alder that may require coppicing in the future. If the structure does not cause excessive erosion issues it may be better left untouched.*

In some areas, sympathetic tree management might be beneficial. Figure 14 shows a slumped alder tree that has fallen partially across the channel. While this feature provides valuable habitat and should ordinarily be left in place, it could increase erosion of the adjacent bank and the landowner tenant may wish to have it removed. In that instance, coppicing the tree to allow it to be retained in place while reducing the impact upon flow conveyance and the bank could be a mutually agreeable compromise. However, if this work is undertaken, the requirement for future maintenance should also be considered as coppicing or tree maintenance has the potential to encourage vigorous regrowth.

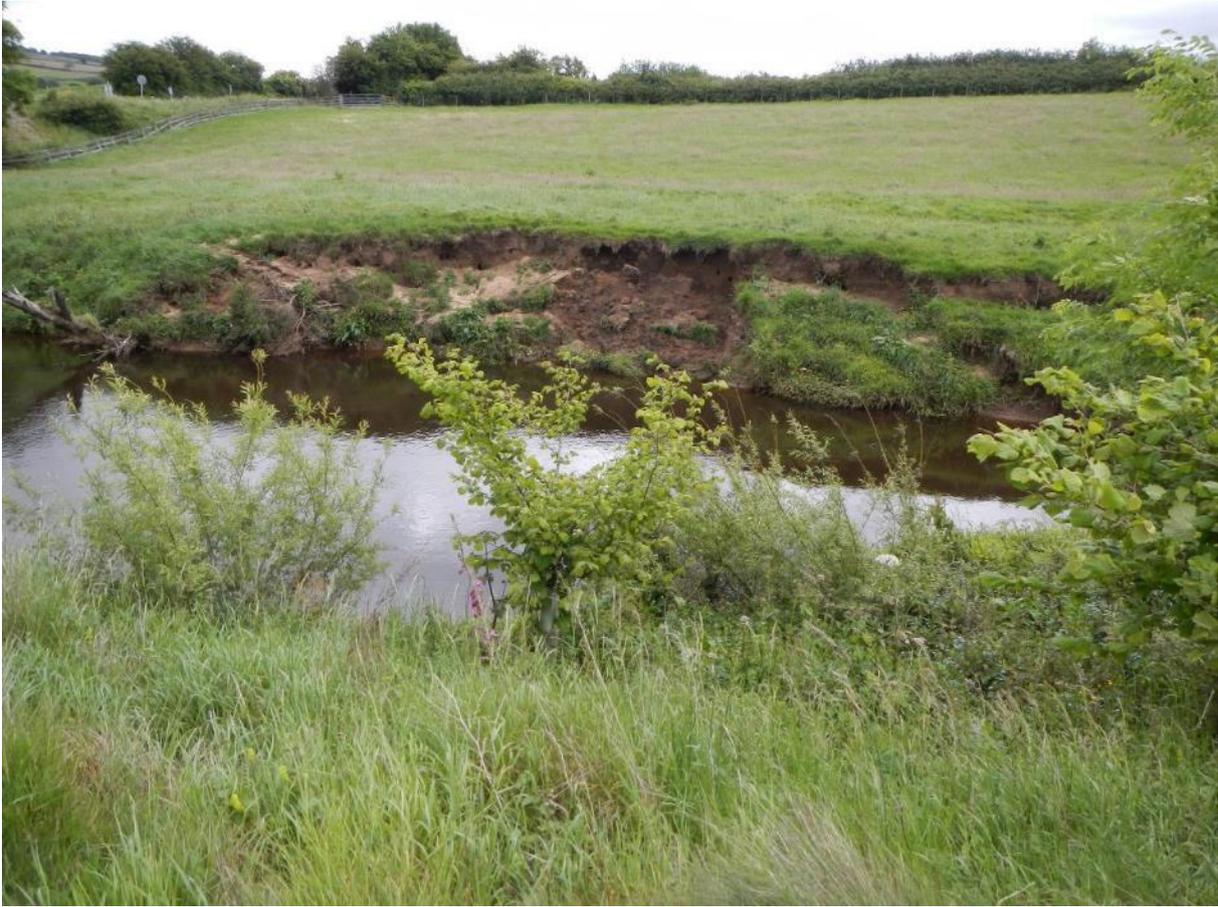
Towards the d/s end of the fishery, the remains of low-level boulder weirs were observed. Such structures were historically used all over the country in attempts to improve habitat but, in fact, weirs create more issues than they solve, impounding flow, interrupting sediment transport and often increasing bank erosion locally. For this reason it is far better to allow natural cover and flow diversifying features like fallen trees and overhanging branches to develop. Fortunately, the weirs have largely disintegrated and now pose a minimal issue. However, the localised impacts on bank erosion can still be seen in some places (Fig. 15).

**Figure 15.** *The localised bank erosion immediately d/s of a now defunct boulder weir. The interruption of sediment supply downstream (and associated bed lowering) and turbulence and lateral scour often leads to accelerated bank erosion d/s of a weir. Fortunately in most cases the weirs have largely disintegrated and their impact upon the banks should continue to reduce as they degrade.*

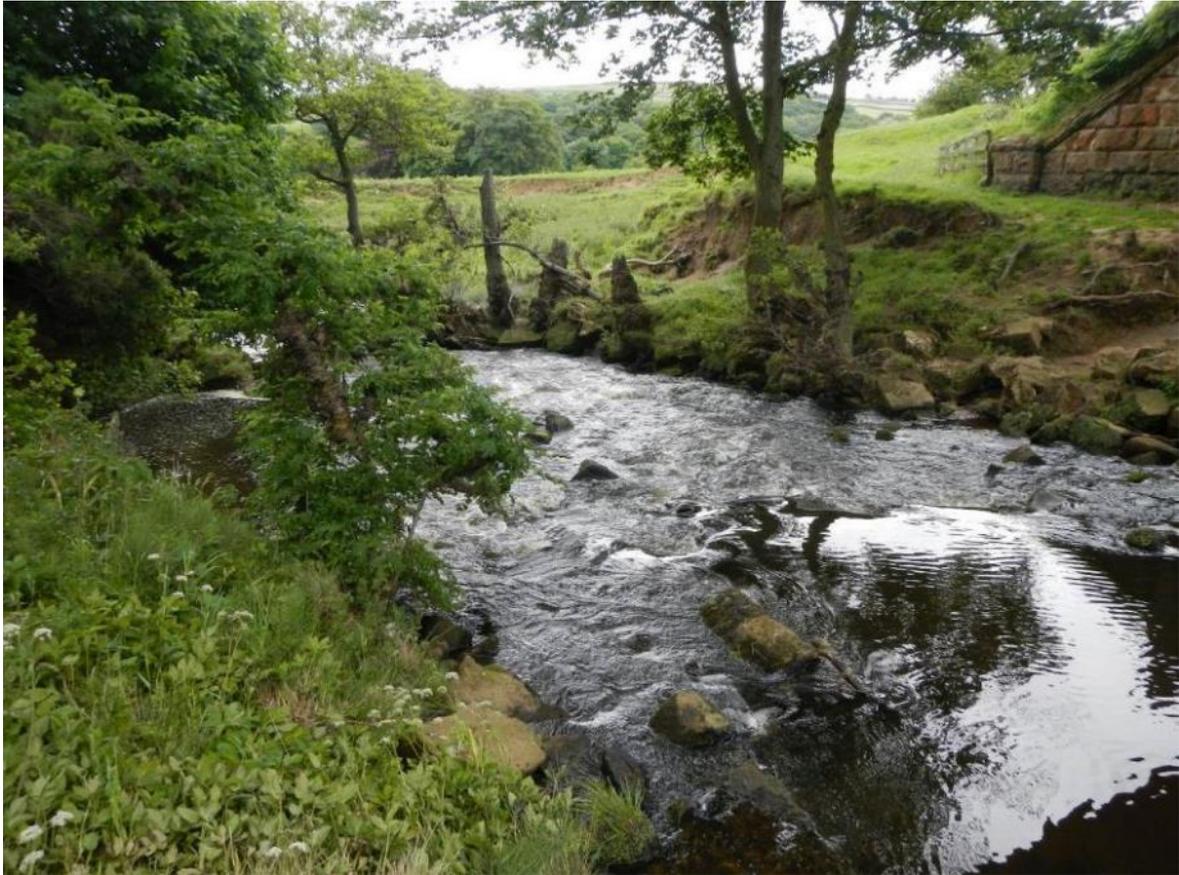
At the d/s limit of the reach walked, what appeared to be rock armouring of the bed around the railway line creates an un-natural but reasonably well passable obstruction in the channel. The raising of the bed level created also impounds the river upstream. Ideally, structures near watercourses should be set well back from the channel (or buried well below) to allow the establishment of a natural channel width and gradient through the area. That would be the best practice standard today, but was often not the case historically and the legacy of past channel alterations and in-channel structures often remain.

**Figure 16.** Rock armouring of the river bed. The obstacle created is not great (similar to a steep rock ramp type fish easement) but the impoundment created upstream reduces habitat quality. Possibly one of the reasons for the past attempts to improve habitat with weirs which, sadly, only exacerbates the problem.

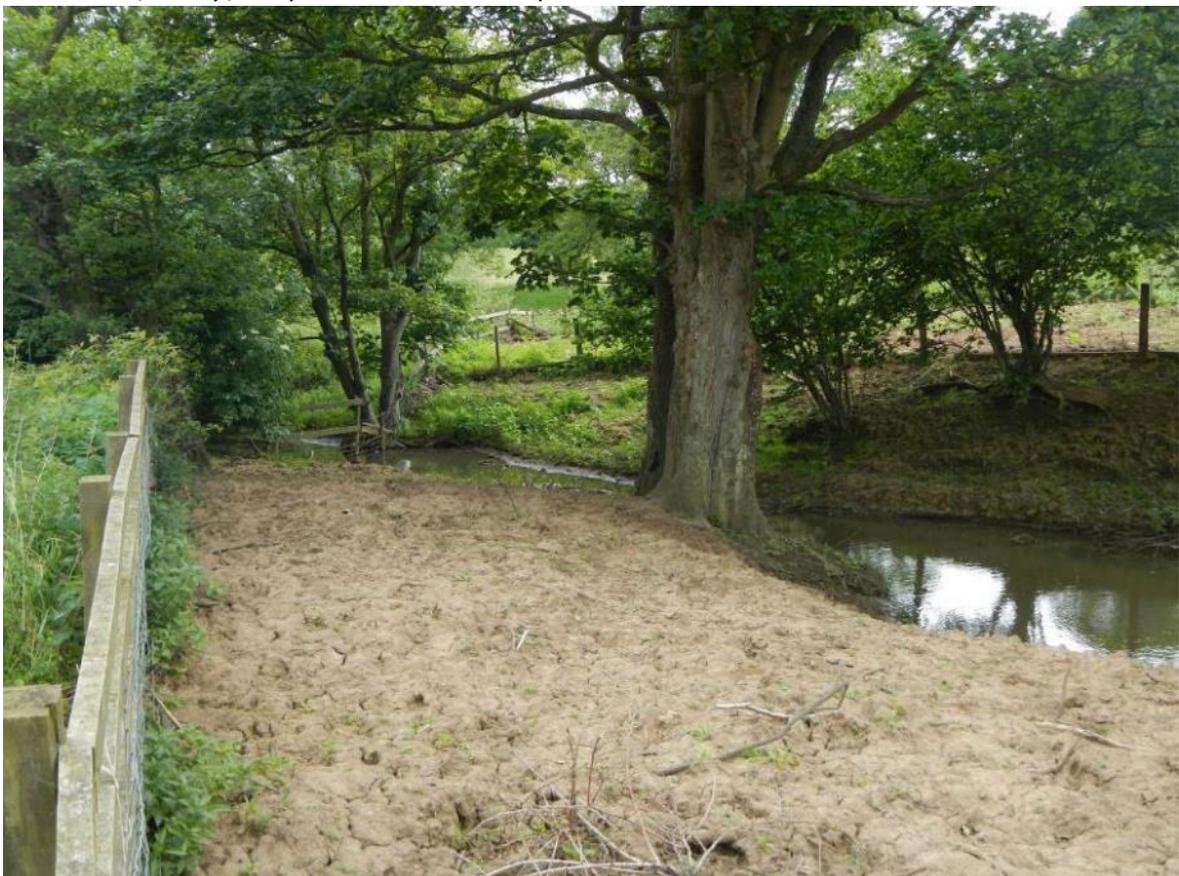
On the walk back up the river, a fenced area (pig pen) enclosing a small tributary/drain was observed. This watercourse discharges into the river and any increased erosion and fine sediment input entering that watercourse will end up in the river, particularly following heavy rainfall. Ideally areas where livestock have access to water and have the potential to increase sedimentation should be offline (e.g. an enclosed pond) so that fine sediment pollution of watercourses does not occur. This is something that should be discussed with the owner of the livestock to ascertain whether the sediment input to the watercourses can be prevented.

**Figure 17.** The pig pen and small tributary/drain. Ideally if livestock, particularly pigs, are given access to water it should not be connected to the river.
