**Advisory Visit**  
**River Esk (North Yorkshire)**  
**13/06/2017**

**Undertaken by Gareth Pedley**

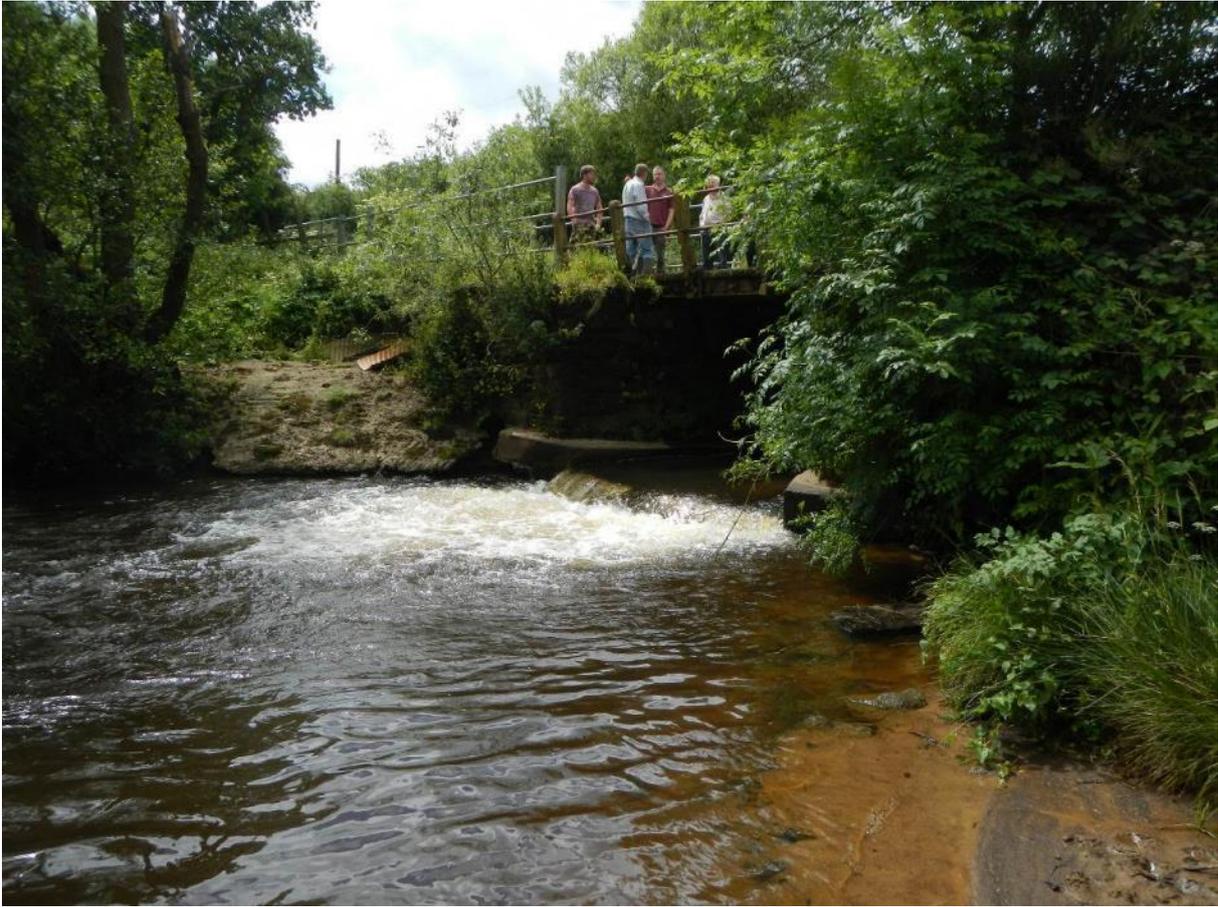
Following the river walk, brief inspection of two potential barriers to fish movement was undertaken. The first structure, a farm access bridge/culvert at NZ 72713 07336, does pose an obstruction, particularly for the u/s passage of smaller fish with low swimming ability (Fig. 18).

**Figure 18.** *A relatively low obstruction but the step and air cavitation, coupled with high flow velocities with the smooth bedded culvert, and the prolonged burst swimming speeds required to pass make this structure an issue for fish passage.*

The best practice when installing any crossing of a watercourse is to make it clear-span and of sufficient capacity to accommodate all flows received (e.g. much greater capacity than the current structure). Additional overspill pipes have already been required at either side to handle flood flows and this further demonstrates the poor suitability of the structure. Where a clear-span structure is not possible, an oversized, sunken culvert should be the alternative option (as opposed to an undersized perched one in this case). Before any further maintenance is undertaken on this structure it is strongly recommended that replacement with the aforementioned options is considered. Either option would not only alleviate the fish passage issues but also reduce the access issues that will currently occur during floods owing to the lack of capacity under the track. Allowing sediment transport past any structure would also prevent it from becoming perched and greatly reduce the requirement for future maintenance.

Short term, it may be possible ease fish passage at the site. The LB side of the structure is lower, reducing the jump required to enter the culvert and this is likely to be the preferred access route, although the narrow width within the culvert creates quite high flow velocities over a smooth bed which smaller fish will struggle to pass. Culvert passability is usually improved by bolting baffles or baulks onto the bed of the culvert to increase turbulence and often the depth within the structure. Here, lack of depth is not a particular issue as the flow is already pinched within a narrow channel. Any proposed improvements must bear this in mind, ensuring not to overly restrict the channel width and further increase flow velocities.

Short baffles could be installed into the culvert to dissipate flow energy at either side and create resting areas for fish ascending the structure. More detailed dimensions and, ideally, flow measurements would be required for a detailed design, but a simple array of alternating baffles is likely to be a suitable solution. Each baffle would increase turbulence on the u/s and d/s side of it, creating resting areas from which structure could be traversed in several small steps, rather than one prolonged burst. The design would have to take into account the natural access point at the lower, LB side and ensure not to reduce impede passability there. The air cavitation occurring under the water, along the d/s edge of the culvert also poses an issue, making it difficult for fish to swim straight in. This issue could be greatly reduced by grading out the step or by chamfering the corner of the step / installation of an adherent nappe.

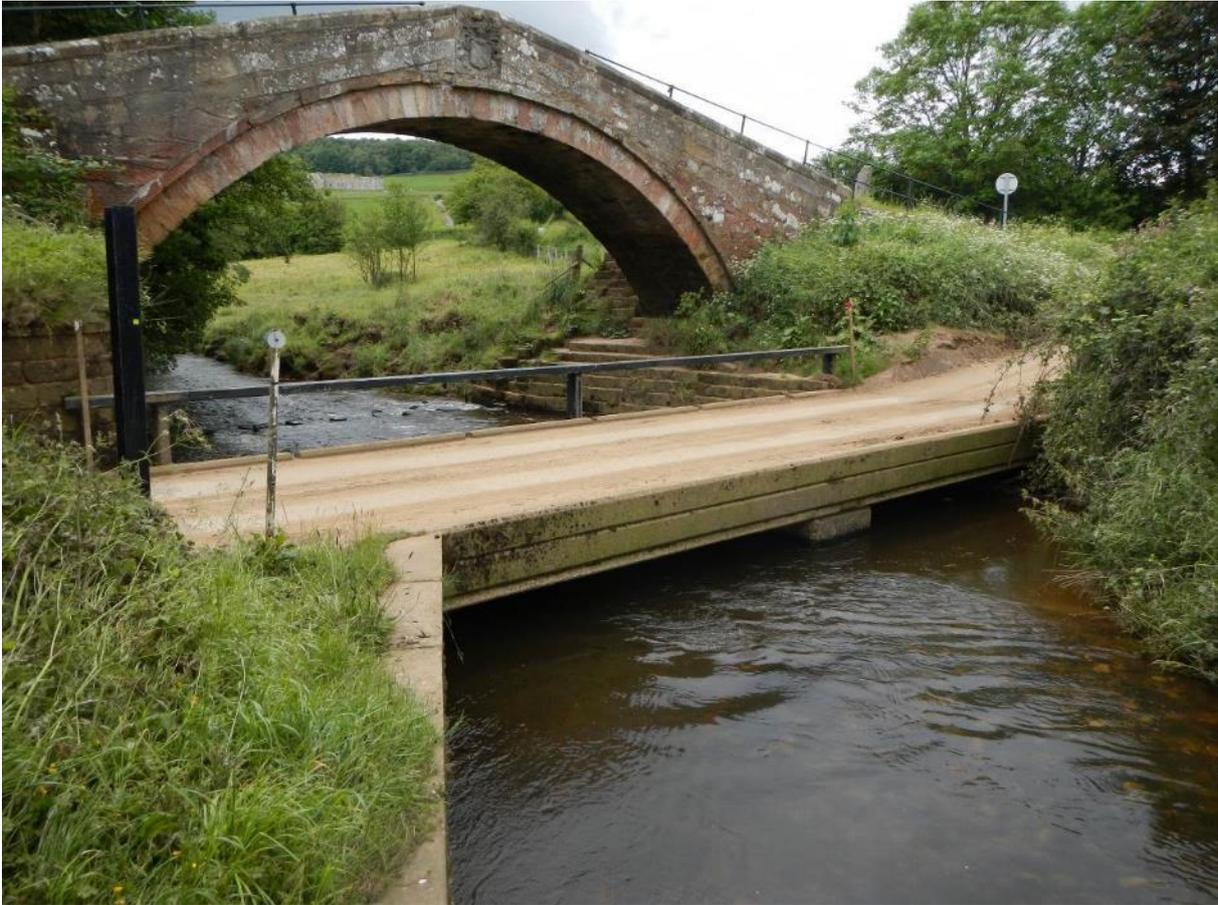
The second structure observed is a culvert variation of a piped ford, at NZ 71957 07747 (Fig. 19). While this structure is far from ideal, the fact that it has been created using reasonably large-sized culverts, which have been sunken well into the bed, reduces its impact. This has allowed the river bed to regrade through the culverts, making it almost as passable as a natural river section at low-medium flows. At higher flows the constriction of the channel created is likely to render it less passable, especially as debris becomes accumulated on it, but this structure is considered to be less of an issue than many others on the catchment and will be passable in most conditions.

**Figure 19.** *Two sunken culverts employed to create a kind of pipe ford. While this is not ideal, it has been installed in a reasonably sympathetic way and does not pose a significant obstruction.*

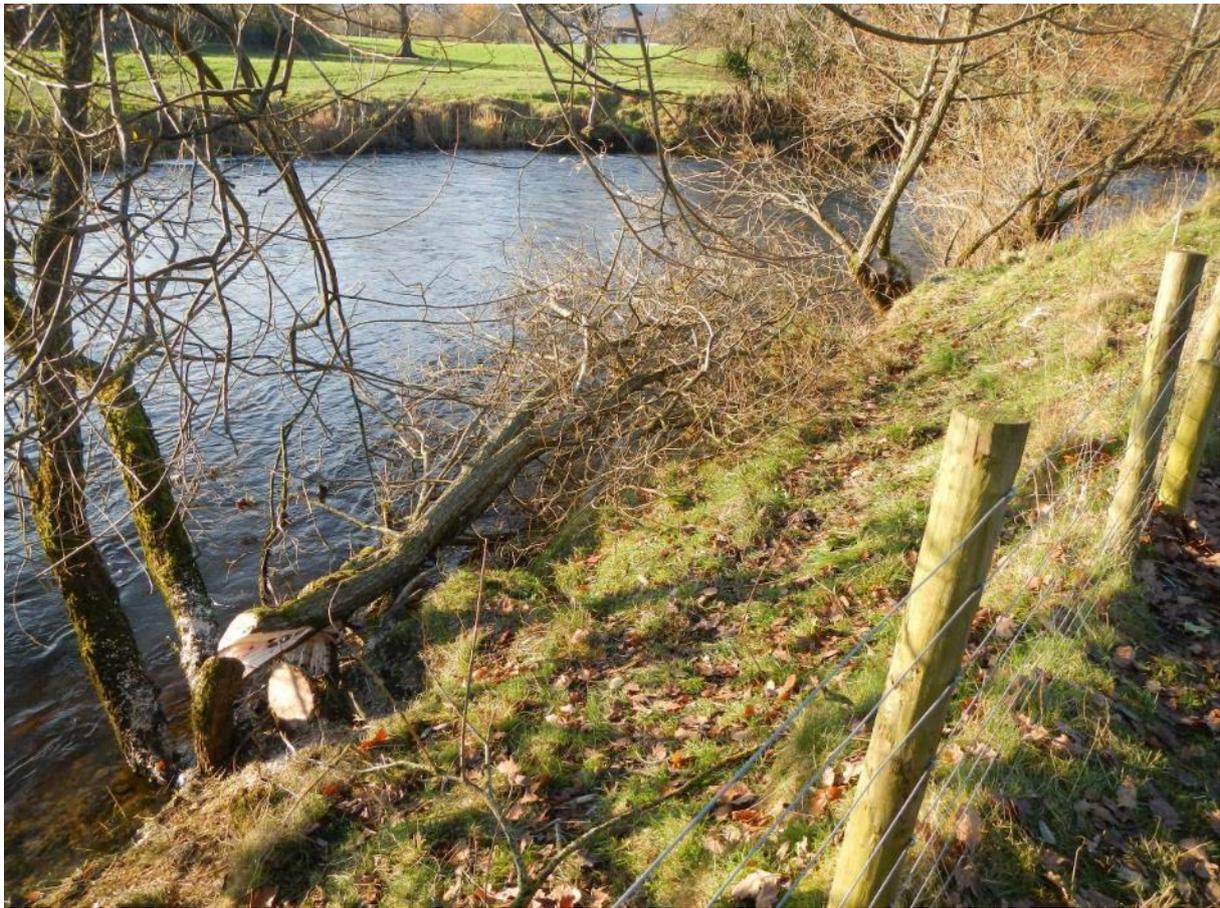
**Figure 20.** Willow hinged into the river margin to increase cover and structure.

Where trees of a suitable species are already established along the banks, habitat improvements can be quickly and easily achieved by laying the trunks, or branches down into or over the watercourse. However this should be undertaken sparingly as the habitat available in most places is already good.

Laying is usually limited to pliable species, predominantly willow (*Salix* spp.), hazel (*Corylus avellana*), elm (*Ulmus minor*) and small alders (*Alnus glutinosa*), but some others can be laid carefully when they are small. Willows are the best species' to lay into the water as they will thrive in the wet conditions, other species are usually better laid along the bank / water interface, so the majority of the canopy is not submerged.

The laying method involves cutting part way through the stem/trunk, a little at a time (ideally while it is under light tension), until it can be forced over into the river (Fig. 15). The depth of the cut should be limited to only that which is required to bend the limb over, as this will maintain maximum size and strength of the hinge and the health of the tree/shrub. Fast growing trees like willow can even be strategically planted in anticipation of employing this technique once they become established.
