**Site assessment**

**River Esk – Ruswarp**

**North Yorkshire**

**23/08/16**

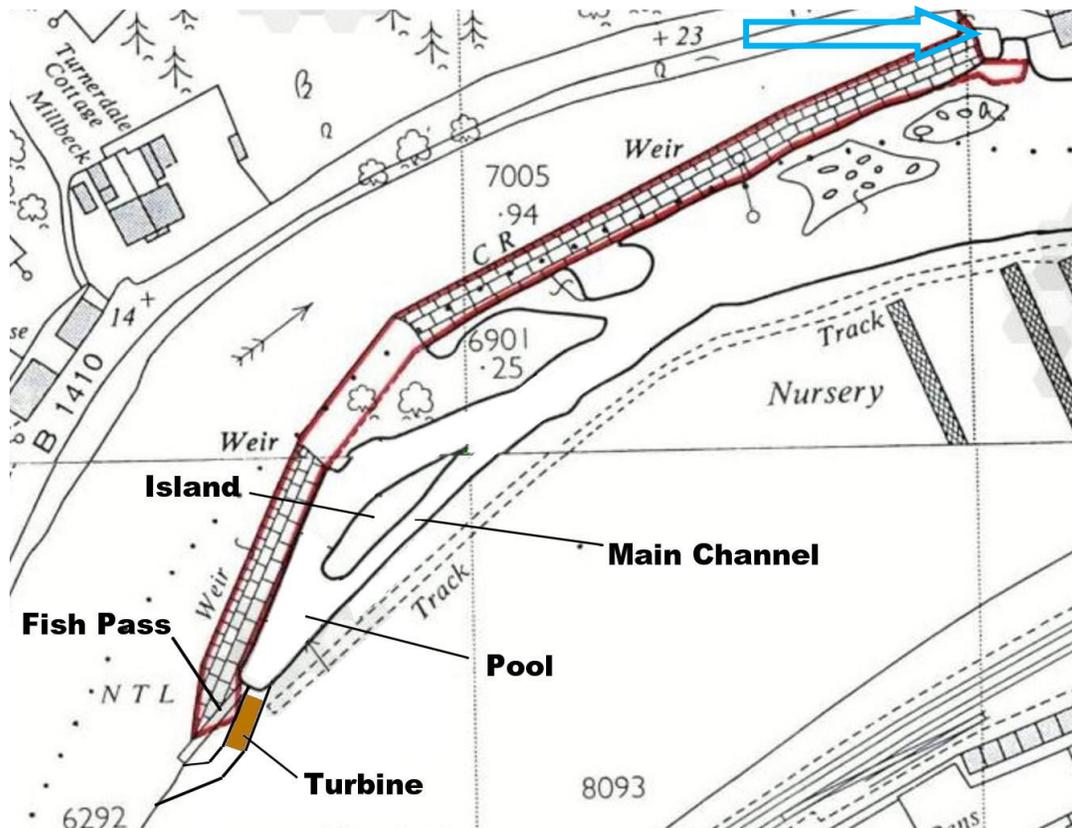
Figure 1. Ruswarp Weir location plan.

As shown in Figure 1, Ruswarp Weir is a c.270-metre long, 10-m wide block stone and concrete structure that spans the full width of the River Esk in a slight dog-leg that is further u/s at the RB than the LB end. Until installation

of the current Larinier pass in the summer of 2012, u/s fish passage was provided by a pool traverse pass at the u/s (RB) end of the weir (in the location of the current Larinier pass) and a diagonal baulk pass approximately mid-way along its length. Passage d/s may occur via these routes, over the weir (in high flows) or via a smolt pass located at the d/s end of the weir which is operated during peak migration times (blue arrow).

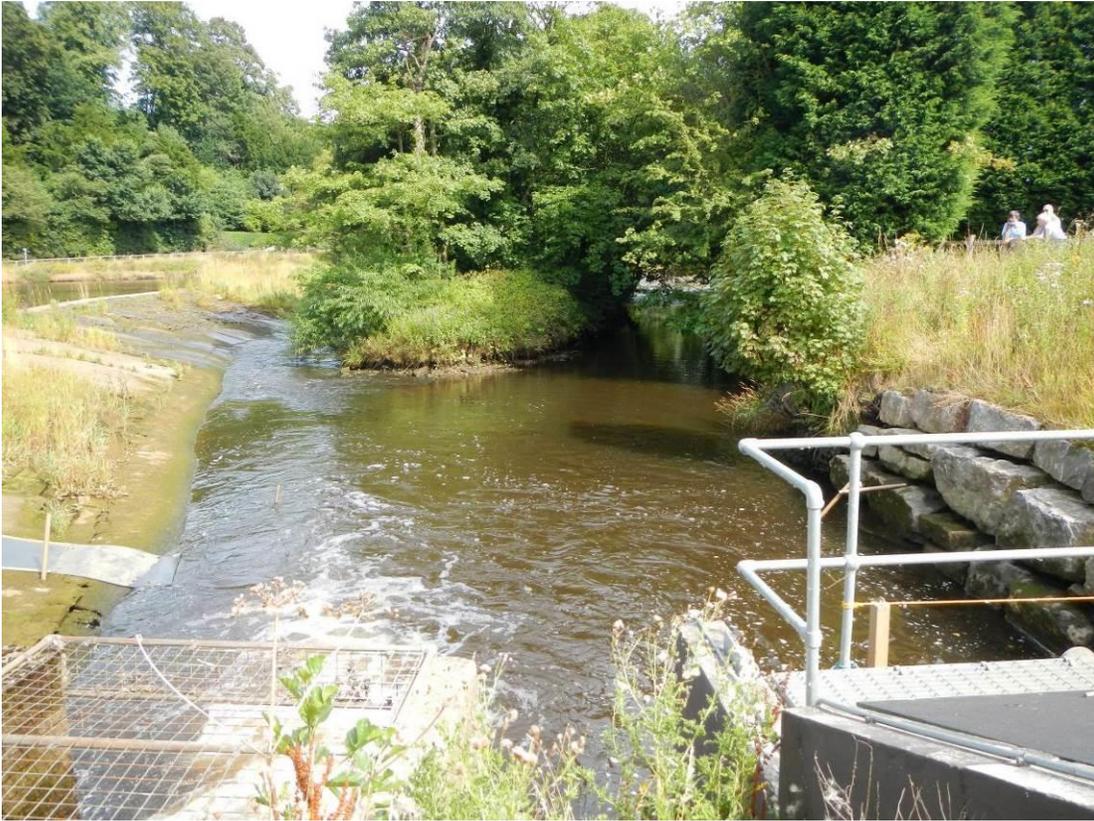
Downstream of the weir, a permanent, vegetated/wooded island splits the channel (Fig. 2), funnelling flows down a relatively uniform width (c.10 metres wide) channel along the RB (Fig. 3), with a more variable but apparently similarly discharging (on the day of the visit) channel down the LB side (Fig. 4).

For clarity, the channel to the LB side of the island will be referred to as the LB channel and the channel to the RB side the RB channel. Both channels appeared to be supporting juvenile salmonids (as evident by surface feeding) but the left channel generally provides greater morphological and flow diversity, a greater occurrence of pool and riffle features, and shade variability; correspondingly, providing greater general habitat quality despite adjoining the weir. The dredging proposed is to lower the bed level within the RB channel, which would therefore mean that it take a greater proportion of the flow emanating from the turbine and/or fish pass. This would consequently reduce flows in the LB channel.

**Figure 2. Larinier pass (foreground left) discharging flow that is then split down either side of the island (centre background). The hydropower installation (right of shot) was not in operation (or discharging) at the low flows observed. The proposed dredging would lower the RB channel (right of shot) and send a greater portion of flows down that channel.**

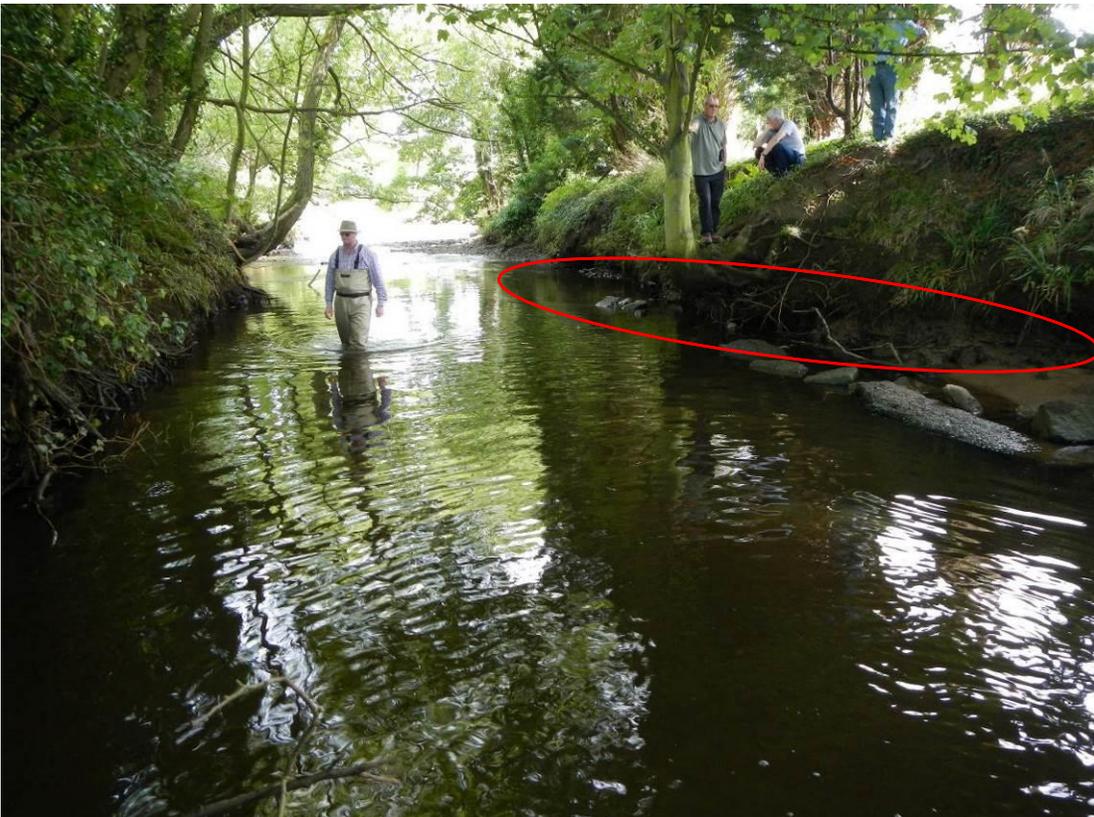
**Figure 3. Looking d/s at the RB channel. Relatively over capacity and poor general habitat. Also note the hard bank revetment/toe and associated significant undercutting of the bank (red ellipse).**

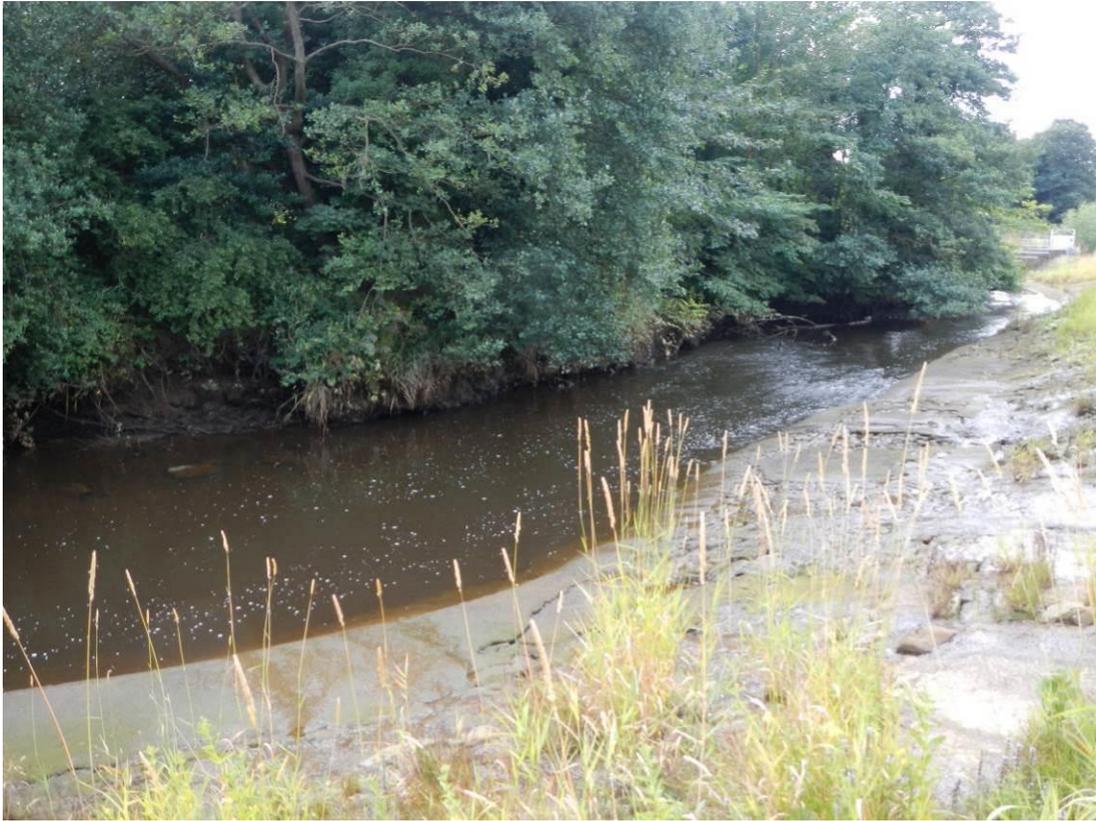
**Figure 4. Looking u/s at the LB channel. Although abutting the weir, this channel generally supports greater habitat and flow diversity, with a pool and riffle sequence, low overhanging and trailing cover and in-channel woody material. Correspondingly, this channel appeared to be supporting more juvenile salmonids, as observed by surface feeding activity.**

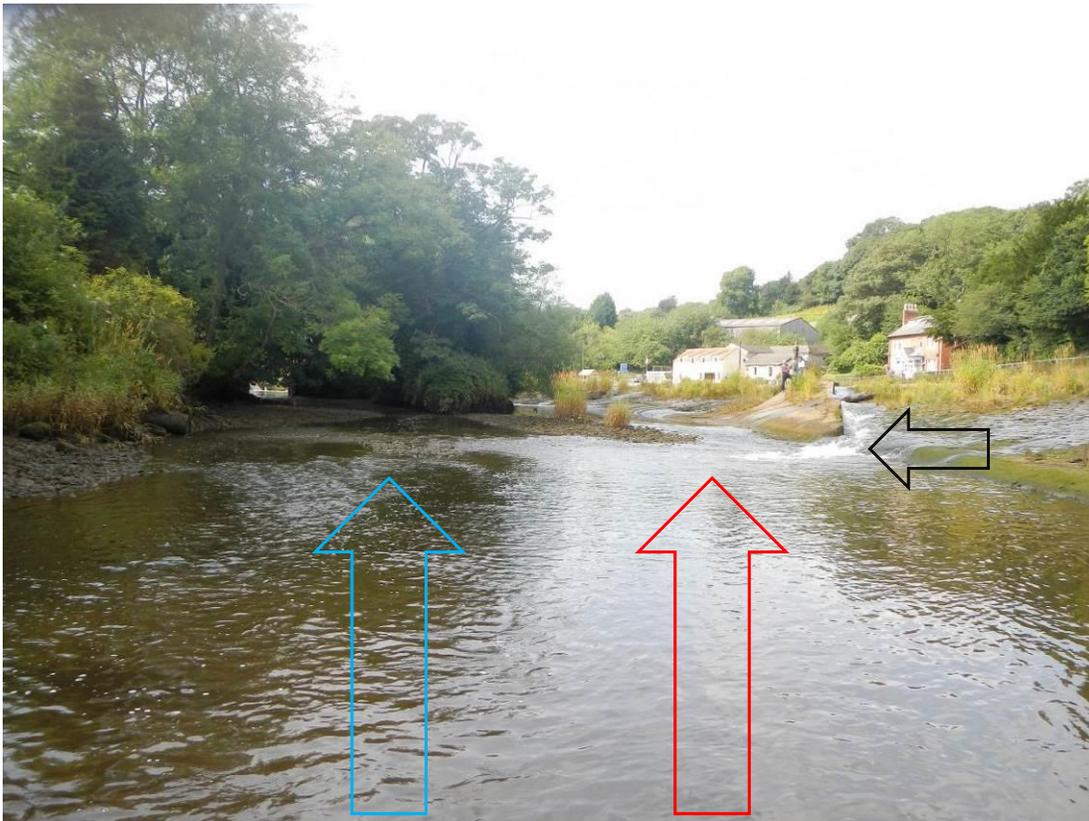
Fish passage here is complex owing to the two potential approach routes (either side of the island) to the main Larinier pass (and hydropower turbine when operating). While the baulk pass is less likely to be utilised in lower flows, it creates an attraction at all flows which, combined with the discharge flow of the LB channel, is likely to draw fish towards the middle of the weir in preference to the RB channel in low flows (Fig. 5 & 6). The access route to the RB channel (at the d/s end of the island) is also shallower over a greater area than the LB channel, providing less attractive flow and poorer passability than the LB channel at low flows. Fish unable to ascend a weir will also instinctively follow that weir to its upstream extent, making the LB channel a vital migration at both high and low flows (in addition to being important habitat in its own right). This is why fish passes are ideally located in the u/s corner of a weir and why free passage along the toe of a weir must be maintained.

**Figure 5. Looking u/s at the two possible approach routes around the island, from the d/s end. The longer, shallower access route to the RB channel (blue arrow) and the narrower, deeper access route to the LB channel (red arrow), via the deeper area of the d/s river channel. Note the additional attraction to the LB channel provided by the baulk pass (black arrow).**

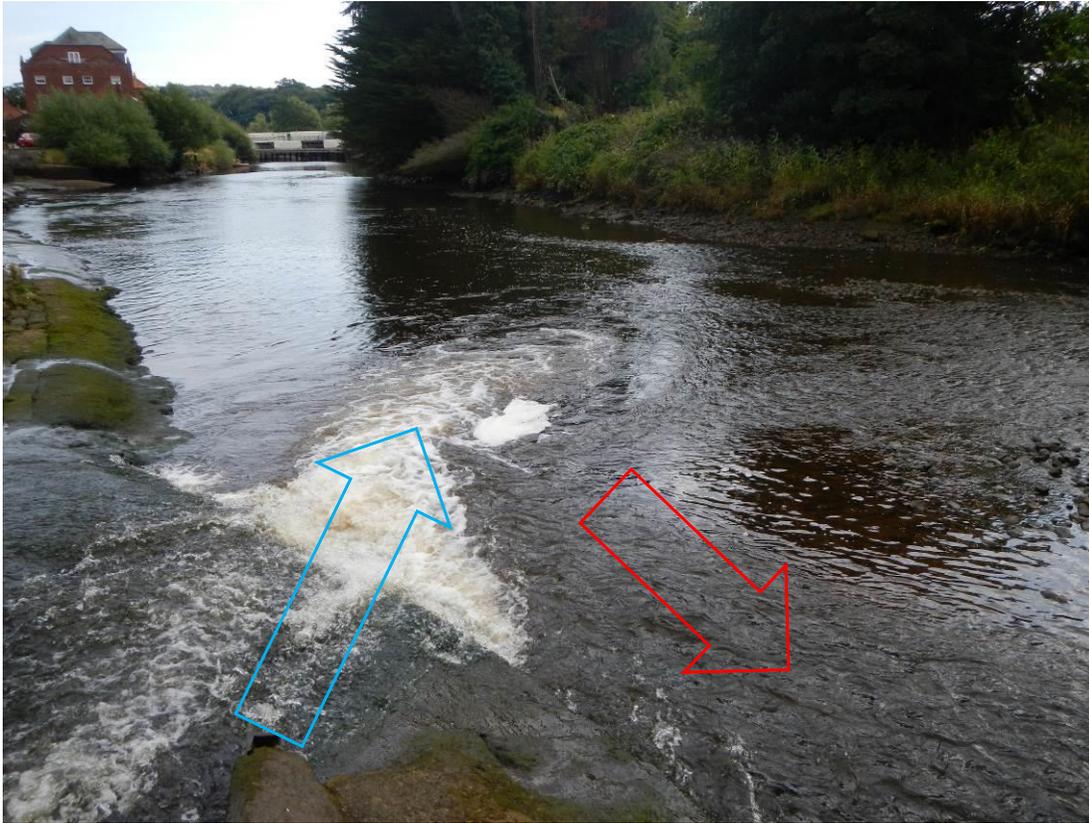
**Figure 6. Looking d/s at the discharge from the baulk pass (blue arrow), creating a major attraction towards the baulk and, when the baulk is not passable, to the LB channel (red arrow). Note the wider, shallower, less attractive approach to the RB channel (far right of shot).**

There could be an argument for closing the baulk pass completely and optimising passability at the Larinier pass. This could consolidate some of the attraction flows, but not once the weir is overtopping and attraction increases along the weir toe and LB channel. There is also the consideration that the efficacy of the Larinier has not been established and the baulk pass may remain an important migration route at higher flows. Passage via the Larinier pass may also be delayed by attraction to the hydropower turbine discharge, whereas fish that find the baulk pass, and are capable of ascending it (of sufficient size and power) may not experience such delays.

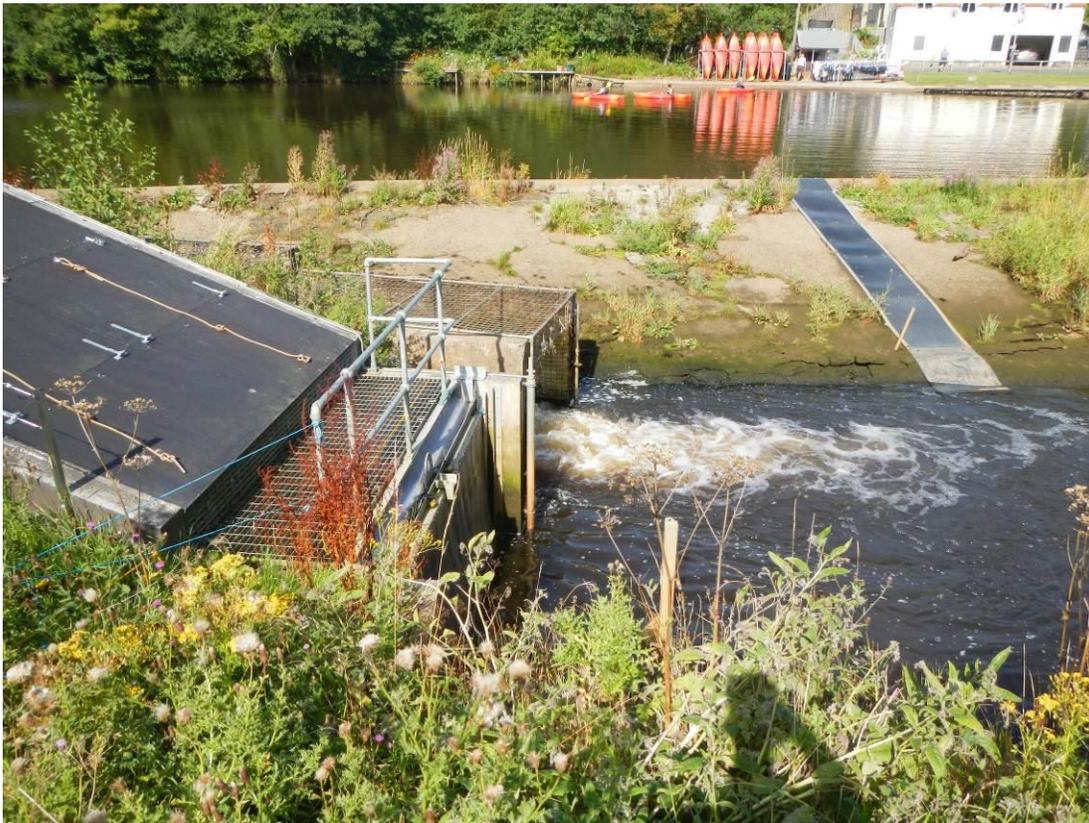
The Ruswarp pass has 100 mm baffles (suitable for small and large fish) and lies within the other guideline parameters, although being at the upper limit for both length (10917 mm + 500 mm to exit the u/s end of the channel) and gradient (15%). This restricts the scope for alterations to any of the parameters.

Observation and brief inspection on the day of the visit identified the pass discharge to already be very close in height to the d/s water level; something that may have already been exacerbated by previous channel dredging undertaken during the hydropower turbine installation (M Ford 2016, pers. comm., 23 August 2016). Unlike pool traverse passes designed to allow fish to jump between deep pools of water, Larinier passes assist fish by baffling flows to create lower-velocity water, within which it is easier to ascend an obstacle. If Larinier passes become perched, their efficacy is greatly diminished as fish cannot easily or safely jump into shallow turbulent water over hard angular metal baffles. To function properly, the d/s entrance of a Larinier pass must therefore discharge below the d/s water level, with several sets of baffles submerged in the d/s pool, even at the lowest river flows (this also assist fish attraction to the pass).

**Figure 7. The d/s end of the fish pass, the level of which already appeared very close to the d/s water level. Ideally, a Larinier pass should terminate well below the d/s water level to allow fish to enter the plume within the water column of the pool.**

These are major considerations in light of a proposal to lower the d/s bed and water level further and alter the conditions from those for which the current pass was designed. While it is understood that a 50% gradient (1 in 2) rip rap (150 - 300 dia. pieces) ramp exists immediately d/s of the pass, the steepness and absence of wing-walls mean it cannot mitigate lowering of the d/s water level as it only serves to assist attraction flows and guiding of fish towards the pass (which was its intended purpose).

- Pass Design – when the pass was designed the existing conditions at the weir and in the pool downstream were taken into account. Altering those conditions could detrimentally impact upon the efficacy of the pass. This is particularly pertinent if lowering of the bed (and water level) increases the height the pass sits above the d/s water level.

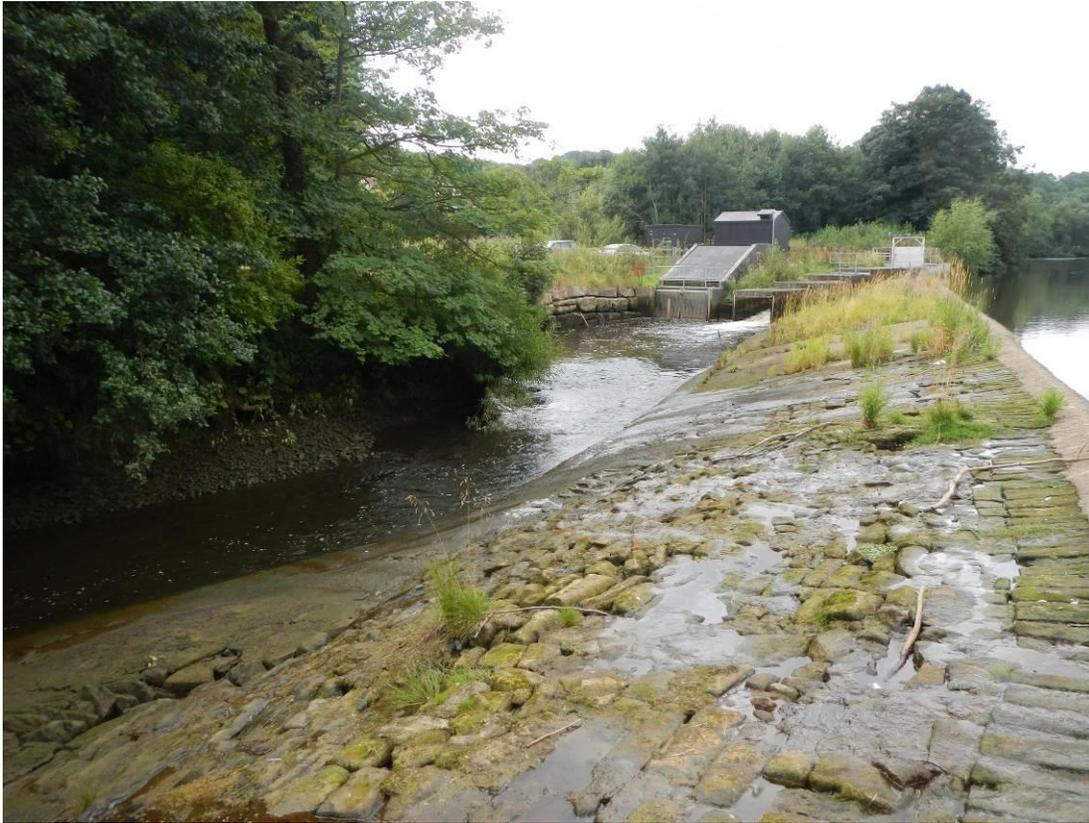
In addition to salmonid passage at the Larinier pass, it is also important to consider the requirement of passage by other species, particularly sea, river and brook lamprey (*Petromyzon marinus*, *Lampetra fluviatilis* and *Lampetra planeri*, respectively) and the European eel (*Anguilla anguilla*) which is in significant decline across its native range. While the weir face may provide some roughness and structure up which some eels may ascend (still less than ideal), the concrete ridge along the weir crest greatly reduces its overall passability (Fig. 8). If, as it appears, the ridge raised the weir height, improvements to fish passage would have been required under the Salmon and Freshwater Fisheries Act 1975 for that aspect alone.

**Figure 8. The size of the weir structure and concrete ridge along its crest also render it a significant obstacle to eel migration.**

It is understood that an eel pass was installed on the weir (P O'Brien 2016, pers. comm., 23 August) but was removed due to a suspected negative impact upon salmonid passage. Options to optimise passage for all species at this site should be made a priority (including eels and lamprey), in line with the Eels (England and Wales) Regulations 2009.

- European eels are in major decline and their passage at the site should also be considered of high importance and optimised, as per the Eel Regulations 2009.

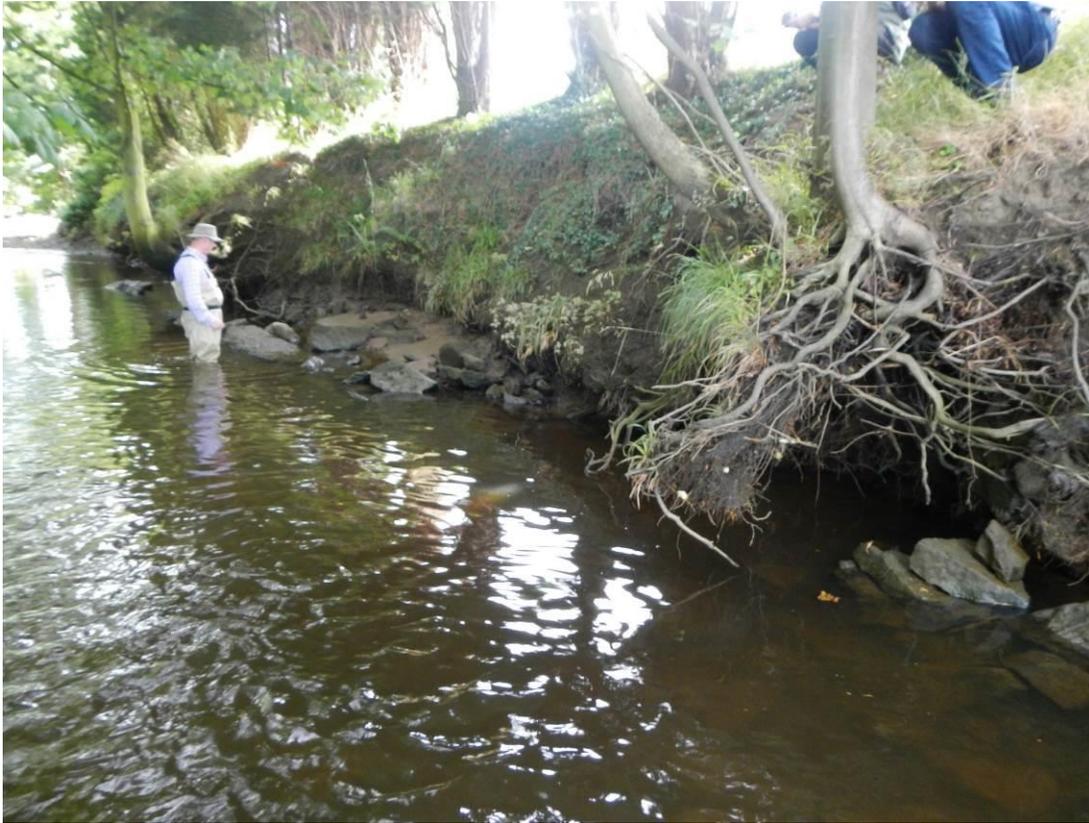
A further major consideration before dredging the channel d/s of the pass is the potential unintended consequences of lowering the bed and removing sediment from an already incised channel with unstable banks (Fig. 9). Dredging will leave the banks further perched above the bed and reduce the supply of sediment downstream. When this is coupled with the increased flow volume and energy down that RB channel (as is the purpose of the dredging) acting upon the already perched, undercut banks (banks that support the access track only a couple of metres from the bank top), the potential for further detrimental bank erosion issues is high.

Past attempts to stabilise the bank toe with block stone have provided some stability there but, as with any installation of hard, immovable structures within a channel, has simply deflected flows and accelerated adjacent bank erosion. The bank stability is also reduced by over-shading from a line of Leyland cypress trees. While the trees provide some bank stability from their roots it is much less than most native deciduous species and their over-shading of the bank prevents establishment of the herbaceous vegetation that would ordinarily protect and stabilises the topsoil.

**Figure 9. Significantly undercut, perched RB of the RB channel. Dredging this channel to lower the bed level will not only increase the flow and erosive forces acting upon the bank but also increase the height by which the banks are perched, encouraging even greater undercutting and tree loss and further reducing bank stability.**

- Removing substrate from the channel d/s of the turbine will render the banks even more perched and potentially subject to major erosion issues. This could jeopardise the access track if bank slumping occurred.

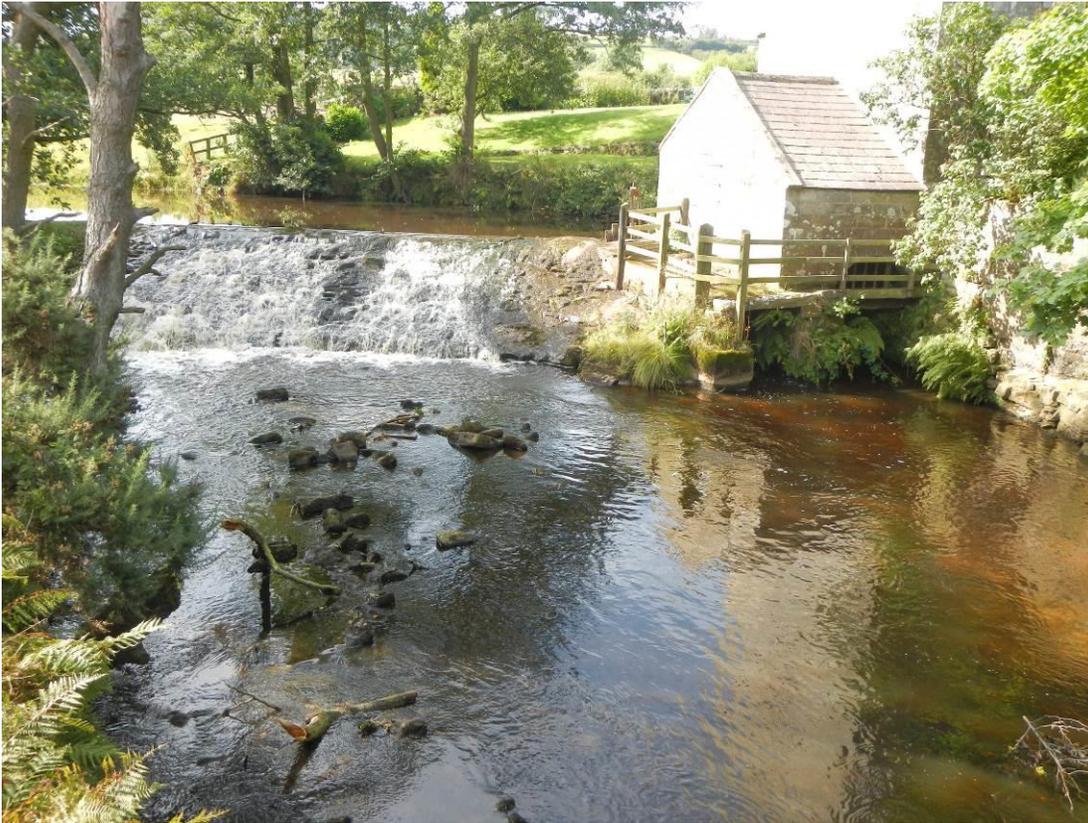
**Figure 10. Danby Weir.**

The second site visited was much further u/s at Danby, to provide an opinion on the potential impact of a large mill weir. While it appeared that the structure is no longer in use for milling, the large diagonal weir across the river remains (Fig. 10).

At the time of the visit, the vast majority of the river flow appeared to be passing over the crest of the weir with a little discharging via the sluice; neither route was passable to fish. The dimensions of the structure (>2m high) and c.100% slope (1 in 1) make it impassable to salmonids in low and medium flows and very poorly passable to most fish at all other flows. Especially in light of the poorly performing fish stocks on the Esk system, fish passage at such a major obstruction should be considered a top priority. Improving fish passage there could increase access to a large area of the catchment, including the upper river and its tributaries, which are likely to include some of the prime salmonid spawning and juvenile areas.

The EA are looking into improving fish passage at the site and it is on their fish pass prioritisation list (P O'Brien 2016, pers. comm., 23 August) to be addressed; this should be a major goal in the management and improvement of the River Esk. As with the Ruswarp site, eel passage as well as salmonid passage must be considered.

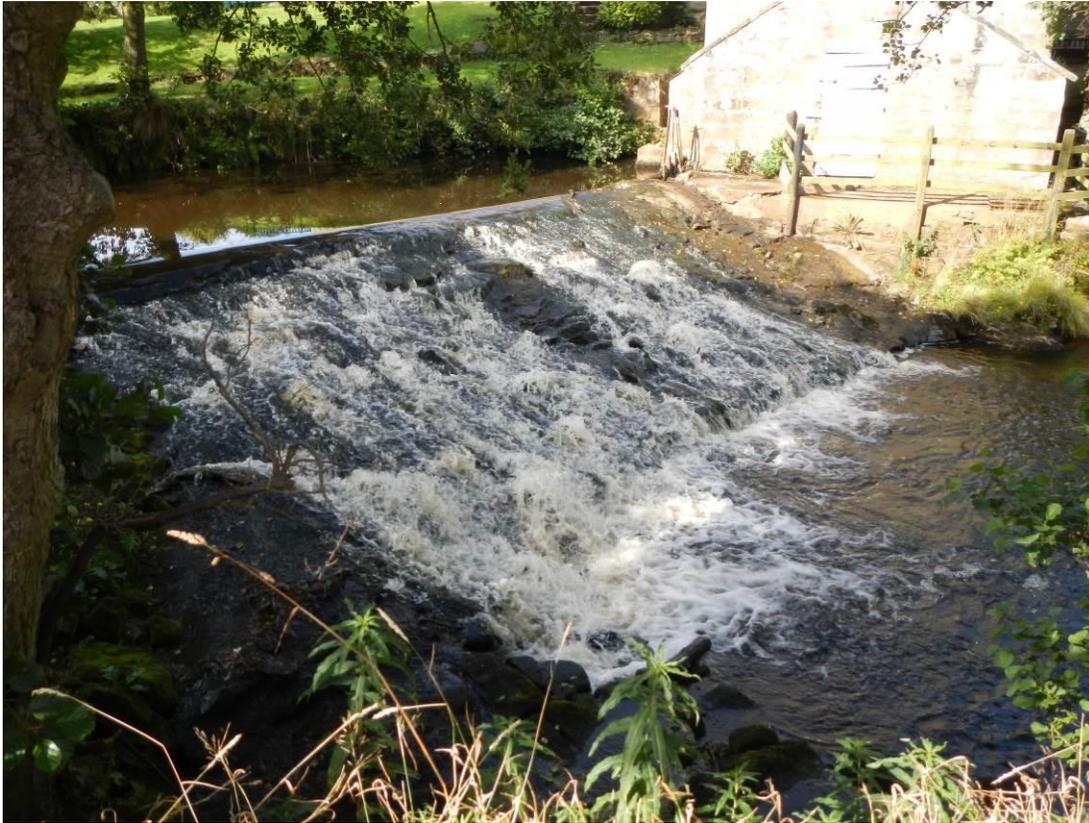
**Figure 11. The height and steep c.100% slope makes Danby Weir a major barrier to fish passage severely inhibiting utilisation of spawning and juvenile habitat in the upper river.**

Ideally, weirs should always be removed once they have ceased to perform their intended purpose, to remove the major impact they create upon a river. However, some structures continue to provide amenity and historical value and other options may have to be explored. The site does provide two locations (sluice or wheel housing) in which fish passes could be relatively easily installed, although, unfortunately, they are not in the optimal, u/s corner of the weir. Sympathetically removing the weir structure (or a significant portion of the weir) would be by far the best outcome for the ecology and geomorphology (often overlooked) of the river, and for fish passage. Consideration would also have to be given to the likelihood of subsequent natural bank and bed regrading u/s and reinstatement of any abstractions dependent upon the u/s water level.
