## **River Frome, Bovington, Dorset**

**An Advisory Visit by the Wild Trout Trust October 2014**

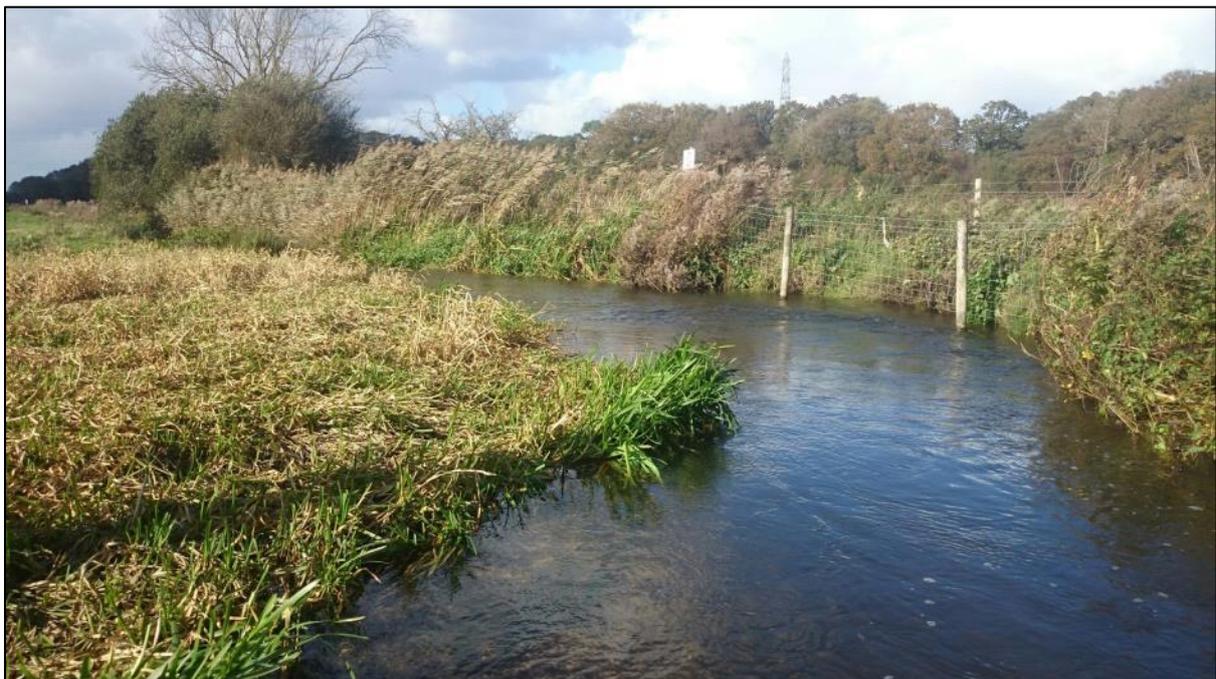
At the upstream extent of the water visited the small carrier has at some point been artificially straightened. The straightening imposes a limitation on channel morphology, reducing the diversity of depth and flow conditions, which in turn impacts on habitat availability. In particular, shallow-gradient marginal habitat is scarce, limiting the abundance and diversity of marginal plants. Marginal plant diversity on the RB is significantly lower than on the LB. This is probably the result of the RB being unfenced whilst the LB is fenced to keep out grazing livestock. The LB is not devoid of marginal habitat however; what appears to be a derelict cattle drink on the RB towards the boundary with the next field downstream, has developed into a shallow bay and become colonised by reed sweetgrass (*Glyceria maxima*). This suggests that grazing pressure may have been more intense in the past (causing bank poaching) but has eased in recent years (allowing the poached bank to become colonised). (Figure 2).

Figure 2: The vegetated shallow bay in the derelict cattle drink.

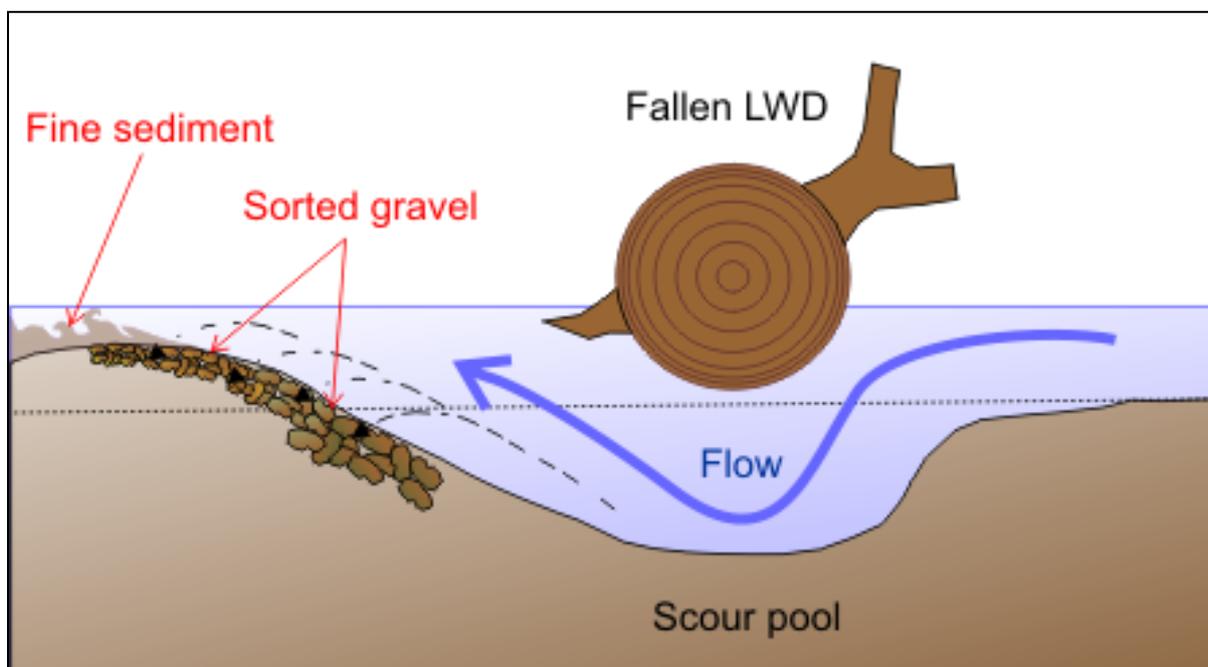
Flows deflected around and/or over and under large limbs and trunks are locally accelerated and scour the bed and banks. This redistributes bed material and increases depth variation and bank sinuosity. This action can help to naturally 'sort' bed material as the finest particles are carried the furthest downstream whilst larger cobbles drop out of suspension sooner (Figure 3). The result is an area of gravel graded by size and swept clean of fine sediment. Well-sorted gravel at the tail of a scour pool is perfect spawning habitat for trout, especially if the pool has some overhead cover where fish can hold up for an extended period.

Figure 3: Longitudinal stream section showing that Large Woody Debris (LWD) across the channel can often result in the cleaner, well-sorted gravel

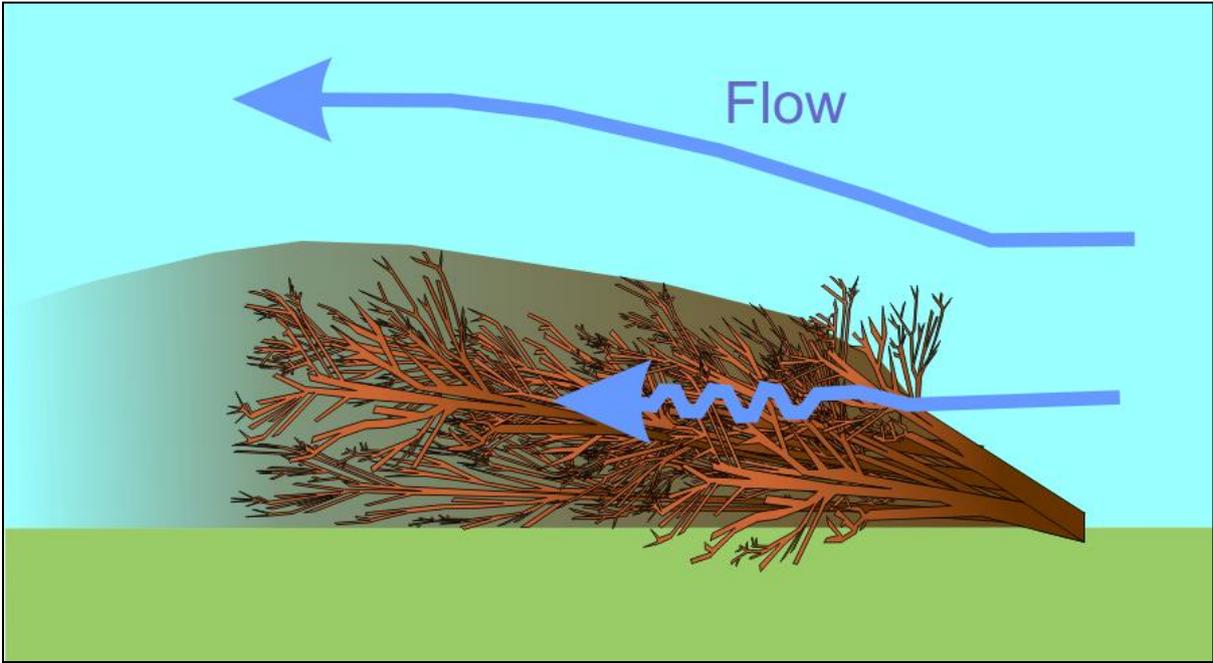
Coarse woody material in the form of branches and brushwood is also important. It locally slows flow, creating a depositional environment that traps fine sediment (Figure 4). This provides habitat for silt-loving species and marginal plants. It also provides excellent refuge habitat for juvenile trout and provides an area of slackened flow where trout can conserve energy and dart in and out of faster flows to snatch passing prey.

Figure 4: Plan view of a stream section showing that brushwood in the channel naturally slows flows and traps sediment.

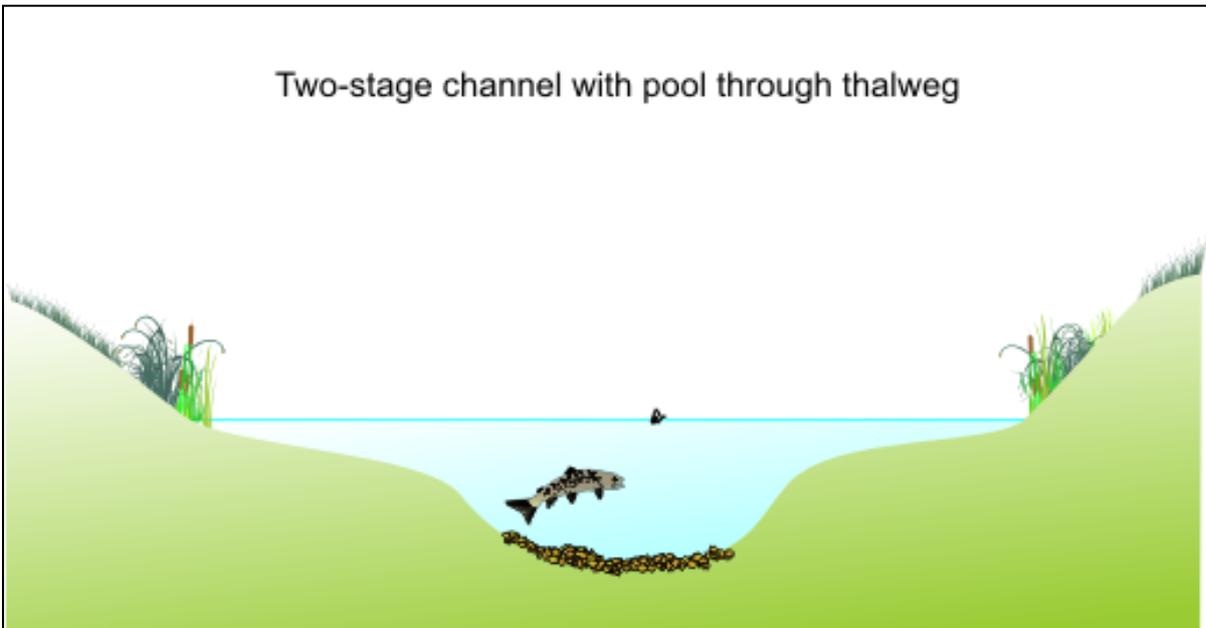
The scouring effect of in-channel woody material helps to create a sinuous flume of fast-flowing water that meanders through the channel. Providing the bed is not too armoured (e.g. with tufa), this eventually scours a relatively deep trench in the bed which becomes the very bottom of the valley known as the 'thalweg'. This trench acts as a low-flow channel which allows the river to naturally self-narrow during low flows and retain both depth and water velocity (Figure 5). A river with a well-pronounced thalweg is said to have a 'two stage' channel.

Figure 5: An illustration of a two stage channel cross section with a deeper 'low-flow' channel holding trout during low flows.

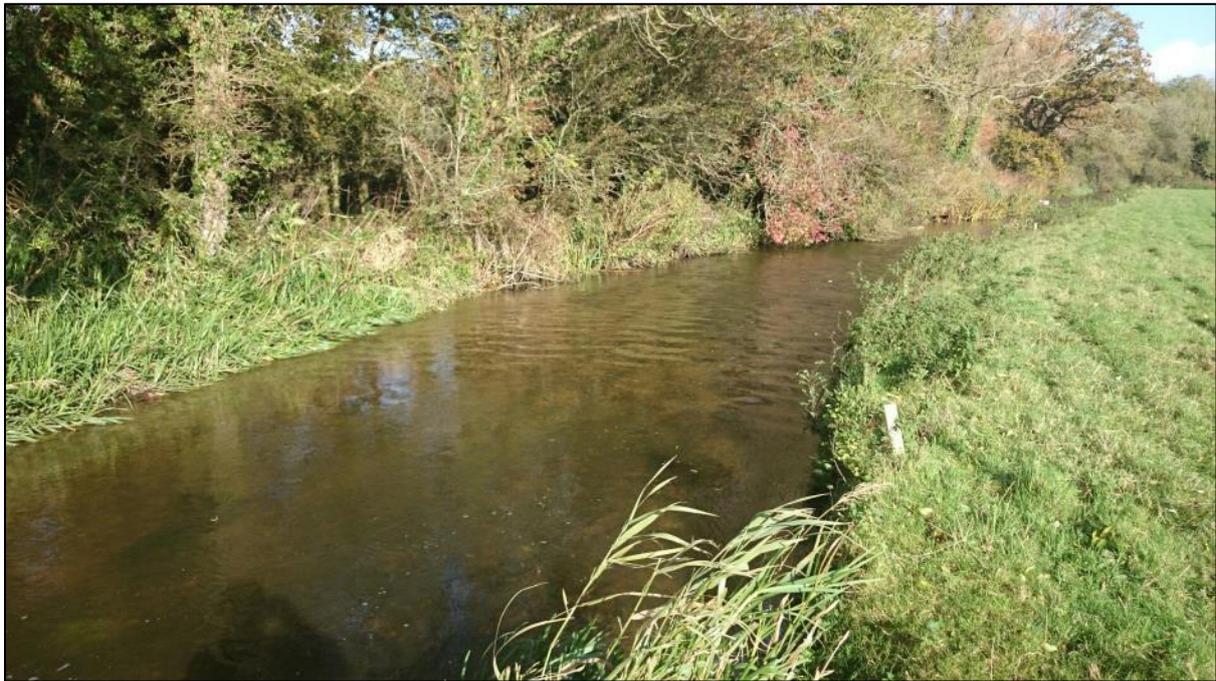
Dense tree cover on the LB through the downstream half of the second field may provide materials for the introduction of some woody habitat features (Figure 6).

Figure 6: Dense tree cover on the LB may provide an opportunity to won materials for in-channel habitat enhancements

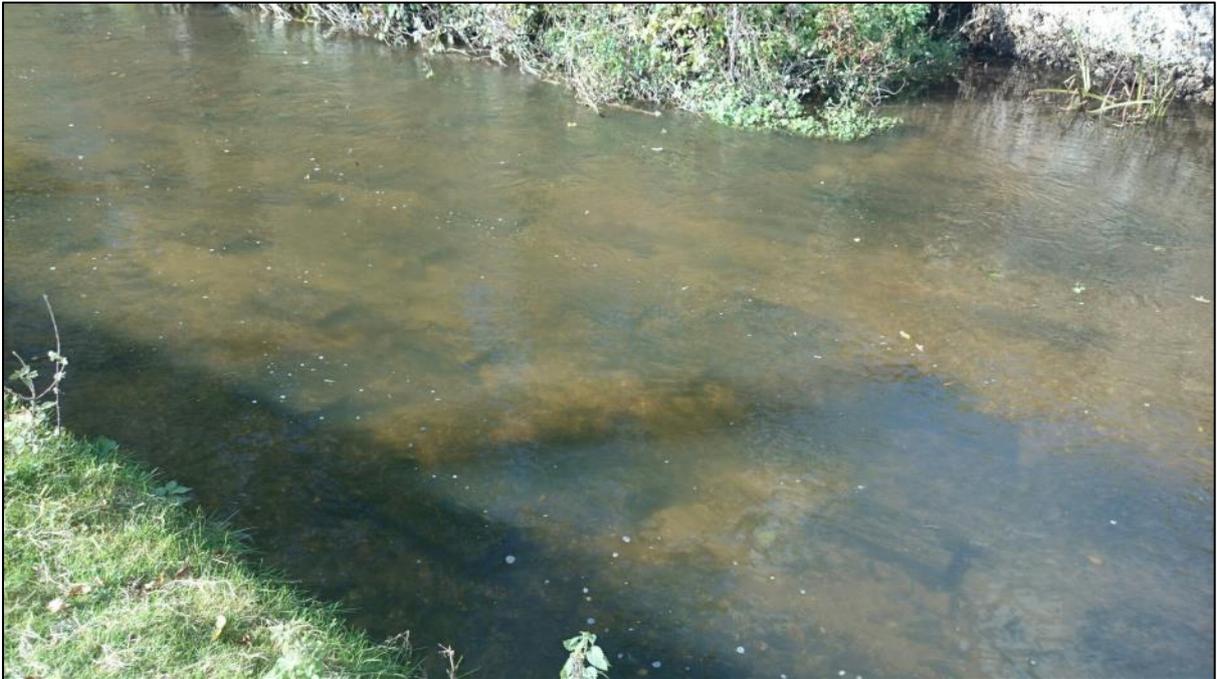
Approximately mid-way through this field a large quantity of concrete blocks was observed evenly spaced on the bed (Figure 7). Why these had been placed in the channel was unclear. It is possible that the blocks have been placed in the channel to break-up the open water in an attempt to increase habitat for salmonid parr. It is also possible that the blocks have been placed in the channel as a precursor to introducing gravel to create a riffle, or in an attempt to anchor newly-planted water crowfoot (*Ranunculus* sp). Whatever the purpose of the blocks, they are an inappropriate material to introduce to the river and in any of the scenarios suggested above, large flint cobbles would be both more appropriate and function better. It is highly unlikely that the Environment Agency and/or Natural England would have consented the introduction of concrete blocks into a SSSI chalk stream for any purpose (with the possible exception of scientific research).

Figure 7: Regularly spaced concrete blocks installed on the bed of the river

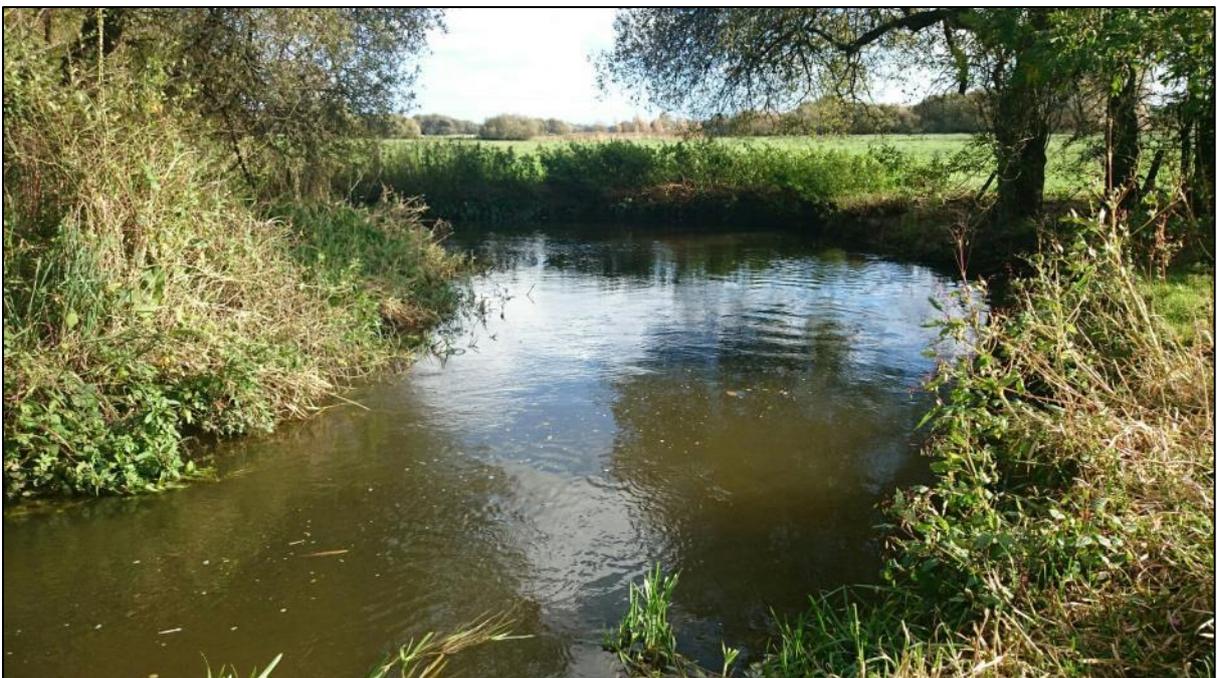
Downstream of the blocks a deep pool has formed on a sharp left hand bend (Figure 8). This site is reportedly a good holding pool for trout (pers. comm. Jeremy Hann). Pools often naturally form where flows are accelerated around the outside of sharp bends. Material scoured out from pools is usually deposited a short distance downstream, diversifying depth conditions and often forming point bars or riffles. This site highlights the importance of sinuosity in helping maintain good habitat diversity in a healthy trout river.

Figure 8: A deep pool on a sharp left-hand bend is reportedly a good holding pool for trout

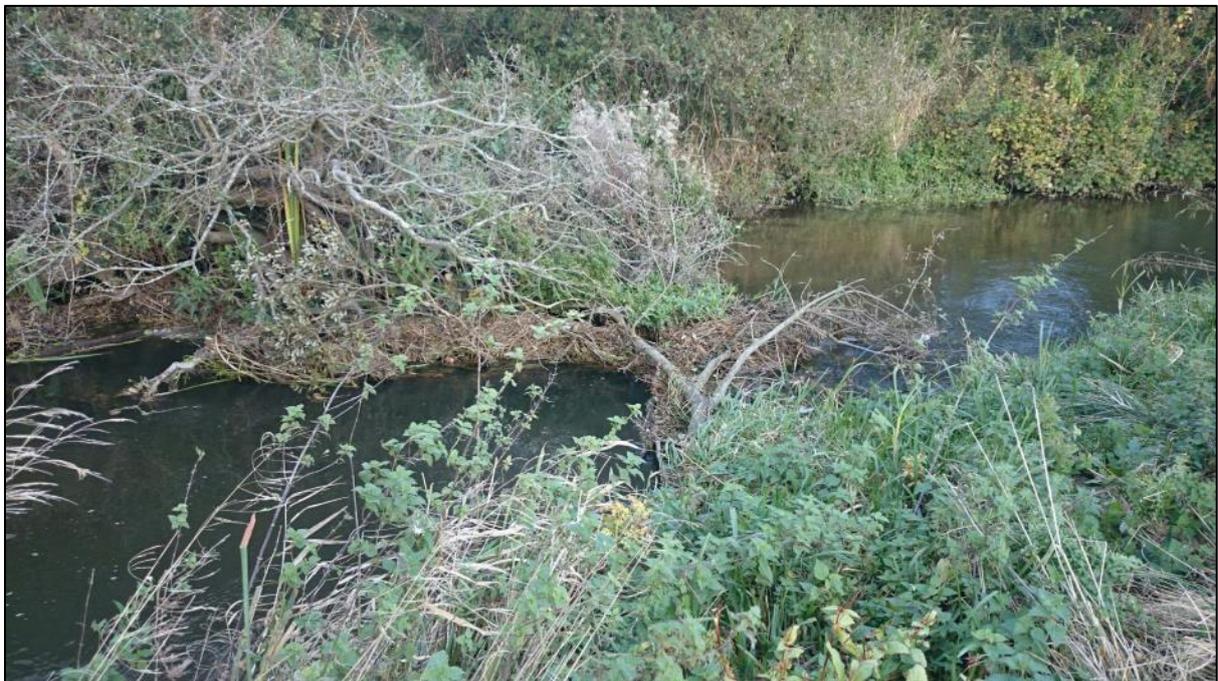
Immediately downstream of the bend a small debris dam was discovered which consisted of a small recently-cut tree limb snagged on some low branches (Figure 9). Debris dams are naturally occurring features that can have a variety of effects on habitat. They are sites where small, coarse woody material collects and decomposes, providing good habitat and food for invertebrates that in turn become food for fish. Debris dams can also increase bed scour and provide habitat refuge from predators. However, debris dams can also become obstacles to fish passage and impound flows, causing a reduction in habitat quality upstream and in some cases lead to increased flood risk. Whilst the structure observed did not appear to be causing any immediate problems, it may be worthwhile adjusting the structure so that it no longer blocks the entire width of the channel, perhaps moving the cut limb into the lee of the trailing branches or making use of it elsewhere.

Figure 9: A small debris dam is not causing an immediate problem but may require some subtle adjustment.

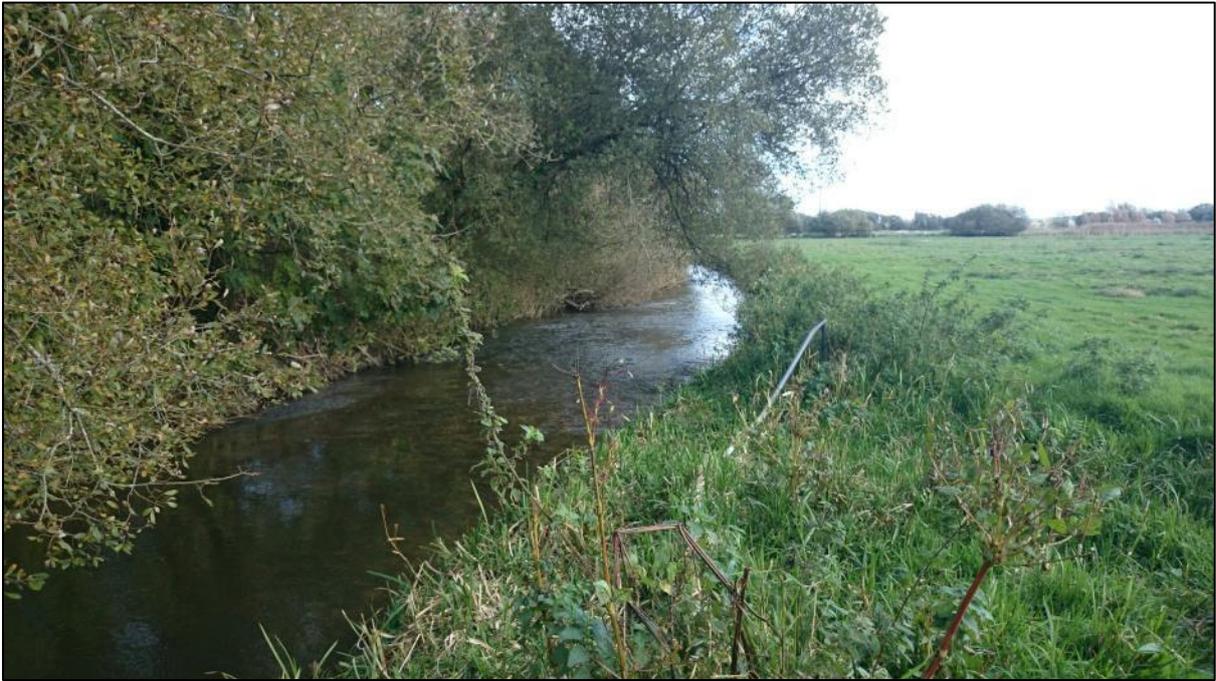
As the carrier flows alongside the next field downstream, the diversity of flow and bed morphology is improved. More distinct pools, riffles and glides are present (Figure 10). Diversity of light conditions could be improved as the LB remains heavily wooded whilst the RB is more heavily grazed and lacking in marginal habitat and bankside cover (Figure 11).

Figure 10: A greater diversity in bed depth and flow is visible downstream of the debris dam

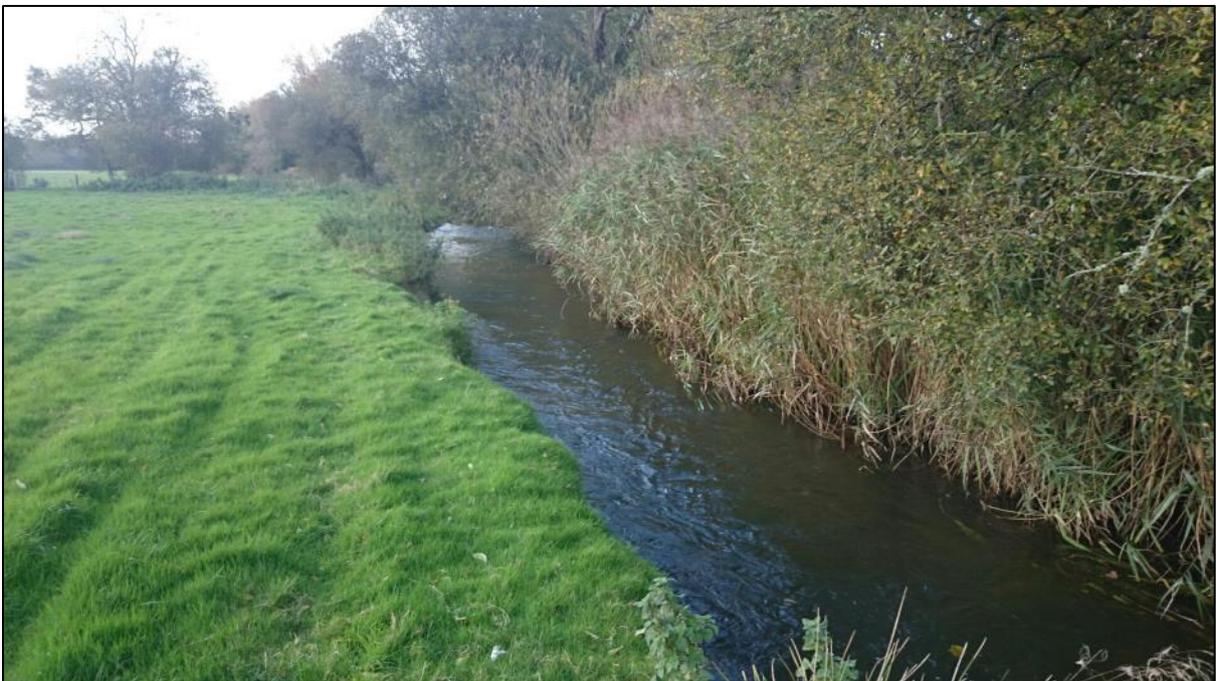
Figure 11: The RB is heavily grazed, creating a monoculture of grass

1. Engage with the land owner/tenant farmer to discuss the possibility of fencing the upper bank to protect it from grazing livestock. Ideally, fencing should include occasional gates to allow grazing in the margin once or twice a year. This will help prevent a mono-culture from developing and maintain bankside biodiversity.

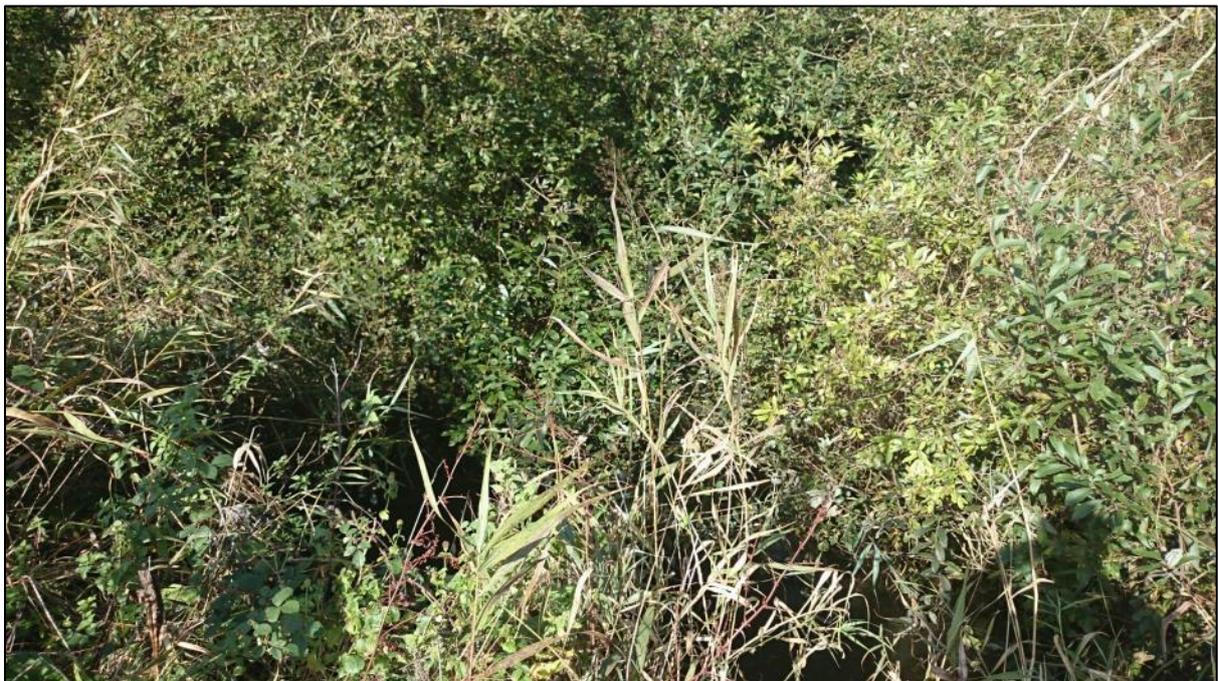
As the carrier flows towards Great Perry Coppice, the contrast between the two banks becomes stark as the LB becomes steadily more overgrown and the heavily-grazed RB is near-vertical with very little marginal habitat. The LB through the bottom third of the carrier is so overgrown that the channel is over-shaded and in some places inaccessible (Figure 12). The balance of light and shade over a chalk stream is an important factor in the performance of the ecosystem. Shade plays a vital role in regulating water temperature and

Figure 12: In places the channel is completely overgrown and inaccessible

The reach would benefit from a programme of tree works and some selective clearance to let more light into the channel. This would help promote the growth of beneficial aquatic plants such as water crowfoot as well as helping to facilitate angling. However, care should be taken to ensure that an appropriate quantity of woody habitat features are retained. For example, where large trees such as the willow in Figure 13 sprawl across the channel, large submerged limbs and root balls should be retained where possible to encourage scour and provide cover for fish. Smaller branches and higher limbs could be removed to improve light penetration and angler access.

2. Initiate tree works to open up the lower reach of the small carrier to allow more light into the channel and facilitate angling. Once the channel is more open and accessible, initiate a programme of continued tree works on a 5-10 year rotation to maintain a broader range of canopy heights and densities. This will provide a greater diversity of light conditions over the river and also give rise to woody material that can be used to enhance in-stream habitat.

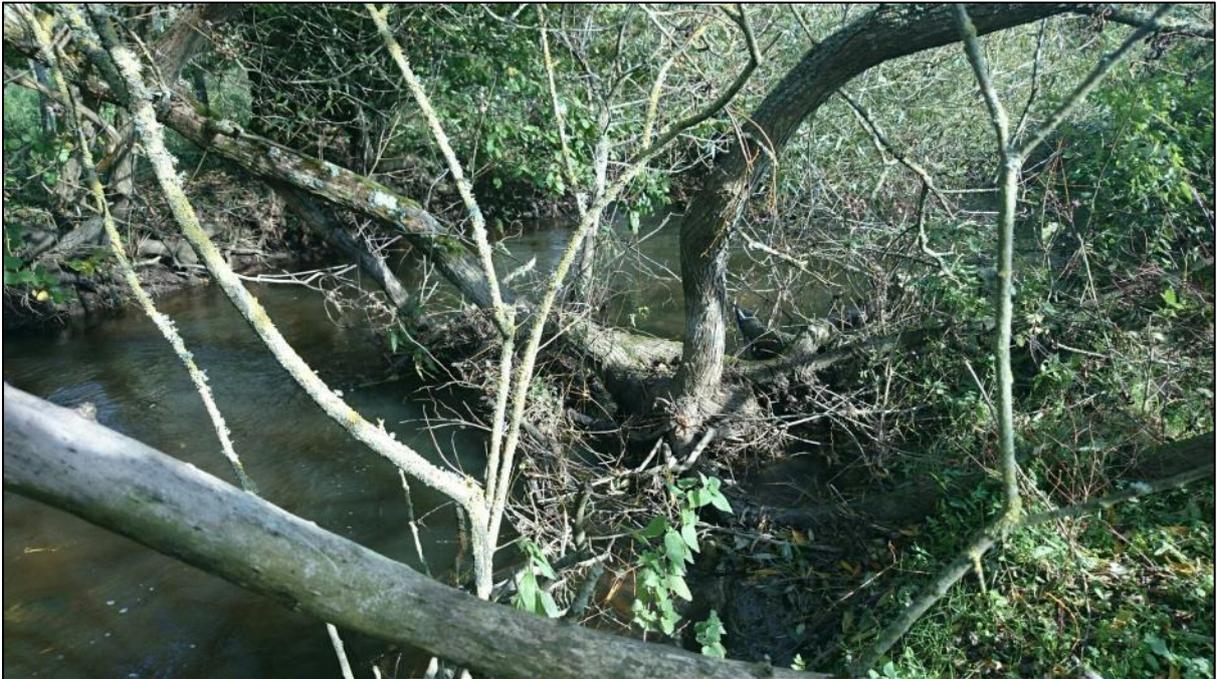
Figure 13: Large overgrown limbs can be cut back to facilitate angling and increase light levels. However, retaining as many large submerged limbs will help maintain flow diversity.

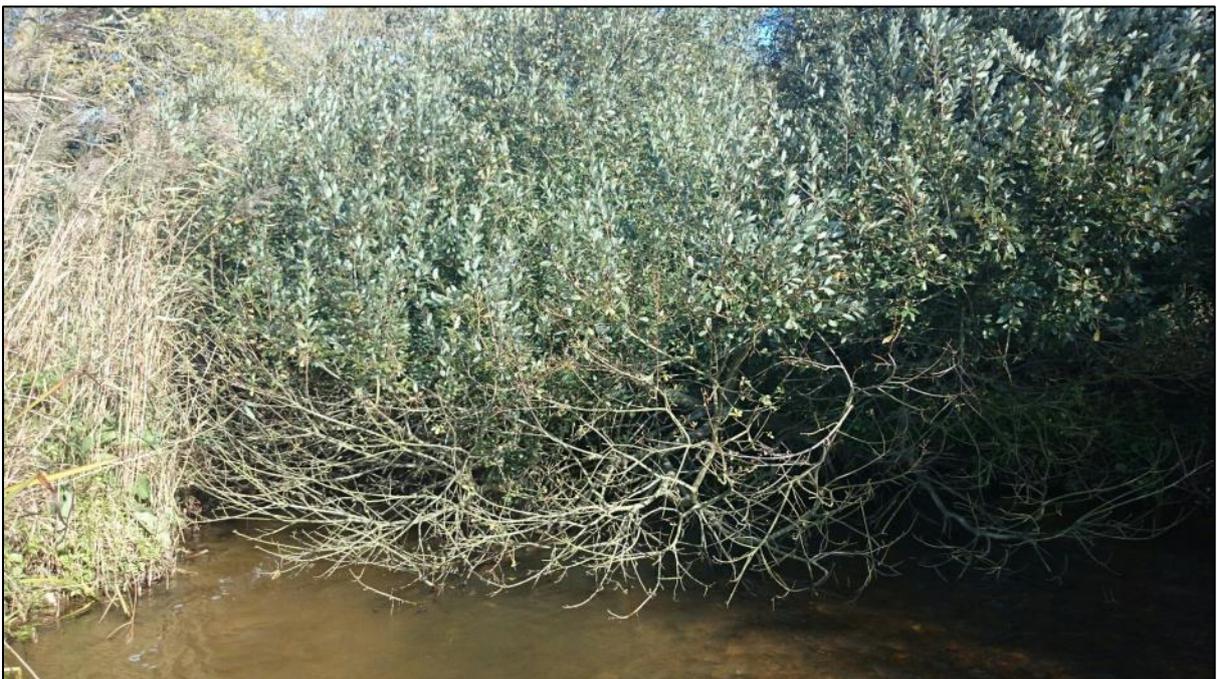
Near where the carrier confluences with the main River Frome, a partially fallen willow has forced the stream to carve out a deep pool (Figure 14). Gravel scoured out from the pool has created a shallow glide downstream (Figure 15). This could be an excellent spawning site for wild brown trout and illustrates how woody habitat features help to enhance habitat.

Figure 14: An overgrown willow blocks the channel

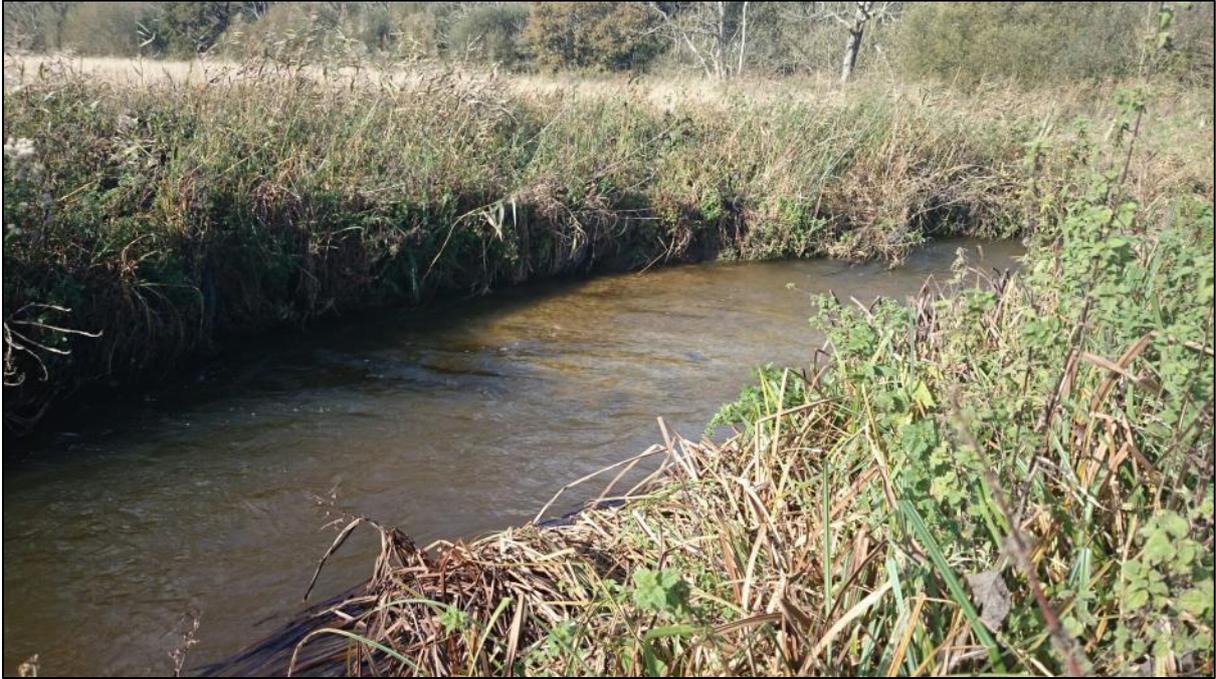
Figure 15: A well-sorted gravel glide is a potentially good spawning site

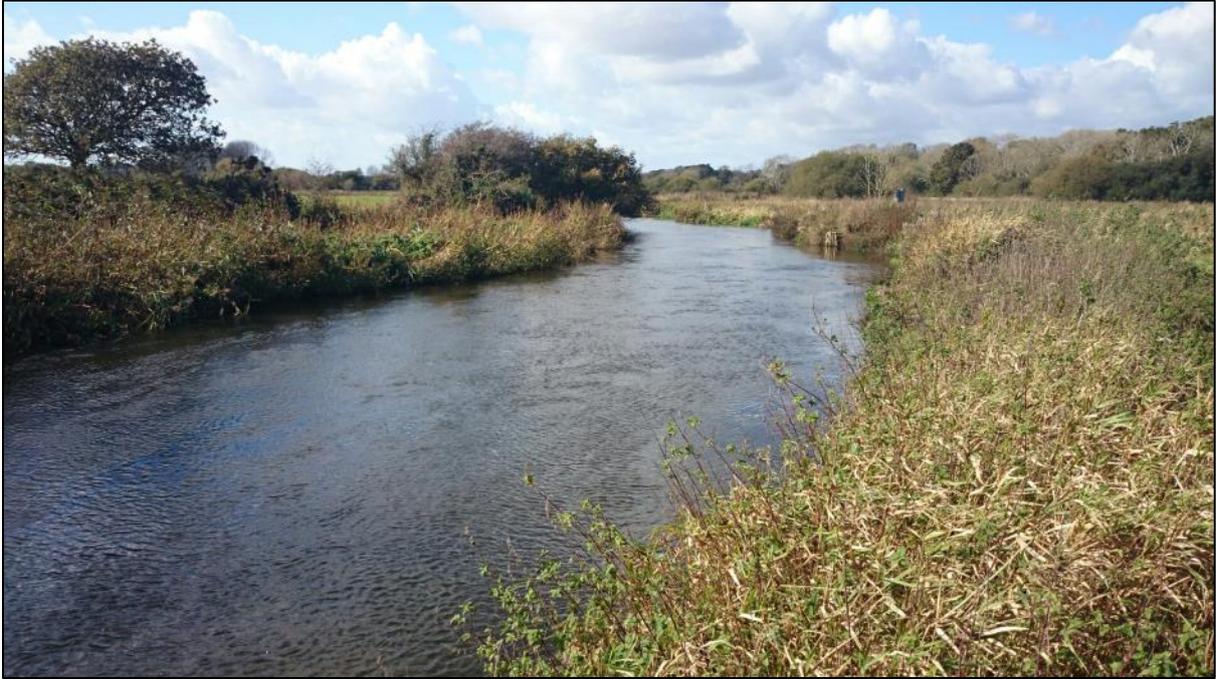
The section of the main carrier visited flows through a wetland meadow not used for agriculture. The wide margin of wetland species and the rough semi-inundated grassland beyond provide excellent habitat for invertebrate species that have an in-river life-stage. Depth variation within the channel is relatively good but the river would benefit from increased diversity of flow direction and speed. There was also a considerable lack of tree cover (Figure 16). Fortunately, an abundance of small goat willows (*Salix caprea*) within the flood plain (Figure 17) give rise to the opportunity to introduce some low-growing tree cover into the margins.

Figure 16: The main carrier is lacking in bankside tree cover

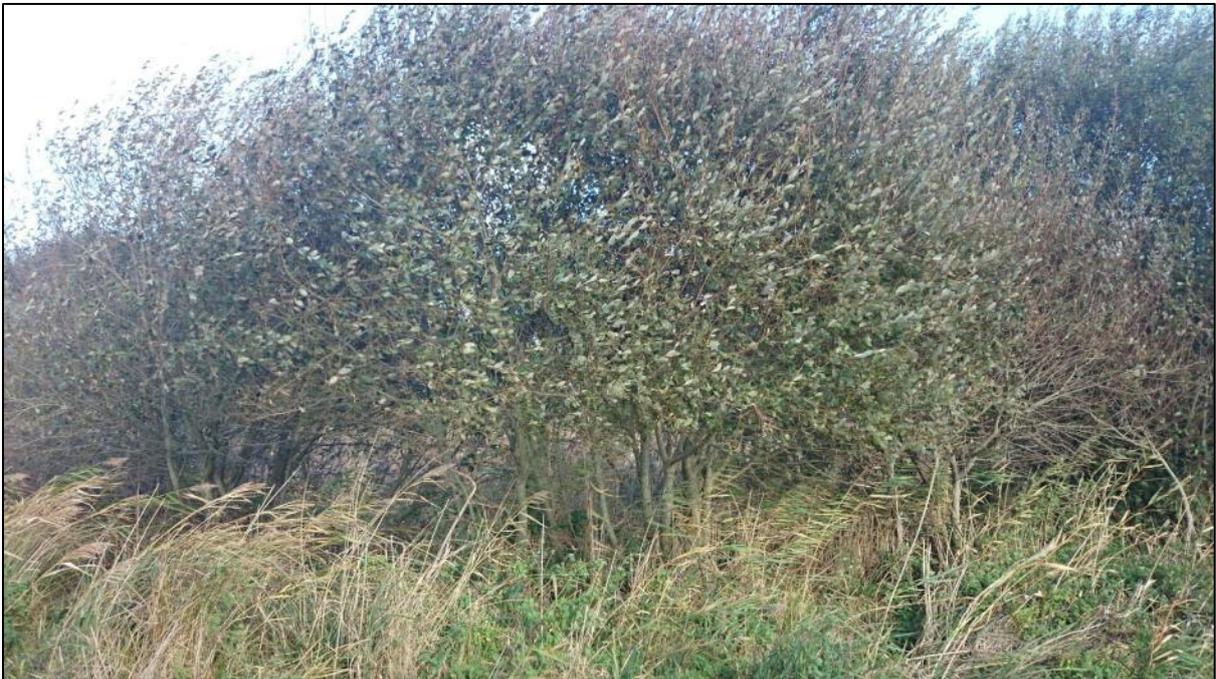
Figure 17: Straight limbs cut from goat willows within the floodplain could be used to plant new trees

Goat willows are low-growing and provide excellent low cover for fish with minimum maintenance implications. Short sections of live willow can be cut from the existing trees and driven into the bank. If undertaken during winter months when the willow is dormant, it should have a very good chance of taking root and growing into new trees.

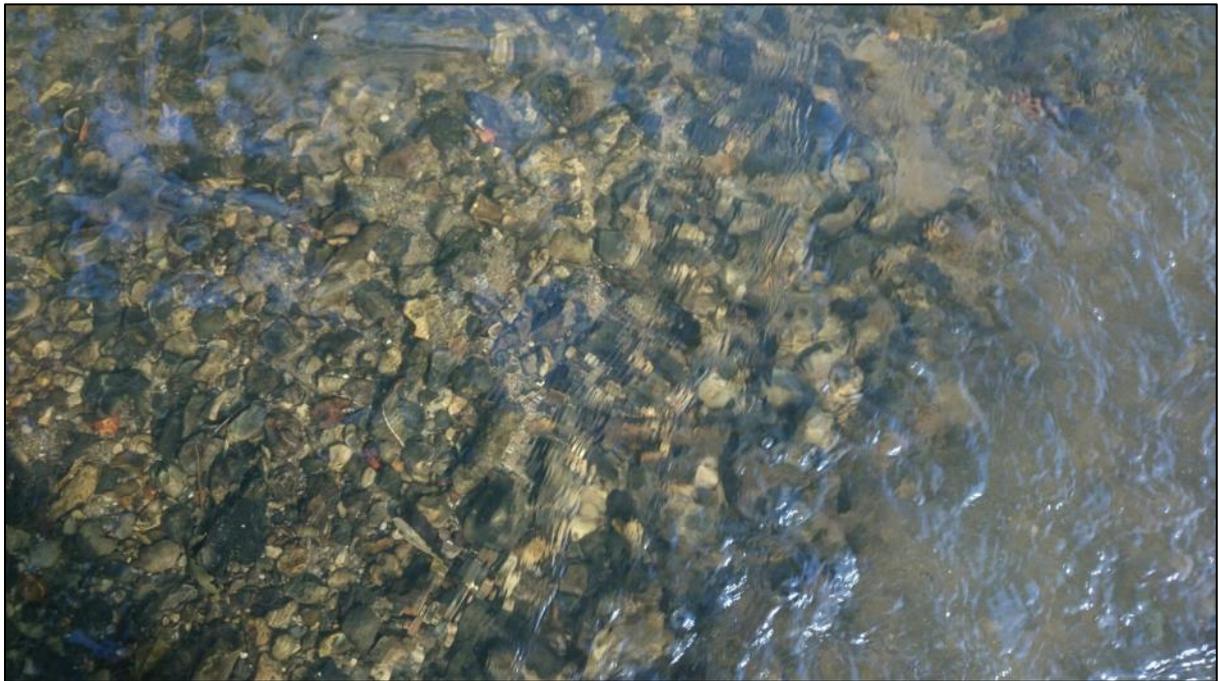
All three reaches have overly uniform flows and the gravel bed is poorly sorted as a result (Figure 18). The introduction of some carefully positioned and secured woody habitat features would greatly improve salmonid habitat.

Figure 18: Poorly-sorted gravel compacted with fine sediment, limiting the quality of spawning habitat.

3. Make use of site-won limbs and brushwood to introduce a variety of woody habitat structures to deflect flows and introduce scour, as well as creating some low-level marginal berms to introduce additional marginal habitat and increase in-stream sinuosity (see examples Figures 19 to 22).

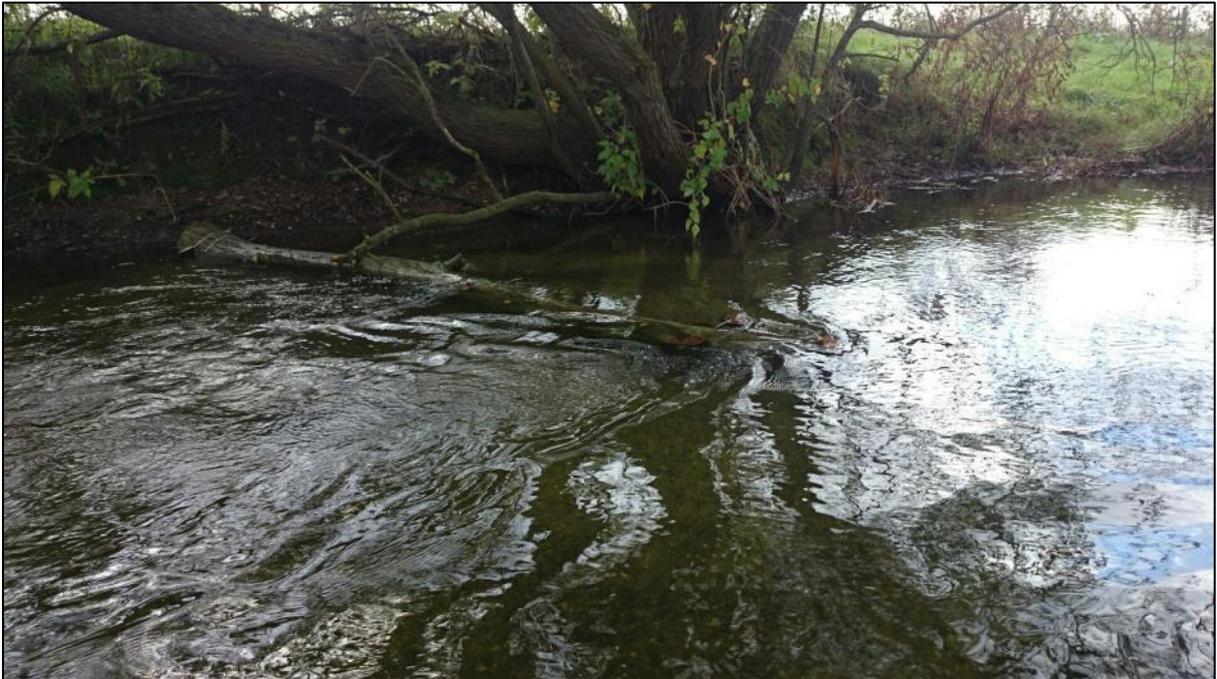
Figure 19: An example of a simple log deflector positioned approximately 45 degrees upstream and secured to the bed with sweet chestnut stakes and galvanised fencing wire.

Structures should be positioned to emphasise existing natural processes. Installing brushwood structures on the inside of bends in the river will increase deposition within the structure and scour around it. Log deflectors on the outside of bends will accelerate flows as well as create good lies for trout. Both structures can be used to increase flow diversity and sinuosity through straightened sections. The WTT's Wild Trout Survival Guide (available to order

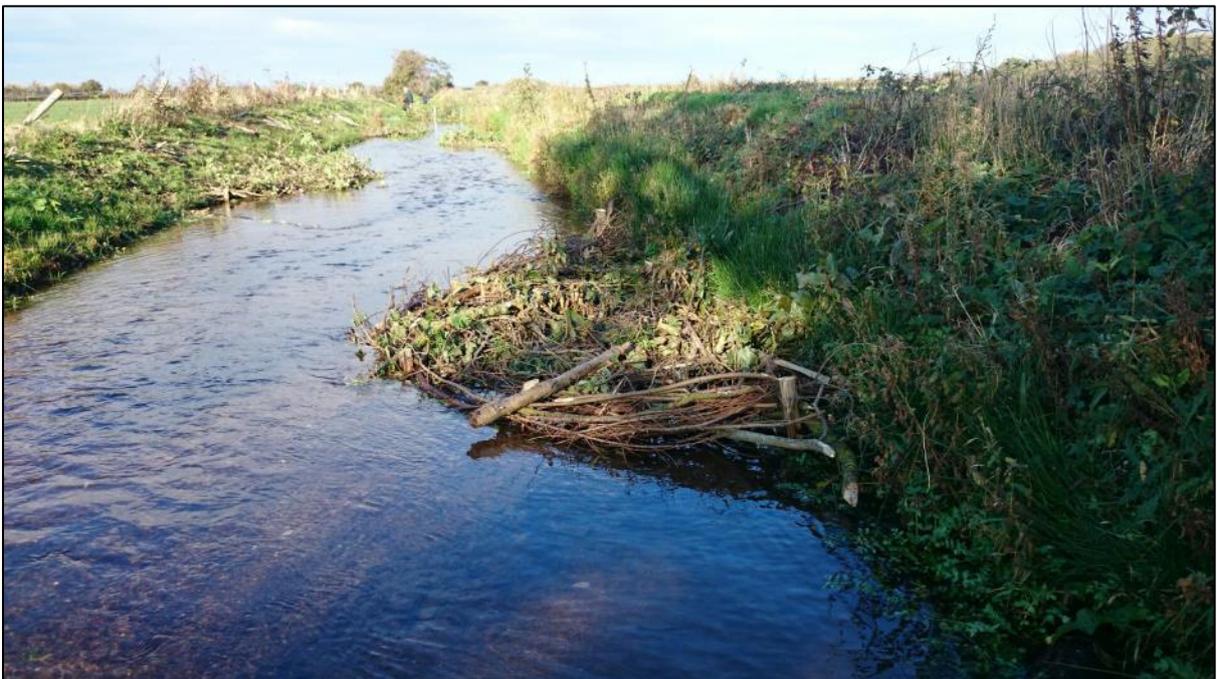
Figure 20: An example of a low-level brushwood berm installed to introduce greater sinuosity and provide marginal habitat

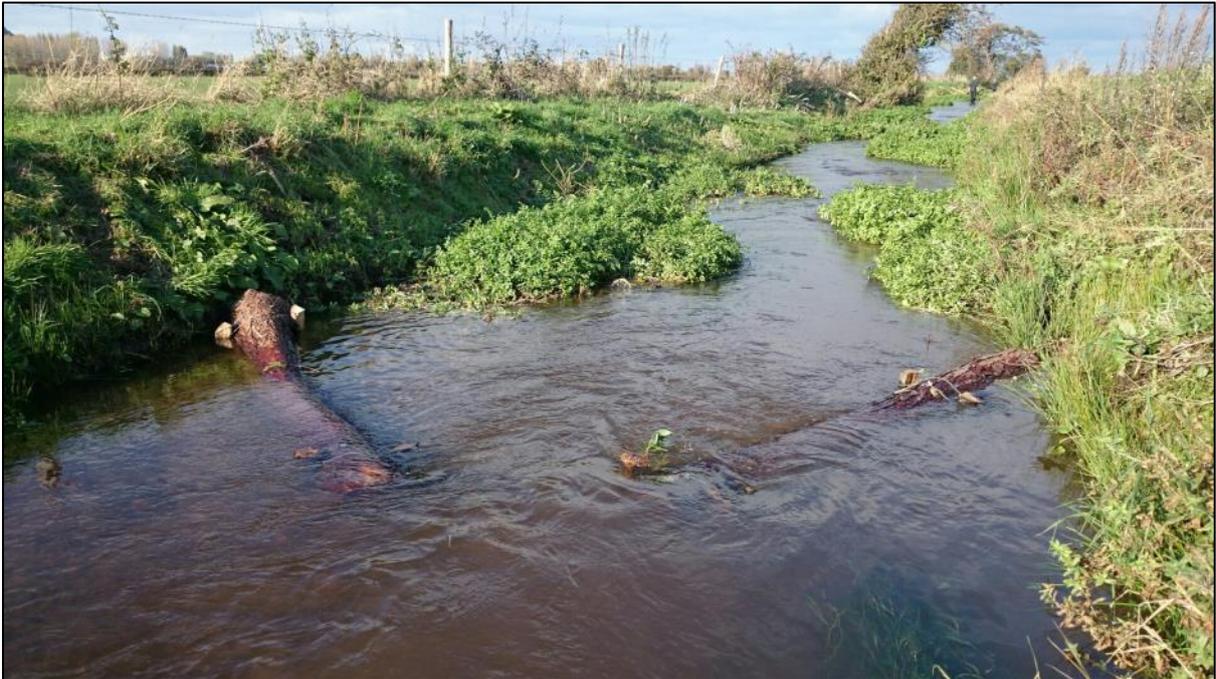
Figure 21: An example of a pair of opposing log deflectors both pointing approximately 45 degrees upstream to enhance scour through the centre of the channel.

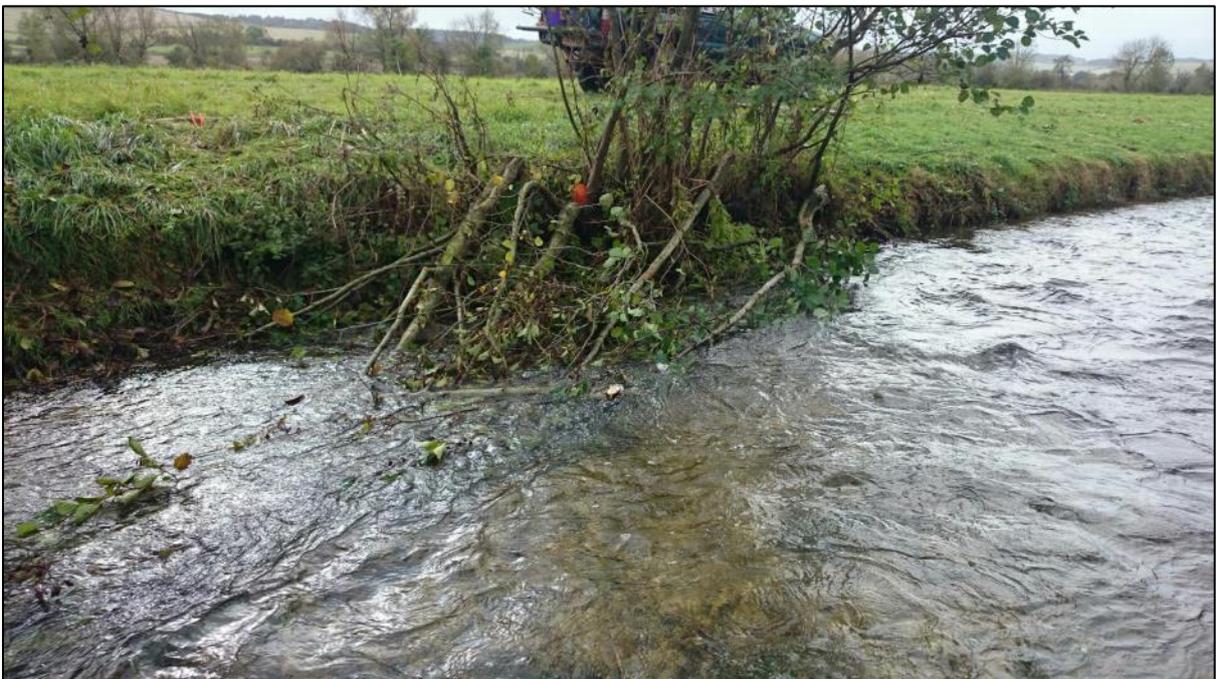
Figure 22: An example of 'hinging' (partially cutting and folding over) living bankside limbs to create some marginal cover refuge habitat and enhance flow diversity.

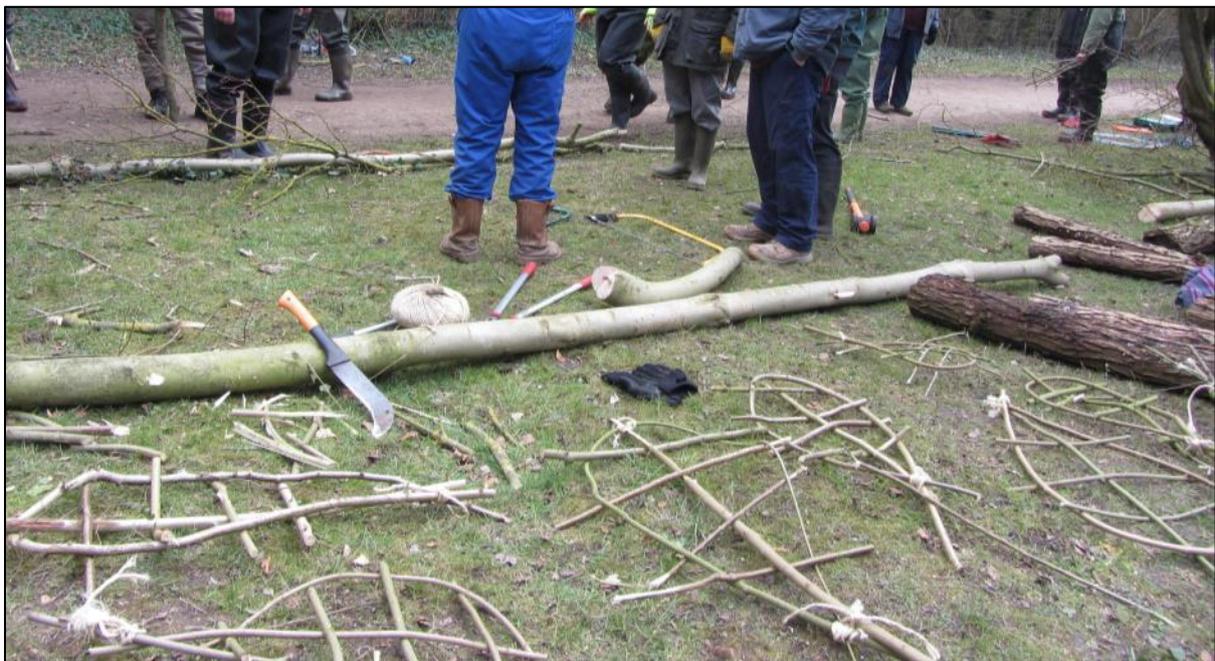
Figure 23: 'Snowshoes' ready to be interwoven with water crowfoot

4. Consider trans-locating some water crowfoot into the small carrier from nearby on the Frome. One technique that has been successful on chalk streams is to use 'snowshoes'. This technique involves bending flexible stems of hazel into snowshoe-shaped structures, winding crowns of crowfoot into them and securing them to the bed (Figures 23 and 24).

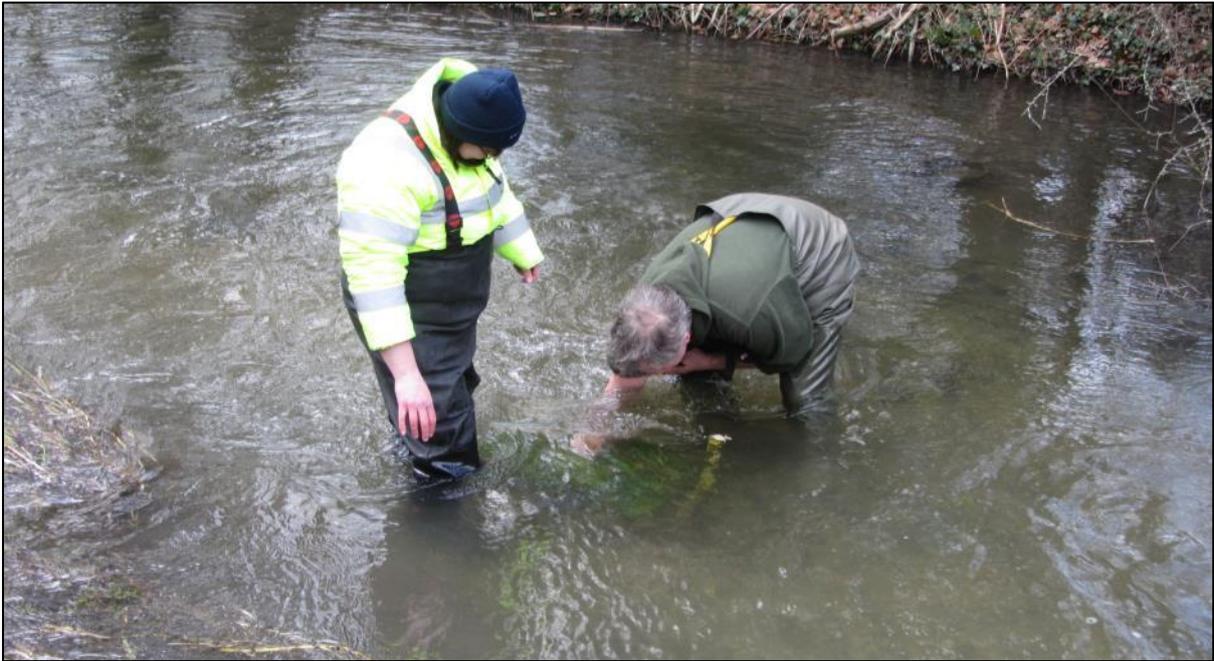
Figure 24: A snowshoe loaded with water crowfoot is fixed to the bed of a chalk stream
