## **River Frome, Bovington, Dorset**

**An Advisory Visit by the Wild Trout Trust October 2014**

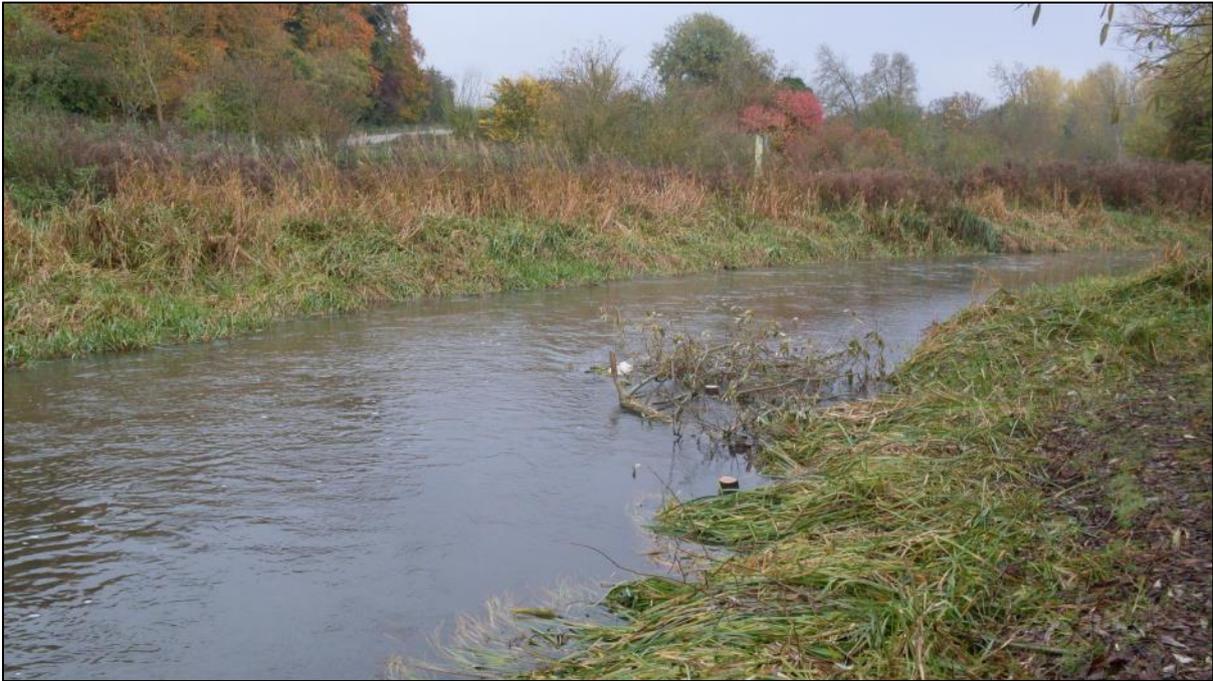
Figure 25: A live willow limb fixed into the margins of the Hampshire Avon

5. Consider the option of reducing gradient of the bank and introducing greater sinuosity by re-grading the banks in a few locations with a 360 excavator. A relatively small excavator (such as an 8 Tonne machine) should be sufficient and may be a quick and cost effective option.
6. Cut some live willow 'whips' from the small goat willows in the floodplain of the main carrier and drive them into the banks in 5-10 different locations along the section of the main carrier visited in order to introduce some bankside cover.
7. Also make use of live willow to create some submerged live willow habitat to provide additional refuge habitat. These features will help shelter fish during high flows as well as providing good refuge from predators such as piscivorous birds (Figure 22).
