River Glyme upstream of Woodford Bridge, Enstone.

Advisory Visit June 2016

1.0 Introduction

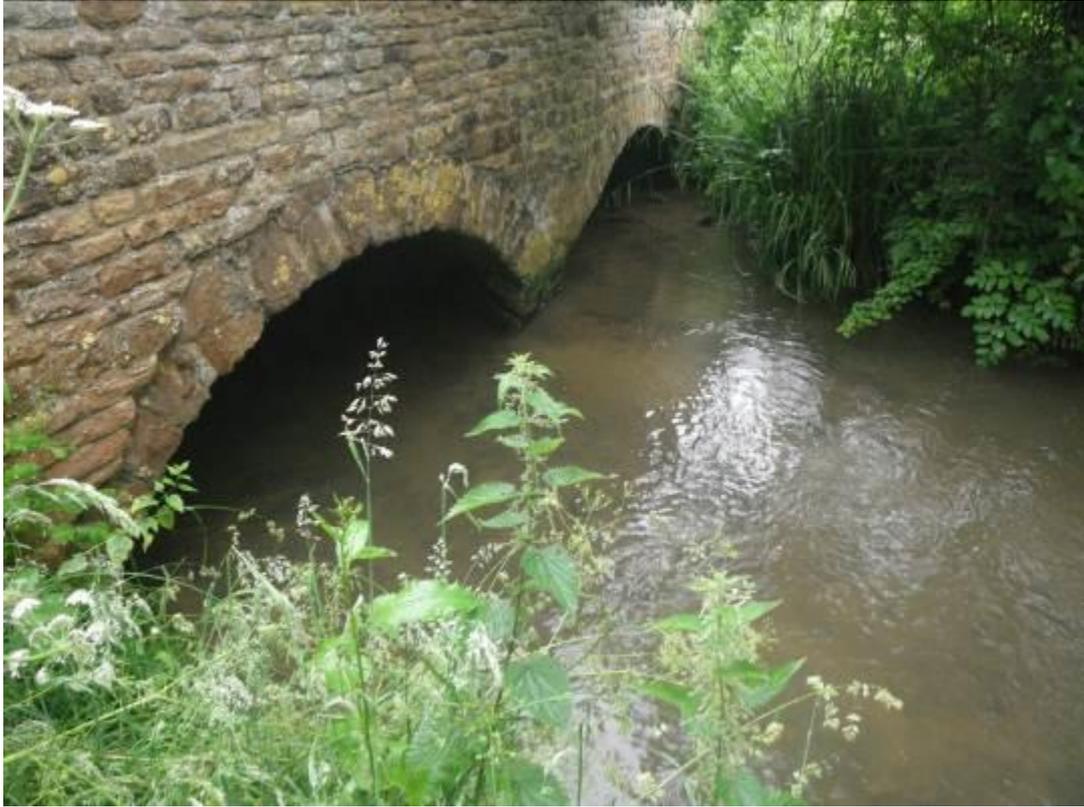
Habitat quality within the main Glyme is adversely impacted by the lack of bed gradient and the existing uniform channel shape. The lack of bed slope is also probably compounded by the invert of the Woodford Bridge (photo 1) on the downstream boundary.

Photo 1. The downstream side of Woodford Bridge. The limited capacity of the bridge and potentially bed armouring underneath may be responsible for sedimentation issues on the reach above.

It is recommended to keep the arches of the Woodford Bridge clear of woody material and to promote a more open channel on the bottom section of the Heythrop stream to reduce flood risk to neighbouring houses.

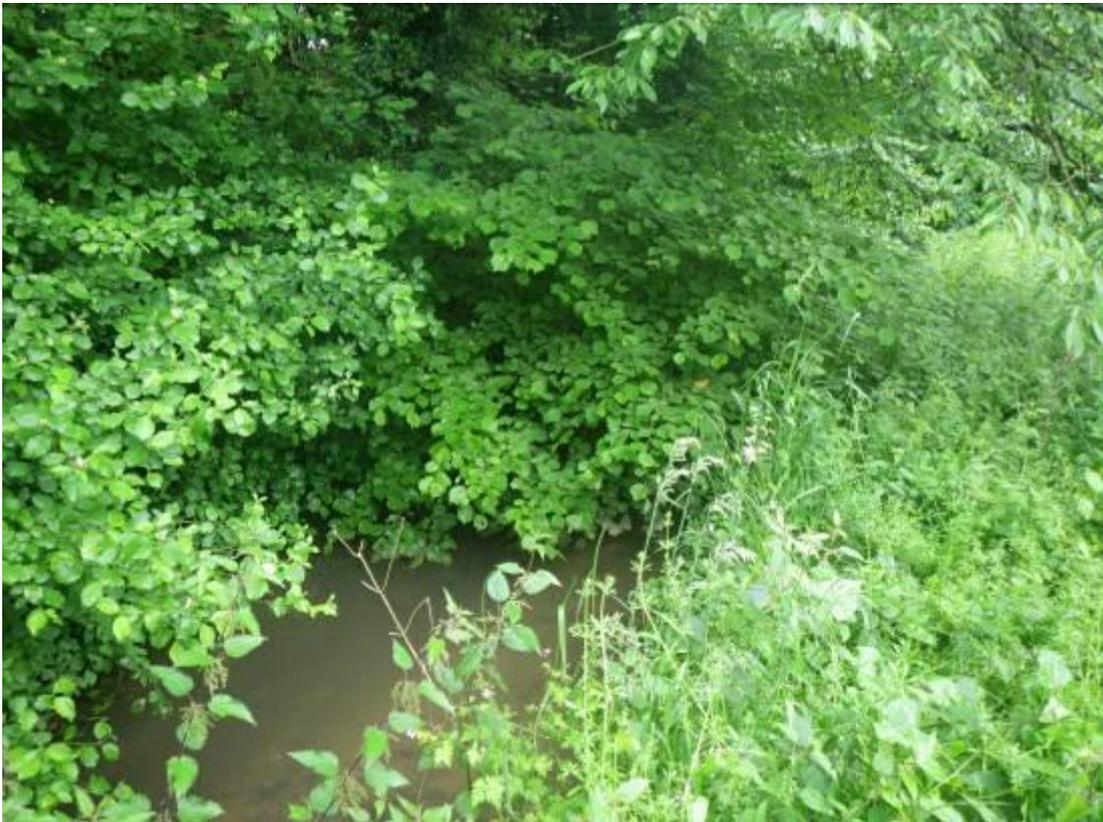
Upstream of the bridge, the in-channel habitat comprises shallow, uniform "glide" habitat flowing over a mainly fine-sediment laden river bed. Poor habitat diversity is compounded by the extensive shading emanating mainly from the southern RB (photo 2) which severely restricts direct sun light hitting the river bed and as a result limits the success of in-channel aquatic plants.

Photo 2. Extensive tree shading from the RB.

Low level shading that brushes the water surface and provides cover for fish is valuable and should to be encouraged. Heavy shading of long reaches by blocks of tall trees should, if possible, be managed with occasional clumps subjected to rotational coppicing.

As a rule of thumb, low scrubby tree species such as willow, thorns and elder provide wonderful cover, without completely shading out long sections of channel. Identifying tall, leggy alders and crack willows for coppice, or low-level pollard, will benefit the river environment and encourage beneficial low re-growth. Care should be taken to avoid selecting trees that might support high quality bat habitat (cracks and holes in main trunks) and all tree work must be delivered outside of the bird nesting seasons. Creating a reach where there is 50:50 dappled light to shade regime is ideal but does require regular work to maintain the ideal balance.

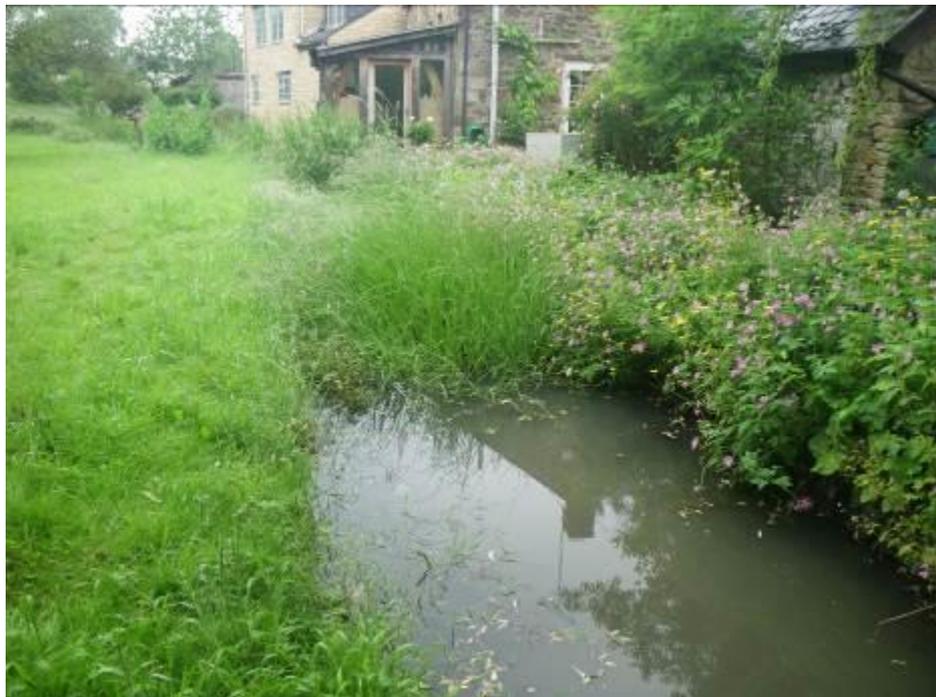
The Heythrop Stream discharges into the Glyme immediately upstream of the Woodford Bridge. This section of channel is severely choked with emergent plants (photo 3) and may benefit from some intervention to maintain a narrow, open channel. Flow at the time of inspection was virtually static, giving the impression that the channel was more akin to a ditch than a flowing watercourse. It will be important to ensure that there is adequate flow conveyance for flood defence purposes in the section adjacent to, and immediately downstream of the houses pictured. Some low-level planting to create shade and restrict emergent reed growth in the section just upstream of the channel confluence, possible coupled with some sensitive mechanical removal of excessive mid-channel reed growth to create a narrow channel should be investigated.

Photo 3. A large plug of emergent vegetation is currently restricting flow conveyance in the bottom of the Heythrop stream. A combination of low-level shading and some thinning is recommended to create a narrow, self-cleansing channel in this sensitive location.

- Consider a project to create a connected flood plain pond.
- If the watercourse here is classed as 'main river' by the Environment Agency, any work within 8m of the top of the river bank will require a consultation with the Environment Agency and quite possibly a permit for work.
- Control excessive spread of emergent plants on the bottom end of the Heythorp stream by some local shrub/tree planting to create shading and if necessary some mechanical cutting to create a narrow open channel for improved flow conveyance.

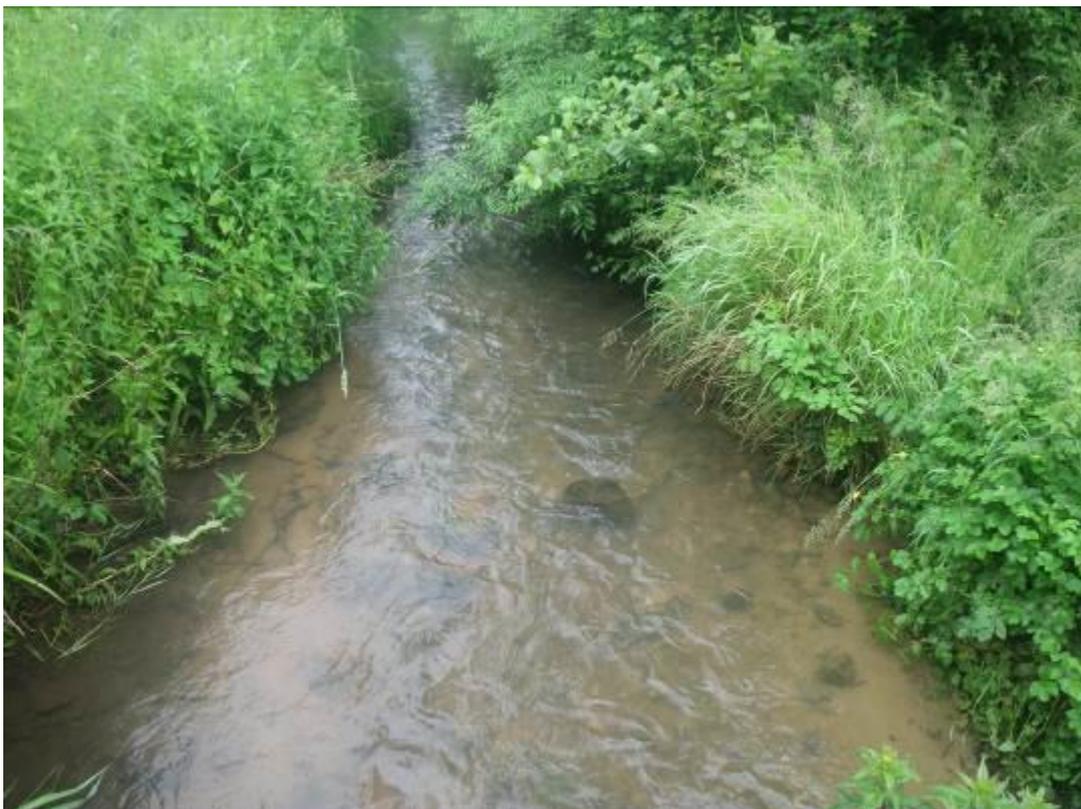
Occasional short sections of clean gravel (limestone chip) bed were seen in a few areas of the main Glyme located further upstream. Here the channel width is naturally squeezed (photo 4) promoting locally elevated flow velocities which have swept away some of the fine sediment, although a cleaner bed could be expected in a location like this. These sections are extremely valuable, potentially providing winter spawning opportunities for brown trout *Salmo trutta* and other gravel-spawning fish species such as dace *Leuciscus leuciscus*, minnow *Phoxinus phoxinus* and bullhead *Cottus gobio*. Protecting, or even creating areas of clean gravel bed can help to boost local fish populations

Photo 3. A pinched channel width, increased flow velocity and exposed gravel providing potential winter spawning opportunities.
