Advisory Visit
River Kent – Levens Hall
10/04/2017

Undertaken by Gareth Pedley

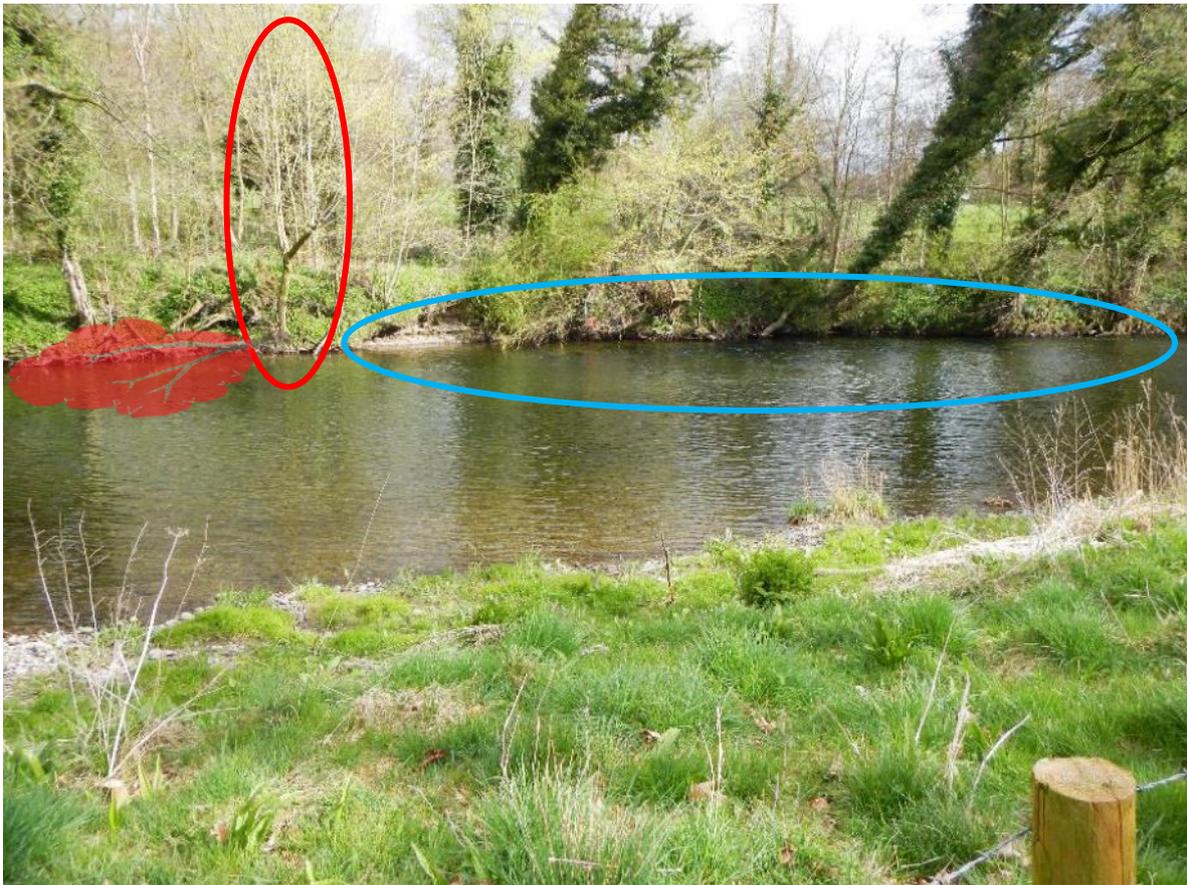
The first pool viewed is relatively wide and open, with a rough buffer strip along the LB, adjacent to a lightly grazed livestock field. The breast-wire buffer fence excludes cattle but any sheep within the field have access to the LB. Sheep access is usually of detriment to the beneficial river bank vegetation and limits tree regeneration. However, here, it appears that the extent of sheep grazing is limited. As a result, a visible improvement in the habitat quality is still achieved within the buffer (Fig. 1). Fencing to completely exclude sheep from this area would further improve the quality of that habitat but would require a fence that would be more susceptible to fold damage, and could allow a proliferation of Himalayan balsam that would then require control. Marginal habitat along the LB is limited owing to the natural morphology of the pool (e.g. relatively shallow water gravel bed) but provides some refuge for fry. This habitat could be enhanced by laying the bankside willow into the river margin to provide additional cover and shelter.

The far bank provides a greater extent of cover through increased flow and water depth, and the presence of bankside trees; this is the area around which most of the anglable fish are likely to hold. However, the quality of habitat along the RB is greatly limited by past tree maintenance work to improve angling access (primarily removal of any low/trailing branches). This kind of work is often undertaken with the best intentions but greatly reduces the availability of in-channel structure that is required for fish-holding habitat and as refuge from high flows and predators (Fig. 1). The reduction in habitat availability and quality actually reduces the number of fish the pool can hold.

Figure 1. Note the general lack of low and trailing cover resulting from past tree pruning/maintenance (blue ellipse). Some of the now lacking cover could be quickly and easily reinstated by laying the willow tree (red ellipse) down into the water along the river margin.

To greatly improve the quality of that habitat, bankside trees should be allowed to develop naturally and overhang, and ideally trail into the watercourse. To rapidly reinstate some of the lost cover and greatly improve the habitat and fish-holding potential of the pool, the previously pruned willow tree (suspected to be crack willow *Salix fragilis*) on the far bank could be laid into the river margin (see Recommendations).

Where trees of a suitable species are already established along the banks (like the willow identified in Fig. 1), habitat improvements can be quickly and easily achieved by laying the trunks, or branches down into the watercourse. Laying is usually limited to pliable species, predominantly willow (*Salix* spp.), hazel (*Corylus avellana*), elm (*Ulmus minor*) and small alders (*Alnus glutinosa*), but some others can be laid carefully when they are small.

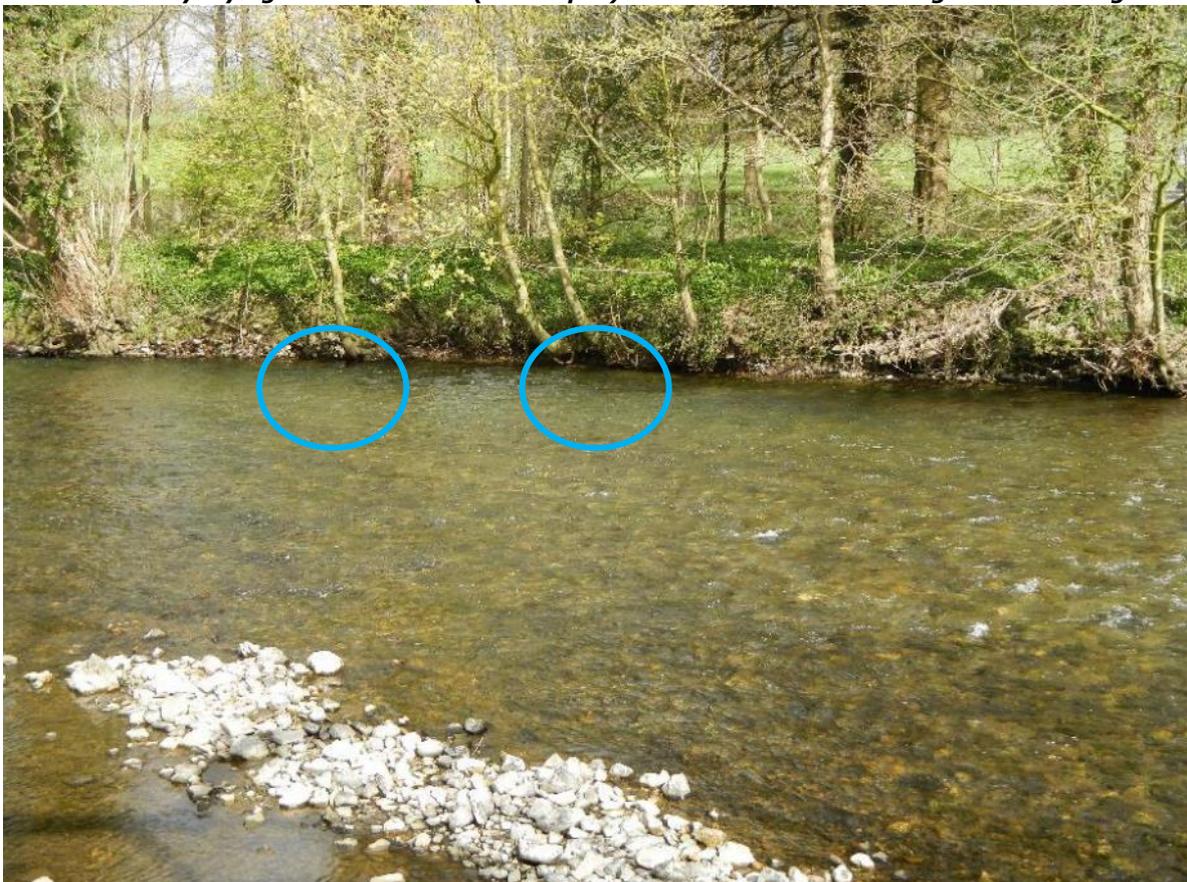
Slightly further u/s in the pool, similar pruning work on the bankside sycamore trees (*Acer pseudoplatanus*) has also denuded them of low and trailing branches (Fig. 2). Coppicing of one or two of these trees would encourage low level regrowth and help reinstate some of the lost habitat.

Figure 2. Raised canopy through past pruning work (some will also be lost through high flows/natural breakage, so it is important to preserve/promote this habitat wherever possible). Coppicing one or two of the trees, low to the water (blue circles), would help reinststate the lacking cover.

Particularly where there is a predominance of one age class of tree and/or the canopy is of a uniform height, low coppicing can be a great way to increase habitat diversity by rejuvenating low-level regrowth. This technique would be ideal for the trees highlighted d/s of the A6 road bridge (Fig. 2). This technique should always be undertaken sparingly, only on the occasional tree, to ensure that one type of habitat is not gained at the expense of another. The resulting material can then, potentially, be employed as tree kickers.

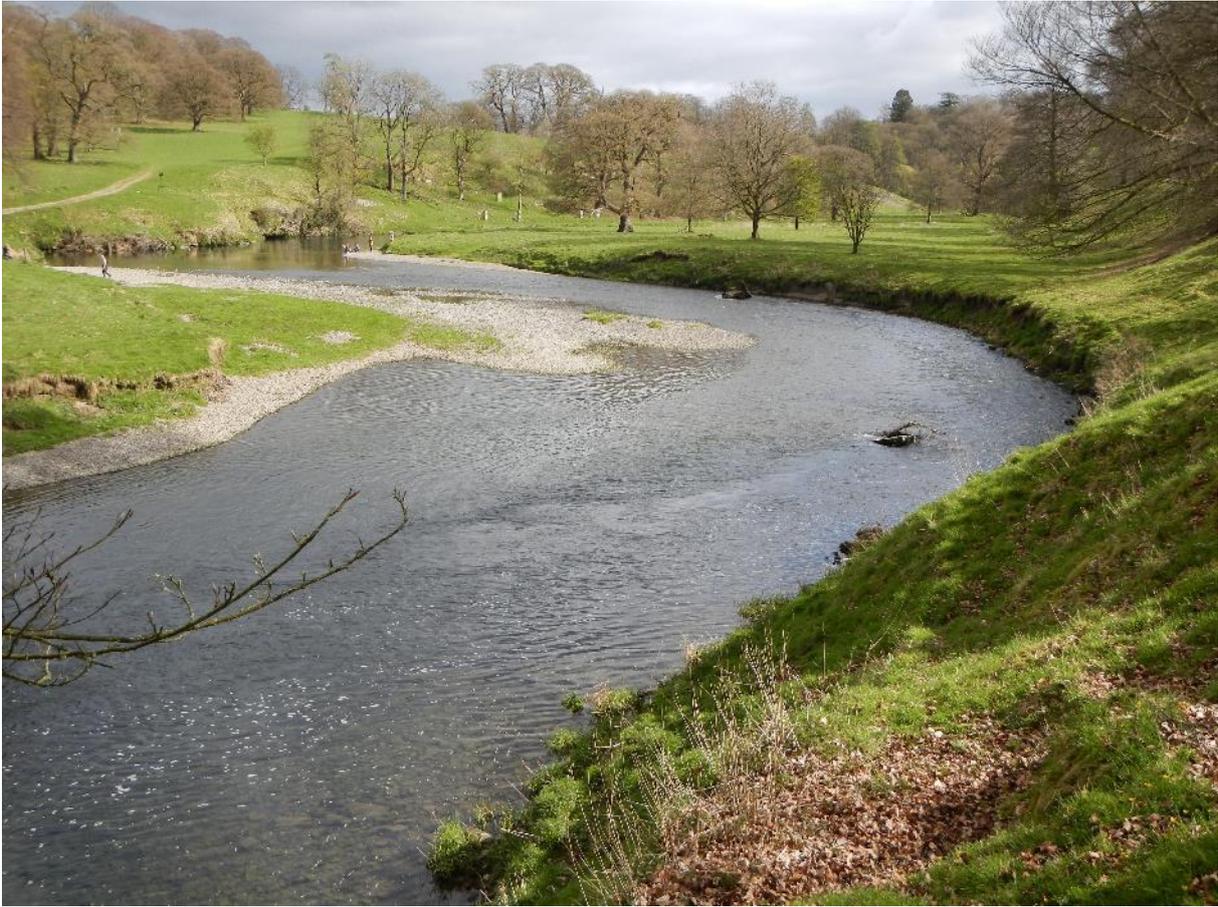
The river is naturally active geomorphologically and provides a beneficial supply of coarse sediment through the reach, to the benefit of both invertebrate, and salmonid spawning and juvenile habitat (Fig. 3). Although resident trout often seek spawning sites on smaller tributaries, some main stem spawning is likely to be undertaken, with salmon and sea trout almost certainly utilising the main channel. Increasing cover and structure within the river margins is a sure-fire way to improve juvenile habitat and the survival rates of fry and parr within the main river. Increasing the prevalence of bankside trees and vegetation (and their root matrices within the bank) will also help to stabilise the river bank material and therefore reduce the potential for over-widening of the channel and allow narrowing of the channel in areas over-widened through previous bank erosion.

Figure 3. A general lack of bankside trees for shade and in-channel structure. Note the un-vegetated gravel bar signifying an active transport of coarse sediment through the system.

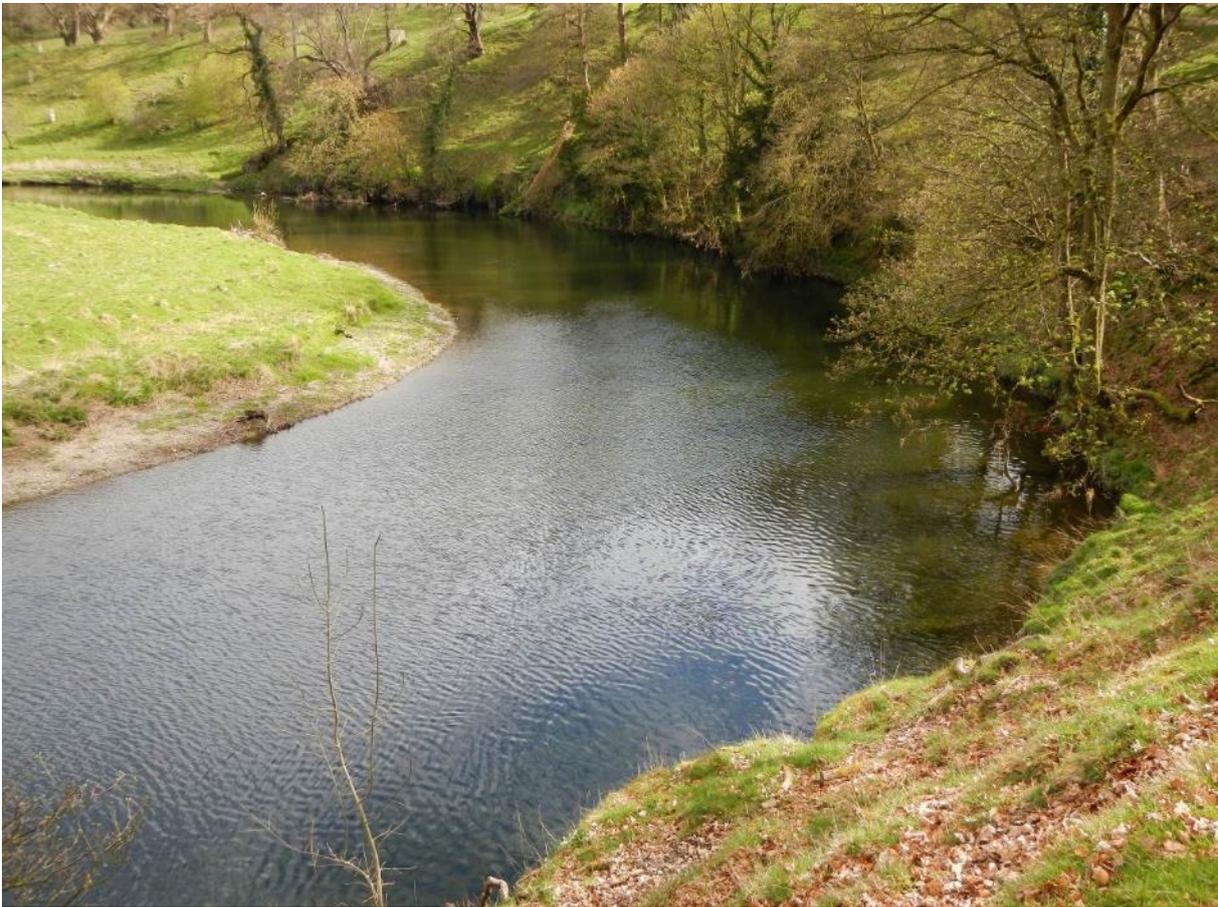
Where established trees are present along the banks they provide valuable shade and cover that it is vital to preserve, avoiding any temptation to trim or prune their branches (Figs 4 & 5). Anglers often feel that they are being restricted from accessing the best lies by overhanging trees, but there is absolutely no point in removing the vital habitat that is accommodating the fish in the first place. Even if fish within a location are not accessible all of the time, they will move to feed in different locations, at which point when they will become available to anglers.

Figure 4. Where bankside trees are present on the outside of bends they greatly enhance the fish-holding potential of those areas. Any trailing branches that meet the water enhance it further, as will any other woody material that can be retained within the channel.

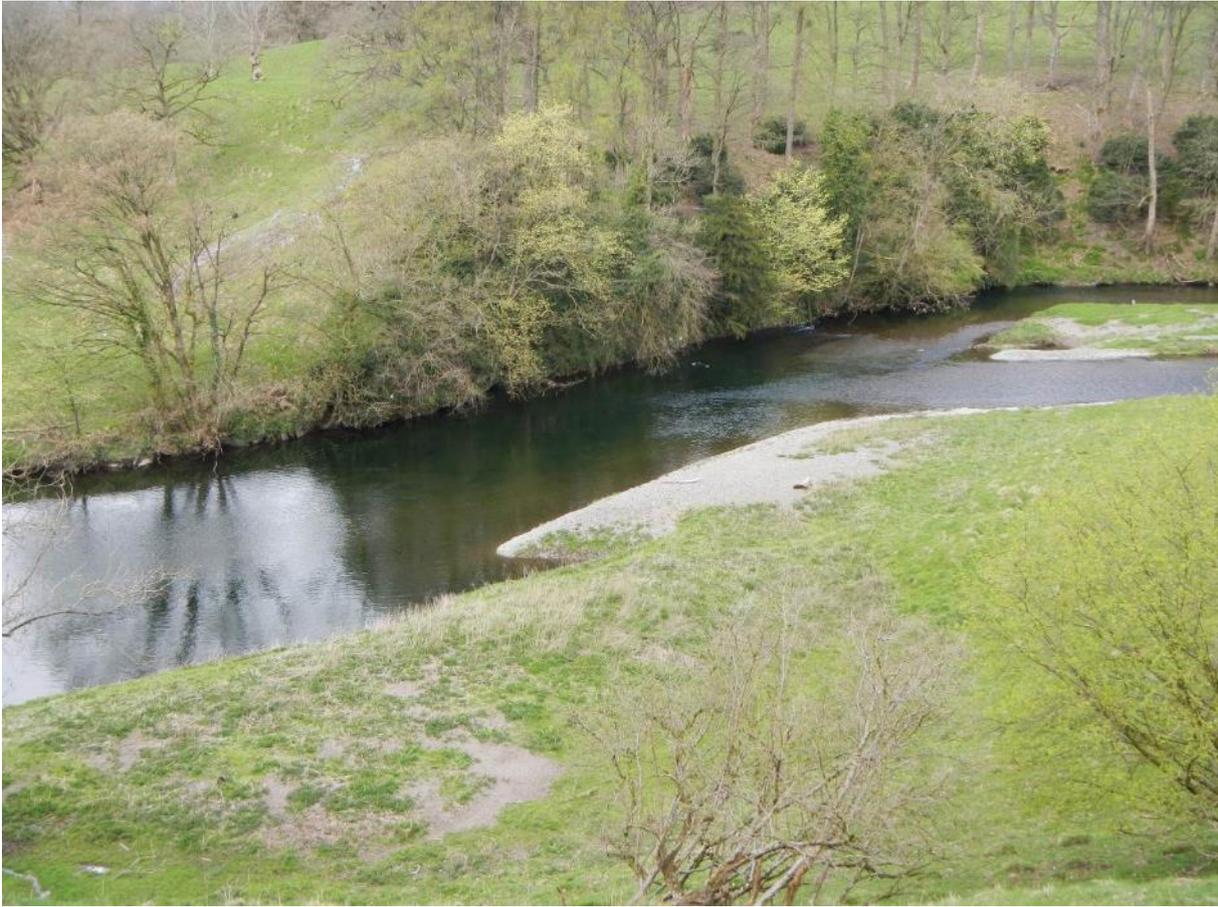
The alternative: removing the habitat that holds fish is likely to result in the fish vacating those areas and the river section holding less fish. Owing to the height of the trees above the water (often influenced by limestone bedrock towards the base of the bank/cliffs – Fig. 5) it is important to allow them to grow out over the channel and trail down into it. Consider that, although some fish may be inaccessible at times, they will all be contributing to the population of a wild fishery, being long-term residents of an area and part of the spawning population. Until the carrying capacity of the river in its near-pristine state is reached (unlikely with today's anthropogenic impacts upon habitat), the more fish present within the river, the more that can be produced and the greater the size of populations that are achievable.

Figure 5. In areas, the rocky nature of the lower bank limits the availability of low tree cover, it is therefore important to allow branches to grow out and over the channel.

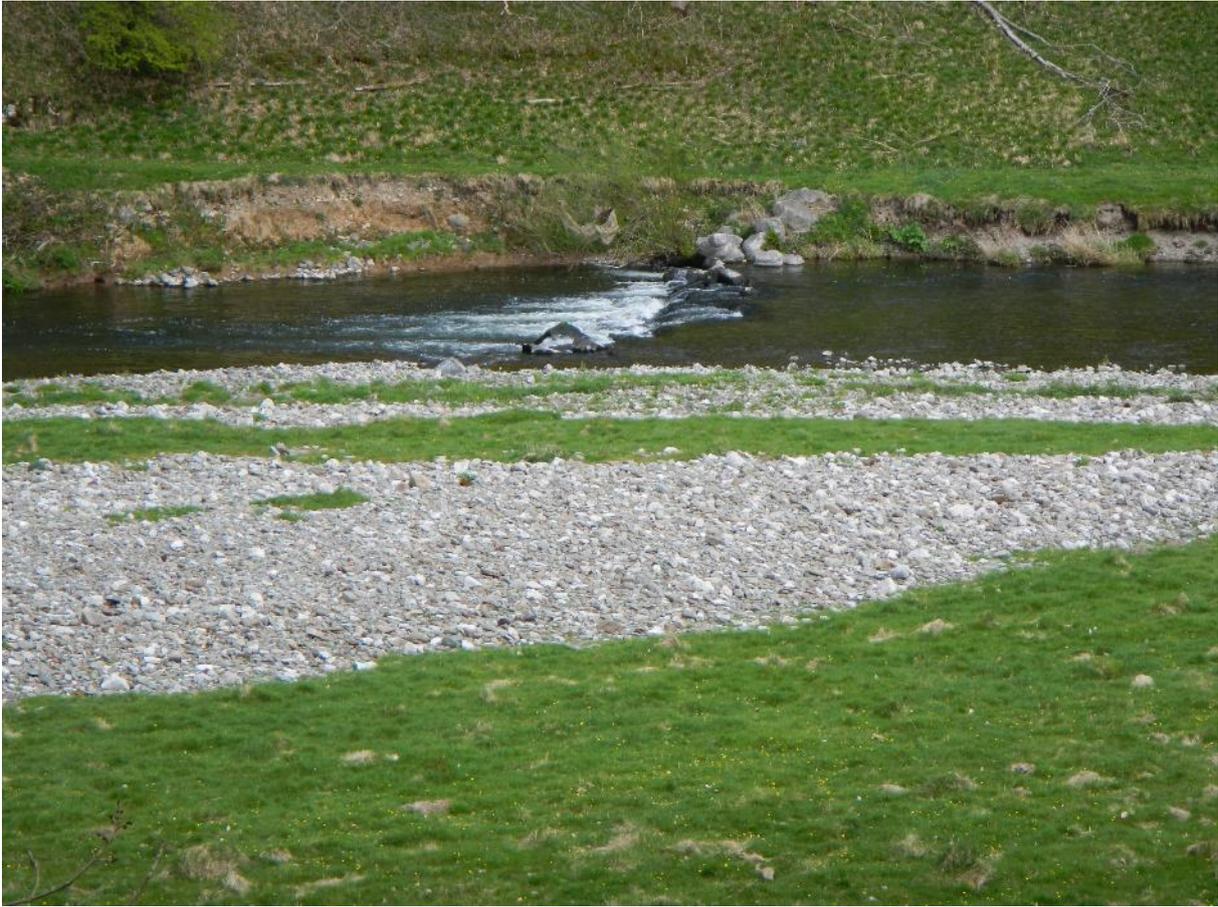
A weir, towards the upper end of the reach, creates an unnecessary impediment to sediment transport and potential behavioural barrier to fish movement (Fig. 6). The impact upon sediment transport (effectively working like a gravel trap) means that much of the water depth the weir once created u/s is now lost. At high flows, more of the river's bed material will also be forced out of channel and across the field (as can be seen), rather than continuing along the main channel. The flow deflection effect around the hard stone structure is also clearly increasing bank erosion.

Although most fish could easily ascend or descend the weir relatively easily, in low flows, they are likely to be at least partially obstructed / delayed by it. This will cause increased numbers of fish to congregate in the area, allowing predators greater feeding opportunities and increasing their impact upon the fish population. The solid structure within the channel also provides a barrier against which fish can be corralled against by predators, making it easier for them to fish the area, again, increasing their impact.

Figure 6. An unnecessary impediment to sediment transport and fish movement that is also likely to increase the impact of bird predation upon the fish. Note the increased bank erosion around the hard stone structure.

Removal of the weir towards the u/s end of the fishery (Fig. 6) would be beneficial to reinstate substrate transport and reduce the potential for increased bird predation. This would also reinstate more natural sediment transport through the section. The redistribution of sediment (bed material of all sizes) is central to the creation of varied habitat features that trout and invertebrates need to complete their full lifecycles.

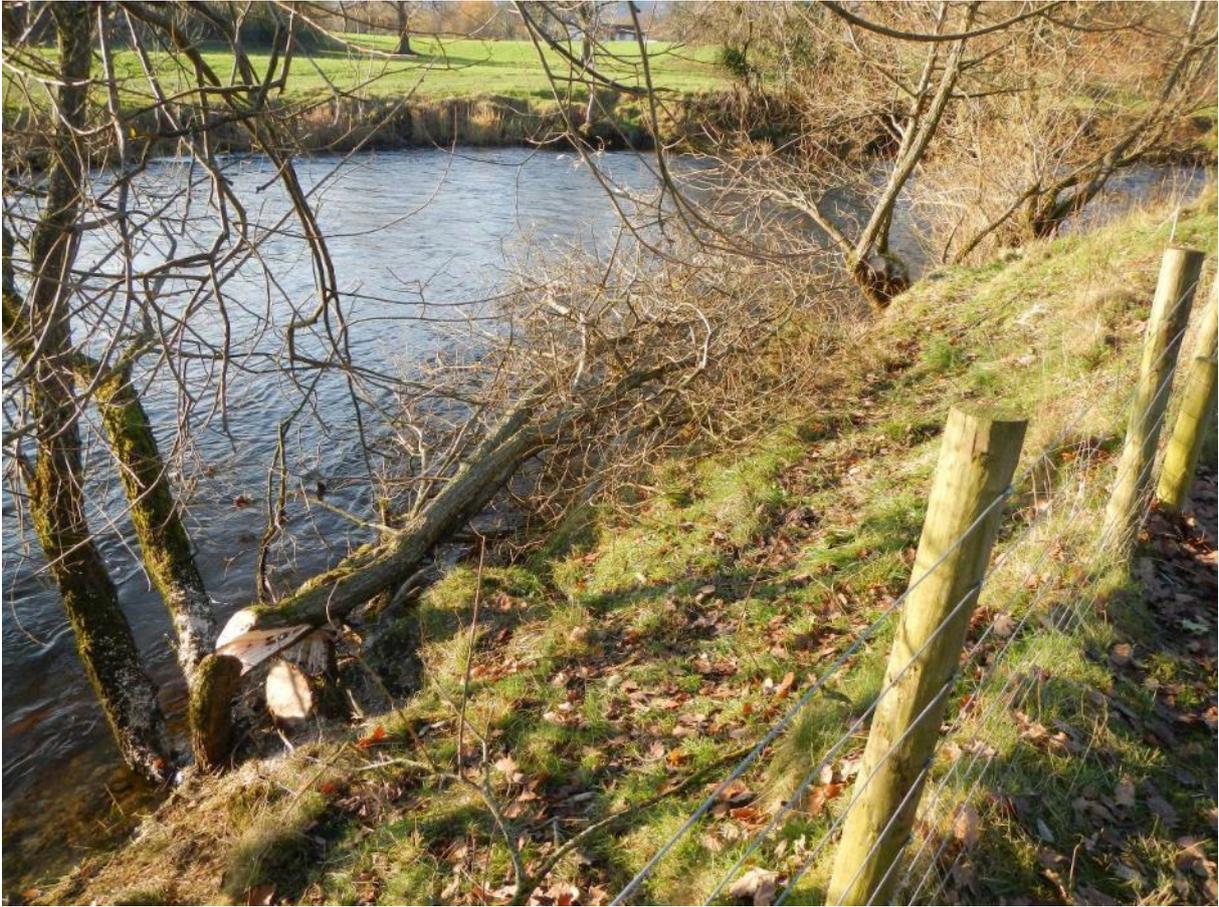
Figure 7. Willow hinged into the river margin to increase cover and structure.

The method involves cutting part way through the stem/trunk, a little at a time (ideally while it is under light tension), until it can be forced over into the river (Figs 7 & 8). The depth of the cut should be limited to only that which is required to bend the limb over, as this will maintain maximum strength in the hinge and the health of the tree/shrub. Fast growing trees like willow can even be strategically planted in anticipation of employing this technique once they become established.

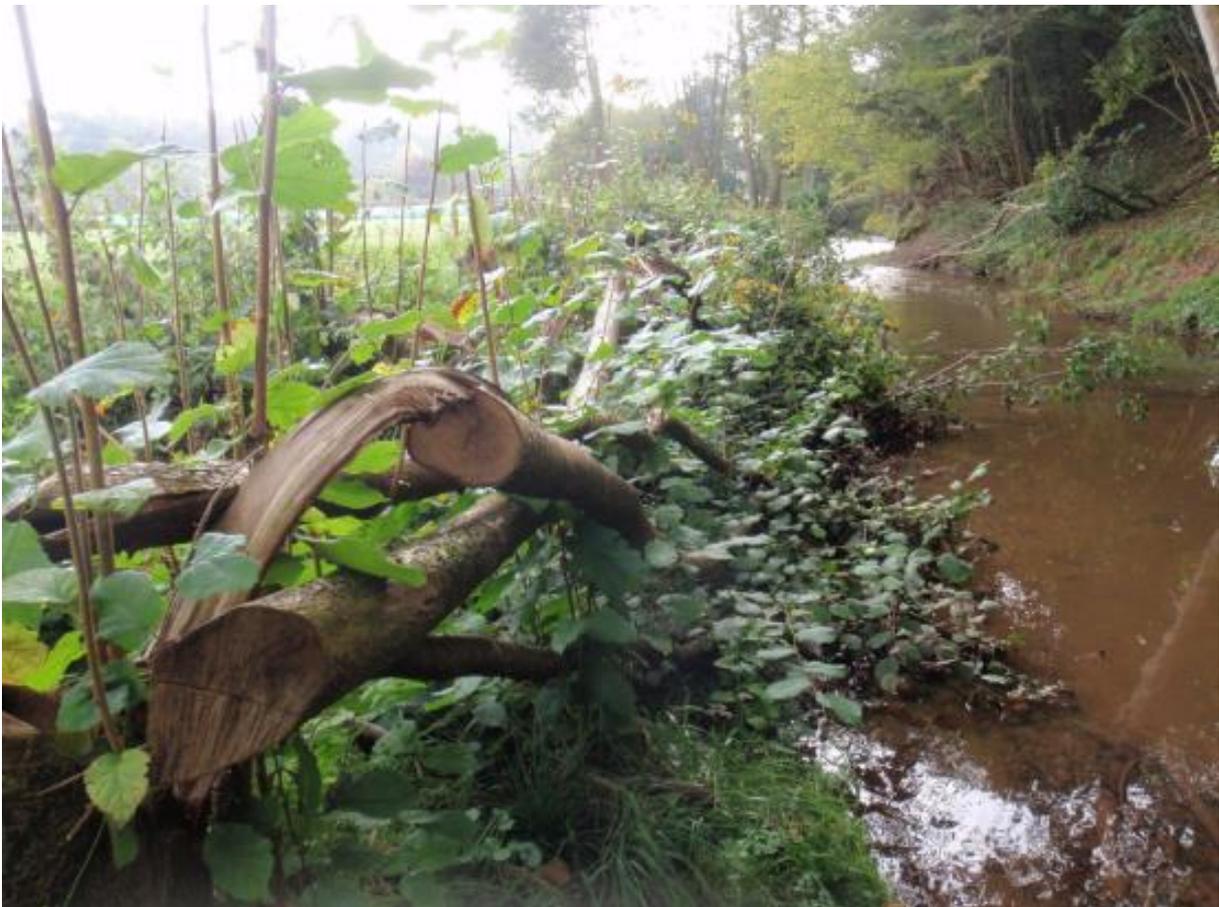
Figure 8. Hinged hazel.

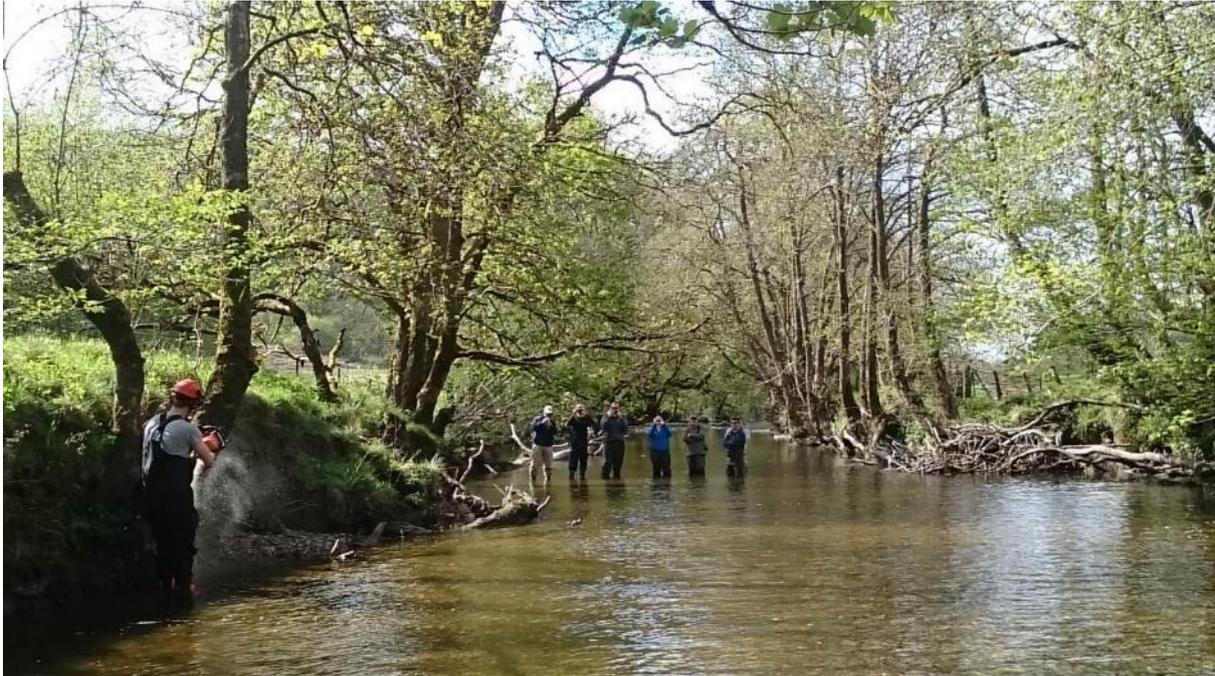
Figure 9. Felling the tree.

Dead woody material can also be introduced to the channel to provide significant habitat enhancements and increase the level of protection from predators (particularly piscivorous birds). The technique involves cutting a tree/shrub and then cabling it to its own or an adjacent stump, to keep it in place (Figs 9 – 13).

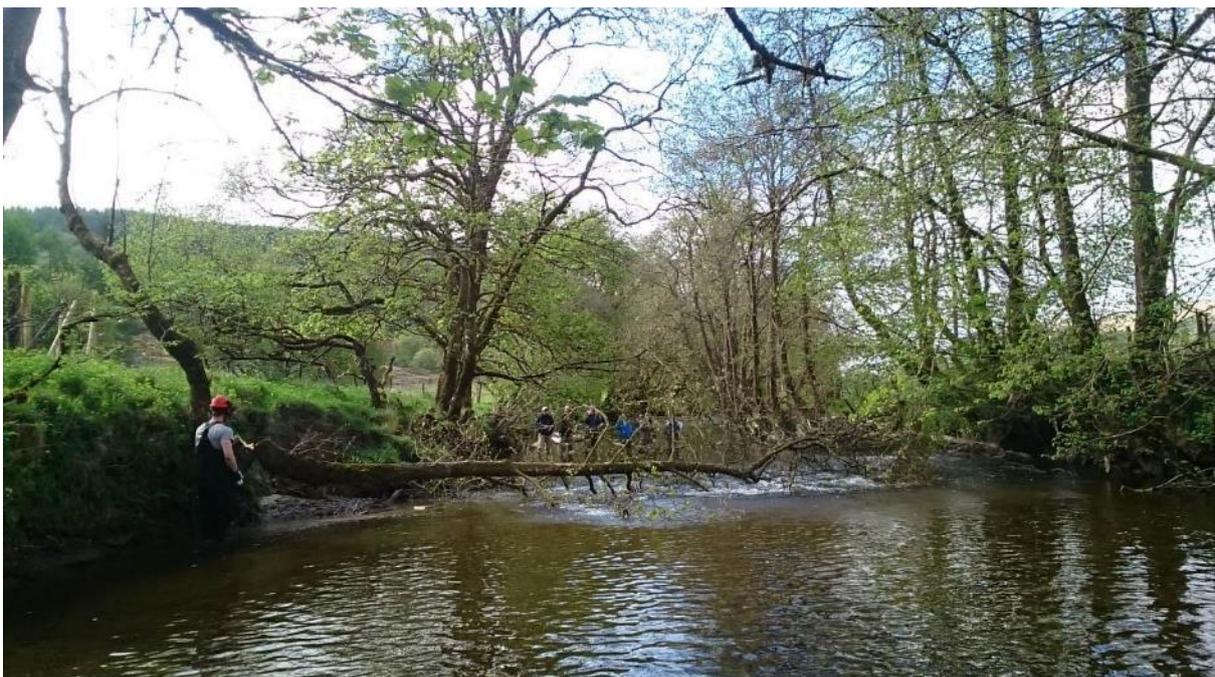
Figure 10. The tree is down and just needs slewing round into the river margin. It could be left for the river to do this during the next high water event, providing the tree is well cabled to its stump before it is left.

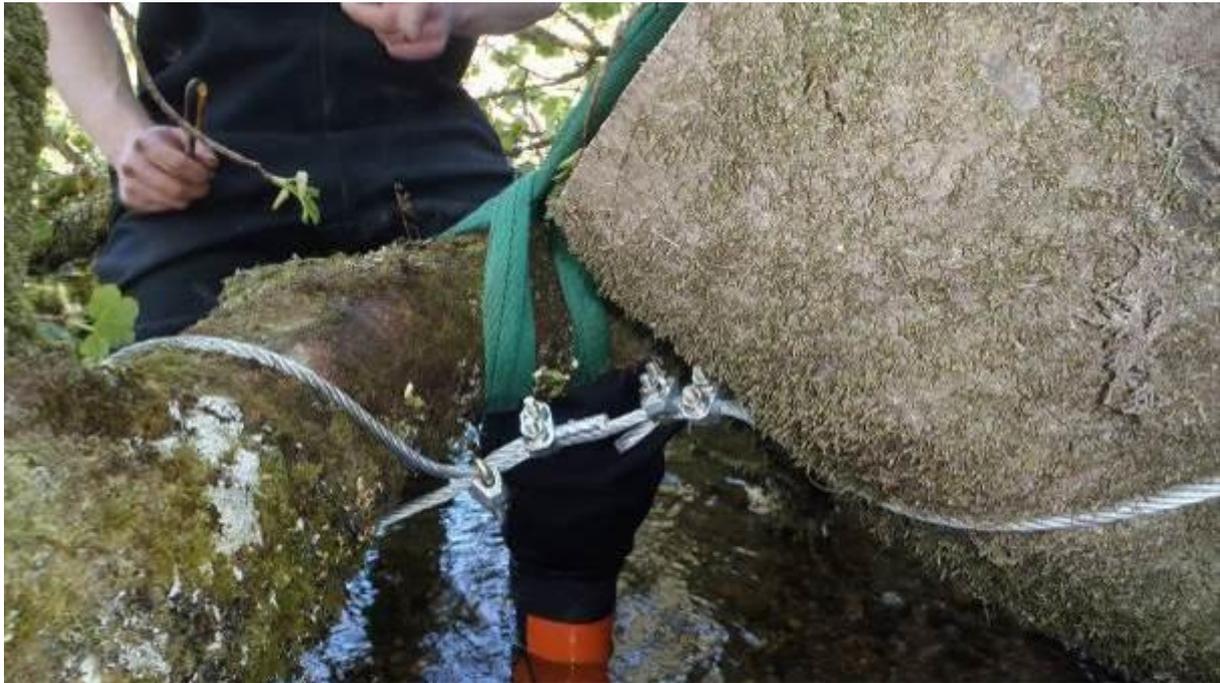
Figure 11. A basic tree kicker setup using 4000 kg breaking strain cable and two pairs of cable clamps on either end. The webbing strap in the background is used to pull the kicker close to the stump for fastening but is removed once the cable is fully fixed in place.

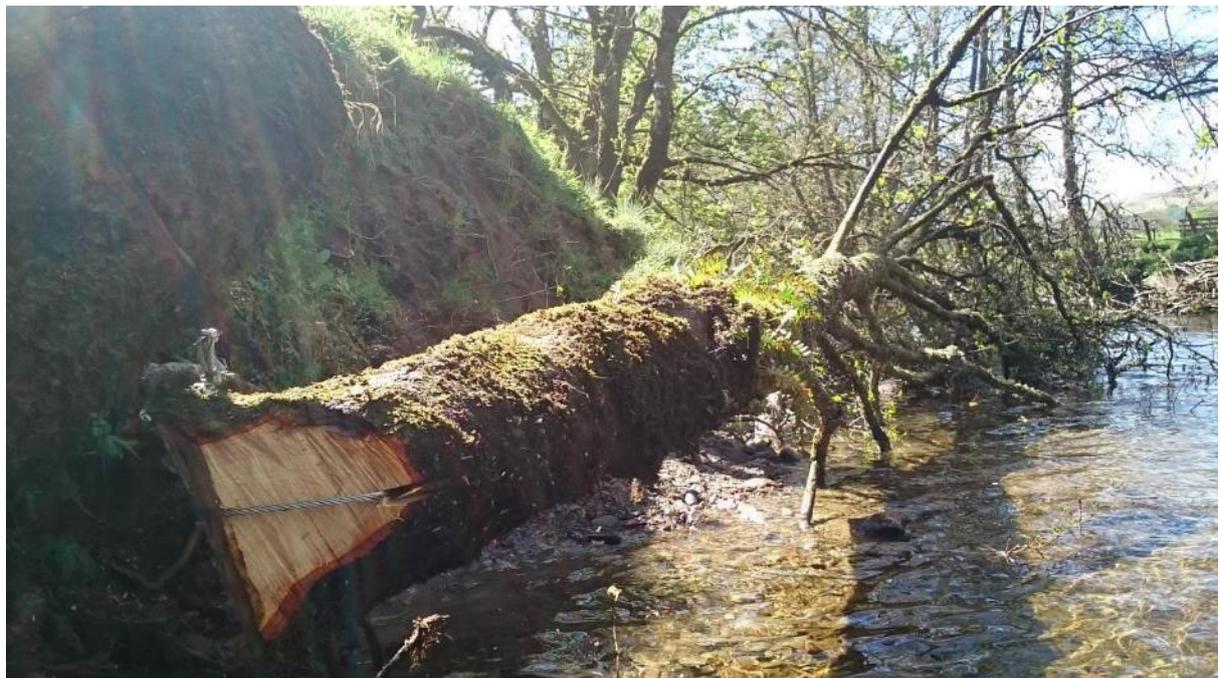
Figure 12. Tree kicker cabled and slewed round to lie along the bank. In this instance a bore cut has been made into the trunk, through which the cable is passed.

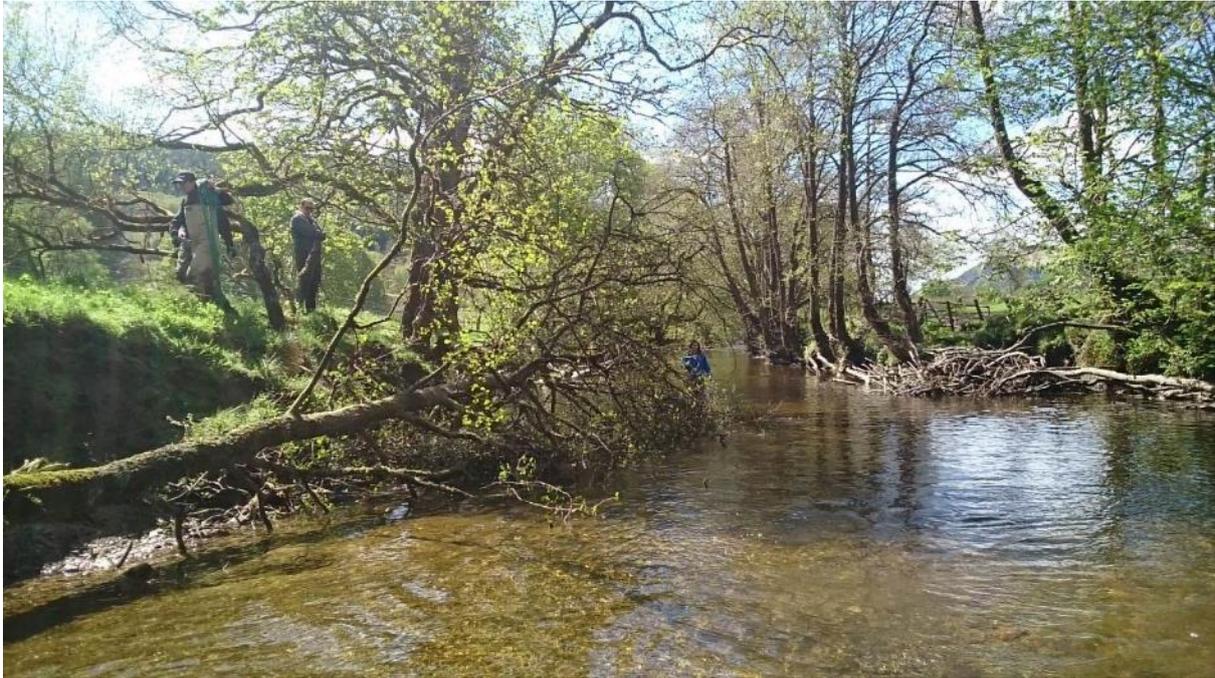
Figure 13. *The finished job – a tree kicker employed to provide cover within the river margin and focus flows down the far side of the channel. When installed on the shallower inside of a bend (depositional areas), this method can be employed to increase sediment deposition. When installed within the main flow, the technique can be employed to increase in-channel cover and fish-holding structure.*
