River Meon. Grange Farm Warnford

Advisory Visit December 2016

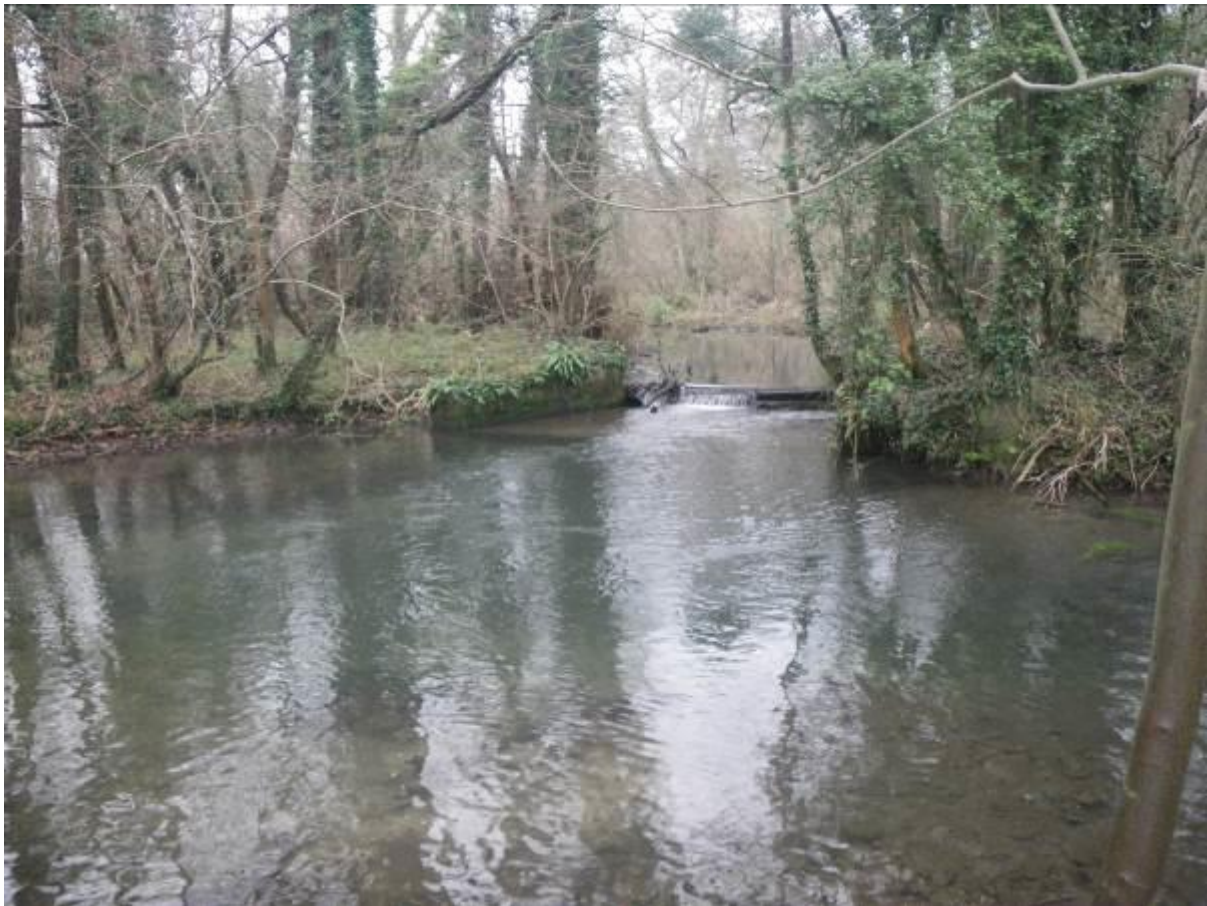
Near the top end of the reach there is an old, semi derelict weir (cover photo and photo 1) which was probably installed to create a small head of water for either irrigation or improved access for live-stock drinking. The reach immediately upstream of this structure was not inspected but it is assumed that the weir will be responsible for significant sediment deposition in the reach above and is likely to be compromising the development of high quality in-channel habitat in the upstream reach. The structure is not considered to be a major impediment for fish migration, however, in a low flow autumn the structure may well delay upstream sea trout *Salmo trutta* migrations. Any delay in fish migration can result in increased levels of predation and put increased pressure on vulnerable populations.

The first consideration is the management of the semi derelict weir at the head of the reach. There is no doubt that in the long run, the removal of this structure would significantly enhance habitat quality in the reach above, as well as reconnecting the natural transport of bed sediments to the downstream reach. Knocking out the central third of the weir to bed level will elevate upstream flow velocities and allow trapped sediments to be flushed through the system. This would also ease concerns over delays for fish migration. Initially the reach upstream of the weir would look awful with reduced water levels and exposed muddy margins. These will rapidly recover and it is highly likely that more diverse in-channel plants will flourish where sufficient light reaches the channel.

- The removal of the weir will promote a marked improvement in habitat quality in the reach above.

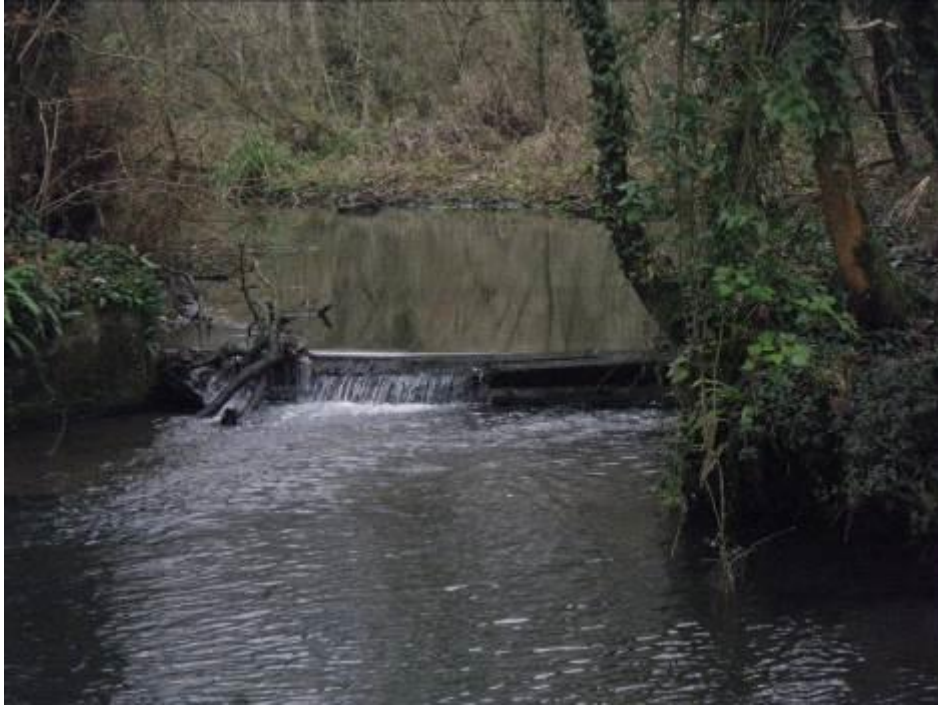
Photo 1. Small weir at the top of the reach could delay fish migration in a dry autumn and will be adversely impacting on upstream habitat quality.

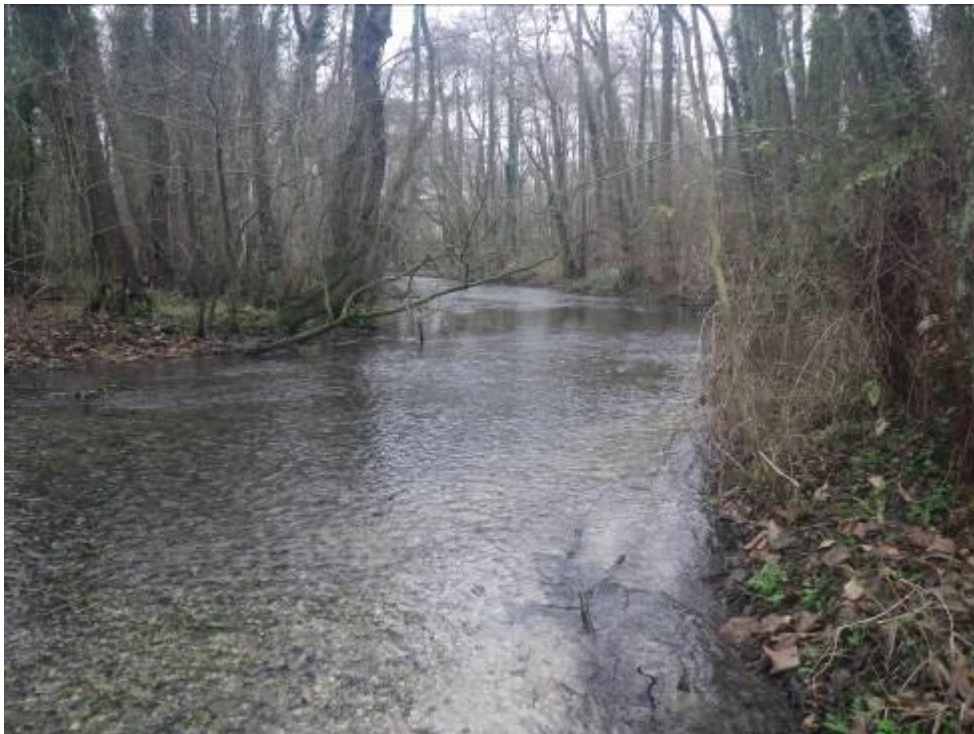
Downstream of the weir, the river meanders through a comparatively wide and shallow channel, comprising of a mainly gravel/cobble bed and fine sandy sediments (photo 2). The dense tree canopy has enabled this wide channel to develop, not being constrained by typical herb-rich chalkstream margins found on managed sections of the Meon elsewhere.

Photo 2. The channel D/S of the weir is wide and shallow. The heavy shading restricts any weed growth and sections without fallen woody material for cover will be a hostile environment for fish.

Potentially this section of river could be exceptionally good as a trout spawning and nursery area but large areas of the bed are too flat, with the bed gravels poorly sorted and heavily infiltrated with fine sediments. One or two small brown

trout redds (trout spawning site where eggs are deposited into shallow scrapes in the gravel) were observed but not as many as could be expected in such a gravel-rich reach.

On the wide, shallow reach downstream of the weir, improvements could easily be made with the addition of more woody material. This would need to be secured to the river bed and potentially this work could be delivered in partnership with the SDNPA volunteers and supervised by the WTT. In addition to the benefits of creating a more diverse shape to the river bed, it is possible that if strategic stands of alder were coppiced from key riverside locations then there would be opportunities to let in shafts of light to the bed and banks. This reach is unlikely to be a haven for water vole because of the shading and lack of marginal vegetation. Creating a handful of small areas where both cover and increased plant growth can be promoted may help water voles in transition between population, or individuals moving out from established populations.

- Introduce woody material to the channel to promote bed scour/sorting and provide cover. Use large woody material to promote bed scour, parallel cover logs for adult trout cover, and brushwood to help stabilise the margins and provide micro habitat for small fish.

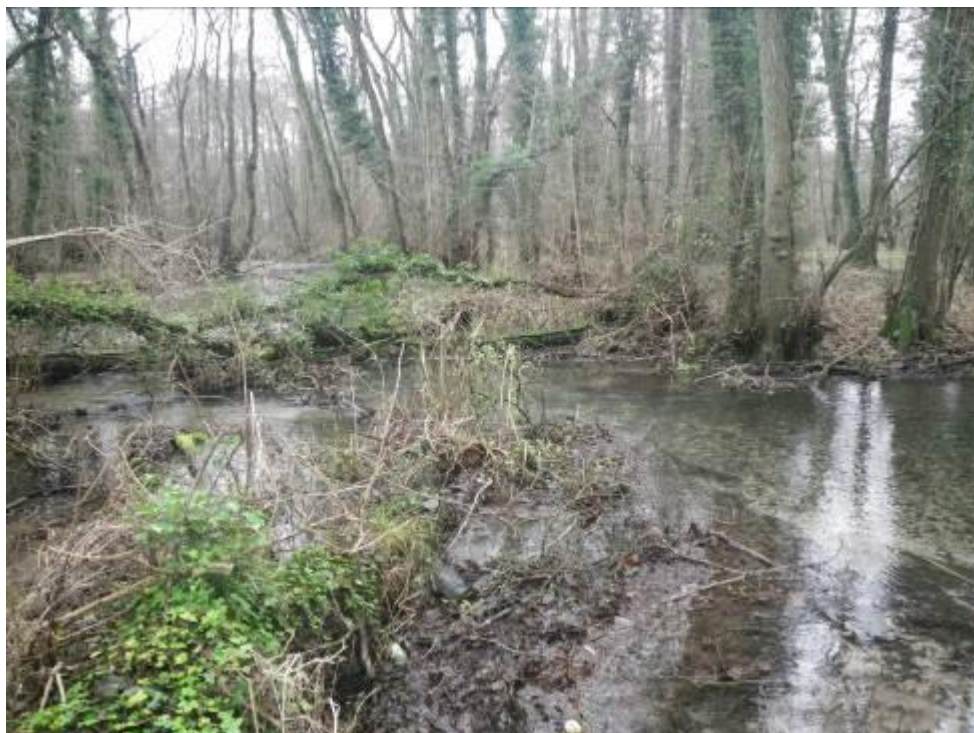
Further downstream habitat quality was considered to be much better as a direct result of the presence of more fallen woody material (photo 3, 4 and 5).

In addition to providing cover and food, woody material also helps to promote topographical diversity to the riverbed and planform. Without any fallen trees, long sections of the river would be wide, flat and shallow. The fallen trees in this reach have promoted some local bed scour to create deeper pool habitat, ideal for supporting adult trout. In addition the wood has acted as a flow deflector and helps to grade the gravels blown out of the bed into sediment free ramps of clean gravel. These sites are then utilised by spawning fish.

Photo 3. Fallen trees help to squeeze the channel width and energise flow velocities, scouring pool habitat and also consolidating fine sediments. High quality habitat.

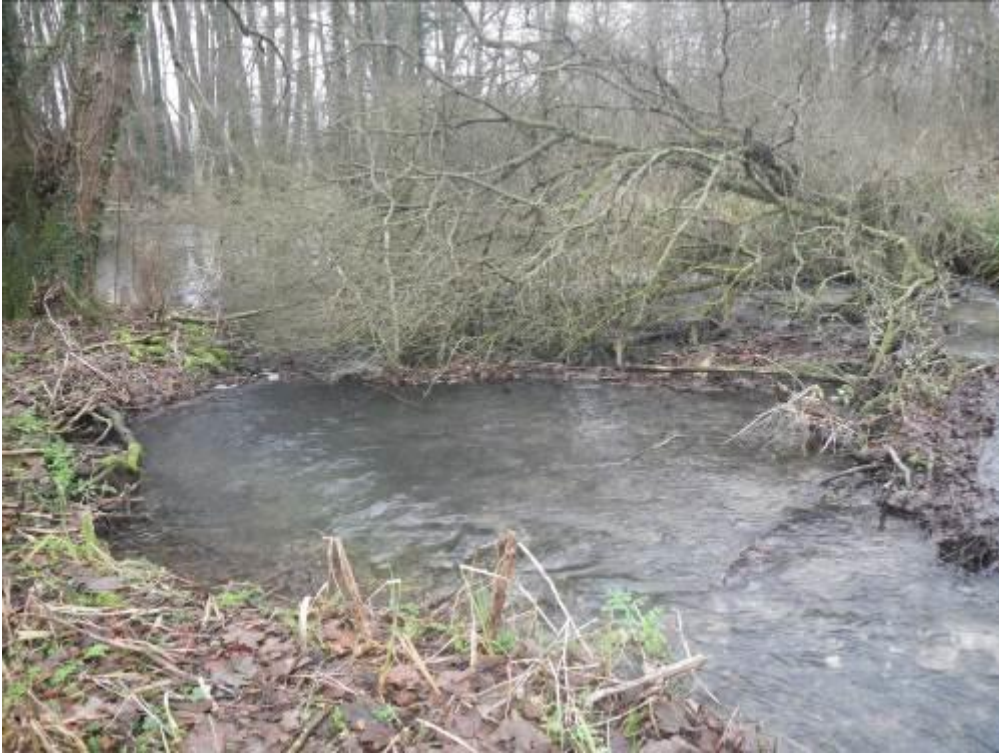
Photo 4 Deeper water promoted by the fallen tree provides a safe refuge for adult trout.

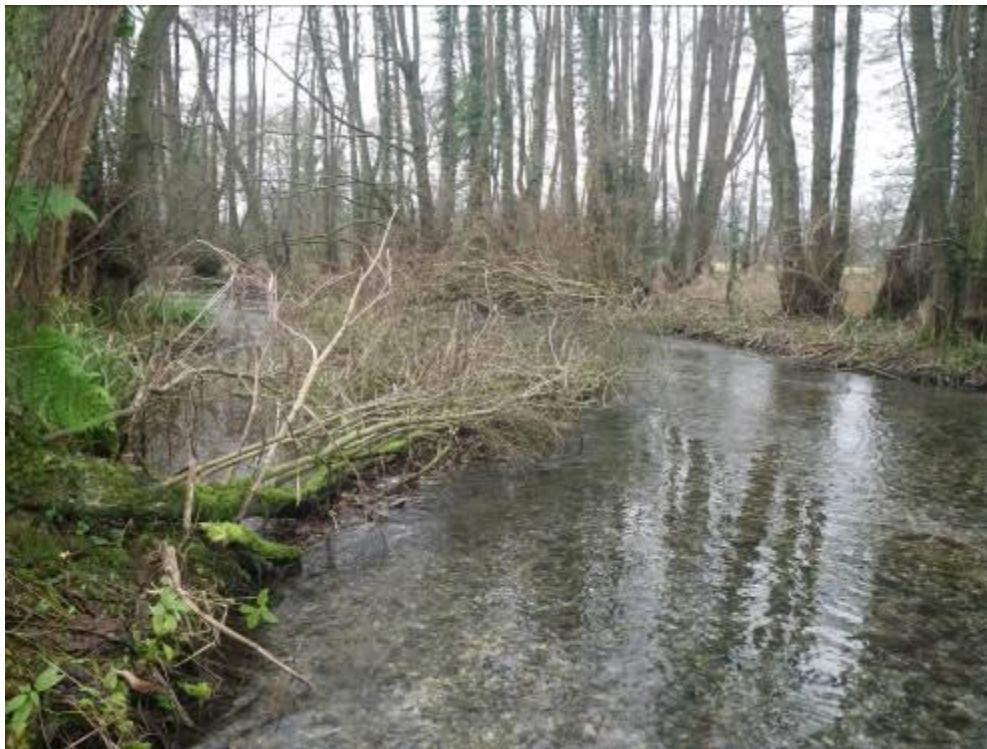
Photo 5. Trees that have fallen can help to promote meandering flow patterns which provides opportunities for both slowing and speeding flow velocities and storing fine sediments. Diversity in flow velocities promotes a variety of habitat niches for plants, invertebrates and fish.
