River Meon at Manor Farm, Exton

An advisory visit carried out by the Wild Trout Trust – May 2012

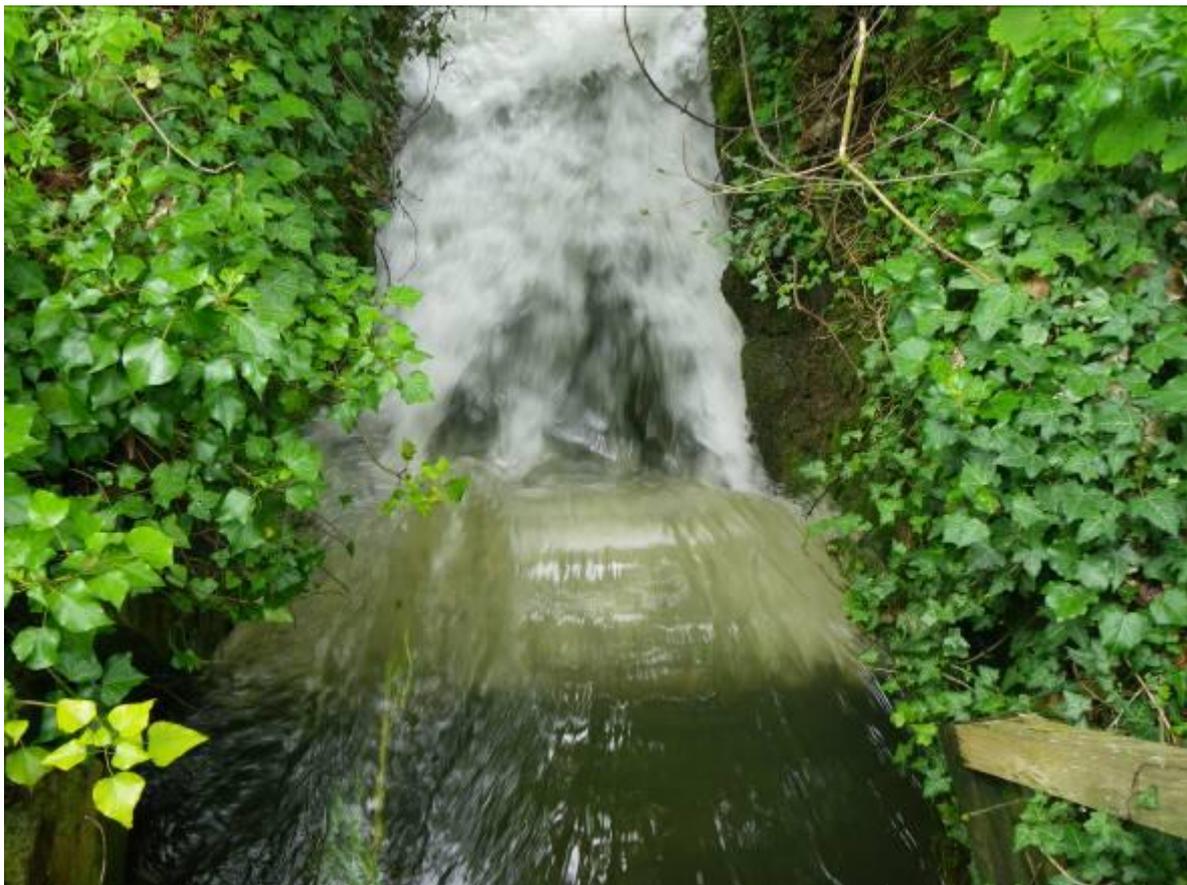
Photo 1. Hatch structure just below the Manor Farm bottom boundary

The structure itself looks to be a significant block for upstream fish migration. This structure has been highlighted in a report (commissioned by the Environment Agency and written by Dr. David Solomon) to review fish migration issues on the River Meon. It is understood that there are no immediate plans to improve fish access at this site. The structure is above the reach normally associated with sea trout spawning and this may have reduced the priority for mitigation work. It is unlikely to be a complete block for sea trout migration as occasional fish have been seen spawning above this structure. It will, however, delay free migration of even large sea trout in a low flow year, and will be a complete block to smaller salmonids, both resident brown trout, and small sea trout.

Improving access for fish migration at this site would be worthwhile and would provide an opportunity to enhance up-stream in-channel habitat if combined with a reduction in the height of the structure. Reducing the head-loss at the structure would substantially increase velocity upstream, and result in a rapid

natural recovery of this section to one which would be more sustainable and ecologically more valuable. Local trout populations would certainly benefit from improved habitat and free access.

Exploring options for lowering the bottom hatch impoundment are worth exploring. Help and support for improving habitat and fish passage might attract funding from external sources. It is recommended that an approach to the Environment Agency is made to discuss options for improvement. The WTT is also available to provide support and advice if a potential project is deemed desirable.

- Explore options for lowering the impoundment near to the bottom boundary.

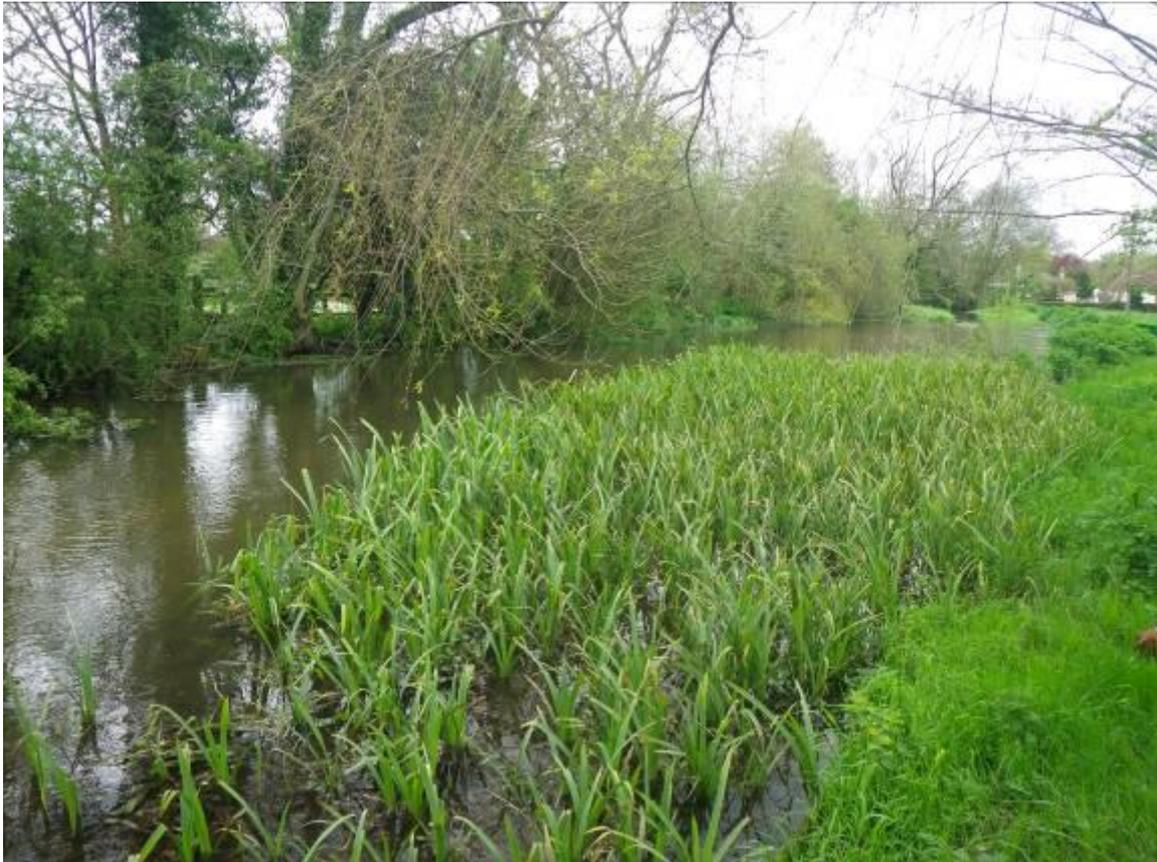
Photo 2. Impounded reach lying just above the hatch structure in Exton.

Habitat quality in the reach immediately above the structure is severely impacted (Photo 2). The channel is wide, slow flowing and has significant quantities of deposited fine sediment. It is presumed that the channel here has been dredged in the past. There is evidence that the channel is responding to the low water velocity and sedimentation as marginal emergent plants are becoming established (mainly burr reed and flag iris). Where this is happening, the channel is being squeezed, promoting faster flows and creating some reasonable holding water for adult trout adjacent to the LB.

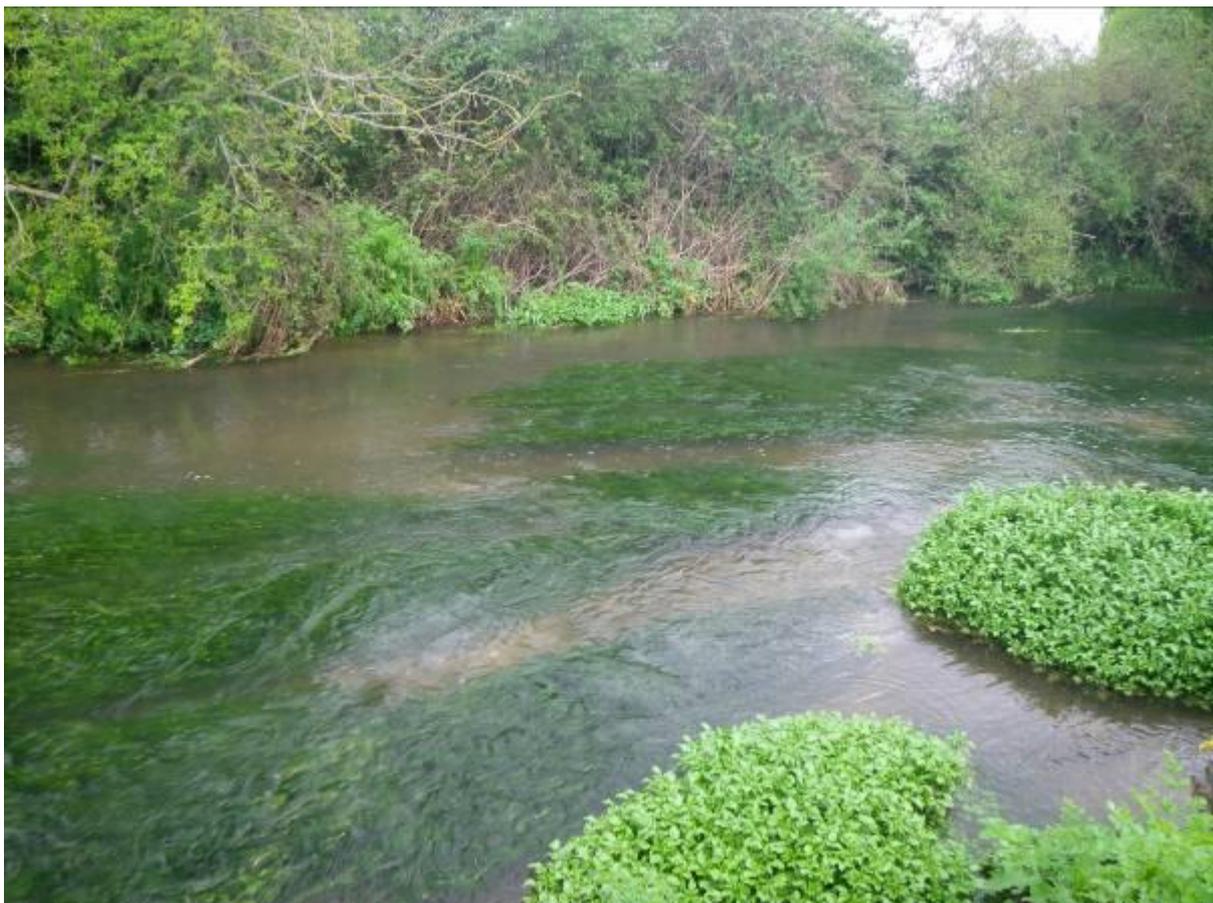
Fortunately the comparatively steep gradient found on this section of the Meon has reduced the extent of the impounding influence of the structure. The majority of the Manor Farm beat above enjoys good quality chalk stream habitat, with the river flowing briskly over a clean gravel bed. The steep gradient and energetic flows have moulded some high quality habitat for all trout life stages, with good examples of habitat suitable for adult holding and spawning, as well as some excellent shallow riffle sections ideal for fry and parr.

Unusually for a Hampshire chalk stream, the river bed is quite varied in shape with lots of examples of humps and hollows and numerous sites that are suitable for trout spawning. The relaxed approach to channel maintenance has certainly helped, along with previous efforts to encourage local bed scour using woody debris deflectors. Some of the variations in bed topography are likely to be the result of previous trout spawning activities. This beat is known to support good numbers of wild trout and this is largely due to the above average condition and availability of high quality habitat (photo 3).

Photo 3 A typical section of the Manor Farm Beat.

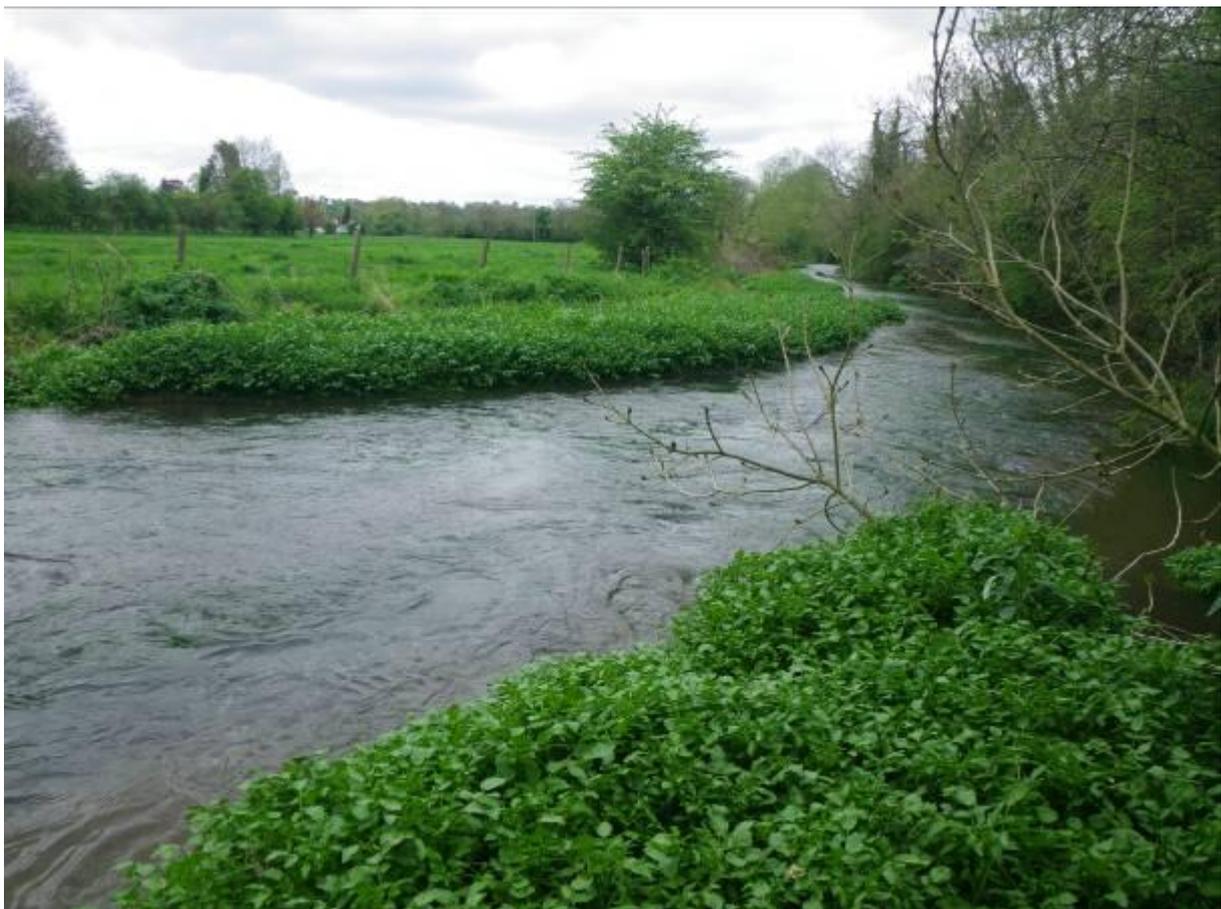
At the time of the visit, cress was growing strongly into the channel from the margins, locally pinching the channel and providing excellent fry cover. The

accelerated flows mid-channel also provide a quality environment, with luxuriant beds of water crowfoot providing a superb habitat for invertebrates and fish. This high quality environment is further enhanced by a 'scruffy' margin on the RB, which has trails of vegetation into the river margins, again providing good cover for fry where the water is shallow. This state of equilibrium is very much dependant on a number of factors including prevailing flow, light penetration and the relationship between the marginal cress growth and the central channel water crowfoot (photo 4).

Maintaining the balance between these plant communities is an area of concern for Mr. Martin and he is well aware of the relationship between the various plants and the underlying flow and climate conditions that drive them. Maintaining this fine balance on a perched channel with low banks is problematic. Too much crowfoot growth in a wet year and the levels will rise, potentially threatening the vulnerable banks with breaching. In a low flow winter, when the cress dies back following hard frosts, the channel can become much too wide with flow velocities dropping away along with central channel crowfoot growth. The net result is a wide and comparatively bare channel that is a hostile environment for trout. Finding a suitable maintenance regime that keeps the channel in good condition over a wide range of flow conditions is a priority for this fishery.

Photo 4. Thick beds of marginal cress squeezing the channel and maintaining good central channel habitat.

One way of supporting this vulnerable balance is to install some large woody debris (LWD) tree trunks, or long thick branches and peg them into the cress beds to provide perpendicular groynes to the river channel. These LWD groynes should be sufficiently high so that over topping only occurs when the river is very high (virtually out of bank). This will ensure that they function as a support structure for marginal plants, rather than acting as a weir, or scouring structure. Some bed scour will occur off the outside edge of the structures, and this will enhance the reach and provide good holding habitat for adult trout.

Following heavy frosts, when the cress dies back, the LWD groynes will help to maintain vigorous flow velocities in central channel areas, thus maintaining the crowfoot growth even in a dry year. Following a wet winter, crowfoot will need to be manually cut to maintain habitat quality. Bar-cutting techniques can be used to hold up water levels if required, or cutting longitudinal channels will drop levels and promote runs between weed beds. This work can be undertaken to relieve pressure on vulnerable margins. Unfortunately with chalkstreams there is rarely a "do nothing" option.

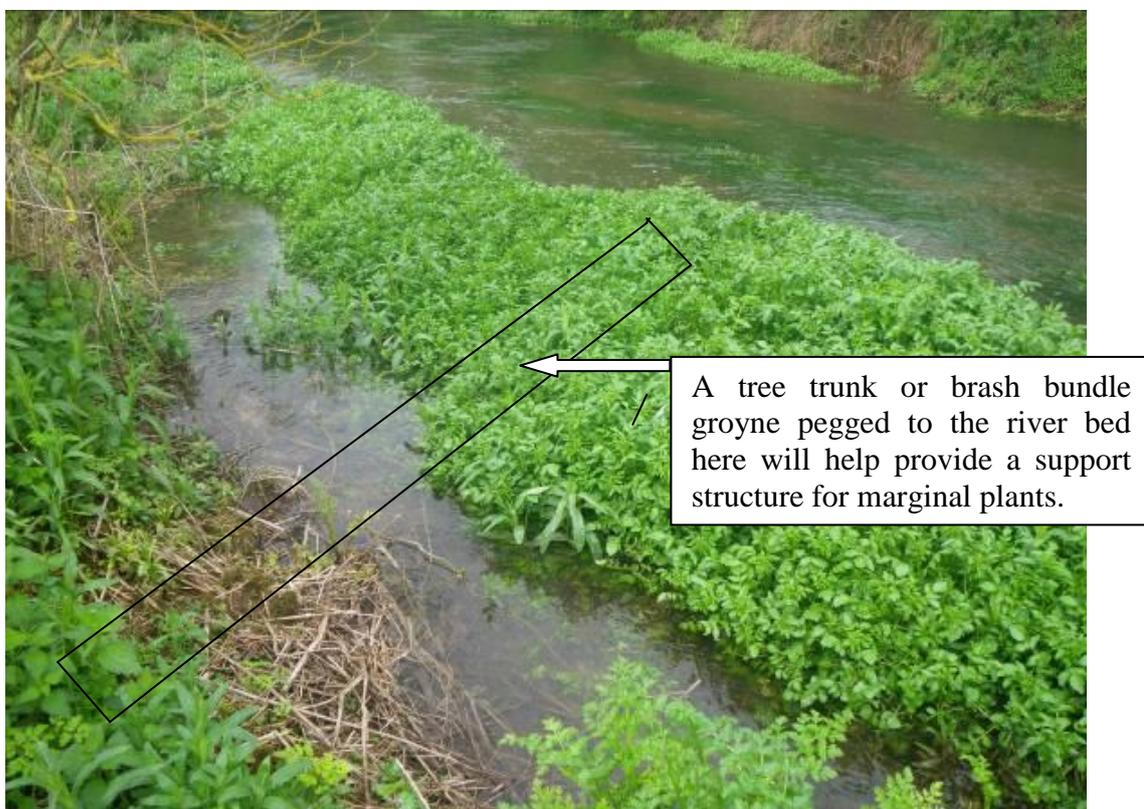
A consequence of introducing LWD groynes might be some subtle changes in the marginal plant communities. Cress thrives in areas where there is a slow percolation of water over a firm gravel bed in shallow margins. The groynes will most likely restrict the percolating flow and encourage the local settlement of soft sediments. The sediment could promote other marginal emergent plants such as reed and sedge. More diversity in the marginal plant species may help to slow down the "boom and bust" scenario where either too much cress, or too much crowfoot leads to loss of in-channel habitat and maintenance issues associated with bank erosion.

Photo 5. Vulnerable marginal plants could be supported with LWD groynes or brash bundles.

- Maintain an appropriate channel width through active management of the marginal and in-channel plants.
- The installation of woody support structures may help to support in-channel habitat in low flow years. Details on how to install these structures are available in the WTT's chalkstream habitat manual (CD) or can be downloaded as PDF documents from the WTT website (<http://www.wildtrout.org/content/wtt-publications>)
- Hand cutting the water crowfoot may be required following a wet winter to maintain high quality habitat and reduce the risks of the channel becoming over wide.
- Consider the use of some flow deflectors to promote slightly deeper holding water for adult trout.
