River Meon at Exton

Advisory Visit June 2016

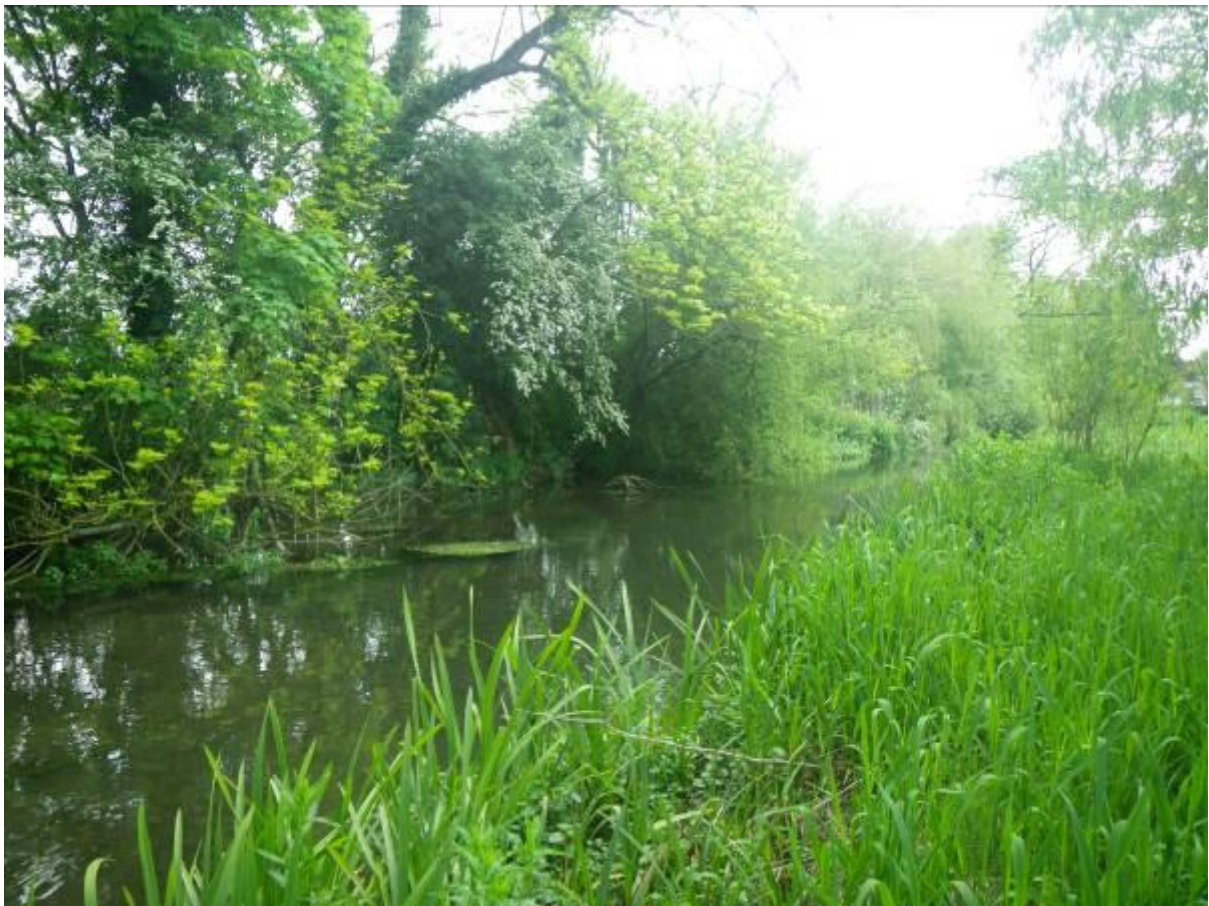
It is likely that the channel upstream of the weir has been artificially widened to provide more capacity. There is also evidence that the bank has been raised to create a greater head of water, either for more efficient milling, or to push the water out via off-takes into "drowning" channels located further upstream. Over time, the river has naturally adjusted to the reduced flow by filling the slowest flowing areas with deposited sediment, evident by the banks of soft silt building out from the RB, now supporting beds of emergent aquatic reeds and grasses (cover photo).

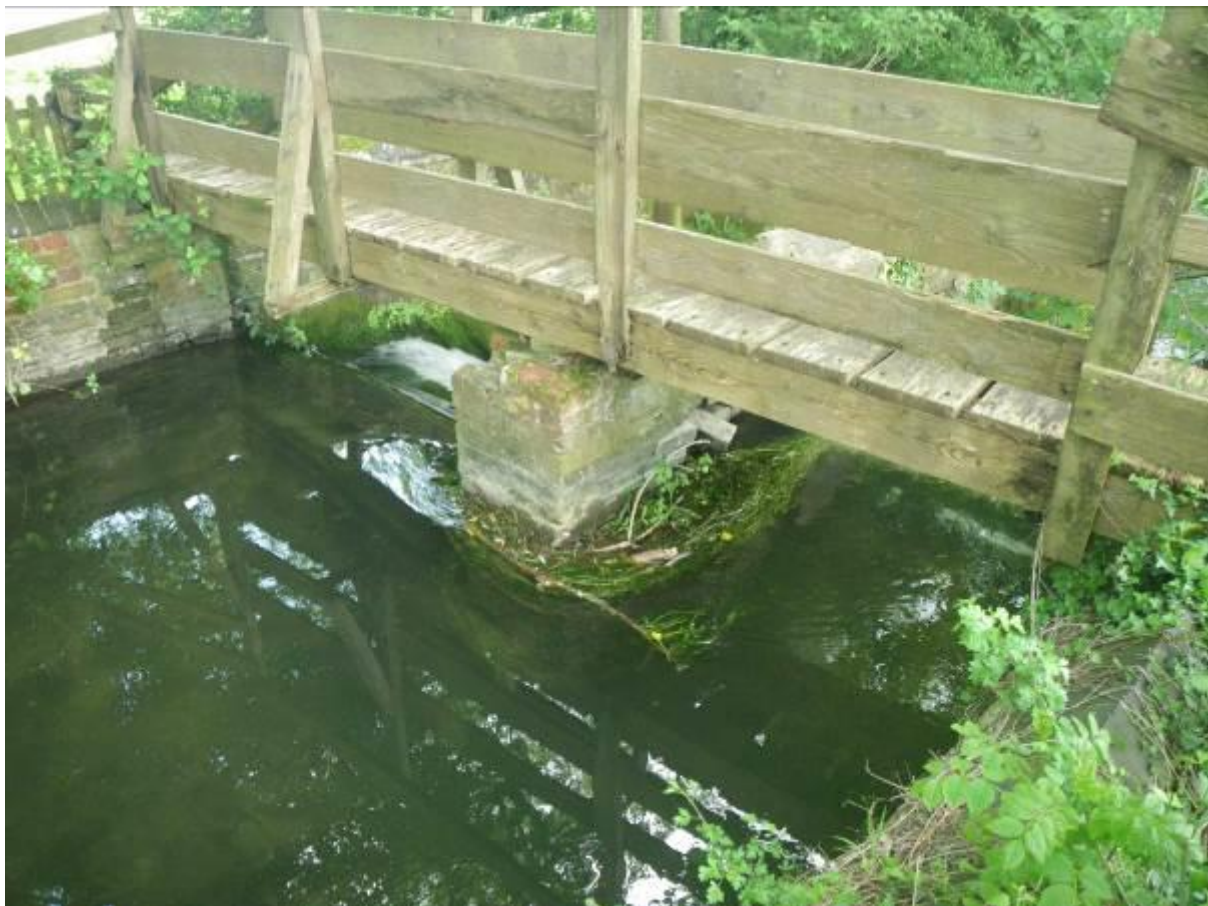
The fishery can be broadly divided into two sections which are bisected by an old water level control structure located under a footbridge (photos 1 & 2). It is not entirely clear what purpose the weir served but it is possible that the structure was used to build a head of water either for milling power, or possibly for agricultural irrigation. The structure is in very poor condition. Currently there are ad hoc level-control boards situated in the two hatch chambers. These are currently operating at different levels, with the RB chamber having a double impoundment. Access for fish migration via either chamber was considered to be very difficult at the time of inspection.

Photo 1. Access footbridge spanning double weir hatches

Complete weir removal would be the ideal option. If this is not deemed possible then the height of the impoundment should be reduced by pulling out all of the water level control boards. This action would result in the water being pulled through at a much faster rate and at a lower level. Initially the channel will become narrower and even more sediment at the margins will be exposed. Given sufficient light penetration, these areas will soon colonize with a range of chalk stream aquatic plants and herbs. In reducing the height of the impoundment, over time, the bed level will start to drop via the action of increased flow velocity and river-bed scour. Fine sediments currently smothering the bed in central channel locations will be mobilised and the bed will slowly

Weir removal will require a consultation with your upstream neighbour and the local Environment Agency. Note that any reduction in upstream water levels will result in drier banks and changes to riparian habitat.

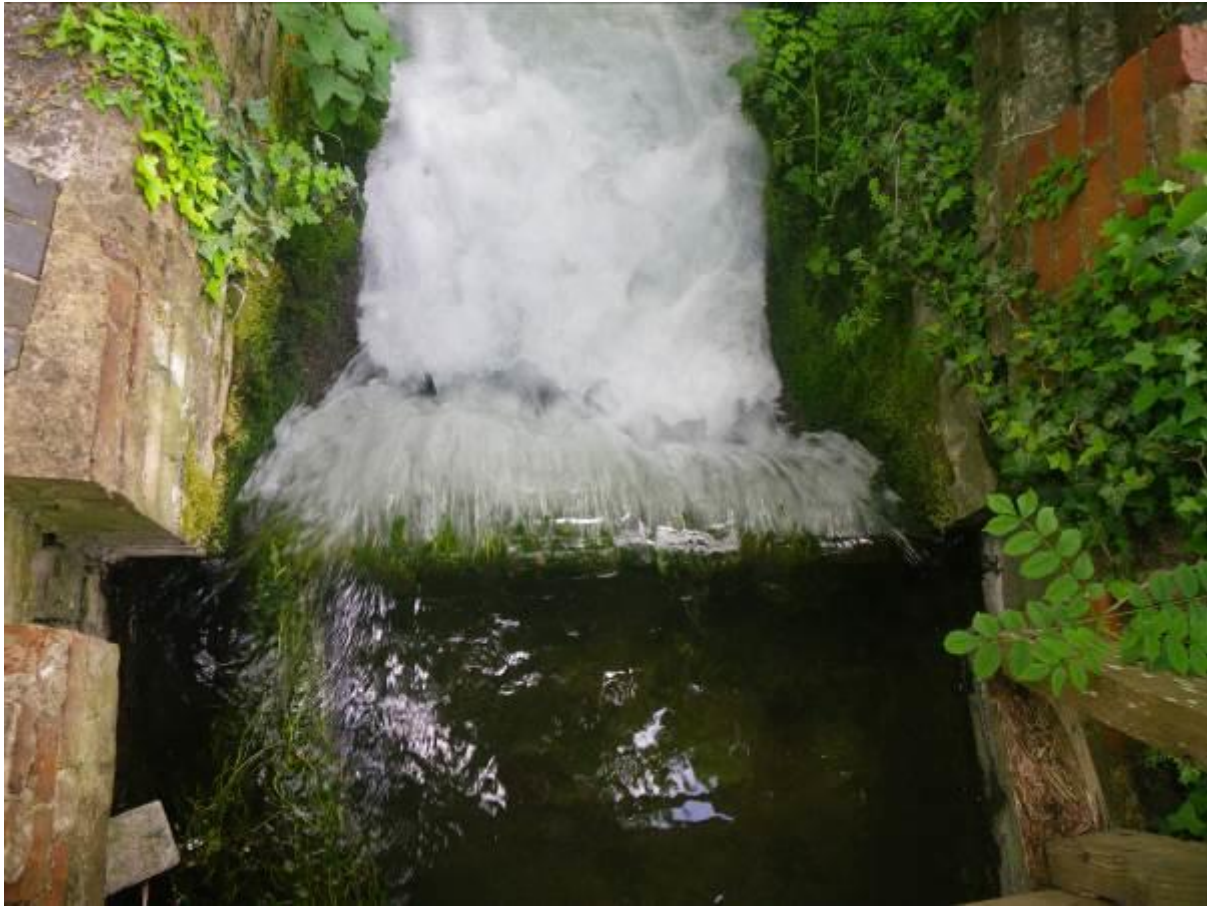
Photo 2. Significant head loss in excess of 300mm represents a blockage for all but the largest trout during high water conditions.

In-channel habitat found within the upstream impounded section is dominated by laminar glide habitat, flowing over a predominantly silt-laden river bed. The structure itself has promoted sediment deposition by significantly reducing flow velocities in the upstream reach, evident by the bed level being significantly higher upstream than in the reach downstream of the weir hatches.

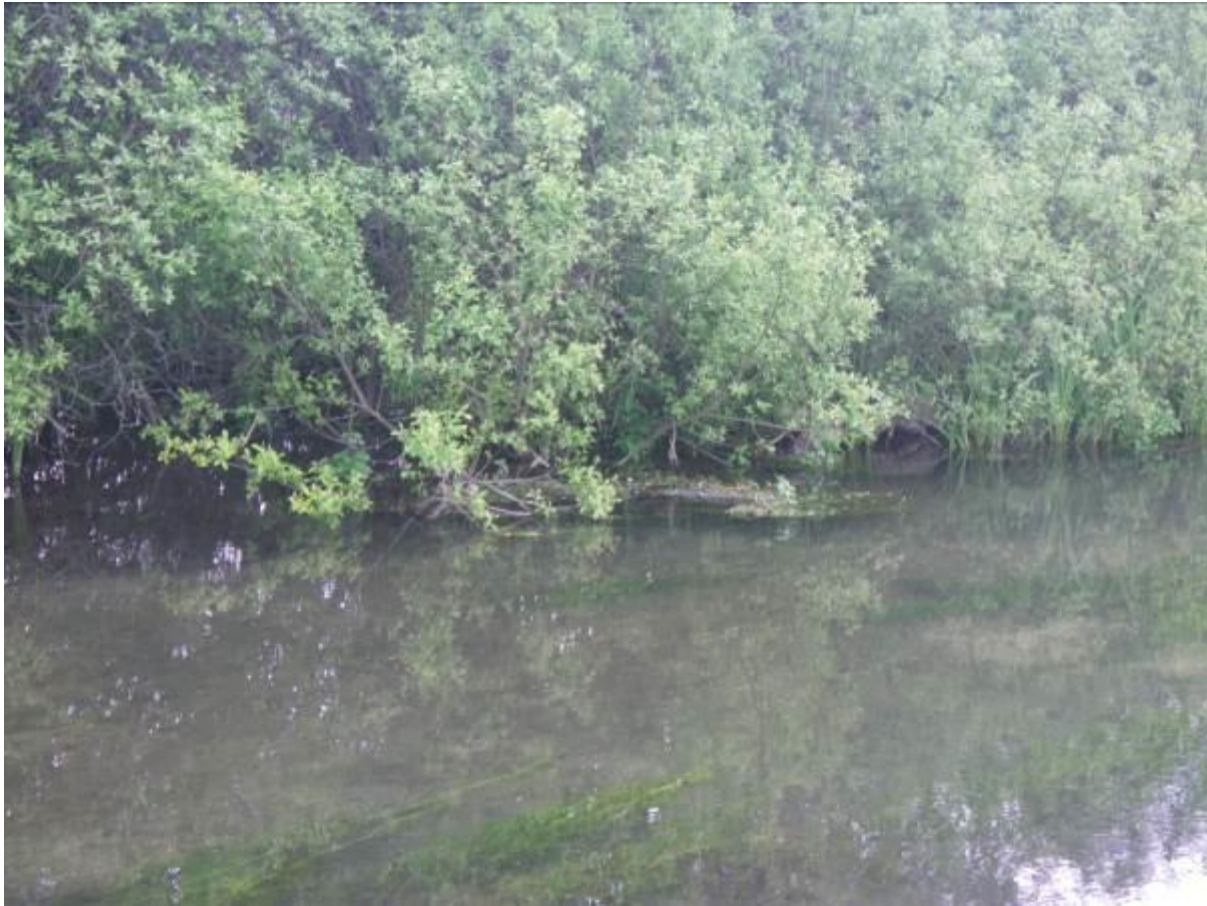
Habitat adjacent to the LB is dominated by a line of mixed native trees, including valuable low, scrubby species such as goat willow *Salix caprea* which provide excellent bank protection, as well as cover for fish (photo 3).

Photo 3. Low scrubby cover supplied by marginal tree species adjacent to the LB.

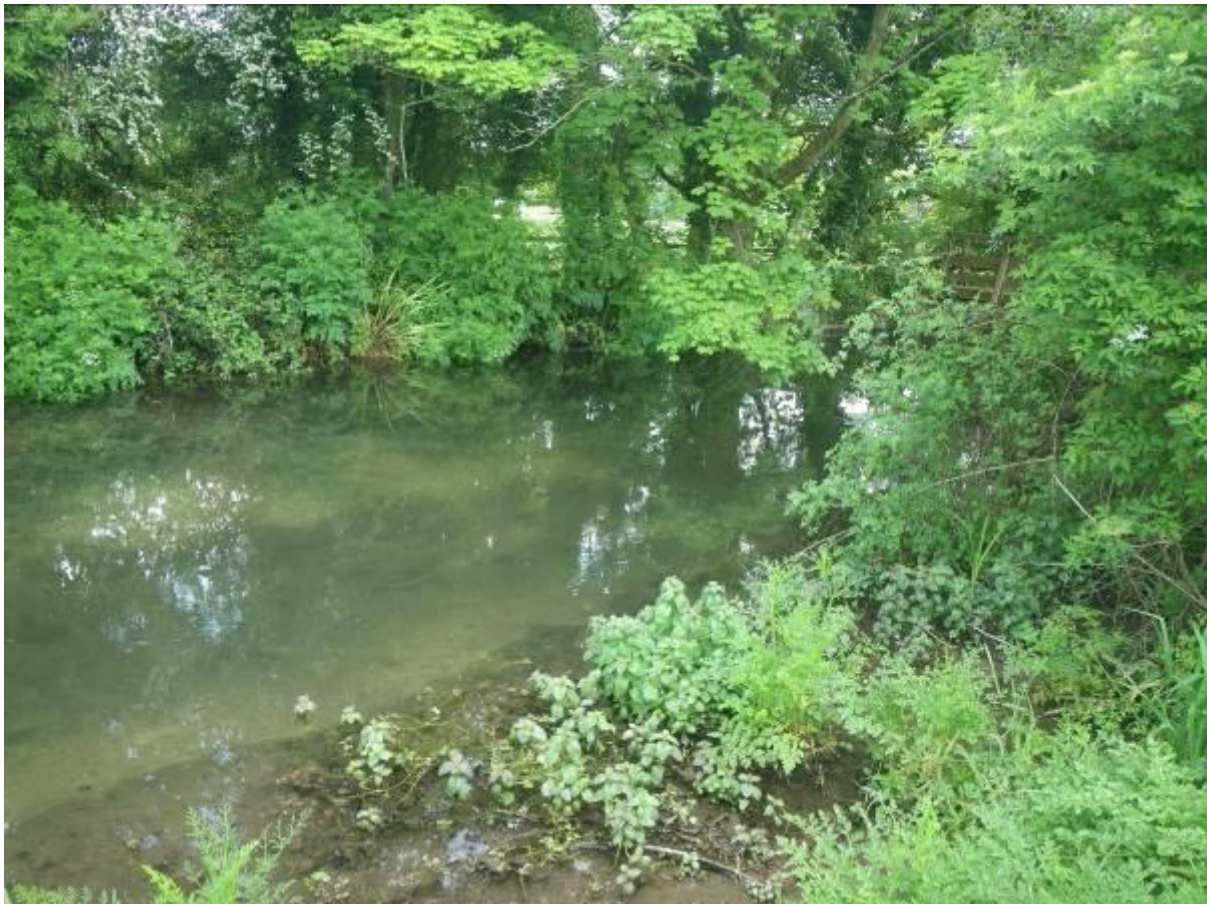
Whilst in several locations the accreted sediments are being colonised by marginal emergent plants, in others the process appears to be slow (photo 4). The transition from wetted channel to dry bank is less defined where the channel is heavily shaded from tall trees growing up from the LB. A combination of allowing in a little more direct sunlight, coupled with planting, will help to accelerate the process of consolidating settled sediment.

Photo 4. Fine sediment in the RB margin could be consolidated into a soft, vegetated chalk stream margin with a combination of weir lowering, coppicing of dense tree shading and planting.

- Coppice occasional clumps of trees on the LB (south bank) to encourage improved light penetration to exposed bank sediments on the RB.
- Accelerate the recovery of exposed sediments on the RB margin by thinning and then replanting emergent reeds and grasses from those areas where recovery is well underway.

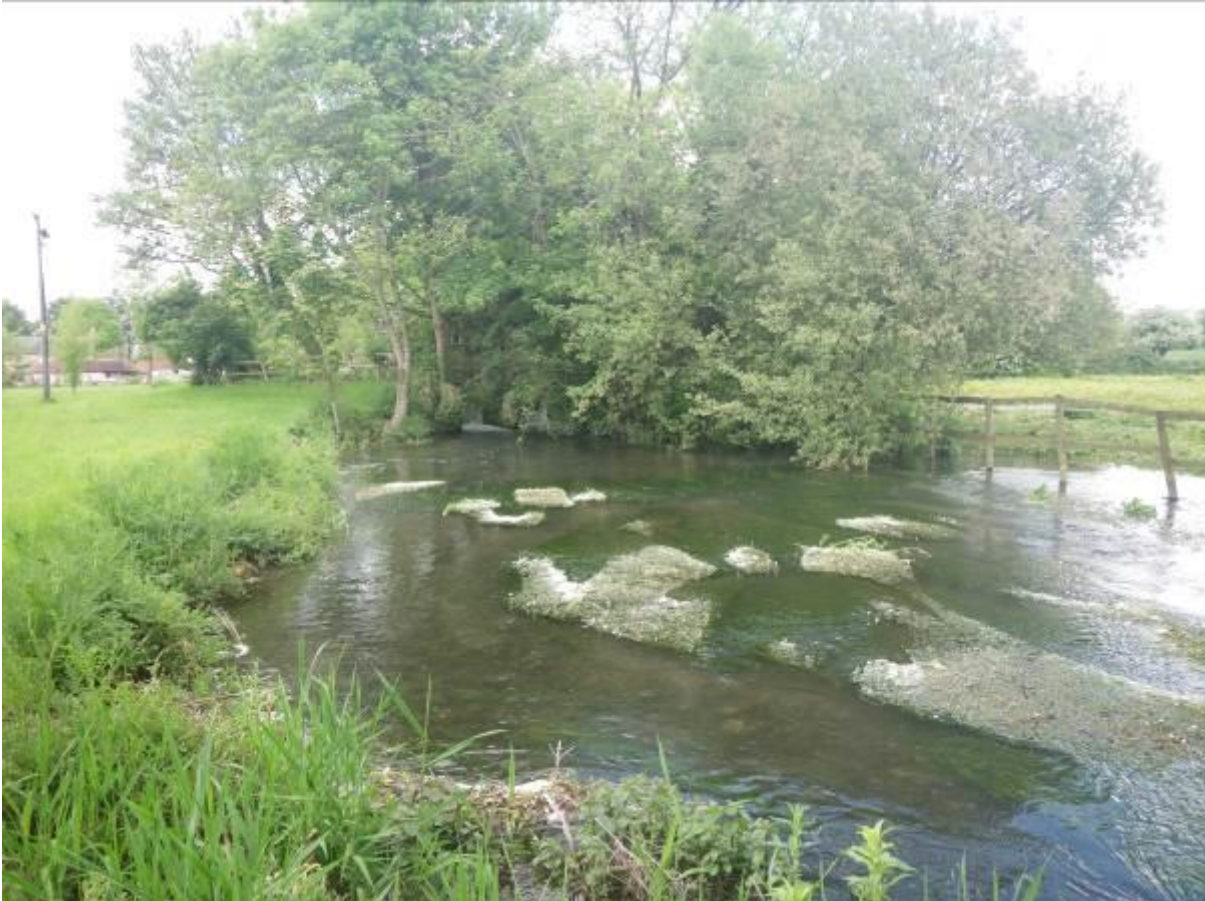
Downstream of the weir impoundment, the channel is far more natural and dynamic. Deeper pools, shallow runs and riffles, and dense beds of water crowfoot emerging from a clean gravel bed are all evident (photo 5).

Photo 5. Healthy beds of water crowfoot and a clean gravel bed is evident within the unimpounded section downstream of the weir.

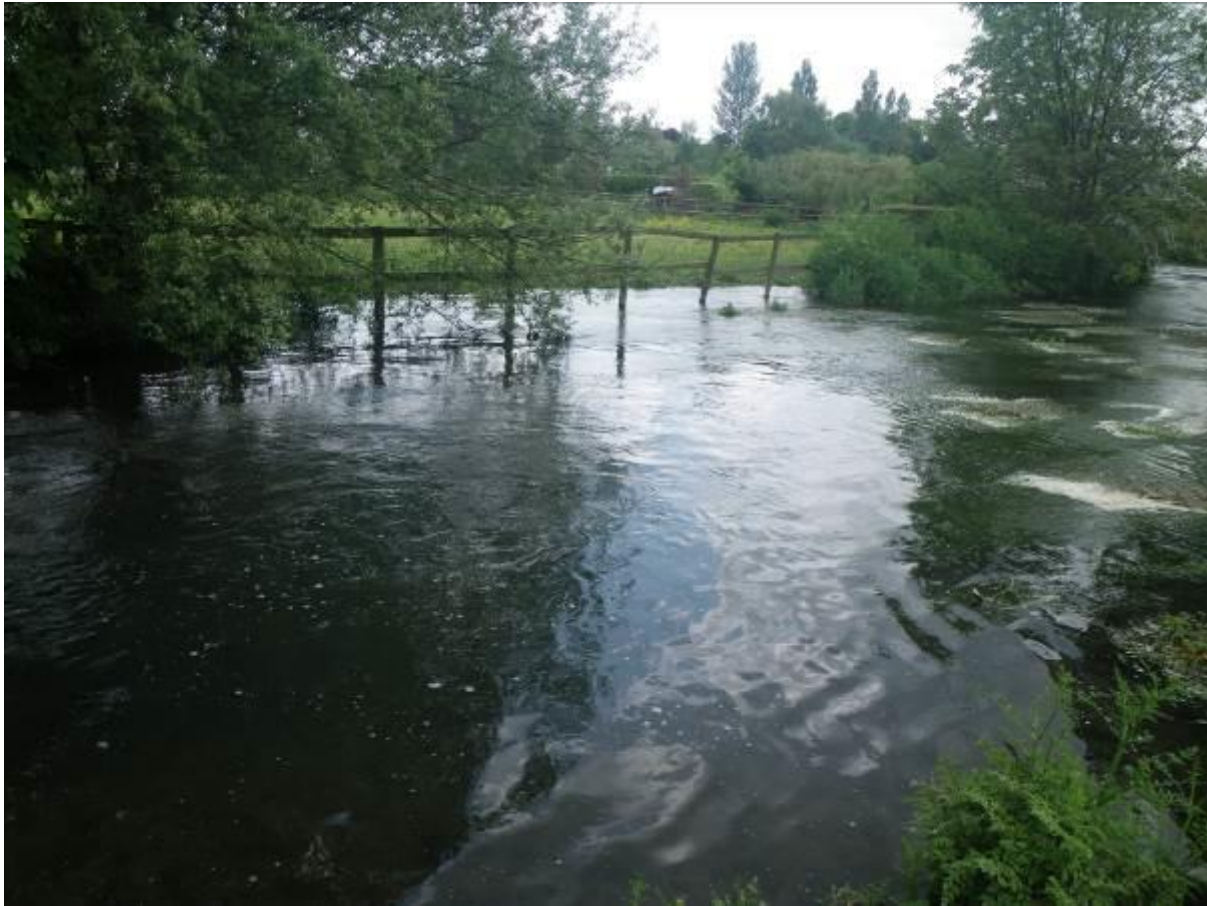
At the tail of weir pool itself the channel is relatively wide and shallow, where the left bank has been trampled down by livestock access for drinking (photo 6). Provided the density of animals using the drinking bay is small then this

Photo 6. A drink bay adjacent to the LB needs to be managed and maintained to avoid excessive bank damage and over-widening of the channel.

shouldn't be an issue. Care should be taken to maintain the fence rails and restrict the area of bank available for livestock drinking. This is particularly important if the number, or size of the beasts being able to access the river is increased. Light grazing and even some light bank trampling is not a problem if carefully monitored and managed.

- Monitor the levels of meadow grazing on the reach downstream of the weir and do not allow unfettered access for grazing to the whole reach.
- As the watercourse is classed as 'main river', any work within 8m of the top of the river bank will require a consultation with the Environment Agency and quite possibly a permit for work.

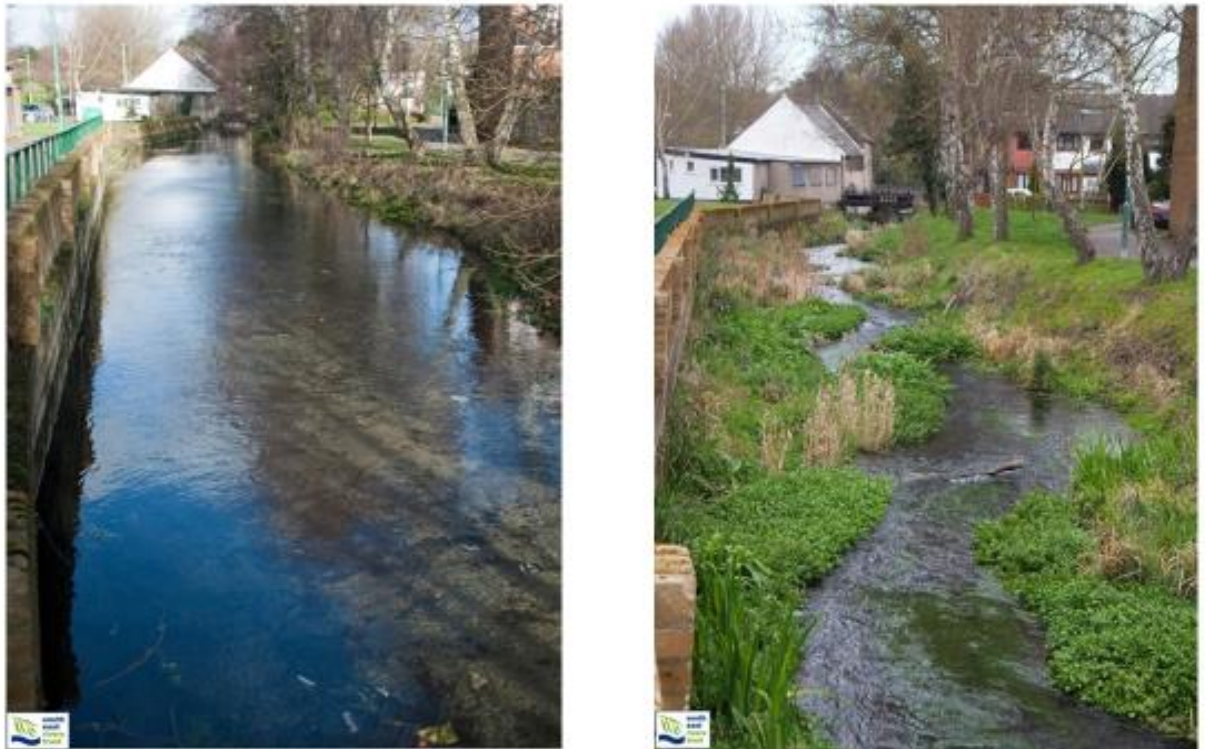
Once the boards have been removed, the river should be given at least a year to settle down to the new level regime before contemplating any further work. Further improvements could then be made by installing natural woody flow deflectors in the reach upstream of the weir to help with the bed scouring process. The key principles here are to squeeze, rather than impound the river flows to help drive the river bed down to create sufficient water depth for adult trout to comfortably lie-up. Creating diversity in the river bed shape and depth, with adjacent overhead cover, and the exposure of a clean gravel bed will create improved opportunities for weed growth, invertebrates and fish, including brown trout. Example photos below (photo 7) of a reach of the River Wandle where

weir removal was recently undertaken clearly demonstrates how natural channel characteristics can be restored following the removal of a weir structure.

Photo 7. Before and after photos of the River Wandle at Butterhill following weir removal
