Project Proposal

Knaresborough Anglers

River Nidd – Yorkshire

1. Introduction

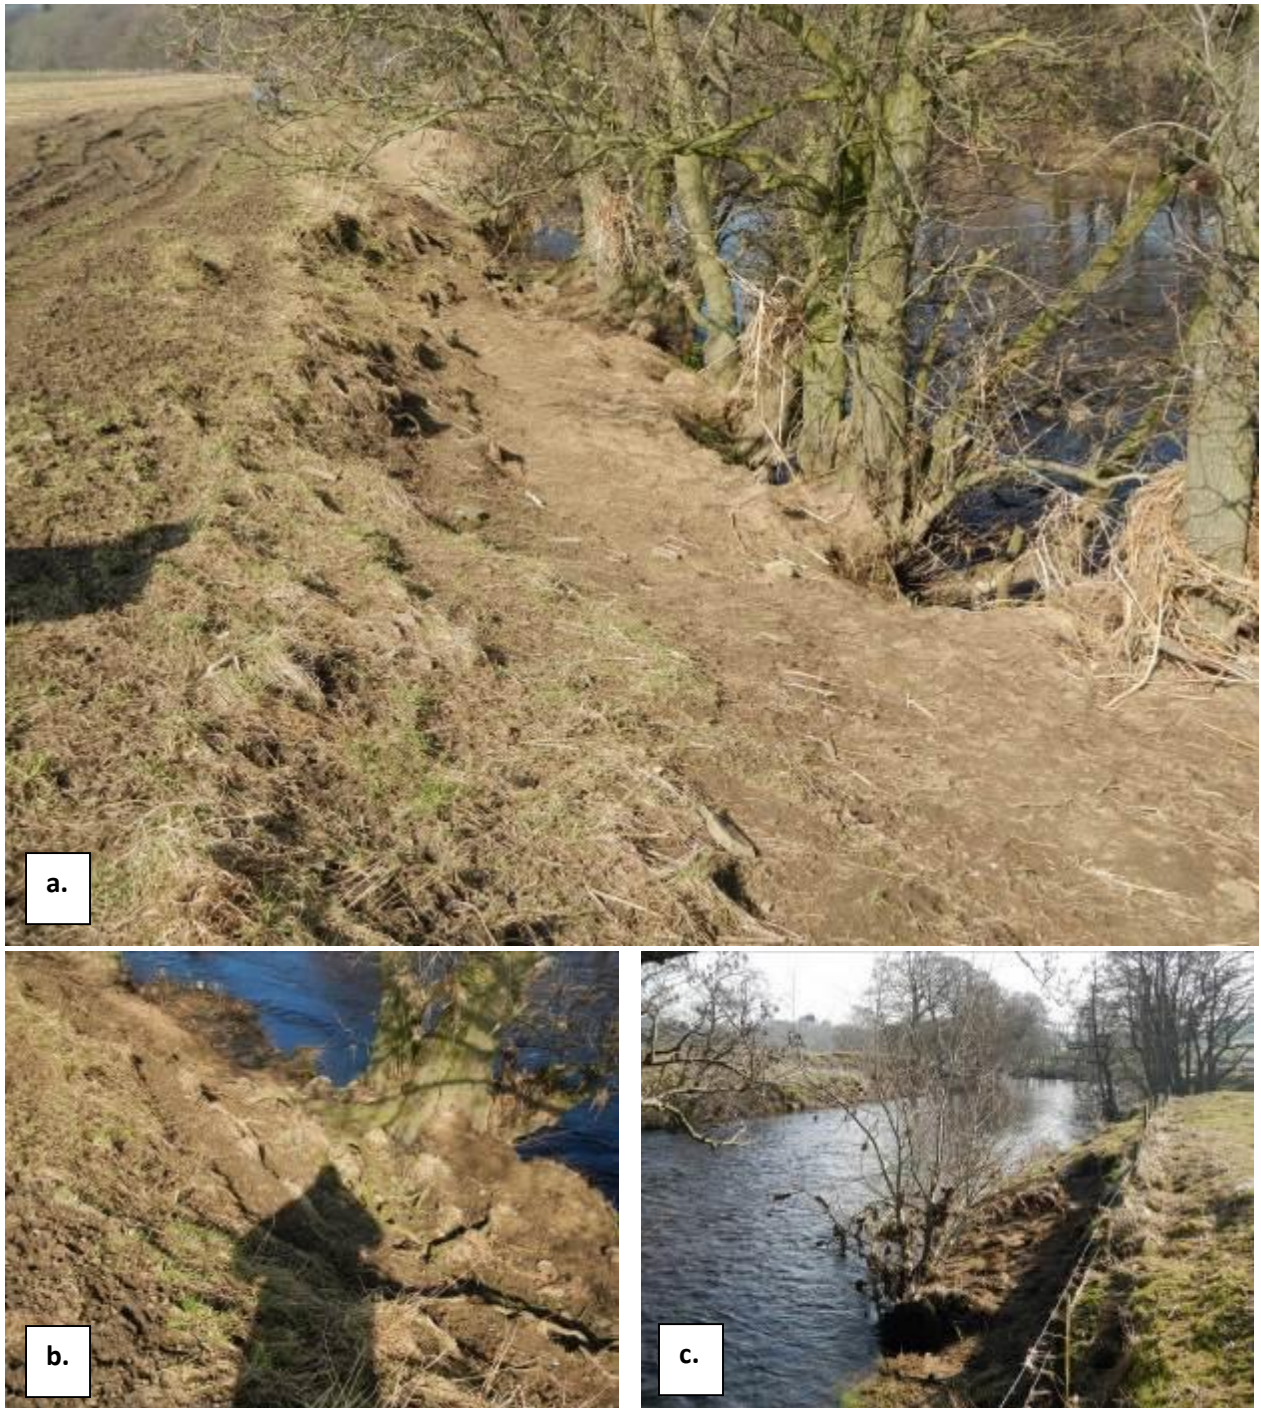
Grazing remains a major impact upon the habitat quality and bank stability in the un-fenced river sections, with banks observed to now be in a poorer state than on the previous visit. Grazing pressure is perpetuating a near monoculture of sparse grasses (grass being the only species that can withstand long-term sustained grazing) and even so, they are struggling (Fig. 1a). This is leaving significant areas of bare bank and a general lack of root-mass within the ground to bind the banks together. A notable knock-on impact of this being that high flows cause significant additional erosion around bankside trees (Figs. 1b & 1c), eventually leading to their loss into the river.

Grazing (even quite low intensity) also inhibits the natural tree regeneration that would ordinarily occur along a riverbank meaning that as old trees die or are lost to erosion there is little or no understory to replace them. In the absence of trees, vital habitat is lost and banks are further destabilised leading to even greater erosion and habitat degradation.

Figure 1a-c. Prolonged grazing pressure on the river banks has created a sparse grass monoculture, leaving a bank that is highly susceptible to erosion and loss of trees. The two-strand barbed-wire fence is ineffective at excluding sheep. In the short-term, the trees in 1b & c are likely to be lost, with the trees in 1a also being lost ultimately. This would greatly denude those bank areas of habitat and further destabilise the area, leading to channel over-widening.

The simple solution is to exclude stock from the bank between NGR SE 2704759366 and SE 2804559373, ideally with stock netting above a strand of plain wire and possibly one or two strands of barbed-wire on top. Fencing will have to be undertaken in conjunction with management of Himalayan balsam (*Impatiens glandulifera*) as the grazing is likely to be providing *some* control of the weed at present.

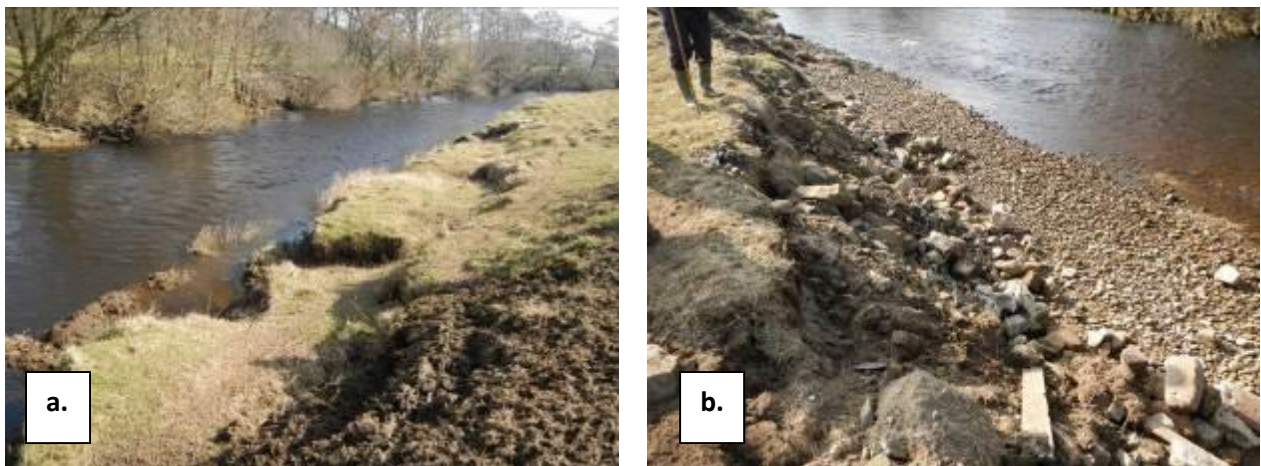
Correspondingly, long open sections of bank now exist in the grazed areas and, while grazing pressure continues, there is no real scope for the situation improving naturally as any regeneration of herbaceous vegetation and planted trees will simply be eaten by the livestock (Fig. 2). Owing to the far more stable un-grazed opposite banks, the grazed banks are often eroding and slumping, despite being on the inside of the bend where they should be more stable. Attempting to protect the bank with rubble is not appropriate and is likely to exacerbate erosion issues through scouring around the hard material (Fig. 2 a & b). As the rubble is also a very poor growing medium, it will prevent those areas of the bank from being colonised by vegetation, further perpetuating the problem.

Figure 2a & b. Long, open sections of bank with a lack of herbaceous vegetation or trees. 2b. Rubble dumped on the areas of eroding bank will only exacerbate the issue.

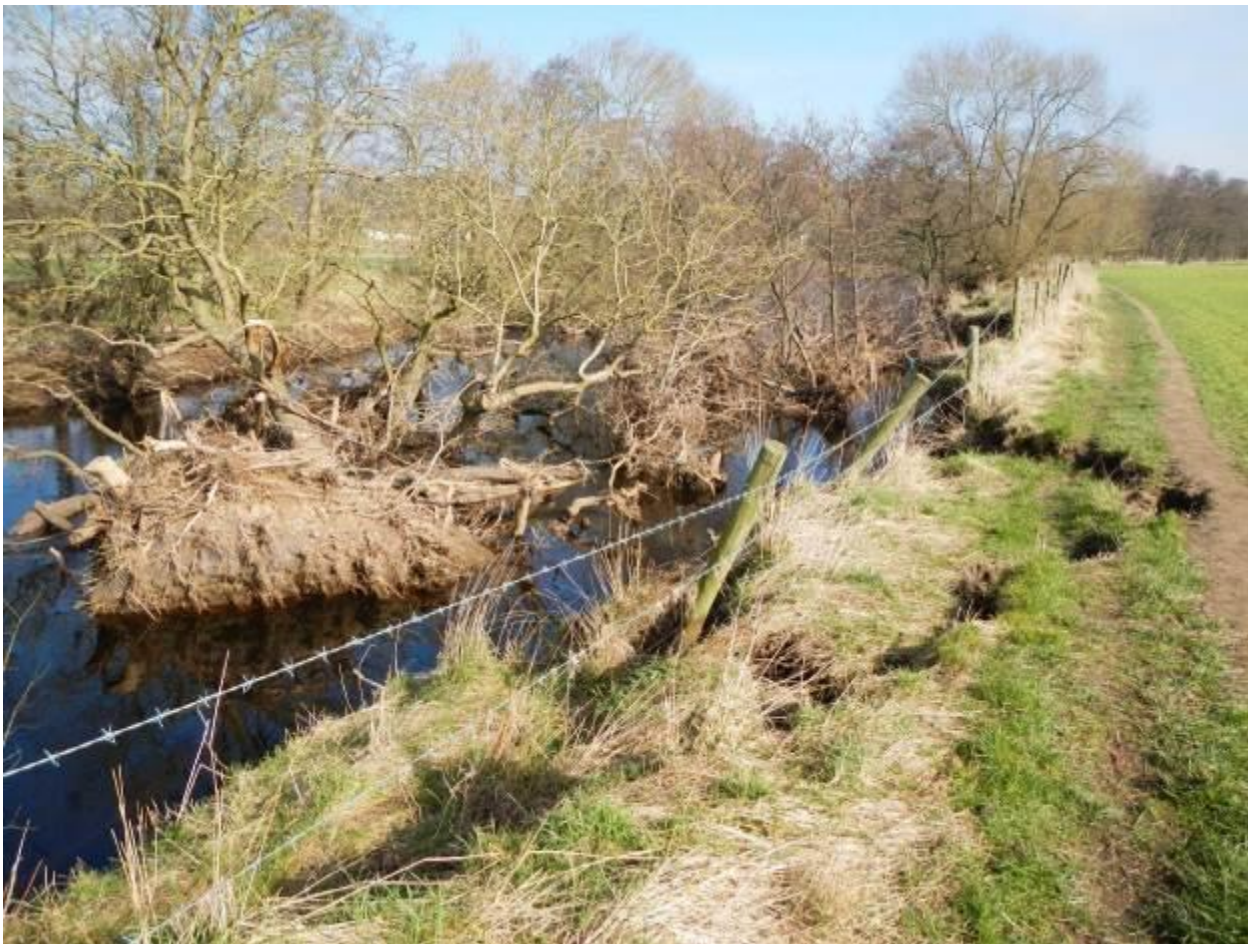
Another area of bank erosion, associated with some large trees that have collapsed into the river from the bank (with the addition of trees accumulating from u/s) may also require some action. From a fishery perspective, the large amount of woody material is a significantly positive addition, providing habitat and refuge for fish and invertebrates while also driving beneficial bed scouring and pool formation/maintenance. The small inconvenience of fishing around the structure is far outweighed by the greatly increased number of fish that the area can support. As these structures have been assessed as having no impact upon flood-risk by the Environment Agency, the recommendation, from a fishery management perspective, would definitely be to leave them in place, allowing them to naturally redistribute, if necessary.

Figure 3. Large accumulation of trees/woody material and bank erosion, immediately d/s of sheet piling in the bank which has undoubtedly deflected a greater energy of scour onto the bank in the erosion area.

It is understood that the farmer of the adjacent land is concerned about further land loss and wishes to remove the trees; however, this action is also likely to cause yet further erosion, leaving the steep, un-vegetated bank completely unprotected and exposed to high flows. The bank will always be susceptible, being high/perched and immediately d/s of a sheet-piled bank section – a treatment that invariably increases scouring in other areas as flows hitting that area of bank are simply deflected elsewhere, with little energy dissipated from those flows. For this reason, it is recommended that if work is to be undertaken with the trees, at least some whole trees are pulled tight into the eroding RB. Whole trees are important for this as the root ball forms an anchor while the canopy creates the greatest dissipation of flow energy, increasing retention of substrate locally and helping the steep bank to regrade.

Unless the bank material can be retained for long enough to revegetate and stabilise enough to regrade, it will remain steep and subject to major erosion. A larger buffer strip between the worked field and river should also be created to allow the growth of new trees and vegetation that will be required to consolidate the bank material.

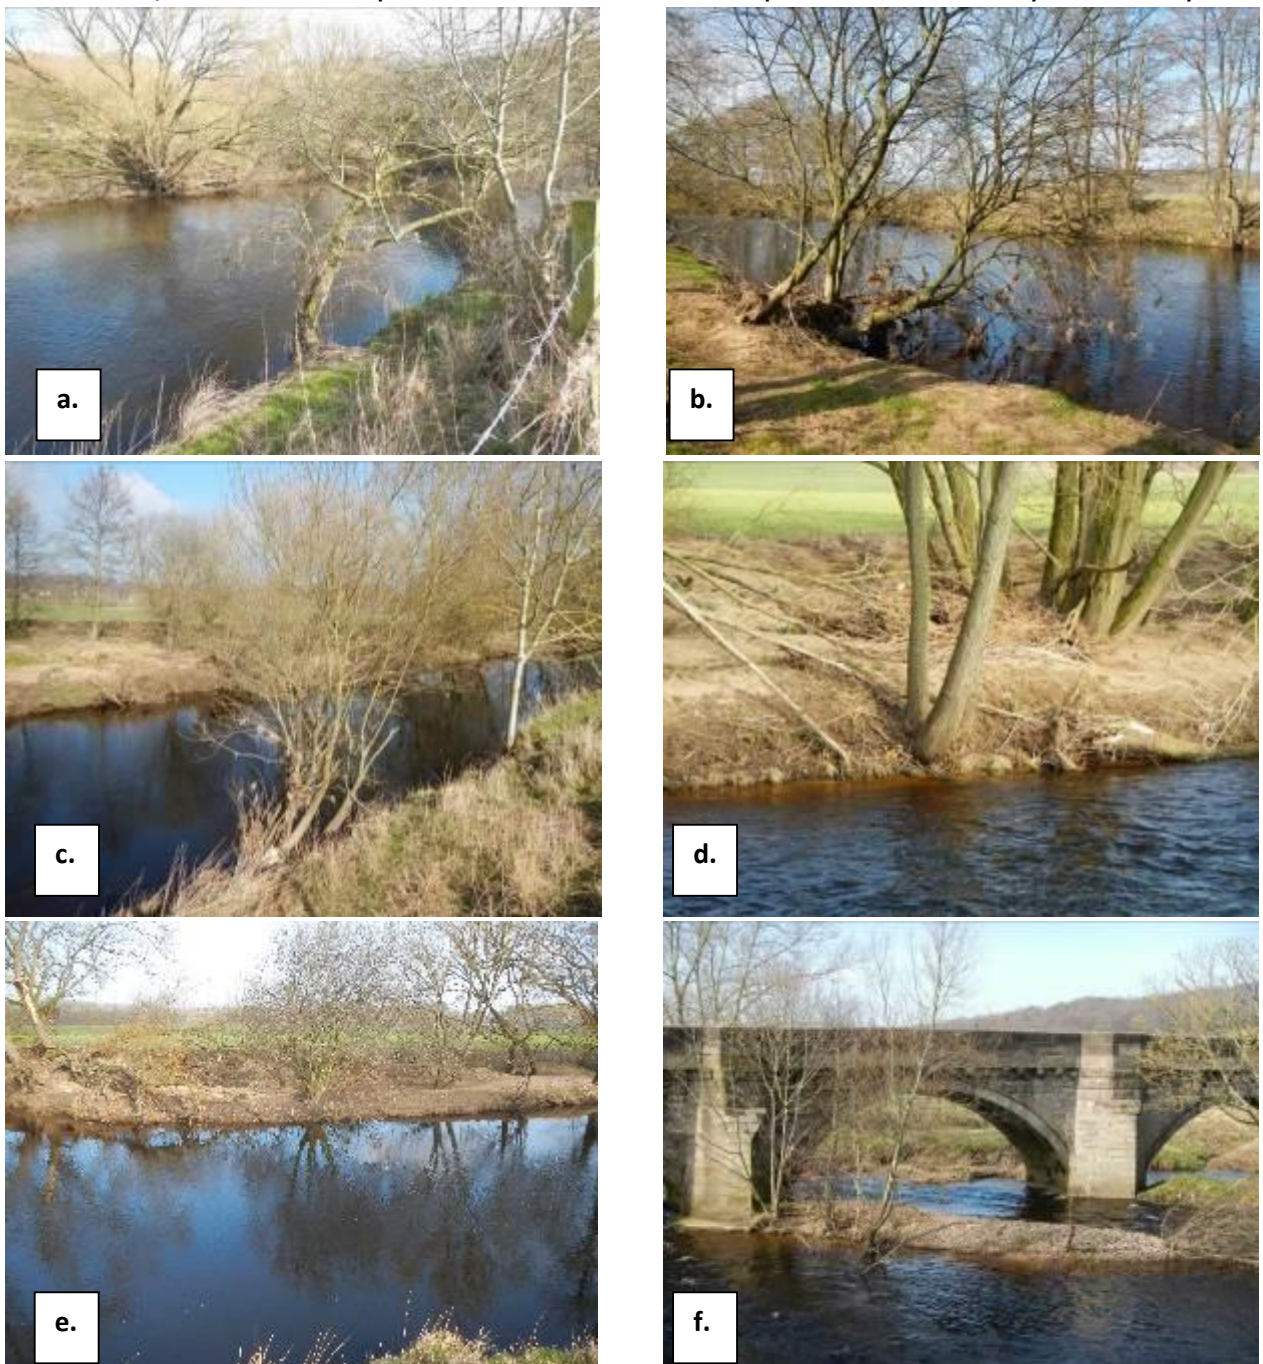
Figure 4a-f. Locations for laying willow to promote cover and flow diversity. NGRs SE 2864859651, SE 2851359578, SE 2836159423, SE 2820959361, SE 2811159360 & SE 2606959139, respectively.

The recommendation from the previous report of retaining any woody material that is low-lying, trailing or falls into the channel remains. These features greatly increase the fish-holding capacity of the river, diversifying flows in uniform sections and developing bed morphology while also protecting the banks. Such features should actually be promoted by laying occasional trees and branches into the channel where they will be of benefit. Suitable locations could include but are not necessarily limited to Figs. 4a-f. It is recommended that Flood Defence consent be sought for (X) No. of willow trees/branches to be laid into the channel throughout the length. As the EA have already taken the decision that the much larger trees within the channel present no major flood risk, the consent process should be a simple but necessary formality.

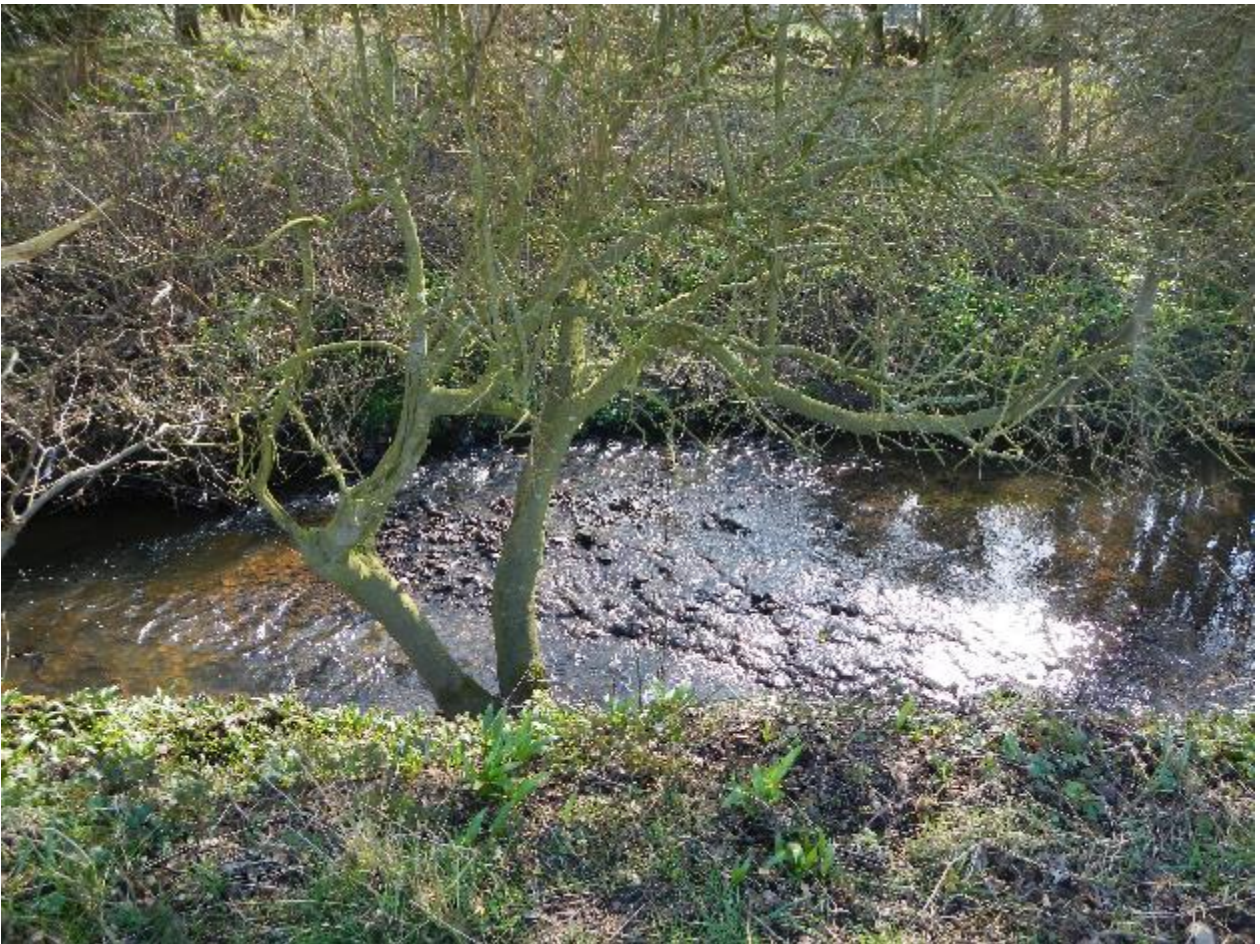
Cockhill Beck has great potential as a spawning tributary and juvenile salmonid habitat but is severely impacted by fine sediment input and suspected channel realignment and dredging. Channel 'maintenance' has created a straighter, more uniform channel, reducing the occurrence of discrete areas of scour and deposition to sort bed materials (Fig. 5). This means that, while the watercourse does provide suitable sized substrate for spawning, its quality is greatly compromised by infiltration of fine silt which is deposited on the bed and blocks the spaces between the gravels. This degrades the habitat in which many beneficial invertebrates live and reduces the flow-through of water that is required to oxygenate incubating fish ova.

Figure 5. Good spawning and juvenile salmonid habitat on the Cockhill Beck but the substrate is severely compromised by fine sediment infiltration. Increasing woody material within the channel and laying willow branches to create scouring flows will potentially improve bed sorting and be greatly beneficial in for general habitat improvement but the siltation issues must also be addressed at source.

As the channel is unlikely to be restored (re-meandered), at least in the foreseeable future, optimising the habitat it can provide will be an important step to improving the wild fish stocks of the Beck and the main river. Increasing the occurrence of structure such as large woody material and branches etc. along with trailing tree branches with techniques such as tree

laying will be vital in assisting the currently reduced geomorphological processes, and in naturally maintaining sorting of the bed material. However, identifying and addressing the sources of fine sediment entering the Beck will be of even greater importance. A spot-check of the Beck from a bridge in Hampsthwaite Village identified that, even on the day of the visit when there had been no rain for a while, the Beck was running very coloured (Fig. 6). This should not be expected and is likely to constitute a chronic pollution incident.

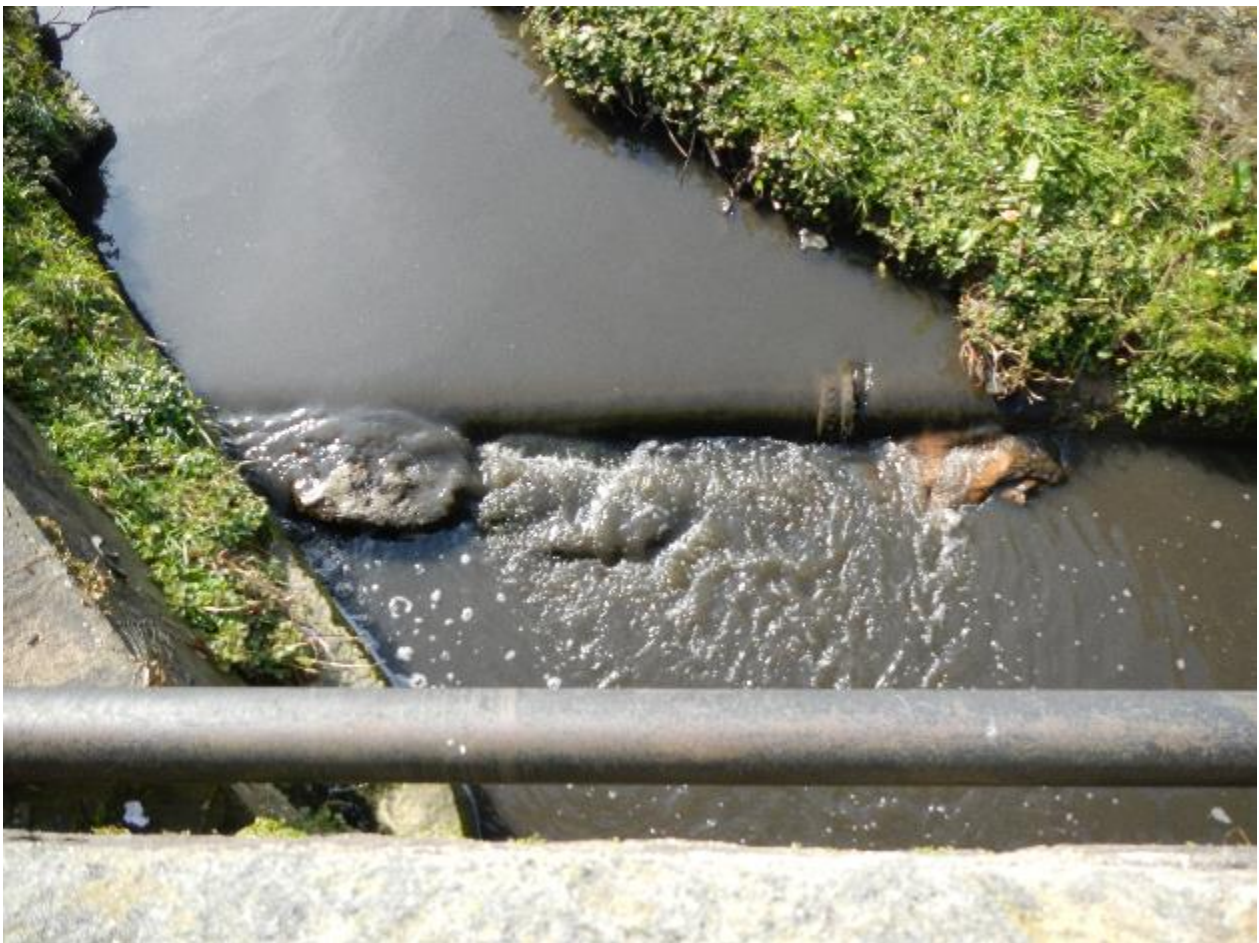
Figure 6. Looking off a bridge in Hampsthwaite at a notable loading of fine sediment in Cockhill Beck after a long dry period. This certainly should not be occurring and could constitute a pollution incident.

It is therefore recommended all such occurrences of pollution or water discolouration are noted, investigated and immediately reported to the Environment Agency on their Pollution Prevention Hotline (0800 80 70 60). It is also recommended that a specific project of walking-over the Cockhill Beck be undertaken, noting the issues such as silty field drains, road runoff, erosion and livestock access to the banks (if occurring), along with any other potential pollution sources, with a plan for addressing those issues with the possible culprits. Perusal of Google Maps identifies an online pond on the Beck and this may also be linked to the issues and is well worth inspection.

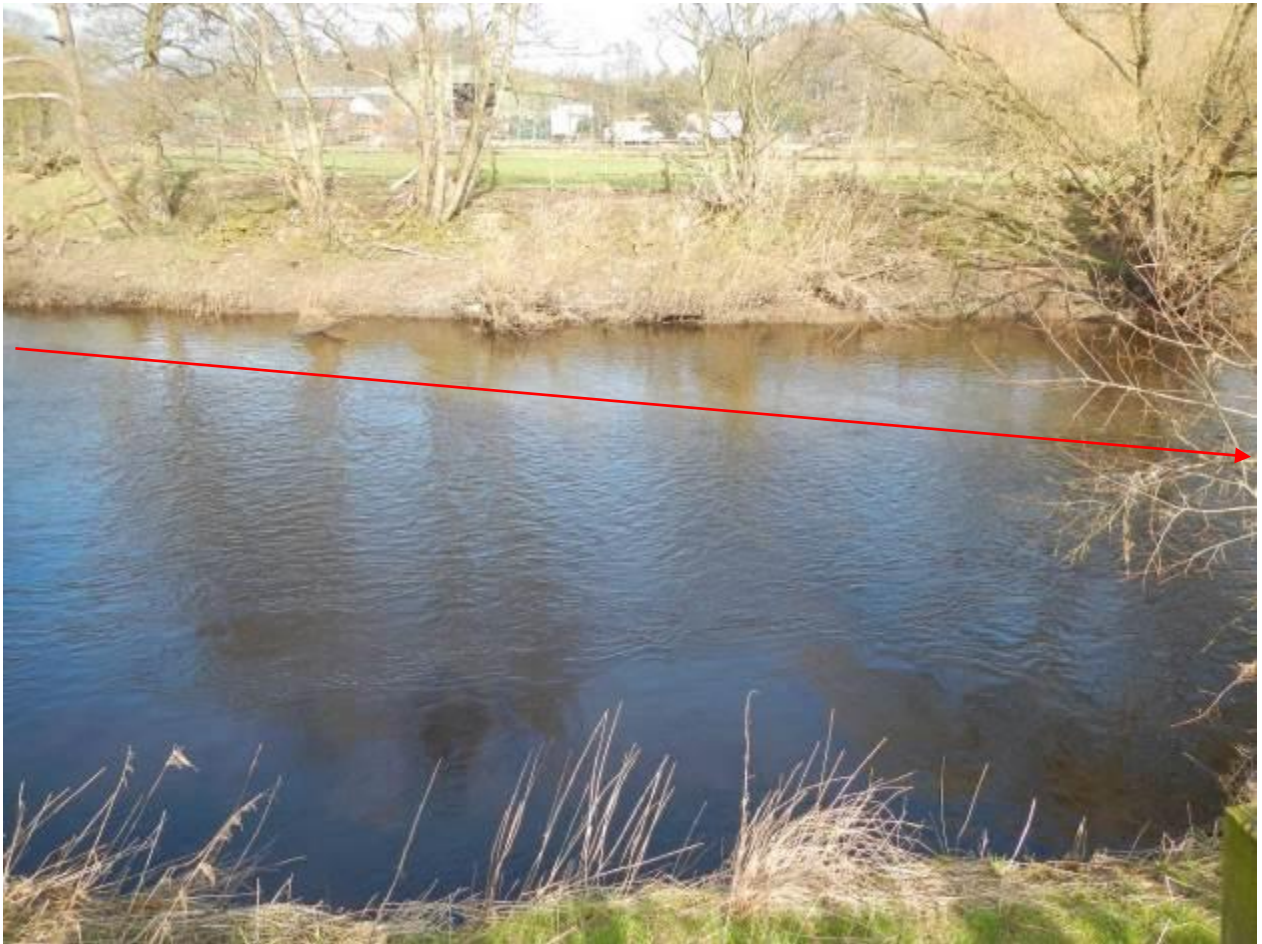
As with Cockhill Beck, Ripley Beck also poses a significant input of fine sediment to the River Nidd (as noted on both the 2012 and 2016 visits). Again, it should not be expected that a beck is running that coloured after little or no rain, but certainly not constantly as appears to be case. This is not only an impact on the main river but also greatly degrades the habitat of the Beck as fish habitat in its own right, and as a spawning and juvenile area. It is therefore recommended that investigation is also undertaken into the exact source(s) of the issues on this watercourse in the same manner as on Cockhill. If, as suspected by the club, it is associated with online ponds, the operators of the ponds should be approached to ascertain whether those ponds could be managed in a way that reduces the sediment input. If ponds are online, they will be subject to greater siltation and reducing/preventing the through-flow of water is also likely to greatly reduce the requirement for their maintenance.

Figure 7. Immediately d/s of the Ripley Beck / River Nidd confluence. Note the plume of discoloured water entering the river along the far bank (the extent of dispersal indicated by the red line).

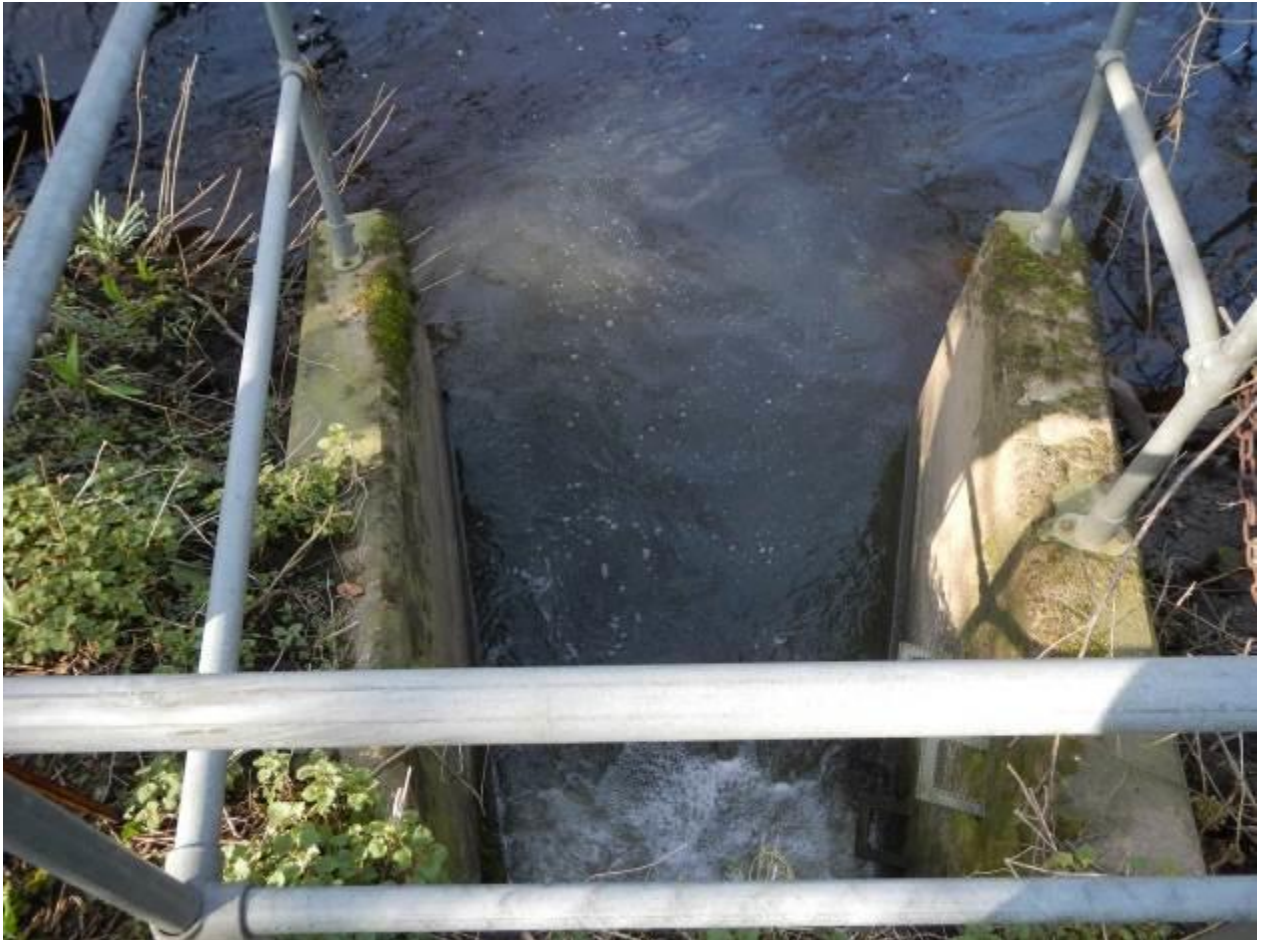
As noted on the previous visit, the outfall of Killinghall STW was discharging discoloured water (Fig. 8). It may or may not be operating within the discharge consent but it is certainly not a good thing; it is worth checking if it is meeting the required standards. The Environment Agency should be asked to sample the water during a period that it is discharging the cloudy, odorous water as it is almost certainly contributing to eutrophication of the river and will increase algal blooms, particularly in low summer flows.

Figure 8. Killinghall STW discharge – well-worth having inspected to ensure it is not breaching its discharge consent.
