**River Ray & Tetchwick Brook – BBOWT Reserve
Blackthorn**

An Advisory Visit by the Wild Trout Trust – November 2014

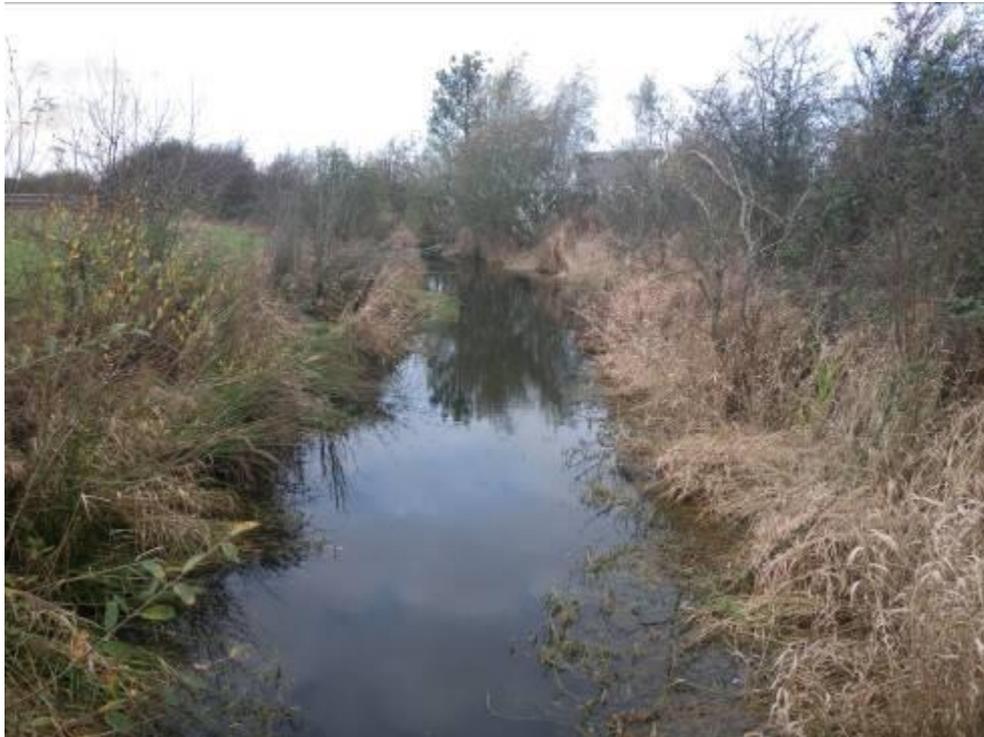
The upper section of the Brook is heavily impounded (photo 1) by a ford structure (photo 2) that was constructed and then modified in an attempt to force water out of the old straightened channel (photo 3) and into an old paleochannel (photo 4).

Photo 1 Impounded section of the Tetchwick Brook approximately 100m above the ford/dam: a good environment for fish like roach, perch, pike and eel.

stocks was the impounded section located upstream of the ford. This section appeared to be favourable for some fish species such as weed and root substrate spawners like roach, perch and pike. The reach also provided favourable habitat for eels.

One option on the Tetchwick Brook is to install a series of level control structures and back the levels up on the long straight section to create linear pond habitat. The current margins that have been cleared of thorn trees could be re-profiled to create a low, wet berm, ideal for a range of wetland plants and suitable for winter wader foraging. The deeper water should ensure that no full channel reed encroachment takes place, preserving some "open" water habitat.

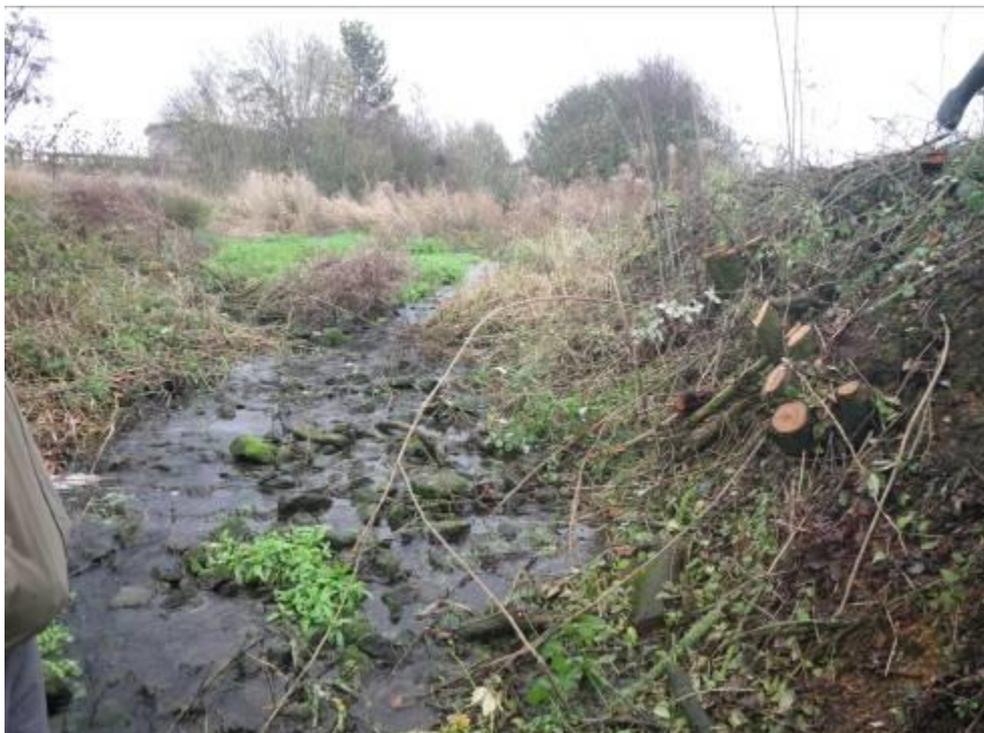
Photo 2. The downstream face of the ford structure looking up towards the top of the structure.

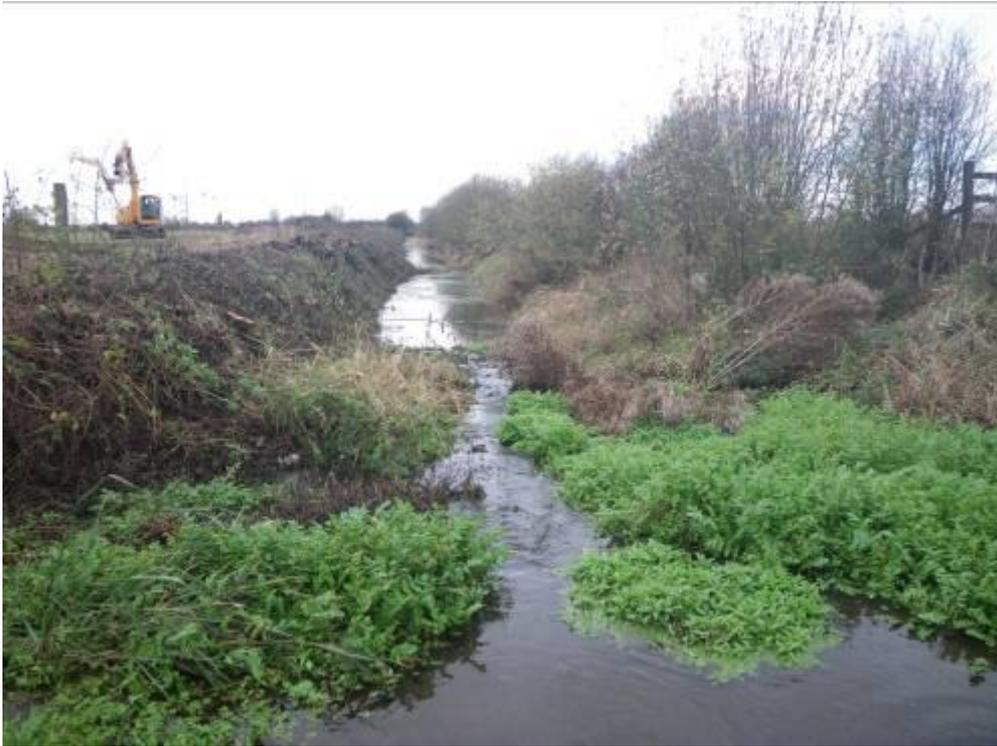
Photo 3. Looking downstream of the ford at the straightened channel

Downstream of the ford, the channel is very straight and trapezoidal in cross-section, suggesting a legacy of past drainage works. At the time of the visit, the thick hedge-like margin of thorn trees were being coppiced to promote more local foraging opportunities for wading birds.

- Explore options for raising water levels in the entire straightened section of the Tetchwick Brook and the creation of a low wet, marginal berm. Perhaps the objective should be linear pond habitat with valuable wet margins, rather than flowing stream habitat.

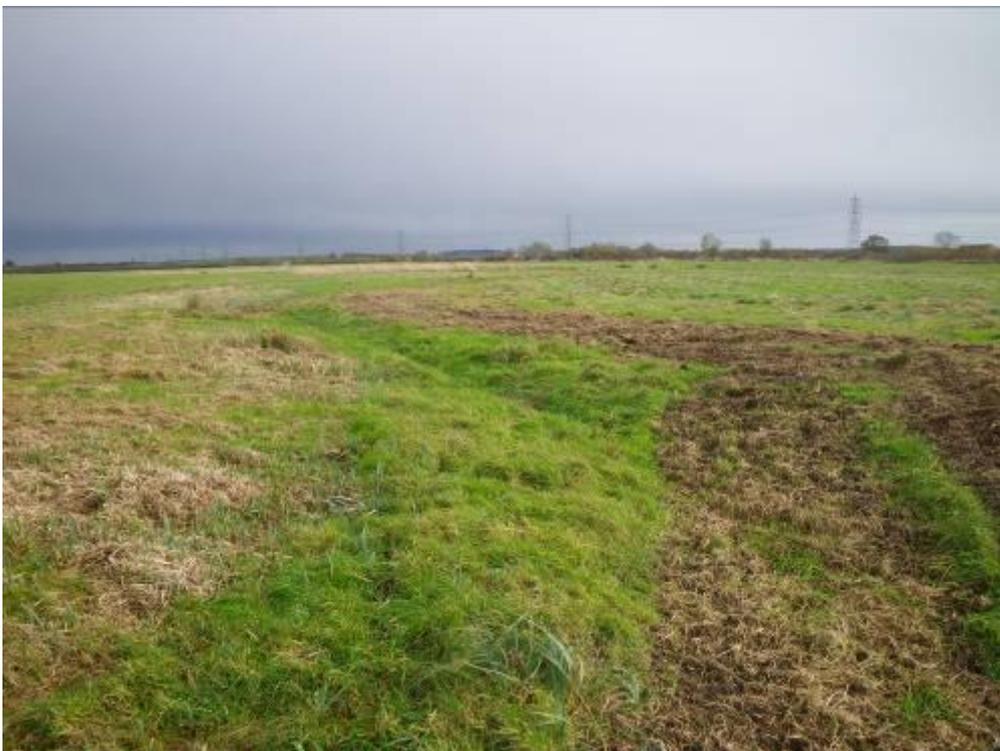
The option to try and restore some semi-natural morphology to some of the heavily degraded sections has been considered by BBOWT, with attempts made to reconnect the Tetchwick Brook into an old paleochannel which has unfortunately been unsuccessful.

Photo 4. Gently meandering paleochannel running to the north of the existing modified channel.

It is unfortunate that attempts to divert the Tetchwick Brook back into an old paleochannel failed. Even if it were possible to raise the water levels sufficiently high to feed into the old channel, it would still be extremely difficult to create a sustainable habitat synonymous with classic flowing stream conditions because of the increased length of the meandering channel and the chronic lack of available gradient. In managing the Brook, it will be essential to have the objectives for the land high up on the list of conservation priorities. As passionate and committed "fish folk" this is a very difficult message for the WTT to convey.

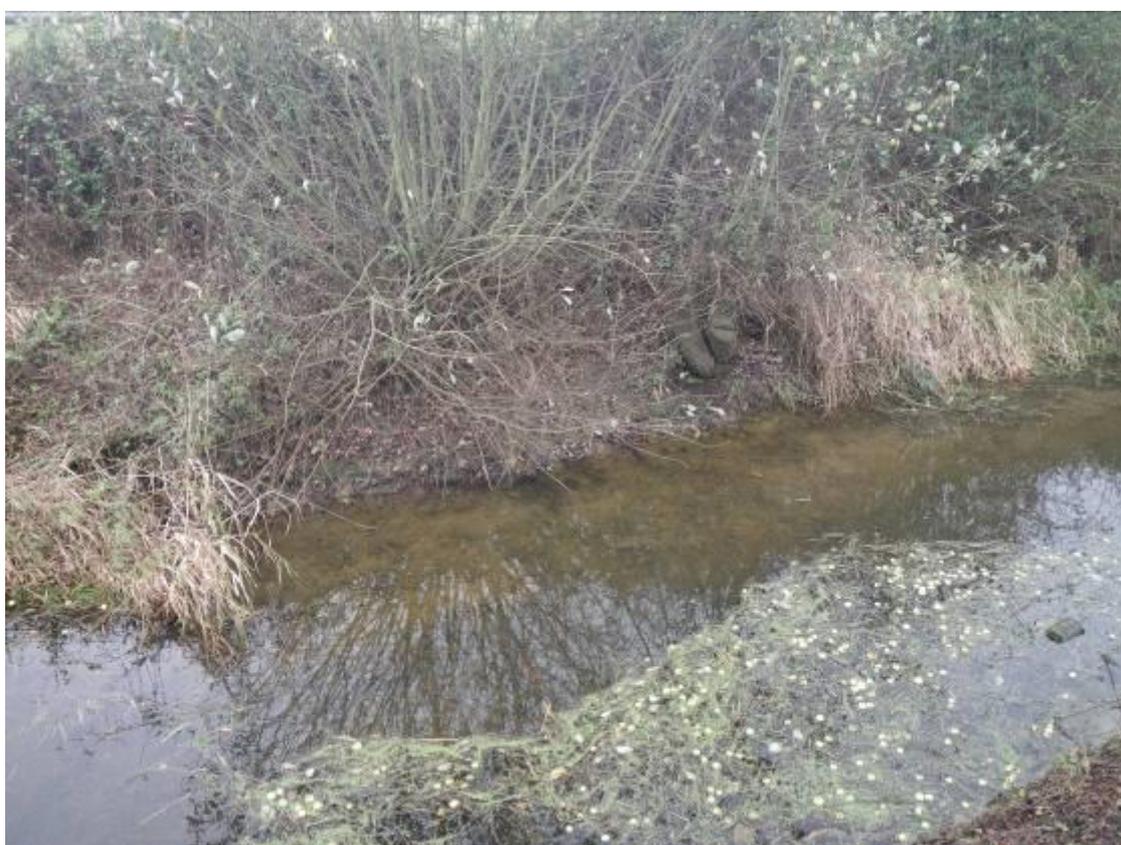
The wetted stream channel is comparatively wide and the whole reach consisted of a long, flat-bottomed shallow glide (photo 5). Without further intervention, the available light that can now hit the channel bed will promote vigorous growth of emergent species such as reed canary grass and branched burr reed.

Photo 5. Typical section of the Tetchwick Brook which is wide and shallow and lacking any discernible evidence of flow. The low willow growing out of the toe of the RB is promoting some "open water" via shading.

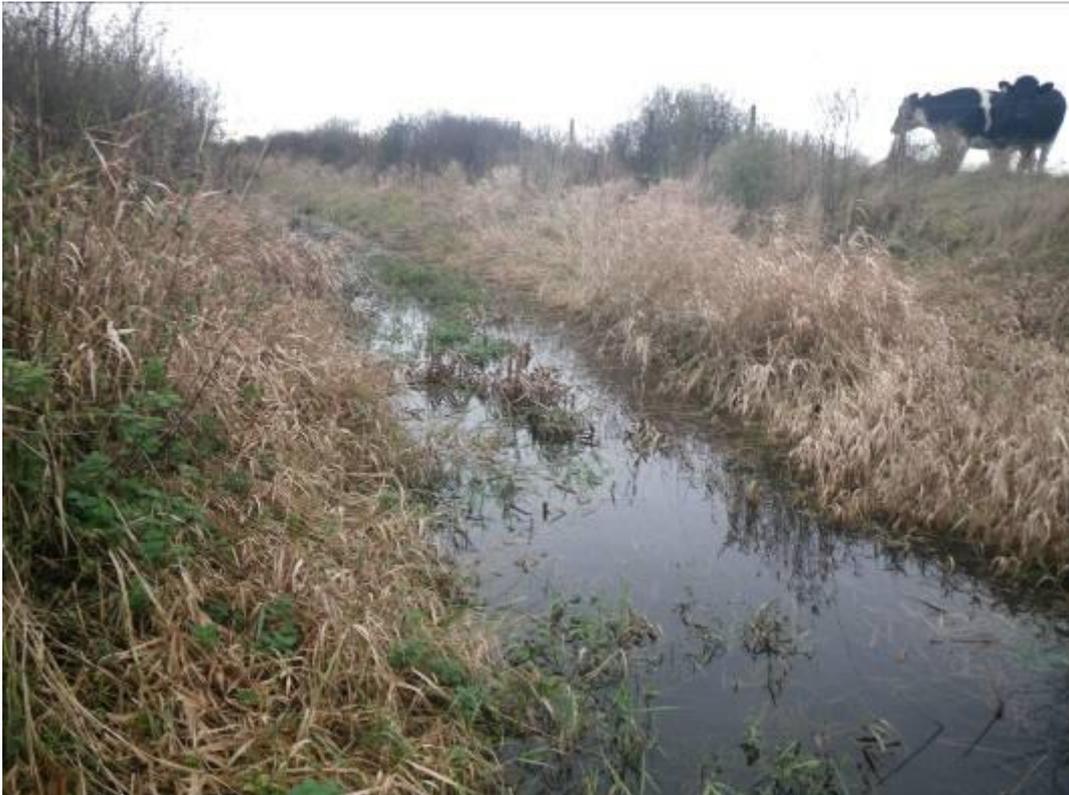
Maintaining emergent reed growth in river margins is a good way of providing habitat for invertebrates, cover for fish and reducing bank erosion. However, in engineered channels where the average flow discharge is too small for the existing channel width, emergent plants often grow in central channel locations, sometimes completely occluding the channel (photo 6).

Photo 6. Heavy emergent reed and grass growth will block the channel in high summer

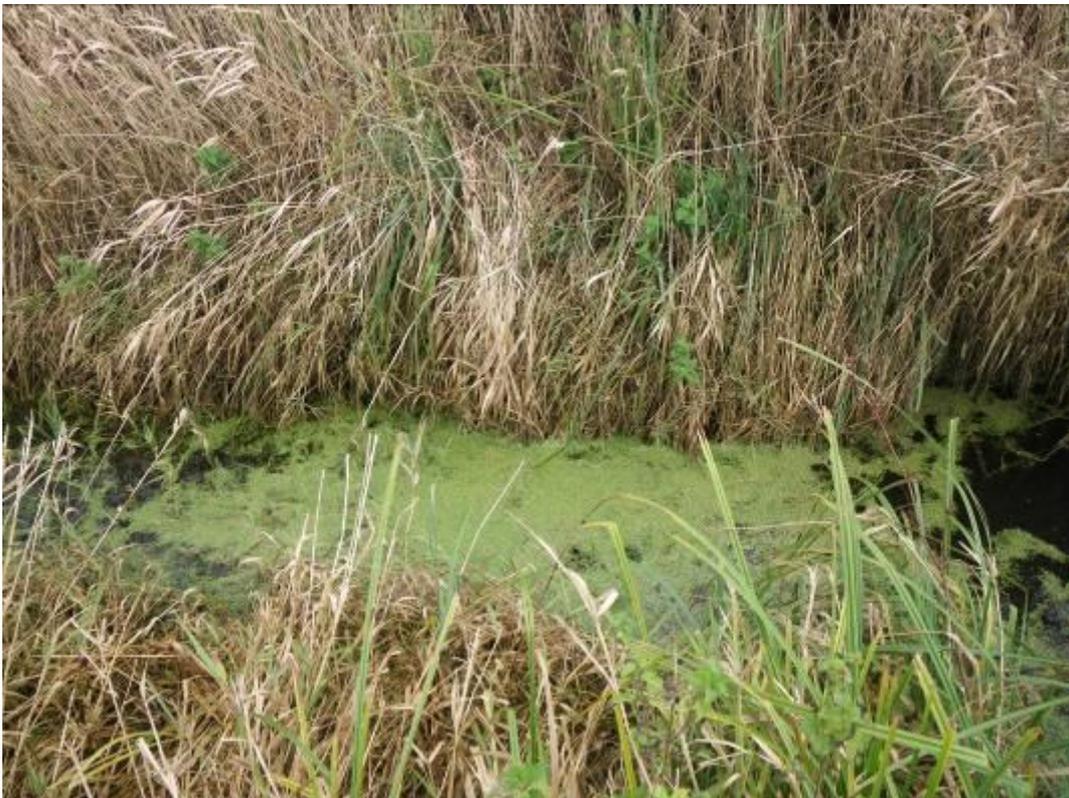
The elevated nutrient status of the Brook is promoting heavy weed and algal growth wherever the channel is in direct sunlight. Where the channel is blocked, the surface film is also occasionally covered with duckweed (*Lemna* spp, Photo 7).

Photo 7. In places the surface is covered with duckweed, a potential issue impacting on dissolved oxygen concentrations.
