**Advisory Visit**  
**River Rede – West Woodburn**  
**20/04/2017**

**Undertaken by Gareth Pedley**

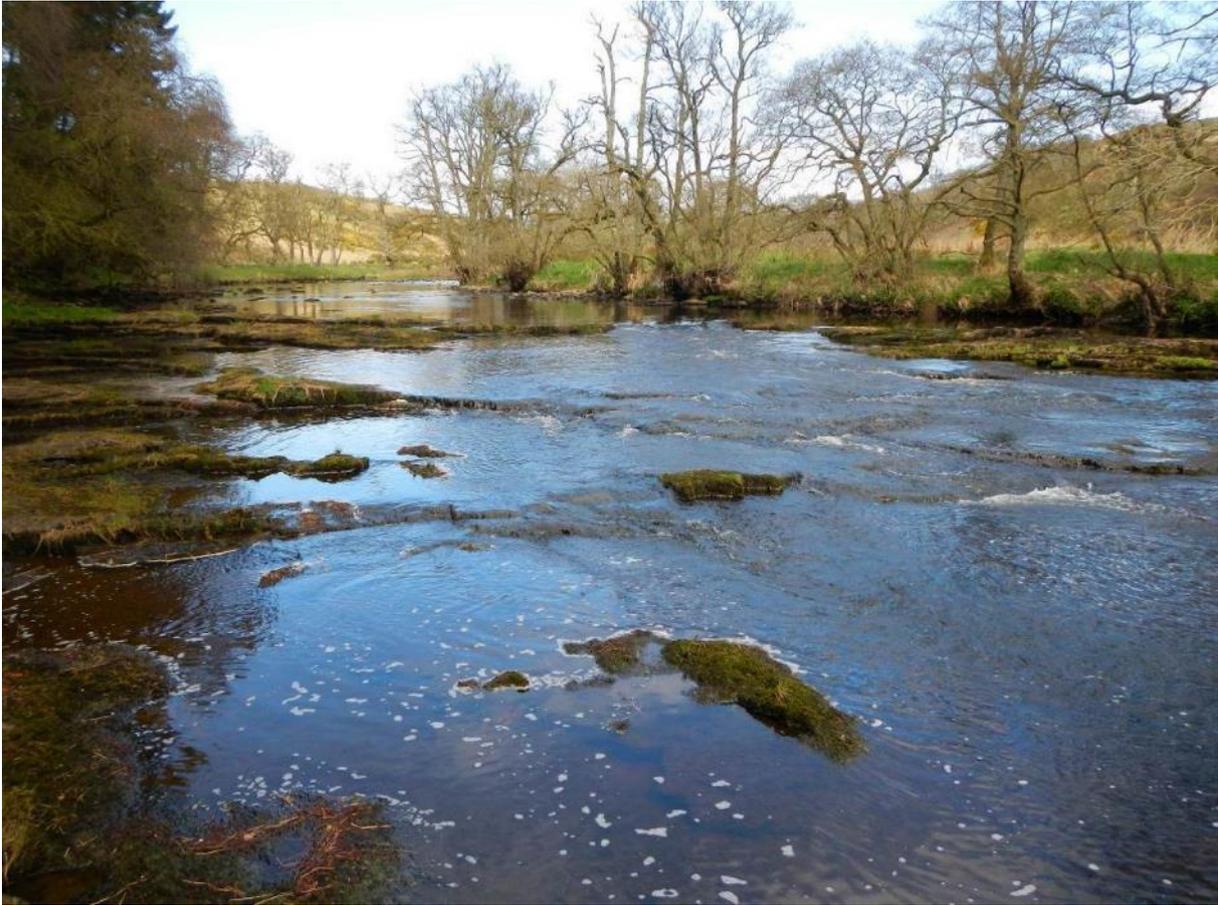
Exposed bedrock at the upstream extent of the fishery limits the potential for improvements there, but provides valuable range of microhabitats for juvenile salmonids and invertebrates (Fig. 1). Bankside trees offer a natural balance of shade and light, with the channel being wide enough that over-shading is unlikely to ever be a problem – this is true for most of the fishery. When considering the optimal ratio of light and shade on a watercourse it is also important to consider whether aquatic vegetation would be there even without shading. In this case, the naturally peaty water, flashy flows and coarse substrate are likely to preclude abundant growth of macrophytes within the channel anyway, so work to reduce the availability of tree shade and cover would only be counterproductive, denuding other habitats. Bankside trees also provide a valuable source of terrestrial invertebrates and refuge for others emerging from the watercourse which will rest there while they moult, before returning to the river to lay their eggs.

**Figure 1. Natural bedrock areas provide a range of habitat primarily suited to juvenile fish and invertebrates.**

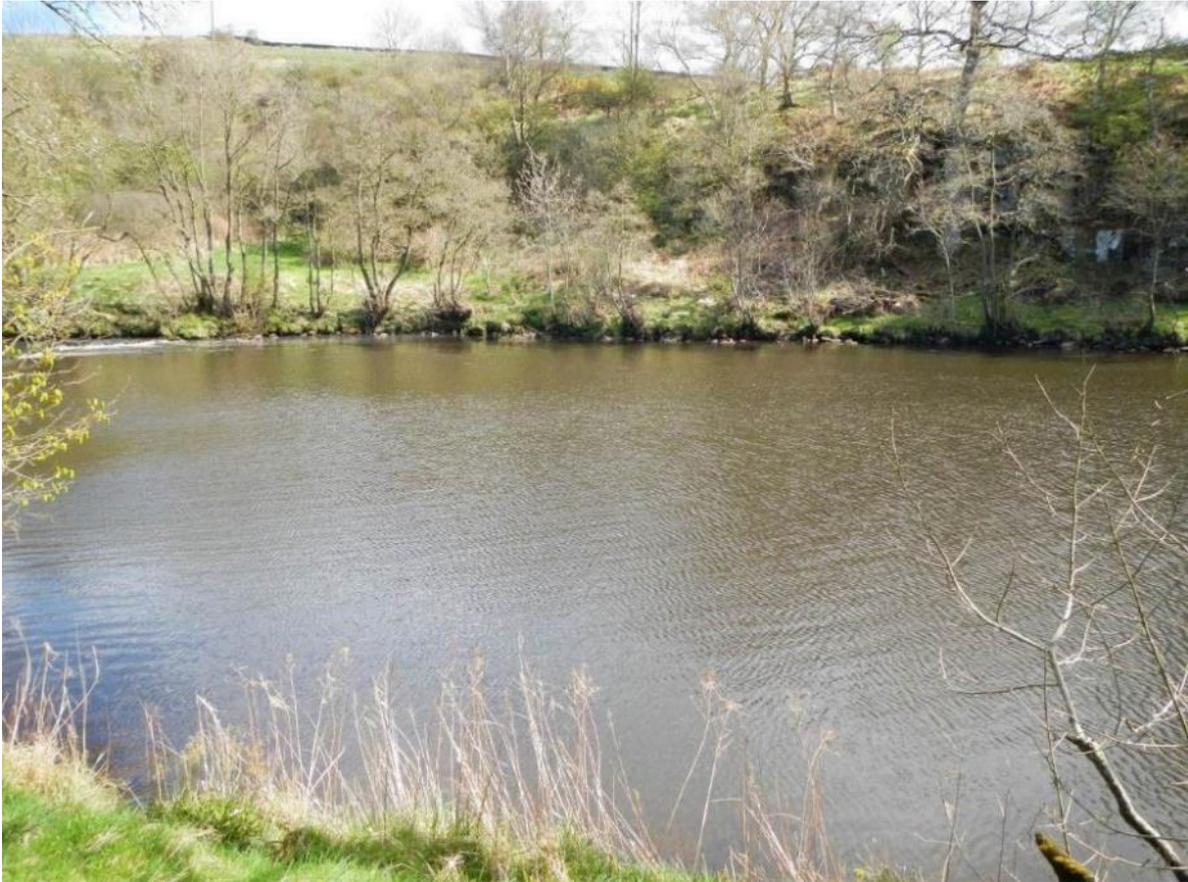
At a large, deep pool, the channel opens out to approximately twice its average width (Fig. 2). The size and depth of this pool makes it tricky to access the main fish lies within the flow along the true LB, leading to past tree maintenance which has removed all of the low hanging and trailing branches along the LB to allow access. That is one solution to a tricky situation; however, another option could have been to fish the pool from a small tethered boat, which would have allowed cover and structure along the fish-holding bank to actually be increased, thereby increasing the number of fish it is likely to hold and improving the angling prospects. If the alternative option were considered favourable, coppicing a few of the trees and tethering the resulting material to the stumps would create low-level regrowth and instant in-channel structure.

***Figure 2. Wide, deep pool at the d/s end of the bedrock outcrop. Tricky to access the fish but an alternative angling strategy could allow habitat to be enhanced along the far (LB) bank, to the benefit of the fishing.***

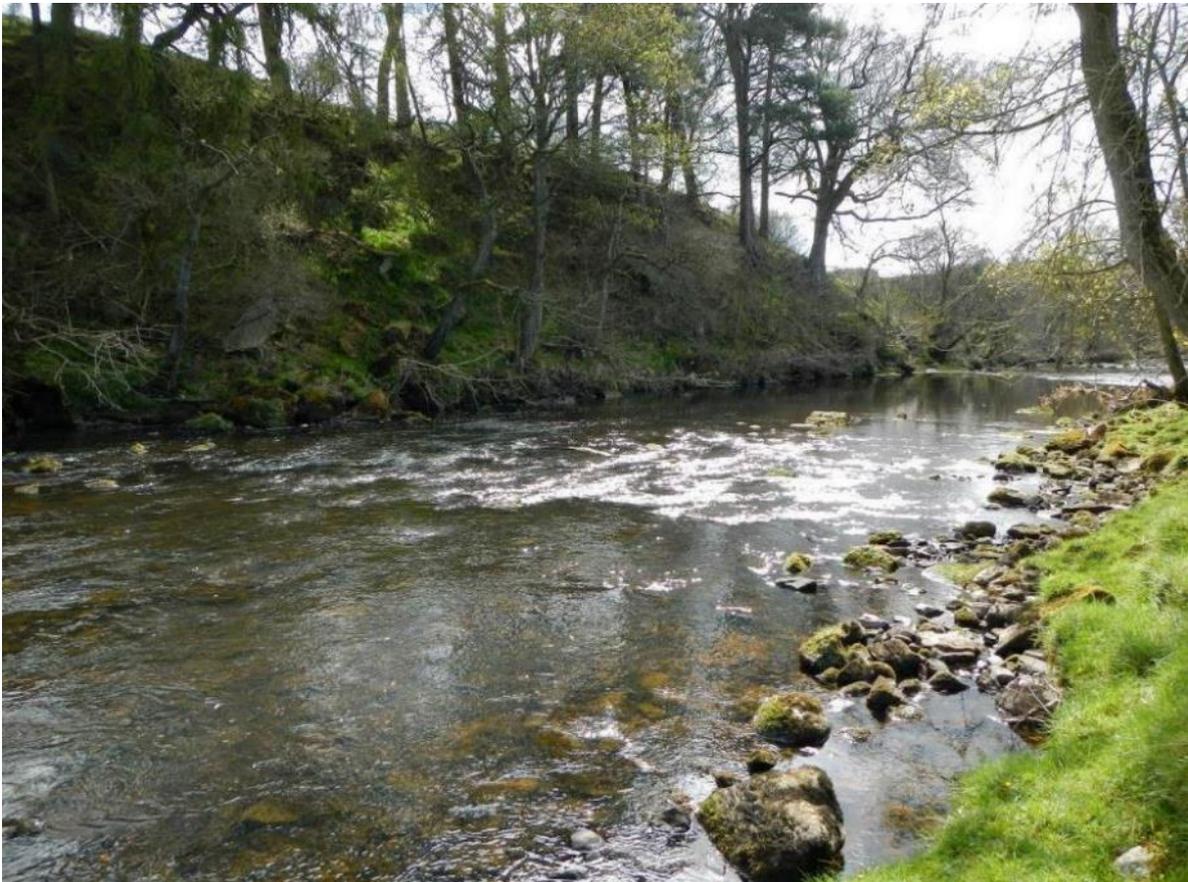
The channel d/s of the pool becomes more typical of a steep upland river, with fast riffles flowing into glide / shallow pool habitat (Fig. 3). Grazing on the RB impacts upon the bankside vegetation and bank stability, limiting the diversity of species present on the bank, and reducing structure within the ground, as energy is directed into replacing lost foliage rather than development of root systems. Note the contrast with the well treed, well vegetated, ungrazed / barely grazed far bank (Figs 3 & 4). Grazing usually leads to a loss of trees over time as the natural regeneration required to replace old trees is simply grazed off before new trees can establish.

***Figure 3. Riffle and glide habitat provides valuable habitat for invertebrates and all stages of the salmonid lifecycle, but note the grass monoculture of the RB bank (right of shot) resulting from grazing – no herbaceous vegetation or natural tree / shrub regeneration.***

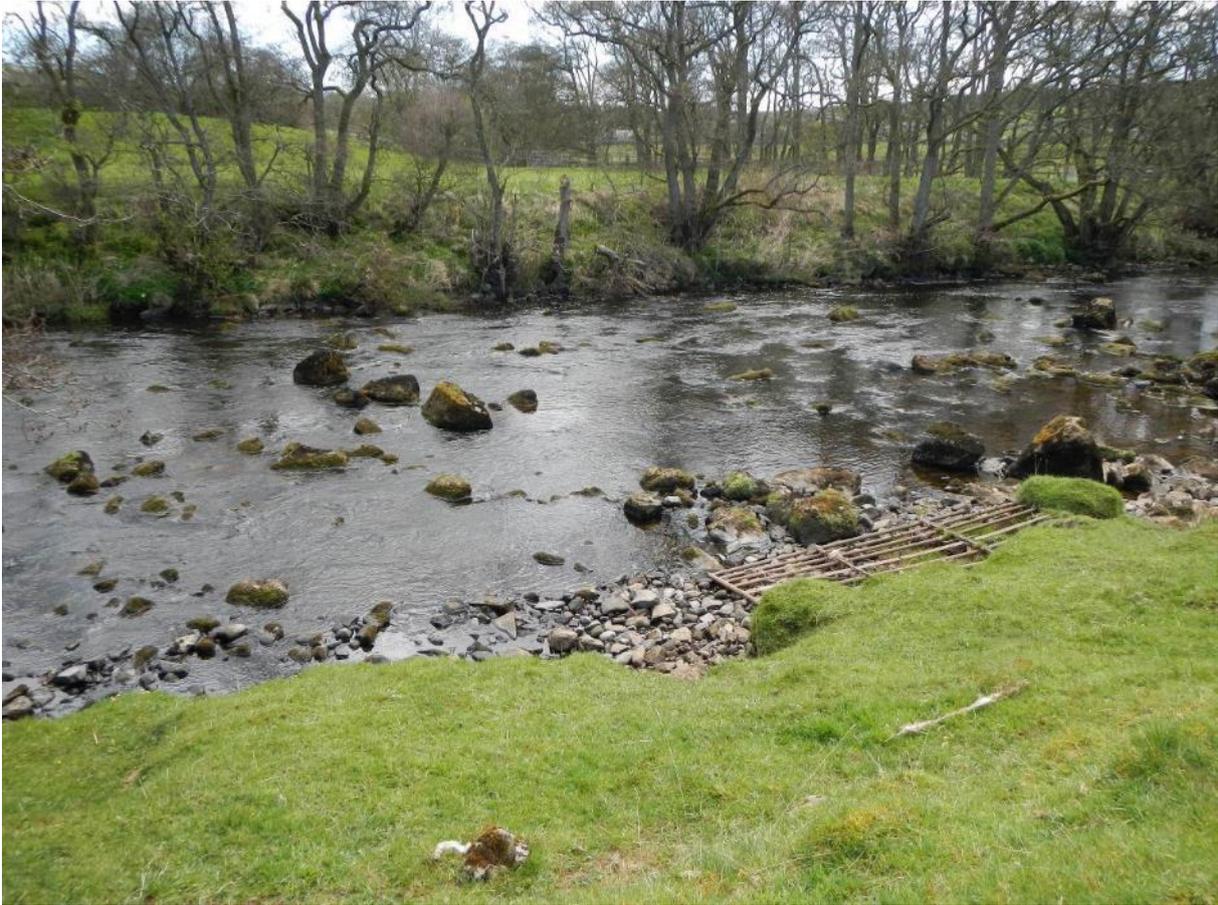
**Figure 4. Poor bank stability and bankside habitat on the grazed, near bank, in contrast to high quality habitat of the relatively ungrazed, tree-lined and well vegetated far bank.**

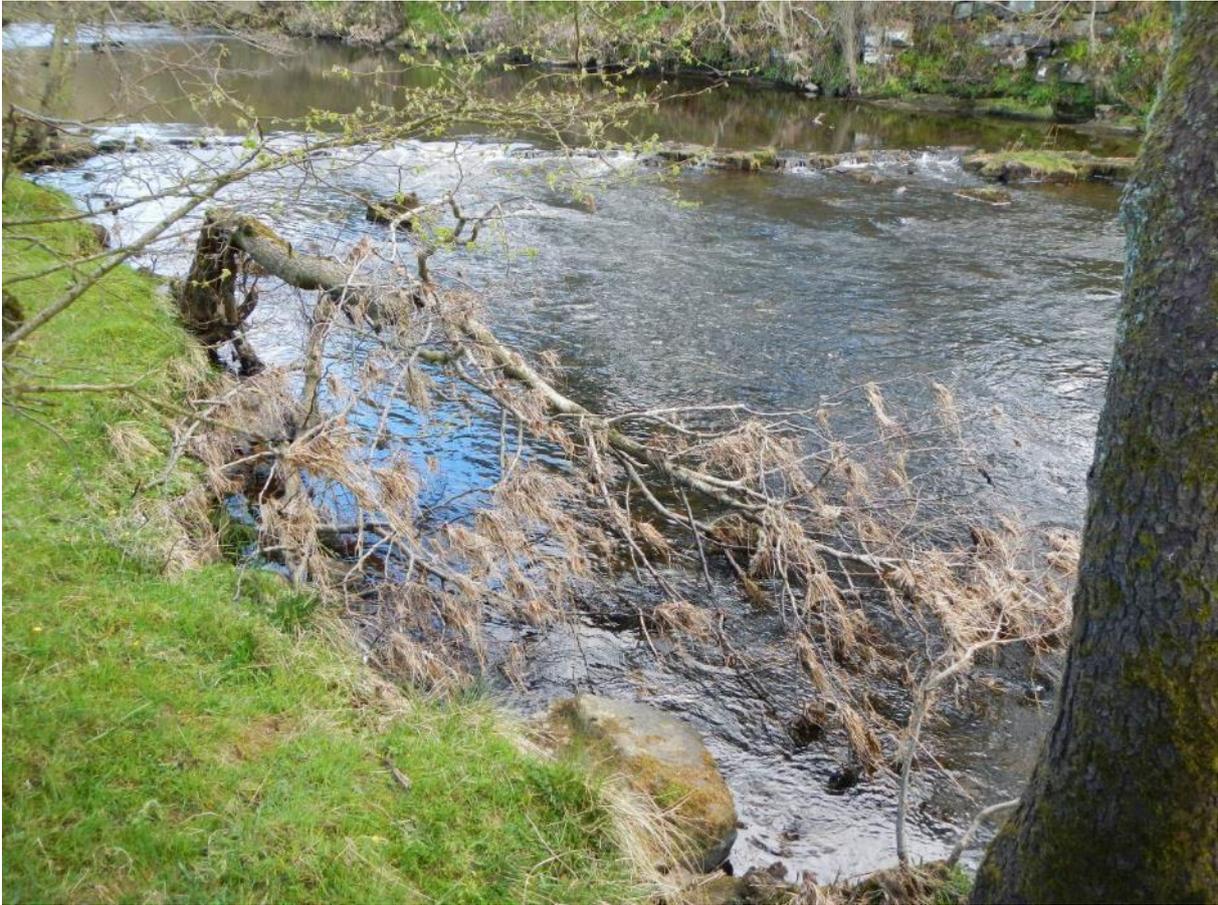
A collapsed alder (*Alnus glutinosa*) tree on the RB offers excellent natural cover and structure that is vital on rivers, providing refuge for fry and other juvenile fish, along with shelter from high flows and structure in which fish can evade predators (Fig. 5). Where a lack of trees and in-channel structure is observed, willow can be quickly and easily planted as whips, to create new trees (providing that livestock can be excluded). Once established, willows can be laid into the channel to replicate naturally occurring cover. Existing willow trees / shrubs can also be treated in this manner; however, it is worth noting that wherever there is a long history of sheep grazing there is usually a lack of willows as they are a favoured species on which to browse. This point is demonstrated on the grazed RB (Fig. 6), which supports only mature trees and poor bankside habitat, whereas the ungrazed LB supports mature trees and a marginal fringe of willows (*Salix* spp.) and bird cherry (*Prunus padus*) providing far higher quality habitat.

***Figure 5. A naturally collapsed alder provides valuable in-channel cover and refuge structure.***

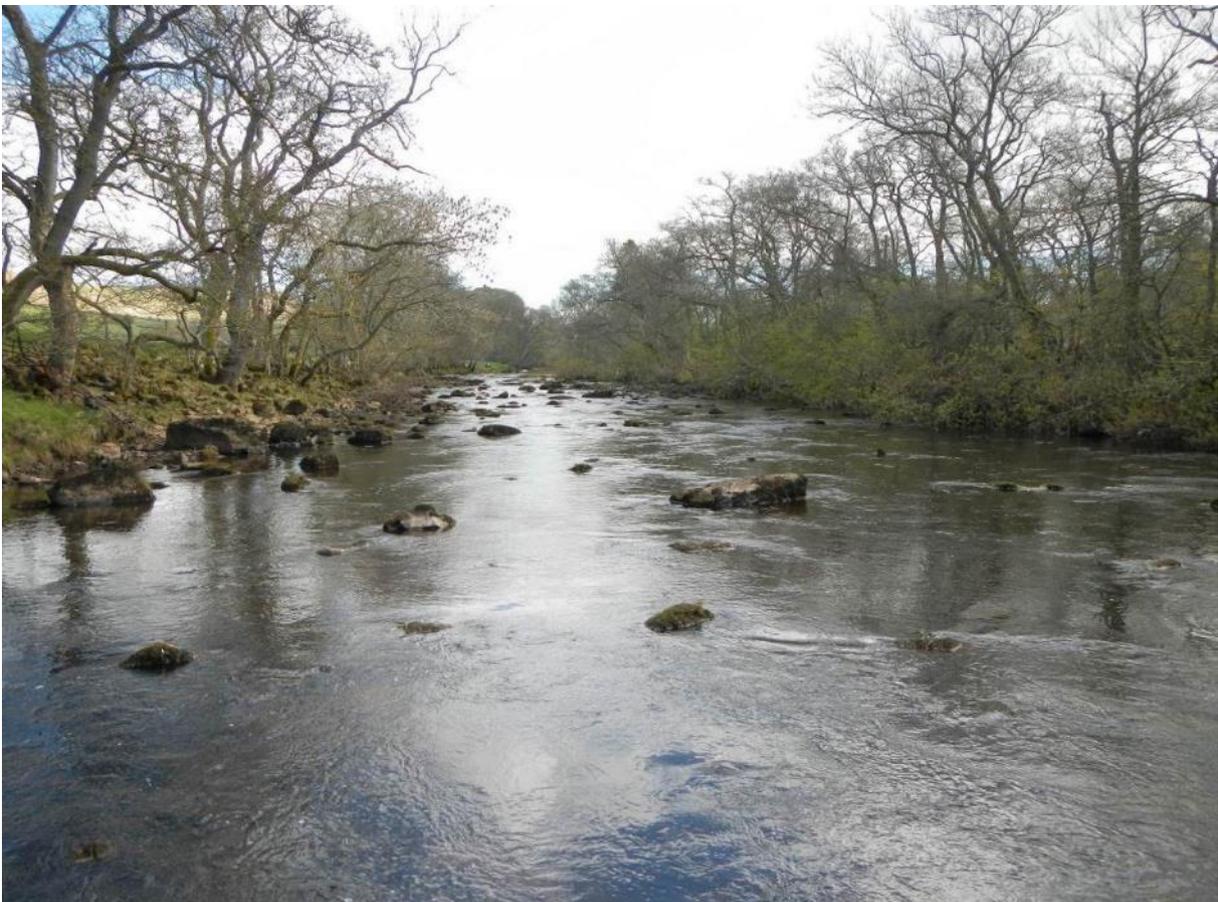
***Figure 6. Looking u/s at the grazed RB (left of shot) with a lack of vegetation and natural regeneration, which is in stark contrast to the ungrazed LB (right of shot), where a diverse margin provides high quality habitat structure and low and trailing cover (great protection from predators).***

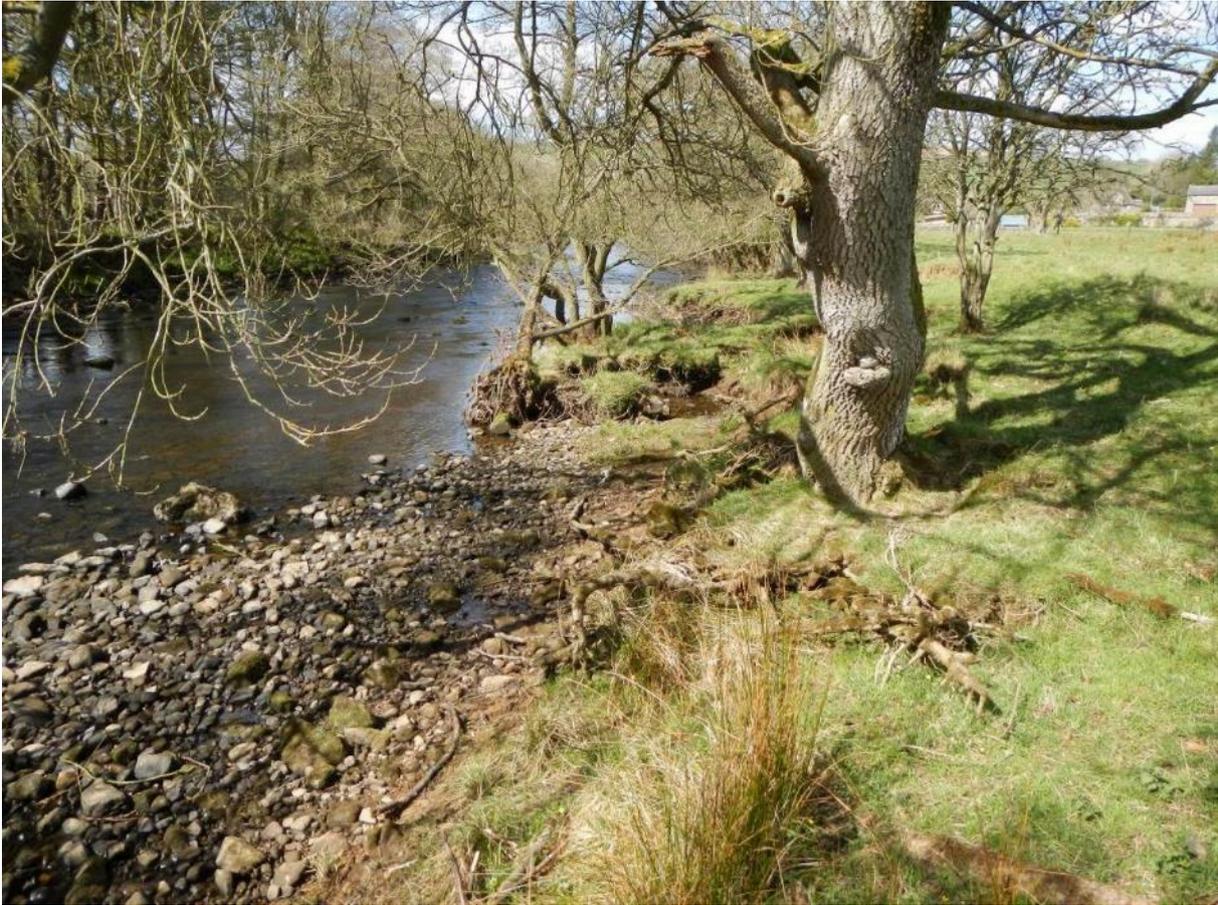
Further grazing issues are evident d/s, where the lack of bankside vegetation, coupled with trampling / sheep scarring, has allowed major erosion around the base of the trees (Fig. 7). Unchecked, this will lead to loss of the trees through erosion in high flows and, without the potential for natural regeneration, the long-term result will be a complete loss of trees from the bank, loss of more land and over-widening and shallowing of the river, and increased sediment input and deposition on the bed.

***Figure 7. Grazing and trampling of the banks is leading to increased erosion and loss of trees, with no potential for natural regeneration as it is all grazed off.***

The most significant benefit to this fishery would be won via installation of (or utilisation of the existing) buffer fencing to exclude livestock from the river bank. This would allow a greater diversity of bankside vegetation and shrubs to establish, providing improved habit and bank stability. Once established, some of this material could then be laid into the river to improve in-channel habitat.

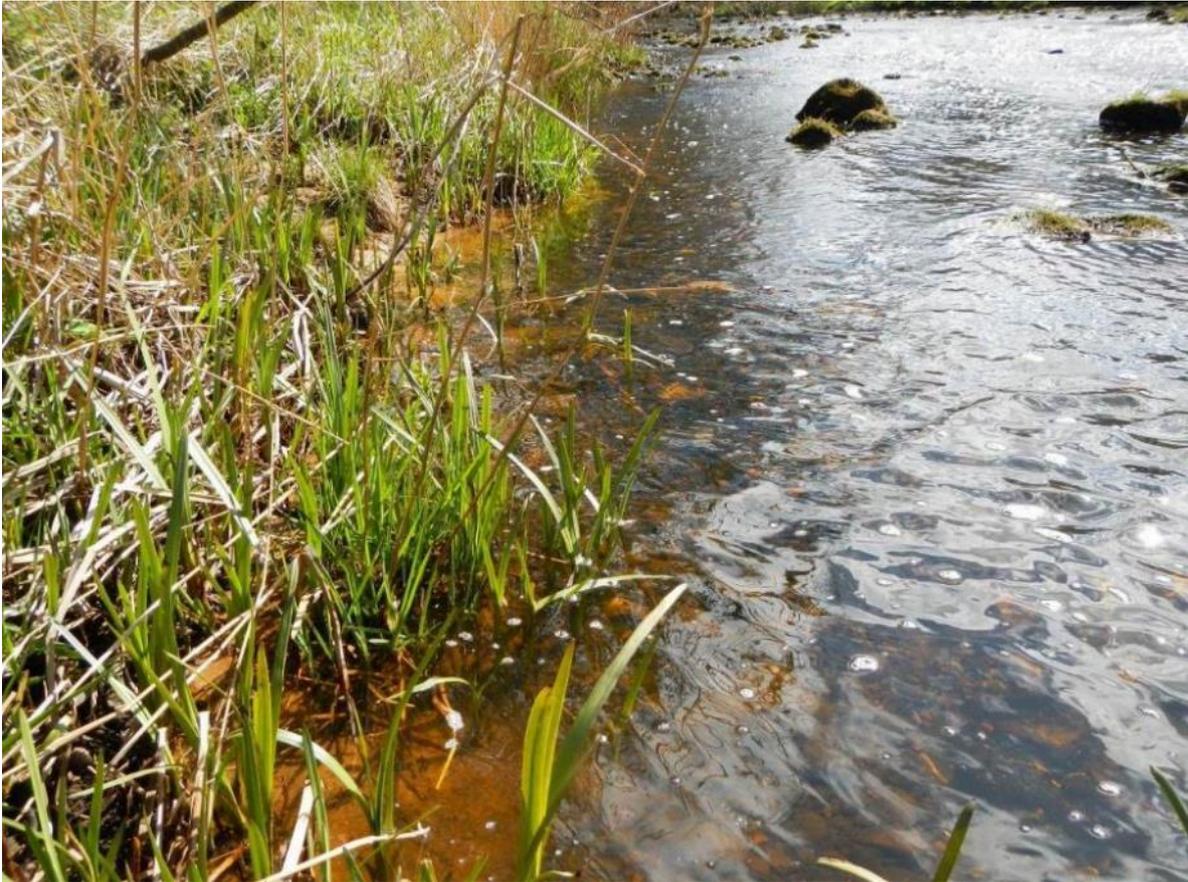
In stark contrast to the eroding, grazed areas, the stock-excluded area alongside the gardens, between the grazed fields and West Woodburn Village, provide high quality marginal habitat with emergent vegetation encroaching into the channel (Fig. 8). Such growth ensures that the toe of the bank is adequately protected from erosion and stable. It also ensures that the channel is naturally maintained to an appropriate width, with the ability to subsequently naturally encroach inwards if it does become too wide through scour in very high flows. It was no surprise to also see salmonid fry utilising the cover and structure in those areas. Willow in the ungrazed areas d/s on the left bank offer some potential for laying, to further enhance flows and in-channel habitat (Fig. 9). The opposite, grazed bank is again limited to mature trees, minimal vegetation and poor habitat.

**Figure 8. In ungrazed areas marginal, emergent vegetation offers protection to the banks and ideal juvenile salmonid and invertebrate habitat. Such margins will naturally encroach into the channel as they trap fine sediment, but remain in-check by higher flows, thereby naturally to maintaining an appropriate bank width and sediment conveyance.**

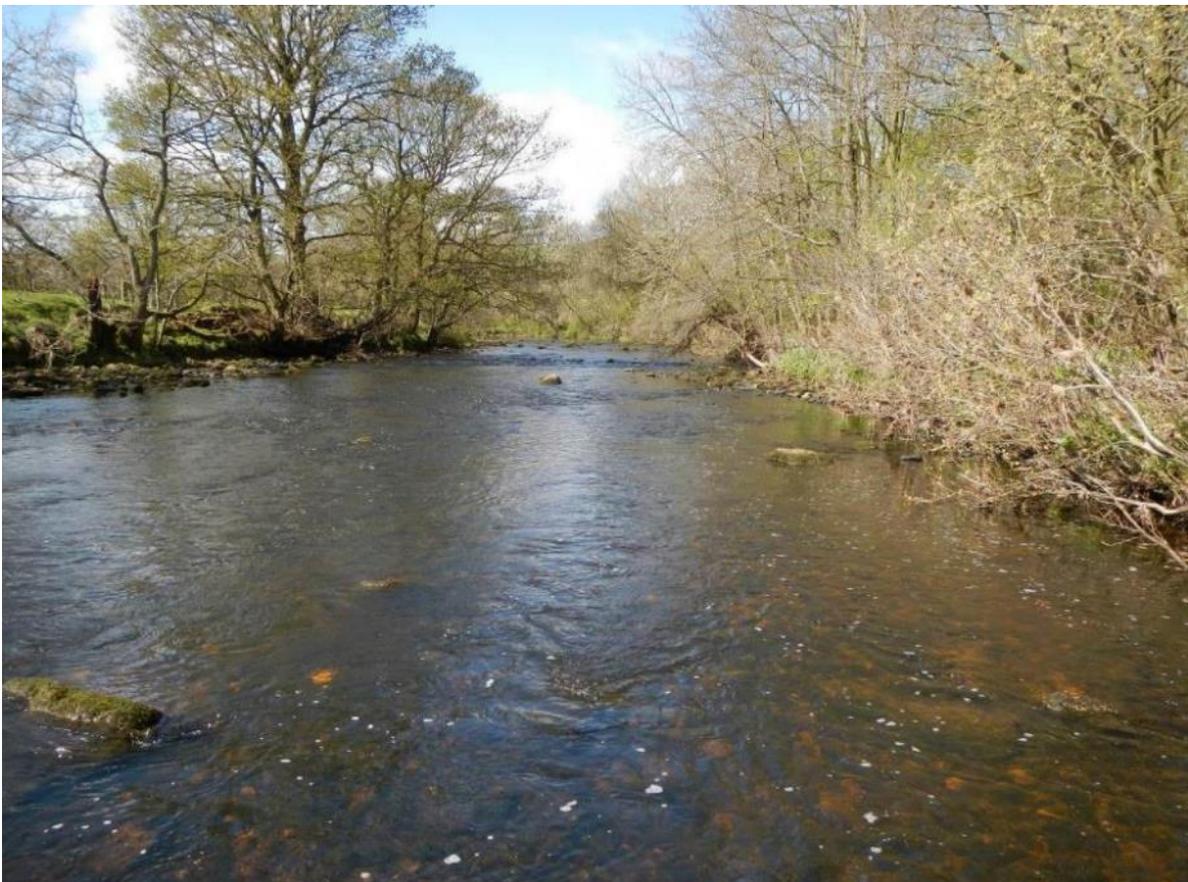
**Figure 9. Willows on the RB offer potential for laying. The grazed opposite bank supports no willow trees and a lack of herbaceous vegetation / tree regeneration.**

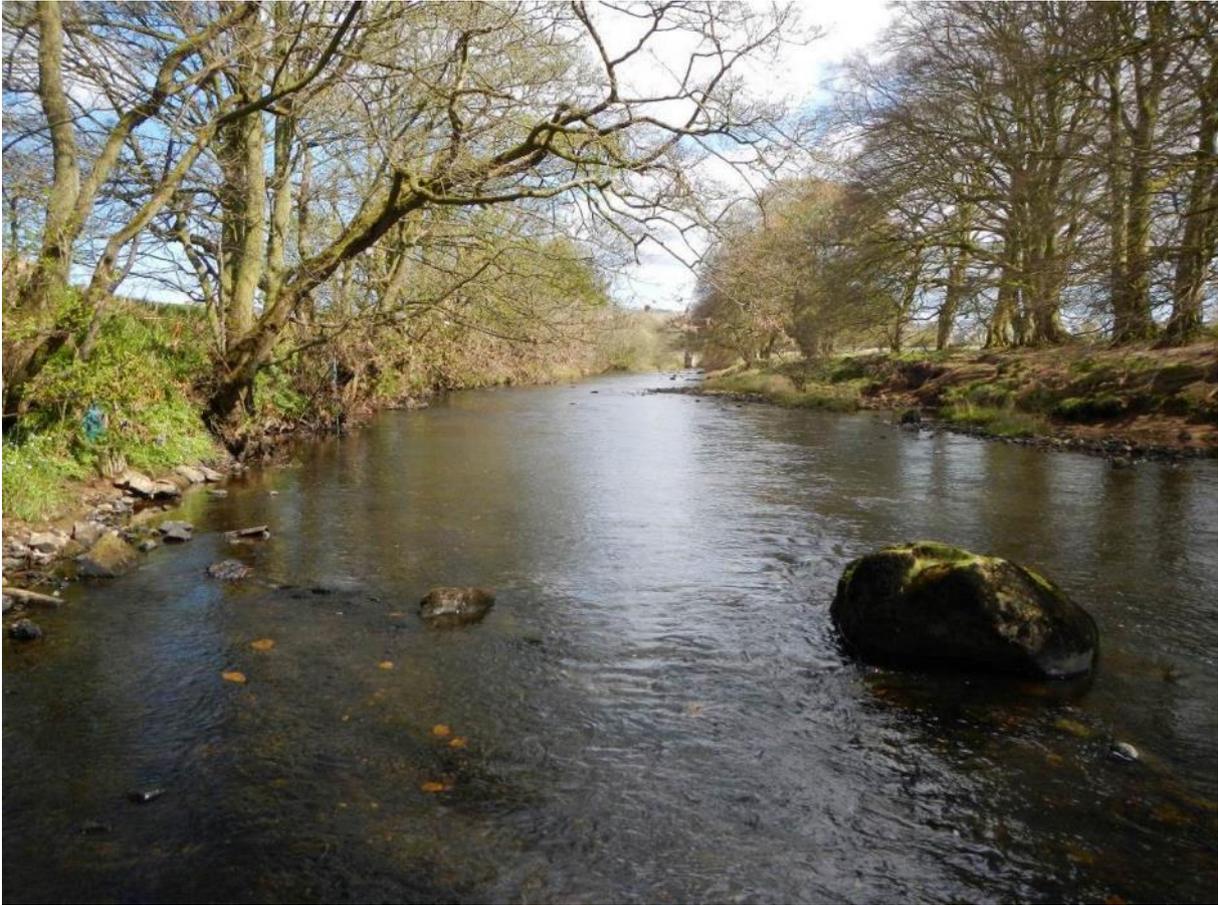
The channel immediately d/s of West Woodburn Bridge is particularly straight for several hundred metres and therefore lacks depth variation (Fig. 10). This provides some juvenile habitat but limits the availability of larger adult trout habitat. Greater availability of structure to drive bed scour and to retain in-channel bed features could help to develop the morphology of the reach but the potential for impact upon conveyance and flood risk must be considered. A particularly high nutrient discharge was noted in this reach, possibly from a poorly maintained septic tank (Fig. 11 - NY 88837 86593). This should be addressed as a pollution and the source identified.

**Figure 10. The long, straight section d/s of West Woodburn Bridge offers limited potential for larger adult trout but provides some juvenile salmonid habitat. It would be improved by a greater availability of cover/structure within the channel to help develop a more varied bed morphology.**

In the d/s section, below West Woodburn, willow in particular could be planted directly into the bank/water interface on the inside of any slight bends to accentuate the sinuosity of the largely straightened channel. In addition to the cover and structural habitat benefits, this would perform two major functions, focussing flow over to the far bank and intercepting sediment transported from u/s. Over time, this should help the river channel to recover a more varied morphology and improve habitat quality.

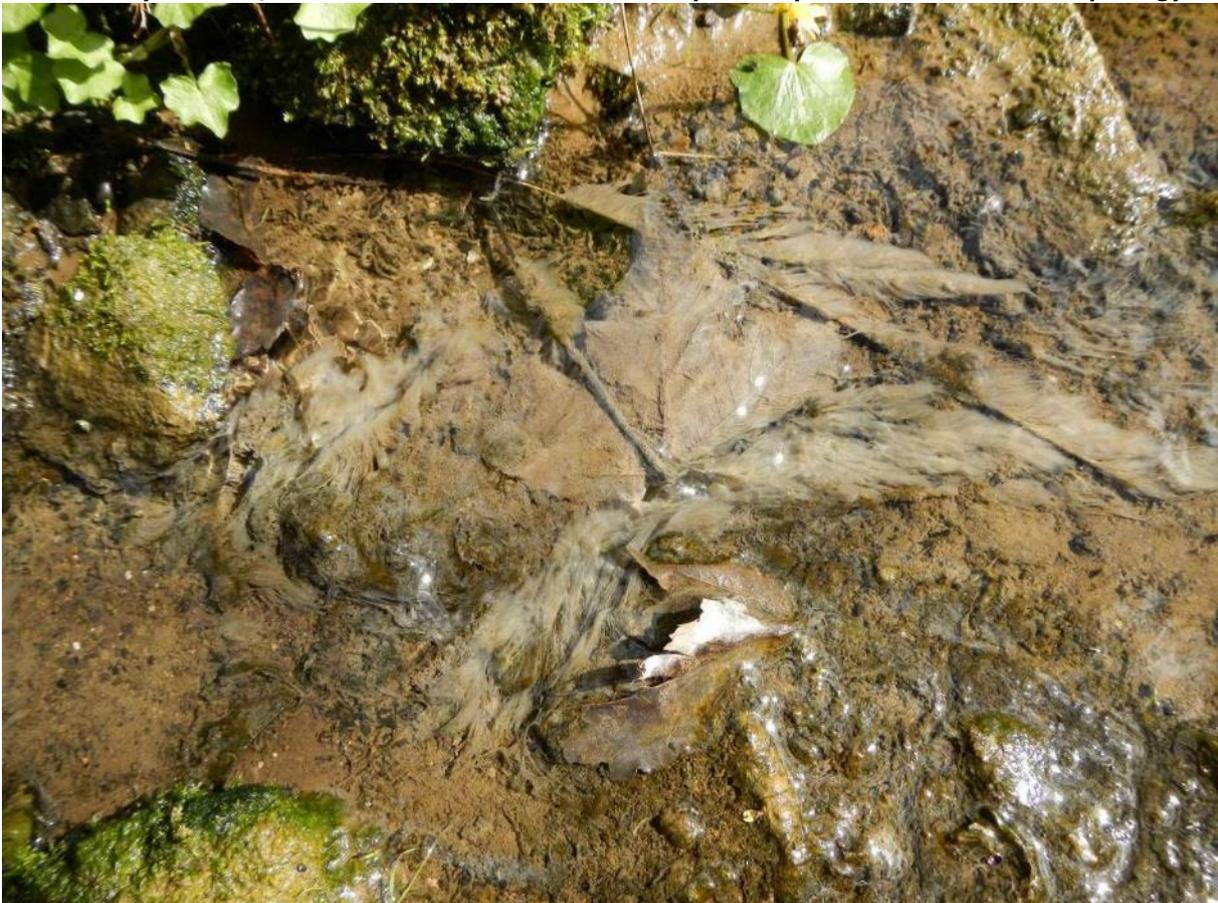
**Figure 11. High nutrient discharge entering the river, as evident by the sewage fungus / excessive biofilm growth within the channel.**

- The source of the pollution entering the watercourse at NY 88837 86593 should be identified and stopped.
- It would be well worth undertaking a walkover of the Lises Burn to identify any potential issues that might limit habitat utilisation and natural fish production of what is likely to be a prime spawning tributary.

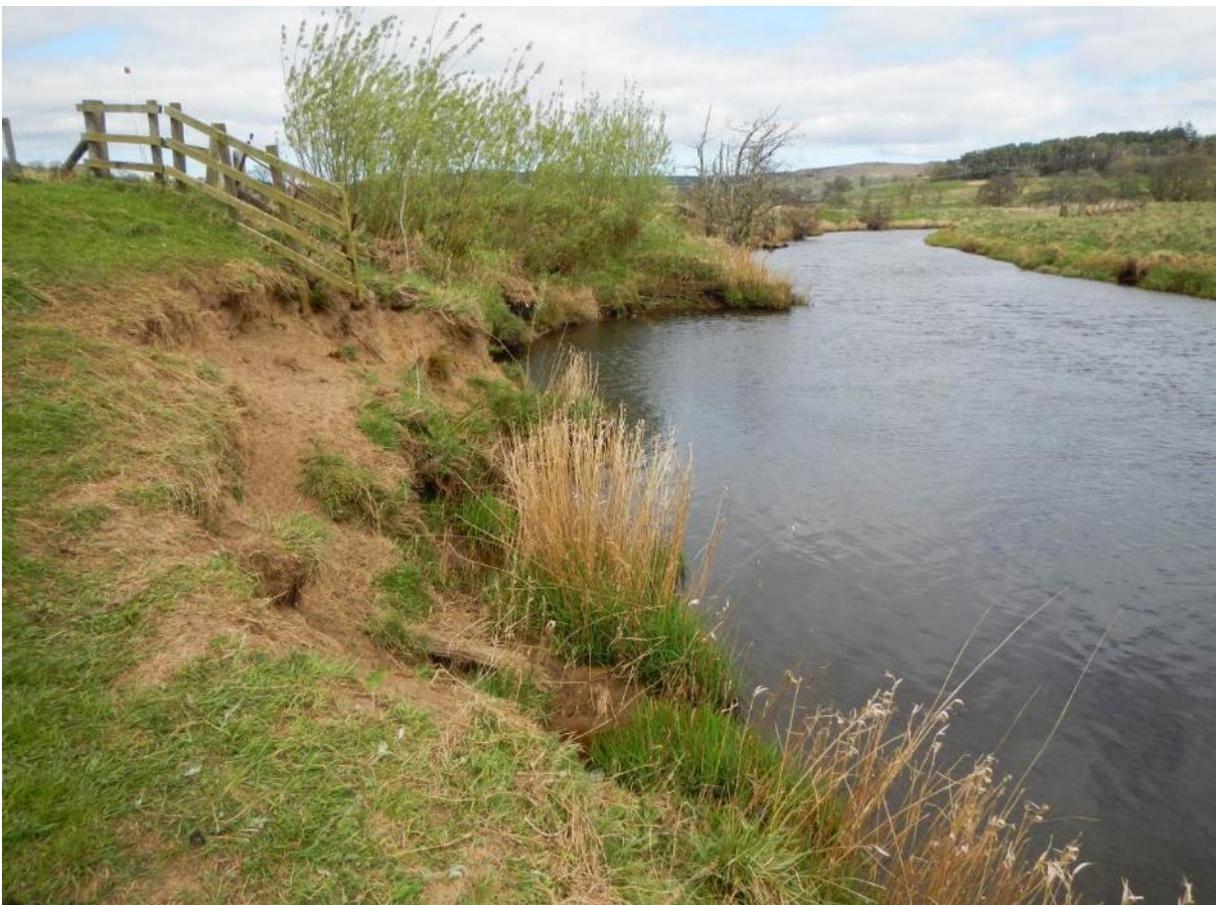
The lower end of the fishery different in character, being dredged and overly deep, rather than shallow. This limits the potential of much of that area for juvenile salmonid habitat (although some are sure to reside there) but does offer greater potential for larger resident fish holding, if the availability of shade, cover and structure can be increased (Fig. 12). Grazing is again an issue, with major erosion already having been addressed with willow spiling; however, the unprotected bank d/s remains in jeopardy. Strangely, a buffer fence is in place, but the gates at either end were left open and little difference was noted within the fence line, suggesting that this is a regular, notable problem. This seems strange when the tenant / landowner are clearly losing land to the erosion and risking further major destabilisation of the bank.

The lack of trees long this length is almost certainly due to the long history of grazing/livestock access as some extent of natural regeneration would be expected from propagules and seeds from u/s, even in areas largely devoid of trees. Sheep access to the existing willow spiling is also likely to be an issue as they gradually work their way through the shoots and kill the living bank protection. The ideal solution here is to completely exclude the livestock and undertake planting of mixed deciduous tree species along the bank to provide improved habitat and greater bank stability, thereby benefiting all concerned.

**Figure 12. The channel towards the d/s end of the fishery is uniformly deep and over capacity, with a lack of structure and bankside trees. Livestock access within the buffer strip is greatly compromising the bank stability and jeopardises the existing bank protection.**

It is recommended that planting with locally native, deciduous tree species is undertaken wherever cover is lacking along the banks, particularly in the lower section of the fishery. Saplings could be purchased or possibly obtained from the Woodland Trust (or possibly through Tyne River Trust), to provide a natural variety of species.

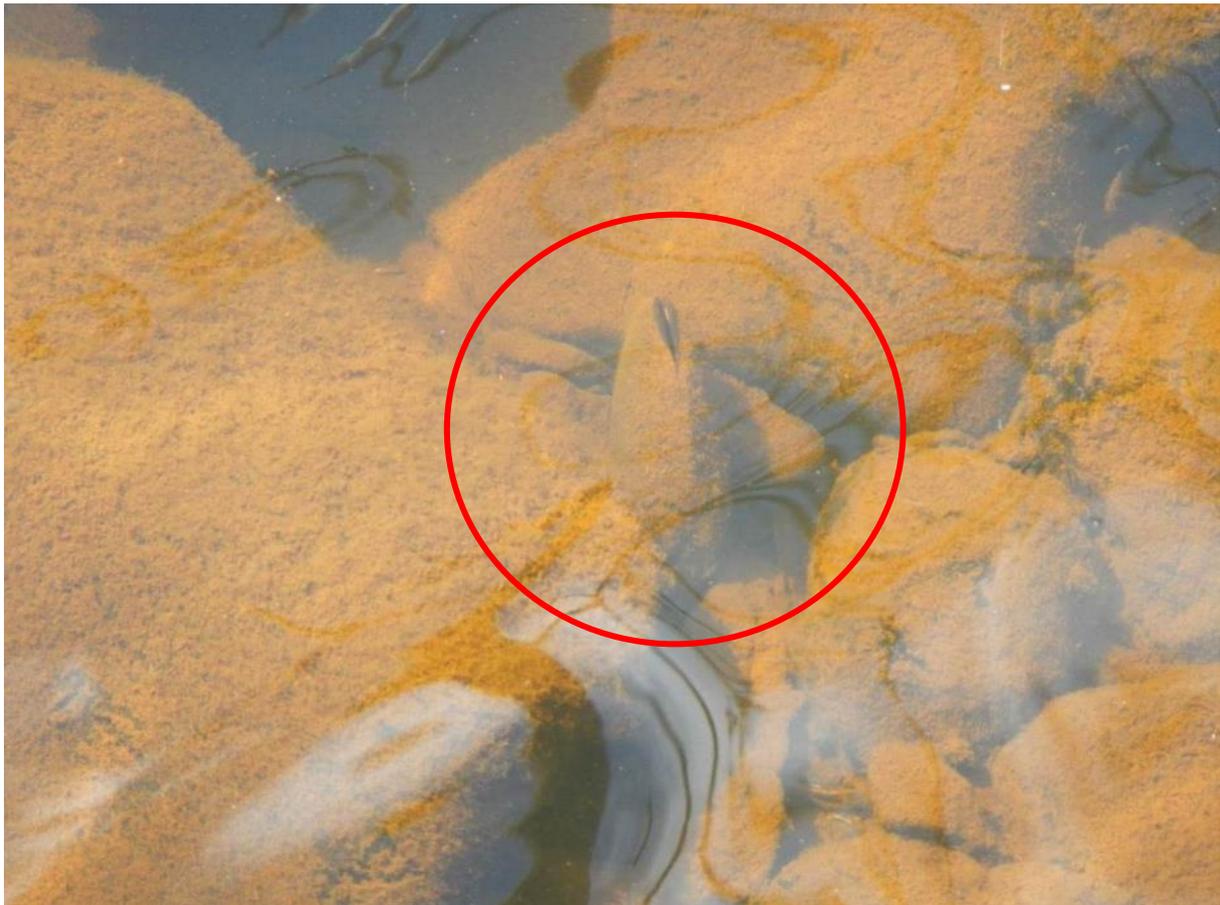
A further point worthy of note is the population of freshwater pearl mussels the River Rede supports, which were observed during the visit (Fig. 13). This rare, protected species is managing to cling on within the catchment but is susceptible to major impact from fine sediment input and pollution – such stresses may well be some of the major issues inhibiting their recruitment. For this reason, along with the impacts upon invertebrate and salmonid spawning habitat, all issues of accelerated bank erosion should be addressed, with livestock ideally being permanently excluded from the riparian area.

**Figure 13. A freshwater pearl mussel looking rather overwhelmed by fine sediment.**

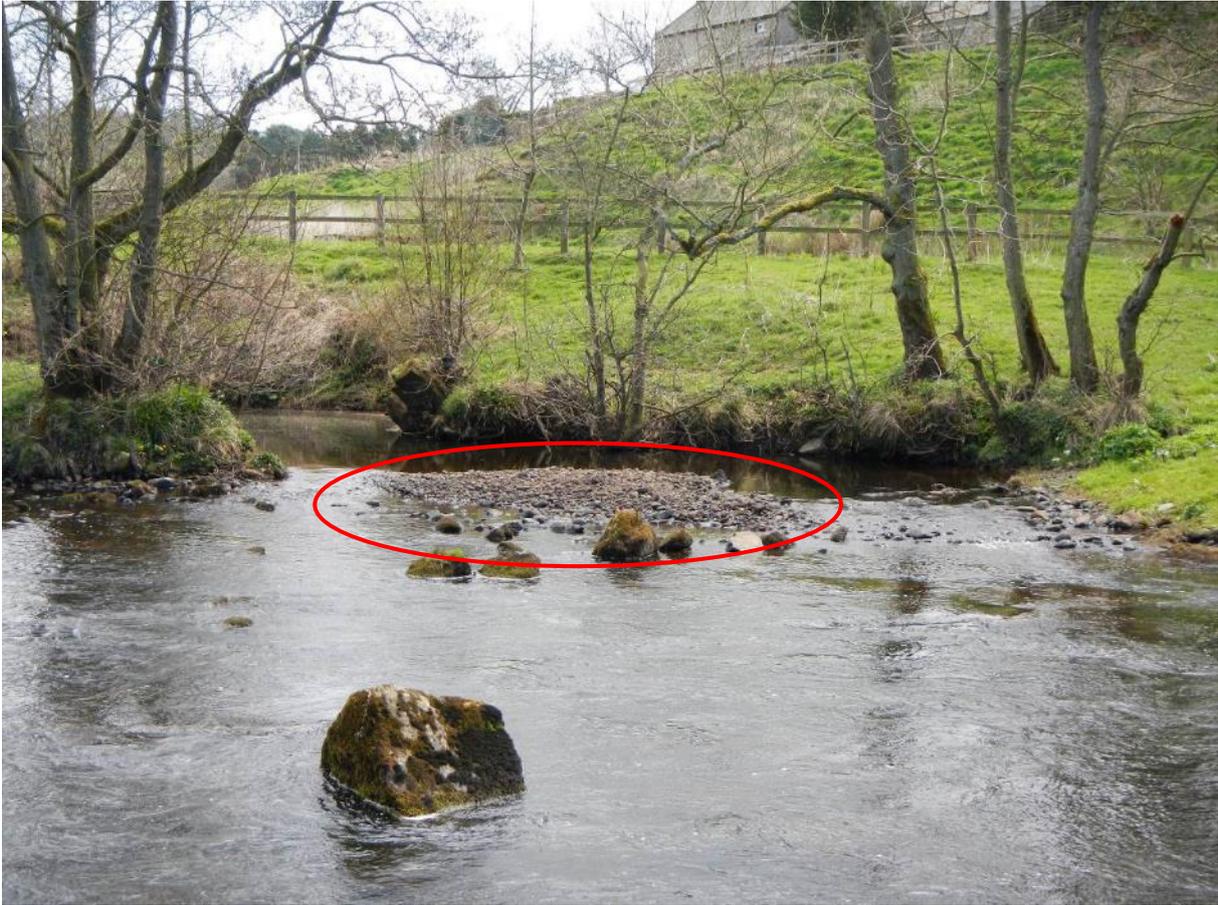
In addition to the main River Rede, a small tributary (the Lises Burn) was observed to confluence along the far bank and, from the local gravel deposition, it appeared to have notable potential as a spawning and juvenile tributary (Fig. 14). It would be well worth investigating this burn to ascertain its full potential and whether any of the basic issues identified along the main channel are impacting upon it, so that they can be addressed to improve the habitat quality and natural fish production of the area. Key aspects to assess are overgrazing and fine sediment input, along with any manmade obstructions that might prevent access or limit utilisation of the burn.

**Figure 14.** *The confluence of a small tributary burn and the River Rede. Note the potential salmonid spawning substrate of the burn (red ellipse).*

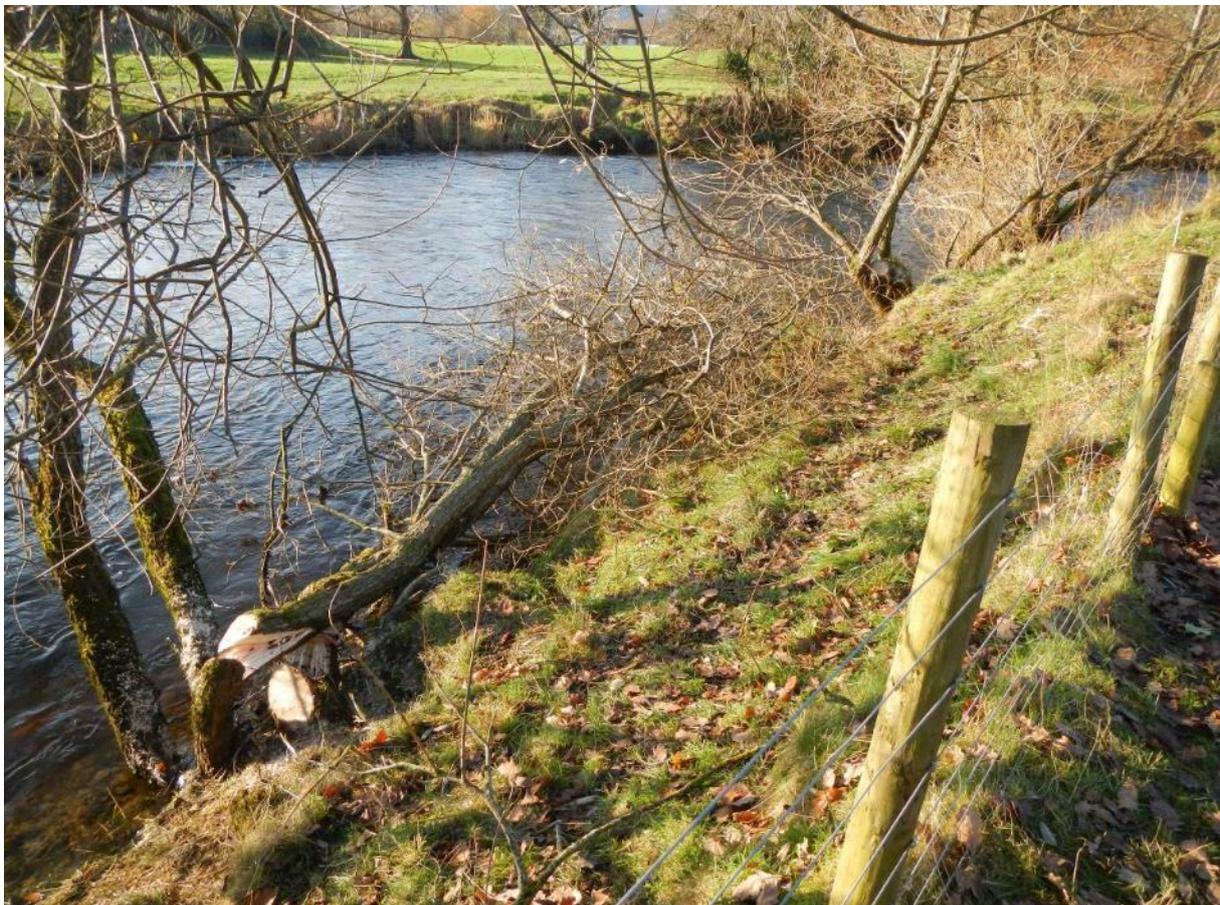
**Figure 15. Willow hinged into the river margin to increase cover and structure.**

The laying method involves cutting part way through the stem/trunk, a little at a time (ideally while it is under light tension), until it can be forced over into the river (Fig. 15). The depth of the cut should be limited to only that which is required to bend the limb over, as this will maintain maximum size and strength of the hinge and the health of the tree/shrub. Fast growing trees like willow can even be strategically planted in anticipation of employing this technique once they become established.

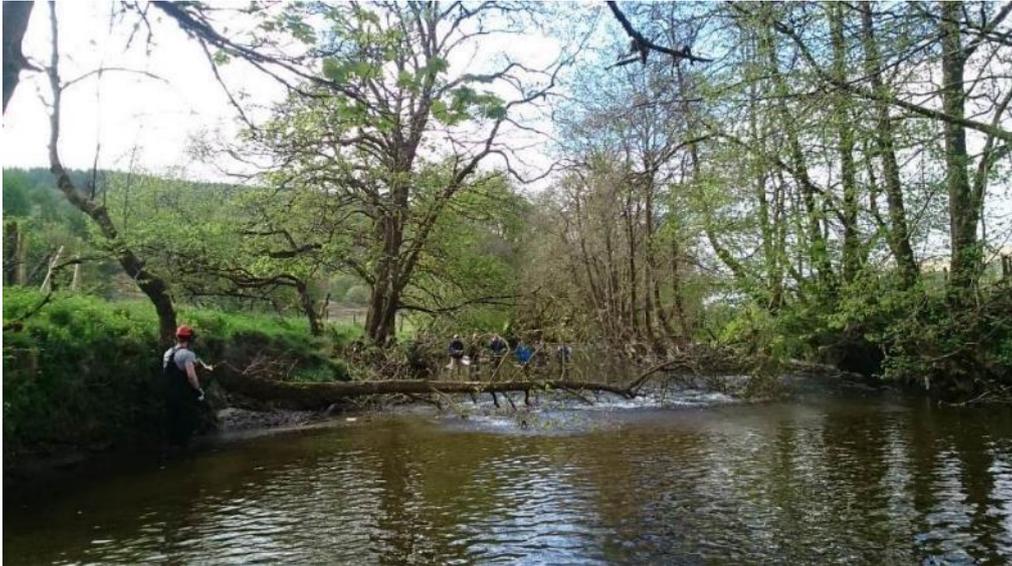
**Figure 16. The tree is felled into the river margin, then realigned parallel to the bank.**

Dead woody material can also be introduced to the channel to provide significant habitat enhancements and increase the level of protection from predators (particularly piscivorous birds). The technique involves cutting a tree/shrub and then cabling it to its own or an adjacent stump, to keep it in place (Figs 16-18). This would work for some of the LB trees on the large pool towards the u/s end of the fishery, if angling were to be undertaken from a boat tethered along the RB.

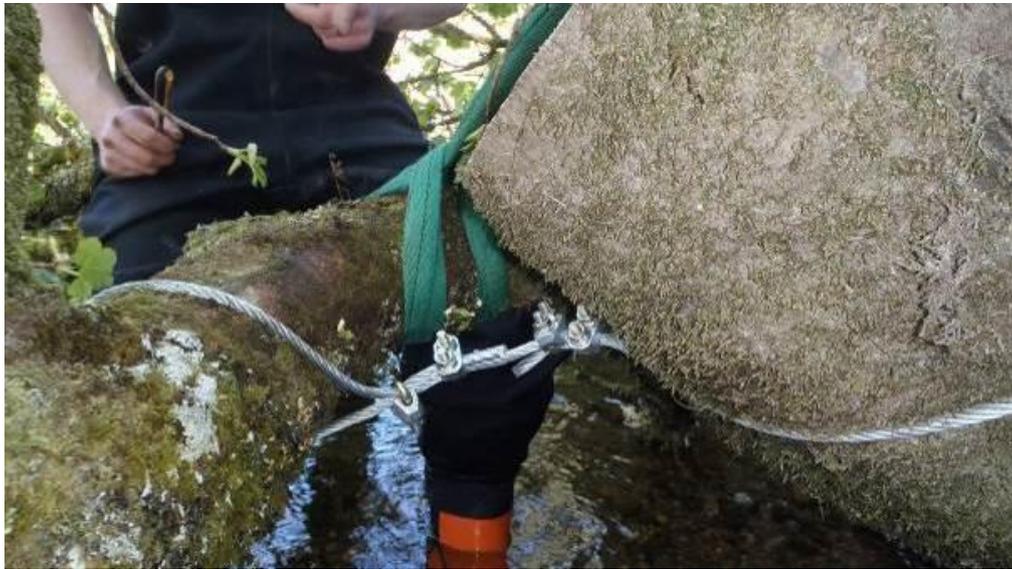
**Figure 17. A basic tree kicker fastening using 4000 kg breaking strain cable and two pairs of cable clamps on either end. The webbing strap in the background is used to pull the kicker close to the stump for fastening but is removed once the cable is fully fixed in place.**

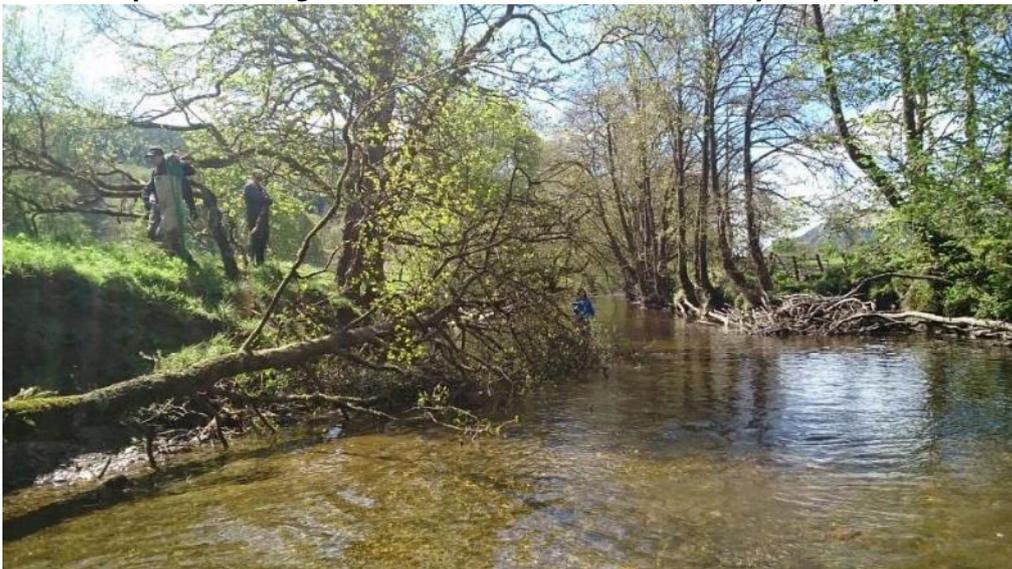
**Figure 18. The finished job – a tree kicker employed to provide cover within the river margin and focus flows down the far side of the channel. When installed on the shallower inside of a bend (depositional areas), this method can be employed to increase sediment deposition. When installed within the main flow, the technique can be employed to increase in-channel cover and fish-holding structure.**
