**Advisory Visit**  
**River Ribble – Lancashire**  
**24/03/2015**

## 1.0 Introduction

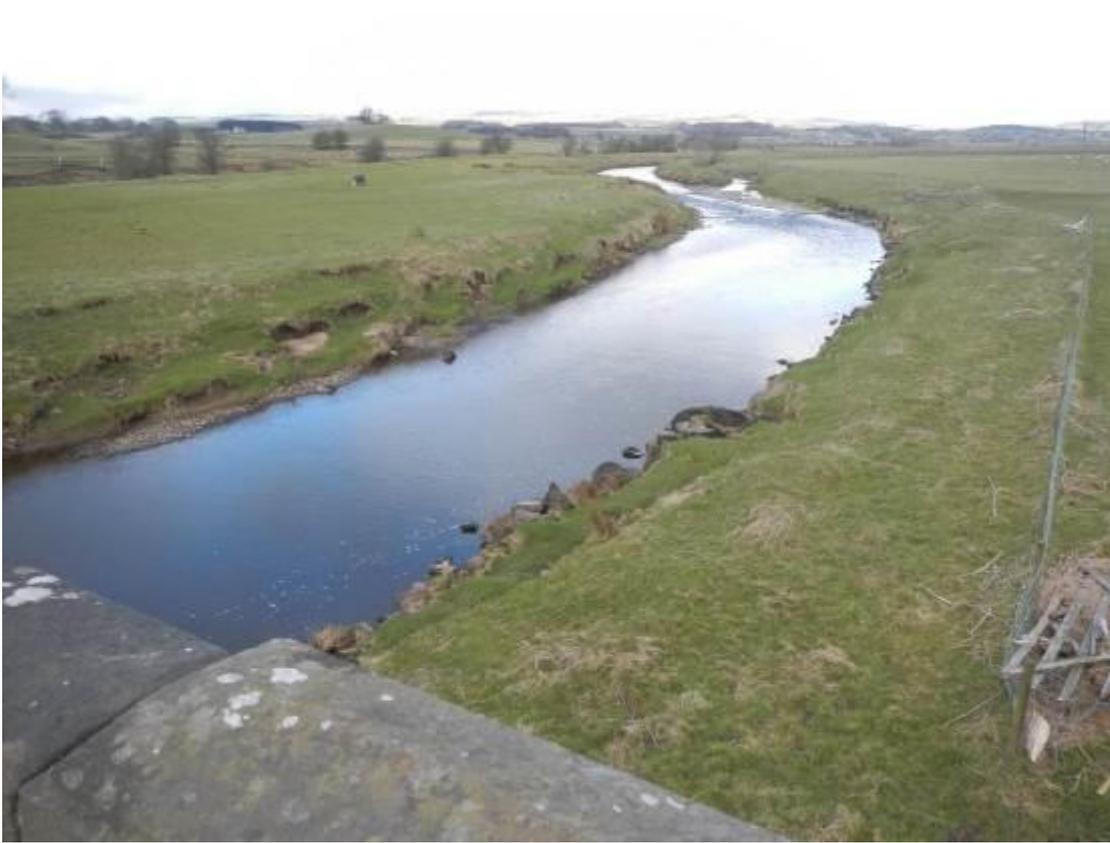
The negative impact of grazing along the Long Preston beat is significant. This is likely to have been occurring over many years as it has resulted in an almost complete loss of bankside trees and prevented recolonisation with shrubs or herbaceous vegetation which in turn leaves a serious lack of cover along the river (Figures 1 & 2).

**Figure 1. Upstream of Cow Bridge – a distinct lack of bankside trees and cover resulting in bank instability.**

It is possible to begin addressing these issues by stabilising the banks and reinstating some of the natural geomorphological river processes. To achieve this, stock exclusion from the riverbank is vital. This will allow herbaceous vegetation and trees to re-establish and result in natural variation in river width as bankside trees and LWD enter the channel. As a future habitat improvement, established trees can then be laid into the channel to further increase channel diversity.

In the short-term, there may be benefit in trying to establish areas of low and trailing cover with willow whip planting along the waterline (as far out of livestock reach as possible). Consider each new shrub that can be established as potential holding habitat for additional fish within the reach. This treatment would be beneficial throughout the Long Preston Beat, particularly the locations depicted in Figures 1, 2 & 3.

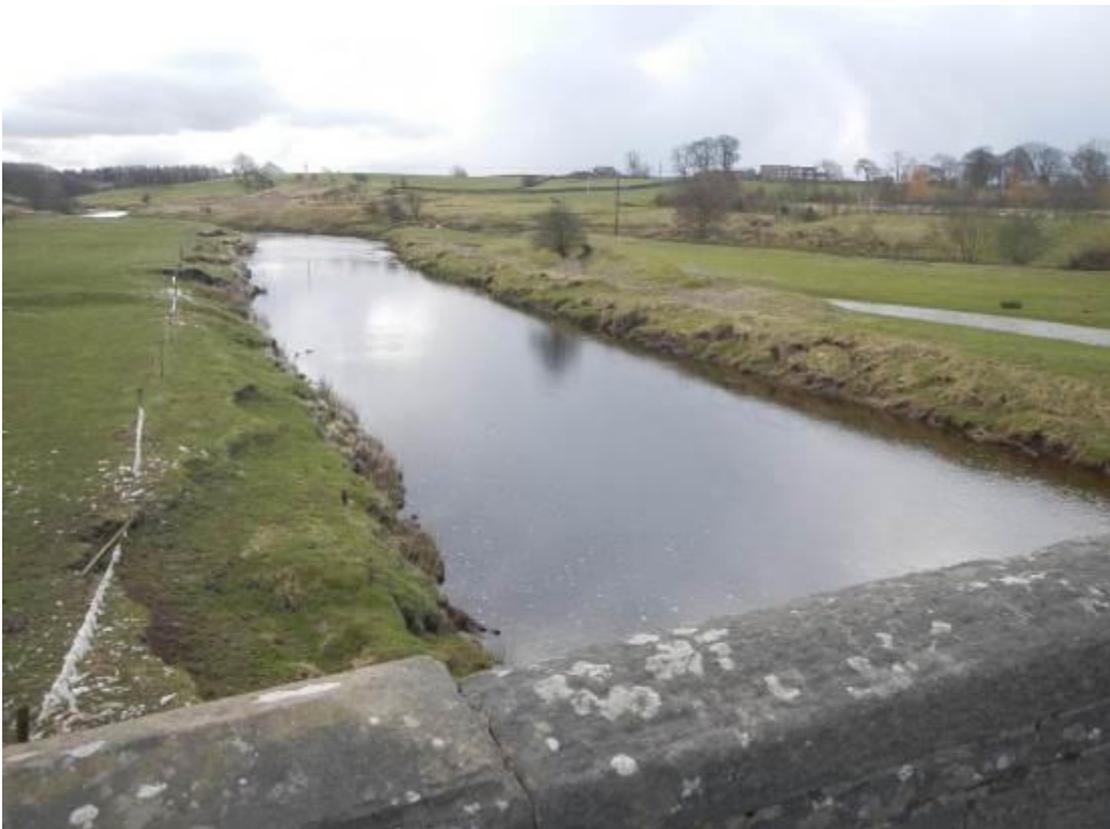
**Figure 2. Downstream of Cow Bridge – a distinct lack of bankside trees, cover and hence, bank stability. Also note the obvious straightening and over-capacity channel.**

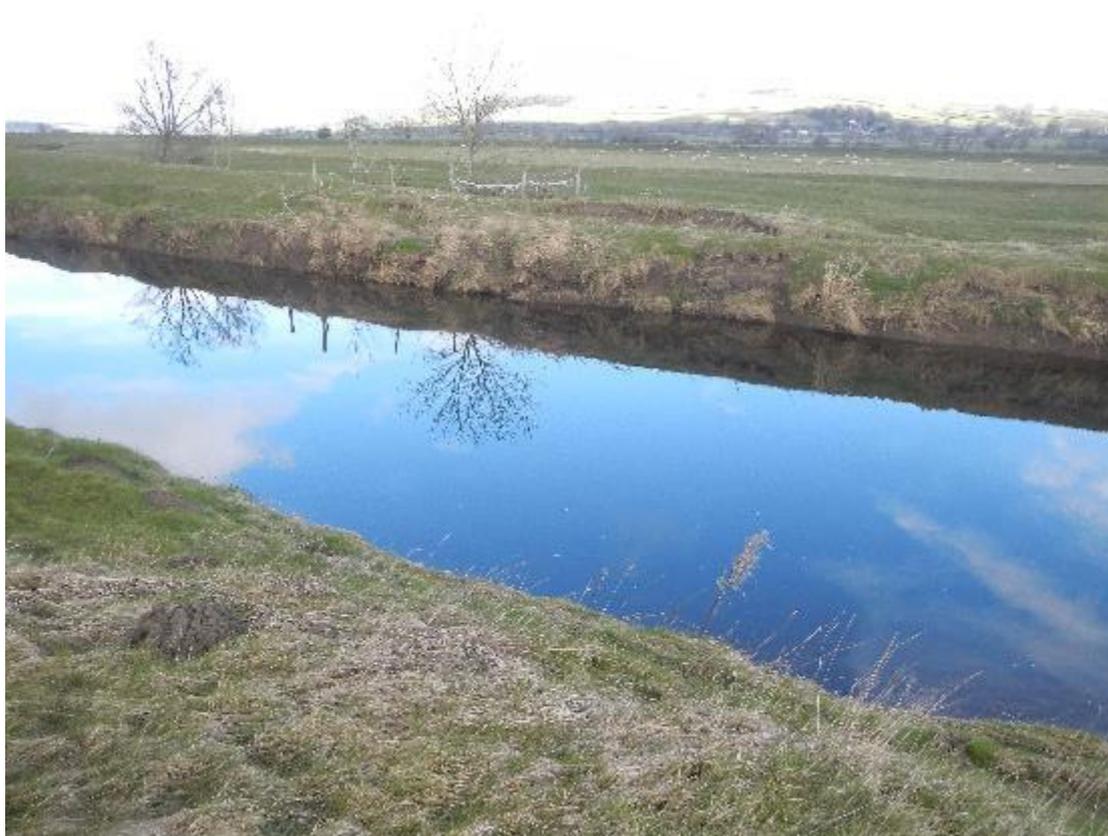
**Figure 3. Greatly over-capacity channel with a significant lack of trees, cover and in-channel structure or flow diversity.**

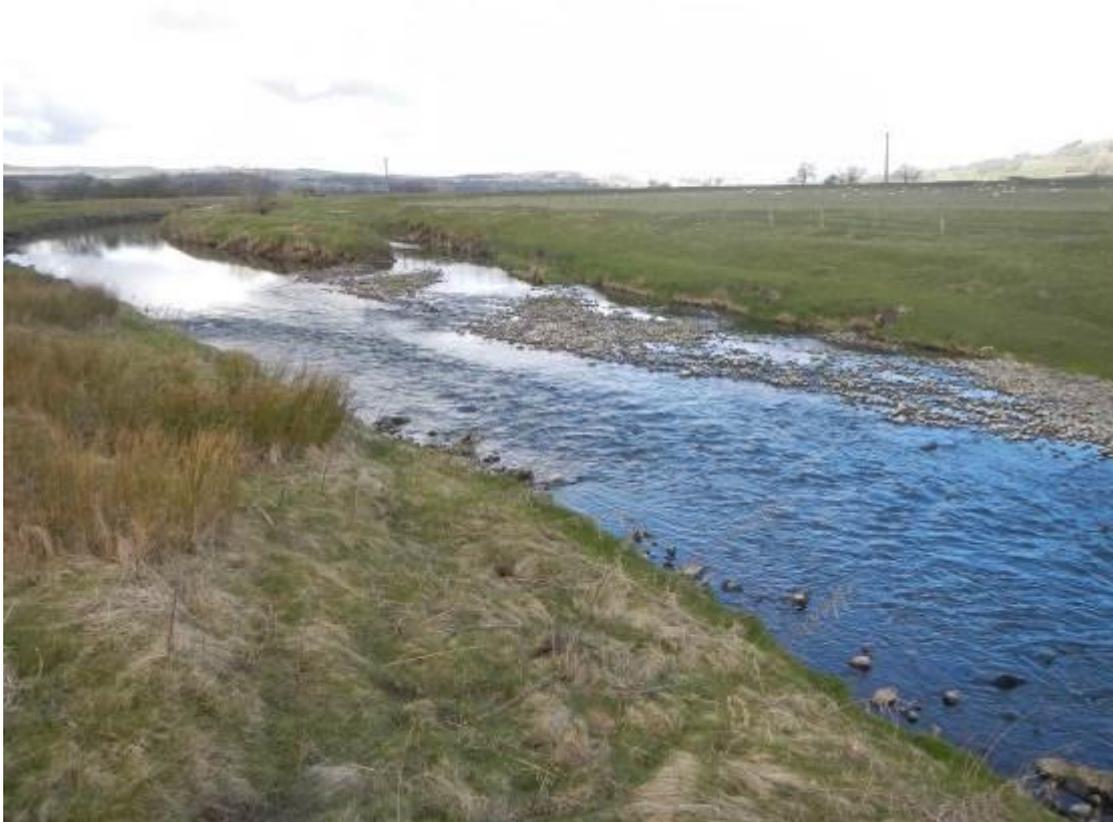
A short distance upstream of Cow Bridge, Long Preston Beck enters the Ribble on the LB (Figure 4). The Beck and its confluence with the Ribble are reported to be significant areas for spawning (particularly for salmon). The location within the catchment and the availability of mobile, large gravel and cobble substrate are likely to be major factors in this, and it does appear to provide reasonable spawning substrate. However, poor juvenile and nursery habitat in the immediate area will undoubtedly reduce juvenile output, so to counter this, buffer fencing and increasing the cover and in-channel structure should be promoted.

**Figure 4. Confluence of the Long Preston Beck and the Ribble, where the coarse gravel and cobble substrate provide valuable salmon spawning habitat. However, the paucity of surrounding juvenile habitat significantly reduces the potential for natural recruitment in the area.**

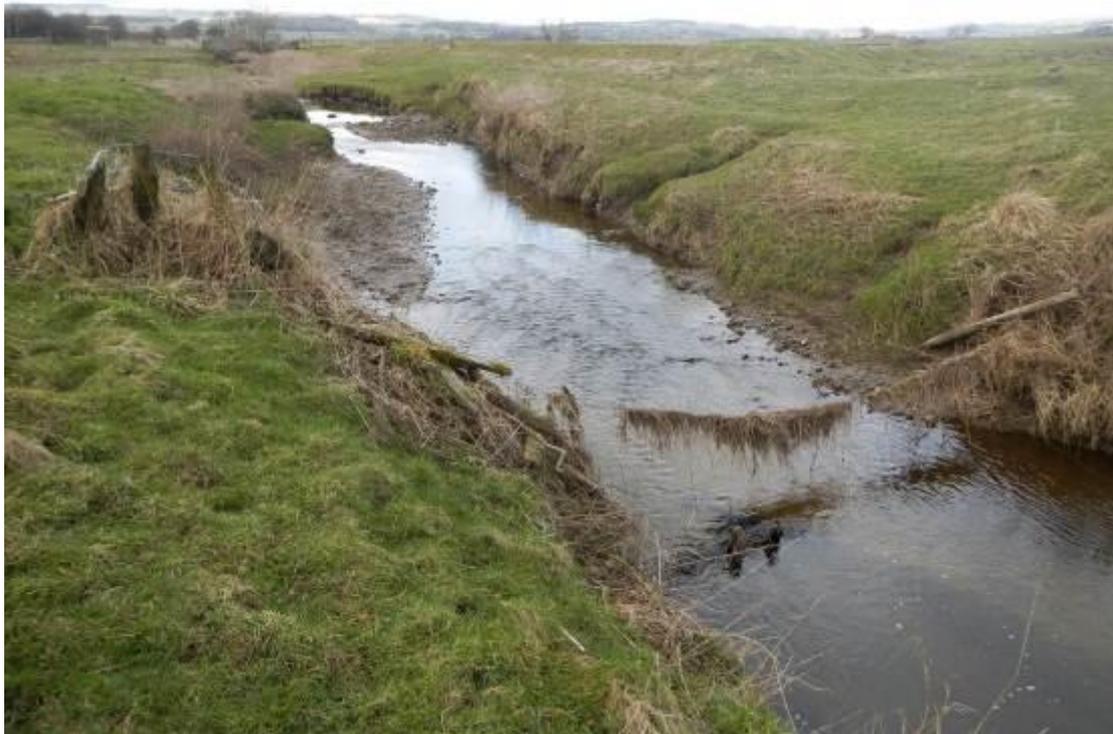
(10-50mm dia.) trout require for spawning. In the absence of cover/shelter, juvenile salmonids are also likely to be displaced from the beck into the main river by high flows. For this reason, it is important to look at other small local tributaries, where improvements may be made to trout spawning and juvenile areas; e.g. Teenley Spring, a small tributary a short distance upstream on the RB (Figure 5).

**Figure 5. Grazed areas around the confluence of Teenley Spring and the Ribble. A short distance upstream, the RRT have undertaken stock exclusion fencing and within that area habitat improvements (inc. willow planting) would be greatly beneficial to improve the habitat as a trout spawning and nursery area. Note the gravel suitable for trout spawning, but compromised by sediment.**

The Ribble Rivers Trust (RRT) have already undertaken fencing on Teenley Spring (starting a short distance upstream from Figure 5), where potential trout spawning substrate was present although compromised by sedimentation and channel over-widening. Where stock are excluded upstream, it would be worth the BGFA investigating the possibility of undertaking habitat improvements such as willow whip planting and increasing in-channel structure, to provide bed scour (gravel sorting) and cover to improve the juvenile habitat.

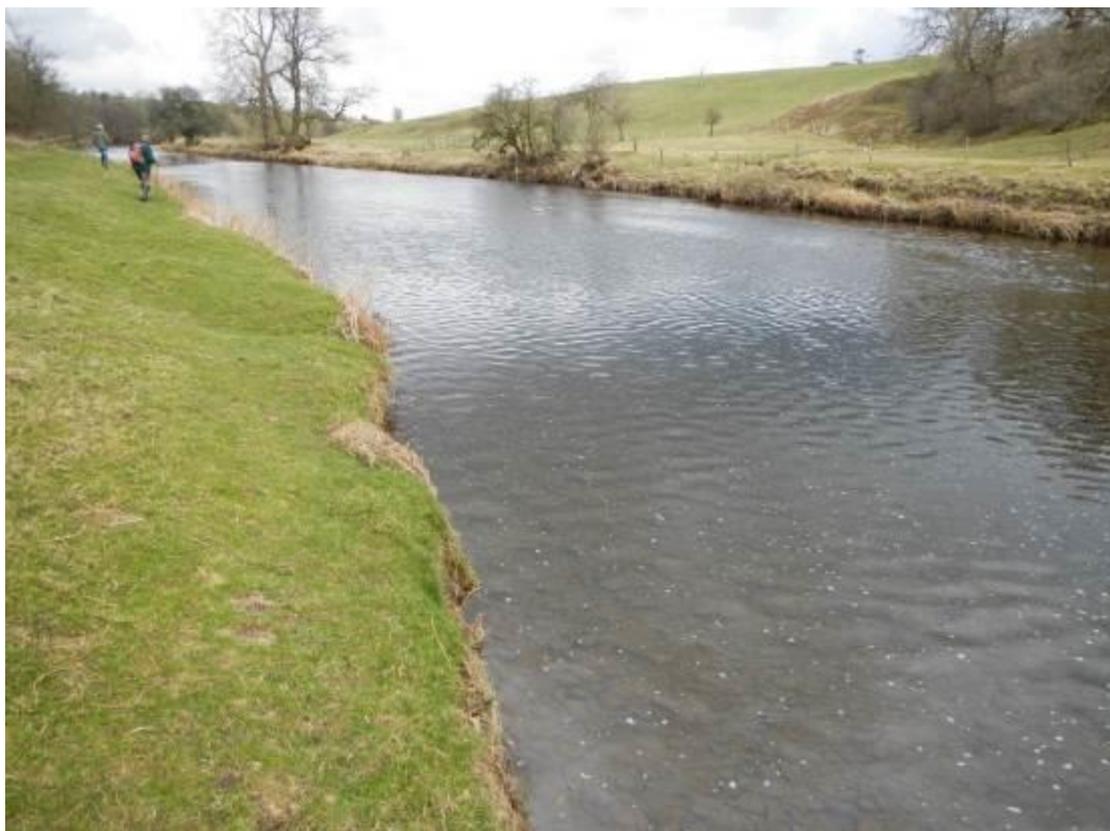
**Figure 6. Looking upstream at an open, over-wide section upstream of a weir. This area is lacking in bankside cover and in-channel structure that could greatly increase the fish holding capacity. Also note the difference between the heavily grazed RB (left of shot) and reduced stock access LB (right of shot). The poorly vegetated RB provides poor cover for fish and has at a much greater susceptibility to erosion.**

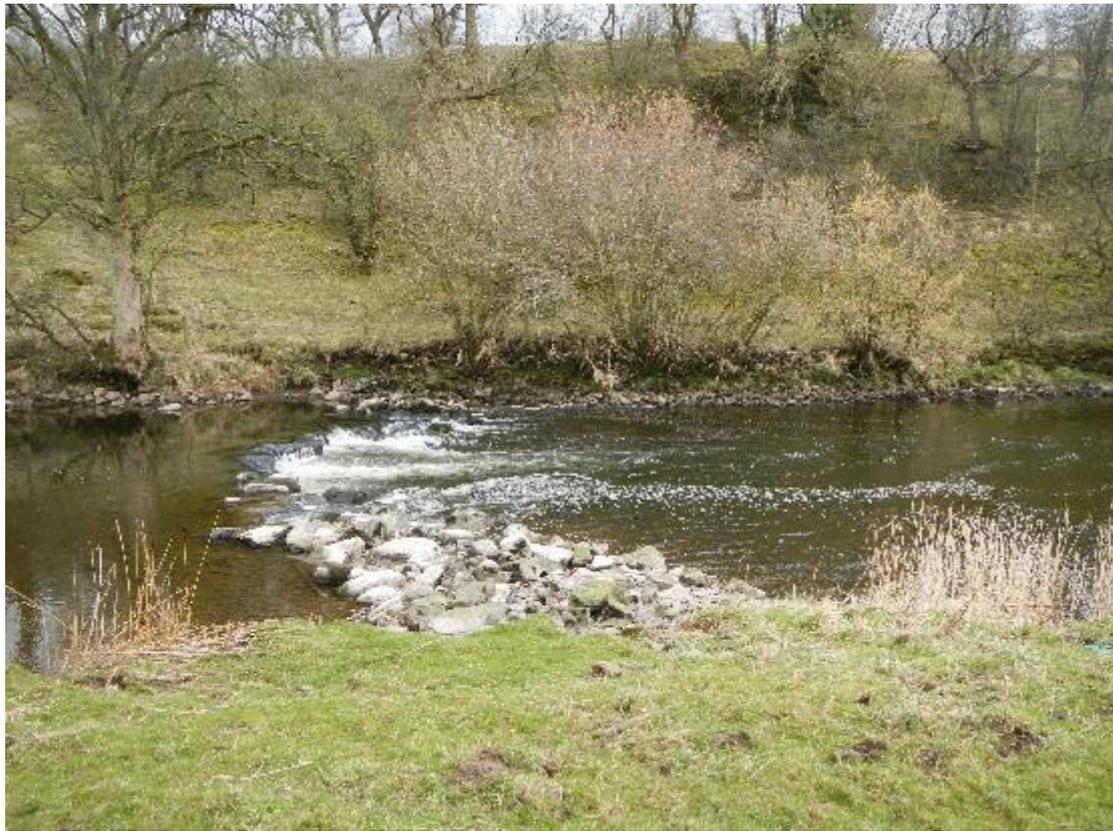
The Paythorne beat is subject to significant channel modification through a series of man-made weirs which impound the river upstream and over-widen the channel (Figure 7). The fixed, raised channel cross-section that is created greatly inhibits bed scour upstream, preventing the natural maintenance of channel width/pool depth. This means that pools get progressively shallower over time

**Figure 7. One of the several weirs which impound the river and reduces the potential for bed scour upstream.**

Weir removal may not be a popular option with some anglers, and it would be a massive undertaking but the benefits generally outweigh the costs. For instance, removal will facilitate some reinstatement of the natural geomorphological processes that maintain pool depths, and facilitate the natural downstream transition and sorting of bed material that is currently inhibited. In the short-term, removing the central 1/4 - 1/3 of each weir would be beneficial to reinstate some connectivity and reduce the effectiveness of piscivores.

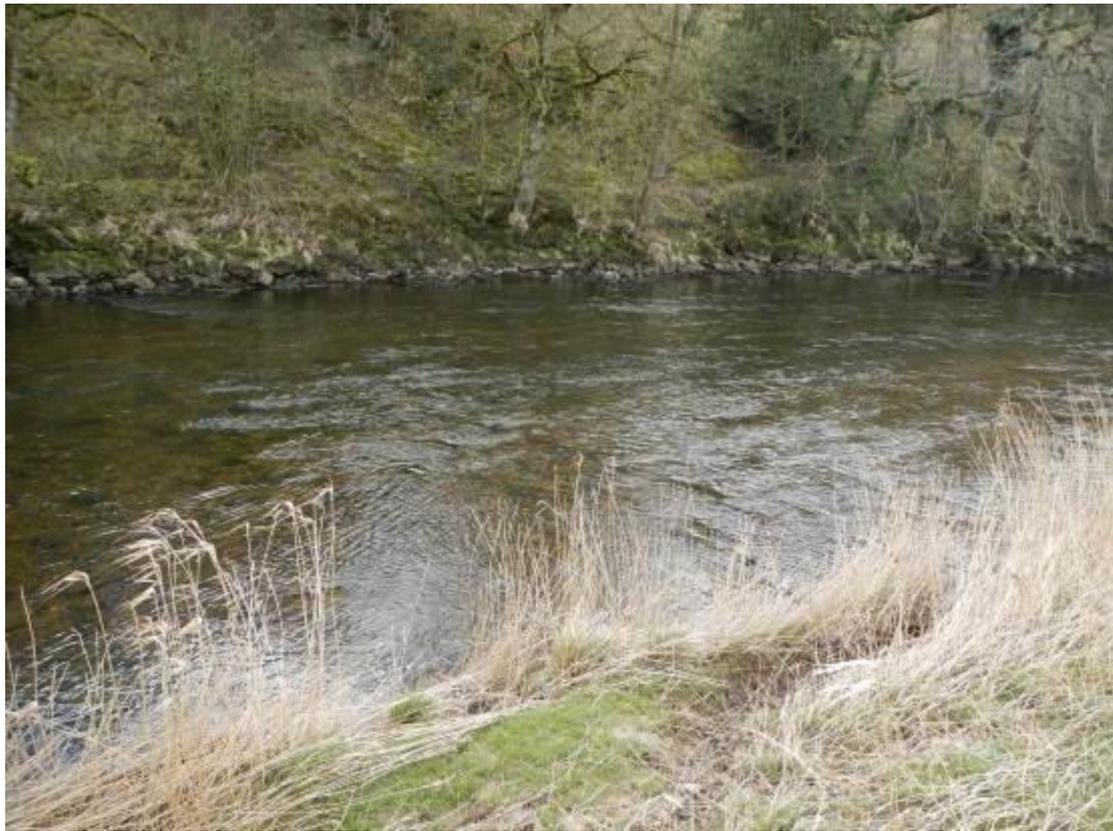
Bedrock naturally limits scouring of the riverbed in certain areas, but free from the impoundment effect of a weir, those areas create valuable wide glide and riffle habitat that are vital for juvenile trout and salmon (Figure 8). Fry will inhabit the shallower, more sheltered margins with parr taking up residence in the diverse pockets of flow within the mainstream. These shallower areas may hold fewer adult fish than juveniles, but they are an essential component in the production of healthy wild juvenile trout and salmon stocks; they support many of the invertebrate species beneficial to anglers, and larger adult fish may move into them to feed, providing they have easy access.

**Figure 8. Wider shallow glide and riffle areas provide vital fry and parr habitat.**

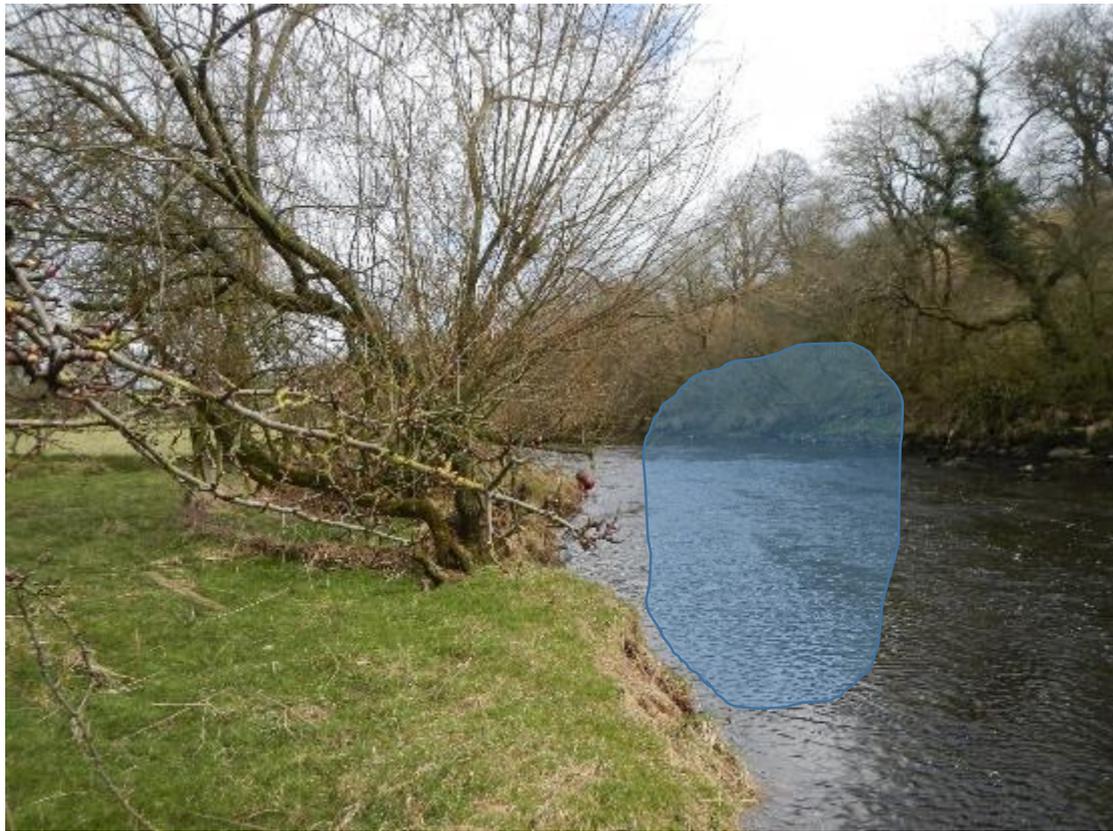
**Figure 9. Recent tree pruning work that has significantly degraded habitat. Left *in situ*, the trailing branches would have provided valuable cover (blue shading), but also potentially increased sediment deposition in the river margin to narrow the channel, increasing flow velocities and scour mid-channel, and thereby increasing and maintaining pool depth.**

Rather than pruning, as in Figure 9, a far better course of action is to lay more trees and branches into the river. The problem depicted in Figure 8 could be rectified in this way, over time. Where canopies have been lifted by inappropriate pruning (Figures 10 & 11), coppicing to encourage low-level regrowth would be beneficial, as would planting along open sections of the bank to create fish refuge. Better vegetated margins will also greatly benefit terrestrial invertebrates. Low branches may make access trickier, but will greatly increase the fish carrying capacity, which will ultimately improve the angling - better slightly harder access but plenty of fish!

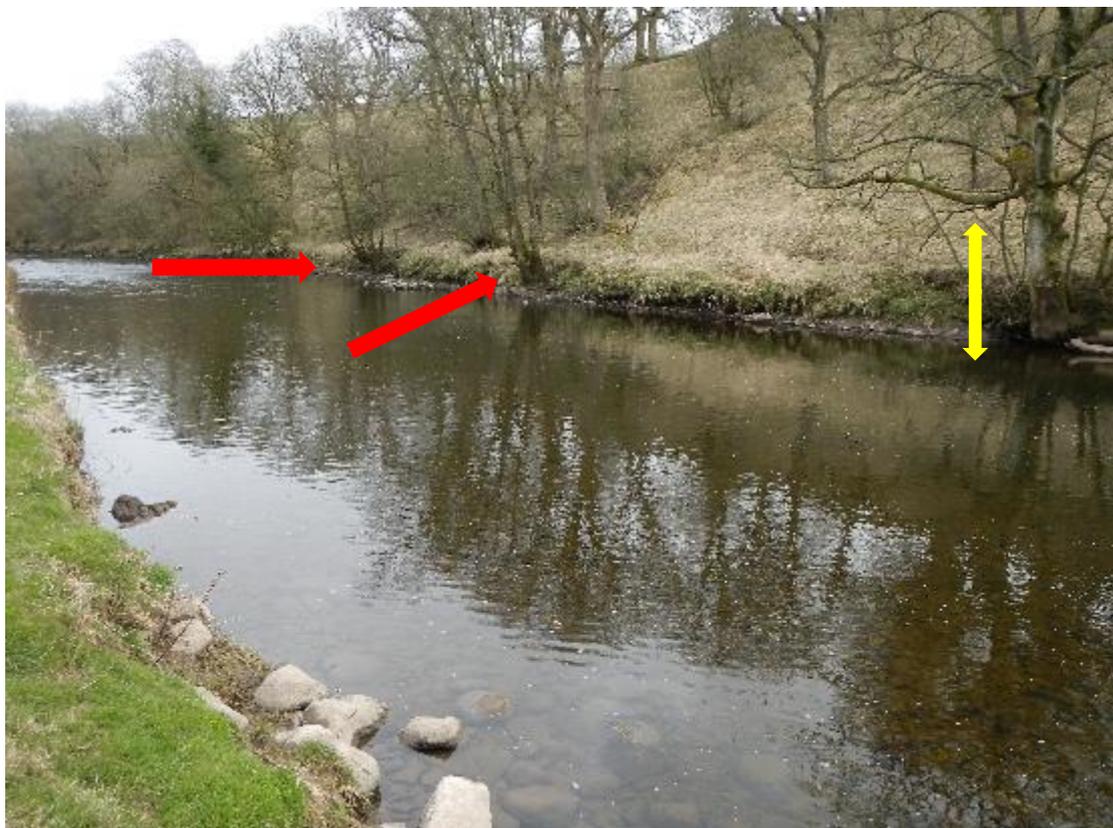
**Figure 10. Evidence of a history of tree maintenance and pruning of the vital low branches (red arrows). The yellow arrow demonstrates the lack of branches within >2m of the river,**

following recent pruning, and is exactly the location within the pool that would benefit from low cover to provide habitat for adult salmonids.

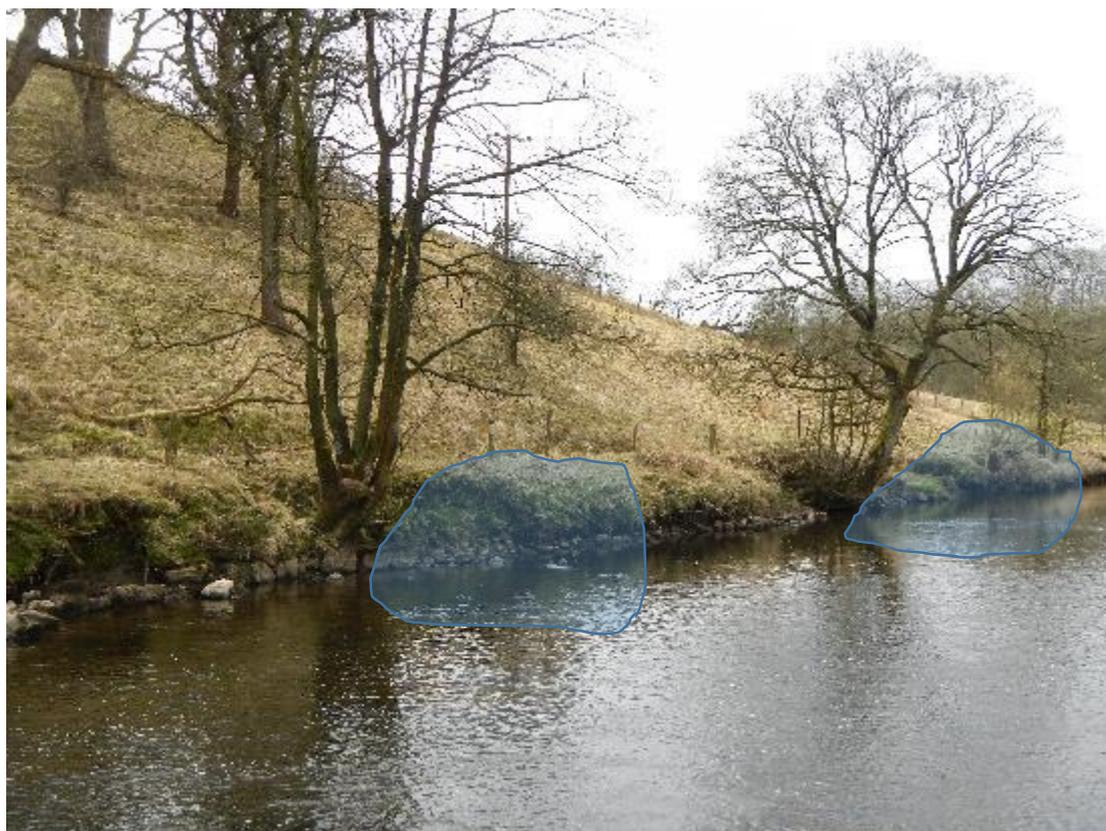
**Figure 11. The areas shaded blue demonstrate areas in which valuable fish-holding habitat has been lost through pruning of the low branches. Once a canopy has been lifted like this the only real solution is a low coppice to promote low-level regrowth.**

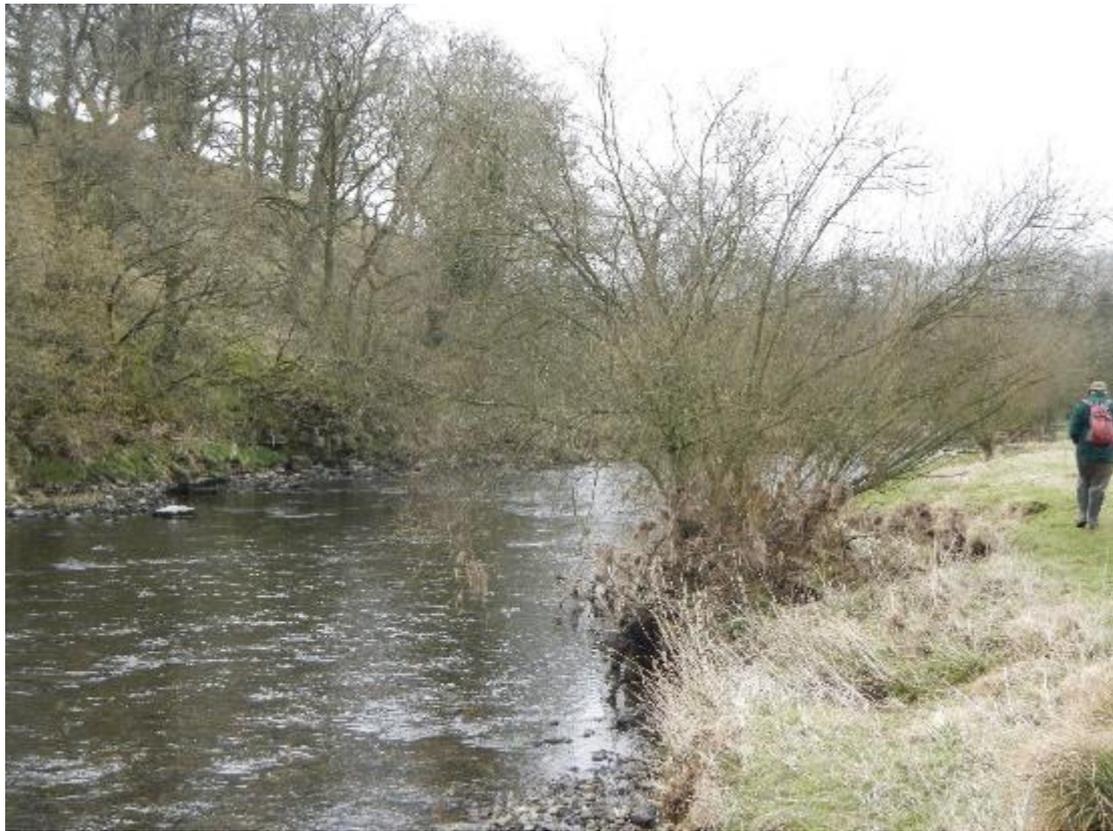
A short distance upstream from the heavily pruned willow (Figure 9), a similarly located shrub (Figure 12) could be laid into the channel to greatly enhance in-channel habitat structure. Some of the mature willows at the tail of the pool could also be given this treatment (Figure 13). See how the smaller, lower goat willow (*Salix caprea*), between the larger willows, provided valuable in-channel cover around which fish will hold, while the larger trees just provide shade.

**Figure 12. Small willow shrub that could be laid into the channel. The small area of erosion around the bankside edge is likely a consequence of sheep grazing and trampling. This could be stabilised with willow whip planting, but livestock would have to be excluded or they would eat any fresh growth.**

As described, where trees are already established along the bank, habitat improvements can be achieved by laying the trunks, or selected branches down into the watercourse to increase low cover and structure. The method is usually limited to species that can be easily manipulated without snapping (e.g. willow, elm, hazel, hawthorn and small alder), but some others can be laid carefully. Small to medium shrubs tend to work best, although quite large willow such as those in Figure 12 can be successfully laid.

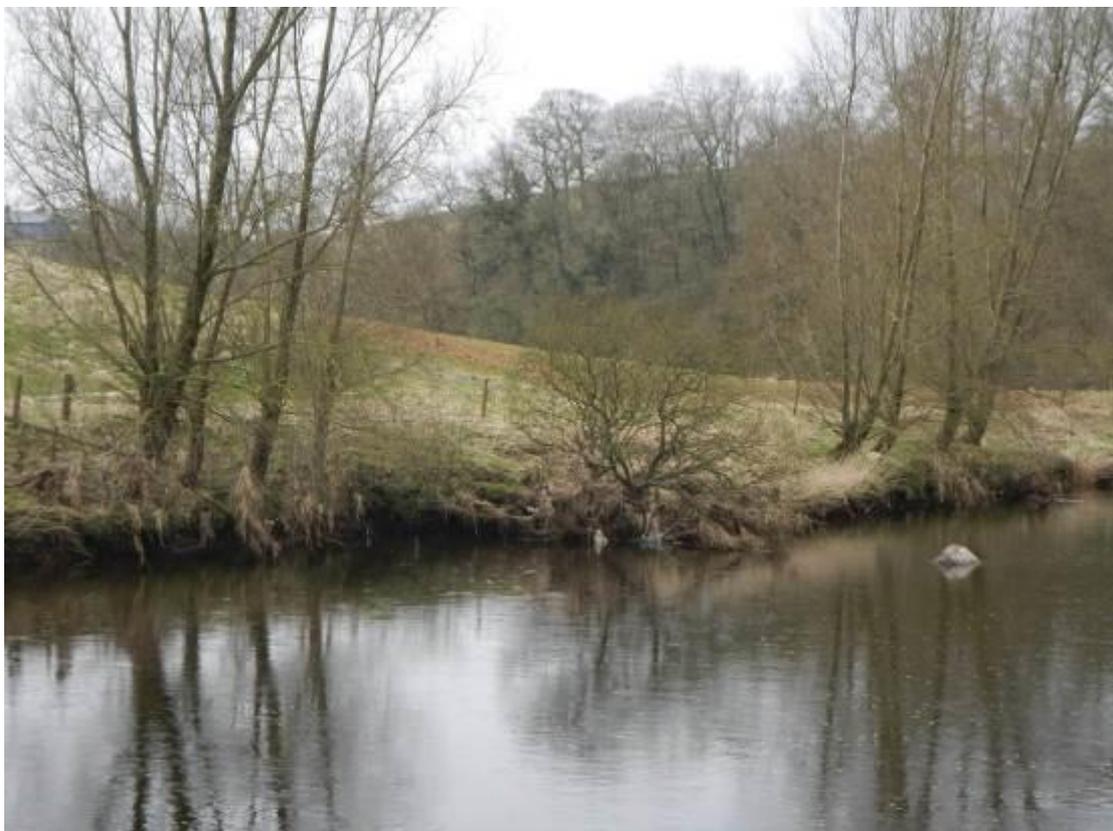
Figure 13 serves as a good example of the two predominant willow types present on the river and can provide guidance as to which should be used for habitat improvements. The taller trees to the right and left of shot are crack willow (*Salix fragilis*), a large, fast-growing species that, tends to crack and collapse under its own weight. These trees are useful for creating a natural source of in-channel LWD. The small goat willow in the centre, also known as pussy willow or sallow, is a much smaller, denser-canopied species, generally growing to around 4-6 metres, and is ideal as a shrub for low cover. Both species can be easily laid into the channel and will take (regrow) from whip cuttings driven into damp ground around the river margin or anchored in place within the water where they can root into the bank.

**Figure 13. A goat willow shrub (centre), low and bushy providing valuable cover, with much larger crack willows either side; some of which could be beneficially laid into the channel.**

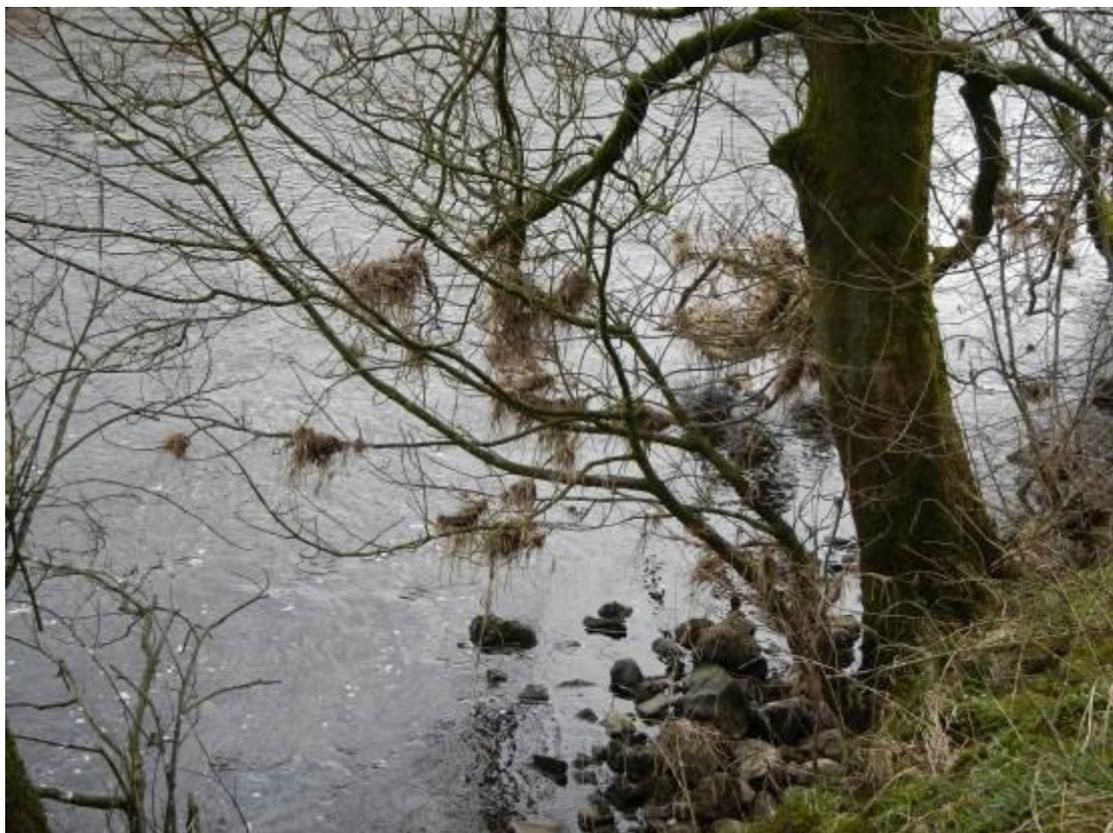
In some areas (Figure 14), low branches over the channel have been left uncut and it is important that these are preserved to prevent further denuding of habitat along the river margins. The material that has caught up on the branches demonstrates how they become submerged at high water levels and provide valuable shelter by slowing flows both within and immediately downstream.

**Figure 14. In the locations where low branches are present, they should be preserved to prevent further loss of important habitat.**

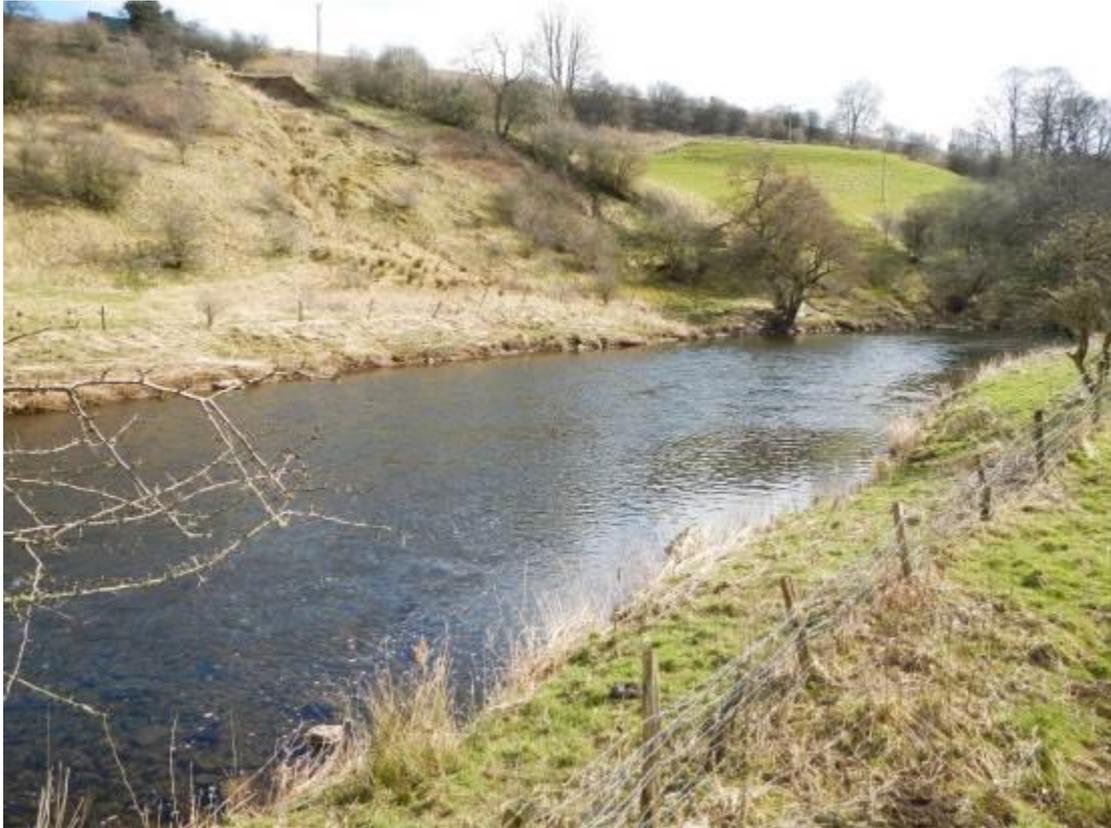
Many open sections lacking in trees along the waterline (similar to that shown in Figure 15 & 16) were observed throughout the beat, particularly along the pools. All of these could easily be enhanced by planting along the bank line or laying any willows or hazel present there (Figure 16 – far bank centre of shot) down into the channel.

**Figure 15. One of several locations that are open and lacking in bankside trees. These can be easily enhanced by planting willow whips along the bank line to create new shrubs.**

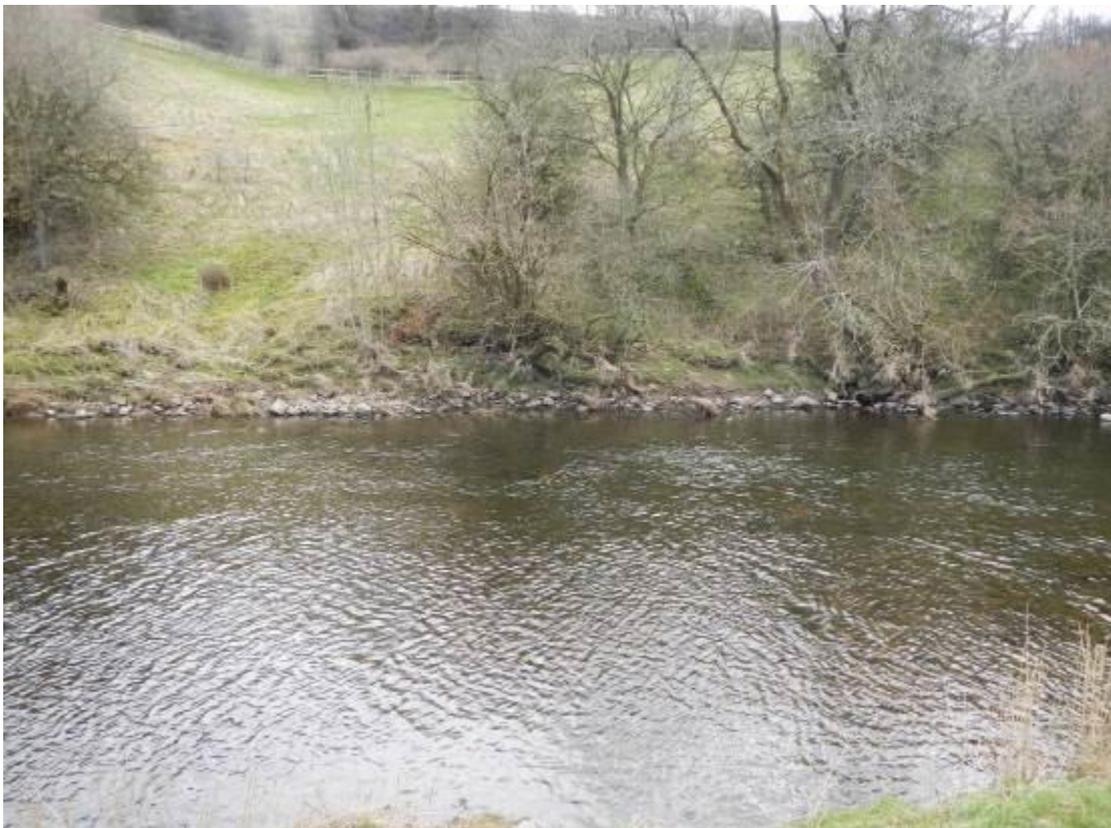
**Figure 16. The hazel shrub (centre of shot) could be laid down into the channel to enhance the river margin habitat.**

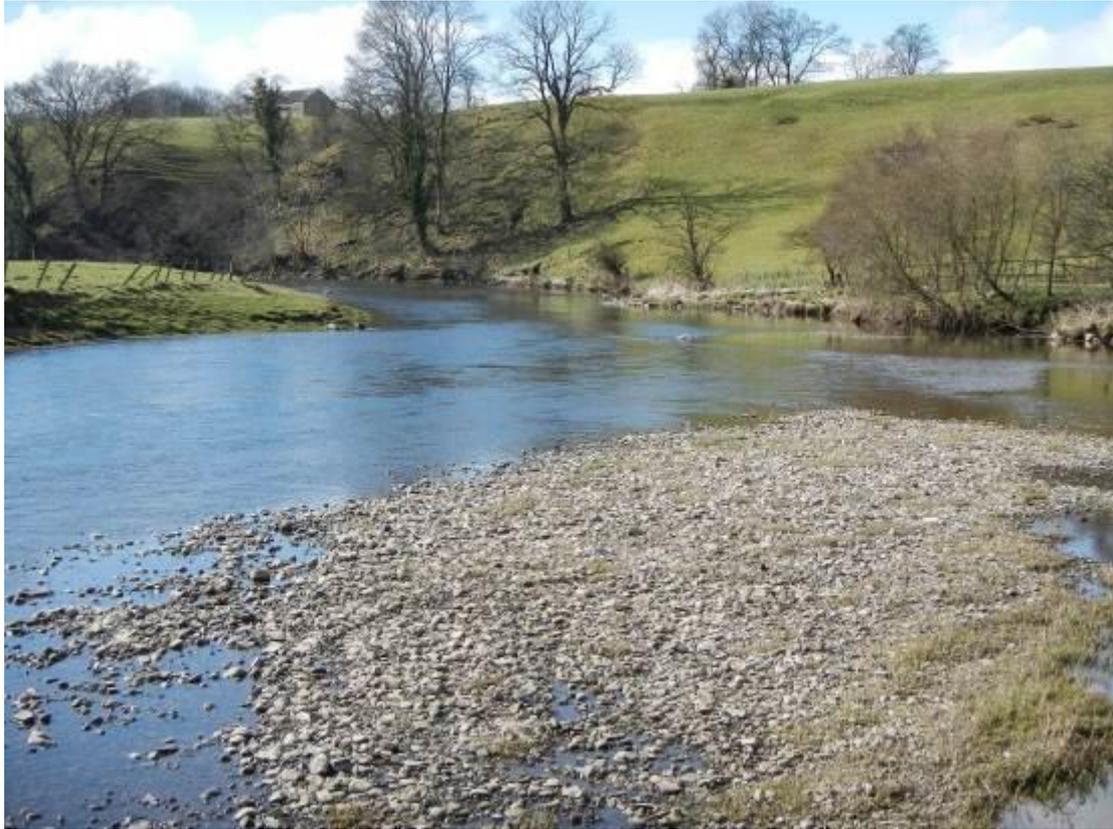
At the downstream limit of the section (walked as part of the AV), higher intensity grazing was evident on the LB (Figure 17) and as with all other areas with stock access, buffer fencing to exclude them would be beneficial. A gravel bar forming within the river also suggests that the channel has become over-wide at this point and that the reduced flow energy is allowing substrate deposition. Such deposition is a positive, natural process as the bar will help to re-energise flows by narrowing the wetted channel back to an appropriate width, provided that stock are excluded and the bar can become vegetated to stabilise it further.

**Figure 17. High intensity grazing on the LB. Also note the gravel bar that is forming and becoming vegetated which suggests that the channel is over-wide and naturally re-narrowing.**

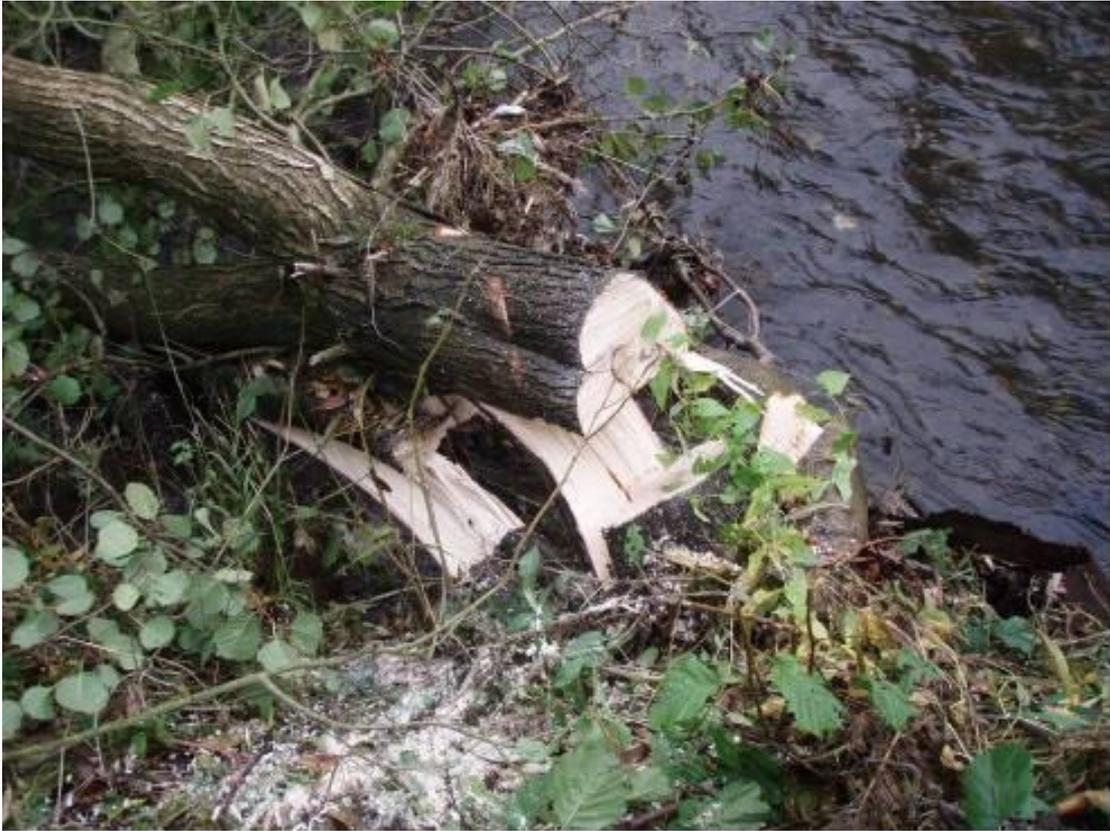
**Photograph 19. Hinged willow.**

The process involves cutting part way through the stem/trunk, a little at a time (like laying a hawthorn hedge), until it can be forced over into the channel (Figures 19 & 20). The depth of the cut should be limited to only that which is required to bend the limb over, as this will retain maximum strength in the hinge and maintain the health of the tree/shrub.

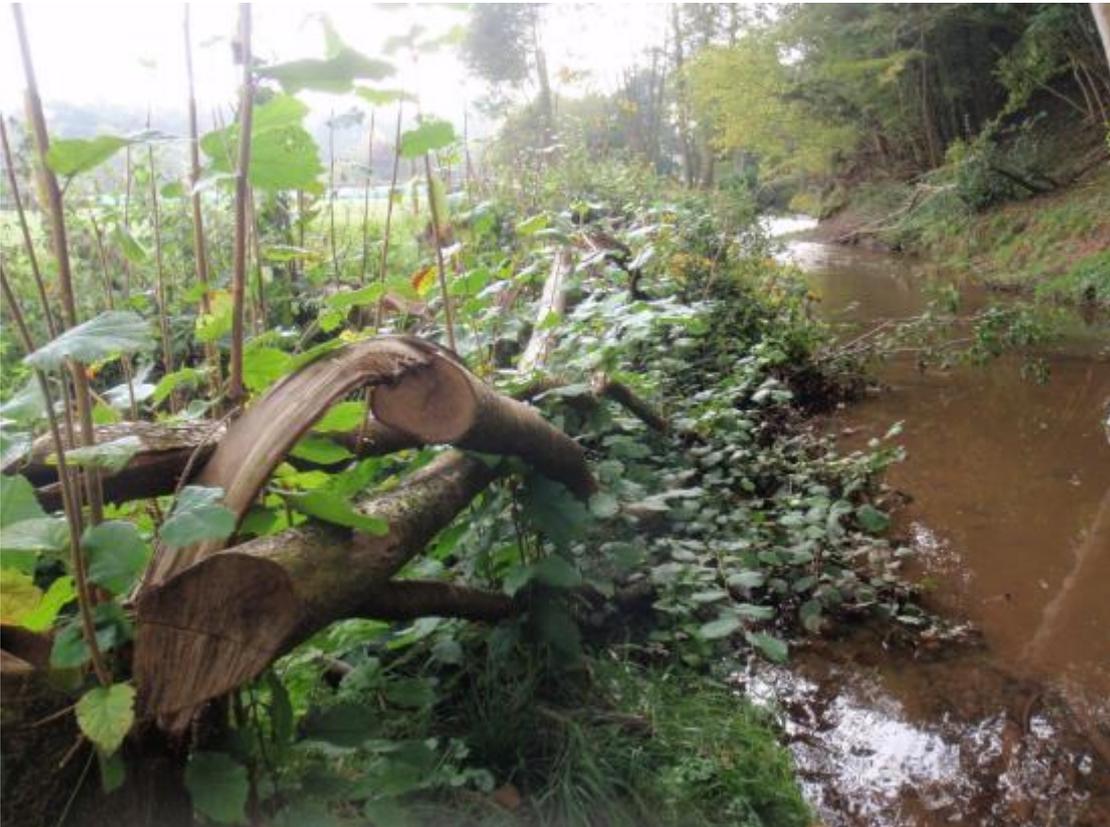
**Photograph 20. Hinged hazel.**

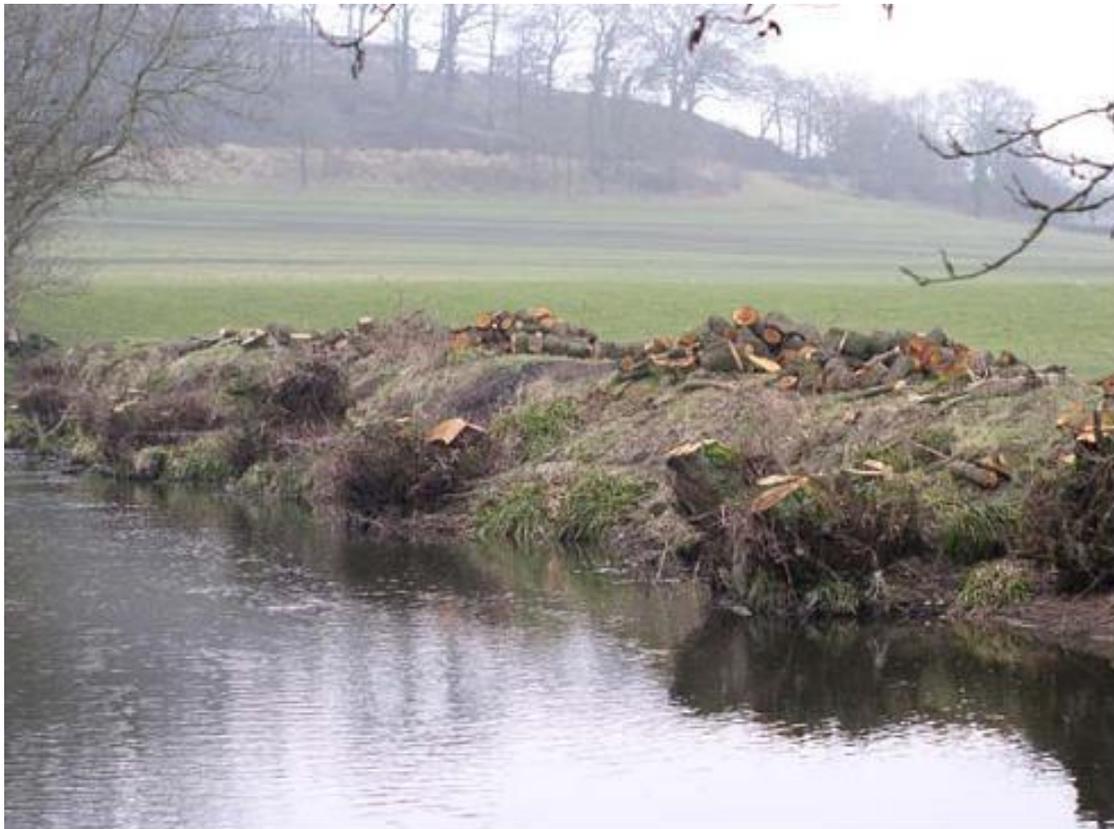
**Figure 21. Recently coppiced alder (photo courtesy of the Environment Agency).**

Where trees are present but the canopy is well above the water level (>1m), coppicing can be undertaken to encourage low-level re-growth and rejuvenate the tree. This should ideally be done in locations like those shown in Figures 10 & 11. The treatment should be undertaken sparingly, as tree canopies also provide habitat for many other species, create valuable shade over a watercourse and supply terrestrial invertebrates and leaf litter to supplement food webs in the river. When undertaking coppicing, existing low cover should also be retained and care should be taken to ensure that work does not disturb bats or nesting birds, as this would constitute an offence under the Wildlife and Countryside Act 1981. Figure 21 (immediately after) & Figure 22 (2 years after) show how effective coppicing can be at reinstating low cover.
