**Advisory Visit**  
**River Ribble – Lancashire**  
**24/03/2015**

## 1.0 Introduction

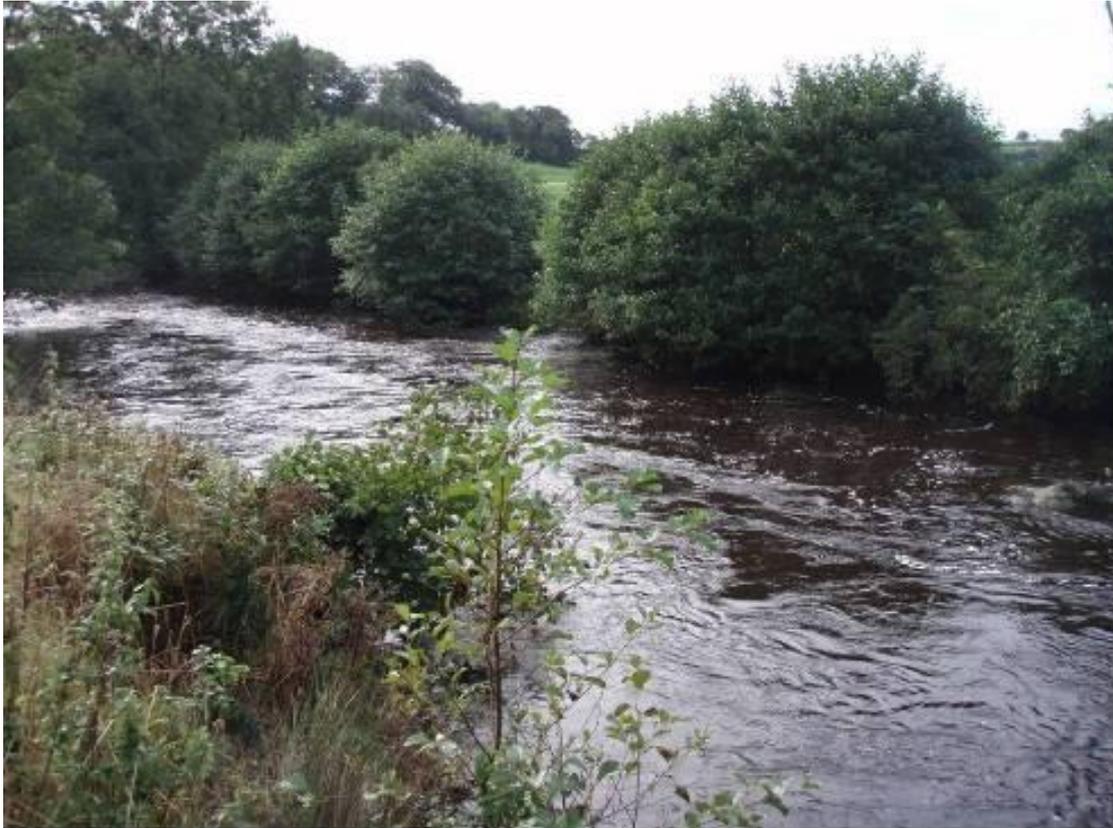
**Figure 22. Alder 2 years post coppicing now providing high quality low-level cover and excellent features around which to fish (photo courtesy of the Environment Agency).**

Where trees are present but the canopy is well above the water level (>1m), coppicing can be undertaken to encourage low-level re-growth and rejuvenate the tree. This should ideally be done in locations like those shown in Figures 10 & 11. The treatment should be undertaken sparingly, as tree canopies also provide habitat for many other species, create valuable shade over a watercourse and supply terrestrial invertebrates and leaf litter to supplement food webs in the river. When undertaking coppicing, existing low cover should also be retained and care should be taken to ensure that work does not disturb bats or nesting birds, as this would constitute an offence under the Wildlife and Countryside Act 1981. Figure 21 (immediately after) & Figure 22 (2 years after) show how effective coppicing can be at reinstating low cover.
