Advisory Visit to the River Roe, Cumbria
Roe Beck (Lower) Waterbody - GB102076073770
06 March 2014

1.0 Introduction

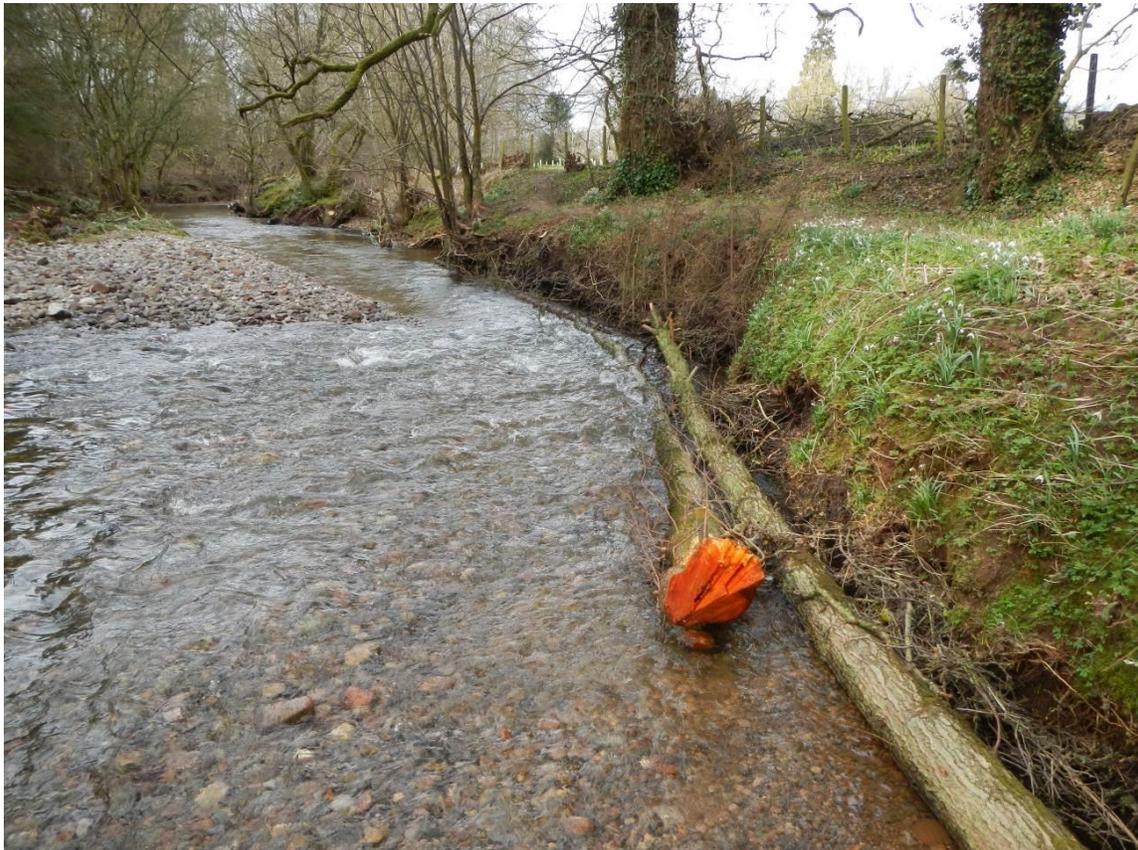
Initial assessment of the site identified several factors impacting upon river bank stability. The surrounding sandstone geology of the Roe and Ive catchment mean that topsoils comprise a high proportion of in-cohesive, inorganic sandy material, which has a tendency to erode in high flows. The shady, wooded nature of the site also reduces vegetation colonisation of the

banks and surrounding ground; vegetation that would ordinarily provide consolidation of the highly friable soils through its root matrix (Figure 1).

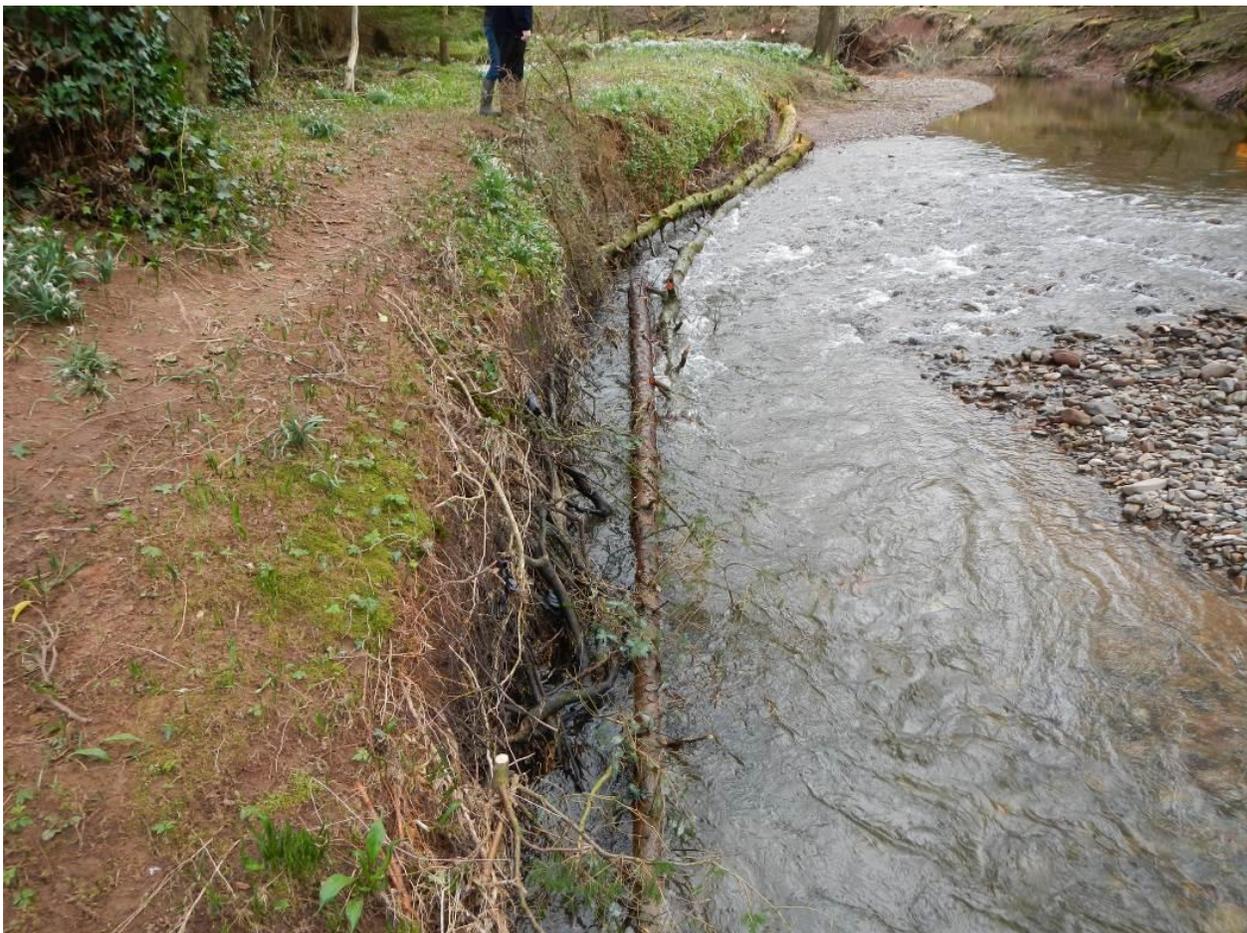
Figure 1. Initial bank revetment work along-side a steep, in-cohesive sandy bank.

Initial attempts have already been made to protect RB with log revetment (Figure 2). This is a great initial step which will create a base on which to install additional bank protection, but left simply as a log toe, this is likely to deflect flow energy around the logs, rather than dissipating it, and may create other erosion issues over time.

Installation of additional softer brush type protections between and around the logs would help to mitigate this by creating a diffuse barrier that baffles and dissipates the energy rather than simply deflecting it onto another area. This will facilitate deposition of a portion of the sediments transported by the river to be deposited within the bank revetment, turning the previous area of erosion into an area of deposition and assisting formation of a new

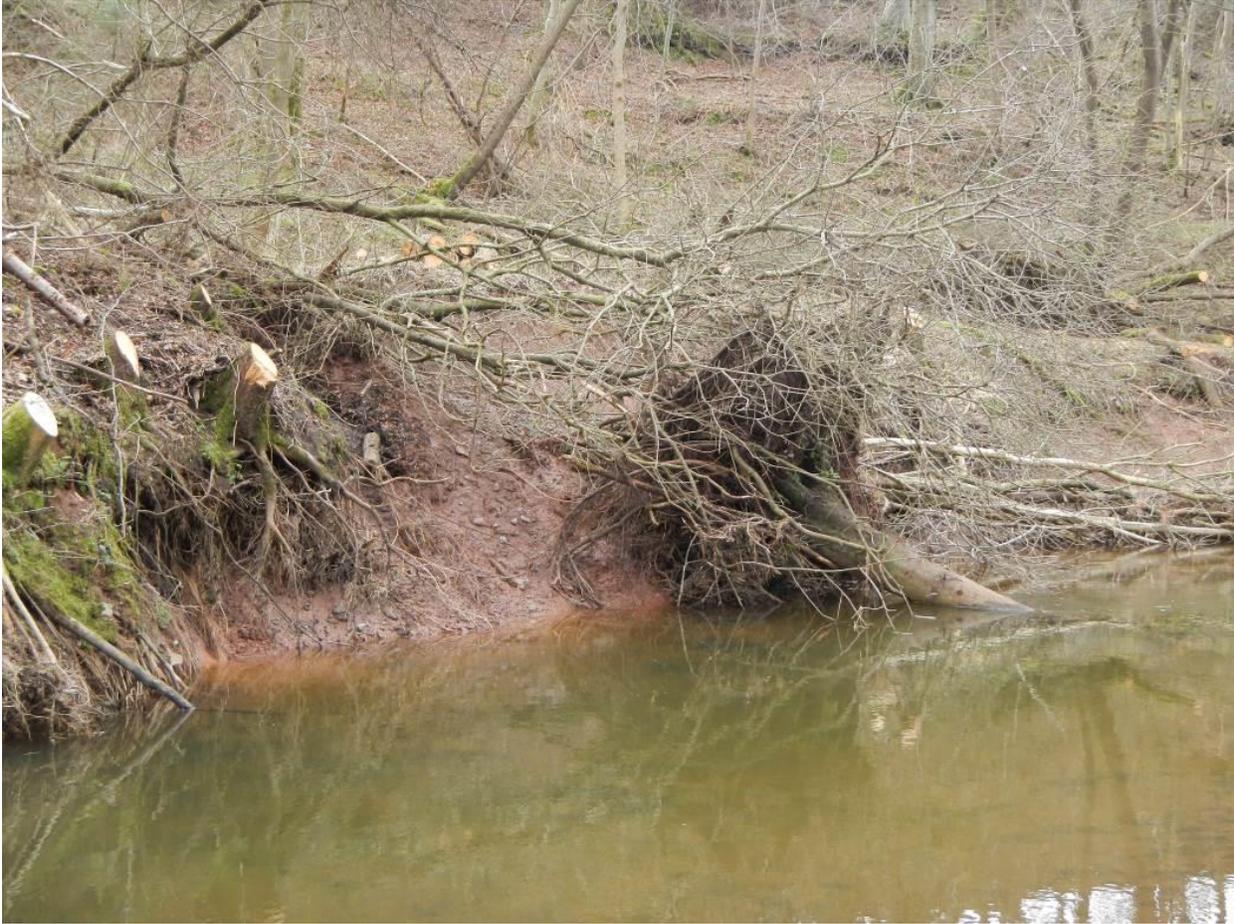
Adding to the issue on the steep gradient LB, is the presence of relatively impermeable clays and clay-based sub soil. This restricts much of the tree and vegetation root growth to the shallow surface layers, reducing deeper ground penetration that would increase bank stabilisation. The impermeable clays also prevent rainfall from penetrating the ground, leading to water-logging of the topsoil, particularly in wet conditions. As consequence, the soil becomes saturated and increasingly susceptible to slumping down the slope. Trees help consolidate the soil, but larger trees, create additional pressure on the bank through increased weight and leverage. Consequently, larger trees may topple or slip down the bank (Figure 2).

Figure 2. Slumped tree leaving the clay sub-strata exposed.

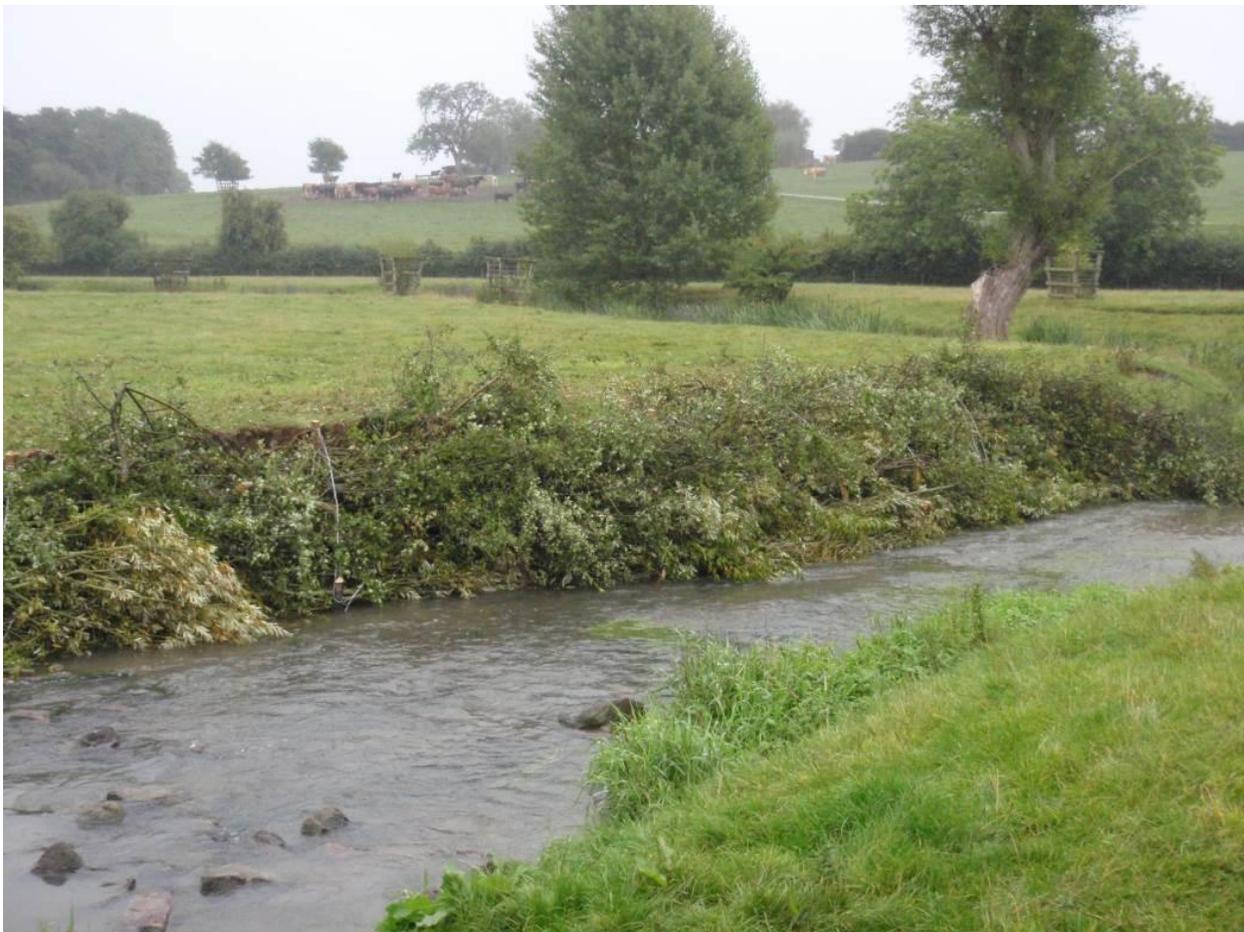
If living willow is incorporated and maintained in contact with water and earth, the branches are likely to take root, further aiding bank protection. The technique is demonstrated in Figure 3, where brush is packed along the bank face and secured with wire criss-crossed between chestnut posts, and Figure 4, where willow brush bundles are used to create a line along the base of the bank, again, secured with wire and chestnut posts.

Figure 3. Brush revetment (willow and hawthorn) installed by the WTT along an eroding bank.

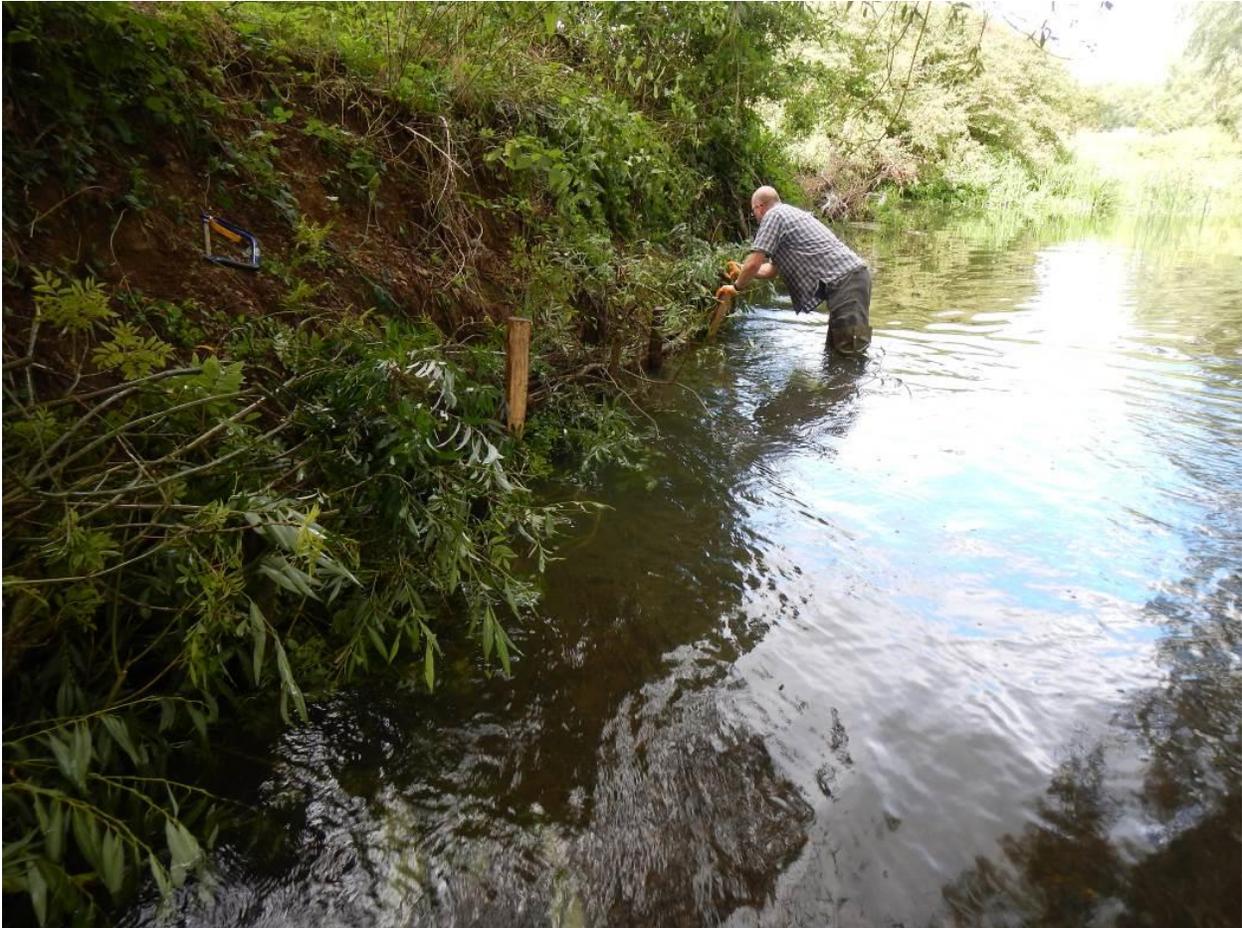
Figure 4. Willow bundles (faggots) installed during a previous WTT workshop to create a line of living willow that dissipate flows and accumulate sediments to stabilise the base of an eroding bank.

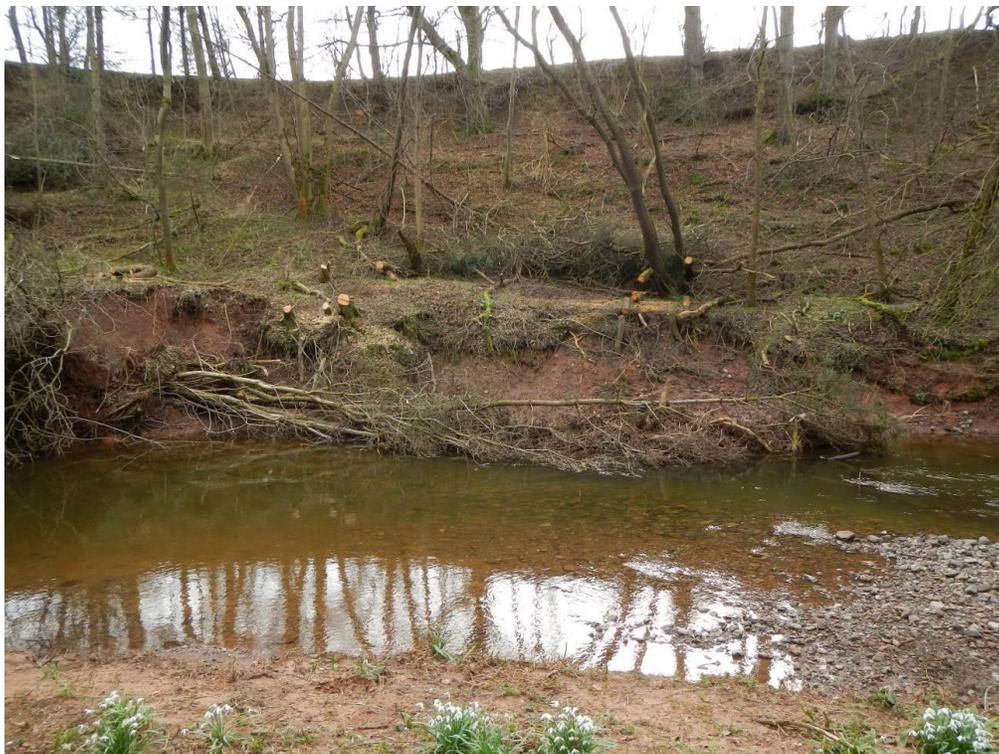
Stabilisation could be further assisted by retention of the two fallen trees that now lay along the base of the bank (Figure 5). These are acting as natural 'tree kickers' (trees that are anchored along river banks to provide flow dissipation, bank protection and habitat) and should be retained.

Figure 5. Fallen trees now lying along the bank, providing flow dissipation and bank protection.

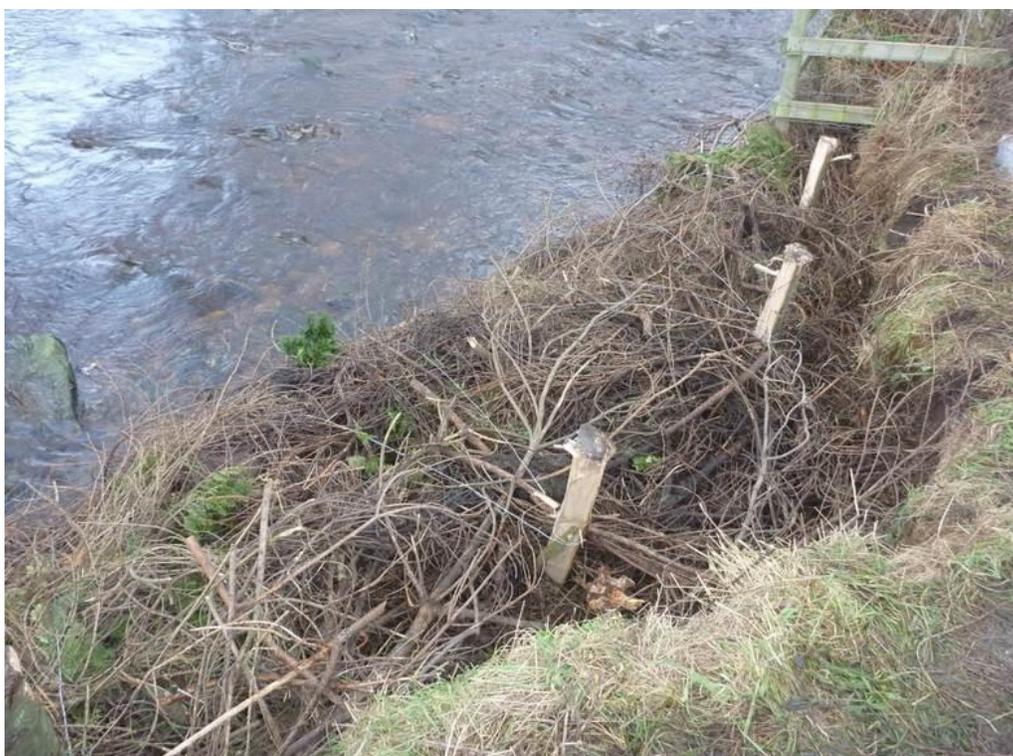
Figure 6. Over-wired brush to increase sediment accumulation around a previously eroding bank.

In the erosion bays around tree stumps and slumped banks, further sections of brash, wired along and below the waterline, would help to reduce erosion and provide valuable habitat structure (similar to the previous prescriptions e.g. Figure 6). Willow stakes/whips driven directly into the bare areas would also accelerate recolonisation of the area and bank stabilisation (Figure 8).

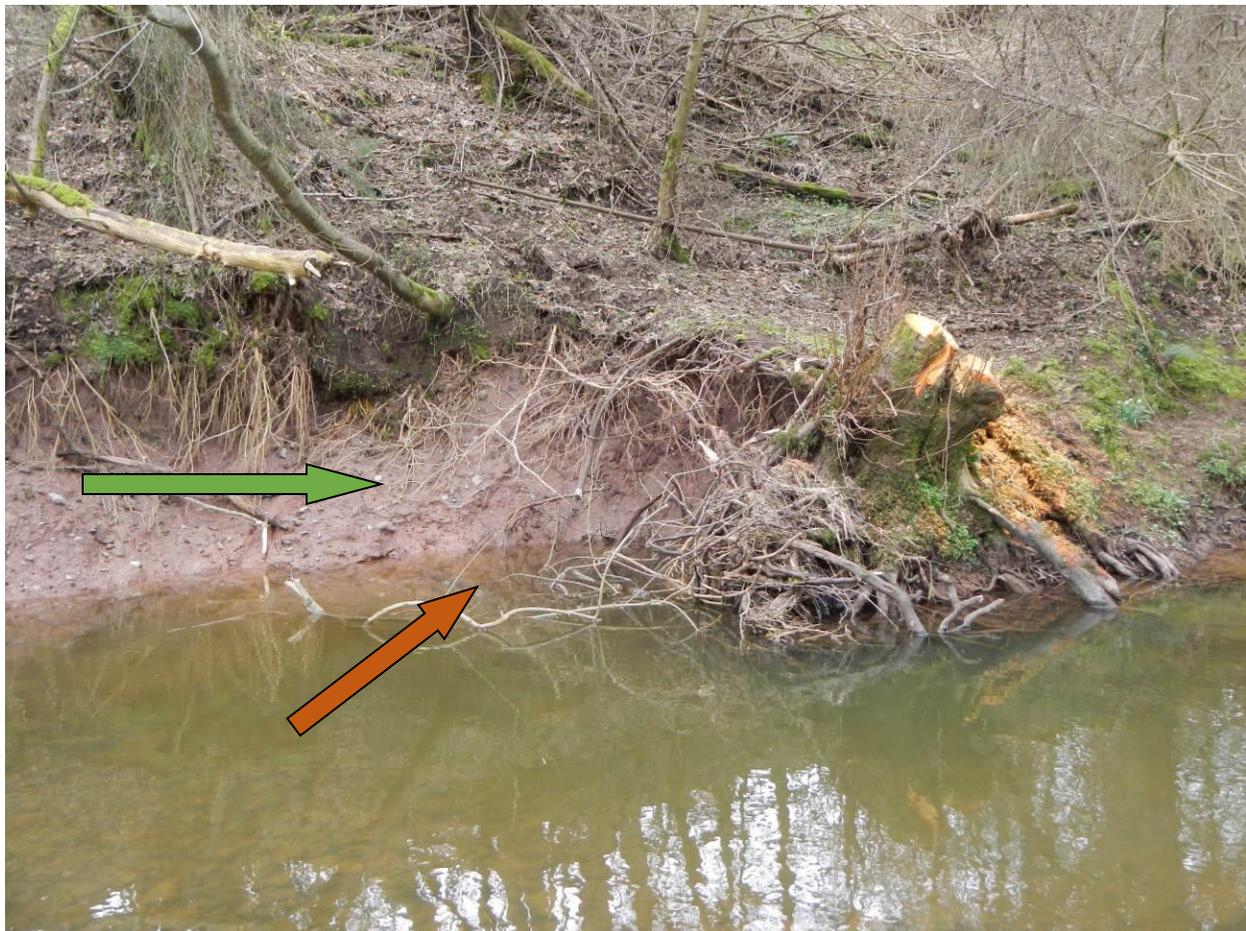
Figure 8. Bare earth where stabilisation could be assisted through planting of multiple willow stakes and possibly brash mattress (area indicated with green arrow). The brown arrow indicated the erosion area that could also be in-filled with brash.

Ideally, cuttings should be taken from willow branches/whips and driven directly into the ground. The whips need only be 500-800mm and protrude 1/3 of their total length out of the ground. Burying 2/3 of the stake into the ground provides plenty of material from which the vital root system can sprout, giving the greatest potential for acquisition of water and reducing the distance it must be transported within the shrub.
