Advisory Visit
Ryedale Anglers' Club
River Rye (North Yorkshire)
20/10/2017

Undertaken by Gareth Pedley

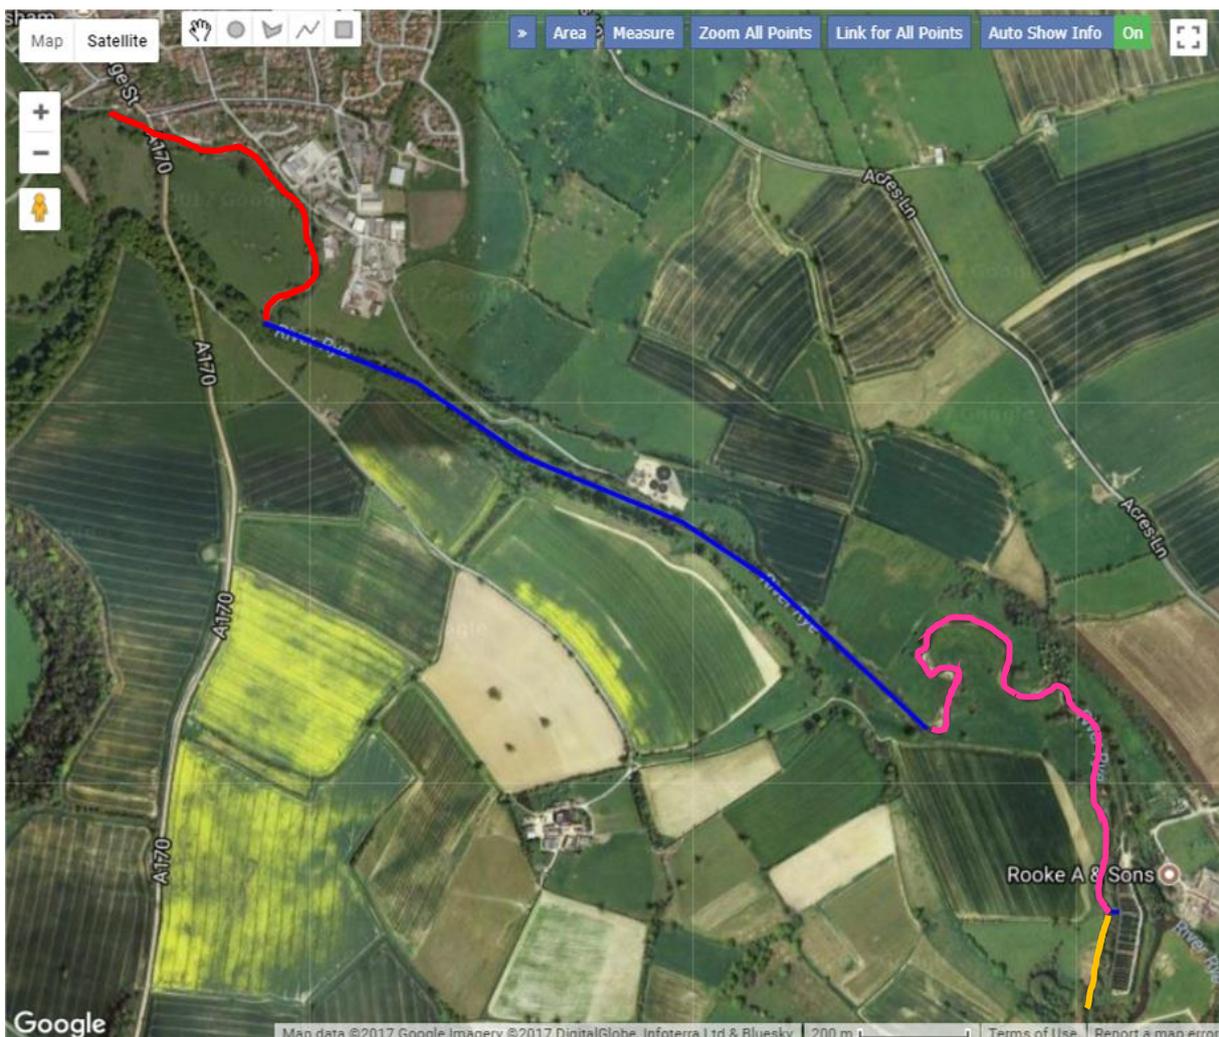
Map 1. The straightened section u/s and d/s of the STW (blue line) and adjacent, more naturally sinuous sections around Helmsley (red line) and upstream of the Harome trout farm (pink line). Also marked is the uniform section alongside the trout farm (orange line), which may also have been straightened and / or dredged in the past, although less clear evidence of alteration was observed.

Two sections of the river were visited on the day (Map 1). The first, alongside Harome Trout Farm and the second, upstream of Helmsley sewage treatment works (STW). Both of these sections of channel are straight; the section upstream of the STW particularly so, with clear evidence that it has been straightened artificially in the past. The conditions on the day of the visit were dry; however, the river flow was elevated and carrying colour (fine sediment).

The channel has clearly been artificially straightened, evident by the increased gradient, paleo-channels (the old river course) within the adjacent fields and the unnaturally long (~1.5km) section with little more than a slight bend (Map 1) - comparison with the relatively sinuous nature of other adjacent areas of the river alone would provide a strong indication of artificial straightening. While higher gradient and narrower valleys can lead to the natural development of straighter channels, the length of straight channel and extreme straightness preclude it from having occurred naturally.

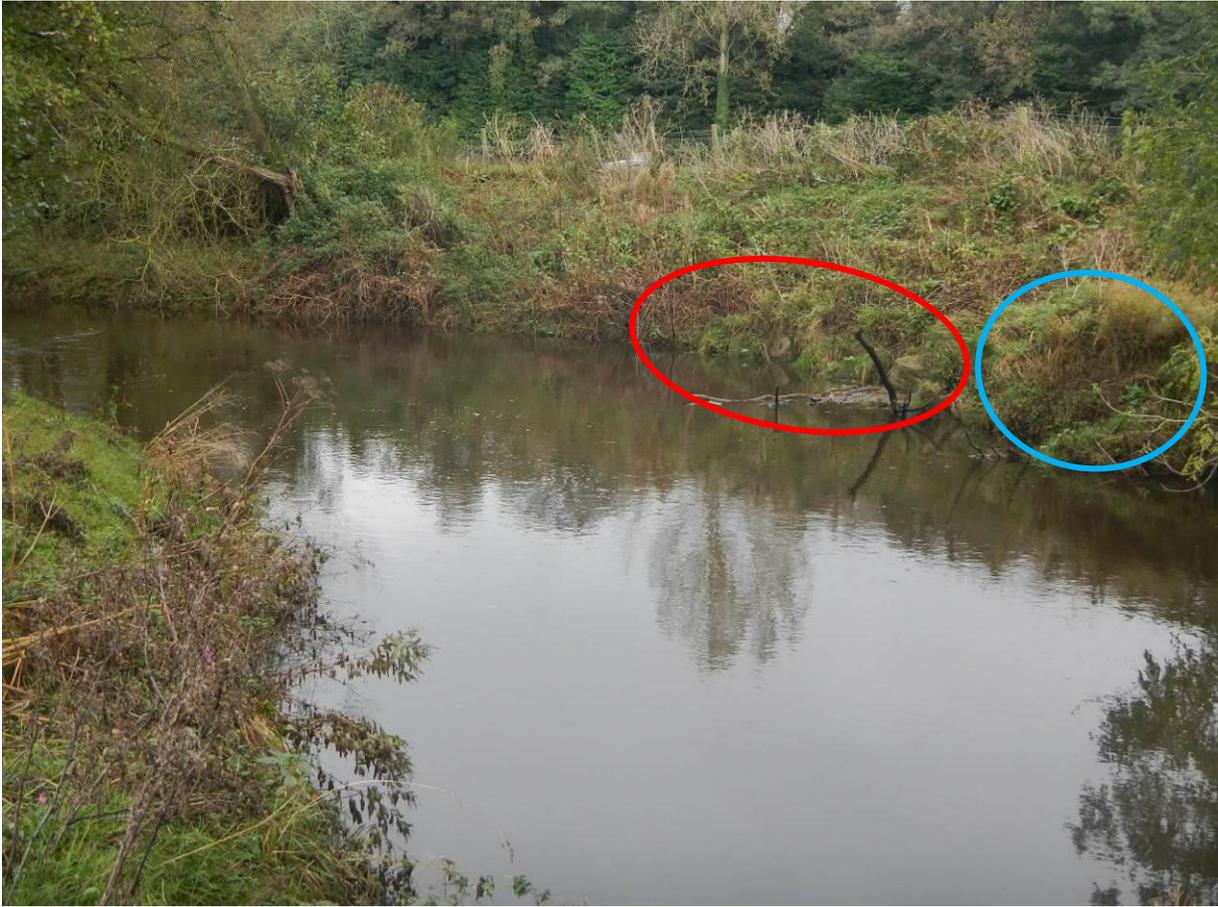
The bank has clearly been reinforced with block stone revetment in an attempt to protect it but is lacking in trees which would provide more effective, natural protection (Fig. 1). Unlike block stone which simply deflects flows and exacerbates erosion elsewhere, trees and vegetation create roughness, slowing flow velocities along a bank and dissipating the energy and erosive force. Their roots penetrate into the bank, providing structure/reinforcement and consolidating the soil. The floodbank along the LB also exacerbates issues, preventing high flows from spilling out onto the floodplain which would ordinarily allow the flow energy to dissipate. Clearly in this situation, however, the banks are required to prevent the trout farm from becoming inundated by high flows.

Figure 1. Looking u/s, the bend alongside Harome trout farm provides some flow diversity, creating deeper areas on the outside, along the LB. Block stone (red circle) along the bank is likely to exacerbate erosion in the long term. The remains of the fallen tree's rootball can also be seen (blue circle).

Rather than block stone, the susceptible area of bank would be far better protected by re-planting a mix of native, deciduous trees which would also improve the habitat quality (shade, food, shelter etc). Those trees may require some light maintenance over time, but this would be far cheaper and much easier than maintaining block stone revetment which will become out-flanked and / or undermined. The remains of a mature tree root-ball (Fig. 1 - blue circle) was observed adjacent to the block stone and it is very likely that tree was undermined as a result of scour deflected by the stone revetment. The deflection which occurs leaves the banks at either end of stone revetment at greatly increased risk of erosion.

In areas lacking in tree cover and, importantly, where livestock is excluded, planting with some locally native, deciduous tree species can be undertaken. A prime location would be the area of open bank alongside the trout farm, to help consolidate and protect the bank. Saplings could be purchased or possibly obtained from the Woodland Trust, Trust for Conservation Volunteers, or possibly through NYMNP, to provide a natural variety of species.

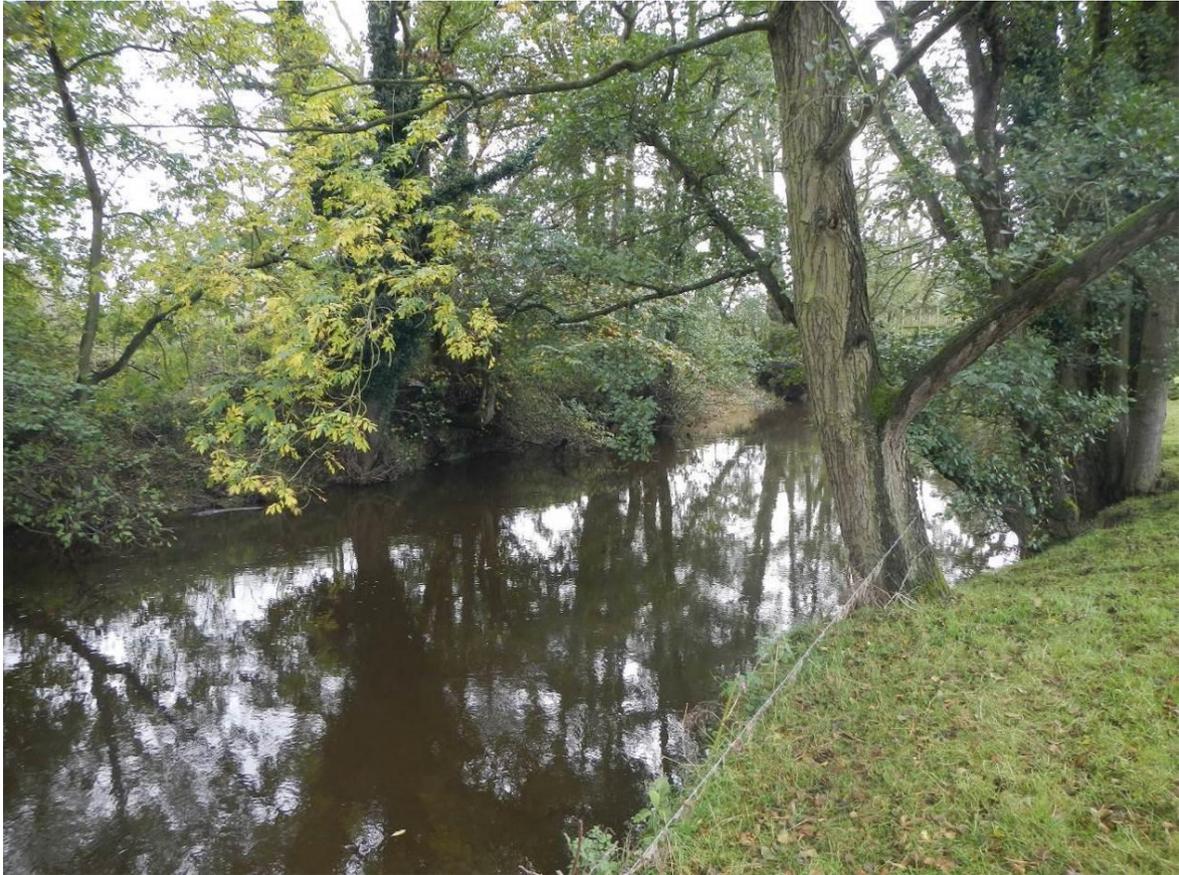
The long section of straight, uniform channel d/s of the bend (possibly dredged in the past) imparts little flow diversity and, outside of the influence of the bend, lacks discrete features (Fig. 2). With uniform flow and width, bed scour at high flows and sediment deposition at lower flows will be relatively uniform across the full width of the bed, leading to a lack of discrete bed features. It should also be considered that in low summer flows or drought conditions, the flow diversity will decrease further, leaving water that is poorly suited to flow loving species like trout, and many invertebrates. This limits the number and size range those species that the section can support. Such areas are also less productive for anglers, with fish moving long distances if they are disturbed (spooking the rest of the pool in the process) rather than simply tucking into a nearby bolt-hole.

Figure 2. The straight, uniform section alongside the trout farm. The lack of flow diversity leads to more uniform scour and erosion and a relatively bland, uniform river bed.

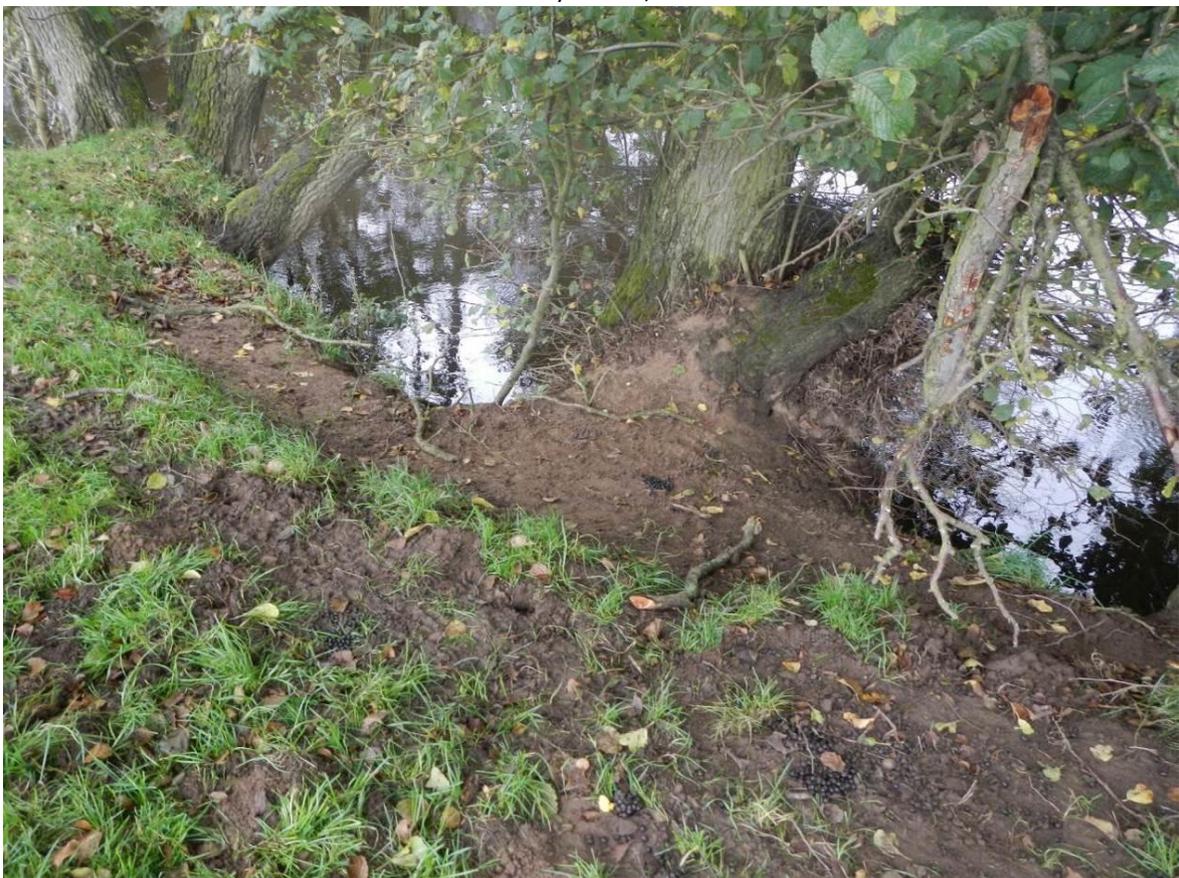
It should be noted that sheep grazing and trampling along the RB is also preventing the development of herbaceous vegetation and natural tree regeneration, threatening the stability of the bank (Fig. 3). Most of the trees are now large/mature but there are no smaller saplings being allowed to develop and replace those lost through disease, old age or erosion. Without stock exclusion, the reduction of vegetation and bank cover between the trees and around their roots and increased bank erosion places the trees at even higher risk of being washed out or toppling into the channel. If this is allowed to occur the stability the trees currently provide in locking the whole bank line together will be lost and much more extensive erosion is likely to occur. However, simply excluding livestock from the riverbank could greatly reduce the chances of such issues from occurring.

Figure 3. The lack of vegetation between and around the base of the bankside trees leaves those sections of bank at greatly increased risk of erosion (as can be seen by the erosion bays developing between them). Losing these trees would result in a loss of habitat and further bank destabilisation. Contrary to common belief, sheep grazing can be equally, if not more, detrimental than cattle in destabilising banks as they more often graze and trample a bank bare.

Along the RB, opposite the trout farm, clear impact from the livestock access was evident. It would be well worth installing buffer fencing here, and any other areas where livestock has access to prevent further bank instability and allow natural regeneration of vegetation, shrubs and trees that will improve habitat and bank stability.

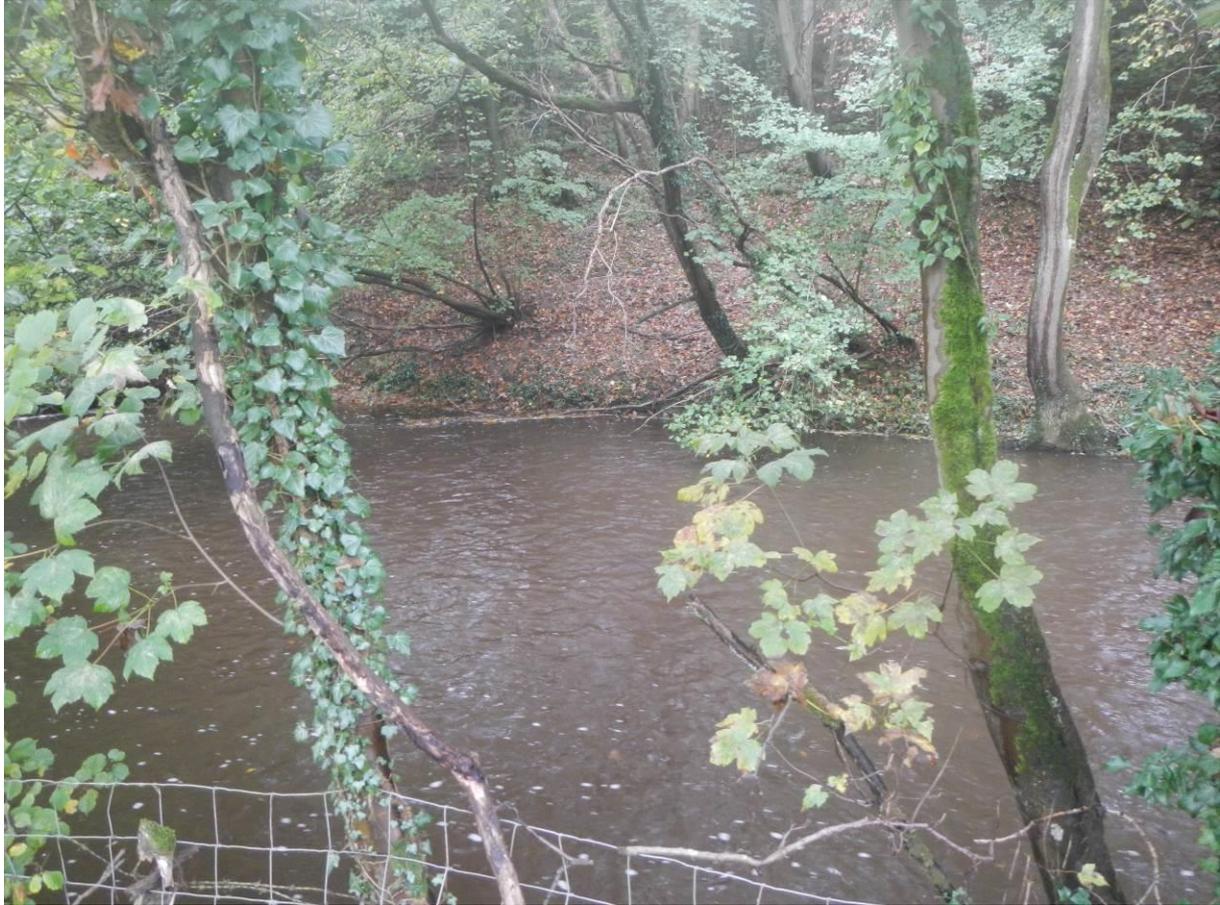
The section walked u/s of the STW suffers a similar basic issue to that alongside the trout farm, being overly straight, with uniform width and flow, and generally lacking discrete in-channel features (Fig. 4).

Figure 4. A typical example of the channel u/s of the STW, being straight with uniform width and flow.

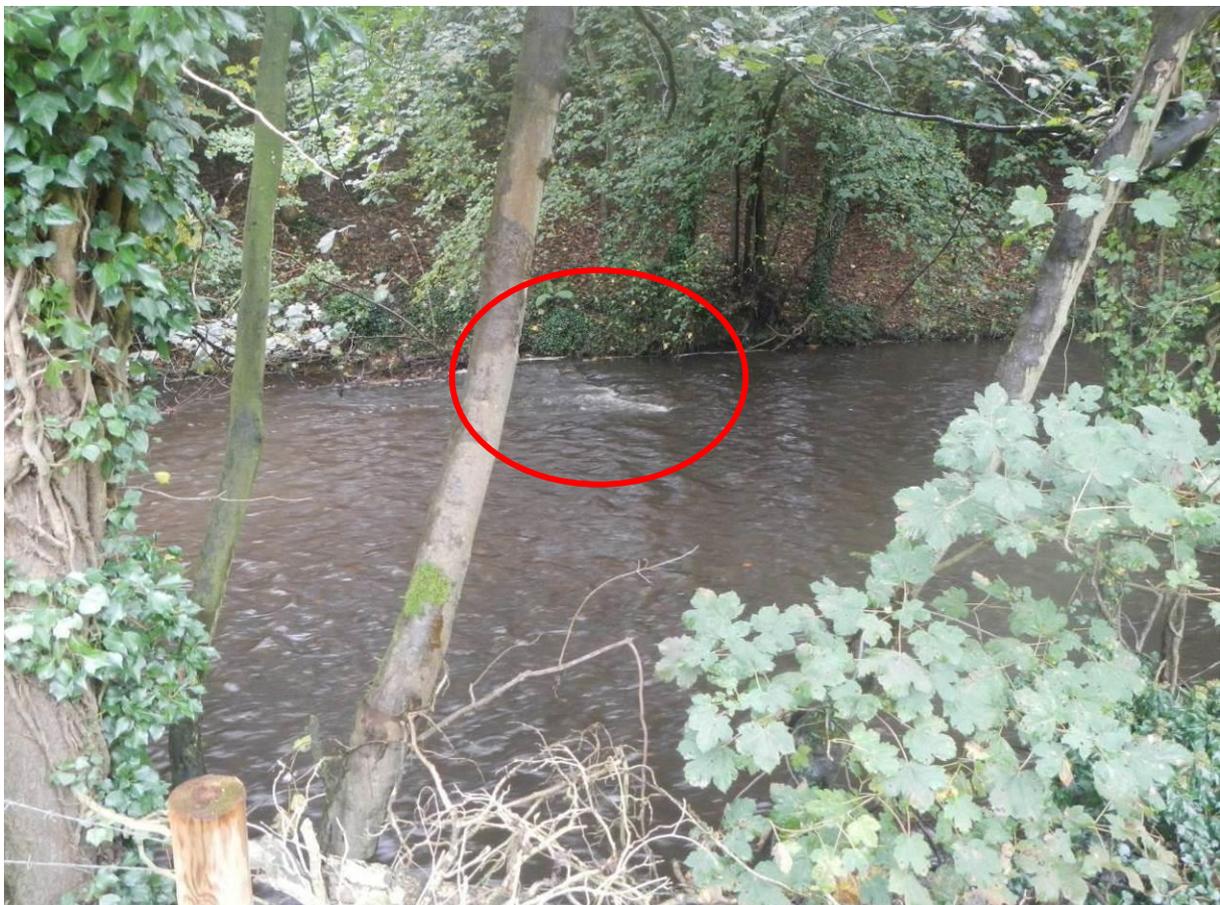
Flow deflectors (partial channel width) can produce beneficial effects within unnaturally straight or uniform channels, increasing flow diversity and encouraging discrete areas of scour and deposition. However, it is important that they are only partial channel-width structures, to prevent impoundment of the flow and to maintain sediment transport through the reach. A stone deflector in this reach (Fig. 5) and dilapidated weir (with adequate gaps – not full width) do provide some beneficial bed scour adjacent to and d/s of those structures, with the resulting depth being naturally maintained by the flows received, but they are quite artificial and similar benefits can be attained more naturally.

Figure 5. Again, note the uniform channel where some localised flow diversity gained through the stone flow deflector against the far bank (red circle).

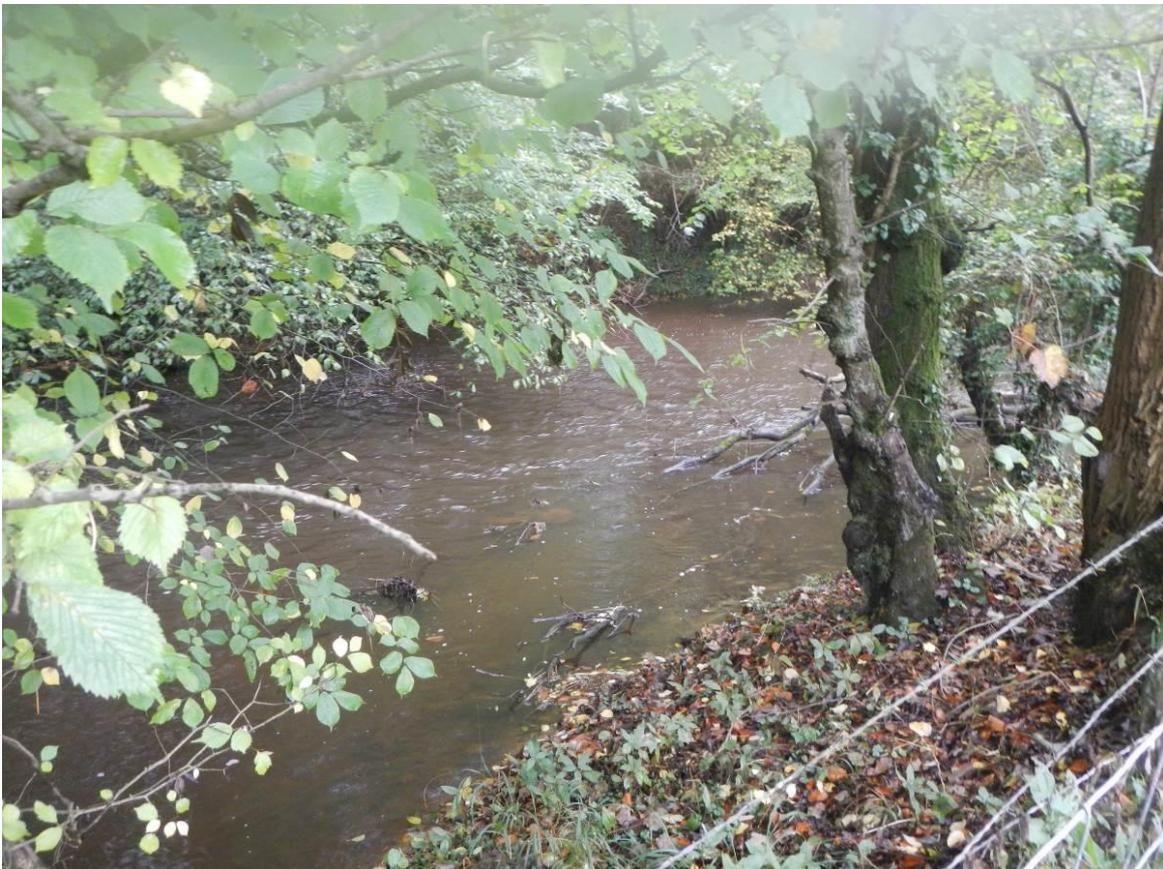
Figure 6. Natural woody material in the LB margin. Note how the flow deflection and dissipation creates a much slacker area along the bankside and focusses flow into the centre of the channel, ultimately kicking more flow over towards the other bank.

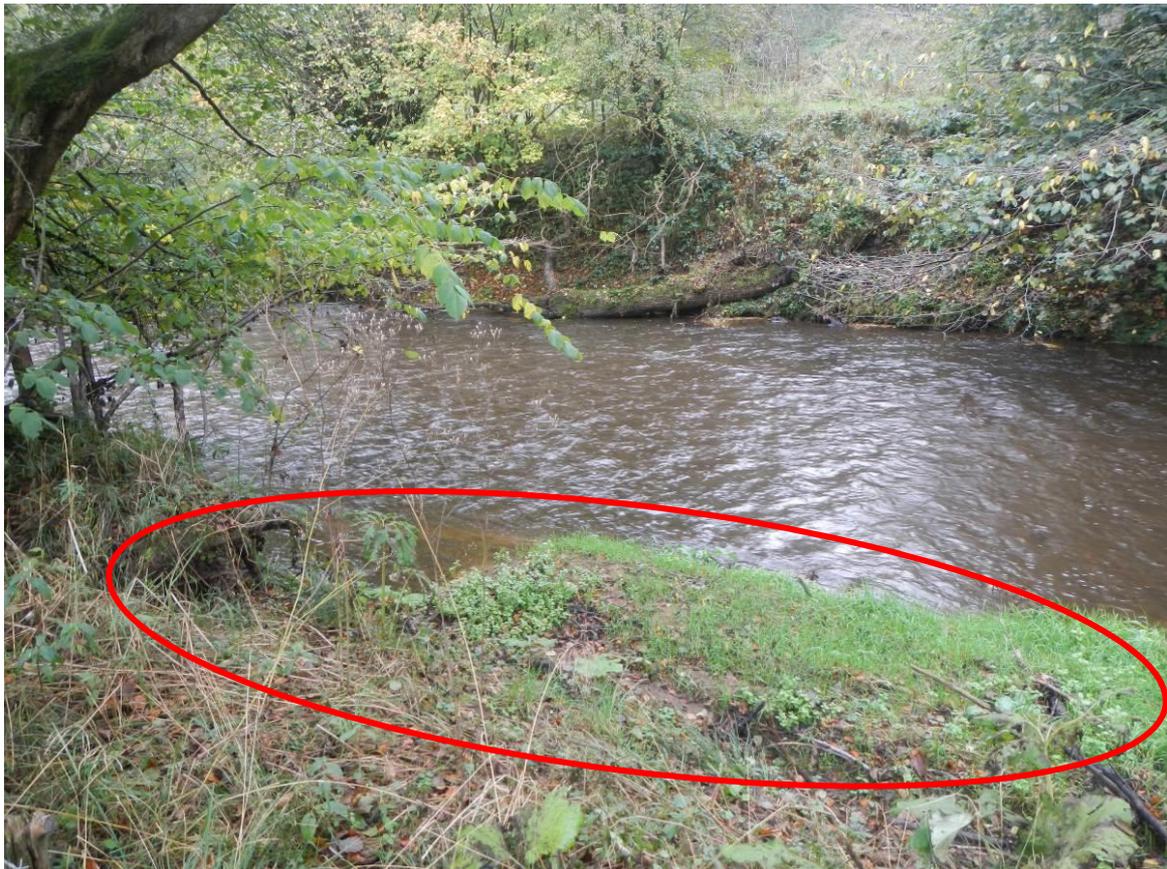
Figure 7. A natural depositional feature comprising fine sediment that has accumulated d/s of woody material (red ellipse). The localised natural narrowing of the flow here is a result of the river starting to develop more sinuous flow pathways (even within the banks of the straightened channel). This will ultimately help to diversify the river bed and create a greater variability of water depth.

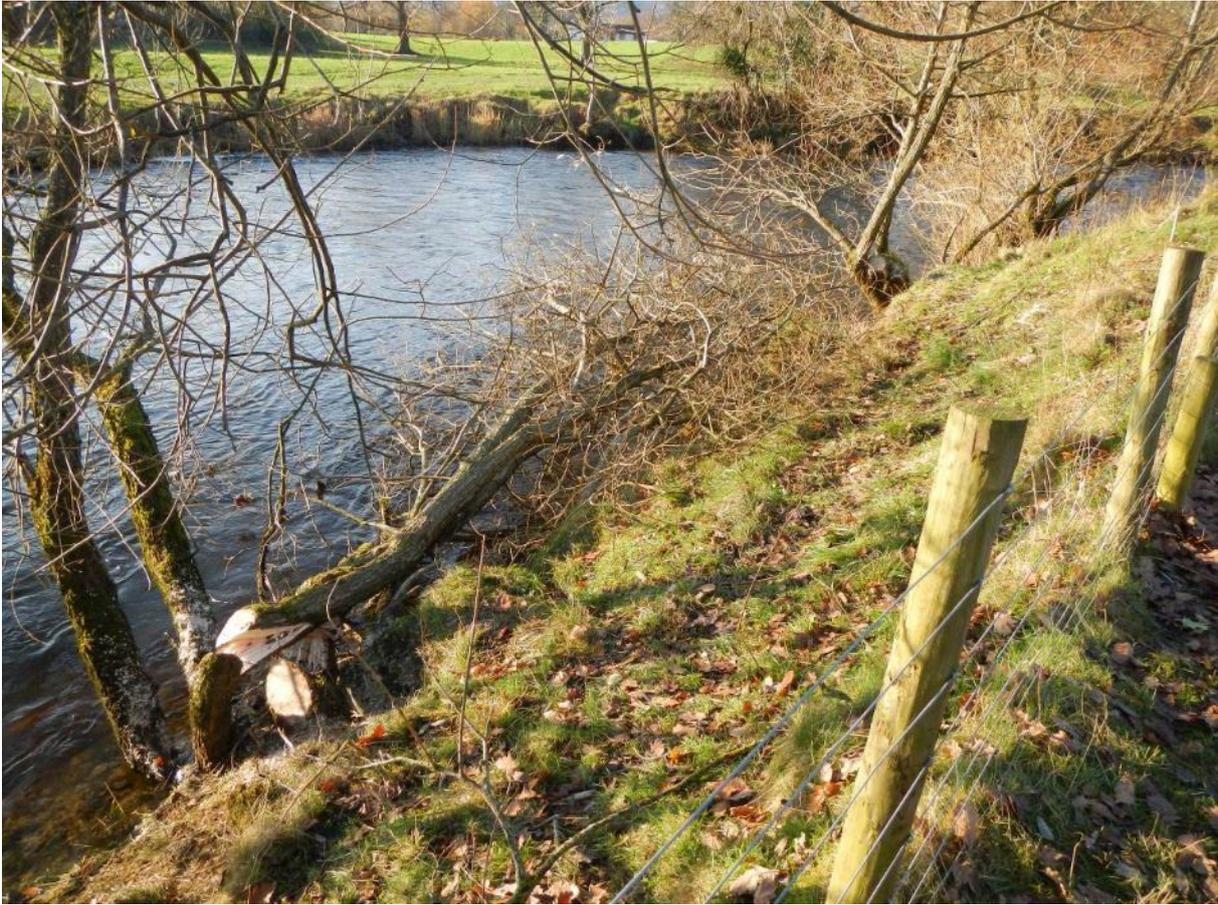
Figure 8. Willow hinged into the river margin to provide cover and structure and increase flow diversity.

The laying method involves cutting part way through the stem/trunk from the upstream side, until it falls or can be forced over in a downstream direction (Fig. 8). The cut should be made quickly to halfway through the trunk (to reduce the potential of the split running up the trunk), then as little extra as is required to bend the limb over, as this will maintain maximum size and strength of the hinge and the health of the tree/shrub. Fast growing tree species (willow, hazel etc) can even be strategically planted in anticipation of employing this technique once they become established.

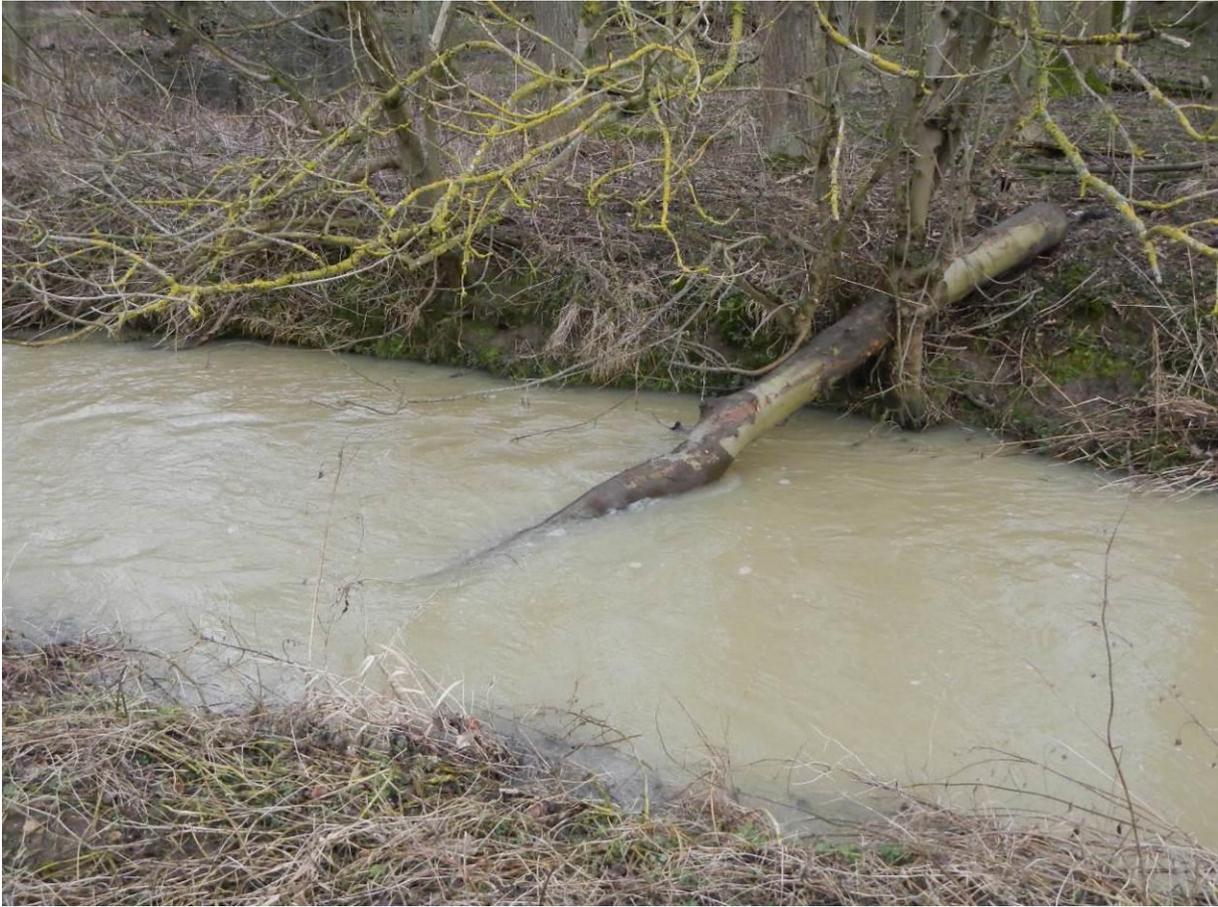
Figure 9. A lodged flow deflector – the technique can be used with a single pole (primarily to increase scour) or a branched limb (to create greater flow dissipation). The elevated butt end (bank end) reduces the potential detrimental bank scour usually associated with d/s deflectors as a through-flow is maintained along the bank.

The process involves selecting a tree or branch (ideally from a species that coppices well, so as not to kill the stump) and cutting off the desired length (dependent upon channel size and desired impact). The branch or trunk is then naturally secured to one or more intact living trees. This can be by pulling or winching the deflector between two or more closely adjacent trees and allowing the deflector to swing round to lie at a d/s angle. Figure 9 depicts the technique where the deflector has been winched (a good, secure, tight fit) between two branches and the leverage of the flow alone completely secures the deflector in place (where multiple stem trees are present additional points of contact can be made). This technique simply mimics the very natural and regular occurrence of a tree or limb falling between standing stems/trunks.

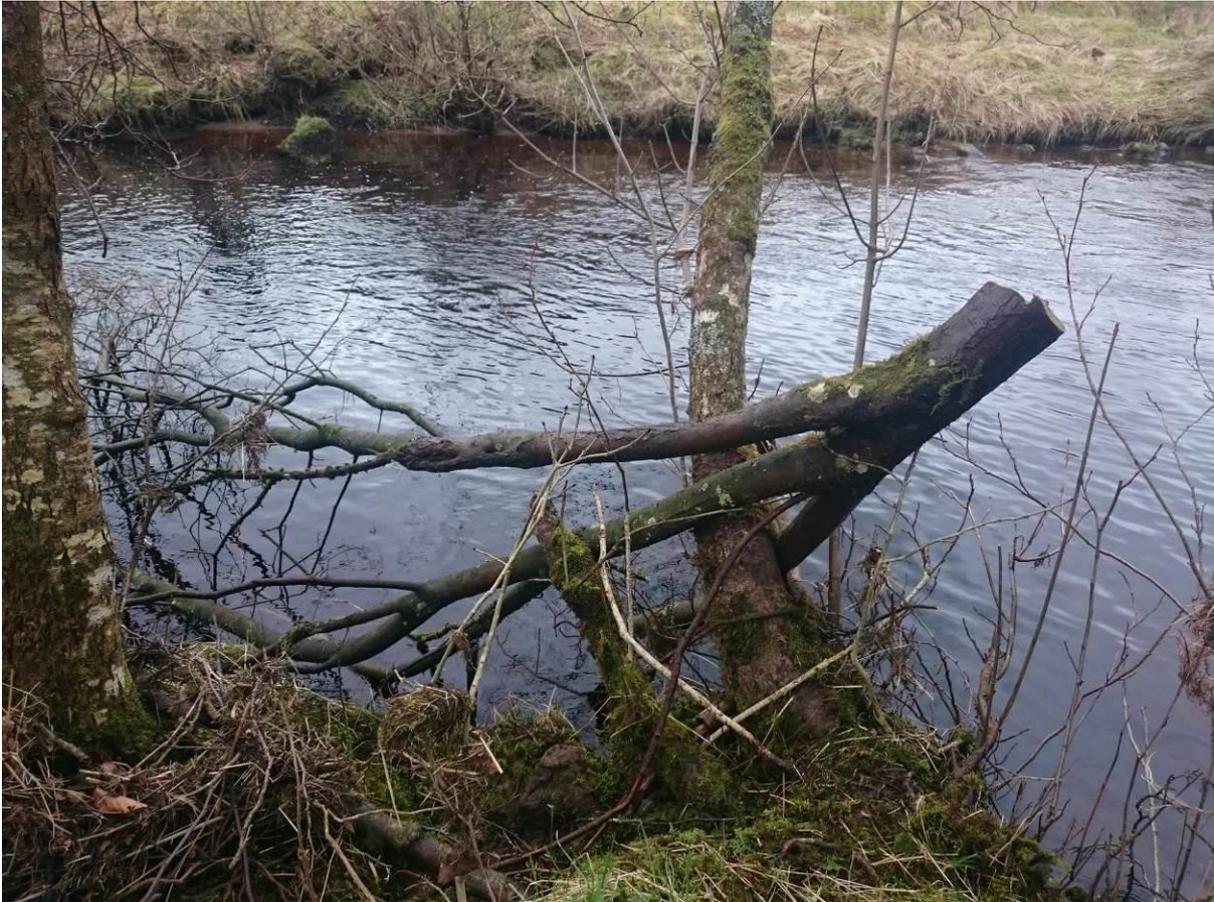
Figure 10. A medium sized deflector which is securely anchored in place against an upright tree.

The alternative lodged flow deflector method is equally simple but relies upon a deflector with multiple branches (Fig. 10) and simply involves hooking one of the branches around an upright tree. The example uses a medium sized branch but any size of branch or tree that can be moved can be employed, providing the anchor tree is of sufficient size and is stable. A winch can even be used to manoeuvre larger deflectors.

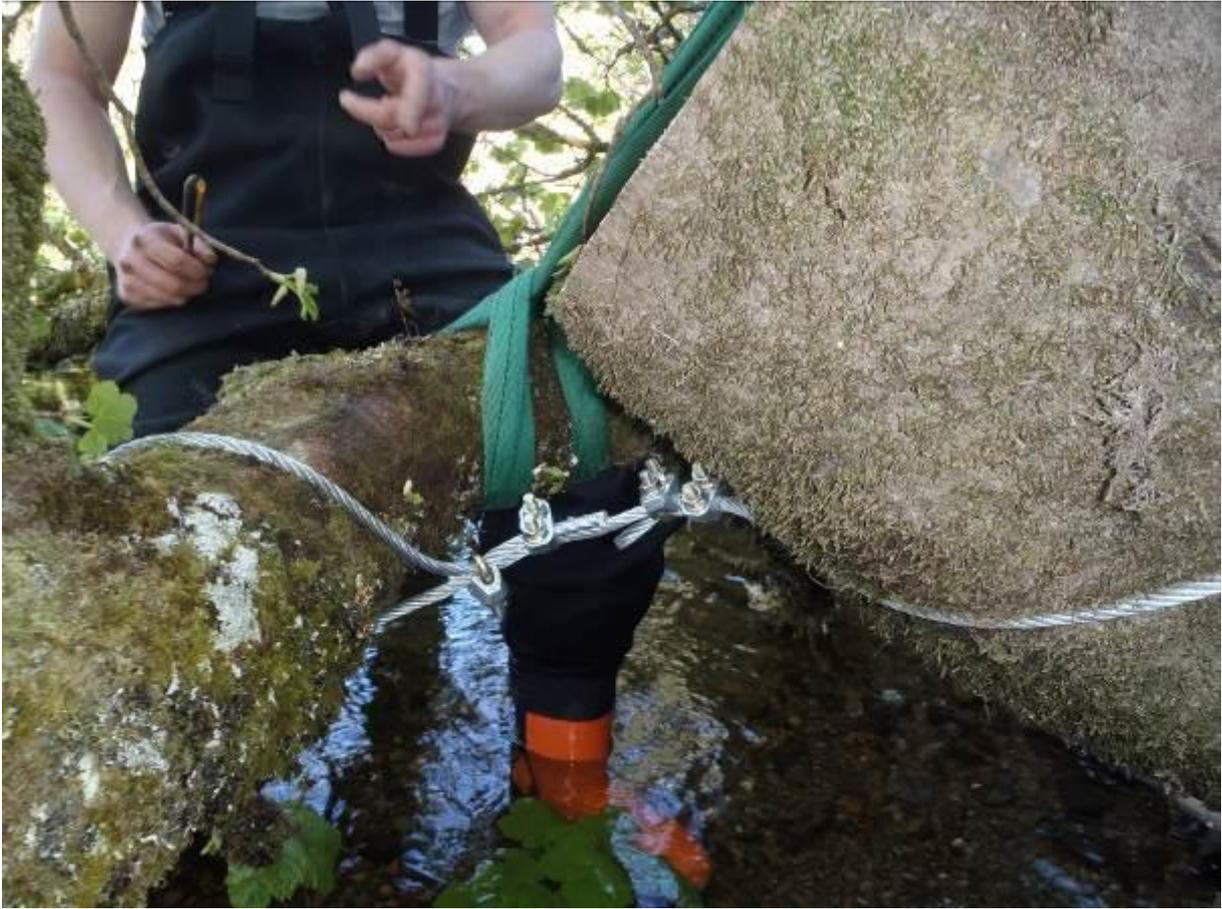
Figure 11. A basic tree kicker cable setup using 4000 kg breaking strain cable and two sets of cable clamps. The webbing strap in the background is used to pull the kicker close to the stump for fastening but is removed once the cable is fully fixed in place.

Woody material can also be secured into the channel in the form of a tree kicker (Fig. 11). The technique involves selecting and cutting down an appropriately sized tree/shrub (as for a lodged deflector) and then cabling it to its own or an adjacent stump, to hold it in place (Fig. 12).

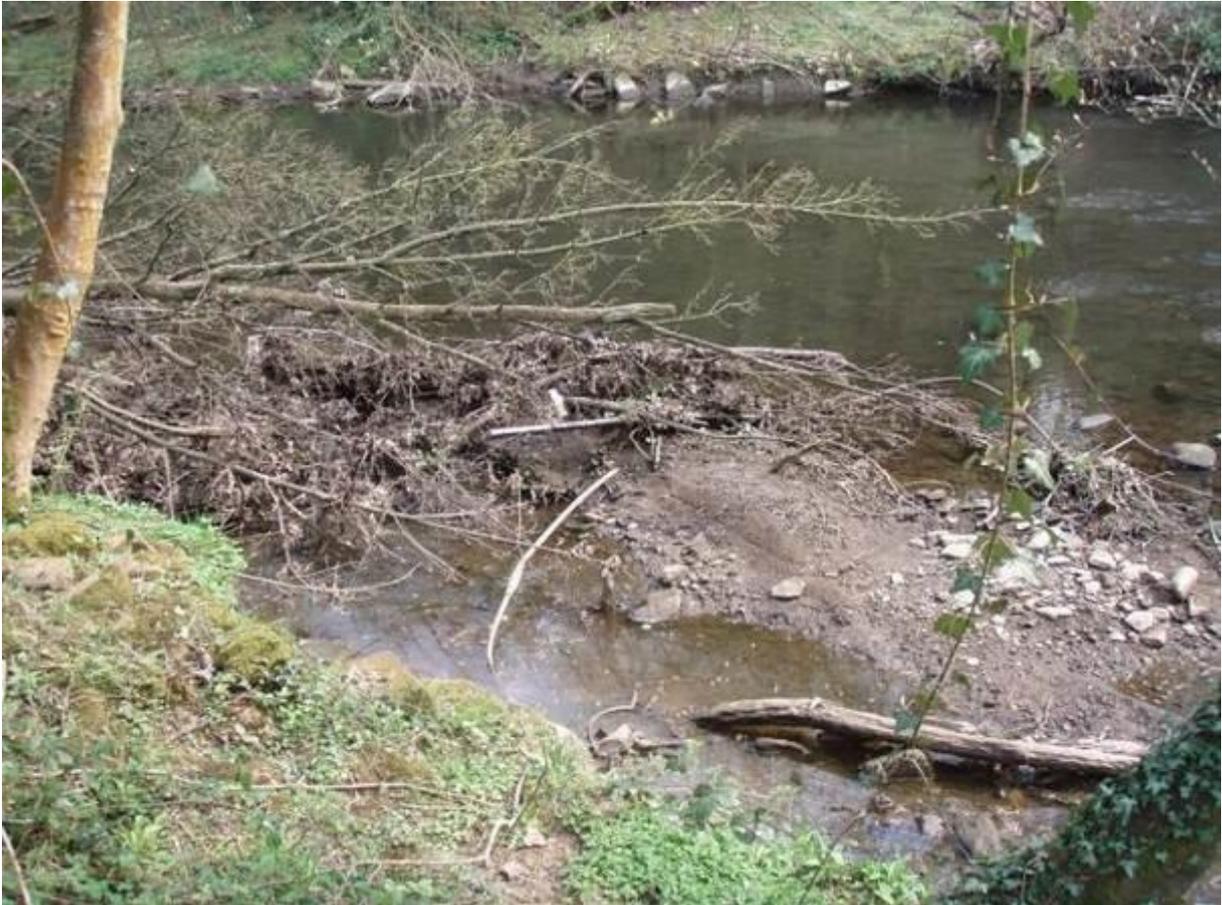
Figure 12. A perfect example of how a tree kicker can be employed to diversify flow and increase deposition in the river margin that will focus flows down the far side of the channel.

In many cases, where more diffuse structures are employed to increase deposition, the deposition in and around the limbs will further secure the structure in place as the lower parts become buried (as is occurring in Fig. 12). In addition, the orientation of the structure with its streamlined shape (tree butt u/s) also means that once it is partially submerged and high flows are passing over it, the structure will be forced in a d/s direction, but also downward towards the bed, further securing it in place.
