River Test – Lower Mill, Longparish

An advisory visit carried out by the Wild Trout Trust – December 2012

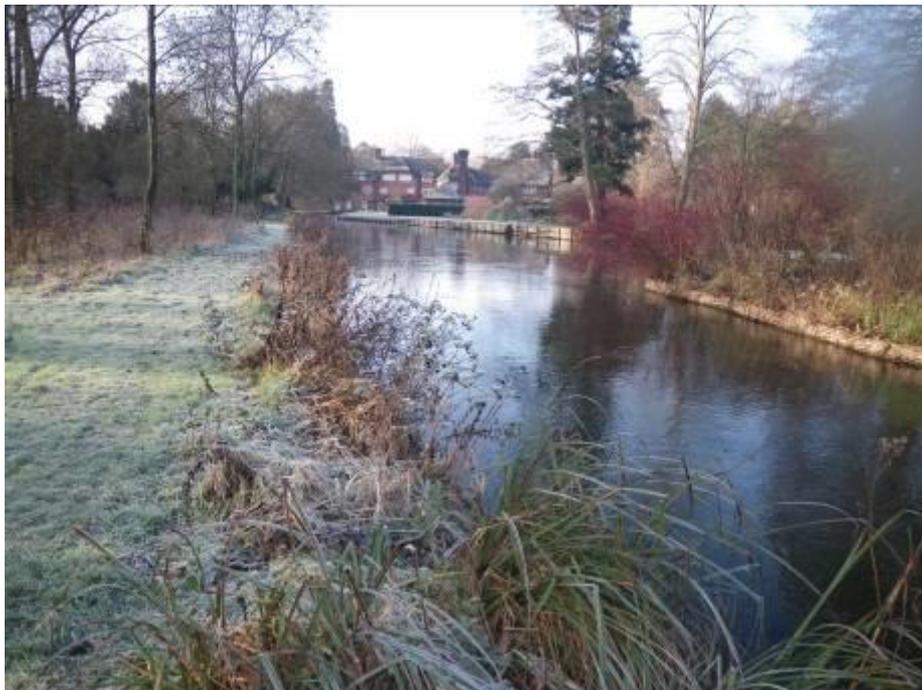
Photo 1. Taken from near to the LB looking downstream towards the Mill.

Habitat quality within the main channel beat was typically uniform shallow glide habitat (photo 1). The reach is defined by vertical, mainly revetted river margins on the RB and two impounding structures adjacent to the Mill House. The main hatches are used to regulate upstream water levels and (together with adjustable hatches on the milling leat) control the flow splits between the main and remaining channels.

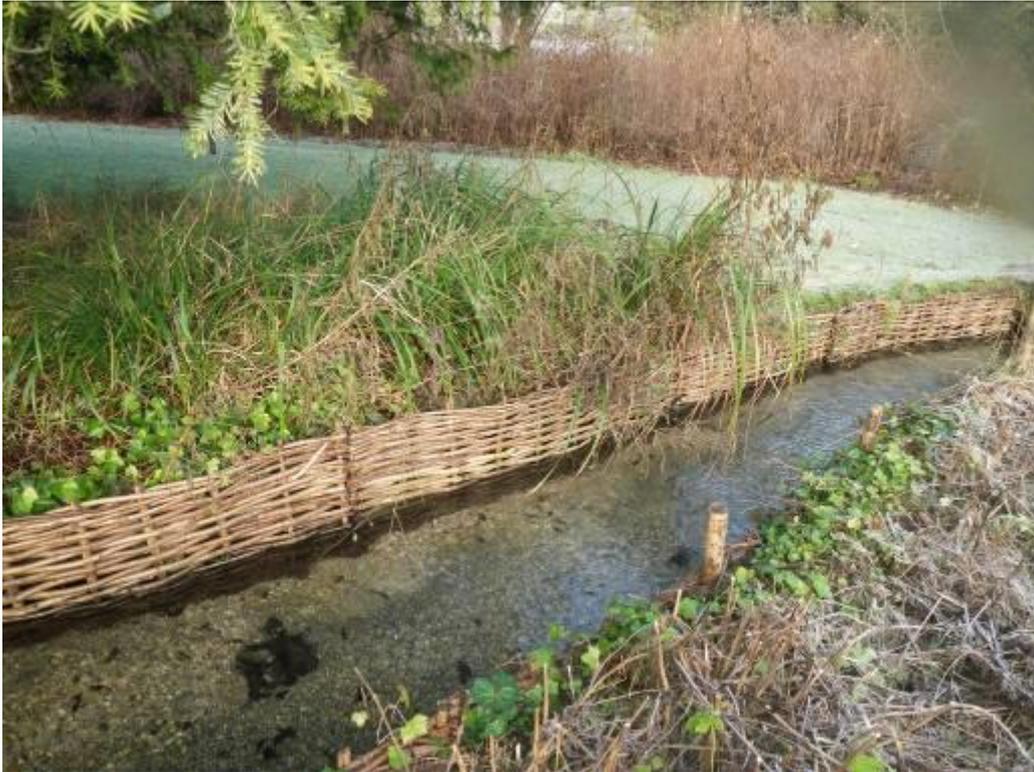
Photo 2 Hazel hurdle revetment on the by-wash channel.

The wet margins of the bank of most river systems are the most biologically valuable section of the entire river corridor. Well-covered, shallow margins are critically important habitats for a range of plant, animal and invertebrate species, including juvenile trout. Although the toe boarding and hurdle revetment will provide the odd gap and nook for tiny fish and invertebrates, a semi natural margin with a shallow batter, supporting a wide range of native chalkstream emergent plants and herbs will be much more productive and provide a more durable form of bank protection. Many of our native chalkstream plants produce attractive flowers and a carefully managed 'natural' margin will work biologically but can also be aesthetically pleasing.

The toe-boarded vertical margins adjacent to the formal garden could be softened by installing a narrow toe to the foot of the bank. A partially submerged log, or even a rock roll revetment could be pinned in place and then back filled with gravel to just above normal summer levels and then planted with attractive native emergent plants and herbs. The installed shelf need only be 0.5 to 1m wide but should provide a valuable toe to the bank that will support a biologically rich habitat. Adjacent to the formal lawn setting, the plants could be trimmed at the top of the bank level to maintain the neat formal look to the garden from the LB. From the RB, the view toward the house would be much improved and the

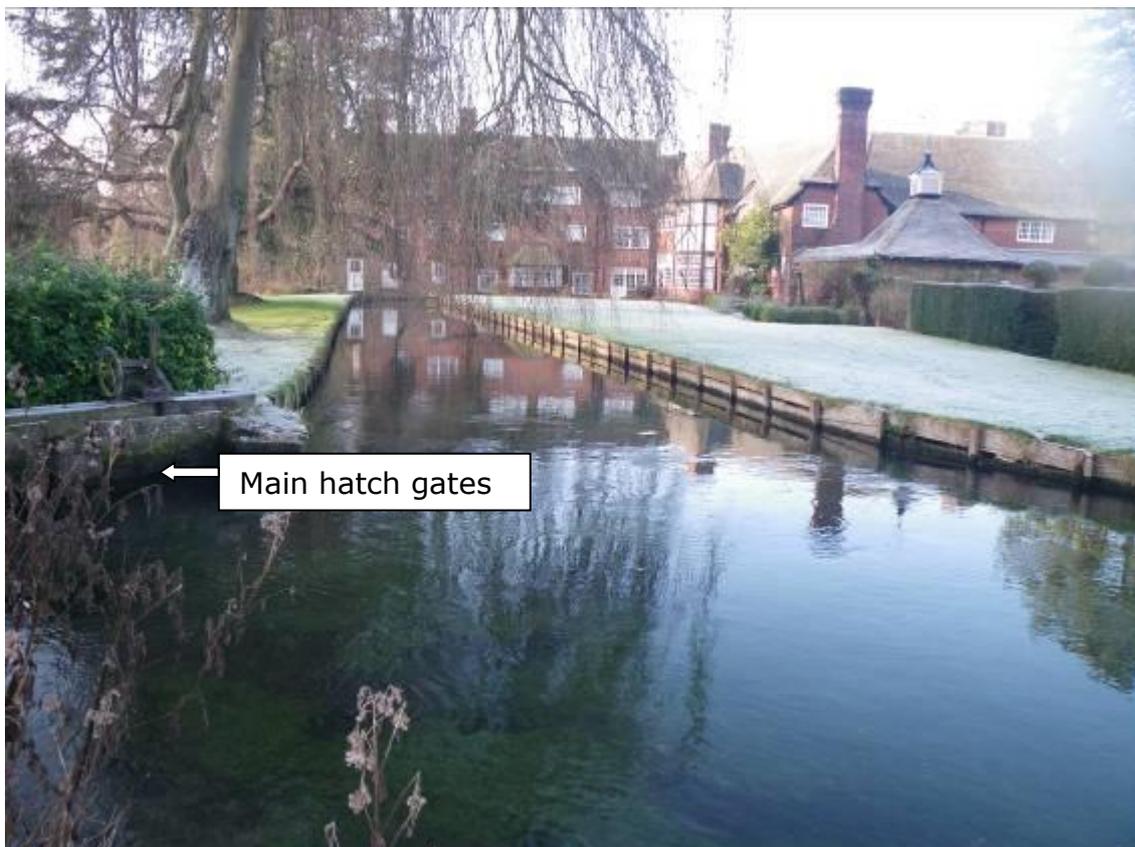
Photo 3. Main river hatches used to regulate upstream water levels and flow splits between the channels

The undershot hatch gates (photo 3) are acting as a barrier to fish migration.

It is possible that under certain flow conditions large adult salmonid fish may be able to negotiate this structure. It is highly probable, however, that the water velocity through the hatches, coupled with the significant head-loss will severely restrict upstream fish movements. Fortunately, the milling leat does offer a route for migration, thanks to a series of fish-friendly 'pool and traverses' (photo 4). A viable route for upstream fish migration is essential for the whole river to perform well and fragmentation of fish populations has been identified as a major issue on the River Test. In searching for a route upstream, fish will follow the route of strongest and fastest flow. For a passable route to work, therefore, would mean allowing more flow down the milling leat at crucial migration times (autumn and early winter), or alternatively by squeezing the outlet confluence

A review of the use and operation of all the sluices could highlight potential opportunities for improving both in-channel habitat and improve fish passage. Drawing the hatches on the main weir and reducing the upstream water levels will increase water velocities and reduce the siltation levels on the reach upstream. A shallower and faster reach will promote improved water crowfoot growth and improve habitat for plants, invertebrates and fish. Water depth in strategic locations can be maintained by using woody debris flow deflectors to help scour the river bed and create deeper pools. Large woody debris (LWD) flow deflectors are only an option on the upstream section if increased water velocities can be achieved.

It is recognised that lowering upstream water levels may not be possible without seriously impacting on flows entering the by-wash channel and possibly also the mill leat. There may be level controls on the mill leat that will enable a corresponding lowering of the inlet to still enable sufficient water to draw through via this route. This will be important, particularly during the autumn and winter period to ensure that fish can safely migrate upstream.

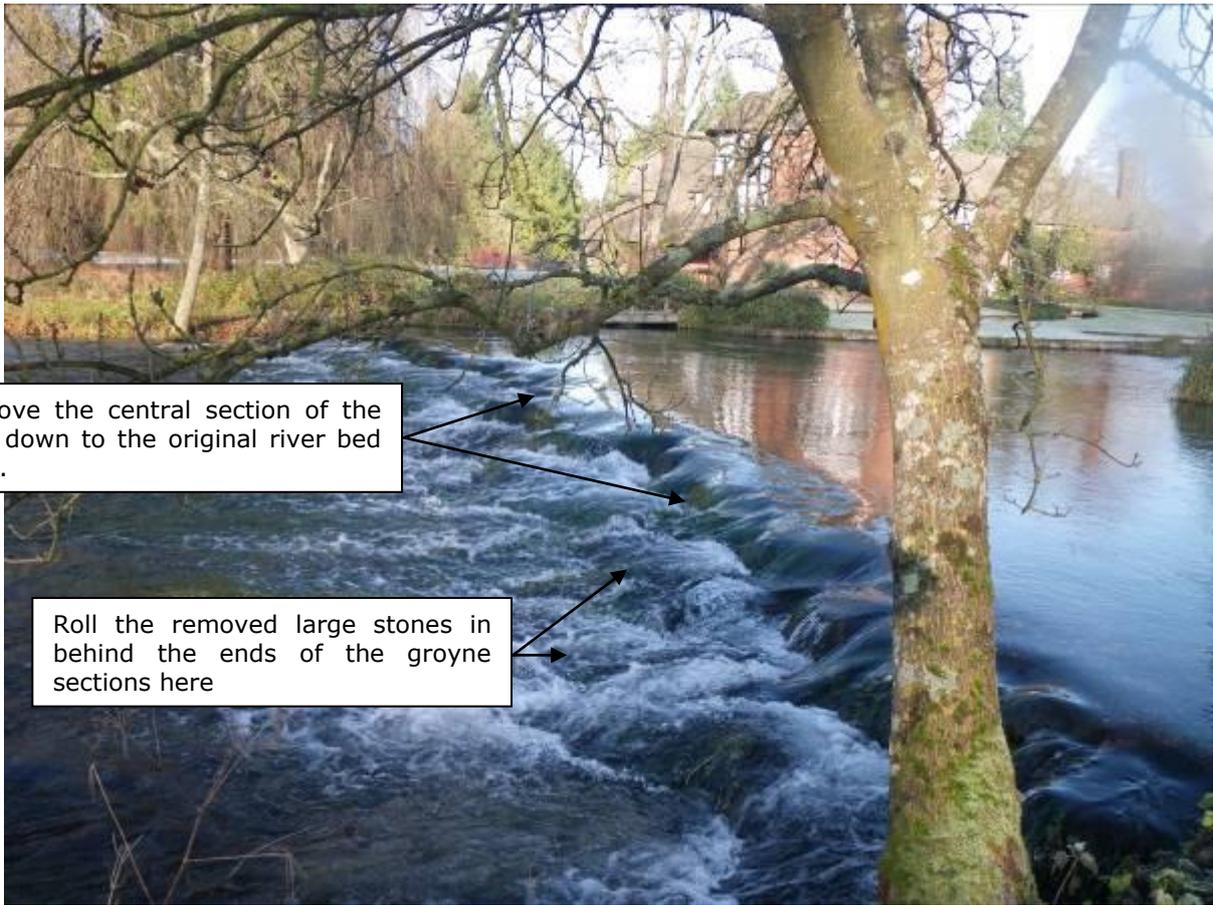
Photo 5. The blockstone adjacent to the house could be modified to improve in-channel habitat

Downstream of the main hatches there is another small weir constructed from large block stone. It is not clear what purpose the weir serves other than to hold up water levels in the section adjacent to the house. Under strong flow conditions the weir will be passable for fish, however the structure is having an impounding effect which is seriously reducing habitat quality on the reach upstream to the main hatches. Removing a central section of the weir will pull water strongly through this reach, slightly lowering the upstream water levels and scouring the central section of river bed – all improvements to the habitat. On the downstream side, the river will scour a significant holding pool, and throw up river bed gravels to form a shallow ramp, or pool tail which will be ideal for trout, or even salmon spawning. When lowering water levels, the river margins will initially look bare but will soon recover, especially if combined with re-profiling to a gentle slope, rather than vertical sides.

Forcing more water through the central section of the weir will place increased pressure on the remaining ends of the structure. Using the large stones to support the downstream side should strengthen what remains of the original weir. You may decide to seek advice from a qualified engineer before making this change.

The rock weir represents the easiest 'win' and notching out a central section of the weir is recommended.

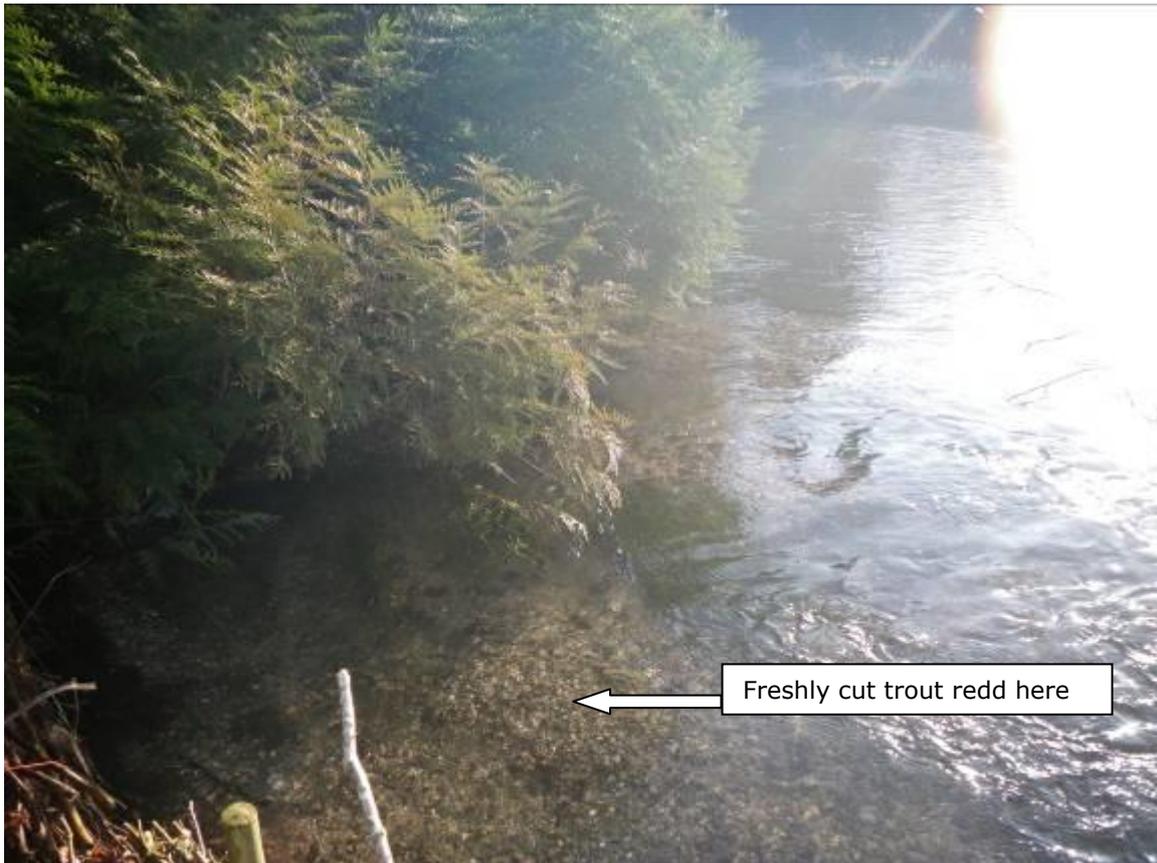
Photo 6. A trout redd (buried nest of trout eggs) immediately adjacent to a bolt hole upstream. The faggot revetment seen in the margin provides lots of micro spaces and cover for trout fry which will hatch out of the gravel in March and bolt into the shallow margin for cover.

Habitat quality on the main channel downstream of the weir is excellent, particularly in the areas where the margins are shallow and gently sloping. Some low, overhanging tree cover, albeit from ornamental coniferous trees adjacent to the RB, provide cover and sufficient security for some recent spawning activity (photo 6). The reach could be further improved by removing hard bank defences and planting the occasional low scrubby tree. The goat, or pussy willow (*Salix caprea*) would be a better option and would provide excellent riverside cover without growing too tall and shading out the adjacent milling channel.

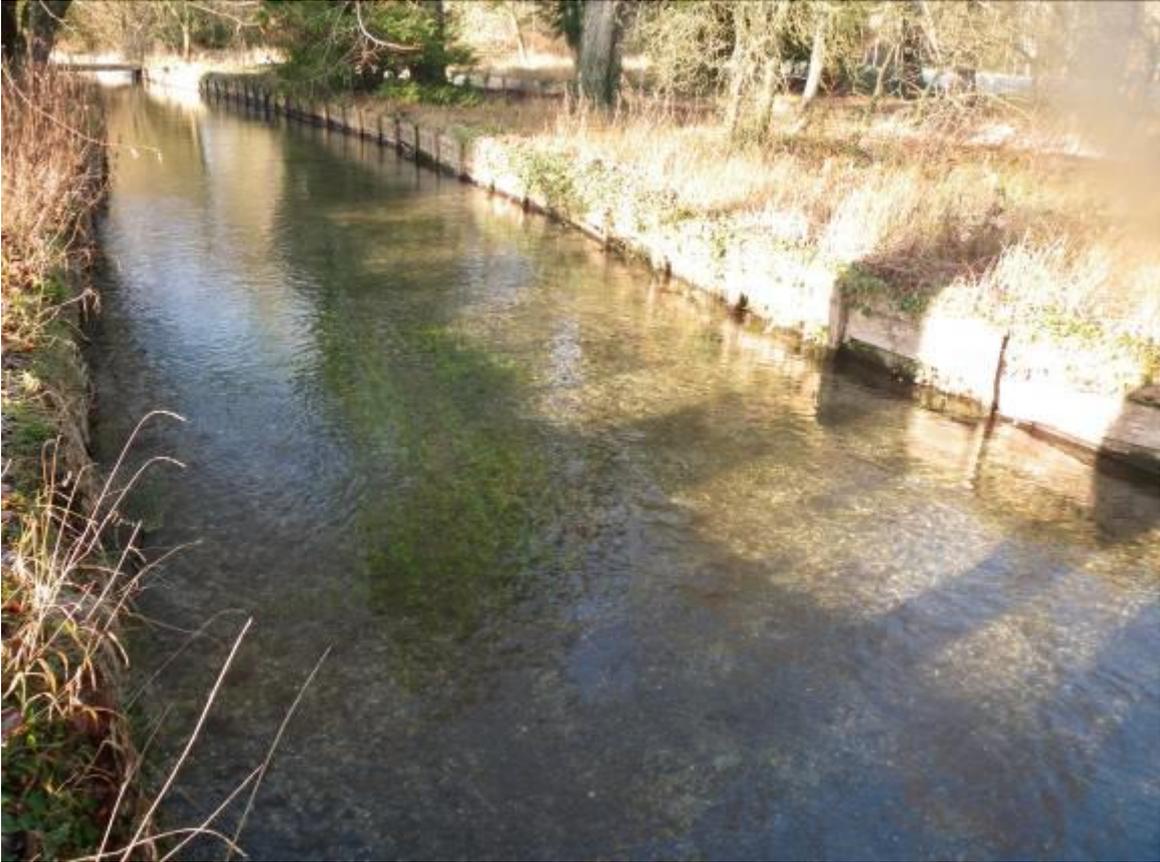
Photo 6 Downstream end of the milling channel

The tail of the milling channel has enormous scope for enhancement (photo 6 and 7). Currently the river banks are vertical and heavily defended with toe boarding. The river bed is flat and the flows are predominantly smooth laminar glide. Weed growth is poor, with no crowfoot and a few clumps of starwort and water parsnip. The river is heavily shaded adjacent to the LB and there is a lack of flow velocity because the channel is over wide for the available discharge. River bed gravels are flat, poorly sorted and heavily infiltrated with fine sediments.

The lack of any valuable river margins, paucity of in-channel cover and flat bed topography make this channel a hostile environment for wild fish. Stocked fish may reside here for a while immediately post introduction, but even for them, the environment lacks cover and diversity, probably leaving even the most domesticated trout very nervous and highly likely to vacate the reach in a downstream direction!

The mill leat channel itself is ripe for enhancement. This can be achieved on a number of levels. Simply allowing a little more light to reach the channel by thinning the conifer canopy will help, as will the installation of LWD to kick the flows patterns from side to side and promote some variation in bed profile. As the leat is significantly impounded by the Mill structure, there are huge opportunities to pinch the width of the channel in places downstream without increasing flood risk. A wonderful enhancement could be achieved by removing the toe boarding on one, or both margins outside the formal garden area and

pushing the top of the bank into the channel behind a newly installed log, or hazel faggot revetment. Currently the channel is far too wide for the given discharge and narrowing the channel by approximately 50% is entirely possible with no risk of flooding. It would be wonderful to have a naturally meandering channel with a variety of depths, bank heights and channel widths. This could still be achieved with the toe boarding in place by redistributing the existing bed material with a tracked excavator. A mixture of narrowing and creating a meandering channel would provide the best results.

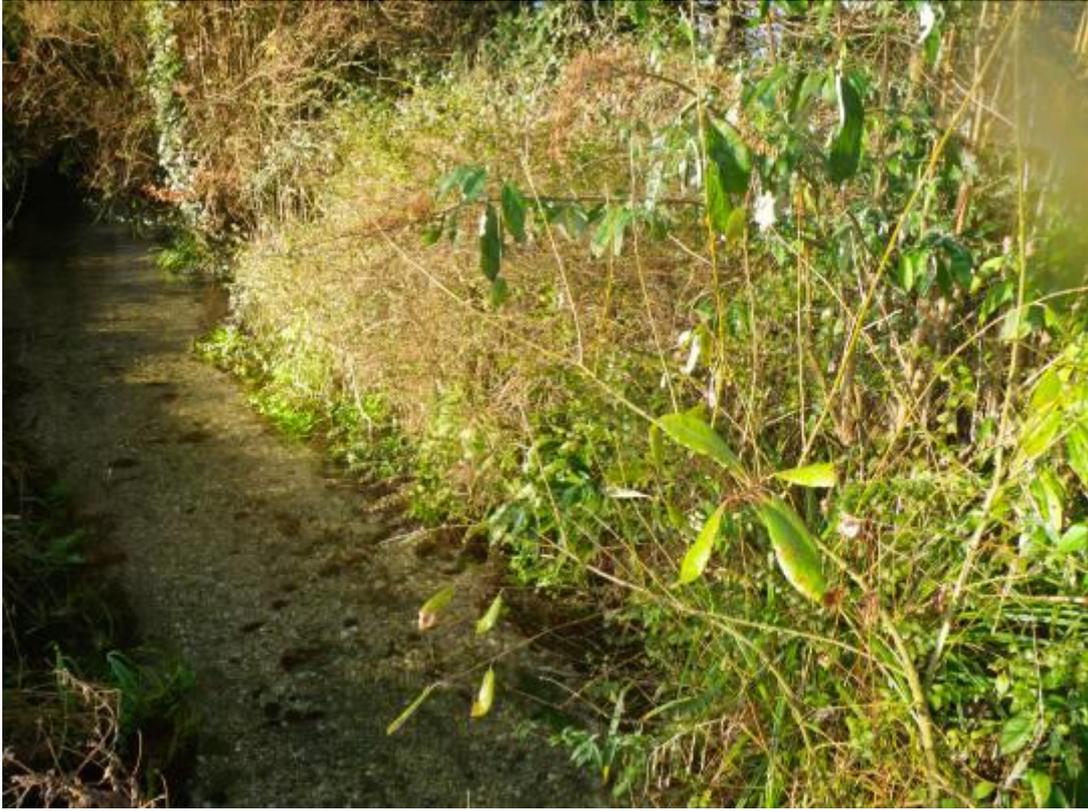
Photo 8 A natural margin providing excellent bank protection and cover for small fish

The small by-wash channel (photo 8 and 9) flowing around the western side of the mill does provide some good habitat for small wild fish, thanks to the sensitive management regime which I understand has recently been adopted.

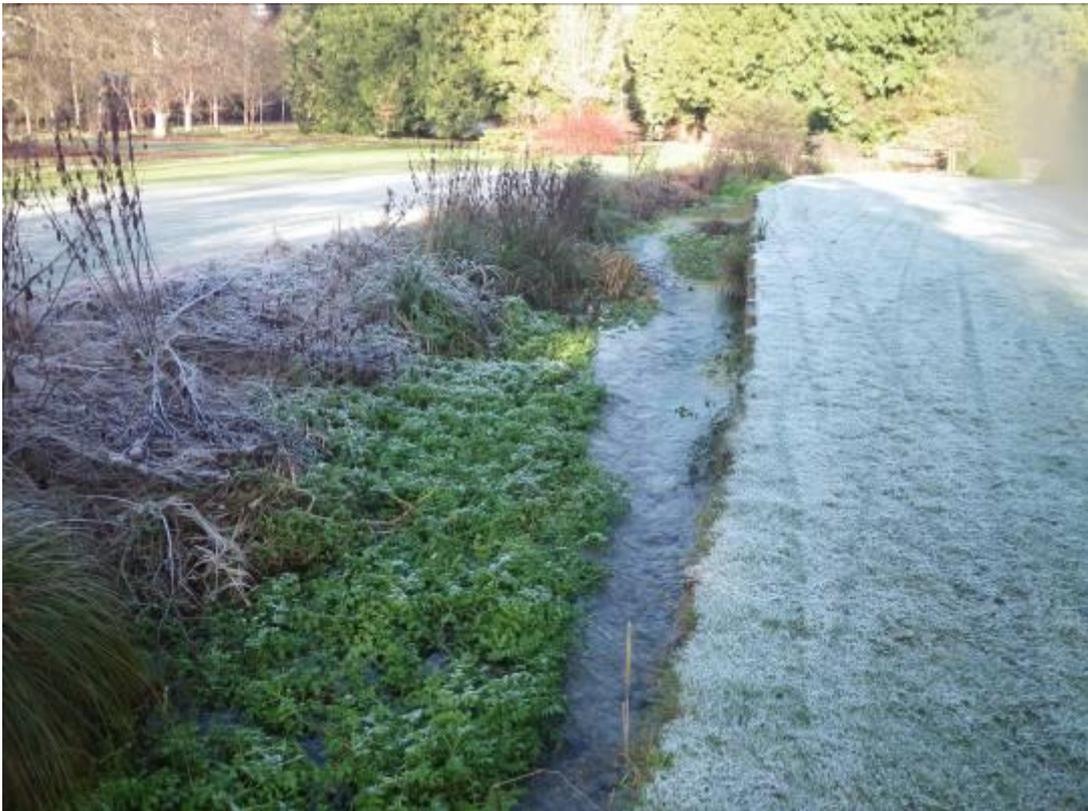
Photo 9. A recent change in maintenance has enabled the cress fringe to encroach from the RB, squeezing the channel and elevating flow velocities. Where the flow is strong, the gravels are bright, healthy and silt free. The cress will die back once the winter frosts arrive but the principles of providing great cover and natural flow deflectors can clearly be seen. These features could be replicated on a bigger scale in the milling channel.
