River Thaw, Vale of Glamorgan, South Wales

An Advisory Visit by the Wild Trout Trust March 2017

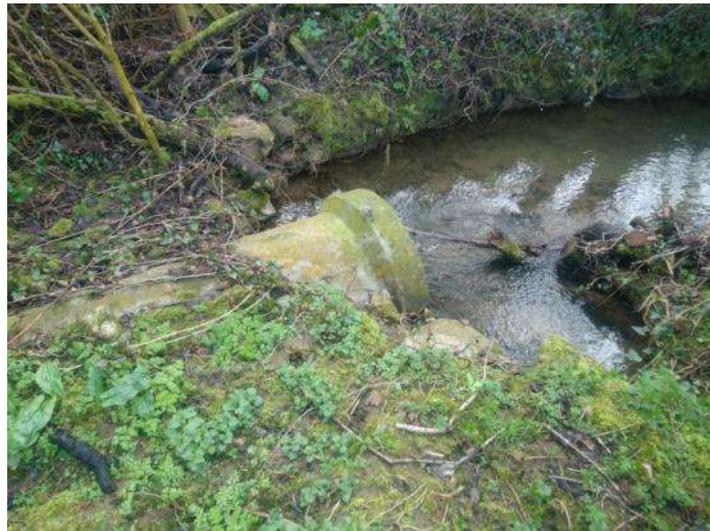
the report. There were several natural limestone outcrops in the river bed that cause a series of steps and plunge pools. Of note were at least three manmade structures, a dual concrete piped culvert in the middle of the reach, and what appeared to be block limestone remains from the former milling industry, visible among heavy tree growth at the downstream end of the reach. There also appeared to be the remnants of a stone footbridge half way along the reach and inspection of the deed plans confirmed this. All three structures are having an impounding effect on the river with associated build-up of sediment visible immediately upstream.

Dual concrete pipe on Factory Brook causing impoundment

The dual concrete pipe impoundment on the Factory Brook is impounding the river, causing sedimentation upstream. The culvert pipe is also limiting the ability of the brook to meander naturally. The bottom section of the culvert pipes could easily be dry in low flows or depths could be so shallow that fish would not be able to pass up or downstream. Both pipes could easily be removed using either an excavator or telehandler with lifting chains. The culvert pipes apparently served as a bridge that is now serving no useful function because of dense bank side tree growth, and therefore should be removed. Ownership of the pipes should be determined and the pipe removal should be discussed with the landowner on the RB before works begin.

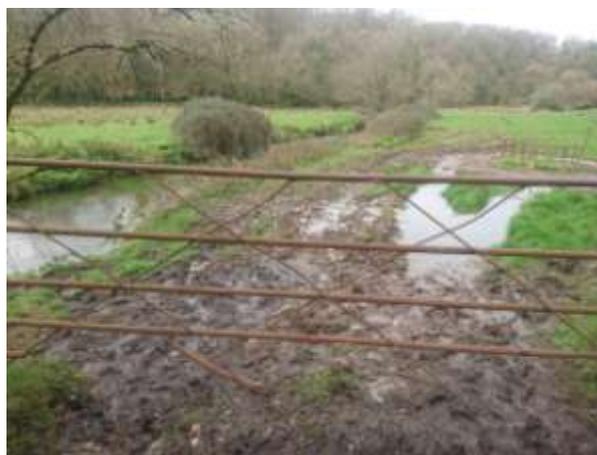
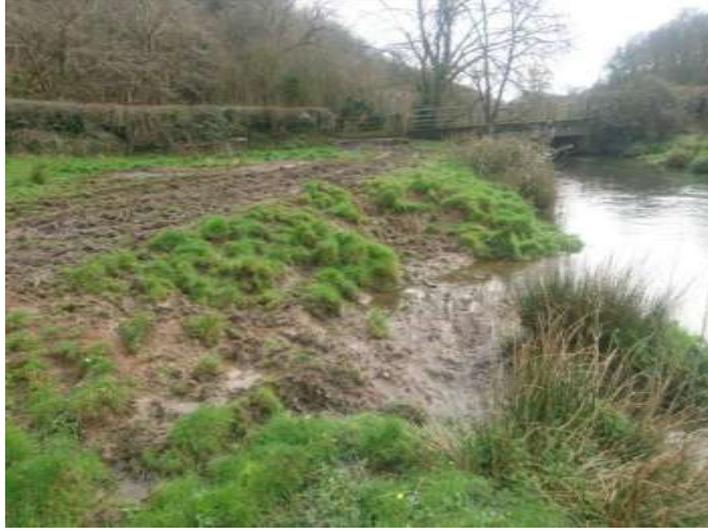
Upon entering the first field next to the bridge a cattle feeding area was immediately visible. The bank edge had been severely poached by cattle and much of the bank was visible lying in the river channel. Immediately upstream of the feeding area, the poaching has been so acute that only a sheer vertical bank face was left. It is quite possible that many of tons of soil could have been washed in from this area over time. There were also visible streams of effluent from slurry leaching into the river that appeared to be caused by congregations of cattle standing next to the feeding station.

Severe poaching at the roadbridge at Llandough

Erosion of the bank in this area needs to be addressed as a priority. Vertical banks are unable to be colonised by marginal plants and when left exposed to high flows can quickly become unstable. This problem is likely to become worse because of the sandy friable soil type in this area. Simple fencing off of the riverbank and installation of a formal cattle drink could quickly improve erosion of this type and prevent future problems. There is also scope for installing a pasture pump which prevents the need for the cattle to enter the river altogether. Poaching of riverbanks is a common problem on many rivers and can be solved by a simple open discussion with the landowner. More often than not, an offer of mutual funding between fishing club and landowner for fencing is a good way forward. When planning fencing, it is important to retain a buffer strip a minimum of 5m back from the river edge. This will allow the river bank to recolonise with marginal plants that will help to stabilise soils and slow erosion in the long term. It will also provide a rough overhanging edge that will provide beneficial cover for all stages of the life cycle of brown trout and the invertebrates which form their prey.

The main issue on the Thaw at Llandough is the lack of adequate fencing. Livestock have poached much of the LB, particularly on the lower beat, there was also some evidence of poaching and bank collapse on the LB on the upper beat nearer the sewage treatment works. This could be addressed in two simple ways. Firstly, an open discussion with the current landowner to install stock fencing that creates a buffer strip of ideally at least 5m extending back from the bank edge. This should still allow fishing access and leave enough space for a marginal plant community to flourish. This problem should be addressed as a priority before the banks deteriorate further. Secondly, it would be beneficial to install a purpose built cattle drink with appropriate fencing to keep the livestock in one spot rather than damaging the banks. It is worth noting that the cattle drink should be appropriately placed and the work carried out by experienced contractors. Many cattle drinks fail or don't function well because they are badly sited and poorly constructed. Alternatively, small density herds can be trained to use pasture pumps and can be excluded from the river channel altogether. Some information and examples are shown in the Appendix (Section 3)

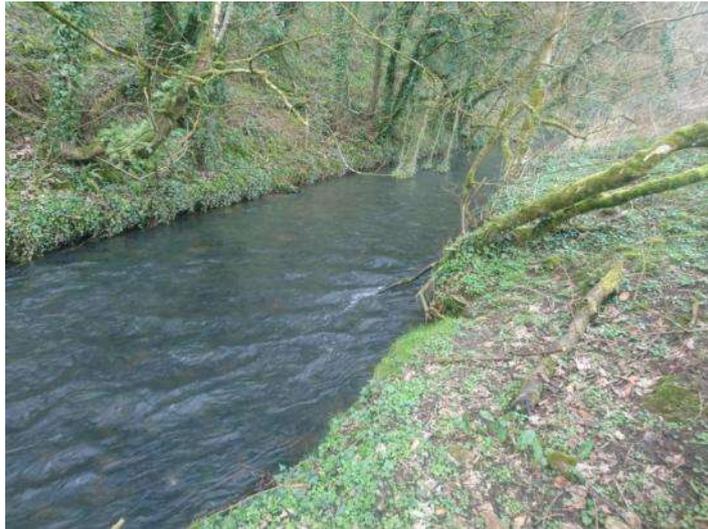
Tree cover was very dense on the RB in the lower half of the reach and some strategic thinning of tree cover would be beneficial. This would allow light penetration to the channel and promote marginal and aquatic plant growth. However, it is important to do this in a structured way that retains some shading over pools and riffles. On a more positive note, there was an apparent abundance of naturally fallen large woody debris (LWD) in the same wooded section. Bankside trees, limbs or branches that fall or are washed into the river play an important role in natural river processes, sorting and scouring gravels, and creating backwaters immediately downstream. The habitat complexity provided by woody debris supports a range of invertebrate prey items for

Heavy tree growth at Llandough, some structured coppicing along RB (left of picture) would be beneficial.

The tree thinning work should focus on coppicing and felling bank-side trees particularly over the most densely shaded areas, preferably rotating the work over a 4-5 year period and creating a canopy of varying heights and sizes. An approximate 'rule of thumb' is to allow 50% dappled light, particularly over riffles, retaining 50% shade over the rest of river as a whole. It is sensible to leave slightly more shading over pools as these act as refuge areas for all life cycles of brown trout during low flows. Retaining some tree shading can limit extremely high 'spikes' in water temperature, reducing mortality caused by low dissolved oxygen levels.

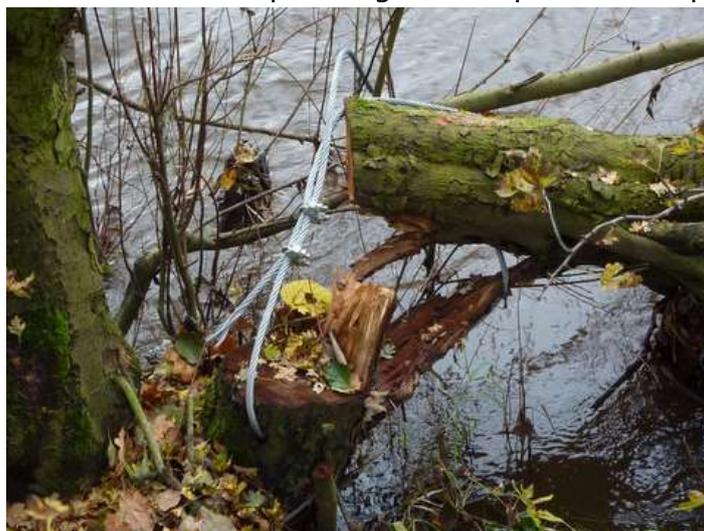
Hinged 'tree kicker' attached with steel rope and crimps

- Hinging of large branches or trees that are close to the water is a good way of introducing 'living' material into the channel. The tree can be partially severed leaving a 'hinge' attached so the tree or branch can still grow. Willow is an excellent tree to work with in this way because of its 'bendy' properties. Once hinged into the channel in the desired direction, it can be pinned to the bed accordingly. Hinging larger trees will require a qualified chainsaw user. Some smaller material can be hinged using hand-saws. Large hinged boughs may need to be additionally secured with multi strand steel rope and crimps or strong (non rot) rope in order to be secure during flood conditions.

Any hinges that snap or are severed during processing can be secured to substantial bankside trees or stumps using steel rope and crimps.

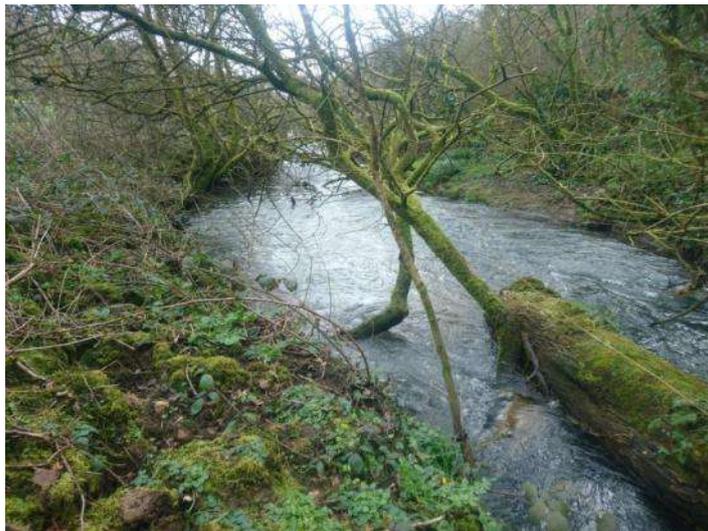
juvenile salmonids. The increased velocity of water over, around and underneath LWD often has the effect of sorting gravel directly downstream, which brown trout and sea trout may find suitable as spawning substrate. During spates, brown trout will often use large logs or branches as a refuge protecting them from high flows. Large tree trunks or submerged branches in this area should be retained where possible as long as they don't pose a serious flood risk.

Superb existing LWD at Llandough, some structured coppicing along banks downstream here would be beneficial).

A post should be driven into the river bed on either side of the log or branch until firm (If the bed is hard then a pilot hole for the post should be driven using a sledge hammer and iron bar). Loop the galvanised fencing wire around the posts either side of the log and use fencing tacks (preferably large) to pin the wire to the posts. Leave several inches of slack wire above the log (this allows the wire to tighten down onto the log during post driving). Drive one post into the bed part way, then drive second post in until wire starts to tighten over the log. Do not over-tighten the wire. Eventually the wire should tighten over the log, pinning it to the river bed. It can be made easier if you have the weight of several people standing on top of the log to hold it down whilst the posts are being driven. Always use the personal protective equipment when working in this way i.e. hard hat gloves and eye protection. Always use extreme caution when using a manual post pounder in the river. Manual handling guidelines and basic training are recommended for this kind of river work.

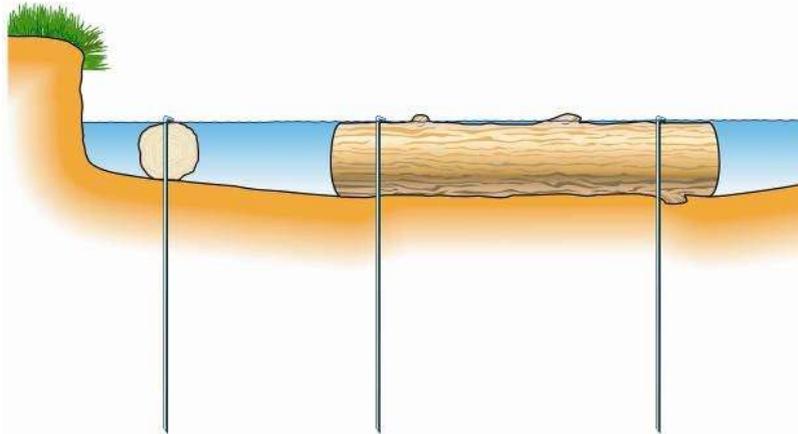
Example of LWD fixed with steel rebar

In some areas it may not be practical to drive chestnut posts into the river bed because of hard substrate. In this case, large woody debris will need to be pinned using an alternative method. Using metal rebar is an effective and secure way to attach large boughs firmly to the river bed.

Rebar thickness and length should be appropriate for the job and chosen according to the size of the LWD being used. If the LWD is likely to encounter high flows then thicker rebar of longer length is recommended. It is easier to sledgehammer thicker rebar above 16mm in diameter as it is more rigid. As an example; a piece of LWD with a diameter of 300mm and a length of 2.5 meters should be secured with at least two 1m lengths of steel rebar. This would leave at least 700mm driven into the bed.

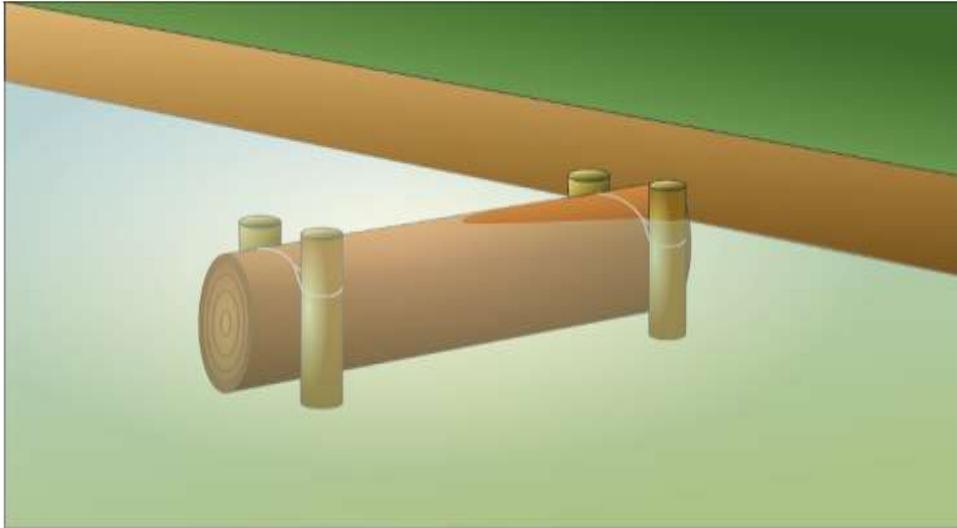
Close-up drawing of pinned LWD

Auger or drill holes just big enough for the rebar into the wood in appropriate places, this is usually at either end and with a piece of rebar and additional pieces for every subsequent 1.5m in length.

Drive rebar through holes and into riverbed until top of rebar meets LWD, making sure that the LWD is secured and doesn't wobble or move.

Talk to a steel fabricator and spot weld a washer on to the top of the rebar or alternatively heat and flatten, or bend, the end of the rebar so it is slightly bigger at the top, this will similarly reduce the likelihood of the LWD coming away from the rebar under high flows. It is recommended that CADAA seek professional advice and training before undertaking this kind of work.

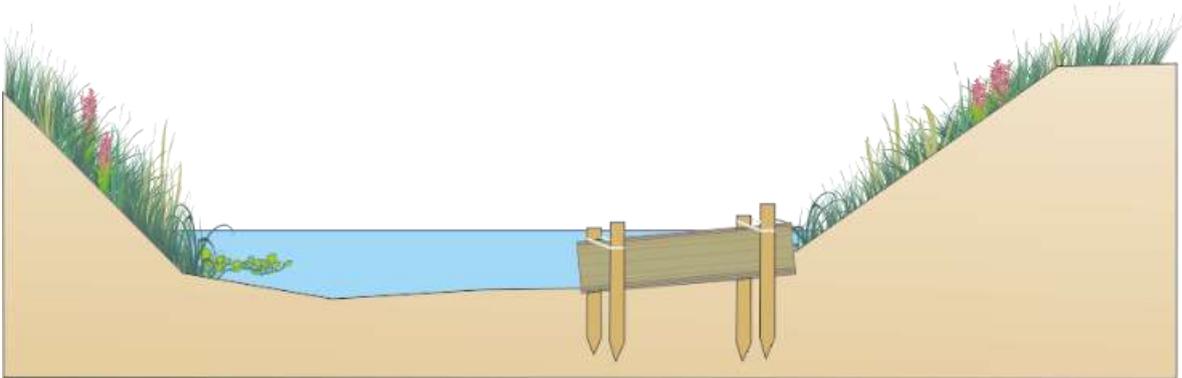
Pinned log deflector with paired posts and fencing wire

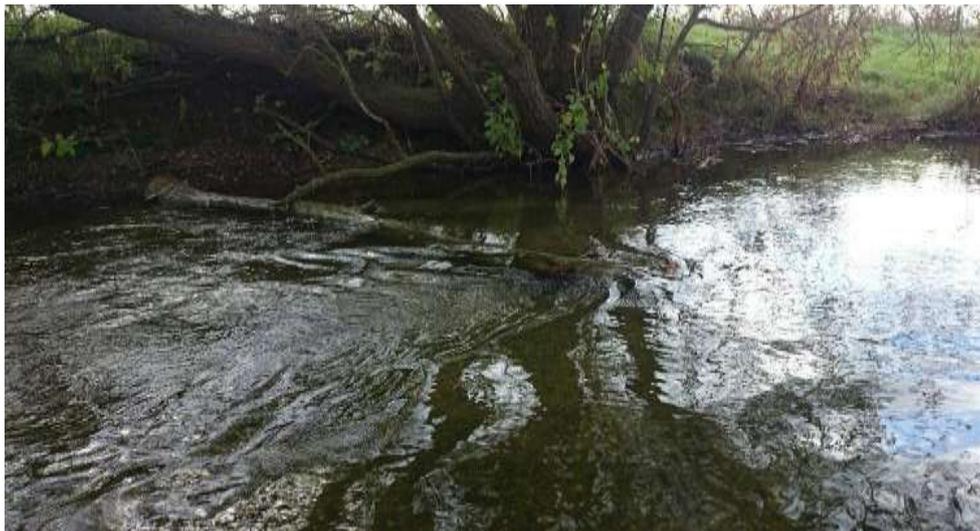
Log deflector pinned with posts and wire (angled upstream, creating bed scour)

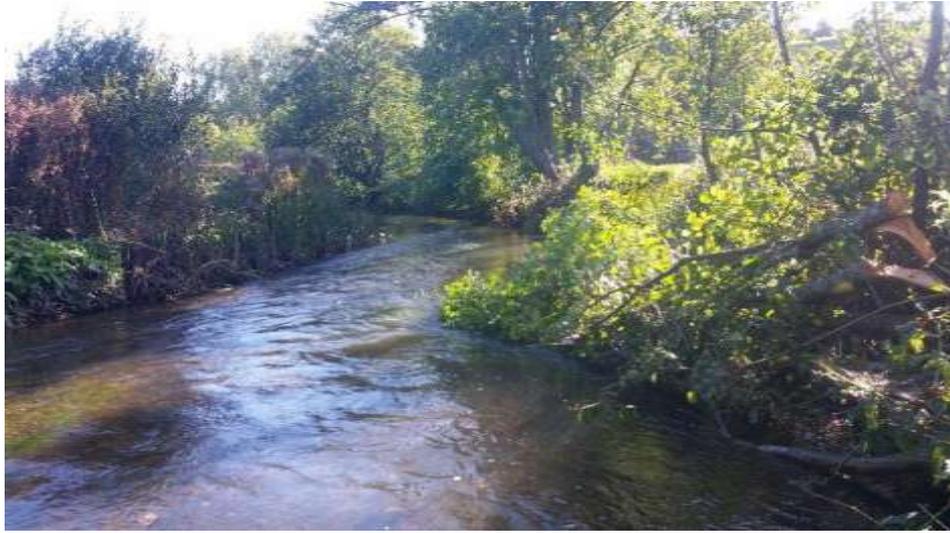
Alder tree with 'living hinge' still attached (angled downstream)

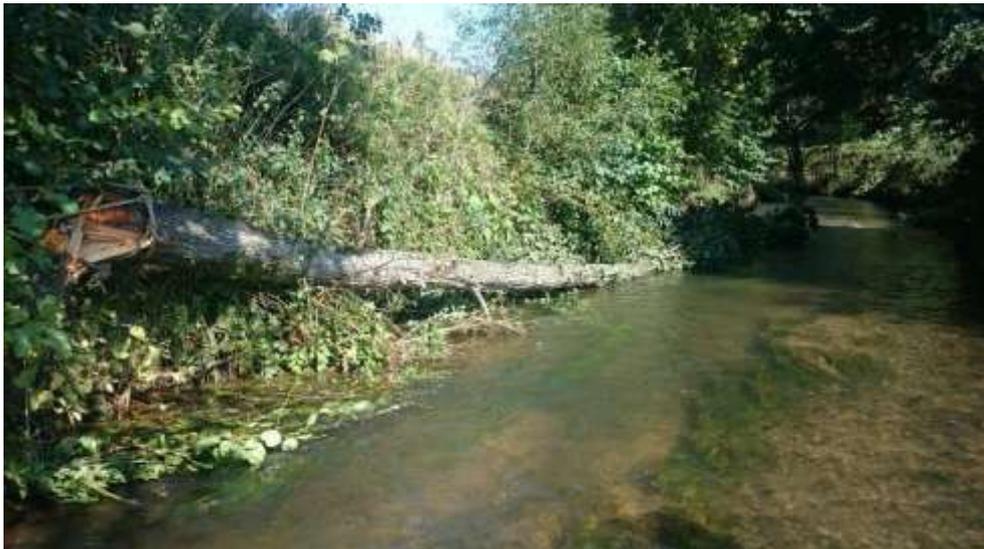
Large hinged Alder tree (Willow is just as good and often responds well to hinging)

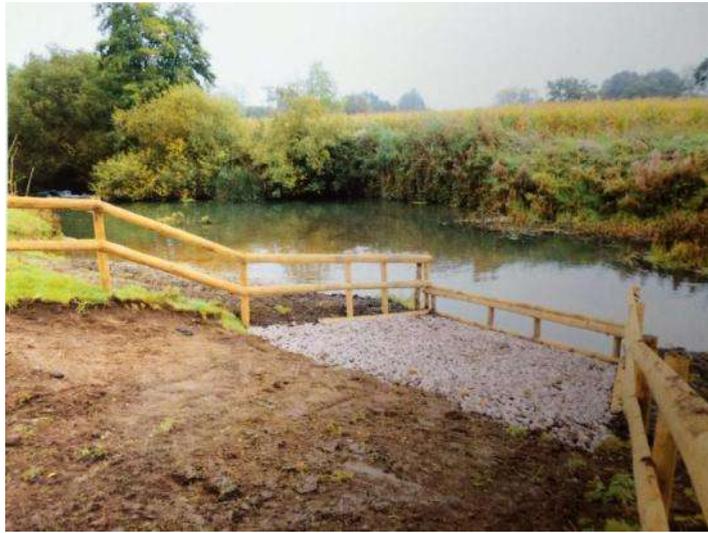
An excellent example of a fenced cattle drink with limestone base.

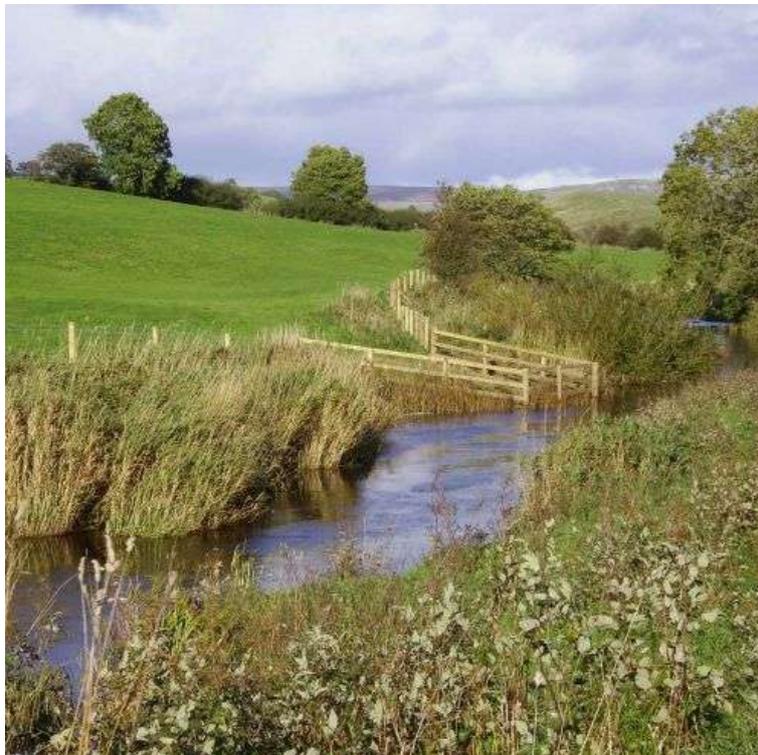
Fenced drinking bay in the Yorkshire Dales.
