Advisory Visit to the River Ure

11th November, 2014

1.0 Introduction

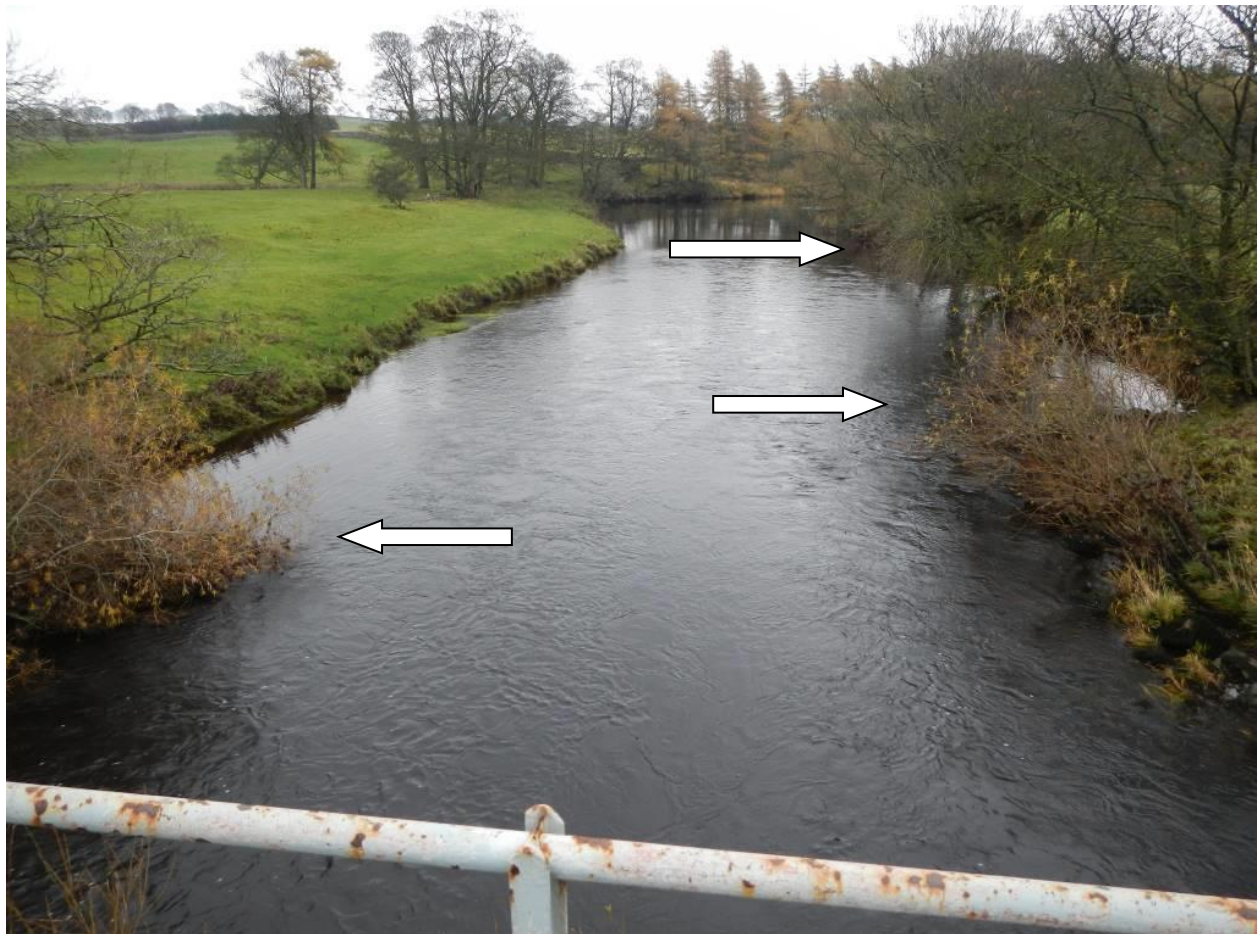
Progressing downstream from the access bridge (u/s limit), low-level and trailing branch cover provides some areas of high quality adult trout habitat (Figure 1). However, grazing pressure from livestock in the first field downstream on each bank is preventing herbaceous vegetation from becoming established and inhibiting the formation of a naturally rough overhanging margin. This greatly increases the potential for bank erosion, reduces the level of juvenile cover available in the river margins, and

Figure 1. Good trout cover from large established trees (white arrows) but a lack of cover on the grazed LB.

Riverside buffer fencing would be beneficial along all sections where livestock have access, especially in the areas where banks are more heavily grazed. Both banks at the upstream limit of the Bear Park Water (Figures 1 & 2) and the RB of the Wensley Water (Figures 5, 6 & 7) are in the greatest need. Fencing throughout the Wensley Water, on both banks, would also be greatly beneficial.

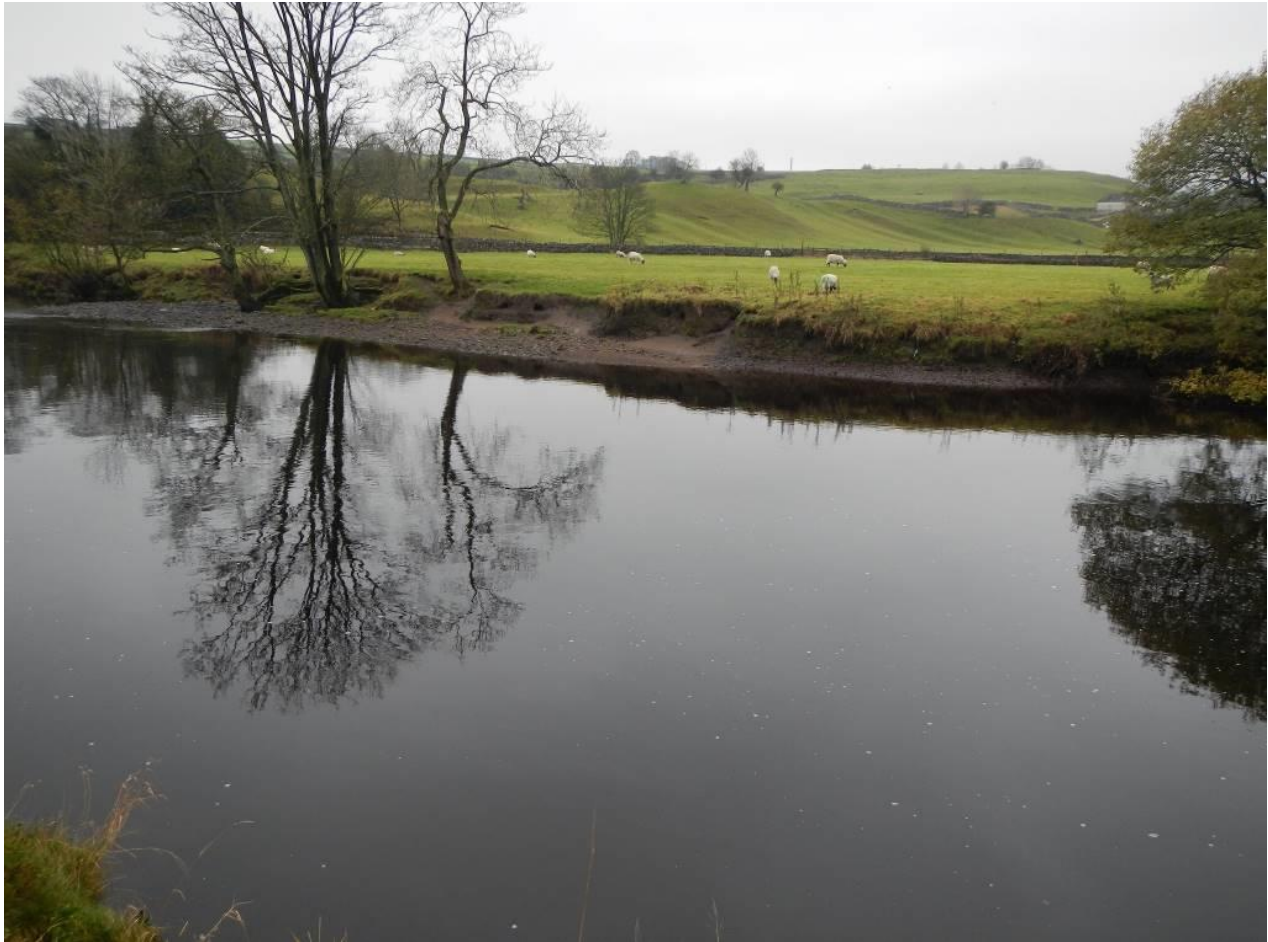
prevents natural channel narrowing that would occur if depositional features in the river margin consolidated with vegetation (Figure 2). Grazing also prevents the natural understory of self-set shrubs that would ordinarily replace larger trees as they die or wash out. This will ultimately lead to a loss of bankside trees and vital cover over time.

Figure 2. Significant erosion on the inside bend, predominantly due to sheep grazing. Note the large mature trees but lack of smaller shrubs.

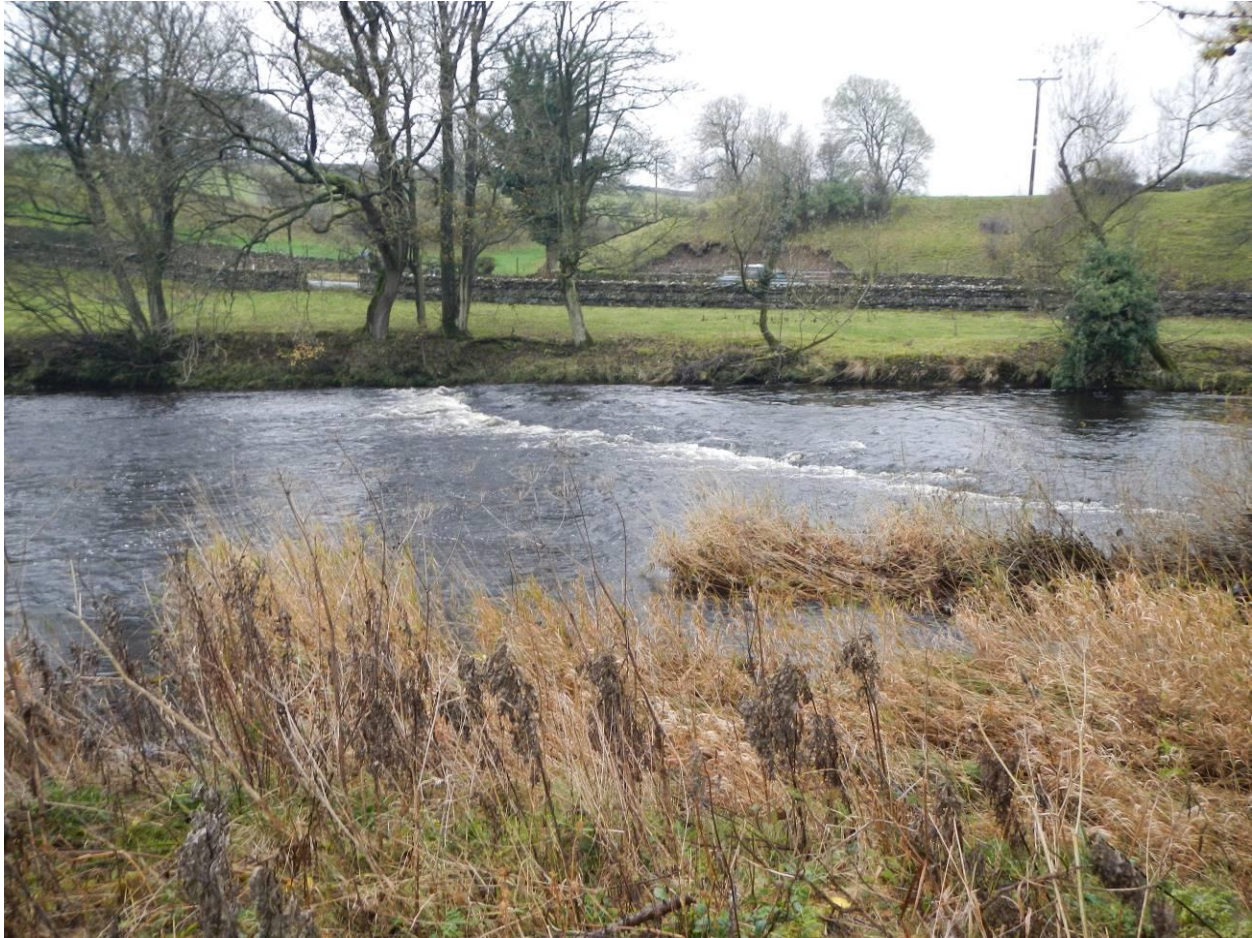
Downstream, where livestock are excluded, a much healthier diversity of grasses and herbaceous vegetation is present along the river banks. Limestone bedrock also becomes more noticeable, and forms the predominant river bed feature for the rest of the section. This limits the availability of deep deeper pool habitat, providing mainly riffles and glides with the occasional deep section around fissures in the rock. This fast flowing, well-oxygenated water provides high quality habitat for all trout and grayling life stages, except spawning gravels, which were in short supply.

Figure 3. High quality habitat provided by long grasses and herbaceous vegetation along the un-grazed LB (foreground) with poor cover/bank protection on the grazed RB (background). The rough overhanging margins (foreground) and bedrock substrata provides a good range of flow disturbance and habitat niches for all life stages.

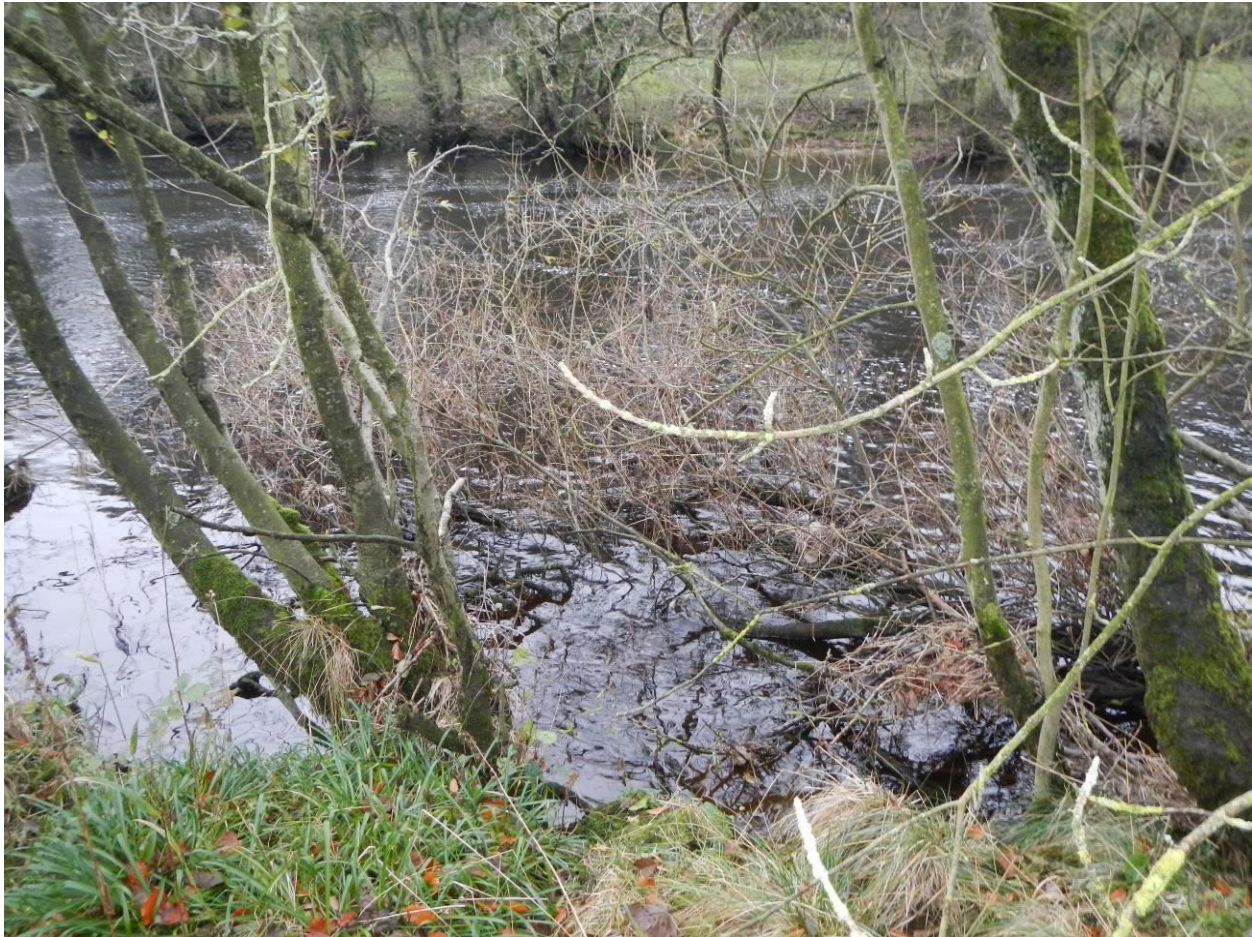
Trailing branches, particularly fallen/lying willows (*Salix* spp.) provide excellent habitat and refuge in the river margins for fish. The shade and cover provided enhances not only the immediate area (within the structure), but also the water alongside, allowing fish to sit in open water where food is readily available, but with the added security of an easily accessible bolt-hole nearby. Should the threat of a predator occur, fish can then utilise the structure as it will be less penetrable by most predator species in comparison to the bolting fish. Studies have shown that even a small reduction in the overall efficiency of predators causes them to give up earlier and move to more profitable hunting grounds.

Figure 4. High quality trailing cover/structure that enhances both the fish holding potential of an area and the ability of fish to evade predators.

It is recommended that the current practice of maintaining natural cover is continued, with minimal or no pruning of bankside trees undertaken. For an additional enhancement, where low-lying branches are present, they can be bent/trained down into the water to create additional lies. This may make

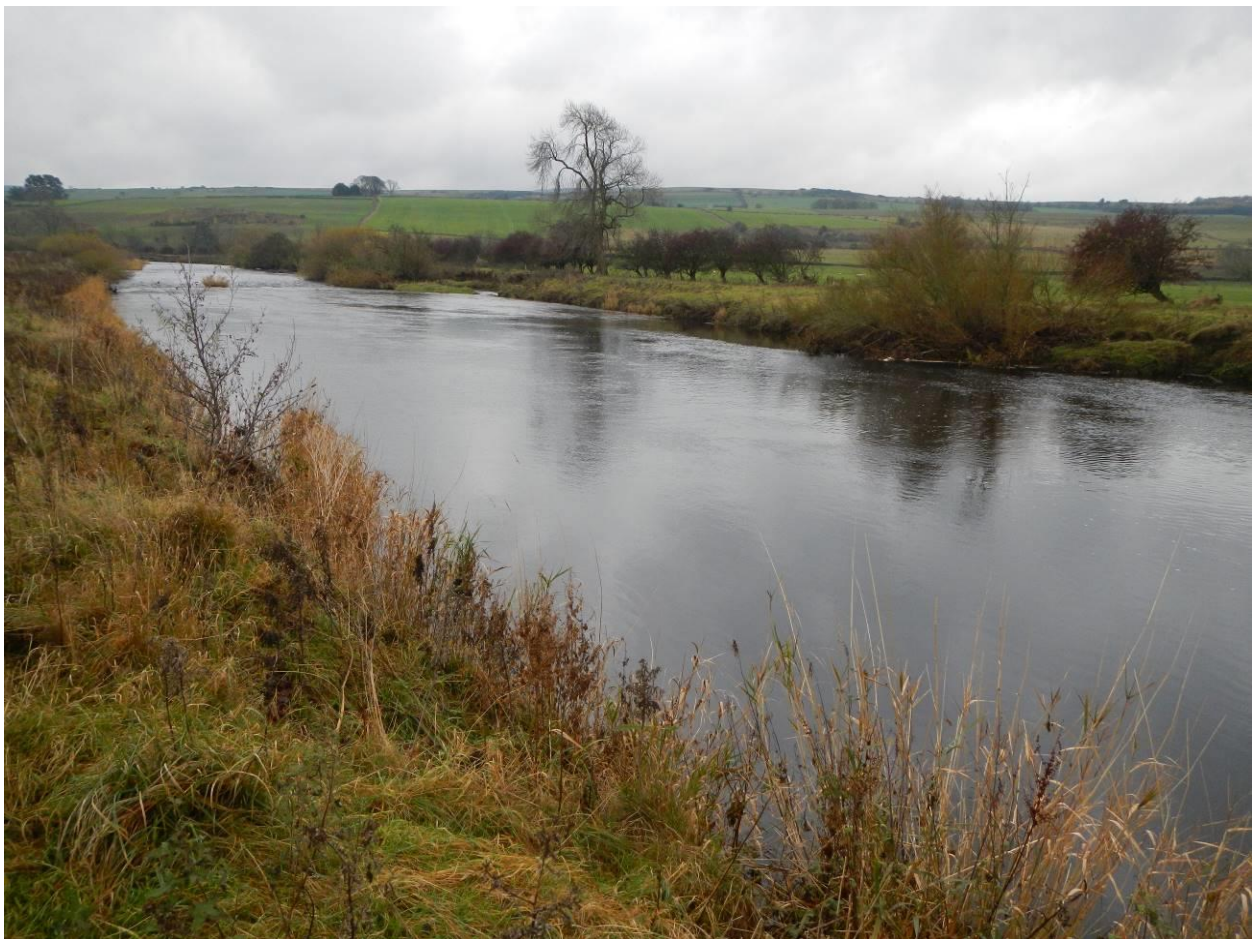
section being particularly straight and lacking the deeper pool areas naturally associated with bends (Figure 5).

Livestock have access to both banks for most of this section and correspondingly, there was a lack of smaller self-set shrubs, particularly on the RB. Un-mown, rough ground along the majority of the LB does appear to be discouraging sheep from grazing that area so heavily (as they prefer the lush re-growth of the shorter mown grass); this has allowed some rougher grasses and herbaceous vegetation to become established although the lack of trees and cover over the river margins was notable and greatly reduced the potential fish carrying capacity of the area (Figure 5). Even light, periodic browsing can seriously inhibit new trees and shrubs from becoming established as livestock will invariably target lush young shrubs.

Figure 5. Rough margin and the occasional self-set shrub (LB) with a lack of vegetation and shrubs on the RB. The occasional established trees provide the only high quality natural cover features.

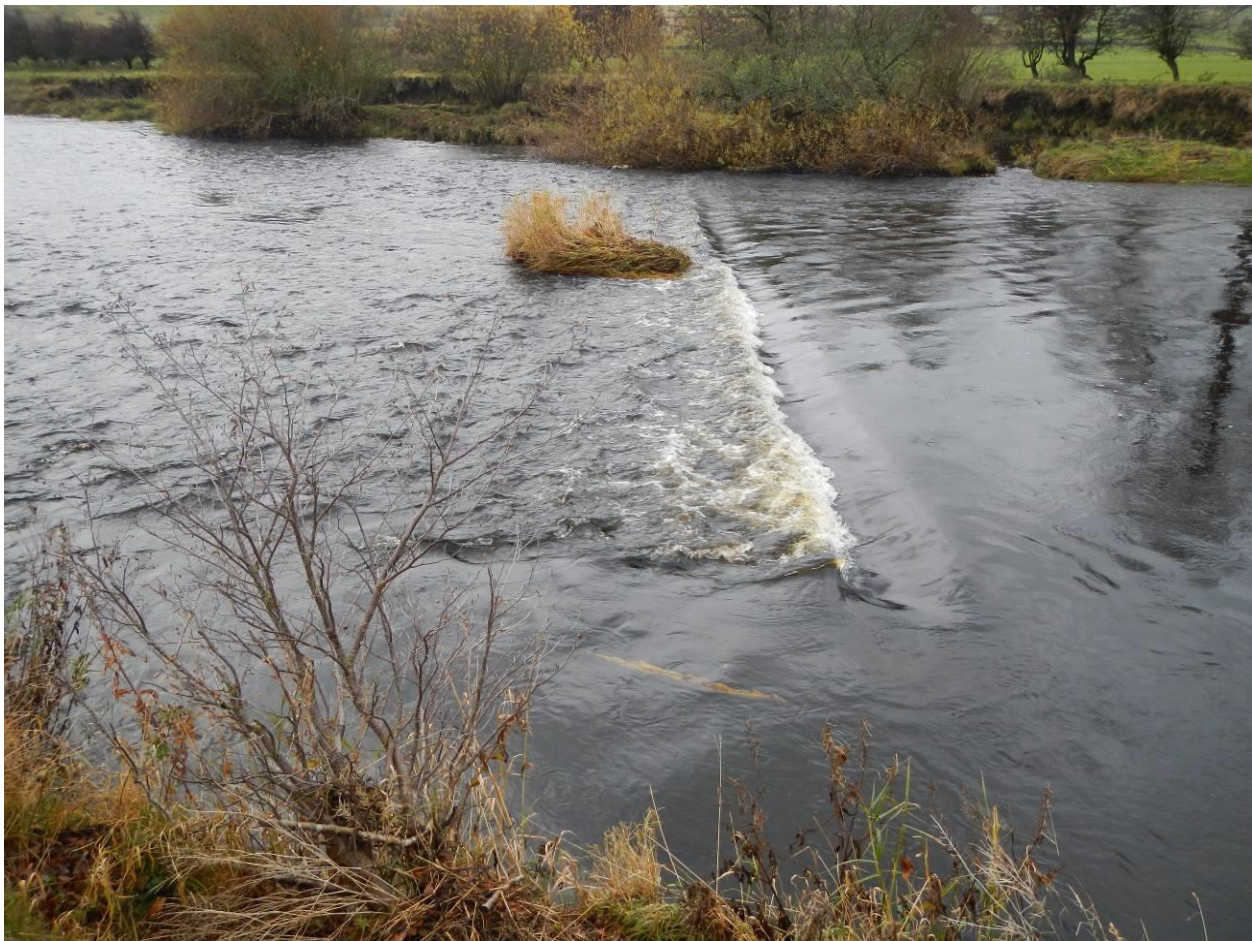
On the straight section, two diagonal groynes are present within the river channel (Figures 5 & 7). The structures do not appear to extend the full

width of the channel, and therefore should not create a significant issue to fish movement; however, they do potentially create an artificial fixed bed level that reduces the potential for bed scouring and natural pool creation upstream. The original purpose of the groynes it is not known, but such structures were often created as bed checks, to prevent incision of the bed, or as fishing structures. While they provide some beneficial flow disturbance, hard engineered structures that force changes to the channel often result in unintended negative consequences in the long term. Current best practice would be to reinstate natural features such as large woody debris/trees that work with natural river processes to facilitate formation of habitat.

Figure 6. Diagonal groyne, the benefits of which are outweighed by the detrimental side effects, particularly fixing of the bed level.

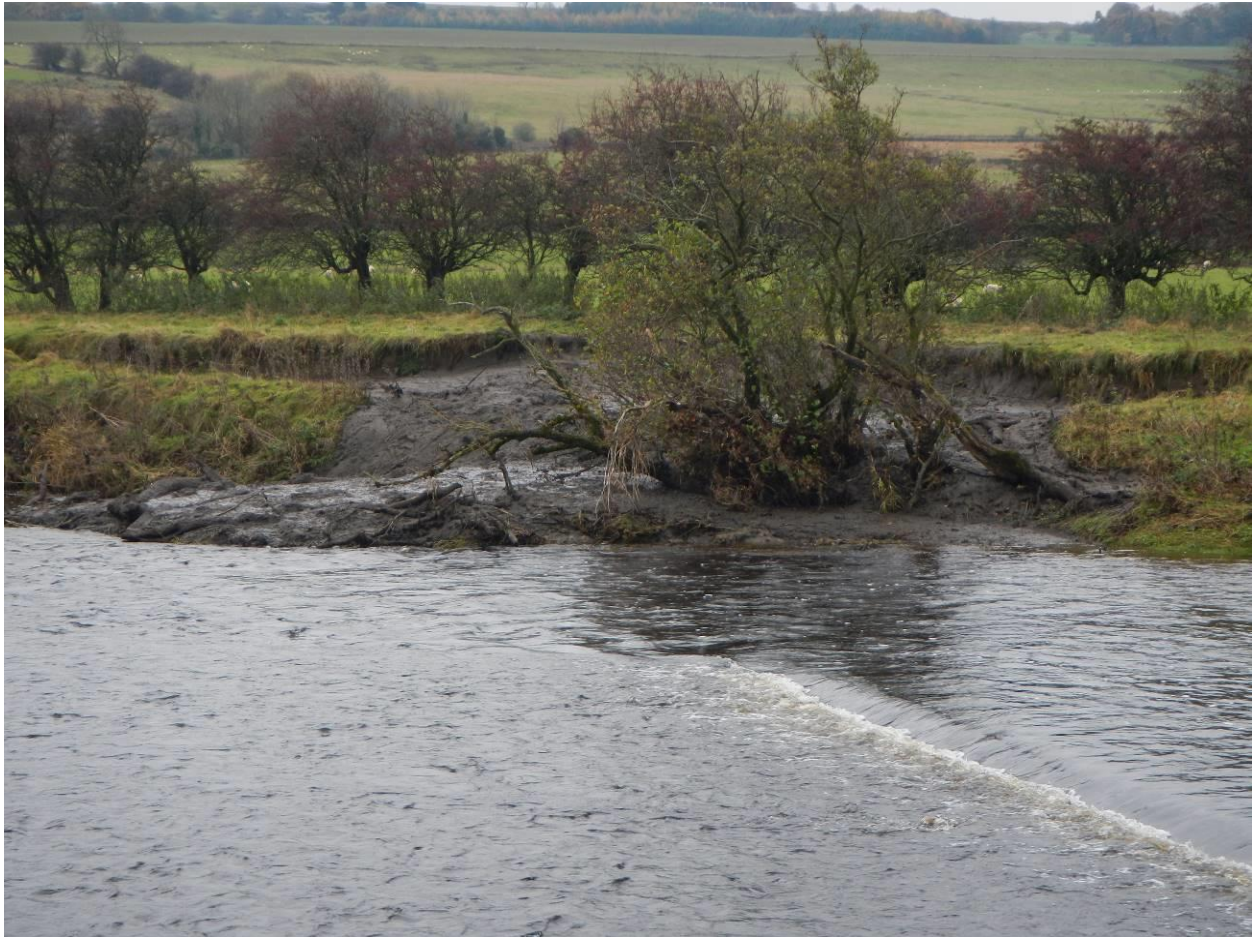
Figure 7 shows another land management issue on the RB. It appears that the tenant/landowner has attempted to counteract an area of erosion around a bankside willow (very probably caused by grazing and trampling/poaching of the bank by livestock) by tipping mud into the void. This is a highly inappropriate action and some of the material has obviously already washed

into the river; the rest has a high probability of washing out in the next high water as there will be no vegetation growth to consolidate the mud during the dormant winter season. When the rest of the mud does wash out it will be a significant and unnecessary sediment input to the river. This actually constitutes a potential pollution incident.

Figure 7. Area of erosion around a willow tree where mud has been tipped and now poses a sediment input to the river.

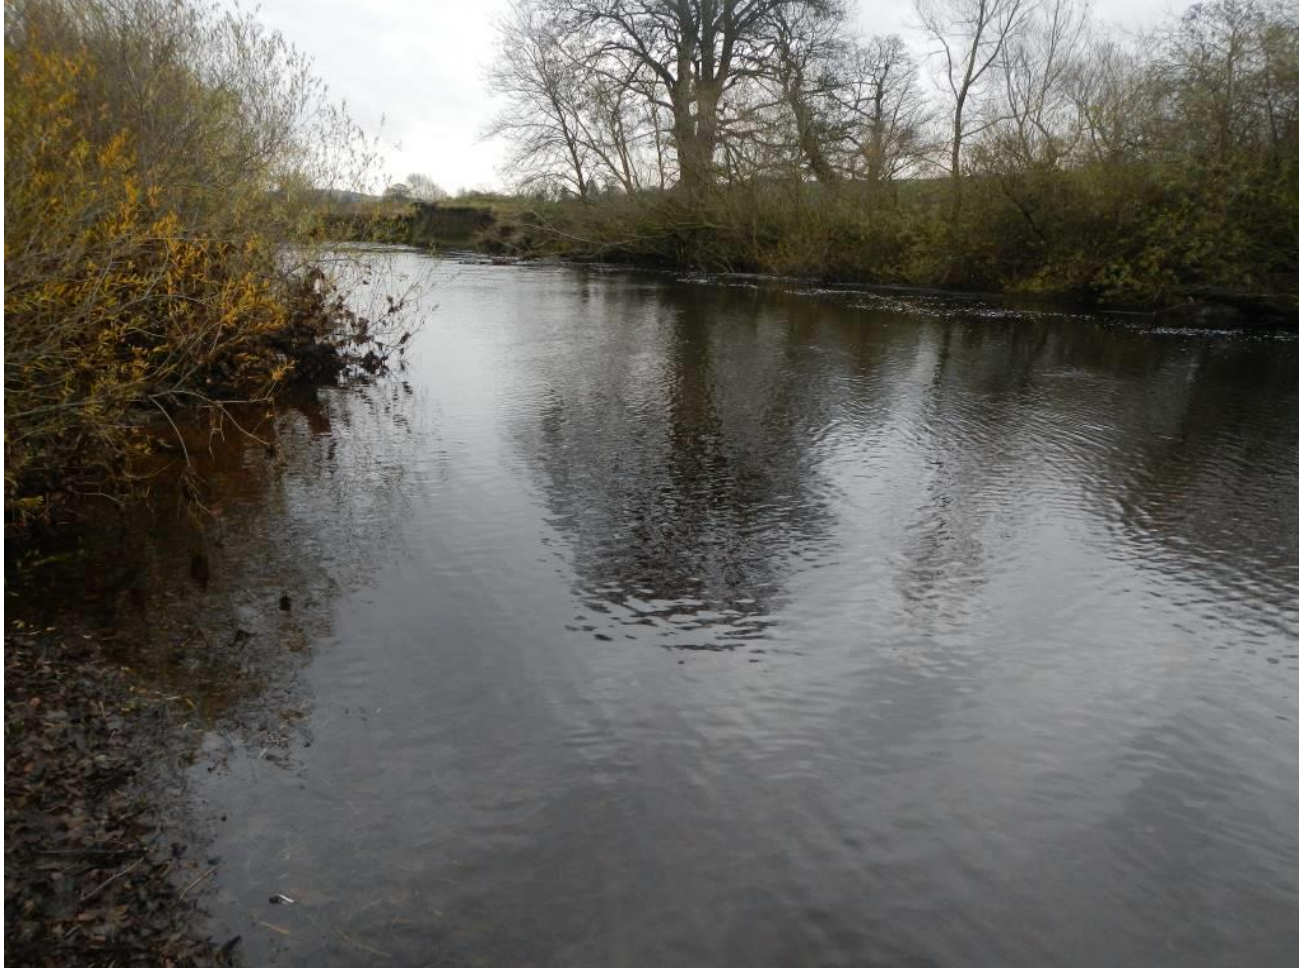
Further downstream, long sections of more significant erosion occur, leaving high exposed earth cliffs that are highly susceptible to further erosion (Figure 8). Where willow trees and shrubs are present the river banks are far more stable and high quality in-channel habitat is provided by their roots and trailing canopy. While the erosion issues are contributed to by grazing of the river banks, it is also probable that the long straight section upstream supplies excess sediment and accelerated flow velocities, due to the increased gradient and lack of pools/bends to slow flows and accumulate sediment. As a result, flows hit the bend harder than would naturally occur, scouring hard on the outside, and depositing bed material on the inside and

Figure 8. Where willows can become established they provide high quality trout cover and vital protection to the river bank.

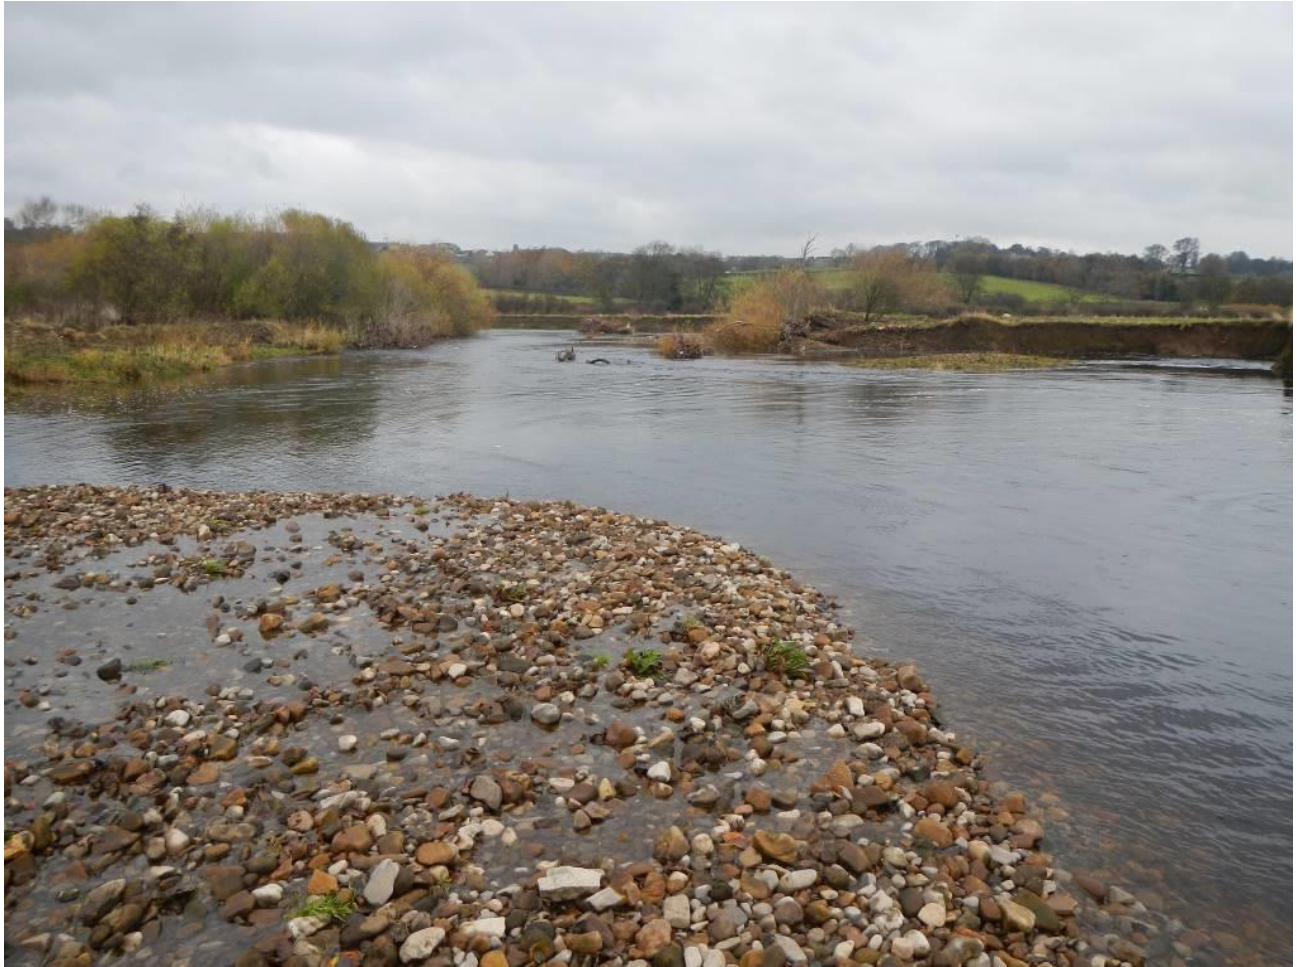
at the tail of that pool where velocities are lower (Figure 9). These depositional features then take up channel capacity and force flows further into the susceptible outside bank.

Figure 9. Significant erosion of the RB further exacerbated by accumulations of bed material supplied from upstream forcing flows into the RB.

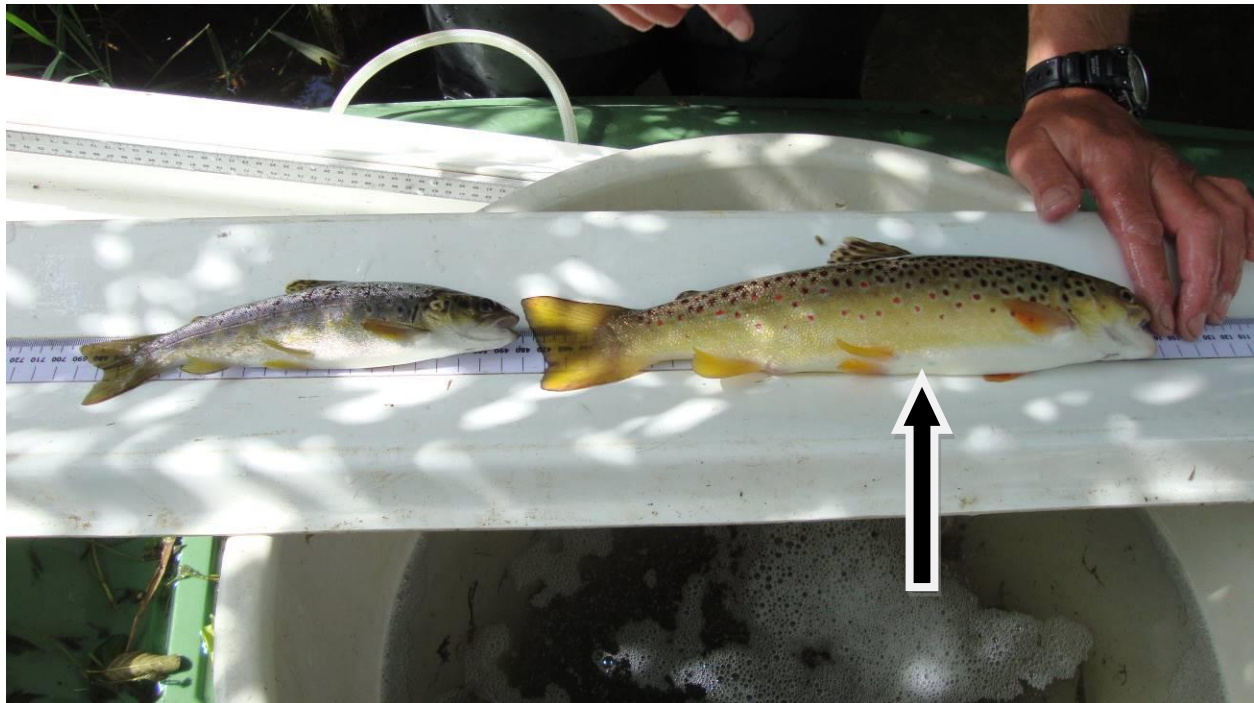
stocking. There is also likely to be charge for the service, but the benefits to BPF should far outweigh the cost implication. Figure 10 shows a comparison between a stocked, panjet marked fish and the smaller wild fish. Note that the panjet mark can be quite subtle and anglers will have to look carefully at each fish.

Figure 10. Small wild fish (left) and larger stoked fish (right), with panjet marks near pelvic fins (black arrow).

There are several methods of marking fish but Panjet marking with alcian blue dye is usually the quickest, easiest and cheapest method, producing a small tattoo-ed spot on the fish's skin. Longer term retention of the dye can be poor, but this issue is lessened by the fact that majority stocked fish are unlikely to persist in BPFF waters for long anyway. The club's trout supplier should be able to Panjet mark the fish but may be reluctant to do so due to the increased work and the fact that it may highlight the poor returns from
