Walkover Report
River Wear – Ferryhill and District AC
July 2014

1.0 Introduction

This report is the output of a site visit undertaken by Gareth Pedley of the Wild Trout Trust to the Rivers Wear and Browney (Ferryham and Brockbank) on 17th July, 2014, which comprise two of several Ferryhill and District Angling Club (FDAC) river beats. Comments in this report are based on observations on the days of the site visit and discussions with Jim Wood (FDAC).

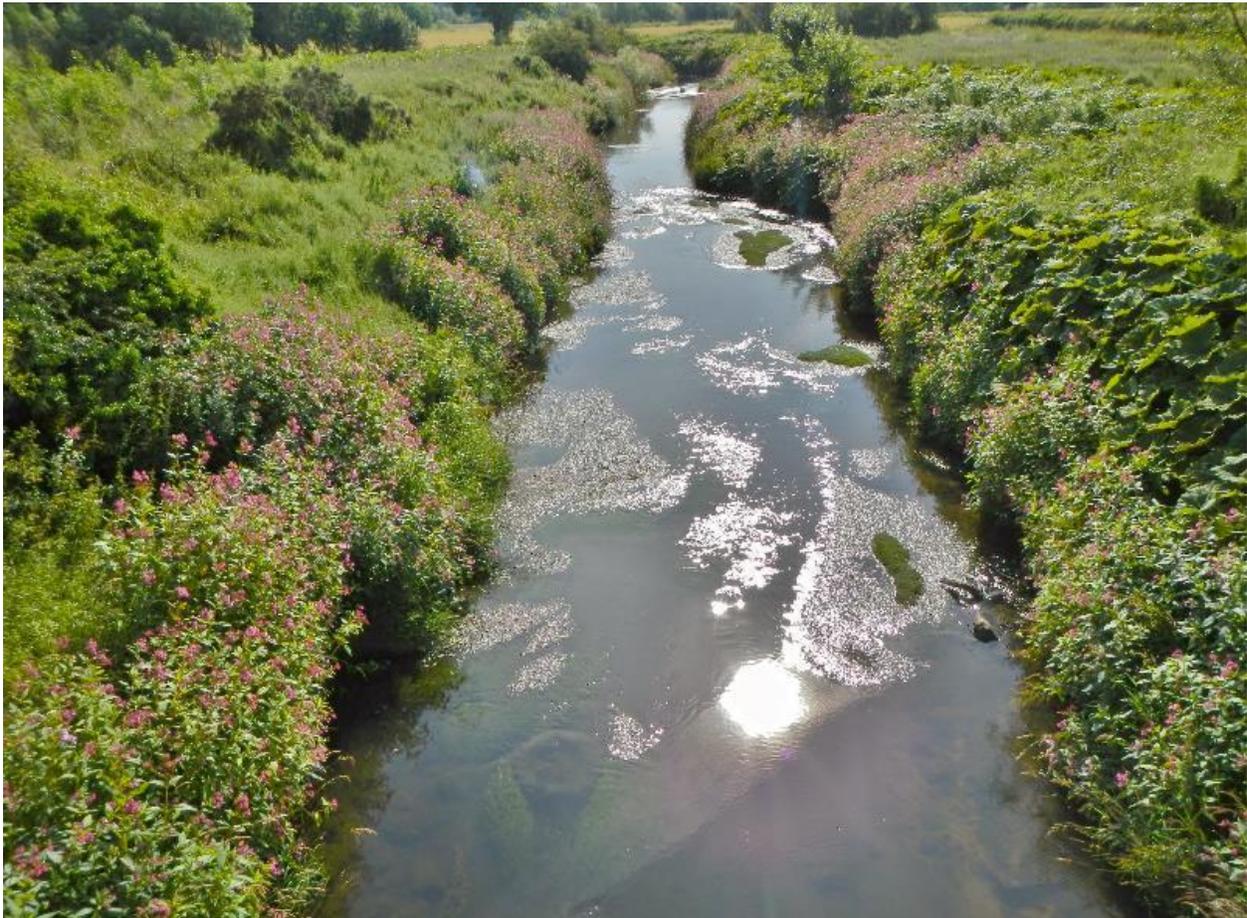
Looking downstream from the A167 bridge (Fig. 1), the straightened nature of the channel and generally uniform dimensions can be seen. Viewing the site on Google maps also show the flood banks along the river which result from the past dredging activity. These impacts have produced a channel in which habitat is significantly degraded; generally being uniformly wide and shallow. Some pools do exist where bends remain (Fig. 2), but are far fewer in number than would naturally be present.

Figure 1. Straight, uniform section of channel downstream of the A167

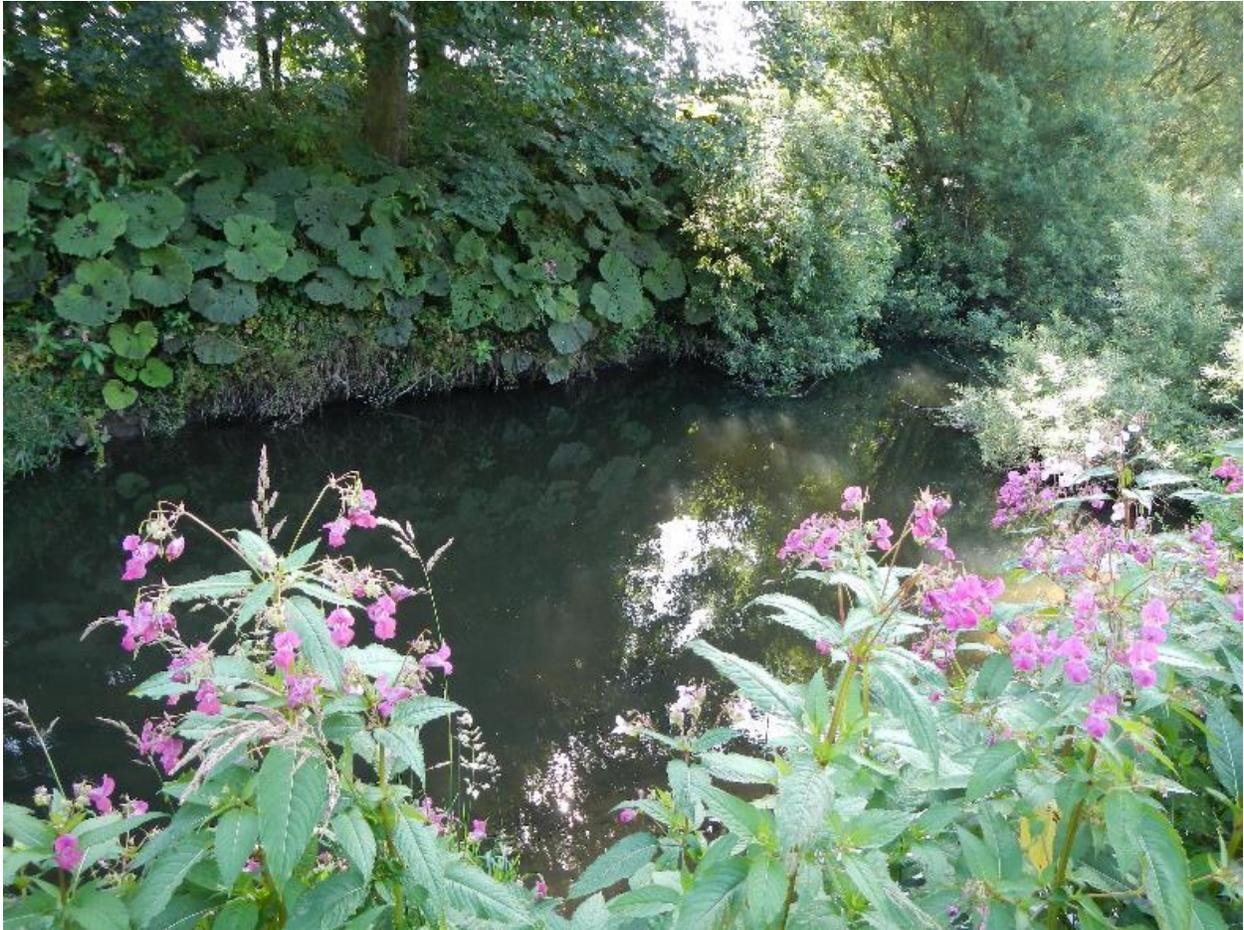
Figure 2. One of the few deeper pools on the lower Browney, with good cover provided by willow (right of shot). Also note the Himalayan balsam (foreground)

Himalayan balsam (Fig. 2), which is visible in all photographs (pink flowers), is a major issue as it shades out other bankside species during the summer, only to die back in the winter, leaving little bank protection increased erosion risk (the associated inputs of fine sediment can choke gravels). This issue is even more significant on rivers with sandy, friable banks, as on Wear and Browney. Balsam can inhibit formation of the vegetated gravel bars and natural channel narrowing as these features often wash out over winter without the protection of vegetation. In addition, Balsam can also create significant implications for upon invertebrate populations (see link - <http://cabiinvasives.wordpress.com/2013/12/10/himalayan-balsam-and-its-impact-on-uk-invertebrates/>)

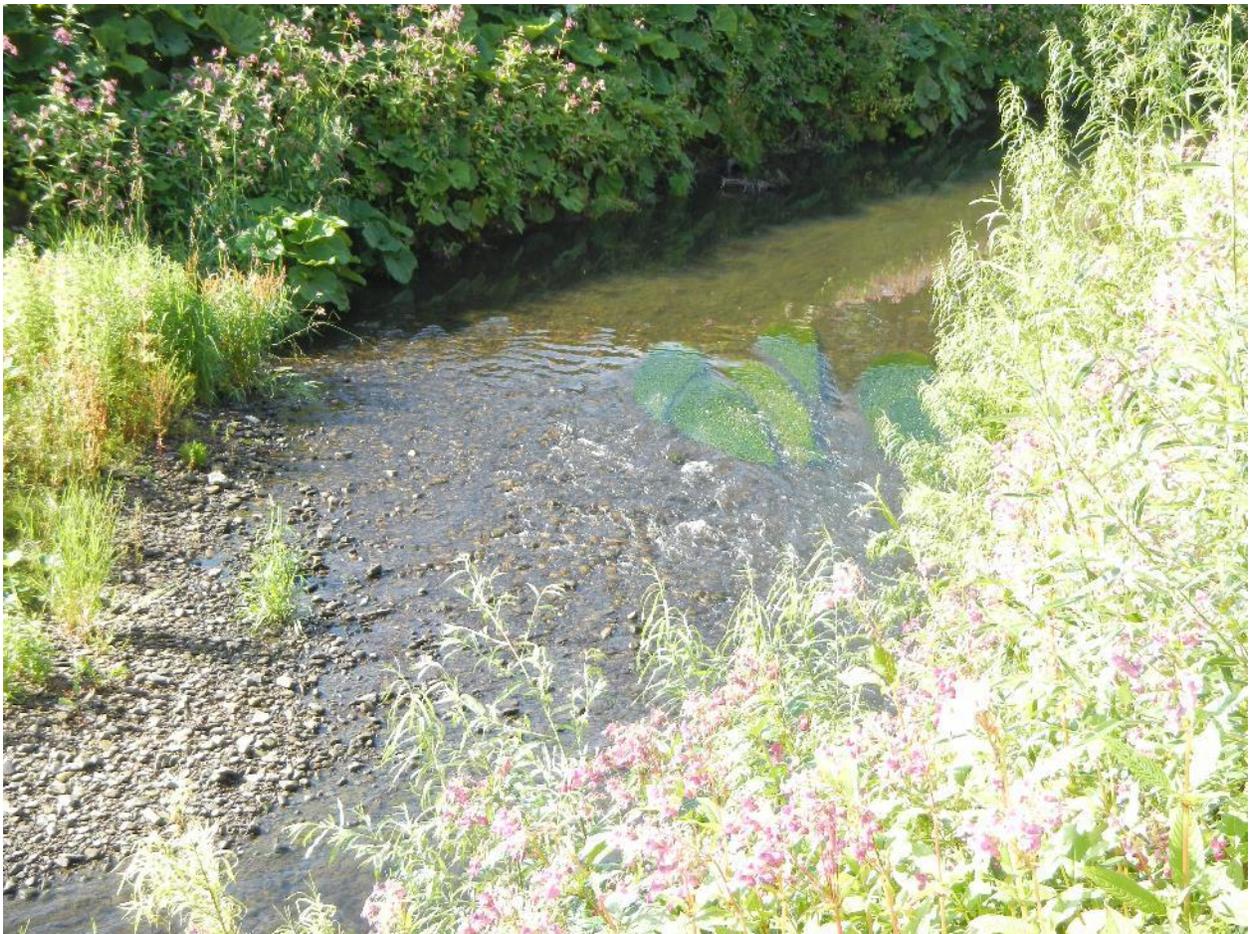
Rivers are, however, adaptable and over time additional materials will aggregate in more sheltered areas, forming bars and shoals within the channel (Fig. 3). These will help to narrow the channel and focus flows, eventually becoming vegetated to reinstate a more natural width. Similarly, bankside trees (particularly willow) will encroach into the channel (Fig. 4), as was occurring in several locations, further accelerating flow in some areas and creating slack water in others (where additional

Figure 3. Naturally forming gravel bar which reinstates some sinuosity and narrows the channel

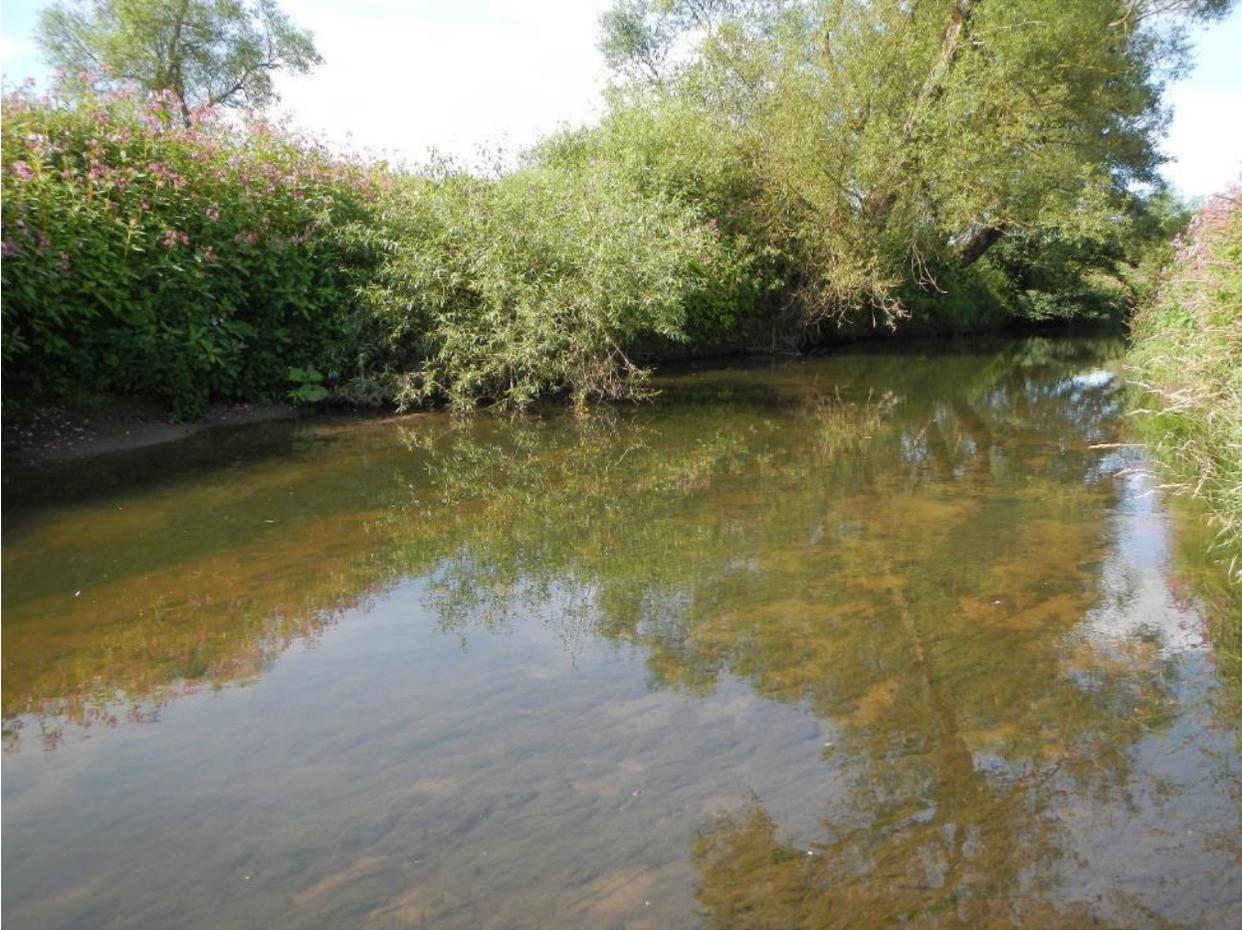
Figure 4. Willow naturally encroaching into the channel. Over time this will aid beneficial narrowing of the over-wide channel, increasing deposition in the river margin. The narrowing effect then works to scour and maintain deeper holding areas within the channel

- This action would be particularly beneficial in the area upstream of the River Wear confluence (Fig. 4). The smaller willow could be easily laid down into the water to facilitate channel narrowing. The same action could also be taken on other similar shrubs throughout the section.
- This could also be undertaken on the larger willow in the background of Fig. 4, to lay it down alongside the smaller shrub.

- As with the tree laying, tree kickers could be created from several trees along the stretch, particularly the large willow immediately upstream of the confluence with the River Wear (Fig. 4). It may be preferable, to attempt to lay the large willow initially, making a tree kicker of it only if the hinge breaks.
- On a small river like the Browney it is also worth employing smaller willow branches/shrubs that can be cut by hand and secured in place along the river margin with stakes. Using living willow means that, as well as the flow variation and sediment deposition created, there is a high likelihood of the branch rooting and forming a new tree, especially if much of the branch is in contact with water and parts of it are driven into the bank or bed sediment.

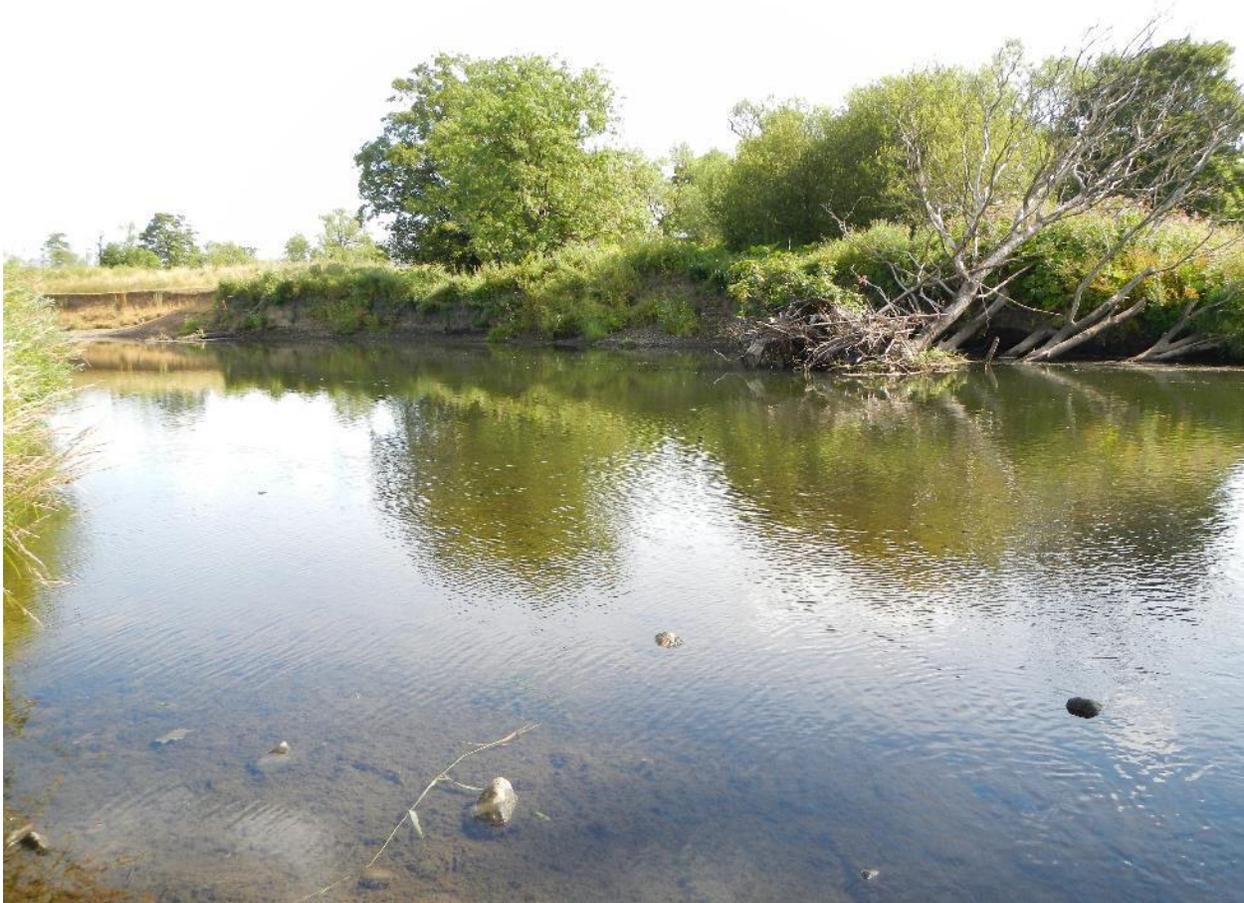
activity is that high flows are trapped within the high banks (unable to spill onto the floodplain), often causing the river to incise further into its bed at peak flows; this destabilises the banks further, often also leading to the loss of bankside trees (Fig. 5). A further consequence is that at lower flows, material supplied from upstream is often deposited uniformly across the straight, flat channel, rather than bars being deposited in the inside of bends (as would occur in a sinuous channel), leading to further shallowing of pool areas.

Figure 5. Over-wide, and shallow section of river with bank erosion issues are causing tree loss. At present, the area around the slumped tree provides the only high quality habitat in the pool but still lacks the level of shade and cover that a living tree canopy provides

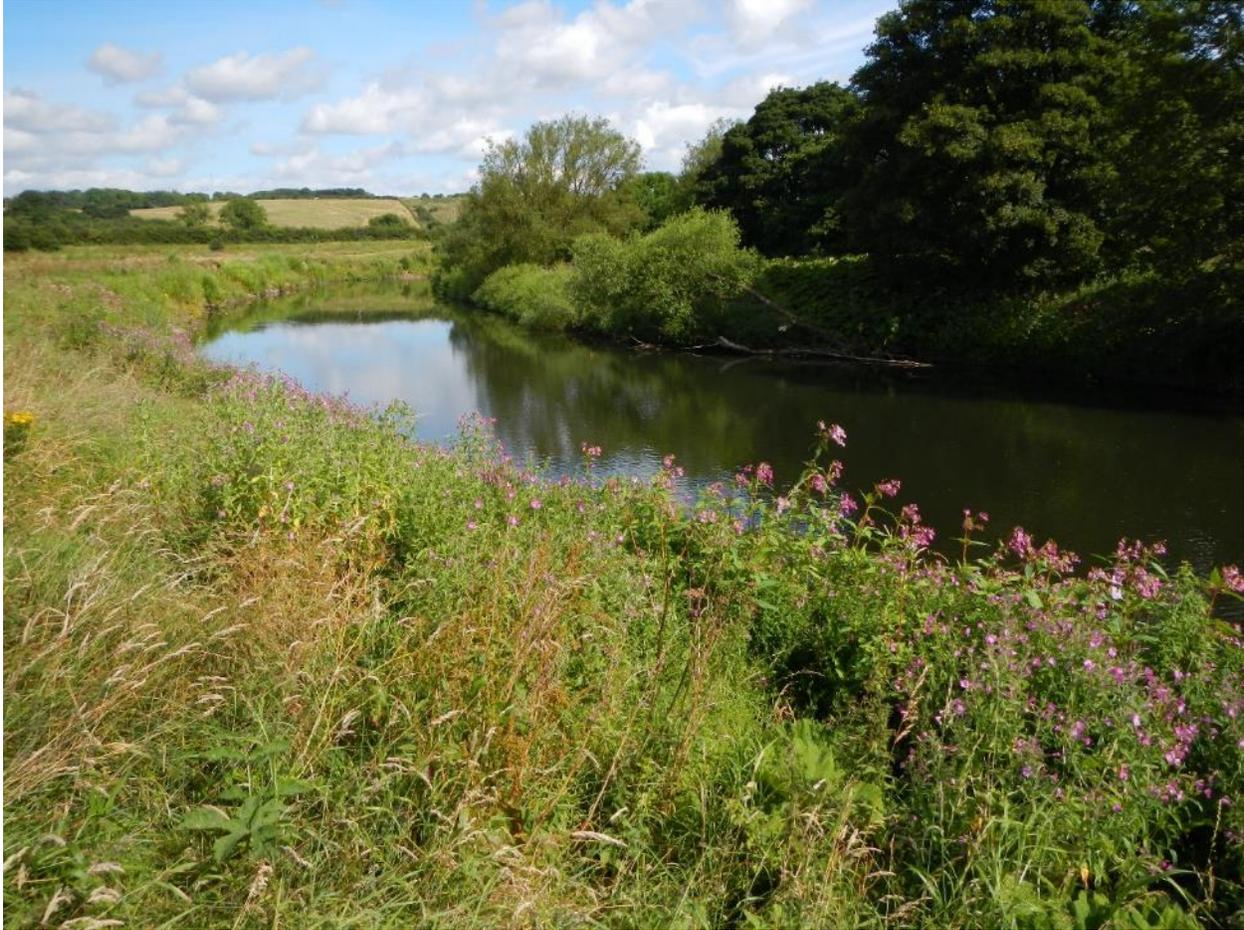
Downstream on the RHB a fallen tree (Fig. 6) represents natural LWD in an otherwise uniform channel and demonstrates the type of feature that could be easily recreated throughout the section with 'tree kicker' type structures. In addition, installing living willow around the LWD will help to increase sediment deposition, locking the materials in place and kick-starting natural channel narrowing. Adjacent to the LWD, a run of osier willow shrubs (*Salix viminalis*) provide good marginal cover, protect the banks from balsam and over time will facilitate valuable channel narrowing. Interspersed with the osier are several crack willows (*S. fragilis*) which also provide great habitat as they collapse into the channel. This is one of the species' methods of spreading, propagating through broken branches that root to create new trees, as well as through catkins/seeds.

Opposite, on the LHB, work using predominantly osier willow has helped to stabilise a previously highly unstable bank. Some of the spilling has washed out in high flows, but in most areas the willow has taken and is suppressing balsam growth.

Figure 7. Natural LWD on the RHB with osier and crack willows downstream. Willow spiling on the LHB

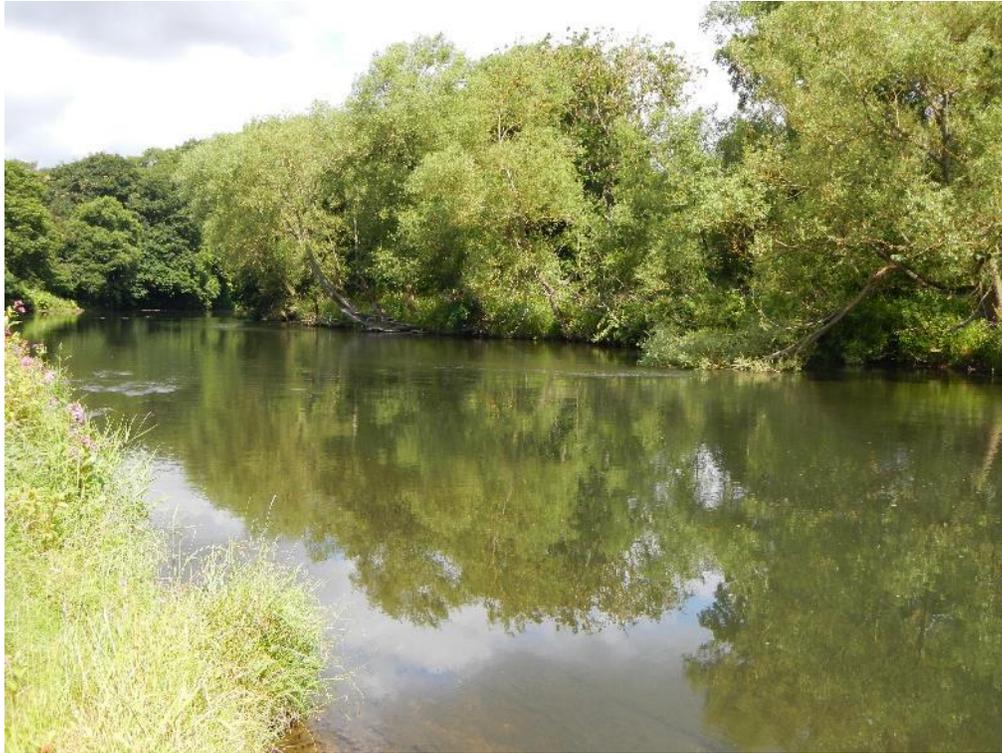
At the downstream limit of the section several mature crack willows provide valuable cover and bank stability (Fig 8.). The most upstream tree in shot demonstrates how the limbs of the species are prone to collapsing under their own weight and fall into the channel (Fig. 9). This provides high quality cover habitat for fish.

Figure 8. Well established mature willow provides good cover and bank protection.

- Laying some of the willows at the downstream end of the section would be beneficial to increase the level of cover and flow disruption. Any of the trees along the RHB as shown in Fig. 8 could potentially be given this treatment to recreate what has naturally occurred in Fig. 9.

- Increasing in-channel structure, particularly in the form of tree kickers would be greatly beneficial in all pools where features and structure is lacking. It is understood that there have been issues with gaining consent for this type of work in the past, this may mean that the technique has to be limited to areas where 'kickers' can be cabled to rooted tree stumps. This too would be ideally suited to the downstream end of the section in the area around Fig. 8.

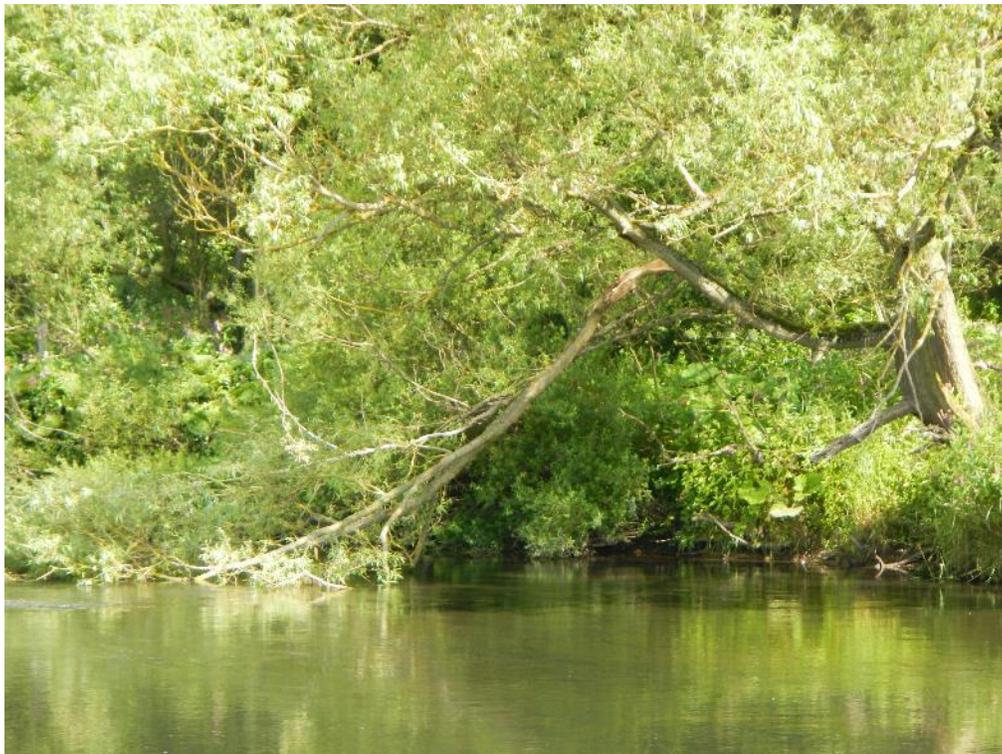
Figure 9. A crack willow limb that has collapsed into the river provides excellent habitat and can be recreated through the laying technique; much like laying a hawthorn hedge.

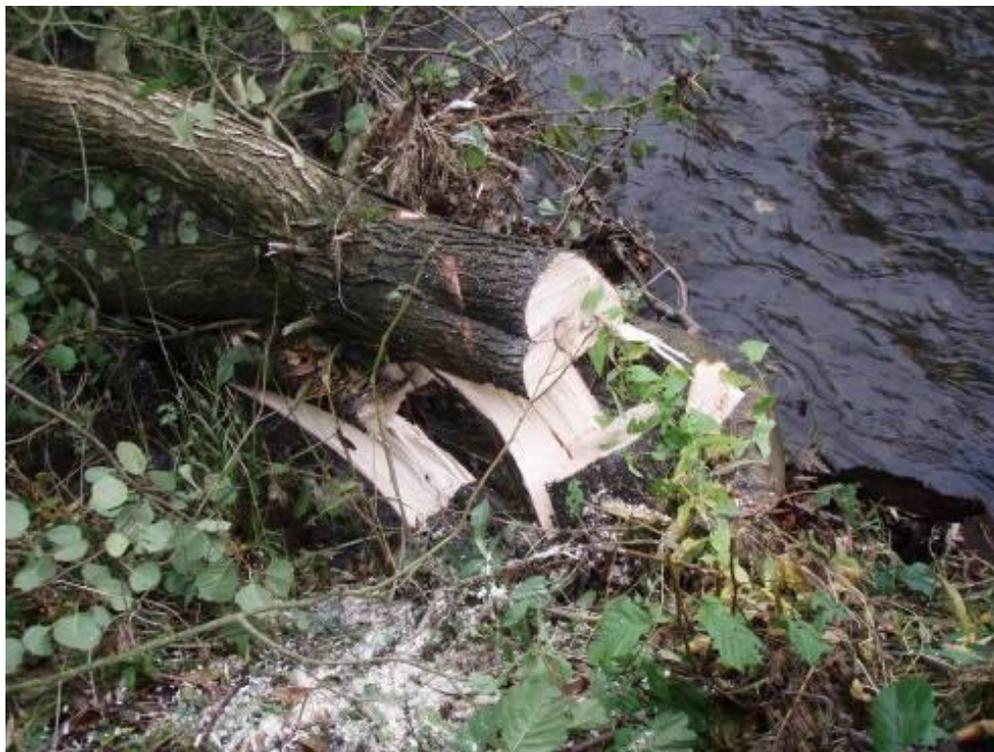
The process involves gradually cutting part way through the trunk to leave a hinge, so that it can be forced over into the channel while remaining attached to its stump (Figure 10). The depth of the cut should be limited to only that which is required to bend the limb over, thereby retaining substantial hinge to provide maximum strength and health of the tree. This treatment can also be undertaken on any planted willows, once they have reached a suitable size.

Figure 10. Hinged willow

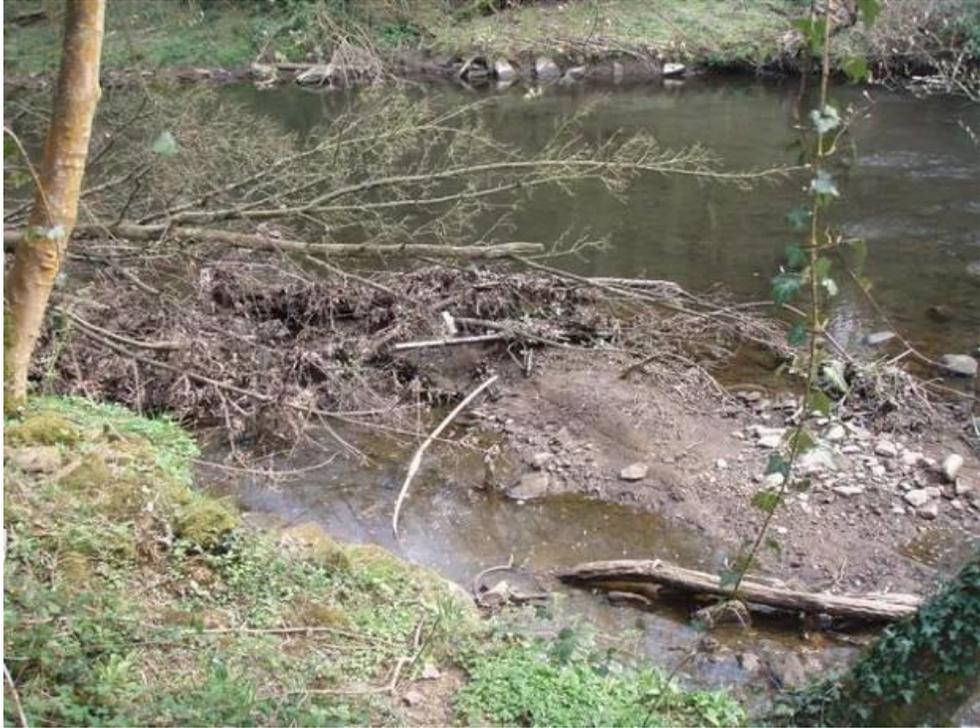
Introducing LWD and structures like tree kickers (branches, or whole trees anchored in place to produce cover and flow deflection) will concentrate flows to certain areas of the channel (usually towards the centre), scouring out deeper pool habitat while creating slacker areas within the margins where deposition will increase (Figure 11). Where trees are close to the river they can be felled and the trunk easily secured in place with cables to create the 'kicker', thereby alleviating any flood risk (Figure 12).

Figure 11. Note the narrowing effect through sediment accumulation in the sheltered area downstream of the tree kicker (centre and right of shot)

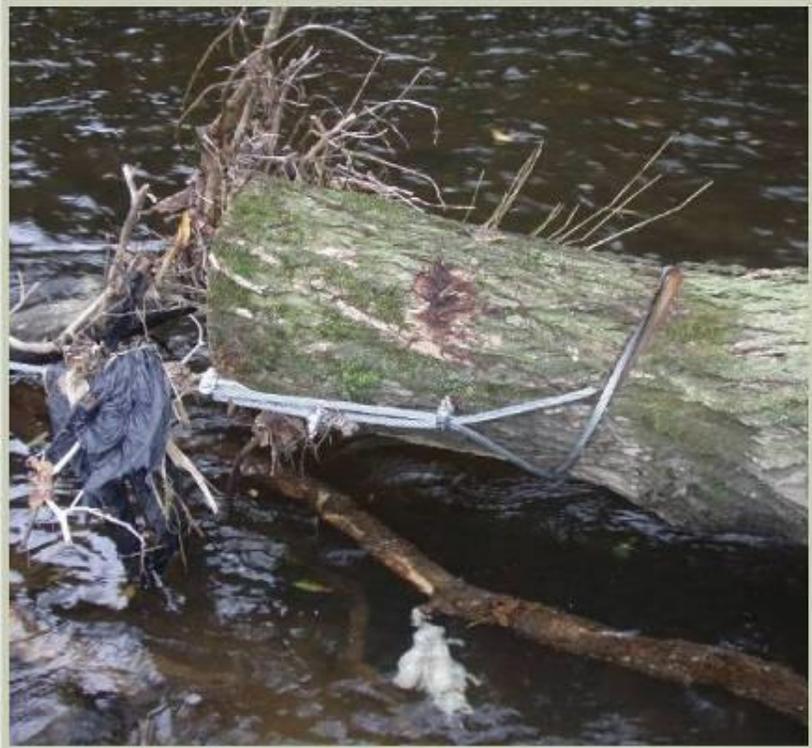
Figure 12. Cabling for a tree kicker.
