Walkover Assessment

River Wear – Upper Weardale Angling Association

July 2014

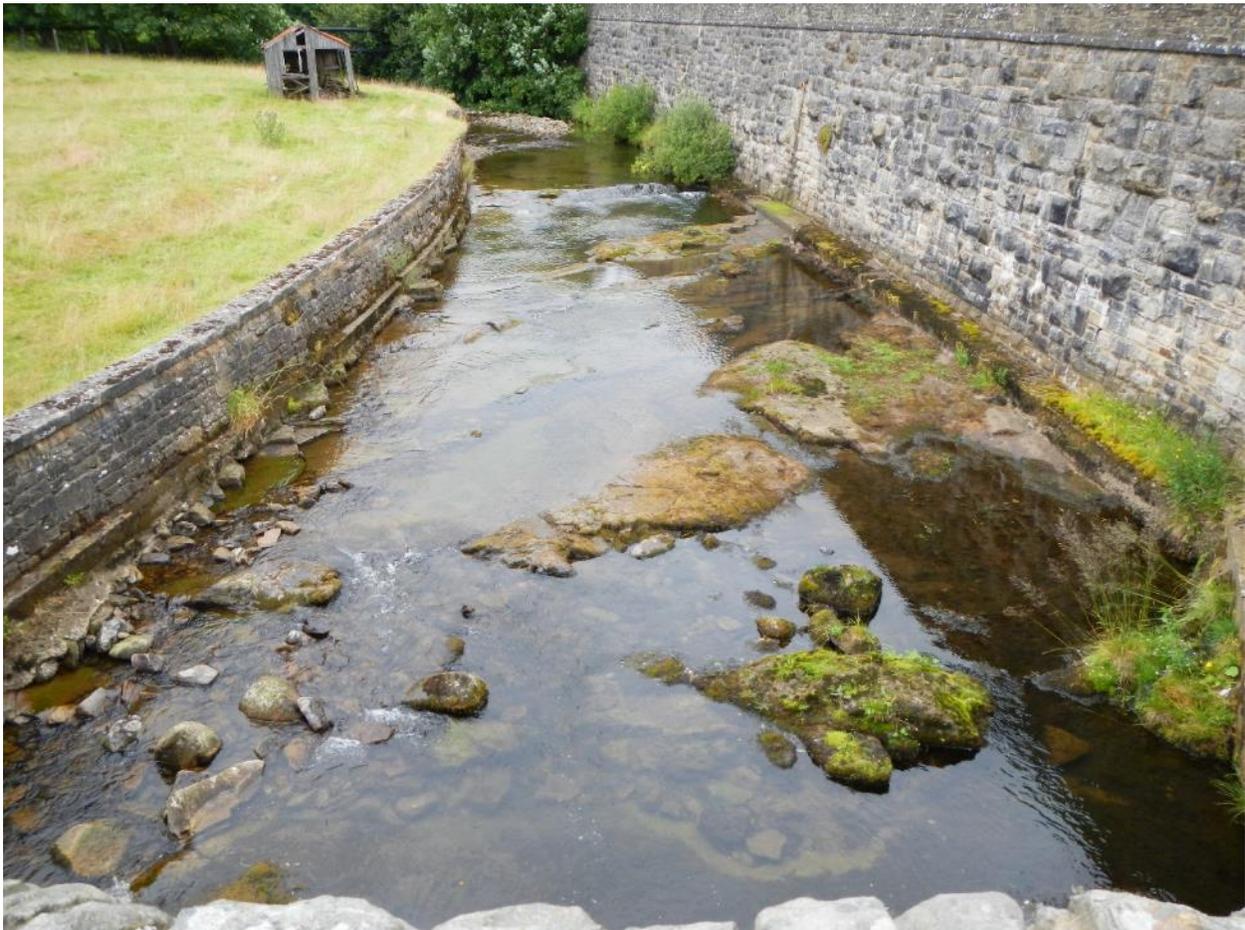
The upper River Wear forms as the confluence of Burnhope and Killhope Burns, with c. 2/3 of the flow on the day of the visit supplied by Killhope Burn. Around Warhead, Killhope Burn is heavily influenced by the limestone geology of the area, with large areas of bedrock exposed on the riverbed (Figure 2). Such surface exposures of bedrock mean that the typical gravel, cobble and boulder substrate of the middle River Wear is absent in many areas, particularly where the channel is confined and increased bed scouring occurs. The bedrock escarpments also create significant natural obstacles to fish passage.

Figure 1. Looking upstream from the upper bridge in Wearhead. Bedrock is a significant feature of the riverbed in this area

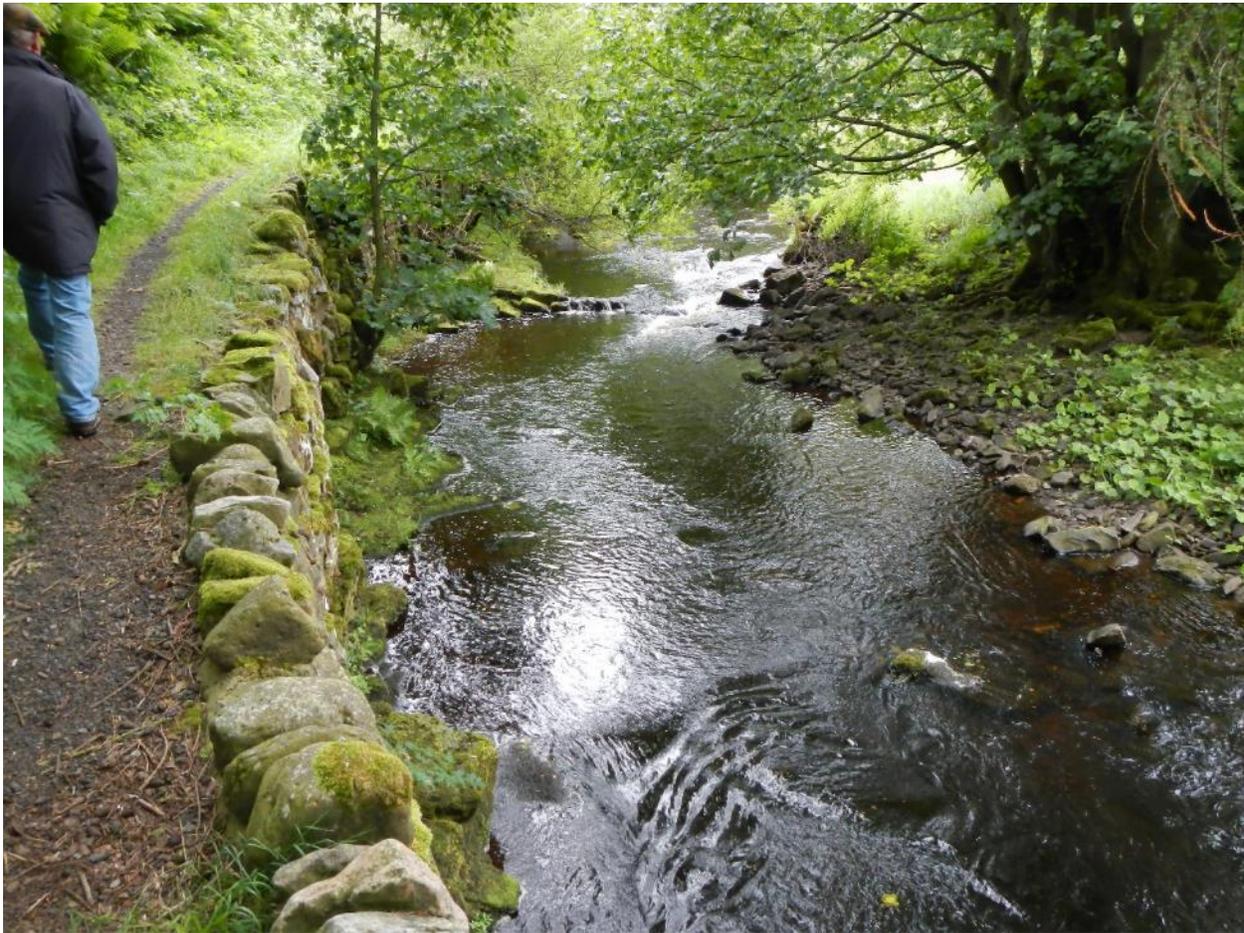
The Burnhope Burn, while also having bedrock outcrops and a significant bedrock waterfall that is an obstacle to fish passage, does have a higher portion of gravel, cobble and boulder substrate. This provides good opportunities for spawning on the burn and good quality juvenile habitat amongst the boulders, particularly for larger migratory salmonids (Figure 2). There is also a good ratio of aerial cover along the channel, creating a mosaic of dappled shade and light. This cover provides protection and security to fish populations in the burn, particularly where bankside willows (*Salix* spp.) trail into the water (Fig. 3), while also helping to mitigate high summer water temperatures.

Figure 2. Areas of gravel, cobble and boulder substrate on the Burnhope Burn provide good spawning and juvenile habitat for migratory salmonids

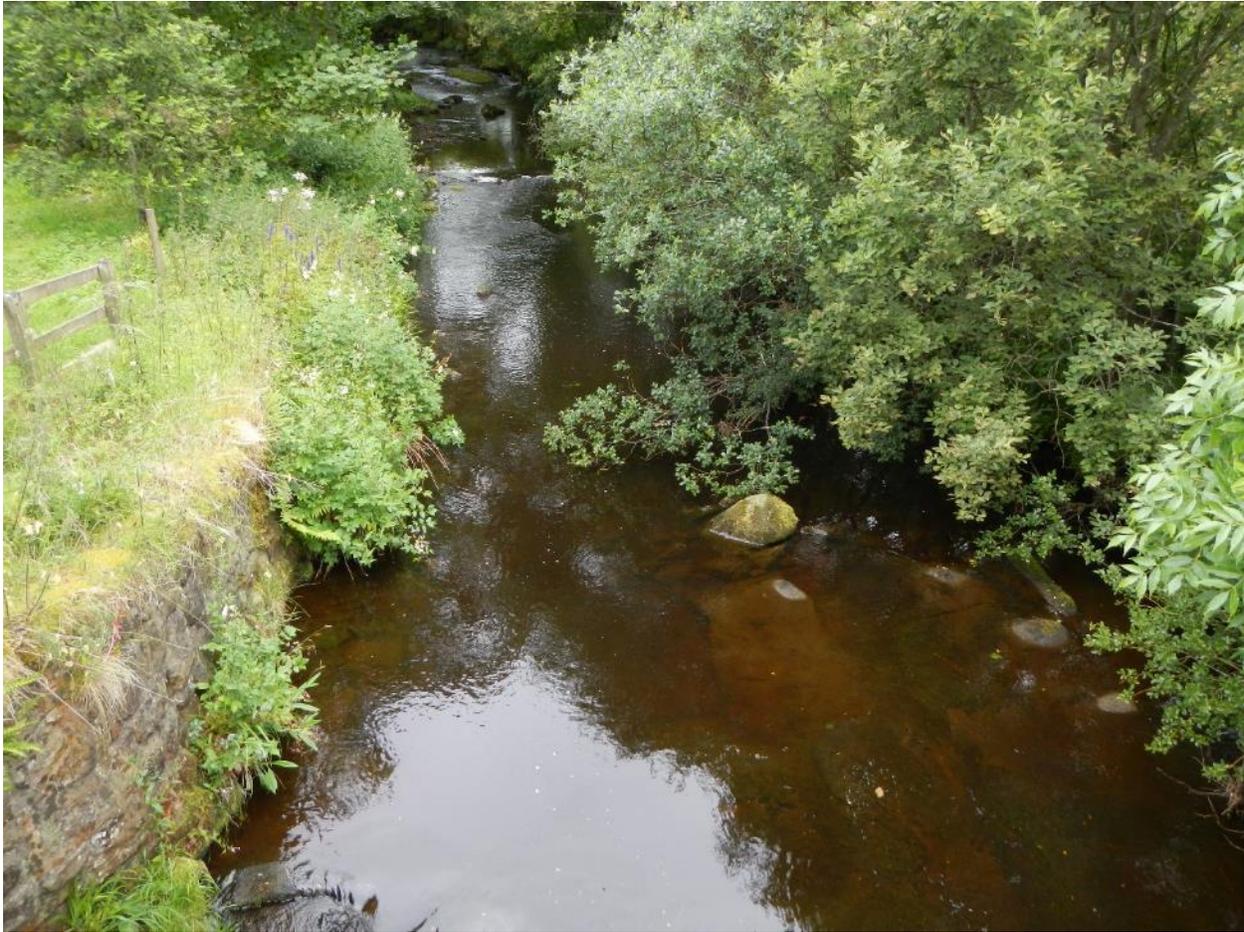
Figure 3. High quality pool habitat created by deep water and overhanging/trailing willow cover

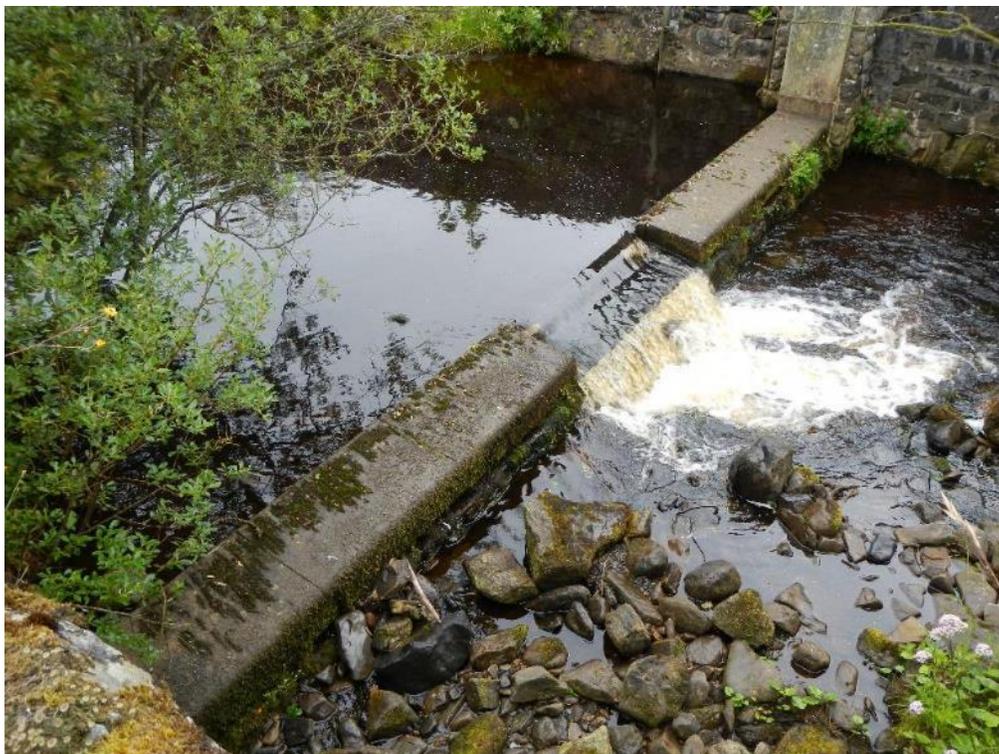
Fish passage is also an issue on the Burnhope Burn, due to both the bedrock outcrops and the presence of several weirs. A waterfall that would ordinarily pose a significant barrier to migration is actually mitigated by the presence of a gauging weir (Fig. 4), just downstream. The downstream proximity of the weir increases the water depth slightly improving passage over the waterfall.

Figure 4. Gauging weir that may actually improve fish passage over the natural waterfall a short distance upstream

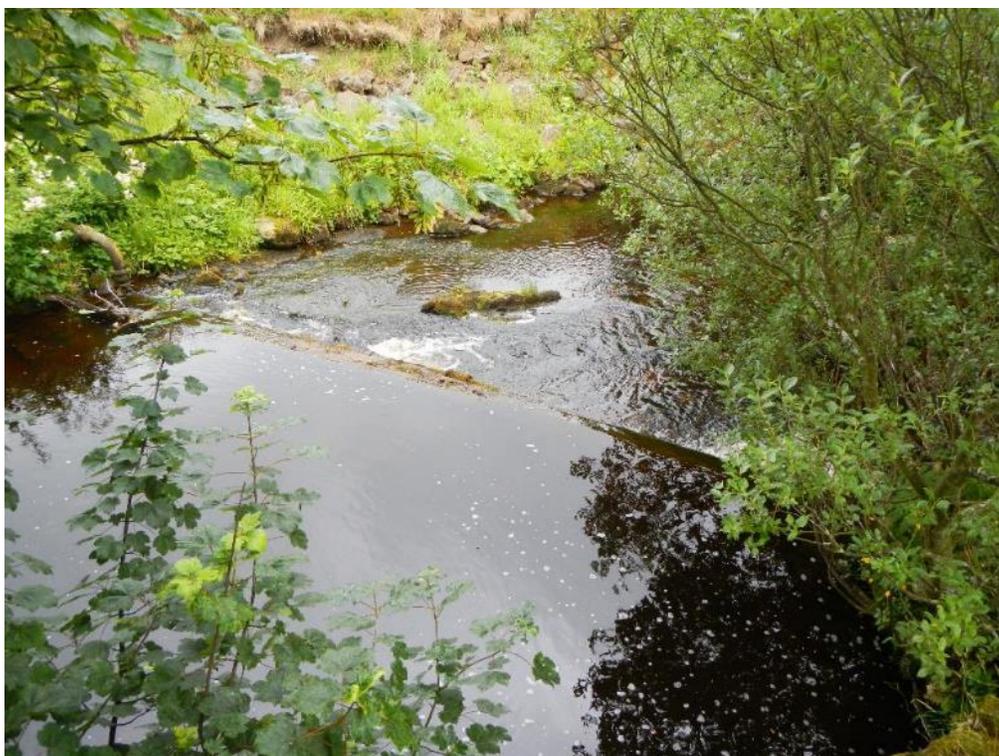
Further downstream, a pipe crossing does pose a negative impact upon fish passage, creating a vertical obstacle in an area of shallow water (Fig. 5); while not impassable, this structure is likely to inhibit fish movements in low water and interrupt the dispersal of juvenile salmonids through the burn.

Figure 5. Pipe crossing that is likely to inhibit fish passage through the Burnhope Burn

Pipe crossing on Burnhope Burn (Fig. 5: NGR - NY8574639472)

The ideal solution for this structure would be to ascertain whether the pipe is still in use. If not, the structure should be removed. If the pipe is in use, it may be worth installing an easement at the location to aid fish passage; however, in most cases it is likely to be costly to create something that will stay in place, and bearing in mind the other barriers in close proximity, it may be worth focussing efforts and money elsewhere. It was hard to see from the RB, but a pipe appeared to be discharging water on the downstream side of the pipe crossing; it may also be that this structure could be adapted to assist fish passage.

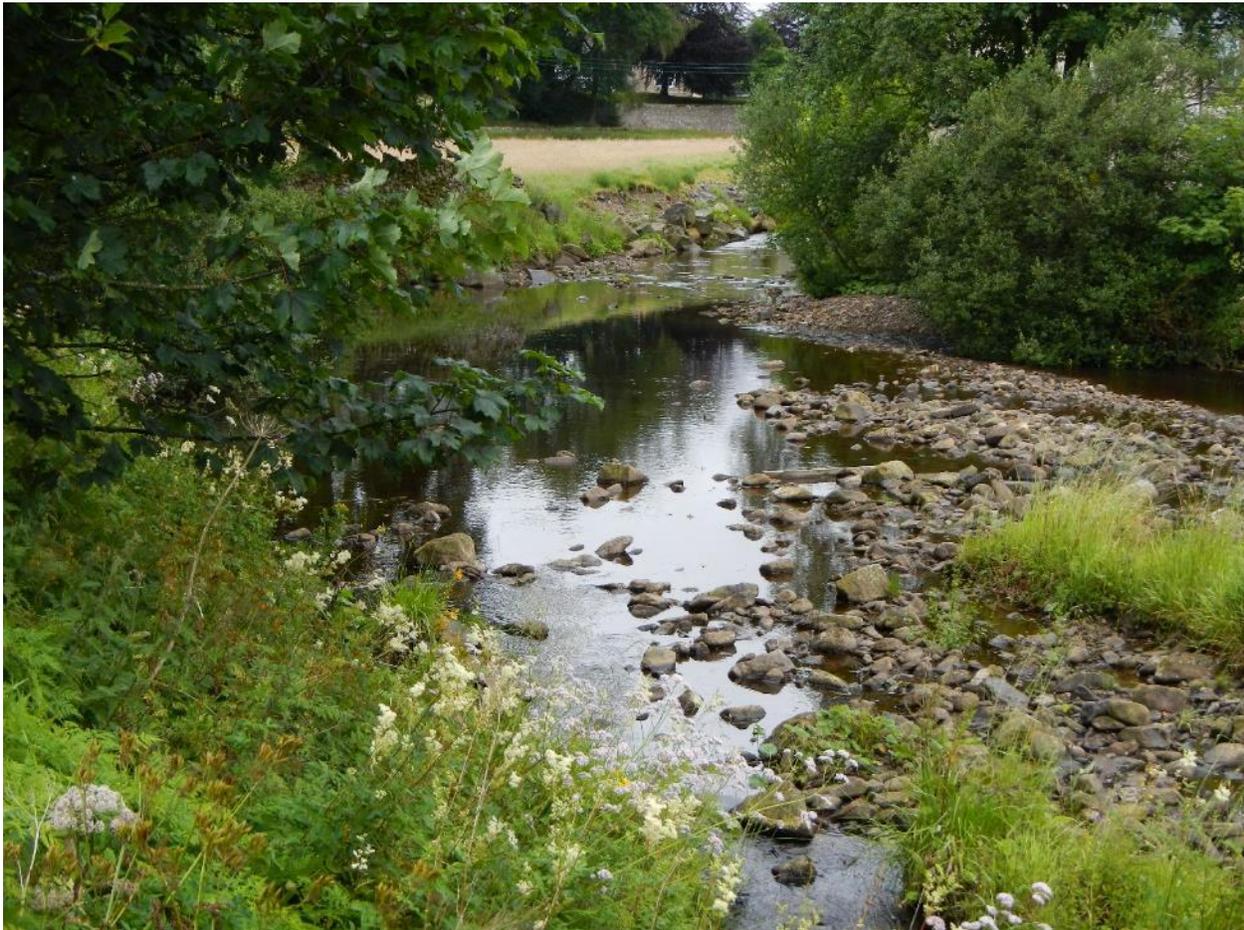
Downstream of the Killhope and Burnhope Burn confluence, substrate on the main River Wear comprises a higher proportion of gravel, cobble and boulders; making it more suitable for spawning and allowing the formation of some deeper pools through scour and deposition (Fig. 6). The increased diversity in the substrate of this area is also likely to support a greater diversity of aquatic invertebrates. Bedrock continues to be an influential feature throughout this length, but is well complimented by other, mobile, substrata; making high quality juvenile salmonid habitat. Deeper pool/glide areas created where the substrate has been scoured, particularly upstream of bedrock ledges, provide some deeper holding water for adult trout (Fig. 7 & 8); these areas are further enhanced by valuable low-level aerial cover from bankside trees. The bedrock outcrops also pose a natural barrier to fish migration and may cause fluctuations in fish populations in certain years when water levels will limit access upstream at vital times.

Figure 6. Main River Wear d/s of the Killhope and Burnhope Burn confluence. Mobile substrate allows scour and deposition to form deeper pool areas and valuable spawning areas

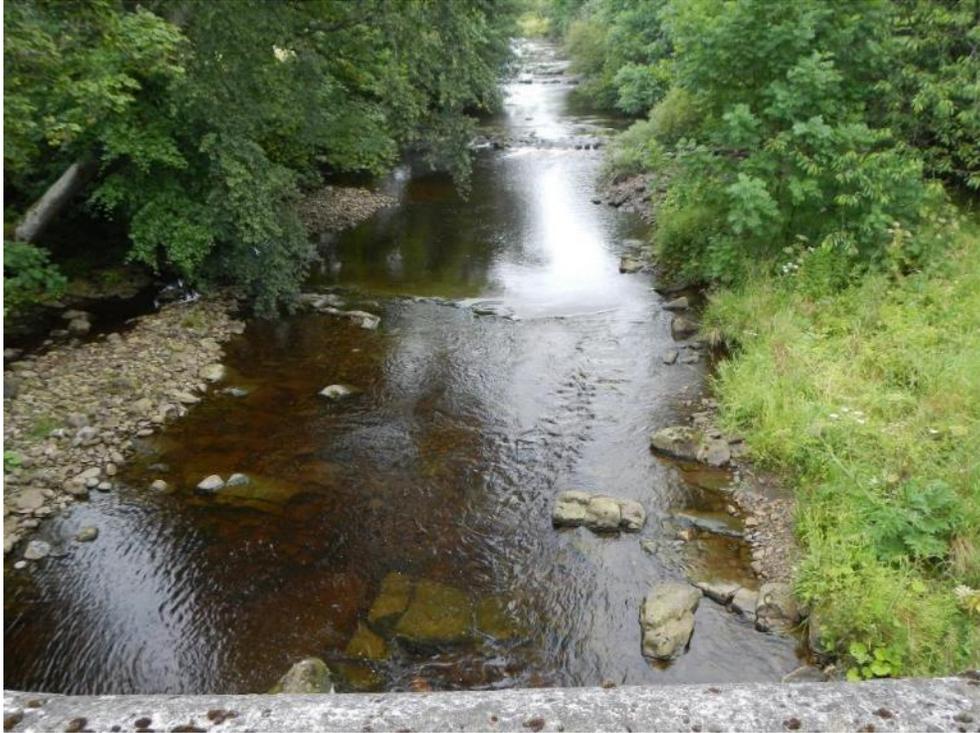
Figure 7. Bedrock shelves and gravel depositions combine to provide high quality riffle, deeper pool and glide habitat, complemented by low-level aerial cover along the margins. Good salmonid habitat!

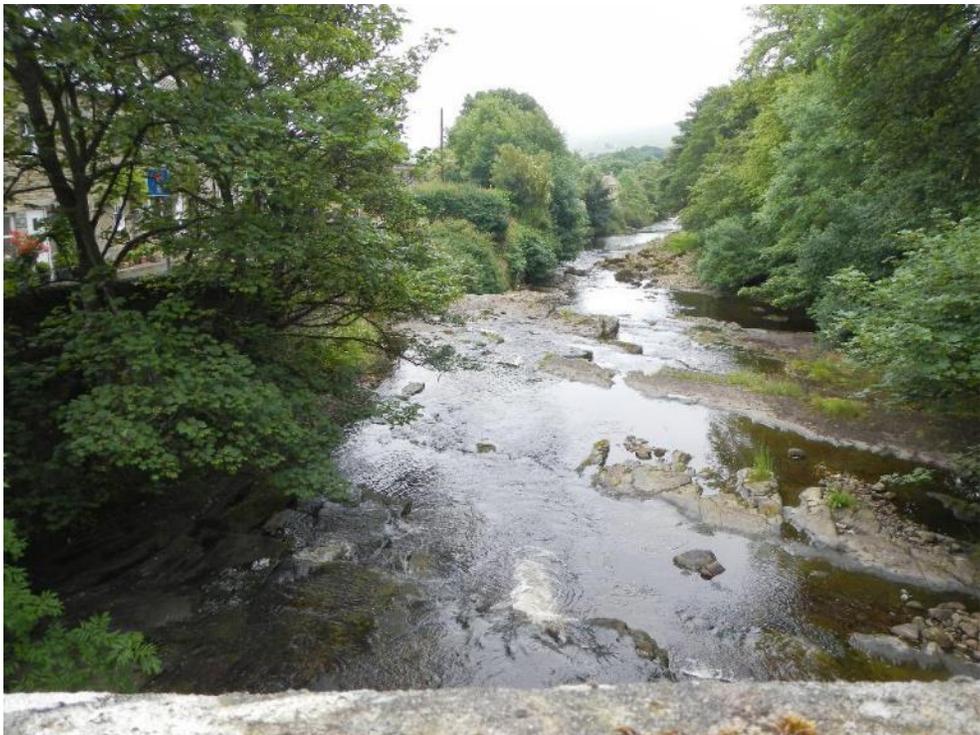
Figure 8. Bedrock pools and ledges provide good habitat but pose a significant obstacle to fish passage in certain flows

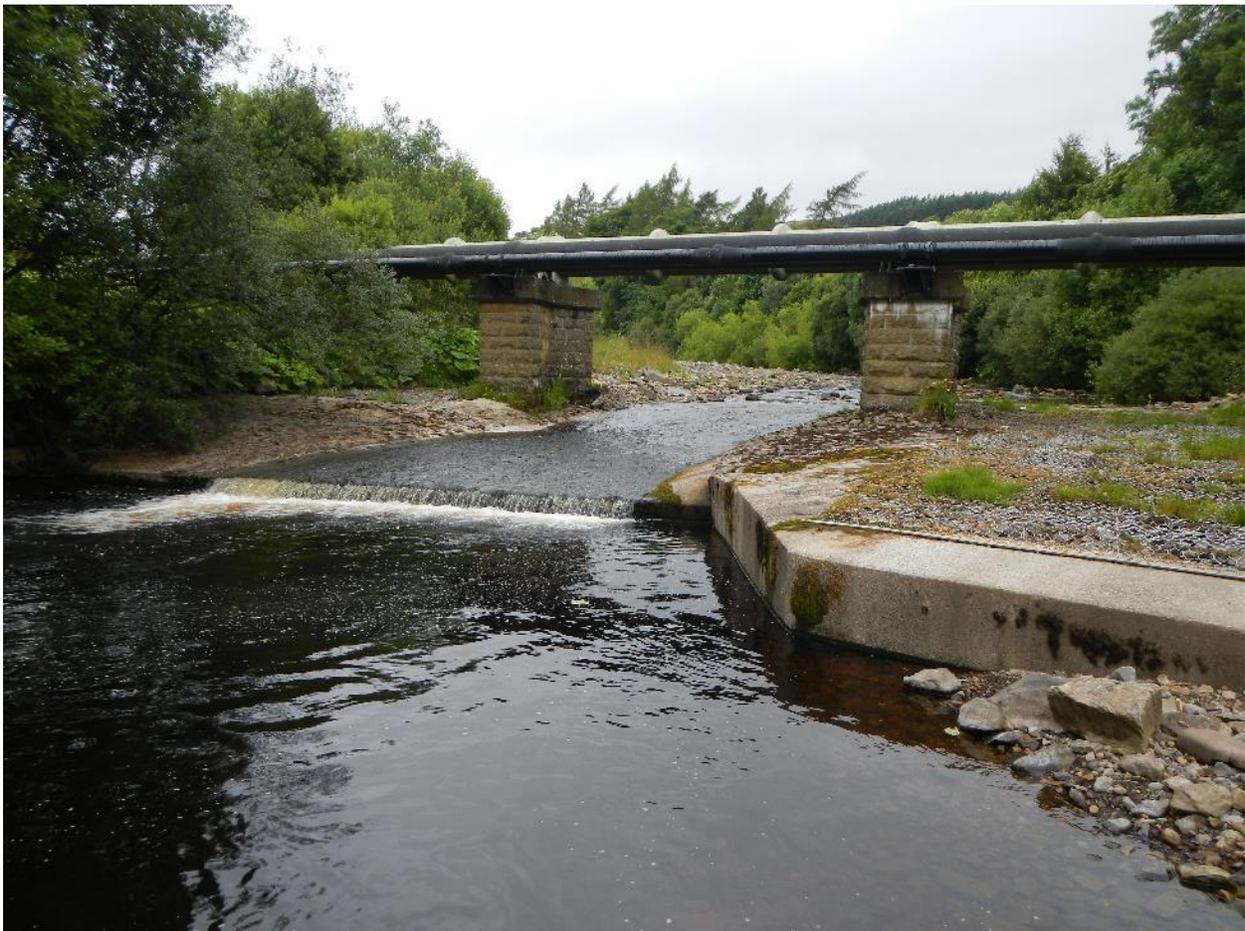
At the upstream end of the middle section visited, the footings of a large pipe crossing pose significant obstacle to fish passage (Fig. 9: NGR - NY 87953 38353). The concrete apron creates a very shallow film of water over a steep gradient. While this is likely to be passable by larger migratory fish in higher flows, it is a significant obstacle to resident trout, particularly juveniles. The crossing also retains a significant volume of bed material upstream, although it appears that it has now filled the void behind the structure and sediment supply past the structure has been partially reinstated.

Figure 9. Pipe crossing, the footings of which pose a significant barrier to fish passage and retain large volumes of bed material upstream

Large Pipe crossing on the main Wear (Fig. 9: NGR - NY 87954 38352)

This is the largest and most significant issue for fish passage noted during the walkover and is something that should certainly be improved upon. The ideal solution here would be for the central portion of the footings to be modified into a clear-span across the channel. A clear-span would not only provide uninterrupted fish passage but also allow free movement of bed material from upstream and allow pool formation within the impounded reach.

In the interim, installation of baffles or a baulk on the apron of the structure could be used as a short-term improvement. The Environment Agency's low cost baffle design could be employed here, or simply a series of juxtaposed upstream battens/baffles (oak or concrete), in a similar layout to those used by Chester Le Street AC on several culverts to increase depth in the central channel (Fig. 22). This would still leave a step, which could be improved by installation of a pre-formed adherent nappe.

Alternatively, the incorporation of a concreted rock-ramp type pass (similar to that already installed by Wear Rivers Trust on the River Deerness; Fig. 23) could be created, whereby cobbles and boulders are concreted onto the face of the apron to create hydraulic roughness and divert flows into a narrower, deeper channel.

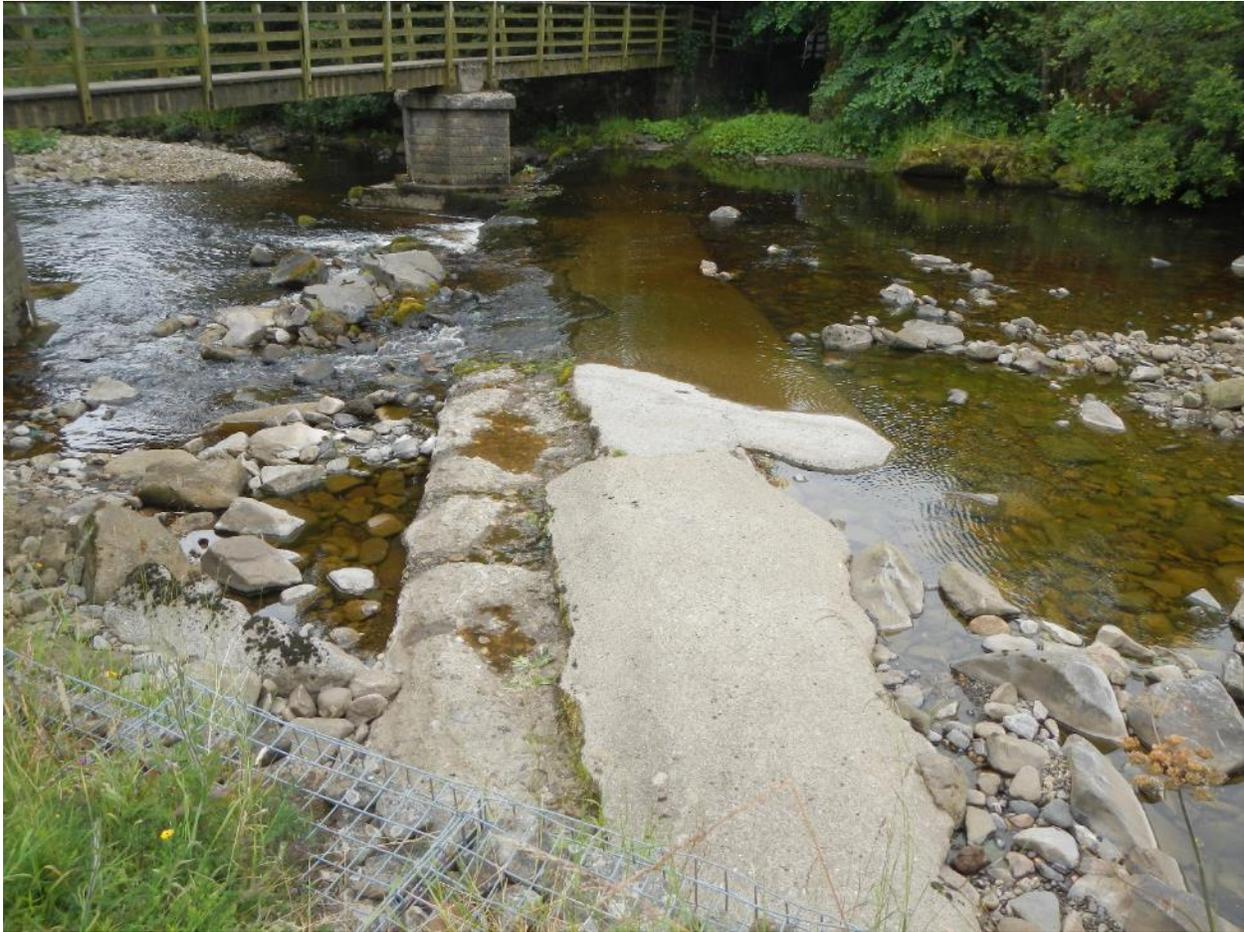
Immediately downstream, another pipe crossing in the riverbed also poses a barrier to fish movement (Fig. 10). This is not such an obstruction but certainly likely to cause delays to fish movements. In assessing the issue posed by this structure it must be considered that it is probably slightly elevating the tail-water level below the footings upstream and so removal may not be beneficial (even if possible) without addressing the larger issue upstream.

Figure 10. Concrete protection around a smaller pipe crossing which also poses an obstacle to fish passage

Bed level pipe crossing (Fig. 10: NGR - NY8801238314)

Just downstream of the large pipe crossing, the bed level pipe crossing also poses an obstacle to fish passage. If the pipe is disused, the ideal solution would be to remove it, but it should also be noted that the bed check it creates does reduce the step up onto the footings upstream, so it should only be removed in conjunction with work on the large pipe crossing.

Alternatively, a wooden or concrete baulk could be installed across the structure to increase water depth, shallow the gradient and assist fish passage (Fig. 24).

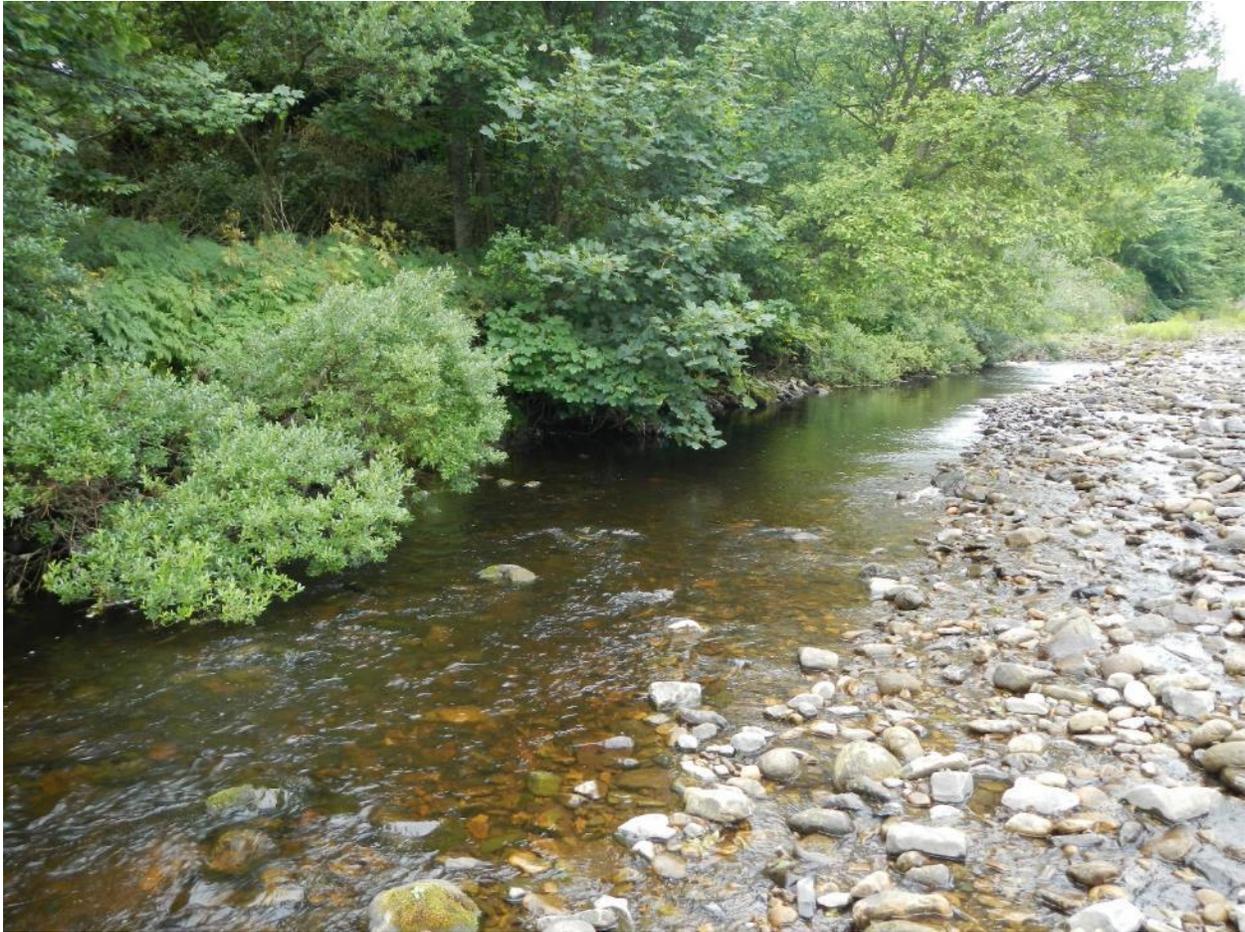
Downstream of the structures, several areas of high quality habitat were observed. Pool, glide and riffle features scoured along a well-vegetated stable bank provide good flow velocities and maintain valuable deeper water areas. The scouring effect also maintains clean, well-sorted gravels that provide high-quality spawning substrate. Abundant aerial cover provided by the bankside trees further enhances habitat, providing ideal conditions for resident adult trout, and holding water for migratory fish moving through (Fig. 11). The mobile nature of the substrate in this area, which has formed numerous gravel bars, also enhances river habitat in dry conditions, creating a narrower, low flow channel where water depth and velocity are maintained.

Figure 11. High quality pool habitat with low-level aerial cover

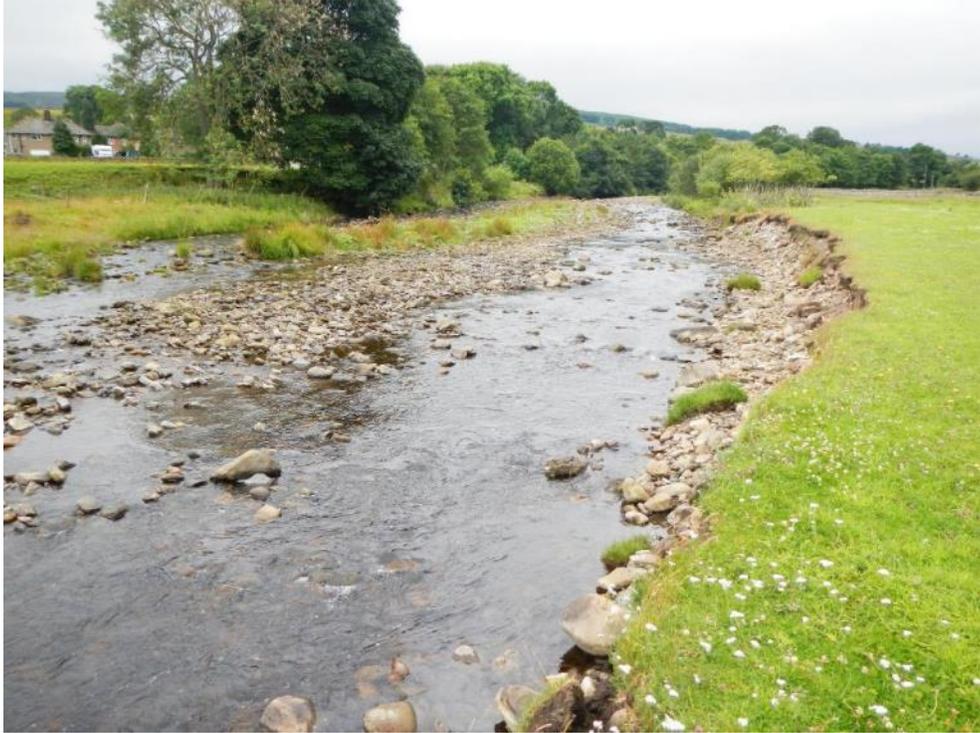
In stark contrast to the high quality habitat in un-grazed sections, further downstream horses have grazed both banks and the loss of structure within the banks has led to significant erosion and loss of land (Fig. 12: NGR - NY8831938320). In the absence of stable banks to force scour into the riverbed, the channel is eroding laterally. This has led to the river becoming over-wide, which dissipates the flow energy and leads to increased sediment deposition. The presence of a bar in the centre of the channel is a good indication of this as, being over-wide; the bar has persisted long enough for grass to colonise. In a narrower, self-maintaining channel, the sediment deposits would be re-mobilised on higher flows, preventing vegetation from becoming established.

Figure 12. Horse grazing has led to loss of trees and vegetation and facilitated excessive bank erosion

The other major issue noted during the walkover was excessive grazing of the bank d/s of the large pipe crossing (NGR: NY 88089 38286 - NY 88490 38252). It is strongly recommended that this area is buffer fenced to prevent livestock access to the river in this area on both banks to increase vegetation coverage and slow the rate of erosion. If stock were excluded it would then become beneficial to plant the banks with willow and other hardy deciduous species, to help bind the banks together. The deep roots of larger shrubs and trees act as an effective reinforcement to bank integrity – a stark contrast to the fragile soil structure beneath the shallow root systems of turf vegetation.

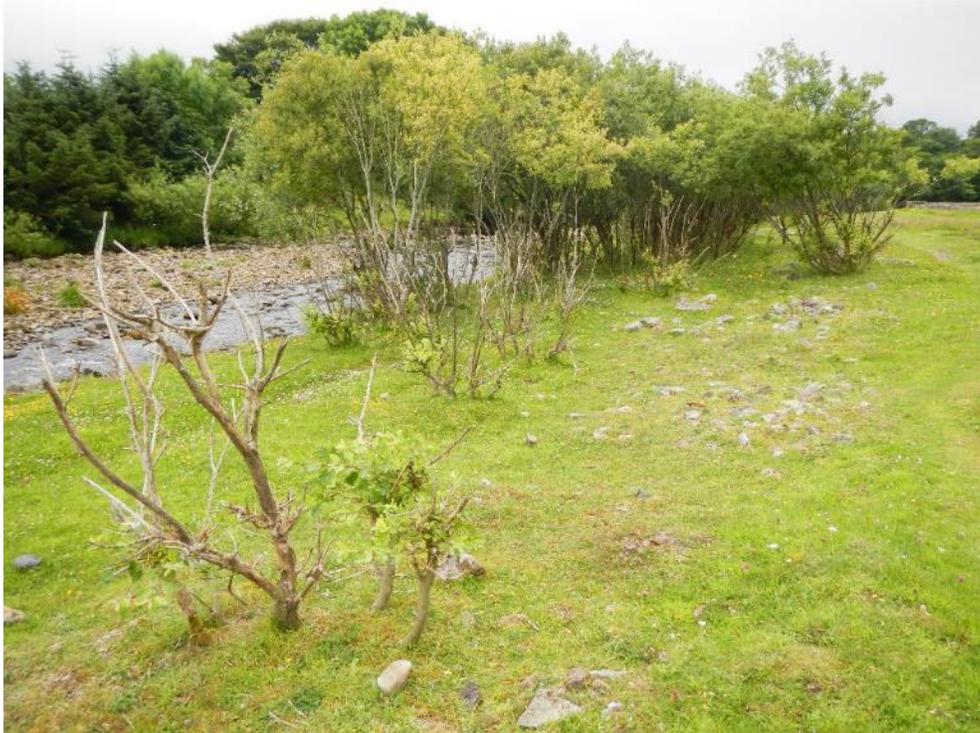
Figure 13. Heavy grazing/browsing of bankside willows, like this, is likely to lead to loss of the trees and further destabilisation of the bank. It also significantly denudes the bankline of valuable cover habitat

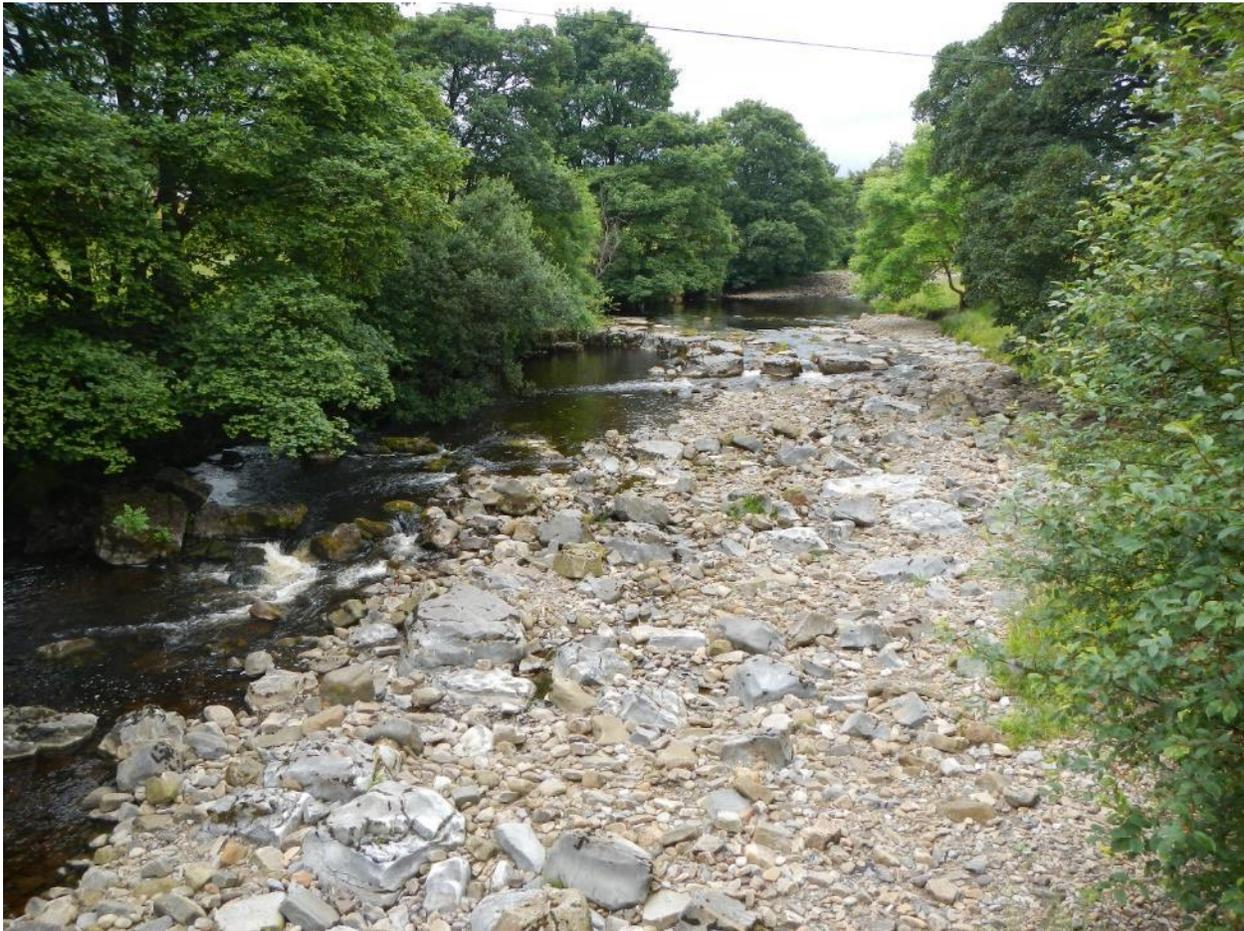
Away from the influence of grazing, river habitat quality returns to a high status, with a pool, glide and riffle sequence, complimented by low overhanging branches and cobble and boulder substrate. Upland rivers such as the Wear are heavily reliant upon flow diversity and tree canopy for cover, as unlike more lowland systems, aquatic weed and associated habitat is often absent. Within the short section depicted in Figure 14, habitat suitable for all trout life-stages is present.

Figure 14. Low Aerial cover over diverse flows and varied water depths provides high quality trout habitat

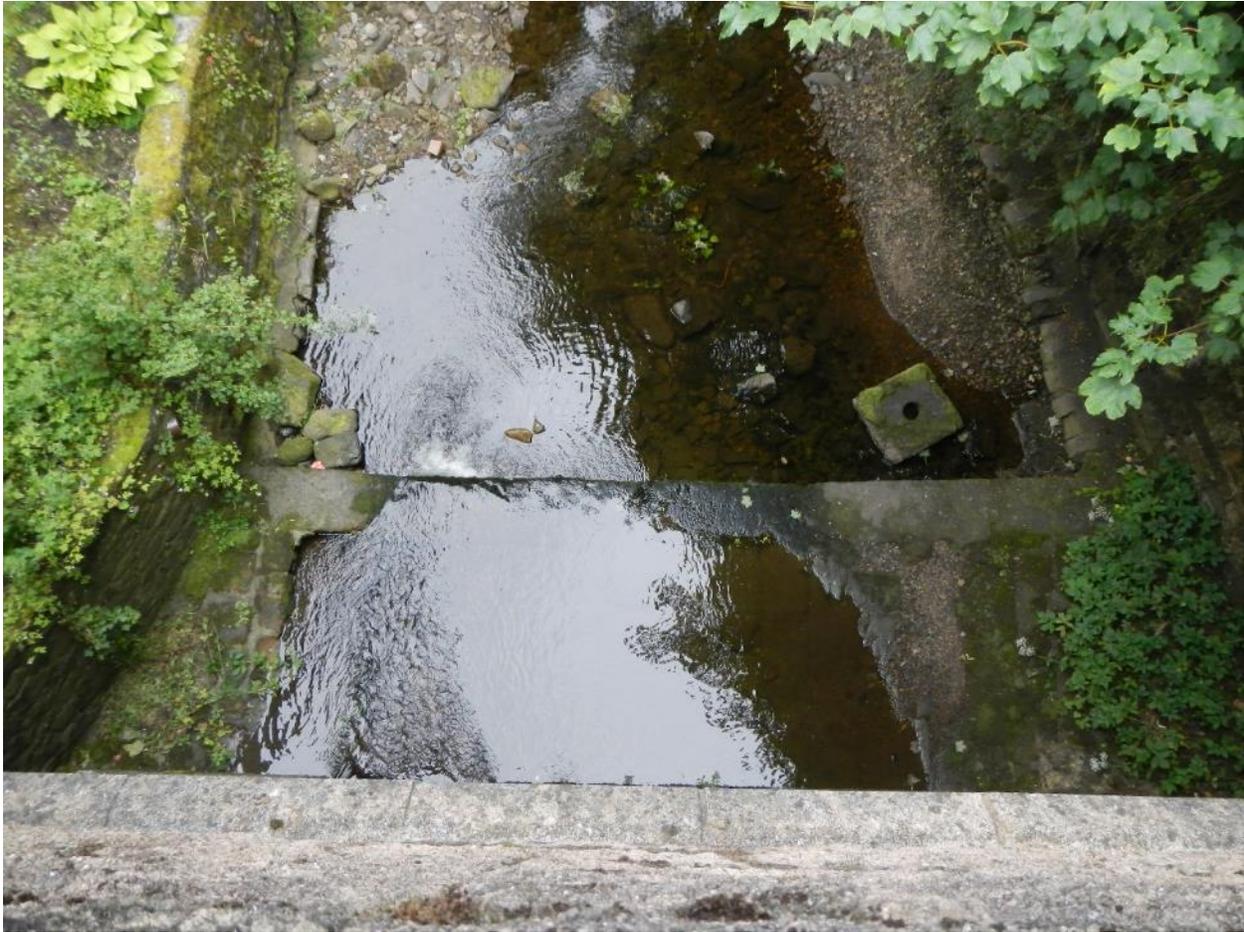
Harthope Burn joins the River Wear in this section. While the Burn was not inspected in detail, conditions appeared to provide good habitat for spawning and juvenile salmonids. The bed comprised predominantly cobble and boulder, with pockets of smaller gravels. Discussion with Tony Ward confirmed the burn was utilised as a spawning tributary, with large migratory salmonids observed towards the back end of the year. A potential issue for fish passage is present, created by the A689 bridge footings (Fig. 15). The footings are relatively low, but the shallow water d/s and over the apron combined with the vertical concrete step will inhibit access to the burn and prevent optimal habitat utilisation by dispersing juveniles.

Figure 15. The A689 bridge footings on Harthope Burn create an obstacle to fish passage

A689 Bridge footings on the Harthope Burn (Fig. 15)

As with the pipe crossing on the main river, this issue could be improved with the use of juxtaposed baffles across the apron of the bridge footings and the addition of an adherent nappe on the step (Fig. 22: NGR - NY 88444 37976). Alternatively, a large cobble and boulder (or faced concrete) rock ramp could be employed to smooth the step and increase water level over the apron (Fig. 23).

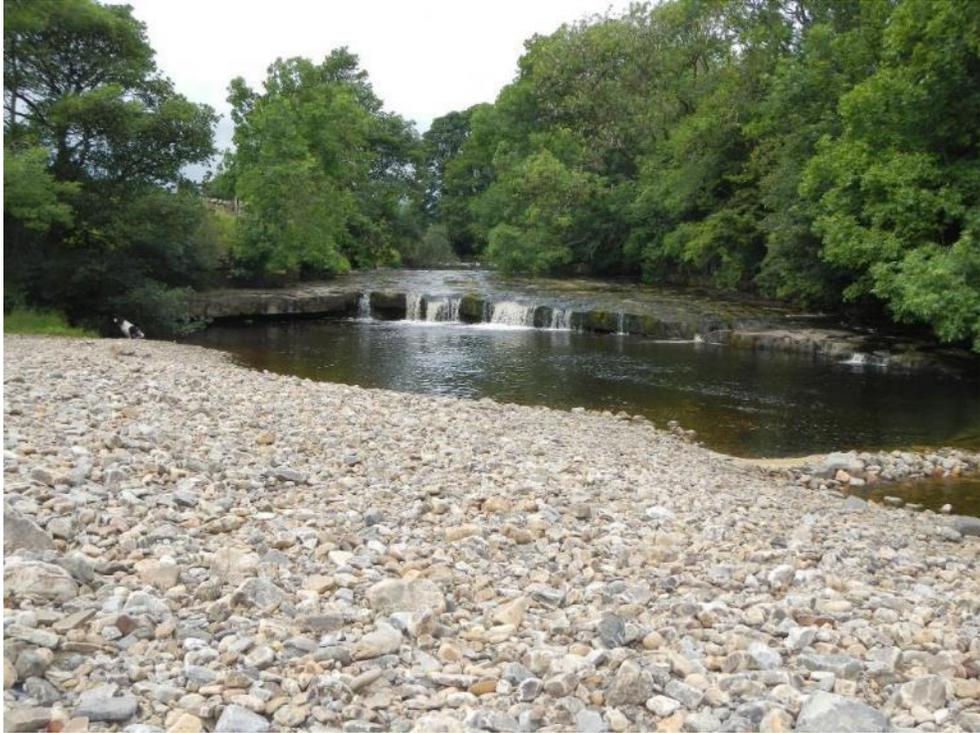
Below Burnfoot Ford, bedrock again becomes a significant influence on the river, with the channel confined between bedrock in several places and the bed comprising exposed bedrock in many areas. This often prevents bed scour and creates a shallow channel, but can also provide deeper pool habitat. Aerial cover remains of a high quality and small bankside willow shrubs create valuable structure within the margins (Fig. 16). Some areas of gravel and cobble substrate are also present, primarily in wider areas or around bends, where the energy of high flows is dissipated (Fig. 17). Throughout the upper Wear, bedrock creates challenges to fish passage; however, they rarely have as severe an impact as man-made angular structures, such as fords or weirs. In most cases, bedrock is uneven, with fissures and wetted channels running through that fish can exploit to pass the obstacle in various flows.

Figure 16. Valuable deeper pool habitat below a bedrock obstruction. Note the multiple options for fish passage that will be available at a range of flows

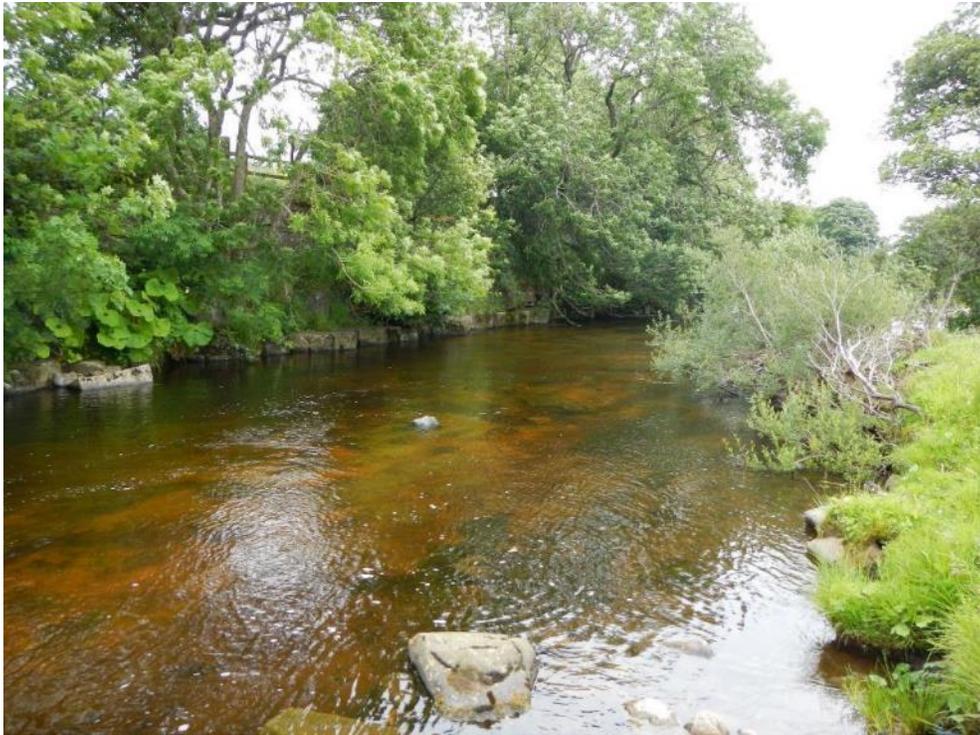
Figure 17. Good quality pool habitat over exposed limestone bedrock. Bankside willows provide valuable structure and cover

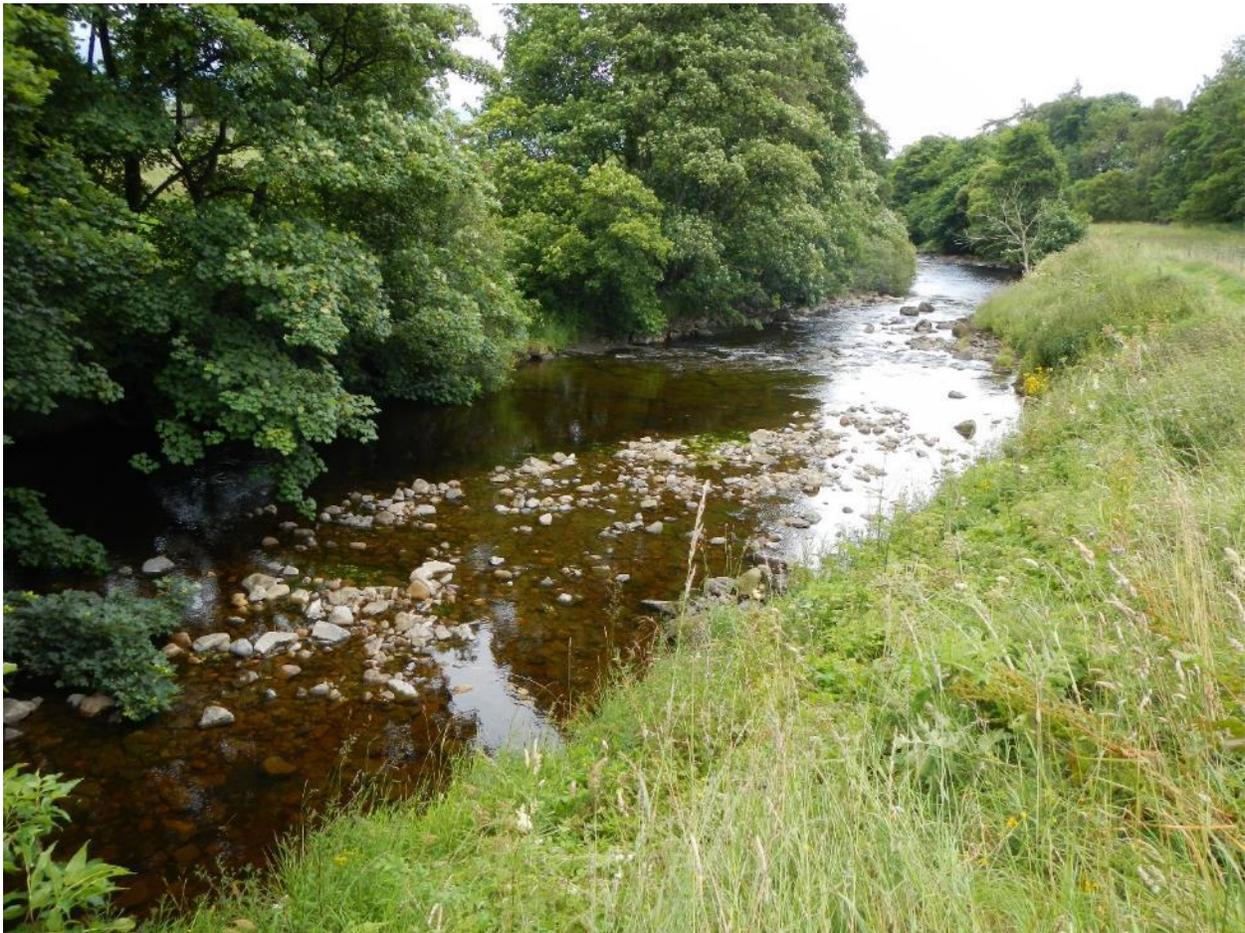
Downstream of the A689 gravel and cobbles become more prominent, and correspondingly, areas of salmon spawning have been noted (T. Ward, pers. com., 16th July 2014). The choice of this area for spawning is probably influenced by the presence of cover provided by the over-hanging trees, which although bare in winter, will provide more security than a completely exposed area (Fig. 18).

Figure 18. Stable, well-vegetated RB with good shade and cover over the LB under which salmon are reported to spawn

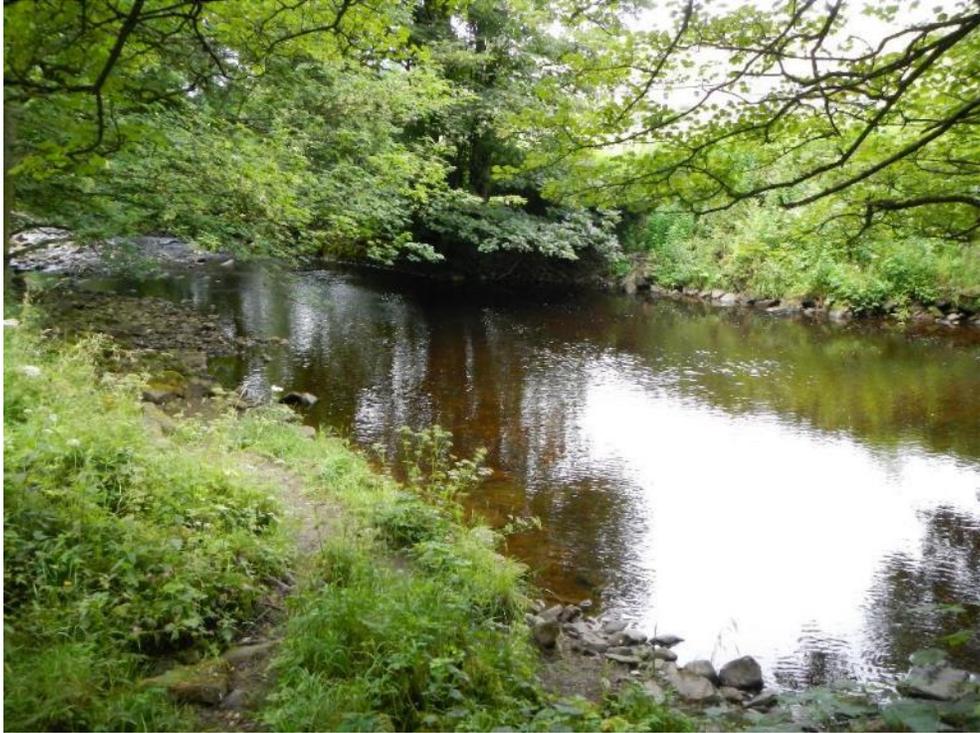
In a heavily tree lined section downstream, tree roots have reinforced the bank and forced bed scour to create another sizeable pool, providing high quality habitat for adult trout (Fig. 19). The tail of the pool then runs out in to more good quality juvenile habitat through cobble and boulder substrate (Fig. 20).

Figure 19. Good adult trout holding water

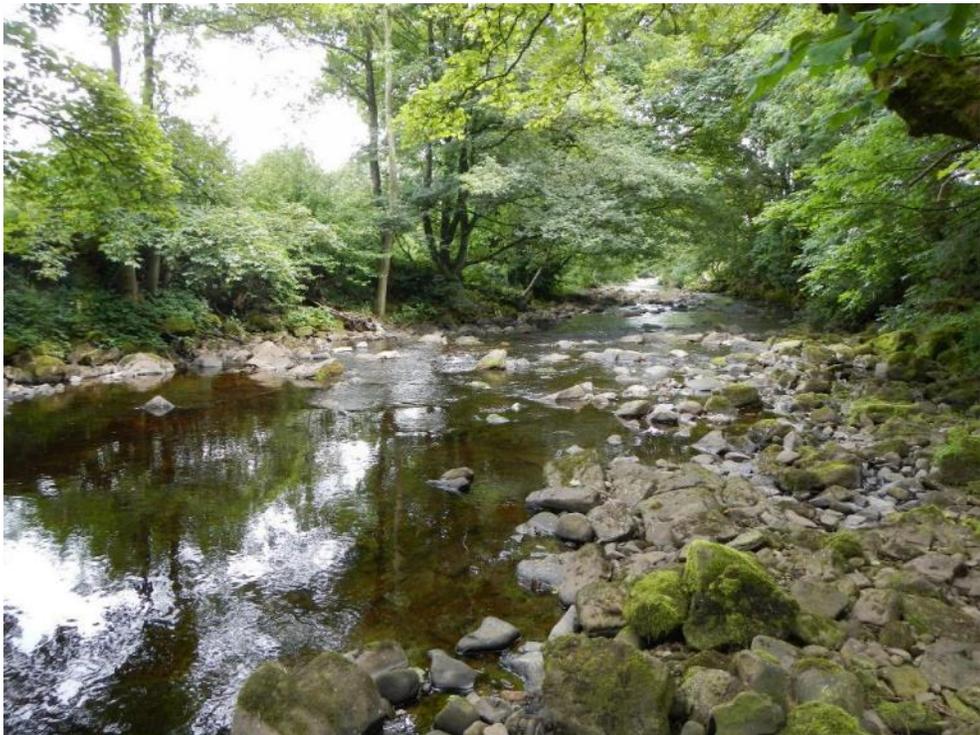
Figure 20. High quality juvenile salmonid habitat
