Walkover Assessment

River Wear – Upper Weardale Angling Association

July 2014

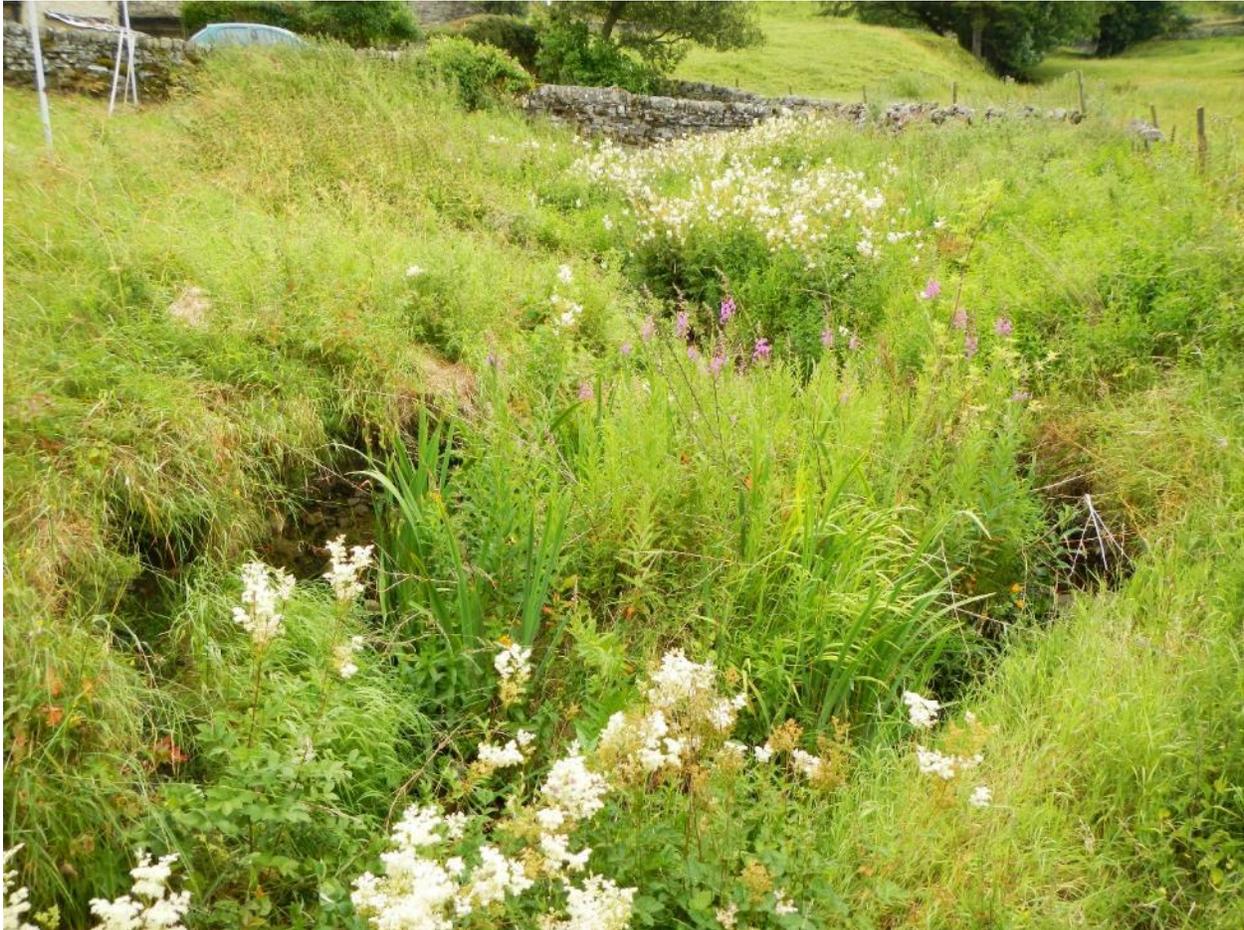
A small tributary enters the river in this section and while on the day of the visit there was very little water, it is understood that large sea trout often ascend the watercourse at spawning time (T. Ward, Pers. com., 16th July 2014). This highlights the importance of even the smallest burns for fry and juvenile production, particularly for resident trout and sea trout, when the main river substrate is very coarse.

Figure 21. A very small burn, but a valuable spawning tributary

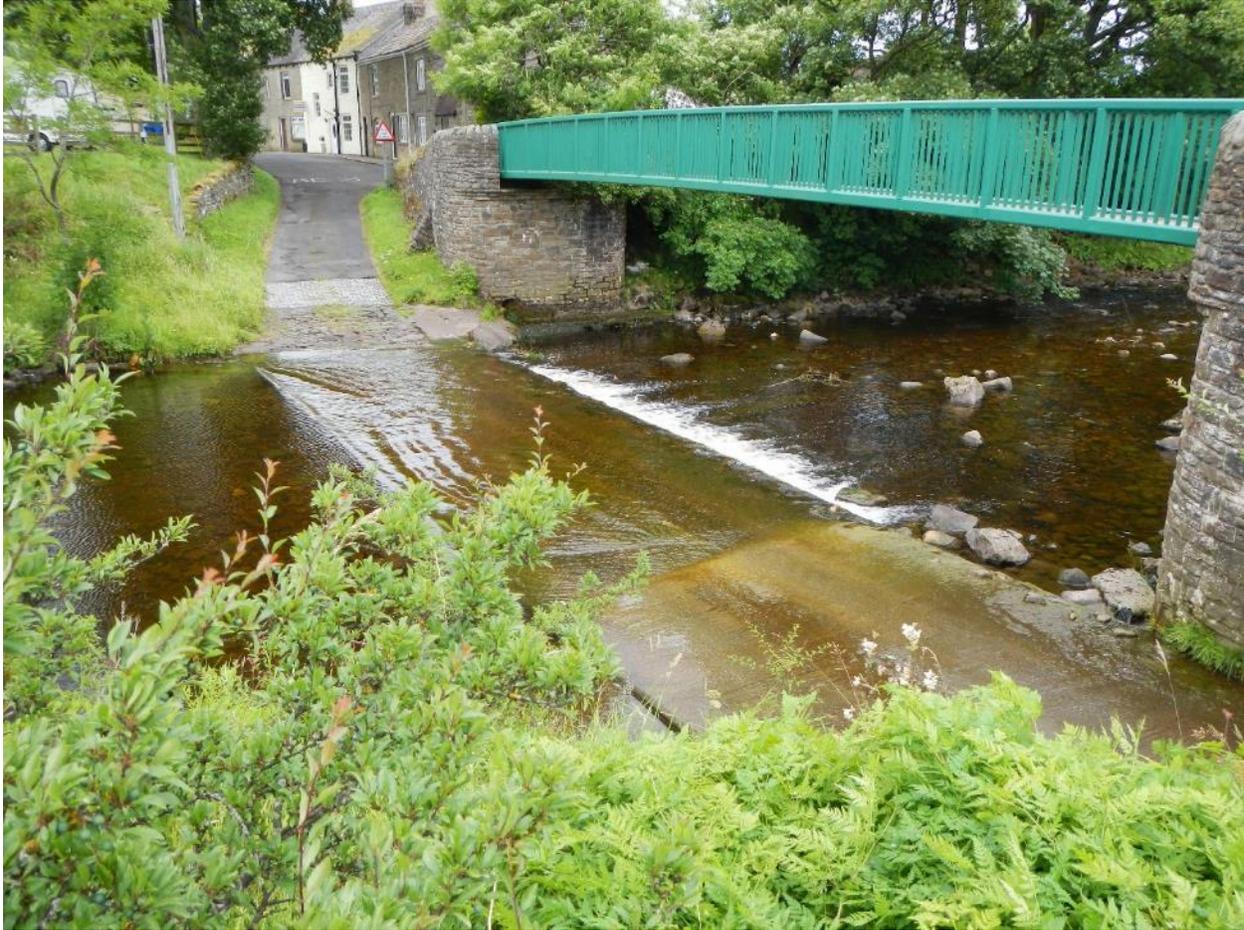
Towards the downstream extent of Upper Weardale AC waters, a concrete based ford creates another impediment to fish passage (Fig. 22). The structure does not raise the bed significantly, but the fast shallow water flowing over a very flat, uniform base is likely to be an obstacle to all fish in low flows and a particular issue for juvenile salmonids.

Figure 22. Concrete ford, which poses an obstacle to fish passage

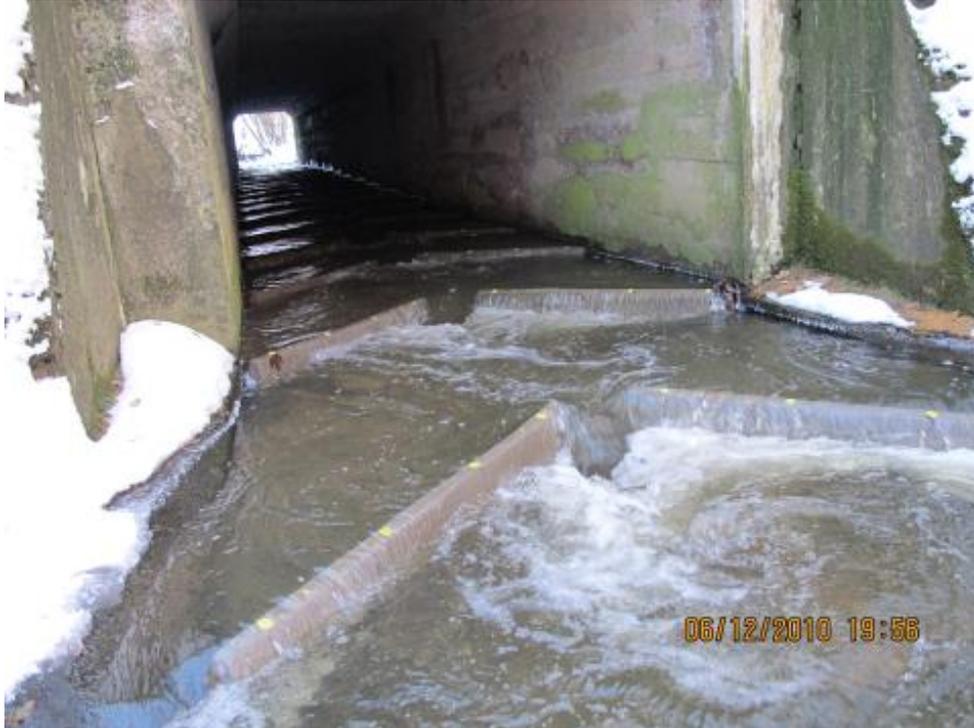
In the interim, installation of baffles or a baulk on the apron of the structure could be used as a short-term improvement. The Environment Agency's low cost baffle design could be employed here, or simply a series of juxtaposed upstream battens/baffles (oak or concrete), in a similar layout to those used by Chester Le Street AC on several culverts to increase depth in the central channel (Fig. 22). This would still leave a step, which could be improved by installation of a pre-formed adherent nappe.

Figure 22. Juxtaposed concreted baffles in a culvert on the Cong Burn

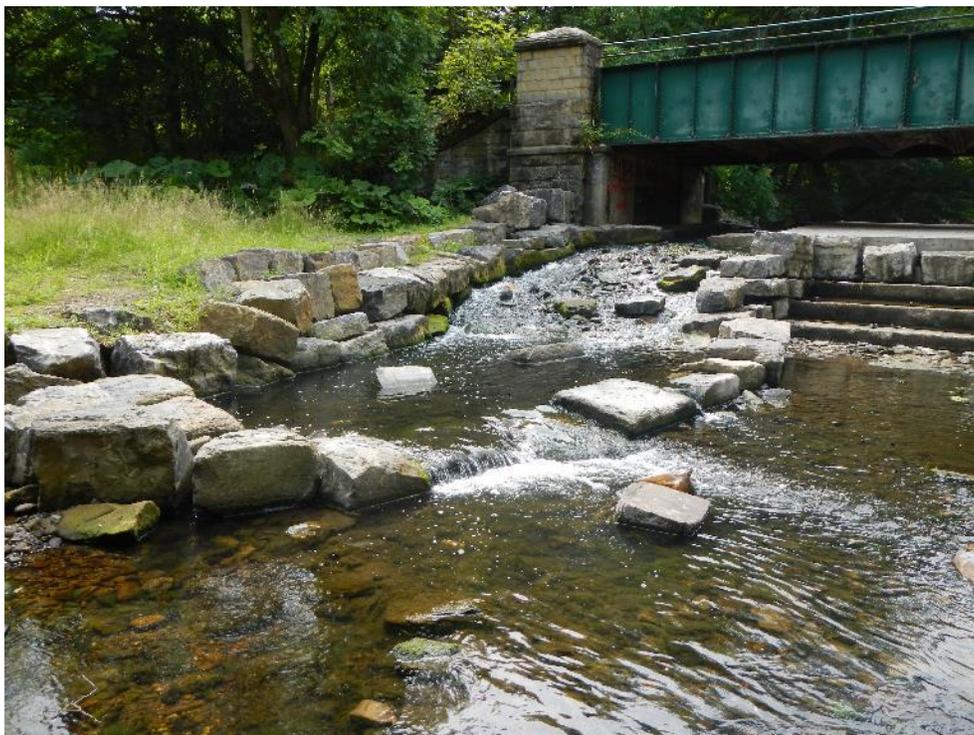
Alternatively, the incorporation of a concreted rock-ramp type pass (similar to that already installed by Wear Rivers Trust on the River Deerness; Fig. 23) could be created, whereby cobbles and boulders are concreted onto the face of the apron to create hydraulic roughness and divert flows into a narrower, deeper channel.

Figure 23. Concreted rock ramp on the River Deerness

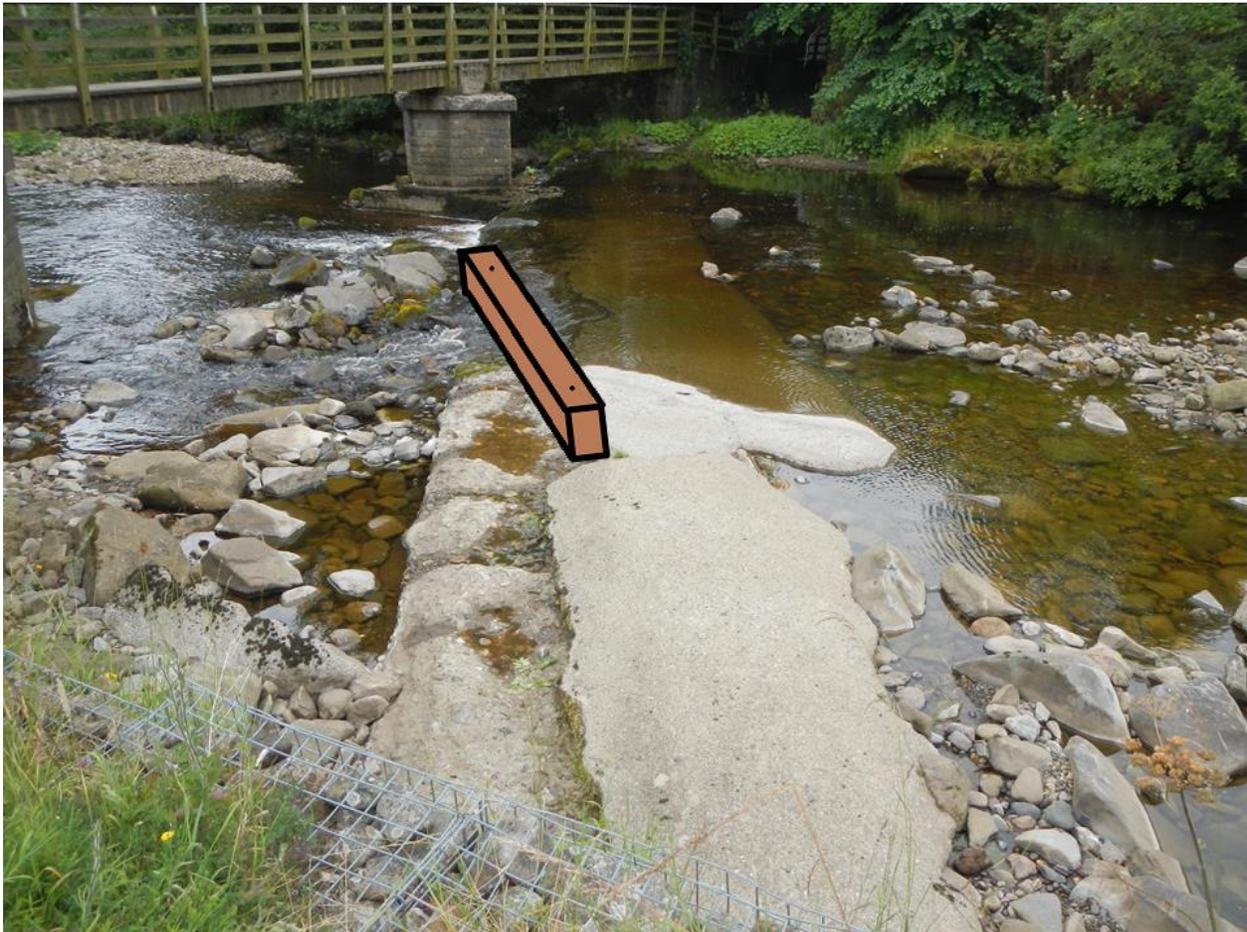
Alternatively, a wooden or concrete baulk could be installed across the structure to increase water depth, shallow the gradient and assist fish passage (Fig. 24).

Figure 24. Possible baulk installation on pipe crossing
