Advisory Visit

River Wear

Willington and District Angling Club

24/06/2016

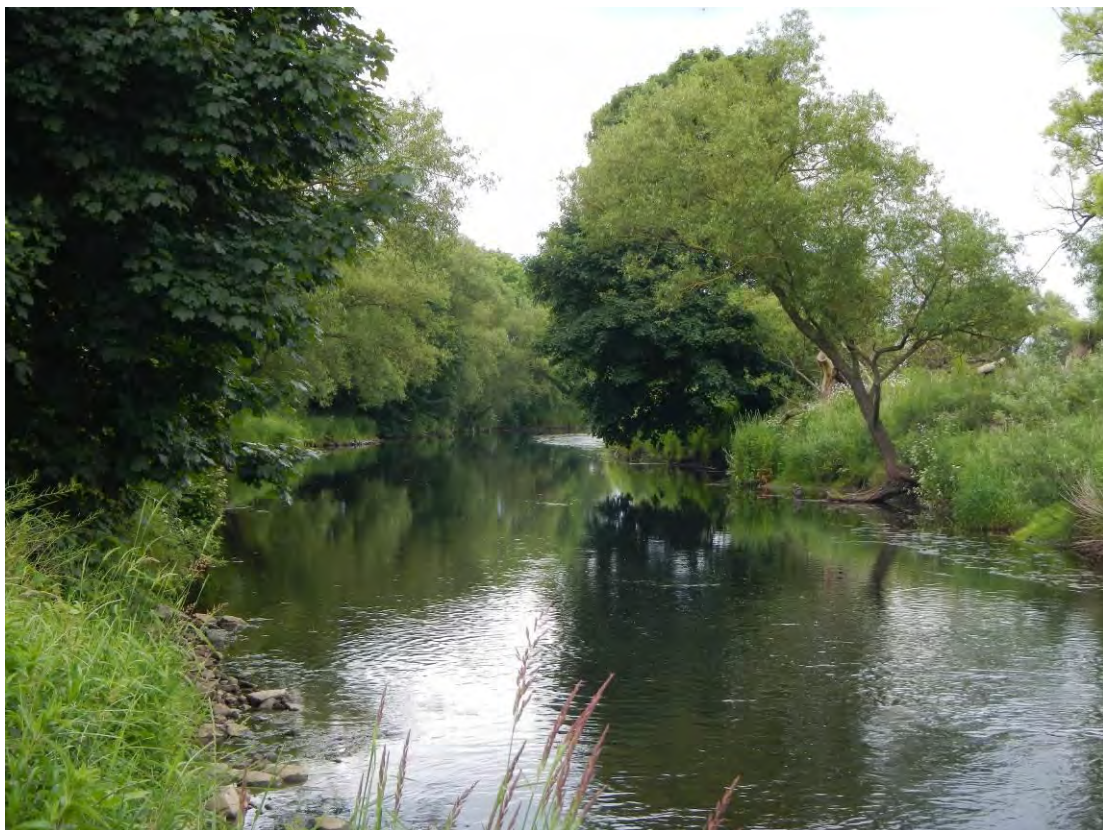
Figure 1. Relatively featureless, over-capacity channel. The area is beginning to naturally recover but the process could be accelerated by increasing structure within the channel to facilitate additional scour and deposition. The willow (right of shot) could be laid into the river margin to assist the process.

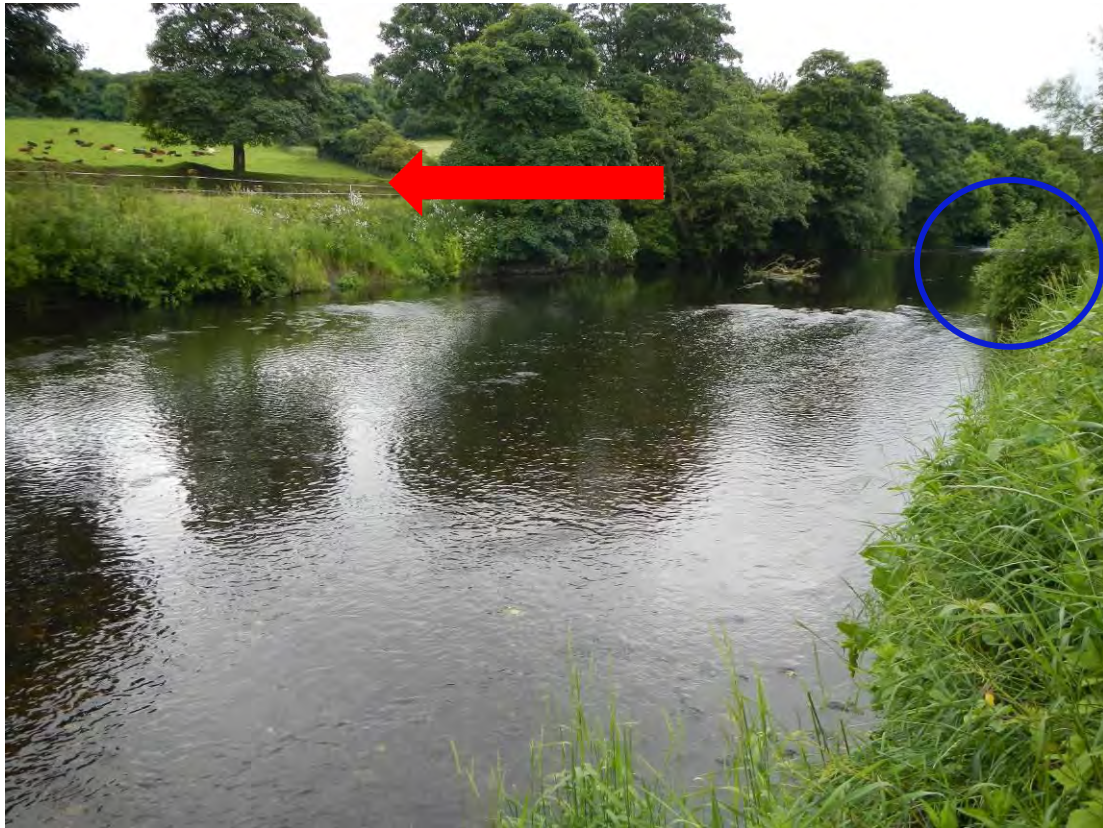
Around the d/s limit, the channel appears quite uniform and over-capacity, with a general lack of in-channel features; this, along with the straight, relatively incised nature of the channel and lack of sinuosity strongly suggests past channel realignment and maintenance/dredging activity (Fig. 1). The presence of at least three separate bunds along the RB provides further evidence of past channel engineering having been undertaken (Fig. 2).

Figure 2. Looking u/s at an overly uniform but recovering channel section. Note the flood bunds along the far bank (red arrow). Given time, the small willow on the true LB (blue circle) will further help to diversify the channel, encouraging deposition in the river margin and diversifying the topography of the bed, providing it is allowed to grow and is not pruned.

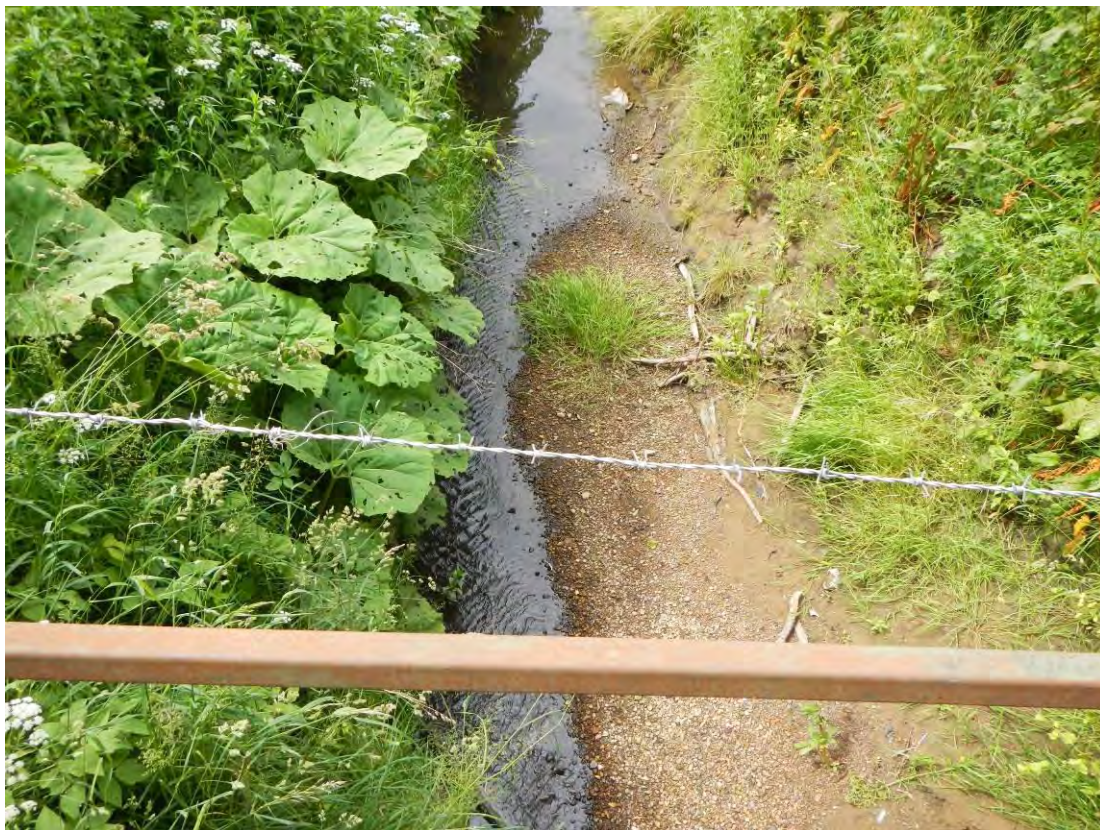
Page Bank Beck, a small, heavily dredged and straightened tributary, joins the River at NZ 23039 35412 and provides some potential for spawning (suitably sized substrate present and salmonid fry observed), although past and ongoing channel maintenance is severely limiting its potential (Figs. 3&4). Allowing gravel bars and natural vegetation to establish within the channel would naturally narrow areas and facilitate scouring and sorting of the substrate, possibly assisted by the use of flow deflectors. Whether the channel will be allowed to naturalise and whether features can be installed to facilitate gravel sorting will have to be agreed with the tenant/landowner.

Figure 3. Small, heavily dredged and straightened tributary. Even since the last dredging activity a gravel bar is already forming naturally, evidence of its ability to recover if the unsympathetic maintenance is stopped.

There is definite potential to improve the habitat quality of Page Bank Beck (NZ 23039 35412) for salmonid spawning, despite the obvious long-term degradation through straightening and dredging. For this reason, it is strongly recommended that the landowner/tenant is approached to see if maintenance of the channel can be stopped to allow recolonisation with vegetation and flow deflectors/in-channel structures be installed to kick-start recovery of the channel. The channel is it is already significantly lower (c.1.5 - 2 metres) than the level of the adjacent fields, meaning that even quite large alterations within that channel will not negatively impact upon land drainage.

Simple paired or alternating deflectors could be used to pinch the channel and drive bed scour, sorting the substrate and greatly improve the habitat quality of the channel (Fig. 28 & 29). The Beck is severely degraded but does already contain some salmonid fry (as observed during the visit), the numbers of which can be increased with more sympathetic management/habitat improvement.

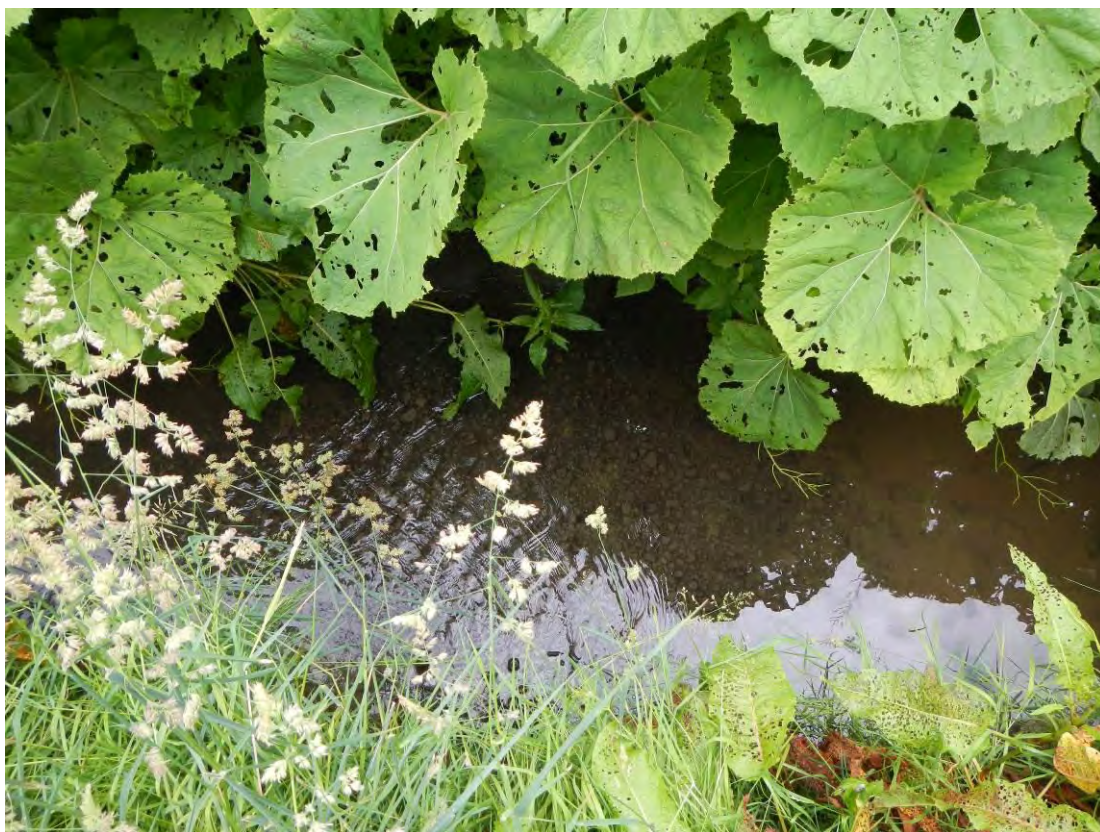
Figure 4. Long, over-capacity sections of the tributary are punctuated with small depositions of gravel. These are signs of some natural recovery and are features which could be enhanced to improve the potential for salmonid spawning.

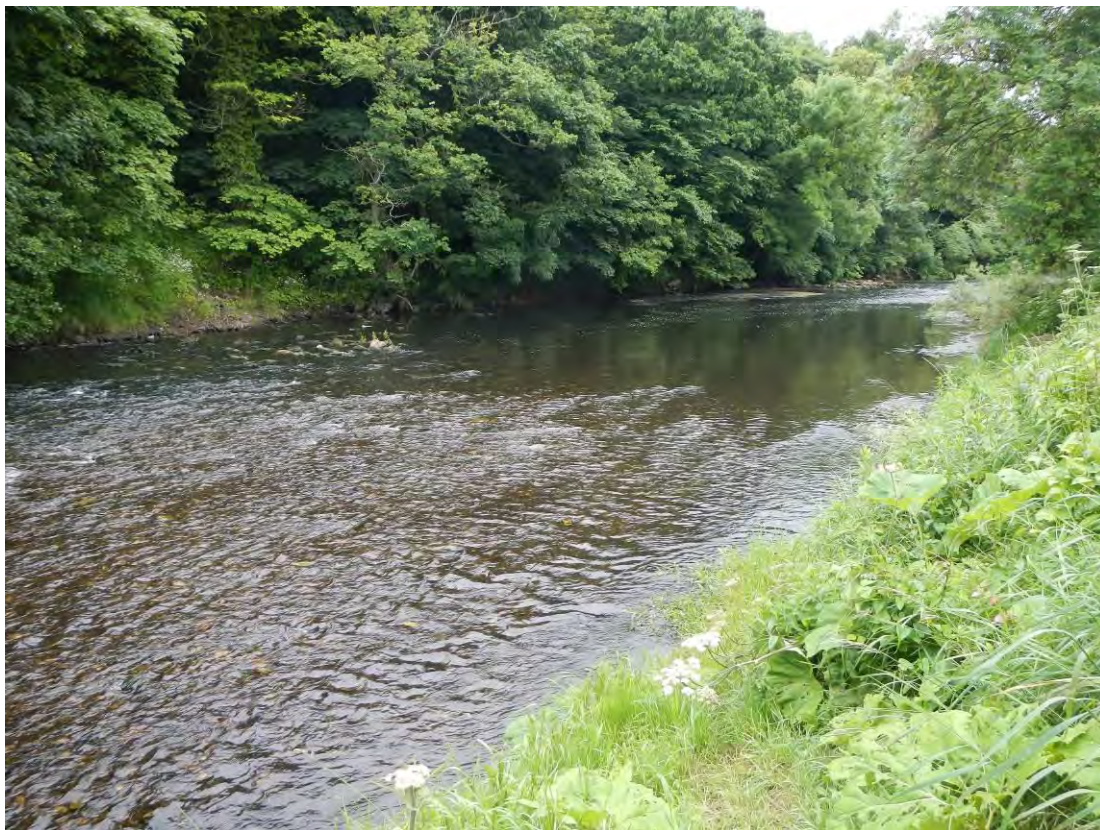
Figure 5. Bedrock has limited the extent of channel modification in some areas and, as a consequence, those areas provide more diverse, higher quality habitat that caters for the full range of salmonid life stages.

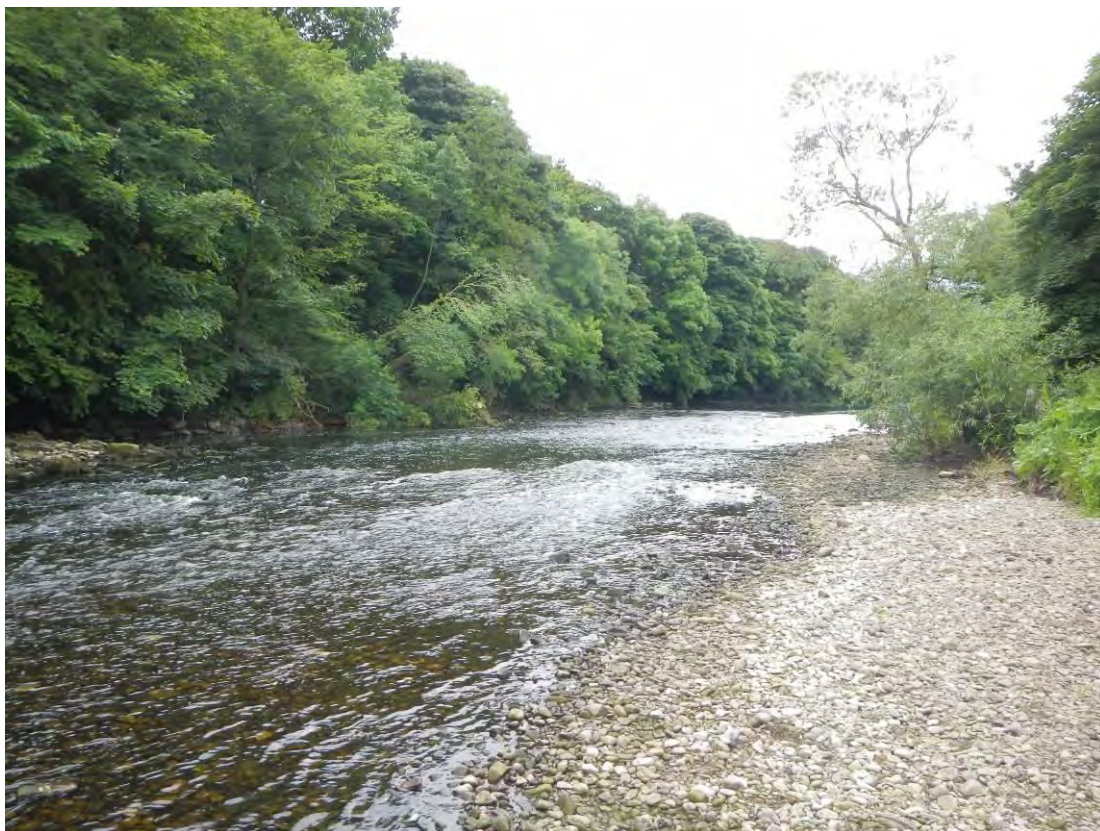
Figure 6. High quality riffle and glide habitat. Note how the presence of willow shrubs on the inside of the bend are likely to have assisted formation of the gravel bar - this naturally narrows the wetted channel, maintaining beneficial bed scouring and water depth.

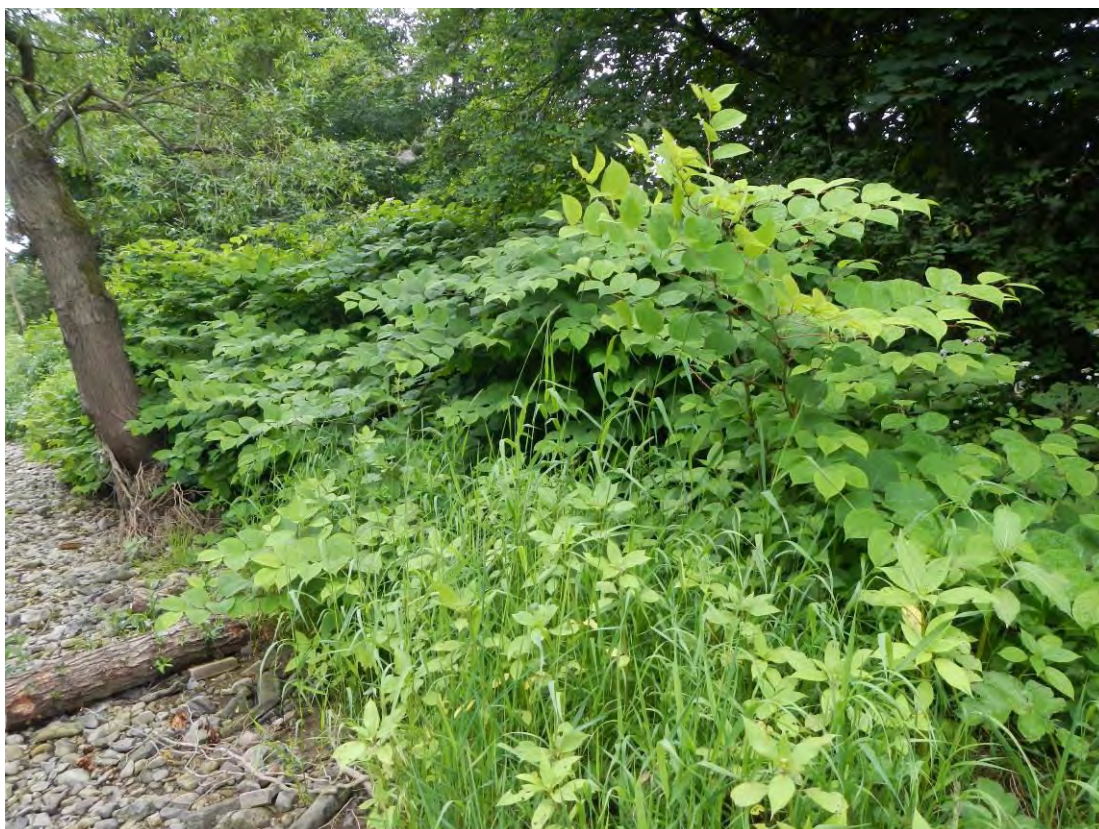
Japanese knotweed *Fallopia japonica* was noted at NZ 22885 34990 and is a particularly detrimental non-native invasive species that shades out native plants. Knotweed dies back in the winter, leaving bare, exposed soils that are highly susceptible to erosion. The coverage currently appears limited to this one area and it should be treated with herbicide by qualified personnel to prevent its spread. Himalayan balsam *Impatiens glandulifera* was also noted throughout the visit and also requires treatment but, being so extensive within the catchment, is likely to require a more strategic approach. Wear Rivers Trust may be able to assist with both of these issues.

Figure 7. Japanese knotweed was observed at NZ 22884 34998. This appeared to be a relatively localised infestation and should be treated with herbicide before it spreads.

Non-native invasive species should not be tolerated and the Japanese knotweed stand at NZ 22885 34990 should be treated with herbicide by qualified personnel as soon as possible. The issue with Himalayan balsam should also be tackled but will require a catchment based approach – something Wear Rivers Trust may be able to assist with.

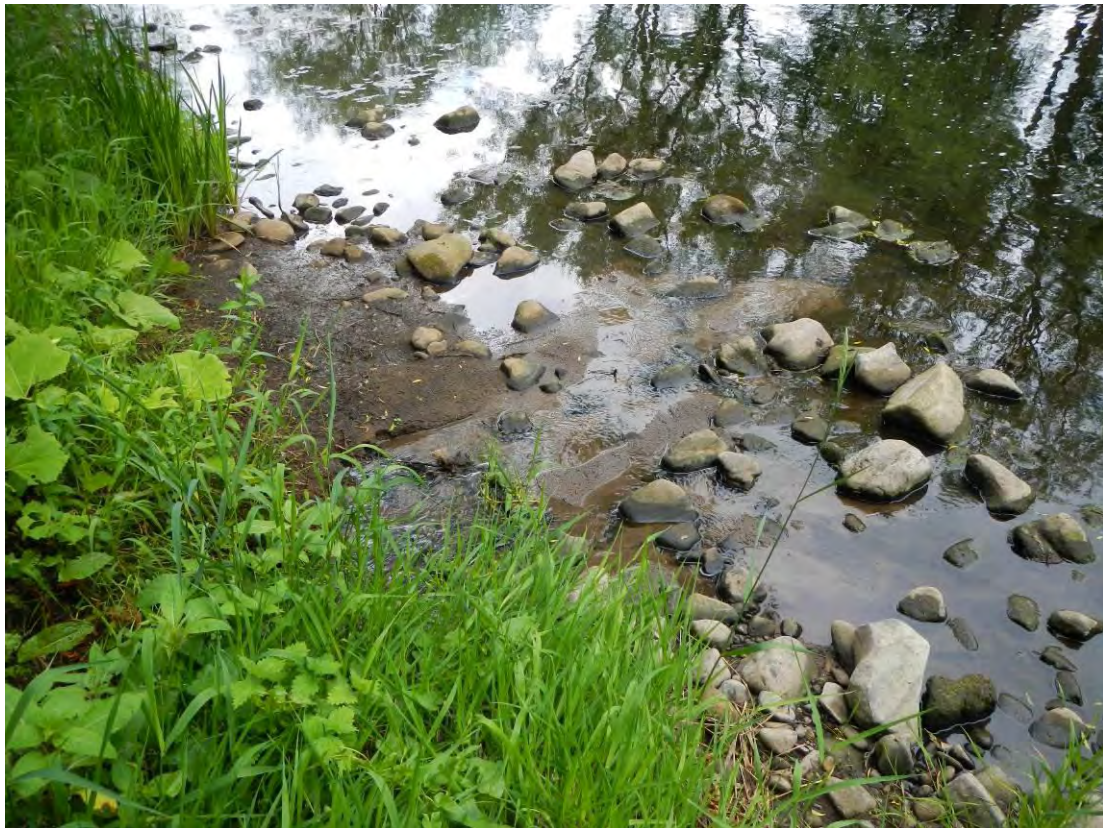
A short distance u/s, at NZ 22550 34808, the outflow from a small pond presents a point source of fine sediment (Fig. 8). It would be well worth investigating why fine sediment is emanating from the outfall and whether it can be prevented. While small sources of fine sediment may appear innocuous, any inputs to the River (particularly if occurring at low flows) can be detrimental. Fine sediment inputs can smother the coarse river substrate, reducing its potential as fish spawning and/or invertebrate habitat. Such outfalls are also often a source of excess nutrients that lead to deterioration of river water quality and issues like excess algal growth.

Figure 8. Any sources of fine sediment input to the River should be investigated and, wherever possible stopped to protect fish spawning and invertebrate habitat.

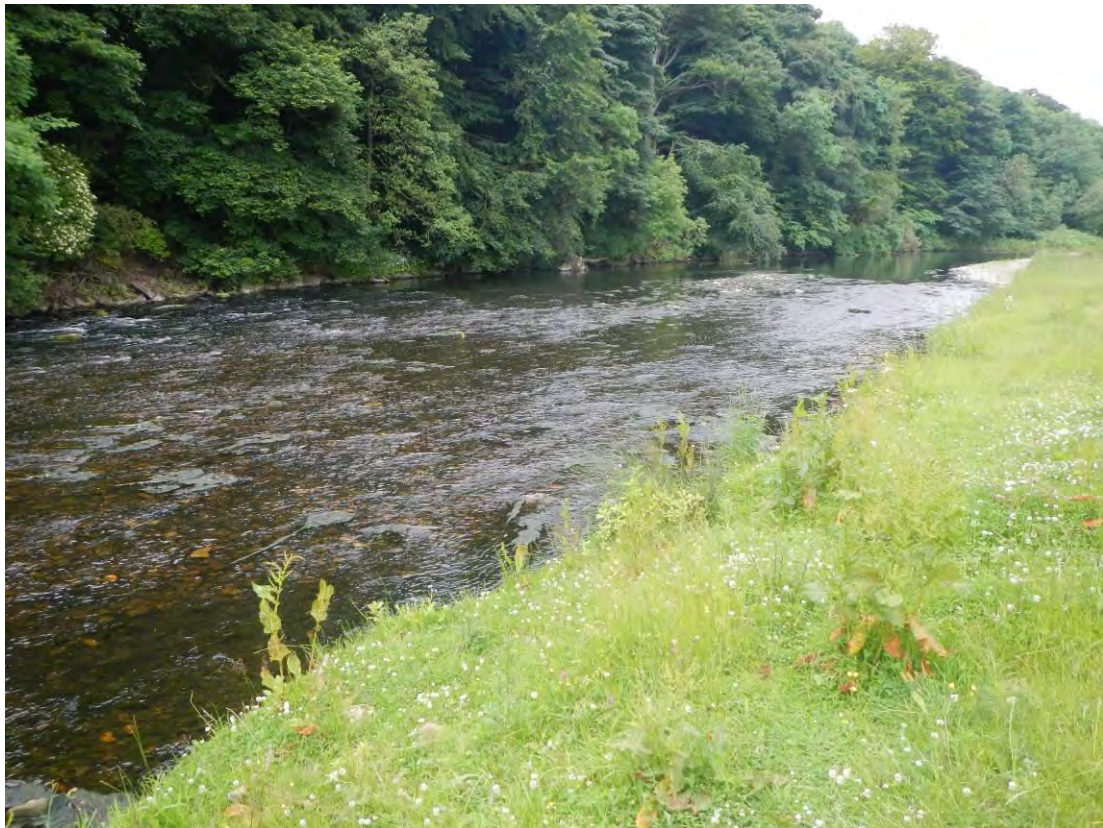
Livestock are excluded from the banks of the River in most areas and, as a consequence, the bankside vegetation and tree cover provide high quality habitat. However, where grazing is allowed, even at relatively low density, the impact can be seen (Fig. 9). There is a general lack of species diversity, other than grasses (which can withstand continual grazing) and unpalatable species like docks *Rumex* spp. Trampling damage and a lack of diverse vegetation has led to bank erosion, significant channel widening and an associated loss of water depth. The lack of bankside trees, particularly trailing branches, also leaves a distinct lack of cover along the LB. Livestock trampling around one of the few remaining bankside shrubs further demonstrates how grazing can denude a bank of such features (Fig. 10) - it too will be lost through wash-out in subsequent floods if the bank is not allowed to revegetate and stabilise around it.

Grazing of the area is also inhibiting vegetation from colonising and stabilising the gravel bars along the left bank. This maintains them in an unstable state and susceptible to movement in high flows. Excluding livestock from the river bank would allow a naturally diverse range of vegetation to become established along the bank and create an area that could be replanted with trees, both of which would greatly reduce the bank erosion and facilitate natural channel narrowing to occur.

Figure 9. Long-term grazing of the LB (right of shot) has greatly denuded it of its natural, diverse vegetation and trees, reducing the availability of cover and the River's **natural ability** to adjust its channel dimensions.

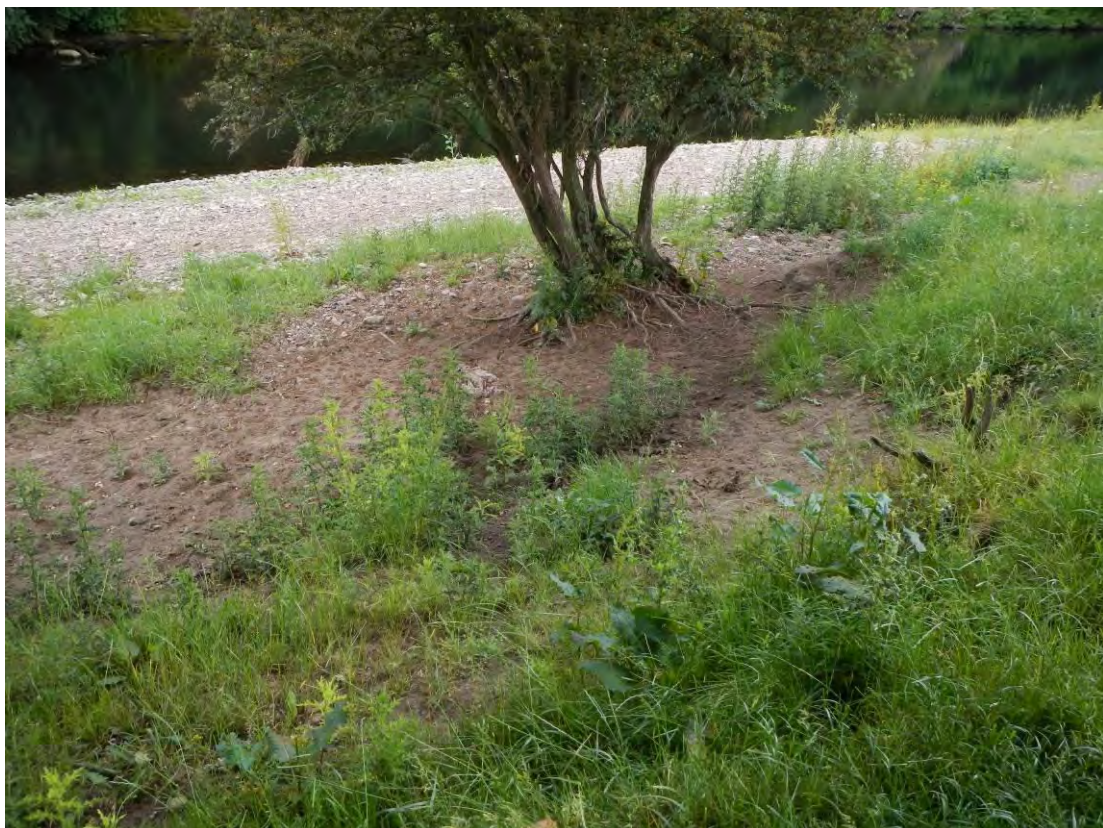
Figure 10. A perfect example of how, over time, river bank grazing leads to loss of not only herbaceous vegetation but also shrubs and trees. Unless the ground around this hawthorn *Crataegus monogyna* is allowed to re-vegetate, it is highly likely that further erosion in high flows will wash it away.

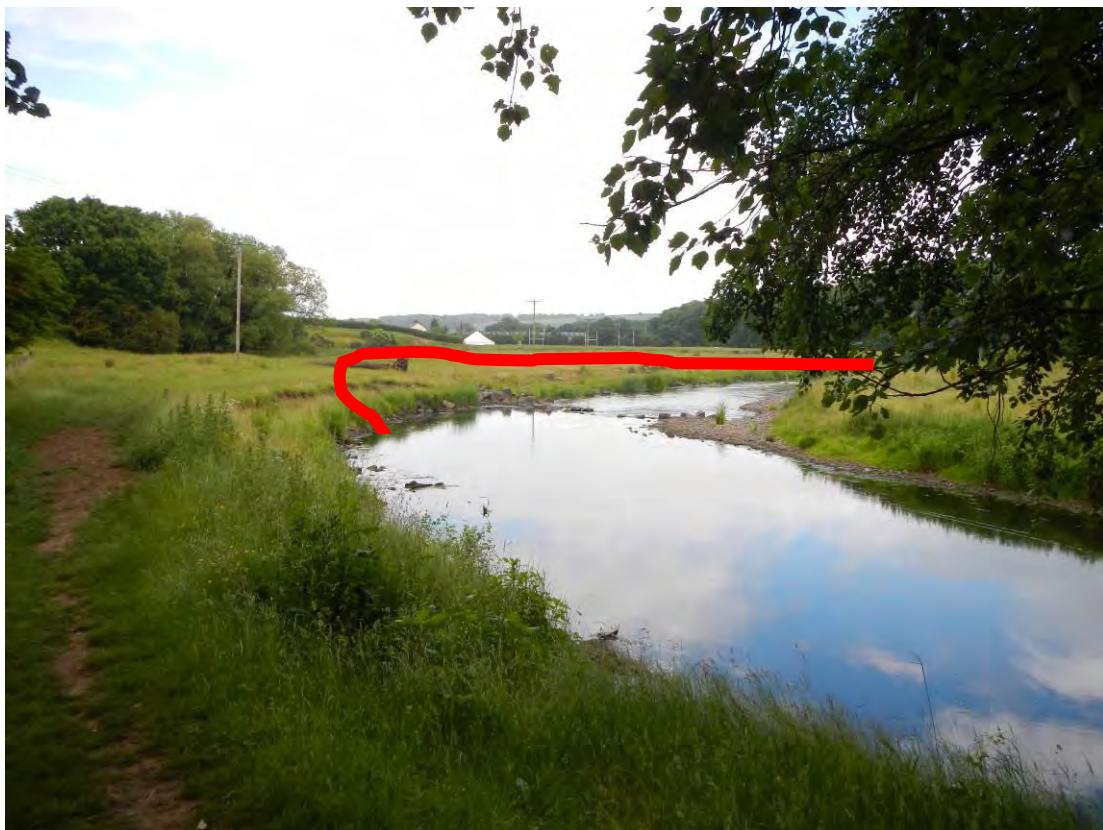
An obvious area of more recent channel realignment is evident a short distance upstream, where a large natural meander has been replaced by a straight section of channel (Figs. 11 & 12). This has extended the shallow character of the River even further upstream. Boulder/stone weirs extend across the channel at either end of the straightened section, probably installed in an attempt to de-energise flows and retain the River in its manmade channel.

Figure 11. Looking d/s at the current channel and old course of the River (red line).

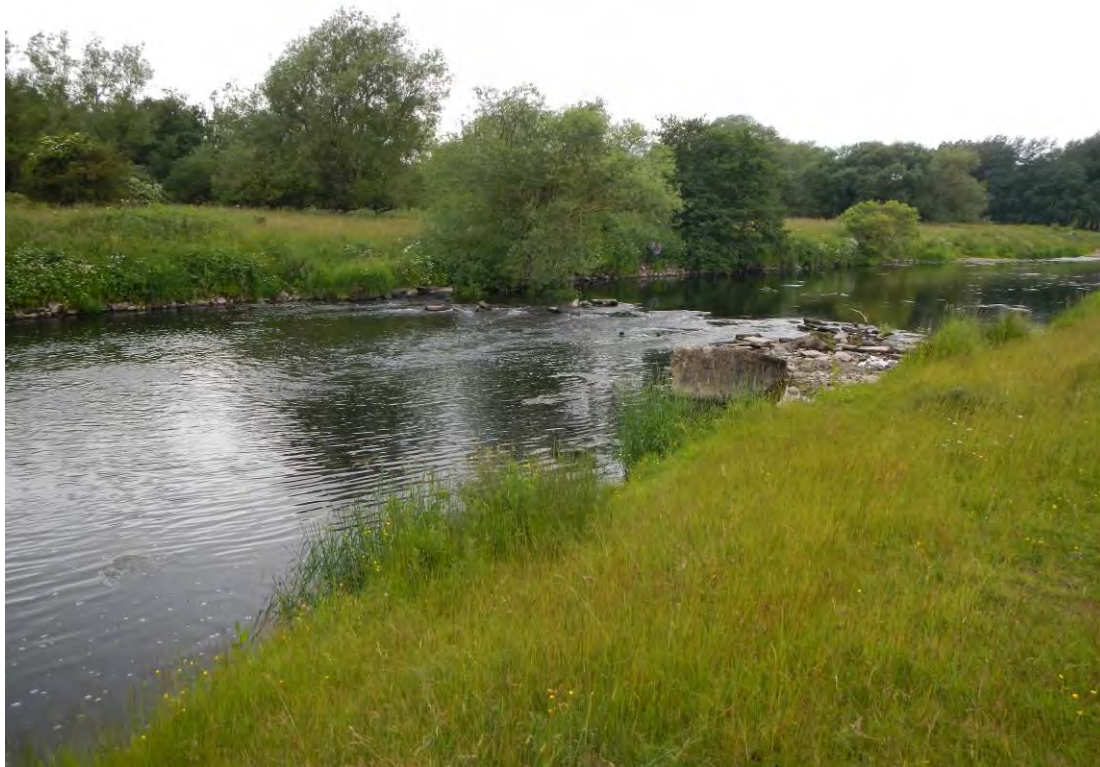
As with all weirs, these structures act as sediment traps and lead to shallowing of the channel upstream, encouraging relatively uniform deposition of substrate across the bed. Leaving at least a one-third channel width gap would have reduced the impact of shallowing by allowing transport of sediment through the central notch. Correspondingly, removing at least the central third of the weirs would allow the development of a more natural channel morphology. Ideally, however, the whole structures would be removed after first installing buffer fencing to allow herbaceous vegetation and trees/shrubs to consolidate the banks.

Figure 12. Weirs form sediment traps and while they may initially increase water depth upstream through their impoundment, they will ultimately lead to a decrease in depth over time as the river bed material supplied from upstream gradually accumulates within the impounded section. The impoundment and reduced substrate movement (scour and deposition) within the impounded reaches also limits flow diversity and inhibits the formation of beneficial habitat features. Note the wide, shallow section u/s.

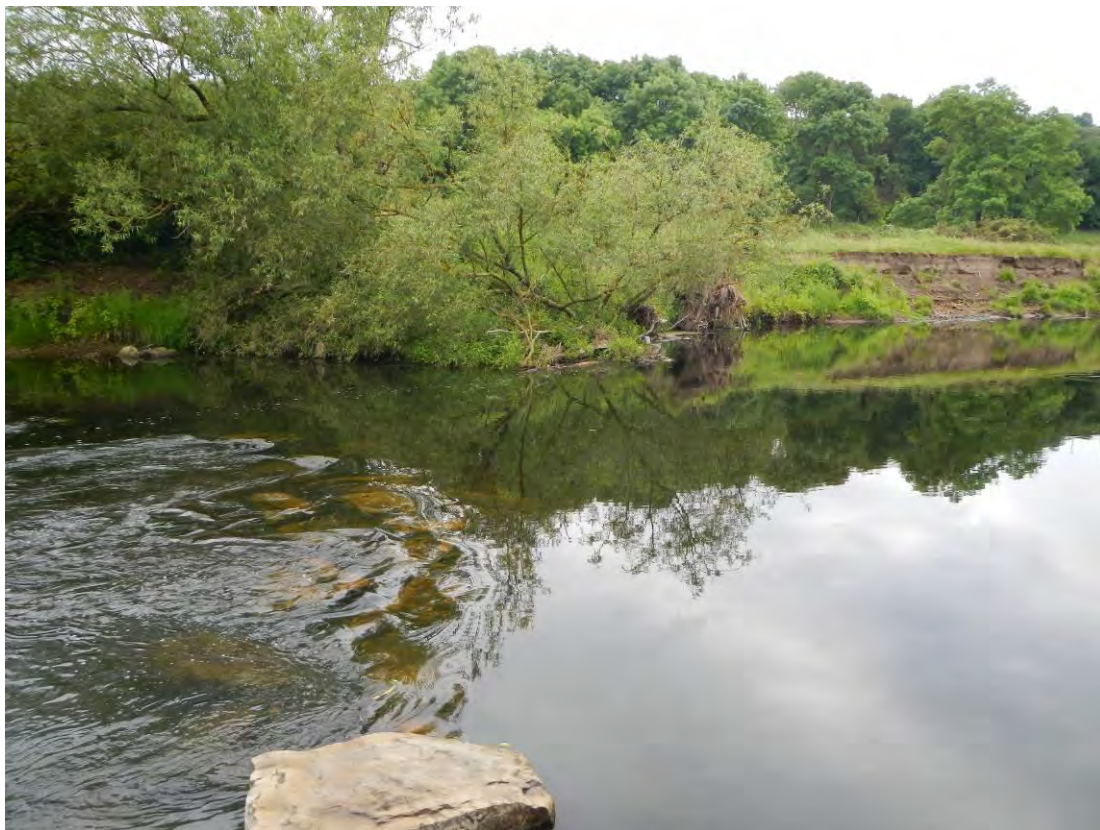
A similar weir further u/s has begun to wash out in the centre, reducing the negative impact of that structure although not completely, with the channel u/s still impounded and natural sediment transport inhibited by the impoundment and the structure.

Habitat u/s of the weir is, however, greatly improved by the presence of a large willow shrub that has fallen into the River, creating highly beneficial in-channel cover and narrowing the channel to increase flow velocities (Fig. 13). It should be remembered that, in addition to providing great cover and shelter from high flows, the presence of such structures also provide vital refuge from, and hence reduce the impact of, predators. Planting willow in more open, featureless sections like that immediately u/s can thereby actually increase the number of fish than can be held within a reach.

Figure 13. A degrading weir that still poses a negative impact through its impoundment and the associated disruption to sediment transport. A fallen willow u/s does, however, provide some habitat enhancement and is exactly the type of feature that should be promoted.

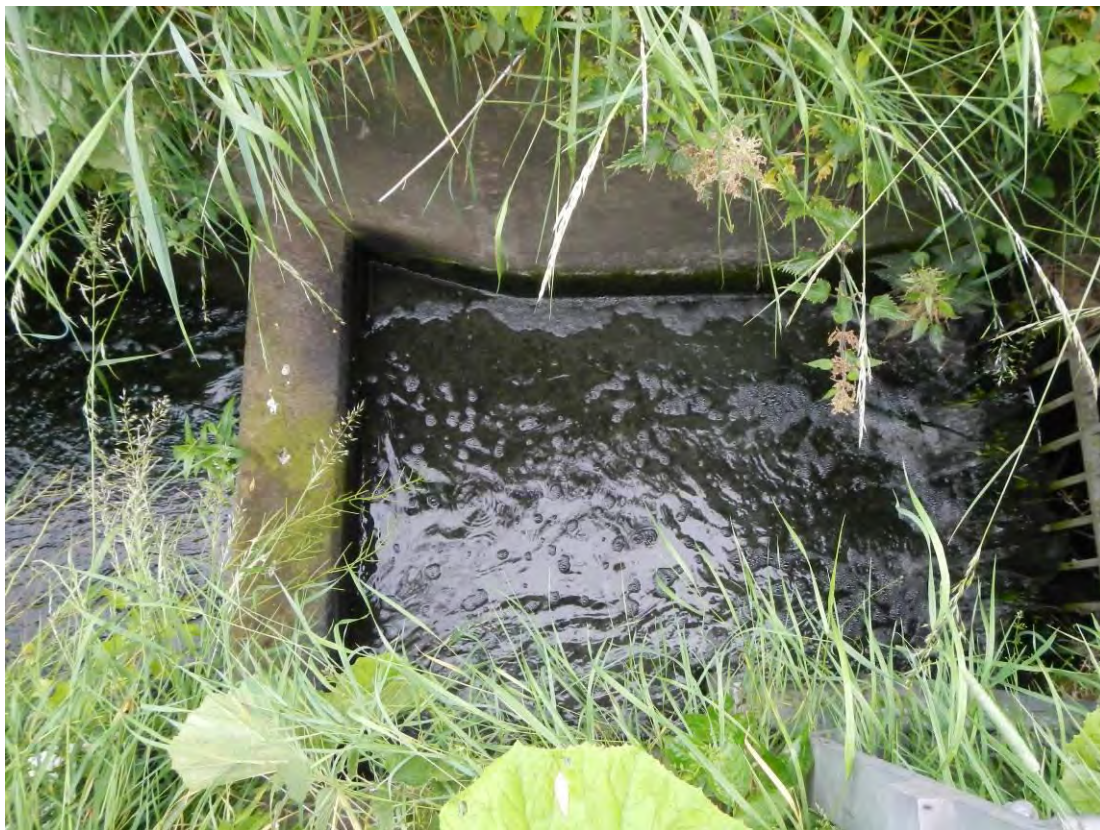
At NZ 21077 34454, an outfall from the sewage treatment works (STW) meets the River. While the water appeared to be relatively clean at the time of the visit, it is suspected that the discharge is often of a much poorer quality, as evident by the sewage fungus (grey) on the bed. The outfall should be regularly monitored and if discoloured or malodorous water is observed to be leaving the works, it should be reported immediately to the EA.

Figure 13. The STW outfall. Note the grey coating on the bed of the channel. This indicates high nutrient/poorly treated water emanates from the outfall at times – something that should be closely monitored, and reported when observed.

To ensure that the conditions are optimised for wild trout production, it is recommended that all outfalls and tributaries to the River are monitored, with any abnormalities or suspected pollution events **immediately reported to the Environment Agency's Pollution Prevention Hotline (0800 80 70 60)**. Unfortunately, this may not always generate a site visit response but it is important to log all incidents that occur to ensure that they are taken seriously and to force improvements to the infrastructure or operating regime.

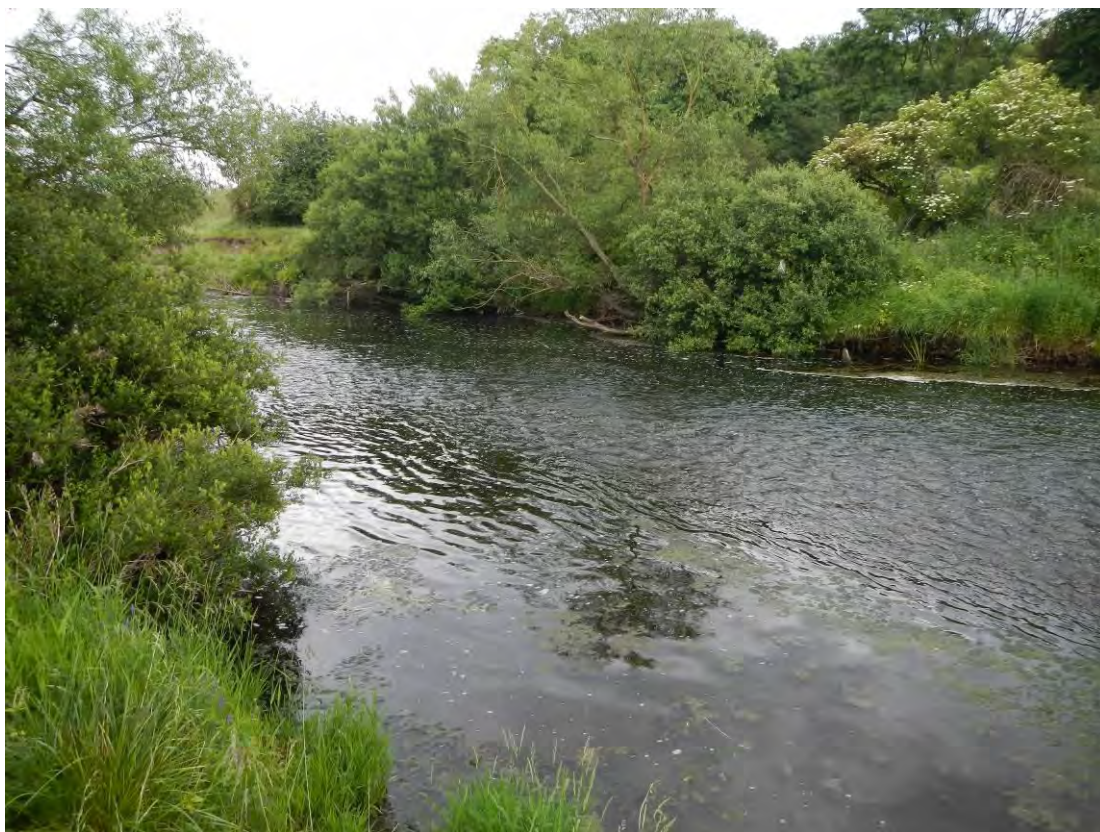
Immediately u/s of the outfall, a perfect example of the high quality habitat that can be achieved by allowing willow trees to naturally encroach into the River channel was observed (Fig. 14). The habitat provided by the trees is a major benefit in this area and, correspondingly, it is likely to hold good numbers of fish, both resident and migratory (at certain times of the year).

Figure 14. Very high quality wild trout habitat provided by a natural abundance of overhanging and, very importantly, trailing willow branches, coupled with diversely vegetated banks.

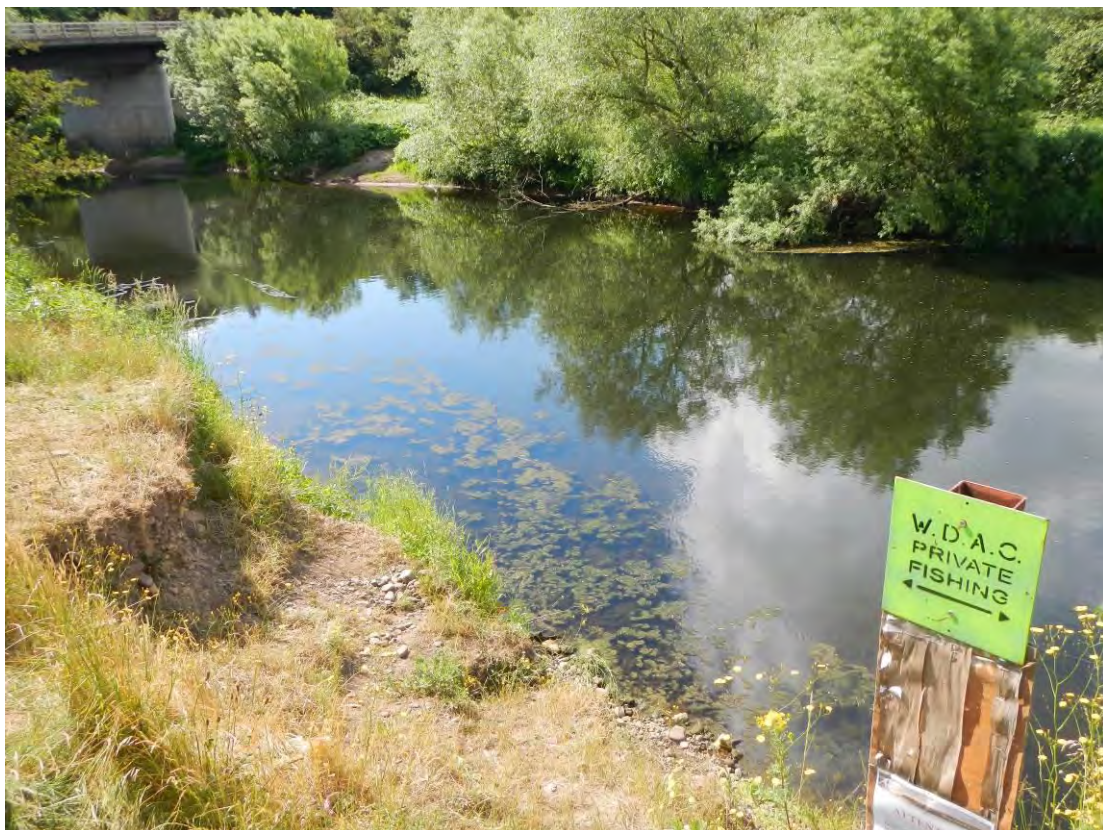
It is not only livestock access and trampling that can exacerbate bank erosion and the section adjacent to Jubilee Bridge carpark is a good example of this (Fig. 15). Here, human and dog access to the bank (coupled with Himalayan balsam growth) has led to erosion of the bank. Addressing the balsam issue and temporarily excluding access from that area of bank would allow the bank to revegetate and naturally regrade, making it far less susceptible to erosion. Formalising a revetted access point for anglers could also help.

The channel in this section is greatly over-capacity (probably due to dredging associated with the bridge) and so should not be susceptible to erosion if the banks can be allowed to revegetate. Aside from the riffle at the head of the pool, trailing willows on the far bank (RB) provide the only valuable habitat features for trout. Again, such features could be replicated along more open bank sections to increase the fish holding capacity - conversely, removing or pruning those features is sure to reduce the number of fish that reside there.

Figure 15. Bank erosion that is greatly exacerbated by trampling (human and dog) and Himalayan balsam.

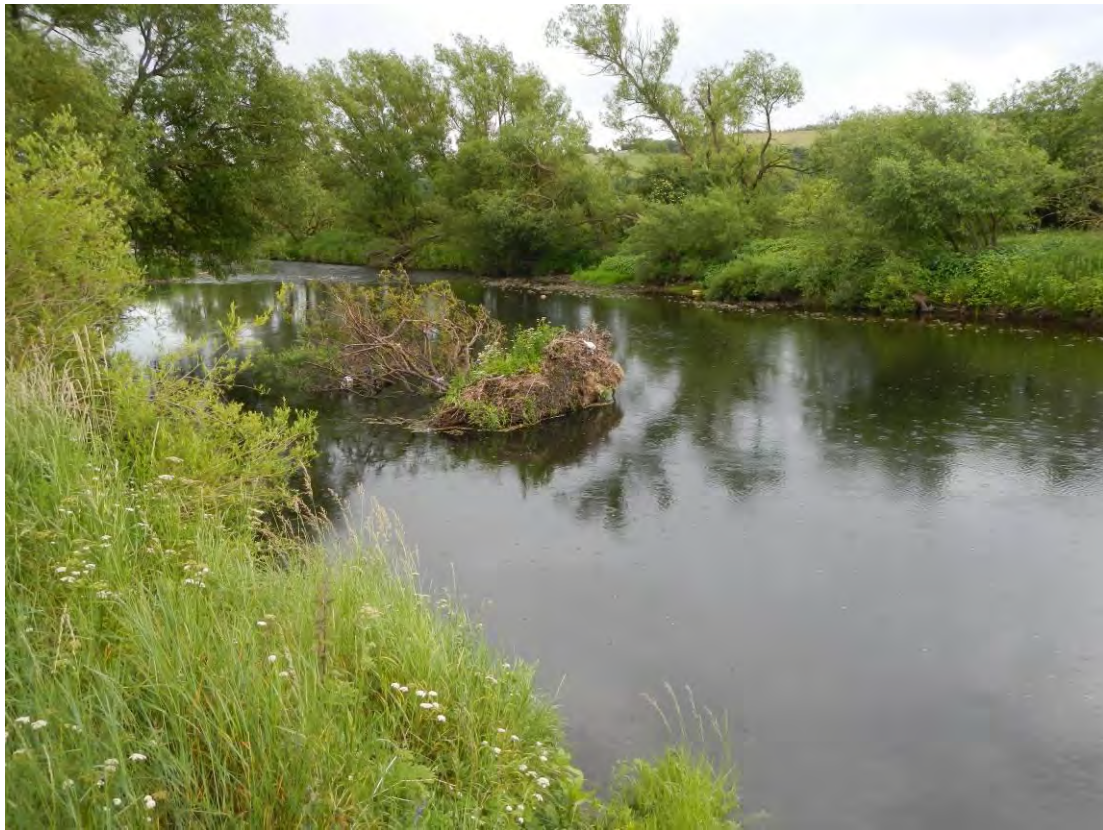
Two other great examples of valuable, natural in-channel structure can be observed a short distance u/s; an alder tree that washed out in the recent floods (Fig. 16) and a large, collapsed willow limb (Fig. 17). Both of these features reduce channel capacity and increase flow diversity, creating beneficial bed scouring in some areas and deposition in others. They also provide habitat for plenty of fish!

Figure 16. An alder tree that has been deposited towards the tail of a pool. This creates a beneficial feature that will hold more and bigger fish than would hold there before. Remove it and the River will be able to hold less fish.

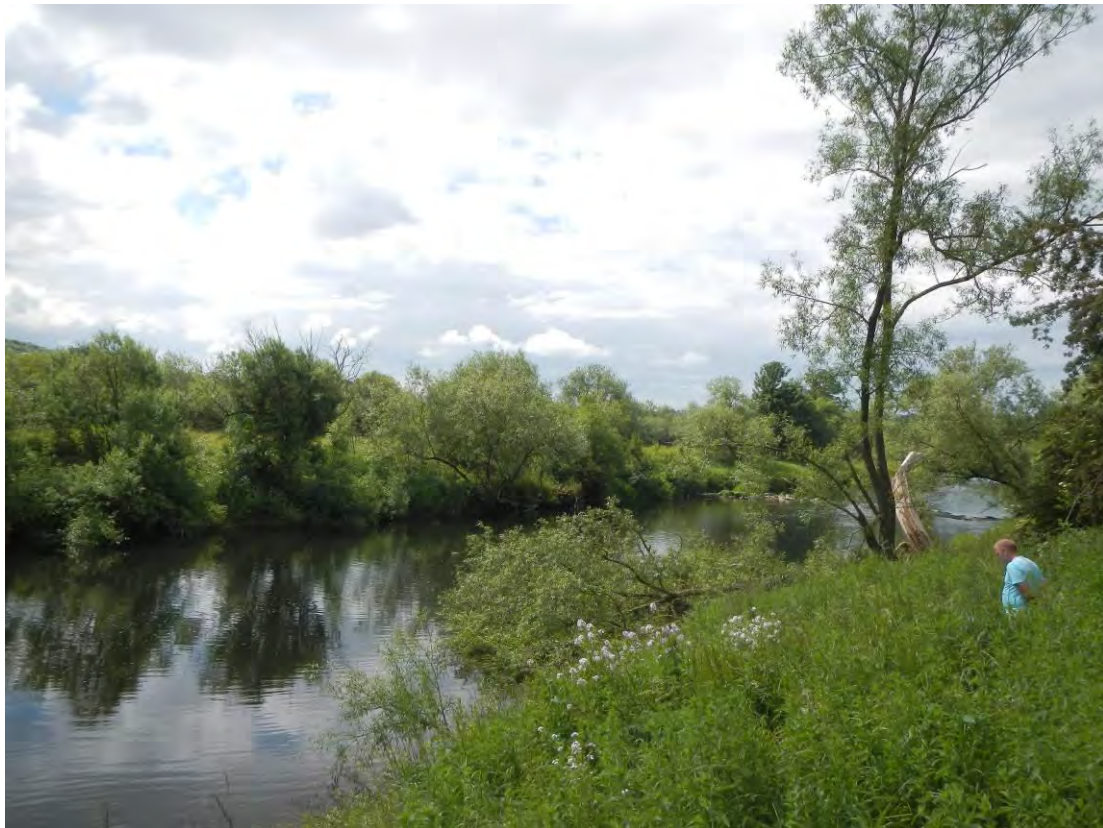
Figure 17. A collapsed willow limb provides valuable shelter and refuge for fish. In addition to these obvious benefits, the dissipation of flow energy along the LB margin will encourage deposition of gravel and other sediments among the structure and d/s of it. This will assist the natural channel narrowing process that will in turn help keep the bed of the remaining channel free from finer sediment and maintain the flow rate and depth of the remaining channel.

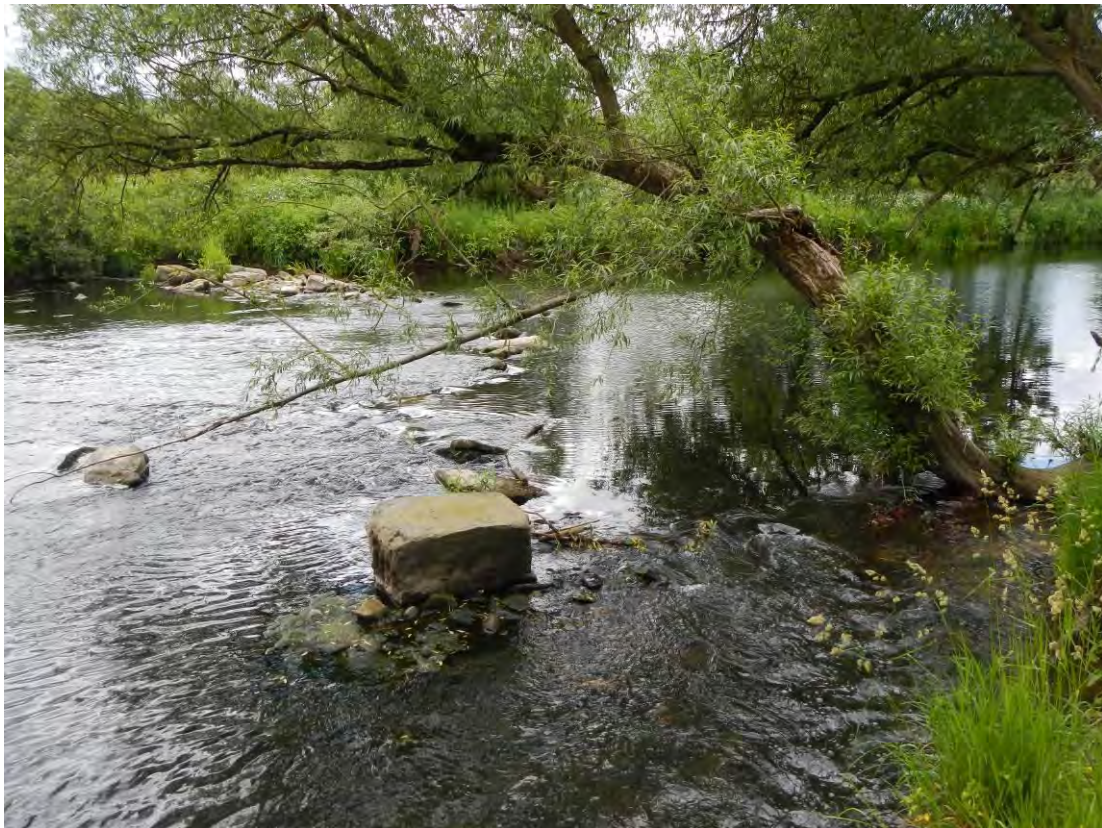
A weir at NZ 20234 34405 creates similar issues to those already discussed, but here, is also causing bank erosion as flows have cut around the structure (Fig. 18). Ideally the whole structure would be removed but removing at least the central third of the structure would reduce the pressure currently acting upon the bank and make any bank protection measures more effective. Filling the erosion void with material such as laid willow or live willow brush should help reduce flows and increase deposition there to fill the void.

Figure 18. Bank erosion issues where another stone weir has been out-flanked by flows.

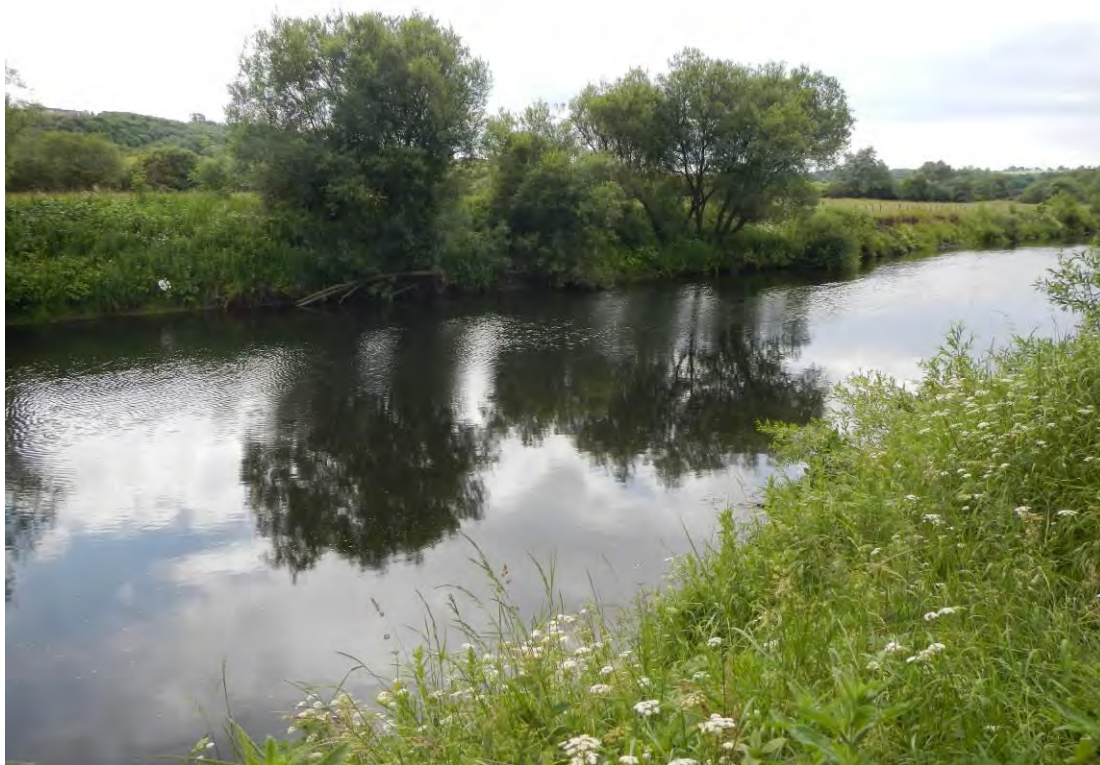
Figure 19. Over-wide channel section with little flow diversity and providing poor trout habitat. Laying willow trees into the channel would greatly improve this area.

The sluggish, low quality habitat u/s of the weir (Fig. 19) could be improved by laying willow trees into the channel to recreate the narrowing and habitat enhancements provided by the naturally collapsed willow d/s. Again, this would also assist the development of greater river bed diversity. The benefits here too would be improved by removal of the weir as the River would then have a greater amount of flow energy with which to develop the channel.
