Advisory Visit

River Wear

Willington and District Angling Club

24/06/2016

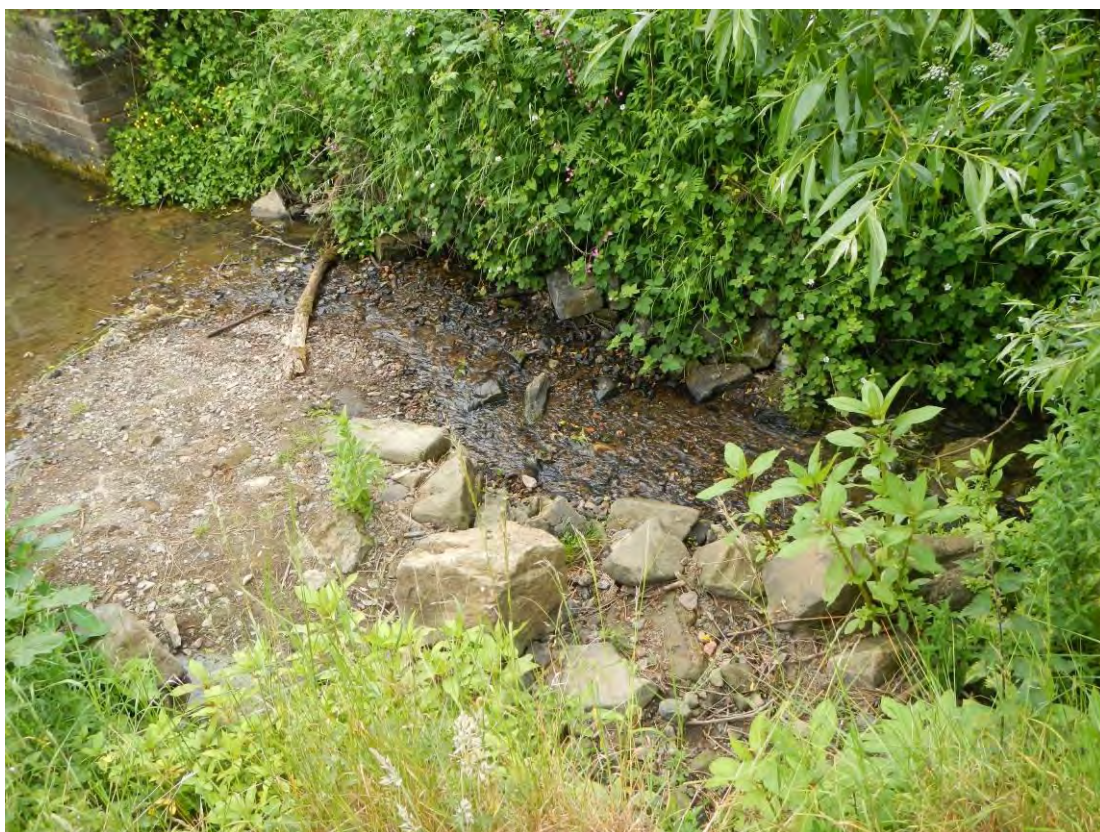
A small section of tributary on the LB (NZ 19993 34112) offers some potential for salmonid spawning (Fig. 20), although it is greatly restricted by the presence of a culvert c. 35 metres u/s of the main River. The RB of the tributary is currently subject to significant erosion (associated with Himalayan balsam), which has allowed it to become over-wide and is reducing natural scouring of the bed that would otherwise help to maintain the gravel free from fine sediment.

Figure 20. Bank erosion on tributary, just d/s of culvert. The issue is greatly exacerbated by Himalayan balsam and unsympathetic rock armouring. Creating a naturally vegetated, more stable bank and therefore appropriate channel width to develop should assist with sorting of the substrate.

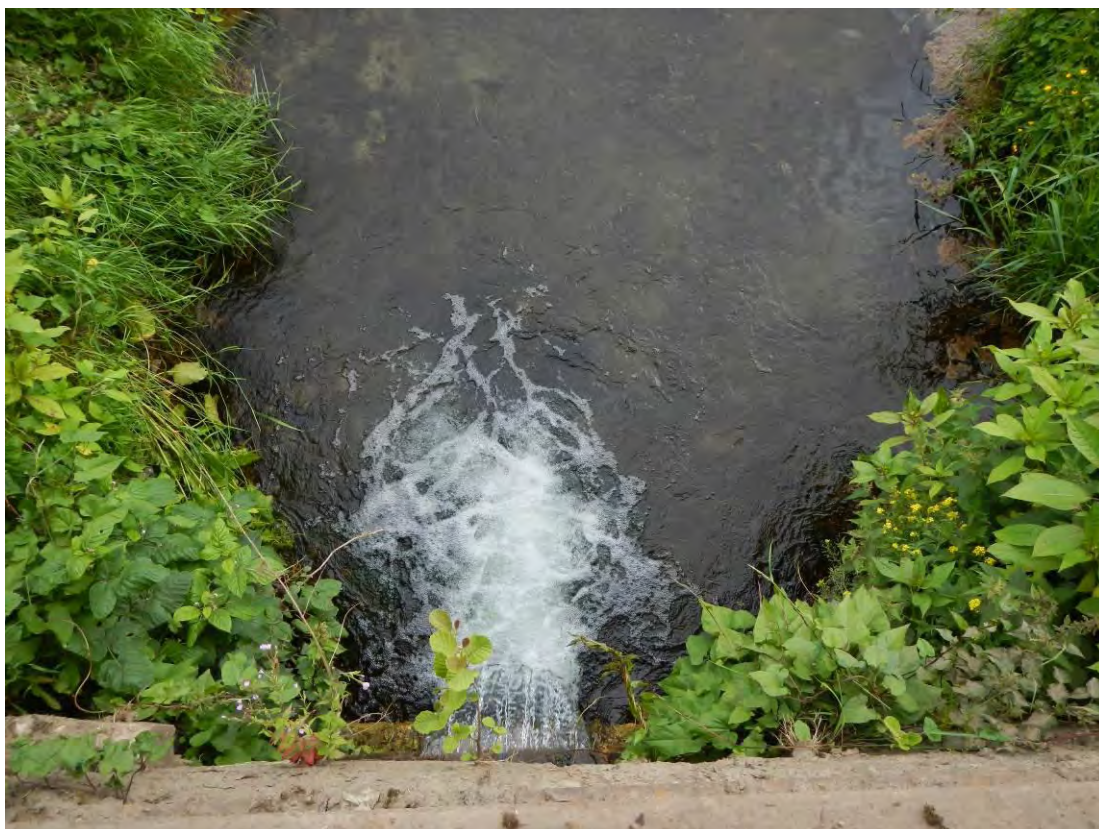
Willington Burn offers potential for salmonid spawning but is again significantly impacted upon. A culvert towards the confluence with the Wear (NZ 19974 34110) presents a small barrier to fish passage (Fig. 21) and the crystal clear water but fine sediment and orange/ochreous discolouration of the bed suggest a mine water influence (Fig. 22).

Figure 21. A small barrier to fish passage – note the crystal clear mine-impacted water.

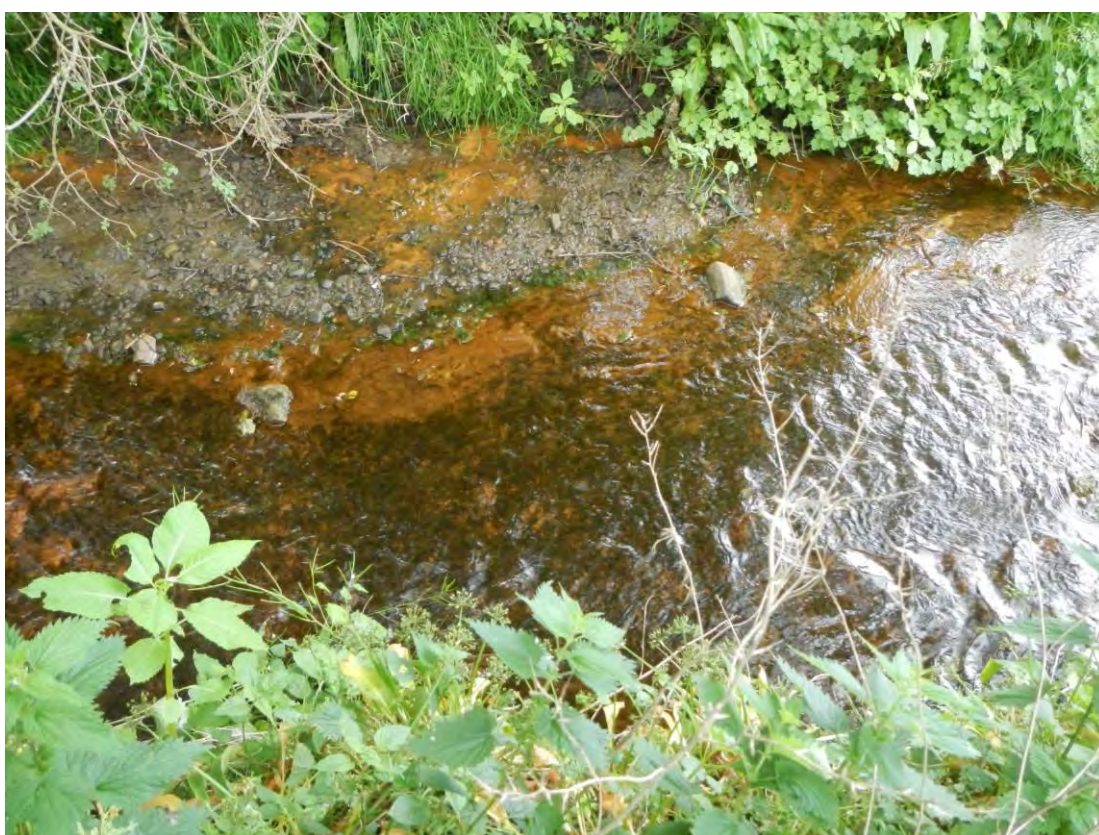
When poorly oxygenated, iron-laden water emerges from the ground the water becomes better oxygenated, iron oxidises and precipitates out of solution, at the same time reacting with any fine sediment particles in the water and causing them to flocculate (clump together) and fall out of suspension. The chemical process can cause issues with deoxygenation of the water, along with the problems of siltation.

Figure 22. Ochreous precipitate and fine sediment deposition on the bed that are both likely to render it poor quality spawning habitat, despite the presence of some suitable sized substrate. Algal growth may be due to a lack of grazing invertebrates or a sign of excessive nutrient inputs upstream – both of which aspects should be investigated.

Further investigation of the Willington Burn should be undertaken to identify whether habitat quality improves u/s, the potential sources of sediment and nutrients and whether they can be addressed.

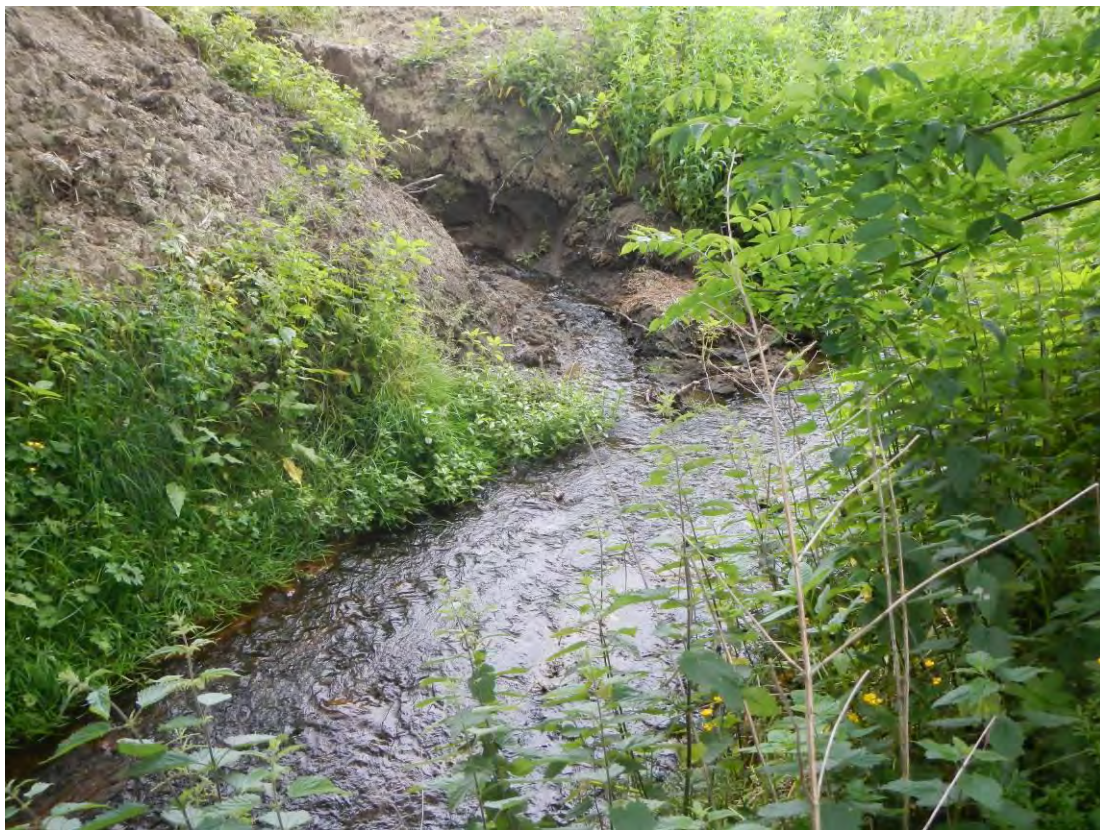
A drainage channel from a spring within the adjacent field presents a further issue (Fig. 2). This spring is suspected to have occurred as the water table rebounded following cessation of pumping within old mines around the catchment. The custodian of the field has then created a ditch within the field to allow the water to escape, in the process, increasing the fine sediment input to the tributary and main River.

Figure 23. Outflow from the spring in the adjacent field. Excavation/dredging of this channel has created a bare earth trench that is susceptible to erosion and an additional source of fine sediment to the system.

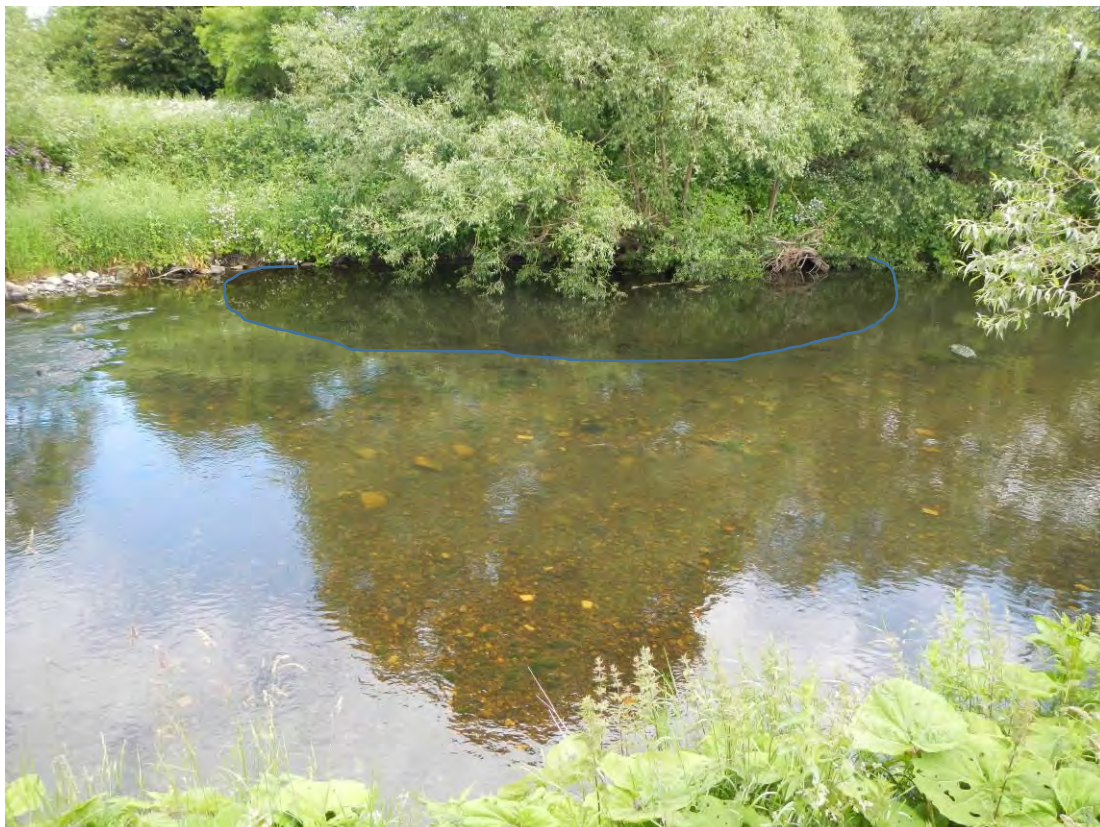
In areas where bankside trees have been allowed to naturally encroach into the channel, the benefits are clearly visible. In addition to shade, cover and refuge, the diversification of flows (particularly high flows) has driven scour into the river bed, creating and maintaining excellent deeper water habitat (Fig. 24). This effect has occurred as the willow is on the outside of a slight bend where it has maximal flow energy working upon it in high water.

Figure 24. High quality habitat created by trailing willow branches – note how the branches have driven high flows downwards into the bed to create excellent, deeper fish-holding water.

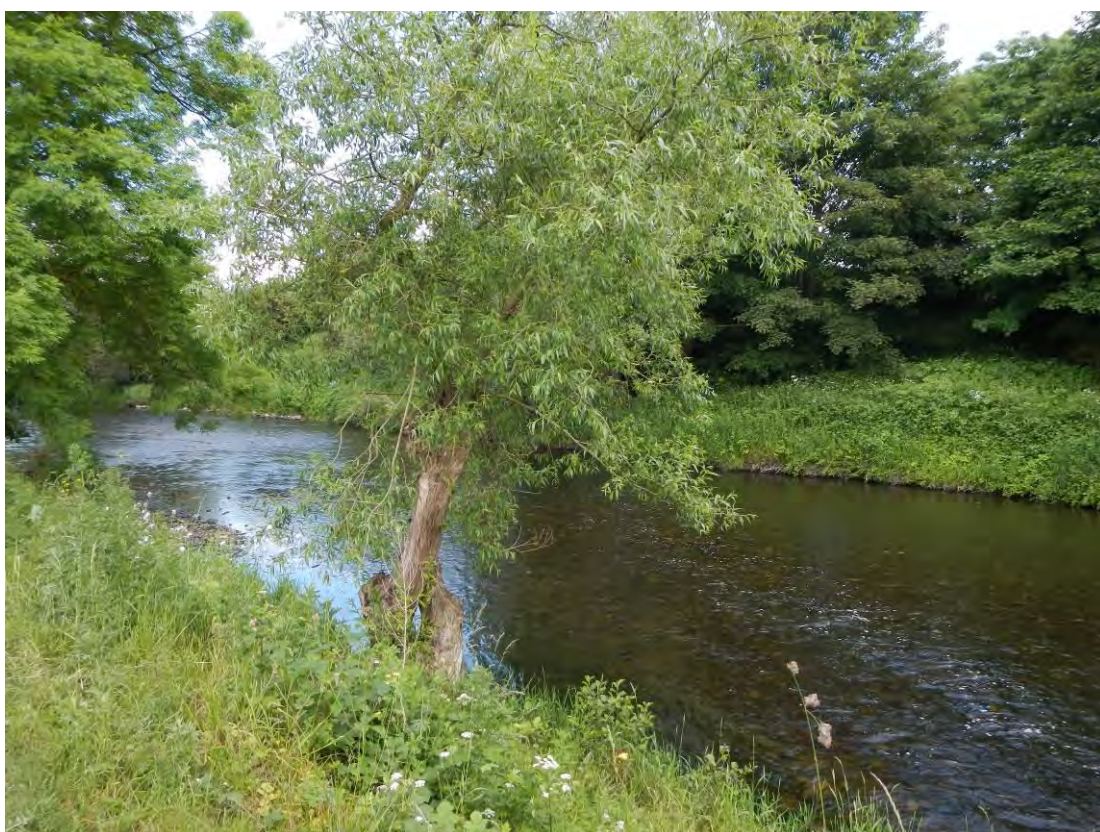
Further u/s, the opposite effect could be initiated. Being on the inside of a slight bend, the willow tree in Figure 25 could be laid into the channel to further dissipate flow energy and facilitate a greater amount of sediment deposition within the river margin. This would help naturally narrow the channel and force more of the flow along the outside of the bend where it will then create and maintain channel depth.

Figure 25. The willow tree (centre of shot) could be laid down into the channel to encourage greater sediment deposition in the near LB margin and maintenance of a deeper-water channel along the far bank. Planting small shrubs along the far bank would also improve the availability of cover there and the fish-holding capacity of the area.

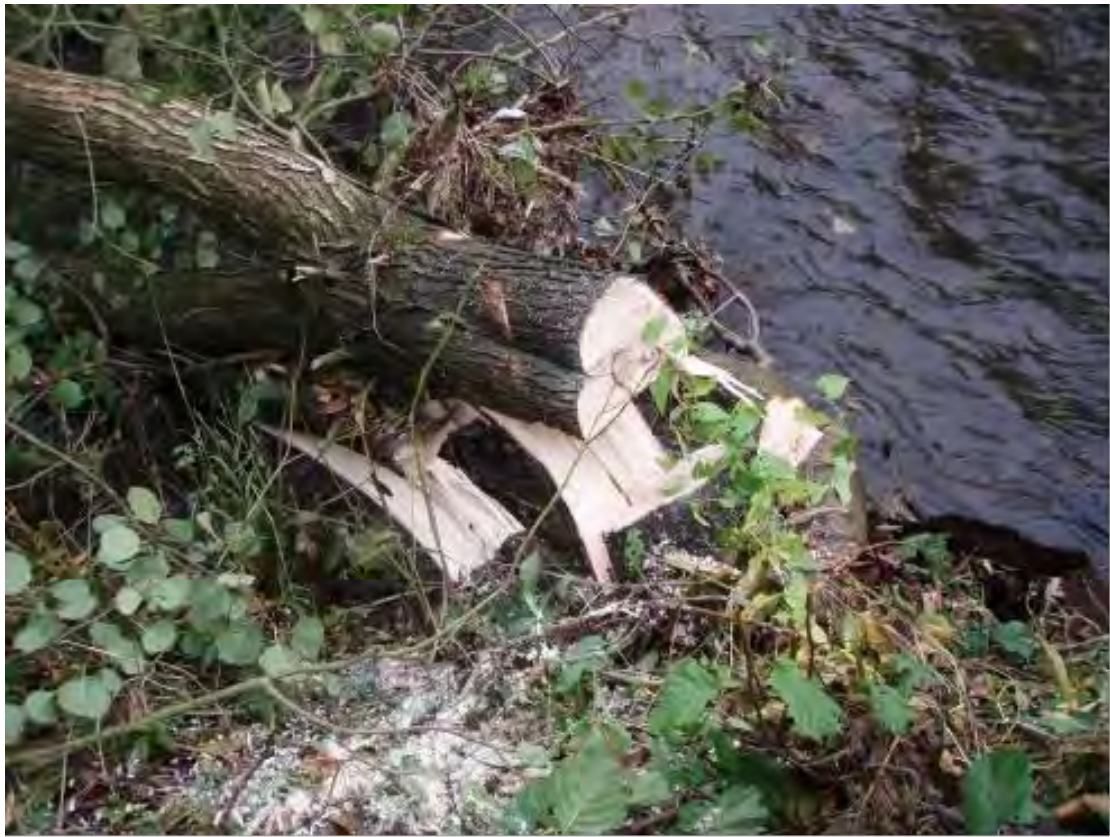
Photograph 26. Hinged willow.

Where established trees of suitable, pliable species and size are present (willow, hazel, elm etc.), they can be laid d/s into the channel at 30° or less to the bank. Laying trees replicates the natural process observed throughout the reach where tree limbs grow out over the river and sag or collapse into the watercourse, so undertaking judicious laying of bankside trees can help to reinstate some of the habitat lost through past pruning and tree maintenance.

Laying involves cutting part-way through the stem/trunk while downward pressure is applied to the stem (like laying a hawthorn hedge), until it can be forced over into the channel (Photos 26 & 27). The depth of the cut should be limited only to that which is required to bend the limb over, as this will retain maximum strength in the hinge and maintain the health of the tree/shrub. On small shrubs, cutting the stem at a very shallow angle then putting an axe blade into the cut and hitting it with a hammer can also work.

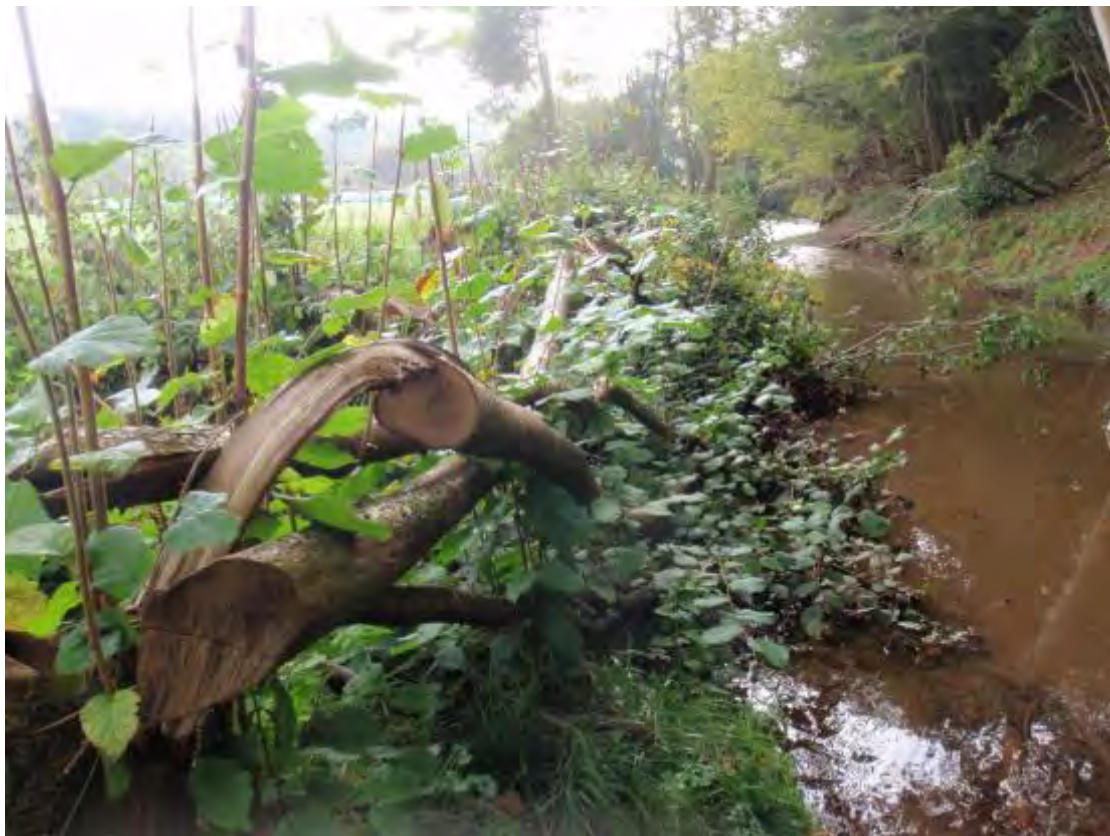
Photograph 27. Hinged hazel.

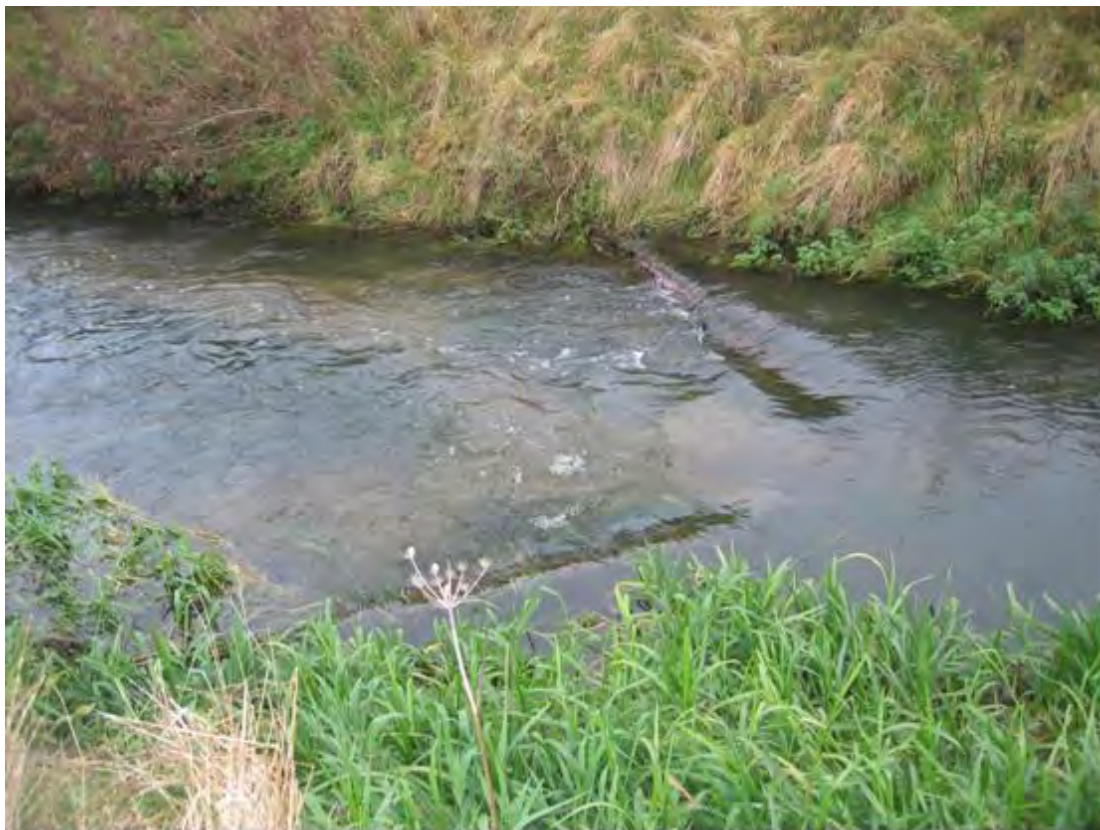
Figure 28. An example of paired, upstream facing flow deflectors that could be employed to improve the channel of Page Bank Beck by focussing flows through a narrower central channel that will create depth and scour and sort the bed.

Simple paired or alternating deflectors could be used to pinch the channel and drive bed scour, sorting the substrate and greatly improve the habitat quality of the channel (Fig. 28 & 29). The Beck is severely degraded but does already contain some salmonid fry (as observed during the visit), the numbers of which can be increased with more sympathetic management/habitat improvement.

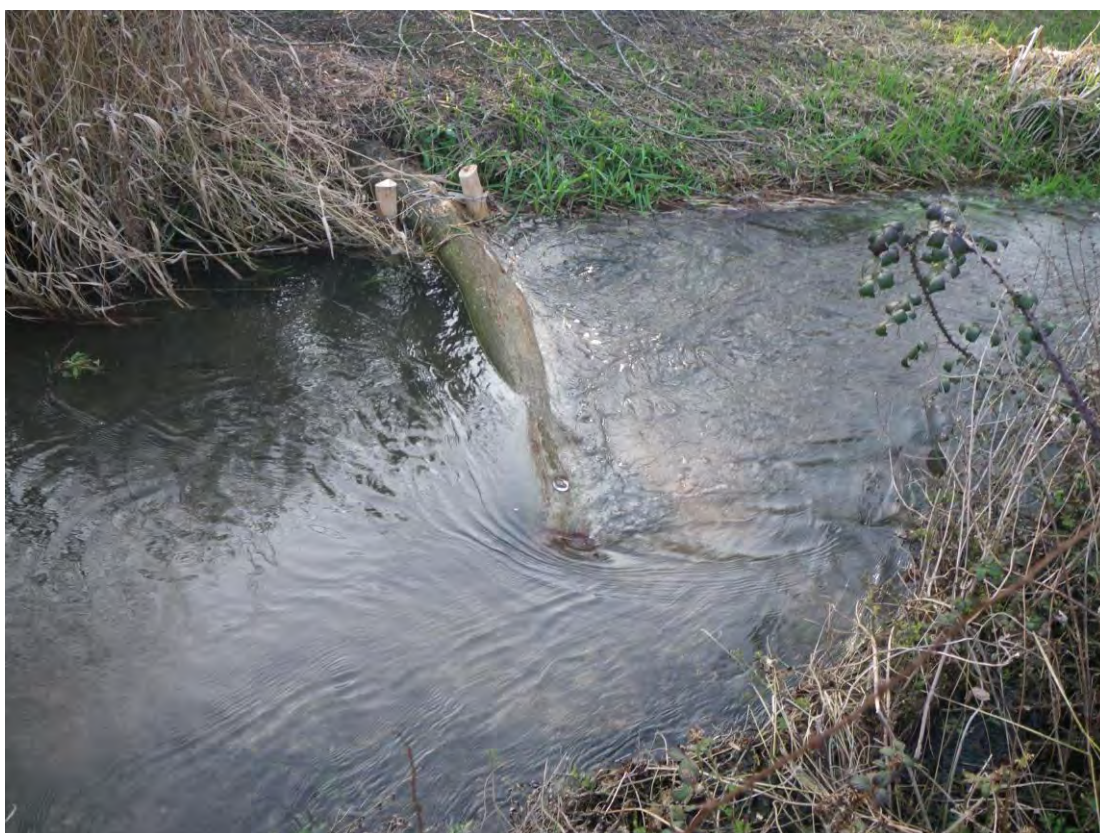
Figure 29. A single flow deflector, as is often used to increase flow diversity, sinuosity (move the flow from one bank to the other) and bed scour within a simplified channel. One would be installed to butt against on one bank and the next installed against the opposite bank further along the channel.
