River Windrush, Barrington, Gloucestershire

An Advisory Visit by the Wild Trout Trust January 2017

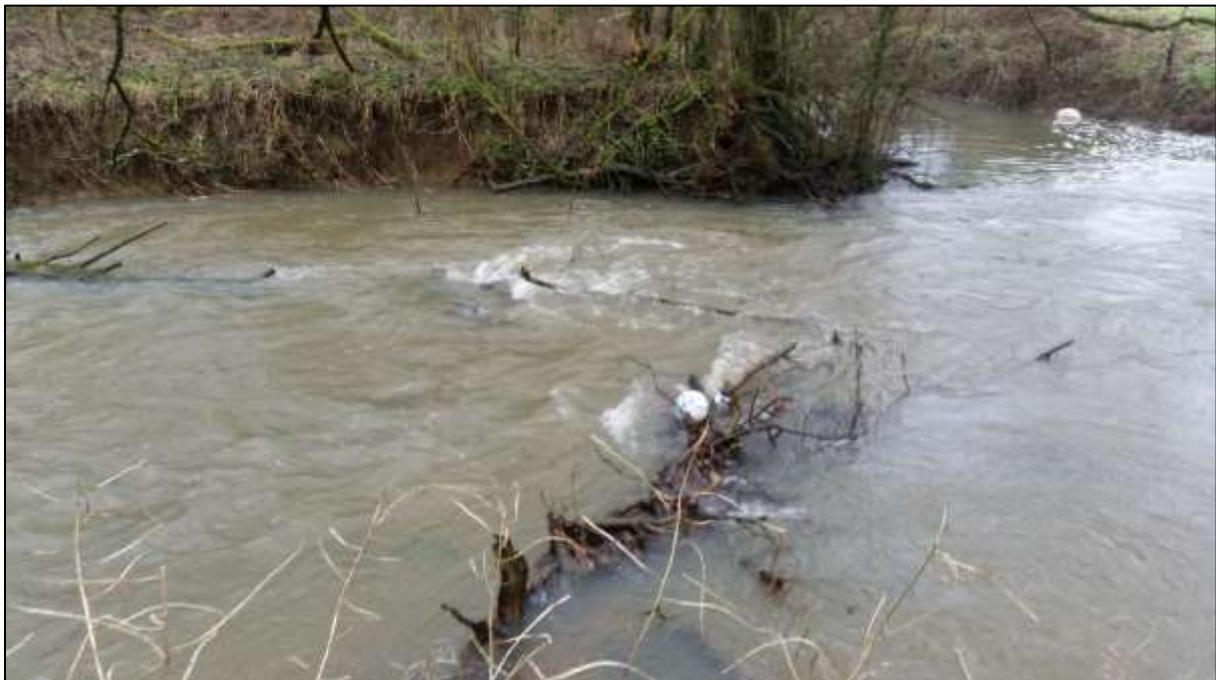
Figure 2: Natural woody features increasing flow diversity

There is scope and opportunity to introduce additional woody features to further enhance habitat diversity. Selective tree works aimed at letting more light into the river, particularly over shallow glides and riffles, will improve in-stream productivity and also give rise to woody material that can be secured into the river as flow deflecting woody habitat. Selected limbs already at risk of falling into the river (Figure 4) could be cut and either secured into the river margins with wooden stakes and mild steel fencing wire or tethered to the remaining tree as a 'kicker'. Already fallen features can be left *in situ* or, if considered a problem, winched around to the margin and secured.

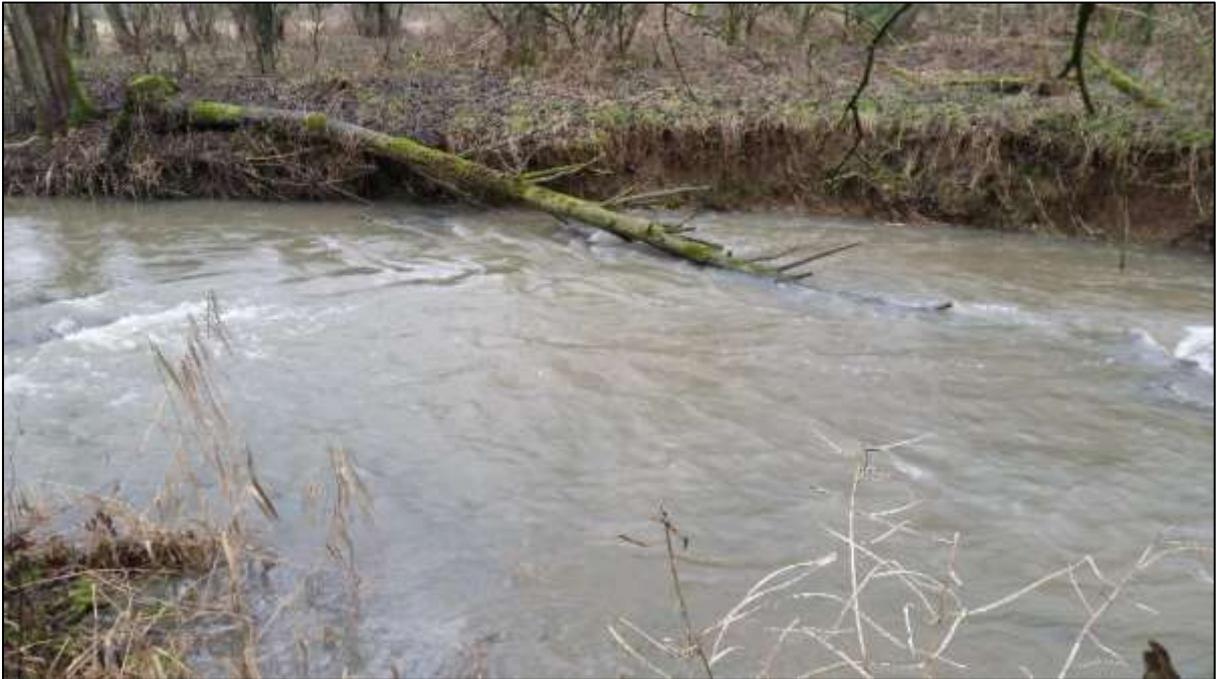
Figure 3: A fallen tree deflects flow

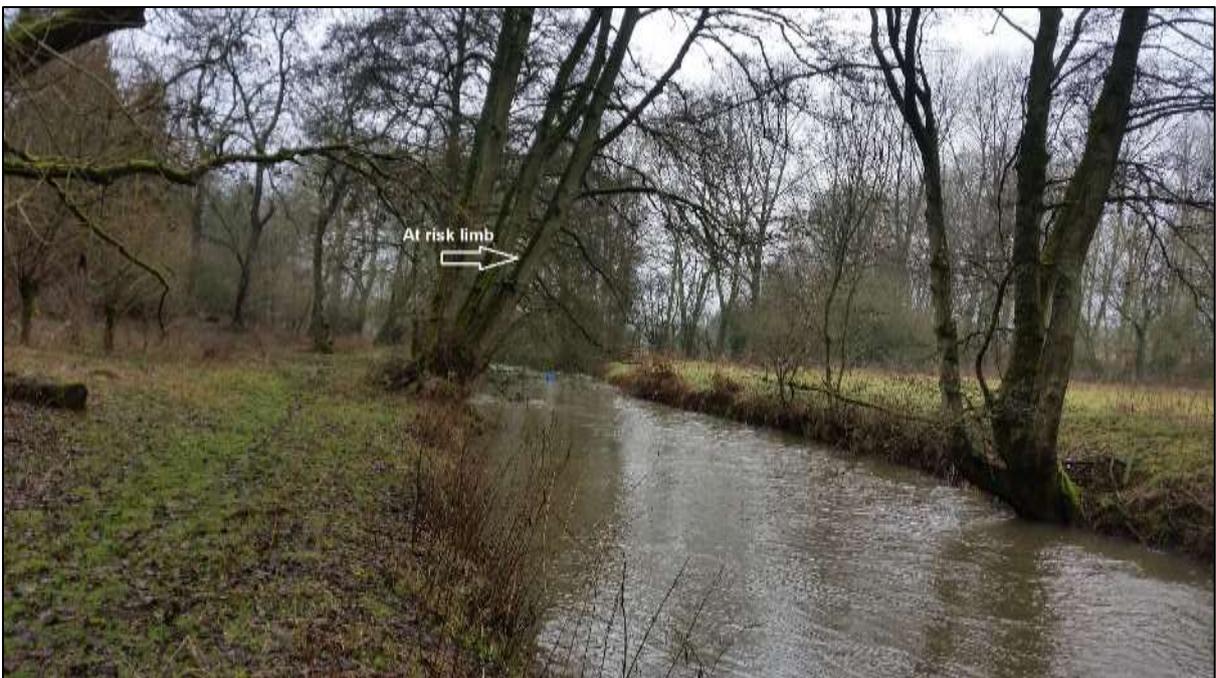
Figure 4: Improving habitat by making use of limbs already at risk of falling will be easier than addressing a problem later

There are a variety of options available for arranging and securing woody habitat features but as a general rule of thumb, the more naturalistic the feature, the better the quality of habitat it provides. Ideally, whole trees or large limbs should be used with the branched ends pointing downstream. This is the alignment in which most naturally fallen wood will come to rest and also the best position to withstand spate flows and not be dragged downstream. Details of techniques for creating and securing woody habitat features are outlined in the *Recommendations* section of this report. As the river emerges from the woodland it meanders sharply (Figure 5). Flow diversity is relatively good as flows are naturally accelerated around the outside of the bends. However, flow could be enhanced yet further by again making use of some of the bankside trees to deflect and accentuate the existing pattern of flow. Some signs of light bank poaching were observed here but overall the impact of livestock did not appear to be especially intense. It may be worthwhile reassessing the impacts of grazing on the river margins during the summer when marginal reeds are growing.

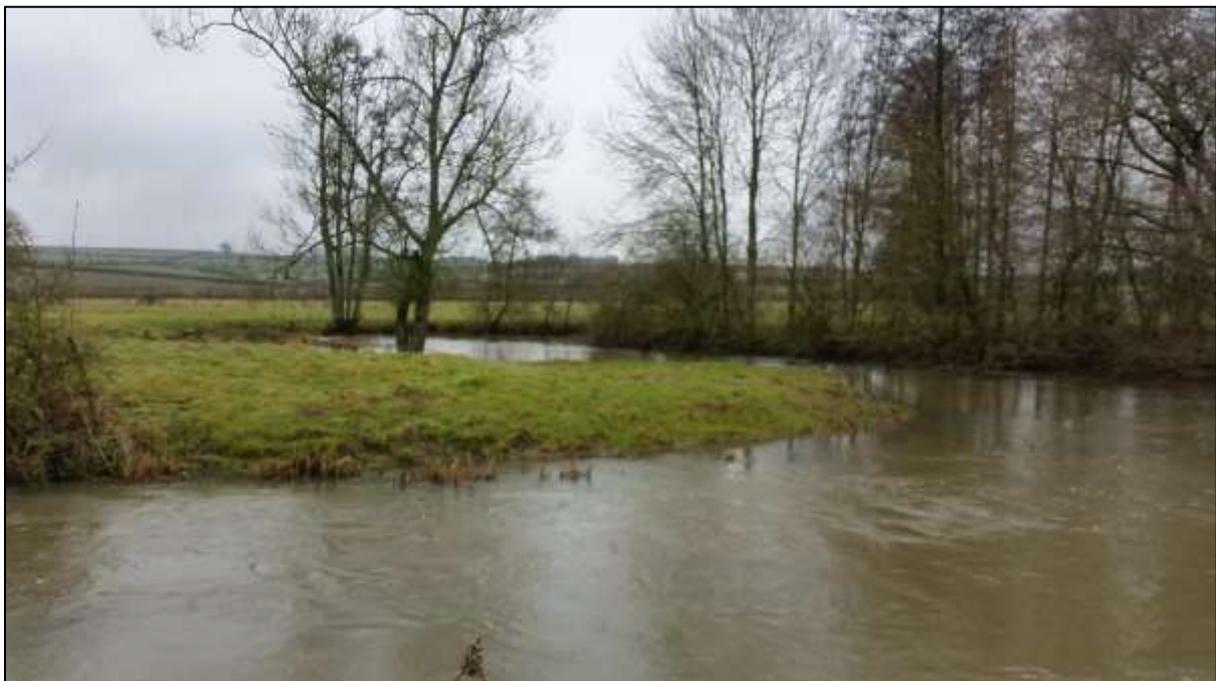
Figure 5: The river meanders sharply, increasing flow speed and providing a more varied habitat

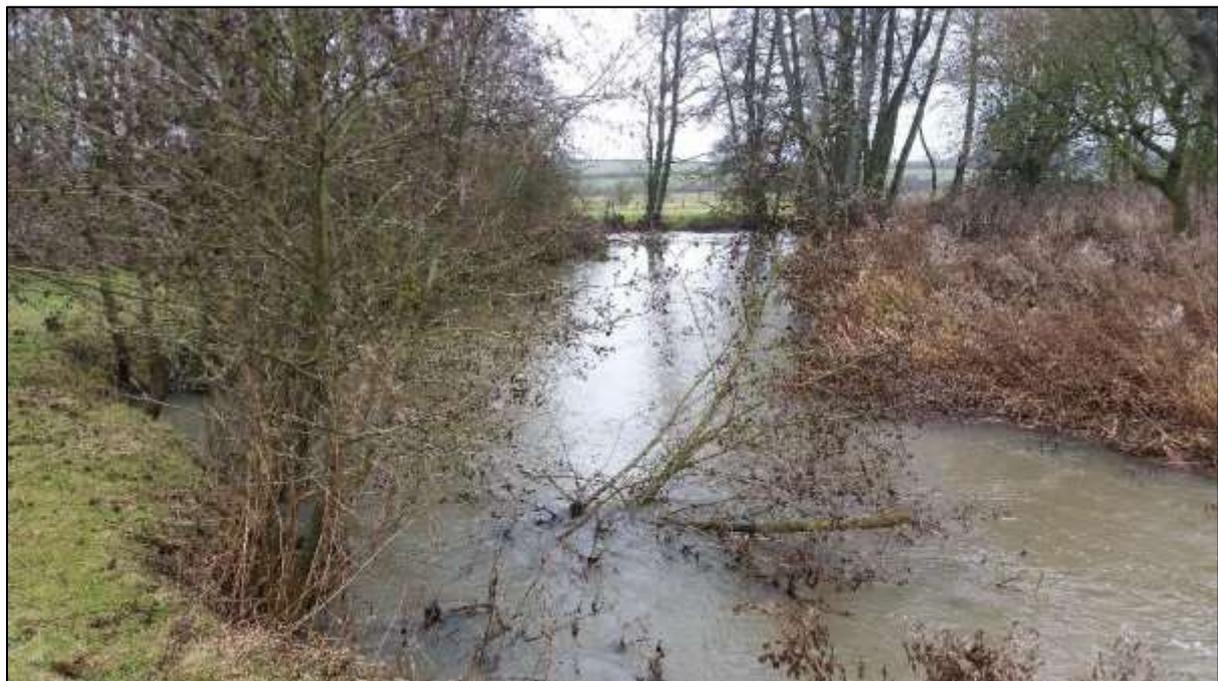
A little farther downstream a number of good quality low cover features were observed in the form of shrubby bankside alder saplings (*Alnus glutinosa*) (Figure 6). Trout are naturally photophobic and favour low cover and shade to hide from predators. Such features can sometimes be in short supply as mature bankside trees shade the riverbank, or saplings are browsed by livestock. Many bankside tree species such as alder or willow (*Salix* spp.) can survive heavy pollarding or coppicing and will send out new shoots the following year. Managing sections of bank with a surplus of mature bankside trees in a ten-year rotation (coppicing 10% of the trees every year) will ensure a steady supply of low shrubby cover as well as a good diversity of light conditions. For most rivers, an approximate 50:50 ratio of direct sunlight to dappled shade is recommended to maintain good levels

Figure 6: Low and submerged branches provide excellent cover and refuge habitat

of productivity whilst also keeping the river cool in summer. A good abundance of young bankside alders and willow also gives rise to other opportunities for in-stream habitat enhancement. Whereas mature alders become brittle around the base, young alders can be easily 'hinged' (cut partially through and laid into the river in a similar fashion to hedge laying). If undertaken correctly the trees should survive and continue to grow. Willows are naturally flexible and are normally the easiest species to hinge. Relatively mature willows can be successfully hinged into the river and even if completely felled will normally survive and continue to grow. Hinging over small alders or willows is a quick and effective way of creating dense, complex submerged refuge habitat (see example Figure 7). Such features are particularly important for juvenile trout. As soon as trout emerge from the gravel as fry they are naturally territorial and rarely shoal like other fish species. Complex 'shaggy' habitat where juvenile trout can stay in cover and remain out of line-of-sight from one another is essential in minimising competition and predation at this early life-stage. Rich and diverse beds of marginal plants are also important for the same reason and also for biodiversity. Hinging a series of saplings is a quick, cheap and effective means of reducing rates of bank erosion. Water flowing through dense brashy material experiences a substantial increase in friction and is significantly slowed. The same effect can be created by creating brushwood berms, or low revetments but such structures normally require a great deal more effort and have a lower chance of surviving long-term compared to hinged living trees. If cut and installed during dormant (winter) months, even small willow cuttings (whips) will sprout and grow. Alder however will not re-sprout unless attached to its roots.

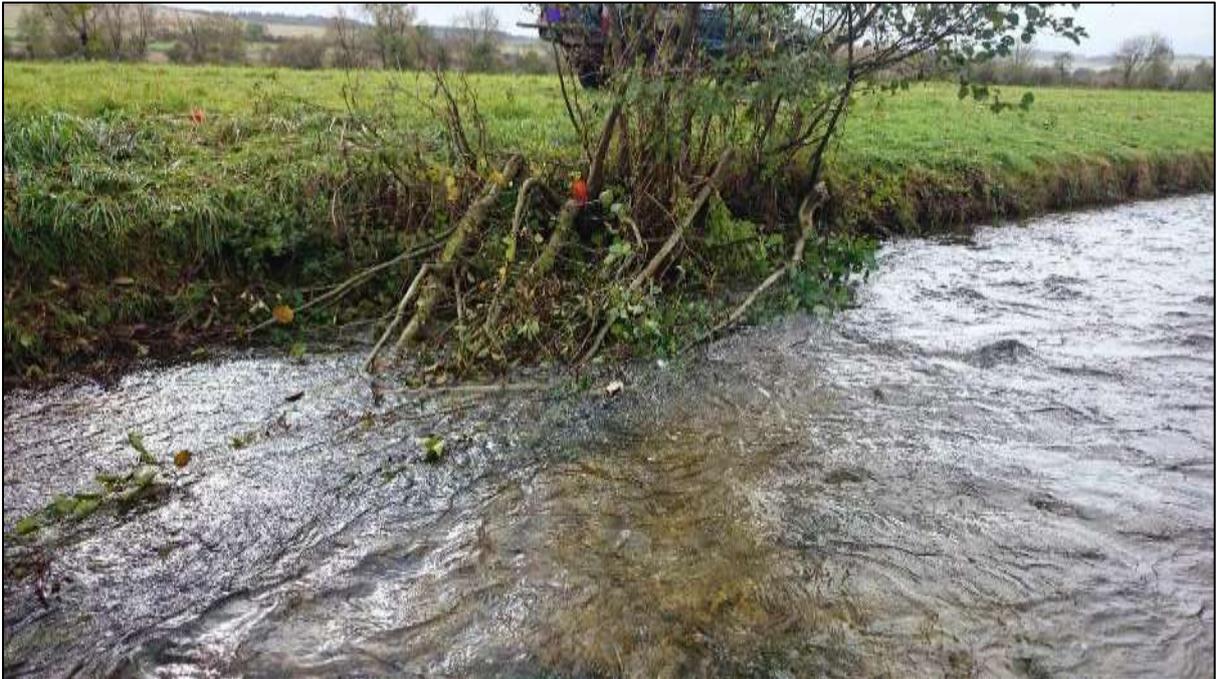
Figure 7: An example of hinged alder being used to deflect flow and provide cover

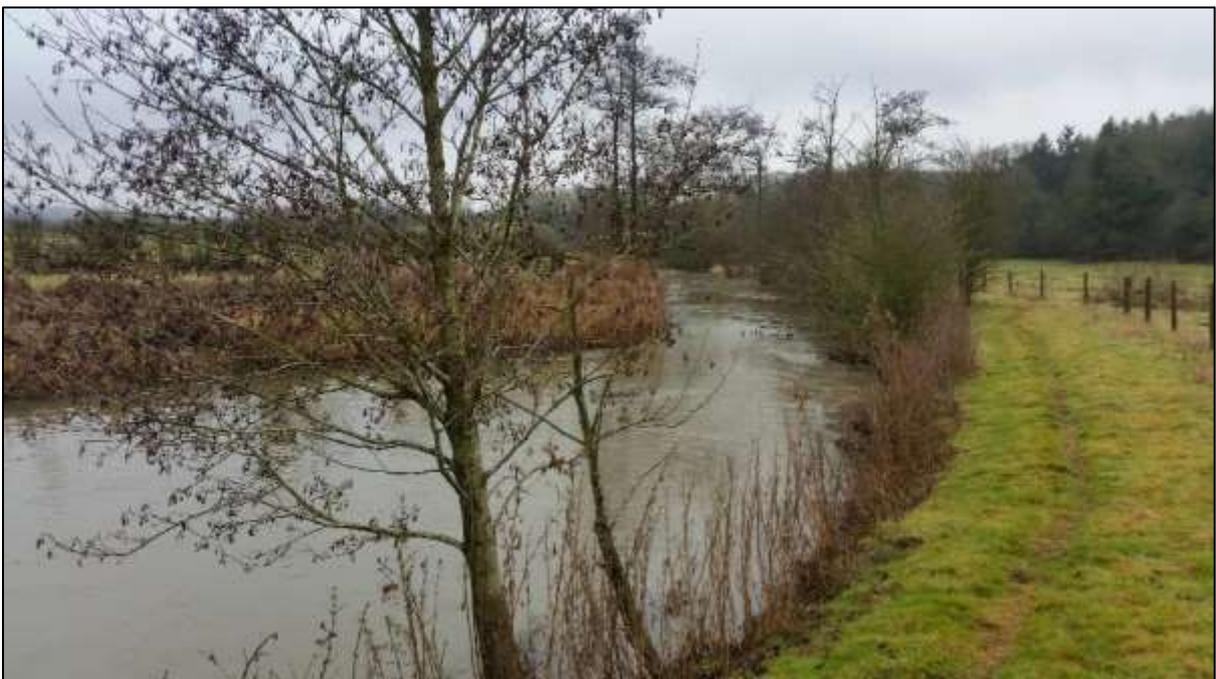
Downstream of the sharply meandering reach, tree cover becomes sparser and the abundance of marginal plants increases. The time of year made it difficult to make an accurate assessment of marginal plant diversity but it is probably fair to conclude that during summer months there is a good abundance of shaggy marginal cover (Figure 8).

Figure 8: Tree cover becomes sparser. Note the bed of marginal plants on the far bank

The river is straighter than the meandering section upstream but not without a few gentle bends. Accentuating the existing bends by strategically installing some large flow deflectors would help to increase the rate of natural morphological

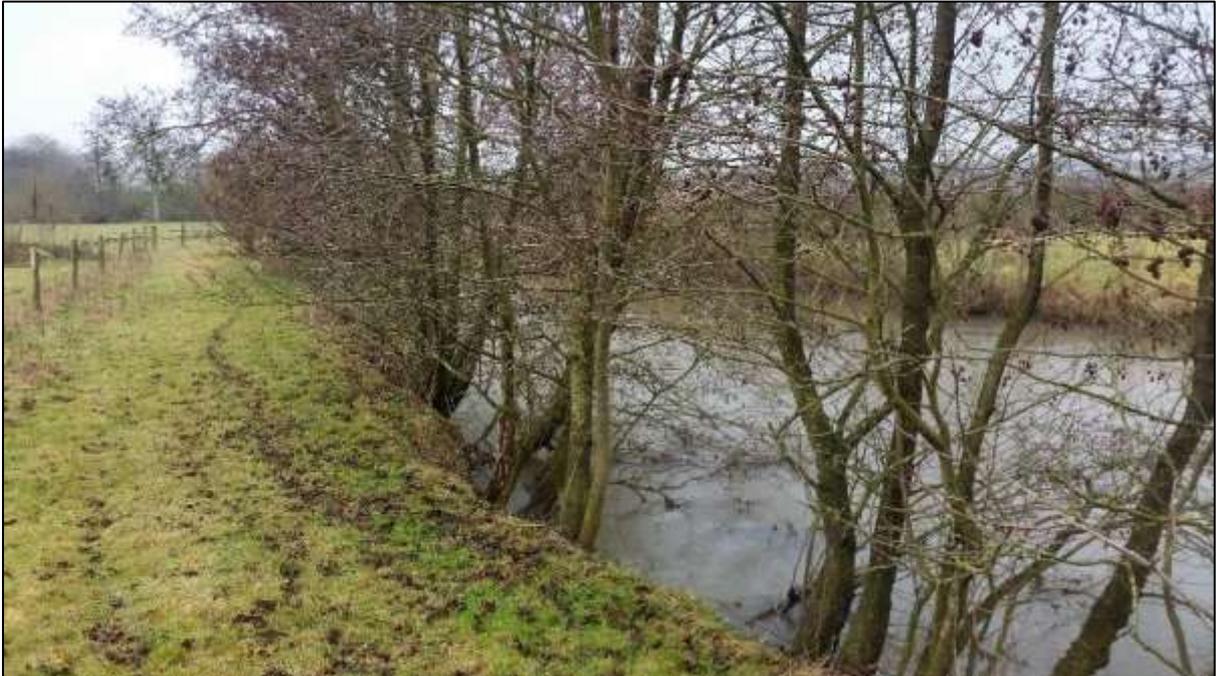
Figure 9: A line of small alders provides an opportunity to introduce more cover

change, aiding the development of key habitat features such as pools, runs and glides. As mentioned above, the increased diversity of flow conditions would also provide additional lies and interesting angling opportunities. A number of small bankside trees are good candidates for hinging into the river but care should be taken to ensure that the bank does not become denuded of cover. Leaving lone trees (such as shown in Figure 8) to mature and hinging a few trees from a cluster (such as shown in Figure 9) will help maintain a good balance.

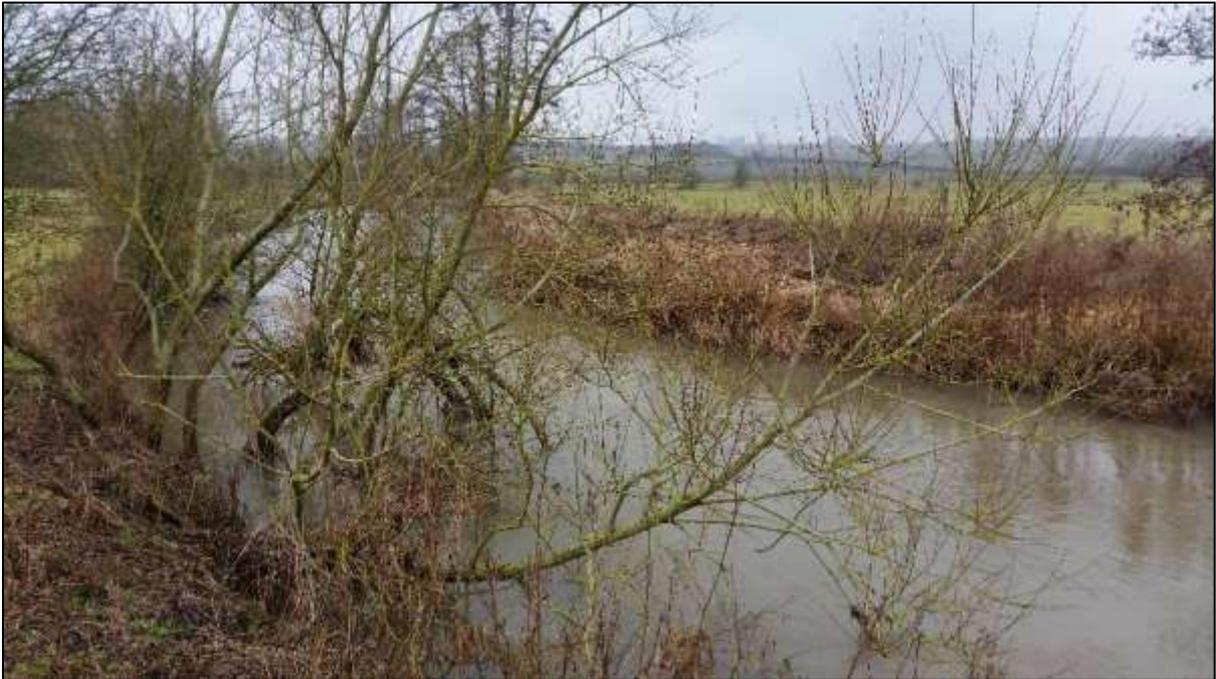
Figure 10: A sprawling crack willow makes for good habitat but may require managing sooner rather than later

Fast-growing crack willows (*Salix fragilis*) can sometimes be difficult to manage if allowed to grow across the channel. Although providing valuable habitat, the partially fallen crack willow in Figure 10 is likely to become a management problem in the future. Hinging the leaning limbs into the margin and pulling (possibly winching) the protruding limbs back toward the bank will retain valuable cover but keep the tree manageable. Acting sooner rather than later can prevent such features becoming problems (trapping excessive amounts of debris or impeding angling) and instead be turned into assets for the fishery.

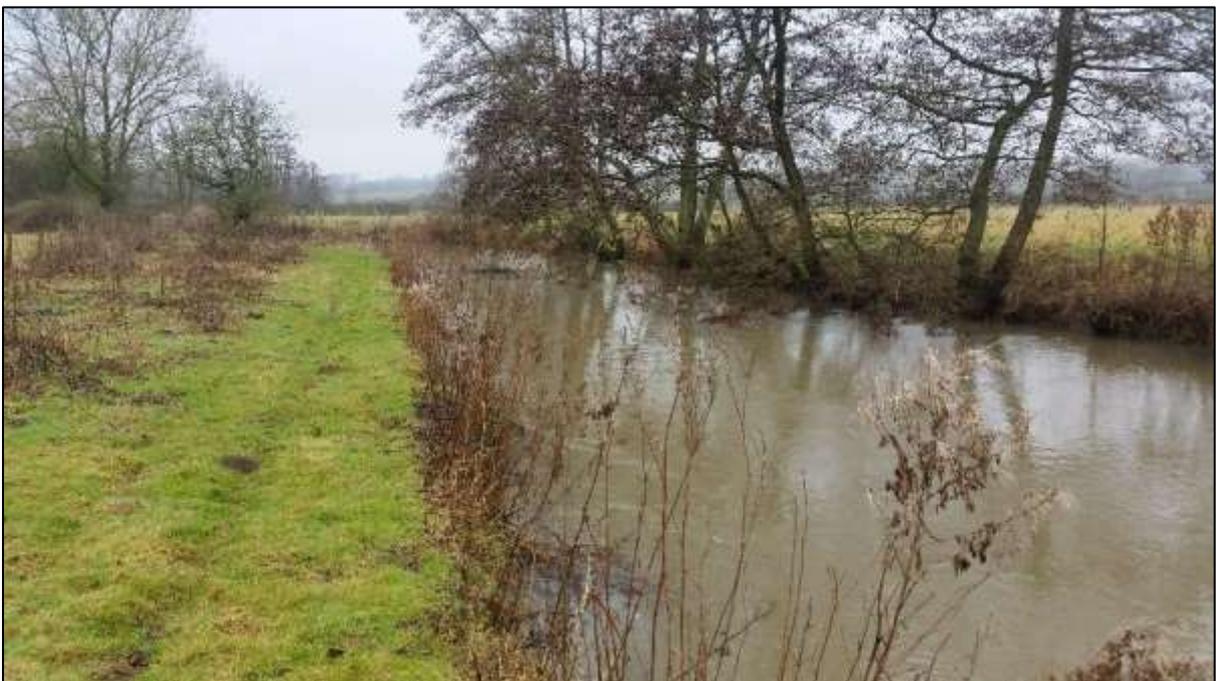
Figure 11: Low, trailing branches (far bank) will make good trout lies. Management should be a light as possible.

Bankside trees with low trailing limbs (Figure 11) can also provide very good cover habitat. Ideally these features should be retained, or at the very least, if deemed an impediment to casting, pruned back as lightly as possible.

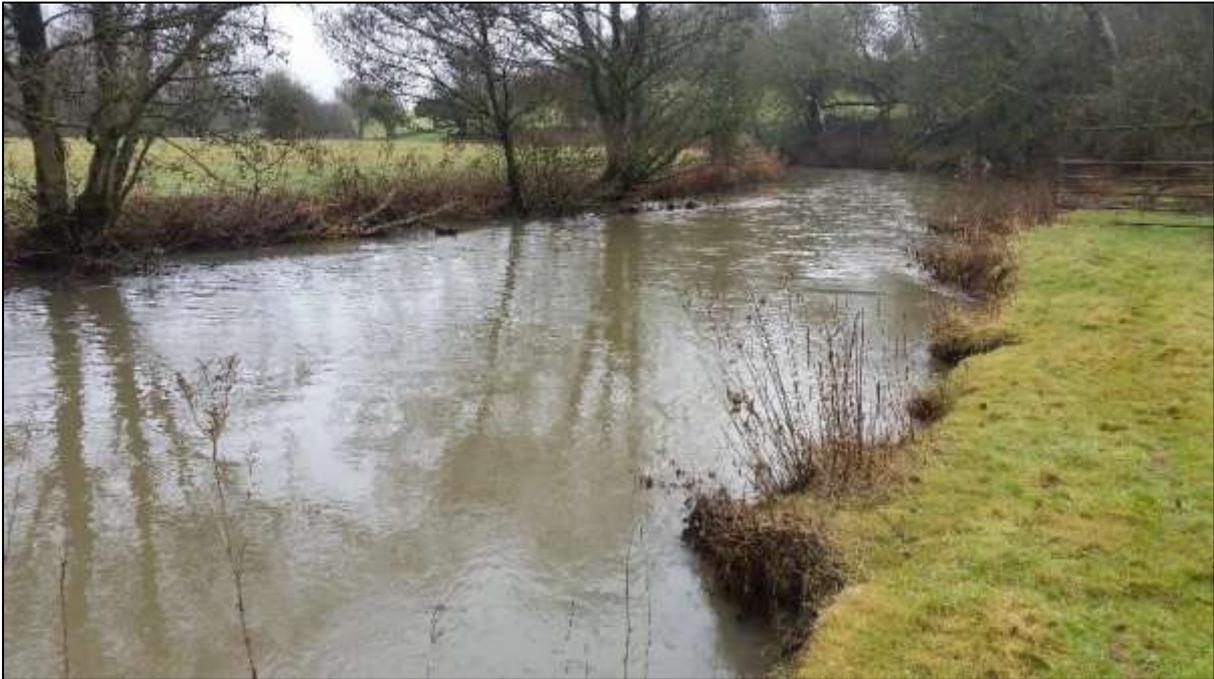
In the middle reach of the fishery the RB is experiencing an accelerated rate of erosion and is denuded of a marginal fringe compared to the LB. Grazing up to the bank edge has reduced the depth and complexity of root structure in the bank but burrowing American signal crayfish and the lack of trees (compared to the LB) may also be contributing issues (Figure 12). Livestock are excluded from a short section of bank downstream which despite being on the outside of a relatively sharp bend (and therefore receiving greater erosive forces), appeared to be relatively stable. Abundance of tree, grass and marginal plant roots have a significant influence on the banks resistance to erosion.

Figure 12: Erosion on the RB caused by grazing up to the bank edge and probably other factors

Engage with land owners/tenant farmers on both banks and seek to protect the river with stock fencing. Even in areas where bank erosion does not appear to be particularly exacerbated by grazing, a fenced buffer strip will allow a more diverse marginal fringe to develop which will improve biodiversity, boosting fly life and potentially providing better periods of dry fly fishing.

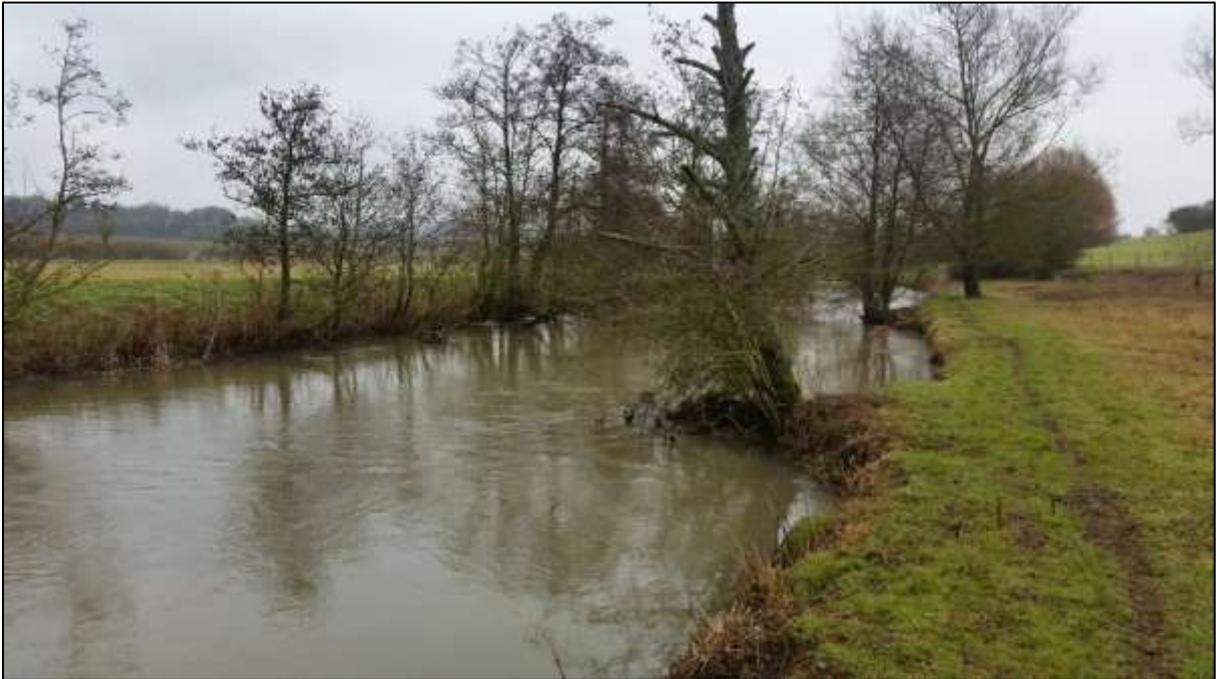
A short distance downstream the excessive rate of erosion is apparent where the bank has retreated back except where resisted by the roots of bankside trees (Figure 13).

From this point downstream through the lower third quarter of the fishery, the river has been artificially straightened and a raised bund on the LB appears to be spoil piled up from historic dredging works. The RB is protected from grazing livestock by a wide fenced buffer but excessive erosion remains a problem in places. As it appears the river was dredged from the LB, it is possible that the work has given the channel an even cross-sectional profile. If the action of dredging the river has resulted in the RB being given a more vertical profile and the LB a gentle, sloping profile (as for example, an excavator bucket was dragged from the RB to LB), this could have left the steeper RB more vulnerable to erosion. The abundance of tree cover on the LB compared to the RB is also notable.

Figure 13: Trees denote the historic position of the bank and the rate of erosion. Note the raised bund on the far bank.

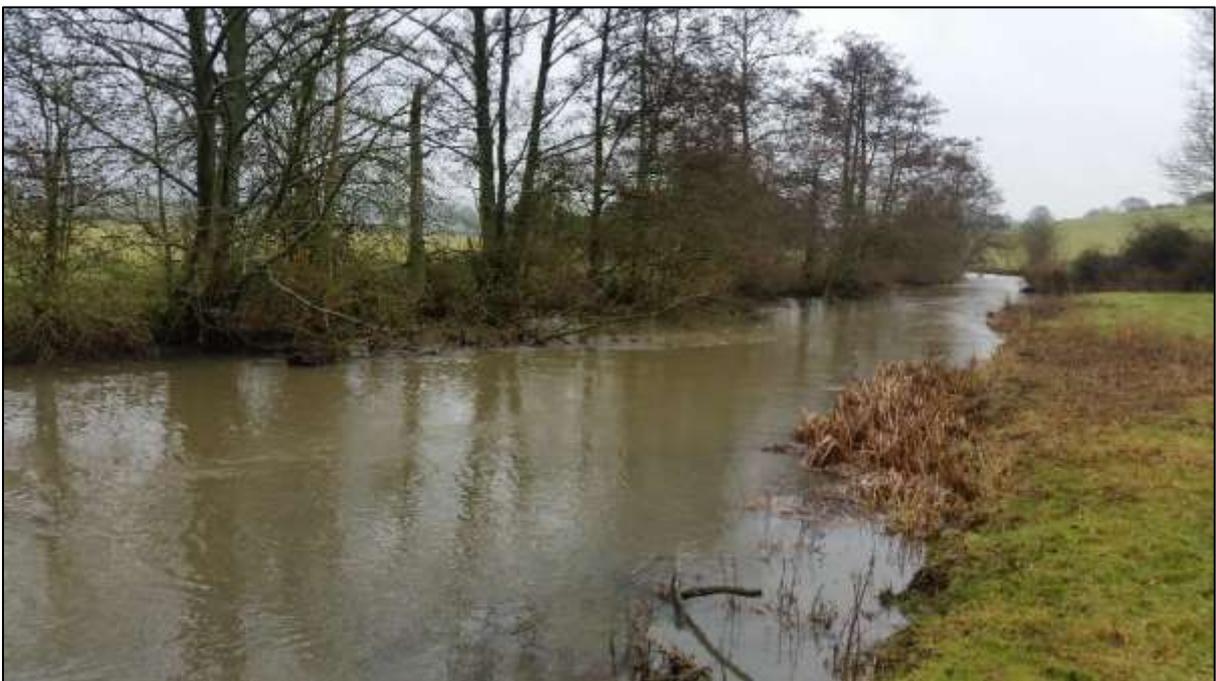
Where woody material has collected, or been placed in the rivers margins, the resulting deposition in the lee of the feature has resulted in an increased rate of deposition and establishment of marginal reed beds (mostly unbranched bur reed (*Sparganium erectum*) (Figure 14). This illustrates the potential for the river to 'heal' itself and hints at the solution to the erosion problem. The trees on the LB are mostly multi-trunked alders and woody material could be won from them without making a significant change to the amount of tree cover on that side. Introducing a variety of woody structures on the RB with the aim of deflecting flow away from problem areas and increasing friction with a series of small brushwood berms would change conditions from erosive to depositional. The woody features would protect the bank in the short-medium term and once fine sediment (loaded with a natural seed bank) has accumulated, marginal reed beds will establish and provide long-term erosion protection.

Figure 14: Woody material in the channel creates an area of slacker water where reeds colonise fine sediment deposits.

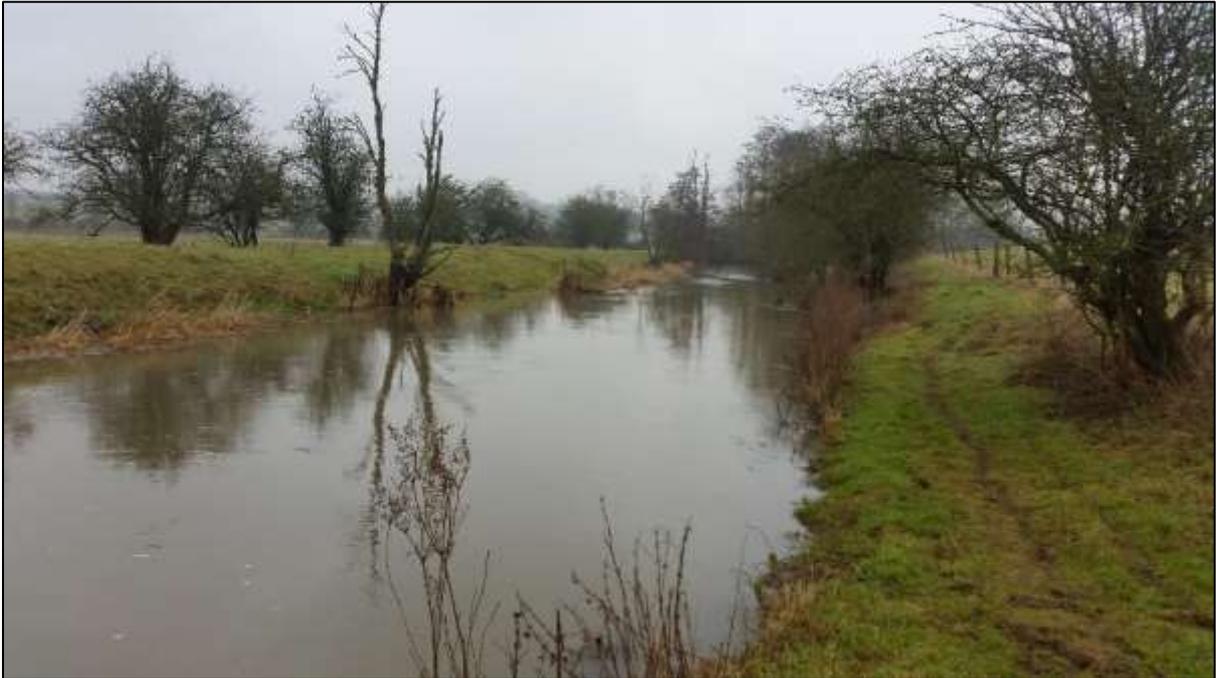
The straightness of the channel is limits the diversity and quality of trout habitat in this reach. Although the riverbed could not be directly observed on the day of the visit, laminar (flat) flows strongly suggest an overly uniform depth profile (Figure 16). Installing flow deflecting woody habitat features such as secured tree limbs, log flow deflectors and brushwood berms along both banks would introduce some much needed diversity. Structures should be installed at approximately 20m-30m intervals alternating from bank to bank. This will create a meandering flow within the straightened channel and allow a more sinuous channel form to develop over time. Where possible, these features should be installed to

Figure 15: A straight channel and laminar flows make for a uniform and limited habitat

In straightened sections of river, flow deflectors should be secured in an alternating pattern to bounce flow from bank to bank, helping to mitigate against channel uniformity, increasing the rate of morphological change and the number of good fishing lies.

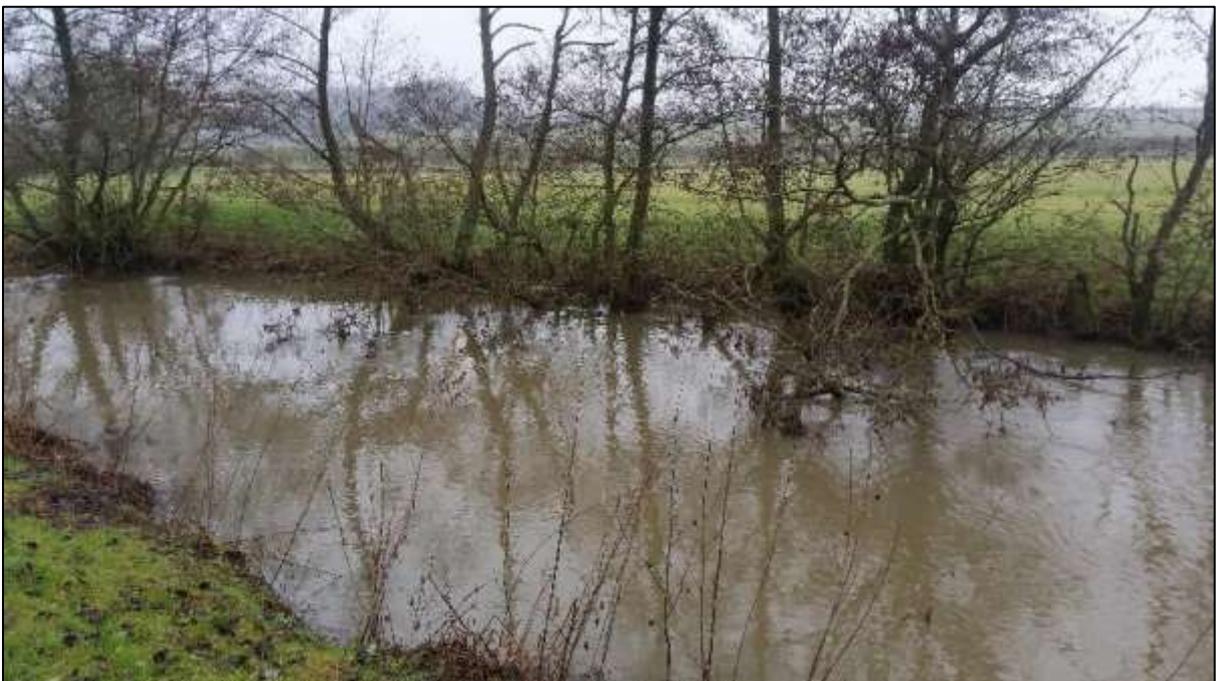
At the bottom of the fishery the river meanders sharply again and benefits from an abundance of low trailing branches providing excellent cover for fish (Figure 19). As mentioned above, these features should be retained wherever possible and only receive the lightest of management if they prevent casting.

Figure 16: More low trailing branches. These should be retained as far as is practical for the fishery

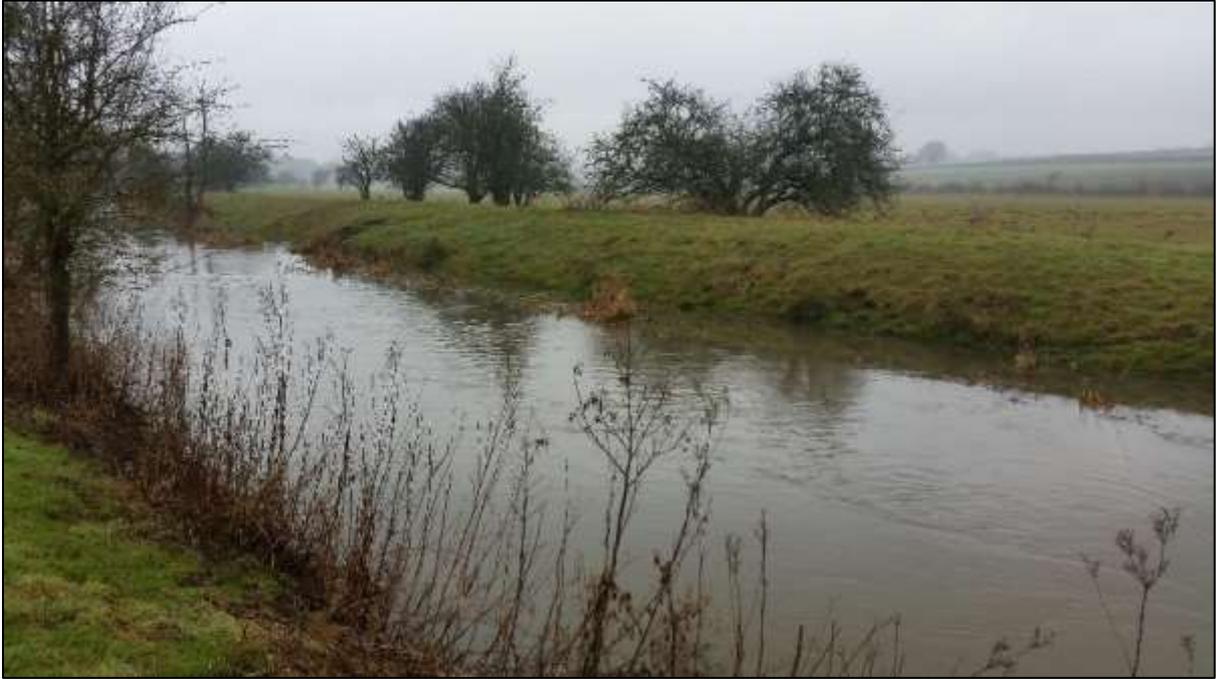
Figure 17: A deflector or small brushwood berm could be positioned on the upstream edge of the emergent reed bed on the far bank.

accentuate existing depositional features and reed beds. Installing a large limb or wedge-shaped brushwood berm at the upstream edge of an existing reed bed (such as shown in Figures 17 and 18) will accelerate its development and help consolidate fine sediment.

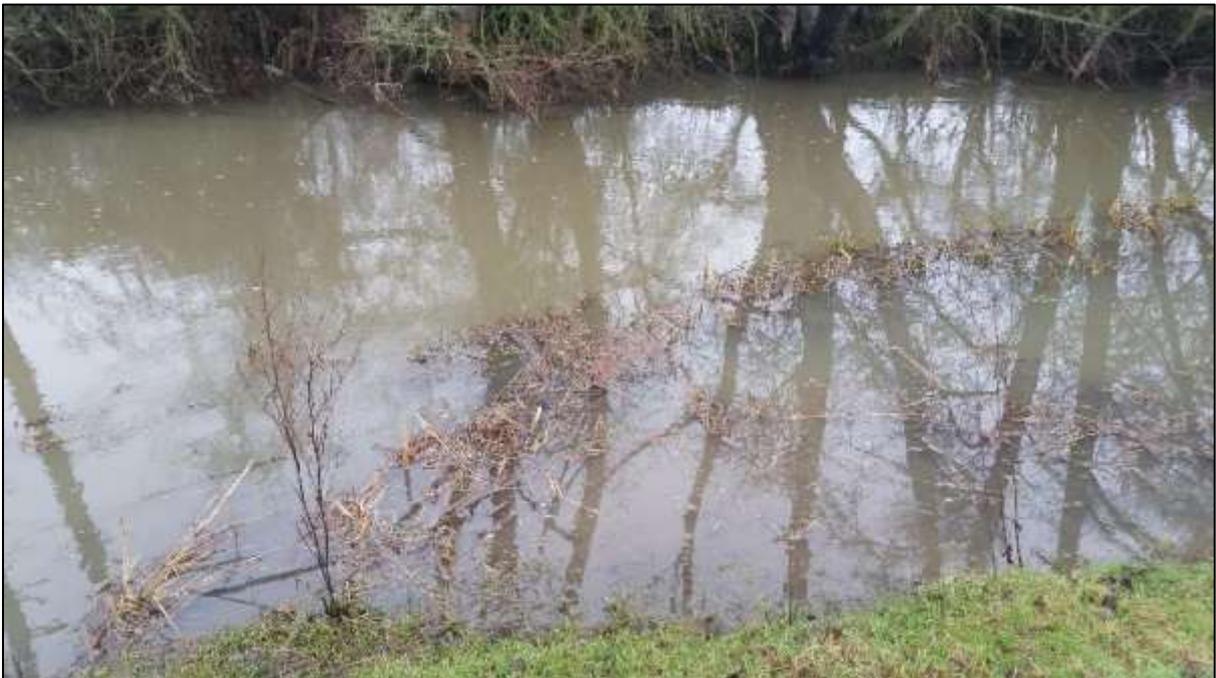
Figure 18: A small brushwood berm or deflector on the upstream edge (left of image) of this reed bed would help consolidate fine sediment. Pinching the channel and creating a faster flowing run that will make a great trout lie..

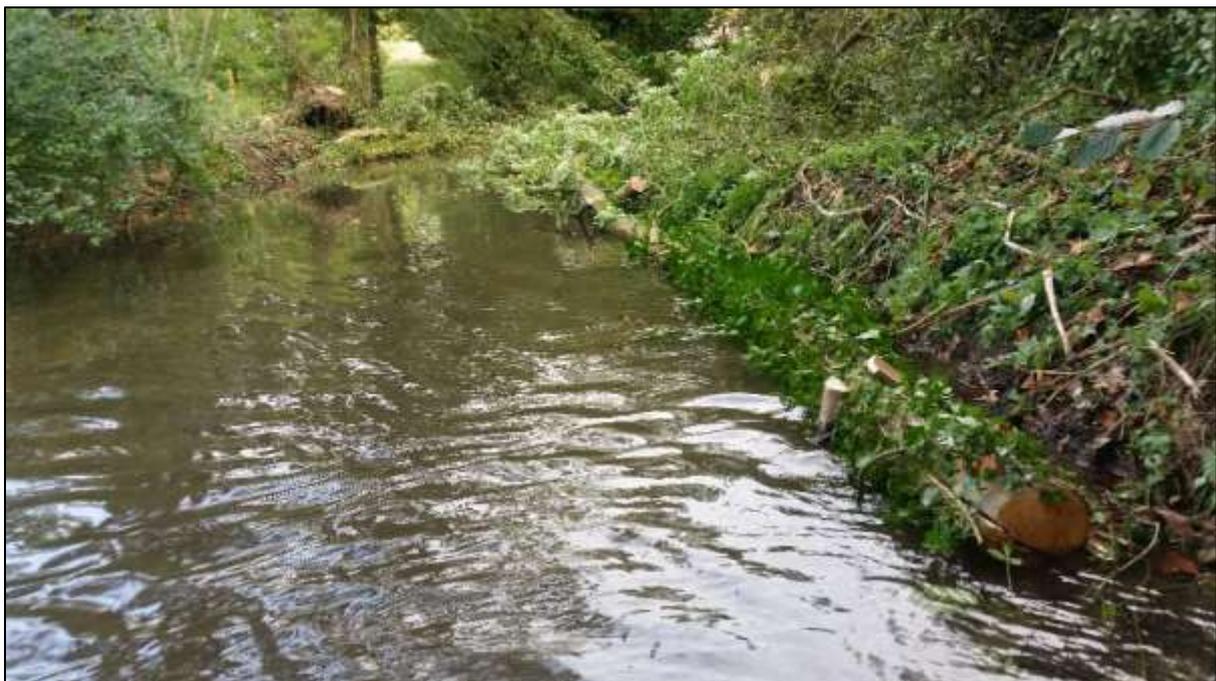
Figure 19: A whole tree secured into the margins of the River Nadder, Wiltshire

- This technique simply involves securing a small tree or large limb in the river margin with the butt keyed into the bank and the branches facing downstream. The limb can then be tied to wooden stakes (ideally untreated hardwood such as sweet-chestnut) with small loop of mild steel fencing wire and a couple of fencing staples.

- If a tree/limb is not successfully hinged it can be installed with stakes as shown in Figures 19 and 21 or tethered back to its stump as a 'kicker'. This technique allows the limb some movement, ensuring good flow deflection during normal flows but also allowing the limb to be pushed against the bank in higher flows. A kicker can be secured with rope but this will need to be monitored and replaced when it shows signs of wear. Alternatively,

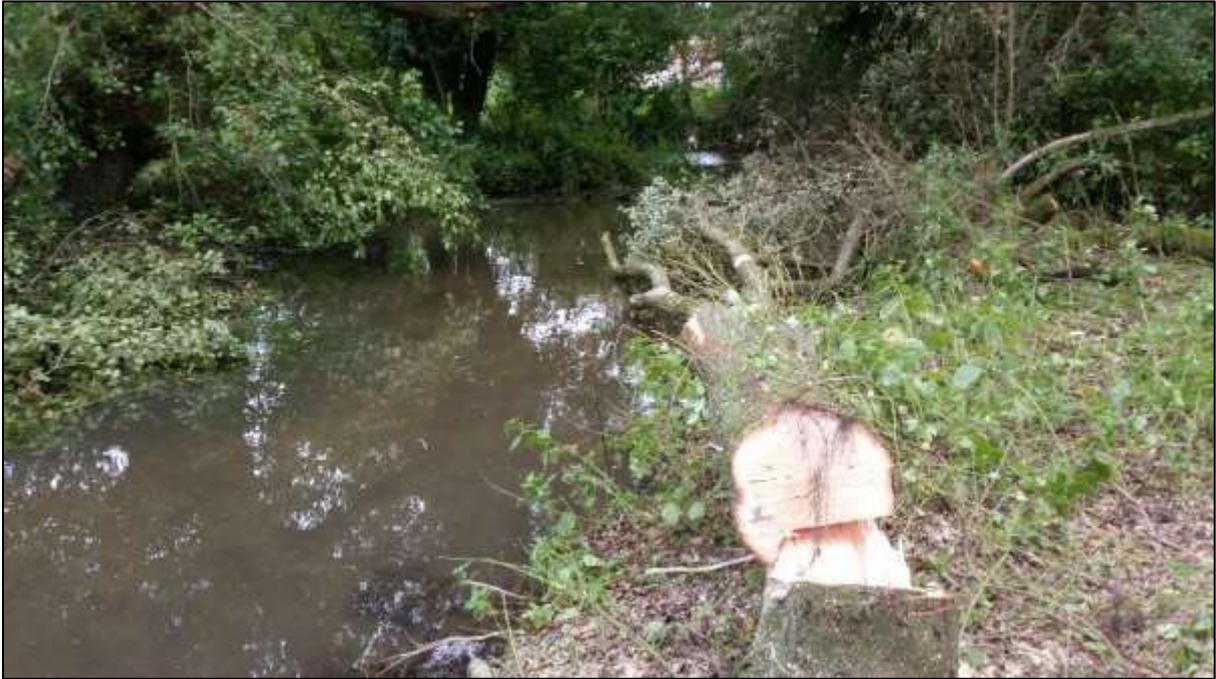
Figure 20: A hinged willow on the same river

- If possible, an attempt should be made to hinge cut the tree/limb and keep it attached to its roots. This will help keep it secure and also give it a better

chance of surviving. Even if successfully hinged it may be advisable to secure the tree with stakes and wire.

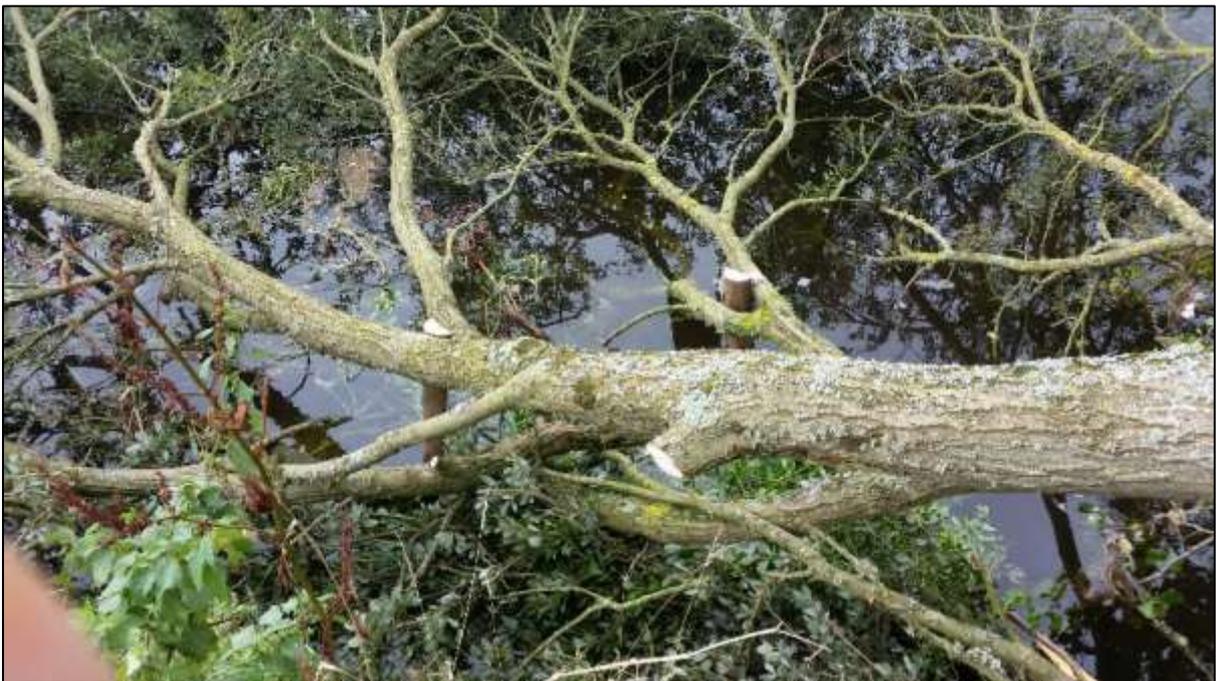
Figure 21: Sweet chestnut stakes and fencing wire used to add extra security to a hinged willow.

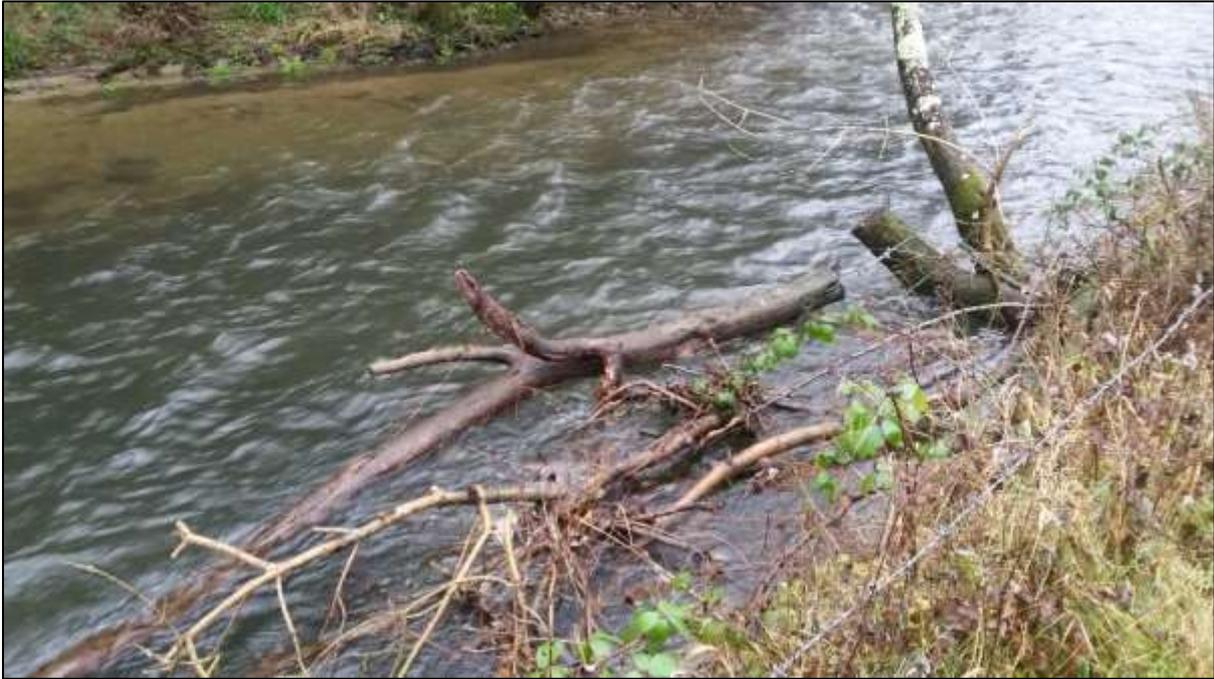
Figure 22: A cabled 'kicker' in a tributary of the River Exe

cable (wire rope) can be used. This technique can withstand very high flows such as in upland spate rivers.

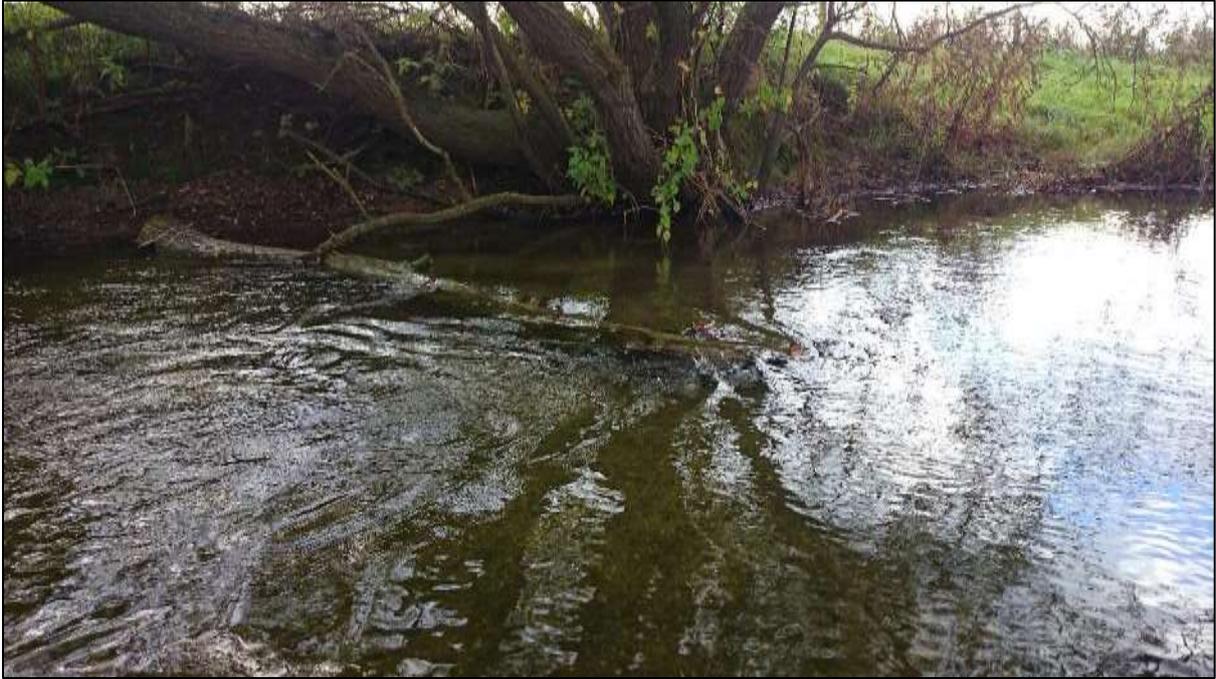
Figure 23: A simple log flow deflector introduces flow diversity.

- This is the simplest technique and involves securing a log in the channel in such a position that it deflects flow across the channel. Logs should be keyed into the bank to prevent the river cutting behind them and ideally be of a diameter that they sit just below the surface. This will cause water rolling over the log to be deflected at 90 degrees (perpendicular from the long axis of the log). They should also slope down into the river from the bank so that the deflector works over a wide range of flows.

- The log should be orientated at approximately 45 degrees from the bank in an upstream direction. This ensures that flow rolling over the log is deflected across the river and not towards the bank.

- The log is secured in place with a pair of stakes at each end. Once the stakes are driven firmly into the bed, secure a loop of wire between them over the log and drive them in a few inches deeper to tension the wire and hold the log against the bed.

- Finally, cut the stakes off as low as possible to prevent them snagging debris.
