River Windrush, Barrington, Gloucestershire

An Advisory Visit by the Wild Trout Trust January 2017

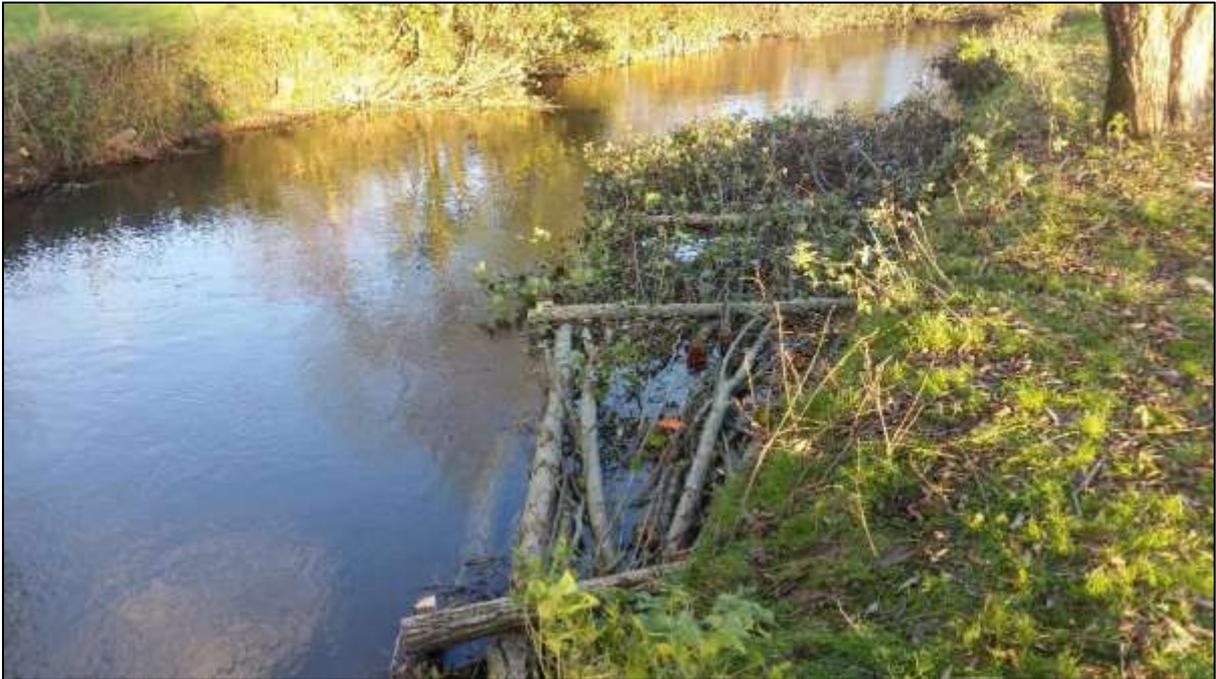
Figure 24: A brushwood berm with cross braces

- Increase channel sinuosity and the abundance of marginal refuge habitat by installing low brushwood (branch) berms. These instantly create a depositional zone where fine sediment will accumulate and if positioned to receive sufficient sunlight, should be colonised by marginal plants.
- The easiest way of installing a brushwood berm is to mark out the shape of the outer (riverside) edge with stakes driven into the bed every 1-2 meters the back-fill with branches keeping the butt ends towards the upstream bank edge and the finer branches pointing downstream towards the outer edges. Once the structure is densely packed, place some long, straight limbs across the structure as 'cross braces' and tie to stakes on the outer and inner (bankside) edges. Finally, drive the stakes in a little deeper to tightly compact the brushwood and trim off any excess.

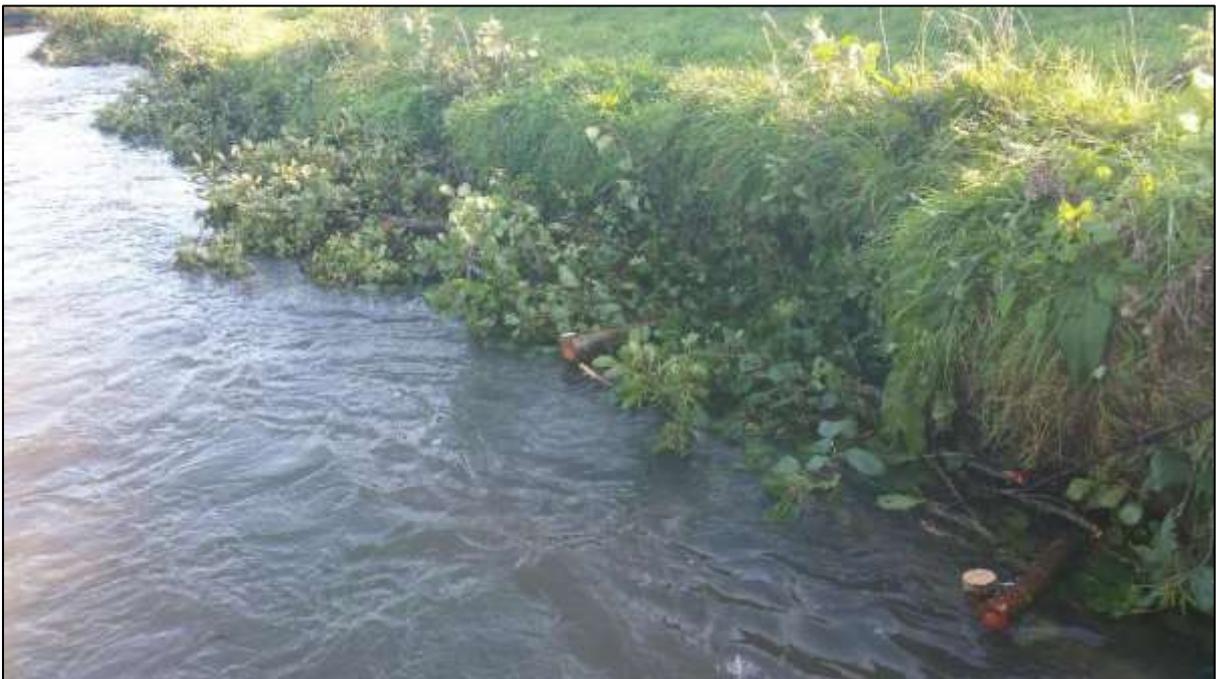
Figure 25: A newly installed brushwood bank protection revetment

- Brushwood can also be used to protect banks from erosion. A narrow revetment of brushwood can be secured behind a line of stakes in method similar to that described above. Once vegetated it will provide good long-term protection from erosion (Figure 26)

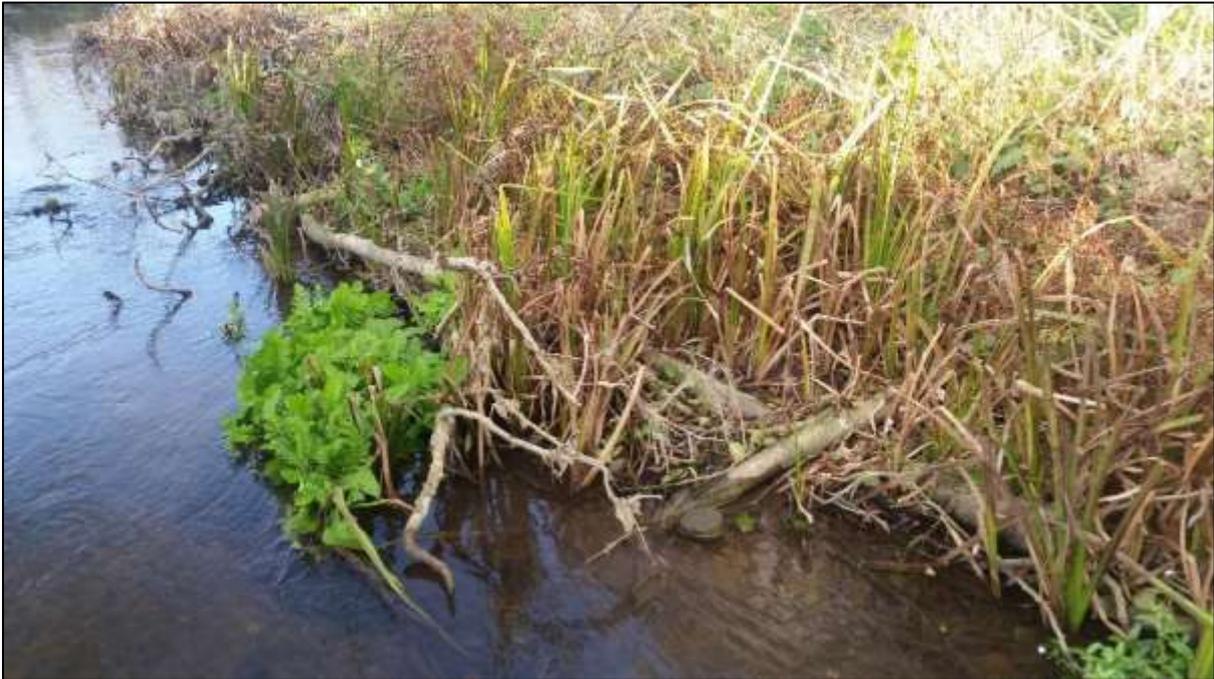
Figure 26: The same structure one year later colonised by marginal plants.
