River Avon (Western Arm) – Willowdene Farm, Charlton Manor

An Advisory Visit by Nick Lawrence on behalf of the Wild Trout Trust
March 2019

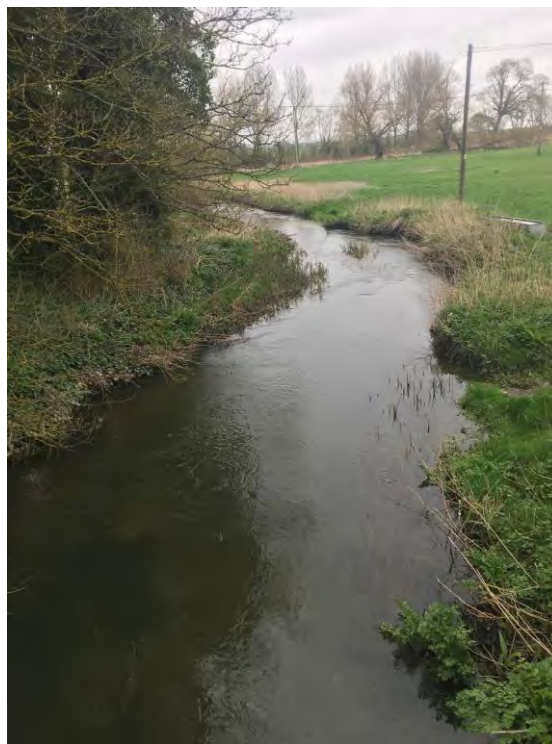
Photo 1 Looking downstream from near Charlton Manor, note incised bank and lack of marginal plants.

The RB in photo 1 is incised, as a result, space for water-loving marginal plants is limited and terrestrial species such as common nettle dominate the upper bank.

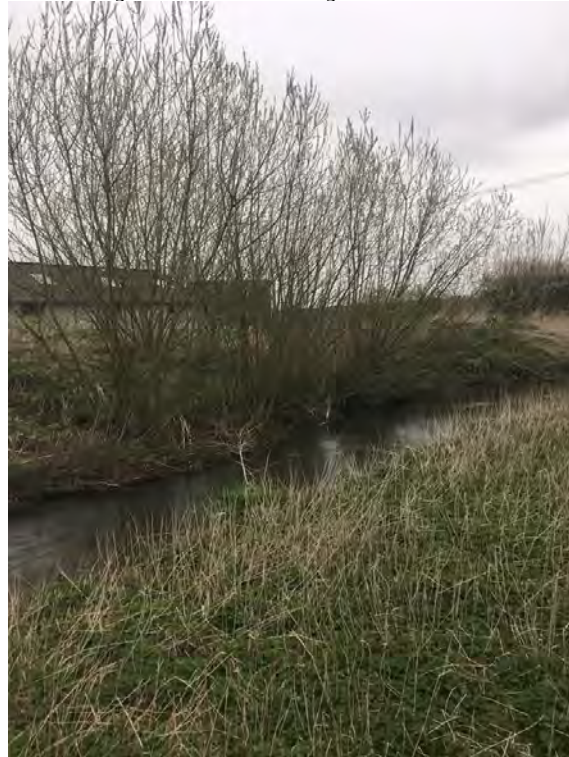
In this straightened section (Photo 2), it is also evident how the RB has poor marginal growth with common nettles seeming dominant. There are a few nice stands of willow on the LB which are ripe for introduction into the channel, to create some channel diversity in a relatively bland section of water.

Photo 2. Near bottom boundary: straightened, poor marginal plants with willows ripe for introducing to the channel to create some diversity.

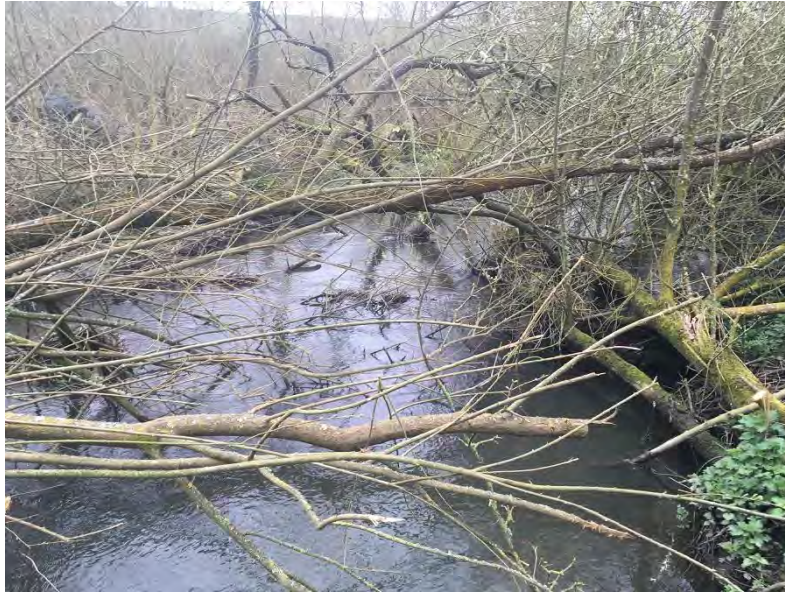
Upstream of Charlton Manor is where the river starts to become very interesting: there is a long section of wet woodland approximately 250 meters, marked in Map 1 in green. This reach is very valuable in terms of habitat because by comparison to the rest of the Charlton Manor, it is unique (Photo 3). Due to the unmanaged nature of the river, this habitat is a fantastic refuge for wildlife. It was discussed on the visit that Natural England and WWT have both commented on this section; **the WTT's stance is very similar.**

Photo 3. Wet woodland oasis, a valuable habitat, a great variety of natural woody material, to diversify the channel and a perfect nursery and refuge for fish and wildlife.

There is some good habitat within the reach, not to mention the sublime oasis that is the wet woodland section that is extremely valuable habitat (Photo 3). This is the most diverse in terms of refuge habitat for juvenile fish and adults alike, as well as having the most diverse tree species and wildlife habitat. This area should be nurtured and carefully managed to retain its ecological value. There were discussions on the advisory visit that a nature walk will be cut through here to enable the guests staying at the farm to engage with the wet woodland; this should be encouraged whilst retaining as much habitat as possible.

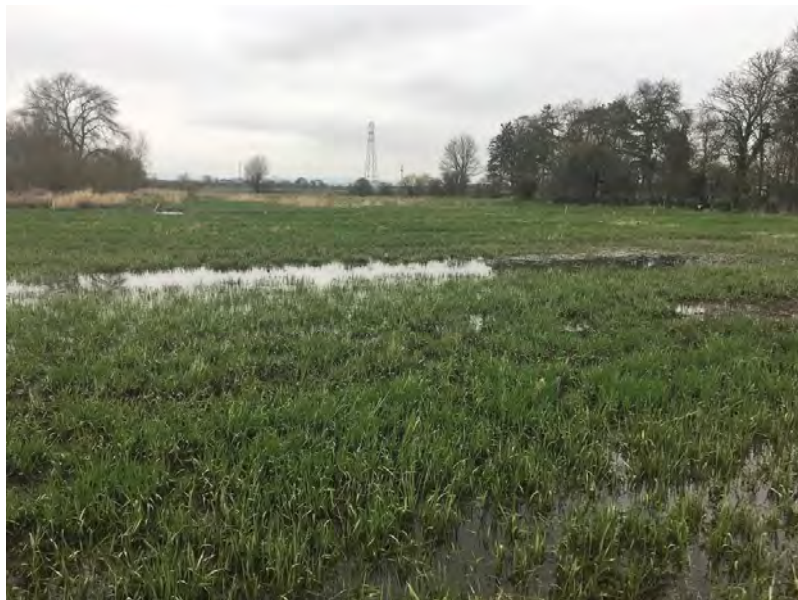
Upstream of the wet woodland is potentially a fantastic location for a wetland **creation, in some ways it's** already there, it just needs expanding. This is a 150-metre section which is already connected to the floodplain on the LB as seen in Photo 4.

Photo 4. Historic water meadow, floodplain connected, possible site for wetland creation/improvement.

This watermeadow appears to be flooded in most riverine conditions which renders the field of no value to farming but of high value to wildlife. This semi-inundated land is populated by a community of wetland marginal plants and provides an excellent wetland habitat, important for invertebrates, amphibians and birds that benefit the overall ecology of the river.

funding could be found and these areas deemed credible for more restoration; there could be more NFM/wetland works centring around the flight pond and water meadow (photo 4 & 5). There is scope to extend this potential project down to the boundary of the fishery with either some woody debris or rechannelling/ re meandering of the existing straightened channel.

- Explore the possibilities of **'Phase 3'** with the WWT, extending the project downstream to do more improvements, and the possibility of improving the wetland area (photos 4 & 5) and using it as an NFM area, which would possibly alleviate some localised flooding downstream in the village.
- Within **these 'Phase 3' possibilities look into the spawning habitat**, to assess fish recruitment within the reach. The Wessex Chalkstream & Rivers Trust may help with electrofishing survey work. This could be used as ammunition for some additions of gravels to improve the recruitment on the reach.
- A possible **'Phase 3' could be extended** further into the straightened reach downstream of the road bridge that extends to the bottom boundary (photo 2). This could be some rechannelling/meandering works or just some simple woody material in the existing channel.

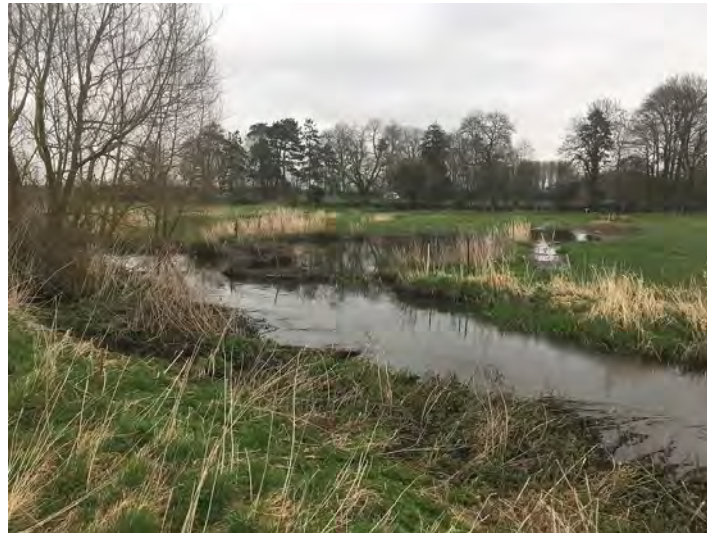
Photo 5. Duck flight pond online to river, within watermeadow, potential for improvements and a useful area for flood storage.

Within the watermeadow on the LB, there is an old duck flight pond (Photo 5) which has been scraped like a fry refuge bay, this area has potential to be a fantastic wetland area for all kinds of wildlife, fish and birds in particular. The pond is small and the areas around it are boggy, if this was made bigger you could have a wetland and river working in harmony together as well as storage for thousands of litres of flood water as well as creating a backwater habitat. The village does have some small flooding issues and this could alleviate that and add to the biodiversity of the river and surrounding land.

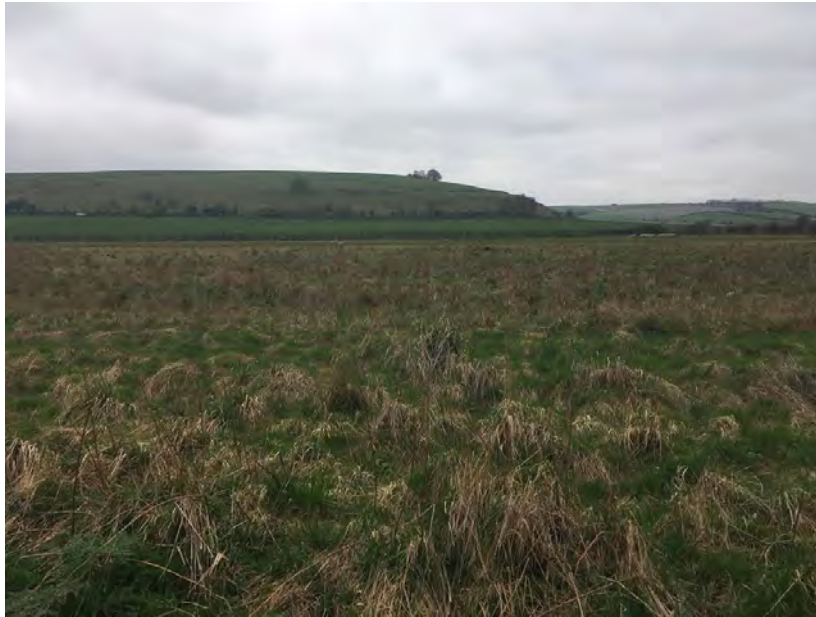
Photo 6. Field on perched RB opposite watermeadow, lacking biodiversity.

After the jungle of the wet woodland, the rest of the fishery has an exposed feel, with tree growth fairly sparse and in small clumps. From a management point of view this is easy; there is sparse tree growth, so most of these trees should stay as these provide small oases of habitat in an otherwise barren landscape. Photo 6 illustrates this to the extreme. It was discussed that some strategic tree and scrub be planted or left to develop to break up the open feel. A set back hedge would work here to break up the field and make the river feel less exposed, and add some wanted biodiversity.

Another area where habitat can be added without consent is tree planting, although advice should be sought as to the best location to plant these trees/ scrub/hedges. As noted in photo 6, there are some areas that feel very open with little tree or hedge cover, I have seen some fisheries use a hedge as a buffer strip from a field and this can be a great break from the elements for wildlife and fisherman.

- Plant trees, scrub and hedges in barren open areas on and set back from the bank, especially in areas like photo 6; this will give the river a less exposed feel and add some wanted biodiversity. Advice should be sought on the positioning of these saplings, to ensure they add to the ecosystem. Hedging/tree planting grants are available from the Woodland Trust (www.woodlandtrust.org.uk/plant-trees).

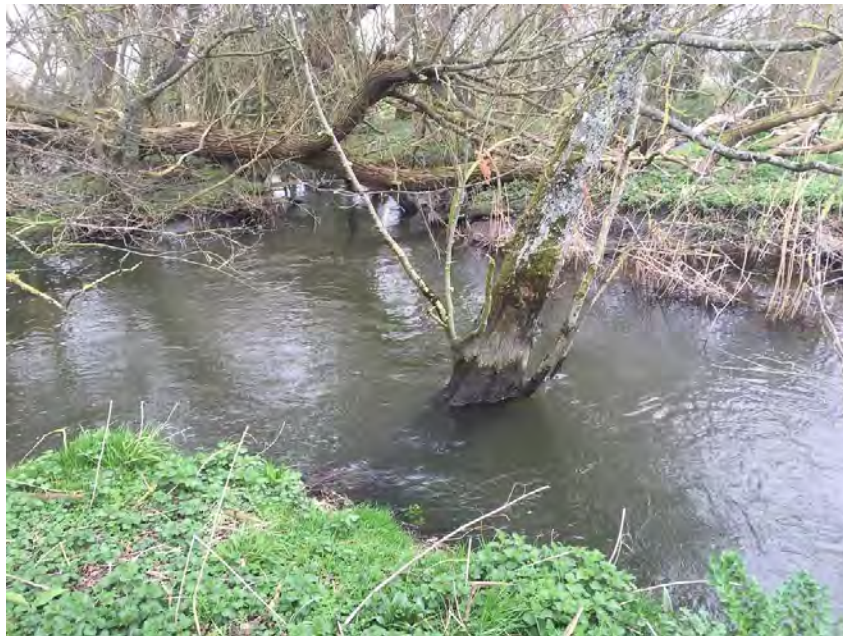
Photo 7. This naturally fallen wood, and low tree cover shows the gems that benign neglect can produce.

The small clumps of unmanaged trees have produced some wonderful gifts from nature; photo 7 and the cover photo are prime examples of this type of habitat. Areas like this should be encouraged, as these are where the fish will hold and feel safe. There might be some minor tweaking required with regards to fishing these spots, but the structure should be left alone. As explained in the fishery overview, no woody material consented and installed can compare to these naturally-formed areas. They are bigger and bolder, and consent would not allow structures this big.

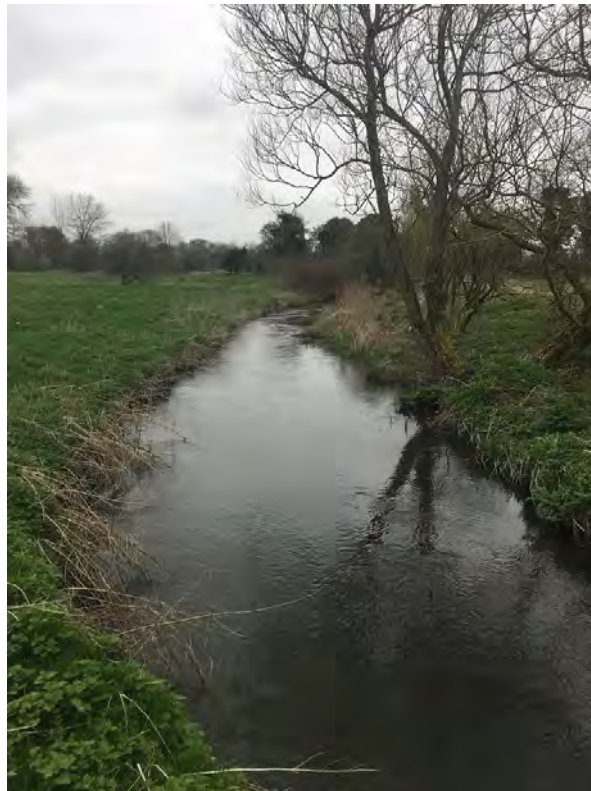
Photo 8. Typifies the nature of an artificial, dredged channel.

Unfortunately, due to historic dredging and milling processes, many of our rivers have degraded channels. Photo 8 typifies the majority of the channel on the Willowdene reach. The upper reaches of the river should be pristine, but like many reaches on the Avon (West), there has been some significant historic manipulation of the channel which means there is little variety in flow apart from the areas with woody material. There are very few shallow areas and no riffles of note, probably due to the dredging; this may have a knock-on effect for fish recruitment, though without a survey, it would be hard to tell. The habitat improvements planned include some gravel addition that will produce a riffle and possible spawning habitat.

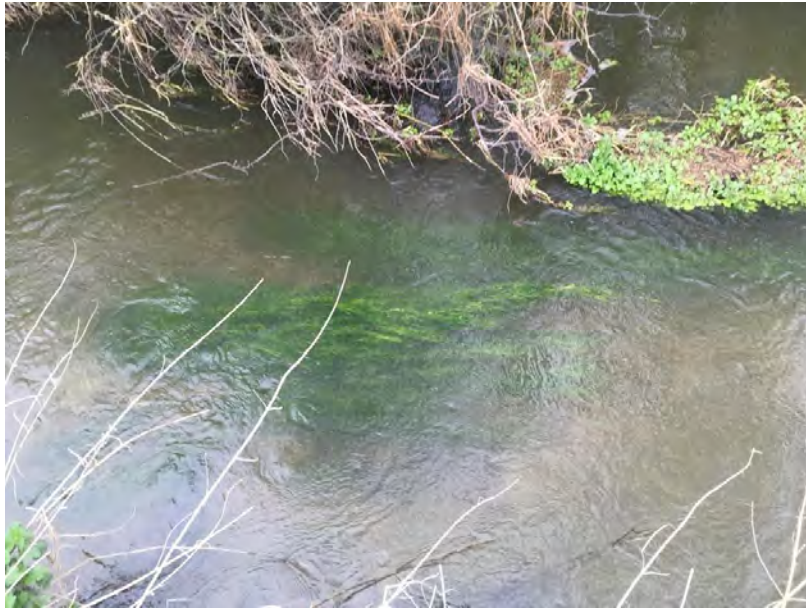
Photo 9. Lush *Ranunculus* grow evident in the upper section.

There was very little *Ranunculus* growth evident along the whole of the 1-mile reach. But in the upper section, there was some good weed showing, no coincidence it was where the best habitat was evident. The majority of the water as shown in Photo 8 was dredged and slower flowing. But these areas where the weed was evident had good gradient and nice gravels; more areas need to be created like this to get the river functioning better, in combination with woody material to give some better spawning habitat.

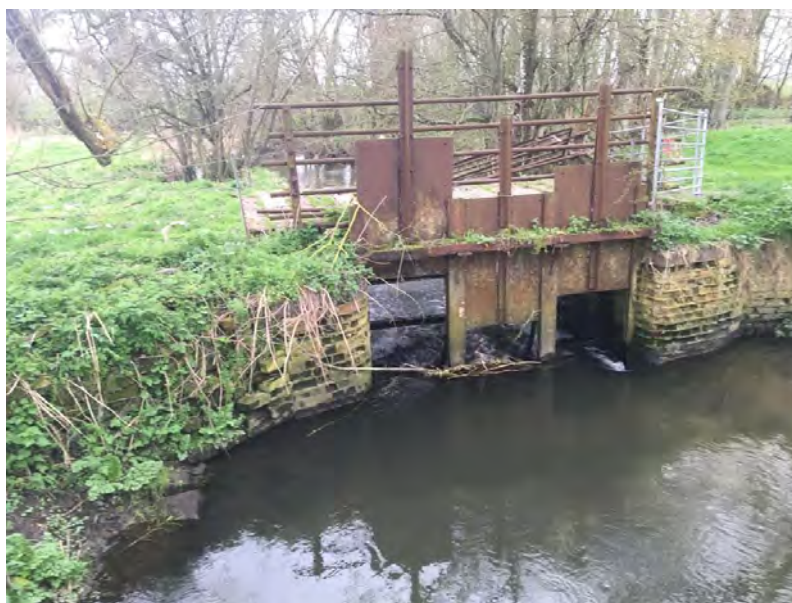
Photo 10. Old derelict hatches, previously used to flood the watermeadow being reconnected in the project by the WWT.

The old hatches (photo 10) were historically used to control the water level to flood the watermeadows. They are now long since derelict and have little effect on fish passage or impounding the reach above as they are constantly open. There

is a classic hatch pool reach downstream of the hatches which looks like it would be good holding water for larger trout.

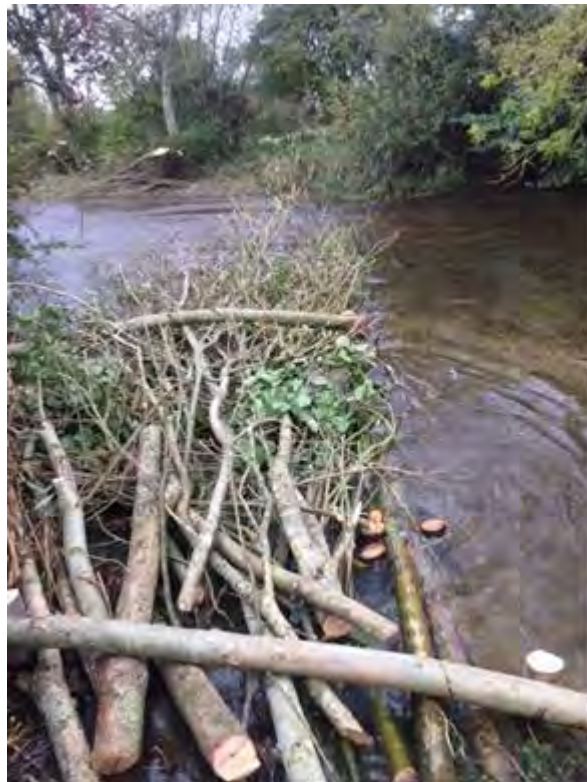
Photo 11. Brushwood mattress constructed with coppiced willow.

- Get involved in the hands-on process of the delivery of the WWT project. They employ volunteer help to deliver these projects. If the Willowdene landowners volunteered and installed these structures in a hands-on way, then they are set up with the building blocks for managing the river better in the future and understanding how the ecosystem works. Photos 11, 12 and 13 show some examples of the type of structures that could be installed.

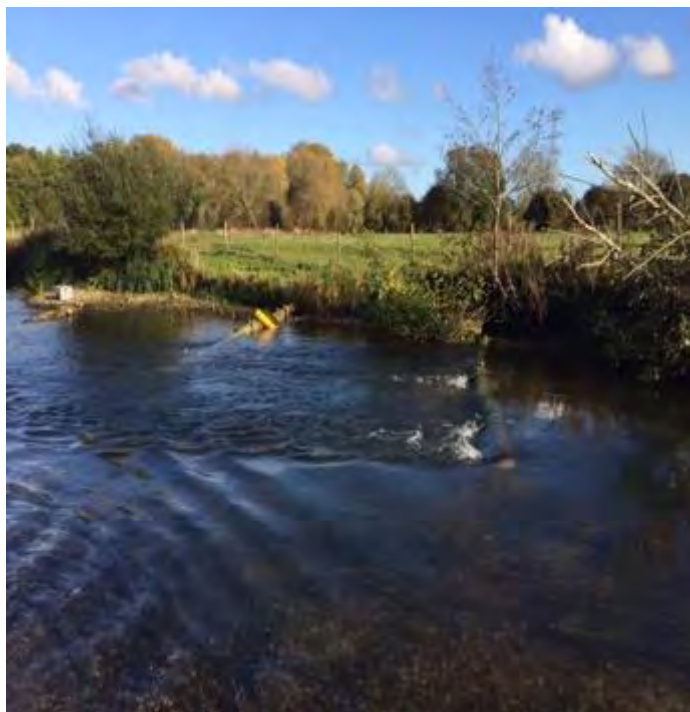
Photo 12. Log deflector.

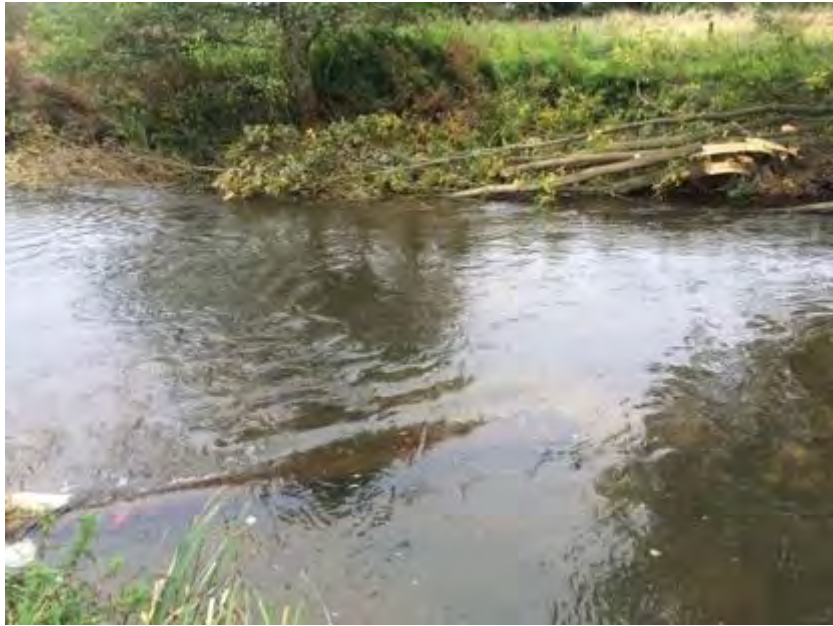
Photo 13. Log deflector combined with folded willow.
