**River Brit, Slape Manor**

**An advisory visit by Nick Lawrence of the Wild Trout Trust, January 2021**

## Introduction

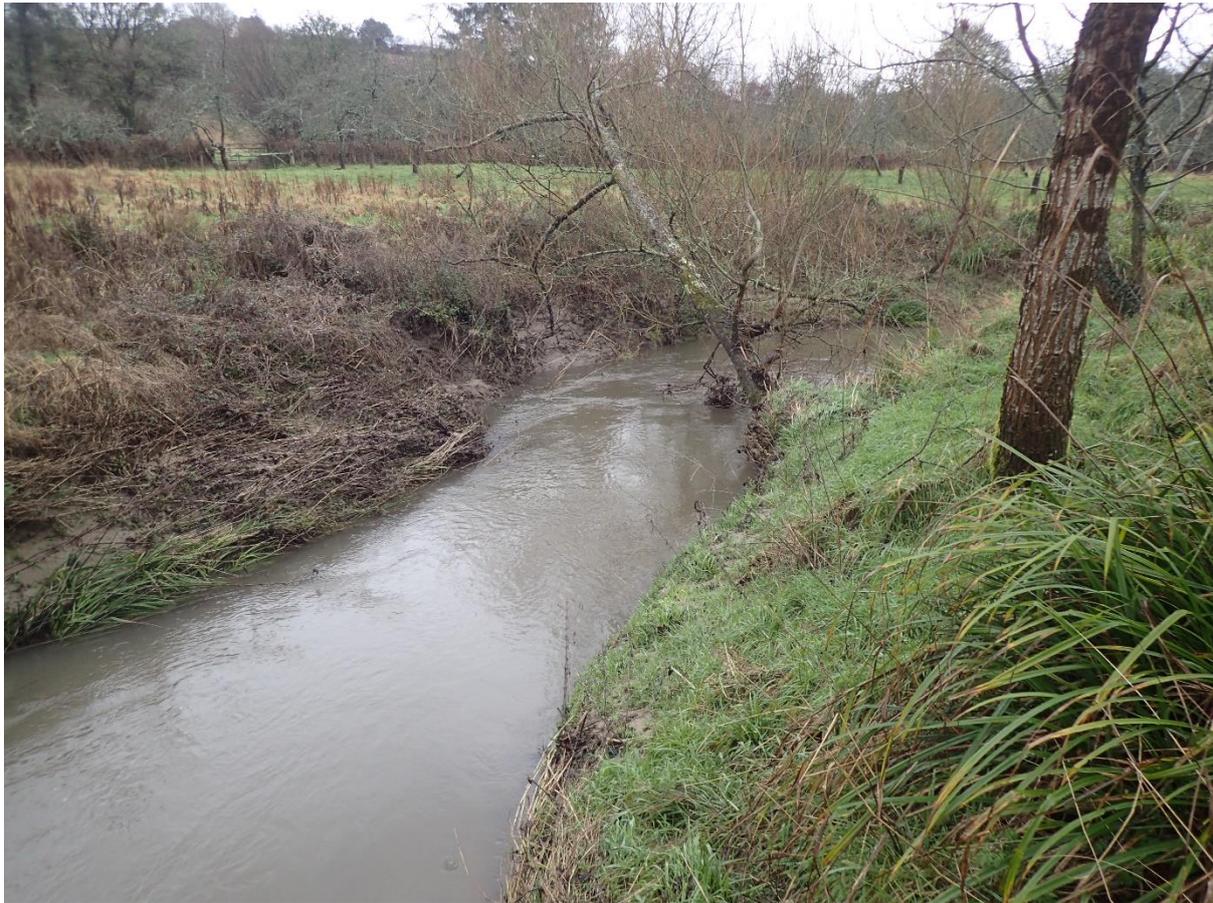
The upper most section has shared ownership, with the RB owned by Slape Manor and the LB owned separately. Both banks have benefited from very light touch maintenance, especially with regard to trees and woody material. Photo 1 shows a good example of low cover over a meander. The LB is completely unmanaged where the RB has been carefully managed, most notably for balsam. Note the lack of balsam stalks on the RB compared with the LB.

*Photo 1: Mixed species of willow and good low cover provided by the leaning willow on the RB, note Himalayan Balsam stalks on the LB.*

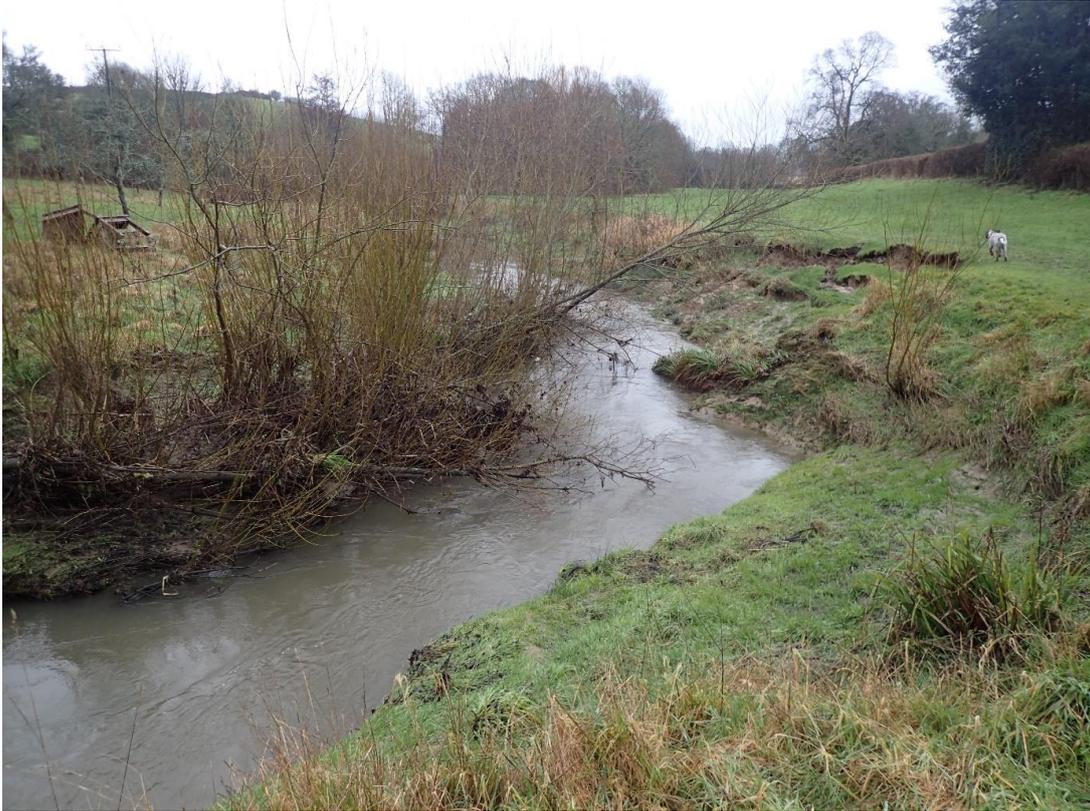
The Brit is an exceptionally spatey and highly erosive river, these factors combined with signal crayfish and HB, lead to high sediment inputs could be leading due to bank erosion and bank collapses (photo 2).

*Photo 2: High quality low willow cover on another meander, note the natural bank slumps on the RB.*

The bank slumps could be shored up by some tree planting with either willows or alder, to secure the bank. When these trees mature, they will become welcome additions to the landscape and biodiversity.

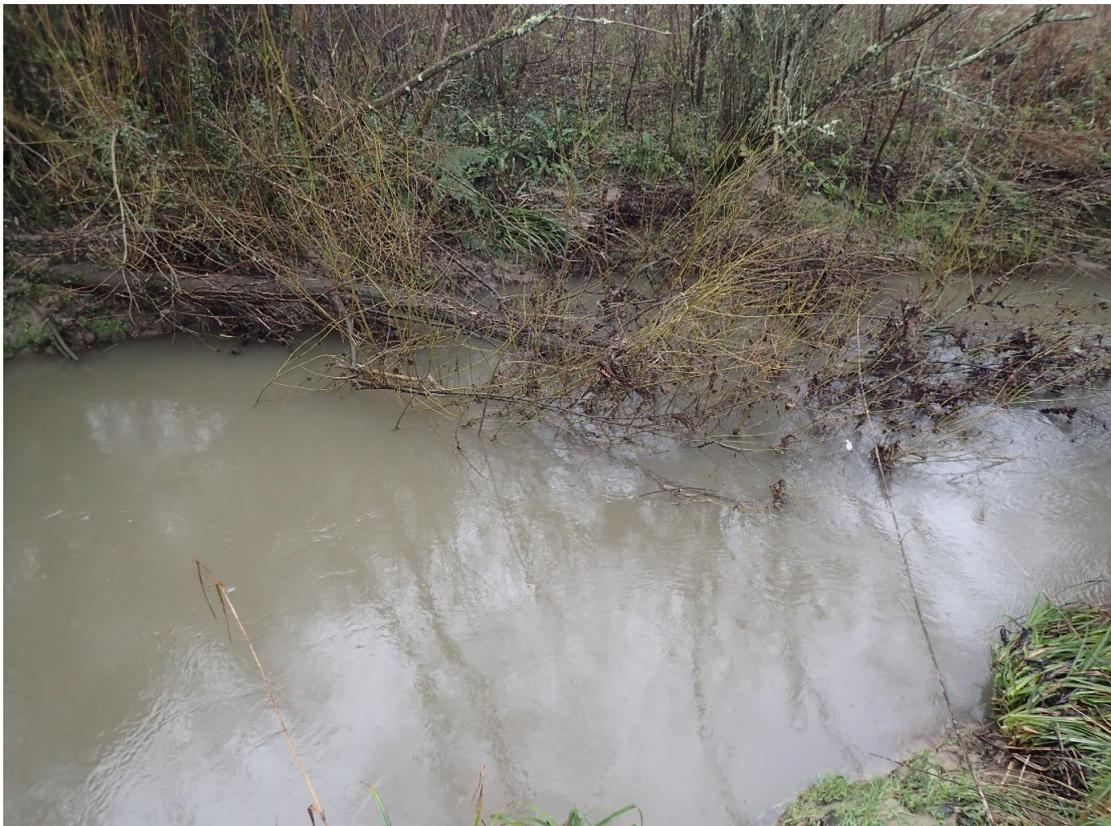
*Photo 3: High quality woody material naturally accumulating in the channel.*

Progressing down the upper section, instances of naturally accumulating woody material were common (photo 3). This willow is now providing valuable refuge for fish and invertebrates. These instances have been left to accumulate by sensible light touch management, ensuring that tidiness does not overcome habitat.

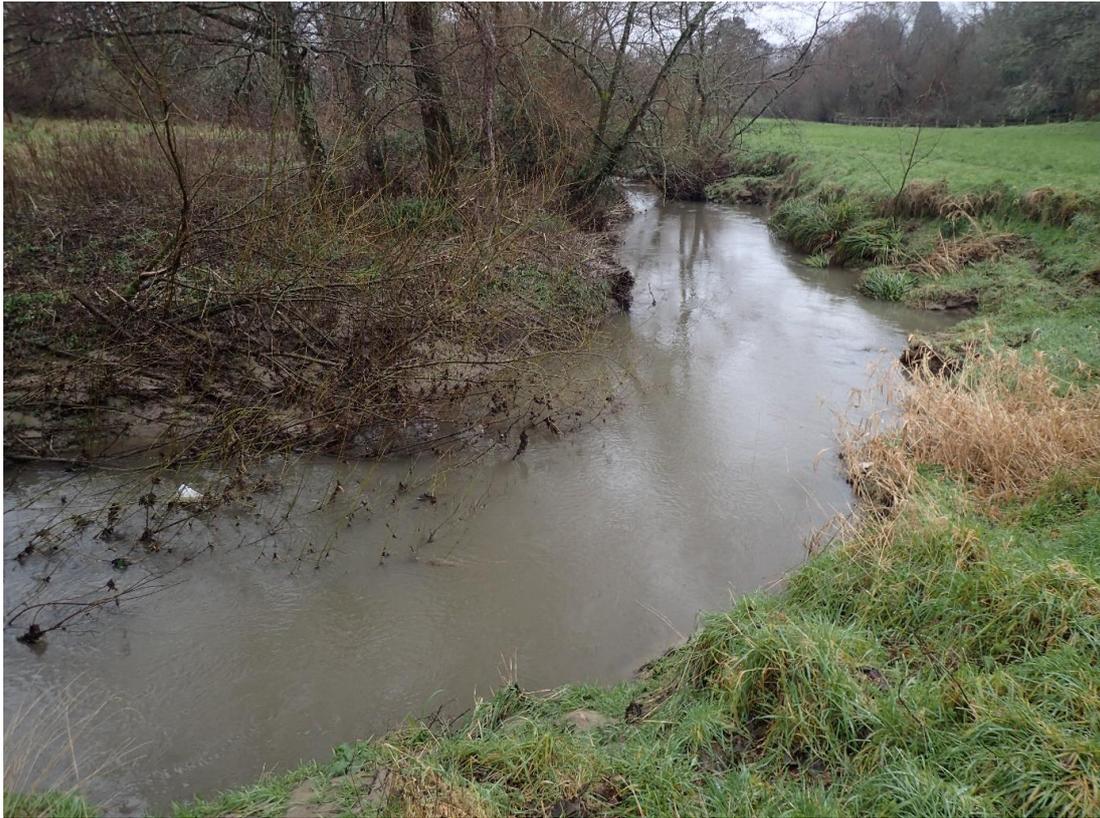
Photo 4 shows the difference between a managed and an unmanaged bank, although HB is well managed on the RB, the land use leads to a loss of tree diversity and marginal plants due to the silage production.

*Photo 4: A stark difference between managed bank on the RB and unmanaged on the LB, note exposed soil from infestations of HB on the LB.*

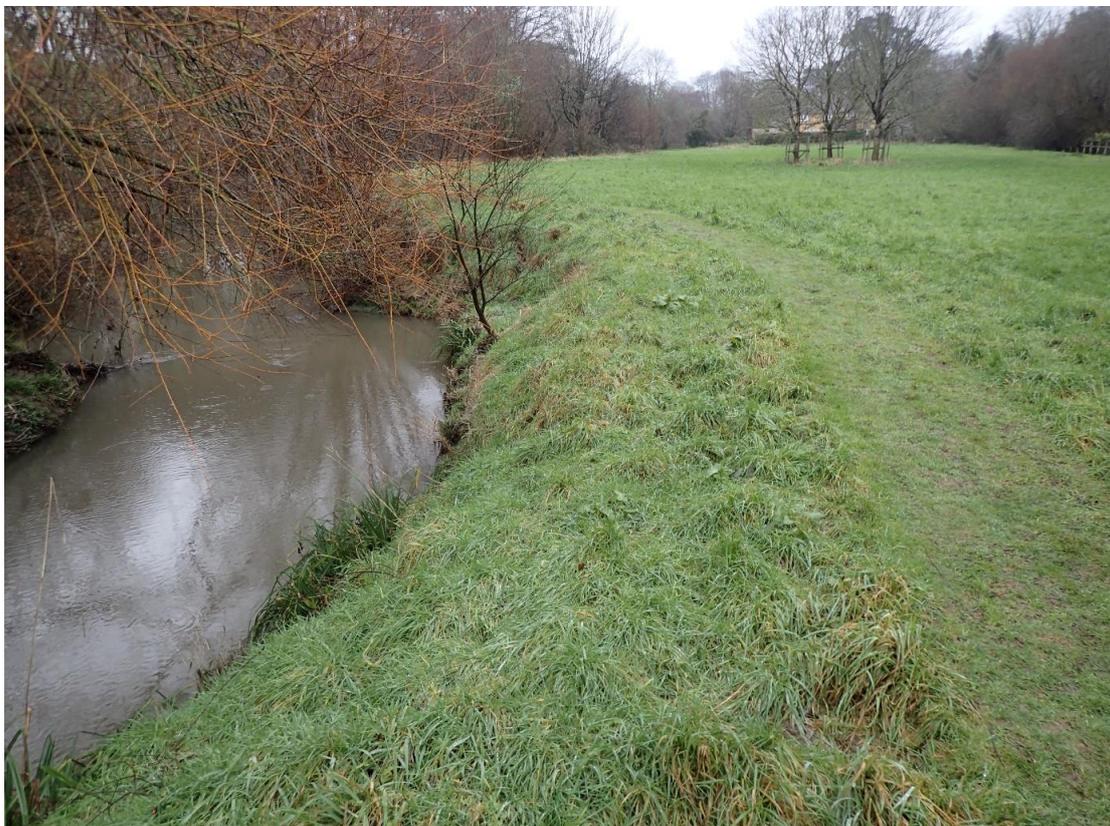
During the visit, land use was discussed and this silage field (photo 5) is potentially going to be taken back in house and managed more sensitively as a wildflower meadow. A larger light-touch management area (10m) should be considered adjacent to the river to provide better habitat niches, encouraging marginal flowering vegetation and scrub.

*Photo 5: The silage field RB – largely a monoculture of grass.*

- Consider changing the management regime within the meadow on the upper RB (SY 47216 98491 - SY 47155 98755) to a wildflower meadow. This in conjunction with a wilder light touch management strip (10 m) along the edge of the river. Supplementary planting of wild British waterside flowers such as like yellow flag iris, great willowherb, meadowsweet, purple loosestrife, water forget-me-not, mimulus and watermint could be used as a basis for this wilder strip.

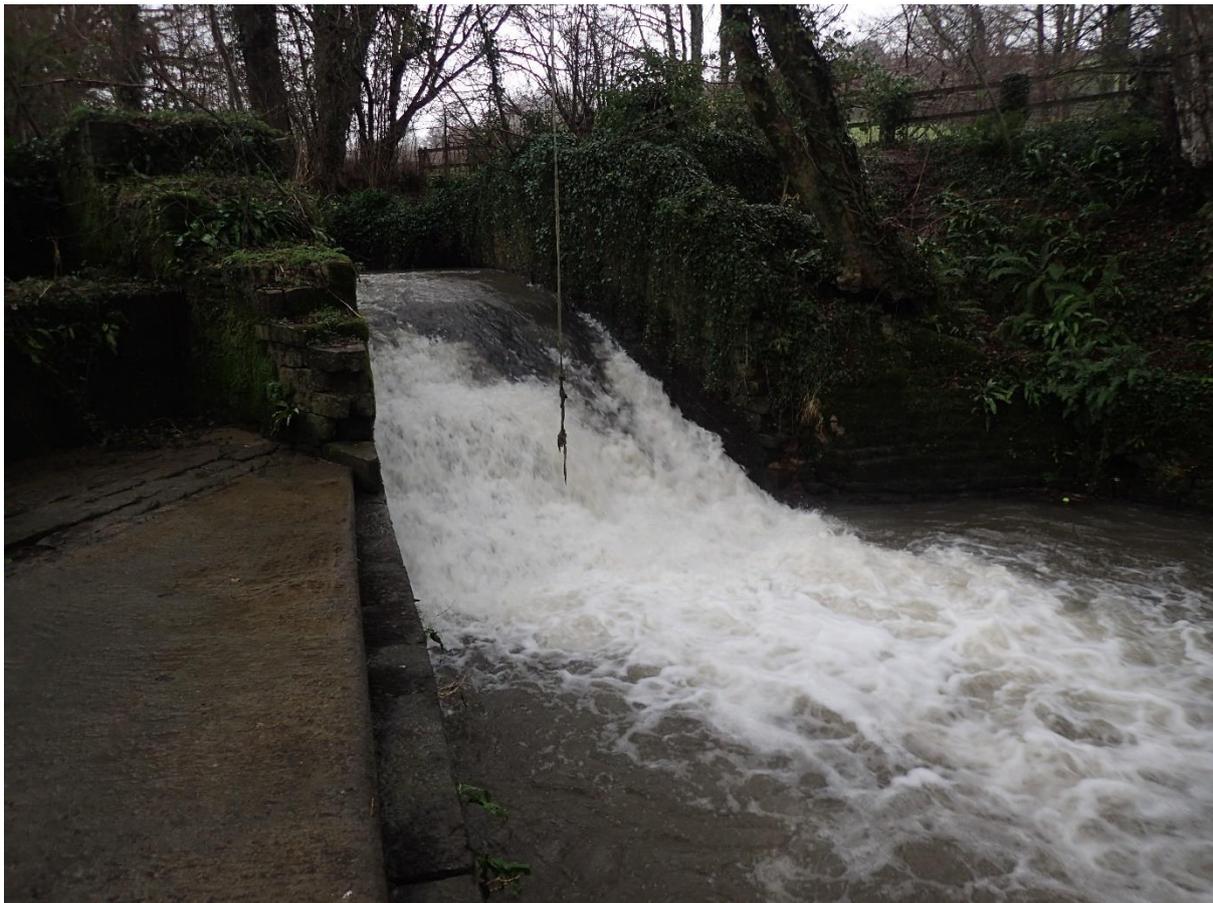
Halfway along the reach is an old weir (Photo 6, SY 47339 98536), which has led to a devastating loss of habitat for some distance upstream. The river has been robbed of its natural flow, and sediment has been deposited on the bed of the river in large quantities, smothering the gravels and restricting the natural processes of the river. Unable to be viewed within the visit but confirmed by the estate manager.

This weir is also an impassable barrier to fish. Fish need to migrate for reasons such as spawning, dispersal to find more space, and to find better places to feed. This barrier is stopping those migrations. It will affect local populations of brown trout and particularly the migratory species such as sea trout, eel and lamprey.

*Photo 6: The old weir upstream of River Cottage, an impassable barrier to fish.*

As the weir is no longer required, the redundant structure should be removed. The leat it once fed has long since dried up and vegetated over. The removal of this structure would restore natural processes to the river upstream and reinstate free passage to all fish. Photo 7 shows how weirs negatively impact local morphology and ecology.

- Invite an Environment Agency representative to the reach for an assessment and discuss the possibilities of weir removal complemented by a restoration project around the weir to account for water headloss. Discussions should be had with a geomorphologist to assess feasibility and see whether EA funding might be available. WTT would be happy to act as a broker to help this meeting happen.

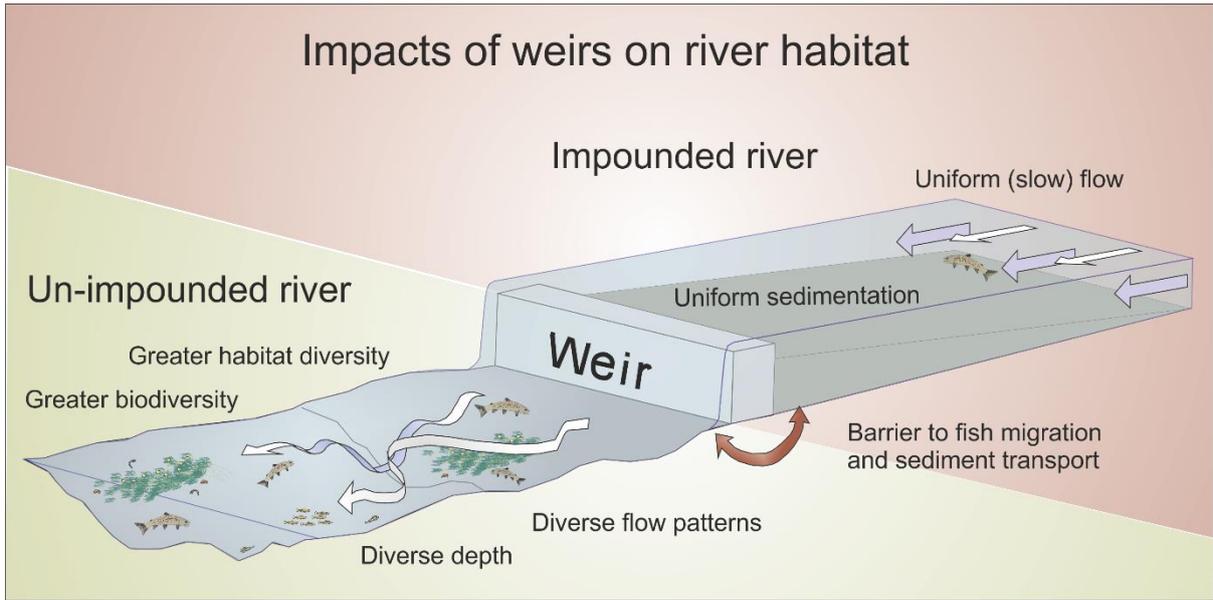
*Photo 7: Diagram explaining how weirs degrade habitats.*

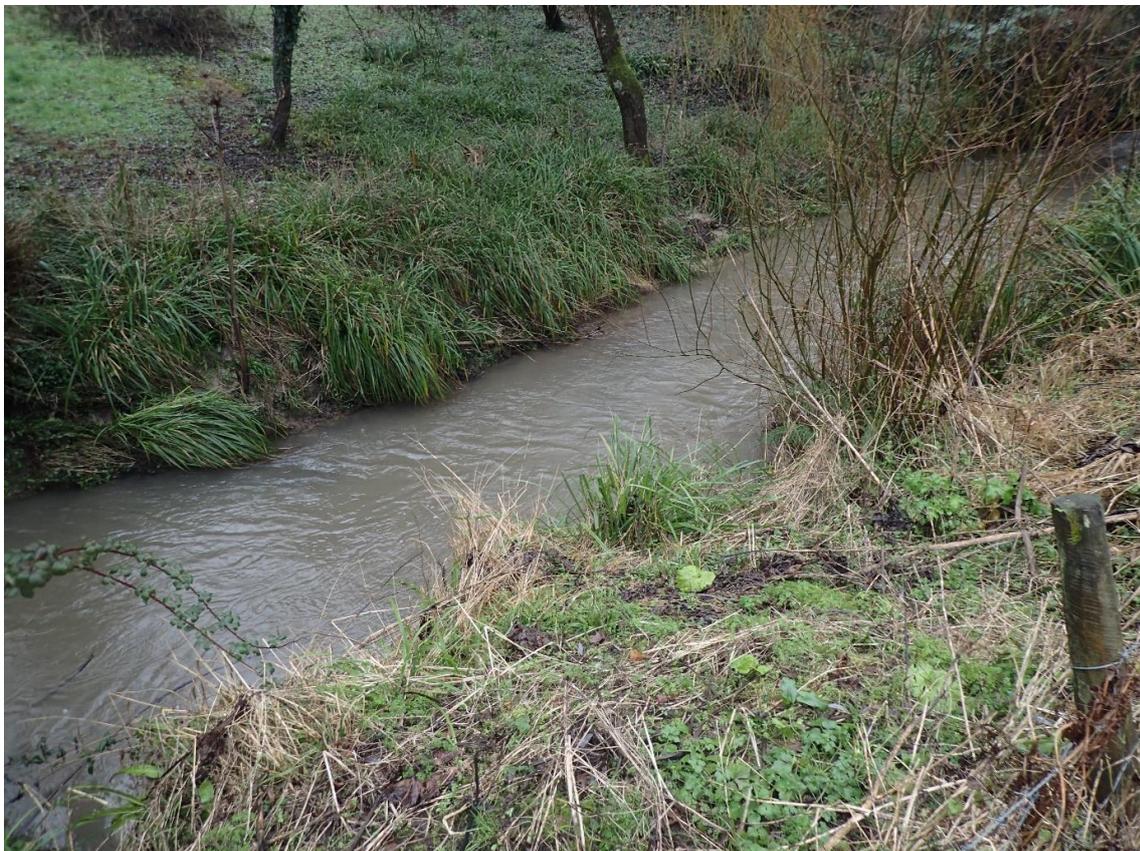
Downstream of the weir, the river reverts to a more naturalised system, with dynamic erosive processes in place and improved marginal vegetation. In front of River Cottage (photo 8), a lush thick marginal fringe of sedges was observed, something notably absent upstream of the weir, possibly due to the unnatural impounded channel.

*Photo 8: Lush marginal growth and quality scrub habitats developing behind the fencing.*

The fence on the RB (photo 8) buffers the riverbank from the silage meadow allowing some scrub habitats to develop. This in time will add more valuable woody material to the river in areas that can be utilised by trout. The river here and downstream of River Cottage, starts to display more natural features such as meanders with deep holes and long shallow riffles.

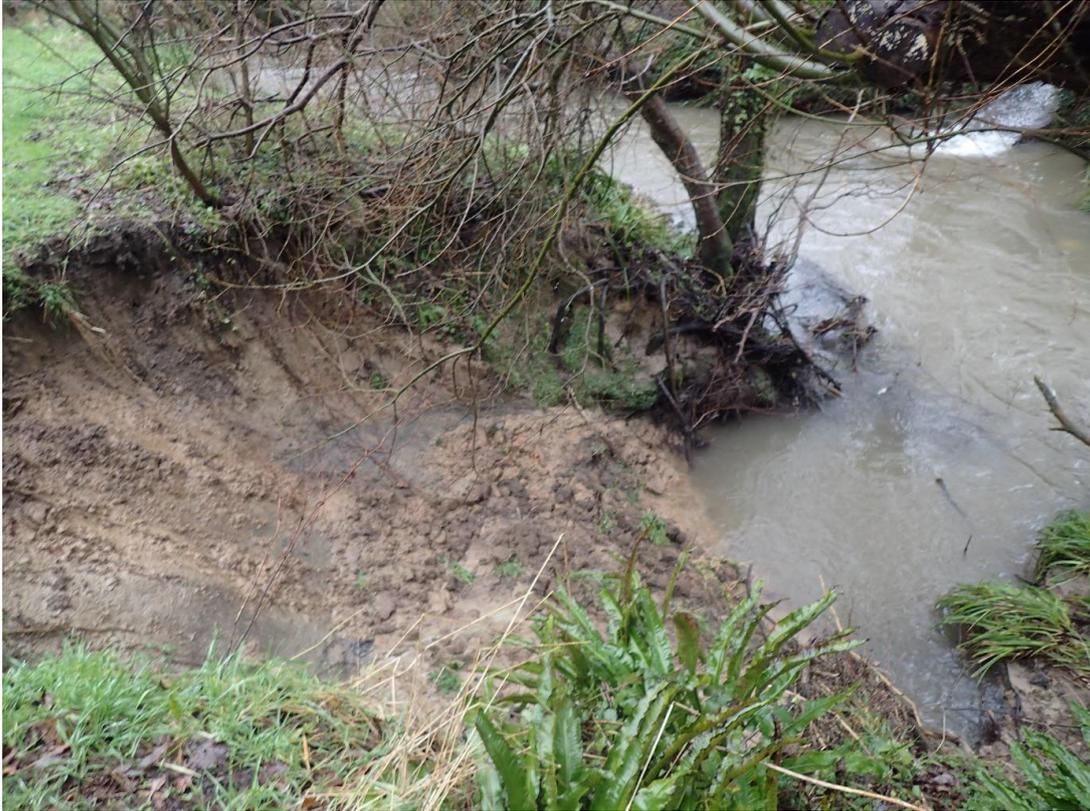
The banks are seemingly very unstable, possibly partly due to previous HB infestations and apparently present are large amounts of signal crayfish. The soil is particularly sandy throughout which may well account for the unstable nature.

*Photo 9: A recent bank slip now exposed to some spate conditions on the river Brit.*

- Where bank collapses are occurring shore up the unstable banks with some tree planting possibly alder or willow. Other rarer trees such as black poplar and elm (disease resistant strains) are now being planted due to their heritage value.

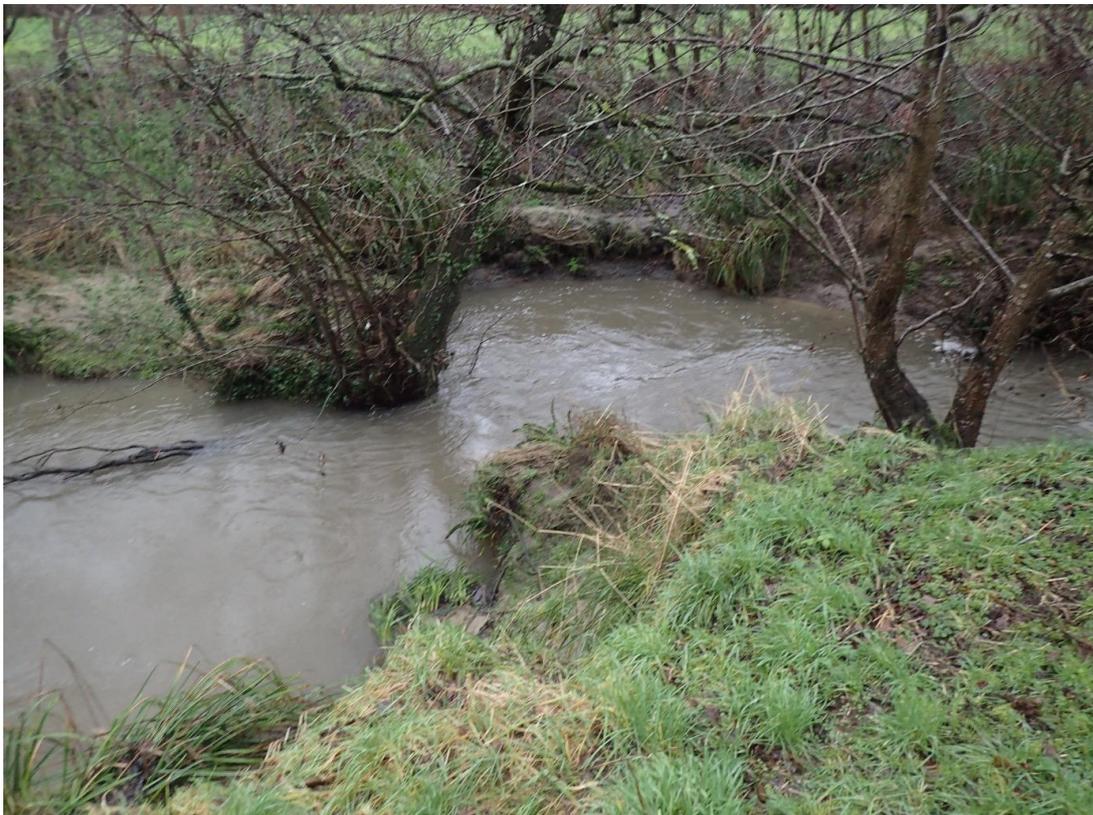
*Photo 10: Fantastic sour pool around alder root systems, perfect for adult fish refuge.*

As the visit moved into the lower section, the natural erosive processes of the river cut under tree roots and scoured out deep holes (photo 10). These are ideal areas for larger adult trout. This lower section has many of the building blocks for good trout habitats.

Instances such as photo 10 are common in the lower reach, where the powerful river has scoured under and around the tree's root structure, contributing to the formation of quality pool features which larger trout will thrive in.

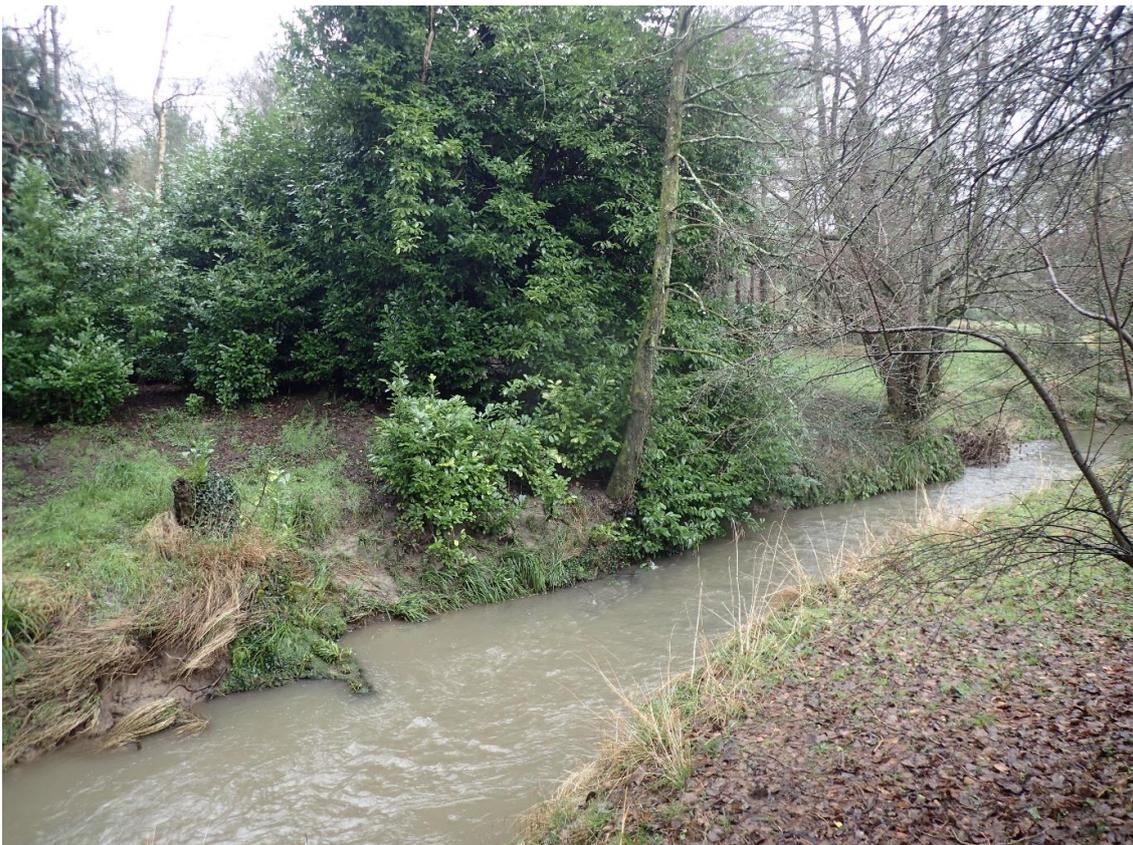
Towards the bottom of the reach, a plantation woodland was situated on the RB. Although this was generally native species planted sensitivity, the laurel within the woodland is undesirable. Laurel is now naturalized within the UK but is highly invasive, particularly in woodlands and along riverbanks where it often grows unchecked. It outcompetes native plants and understory species by overshadowing them.

Laurel within a riverbank environment will inhibit scrub species such as willow, alder, hawthorn and blackthorn, species that do far more for biodiversity than laurel.

*Photo 11: Laurel spreading from the woodland and threatening the biodiversity of understory and riverbank.*

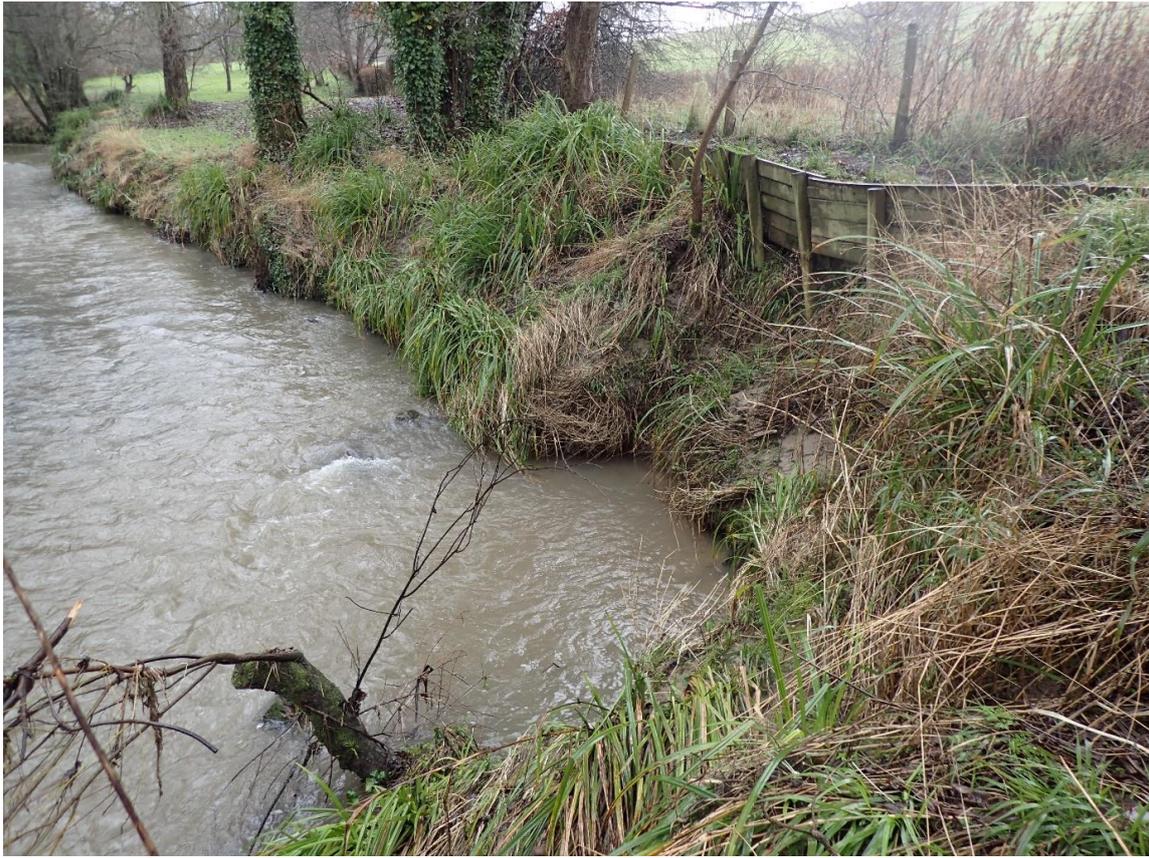
*Photo 12: Erosion against the LB leaving the walkable boundary path vulnerable.*

The lowest section of the fishery is suffering from erosion problems, mainly due to the lower boundary on the LB being very close to the edge of the river. The walkable path in photo 12 is very close to being lost. This erosion problem could easily be slowed down with the use of a willow mattress as shown in the appendix (photo 13) and may well consolidate with fine sediment to solve problem completely.

- In the few areas where unwanted erosion is present such as the footpath at the lower end of the reach, use strategically placed woody structures (as seen in appendix) to consolidate and protect banks that are vulnerable.

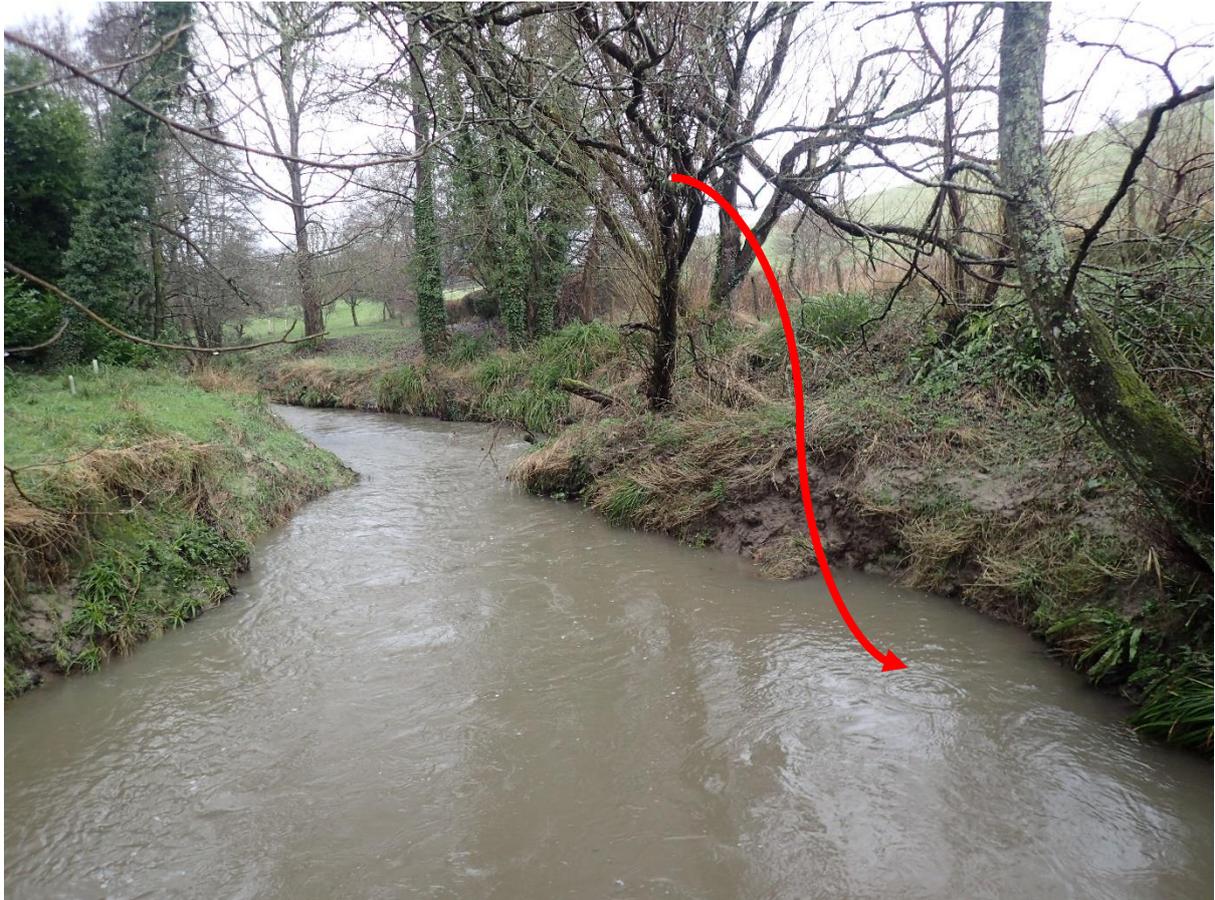
*Photo 12: Erosion right of shot (on the LB). could be reduced by hinging in willow as annotated by red arrow.*

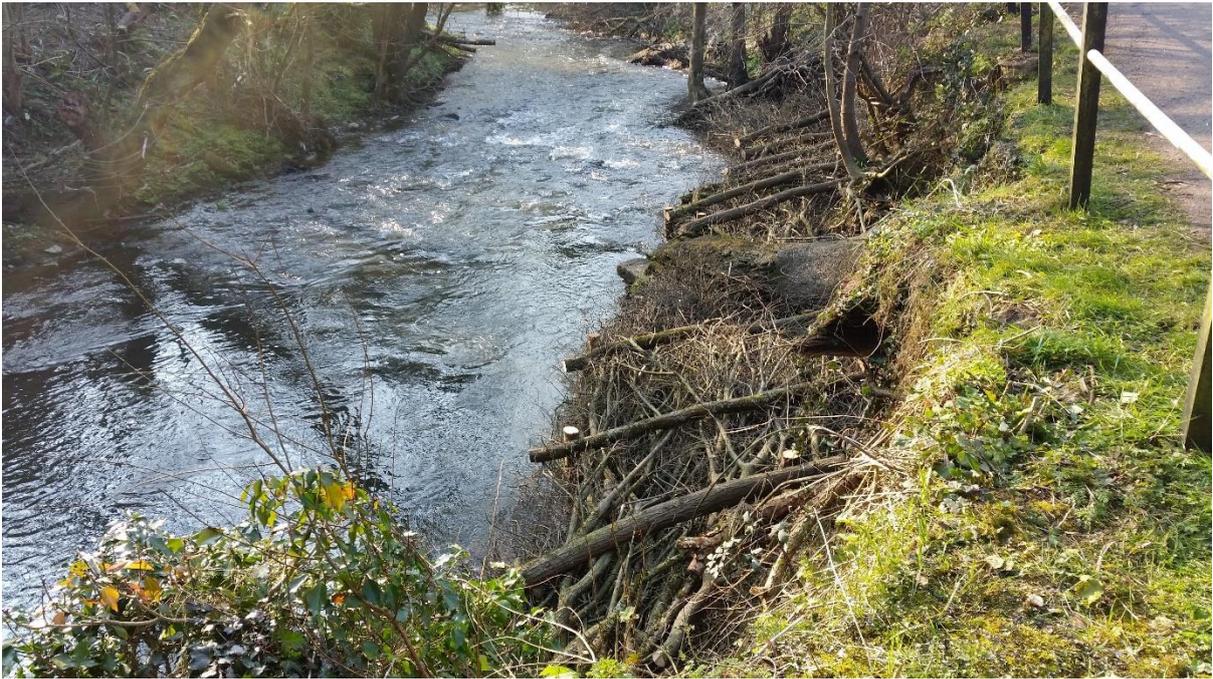
*Photo 13: Willow mattress used to protect and reduce erosion near a track.*

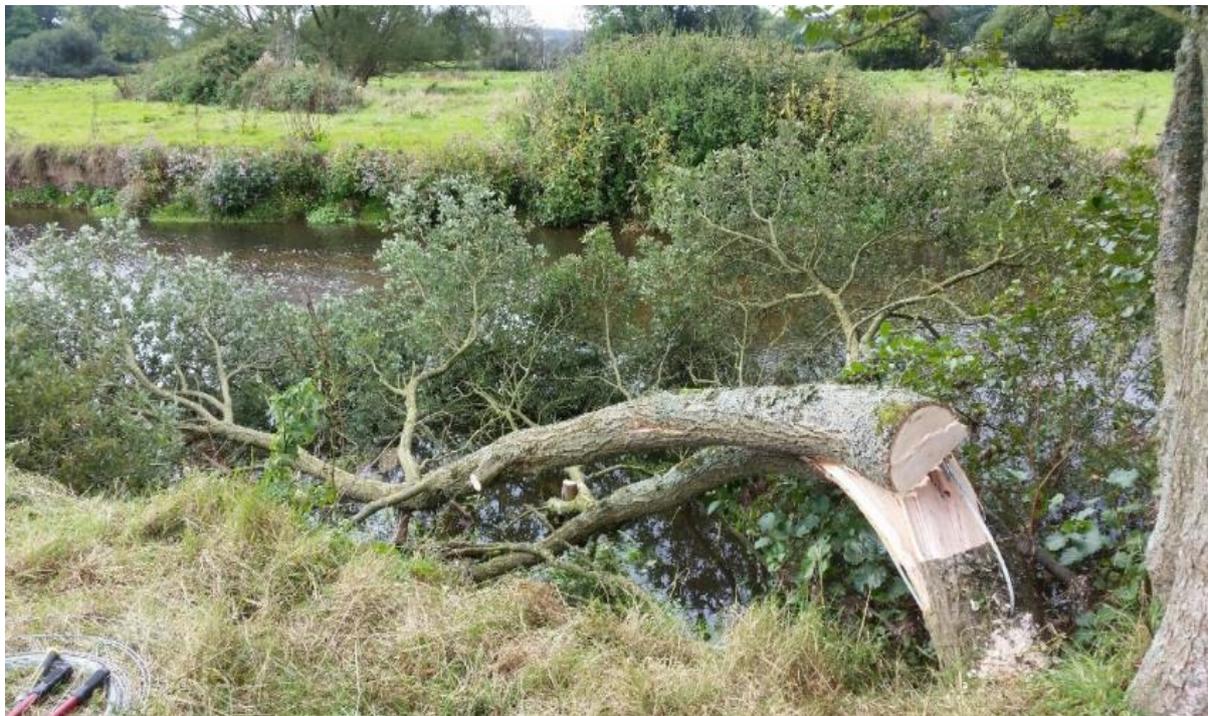
*Photo 14: Hinged willow. Hazel, small willows and small alders can be hinged into a river, creating diversity of flow and in-stream cover for fish. The trees are hinged in a similar manor to hedge laying, where the tree is partially cut through at the base and laid into the margins. Chestnut stakes and fencing wire or sisal rope can be used to secure the trees in place. Willow will survive perfectly well even with 70% of the branches submerged; however, hazel and alder should be laid to retain much of the structure above water level.*

Next to the bridge at the lower boundary, another erosion issue is threatening to bypass the bridge, this again could be solved with some cleverly placed woody mattress or, alternatively, there is a tree that could potentially be hinged into the problem area. Pictures of a hinged tree are exhibited within the appendix (photo 14) which can be used for reference purposes.

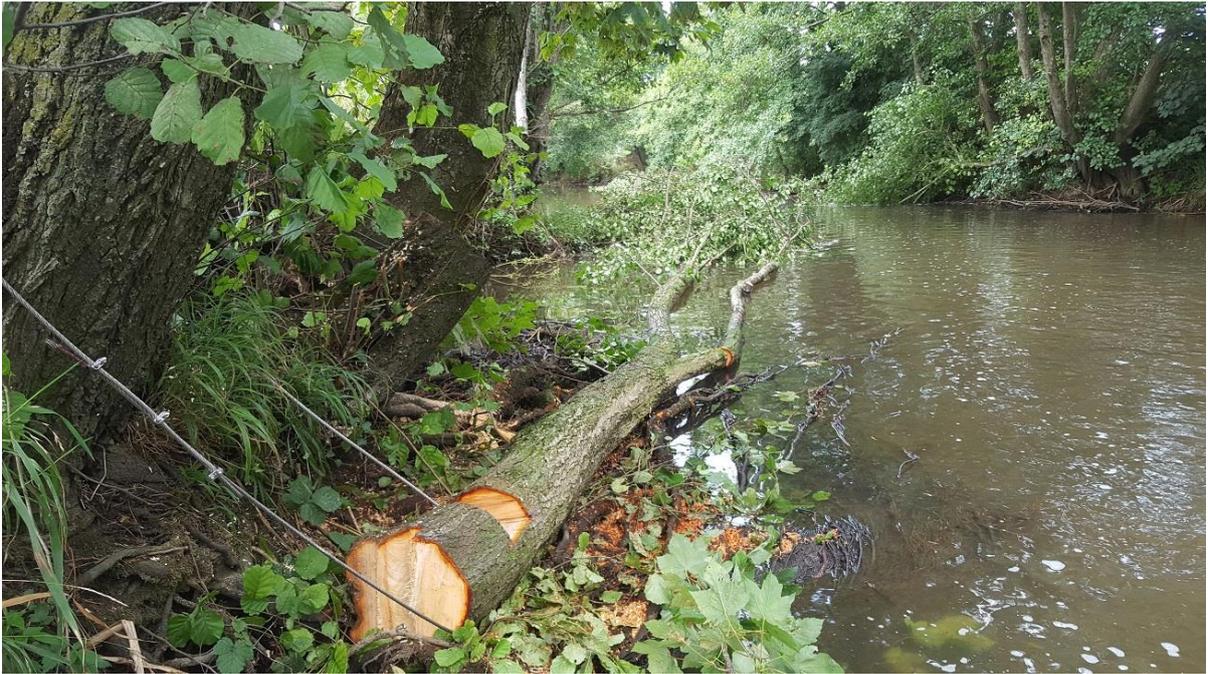
*Photo 15: A tree kicker cabled to an existing tree stump on the River Yeo. Kicker tethers should be as short as can be realistically achieved: apart from too much metal cable being unsightly and unnatural, the risks of the trees being stranded on the banks in floods are significantly increased. Hiring or investing in a hand winch would allow the kickers to be winched back toward the stump, reducing the amount of cable needed, which in turn will reduce the likelihood of the kicker being stranded on the bank after high flows.*
