Advisory Visit

River Carron

20/08/2018

Undertaken by Gareth Pedley

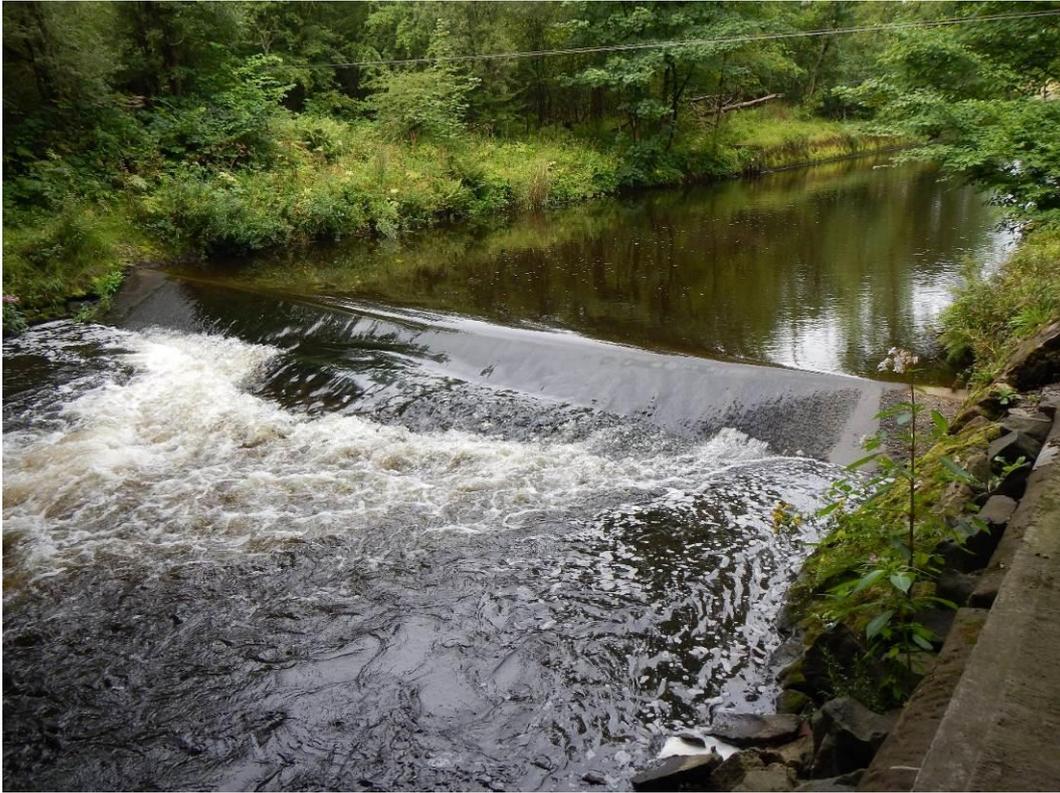
At the u/s end of the section visited, immediately u/s of the M876, a medium sized flat-vee flow gauging weir creates notable obstruction to fish passage and impoundment (Fig. 1). While this structure will be passable at certain flows, it undoubtedly inhibits the migration and dispersal of both resident and migratory fish, of all sizes. Larger, more powerful fish will ascend it more easily in higher flows but the step, with fast/shallow water and hydraulic jump (a standing wave where the high velocity water meets the slower water d/s) hinders the approach. Smaller fish may find their way up either side in certain flows, but the structure is far from ideal.

All too often, the impact of obstructions is overlooked, simply because they are, theoretically, passable. What should also be considered is whether fish can easily pass them when they need to (e.g. to meet tight timings within the lifecycle like short spawning or smolt emigration windows or simply just to make full use of habitat within a system). Animals that are subject to highly density-dependent mortality (like salmonids) require easy access all of the available habitat at all stages of their lifecycle if they are to fully utilise that habitat and achieve optimal population sizes. Restricting any size-class of fish from easily dispersing into new habitat as their requirements change or they become overcrowded will therefore result in increased mortality. This is the unnecessary death of fish that would have otherwise survived without the additional competition that occurs within restricted river sections. Conversely, naturally free fish passage throughout a river system allows fish to disperse and find new territories helping to maximise the number of fish a river can support within the available habitat.

Figure 1. The flow gauging weir at NS 83201 81774 creates poorly passable obstacle to fish passage.

As this is a flow gauging weir, it is suspected to be owned by the Scottish Environment Protection Agency (SEPA) whose responsibility it should be to provide free fish passage at the structure. Ideally, the goal should be replacement of the structure with less intrusive flow monitoring technology that allows uninhibited fish passage, but this will be at SEPA's discretion and is unlikely to occur in the short-term. This should not prevent significant improvements at the site from being a key aspiration.

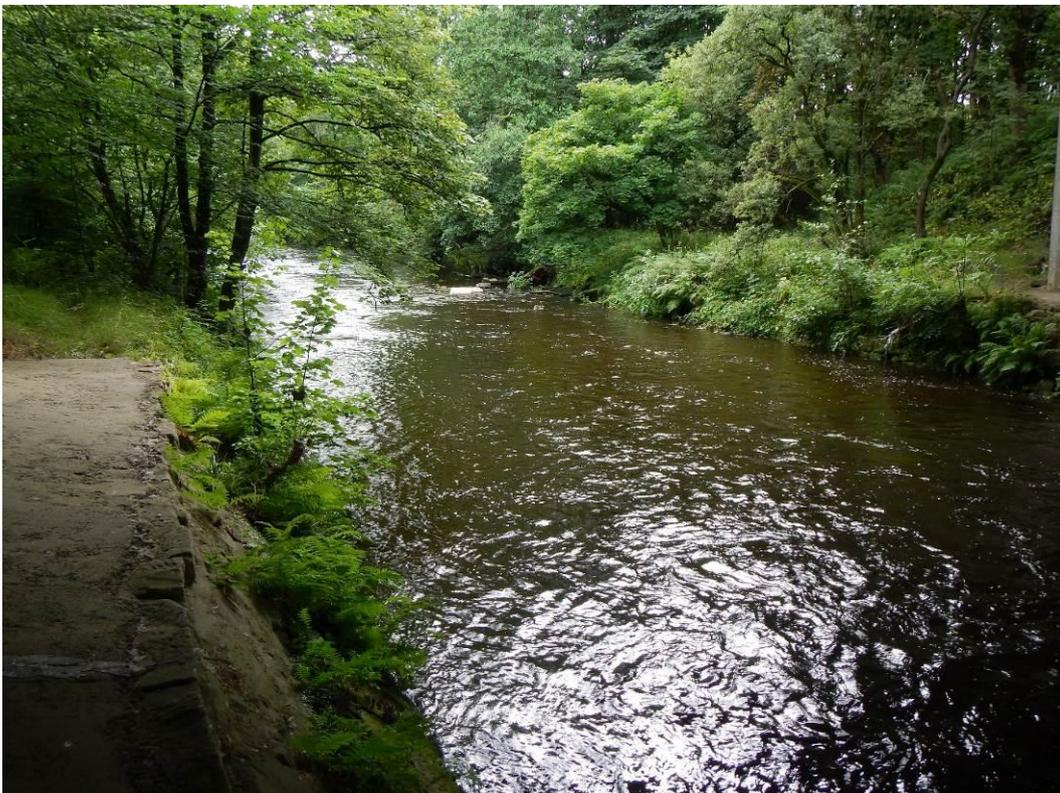
The channel d/s of the weir has been lined with block stone and likely realigned in the past (Fig. 2). This limits the habitat potential somewhat, although a healthy abundance of riparian trees and trailing branches/vegetation does provide some reasonable quality habitat in areas. Retaining as much of the bankside vegetation as possible and increasing the occurrence of trailing branches will help to optimise the potential of the modified channel.

Figure 2. The very straight and consequently uniform channel d/s of the gauging weir is greatly enhanced by low and trailing bankside cover.

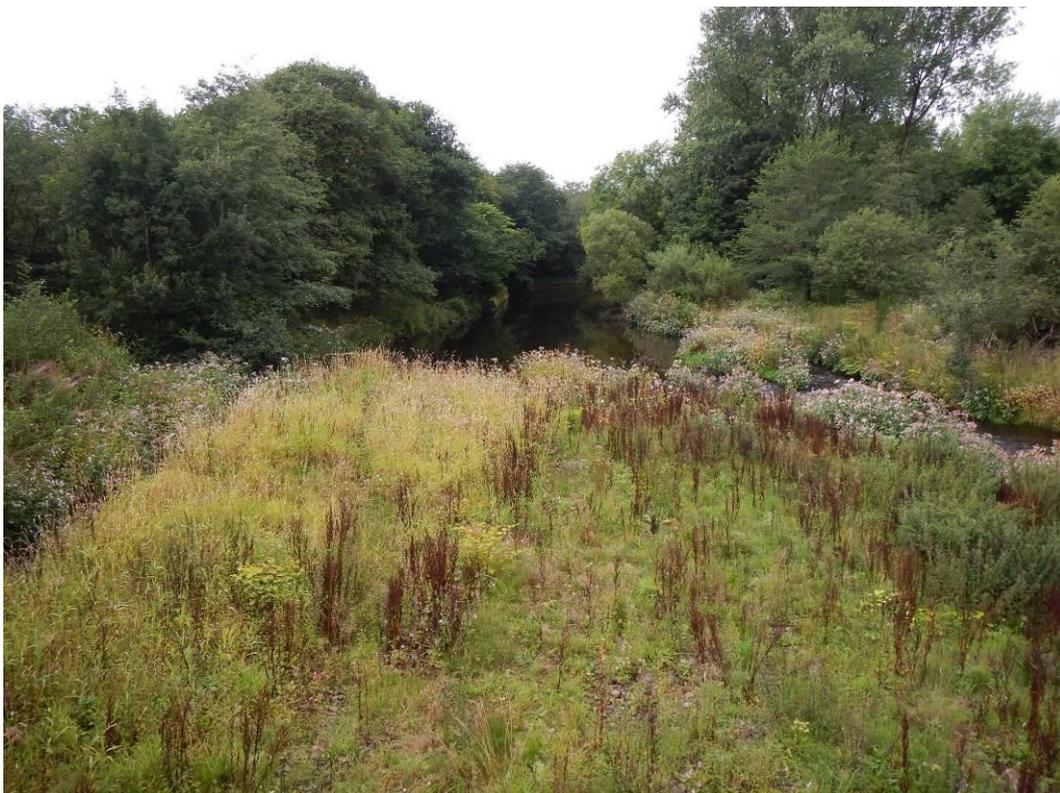
At the next road bridge d/s (B905) the channel widens significantly, which has led to deposition and the formation of a gravel/cobble bar (now vegetated) u/s of the bridge (Fig. 3). This is a natural consequence of the channel being too wide for the usual flow volume it receives and the increased channel roughness caused by the bridge footings (possibly also impacted by the impounding effect of a weir further d/s at higher flows).

The impacted hydrological regime of the river (reservoir abstraction) may also contribute to the problem, with the artificially reduced occurrence of higher cleansing flows allowing the deposited material to remain *in situ* long enough to consolidate with the vegetation. The flow constriction of the bridge and inability of the stone-lined channel to adjust, coupled with the potential flood risk created, make this an ongoing issue, leading to a potential, localised requirement for periodic dredging u/s of the bridge. Between the periodic dredging, the more natural channel capacity created by the narrowing creates good quality habitat in the channels either side of the bar.

Figure 3. Looking u/s at the over-capacity channel (in low flows) and now vegetated depositional bar, u/s of the B905 road bridge.

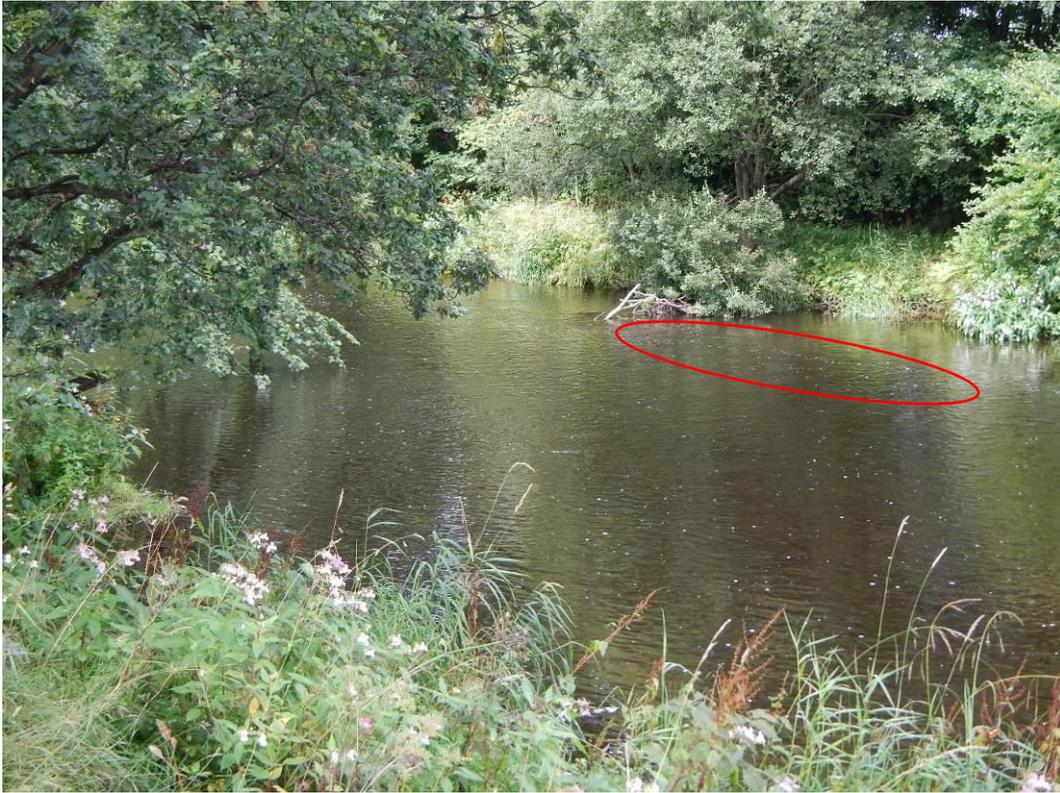
The channel immediately d/s of the bridge provides relatively good quality habitat, with areas of shallower riffle and glide, coupled with deeper areas. Some (possibly all) of the channel down to the weir is suspected to be stone lined (according to LSAC members) but overhanging and trailing branches provide vital flow diversity, cover, and shelter – ideal habitat features for holding adult trout (Fig. 4). Where flow diversity is lower, particularly in areas lacking in-channel structure, habitat quality is poorer (Fig. 5).

Figure 4. Valuable, shallow glide habitat, greatly enhanced by the availability of shade and cover from overhanging and particularly low, trailing branches. Note the food lane created by the trailing willow and associated woody material on the far bank. The bubble line (red ellipse) identifies an area in which flow and food are focused, creating a valuable lie for a larger adult trout that would be unlikely to hold there otherwise.

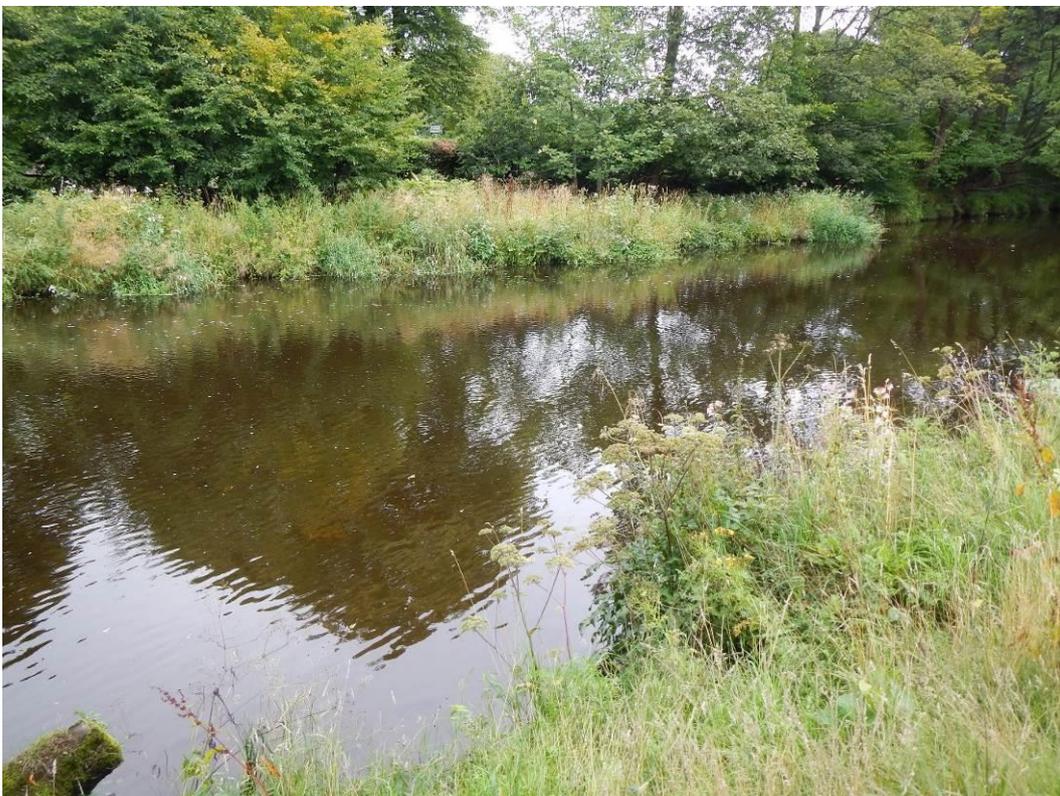
Figure 5. Areas with less in-channel structure (less woody material and/or bed variation) have reduced flow diversity and provide poorer quality habitat. This area could be improved by planting willows on the far bank that will ultimately grow into the channel to increase flow diversity and help improve the bed morphology.

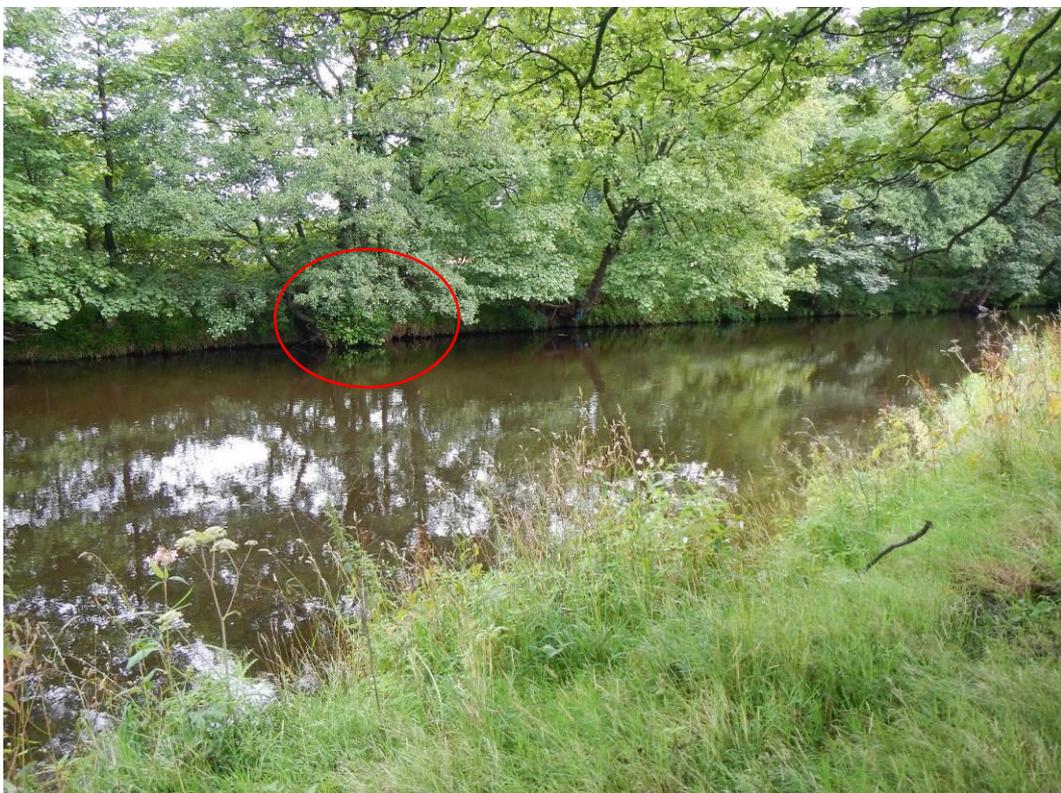
Progressing d/s, there is a good availability of overhanging cover but the canopy is often too far above the water to be providing maximum benefit for fish holding. When branches are much above the water level their ability to provide cover and shelter to fish is reduced when compared to trailing/partially submerged branches. Branches can be broken by high flows but it is often also common practice for pruning of low branches to be undertaken to allow improved casting access; this is usually counterproductive, and actually often maintains branches at a height that is neither optimal for fish holding or casting access (Fig. 6).

Figure 6. Relatively uniform canopy raised well above the water level in most areas, creating a tricky cast to limited fish habitat - note the lack of discrete fish lies. The main area likely to hold good fish is the one piece of trailing branch (red circle). Fish will be found in other areas, possibly patrolling the open water, but fewer than there would be with more in-channel structure and discrete habitat features.

Allowing, or even encouraging, branches to trail down onto water on the other hand is greatly beneficial as this actually creates better habitat, with many more fish lies in areas around the branches, rather than one or two tucked underneath them. Yes, some of those fish may be hard to access, but the greater number held in the area actually means that there are still more to fish for, and for varying abilities of angler. Figure 7 provides a perfect example of an area of structure that will undoubtedly hold several trout (also migratory fish when present in the river), with a range of lies accessible to a range of angling abilities. Removing this kind of structure to assist less proficient casters will only result in less fish being held in those areas (within the river as a whole) and less fish for everyone!

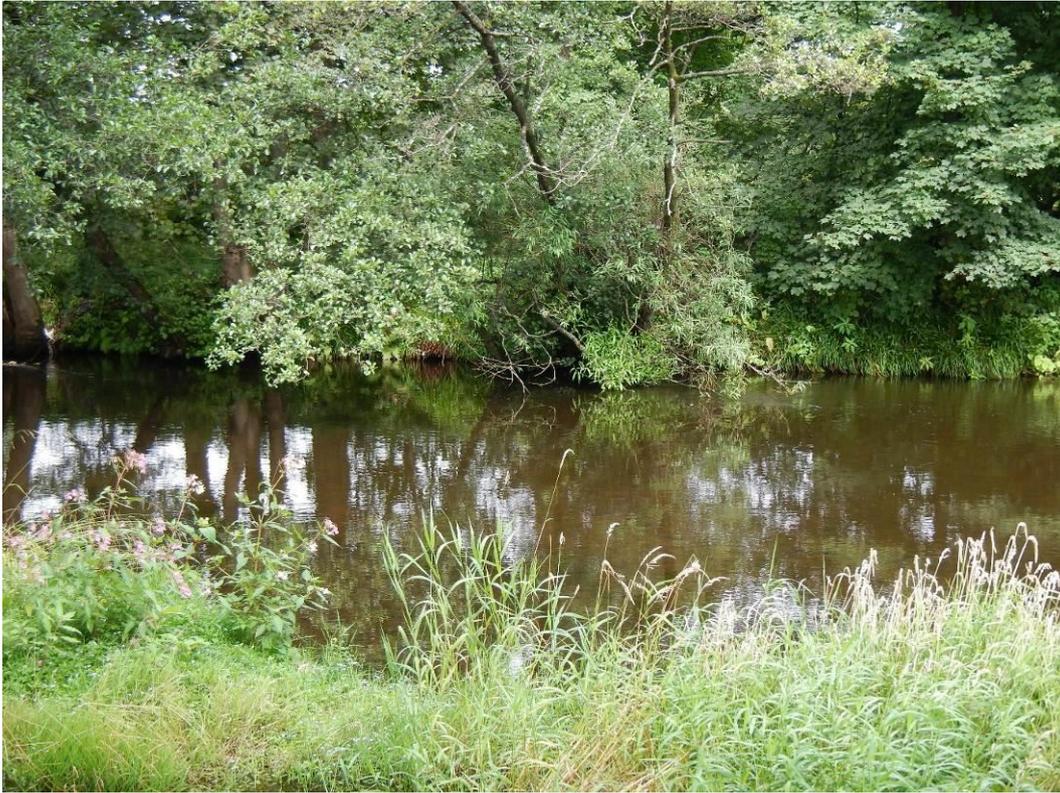
Figure 7. A nice habitat feature of trailing, in-channel structure. This kind of feature holds a range of fish (both sizes and species), each being available to a different angling abilities. These features also provide refuge for fish from predators and high flows and the flow diversity they create also helps to develop discrete areas of scour and deposition which in turn create a more varied bed profile and more fish and invertebrate habitat.

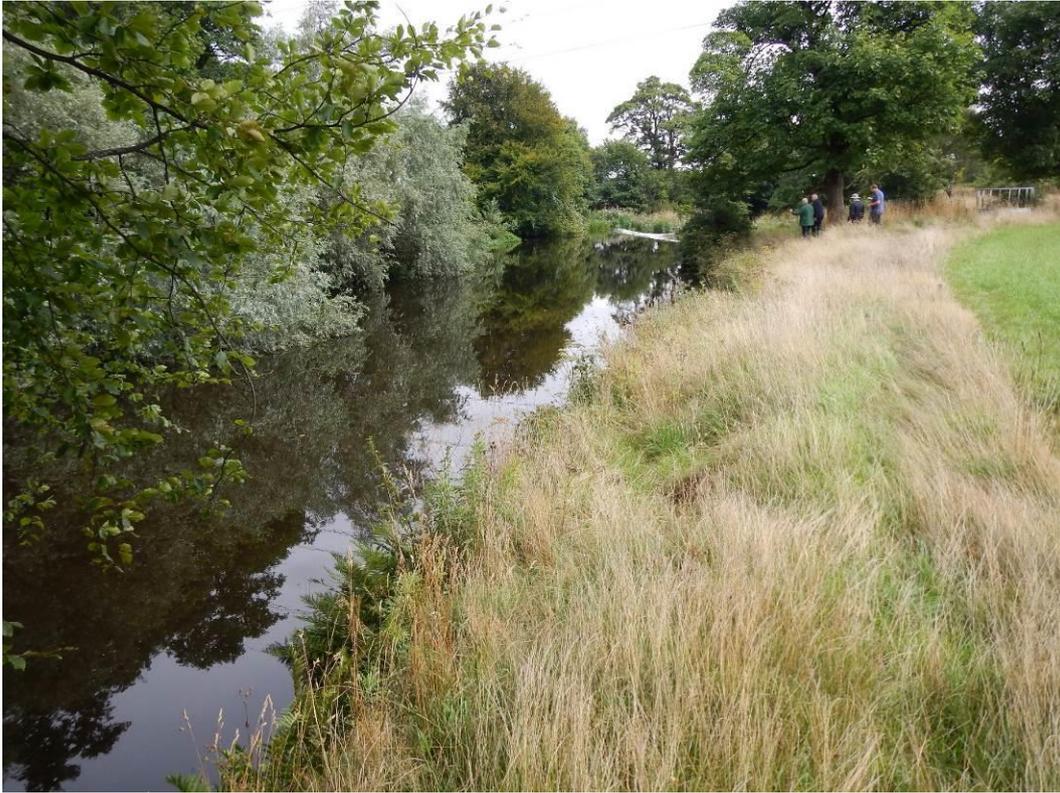
A large, stone weir then creates an impoundment through the next section of channel, where the habitat is consequently degraded for fish and invertebrates (Fig. 8). This weir also negatively impacts upon sediment (bed material) transport through the reach and u/s and d/s. Overhanging and trailing willows provide some cover and shelter but the impoundment is impossible to mitigate fully. For this reason, all non-essential weirs and channel modifications should always be removed, to reinstate more natural conditions and preserve the wildlife of our rivers, including fish populations.

Figure 8. The impounded reach above the weir (NS 83877 81586). This ponded area provides greatly reduced habitat quality for flow loving species like trout, salmon and many of the natural invertebrates upon which they feed.

It appears that this weir no longer serves its original purpose and investigation should be undertaken into the feasibility of its removal to allow naturally free fish passage through the reach. This site is somewhat complicated by the potential of the channel u/s being stone-lined but this should not preclude the investigation or removal of the structures if at all possible.

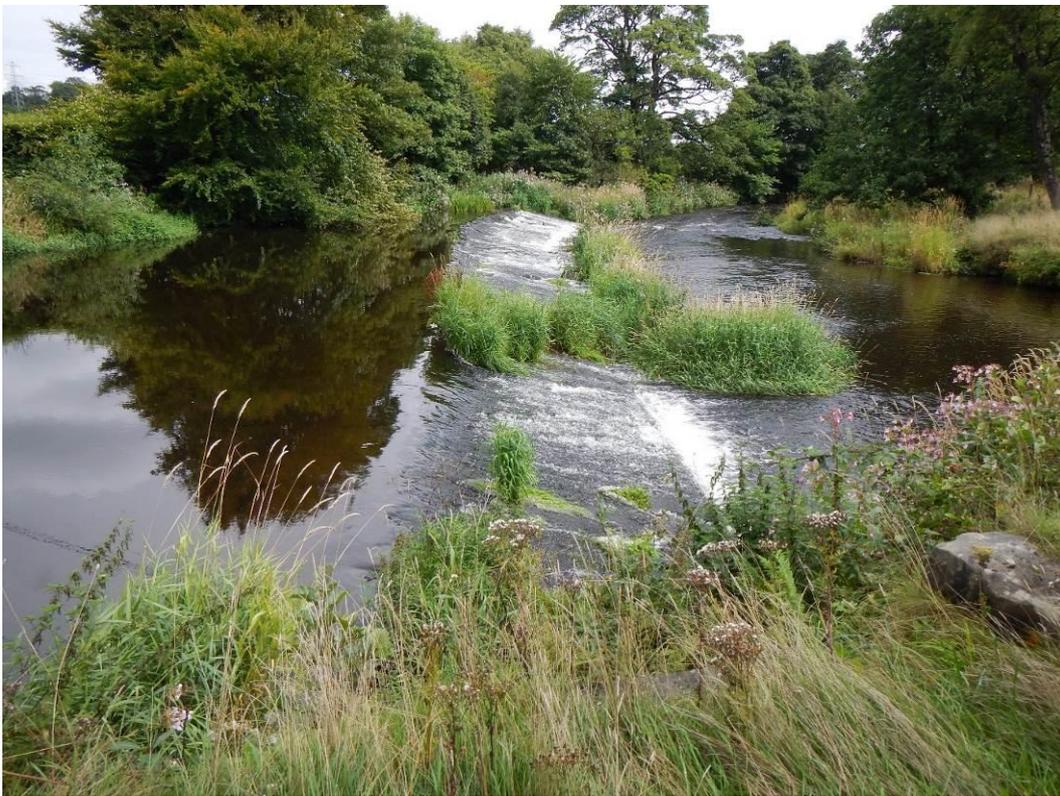
The design of the weir is particularly problematic to fish, owing to the wide span which spreads the available flow thinly, providing little depth and high flow velocities over the steep face. This will inhibit larger fish in low and medium flows but will remain an obstacle even at higher water. Smaller fish will struggle to ascend this in most flow conditions creating the migration, dispersal and recruitment issues discussed previously.

Figure 9. The steep weir face, shallow water and high flow velocities make this weir an obstacle in all flows. Fish will ascend it at certain times of the year, in certain flows, but for how much of the year are fish prevented from moving where they need to?

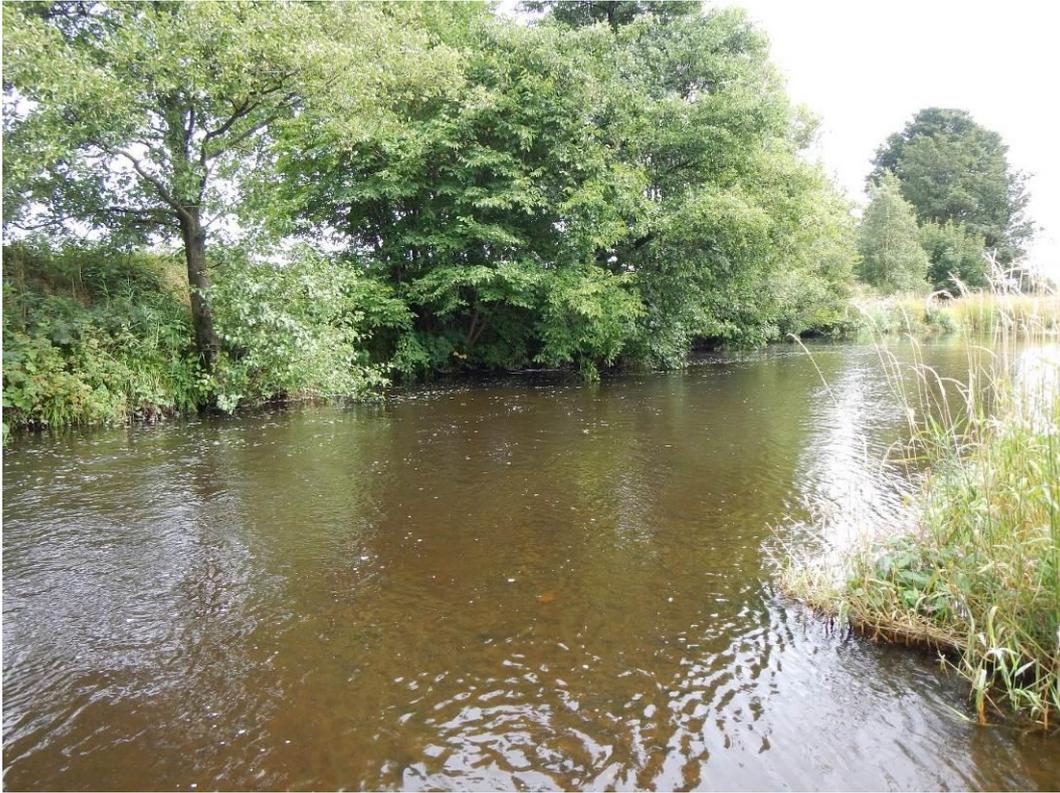
The habitat rapidly improves downstream of the weir and although undoubtedly impacted somewhat by impoundment of sediments u/s of the weir, a more natural pool and riffle sequence is present (Figs 10 & 11). This provides a greater variability in depth, flow and an associated improvement in habitat quality.

Figure 10. Habitat d/s of the weir improves, with the river developing a pool and riffle sequence. Note the valuable low/trailing cover along the far bank.

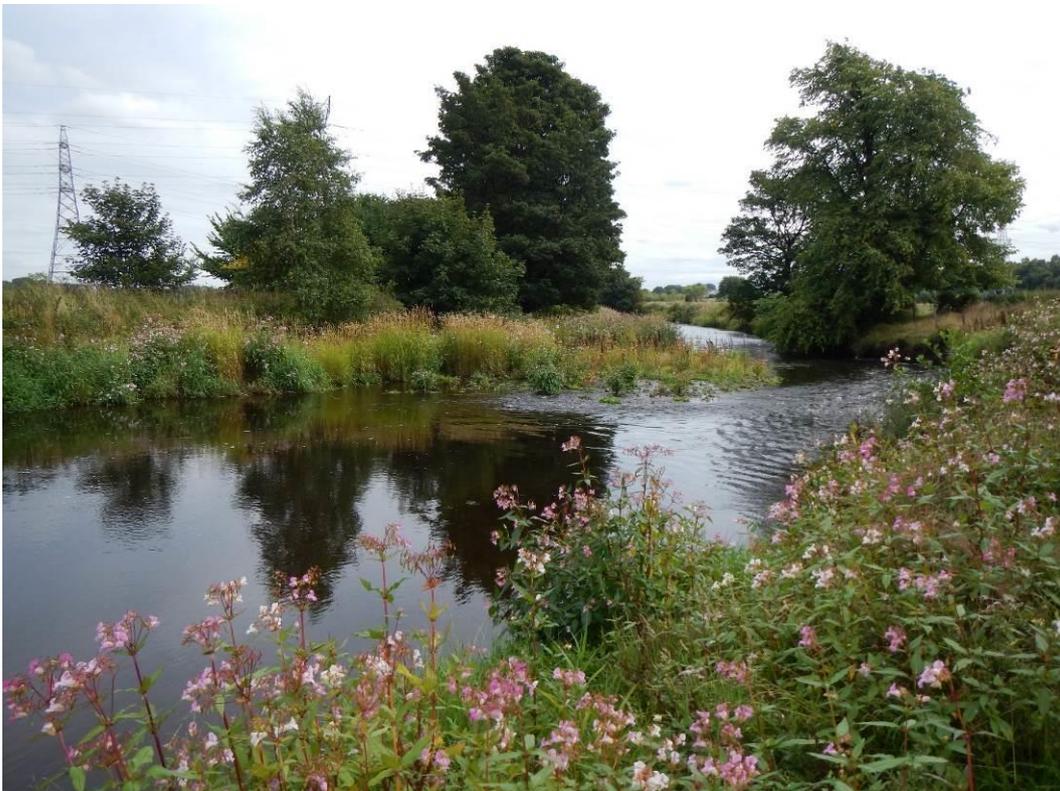
Figure 11. Note how, in the absence of any impounding structures, the bend and associated gravel bar create a valuable riffle and pinch in the channel. This greatly improves flow diversity, accelerating flows into the pool d/s, improving the habitat of the area. Also note the Himalayan balsam in the foreground (pink flowers).

Himalayan balsam plants should be pulled up by hand, cut below the first node (with a strimmer) or treated with herbicide by a licensed operative. It is accepted that the Himalayan balsam issue is rife throughout the areas of the Carron catchment visited but it is not an issue that should be ignored as it will ultimately outcompete most other vegetation. It would be worth collaborating with other river users and catchment stakeholders to identify the u/s extent of the infestation and working gradually d/s through the catchment to eradicate it.

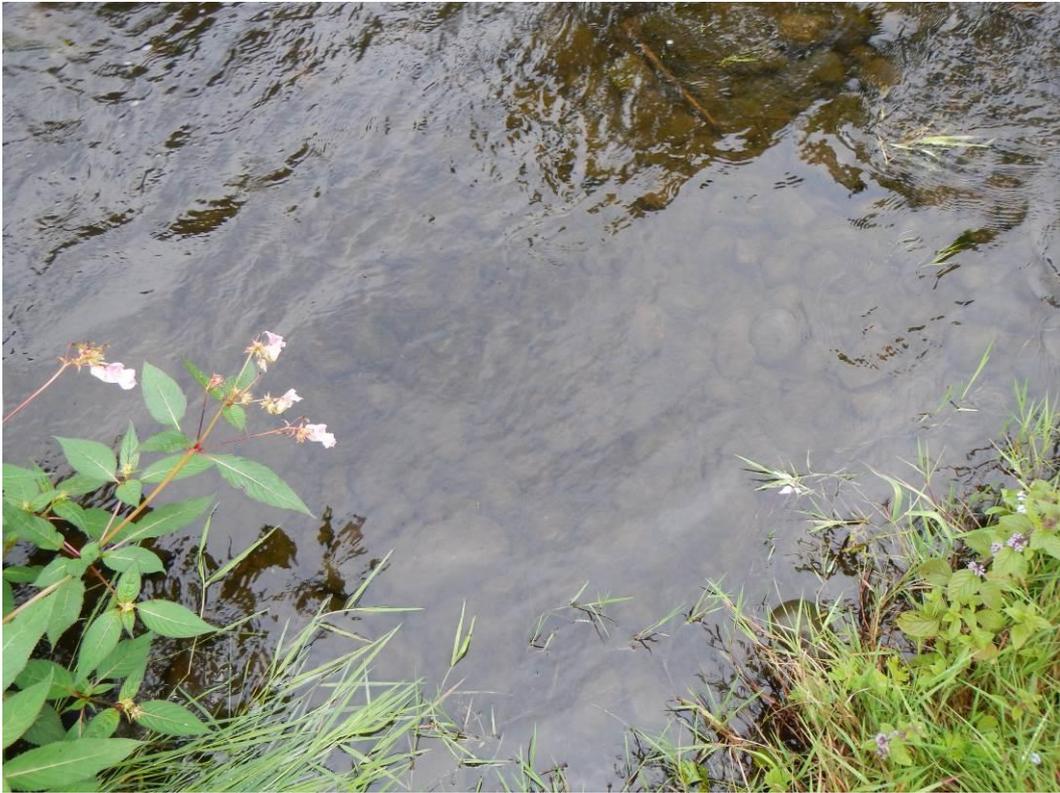
In the area immediately d/s of the weir a strong sewage smell was noted. The source of the smell was investigated but it is likely that there is a discharge somewhere nearby. Inspection of the bed also revealed elevated algal growth which is usually a sign of raised levels of nutrient within a watercourse. Further investigation of the area would be beneficial to try and identify the source of what is likely to be pollution of the river.

Figure 10. Strong sewage smells were noted in the area d/s of the weir and elevated algal growth was observed on the bed.

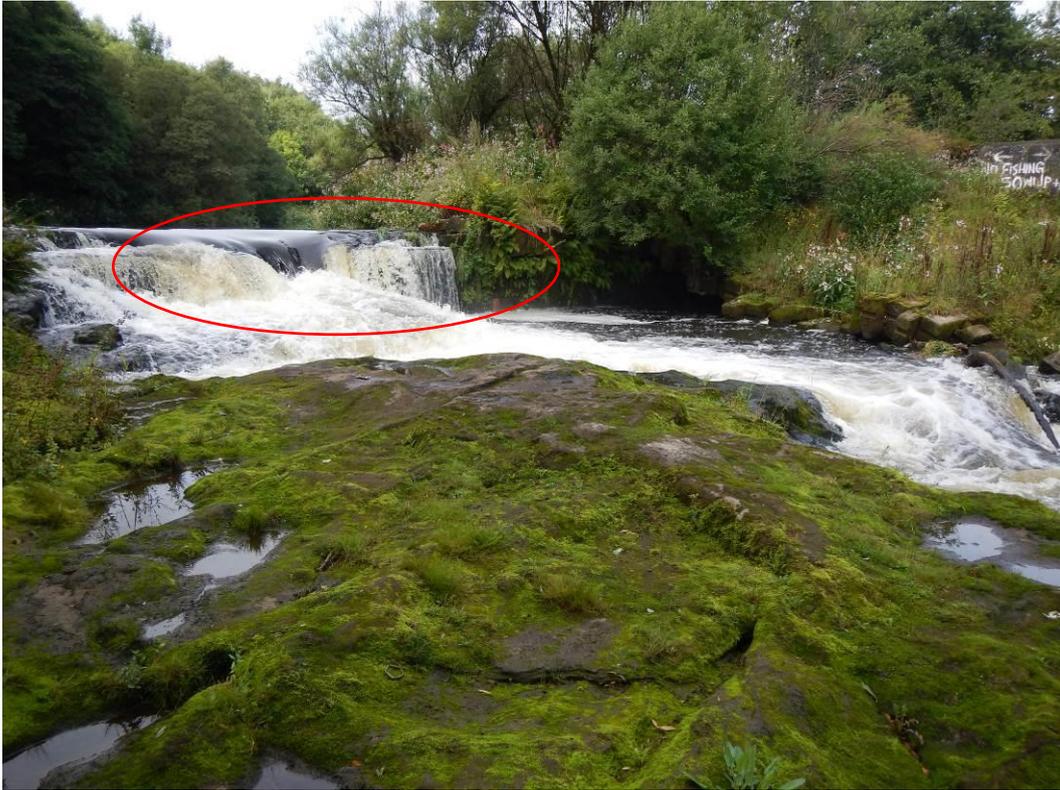
A large weir at an area of bedrock outcrop creates another large obstruction. Slightly elevated water on the day of the visit made it difficult to ascertain what was man-made and what was natural; however, it did appear that a large portion of the upper structure and large step was created by dressed stone blocks, suggesting the greatest impact to be man-made. The straight lines and sharp edges of man-made structures invariably make them more difficult for fish to ascend than even similar sized natural, erratic structures. As the man-made portion of this structure appears no longer to serve any meaningful purpose, its removal could be an easy and significant improvement to habitat quality and fish movement. The obvious bedrock presence in the area should reduce any risks associated with removal.

Figure 11. A natural obstacle that appears to have been made significantly less passable through the installation of a block stone weir (red circle).

The majority of the upper obstruction appears to be created by a large block stone weir on top of a natural bedrock outcrop. The weir appears to serve no present day function and removing the block stones should be investigated as a priority action to greatly improve fish passage.

These weirs should all be removed to allow a natural channel morphology to reinstate, allowing sediment transport through the reaches would also allow scour to create and maintain more natural riverbed features u/s and d/s of the weirs.

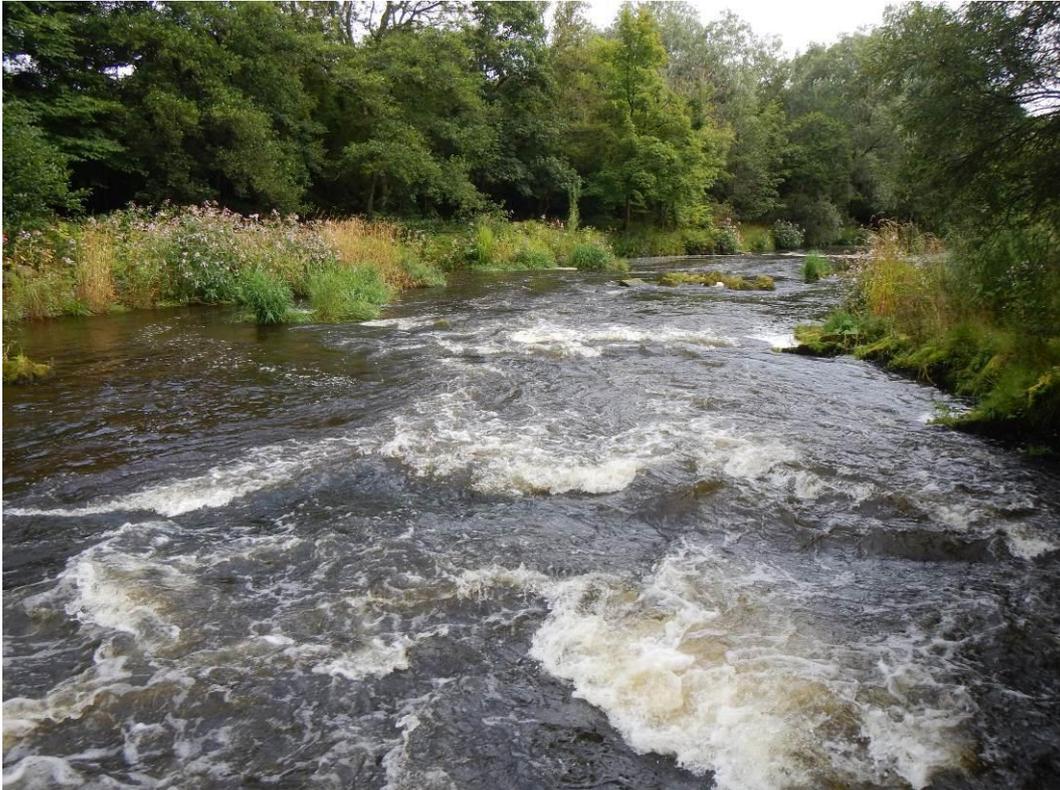
The river continues to flow steeply over bedrock immediately d/s of the weir. This creates a naturally rugged channel which provides chaotic flow and a wide range of salmonid and invertebrate habitat.

Figure 12. The rugged, bedrock channel d/s of the weir creates great habitat diversity for a range of salmonid life stages.

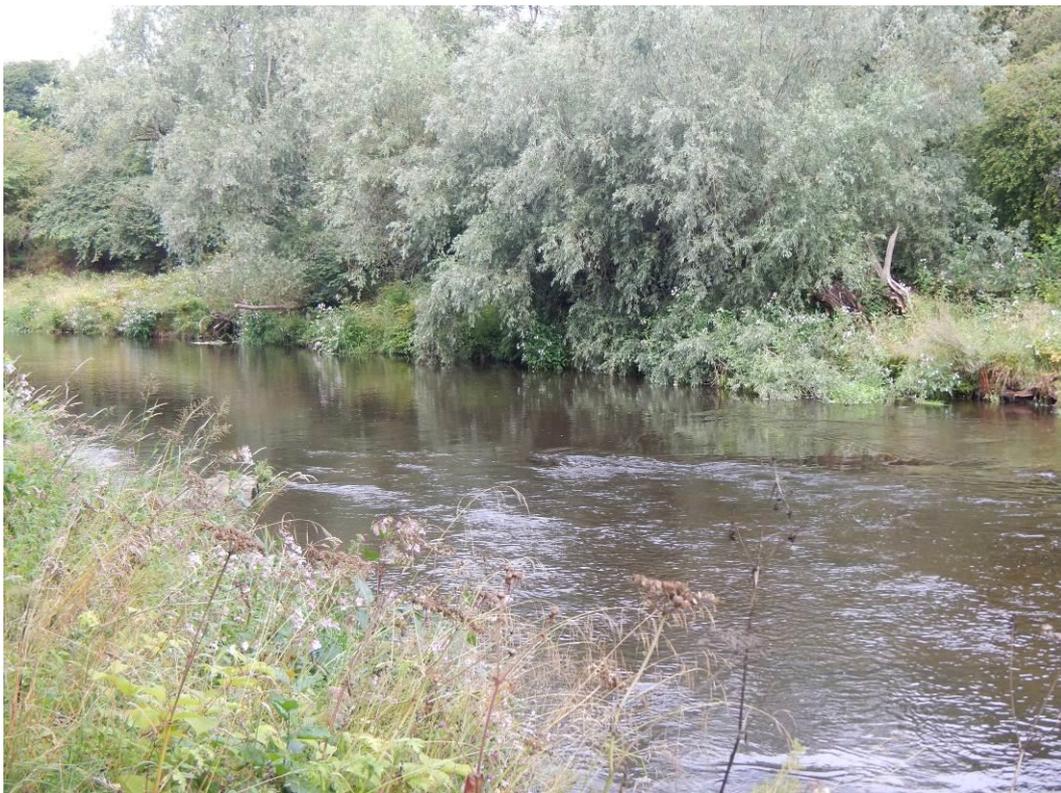
Bankside willows in the area d/s create a valuable addition along the river margins. These trees should be allowed or even encouraged out into the river channel, allowing them to remain there as and when they fall in. Removing them from the channel only serves to denude the river of vital fish-holding features when, if left alone, they will invariably move and adjust on subsequent high flow events, usually swinging in to the bankside or sometimes breaking off to wash d/s to create habitat in other areas. In the process of doing so, new pools and areas of deeper water are also often created by localised bed scour and deposition that will not occur if the tress/branches are simply removed. As such, branches should only be removed or altered if they pose a real (not perceived) flood risk.

Figure 13. Valuable bankside willows. Trees like this should be left wherever possible when they fall into the river, to provide, and help to develop, new habitat features. The perceived, short-term benefit of removing fallen trees is nonsense if the number of fish an area can hold is less without the structure being there. It's far better to simply work out how to fish the area in a different way, taking full advantage of the new habitat and improved fish-holding features.

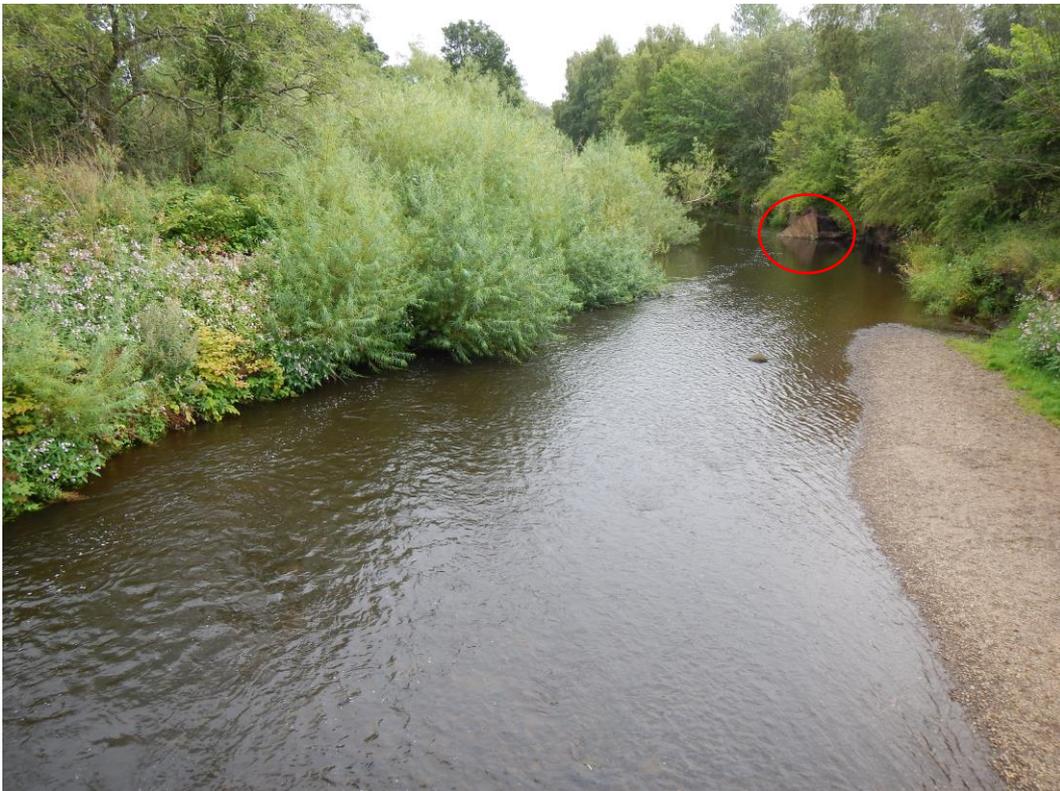
The furthest d/s section of river visited is more lowland in appearance, likely as a consequence of it being in the lower end of the catchment where the valley gradient would be expected to reduce. Where present, bankside willows provide good cover and natural areas of deposition create channel and flow diversity, providing some good habitat and lies for salmonids. Despite this, the channel appears relatively straight (low gradient rivers generally meander more than those on a steep gradient). Inspection of aerial photography identifies an area of ponds/wetlands along the RB side of the river and this may represent the location of a past, more sinuous channel, from which the river naturally migrated or was possibly even realigned. Failing sheet-piling bank protection was also observed on the RB, which appears to be an attempt to prevent the river from migrating into that area.

Figure 14. Faster flow alongside a bank protected by willow roots creates a deeper run along the LB, and provides good habitat. Failing bank protection highlights the rivers migration into the RB (red circle).

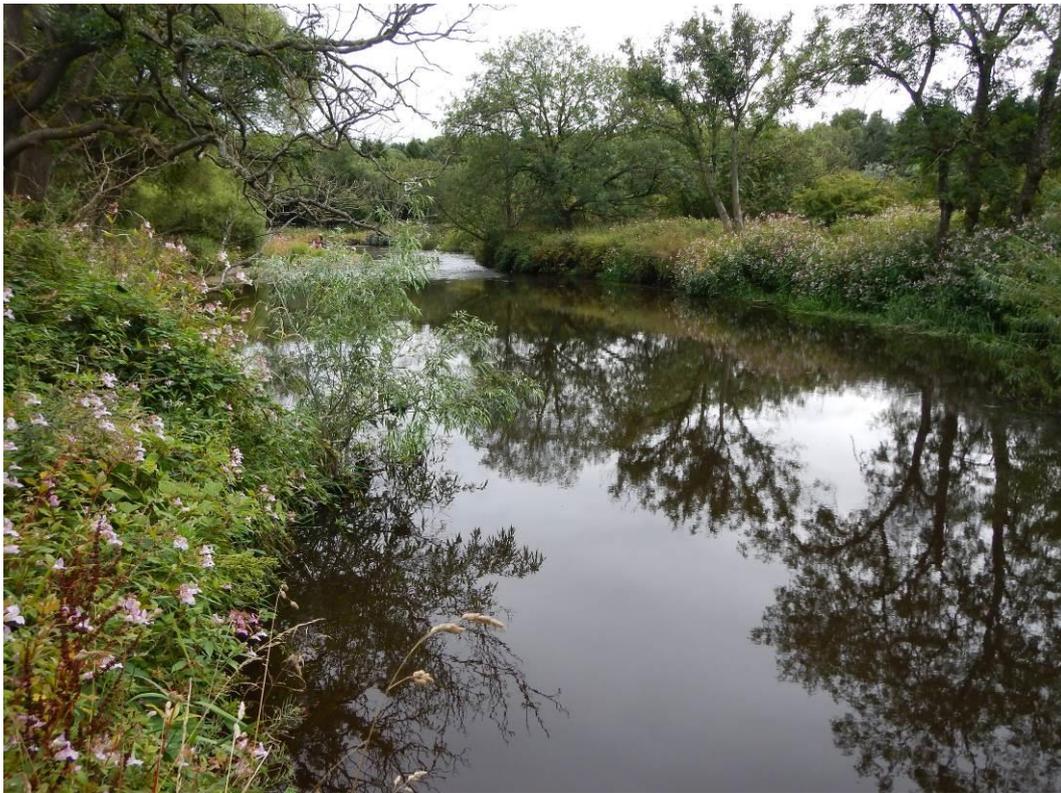
Naturally, larger, slower pools in this area of the river provide good habitat for older salmonids but fish will be heavily reliant upon in-channel structure to protect them from predators and high flows, owing to the large areas of open water (Fig. 15). Bankside shrubs provide valuable fish-holding features and should be retained and promoted. The riffles between the pools in these areas are likely to provide particularly important juvenile and invertebrate habitat owing to the lack of suitability of the larger pools.

Figure 15. The larger pools of the lower river provide habitat for older fish and some juveniles but are also relatively easy hunting grounds for predators. For this reason, the more in-channel structure that can be retained, or even introduced, the better.

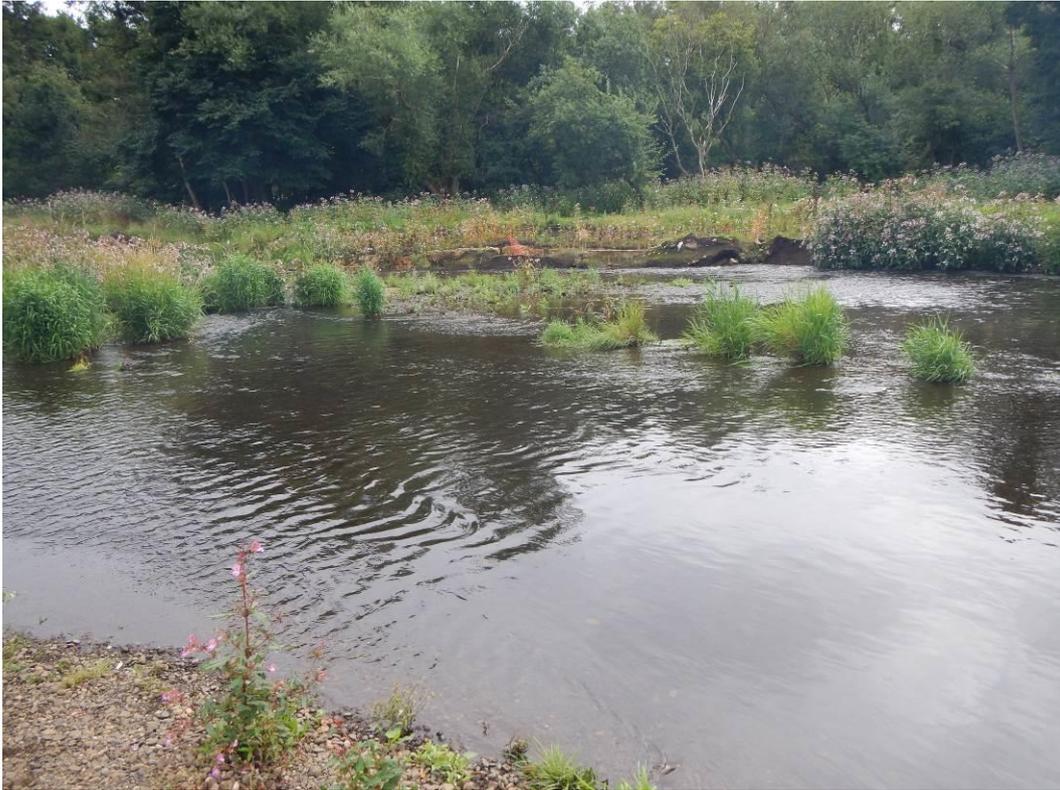
At the furthest d/s area inspected, the remains of some hard structures in the RB are undoubtedly contributing to the issues with bank erosion there. In general, when river banks are in a natural state they are relatively stable, bound together by the roots of bankside vegetation and trees and protected by their foliage. The diffuse nature of foliage further dissipates the erosive energy of high flows and protects the surface of the bank. However, hard structures placed along or installed into a bank, prevent colonisation of that bank with diverse root matrices and provide no dissipation of flow energy. This means that any flow hitting the hard structures is simply deflected onto other areas where the erosive forces are then even greater. The issues in this area are further exacerbated by Himalayan balsam which grows fast, out-competes and shades-out the more beneficial native vegetation, only to die-off in the winter leaving un-vegetated banks that are even more susceptible to erosion. It is not known what the purpose of the hard structures is but as the issue only affects a short section of bank it is not considered to be a major issue for LASAC.

Figure 16. An area of erosion on the RB is being exacerbated by the presence of hard structures and Himalayan balsam.

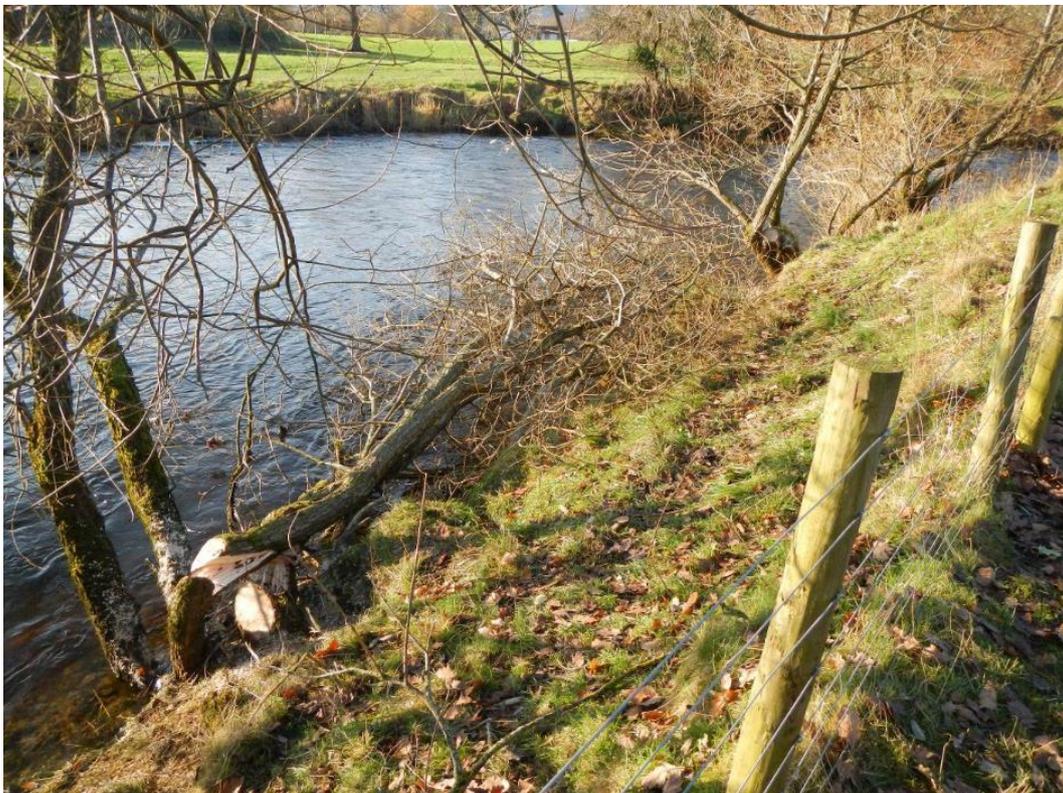
Figure 17. Willow hinged into the river margin to increase cover and structure

Being fast growing, willow can even be strategically planted in areas lacking low/trailing cover in anticipation of laying them into the channel once they become established. Laying involves cutting part way through the branch, quickly through the first two thirds, then continuing until it collapses down over the river (Fig. 19). The depth of the cut should be limited to only that which is required to bend the limb over, as this will maintain maximum size and strength of the hinge and the health of the tree/shrub.
