**Advisory Visit
River Derwent
(River Tyne Catchment)**

Undertaken by Gareth Pedley (WTT)

This report is the output of a visit to Axwell Park and Derwent Valley Angling Association's (APDVAA) section of the River Derwent in Tyne and Wear, on the 16th January 2019. The visit was requested by the association to provide an independent perspective on ways to developed to improve the river for wild fish.

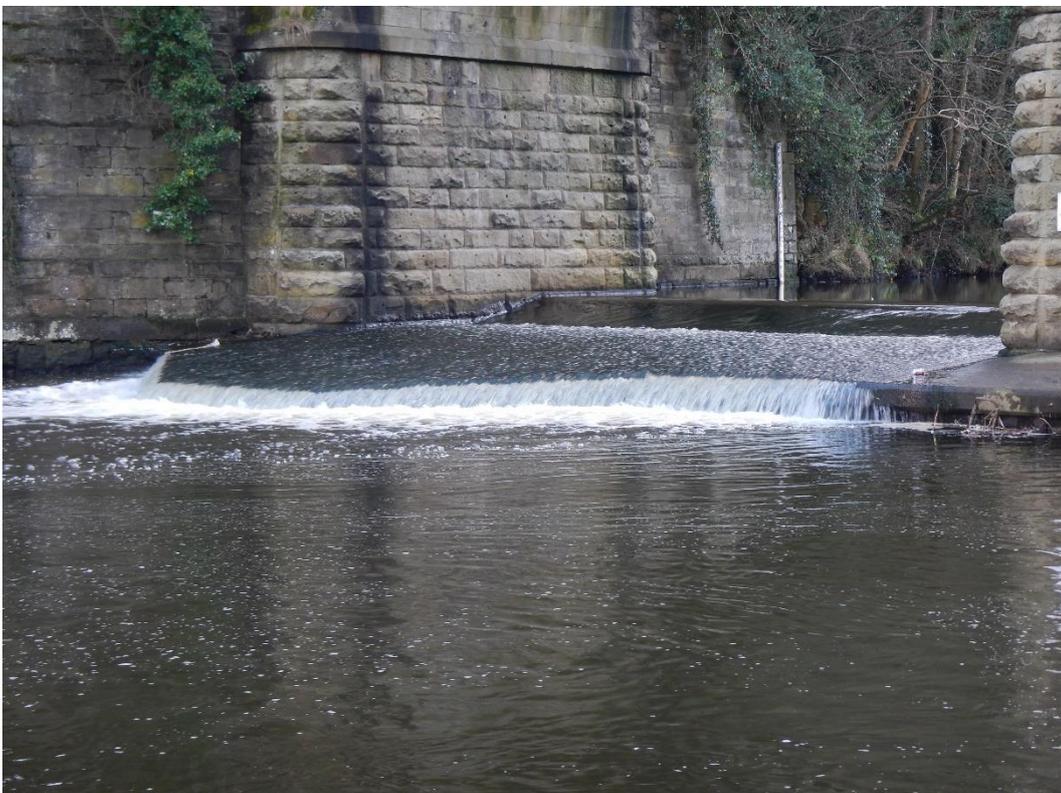
At the upstream extent inspected, the raised footings of Burnopfield Road bridge create an obstruction to fish passage (Fig. 1). The step into shallow water over an angled apron greatly reduces passability and the obstruction is made worse by the additional steeper crump flow gauging weir on top. This creates a barrier to smaller fish in most flows and both a physical and behavioural deterrent to larger fish in low and medium flows.

Figure 1. Bridge footings and gauging weir at the upstream end of the river reach inspected. The step into shallow water over an angled apron greatly reduces its passability. The obstruction is made worse by the additional steeper crump on top of the footings.

Ideally, the bridge footing would be removed down to bed level, although this is unlikely to be possible owing to the dependent infrastructure. Even lowering the crump weir on top of the footings would be a significant improvement.

At many sites around the country, a stable bed cross-section is sufficient to provide the accuracy of flow monitoring that is actually required, be that level data, or more accurate acoustic flow monitoring. Alternative monitoring options for the site may therefore allow the crump to be removed and the obstruction reduced, ideally in conjunction with a fish pass or easement. The potential for this should therefore be investigated with the Environment Agency who gauge flow at the site.

In the short-term, less effective but potentially achievable options are likely to include:

- A rock ramp easement
- Installing baffles to retain water depth and create an easier swim across the apron.
- Installing an adherent nappe to the step at the downstream end to provide swim-through conditions onto the apron (i.e. no jump required)

These options would work in conjunction with removal of the crump.

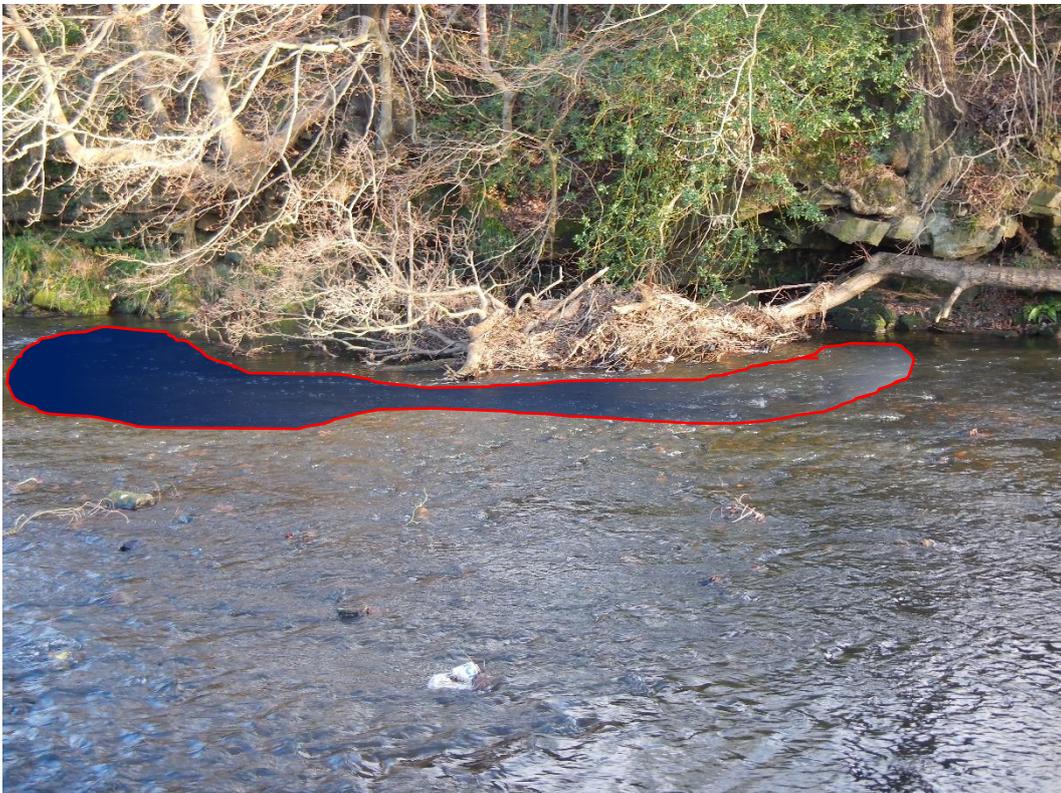
A fallen tree along the RB greatly increases habitat variability and fish-holding potential (Fig. 2). By taking up a small amount of channel capacity locally, the structure deflects flow down into the bed, scouring a deeper pool that runs along the front, side and behind of the branch. As well as creating depth, that scour helps sort the bed material as flow will carry smaller particles further than large ones, effectively grading them along the riverbed. A regular occurrence of this sorting along a river's length liberates fine sediment from the bed and helps to maintain free gaps between the gravel that allow flow-through of water and provide good quality habitat for invertebrates and salmonid egg incubation.

Figure 2. Valuable bed scour and substrate sorting diversifies an area of shallow juvenile salmonid habitat so that larger adult fish can now also hold in the deeper water created along the far bank side.

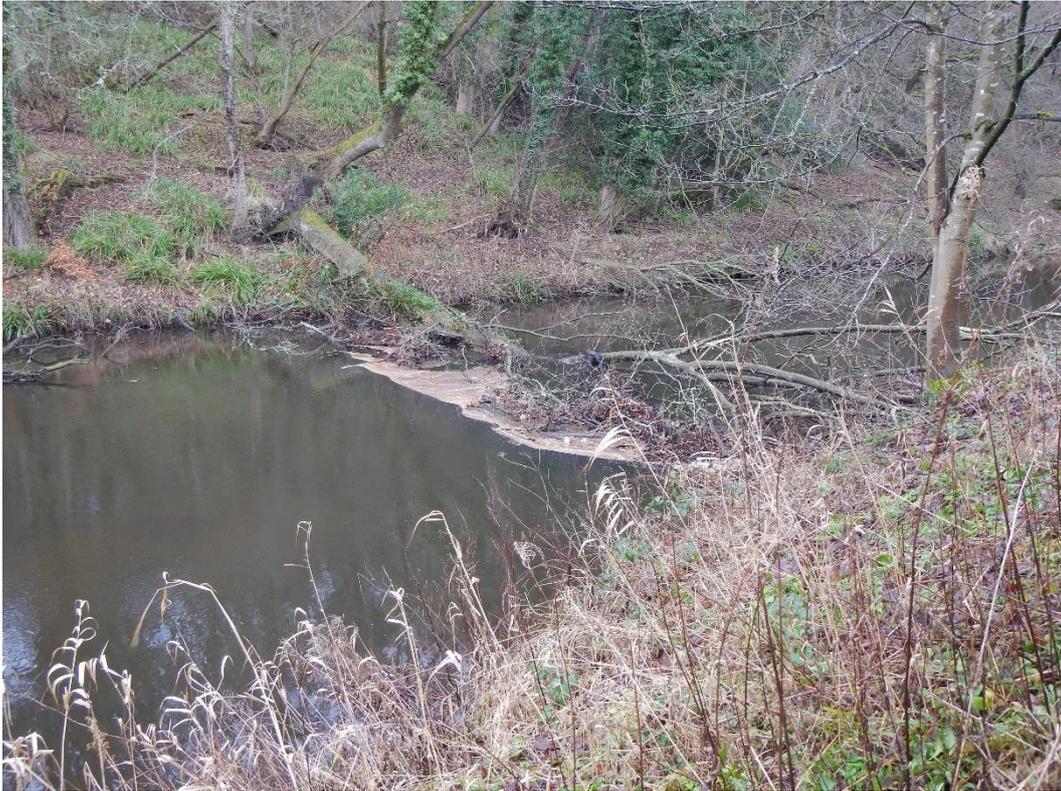
Further downstream, another great example of in-channel woody material is provided where a beech tree has fallen across the channel (Fig. 3). Often, there is a desire to remove or adjust these features, but the first thought should always be whether it can just be left *in situ* as a perfectly natural habitat enhancement. The cover and shelter provided greatly benefits fish, affording the protection from cormorants, goosander and other predators that is so often lacking (because it's usually removed or altered!). Located in such a wide channel, and with lack of infrastructure nearby, the risks of retaining the structure are minimal, especially as it still appears to be connected at the root and may even continue to grow.

Leaving the tree in place has the potential to improve channel morphology locally, as high flows deflected under the structure are likely to scour the bed to develop a deeper pool. As debris collects against the tree the cover provided will increase and on a channel this size, the potential for blocking fish passage is negligible. Should it begin to retain too much debris, the increasing weight of water building upstream should simply swing the tree round to lie along the bank anyway (anchored by the root and/or heavy rootball). Removing or even altering such structures is therefore seldom productive unless they are in a very high flood risk area, which this isn't.

Figure 3. A fallen beech tree provides a great natural habitat enhancement within a relatively open pool. This structure offers much needed shelter from predators, with the potentially benefit of developing new features within the bed of the pool.

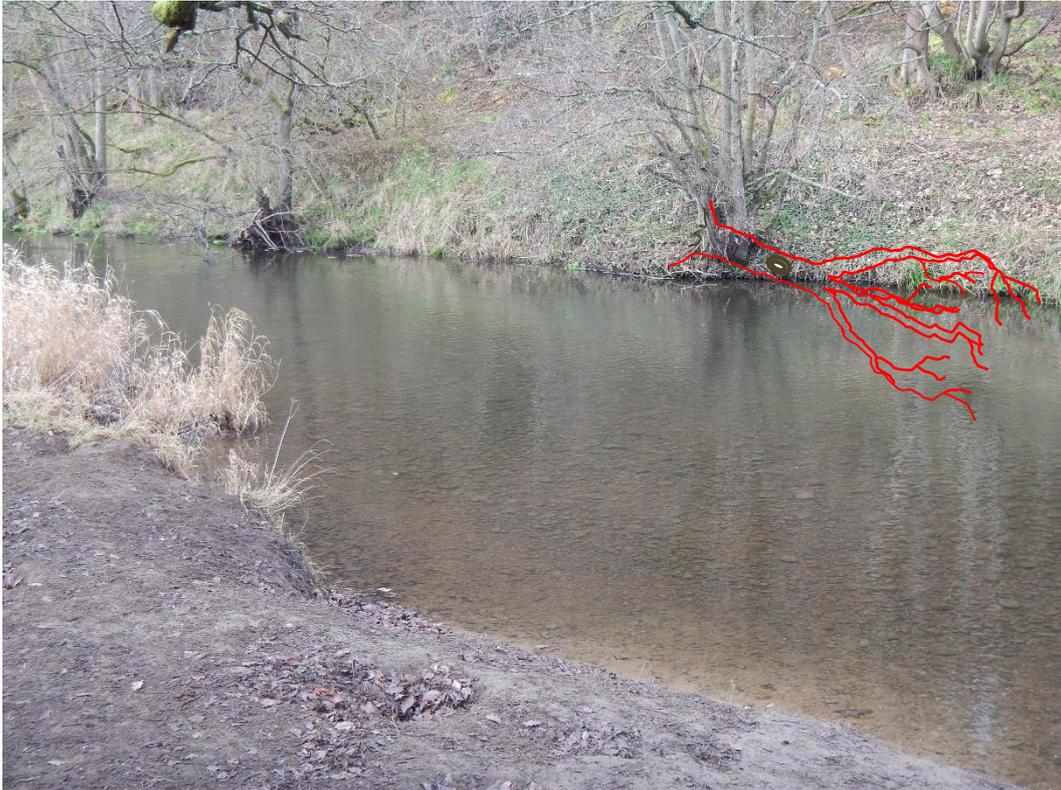
In contrast to the high value habitat created by the fallen tree, the next pool downstream is relatively open, lacking structure and flow diversity (Fig. 4). Bankside trees and their roots provide some habitat diversity that will hold fish, but the area would be enhanced by additional in-channel structure that would undoubtedly increase its fish-holding capacity, along with its interest for anglers.

Figure 4. A wide, relatively open pool that is lacking structure and flow diversity. Although it undoubtedly holds fish, providing additional in-channel structure would increase its appeal to fish and anglers alike. Where multiple tree trunks are in close proximity, they provide an excellent anchor for natural, lodged woody material or tethering a tree kicker (see **5.0 Recommendations**).

Either of these techniques would work well for the location shown in Fig. 4, to increase the availability of structure within the pool without the requirement for additional fixings. The multi-stem alder trees would provide an ideal anchor point.

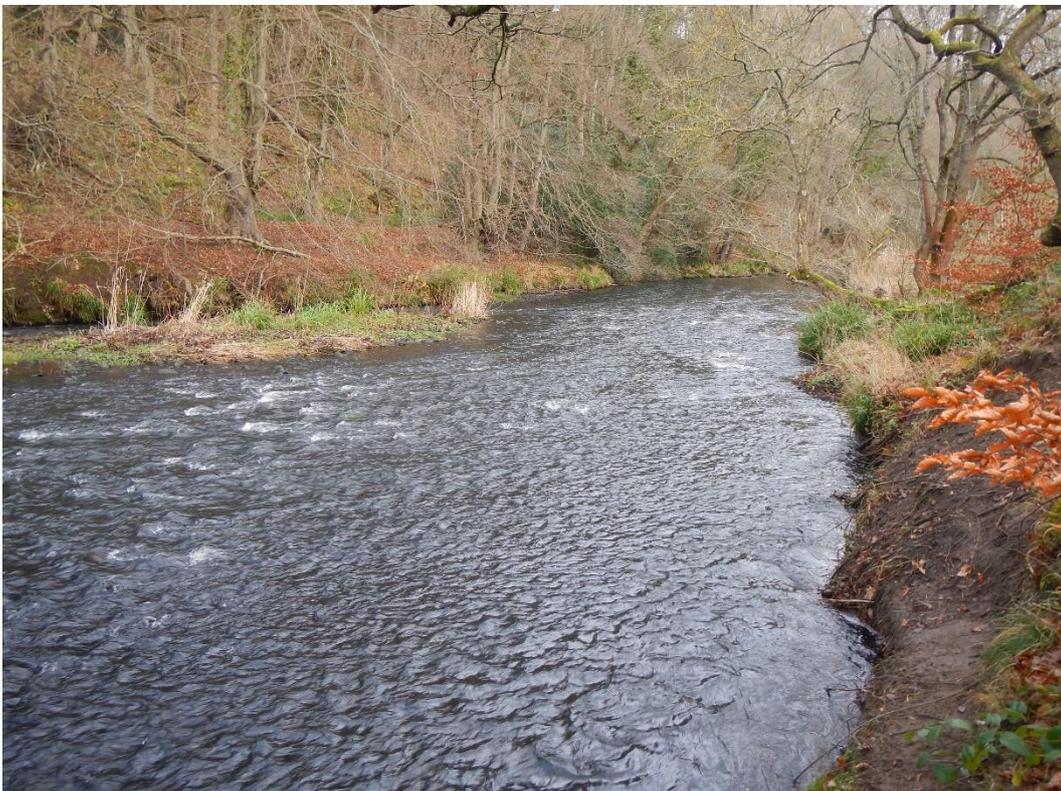
The pools are interspersed with areas of high quality juvenile salmonid habitat, with quite small gravels observed in the wider areas, suitable for small resident trout and grayling spawning (Fig. 5). Such areas are a great asset, especially with the impeded fish passage upstream. However, a high loading of fine sediment was also apparent among the gravel. This suggests elevated inputs further upstream which should be addressed. More locally, trampling denudes the banks and river margin of vegetation, with the lack of root structure to bind the banks increasing erosion rates and fine sediment input.

Figure 5. High quality riffle habitat that will support a range of juvenile salmonids and invertebrates. The slower flowing margins retain gravels that are suitable for smaller resident trout and grayling spawning, however, fine sediment loading limits their potential. Also note the bare, eroding banks as a result of dog and human access.

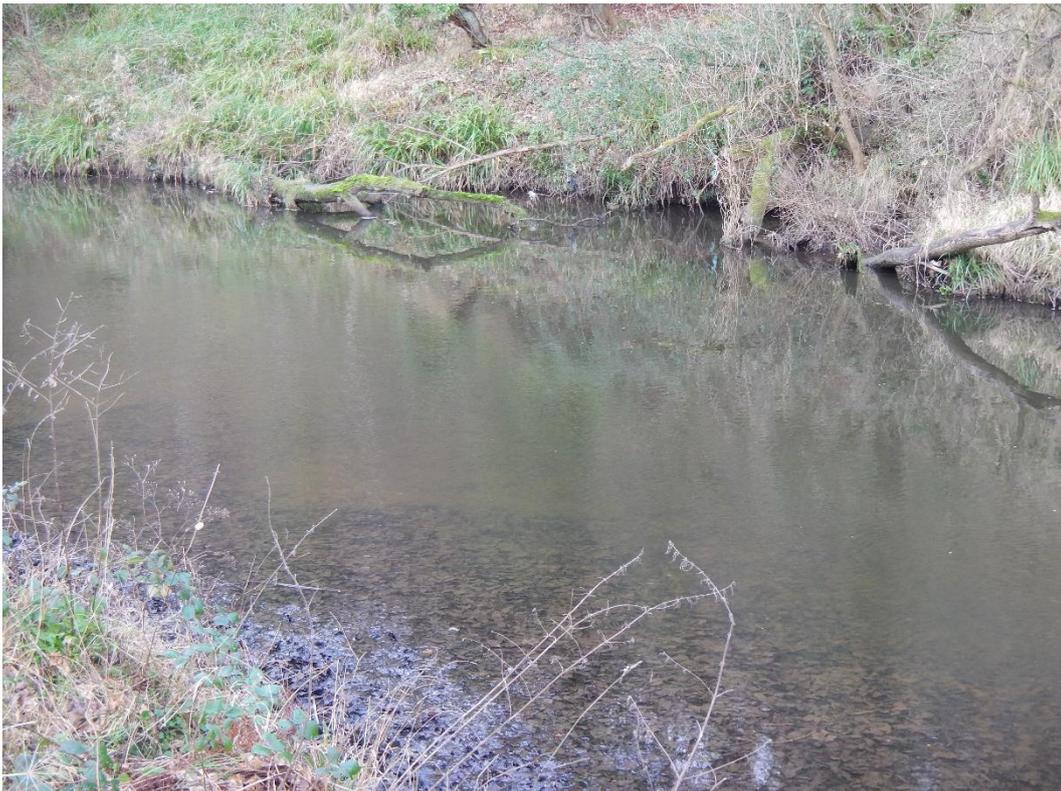
Progressing downstream, the river becomes impounded by the remains of an old weir structure and flow diversity decreases. Woody material (Fig. 6) and overhanging and trailing trees (Fig. 7) provide some fish-holding features within the impounded reach but without the impoundment, a more natural flow regime and morphology would provide higher quality habitat, with more discrete pool and riffle habitat.

Figure 6. The remains of old tree trunks protruding into the channel create some cover and flow diversity, and are an enhancement to the impounded section, although the advanced state of decay means that these structures provide less fish-holding benefit than they once did. Decomposing branches do however provide valuable habitat and food for a range of detritivorous invertebrates as they degrade.

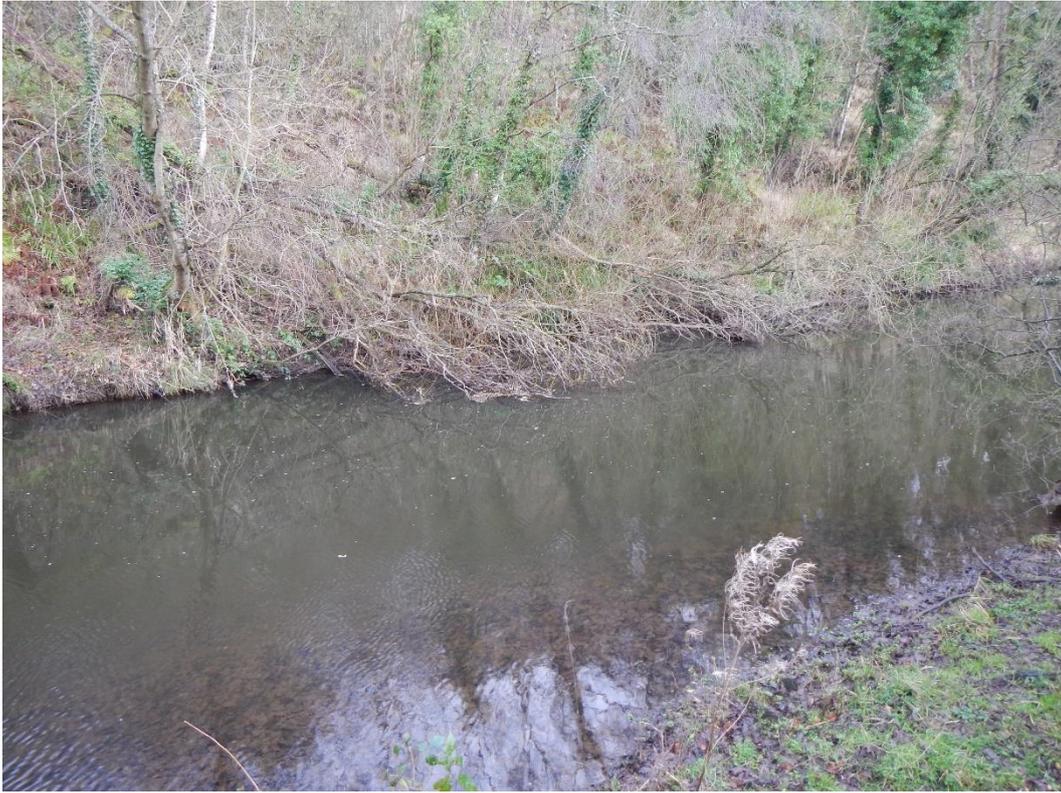
Figure 7. Overhanging and trailing branches provide valuable habitat improvements within the impounded river section.

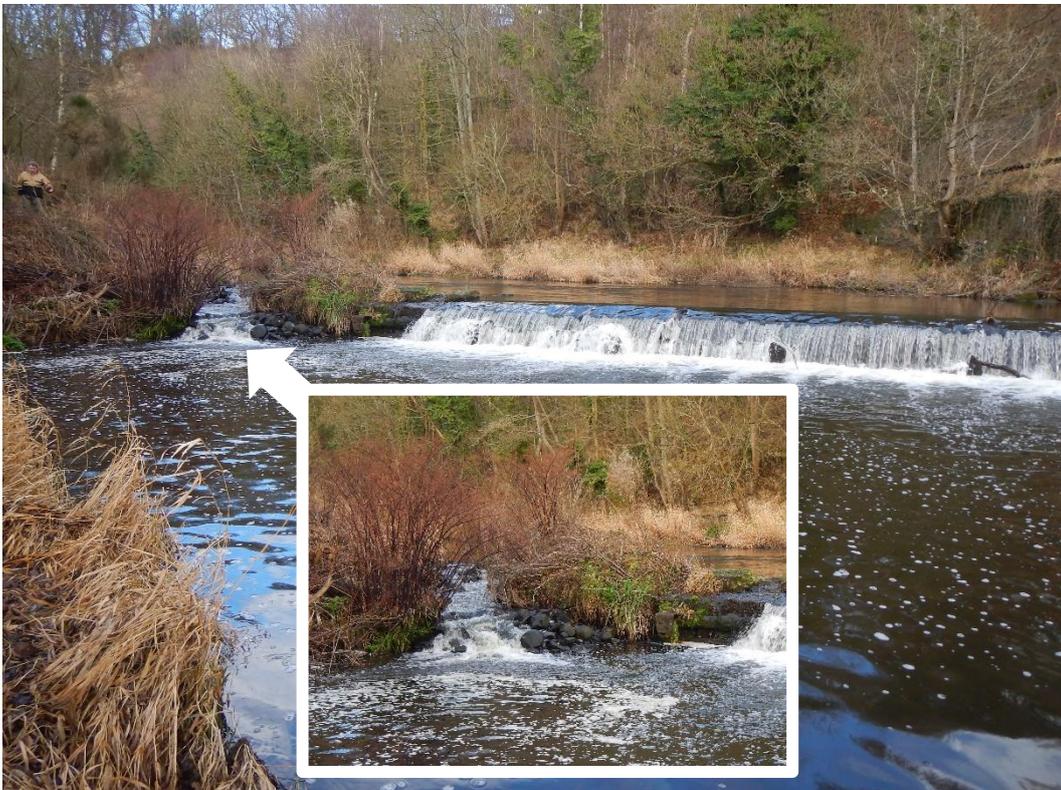
The weir has been eased for fish passage with the creation of a small channel along the RB side, which does improve fish passage. Maintaining this channel at a gradual gradient would improve its passability further (Fig. 8). This work could easily be undertaken as a work party, rearranging the substrate with hand tools.

The easement is clearly an improvement, but it is by no means the ideal solution. Weirs are incredibly damaging to river morphology and ecology, with far too many redundant structures being unnecessarily retained through a lack of regard for the habitat they degrade. All too often, words like heritage and aesthetics are used in arguments to preserve these man-made impacts, with minimal consideration of the natural heritage and aesthetics they degrade.

Figure 8. The now redundant weir has been eased for fish passage, but this still a poor second to removal of at least a significant portion of the weir. Both flows and channel morphology upstream remain impacted, as does the ease of fish movement. Adjusting some of the coarse material at the downstream end of the easement would improve its passability but the whole weir structure should ideally be removed.

Ideally, this redundant structure should be removed to reinstate a more natural channel. Removing a large portion of the structure (at least equal to the natural channel capacity) would be the next best option. In the meantime, it should be ensured that the easement to the RB side of the weir is maintained to as low a gradient as possible.

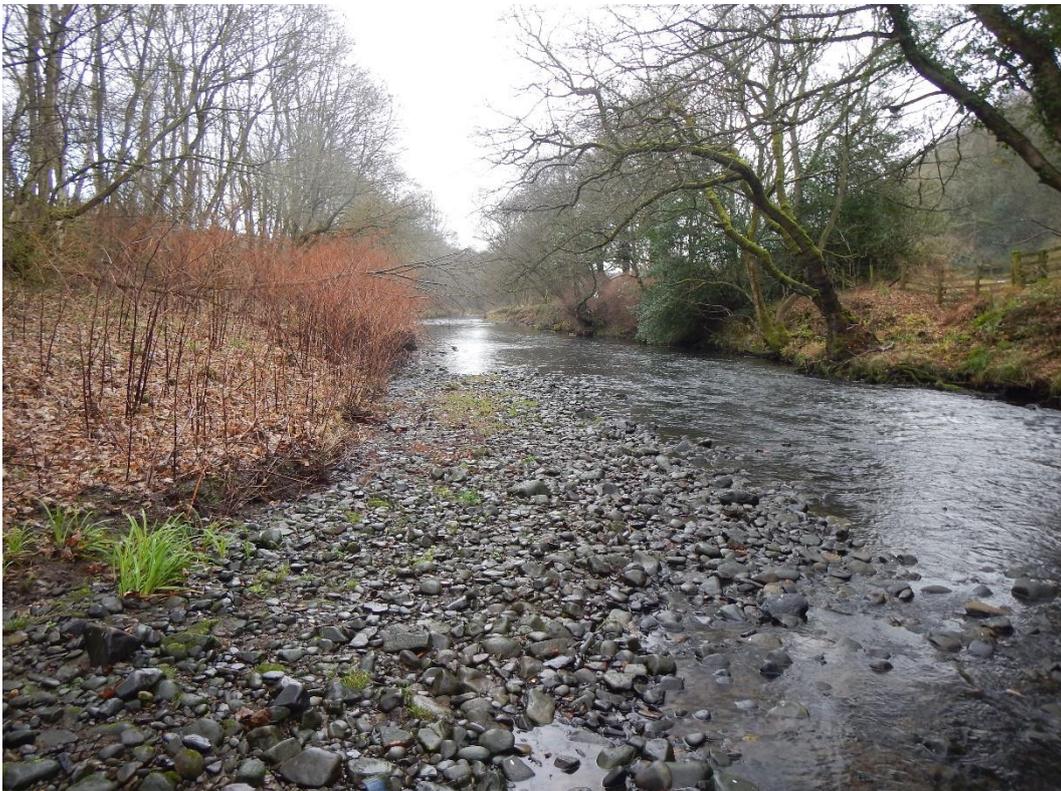
Japanese knotweed was observed in several locations throughout the walkover and those infestations should be addressed (Fig. 9). Being a particularly fast-growing and invasive, non-native species, knotweed invariably out-competes our native plants. This eventually leads to a monoculture of knotweed that dies back in the winter to leave poorly consolidated and protected banks. At low levels the issues are less obvious but as knotweed begins to dominate the banks, severe erosion issues will ensue.

Figure 9. Good flow diversity and basic habitat, if lacking a little in-channel structure and cover. The shallow nature of the reach is no issue for wild fish populations which will grow to a size and abundance suitable to the available habitat and can therefore be increased through habitat improvements. Also note the Japanese knotweed to the left of shot. This should be addressed as a priority before the infestation becomes worse.

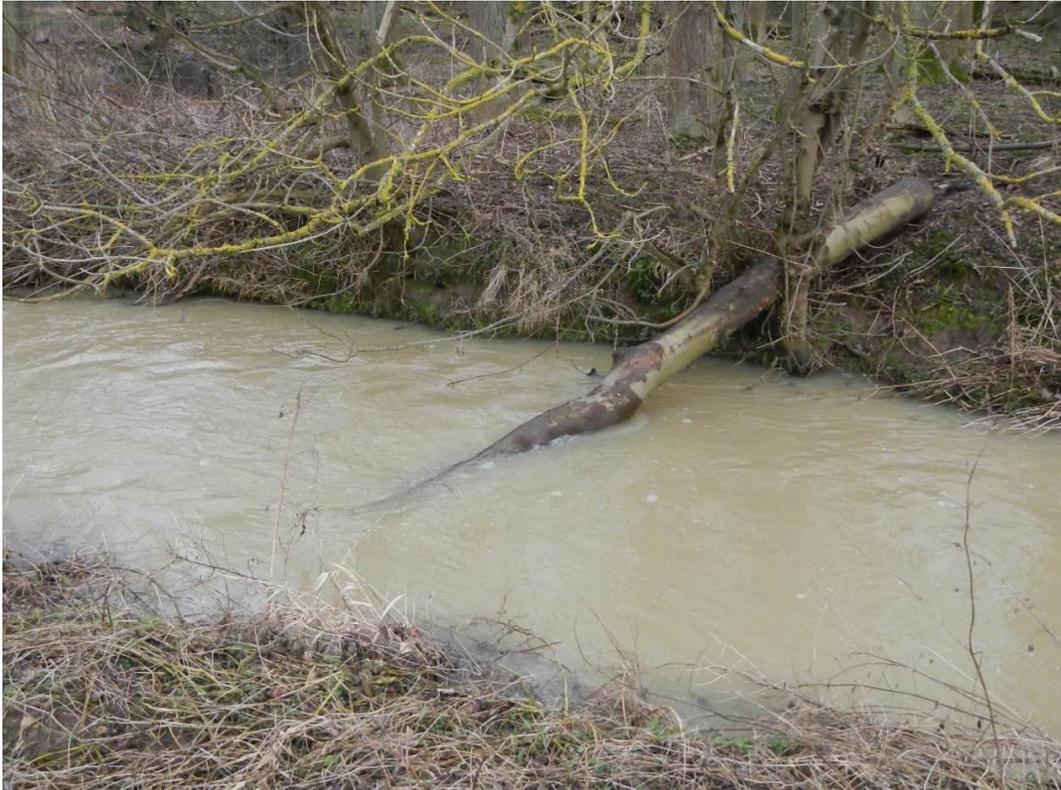
The process involves cutting the desired length of tree or branch (ideally from a species that coppices well, so as not to kill the stump) and lodging it between two or more closely adjacent bankside trees. Figure 10 depicts the technique with a single stem flow deflector that has been winched between two trees. The leverage of the flow against the deflector securely locks it in place against the upright trunks (where multiple stem trees are present additional points of contact can be made). This technique simply mimics the natural and regular occurrence of trees or limbs falling between standing stems/trunks, where the structure will invariably remain in place until it disintegrates.

Figure 10. A lodged flow deflector – the technique can be used with a single pole (primarily to increase scour) or a branched limb (to create greater flow dissipation). The elevated butt end (bank end) reduces the potential detrimental bank scour usually associated with d/s deflectors as a through-flow is maintained along the bank.

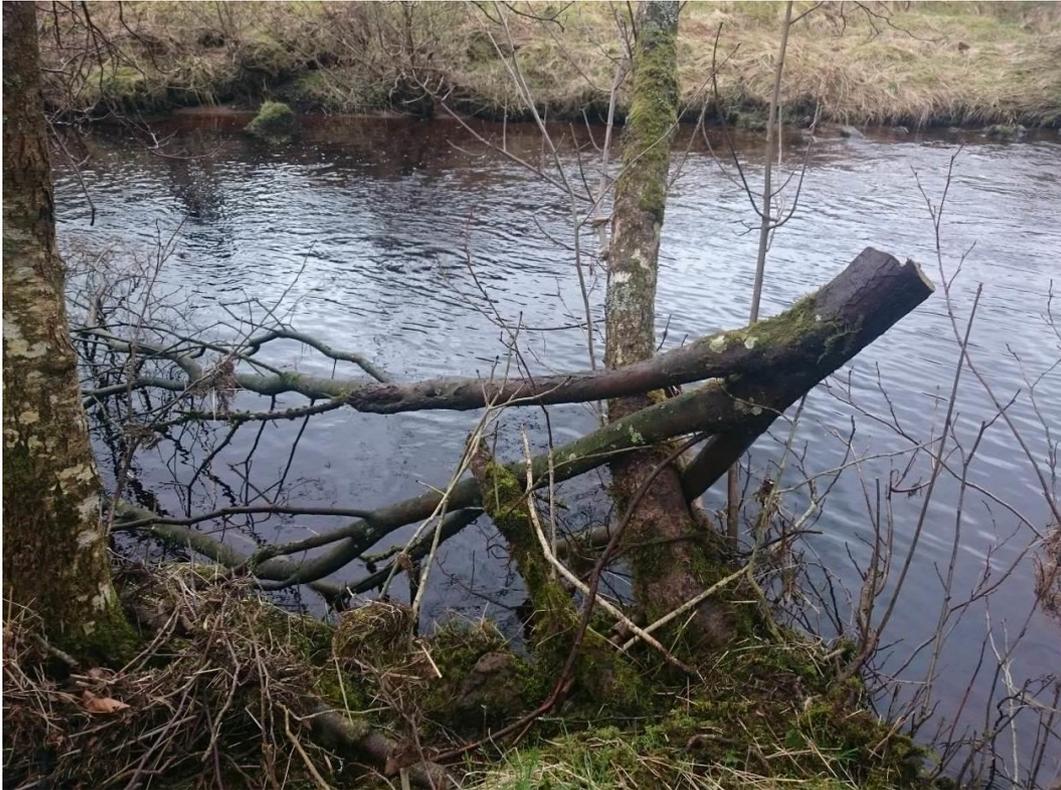
The alternative lodged flow deflector method is equally simple but relies upon a deflector with multiple branches and simply involves hooking one of the branches around an upright tree (Fig. 11). The example uses a medium sized branch, but any size of branch or tree can be employed providing the anchor tree is stable and of sufficient size. A winch can be used to manoeuvre larger deflectors.

Figure 11. A medium sized piece of lodged woody material which is securely anchored in place against an upright tree to provide cover and structure within a pool.

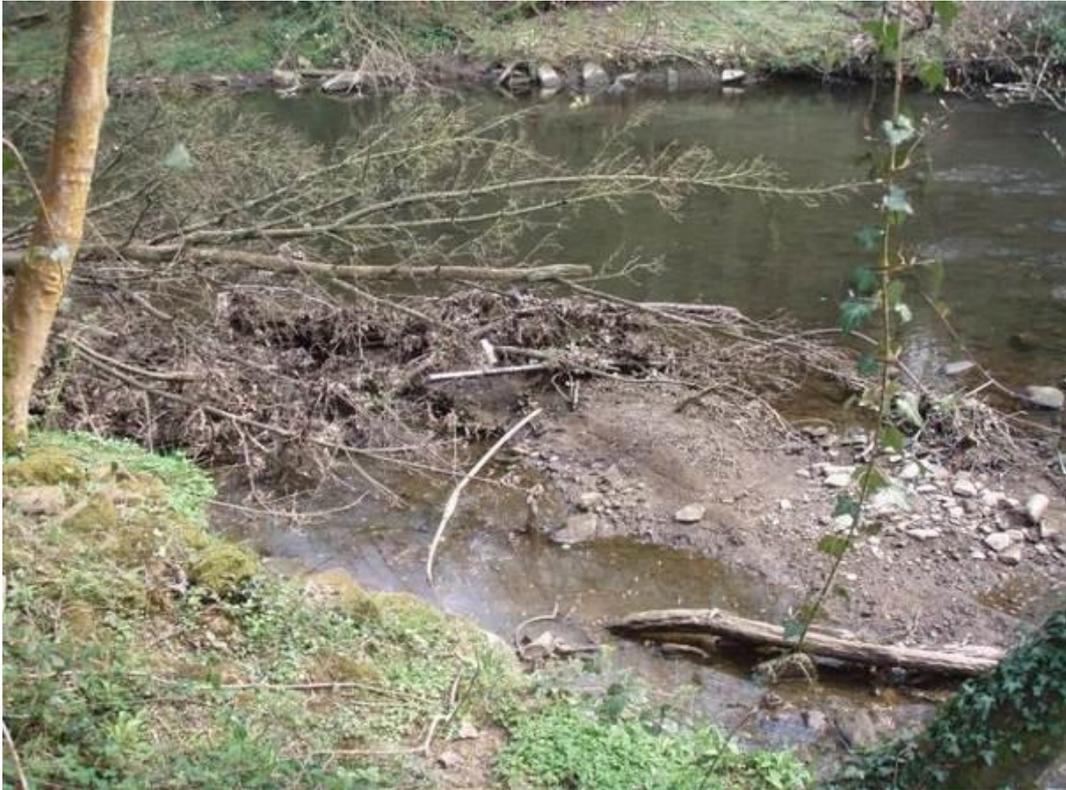
Woody material can also be secured within the channel as a tree kicker (Fig. 12). The technique is slightly less natural but mimics natural features by cabling an appropriately sized tree/shrub to its own or an adjacent stump/tree (Fig. 13).

Figure 12. A perfect example of how a tree kicker can be employed to diversify flow and increase deposition in the river margin that further focusses flow down the far side of the channel. A similar effect can be achieved with the use of lodged woody material.

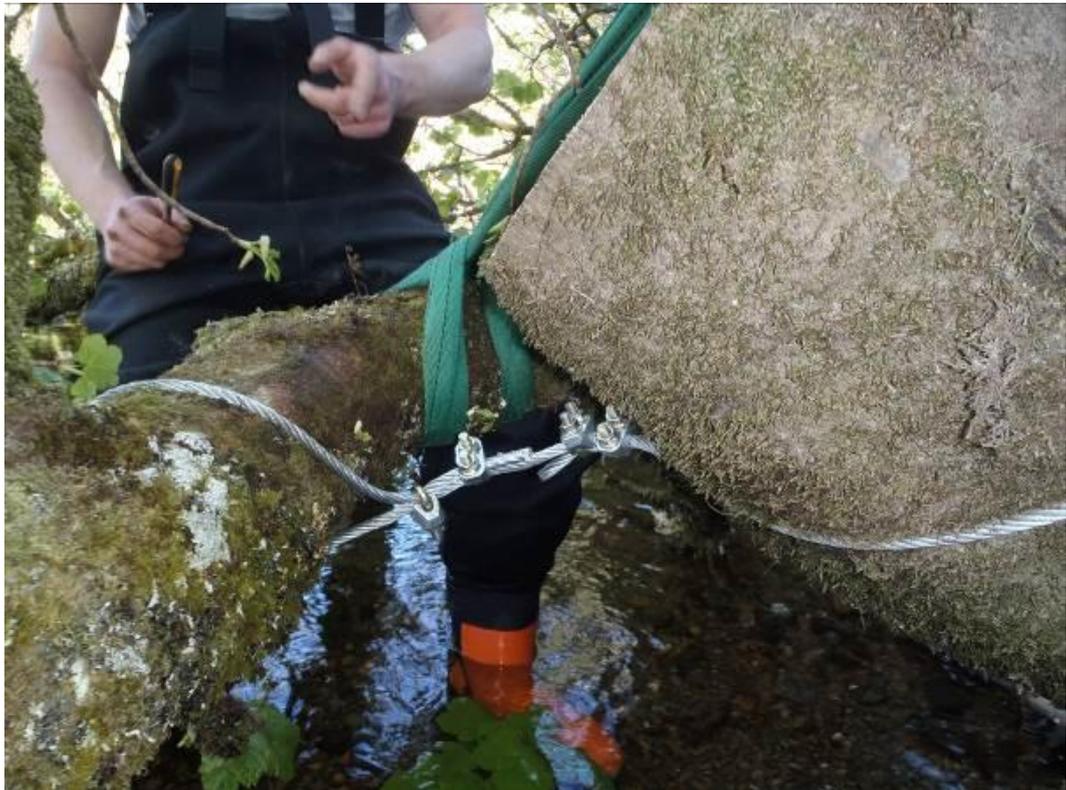
If diffuse branches are employed, sediment deposition in and around the limbs will further secure the structure in place as the lower parts become buried (as is occurring in Fig. 12). The orientation of the structure and its streamlined shape, with the tree butt upstream, means that once it is partially submerged and high flows are passing over it, the structure will be forced in a d/s direction, but also downward towards the bed, further securing it in place.

Figure 13. A basic tree kicker cable setup using 4000 kg breaking strain cable and two sets of cable clamps. The webbing strap in the background is used to pull the kicker close to the stump for fastening but is removed once the cable is fully fixed in place.
