Advisory Visit
River Gryfe (Gryffe)
03/07/2018

Undertaken by Gareth Pedley – gpedley@wildtrout.org

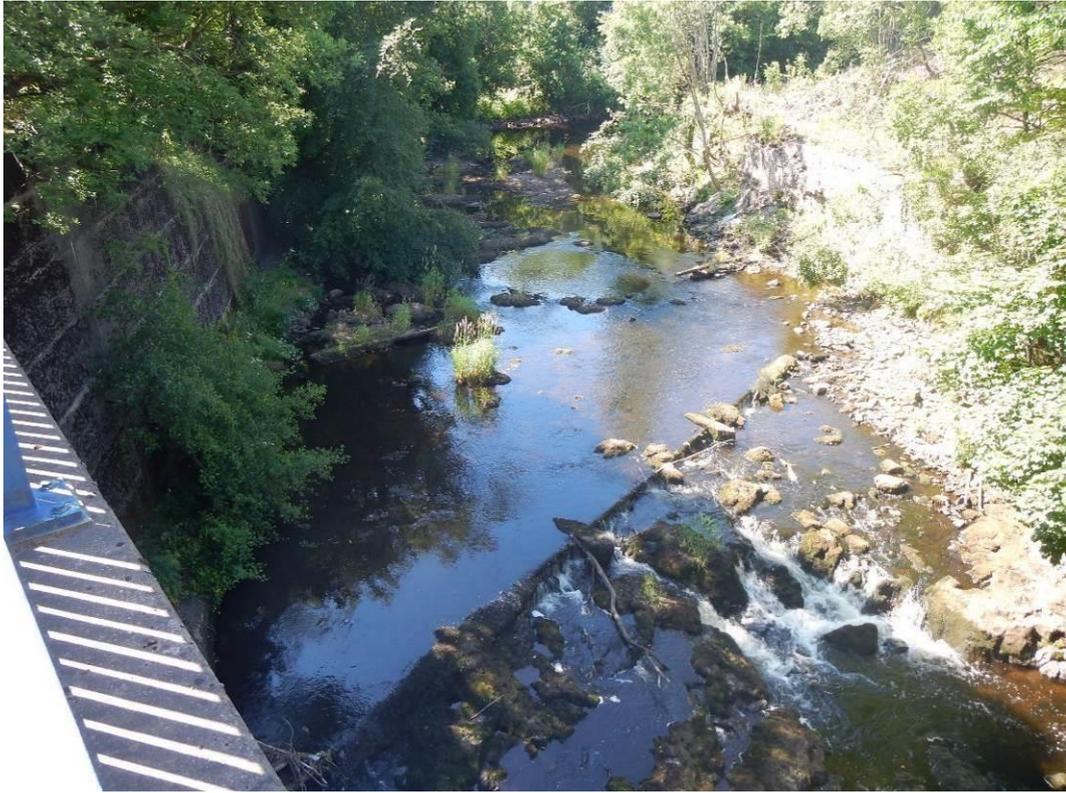
Immediately u/s of the bridge are two pipe crossings (Figure 1); the farthest u/s of the two has disintegrated but the other still creates an obstruction to fish movement. Any raised step in the bed will reduce the potential for fish to move up and downstream, interrupting the flow and preventing easy swim-through conditions. Even small steps can create an issue, particularly in low flows, if the water is spread thinly over a wide cross section like a smooth weir or pipe. It is easy to overlook the importance of free movement for all fish at all flows, including small species and juveniles, which may be reliant on passage at lower flows owing to their reduced swimming ability.

Figure 1. Although relatively low, the vertical step created by an old pipe crossing will inhibit fish passage, potentially preventing fish from migrating u/s or d/s when they need to, particularly in low flows. This may completely prevent the u/s movement of smaller fish if the velocity of higher flows exceeds their swimming ability. The location of the pipe on the edge of a rocky outcrop with little water depth d/s further reduces its passability.

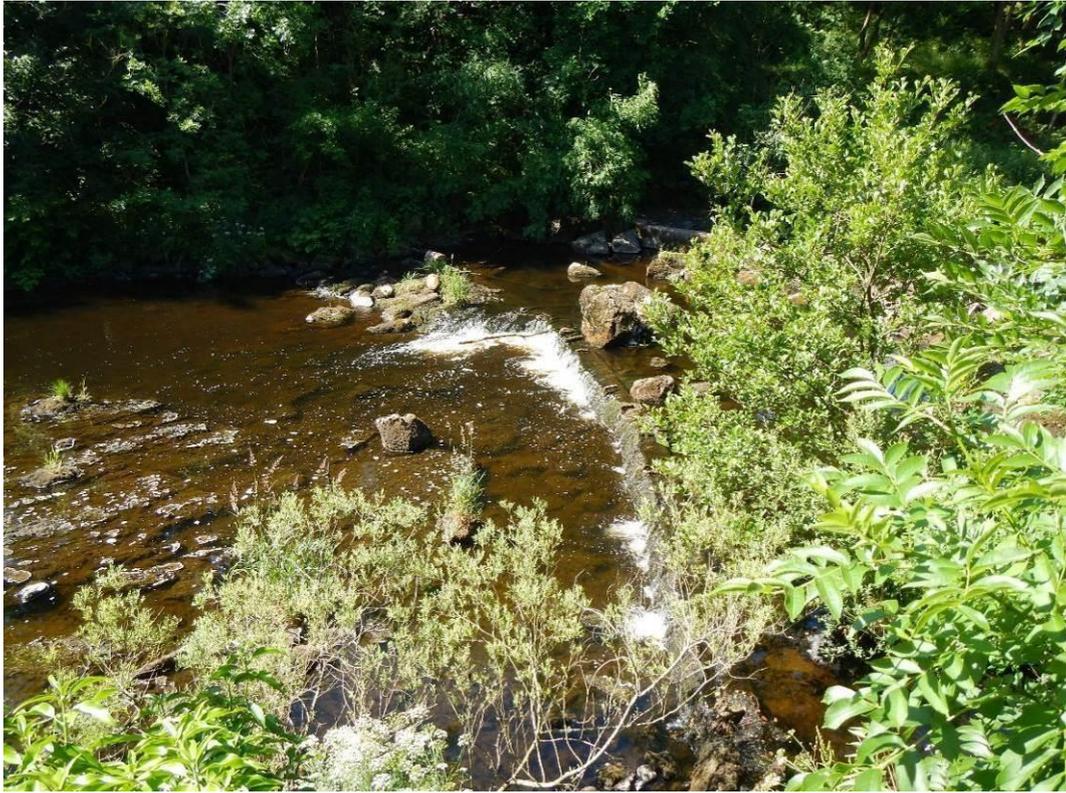
A short distance u/s of the pipe, a small concrete weir creates the next obstruction (Figure 2). This is another relatively small structure but is likely to create a behavioural barrier and will certainly limit the movement of smaller fish. It should also be considered that grayling are very reluctant to ascend obstacles, particularly weirs, so any raised structures within the channel are likely to greatly inhibit their dispersal and habitat utilisation.

Figure 2. A small concrete weir creates another small obstacle. Bedrock at the side of the channel should improve passage somewhat by providing a natural adherent nappe (without a gap or entrained air), rather than the weiring type flow that is occurring along the rest of the vertical step.

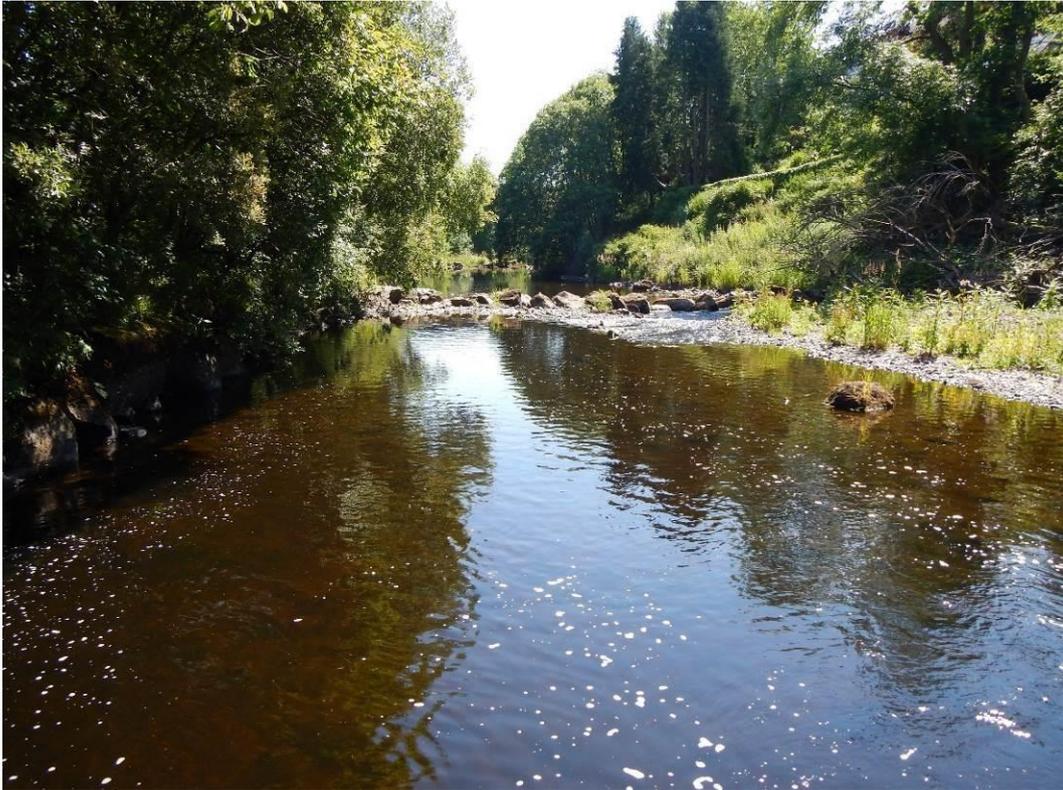
Progressing further u/s, the first of many large boulder weirs was encountered. The boulder weirs were apparently installed as part of a well-meaning attempt to improve the habitat of the river. Now, with a greater understanding of the importance of natural river channels and the free movement of fish and sediment, it is unlikely that the installation of such structures would even be permitted. Other less damaging methods can be employed to increase the numbers of fish that a reach can produce and hold.

Figure 3. Looking d/s at the first of the boulder weirs encountered. Note the impounded flow in the foreground and the increased sediment deposition that is gradually filling the pool.

In the short term, whilst the concrete weir is intact, it is worthwhile leaving the weirs d/s in place, to avoid the risk of lowering the bed and water level immediately d/s of the large concrete weir and reducing its passability further. If the large concrete weir is removed, or fish passage is improved, the boulder weirs d/s should be removed.

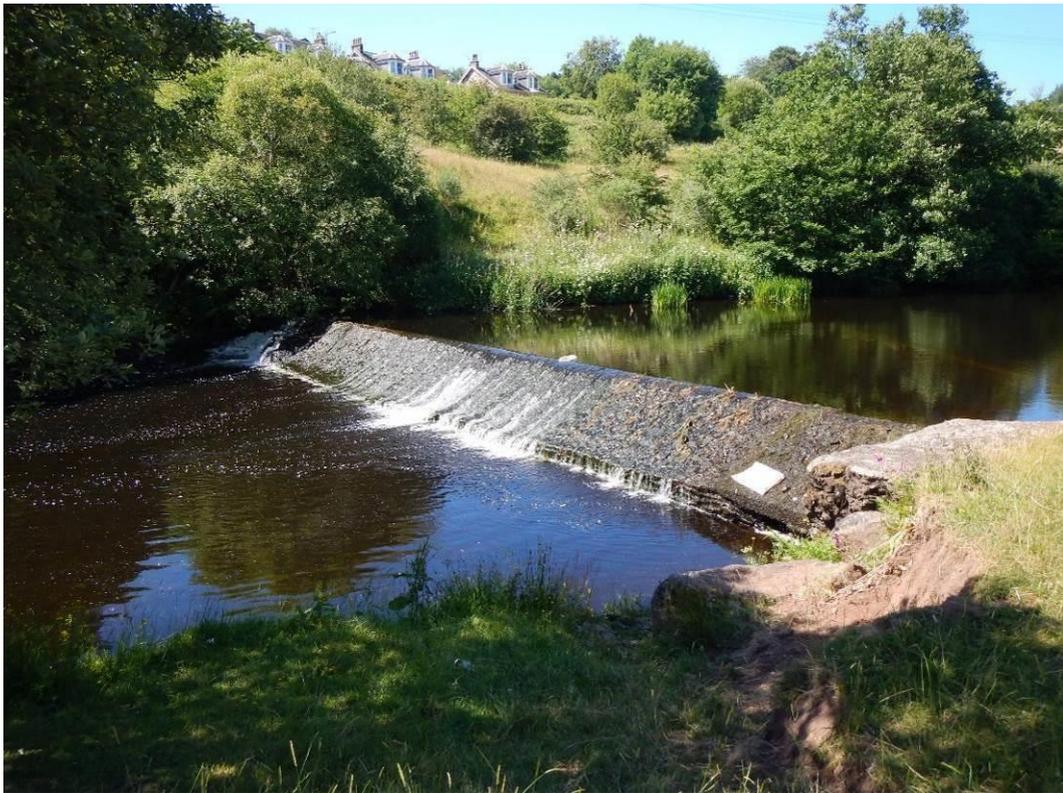
Upstream of the first two boulder weirs, a very much larger and very poorly passable concrete weir impounds the river for several hundred metres (Fig. 4). It appears that this weir was installed to protect a pipe crossing just u/s of it; this is very bad practice. Any service crossing points should be set well below the riverbed level, to protect the crossing and to allow the free movement of flows, sediment and fish past the structure. The weir now creates a major negative impact upon the physical functioning of the river, its habitat and its inhabitants, until it can be removed or altered, at significant expense.

Figure 4. A large, poorly passable weir that appears to have been created to protect a very poorly installed pipe crossing that should have been set below the riverbed level.

Removal of the large concrete weir and the pipe (suspected to be a sewage pipe) that it protects should be seen as a priority. It appears that the pipe is in active use, so the pipe may possibly have to be lowered. This would be a far better option than any fish passage 'improvements' at the structure (even if it were considerably more difficult and expensive to achieve), as it could solve the problem permanently. If removal or lowering proved to be completely infeasible, fish passage options could be considered as a poor second best.

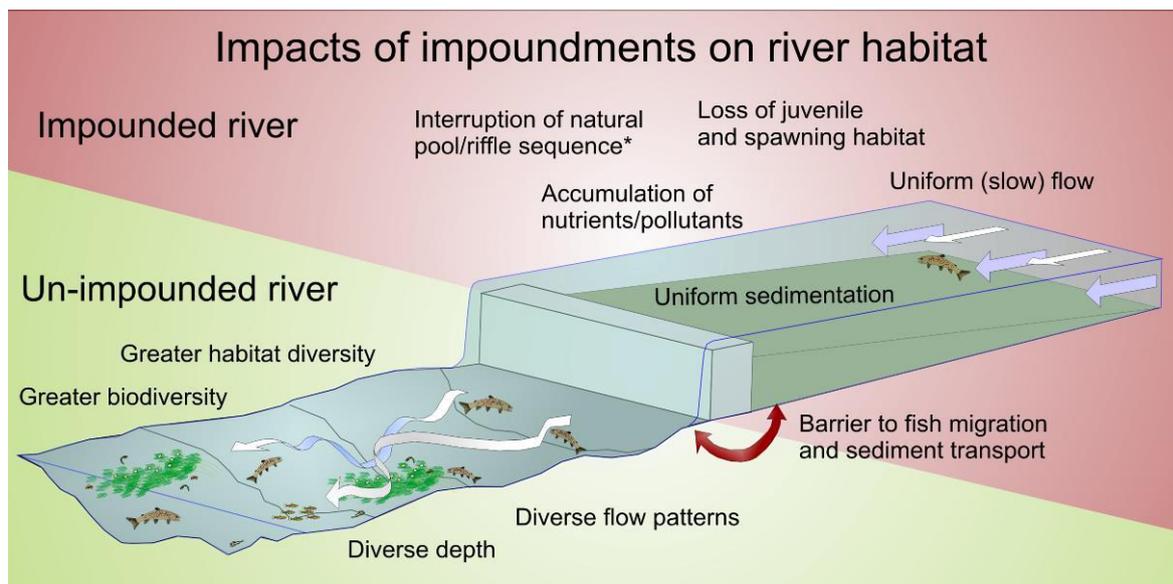
Figure 5 is a simplified diagram to depict just some of the major issues created by weirs and other artificial impoundments. Unlike natural scour pools, gravel bars and riffles, which are part of the natural mobile bed of a river, weirs lock the riverbed in place, preventing the natural grading and sorting of the material and greatly degrading the habitat it would otherwise provide. Impoundments therefore create long reaches with little or no spawning potential and poor invertebrate and juvenile salmonid habitat.

Figure 5. Raised structures such as weirs may temporarily create increased depth but the uniform, low energy flow and increased sediment deposition within the impounded reach ultimately lead to the pool filling in with bed material supplied from u/s.

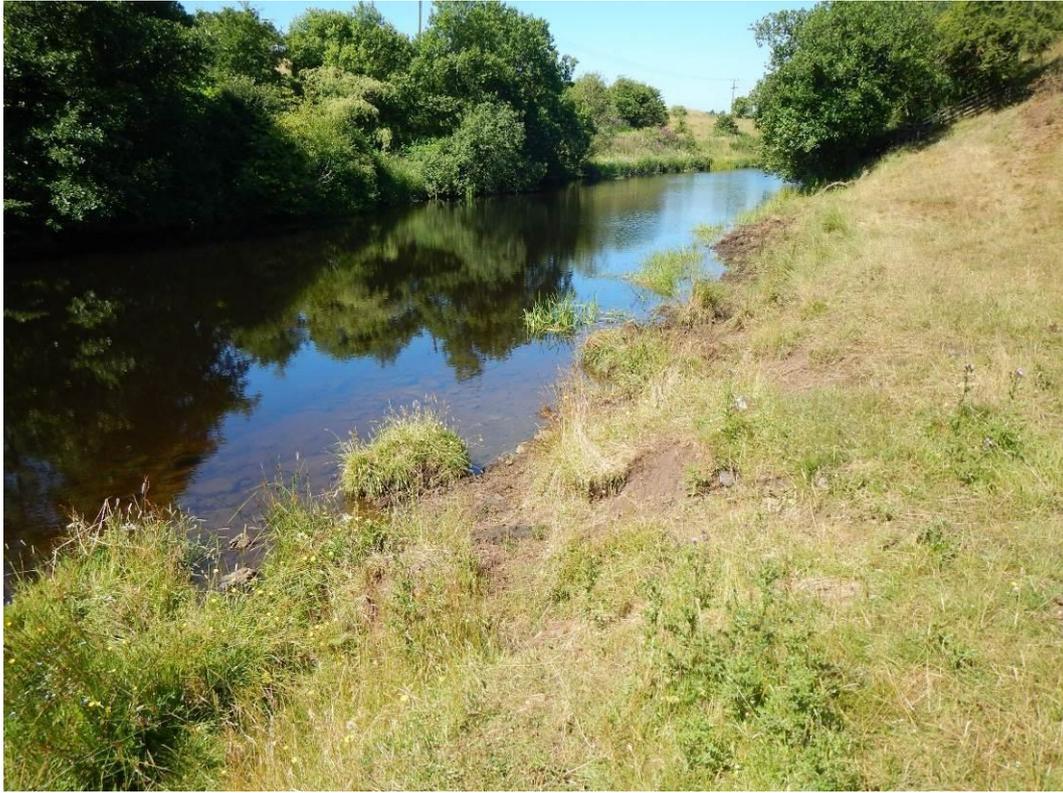
It is difficult to mitigate the simplified habitat (lack of flow, in-channel structure and impacted channel morphology) within the impoundment u/s of an obstacle, where increased predation rates are likely to occur (Fig. 6). This includes parr and smolts on their d/s migrations while delayed by the impoundment. Low branches along the impounded reach provide some cover and introducing more of that structure would clearly be beneficial, as would planting trees like willows that can be laid into the channel once mature. Livestock access to the banks leads to a loss of vegetation diversity, erosion and fine sediment input and should be prevented.

Figure 6. A typical view of the impounded section u/s of the concrete weir, with very little flow and correspondingly poor habitat diversity. Retaining the low branches and introducing additional structures like trees and branches into the channel will enhance the area, providing some refuge for fish from predators and increasing the number of fish it may support.

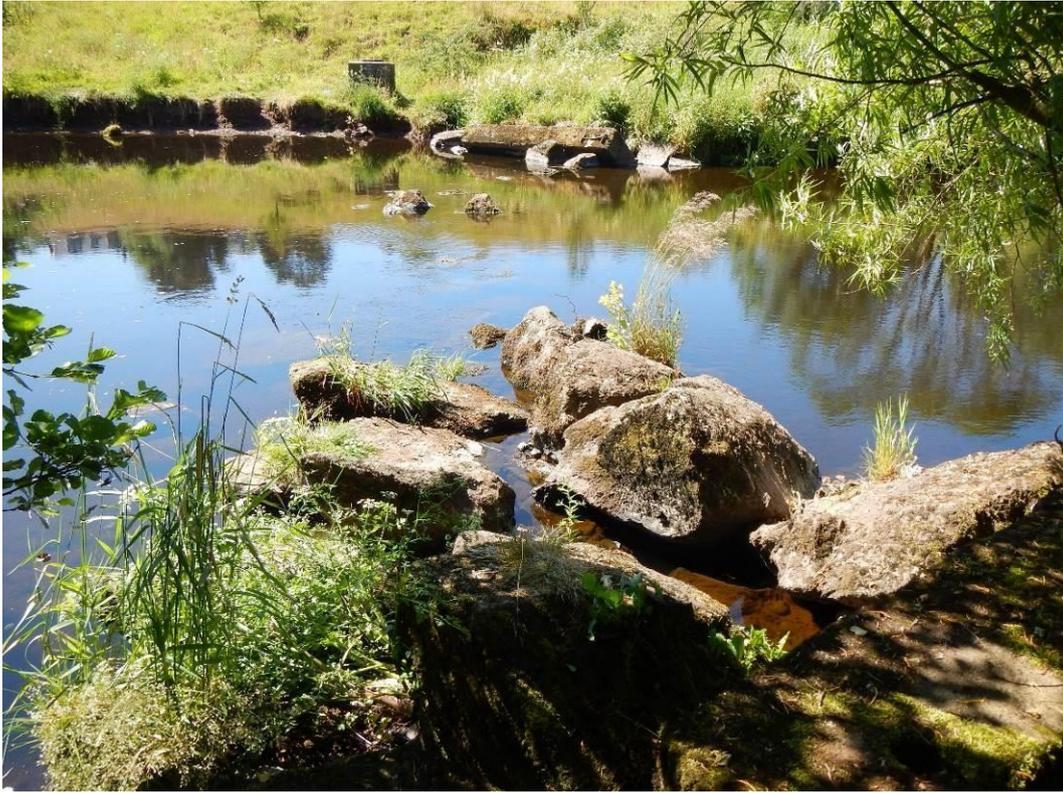
The impoundment from the large concrete weir extends for approximately 300m u/s. Another smaller, largely submerged weir located approximately midway through that reach creates no major habitat issues, although it has almost certainly contributed to erosion of the RB d/s (Fig. 7). A slight fall over the next boulder weir further u/s (Fig. 8) signifies the u/s extent of the largest weir's impoundment. The smaller boulder weir poses negligible issues for fish passage, but the issues of sediment retention upstream (and associated infilling of the pool) are clear to see.

Figure 7. Largely submerged weir, which poses no real habitat issues other than potentially contributing to the erosion of the far bank.

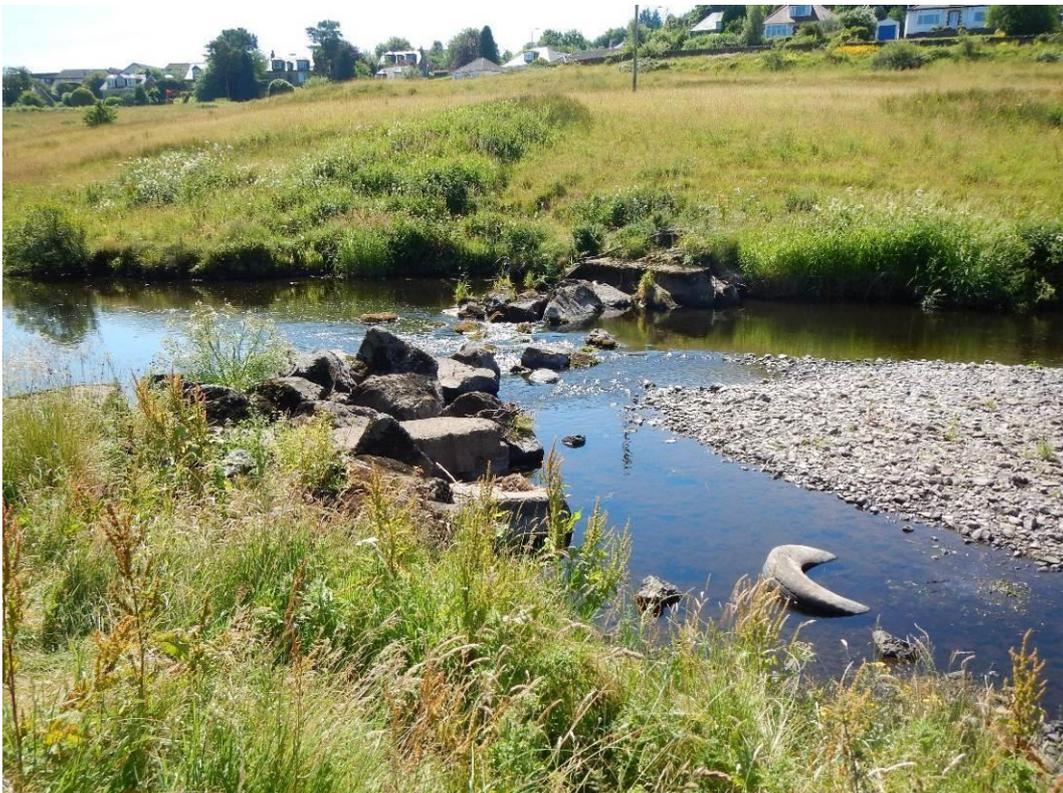
Figure 8. ~300m u/s of the very large concrete weir, a boulder weir marks the first change in water level, with a small head drop over the weir. Note the large volumes of gravel that have been retained u/s of the weir, now filling in the tail of the pool.

These weirs should all be removed to allow a natural channel morphology to reinstate, with bankside willows laid into the channel to develop scour and deposition. If removing all of them is too great a task, in the short term, some could be removed with others notched down to bed level at alternating sides to at least improve flow diversity and facilitate a more sinuous flow pathway down the channel. Removing the impoundment and allowing sediment transport through the reaches would also allow scour to create and maintain deeper pool areas between the weirs. Planting, tree laying and installing flow deflectors could provide additional surrogate in-channel structure.

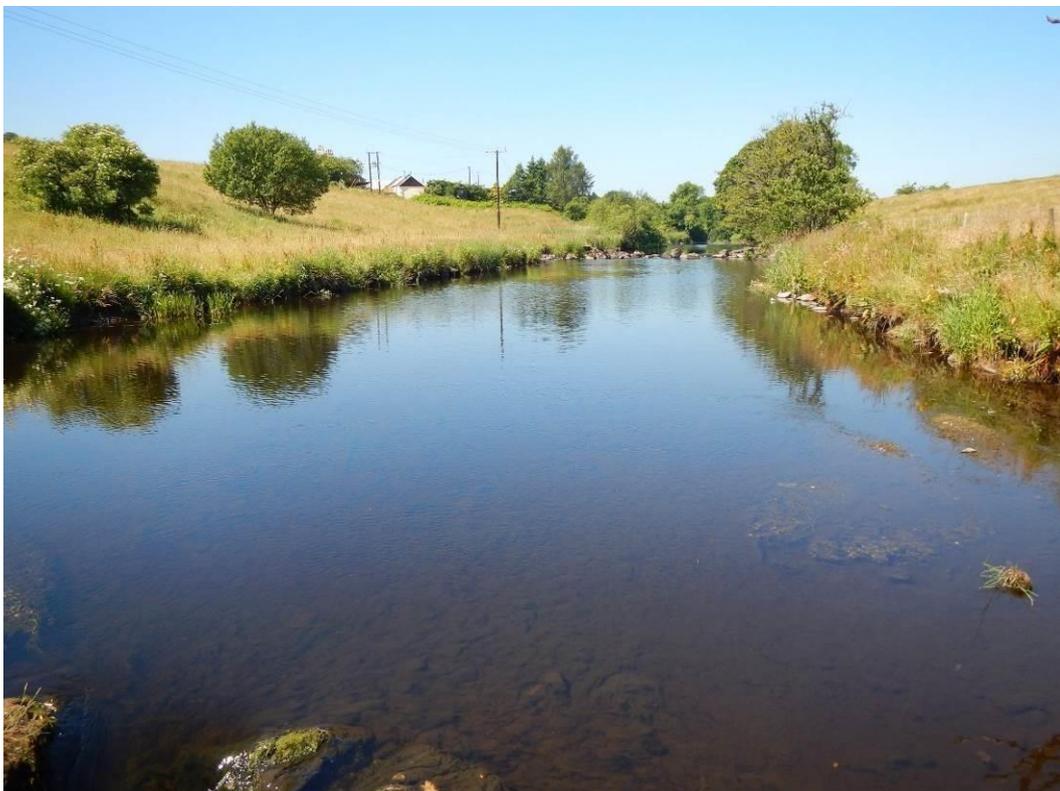
Several similar full-width weirs are present in the reach u/s, creating more impounded, slow flowing pools with limited habitat potential for much of their length (Fig. 9). The uniformity of the flows (dispersed across the full channel width) means that sediment deposition is often quite uniform across the bed. This creates a featureless bed and uniform depth water, rather than allowing gravel bars to form along alternate banks (as would naturally occur) that that would focus flows towards the opposite bank and maintain bed scour and water depth.

If the large concrete weir is not removed, the impounded reach will ultimately fill with substrate and may develop some semblance of a natural bed, but this will take many more years and the lack of gradient (and flow velocity) there mean that it would always be degraded habitat. Removing all of the weirs should therefore be the long-term goal, to allow more natural sediment transport and distribution. However, until that can be achieved, having at least some in-channel structure there could assist with localised substrate retention, providing the structures are not full width weirs that impound the flow and block sediment transport. For this reason, it may be beneficial to notch the first two boulder weirs u/s of the large concrete weir down to bed level at alternating bank sides initially. This would reinstate sediment transport and create a sinuous flow pathway that moves from one bank side to the other between the cobble weirs that are located within the impounded reach of the large concrete weir.

Figure 9. Uniform, low quality habitat created by further weirs and impounded reaches. Notching the weirs down to bed level at alternate bank sides would reinstate sediment transport and provide a more naturally diverse, sinuous flow pathway.

If some of the weirs are only notched, it is those at the u/s end of the large weir's impoundment that would suit that treatment best as they may be providing some beneficial sediment retention in the short-term (e.g. before the majorly impounded reach fills with sediment and natural bed raising occurs). Clearly, this concession would not be required if the pipe and weir (and associated impoundment) can be removed. In which case, the other weirs should also be fully removed.

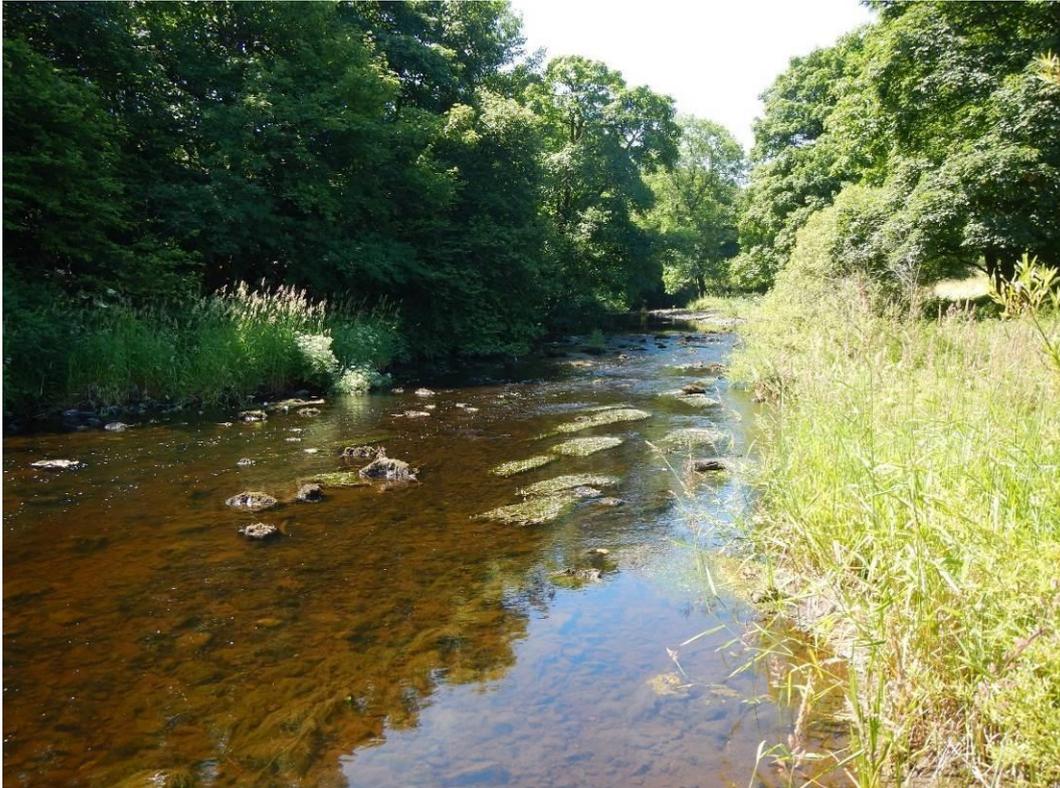
Upstream of the weirs is a short section of natural, un-impounded river and much higher quality habitat for all fish and invertebrates. Aside from the issues already discussed regarding impoundments, drowning out shallower areas of the river also greatly degrades vital habitat that is required to produce invertebrates and juvenile trout. Habitat diversity is the key to healthy, sustainable fish populations and anything that alters the river from the state naturally formed by the flows it receives is likely to be detrimental. Shallower, faster sections are also vital to maintain healthy aquatic vegetation, as was observed in the more naturally flowing reaches.

Figure 10. A naturally shallow section of channel. These are vital nursery areas for juvenile trout and salmon and provide important invertebrate habitat. The shallower areas are also the only places that weed was observed during the visit. Particularly low flows at the time of the visit were facilitating excessive algal growth throughout the river.

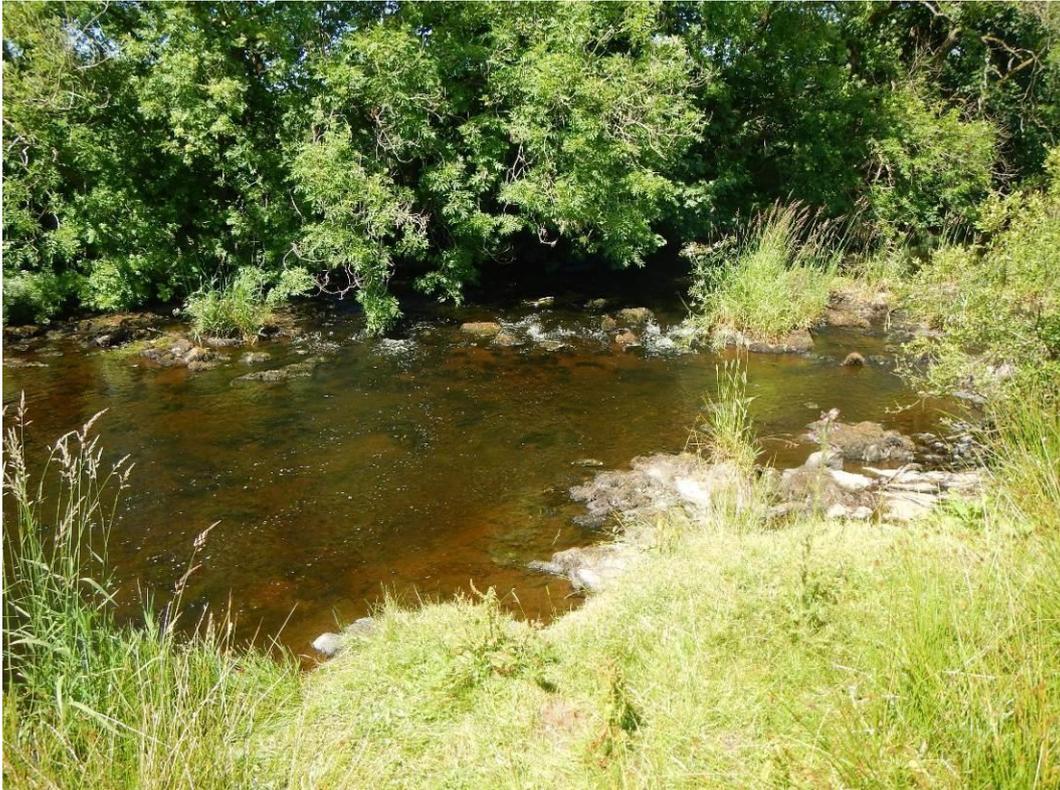
Figure 11. A naturally deeper run that has been produced and maintained by bedrock and deposition of cobble substrate on the far bank side.

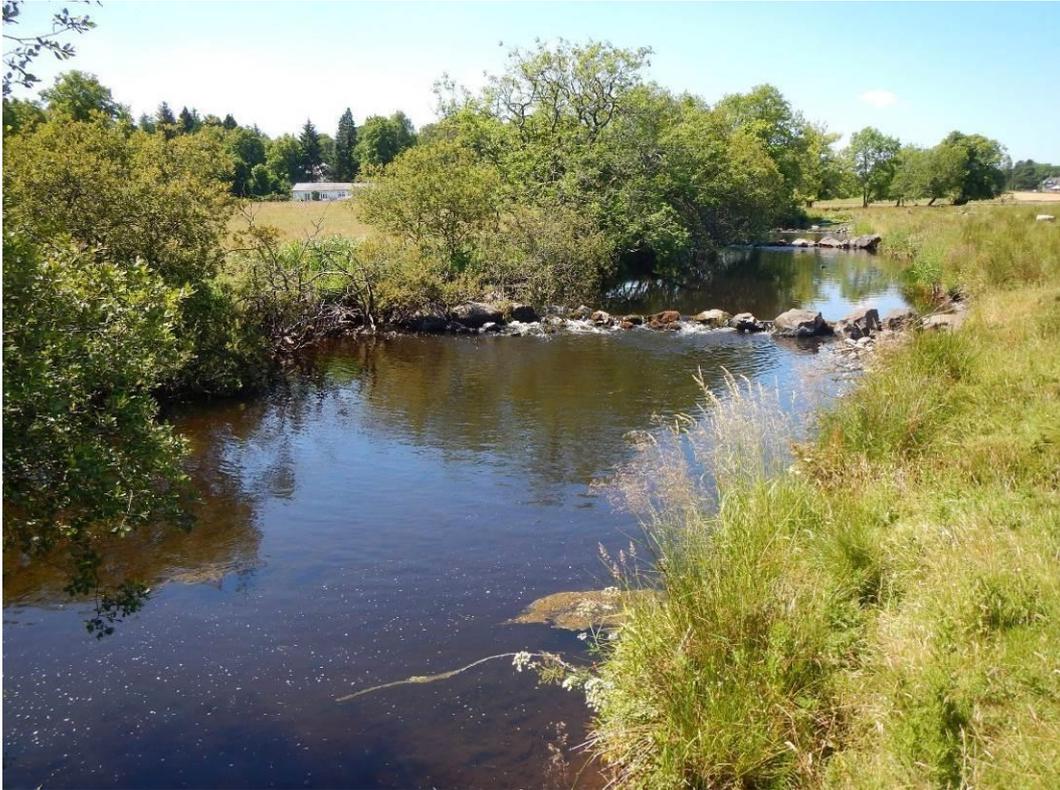
The man-made weirs begin again a short distance u/s, reinstating the uniform, ponded habitat. Valuable bankside trees provide shade and low cover, but the inhibition of natural flows creates a major negative impact upon the river habitat. As these are well outside the influence of the large concrete weir, the best course of action would be to fully remove them. Habitat enhancements such as tree laying and installation of more natural flow deflectors could also be undertaken if required, but it is anticipated that the habitat would greatly improve naturally. However, owing to the extent of the work required (number of weirs throughout BOWAC waters) an initial step could be to at least create alternating notches in the weirs. Reducing the integrity of the weirs may even lead to further redistribution of the boulders naturally over time. Although not particularly badly grazed, this area would certainly benefit from buffer fencing to allow a more diverse herbaceous river margin to develop.

Figure 13. Another series of impoundments. Ideally, these weirs should be removed, but even notching them down to bed level at alternating bank sides would improve habitat.

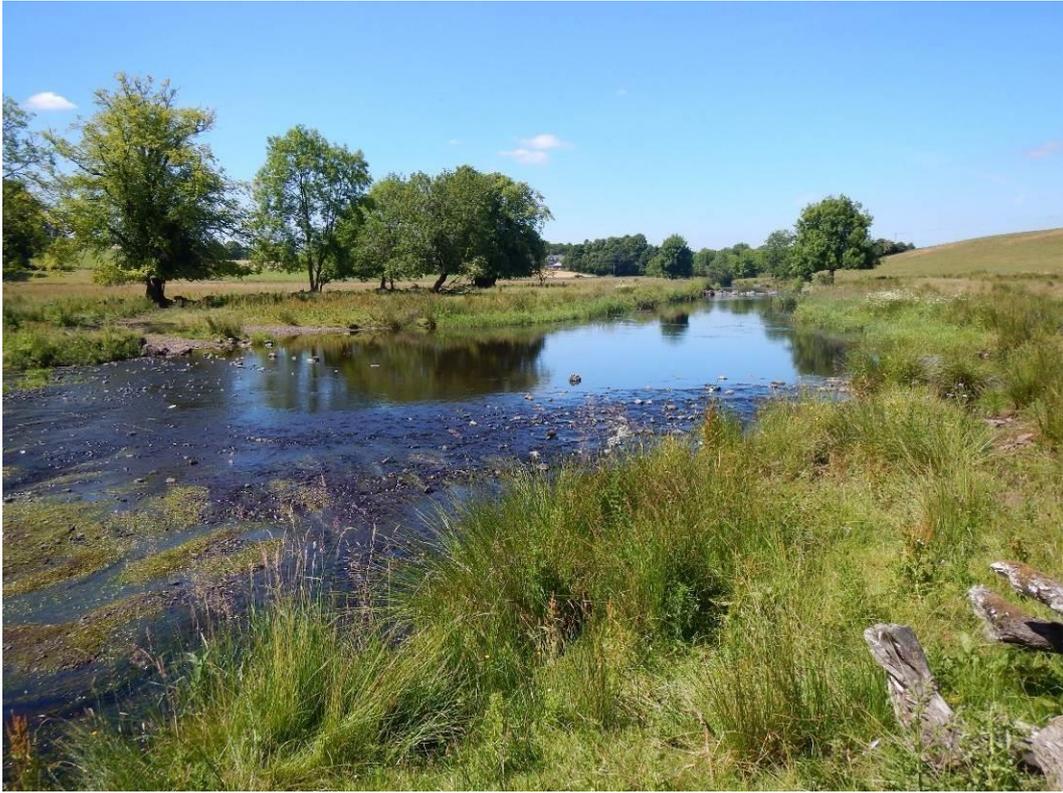
Upstream of the weirs is another uniform, straight section. It appears the channel could have been straightened here although it must have occurred over 150 years ago as it already appears straight on modern maps (Fig. 14). The habitat issues here are almost certainly exacerbated by the lowering of the bed and a lack of sediment retention in the straight, structure-less channel. Widening of the ford at the d/s end is increasing deposition on the riffle d/s, which now forms quite a steep gravel bar. Fencing livestock away from the river here (and any other areas where they have access) would be beneficial.

Figure 14. Straight, over-capacity channel section that would be improved by buffer fencing and tree planting.

In this section, existing willows could be laid into the channel to increase flow diversity and encourage alternating areas of bed scour and deposition that will help diversify the channel. Additional trees (particularly fast-growing crack willow) could be planted to grow out into the channel and improve the habitat with natural inputs of woody material over time.

Livestock access to the banks and the associated erosion and fine sediment input are a moderate issue on the Gryfe. The problems are not as acute as encountered on many watercourses, but installation of buffer fencing would greatly improve bankside habitat, particularly in the upper section. Fencing would facilitate greater diversity of bankside vegetation and tree/shrub regeneration and prevent over-widening of the channel through erosion. Ultimately, suitable trees that become established could then be laid into the channel to provide valuable additional structure.

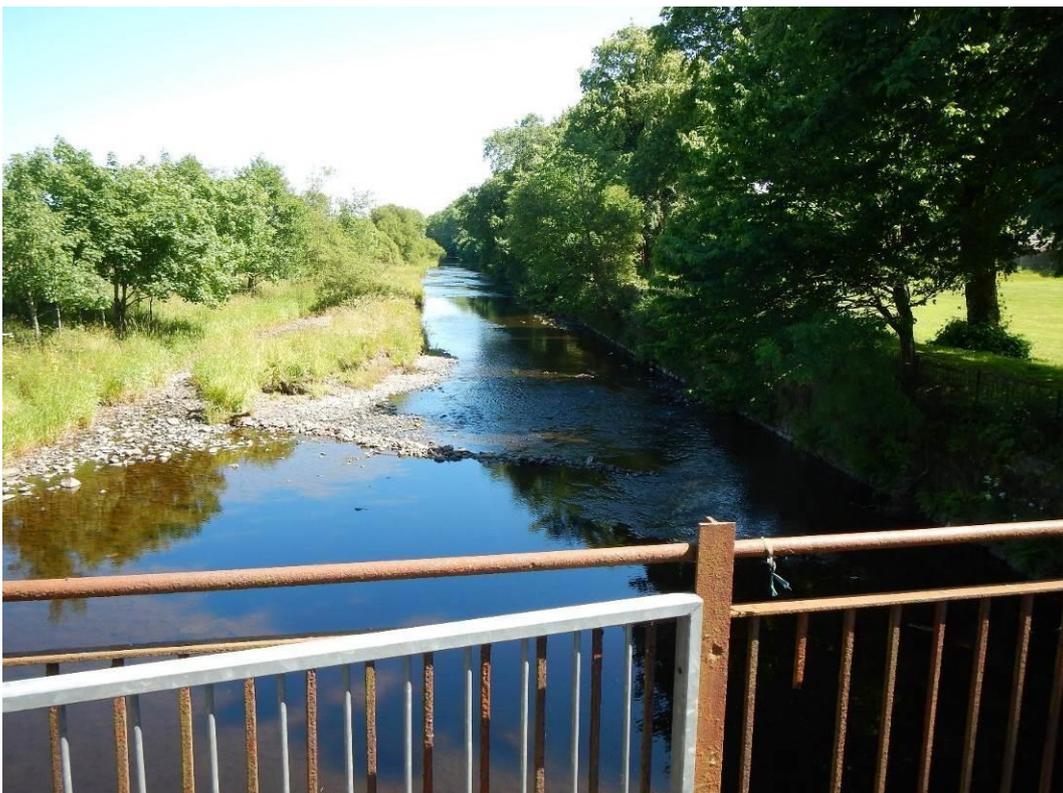
Another straight section u/s has been walled/revetted along the LB (Fig. 15). The straightness of the channel will always limit the water depth but scouring alongside the walled bank should help to maintain some pool habitat. Shade and low cover from trees along the walled bank also provide habitat improvement and increase the numbers of fish the reach will hold.

Figure 15. Looking d/s at the straightened, revetted section.

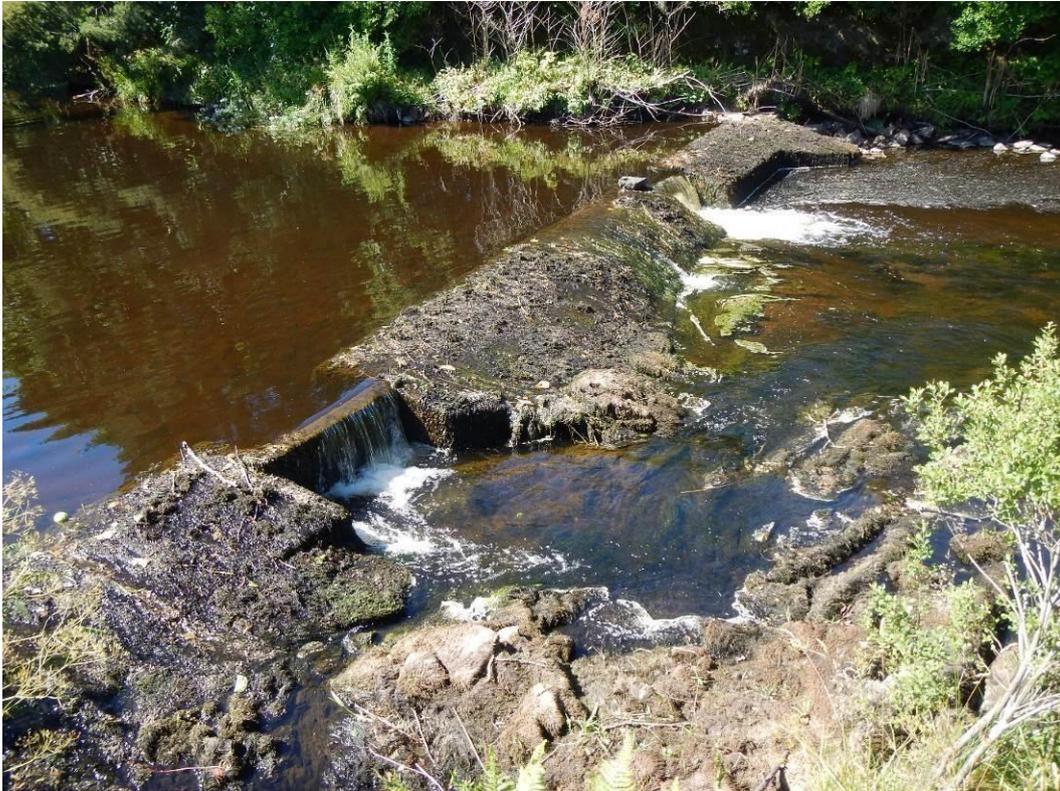
U/s of the straight, walled section another more formal concrete weir was encountered. Again, the ideal solution is to remove the weir completely. If this really cannot be achieved, its passability could be improved by at least removing the wooden boards.

Figure 16. Formal weir with two sets of boards that should be removed.

As with the other weirs, the best outcome for sediment transport, fish movement and river habitat is to completely remove the weir. If this is absolutely unachievable, the weir boards should be removed as a bare minimum.

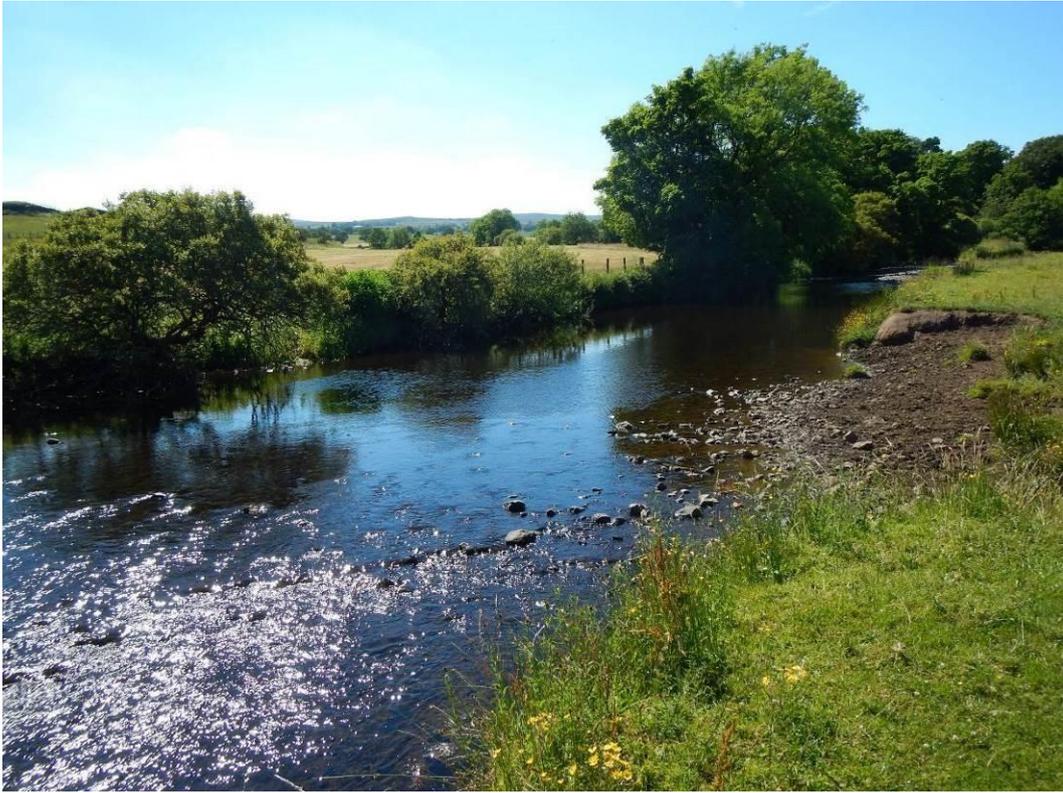
The section u/s of the road bridge, to the limit of BOWAC waters, is far more natural, without the impact of impoundments (Fig. 17). Correspondingly, far higher quality substrate was observed, with several areas suitable for salmonid spawning (which is limited in other areas owing to the weirs). These areas offer similarly improved habitat quality for invertebrates. The LB field is grazed, and livestock access is creating issues with bank stability and erosion where the animals are entering the river to drink. This issue could be easily rectified with buffer fencing and the provision of pasture pumps along the fence line (N.B. a greater number of pasture pumps than normal are likely to be required because the livestock in the field were sucking cows, which will have a greater water requirement). As it appeared to only be cattle in the field (as opposed to sheep), relatively cheap breast-wire fencing may suffice.

Figure 17. Some of the more natural, high quality riffle habitat observed during the visit is found in the upper reaches, well away from the boulder weir impoundments. Grazing is degrading the bankside habitat here and buffer fencing would be beneficial.

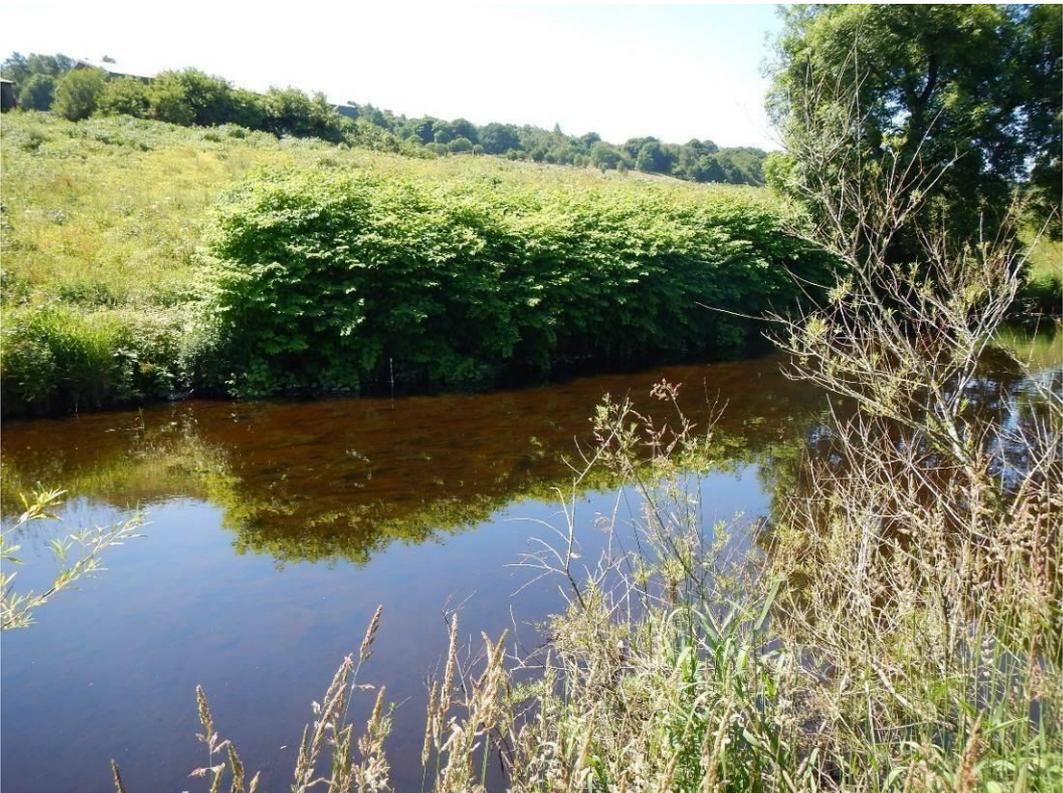
In addition to the general habitat issues, large stands of Japanese knotweed were observed during the visit (Fig. 18). While these seem like a lesser problem, they have the potential to become a very serious issue if left unchecked. All plants should be treated with herbicide by a licensed operative. It would be advisable to tackle the weed at a wider catchment scale, collaborating with other river users and starting at the u/s extent.

Figure 18. A large stand of Japanese knotweed. All plants identified should be treated with herbicide.

All Japanese knotweed plants should be treated with herbicide by a licensed operative. It would be advisable to tackle the weed at a wider catchment scale, collaborating with other river users and starting at the u/s extent.

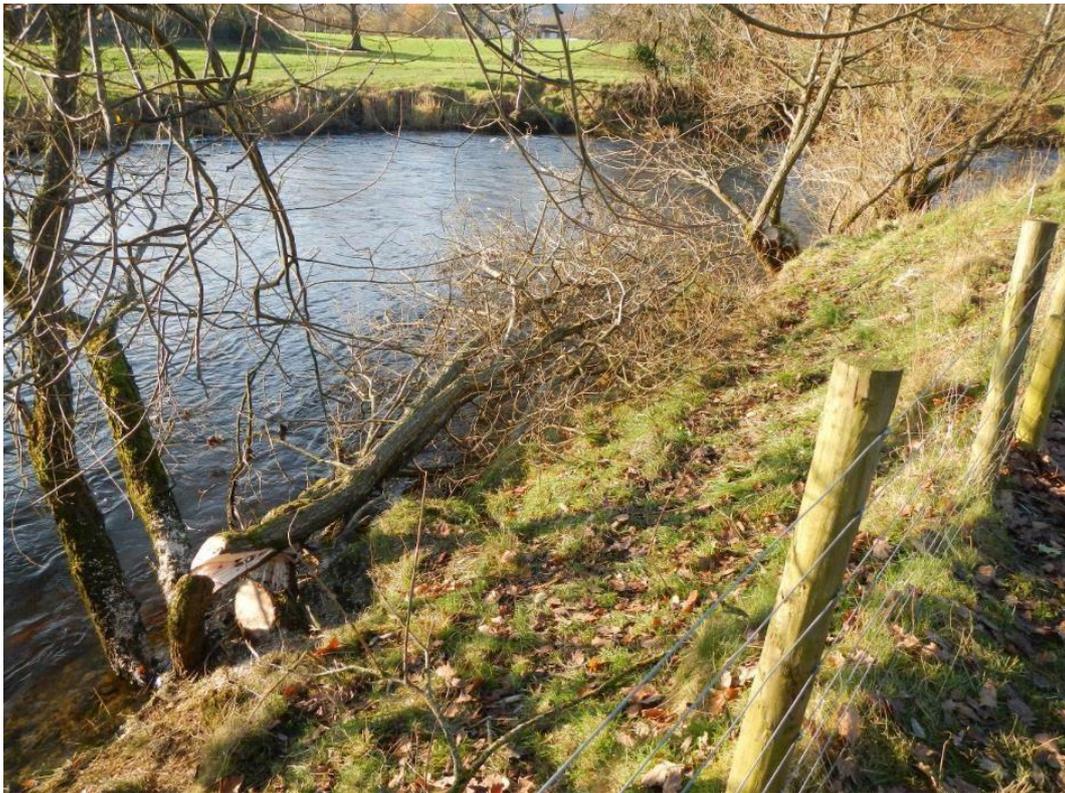
The laying method involves cutting part way through the branch, quickly through the first two thirds, then continuing until it collapses down over the river (Fig. 19). The depth of the cut should be limited to only that which is required to bend the limb over, as this will maintain maximum size and strength of the hinge and the health of the tree/shrub. Being fast growing, willow can even be strategically planted in areas lacking low/trailing cover in anticipation of employing this technique once they become established.

Figure 19. Willow hinged into the river margin to increase cover and structure
