Advisory Visit

River Irt

28/10/2015

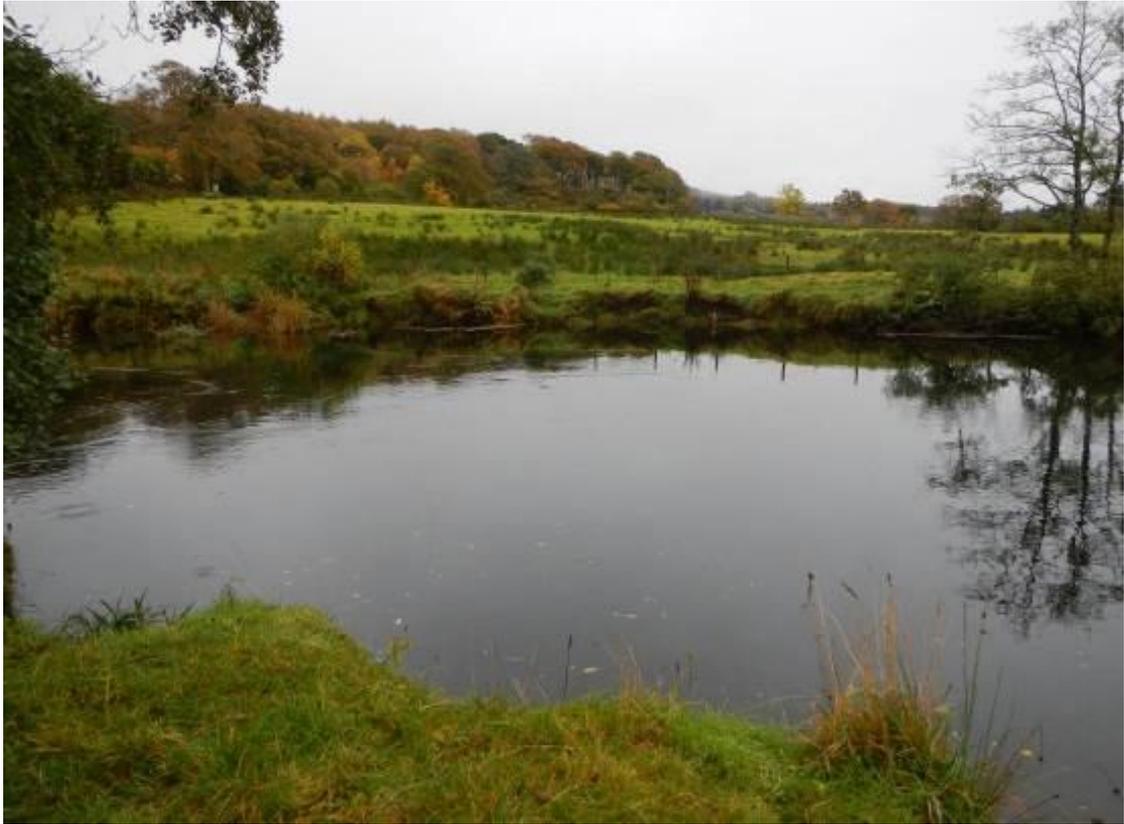
Figure 1. A good fish-holding area where water is accelerated through the bridge and scours/maintains the pool d/s. Historic grazing of the banks has allowed lateral erosion, leading to over-widening of the pool.

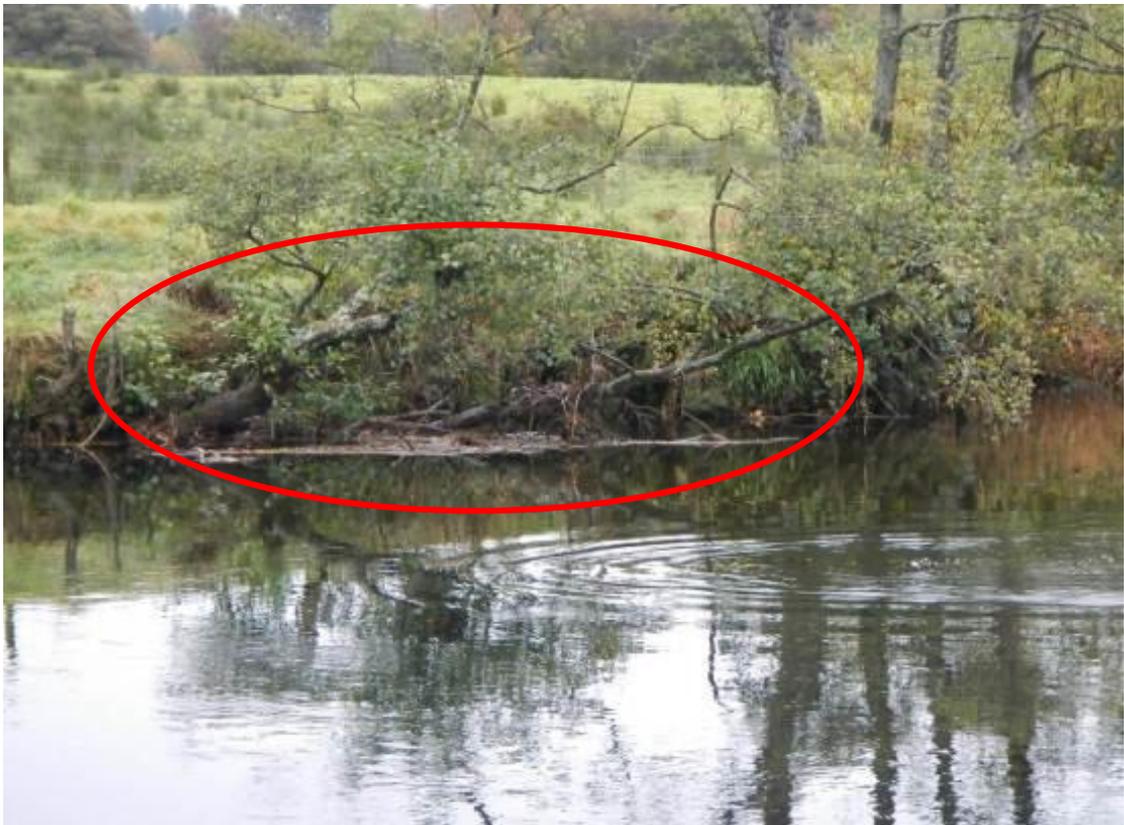
Figure 2. High quality trailing branch cover, provided by a slumped alder tree (red oval), that greatly increases the fish-holding capacity of that area of the pool. This type of structure should be retained and, wherever possible, promoted. It is important to avoid the temptation to trim or prune such structures.

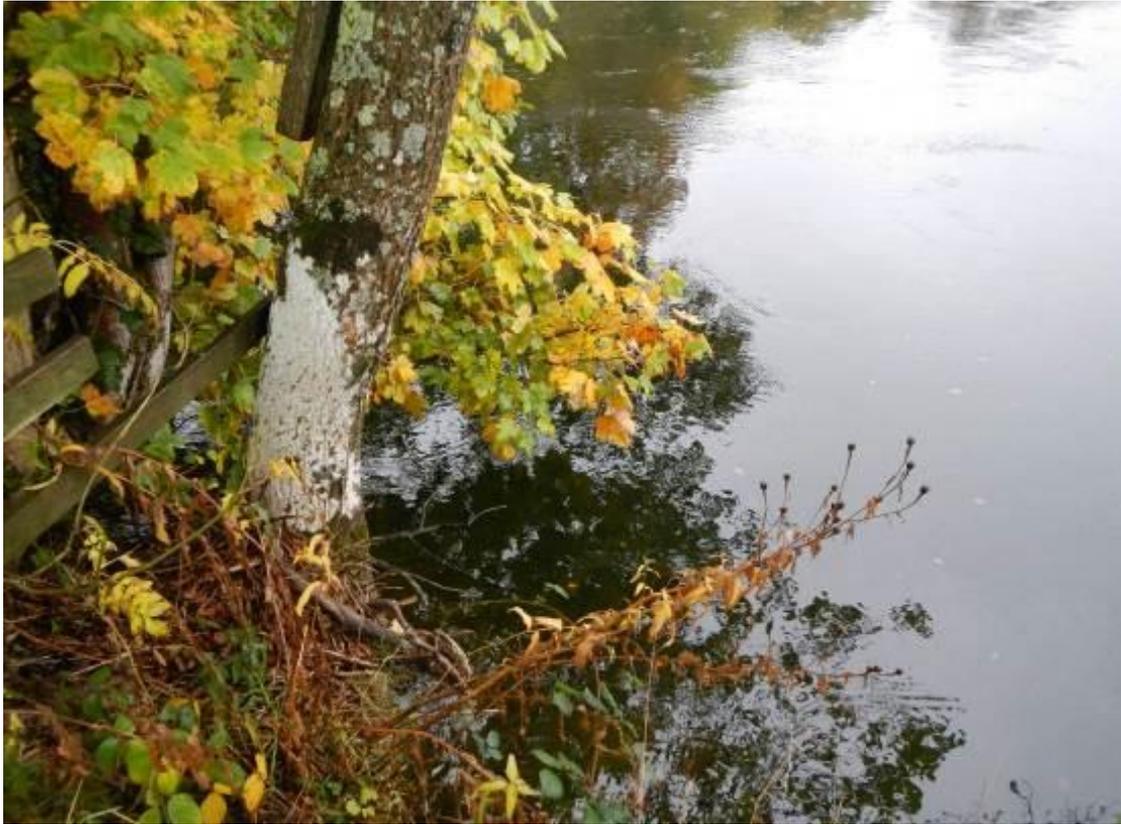
Figure 3. The head of the bridge pool where low-hanging sycamore branches enhance the habitat quality and increase the fish holding capacity. While such features may restrict access from one bank they provide excellent features to fish towards from the other bank.

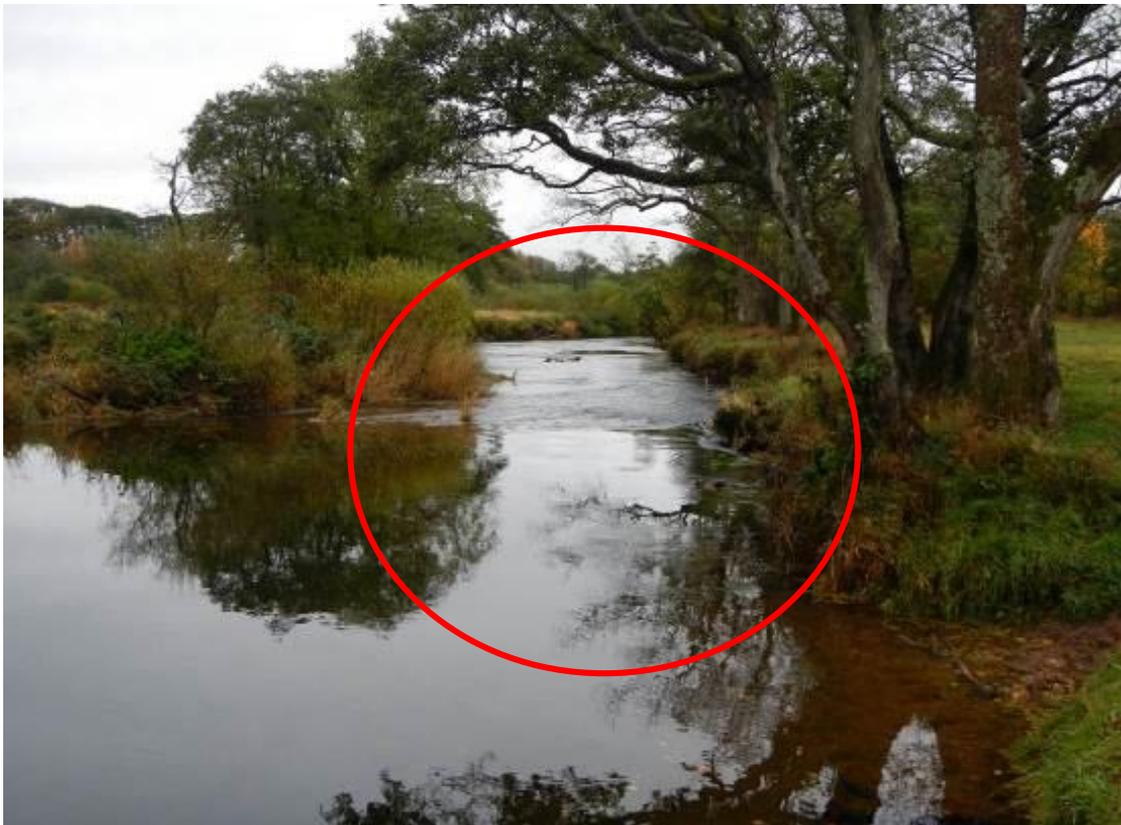
Figure 4. All of the low branches of the alder trees have been pruned, leaving a very open area with reduced fish-holding potential (red circle). With the low branches still attached, this area would have been a likely resting spot for both resident and migratory fish. It is now very open and exposed and of much lower habitat quality.

Where trees are present but the canopy is well above the water level due to past pruning (e.g. Fig. 4), coppicing could be undertaken to encourage low-level re-growth and rejuvenate the tree. The treatment should be undertaken sparingly, as tree canopies also provide habitat for many other species, create valuable shade over a watercourse and supply terrestrial invertebrates and leaf litter to supplement food webs in the river. An exception to this might be the trees on the RB (Fig. 12), the retention of which could be assisted by coppicing all of the precariously leaning trees to reduce the weight acting upon their root structure and hopefully prolong their life.

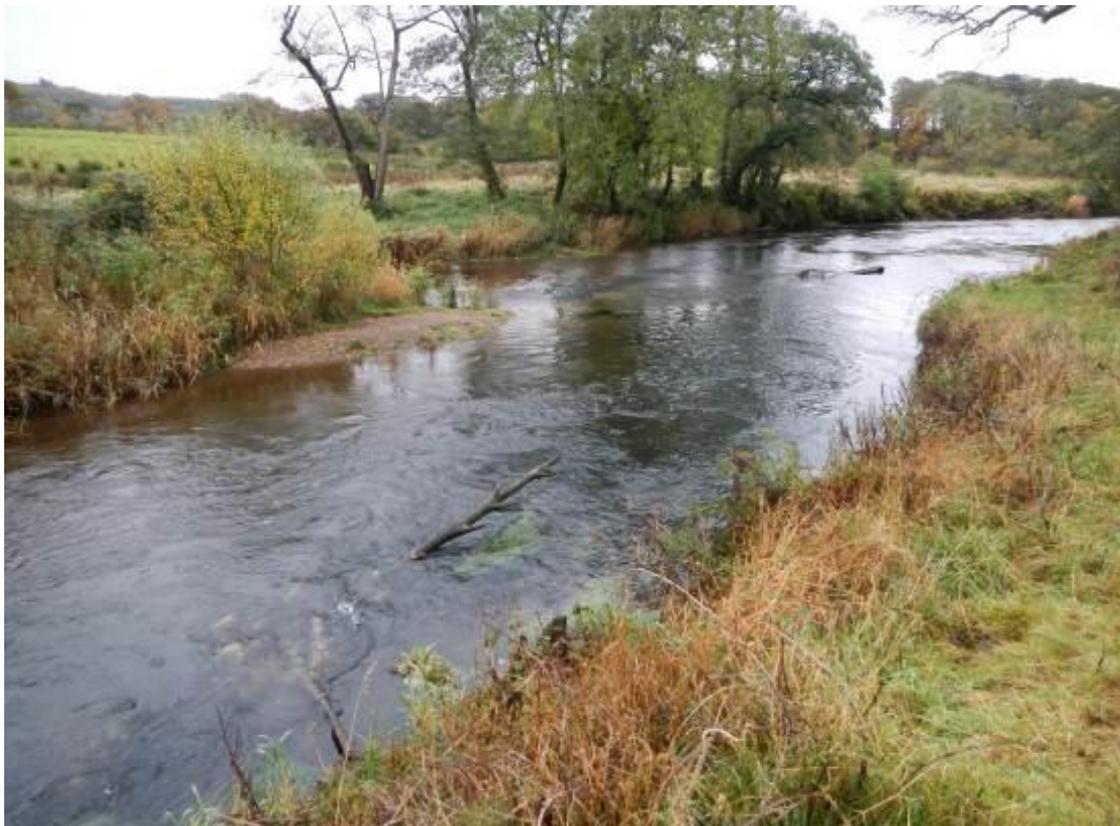
Figure 5. The island represents a depositional feature that occurs when the channel is overly wide for the flows it receives and the reduced flow energy results in beneficial deposition; this narrows the channel and provides increased flow energy in the resulting channels at either side. Woody material in the channel also greatly increases the fish holding potential with cover and structure in which they can evade predators.

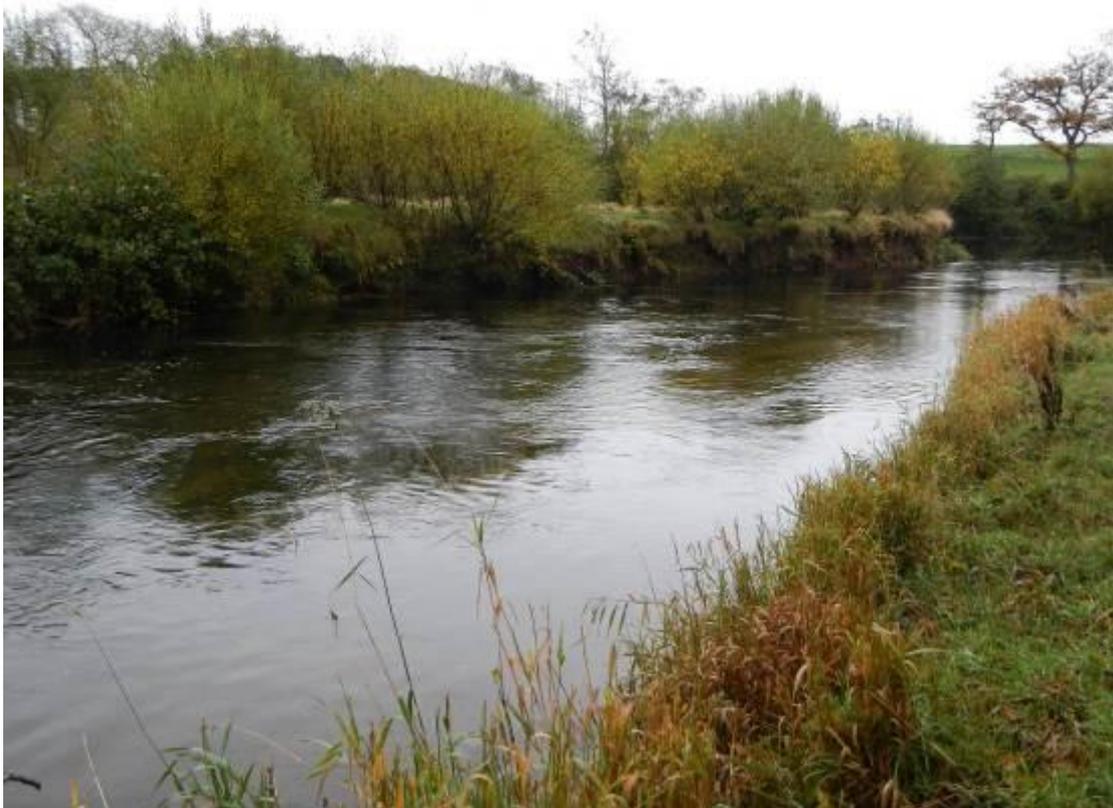
Historic dredging u/s may have also contributed to the bank erosion issues being experienced d/s (Fig. 6), by interrupting the sediment supply, lowering of the river bed and destabilisation of the bank. Once destabilised, a river bank can take time to re-establish a more stable structure and gradient. Willow trees on top of the bank provide some stability through their roots but this area would greatly benefit from willow planting (and laying) along the water line and bank face. As well as stabilising the bank to reduce erosion rates, the willow will provide valuable cover that will improve the number of fish that reside along that bank and create a great fishing feature. In this instance, it may be the angling club on the RB (not in Gosforth Anglers' control), but the increased bank stability will benefit Gosforth Anglers, as will the generally improved habitat of the area.

Figure 6. Eroding bank (probably exacerbated by the dredging u/s) that could be reduced by willow planting along the bank face. The willow would also greatly enhance angling prospects in that area by increasing the number of fish that hold there.

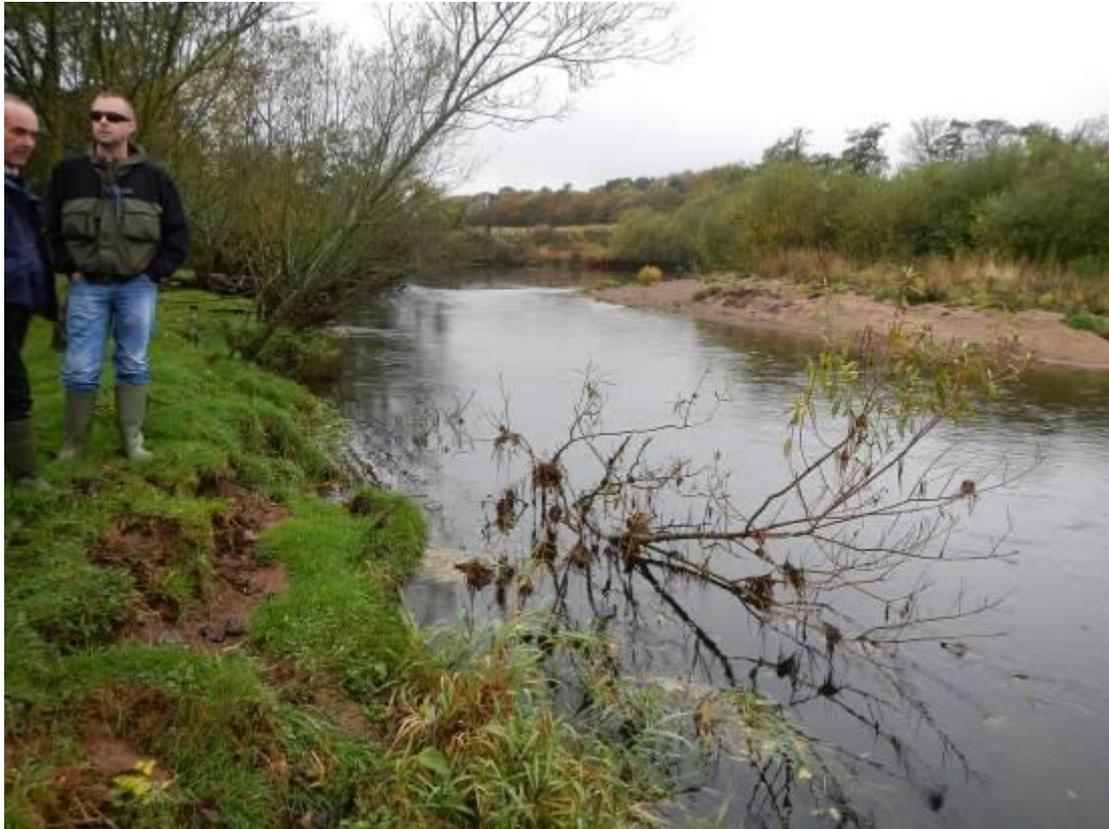
Figure 7. Tree planting and laying (to recreate the structure and bank protection provided by the fallen willow) on the adjacent angling club's bank would reduce their erosion issues but benefit the fishing on Gosforth Anglers' water. This demonstrates how the angling potential lost on one bank is soon compensated by enhancements in other areas.

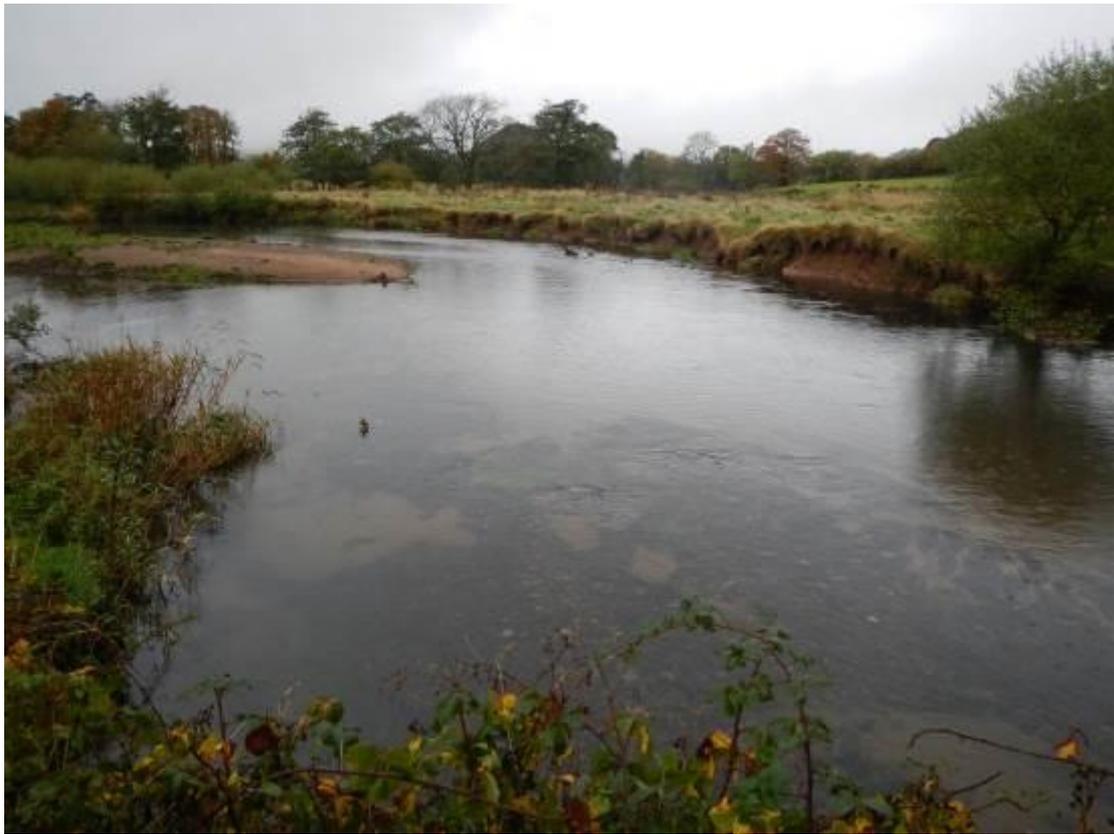
Opposite, the steep bank and lack of trees/root structure on Gosforth Anglers' bank is leading to accelerated erosion. This could be addressed by installing a living willow brush toe and / or mattress along the bank face. The technique creates roughness along the bank that slows flow and reduces the erosive energy. The structure could be easily tied in to the willow tree at the d/s end, which could itself be laid into the channel to enhance habitat.

Figure 8. Long section of bank erosion that threatens the Gosforth Anglers' bank. Soft engineering/brush revetment could be employed to stabilise this section. The willow tree (right of shot) provides a good tie-in point for the revetment at the d/s end and could be laid into the water to improve the habitat there.

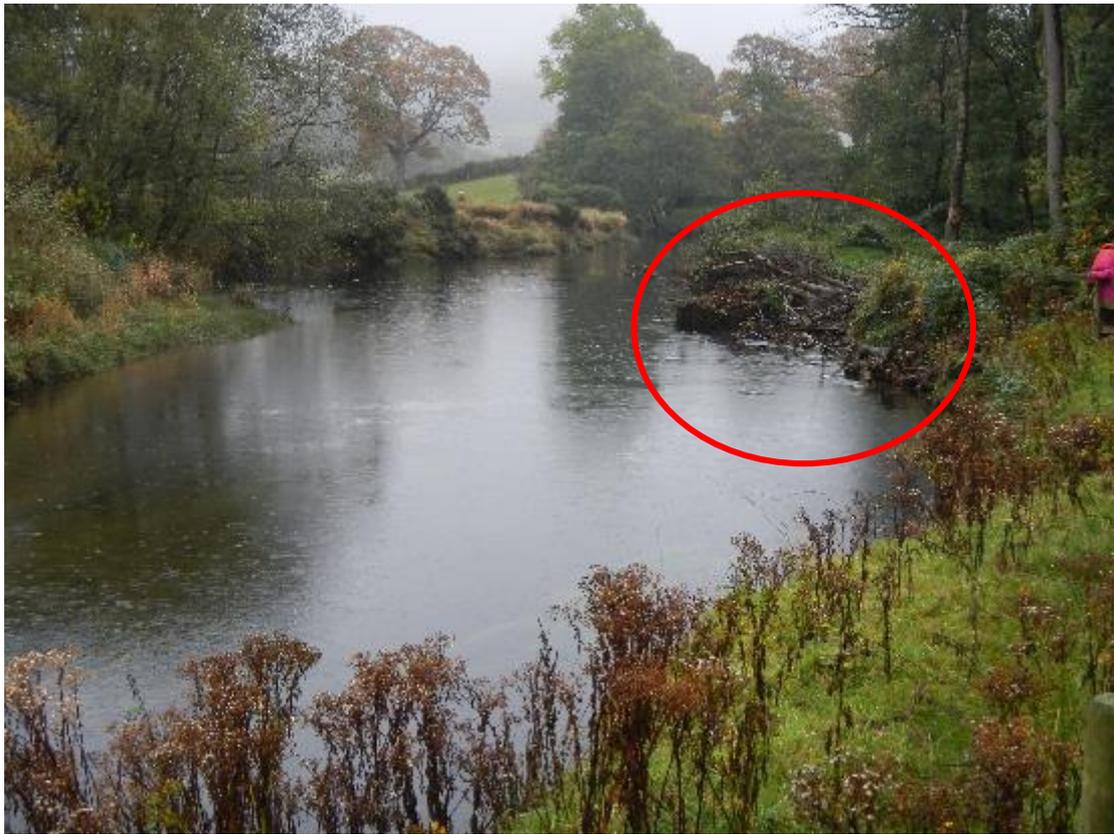
Figure 9. Fallen trees (red circle) that have been dragged into the RB to provide bank protection that enhances in-channel habitat. Willows opposite could be laid into the channel to enhance LB habitat.

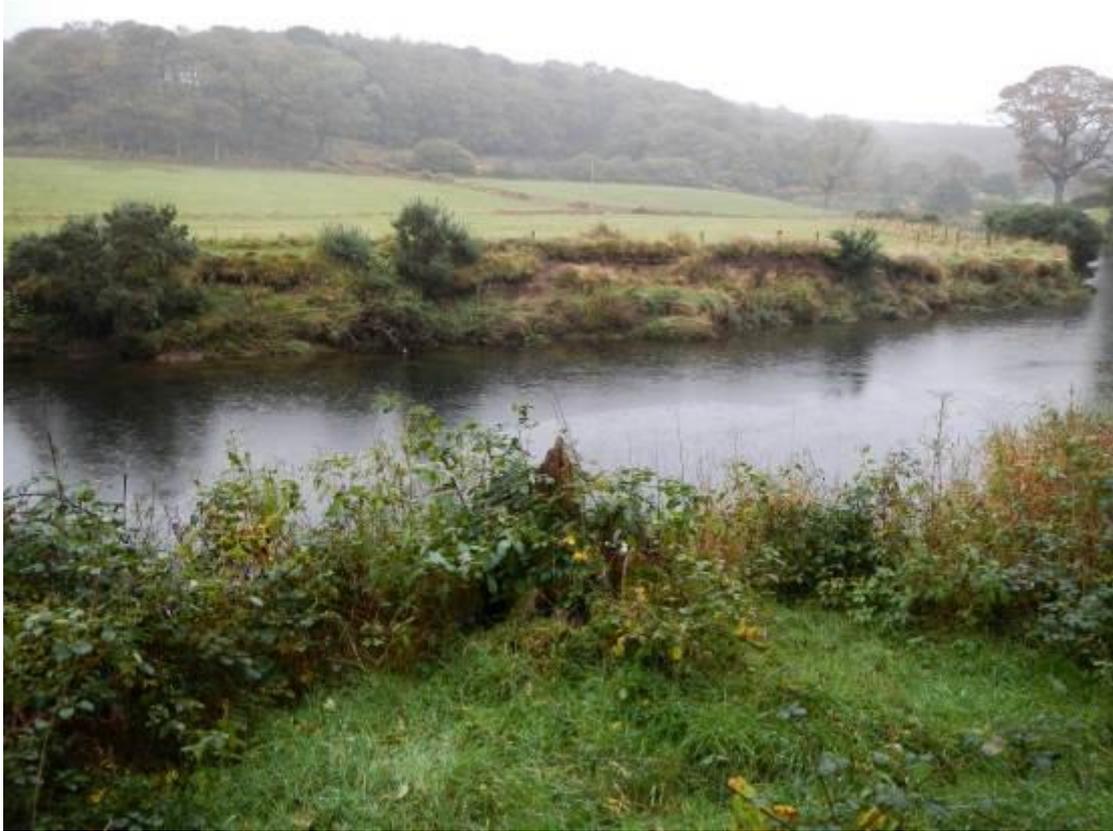
Figure 10. The near (RB) is protected by being at the edge of a wood and the LB is protected by a buffer strip. Both have healthy bankside vegetation but could benefit from additional shrubs/willow whips (red) to increase fish-holding capacity.

Prime locations for willow whip planting are those depicted in Figures 10 and 11. Anchoring cut branches along the posts of the now failed bank revetment (Fig. 13) would also be beneficial.

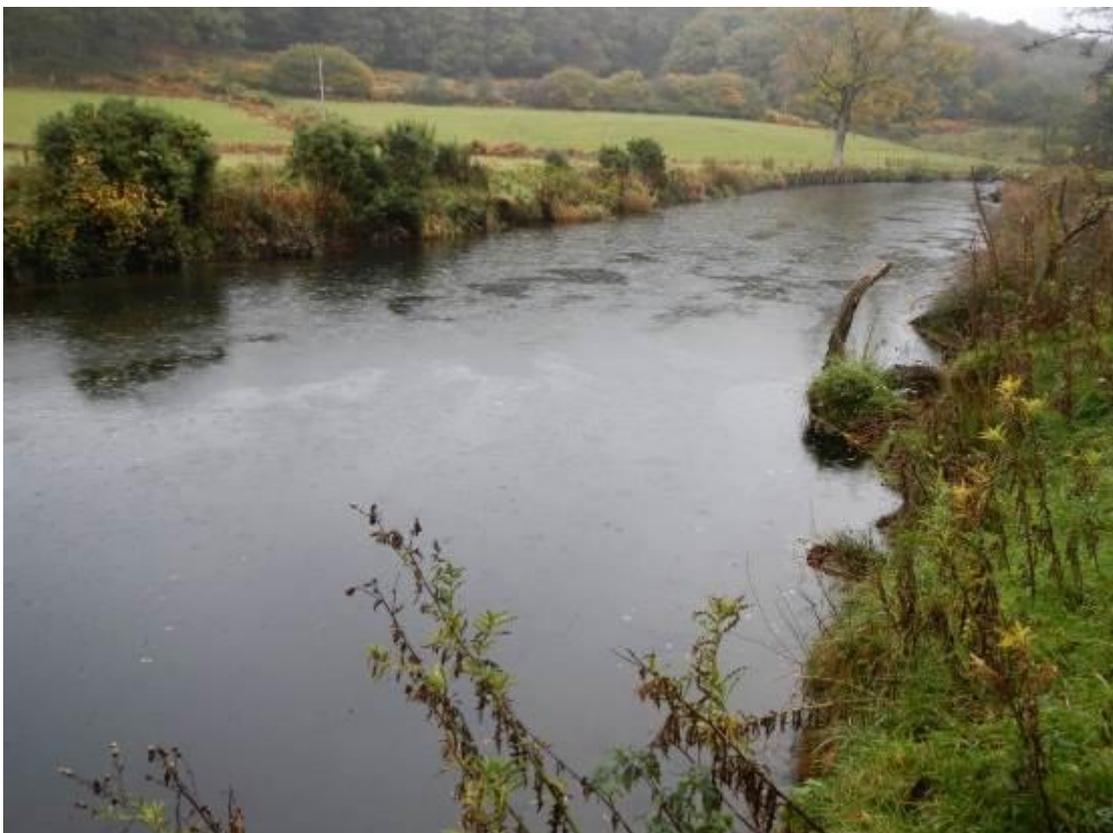
Figure 11. A long, straight, uniform pool that is lacking in-channel structure. Planting crack willow here that will eventually grow and fall into the channel would help to increase the fish holding capacity and enhance angling prospects.

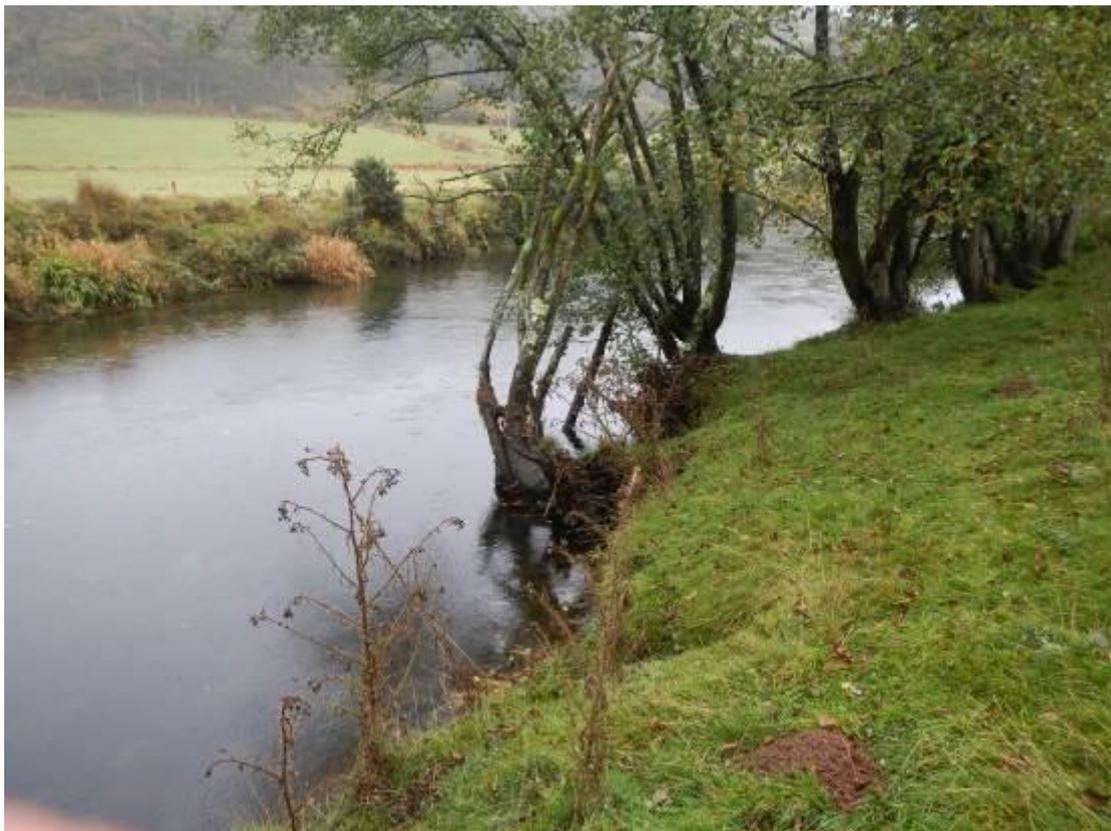
Figure 12. Ordinarily it would be recommended that only 1 in every 3 or 4 alder trees, or branches of a tree, are coppiced, to maintain habitat diversity. However, if fencing is installed to protect any regrowth, it may be beneficial to coppice all of the precarious alders along this section in the hope that they can be retained.

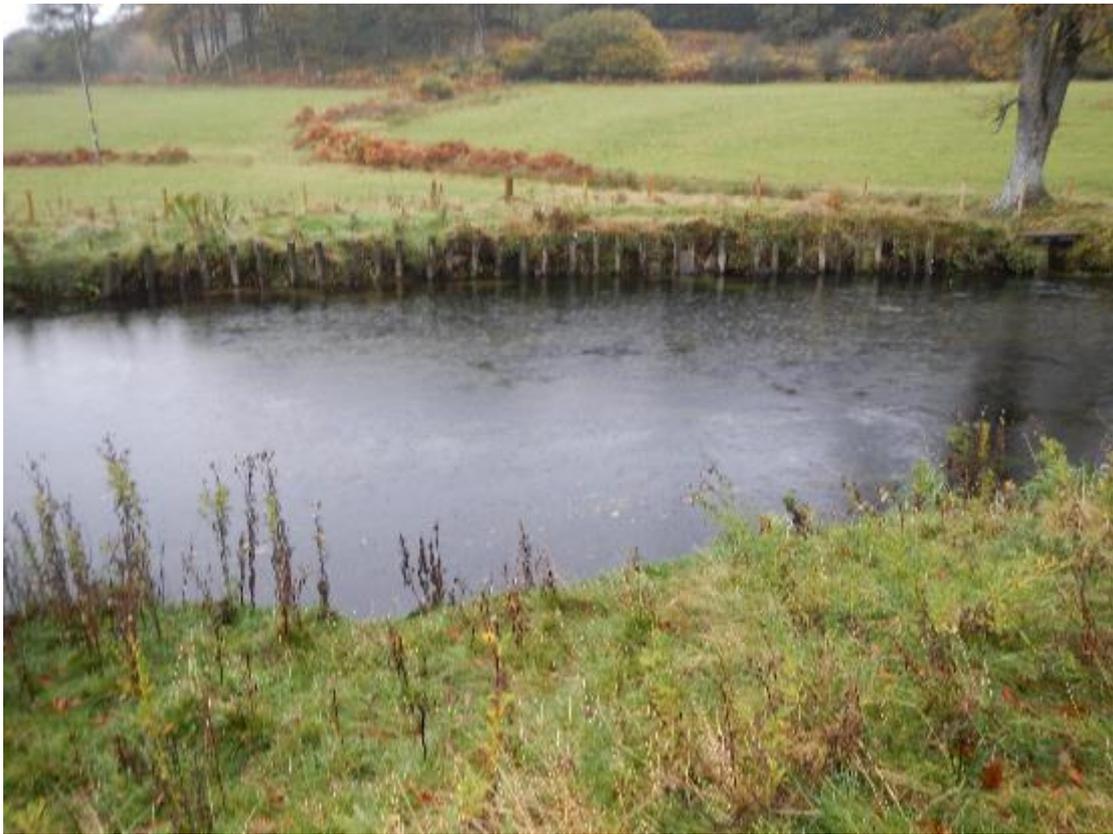
At the d/s end of the over-capacity channel section, remnants of past bank protection is evident and could form a useful anchor point for living willow tree kickers to be installed (Fig. 13). Cutting large willow branches from areas where they are numerous, and provide limited habitat benefit, and securing them between/alongside the existing posts should allow them to stay in place for long enough to become rooted. Backfilling any remaining gaps behind the posts with living willow and securing it all in place would also provide increased protection for that area of the bank once they start to grow.

Figure 13. The remnants of past bank protection could be used as a handy anchor point for securing living willow that would protect the bank and enhance habitat.

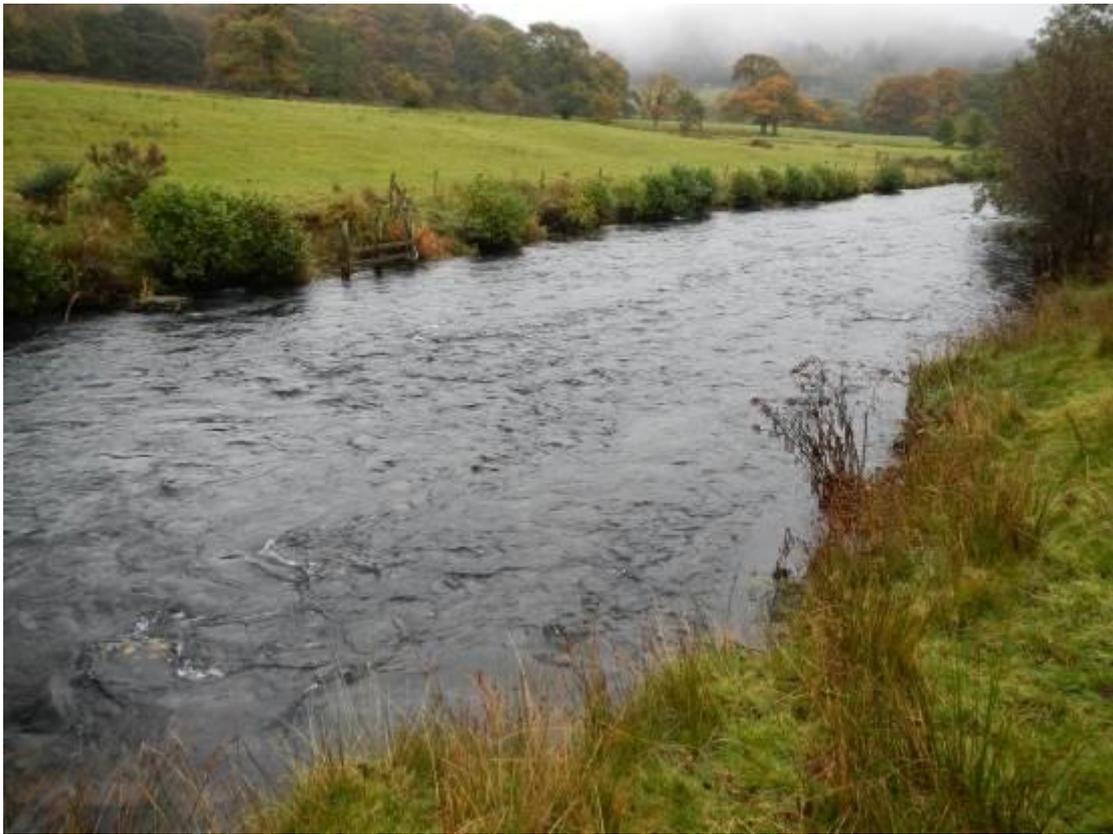
Figure 14. The long, straight, relatively shallow section u/s of Santon Bridge Weir. The area provides some good quality juvenile salmonid habitat and fishing water, but it could be improved by providing a few more over-hanging/trailing branches that come further out into the channel to provide cover and structure and respite from the high velocity flows.

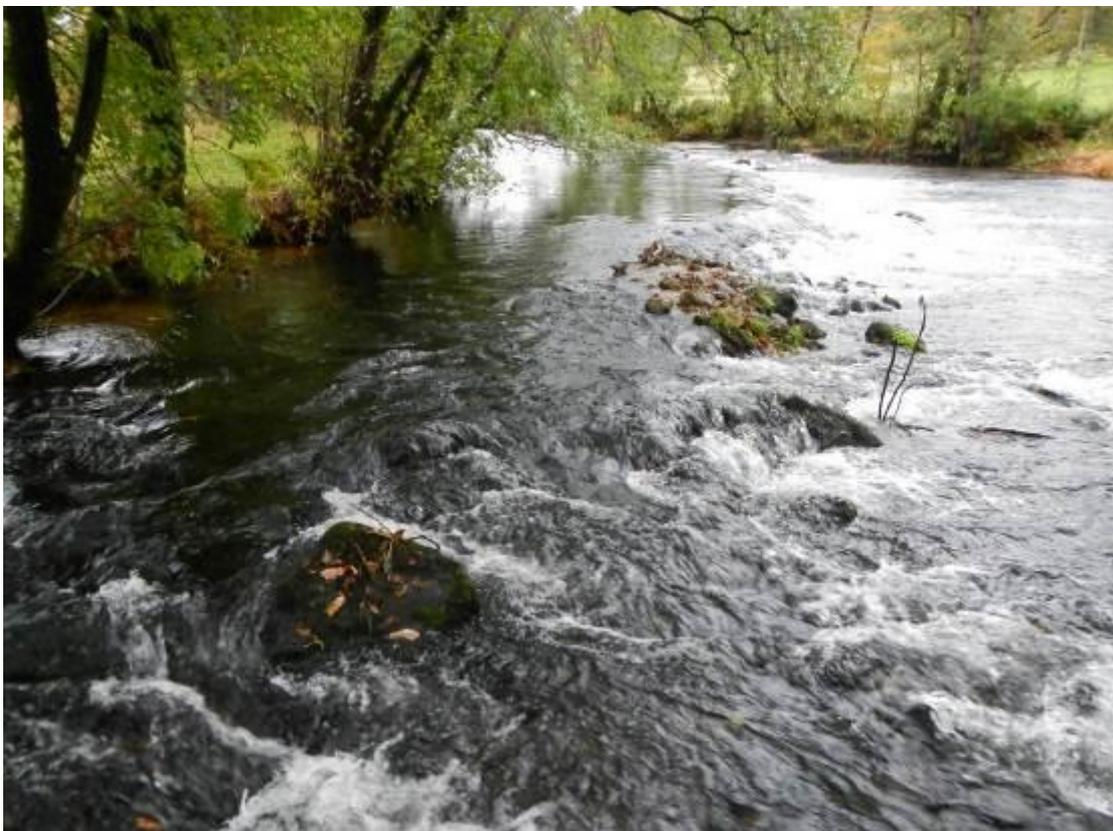
The weir at the d/s end of the section provides a small barrier to fish movement, one that u/s migrating fish may not ascend in low water conditions (Fig. 15). It is also likely to delay d/s migration of smolts and effectively forms a corral type structure that predators can trap fish against, greatly increasing the risk of predation. The weir also acts as a sediment trap (as all weirs do) interrupting the natural transport of coarse sediment, denuding the channel d/s of material and continually shallowing the pool u/s. With all of this in mind, the ideal situation would be to remove the weir, or at least a proportion of it ($\frac{1}{4}$ – $\frac{1}{3}$ of its length), down to bed level. Increased structure (trailing branches, etc.) within the channel u/s will provide higher quality habitat than that which is lost by removing the weir.

Figure 15. Santon Bridge Weir. A barrier to sediment transport and fish passage. At least the central $\frac{1}{3}$ of the weir should be removed to improve fish passage, reduce the potential for predation and reinstate natural sediment transport through the reach.

The only man-made barrier encountered on the river was the weir u/s of Santon Bridge. While this is not a major barrier to fish passage it is still a barrier that is likely to delay fish migration and place them at increased risk of stress and predation. It also negatively impacts upon sediment transport and will be resulting in continual shallowing of the impounded pool reach u/s. For this reason it is strongly recommended that at least the middle $\frac{1}{4}$ - $\frac{1}{3}$ is removed.

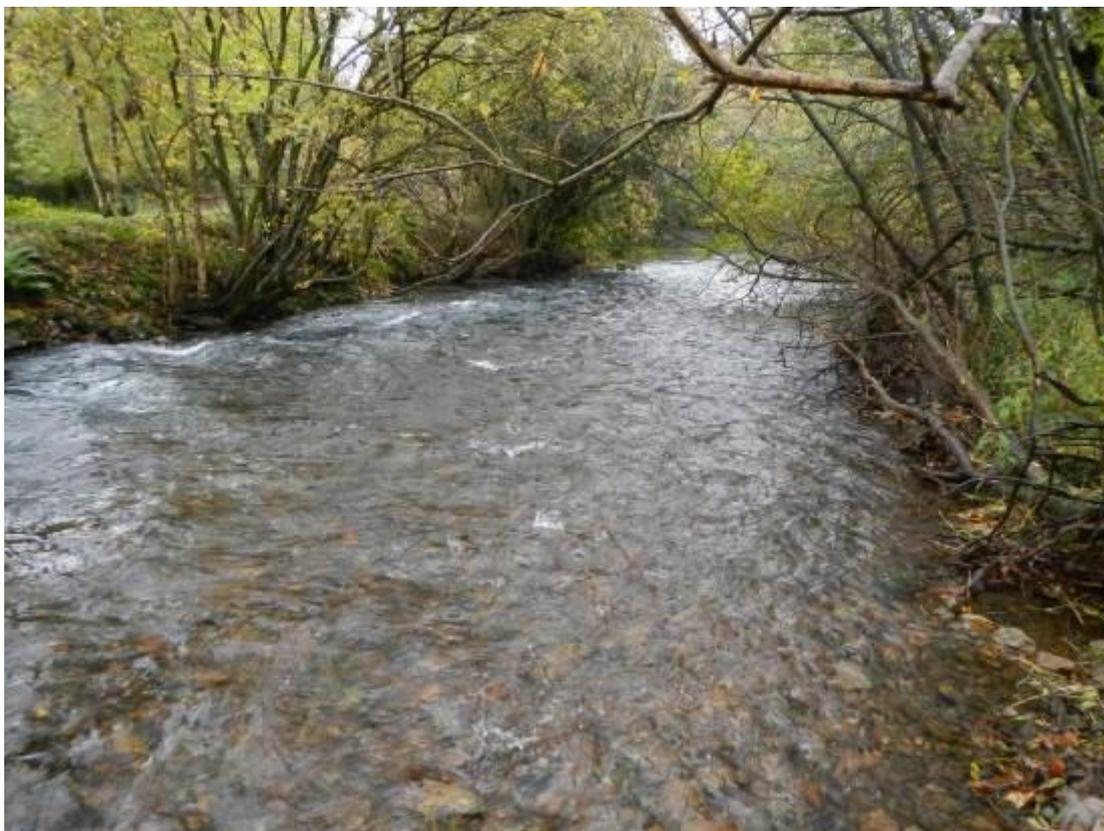
Figure 16. Relatively inhospitable habitat requiring extended periods of exertion to move u/s.

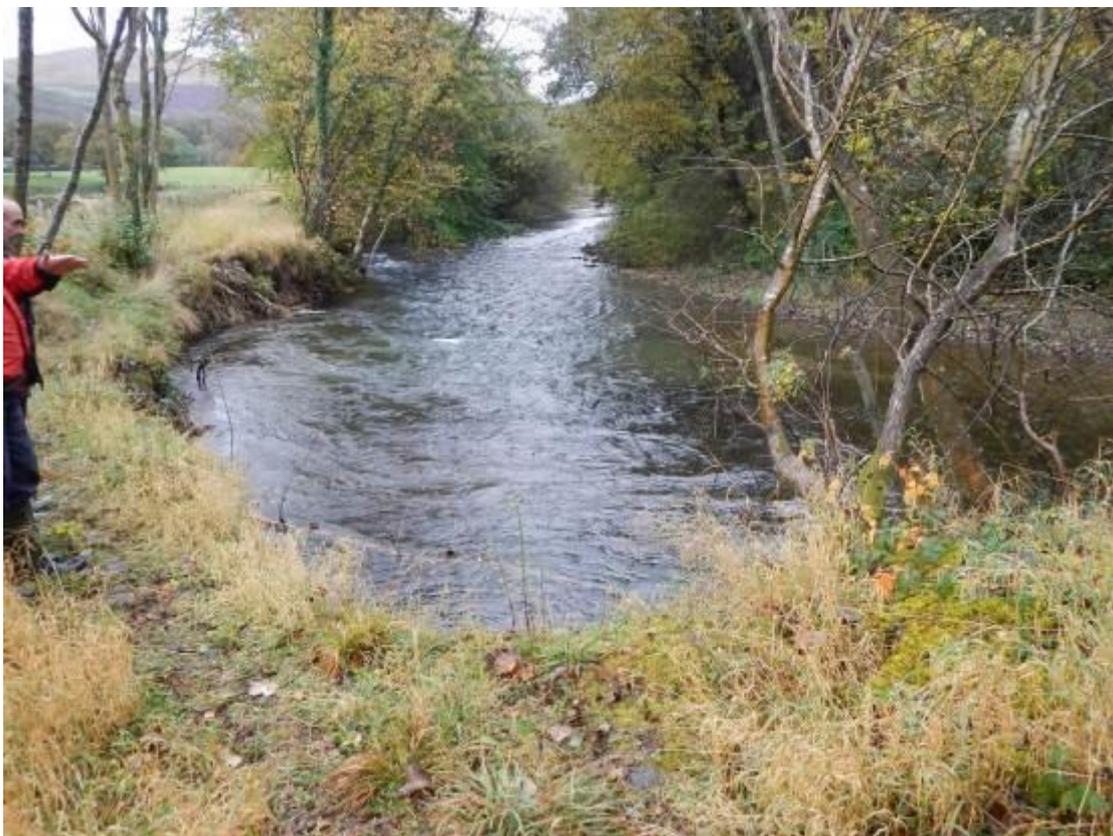
Figure 17. Significant erosion that is actually a very positive thing for the river and should, if at all possible, be allowed to continue.

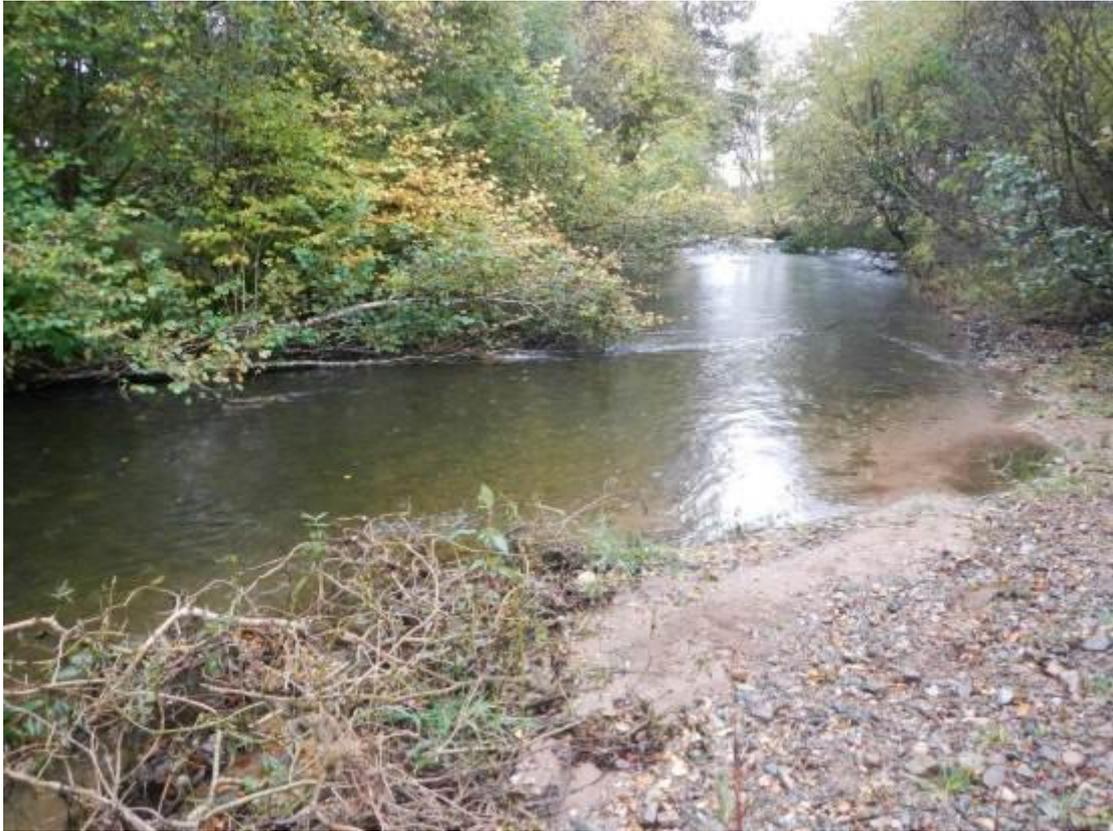
Figure 18. High quality cover on the far bank with deposition in the shallower water on the near bank naturally maintaining the channel width and depth at lower flows. The depositional areas also provide valuable substrate variation that benefits a range of invertebrates and lamprey, among other species.

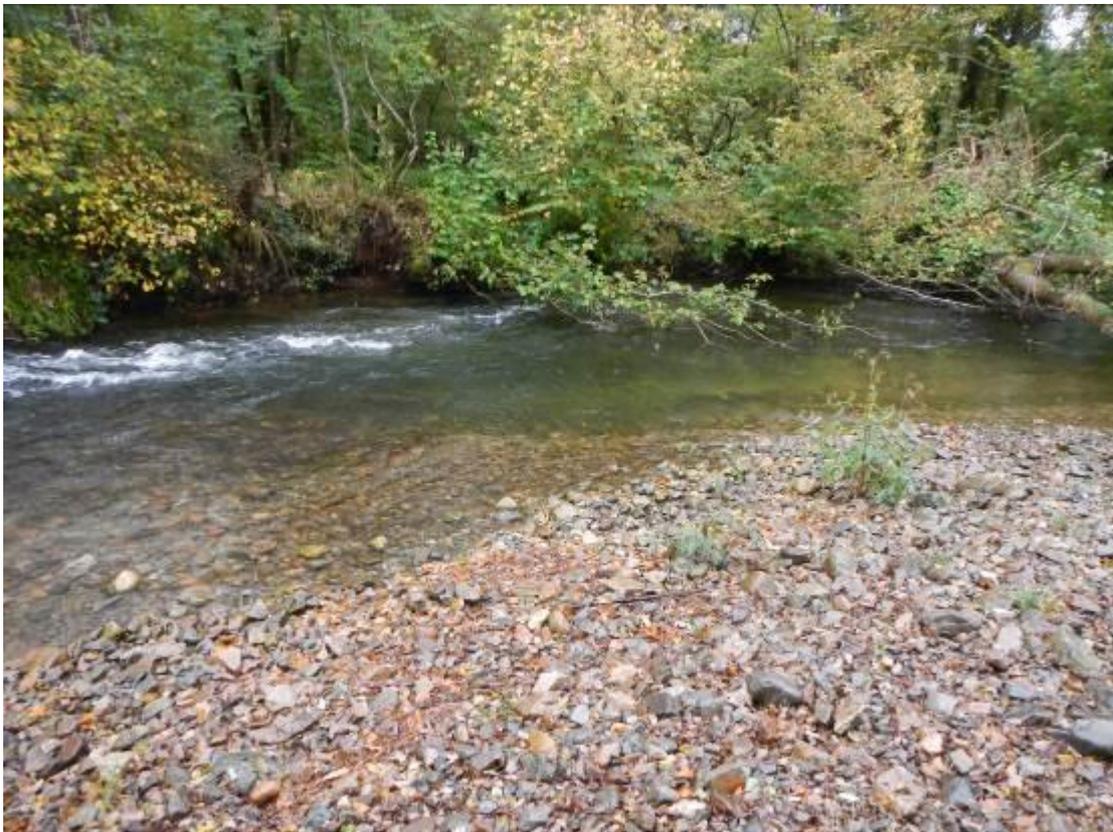
Figure 19. The start of a bend where the channel is naturally reinstating its sinuosity. Trees along the far bank naturally control the erosion rate and force scoring flows towards the bed, developing a valuable fish-holding pool.

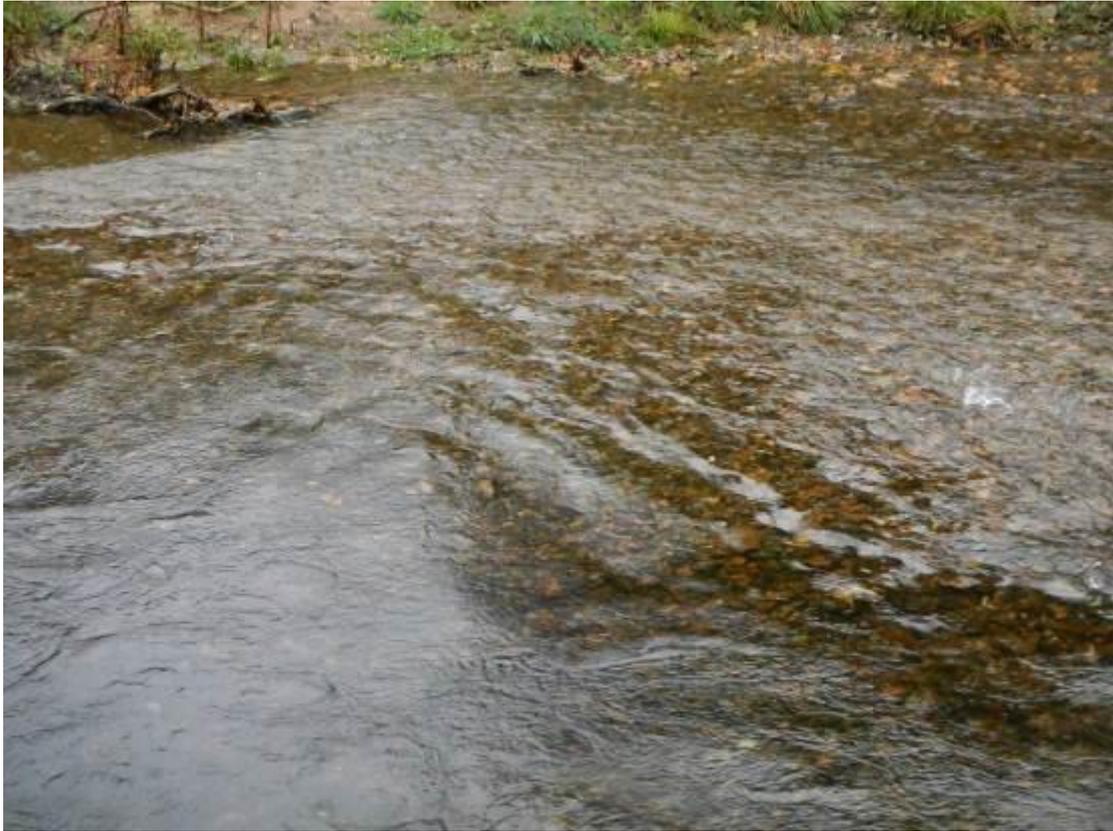
Figure 20. The reduced gradient and increased variation in channel width, resulting from a more sinuous channel and the dissipation of flow energy created by the pools and in-channel structure, allow valuable gravel and cobble substrate to be deposited, on which salmonids can spawn.

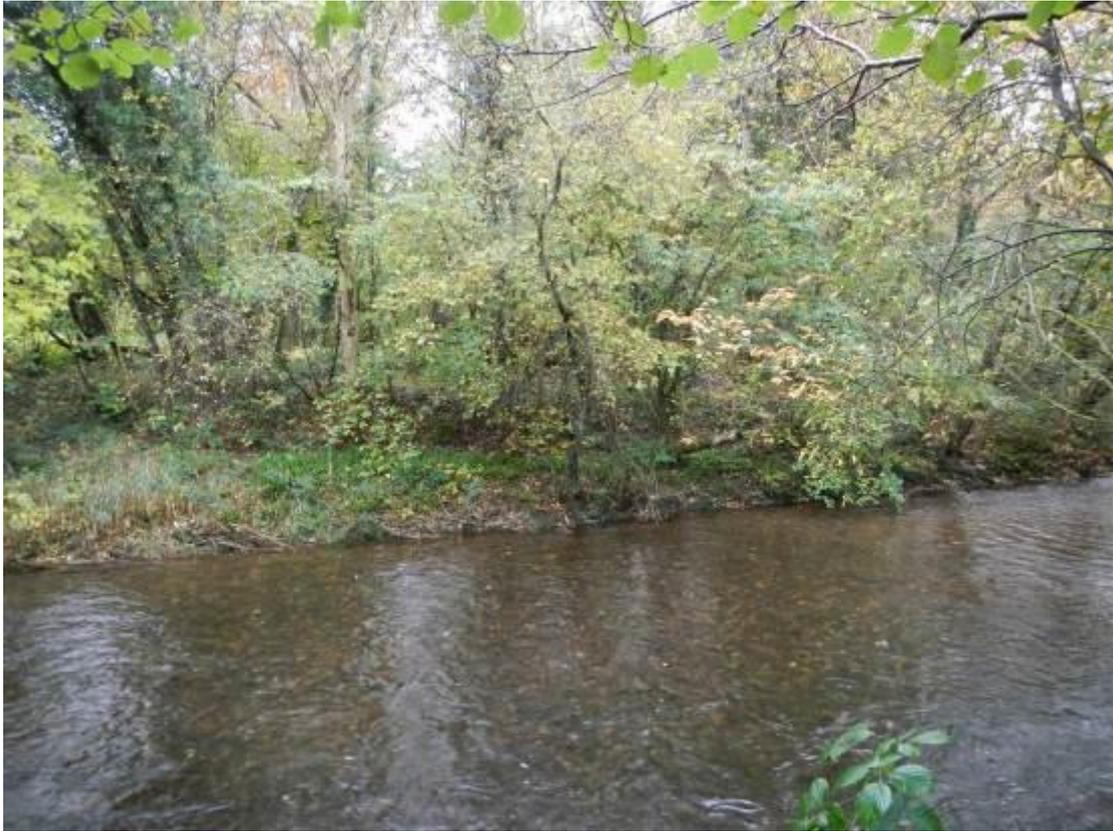
Figure 21. Slightly lower gradient d/s of the bridge provides improved habitat and some spawning potential, but the lack of cover and uniform channel dimensions remain an issue.

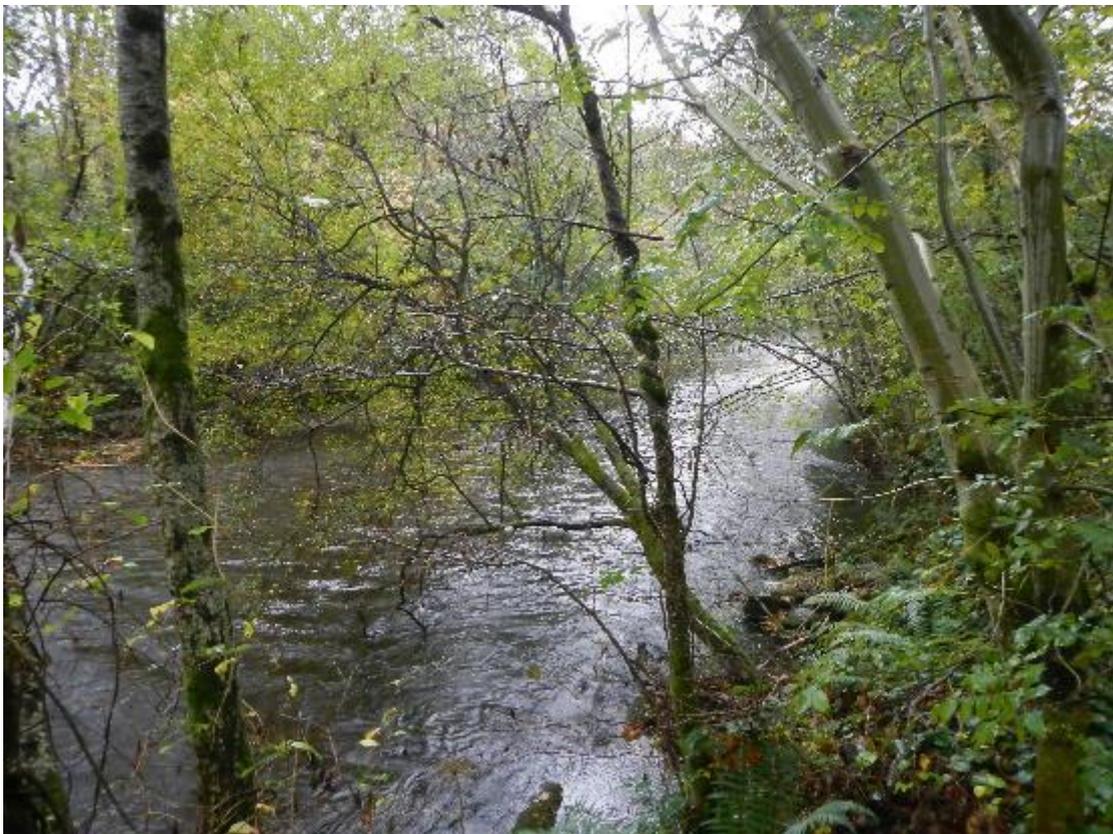
Figure 22. Laying some of the bankside trees into the channel would provide in-channel structure and enhance the habitat quality.
