Advisory Visit

River Irt

28/10/2015

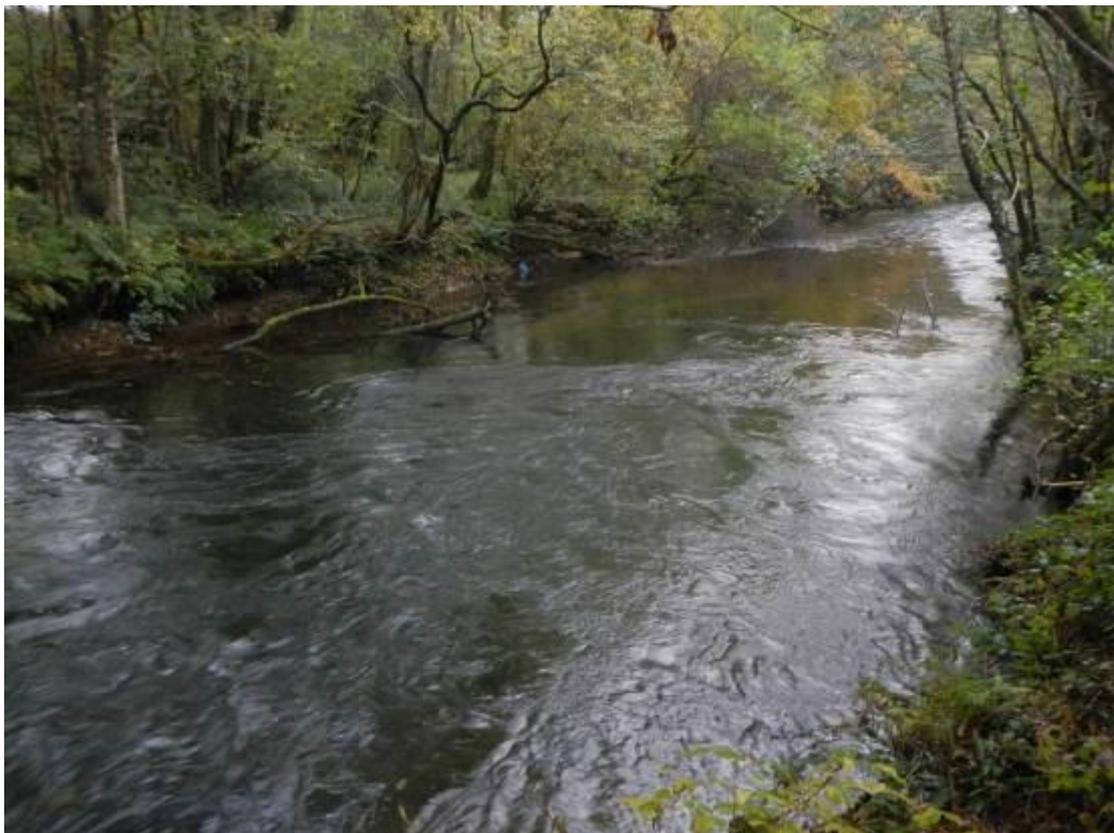
Figure 23. Bends provide increased depth and improved fish-holding water, and an input of woody material to the channel. Lateral erosion in these areas should be allowed wherever possible.

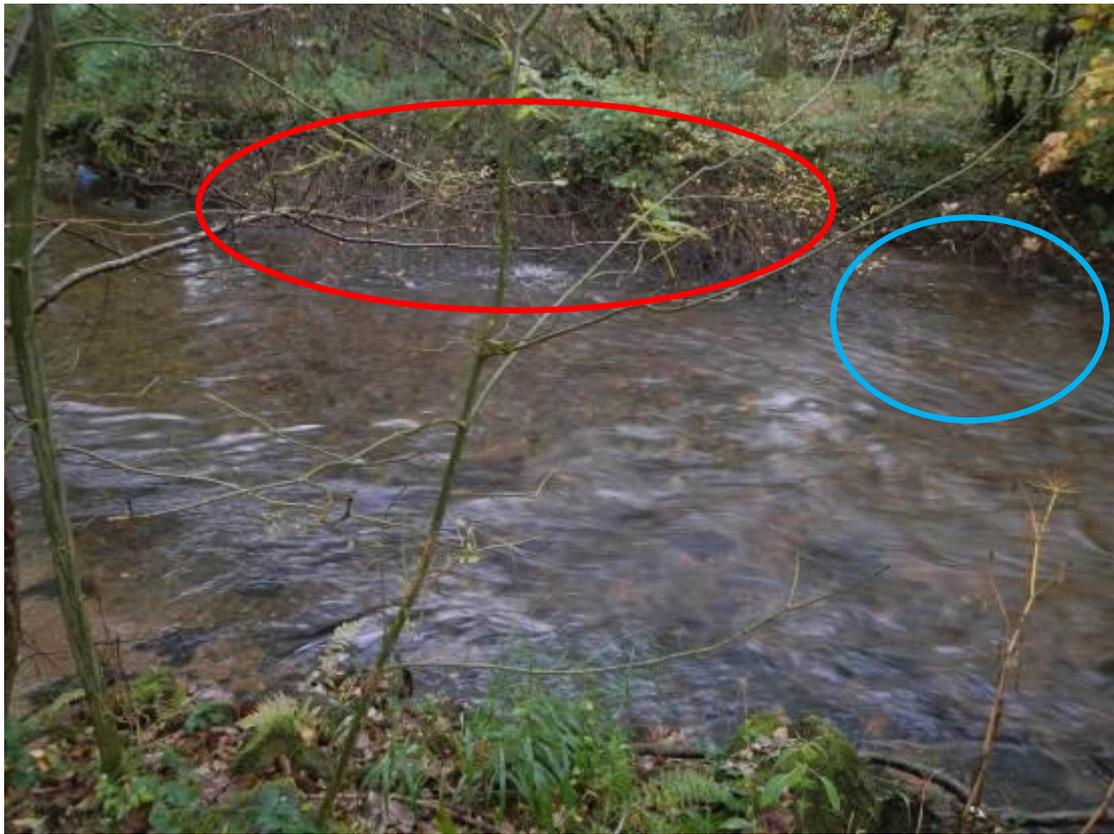
Figure 24. In-channel structure provides areas of flow dissipation (red circle) and slacker water (blue circle) where migratory fish can rest or resident fish can lie.

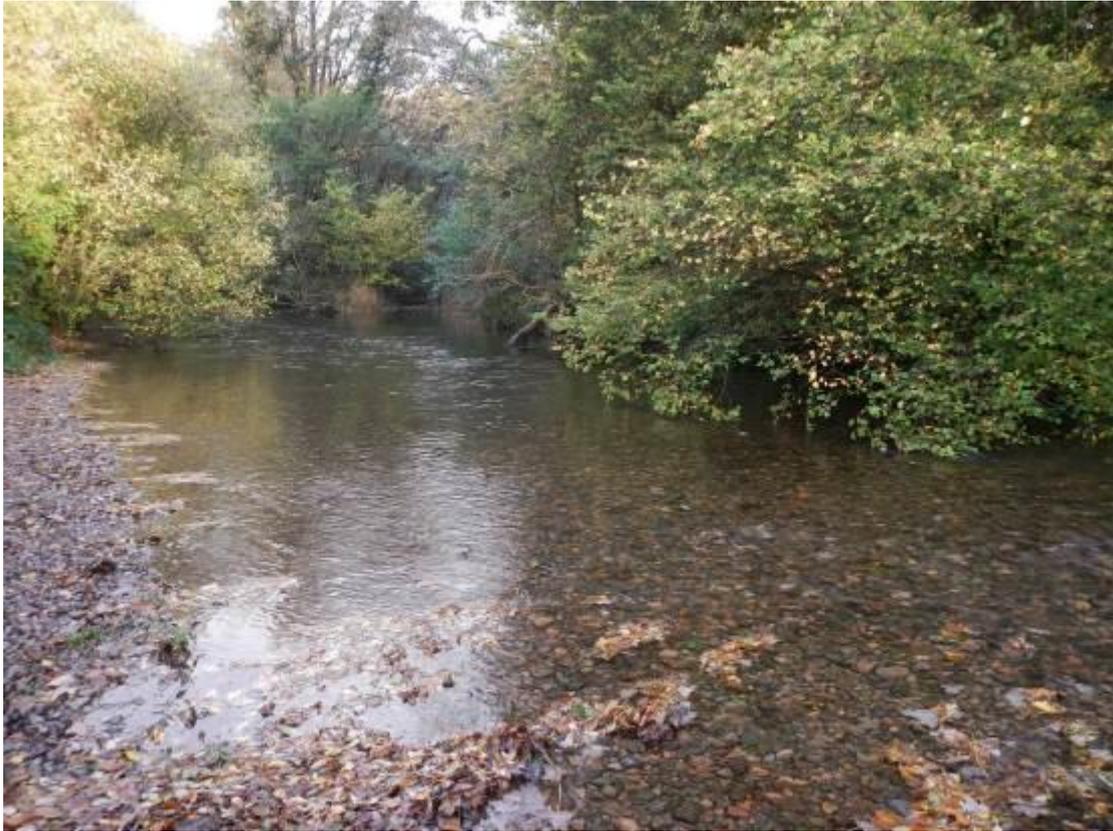
Figure 25. A lower gradient bend with abundant low/trailing cover provides high quality habitat and was one of the few area in which fish were observed.

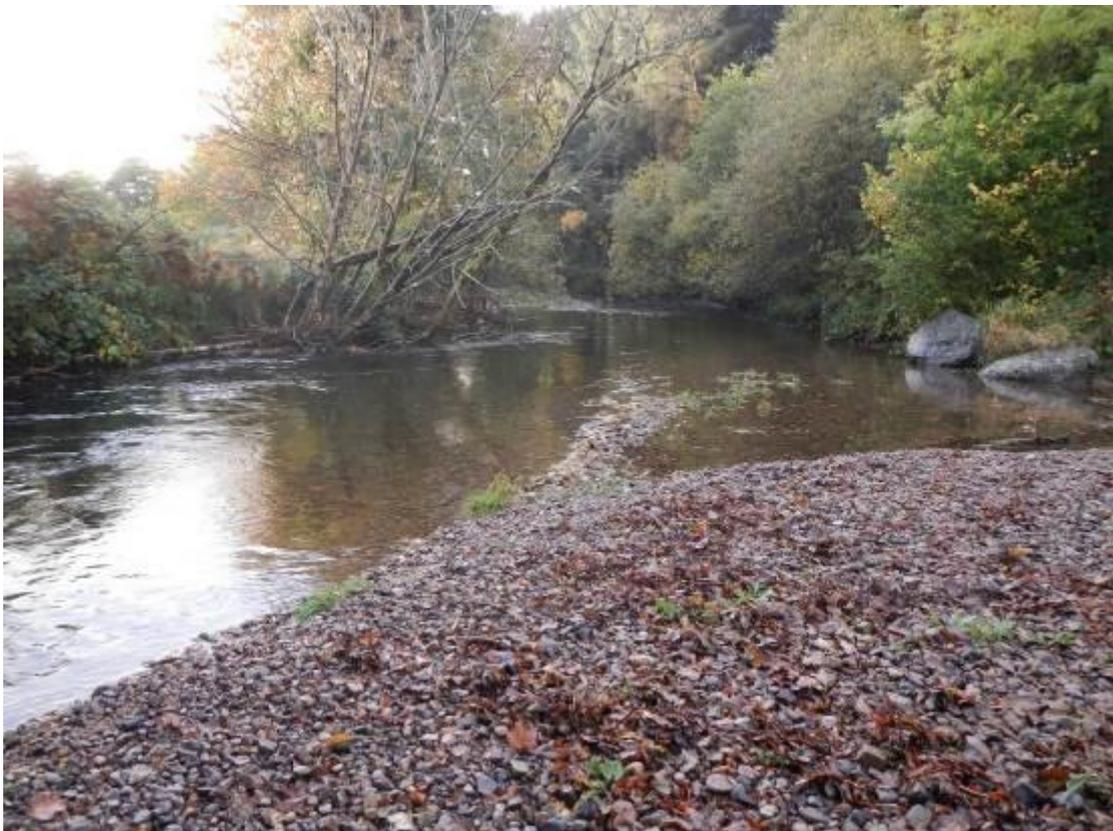
Erosion to the bank that effectively forms the boundary of the wood, before the start of pasture land is, again, beneficial to the development of habitat (Fig. 27). However, this is less likely to be acceptable to the landowner/tenant than allowing erosion within the confines of the block of woodland.

Figure 26. Erosion to the bank at the edge of the woodland is beneficial from a habitat perspective, but may not be acceptable to the landowner/tenant.

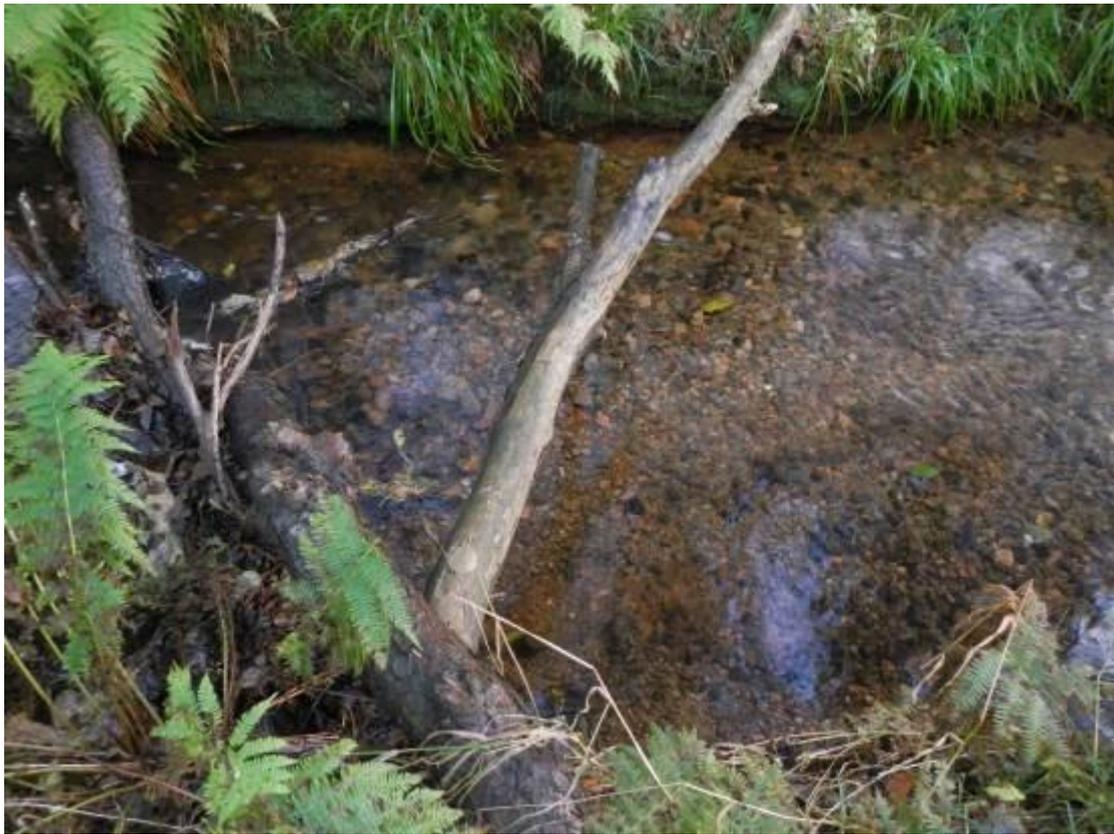
Towards the d/s limit of the section walked, a small tributary enters the river (NY103037) and provides ideal spawning habitat for smaller sea trout and resident trout, along with valuable juvenile habitat. Woody material within the channel further enhances this habitat by creating discrete areas of scour and deposition, naturally cleaning the gravel by sorting the substrate into different particle sizes (Fig. 27).

Figure 27. Good quality spawning and juvenile habitat on the small tributary.

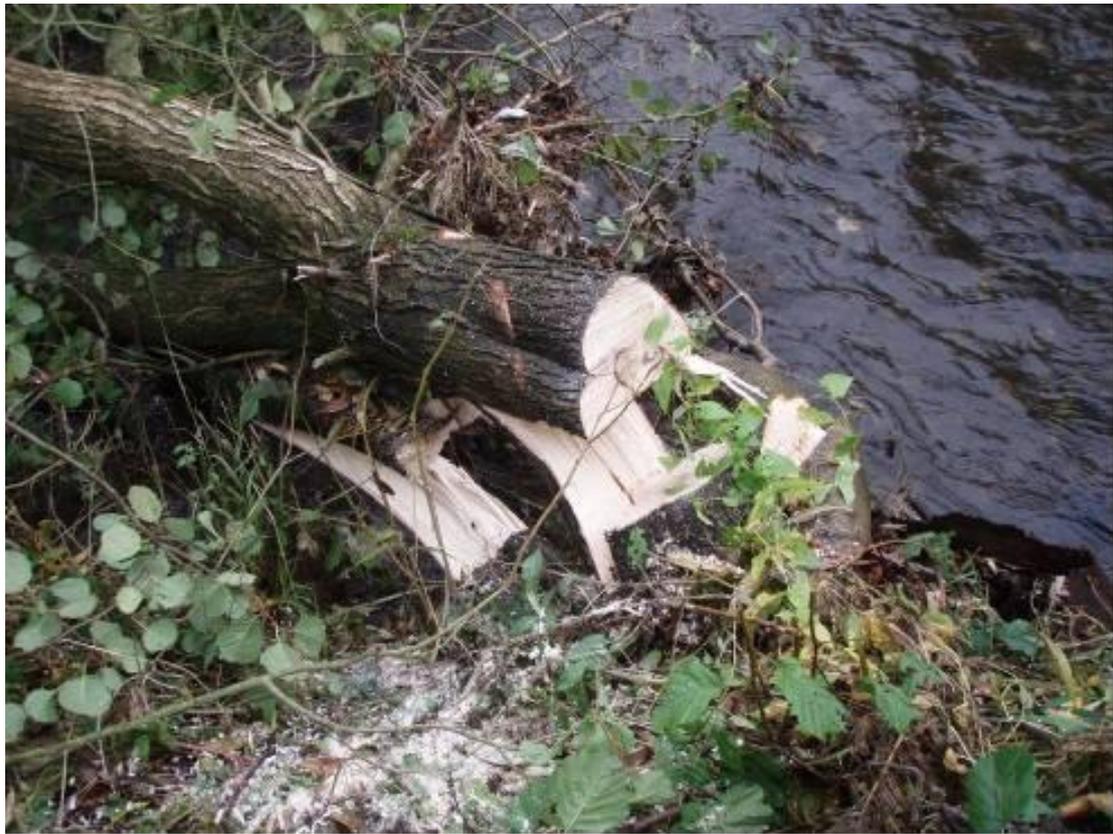
Photograph 28. Hinged willow.

Where easily manipulated tree species are already established along the bank, habitat improvements can be easily achieved by laying the trunks, or selected branches down into the watercourse to increase low cover and in-channel structure. Ideal locations include those depicted in Figures 6, 7, 8, 9 & 22. Small to medium shrubs tend to work best, although quite large willow such as those in Figure 28 can be successfully laid.

The process involves cutting part way through the stem/trunk, a little at a time (like laying a hawthorn hedge), until it can be forced over into the channel (Figures 28 & 29). The depth of the cut should be limited to only that which is required to bend the limb over, as this will retain maximum strength in the hinge and maintain the health of the tree/shrub. Alternatively, on smaller shrubs cutting the stem/trunk at a very shallow angle and then putting an axe blade into the cut and hitting it with a hammer can also help the laying while retaining a good strong hinge.

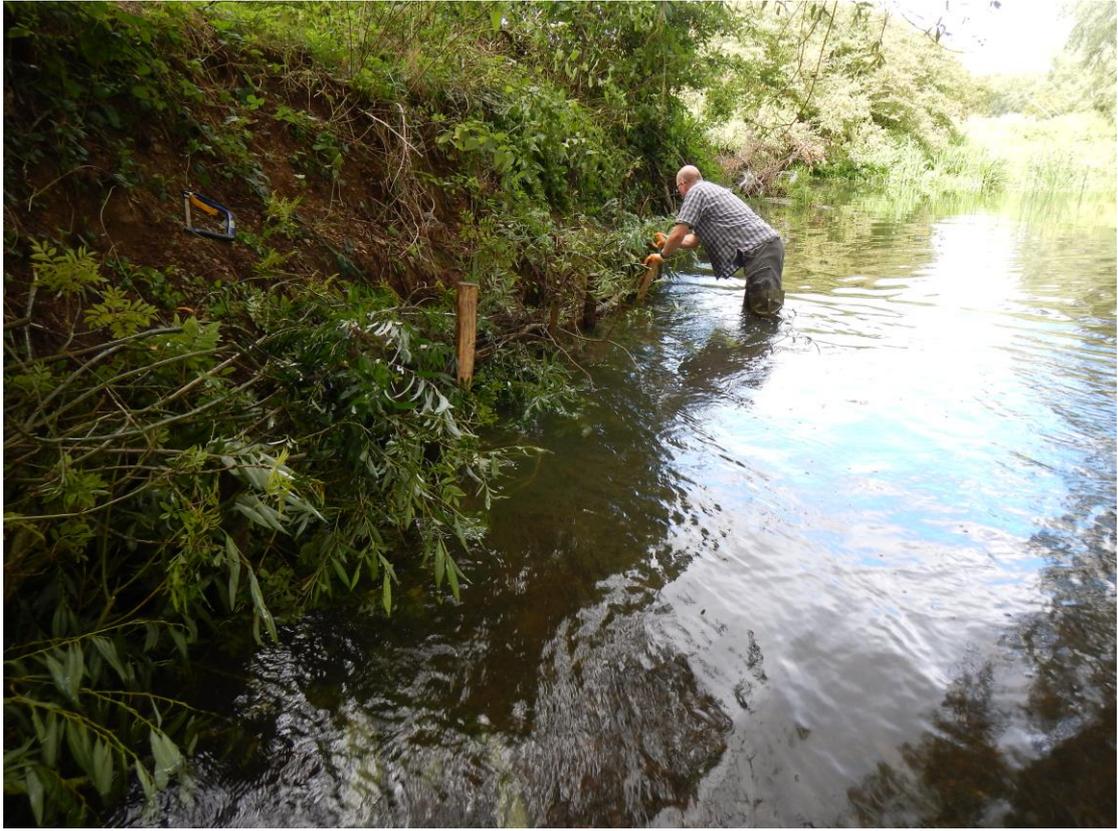
Figure 30. A volunteer on a Wild Trout Trust practical workshop installing a live willow brush bank toe protection.

In areas where bank erosion is not likely to be acceptable or is resulting in excessive fine sediment input to the river, soft bank revetment techniques such as installing a brash toe (Fig. 30) and / or brash mattress (Fig. 31) may be beneficial to protect the bank and improve marginal habitat. This could be applied to the location depicted in Figure 8; however, a much less intensive and more natural solution could be to simply undertake tree planting well back from the current, eroding bank line. Those trees would then form the future, higher habitat quality bank line when the channel migrates to them. Over-capacity pools d/s of the erosion are likely to trap much of the eroded material and limit any negative impacts it may cause.

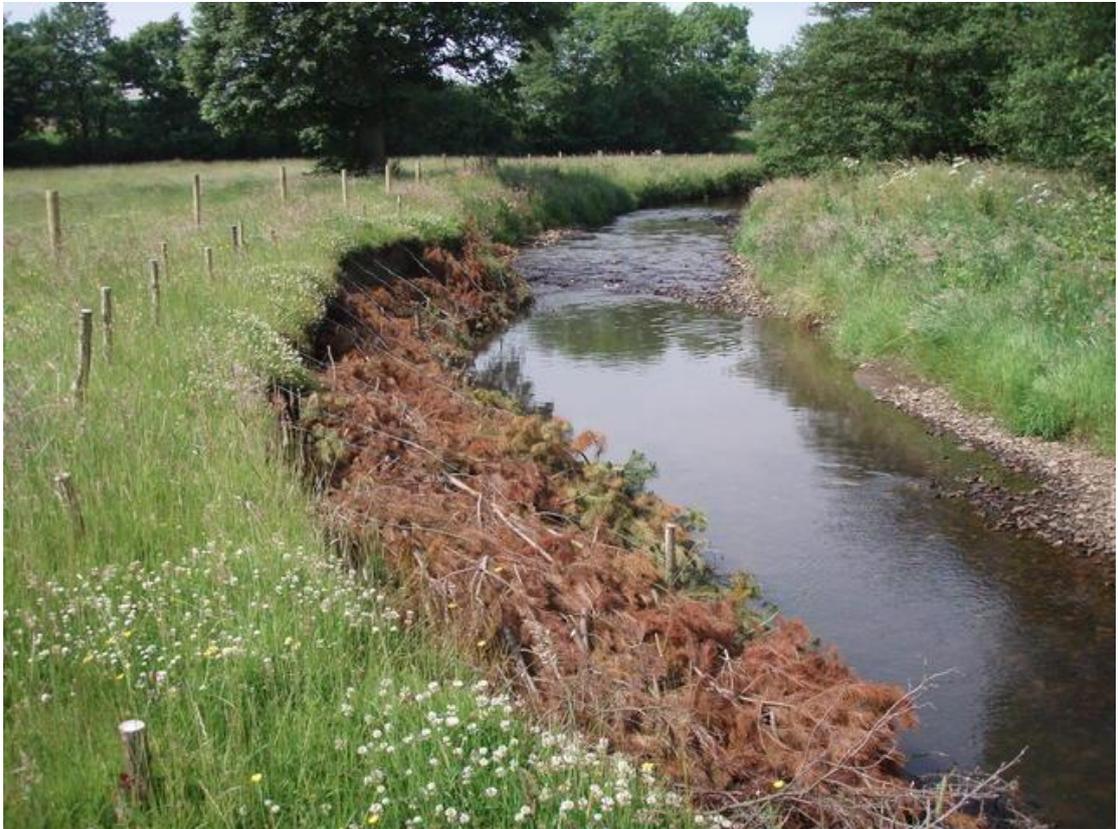
Figure 31. Conifer brush mattress bank protection.
