Advisory Visit
River Leven
(Skutterskelfe Anglers)
26/11/2019

Undertaken by Gareth Pedley (WTT)

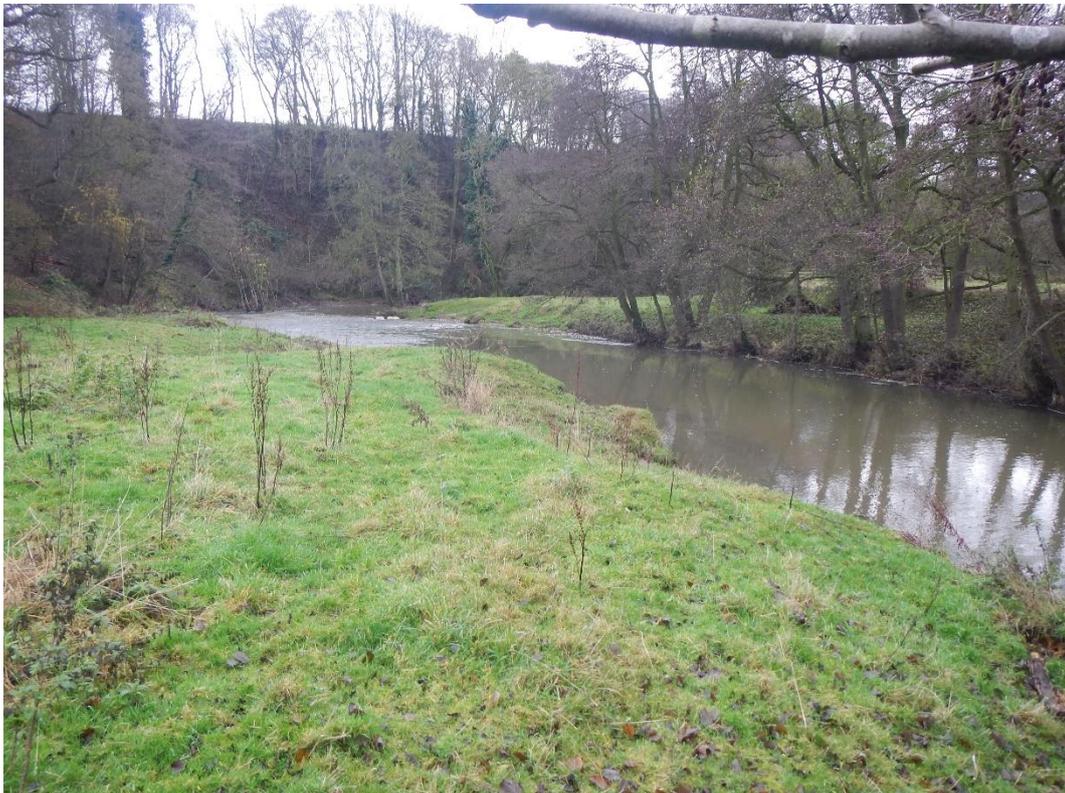
The first section inspected was towards the downstream end of the fishery, around Sexhow Hall Farm. In this area, the banks appear to be relatively stable, with no major erosion issues; however, the unfettered livestock access and grazing pressures creates a distinct paucity of bankside vegetation. Buffer fencing would allow the development of a diverse strip of vegetation, greatly improving the general habitat for invertebrates and improve the river margins for juvenile fish. Very importantly, it would also allow for some natural tree regeneration, which is almost completely absent, with all the trees observed being veteran. This is a particular concern when considering the relatively short life of alders, which were the predominant species. Where present, trees currently provide valuable shade, and bank protection, cover/structure, flow diversity by their roots, and the habitat would be notably poorer without them. As such, any temptation to prune or remove low branches should be resisted.

Figure 1. Good quality trout habitat along the far RB, with alder trees providing shade and cover around their roots. Note the distinct lack vegetation diversity on the near bank and lack of tree generation on either, owing to the grazing.

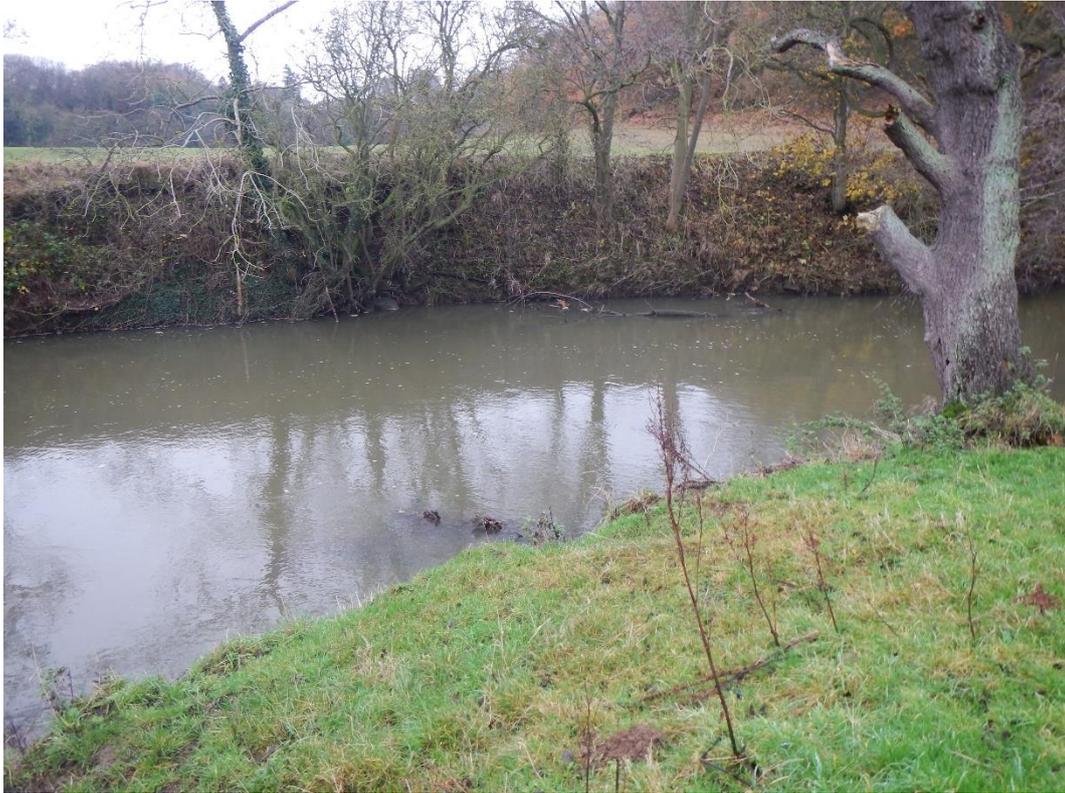
The habitat in this area is further improved by woody material in the channel which provides structure, flow deflection/diversity and refuge from high flows and predators. Many clubs remove woody material during work parties to keep the river looking tidy. This is a mistake, the more structure and cover that can be provided, the more fish and greater range of fish sizes the river can support. Retaining such structure is therefore essential and is by far the easiest option for achieving high-quality habitat.

Figure 2. Retaining fallen woody material as structure within a channel greatly enhances habitat quality. The old, partially rotten tree (right of shot) is also worth retaining. Standing deadwood provides valuable habitat for invertebrates and birds, and a source of woody material to the river when they do fall.

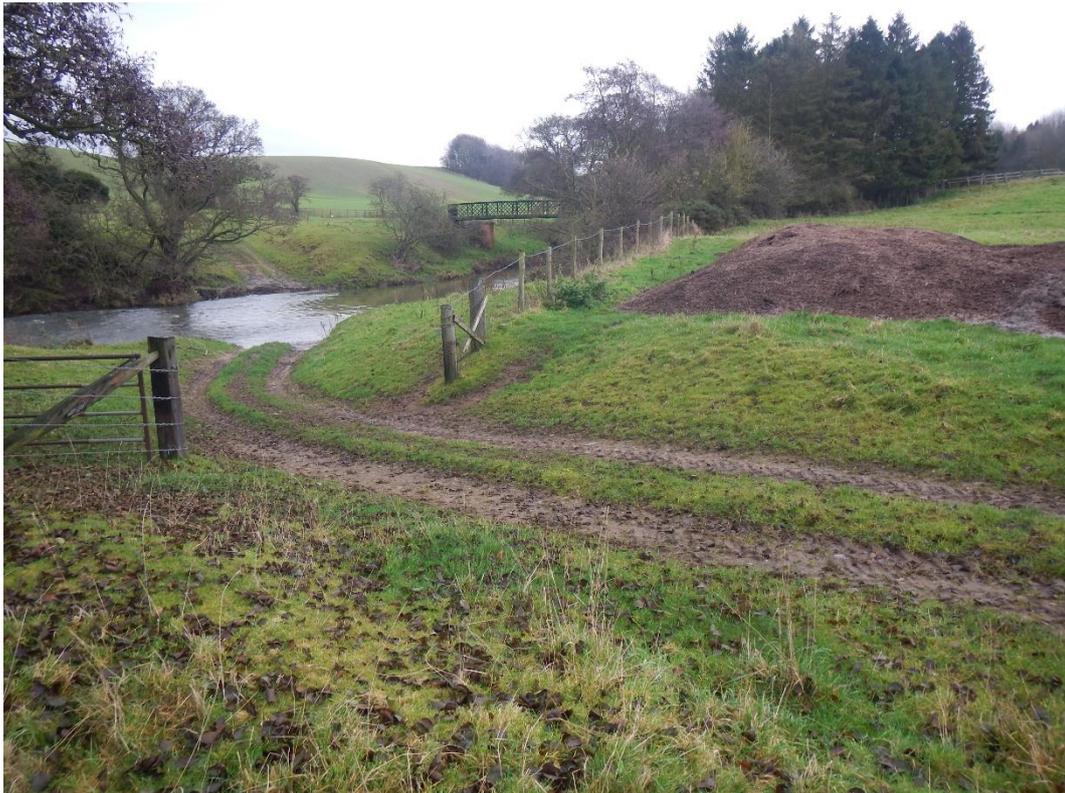
Towards the upstream end of the first field, a few obvious land management issues were observed (Fig. 3). The buffer fence that should be protecting the LB has clearly been left open for a considerable time, as evident by the lack of vegetation either side of the fence line. This could simply be a failure to appreciate the importance of a well vegetated buffer for habitat development and subsequent bank protection, but it could be easily rectified with support from the farmer. Resolving the fencing issue would also reduce the impact of the track, which is pathway for surface run off, and the muck midden at the bank top. The distance of the latter should be a minimum of 10m from the river under the new Farming Rules For Water (www.gov.uk). Whether it is the full 10m away was not confirmed, but its proximity to the track (and potential pathway to the river) and watercourse is not advisable, especially when almost any other location in the same field would offer far greater protection. The far, RB would also benefit from fencing.

Figure 3. Several issues require resolution: the nearside (LB) buffer strip is being grazed, the far bank is un-fenced, and the track and midden create potential runoff issues.

- Tackle invasive species on the catchment like Himalayan balsam and mink.
- Seek reinstatement of livestock exclusion to the existing buffer fenced area depicted in Fig. 3. Seeking voluntary agreement from the farmer to relocate the midden would also be beneficial.

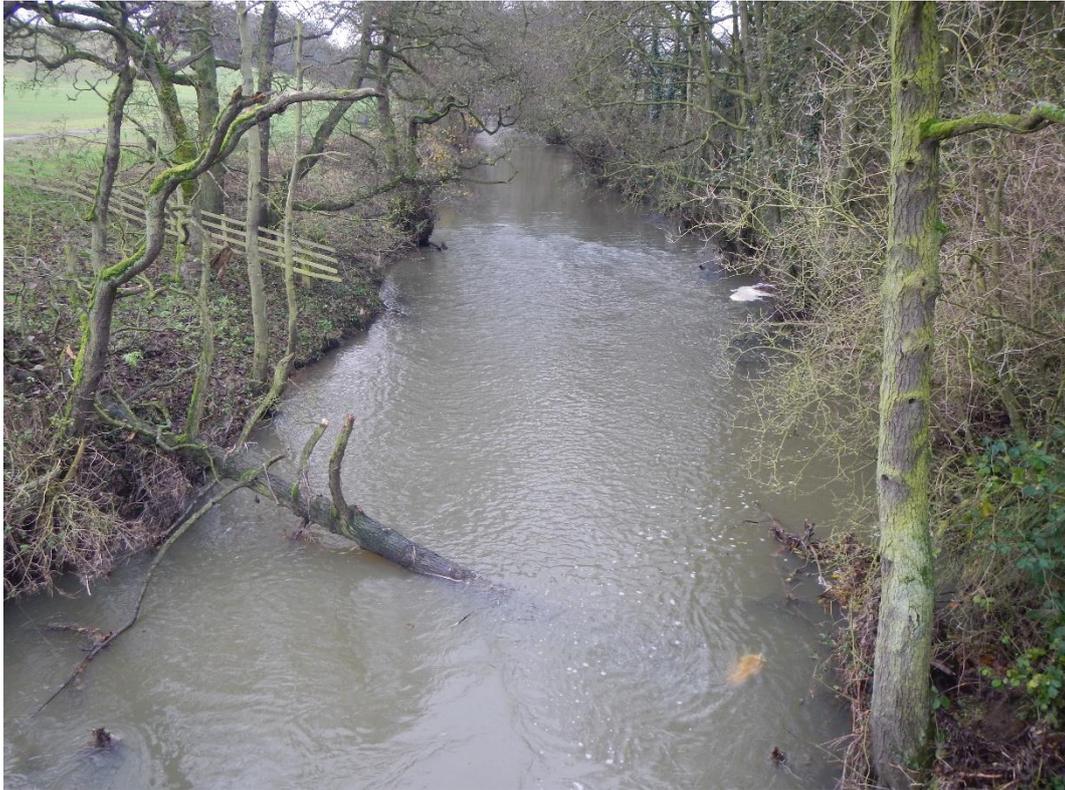
Upstream of the bridge, the channel is unnaturally straight and highly incised for an extended distance, adjoined by a relatively tight canopy of trees down either bank (Fig. 4). While this creates some over-shading for a short distance, it is not considered a problem as the mature tree canopies are beginning to find a balance. Retaining some shaded sections is always going to be beneficial, regulating water temperatures and providing areas that will still fish in bright conditions.

The roots of the bankside alders provide significant habitat opportunities, with each tree creating additional trout lies, increasing the number of fish the river can hold and providing interesting features to fish. Woody material accumulated in the channel provides additional cover and flow deflection. A large tree trunk diversifies surface flows, supplying an increased number of potential food lanes, creating a variety of lies for individual fish. At higher flows, the more significant flow deflection will drive scour into the bed, creating and maintaining deeper scour pools. The complexity of the habitat in this section partially mitigates for the lack of channel sinuosity and the habitat quality is surprisingly good; testament to the high value of bankside trees and an abundance of in-channel structure.

Figure 4. An unnaturally long, straight channel section that retains sufficient structural diversity to provide some high-quality trout habitat, despite the lack of channel sinuosity.

Highly selective coppicing, perhaps only one or two carefully selected trees over the 250m section could be beneficial, to let a little more light in on the shallower water sections. This could encourage weed growth and promote some low-level regrowth of tree branches. It would also provide woody material that could be installed to the channel, replicating the natural structure in Figure 4. However, this work is far from a necessity.

One or two of the trees along the incised reach identified in Fig. 4 could be coppiced to let some light in and reinvigorate low-level bush regrowth. This should ideally be undertaken within the dormant season to greatly reduce the potential for killing the tree – one of the trees is a multiple stem, which does limit the risk.

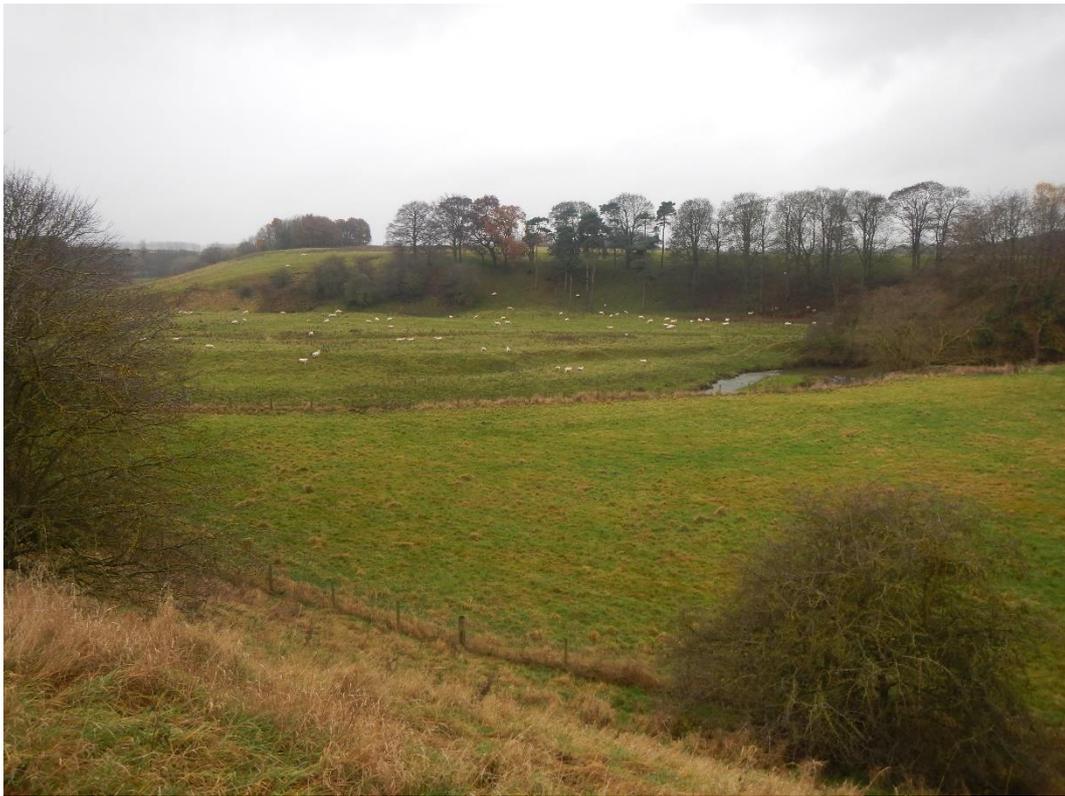
Around the large weir at NGR NZ 48253 06893, the LB has been buffer fenced and could offer an opportunity for undertaking some tree planting (saplings or willow whips) to provide more cover in the open section (Fig. 5). Areas of the RB have been fenced, but sheep have free access to an area on the inside of the bend and the quality of riparian vegetation is reduced as a result. Fenced and un-grazed, largely tree-lined sections upstream and downstream provide much better habitat.

Figure 5. The LB buffer fence downstream of the weir provides improved riparian vegetation and offers an opportunity for undertaking tree planting, but the unfenced RB is heavily grazed and would benefit from further fencing.

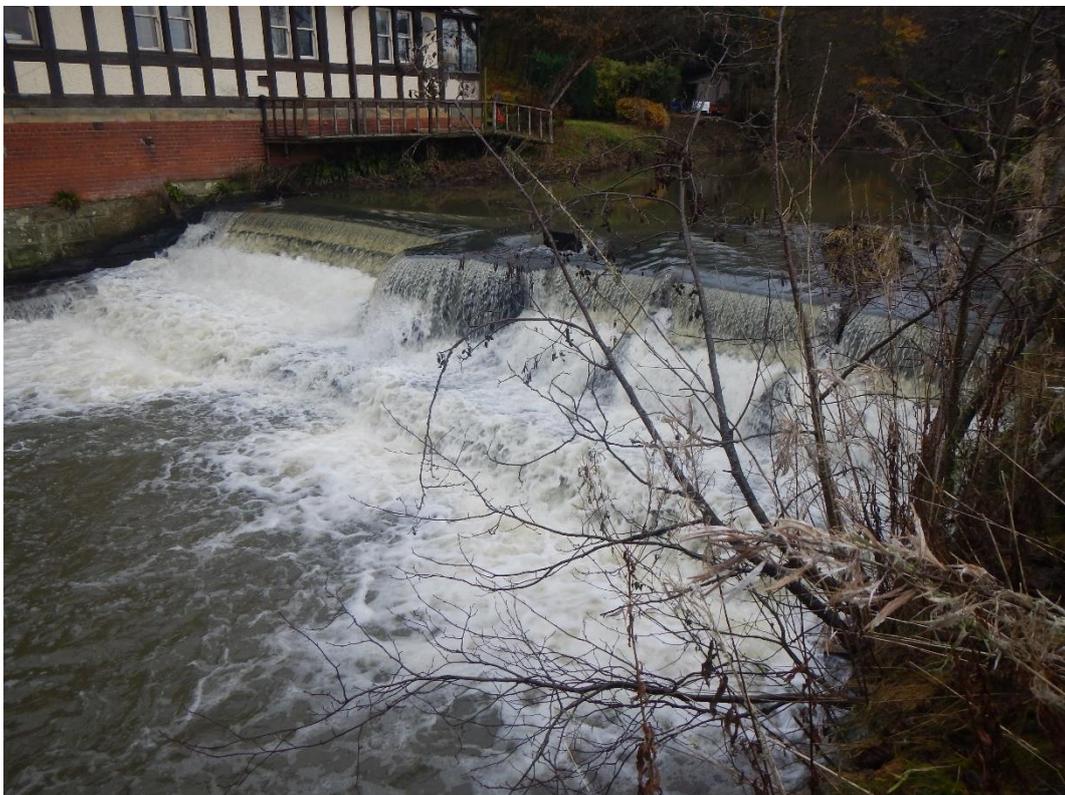
The weir is one of the greatest issues for habitat quality and connectivity on Skutterskelfe Angler's water and is likely to have one of the greatest impacts upon fish populations. The weir is impassable in all but the highest flows and, even then, only to a small proportion of trout and salmon, greatly inhibiting their distribution and utilisation of the habitat around the catchment. Such a large weir creates a significant impounded reach upstream, degrading several hundred meters of the habitat for rheophilic (flow-loving) species such as trout, and many of the invertebrates upon which they feed. The impounded reach also creates a notable obstruction to downstream migrating fish, be they brown trout dispersing around the catchment, or salmon or sea trout migrating to sea. The impounded reach is also easy hunting ground for predators like cormorants and goosander within the deeper, open water. Increasing the availability of structure within this reach would provide at least some protection and habitat enhancement and a fish pass could provide assistance to fish movement but prime habitat cannot develop with the weir in place.

Figure 6. The weir creates a major obstruction to both upstream and downstream fish passage, also degrading several hundred metres of habitat upstream within the impounded reach.

One of the greatest issues is undoubtedly the weir and associated impounded reach upstream. Ideally, options to remove the artificial structure should be investigated. It is understood that Tees Rivers Trust are already looking into options for improvements at the location and it would be in the interests of all local anglers to support that work. Improvements could be made to fish passage with a pass or easement, and within the impounded reach by installing additional in-channel structure but it would not be a substitute for entirely removing the offending weir. Other improvements to fish passage would also be highly beneficial, including removal of the weir on Faceby Beck and improvements to the road crossing at the downstream end of Potto Beck (as highlighted in the Hutton Rudby report).

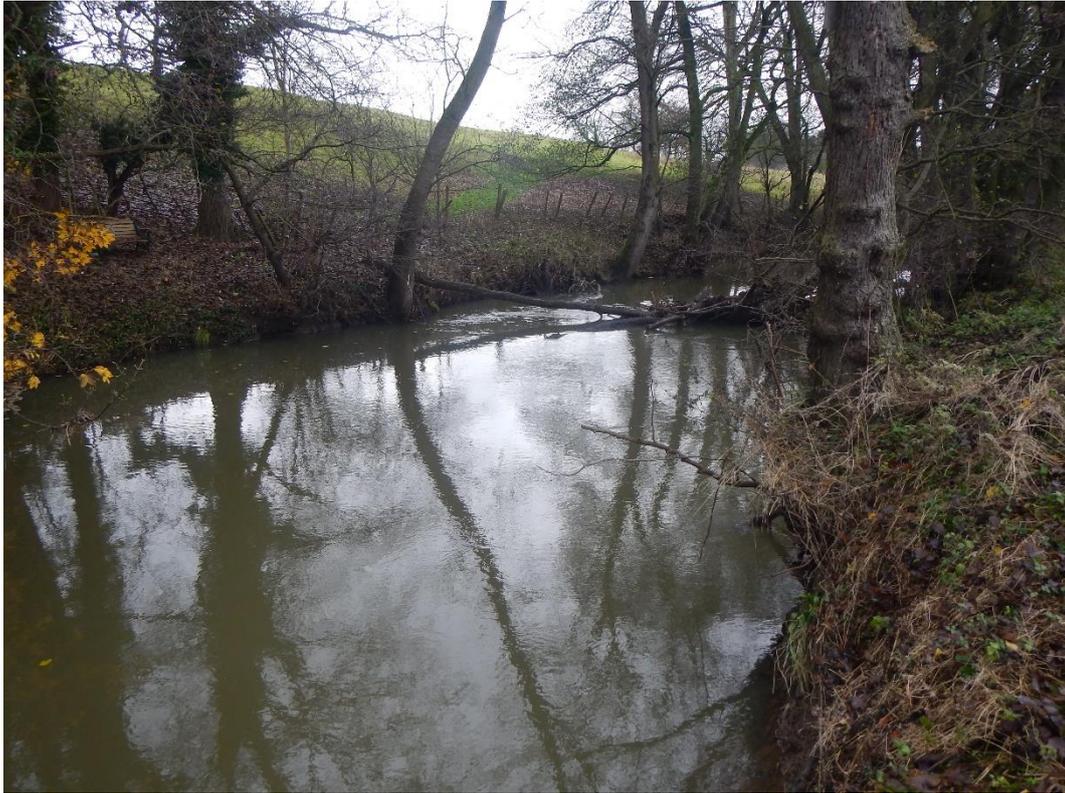
Figure 7. Naturally occurring woody material within the impounded reach introduces some flow diversity, but the slow, overly deep water is uncharacteristic of what this area of the catchment should be like and provides comparatively poor habitat for trout and invertebrates. A relative abundance of trees in this section could provide material for in-channel structure to partially mitigate the homogenous habitat created by the weir.

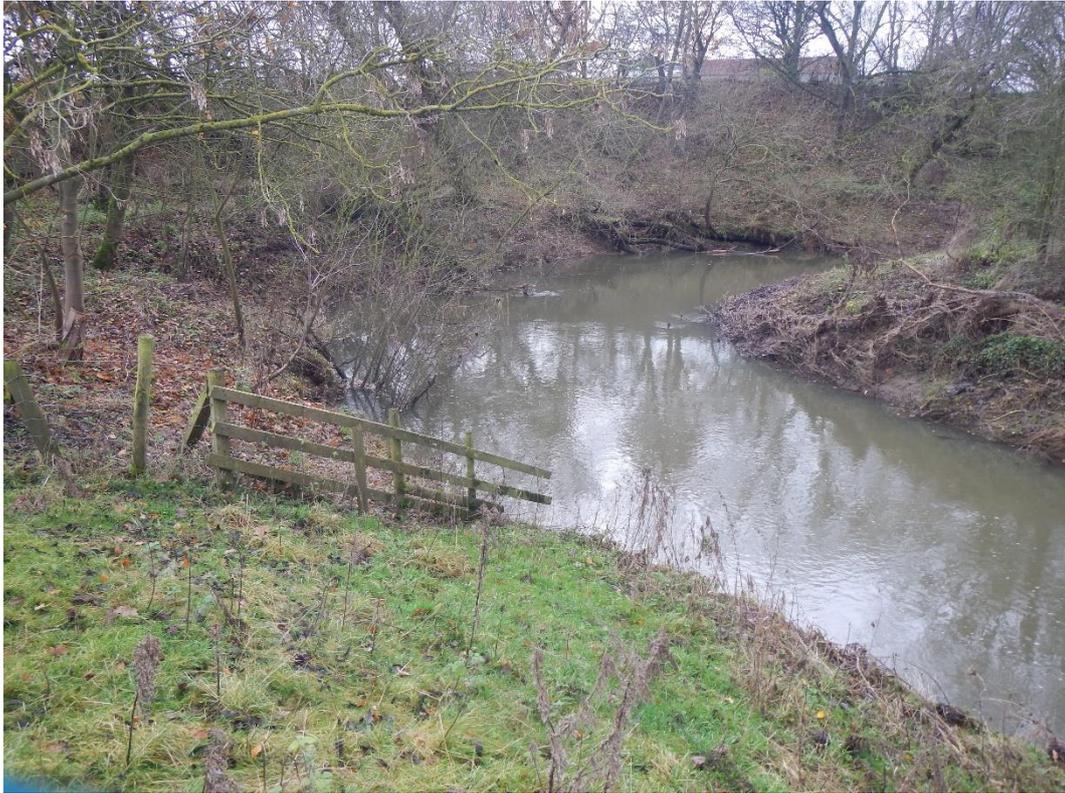
The final section visited was downstream of Faceby Beck, around the upstream limit that is fished. A tight bend with wooded LB provides good adult trout habitat; the kind of area that always has the potential to turn up the odd larger trout (Fig. 8). Trees (live and fallen) within the margins greatly enhance the habitat and create valuable flow diversity. A large fallen tree spanning the entire width of the river had been lodged at the bend until recently but apparently was moved by the last high-water event. This nicely demonstrates not only the habitat benefits of a hands-off approach to river management but also a financial one. The tree will have provided excellent cover habitat within the channel, almost certainly also creating bed scour and developing the pool during high flows before it moved on. A free habitat enhancement that would not occur if such material is artificially removed or altered, even before any cost (time and/or money) associated with removing it. A further added benefit being that the material is retained within the river somewhere to provide further habitat enhancement.

Figure 8. A naturally deep bend, with plenty of cover. Unlike the impounded depth created by weirs, the free flow found in natural pools maintains hydromorphological processes, facilitating the natural adjustment of the bed, maintaining depth and allowing the natural conveyance of water that supplies food to its residents, as well as making the water an interesting place to fish.

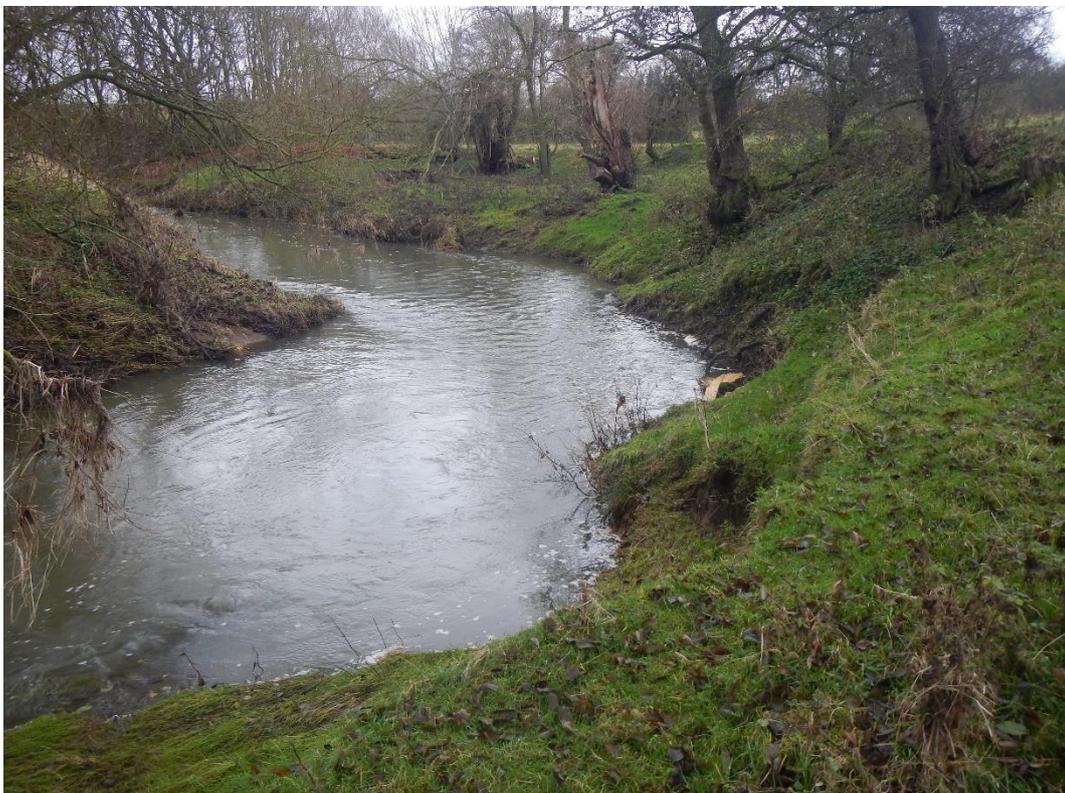
The RB is naturally well vegetated in this area, improving bank stability and providing cover. The LB is unfenced and open to grazing. This has clearly led to bank instability, as evident by erosion bays and attempts at rock armoring of the LB (Fig. 9). While this bank still remains relatively stable, it would be highly advisable to exclude livestock and reinstate more natural stability to prevent the near certainty of major erosion in the future.

Figure 9. An outside bend that has previously been protected with rock. While this area remains relatively stable, it would be advisable to exclude livestock. This would facilitate regeneration and/or planting of native deciduous trees that will further assist in protecting the bank and provide replacements for the now veteran alder trees that are currently protecting the bank but are likely to be getting towards the end of their lifespan.

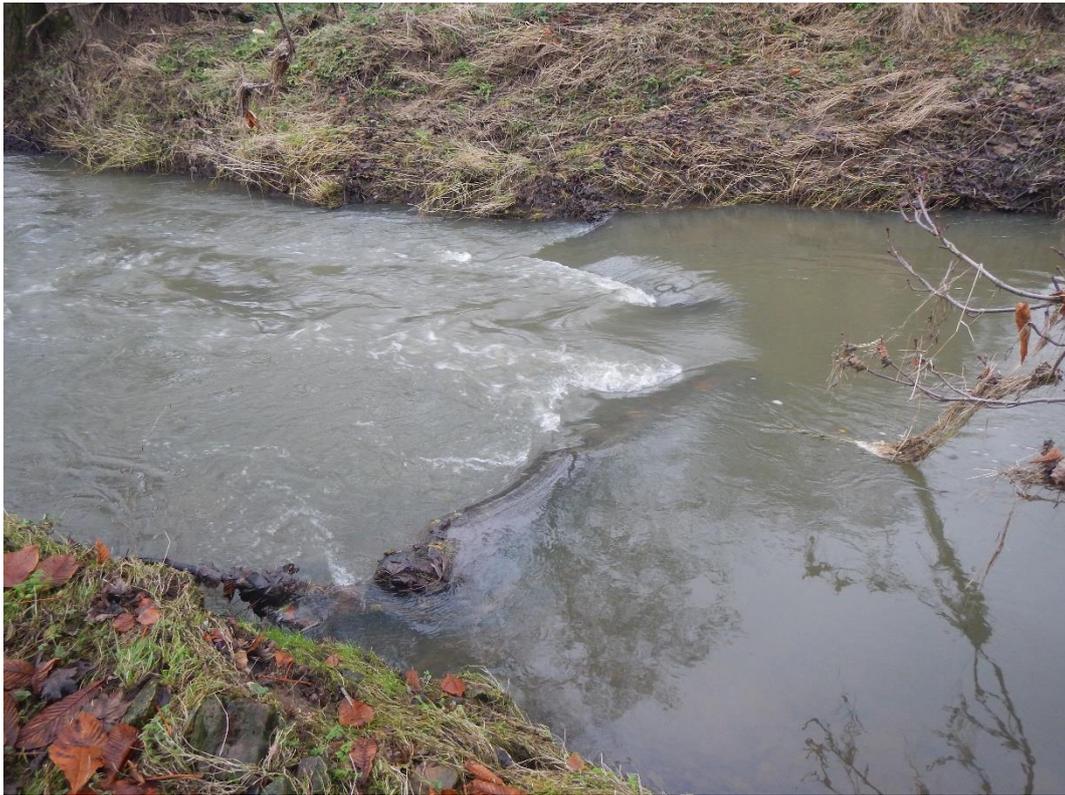
Several in-channel habitat structures were observed in the channel, towards the upper limit. Owing to the high-water conditions, it was not possible to ascertain their purpose as the area of the channel appeared to be naturally diverse already and not necessarily requiring additional structures. Lower flows may have revealed a specific purpose, but it is important to recognise that the natural lifts towards the tail of a pool (where these structures are located) are vital habitat in their own right, providing gravel areas for salmonid spawning and shallow water for juvenile fish.

Figure 10. Paired, upstream-facing deflectors. Their purpose at this location in the channel was not completely clear in the high-water conditions. Such features may have been more beneficial within the artificially degraded, impounded section upstream of the weir.

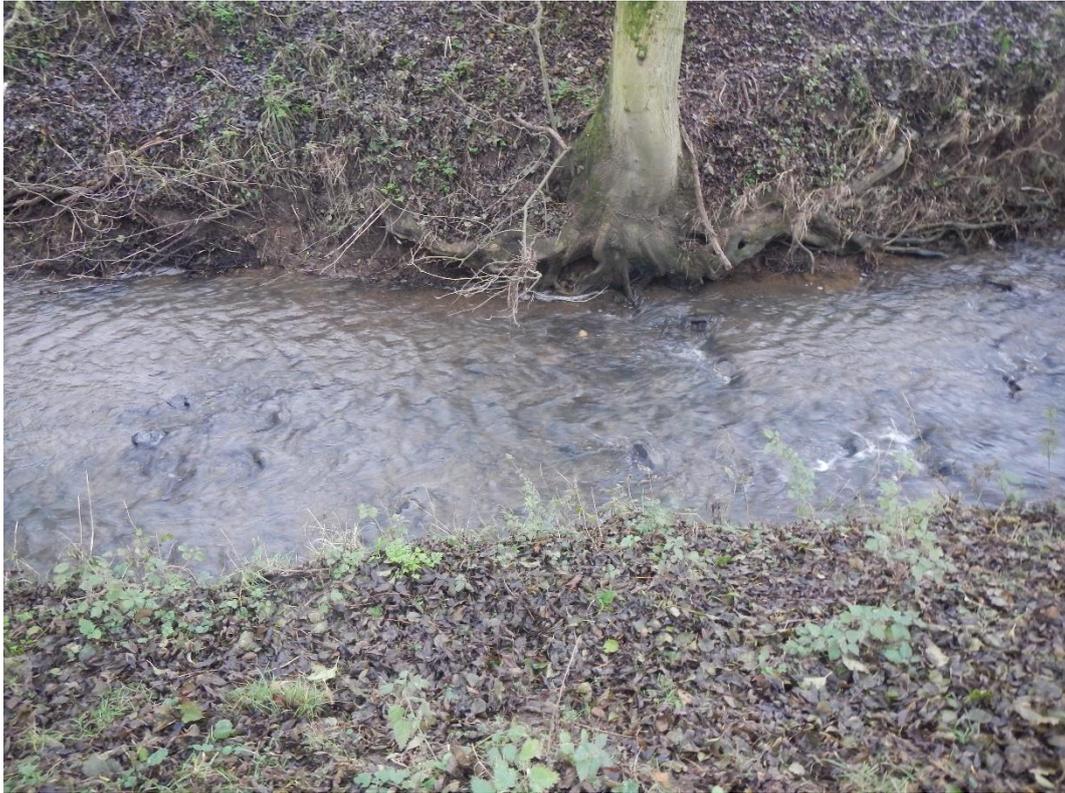
A brief inspection of Faceby Beck revealed potential spawning opportunities in the lower reaches, with small areas of gravel just visible through the turbid water. However, the modified nature of the channel is not conducive to the formation of pools and the associated gravel lifts that are often selected by trout for spawning. No redds were spotted and trout were observed attempting to ascend the weir a short distance upstream, suggesting that they may favour areas further upstream for spawning. The purpose of the weir was not clear, but it does create an illegitimate obstruction to fish passage as sea trout do occasional ascend the obstructions downstream (salmon and sea trout sadly being the only species recognised under our incredibly out-dated fish passage legislation). Shallow water immediately downstream further inhibits fish passage and the value of removing this obstruction that clearly inhibits fish movement into a potentially important spawning tributary should not be overlooked.

Figure 11. Faceby Beck: the straightened channel is not conducive to the formation of gravelly lifts in the bed and riffles, although some small pockets of gravel with potential for spawning were observed.

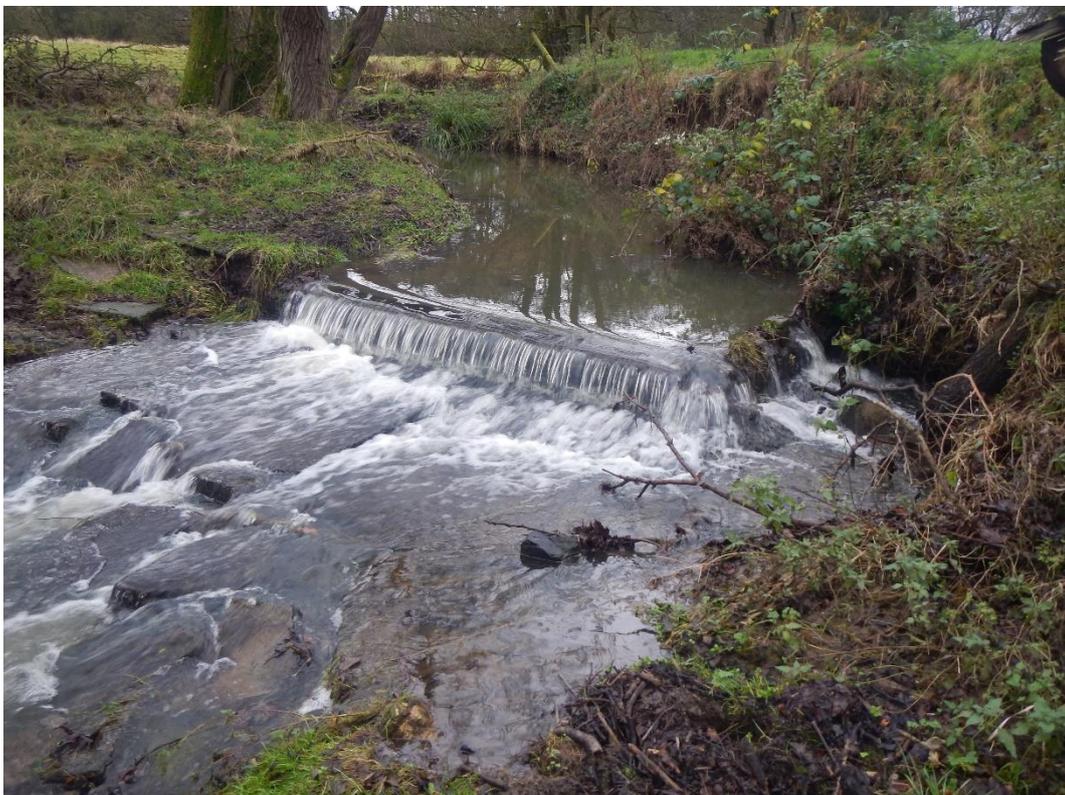
Figure 12. A small but potentially significant obstruction to upstream fish passage. This structure could be easily removed to deliver a major improvement to the potential of the beck for salmonid spawning.

- Seek agreement to remove the weir from Faceby Beck to reinstate free passage to potentially important spawning areas upstream.
- Support Tees Tees Rivers Trust in any projects to:

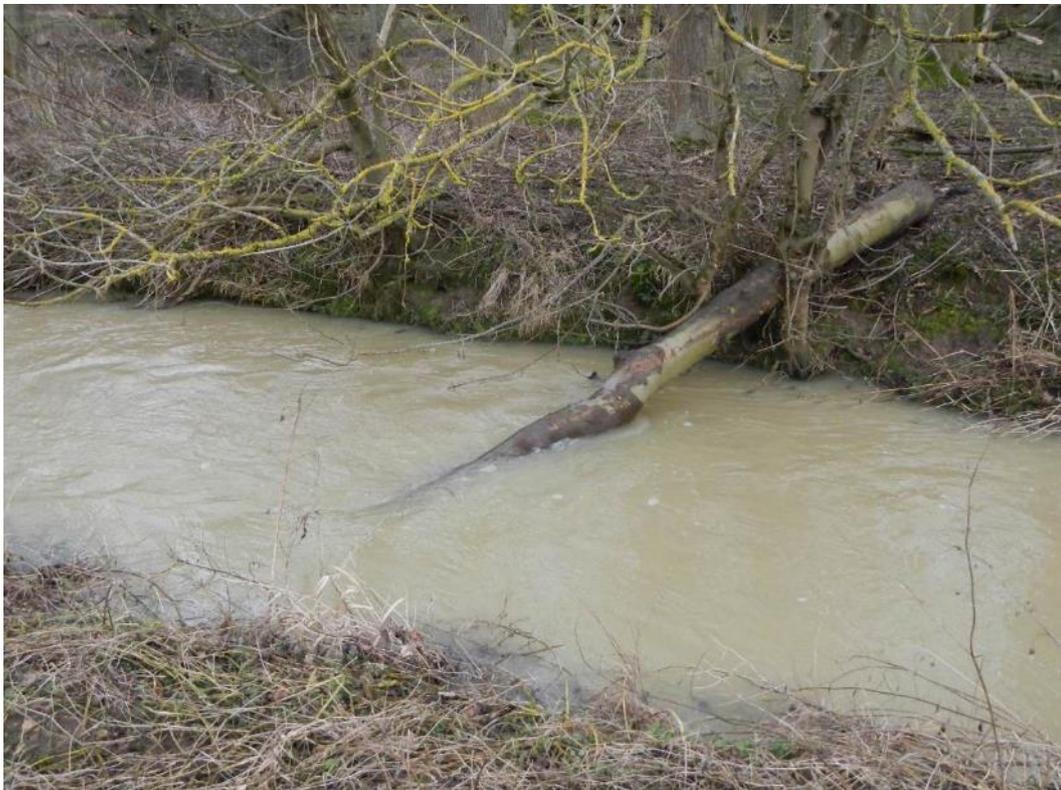
Where multiple tree trunks are present, one could be cut (with no significant detriment to the overall canopy or other habitats) and lodged between two or more the remaining stems, mimicking naturally lodged woody material.

Figure 13. A lodged flow deflector – the technique can be used with a single pole (primarily to increase scour) or a branched limb (to create greater flow dissipation). The elevated butt end (bank end) reduces the potential detrimental bank scour usually associated with d/s deflectors as a through-flow is maintained along the bank.

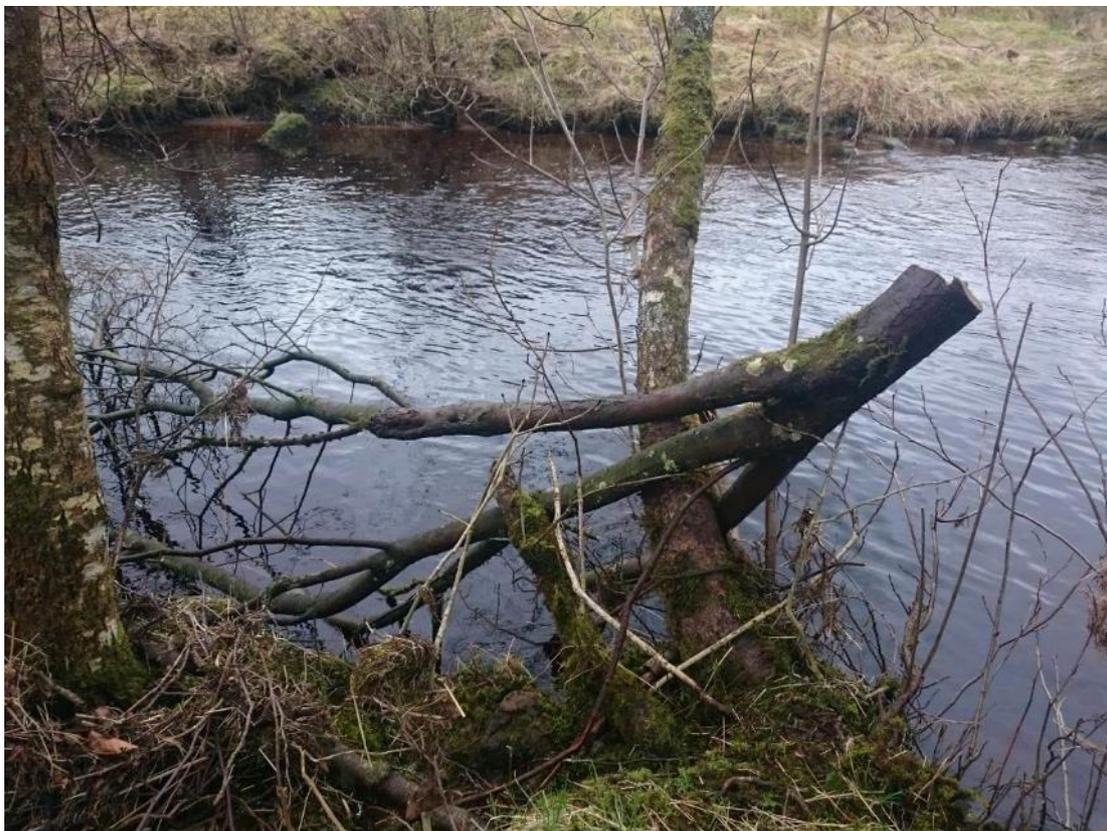
An alternative, naturalistic lodged flow deflector method that is equally simple utilises a deflector with multiple branches. It simply involves hooking one of the branches around an upright tree (Fig. 14). The example uses a medium-sized branch, but any size of branch or tree can be employed providing the anchor tree is stable and of sufficient size.

Figure 14. A medium-sized piece of lodged woody material which is securely anchored in place against an upright tree.
