**Advisory Visit**

**River Rib, Upp Hall nr Braughing, Hertfordshire**

**November 2019**

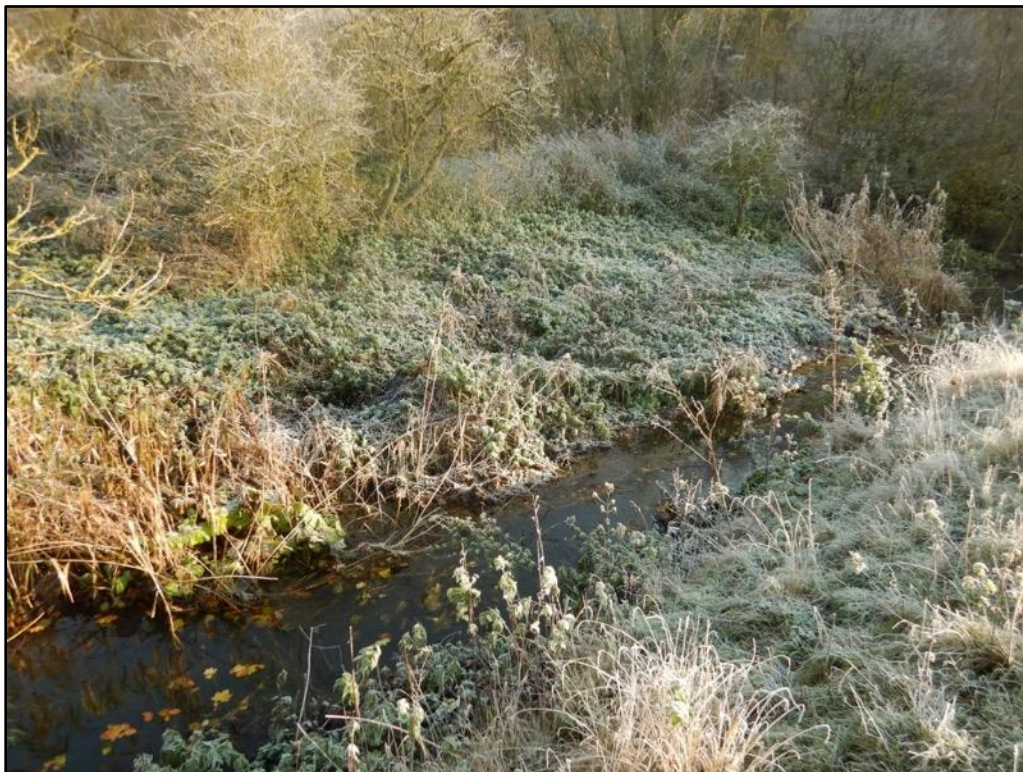
The river's wet-width was ~4m but the proportion of open channel was nearer to 1m, with trailing vegetation narrowing the width, increasing the flow rate and providing habitat (pic 1). The bed was a mix of poorly sorted, silty gravel. The river flow was barely enough to flush fallen leaves from the bed.

Pic 1 (TL 39124 24365) – The upper part of the river was significantly narrowed by marginal vegetation.

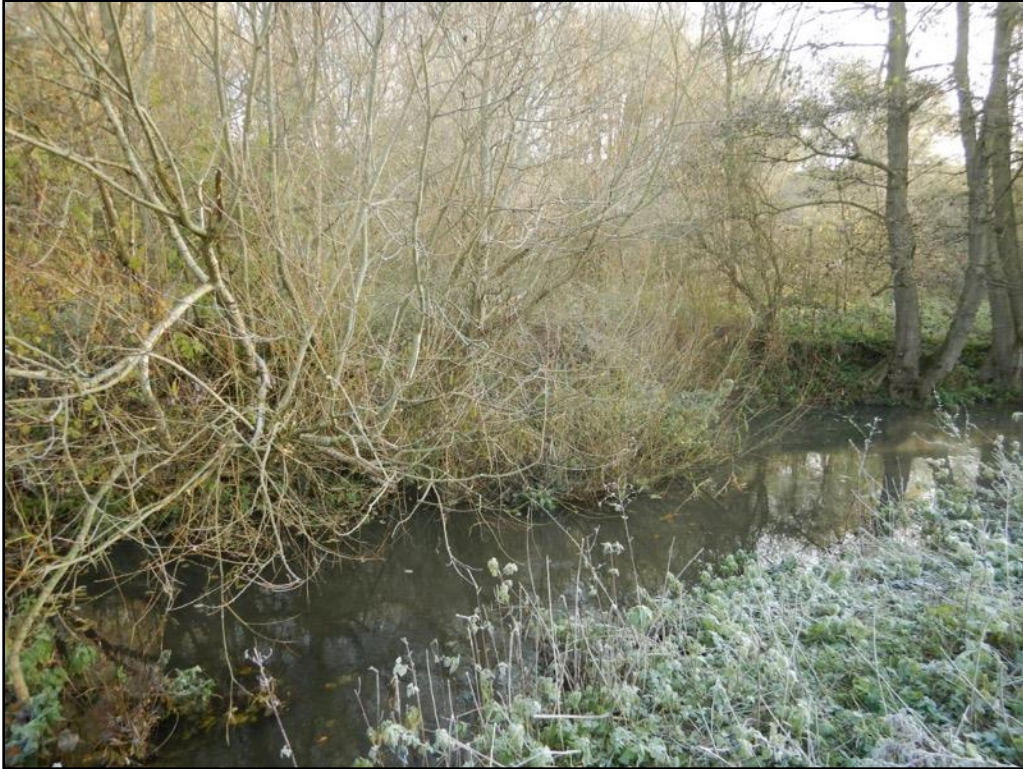
~20m downstream of the bridge, the first notable pool was encountered, Alder Tree Pool. The pool provided depth cover with tree roots providing underwater cover. A willow tree had partially collapsed into the head of the pool from the LB (pic 2) and provided good cover, both above and below water. Other than the one willow trailing into the water, there was a general lack of fallen branches and tree limbs.

Pic 2 – Alder Tree Pool, a partially collapsed willow provided cover.

The occurrence of branches and tree limbs, together with the organic matter that they collect, may look "messy" to some but the presence of such material is of great importance within rivers. Collectively such material is referred to as Large Woody Material (LWM). LWM leads to an increase in the surface area on to which a biofilm (algae, bacteria and other microbes) can grow. In turn, the biofilm may become a source of food for invertebrates, increasing the total biomass that a river can support. Messy rivers will support much more wildlife. LWM also provides underwater cover, offering protection for fish against otters or fish-eating birds. LWM can also provide natural flow deflection which may increase a river's velocity assisting cleansing of the gravel bed. Where LWM presents no flood risk it should be retained. Where possible, branches, tree limbs and even fallen trees should be secured in the river margins to provide habitat.

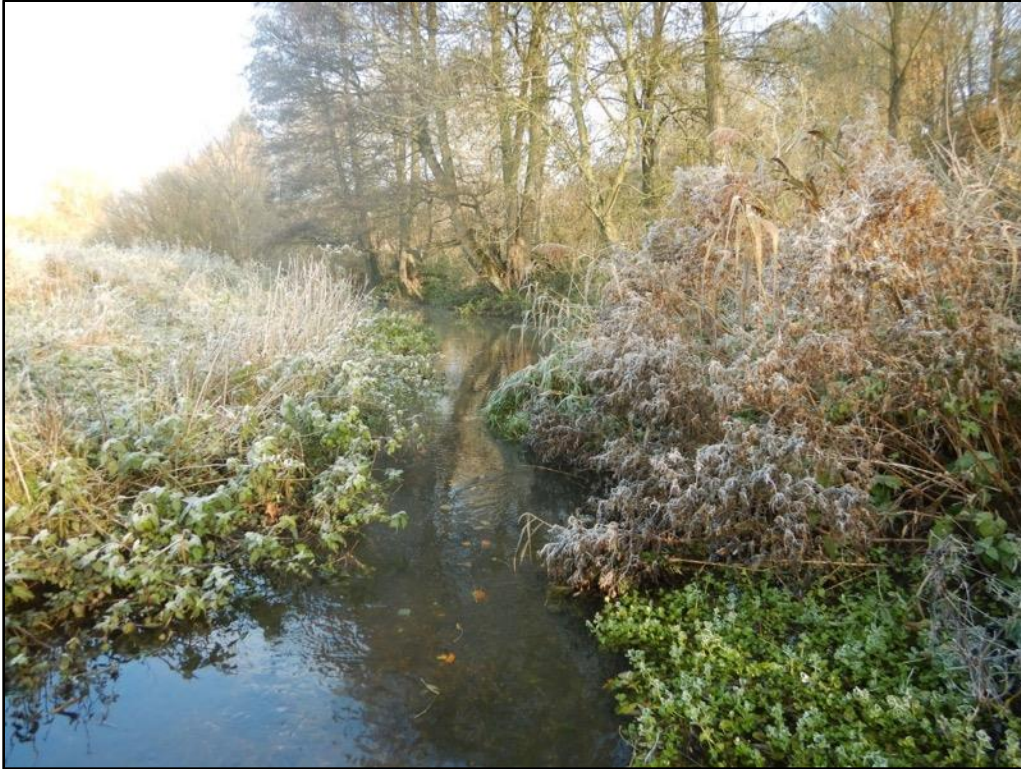
The land use adjacent to the river is largely pasture grazed by sheep. Small copses and tree belts abut the river. The intensity of grazing was low and did not appear to be causing damage to the river. Tall marginal vegetation of great willow herb and reed canary grass was present, which in addition to providing important marginal cover for fish, also provides cover for a wide range of both terrestrial and aquatic invertebrates (pic 3).

Pic 3 (TL 39163 24302) – Riparian vegetation provided marginal cover. Note the high volume of fine organic sediment smothering the riverbed.

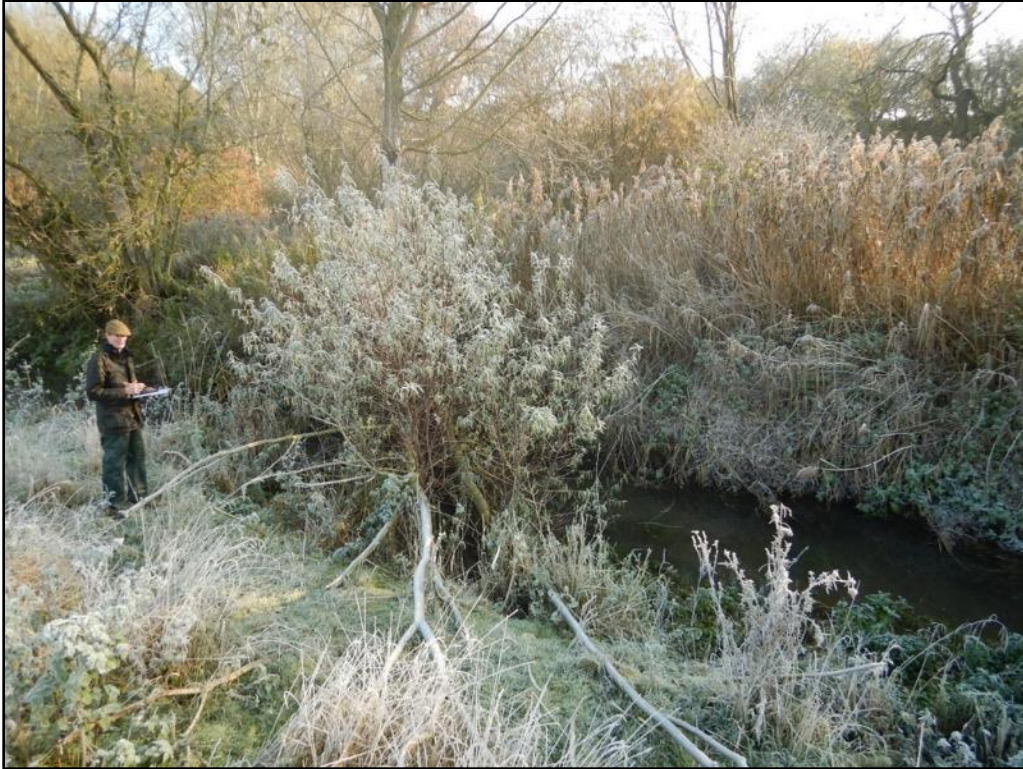
A fallen willow was encountered at TL 39150 24253 (pic 5). The tree provided excellent cover, and the debris which had collected against it created a flume of water, creating bed scour and sediment sorting. The willow tree is still alive and should be left in its entirety.

Pic 5 (TL 39150 24253) – This collapsed willow should be retained as cover. If limbs need to be removed to aid casting then ensure that many are retained for cover above water, and that all are retained below water.

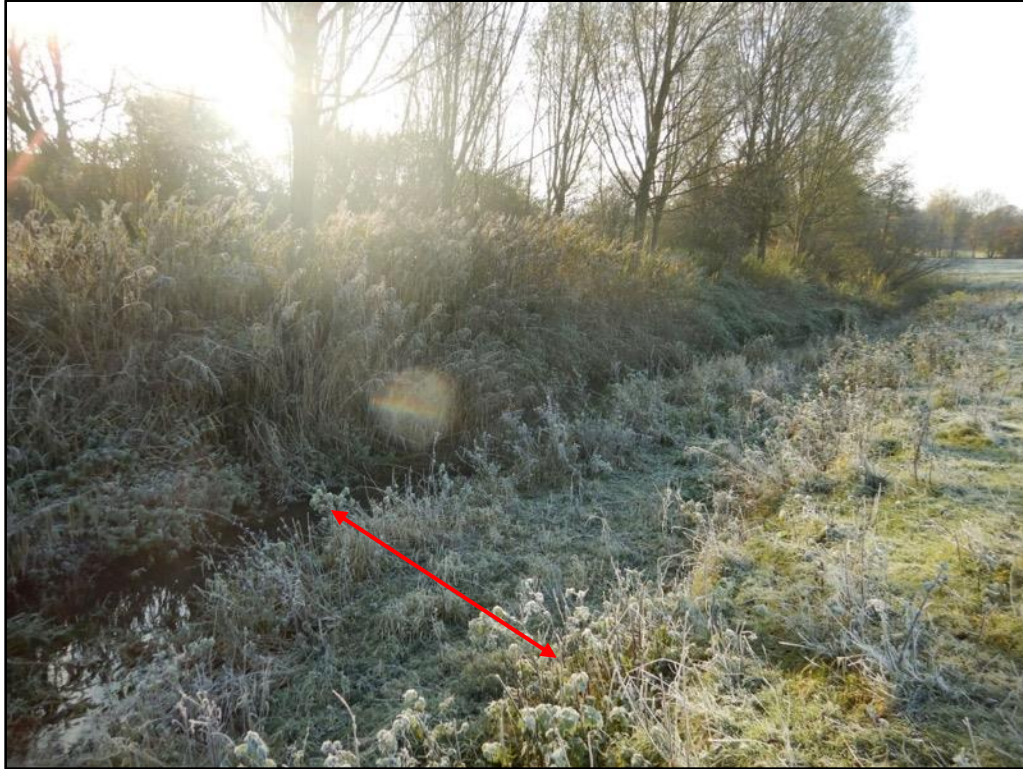
The river has evolved a noticeable 2-stage channel with a vegetated berm, following repeated years of low-flow (pic 6). Vegetated berms provide important sink points for fine sediment. Without vegetation fixing sediment, it may be deposited on the riverbed where it can degrade invertebrate and fish habitats, or it may be deposited in pools causing them to shallow. Vegetated berms provide natural channel narrowing that is in balance with the river flow (as it has been created through the processes of erosion and deposition), and enable a low-flow channel to evolve. This improves a river's resilience to climate change, especially prolonged periods of drought. High flows may scour away berms leaving a widened river cross-section again, with the potential for the process to repeat depending on flow experienced over time.

Pic 6 (TL 39138 24229) – The river has narrowed to create a significant vegetated berm (red arrow) resulting in the 2-stage channel.

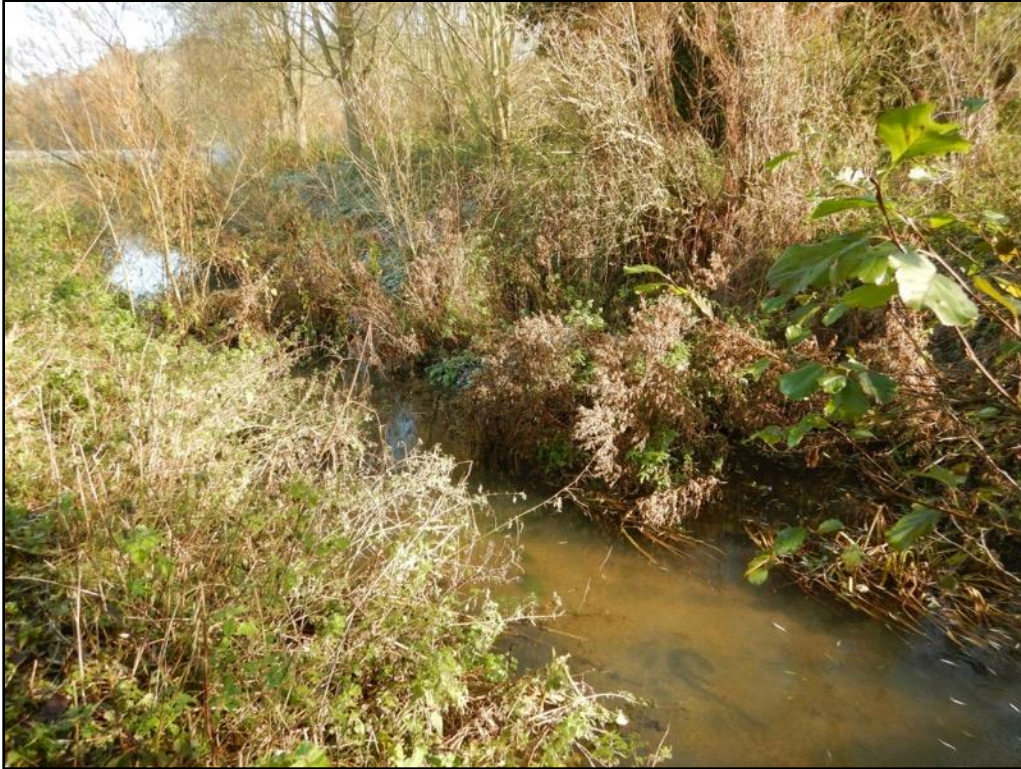
Several low-growing and leaning willows were encountered (pic 7). They provided useful shade to the river and kept areas of river open from vegetation encroachment, thus aiding angling access. The management of shade requires careful consideration. In hot periods shade can bring benefit, but when excessive, it limits the growth of marginal plants which are important for retaining bank strength and controlling fine sediment input. The willows could be manipulated to address the lack of flow diversity.

One of the willows had also collected wrack against it, causing water to flume around it. Evidence of recent bed scour was observed with gravel having been sorted and sand deposit downstream (pic 7).

Pic 7 (TL 39101 24173) – The salallows created scour, with sand sorted from the gravel.

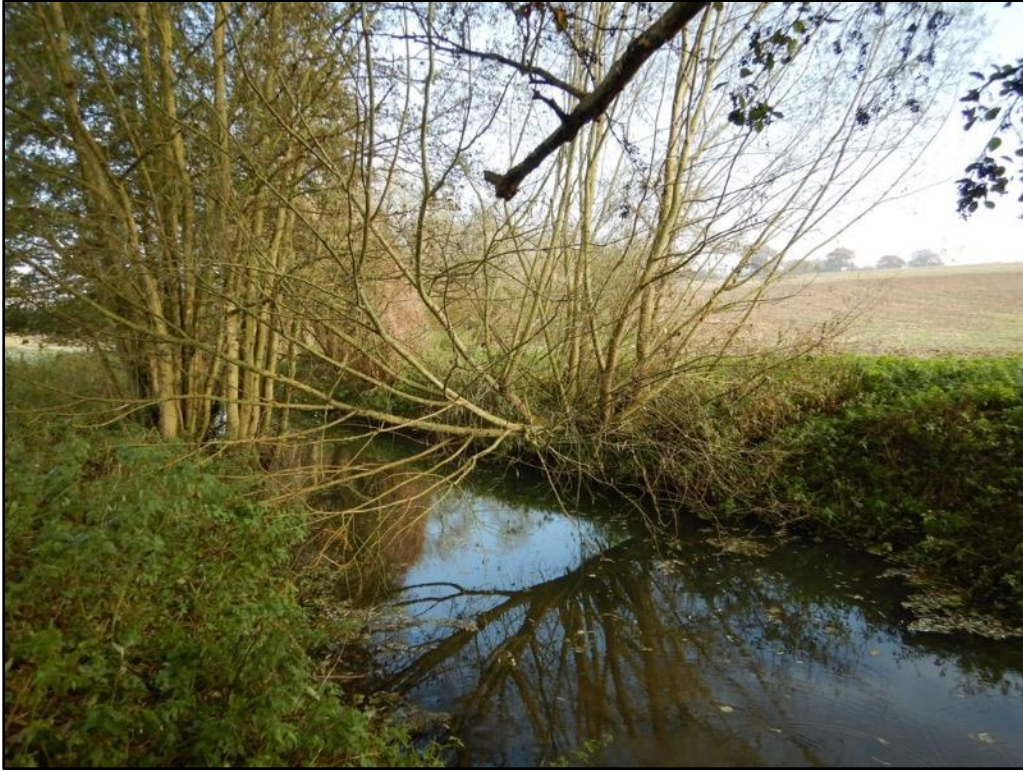
The lack of flow diversity was compounded by tall riparian trees casting shade, restricting marginal vegetation (pic 8). Again, the need to balance shade for water cooling with the benefit of light to initiate marginal growth must be considered carefully. Tree hinging is a technique favoured by the Wild Trout Trust for managing riparian trees and delivering instant woody cover at water level. Trees (large or small) are cut to produce an effect like hedge laying. Species such as willow and hazel respond particularly well. Laying retains a living hinge that secures the cut stem to the tree stump so structural strength is retained. With the tree-top laid at water level, it provides excellent overhead cover, flow deflection and, if beneath the surface, increased habitat for aquatic invertebrates and cover for fish against predators.

Pic 8 (TL 39071 24097) – Riparian trees, especially the leaning willow, could be hinge-cut to create flow diversity to an otherwise over-wide reach of river.

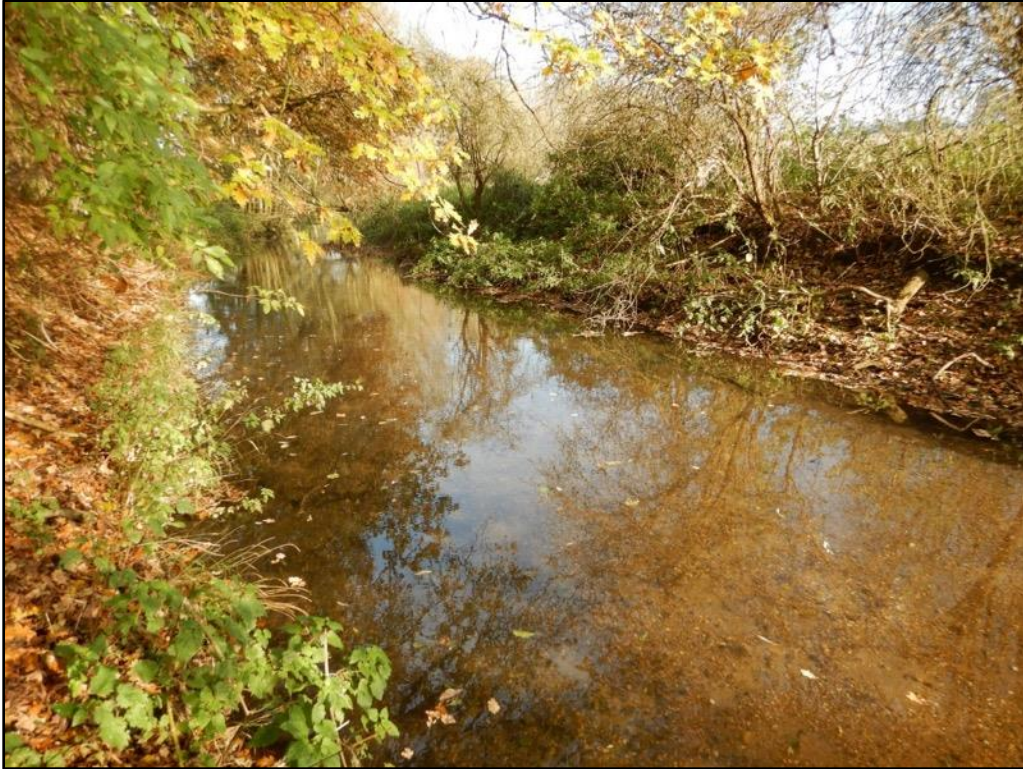
Several mature pollard oak trees were growing from the RB with branches extending over the river. The bed at this point was notably shallower than the length above it. It is possible that the presence of the mature oaks prevented dredging from taking place, which has protected the riverbed. The presence of a high volume of poorly sorted coarse substrate (pic 9) presents an interesting opportunity to use flow deflectors to re-energise the reach, to initiate sediment transport and sorting.

Pic 9 (TL 39069 24041) – The river beneath the mature oak trees is wide and shallow with poorly sorted gravel.

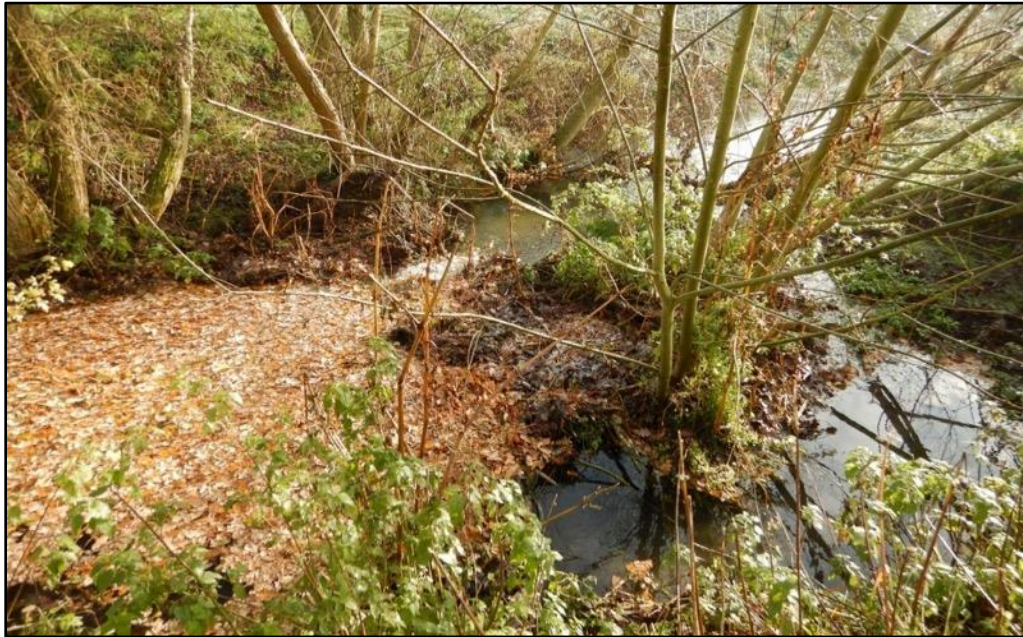
Another collapsed willow provided important cover and flow variation (pic 10). Again, the willow had collected wrack against it which, in addition to causing water to flume over and under the partial blockage, was also causing water to move laterally. The lateral flow had led to bank erosion resulting in the supply of gravel to the river. In time, this action will lead to increased channel sinuosity, bedform variation and flow diversity which is all beneficial for the river and its trout.

Pic 10 (TL 39090 23968) – This willow tree appeared to have formed a blockage, but flow is in fact accelerated under, over and around it leading to valuable bed and bank scour.

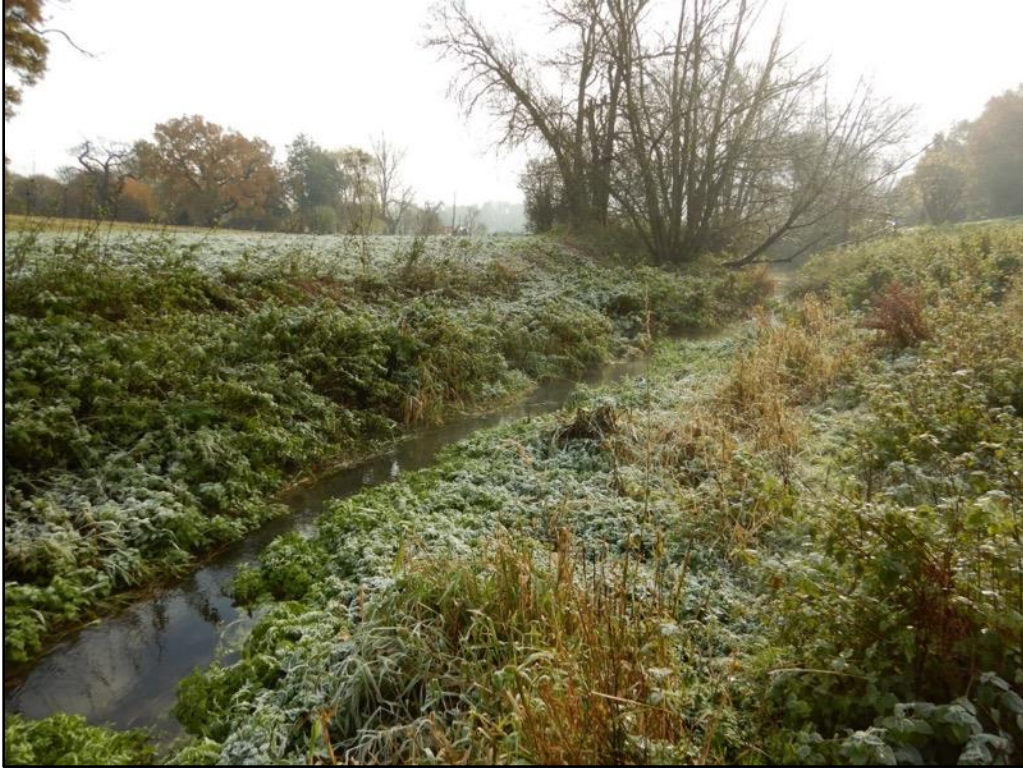
A well-established vegetated berm was present on the RB and through vegetation encroachment, it had narrowed the open water to little more than 1m (pic 11). However, the narrowing resulted in an increased water velocity which supported the largest stand of water crowfoot observed in the fishery. It was encouraging to note the patches of clean, well-sorted gravel (pic 12), suitable for trout to spawn upon (the best seen up to this point). It is also heartening to know that even in an exceptionally low-flow year, the Rib has the capacity to sustain flow-sensitive plants, which in turn will assist the survival of flow-loving animals like trout.

Pic 11 (TL 39098 23951) – A wide vegetated berm forming a 2-stage channel.

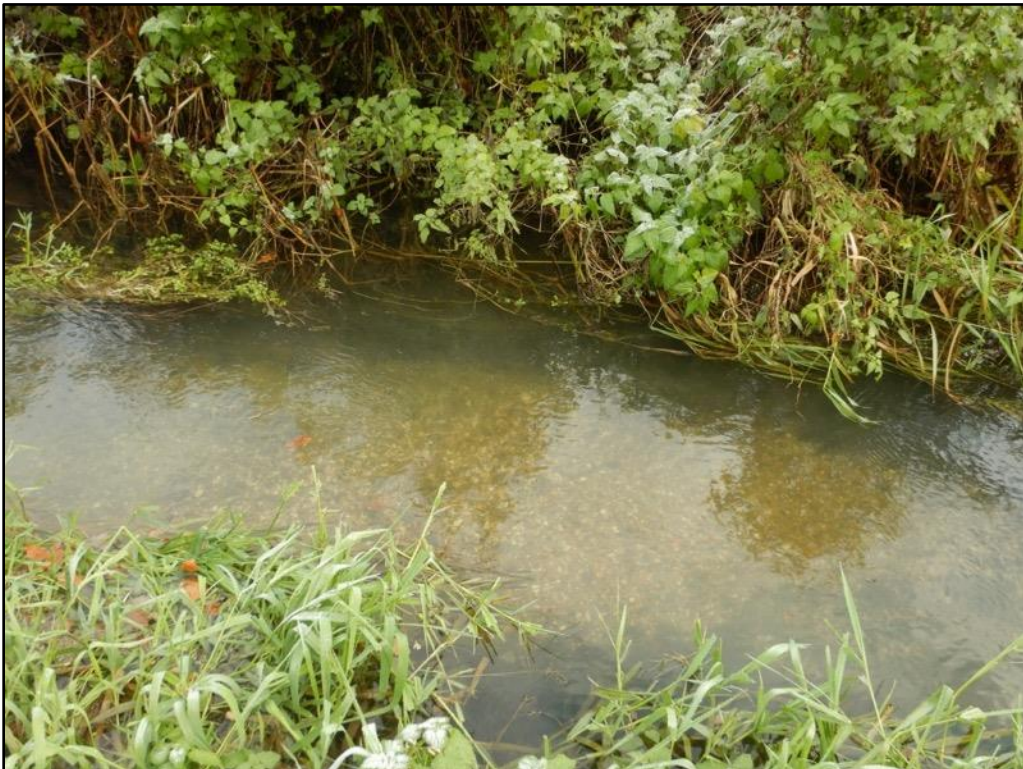
Pic 12 (TL 39102 23945) – Clean and well-sorted gravel suitable for trout to cut redds into.

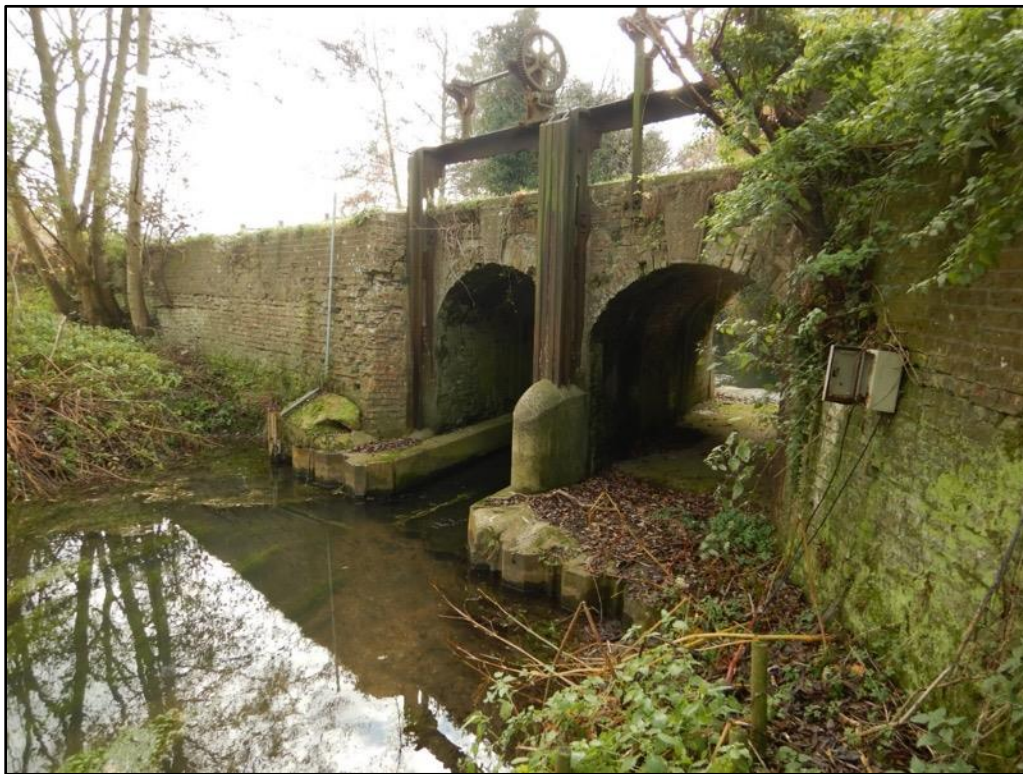
The river then flowed beneath the fishery access road (pic 13). The bridge once formed a sluice that pushed water down a take-off channel for milling. The take-off channel has now been filled and the sluice largely removed. The bridge has channels within it which had previously held boards to retain a head of water. The boards have been removed for several years now. That is beneficial for two reasons: the boards would have restricted the movement of fish, and the impounded water would have retained a greater amount of fine sediment which would have smothered the gravel bed. The bridge no longer presents a barrier to fish movement. Free passage should be maintained at all times, especially in low-flows. It may be tempting to replace boards in low-flows but there is a risk that impounded water will become warmed reducing its suitability for trout (and if the temperature rise does not kill them, it will certainly make them less willing to feed, affecting sport in the fishery).

The bridge also contained the remnants of an EA gauging station, now considered to be defunct.

Pic 13 (TL 39123 23884) – The bridge footings and historic sluice arrangement no longer present a barrier to fish movement.

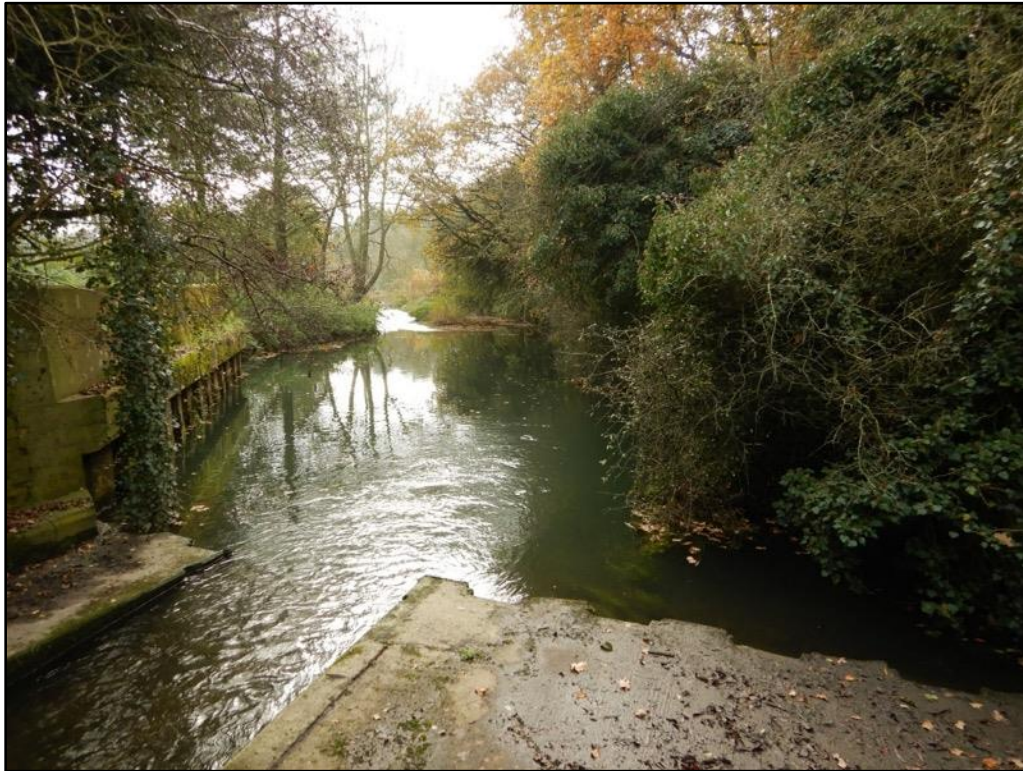
Downstream of the bridge the river widened out to a large pool (pic 14). The pool is reported to be up to 1.8m deep, and in combination with extensive tree cover on the RB, it provided good cover for adult trout. Unfortunately, the LB was reinforced with sheet steel piling and offered little in the way of habitat apart from the trailing ivy. Due to the depth against the LB, it would not be simple for the syndicate to place any habitat enhancement measures in this sheet-piled area.

Pic 14 (TL 39126 23874) – A deep pool offering good cover for adult trout amongst the trailing branches.

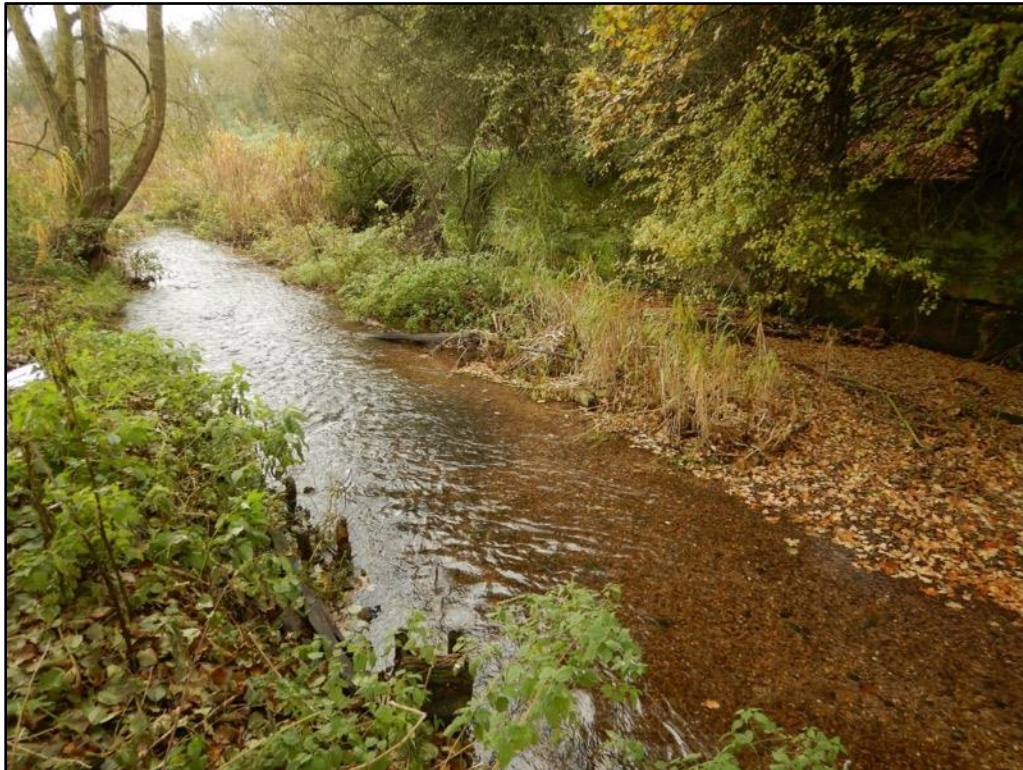
At the end of the pool a large gravel bar was present. The gravel was clean, reasonably well-sorted (albeit with a higher volume of sand than one would wish) and had high-velocity water moving over it, suitable for trout to spawn. Interestingly, the LB had been subject to past habitat enhancement work as a line of posts were still visible (pic 15), and were believed to have once held faggot bundles. A quick win for any spawning fish would be to replace the faggot bundles and/or to fix LWM to the remaining posts to provide cover. It could be argued that such work is maintenance of the previous structures and thus avoids the need to secure further permits or exemptions.

Pic 15 (TL 39139 23837) – A long gravel riffle suitable for trout to spawn upon.

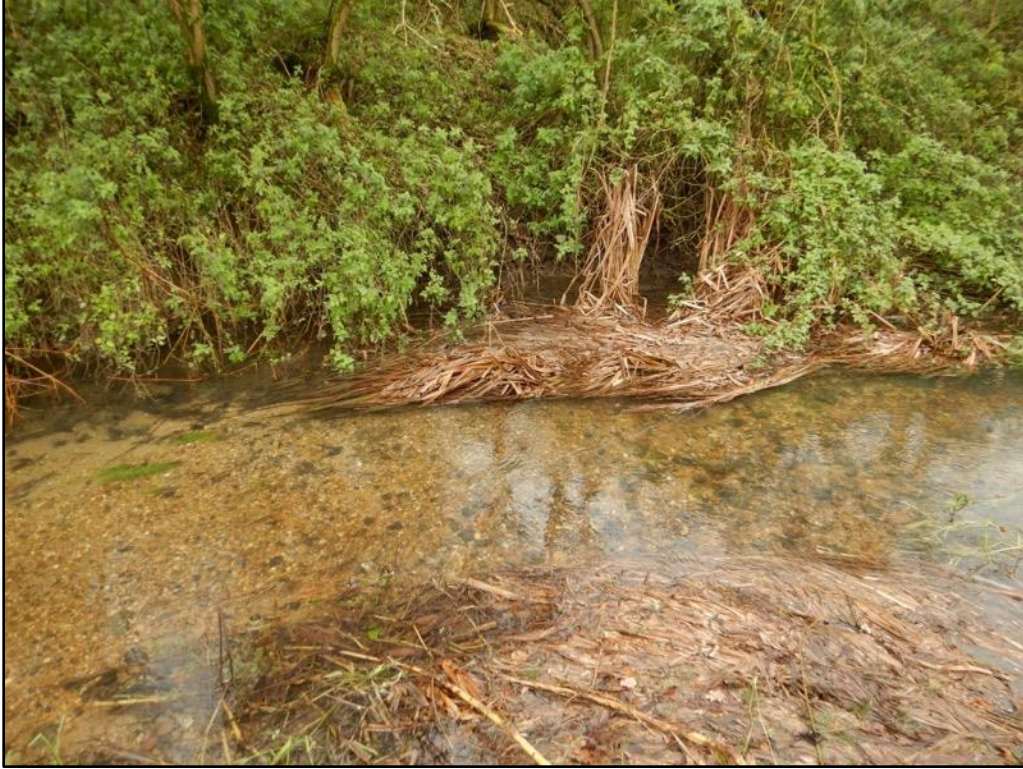
The river flowed with a mix of gravel-rich glides (pic 16) and deeper silty pools. Marginal plants, of branched burr reed, fool’s watercress and water forget-me-not provided cover with brambles and nettles trailing to water level. Starwort was the dominant aquatic plant. The flow was generally slower than one would expect for a river supporting trout, but that is thought to be a consequence of the current drought status of the area. The return of better flows would do a lot to re-energise many of the pools.

Pic 16 (TL 39139 23793) – Branched burr reed (now died-back for the winter) provided cover adjacent to a shallow glide.

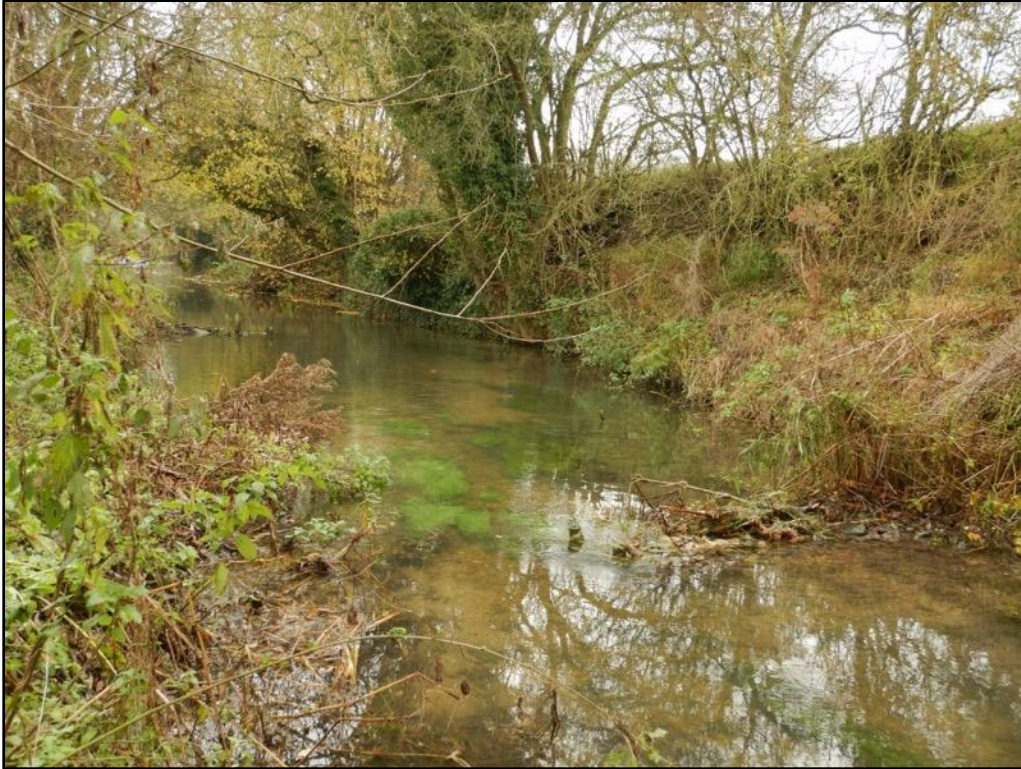
Several flow deflectors were observed at Ash Tree Pool (pic 17) and had clearly been in the river for many years. Some of the deflectors extended to mid-channel yet their effect on flow was minimal. Again, in a normal flow year they may be effective. However, there was little evidence of them having a notable impact upon the riverbed as no scour holes were evident and the substrate was poorly sorted. Many of the flow deflectors were in a state of decline and need replacing to make them effective when (or if) flows improve. Using tree stems as opposed to faggot bundles would increase their longevity and effectiveness.

Pic 17 (TL 39180 23781) – Ash Tree Pool, showing a pair of opposing flow deflectors, now in a state of decline.

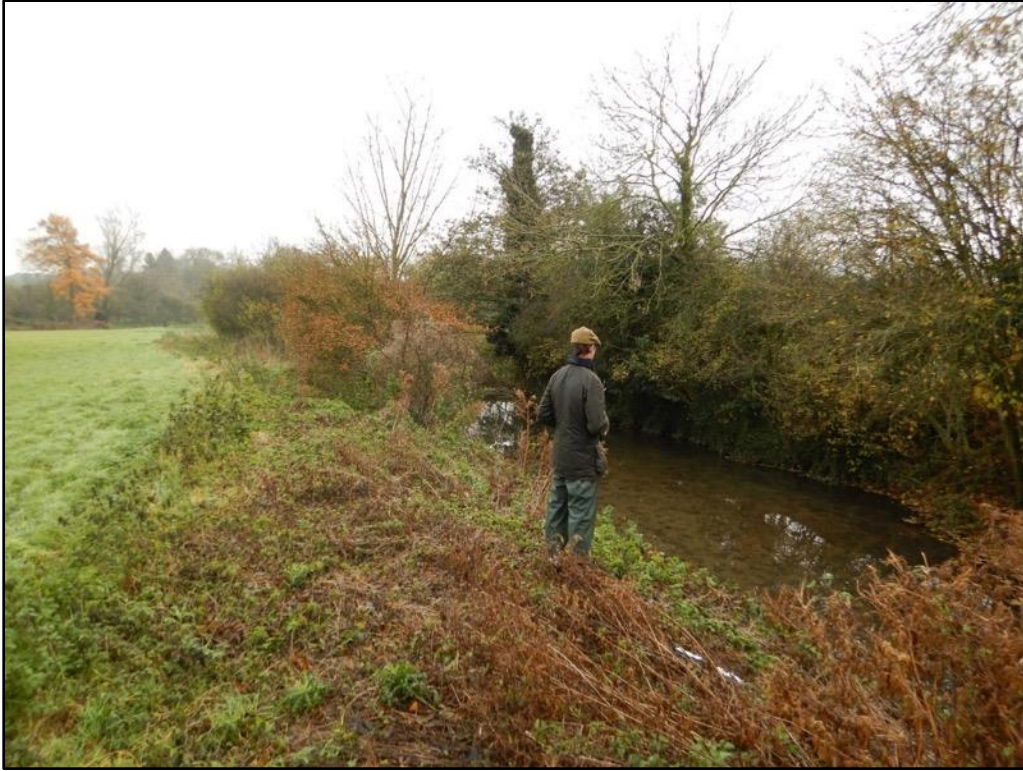
It is considered that much of the river is now vastly overwide for the flow conveyed most of the time. Flow deflectors set for past flow now appear to have minimal effect. The best trout habitat was observed where the river was narrowed, often to little more than 2m. The lower reaches of the river are suitable for further channel narrowing through the creation of vegetated berms leading to the establishment of a 2-stage channel (pic 18). This could be done relatively simply with the use of a large excavator pushing the bank down and out against a line of brushwood faggots to establish a new toe-of-bank. The 2-stage channel enhances the low-flow situation whilst retaining a wider cross-sectional area to convey flood flows. Some parts of the lower fishery already had this type of feature and further work should build upon what is present.

Pic 18 (TL 39207 23771) – This length of bank could be pushed down and into the river, to create a narrowed low-flow river with a 2-stage channel.

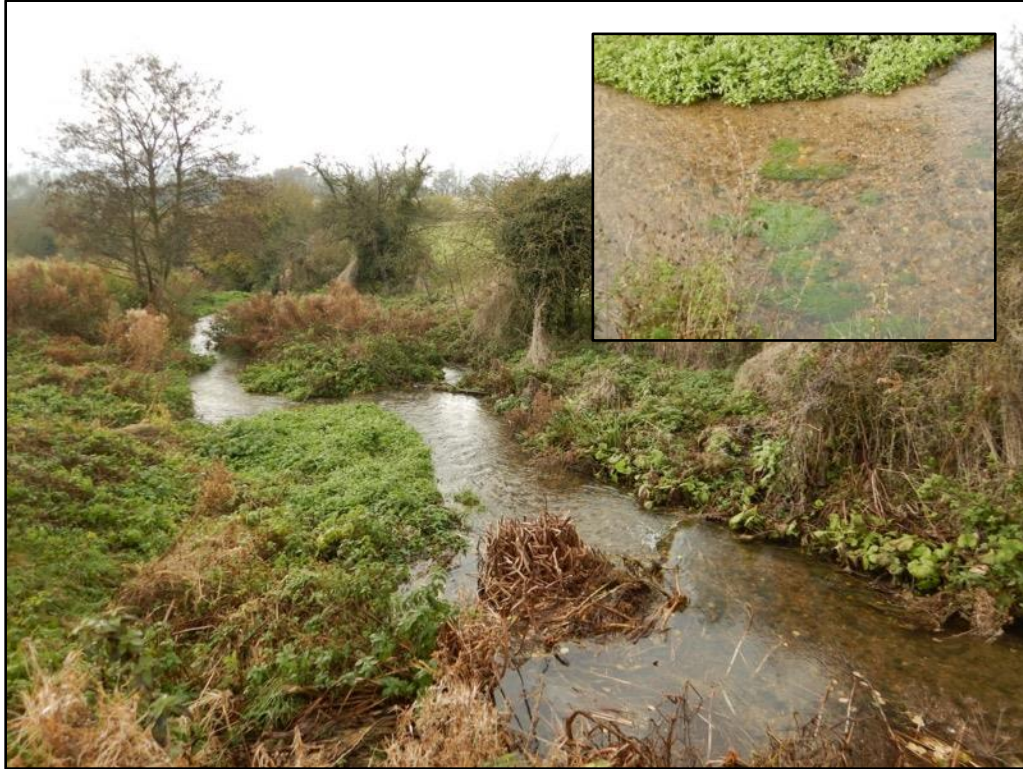
At Cattle Crossing Pool, the river took a 90-degree turn, scouring a deep pool with a high volume of gravel deposited downstream forming riffles and glides. The pool offered good adult trout habitat with a partially collapsed willow tree providing cover and bank protection. The gravel glides and riffles provided excellent juvenile trout habitat with watercress forming mid-channel islands which increased the extent of important marginal cover (pic 20). The gravel was clean and well-sorted with little fine sediment. This reach is likely to be an important spawning and nursery area for the river's wild trout population.

Pic 20 (TL 39279 23721) – Gravel riffles and glides provide important spawning and nursery habitats for trout. The gravel was clean and well-sorted (inset).

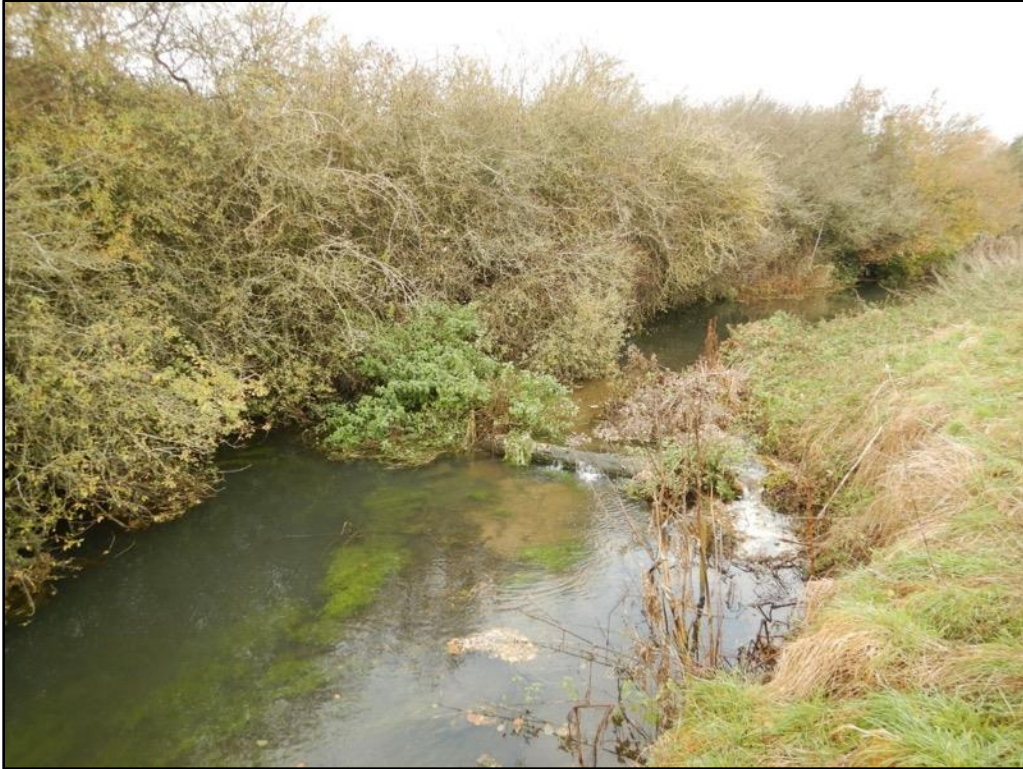
After ~40m of important trout recruiting habitat, the river became deep and slow again with good cover provided by shrubs trailing to water level on the RB. The depth of the pool habitat was maintained by a crudely constructed weir (pic 21). The weir had become blocked forcing water against the LB. The weir was stopping sediment transport and is believed to be why the gravel from the reach above has not moved along the reach, creating further valuable recruitment habitat. The weir should be removed to allow better coarse sediment transfer and the evolution of natural river features of shallow glides and riffles interspersed with deeper holding areas. At the very least, the weir should be reconfigured to focus its main flow in the centre of the channel to initiate bed scour. This could be done by removing a central part of the weir (notching) down to bed level.

Pic 21 (TL 39254 23656) – The weir, which instead of focussing flow in the centre of the channel, is now causing bank erosion and impounds the reach above it.

The weir should be removed to allow winter flow to cleanse the bed of fine sediment and to initiate coarse sediment transfer. If the weir must be retained to hold a head of water for adult trout, then the main flow should be focused in the centre of the river and impounding structures should not extend across the entire channel width. Natural pool habitats can be evolved by fixing trees across the channel to force the flow down against the bed, initiating scour and mobilisation of coarse sediment (pic 24).

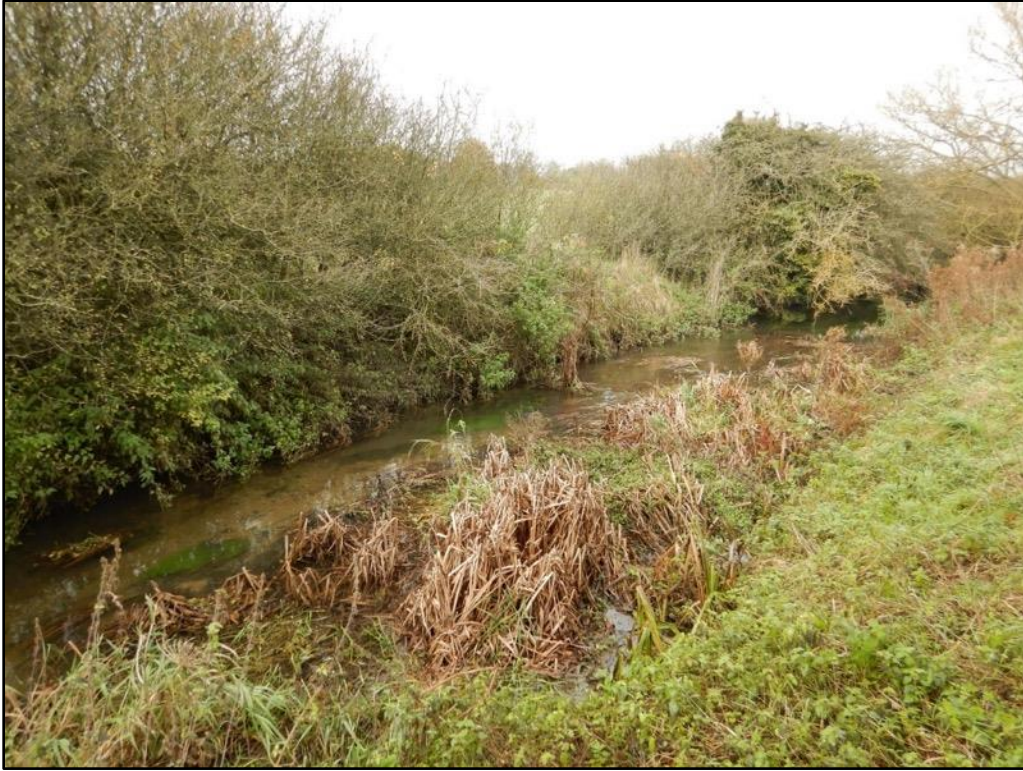
At Junction Pool, the bed shallowed and marginal vegetation encroached into the channel leading to natural narrowing (pic 22). The process could be enhanced through bank re-grading, pushing the bank down and out into the channel. If the bank material contains a high proportion of gravel, it may be possible to omit the use of faggots to establish a new toe-of-bank.

Pic 22 (TL 39259 23561) – Junction Pool, marginal vegetation narrowed the channel. It could be assisted by pushing the bank down and out to form a new berm.

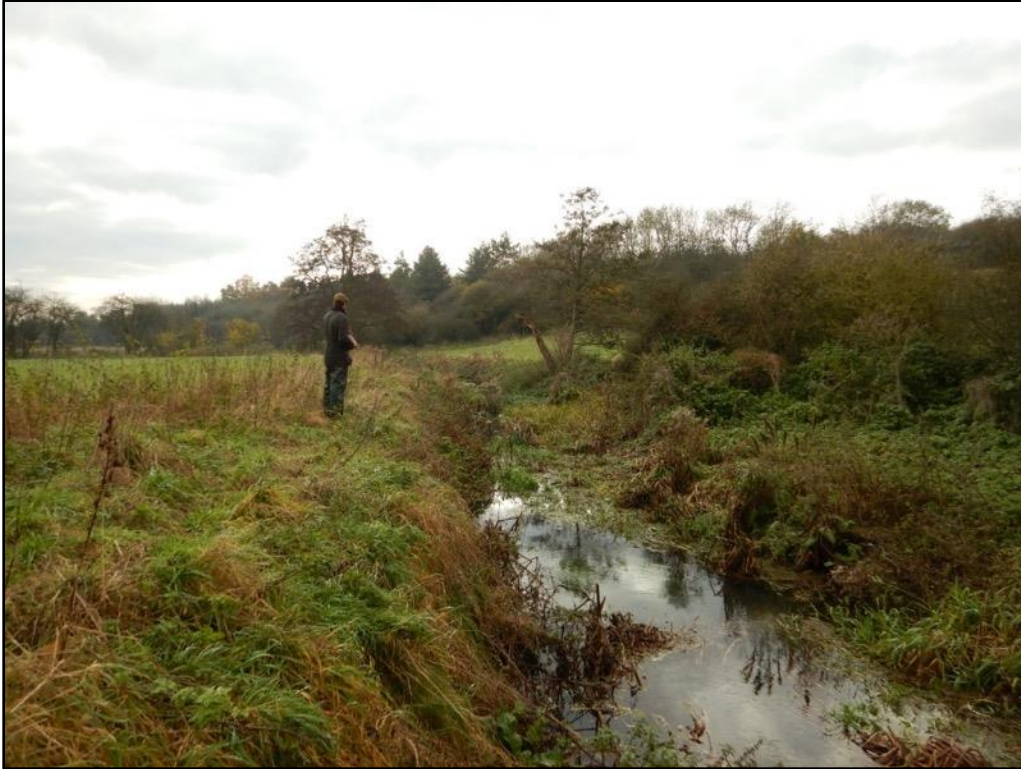
Other reaches of the river remained as an incised channel with little flow diversity (pic 23), dense marginal growth and slow velocities. These reaches require bed raising through the introduction of gravel to increase water velocity, flow and sediment transport.

Pic 23 (TL 39252 23520) – Some reaches were over-deep and require the introduction of gravel to bring about restoration.

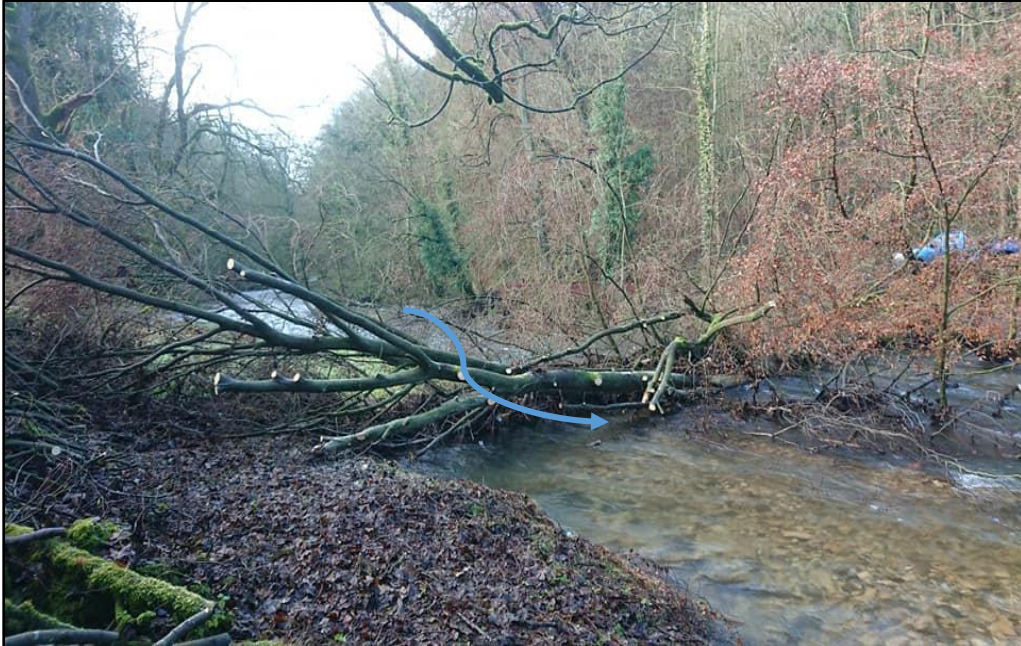
Pic 24 – A fallen tree can produce similar results to a weir when flow scours a hole beneath it. The fallen tree does not prevent sediment transfer and provides numerous habitats.

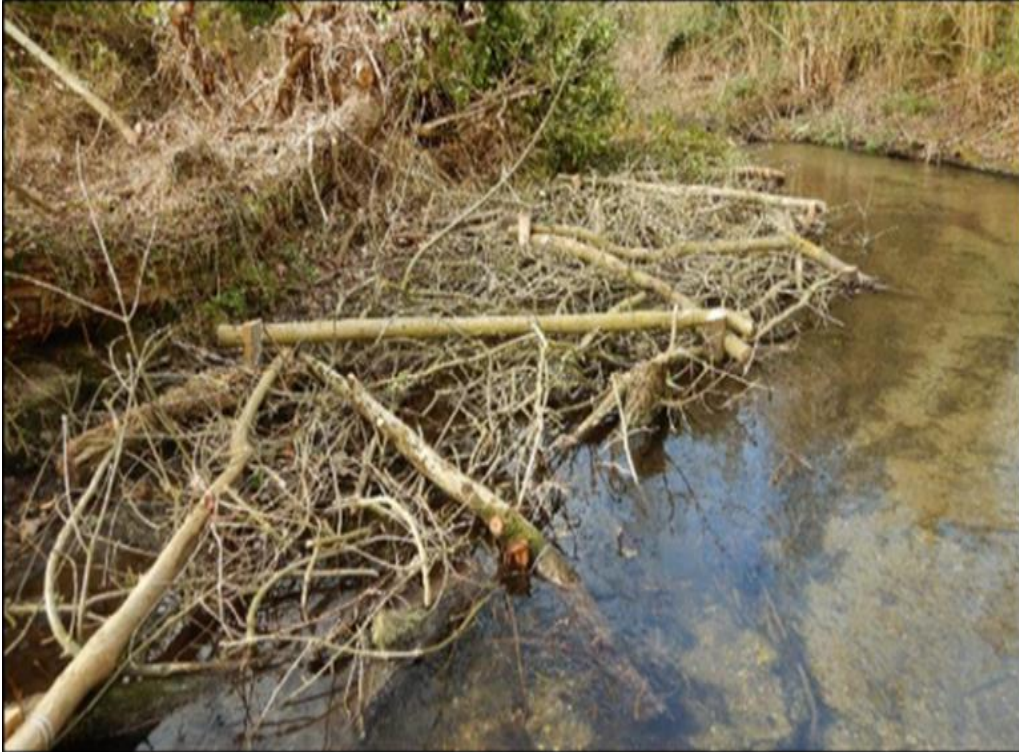
Pic 25 – A low-level brushwood ledge created following tree thinning. They can be particularly effective for enhancing low-flow rivers.

- Brushwood ledges: these features can be created following tree works. A brushwood ledge provides complex cover at, and below, water level. Brush from tree thinning is pinned against the bank in alternating directions or increasing stem thickness, and is securely wired down or held with battens. The brushwood lattice provides niches for invertebrates and small fish, aids silt entrainment and provides a rooting substrate for plants to establish. In time (~3yrs) the brushwood ledge will become a vegetated berm if exposed to full sunlight.
