**Advisory Visit**

**River Rib, Upp Hall nr Braughing, Hertfordshire**

**November 2019**

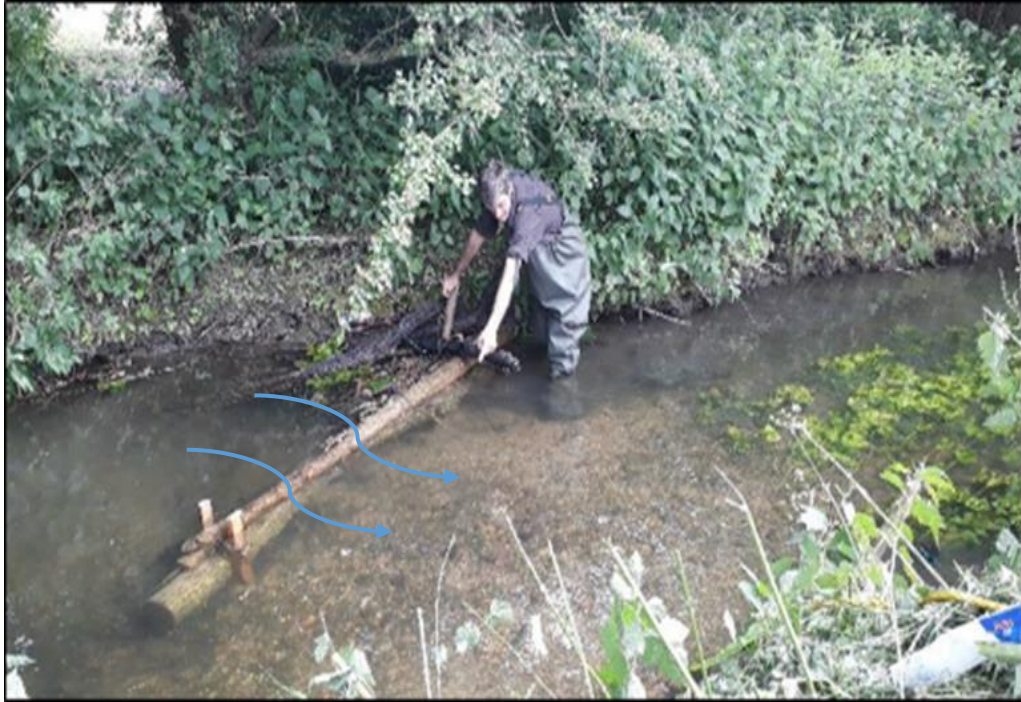
Pic 26 - A flow deflector used to focus flow and scour into the centre of a river.

- Flow deflectors: these features can be used to increase flow diversity and bed scour. They can be simple log deflectors or tethered tree stems. The complex flow that arises creates depth variation, cover and aids sediment sorting. Due to the low flows, the position of flow deflectors needs careful consideration to avoid impounding upstream reaches, and to ensure that the structures are effective.

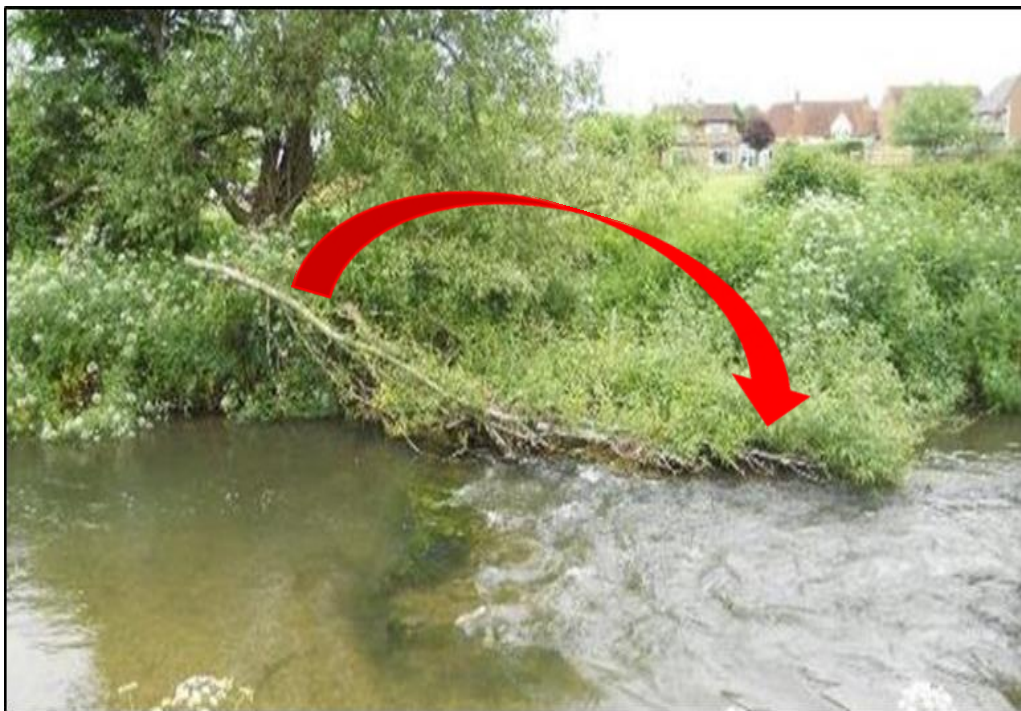
Pic 27 - An example of tree hinging, a simple and effective technique for increasing cover in a river.

- Tree-hinging would be a simple first approach to managing some of the tree stock whilst providing cover at water level (pic 27). The process and benefits of tree-hinging has already been discussed on page 15.

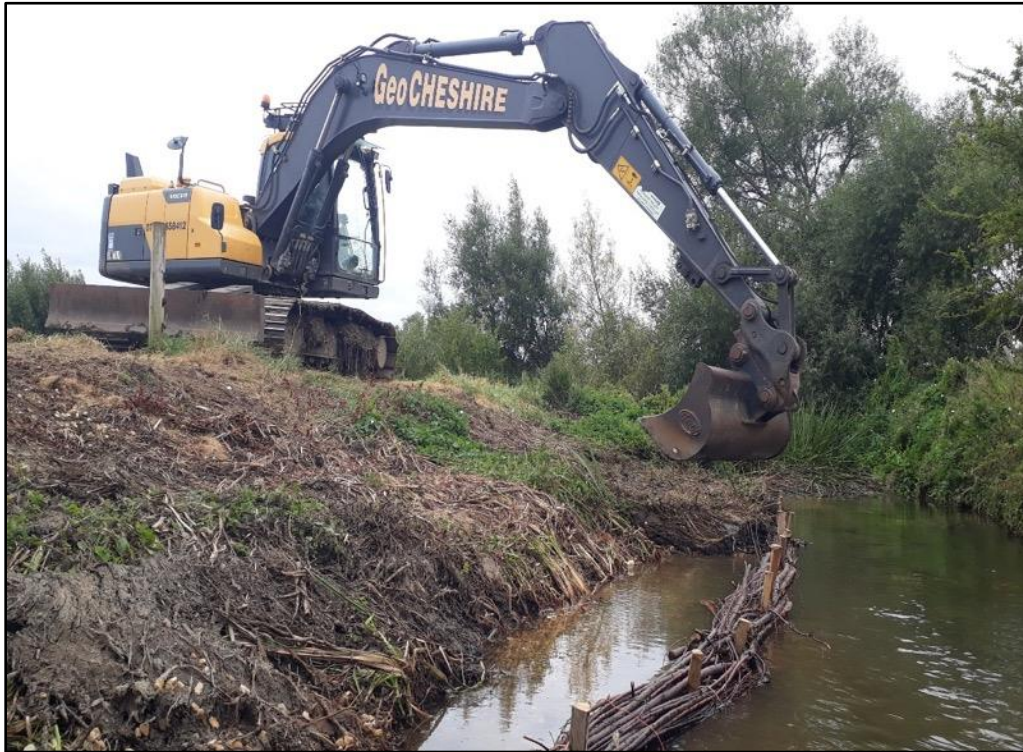
Pic 28 – An excavator can be used to re-grade banks, pushing existing material down and out into the channel.

The lower reaches of the river tended to have an over-wide cross-section. Bank re-grading to create a 2-stage channel could be used to bring about low-flow enhancement (pic 28).
