WILD TROUT TRUST

## **River Wye**

(Litton Properties to Ashford Lake)

14/10/2020

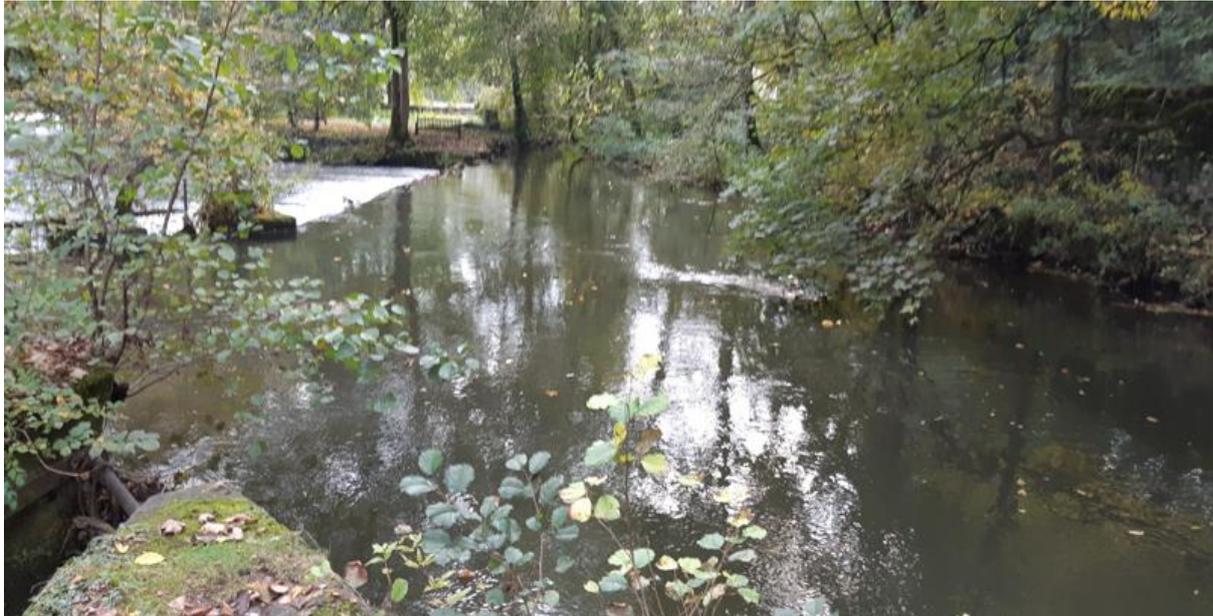
Figure 2: Weir impounding the central/main channel and feeding a mill leat, just visible on the opposite bank from the camera. A sluice gate mechanism - used to balance levels in this interconnected channel network is visible (bottom left)

At the downstream limit of this visit (SK21465 69016) there is a low weir and a sluice-gate system (Figs. 2 & 3) that maintains a head of water in a parallel channel (upstream of this point) and a mill leat (forming a confluence on the RB) which historically served the Victoria Mill.

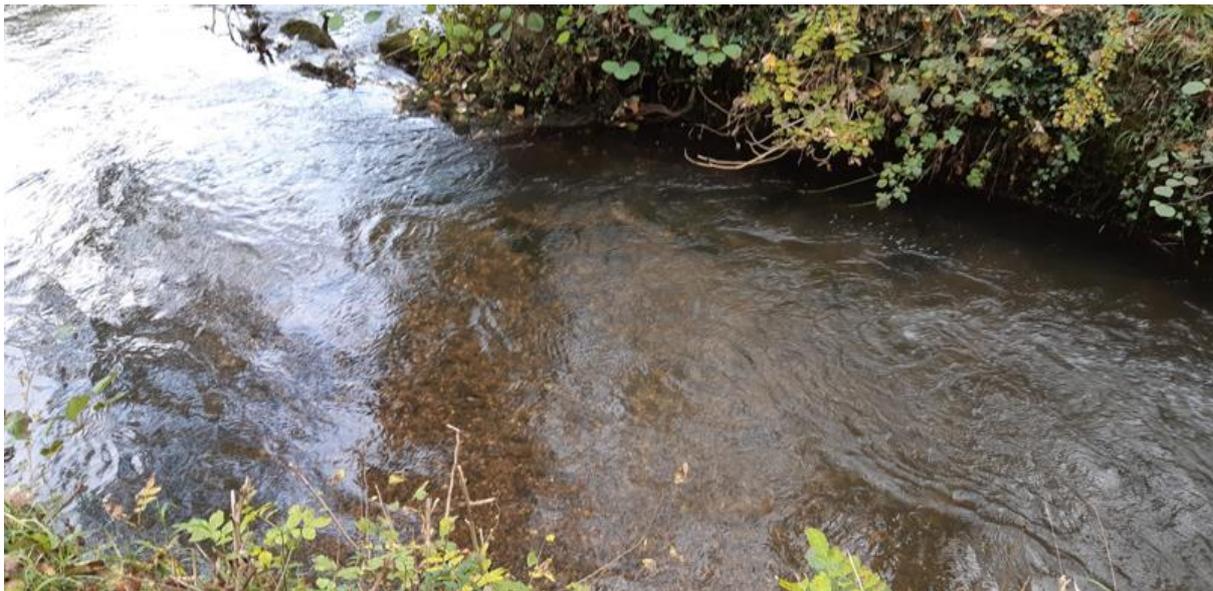
Figure 3: Gravels being "sorted" by pinched flow below the sluice gate in the spit of land dividing the central "main" channel and left hand parallel "backwater" channel

The legacy of historic water management – coupled with surrounding development of premises and infrastructure – creates a very complicated set of conditions. Localised patches of useful habitat exist (e.g. deposits of spawning gravels graded into different particle-sizes by sluice gate structure; Fig. 3). Overall the impact of the weir is to contribute to poorer, more uniform habitat. Of equal importance to the lack of physical/spatial diversity is the *relative lack of variation over time* – due to the reinforced, engineered banks that have not allowed the channel to move and change position within its floodplain. Options to remove or notch weirs are subject to multiple constraints – such as the likely presence of contaminated sediment in the LH, backwater channel (see subsequent photos and information) and the current familiarity with the “water feature” currently maintained by the impoundment (e.g. Fig. 4). That being said, weir notching/removal represents probably the biggest single habitat improvement to this section. It could also create aesthetic improvements.

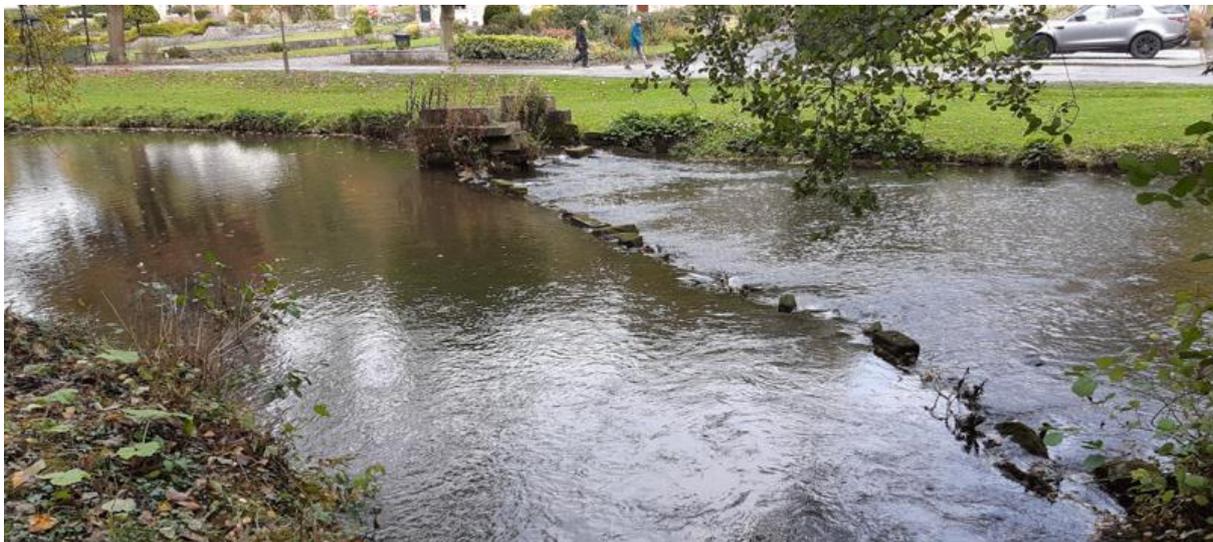
Figure 4: Smaller/lower weir which maintains a head of water (presumably as an aesthetic feature for properties on the LB). However, removing this weir and undertaking habitat improvements could actually improve the aesthetic appeal as well as the ecological status

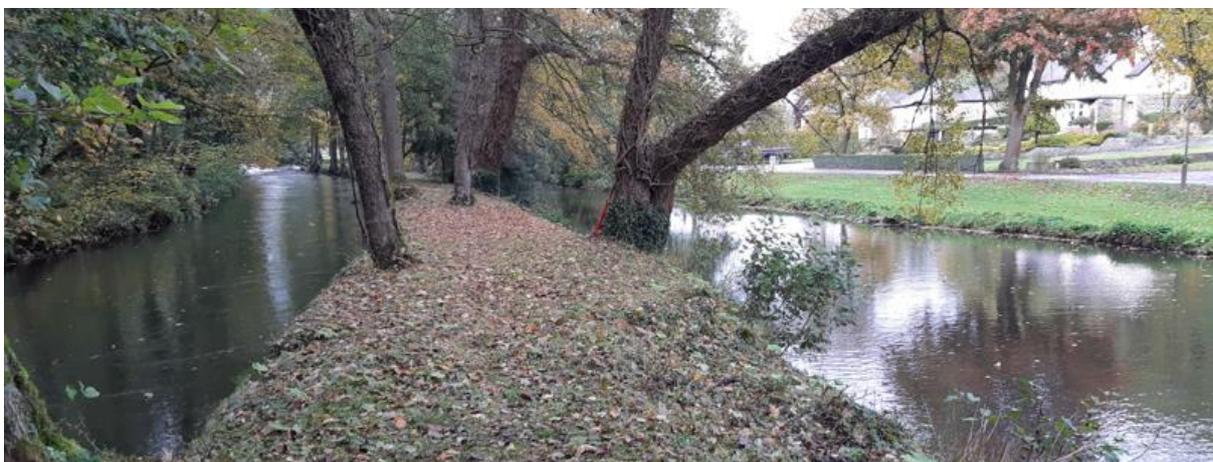
Figure 5: Facing upstream showing height difference between the left hand/backwater channel (**right** of frame) and central/main channel (**left** of frame). The latter serves the Victoria Mill leat and is “perched” (i.e. a channel artificially raised above the valley-base)

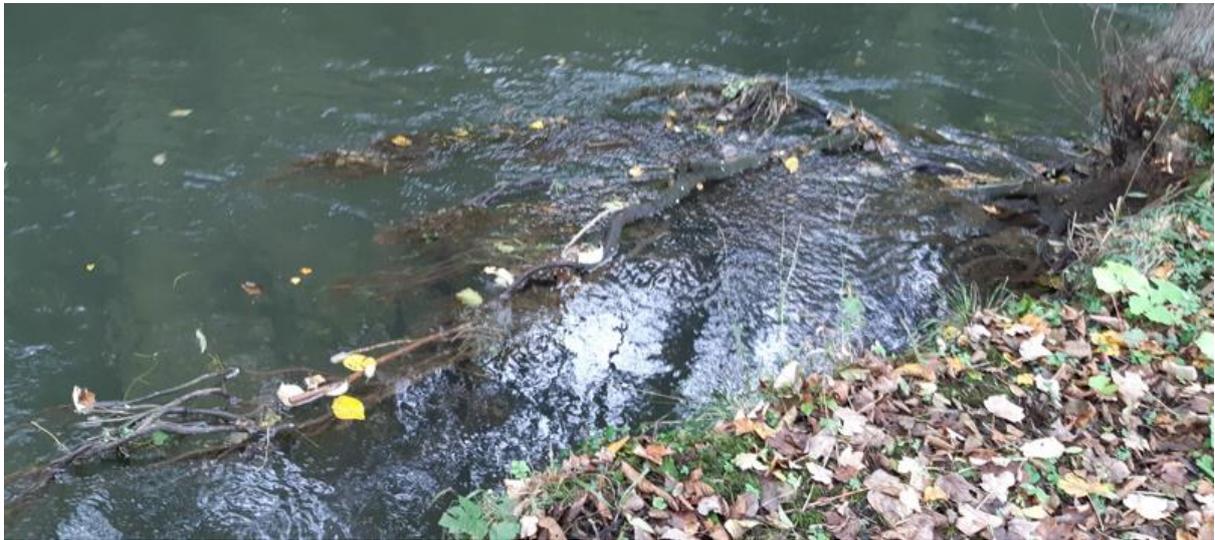
Figure 6: Submerged tree roots

The central/main channel contains habitat features that provide limited cover against predation and spate flows (e.g. Figs. 6 – 8 inclusive) – but overall is very uniform and likely to hold fewer fish than typical sections of the Wye.

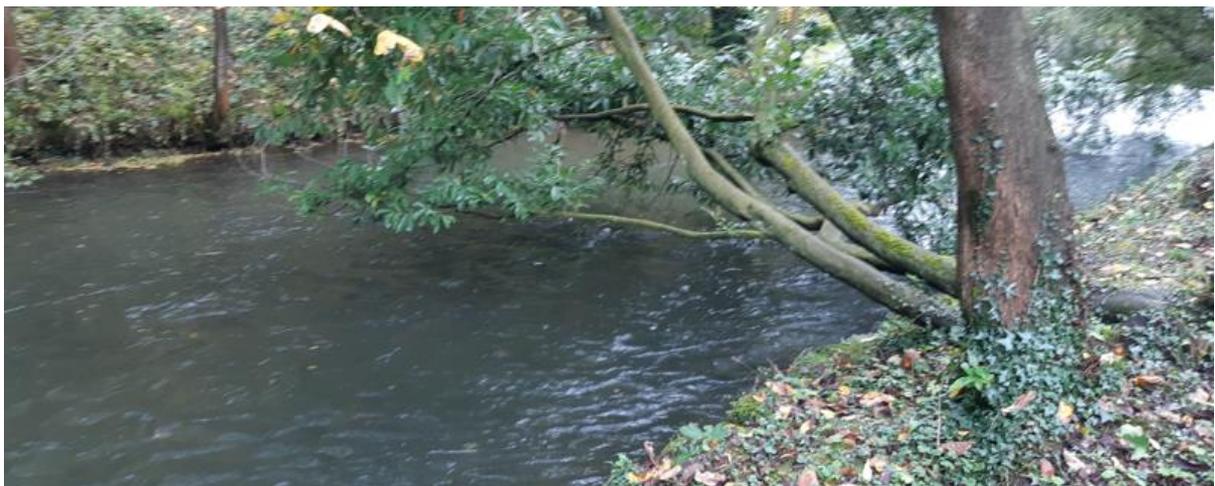
Figure 7: Low, trailing overhanging cover (LB)

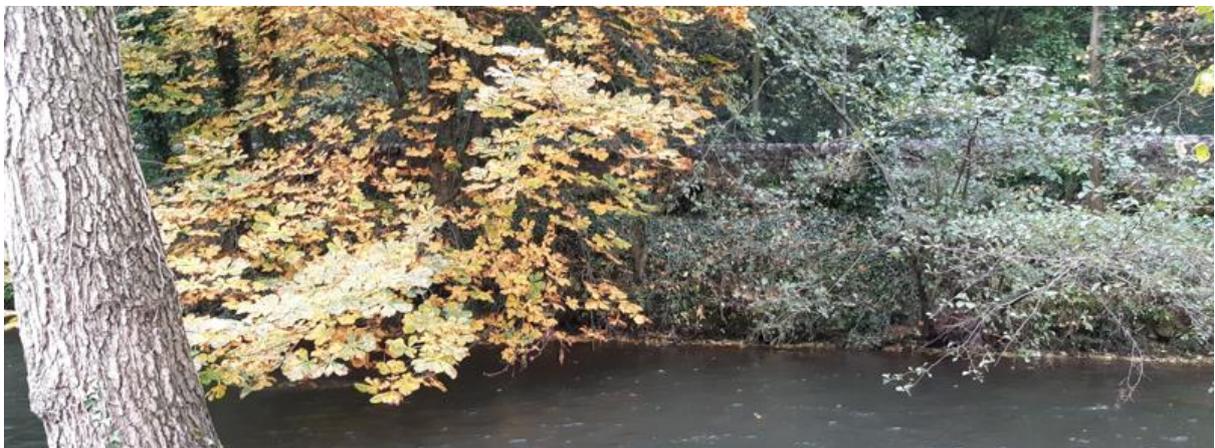
Figure 8: Low, trailing overhanging cover (RB). It is very important to retain an abundance of this type of cover in order to help maintain predator/prey (and light/shade) balances

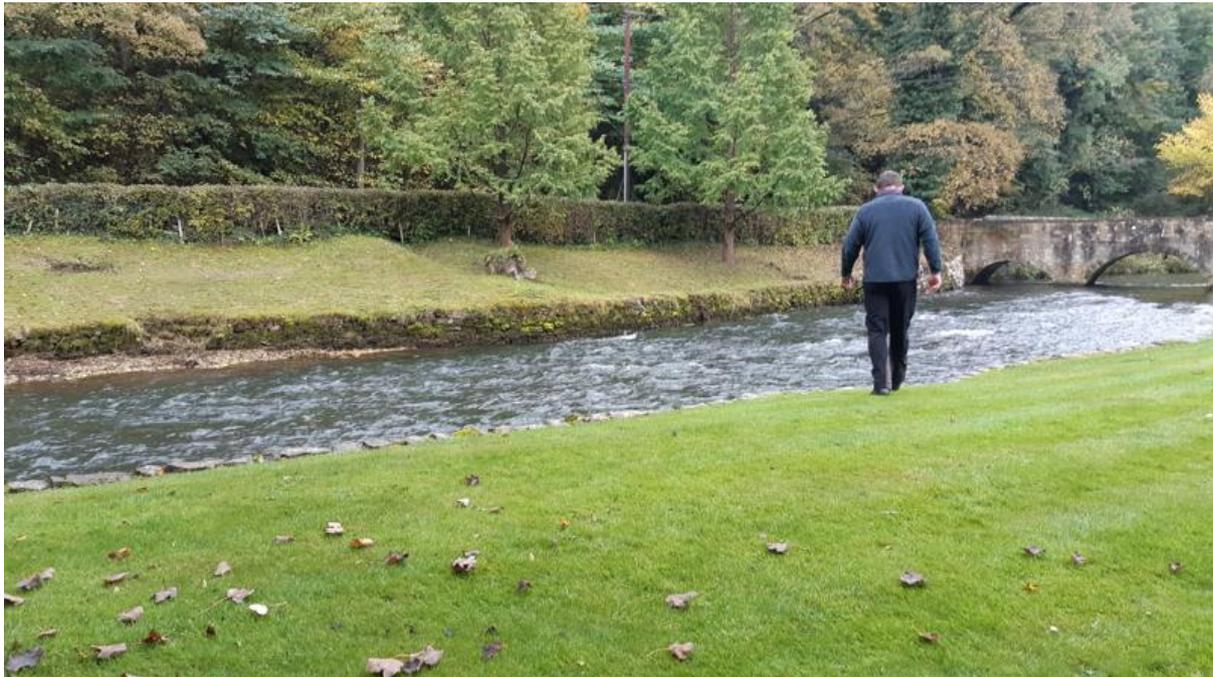
Figure 9: The perched (raised) right hand channel – showing the location of the upstream end of the pipe connection to the left hand channel (Fig. 10)

A connecting pipe runs between the central/main and left hand channels towards the upstream limit of the left hand channel (Figs. 9 and 10).

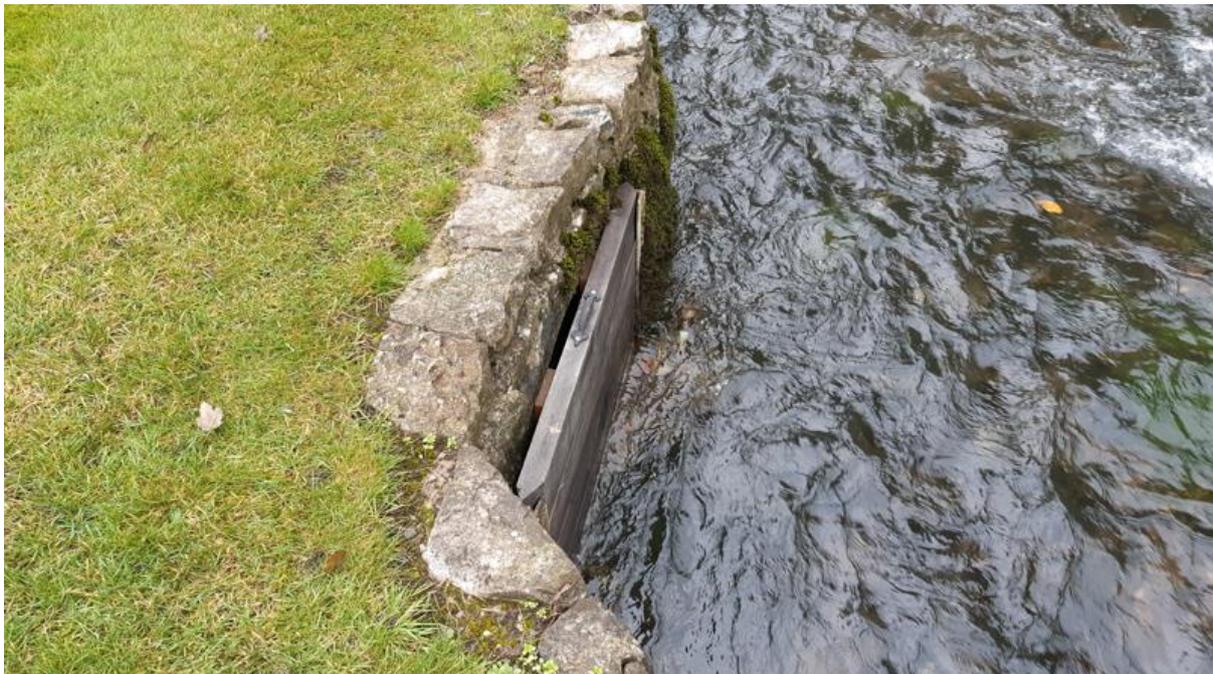
Figure 10: Outlet and sluice gate on the left hand channel at SK 21298 69016

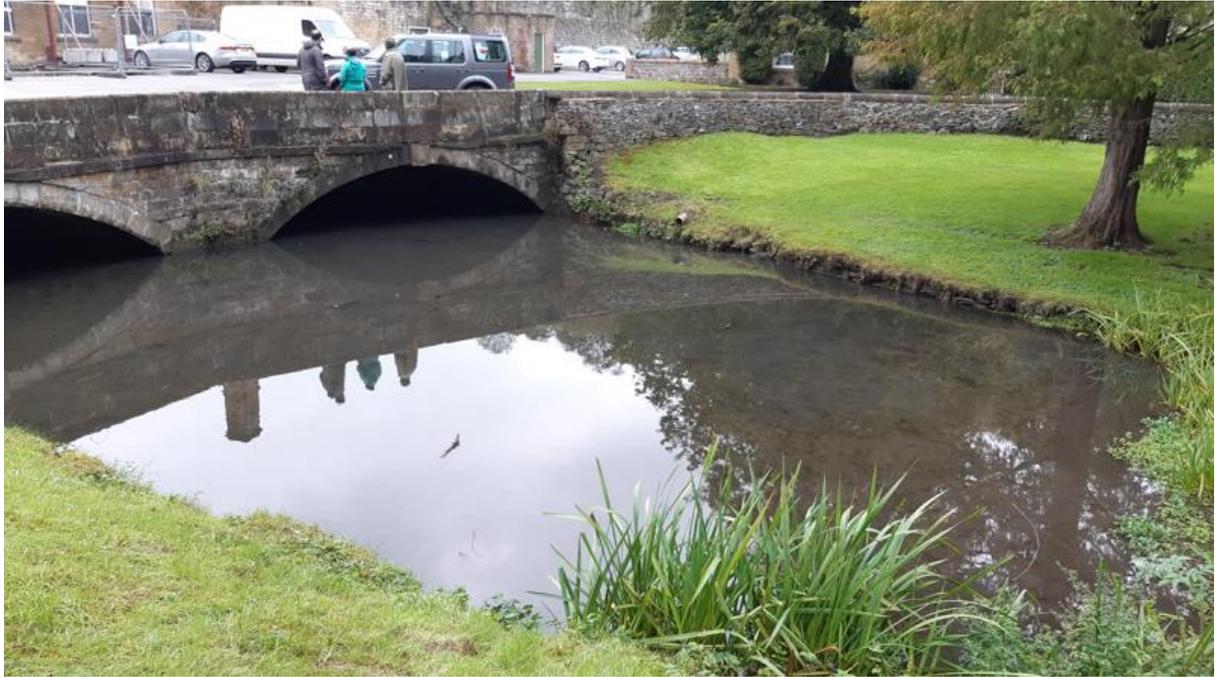
Figure 11: Bridge over left-hand channel at SK 21279 69047 (site of significant historic pollution)

As indicated. In this case there is a significant complicating factor stemming from historic battery manufacturing on the site of the current business park. It is likely that outfalls discharging to the left-hand channel around the reedbeds/bridge at SK 21279 69047 created a legacy of contaminated sediments. Sediment at this location is currently held back behind the beds of emergent macrophytes (Figs. 11 and 12).

Reduction or removal of downstream impoundments is likely to result in the remobilisation and release of contaminated sediment due to the process of head cut erosion/knickpoint creation during weir removal. However, although initially intimidating, there are precedents for stabilising contaminated sediment by pumping it out, placing in the margins and covering with a membrane before planting aquatic vegetation on top (e.g the River Wandle in Carshalton). That would enable physical/structural habitat AND pollution remediation benefits to this section of the Wye.

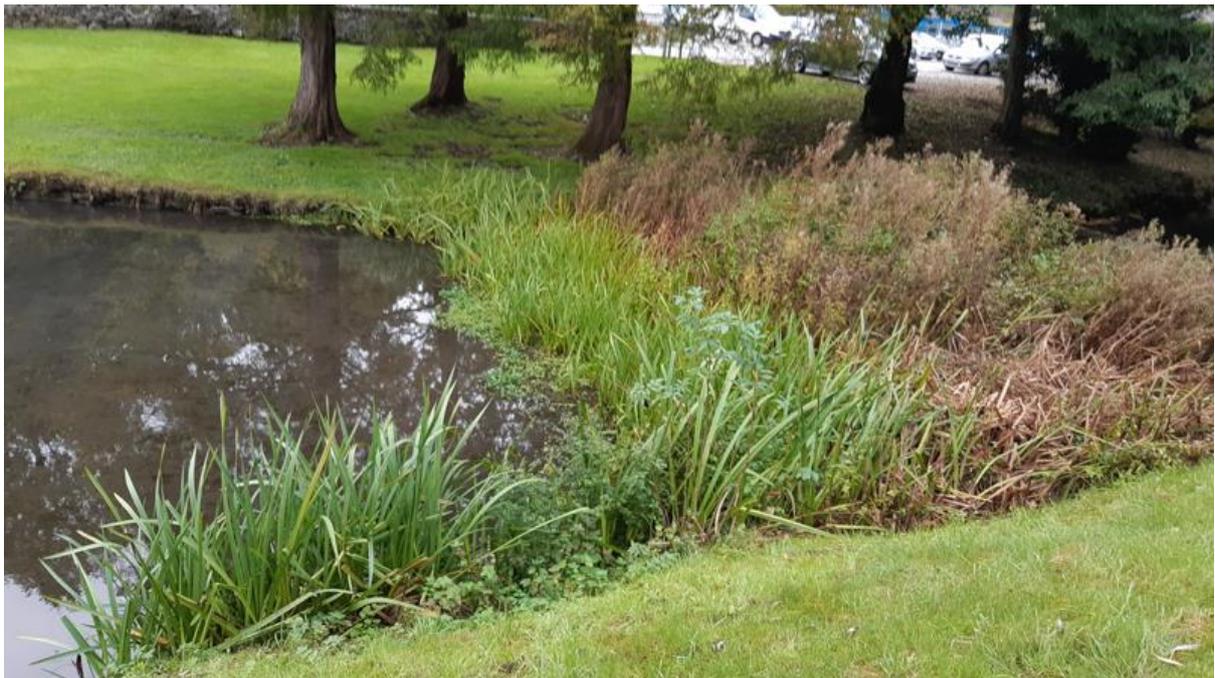
Figure 12: Macrophyte beds currently providing mitigation for historically-contaminated sediment. This effect could be adapted and used to stabilise "side-cast" sediment banks

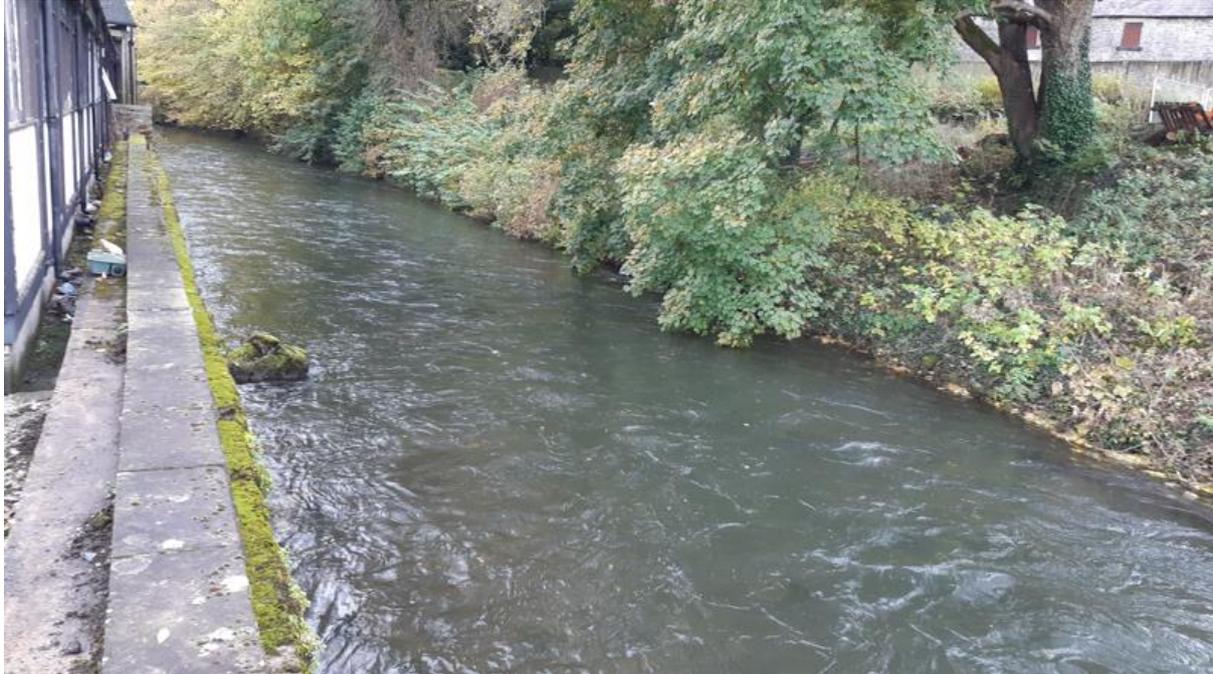
Figure 13: Straightened channel with relatively uniform depth, flow-velocity and substrate characteristics spanning the full cross-section; a bad thing for ecological diversity

Upstream of the bridge, the flow is consolidated into a single channel – which is contiguous with the central/main channel below the bridge. This straightened, walled channel runs behind the buildings along the south-west perimeter of the business park. The substrate, depth and flow all show little variation over the cross-section of this engineered channel (Fig. 13).

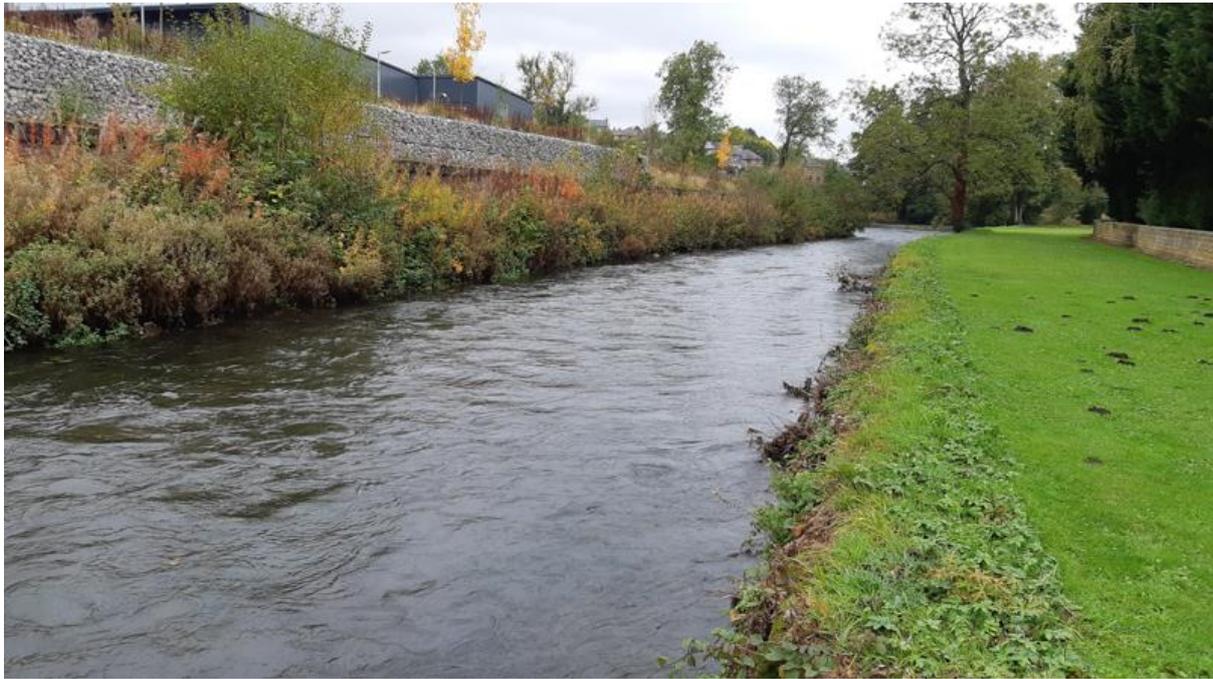
Figure 14: Cutting back bank-side vegetation on the LB at SK 20870 69199 (right of picture) removes cover habitat and tends to weaken the bank. Allowing riparian vegetation to develop and also widening the channel at points along that LB would create diverse pool and riffle habitat with good cover.

Just upstream of the business-park buildings (around the upstream limit of the site), bank-side vegetation is heavily cut back as part of the land-management (Fig. 14). This location also contains the site of a bridge that will be constructed to improve access. There may be an opportunity to instigate more sensitive land management and other habitat improvements as part of the installation of the new bridge. Additionally, widening the river at two to three locations here would shift habitat diversity toward higher-status examples seen further upstream – e.g. Fig. 18 of this report. This could be an easy way to create a pool and riffle sequence; thus remediating some of the impacts of this uniformly straightened and narrowed channel.

- Establishing a marginal buffer strip of vegetation in the area pictured in Fig. 14
  - Planting of feature trees/shrubs in the more open reaches (e.g. Figure 14)

- Selective widening (by sculpting the LB) of the reach in Fig. 14 to promote gravel riffle deposition and pool formation
  - Potential re-sculpting of the channel alongside the factories

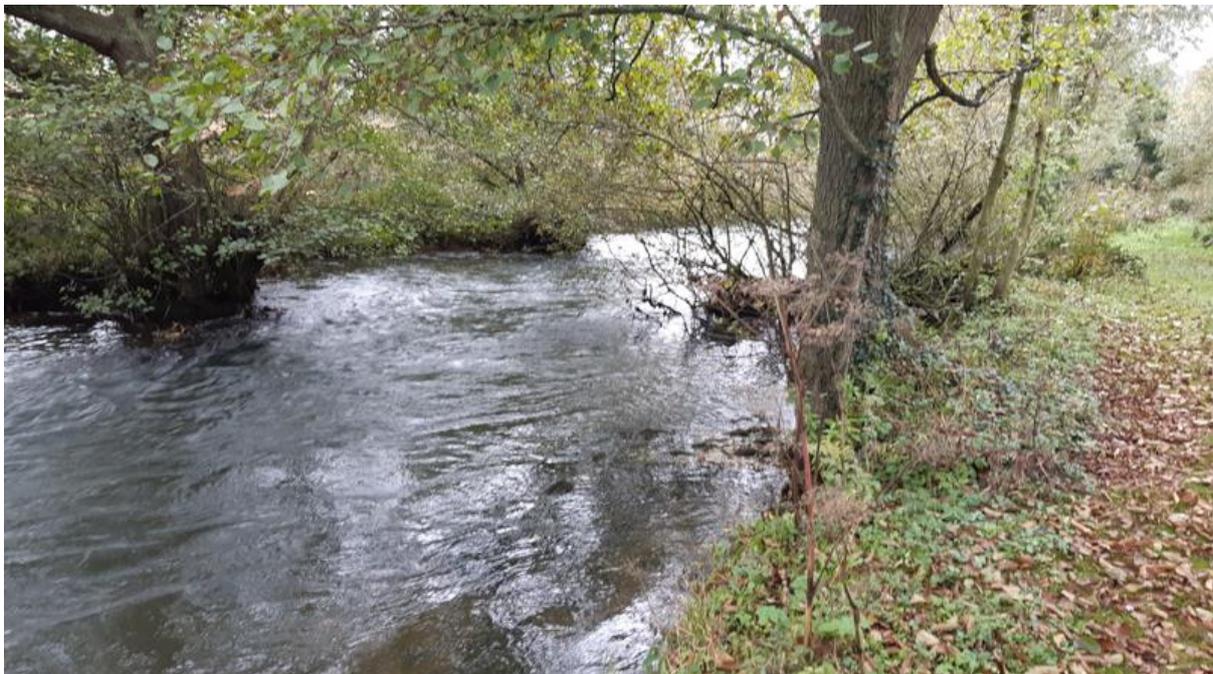
Figure 15: Fallen woody material and bankside vegetation combining to create variation in scour and deposition of the riverbed (creating better quality habitat compared to uniform, straightened sections downstream)

Continuing upstream, both the surrounding land and river channel become generally wilder and somewhat less managed (e.g. Figs. 15 and 16). The physical variation in habitat resulting from this change in land-management creates a wider range of opportunities for many aquatic plant and animal species.

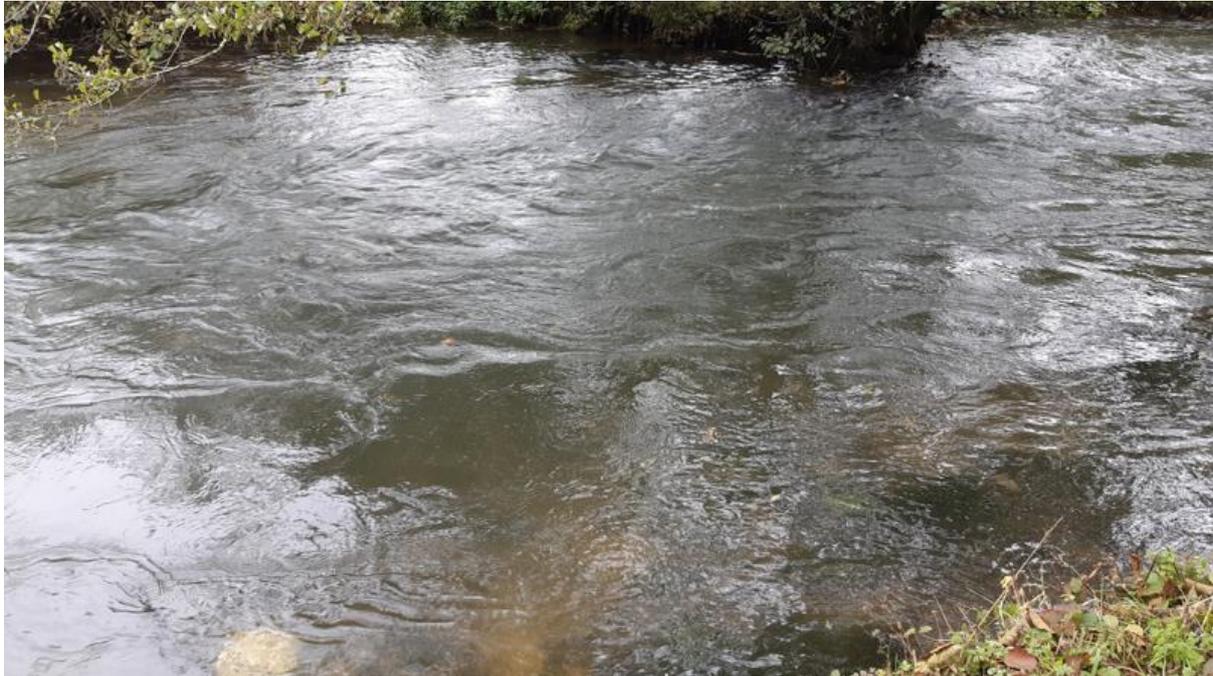
Figure 16: Deep scour hole (bottom of frame) created by woody material (shown in Fig. 15) creates the increased depth preferred by adult fish. Deposition of the material blown out of scour-pools creates spawning beds for gravel-spawning species. Note the wide variation of surface flow velocity in the centre of the channel compared to deeper pool habitat (bottom of frame) and in the shallower back-eddy (top of frame)

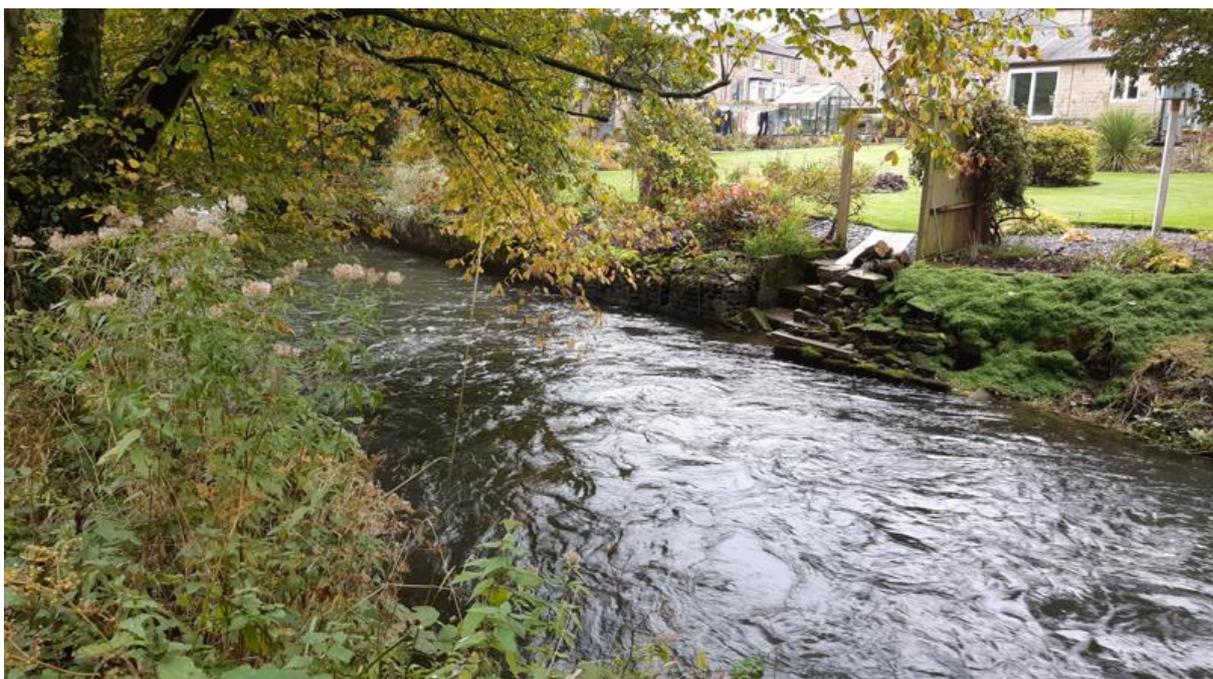
Figure 17: Bankside tree on the LB - opposite residential property

Some light coppicing could help to diversify the age and height structure by allowing regrowth from coppiced stumps on a staggered/rotational basis. This may also prevent damage to residential properties via wind-blown trees on the RB in this section (e.g. Fig. 17 at SK 20870 69292).

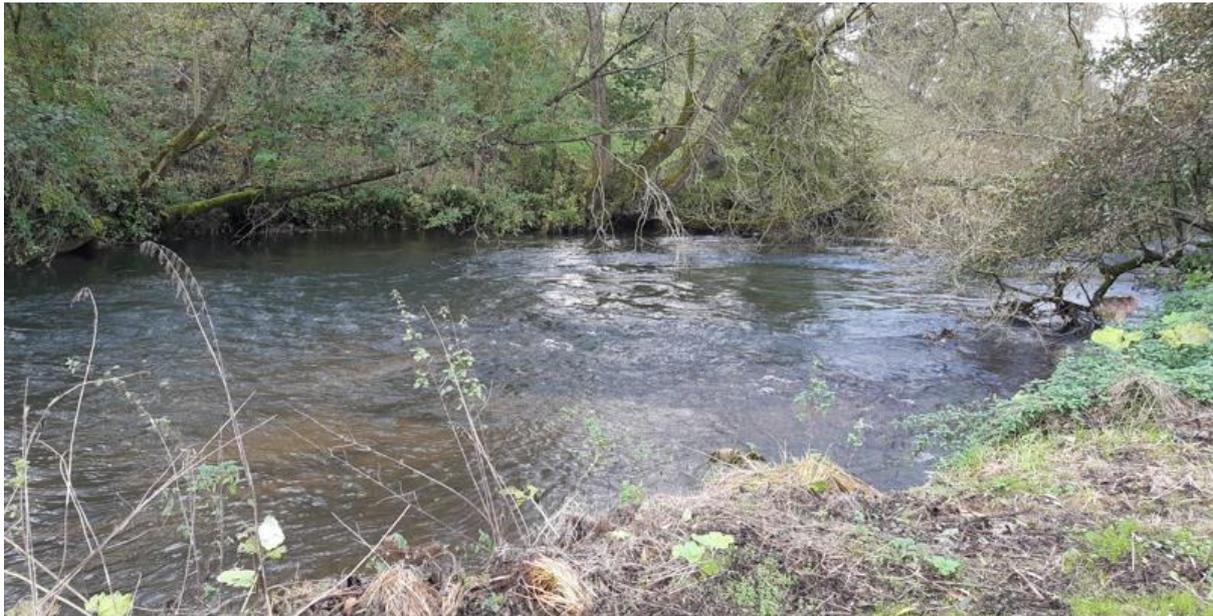
Figure 18: Variety of gravel beds, scour pools and low overhanging/trailing complex cover. Here the **greater channel width** allows deposition and retention of vital finer gravels, suitable for salmonid spawning and a range of invertebrates

Material arising from coppicing works could be securely anchored in place to diversify flow, deposition and cover from predation/spate flows in the more uniform sections of channel. The much greater diversity of channel morphology and vegetative cover in the section upstream of the business park is shown in Figs. 18 to 20.

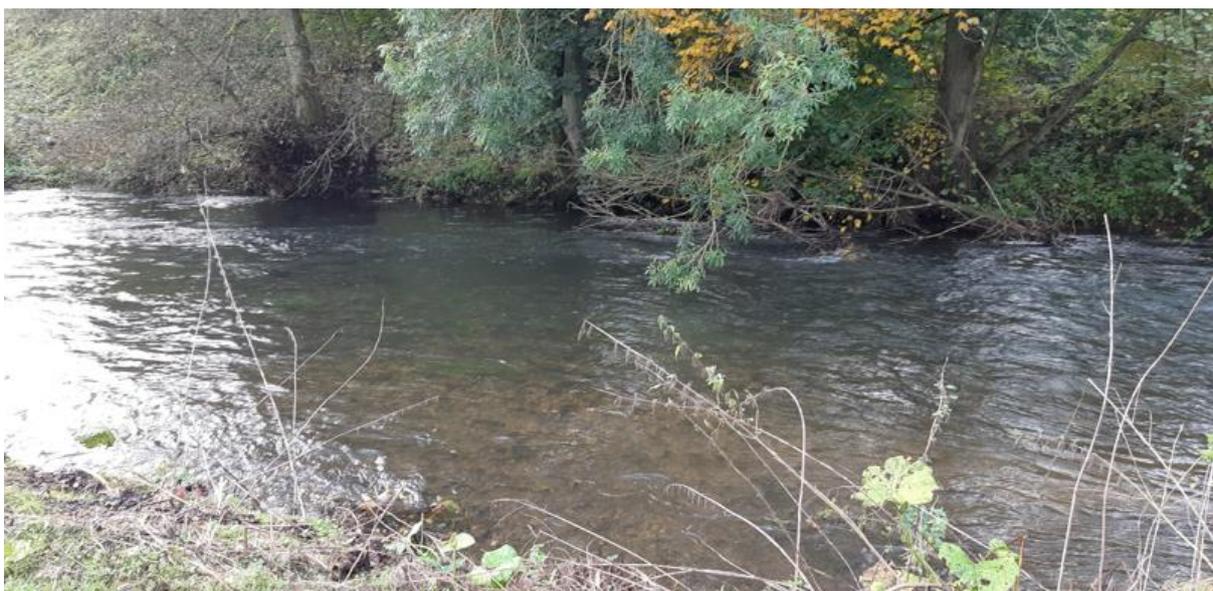
Figure 19: Deposition of a gravel "point bar" on the inside of even a slight meander (bottom of frame) coupled with low, trailing cover above a scour pool. The result is cross-sectional variation in depth, velocity and substrate-character in combination with protective cover

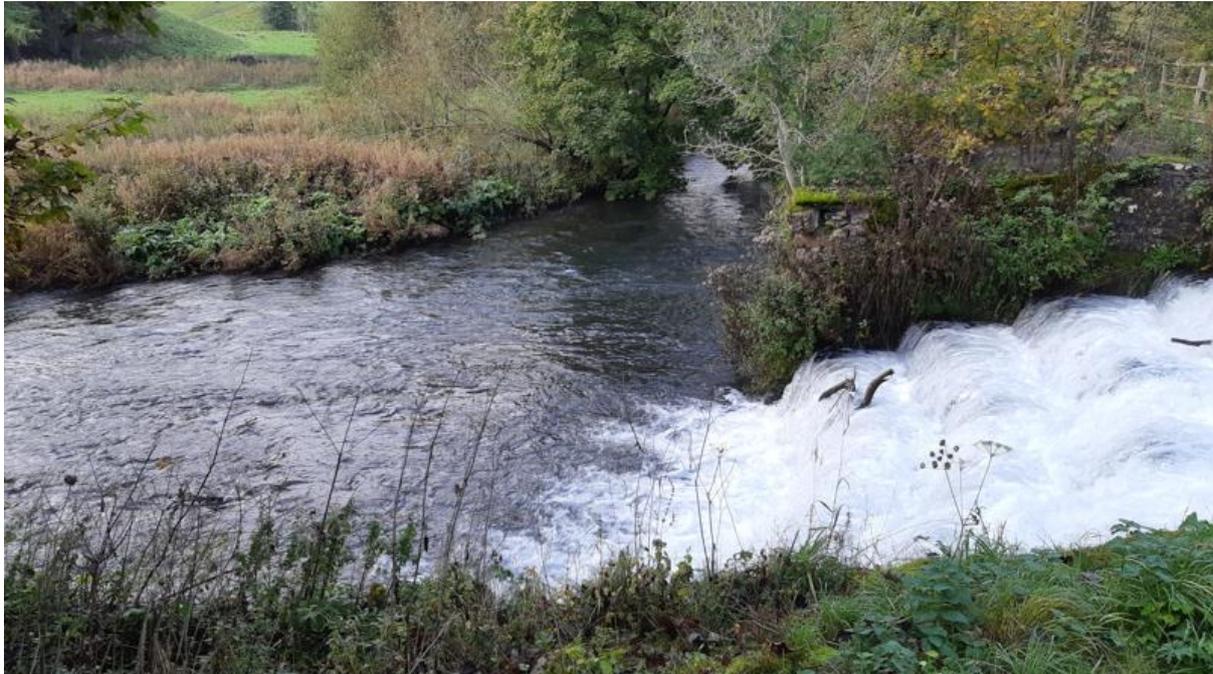
Figure 20: Outlet from Ashford Lake discharging over a stepped weir into the River Wye

The top of the visited reach was at the outlet from Ashford lake (Fig. 20). This was the site from which the Wye's wild rainbow trout were found to have colonised some time in the early 20<sup>th</sup> century.

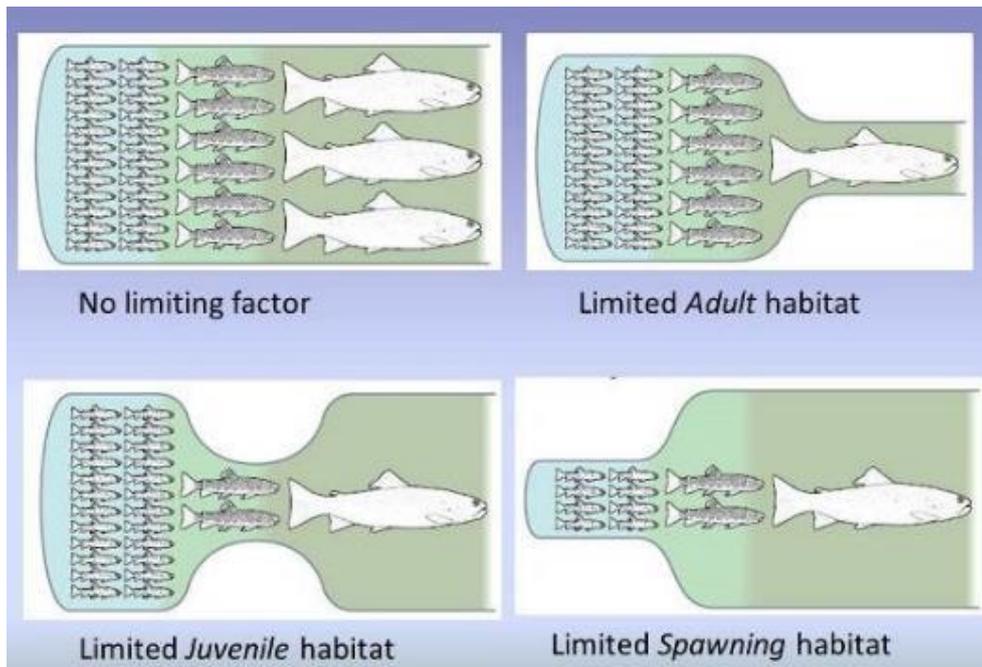
Figure 21: The impacts on trout populations lacking adequate habitat for key lifecycle stages. Spawning trout need to create loose mounds of gravel that maintain a good flow of oxygenated water between gravel grains. Juvenile trout need shallow water with plenty of dense submerged/tangled structure for protection against predators and wash-out during spates. Adult trout need deeper pools (usually > 30cm depth) with nearby structural cover such as undercut boulders, sunken trees/tree limbs and/or low overhanging cover (ideally trailing on, or at least within 30cm of, the water's surface). Excellent quality in one or two out of the three crucial habitats cannot make up for a "weak link" in the remaining critical habitat.

The following short illustrations (Figs. 21 – 24) indicate how diversifying habitat structure helps to avoid bottlenecks for wild fish populations. There are three main types of habitat that trout require in order to complete their lifecycles (spawning, nursery/juvenile and adult). By providing for these key lifecycle stages through wide structural diversity in habitat, a wide range of flora and fauna is also created.

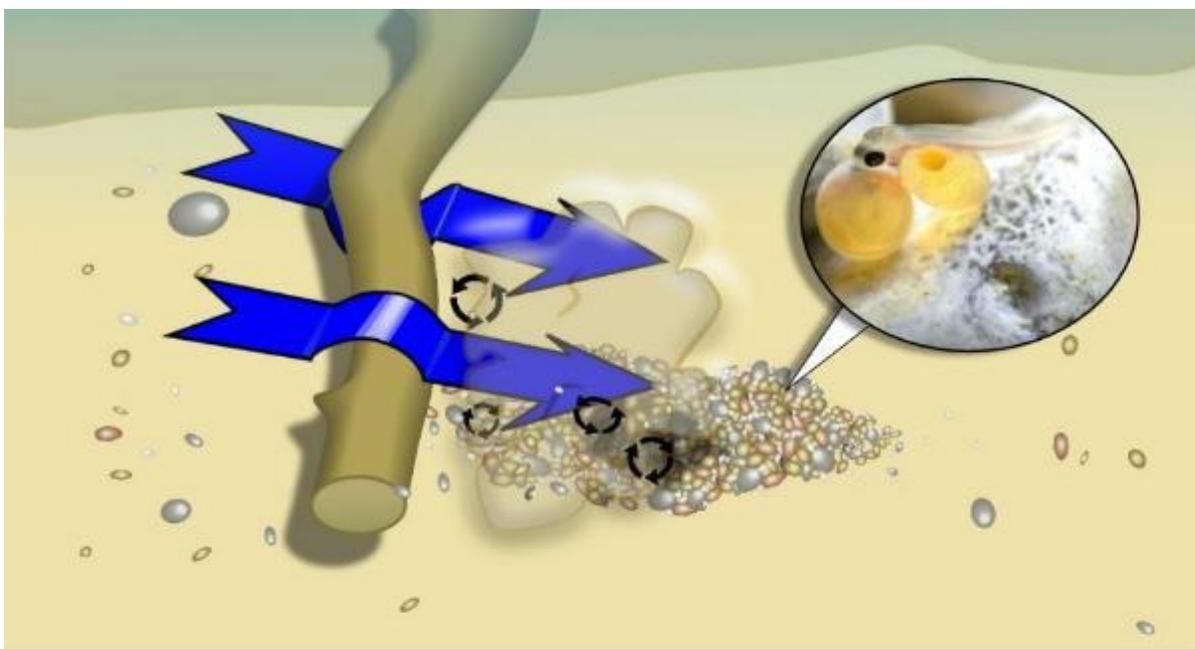
Figure 22: Features associated with successful trout spawning habitat include the presence of silt-free gravels. Here the action of fallen tree limb is focusing the flows (both under and over the limb as indicated by the blue arrows) on a small area of river-bed that results in silt being mobilised from between gravel grains. A small mound of gravel is deposited just downstream of the hollow dug by focused flows. In these silt-free gaps between the grains of gravel it is possible for sufficient oxygen-rich water to flow over the developing eggs and newly-hatched "alevins" to keep them alive within the gravel mound (inset) until emerging in spring.

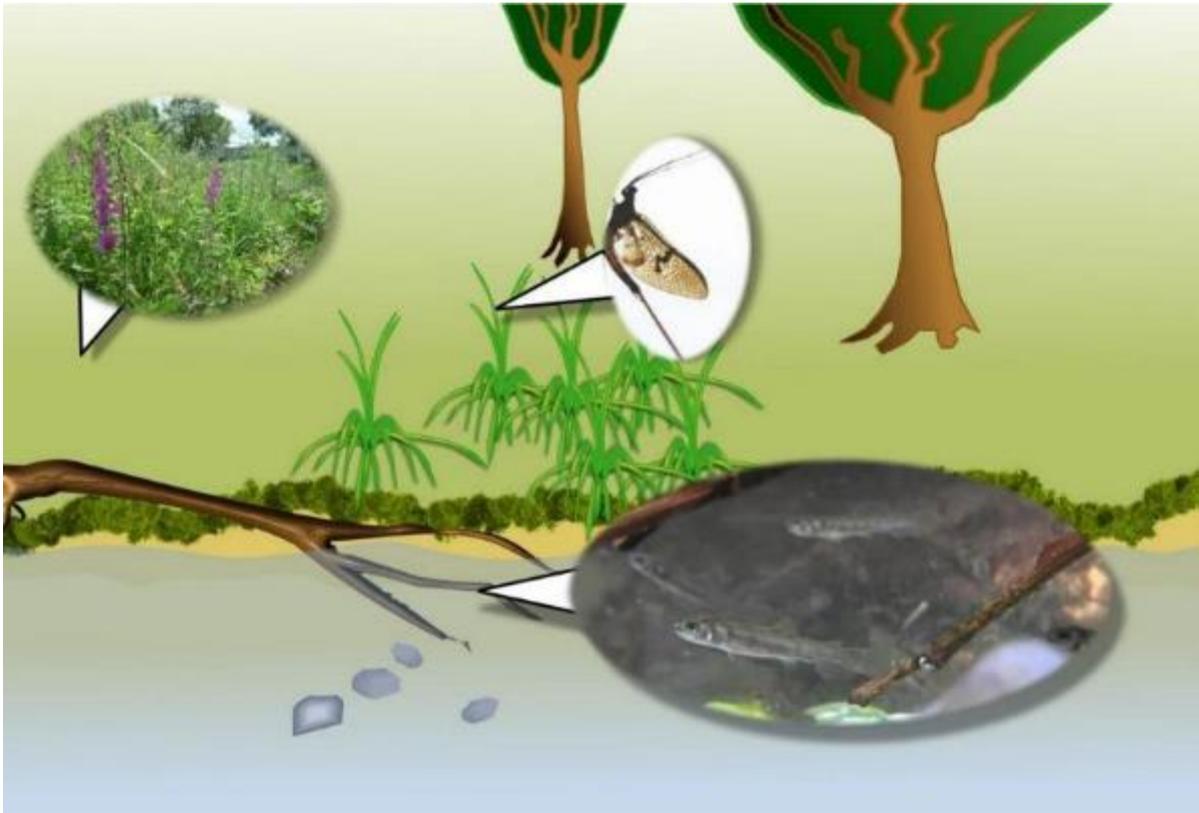
Figure 23: Larger cobbles and submerged "brashy" cover and/or exposed fronds of tree roots provide vital cover from predation and spate flows to the tiny juvenile fish in shallower water (<30cm deep) after they emerge. Trailing, overhanging vegetation also provides a similar function and diverse bank-side vegetation has many benefits for invertebrate populations (some of which will provide a ready food supply for the juvenile fish).

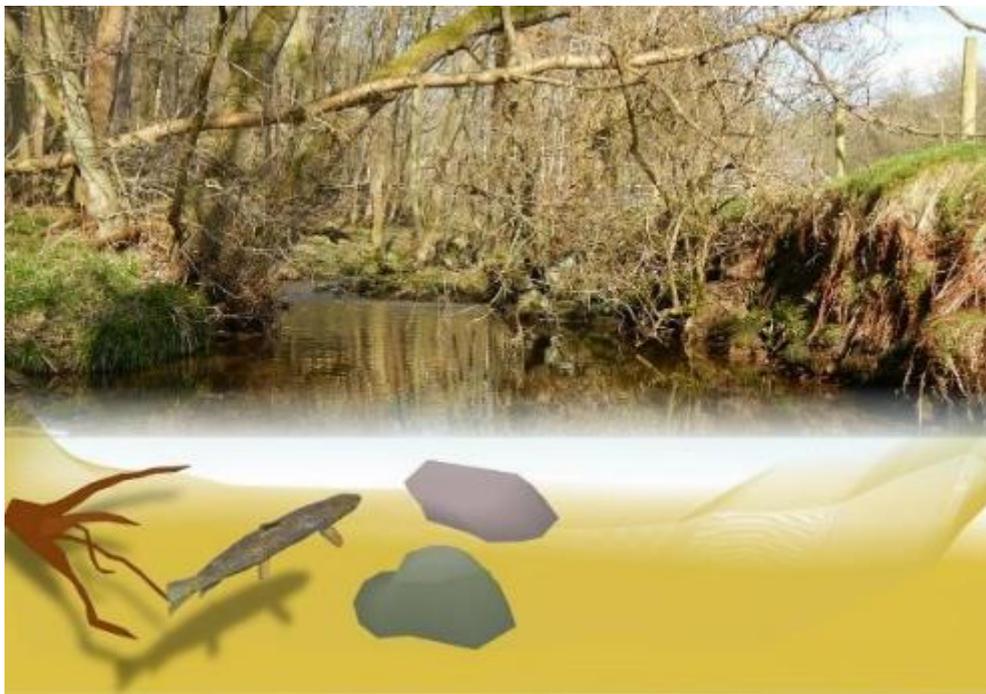
Figure 24: The availability of deeper water bolt holes (>30cm to several metres), low overhanging cover and/or larger submerged structures such as boulders, fallen trees, large root-wads etc. close to a good food supply (e.g. below a riffle and with prey likely to fall from overhanging tree canopy in this case) are all strong components of adult trout habitat requirements.

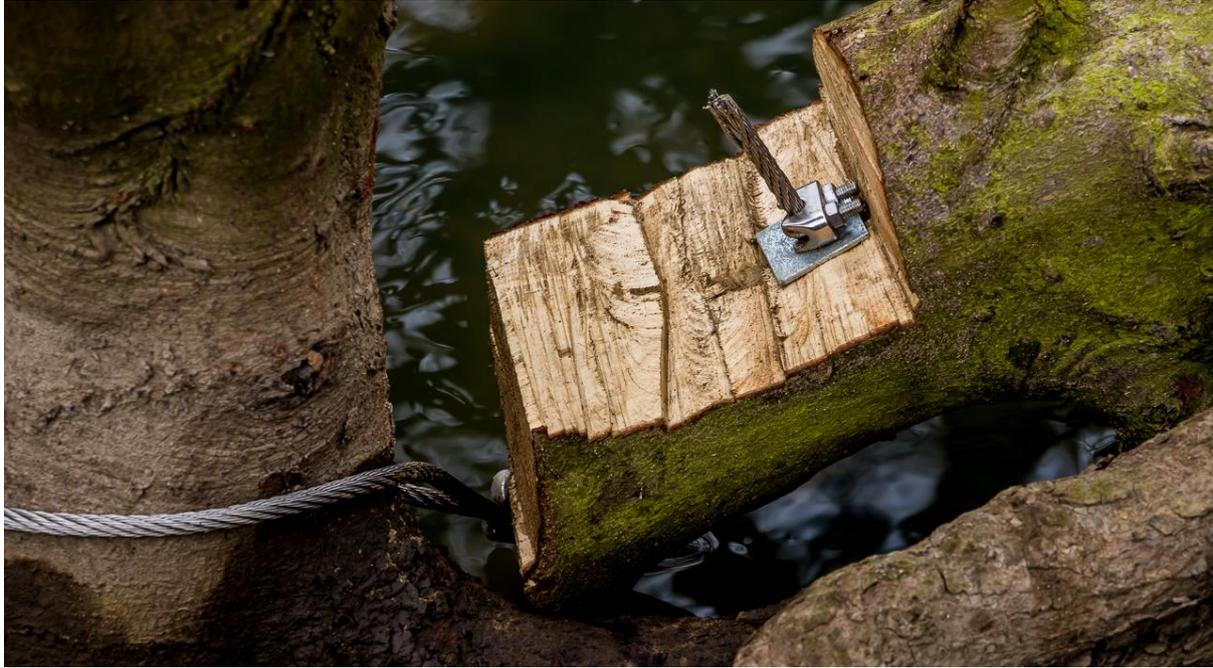
Figure 25: Securely-cabled woody material (attached at the upstream end only - to allow the crown to move up and down with spate flows). Note, slings can be incorporated to preserve valuable "anchor" trees by avoiding ring-barking. An even simpler, more natural (and equally stable) method is to lodge the felled material around a standing tree. This is achieved by slotting the "V" of a major limb and the main trunk of the felled tree around the trunk of the standing tree.

- The light-touch rotational coppicing of veteran, bankside trees to diversify low-level cover and light/shade regime provided by the canopy
  - Secure cabling (or simple wedging of forked limbs/trunk) of woody material in the margins at selected locations to create overwintering cover for adult and juvenile fish - as well as patches of substrate deposition adjacent to a limited amount of gravel “sorting”/localised bed-scour; e.g. Figs. 25 and 26.

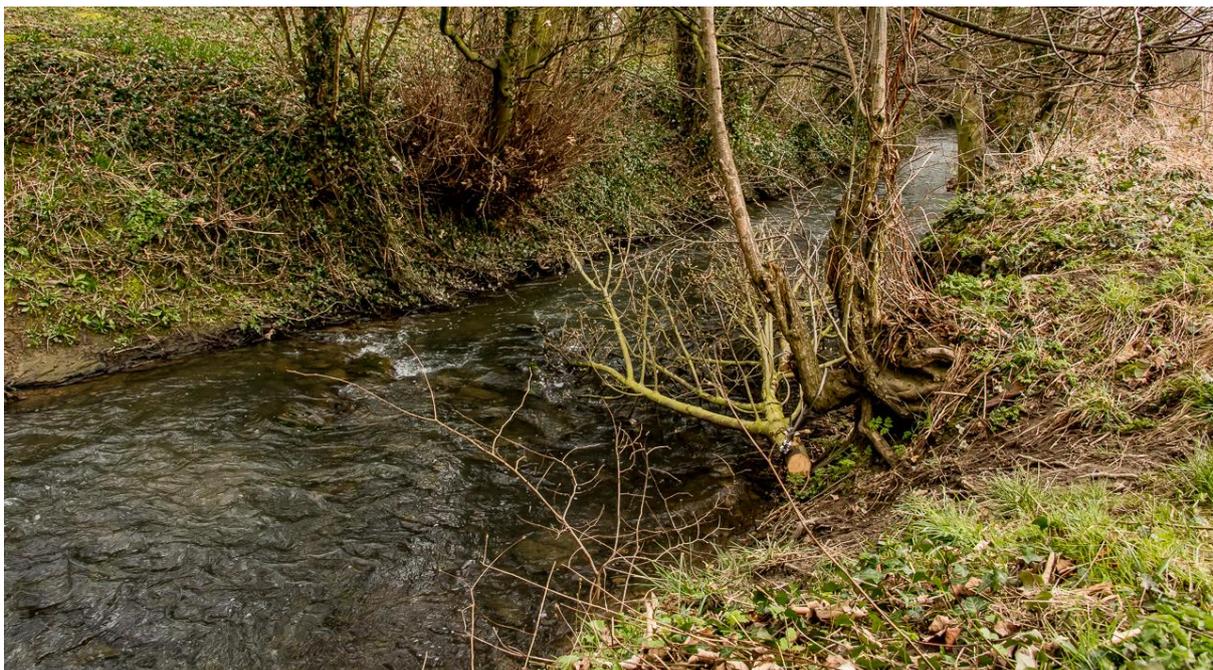
Figure 26: A wide size range of woody material (appropriate to situation and channel size) can be cabled - or lodged - in place
