River Irk – Greater Manchester

An advisory visit carried out by the Wild Trout Trust – Feb 2015

*This report is the output of a Wild Trout Trust Advisory Visit (AV) undertaken along **approximately 3km of the River Irk in Greater Manchester.***

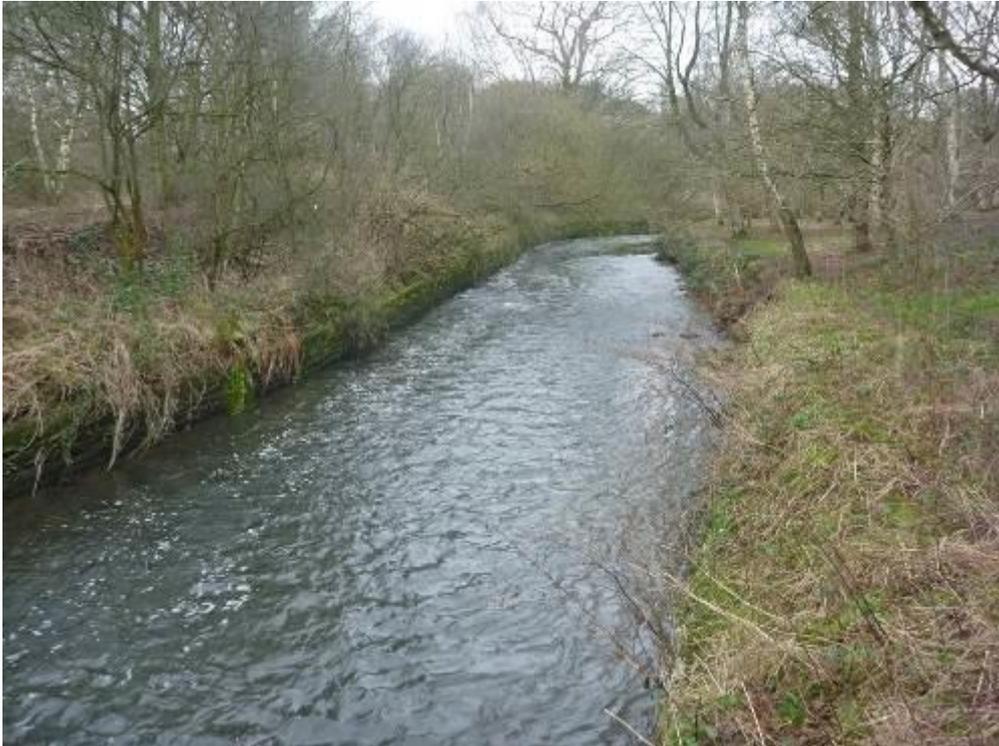
Figure 3: Facing upriver at downstream limit - modified channel is reclaiming a degree of natural physical diversity thanks to steep longitudinal bed-slope and associated redistribution of riverbed material

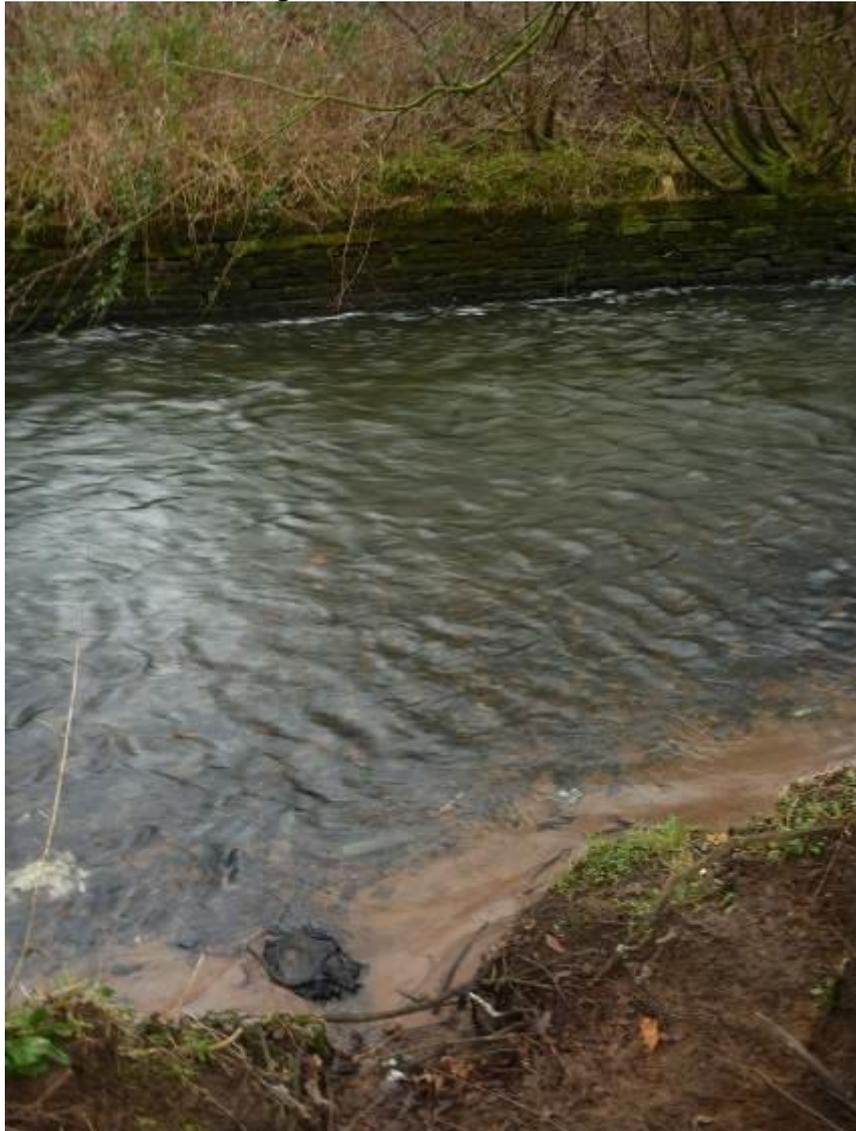
Figure 4: Gravels of potentially suitable size-ranges for trout spawning (SD 83951 03646). However, extensive infiltration of sand and silt between gravel grains currently limits potential egg survival

Increasing in-channel structure would also assist in the retention of gravel substrate, which at present is likely to be washed straight through the uniform walled sections. Gravels that are of a size that would enable trout to attempt to spawn (i.e. approximately 20-50 mm in diameter) were observed (e.g. Fig. 3). However, these gravel deposits also suffered from extensive infiltration of finer sediment that occupied the gaps between gravel particles. Without loose deposits of gravel that have clear gaps between gravel grains (interstices), it is not possible to maintain a sufficient flow of oxygenated water to support good survival of eggs laid in gravel beds.

Localised scour of the riverbed helps to "sort" gravel particles from finer substrate by washing away silt and redistributing the sorted gravel locally. Consequently, another beneficial impact of retaining and stabilising pieces of

woody debris is an increased potential for successful trout-spawning through increased retention and sorting of the substrate.

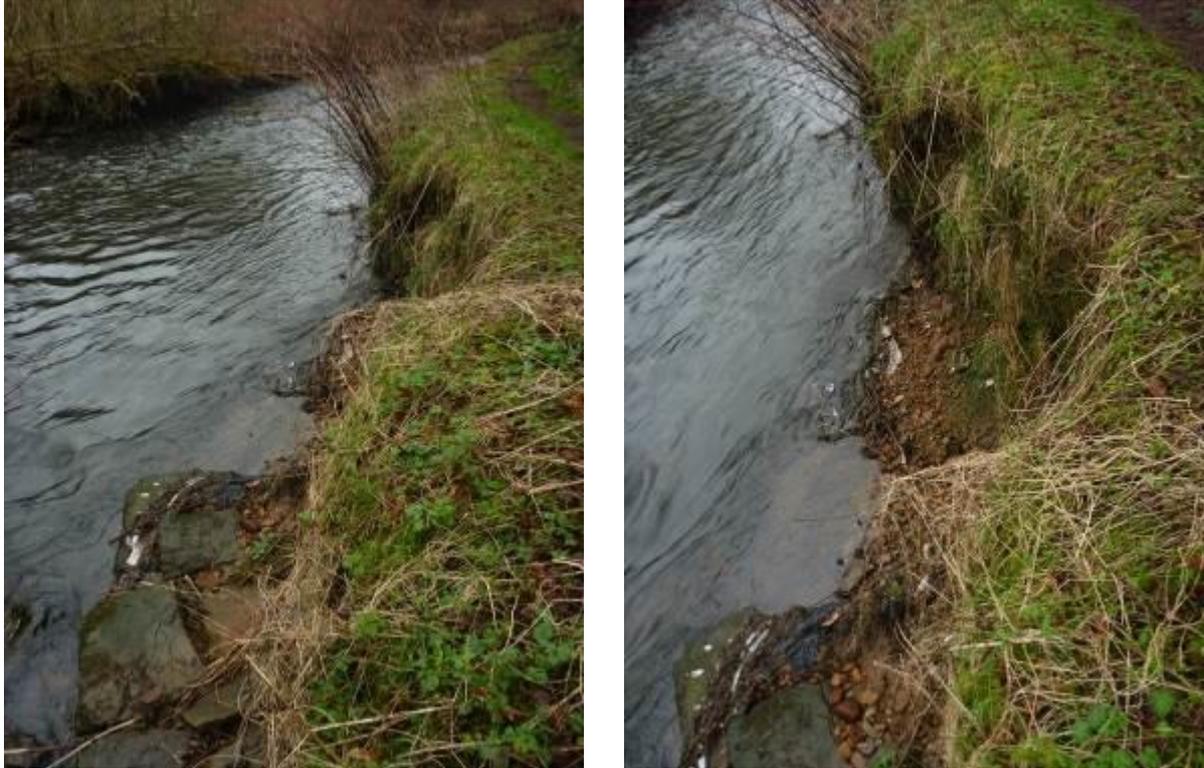
The vital role of an appropriate (natural) rate of bank erosion is illustrated by small sections where the stone-work at the toe of the bank (i.e. where the riverbank joins the riverbed) has failed. In those instances (e.g. Fig. 5) the inputs of valuable spawning gravel substrate – as well as finer particles – can clearly be seen. The key is to have a deep and complex root-structure within the river banks so that the rate of erosion is slow enough to provide beneficial effects without causing additional problems. The use of woodland trees to manage erosion can, and should, be combined with routing/re-routing of access paths so as to minimise damage or failure of formal paths whilst providing maximal habitat benefits.

Figure 5: Small area of bank-toe stonework failure at SD83925 03659 (Left) leading to vital inputs of spawning gravel (Right). Watercourses with stone retaining walls have their supplies of spawning gravel choked off at source. They often also tend to suffer the additional impact from weirs that intercept any gravels that have managed to find their way into the system.

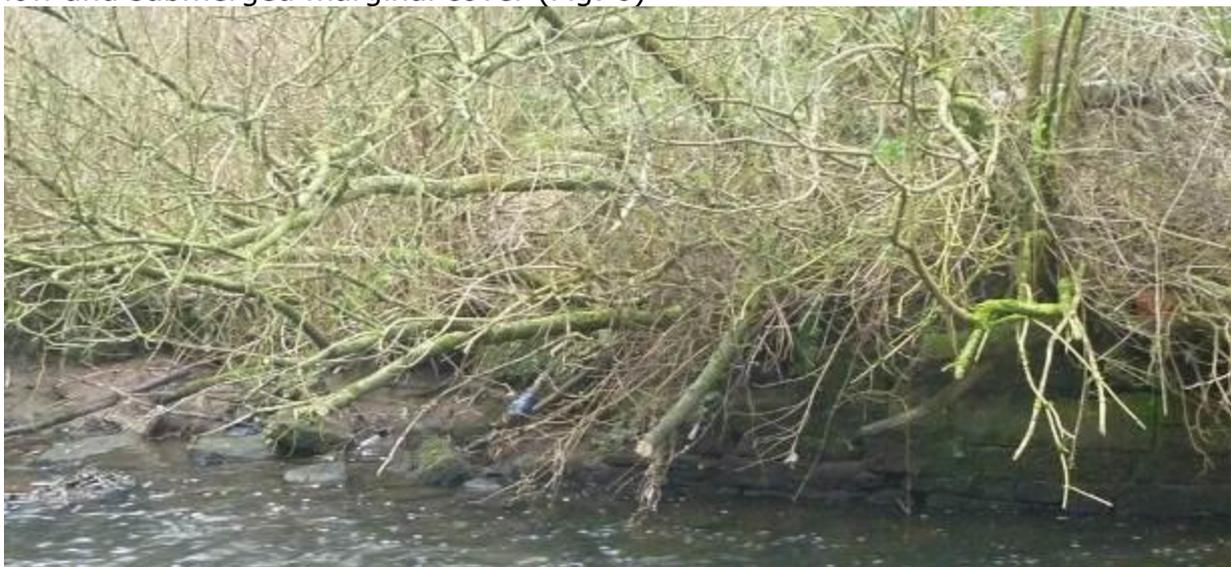
Deliberate management practices are also actively minimising the formation of low and submerged marginal cover (Fig. 6)

Figure 6: Trailing branches that would previously have provided vital over-wintering habitat that have been cut back at SD83925 03675 (usually in an attempt to minimise perceived flood risk). If left trailing within the channel, those branches would also have assisted in gravel retention

A number of similar examples to those depicted in Fig. 6 were noted throughout the visit and such works are often carried out on the assumption that they will reduce flood risk. Commonly, the effect is far more closely related to perception of flood risk than any gains in reducing the frequency and magnitude of flooding events. In many cases, trying to maximise conveyance of flood waters at all points along the course of a river will actually increase the frequency and magnitude of flooding downstream:

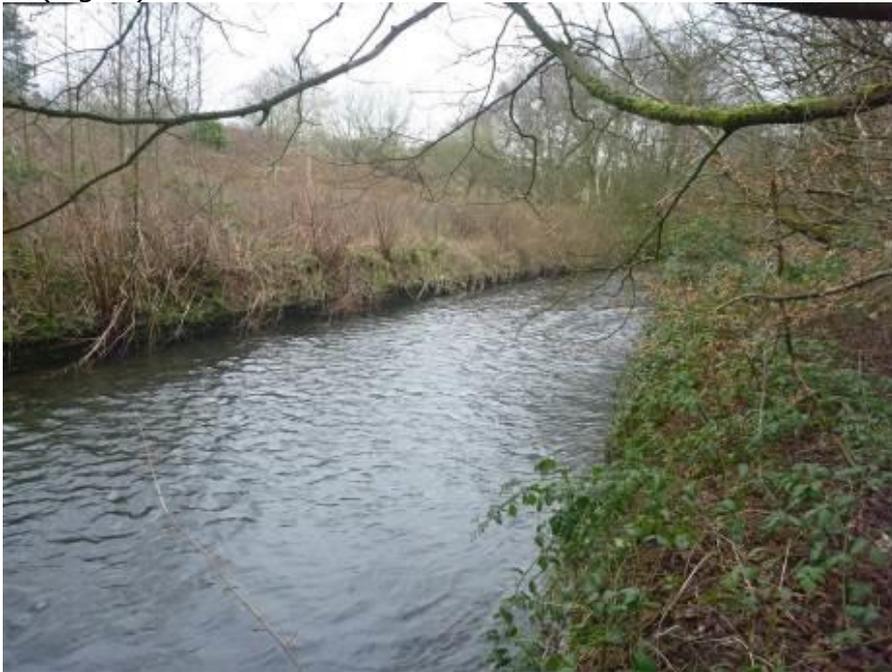
Extensive channelization using stonework to define the dimensions and (straightened) course of a river can have the same effect. It also greatly reduces the physical variety of habitat and associated ecological niches within a watercourse (Fig. 7).

Figure 7: The trailing and low-overhanging vegetation in this section at SD83934 03675 provides at least some (much-needed) cover. However, overall the straightened, stone-walled channel only retains a very small proportion of the structural diversity that would be present in a more natural channel

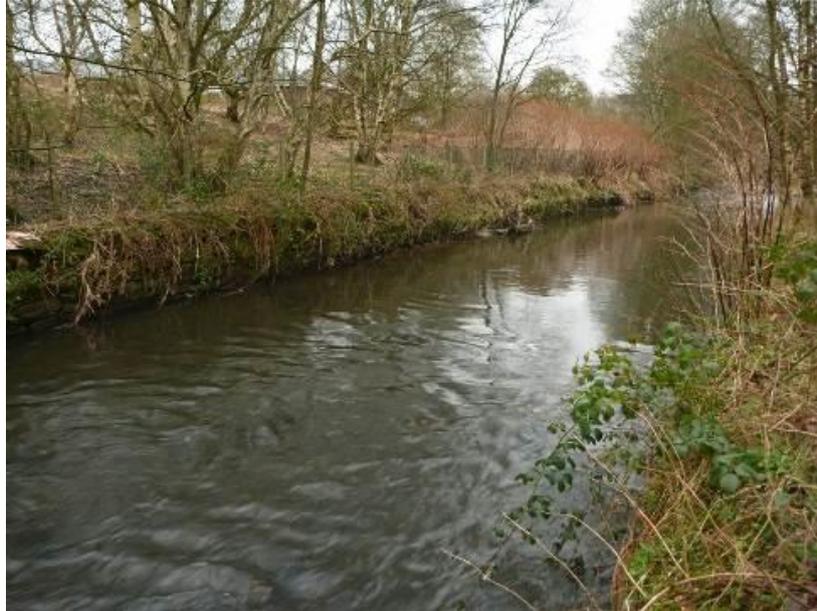
The Irk in these reaches benefits from a longitudinal bed slope and channel dimensions that, together, are sufficient to redistribute riverbed material. As a result, there are examples of regeneration or retention of some structural diversity (e.g. Fig. 8).

Although the channel does not conform to a naturally meandering planform, some variation in patterns of erosion and deposition have given rise to a series of linear glides and pools. The head of the riffle and tail of the pool shown in Figure 8 are an example of this. It was not clear whether the substrate at the shallow tail of the much deeper pool contained gravels that would be suitable for spawning trout. Some of the more visible areas appeared to be dominated by larger (cobble) particles that may only provide viable spawning opportunities for uncommonly large trout. This is likely to be due to the straightening, smoothing and confinement of the channel causing finer material to be washed out of the reach.

Figure 8: A linear pool (upper right of frame) giving way to a ramp of substrate that produces the head of the riffle pictured in the centre and lower-left of frame at SD83959 03742.

If it is possible for fish to dig "redds" (gravel nests) at the location pictured in Fig. 8, the riverbed would certainly benefit from localised bed-scour to "sort" the coarse from the fine particles. This would produce at least localised deposits of loose, silt and sand-free spawning substrate (see section 4 "Recommendations" for additional guidance).

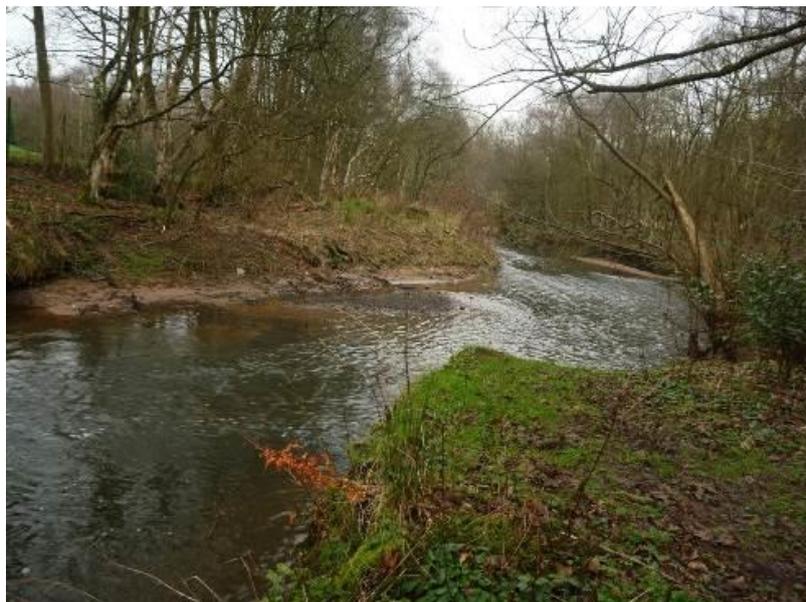
Figure 9: Lack of impoundment and more natural bank profiles - great habitat SD83996 03805

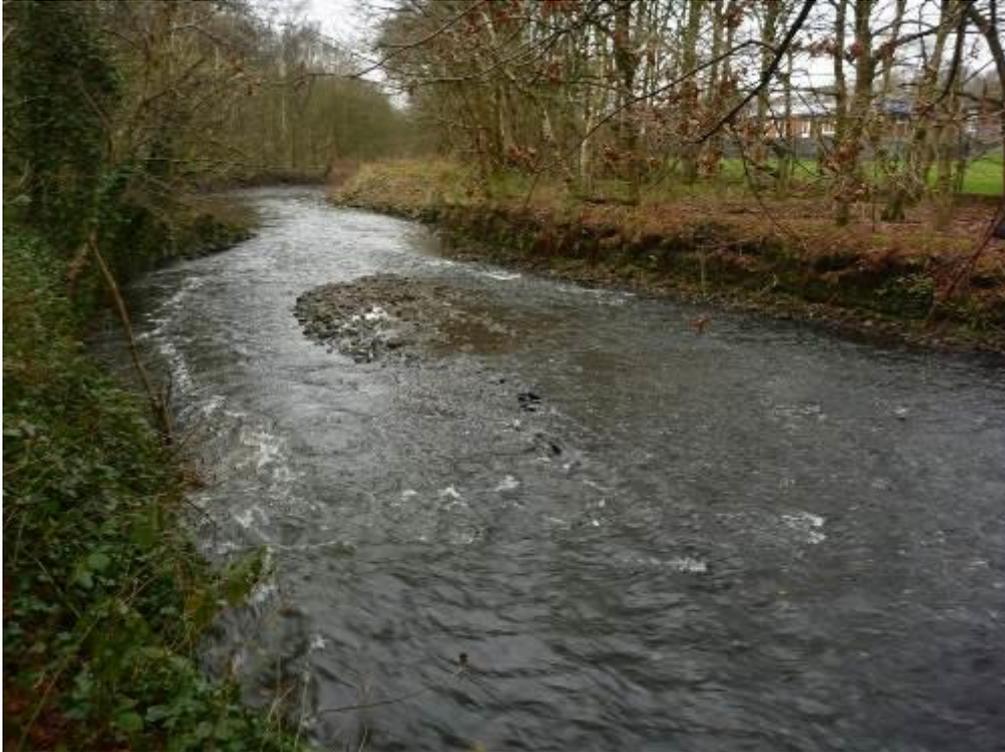
Figure 10: Valuable diverse riverbed features in un-impounded reach at SD 84041 03895

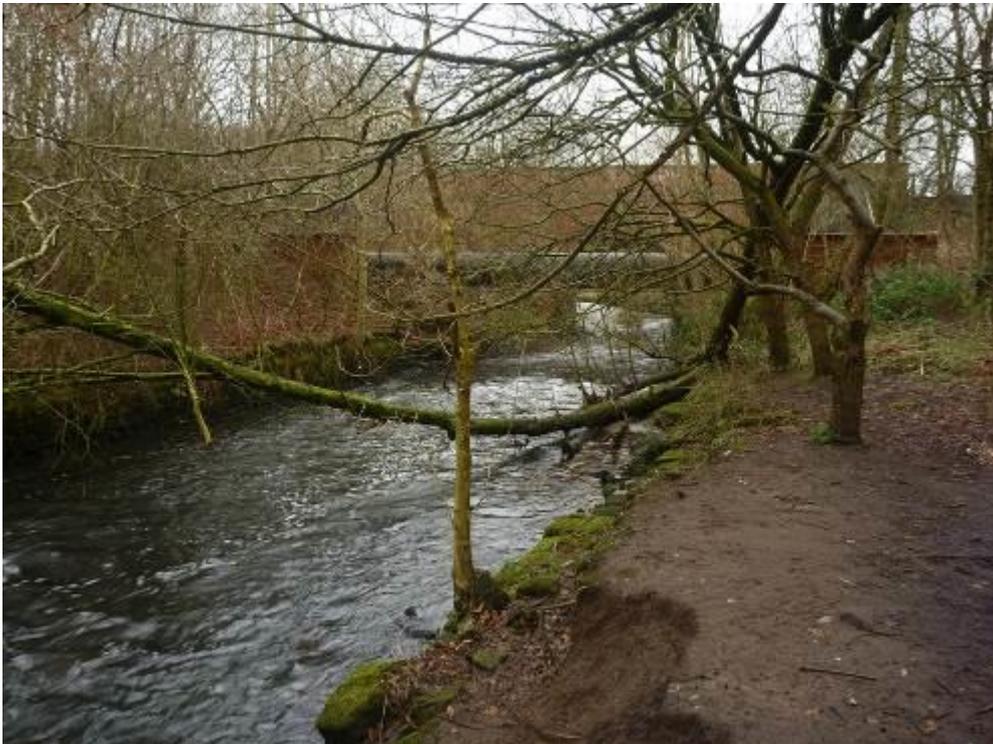
A rare example of a fallen tree that was, at the time of the visit, allowed to remain within the channel (Fig. 11) is providing excellent habitat benefits in the reach just upstream of the small tributary confluence with the main river at SD 84040 03970.

Figure 11: Valuable structural diversity provided by fallen tree trunk. The tree is still well attached at the bank-side end. If there were concerns about its ongoing stability - it would be far better to only remove the uppermost section of the trunk and, if necessary, to provide additional anchoring. This would retain a useful proportion of the benefits it is currently providing to river corridor wildlife in general and the prospects for self-sustaining trout populations specifically

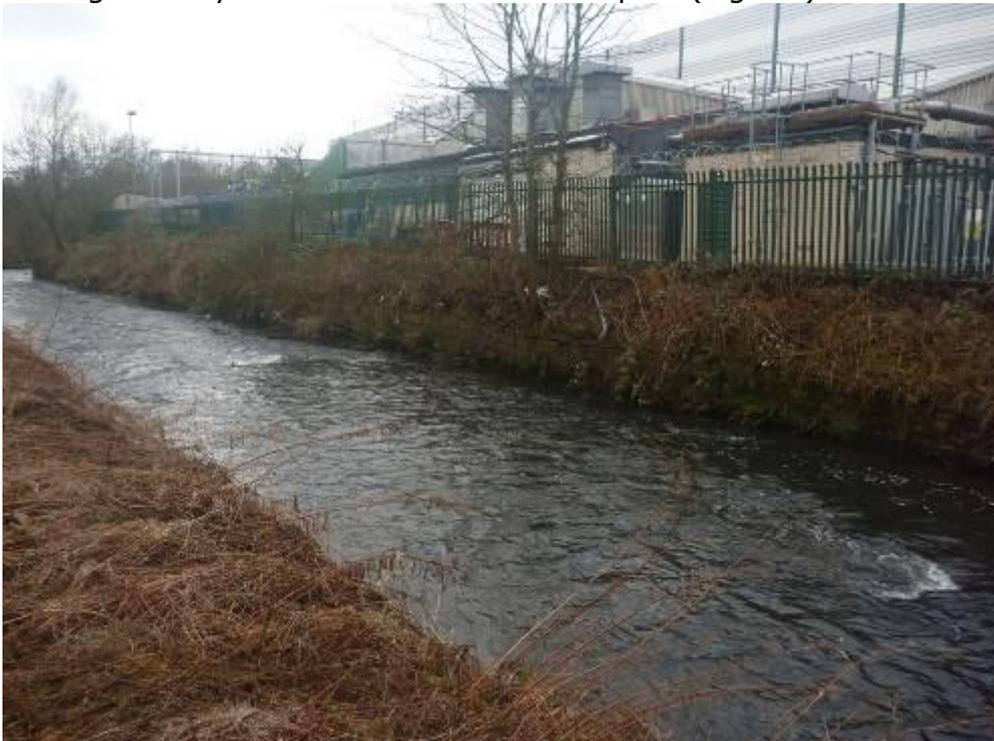
Modifications - both of the river channel and surrounding land - are much more prominent by comparison to Reach 1. The uppermost reaches visited during the current survey are dominated by the extensive Robert McBride Detergents Ltd. site that backs on to the RHB. In 2009, the company was found to be responsible for a pollution event that affected at least 3 miles of the River Irk (<http://www.manchestereveningnews.co.uk/news/greater-manchester-news/firm-fined-over-river-pollution-893476>). The RHB that runs along one part of the perimeter of the site consists of the vertical wall that is topped by the hard-standing of the yard within the fenced complex (Fig. 12).

Figure 12: Right hand bank formed by the edge of the McBride's detergent facility at SD86699 05488

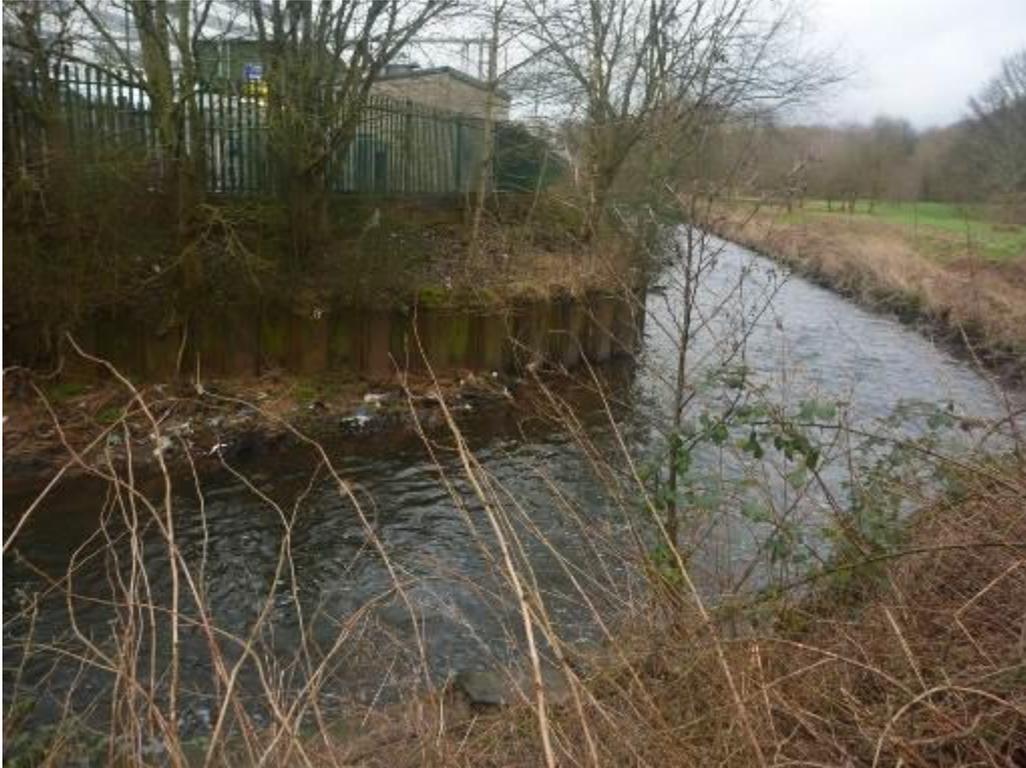
The lack of impoundment in this reach is a significant boon - although the straightened nature of the channel is coupled with a general lack of submerged and marginal cover. The variation in micro habitat types that is lost through channel simplification are illustrated quite well at the artificial bend at the downstream limit of the McBride's complex (Fig. 13). Here, at SD 86617 05447

the simple change in direction introduces additional hydrological “roughness” that allows for more varied patterns of deposition and erosion of substrate. Consequently, a larger variety of available microhabitats are retained in that highly localised example of a deviation from the (artificial) norm.

Figure 13: Not the most visually appealing example - but a clear demonstration that a bend (even when artificial) has introduced sufficient variety in the flow characteristics to promote point-bar deposition and lateral scour-pool formation. Unfortunately, these artificial bends tend to occur at a much lower frequency than those that emerge spontaneously during the natural development of a river channel

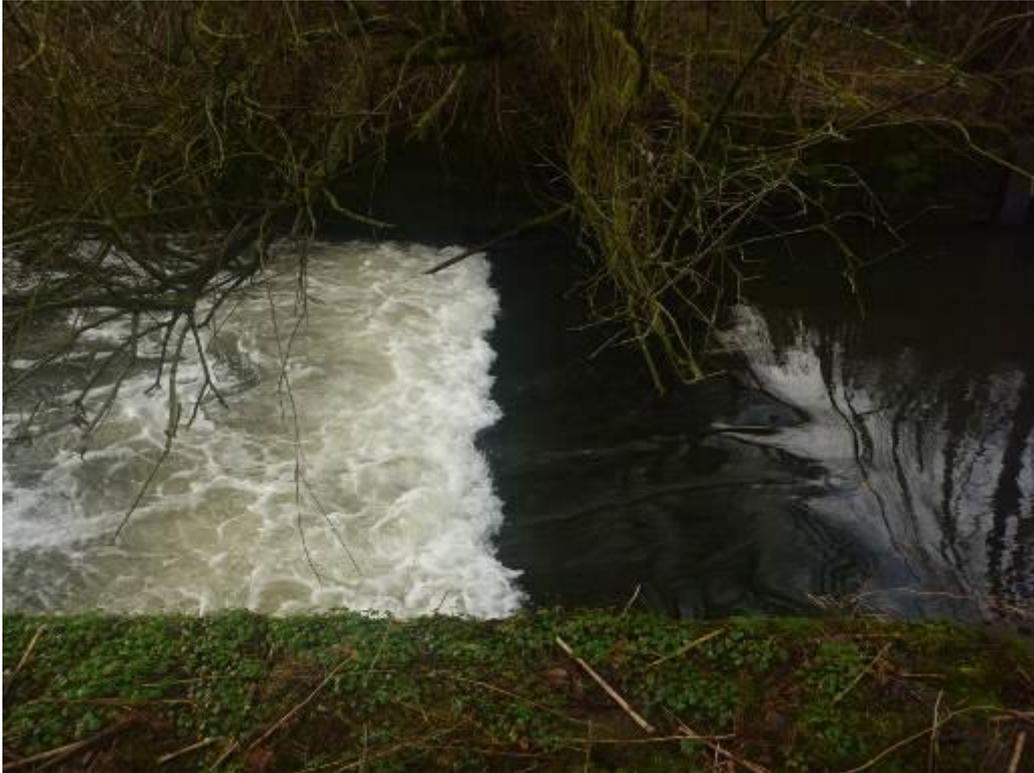
The weir at SD 86557 05424 presents a significant barrier to fish movement due to the shallow/powerful flow over its sloping face (Fig. 14). Often this type of structure is not perceived as being difficult/impossible to pass by fish because they are not a vertical wall. However, appearances are often deceptive since when flows are high enough to encourage upstream migration, the uniformly rapid flow often exceeds the maximum burst speed that many fish are capable of. Similarly, the distance between the bottom and top of the sloping face is too far for many/most fish to jump (even if the pool at the foot of the weir were to be deep enough to allow fish to generate a substantial leap).

What is often overlooked is that the impoundment upstream of the weir acts as another kind of barrier in (at least) two further ways. Firstly, the slowed pace in the impounded section (Fig. 15) often confuses fish that are migrating downstream. For instance, juvenile fish drifting downstream to find unoccupied territories in which to mature – which would include those juvenile fish attempting to migrate to sea. Secondly, the slowing of the water and simplification of the habitat (coupled with the delay in downstream movement past the obstruction) also dramatically increases the mortality due to predation of fish trapped on the upstream side.

Figure 14: Although not the worst example of a barrier - this weir will be passable to a much lower proportion of fish than might be apparent at first glance. Particularly when the consequences of delayed downstream migration are also taken into account

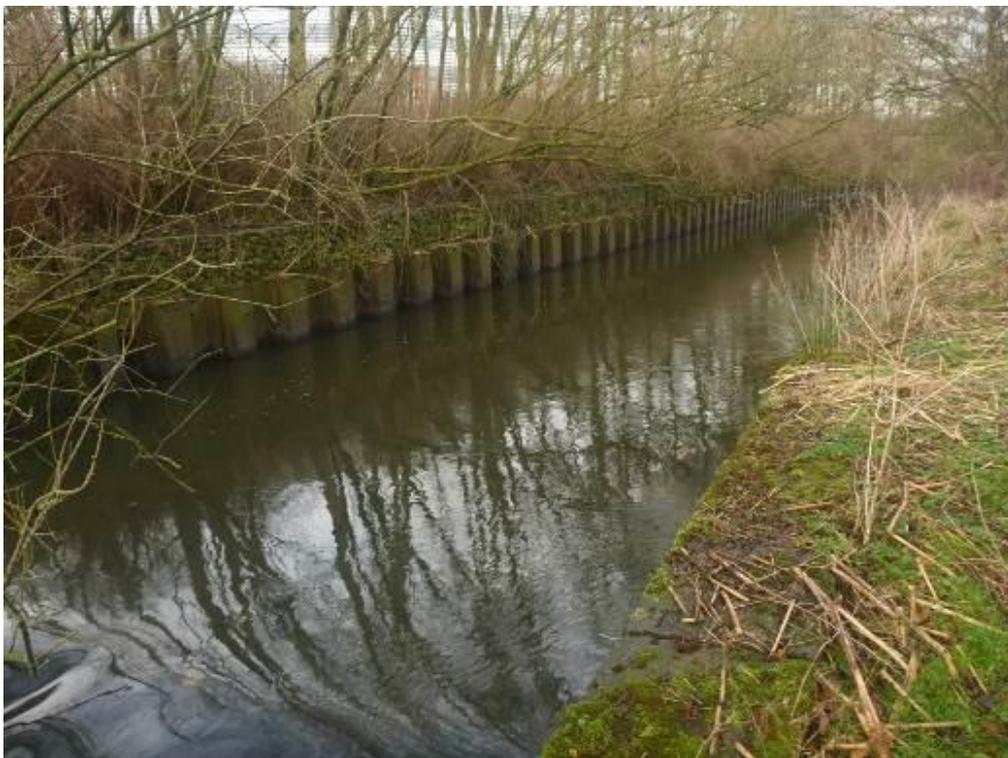
Furthermore, weirs (as mentioned previously) intercept and store riverbed materials that are vital for the supply and creation of intermittently-mobile

habitat features such as gravel and cobble bars. This constrains opportunities for diverse biological communities to form and persist – as well as limiting opportunities for individual species of interest, such as trout, to complete their lifecycle.

Figure 15: Impounding effect of weir pictured in Fig. 14. Riverbed material interception, lack of diverse flows and depths are impacting biological quality in this reach

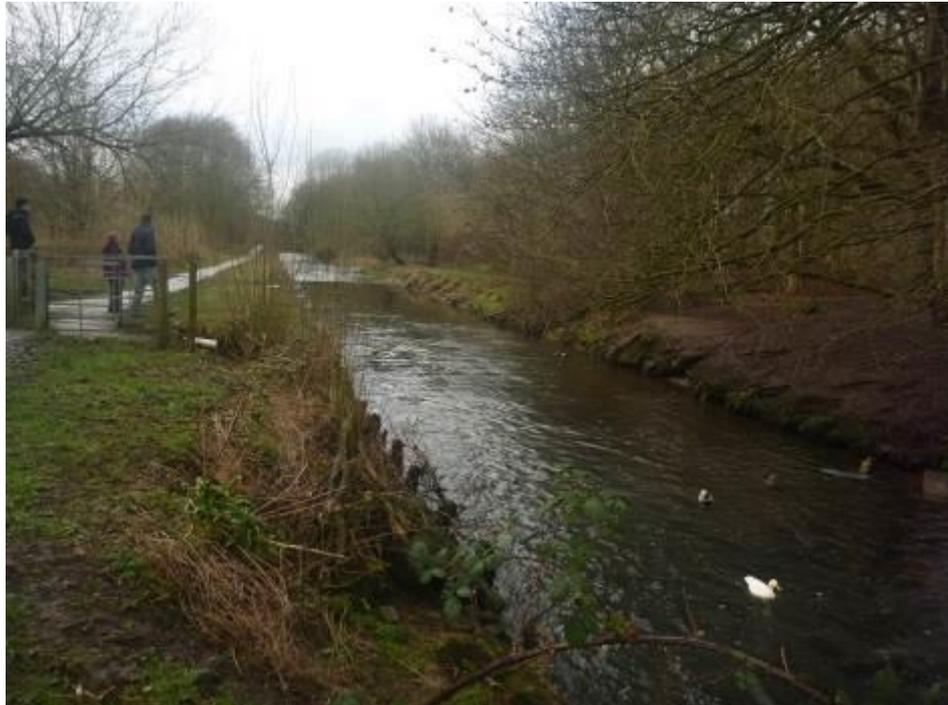
Figure 16: Upstream end of series of low weirs (SD 86464 05331)

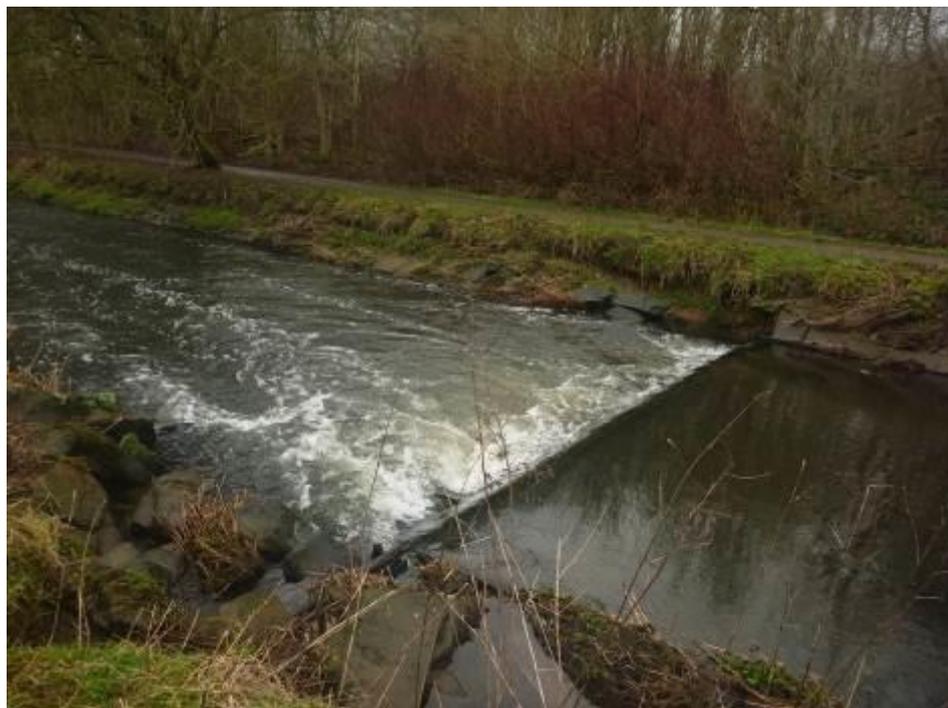
Figure 17: Ornamental weir at SD 86414 05327 showing propensity for bank erosion (both banks – directly downstream of the weir) when barriers are placed across the stream at 90 degrees to the flow.

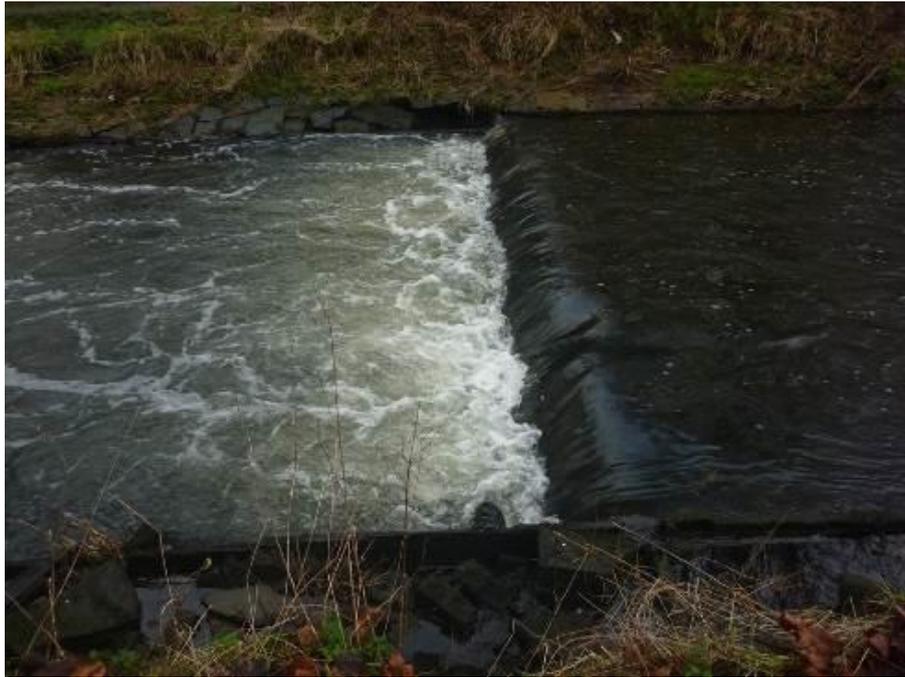
Figure 18: Ornamental weir at SD 86352 05327 - the wooden "toe boarding" and ornamental stonework that form the river banks here are extremely poor in ecological terms

As shown in Figure 18, there are impacts on the ecology of this section in addition to those caused by the weirs. The smooth-walled channel created by a combination of stonework and wooden shuttering (toe boarding) prevent the development of habitat that would support a richer biological community.

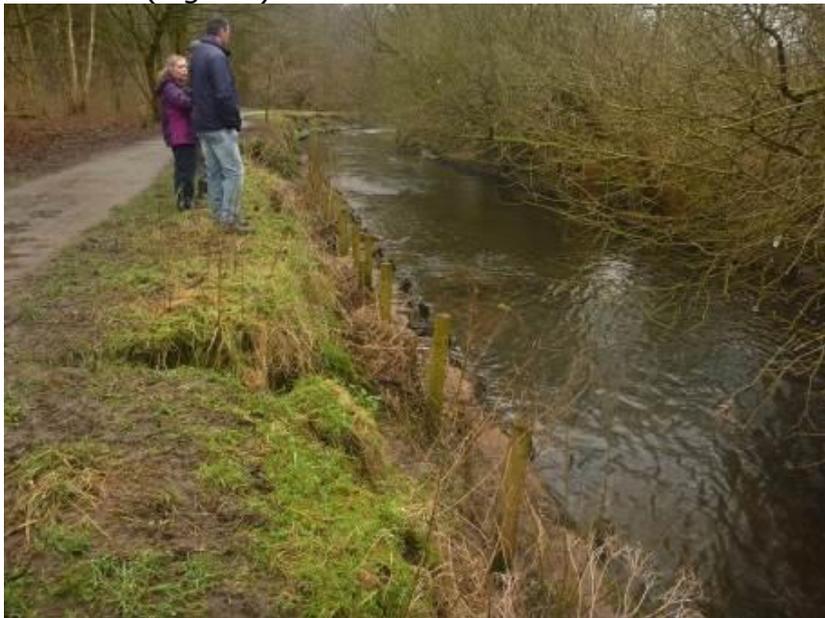
Downstream of the ornamental weirs there are examples of both failed willow spiling (e.g. Fig. 19), more wooden toe-boarding (Fig. 20) and also concrete bank revetment work (Fig. 21).

Figure 19: Willow spiling that has been washed out and dog access point erosion. The spiling may have been installed too high above the water. A stepped terrace or sloping design would have had a much greater chance of succeeding – as would the use of back-filling. Both measures would help to keep the live willow in contact with growing substrate.

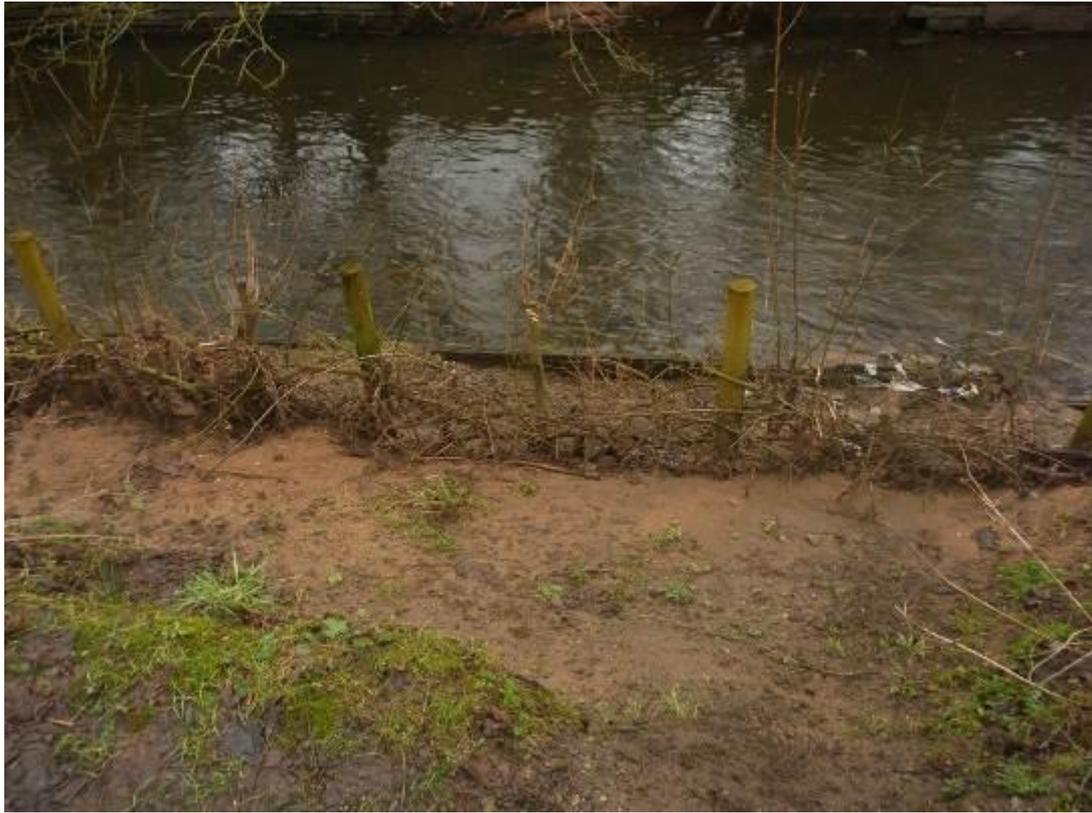
Figure 20: Failed spiling in combination with old toe-boarding at SD 86216 05297. Planting onto the deposited sediments is likely to rectify the problem fairly quickly

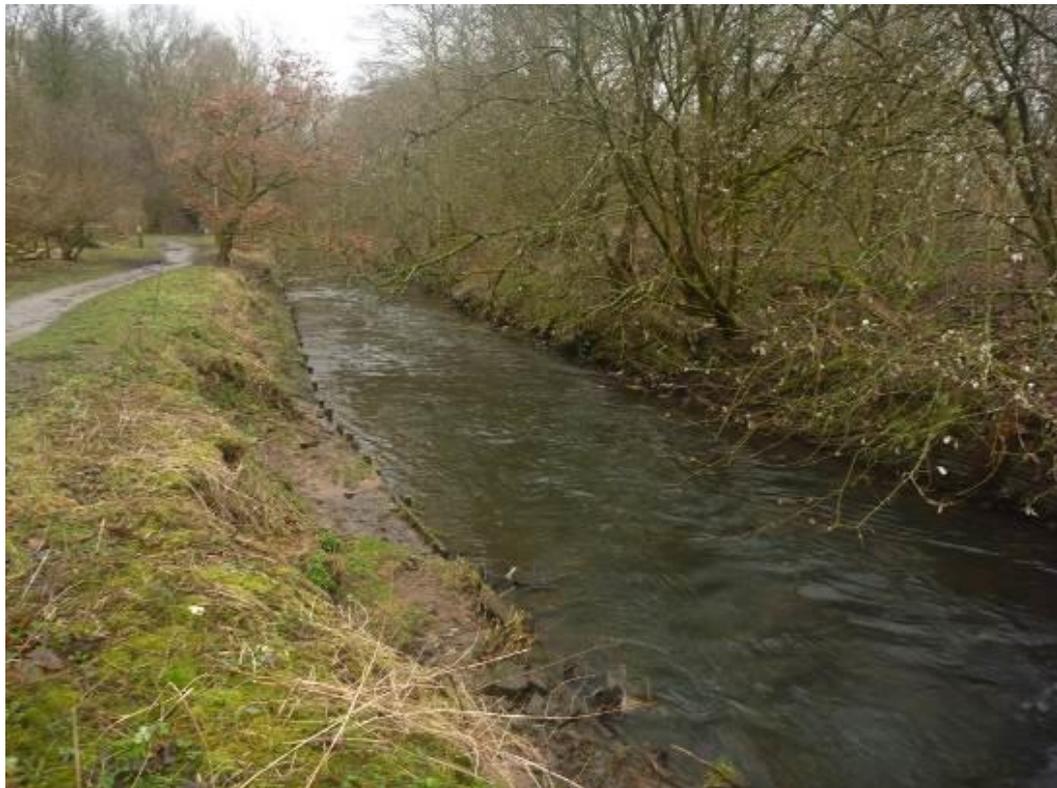
Figure 21: Old toe-boarding on LHB at SD86175 05252. The RHB provides some cover via the riparian woodland – however the stone wall and straightened nature mean that this section would still be characterised as a straight chute of very uniform habitat. The over-narrowed status of the channle is also why it is persistently eating into the bank that supports the footpath. The river is “trying” to regain its inherent, natural channel dimensions – so pulling back sections of the opposite bank would release this pressure.

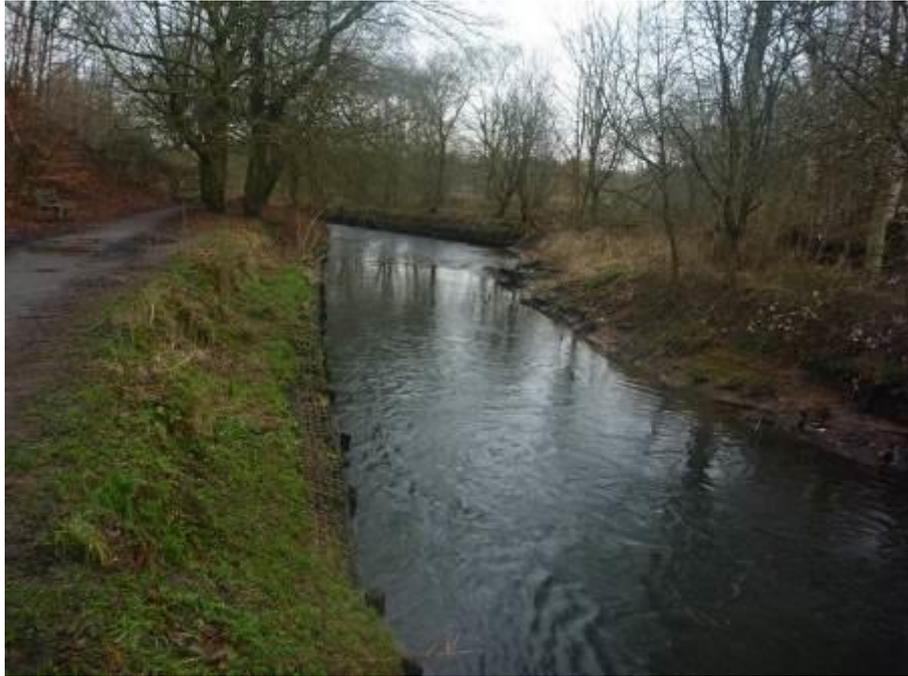
Figure 22: Cast concrete "studded" bank revetment on the LHB (photo taken facing downstream) at SD 86090 05230. The proximity of the footpath and the existence of spiling/toe boarding and concrete revetments indicate the sensitivity of the footpath to the potential impacts of bank-erosion.

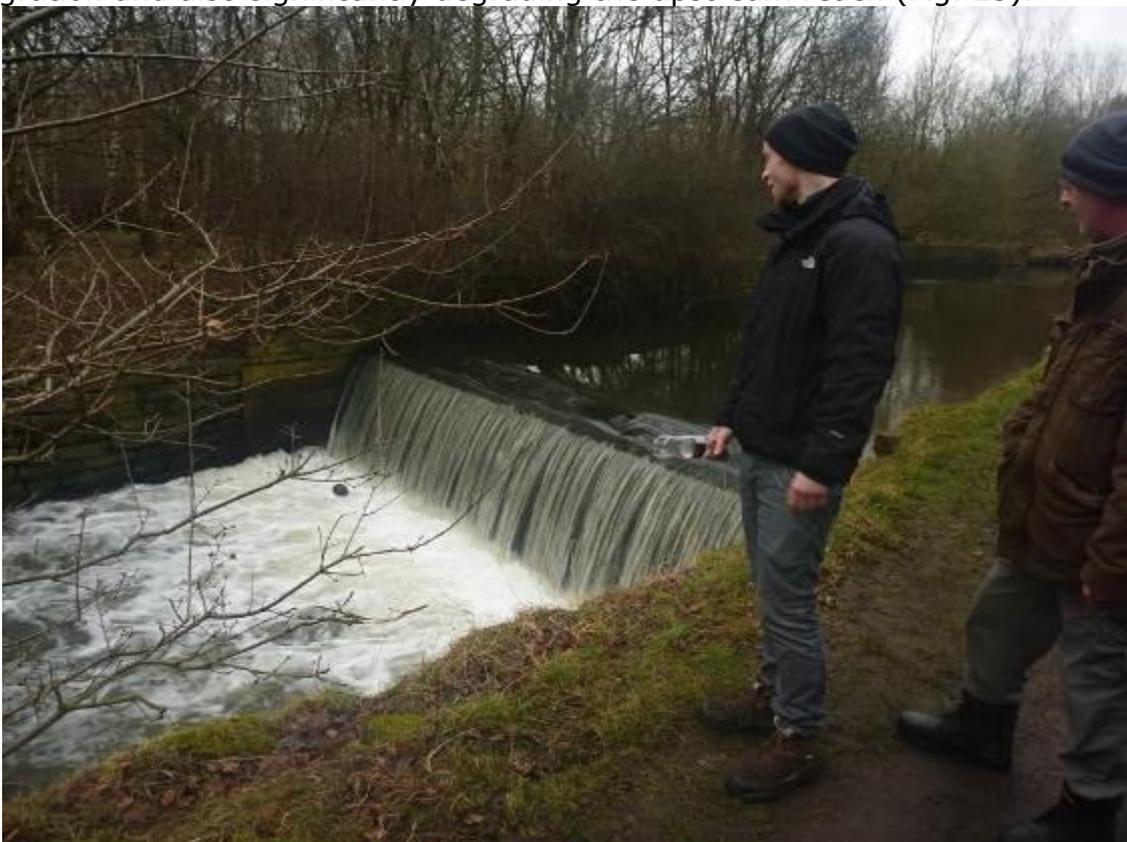
A substantial weir at SD 85892 05151 is a complete barrier to upstream migration and also significantly degrading the upstream reach (Fig. 23).

Figure 23: Large impassable weir at SD85892 05151 and associated upstream impoundment

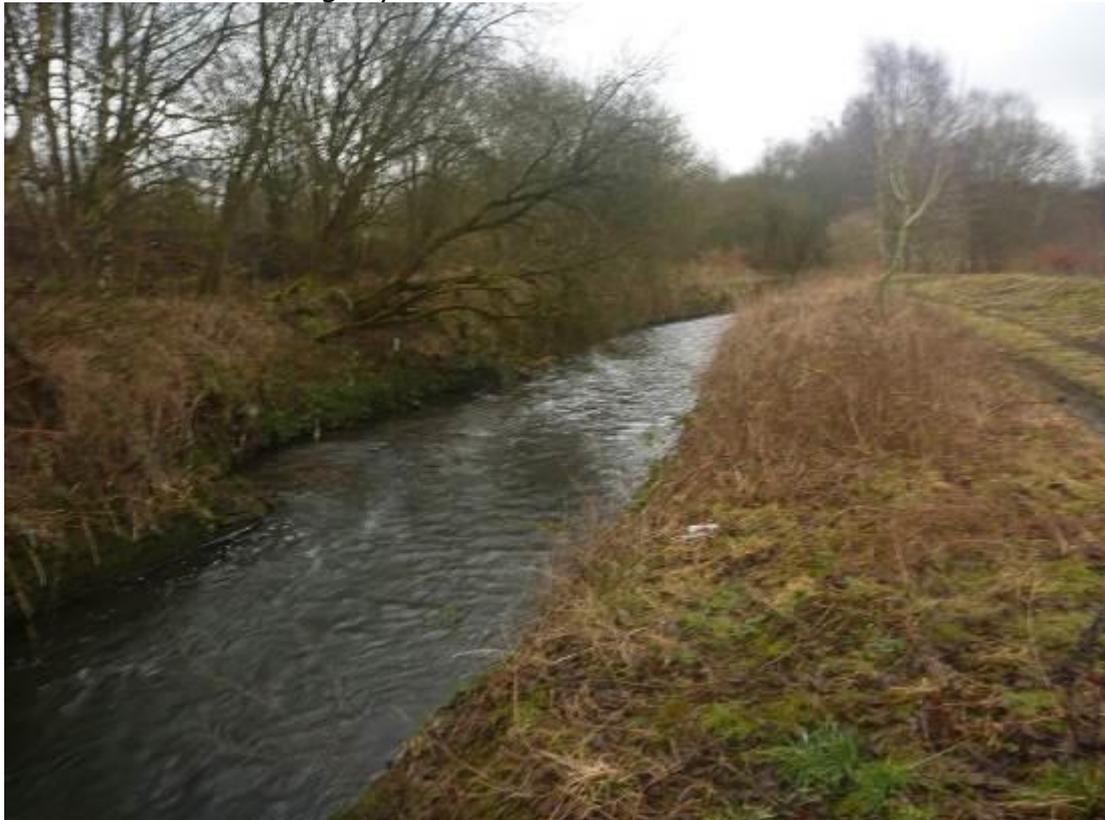
When small opportunities arise for the river to escape the confines of the artificial channel boundaries – highly valuable habitat is produced (Fig. 24). This shows a potential route to increasing the biological value of this channel through localised removal of reinforcing structures to promote lateral movement of the channel into areas that are not sensitive from an infrastructure perspective (i.e. footpath/transport link etc.). For Reach 2, there is frequently dense woodland and plenty of space along the RHB to allow a series of opportunistic channel realignments. This would produce higher quality habitat. In turn, it would also reduce the pressure acting upon sensitive banks that are currently eroding – and whose hard revetments will accelerate (rather than retard) erosion rates once they begin to break up. This breakdown of hard revetments is already taking place and the inappropriate use of spiling to reduce this effect has, in fact, exacerbated the issue slightly.

Figure 24: Small bay produced by the failure (or removal) of stonework at the toe of the RHB (photo taken looking upstream). Consolidating this benefit by installing low, submerged structural cover – or planting willow whips on the toe/margins of the LHB directly opposite this bay would offer both structural and ecological benefits

A far better way to both protect the sensitive banks and simultaneously improve biological status of the channel would be to identify suitable locations that the non-sensitive bank (in erosion terms) could be pulled back. This could be coupled with the secure installation of low marginal structures that would consolidate the opposite (sensitive) banks and direct flows into the channel capacity created. In effect this would achieve a degree of re-meandered flow whilst reducing the need for ongoing hard bank revetment repairs to sensitive banks (see section 4 “Recommendations”).

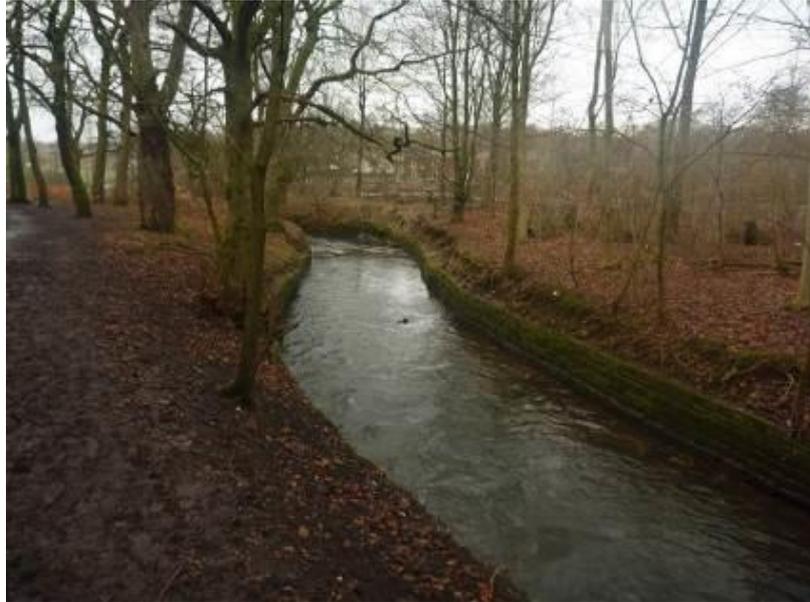
In well-wooded areas where the channel runs between (older) vertical stone walls and the flow is not impacted by impoundment, there is some natural regeneration of relatively good habitat. This is particularly evident wherever the

channel engineers set a slightly meandering path for the river (Fig. 25). This has allowed a degree of recovery of microhabitat variety through geomorphological (erosion and deposition) processes – albeit within the confines set by the position of the retaining walls.

Figure 25: A degree of variation in cross-sectional depth and flow-velocity profiles is evident in some (generally older) engineered channel sections e.g. photo here at SD 85643 05223.

Again there would be benefits having areas with submerged, complex cover in the otherwise fairly blank margins. Similarly, opportunities to remove sections of retaining wall (e.g. on the bank opposite to footpath) should be explored where possible.

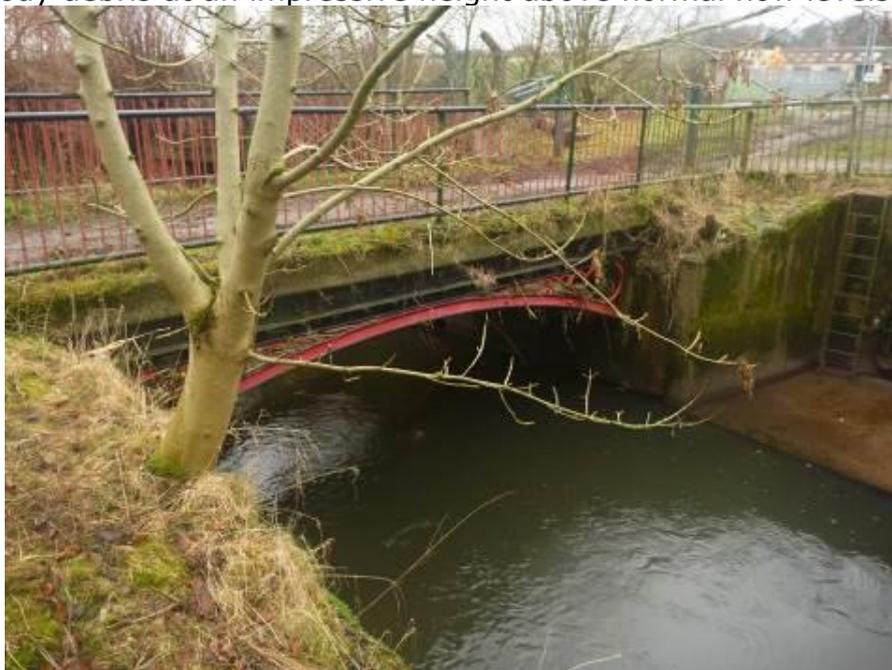
At the points where the channel is artificially narrowed to the greatest degree between high vertical walls – considerable shear velocities will be generated during spate flows. For instance, the bridge arch at SD 85575 05258 carries coarse woody debris at an impressive height above normal flow levels (Fig. 26).

Figure 26: Debris strand-line on the red ironwork on the underside of the footbridge at SD 85575 05258

This structure is likely to set the hydraulic limit for the section upstream of this point. Consequently, there is plenty of scope for introduction of materials into the channel (with or without re-profiling the banks opposite such introductions) whilst having no negative impacts on the risk of damaging flood occurrence.
