River Irk – Greater Manchester

An advisory visit carried out by the Wild Trout Trust – Feb 2015

*This report is the output of a Wild Trout Trust Advisory Visit (AV) undertaken along **approximately 3km of the River Irk in Greater Manchester.***

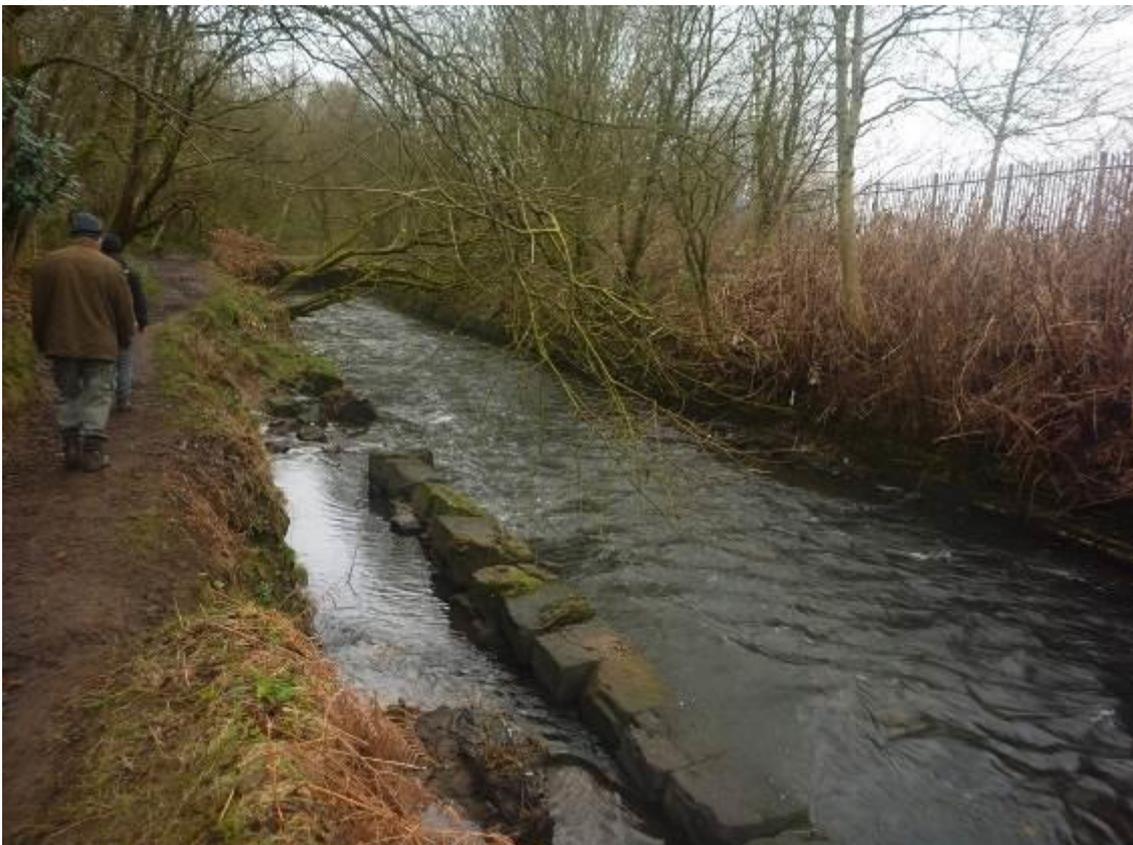
In comparison to “softer” brush bank-toe stabilisation techniques, when water works behind “hard” stonework revetment – the rate of bank erosion is usually much faster (Fig. 27). This is because the hard, angular surfaces deflect and “bounce” fast space flows instead of slowing and diffusing them. In addition, the angular faces are prone to producing strongly eddying currents that are highly erosive. Where brush revetments can be suitably keyed into the bank (or where suitable anchor points for tree kickers exist) – the propensity for erosion is, counter-intuitively, often much less. Furthermore, the dissipation of flows that more complex structures create can often actually increase deposition of substrate in that area.

Figure 27: Failing stonework revetment - this is accelerating the erosion potential into the narrow footpath (note also dead Japanese knotweed canes on RHB)

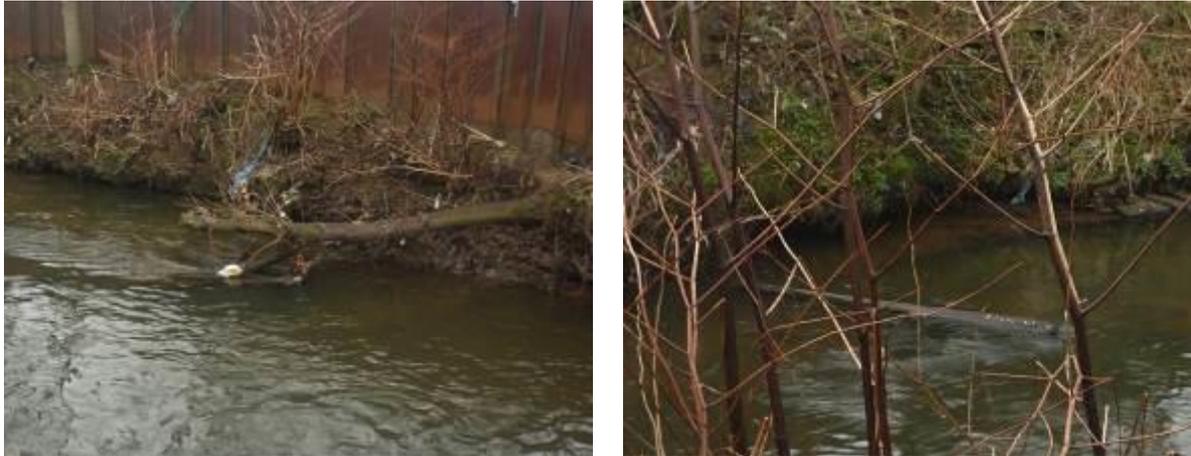
A very few examples of the benefits that stable large woody debris (LWD) can provide to river ecology were noted in this reach. The two most significant are pictured in Figure 28. In both cases the localised riverbed scour and deflection of the current had produced isolated examples of extremely valuable habitat.

Figure 28: Naturally arising LWD generating much-needed habitat diversity around SD 85298 05082 (note the lack of blockage/accumulation of significant additional debris and also dead Japanese knotweed canes)

Opportunities to securely anchor similar structures throughout the reach would bring valuable benefits. Logs that deflect flow in this way typically make negligible difference to “out of bank” flood events upstream of them when modelled. Their streamlined nature also means that they have much lower propensity to accumulate trash than their initial appearance might suggest.

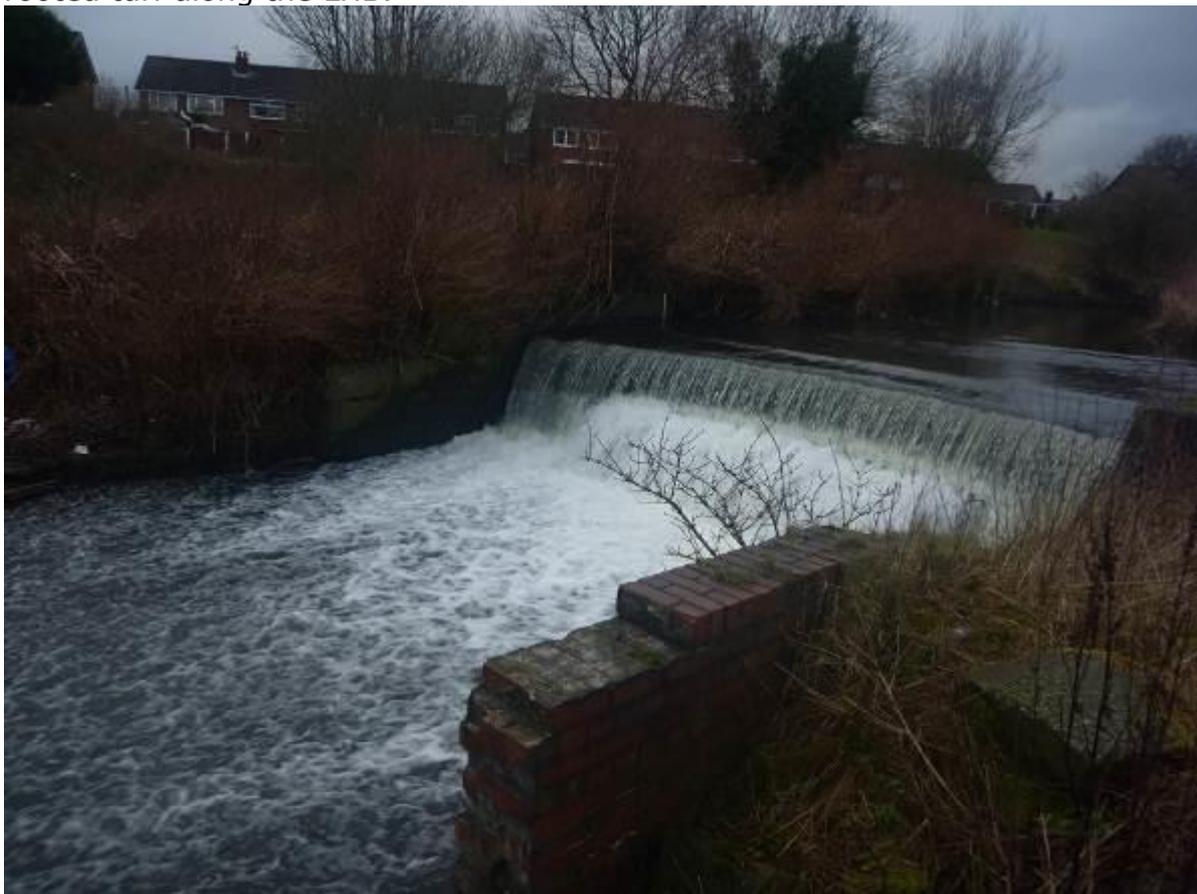
Figure 29: An absolutely impassable weir (and associated significant upstream impoundment) that consists not only of a high vertical face, but also a very shallow stone apron that fish would find impossible to cross to reach the foot of the vertical wall at SD 84977 04963

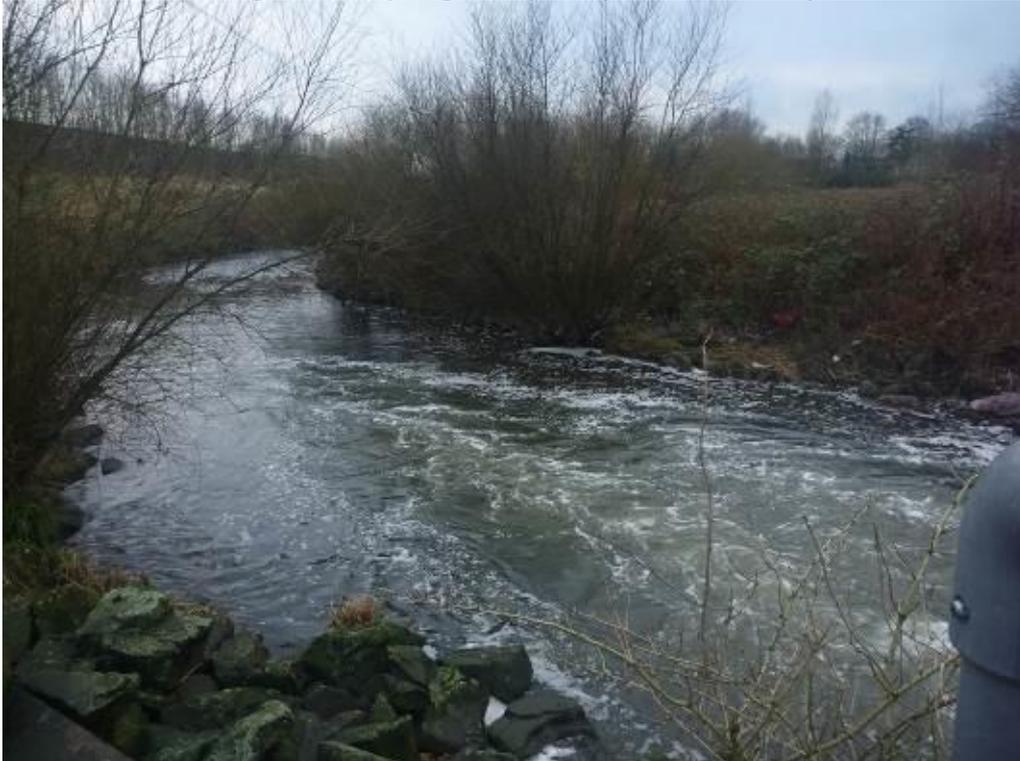
The most valuable habitat tends to occur directly downstream of such weirs – where all of the energy of the water that has been stored up via the upstream

impoundment is discharged and produces scour-pool habitat. However, those restricted areas of better habitat (e.g. Fig. 30) arise at the expense of all similar scour-pool habitat within the impounded reach and, consequently, the overall habitat would be of significantly higher quality without the presence of weirs..

Figure 30: Better habitat than that upstream of the weir - but this is generated at the expense of that degraded habitat within the impounded reach

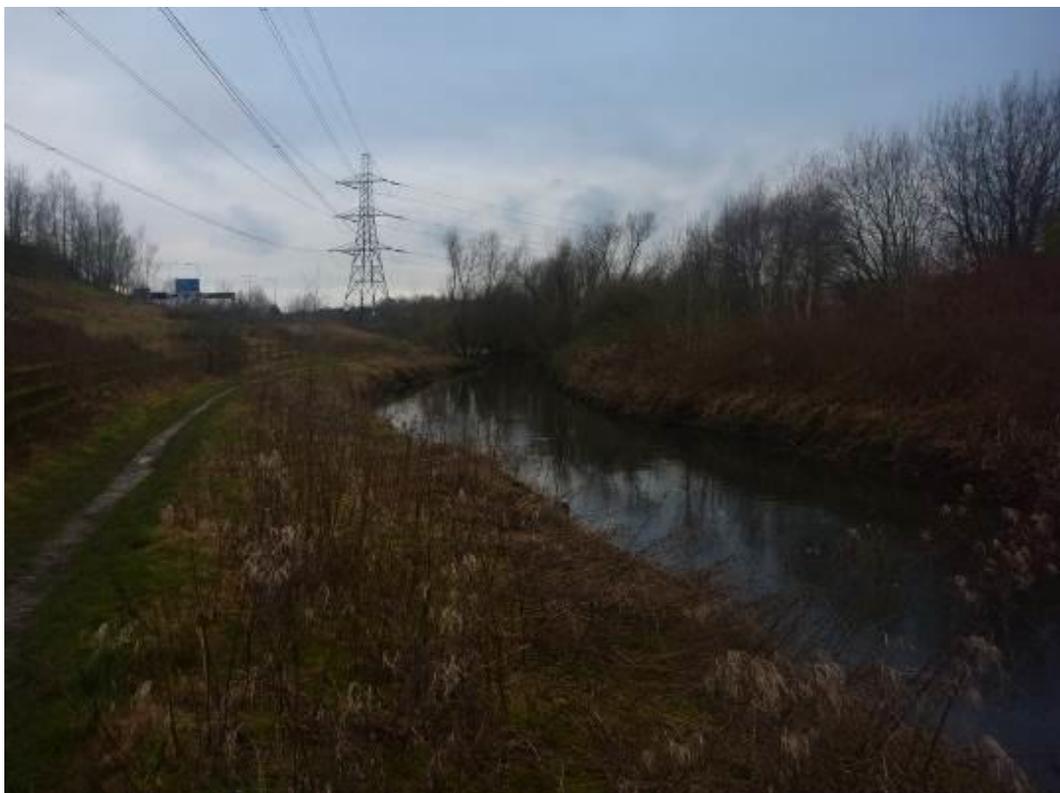
Figure 31: A typical representation of much of the lower sections visited in Reach 2 - shallow root systems on the LHB, long impounded reaches and very uniform channel cross-sections (photo at SD 84874 04911)

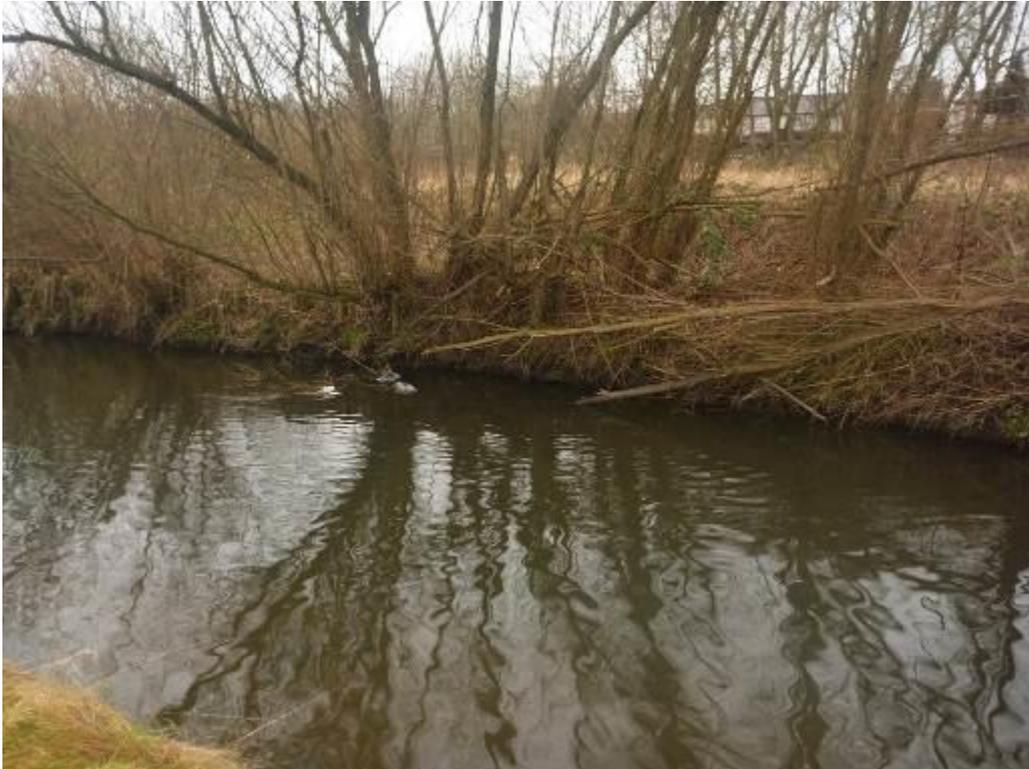
The naturally-occurring tree-kickers (see section 4 "Recommendations" and Fig. 32) will be absolutely vital to the overwintering prospects of any adult trout that find their way into this section (probably via downstream drift over several weirs). Although many such structures have been cut or pruned back during maintenance works, some still persist and these are extremely valuable habitat features. It will be worth identifying and influencing the party/parties carrying out such maintenance towards current best practice measures.

Figure 32: Submerged (left) and low, overhanging (right) marginal cover generated by naturally-occurring tree-kickers. Much of the willow stand growing on the far bank should be hinged into the margins to bolster this rare and small example of submerged cover

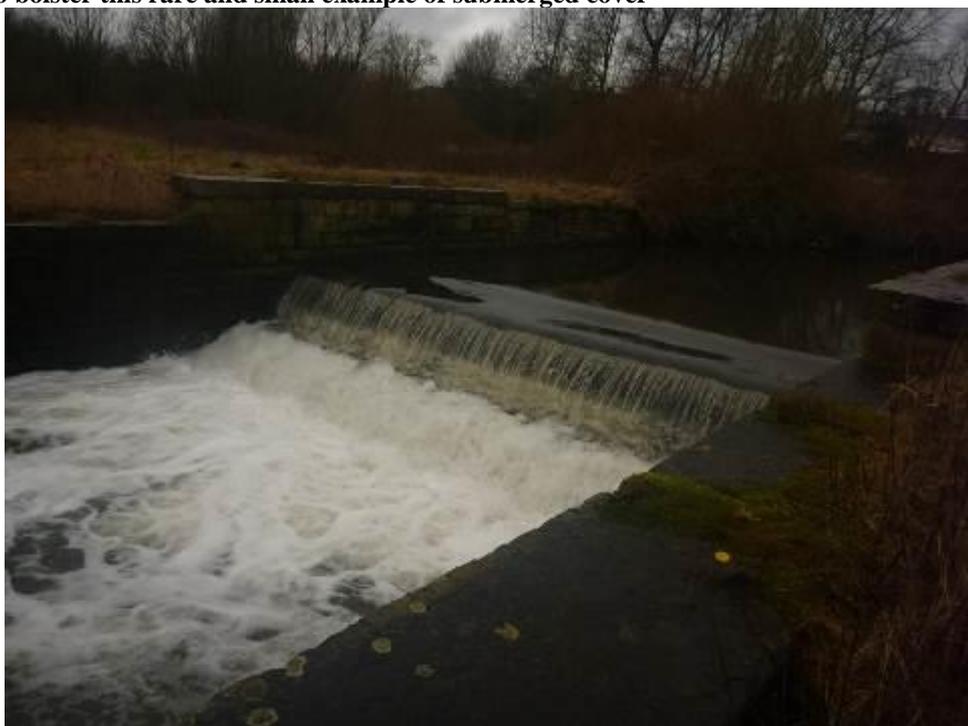
Figure 33: Another weir - this one at SD 84759 04877

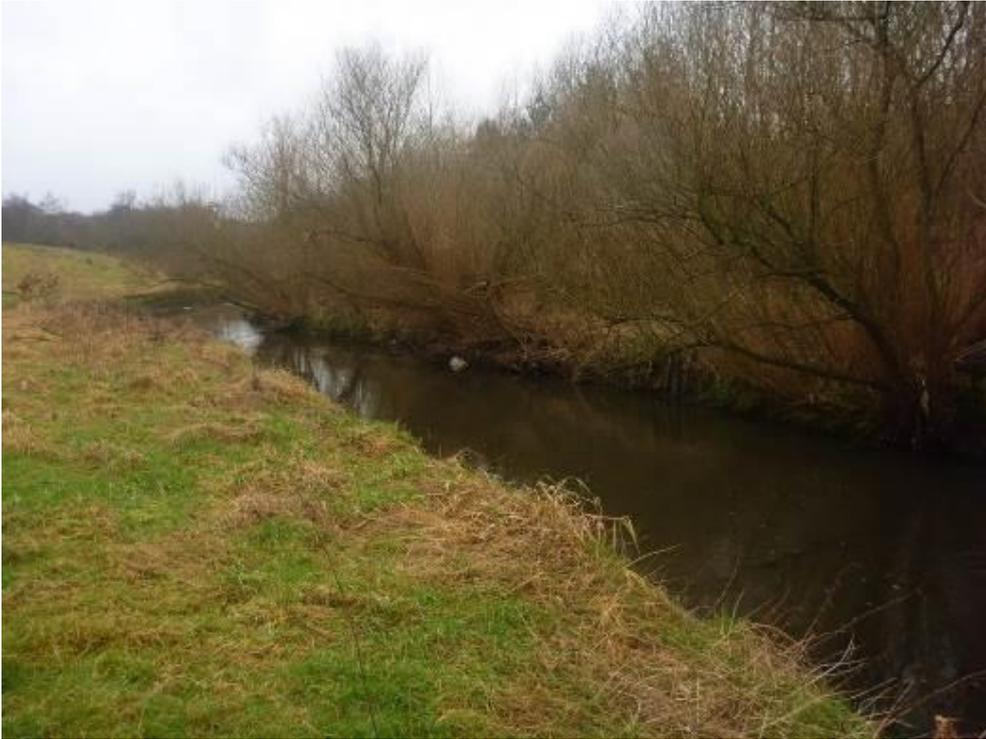
Figure 34: Grassed LHB, long impounded reach (wooded opposite bank) and artificially uniform channel defined by stonework – typical of the lower visited sections of Reach 2. Again, here are extensive opportunities for willow-laying to produce vital submerged cover.

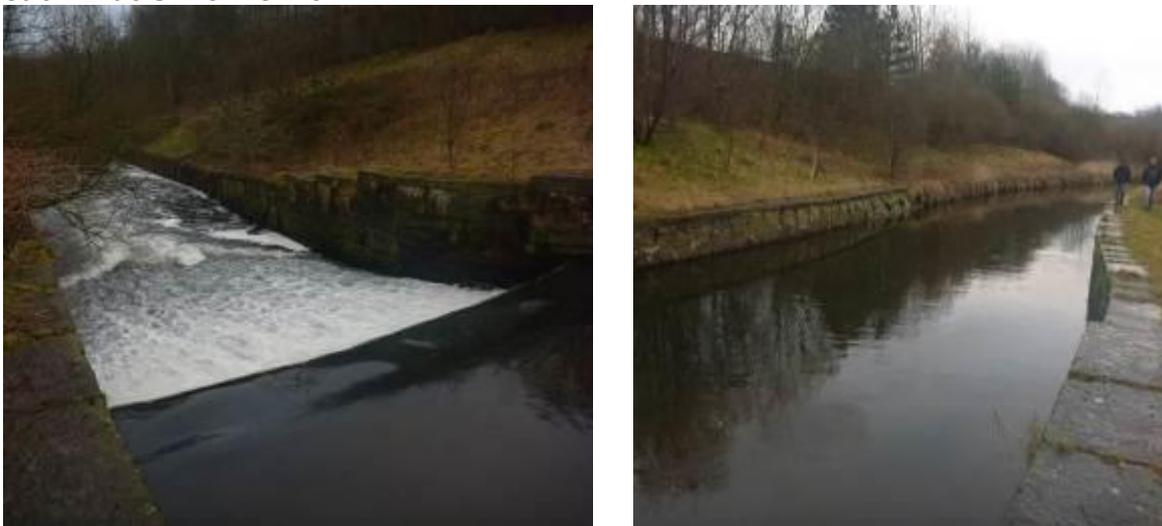
The downstream limit of the habitat assessed in Reach 2 is a useful example of the defining characteristic of the Irk below the unimpounded reaches around SD 85233 05057 down to the weir (Fig. 35) that marks the downstream limit of Reach 2 at SD 84494 04717

Figure 35: Impassable weir (left) and resultant impoundment (right) at SD 84494 04717

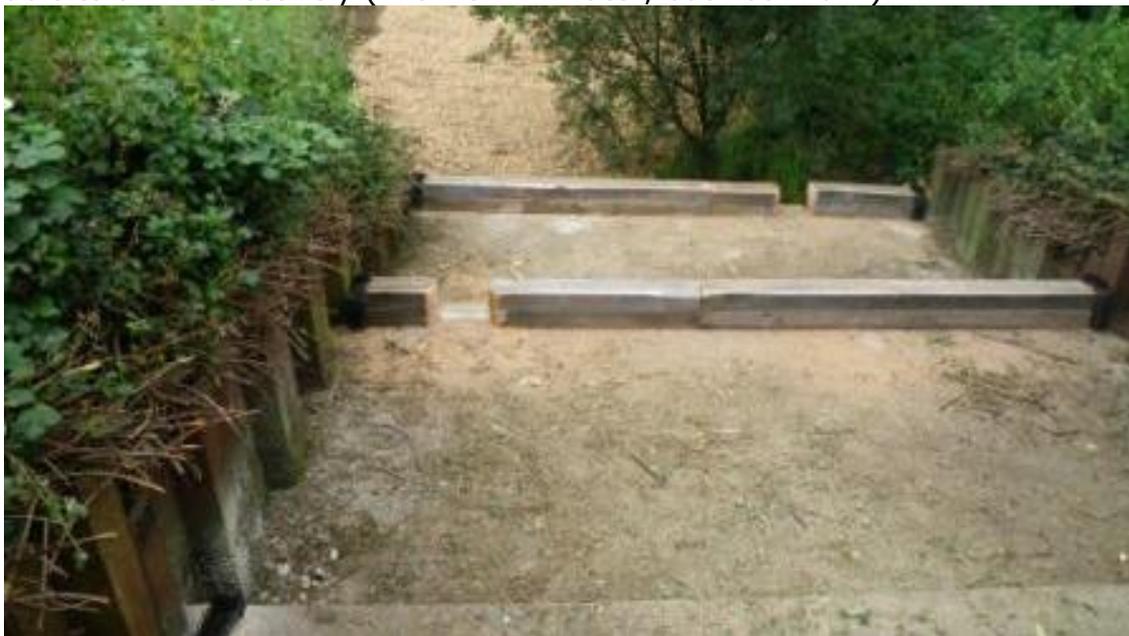
Figure 39: Pre-barrages (shown dry here) constructed to ease passage over a weir on the Sussex Ouse system constructed as part of a partner project between WTT and Ouse and Adur Rivers Trust
