River Sowe (Wyken to Stoke Floods)

Advisory Visit

Wild Trout Trust Report – Following a Site Visit on 23/11/2017

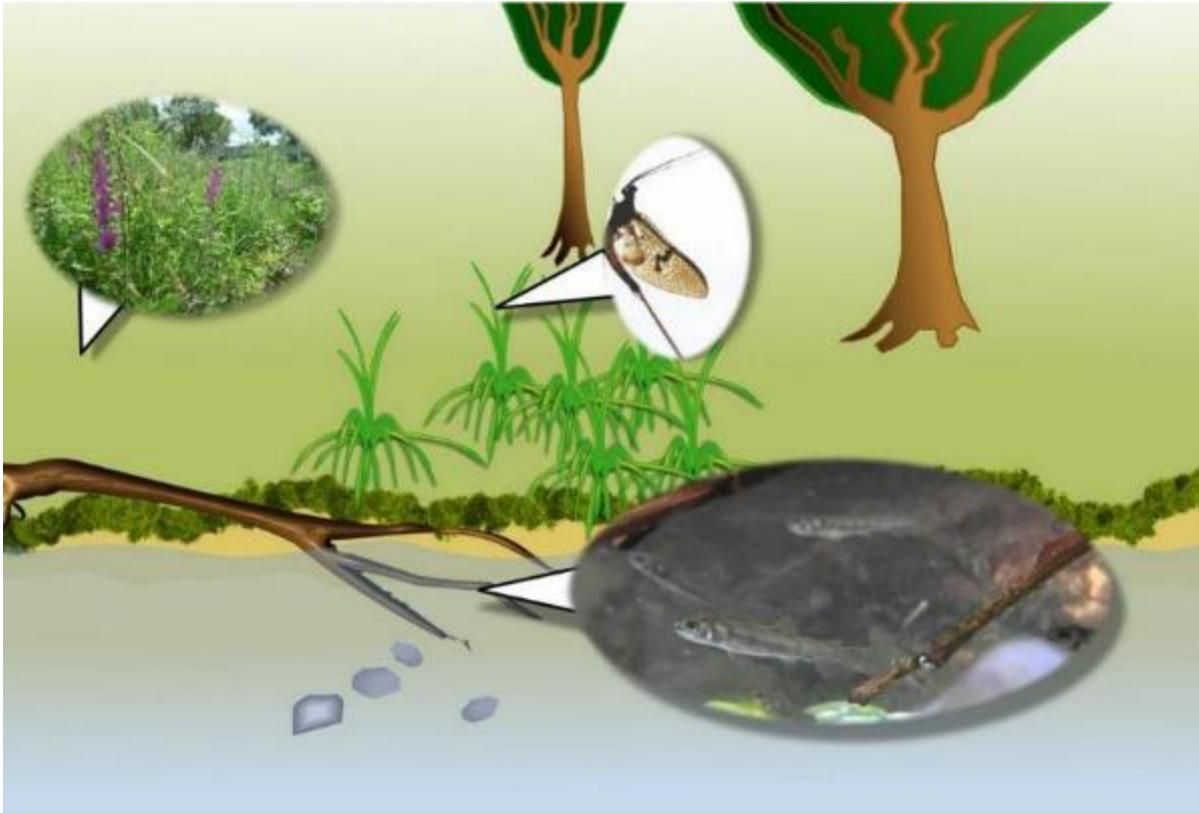
Figure 3: Larger cobbles and submerged "brashy" cover and/or exposed fronds of tree roots provide vital cover from predation and spate flows to tiny juvenile fish in shallower water (<30cm deep). Trailing, overhanging vegetation also provides a similar function and has many benefits for invertebrate populations (some of which will provide a ready food supply for the juvenile fish).

partially owing to the incised channel and steep, high banks. As indicated in Fig. 3, this type of “brashy” refuge is essential for good survival prospects of juvenile fish. It is particularly valuable for over-winter survival of younger fish.

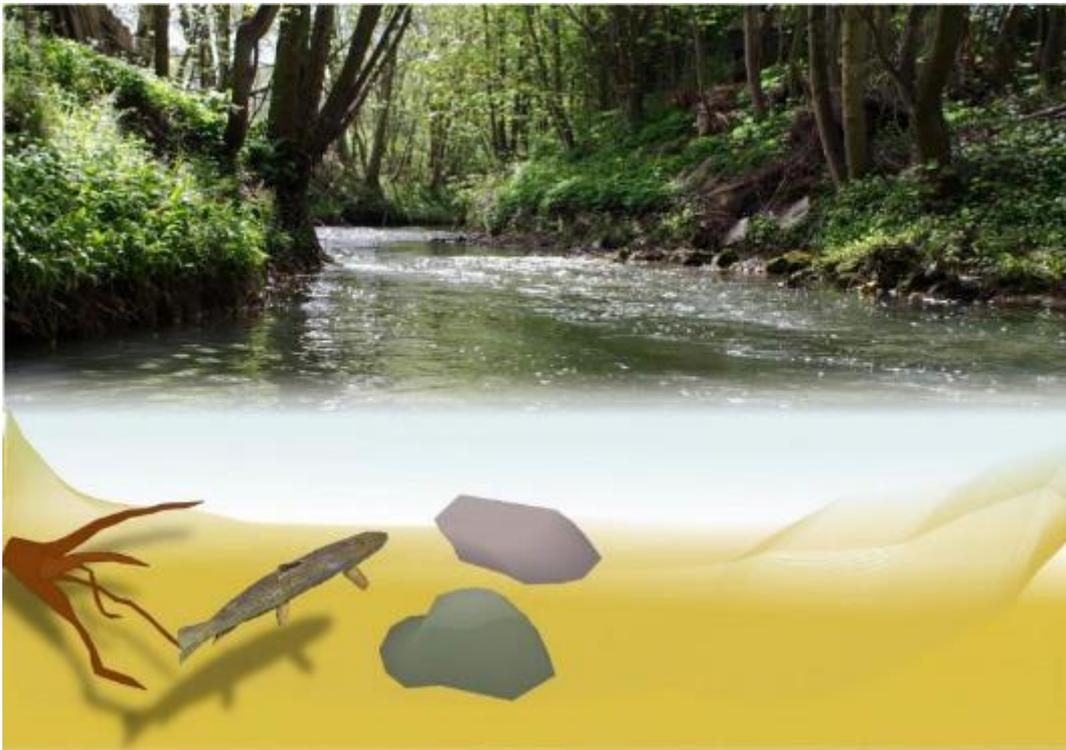
Figure 4: The availability of deeper water bolt holes (>30cm to several metres), low overhanging cover and/or larger submerged structures such as boulders, fallen trees, large root-wads etc. close to a good food supply (e.g. below a riffle in this case) are all strong components of adult trout habitat requirements.

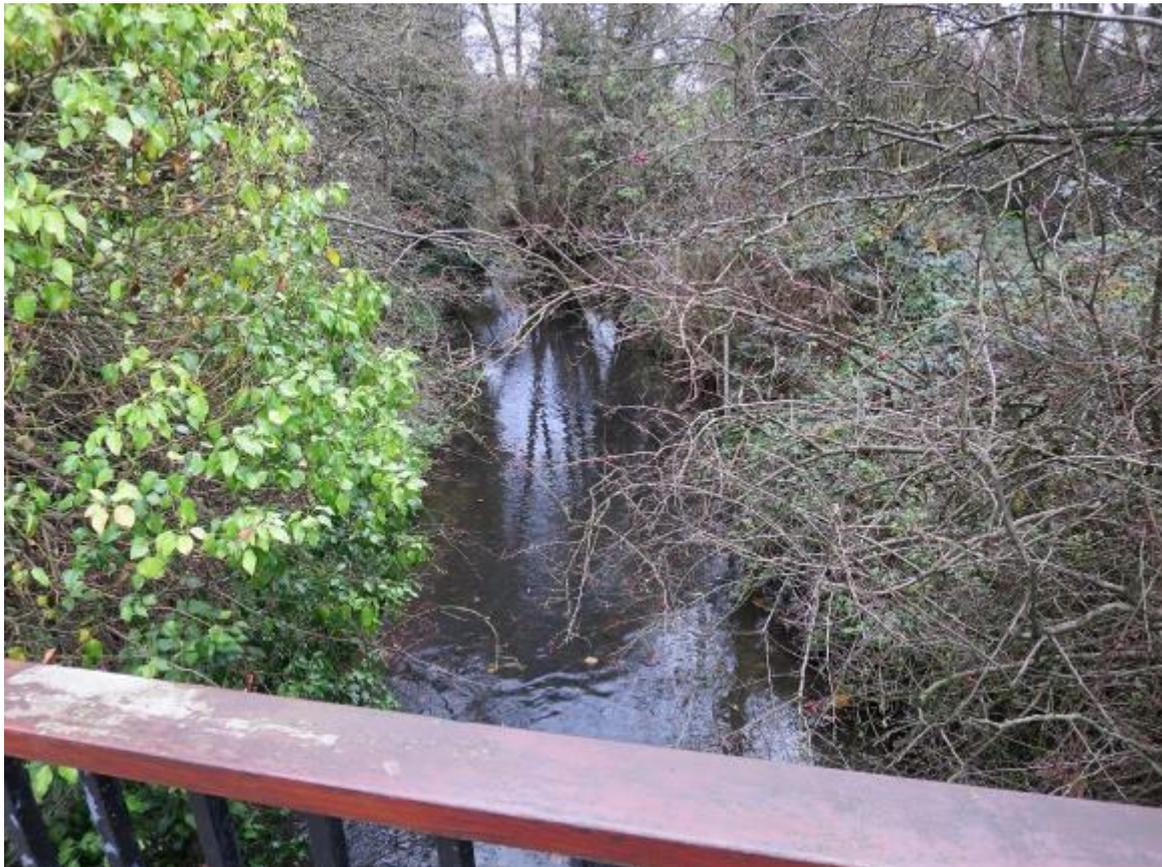
At the upstream limit of this visit at National Grid Reference SP 37787 804467 there is a well-developed woodland corridor (Fig. 5) but the riverbed is relatively uniform and probably historically-straightened.

Figure 5: Highly beneficial woodland flanking the river. More structural variation could be created by light rotational coppicing and using some of the arising material to diversify the habitat within the river channel.

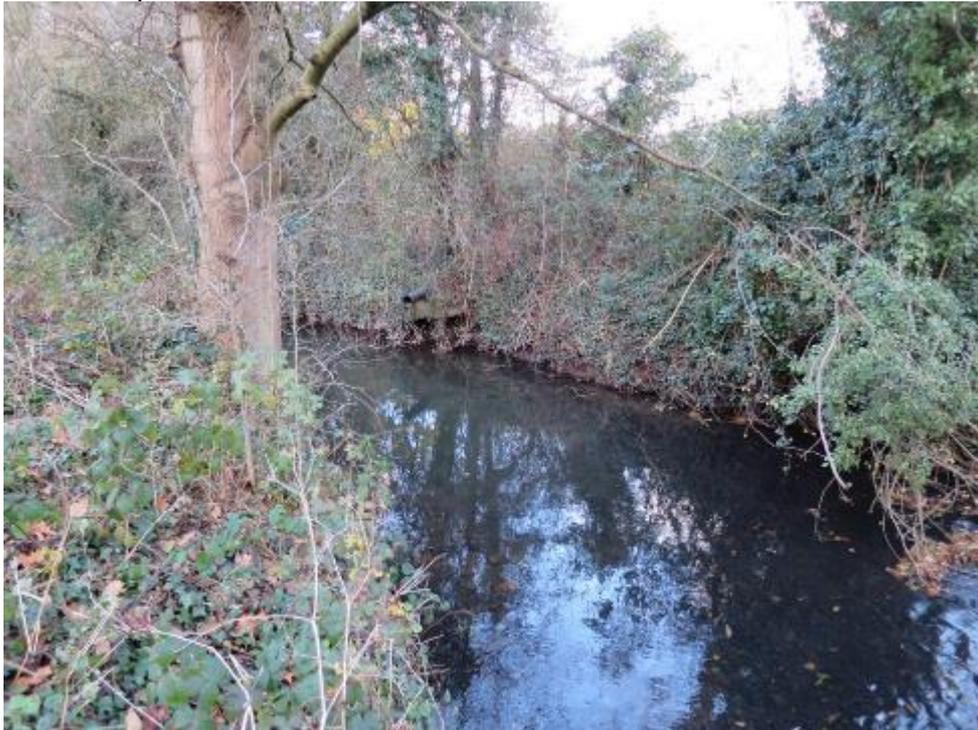
In common with many realigned channels (particularly in relatively soft/sandy geology), the Sowe tends to be quite incised (e.g. Fig. 6). This means that the riverbed is a long way below the top of the banks in many places – and there is little connectivity between the main river and its floodplain. Although it is (normally) undesirable for water to spill into the floodplains that have been inappropriately developed with infrastructure (housing, buildings, roads etc.) –

Figure 6: The "Bank full" depth in this photo would be approximately where the tree (left of frame) joins the undergrowth. This is several feet above the normal water level. If the bank-top is as high as this throughout the reach - the river would need to be running extremely high before it could spill out onto the (undeveloped) flood plain.

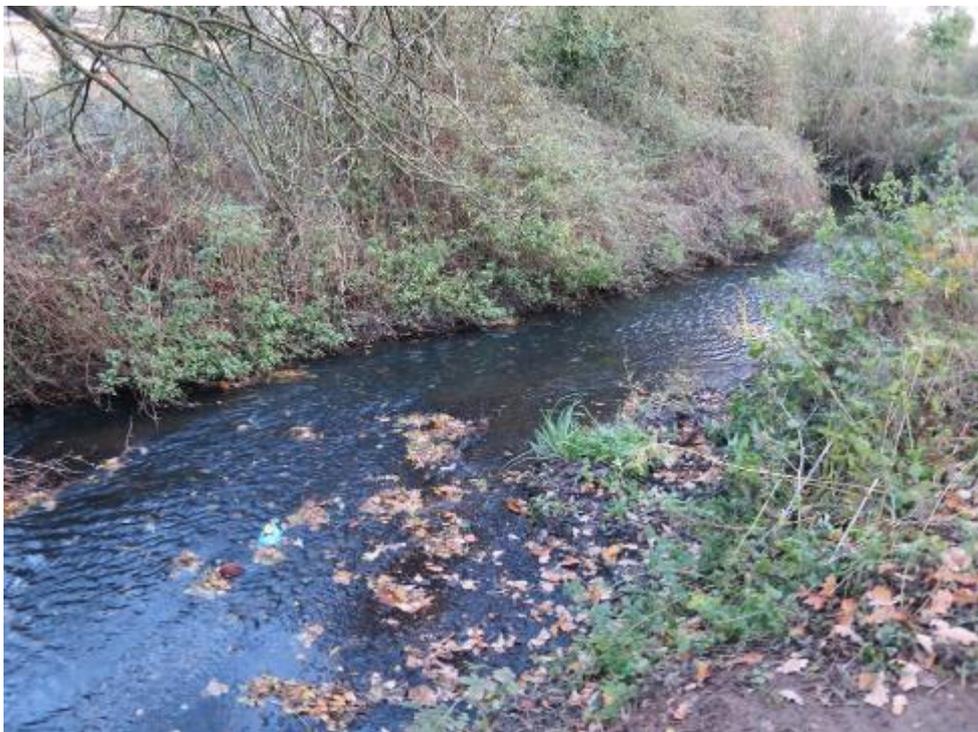
There are some locations (e.g. riffle at SP37832 80404; Fig. 7 and SP3800380335; Fig. 8) where greater floodplain connectivity is evident.

Figure 7: Riffle with increased availability of smaller gravels (potential trout spawning habitat) and less incised channel profile. All these characteristics are probably associated with the bend in the river visible in the top right of the frame).

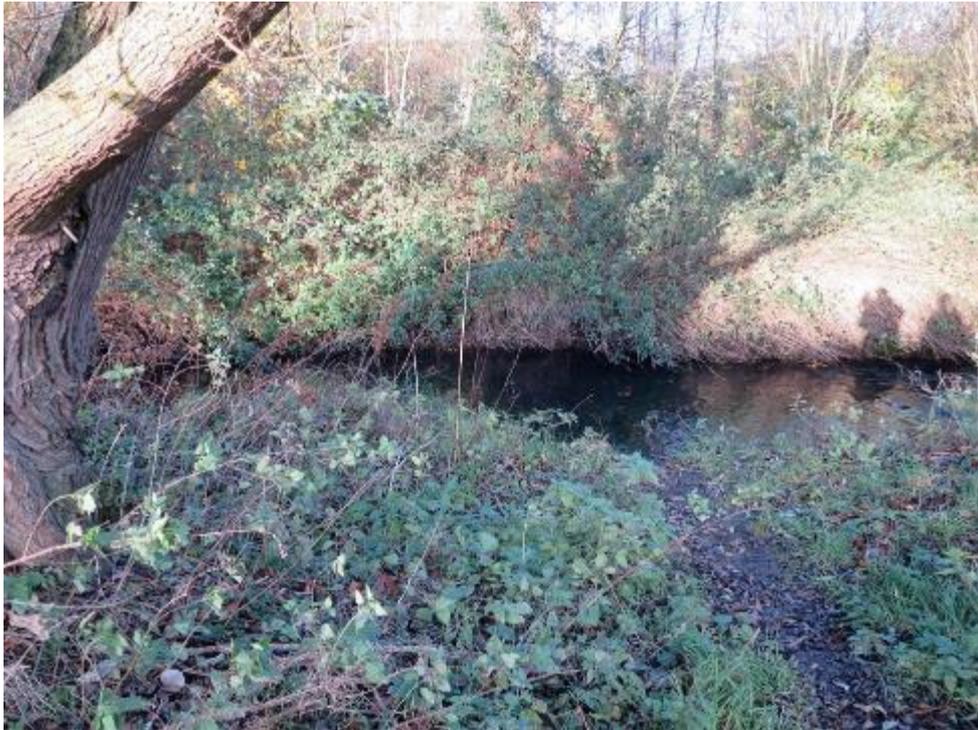
Figure 8: Another spot where the bank-top is not as far above the normal water-level compared to the predominantly "incised" profile (typical e.g. in Fig. 9).

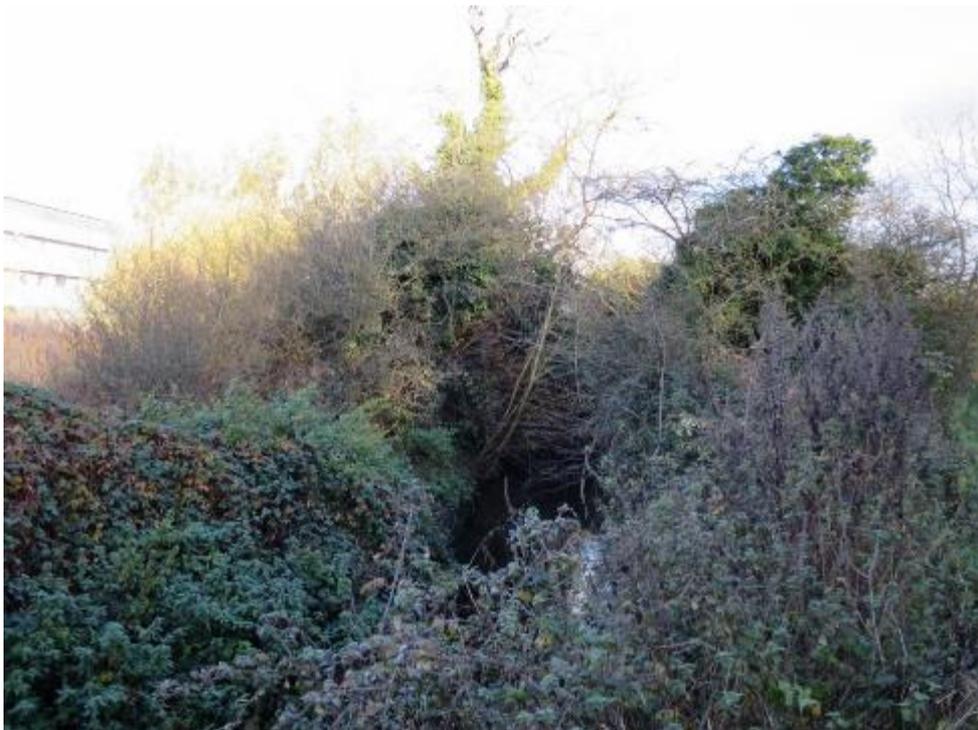
Figure 9: Typical degree of channel incision for the visited reach – photographed at SP 38136 80312.

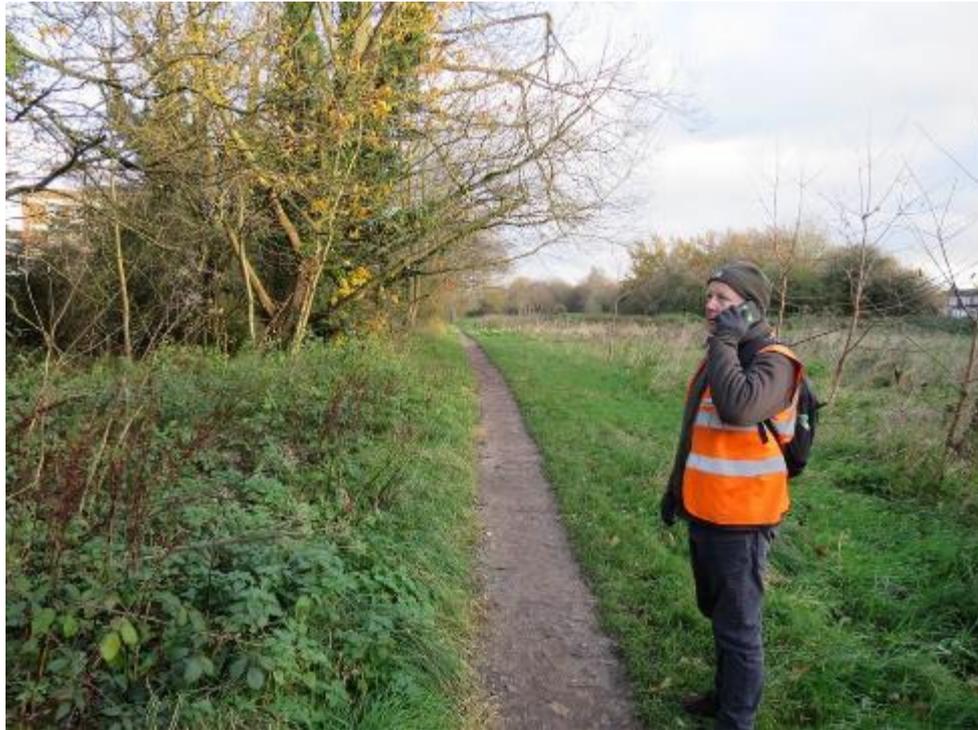
Figure 10: The creation of a wetland scrape to the right of the frame (coupled with a connecting channel cutting through the footpath and associated footbridge) would be highly beneficial ecologically, while offering new measures for managing floodwater in the Sowe catchment.

However, there may be potential to achieve significant ecological and floodwater-management benefits via the creation of wetland scrape habitat that is connected to the river. Figure 10 shows the current footpath and riverside park at SP 37902 80358 – where it may be possible to connect the river channel to a periodically-inundated wetland scrape.

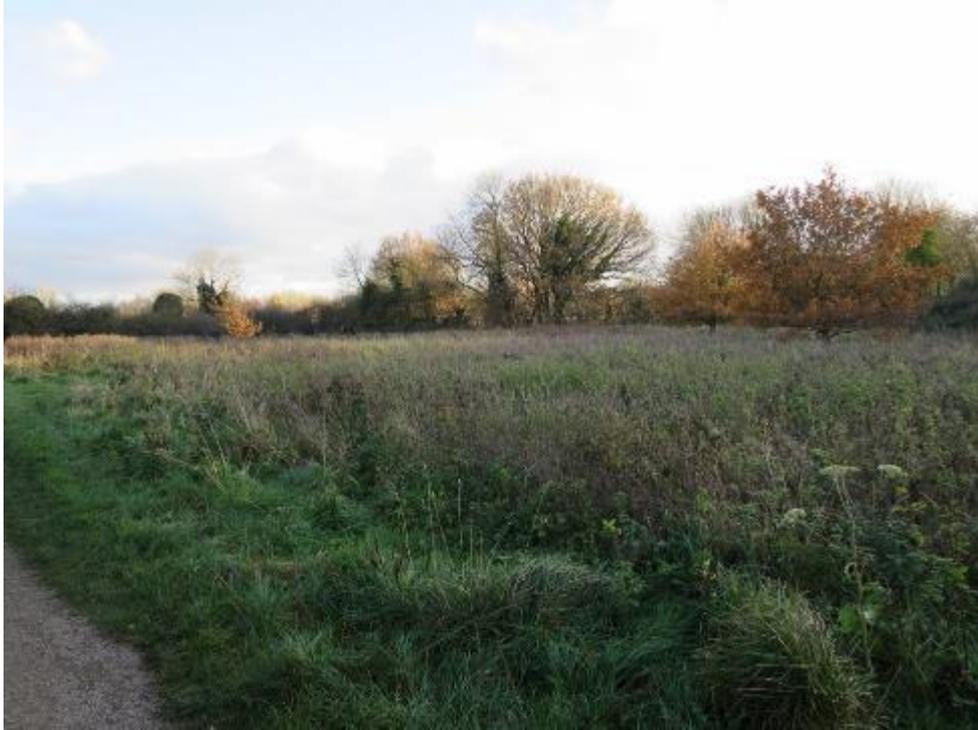
Figure 12: Potential wetland area at SP 38250 80295 (would need to be connected to river underneath footpath).

Further (or alternative) opportunities to create floodplain wetland scrapes connected to the river channel exist at SP 38250 80295 (Fig. 12) and SP 38347 80256 (Figs. 13 and 14). In all cases the channel connection must run beneath the existing footpath. If an open channel/footbridge scheme was unworkable – an alternative would be square-section buried culvert beneath the footpath.

In all cases, it would be necessary to survey the relative elevations of the riverbed and the proposed wetland bed levels to check for feasibility. Care would need to be taken to minimise the potential for the wetland to act as a (temporarily-wetted) “fish trap”. For instance, avoiding the creation of a “step” between either the inlet or outlet ends of channels connecting the main river to the wetland area. A formal survey and detailed feasibility investigation would be required before deciding to adopt this option.

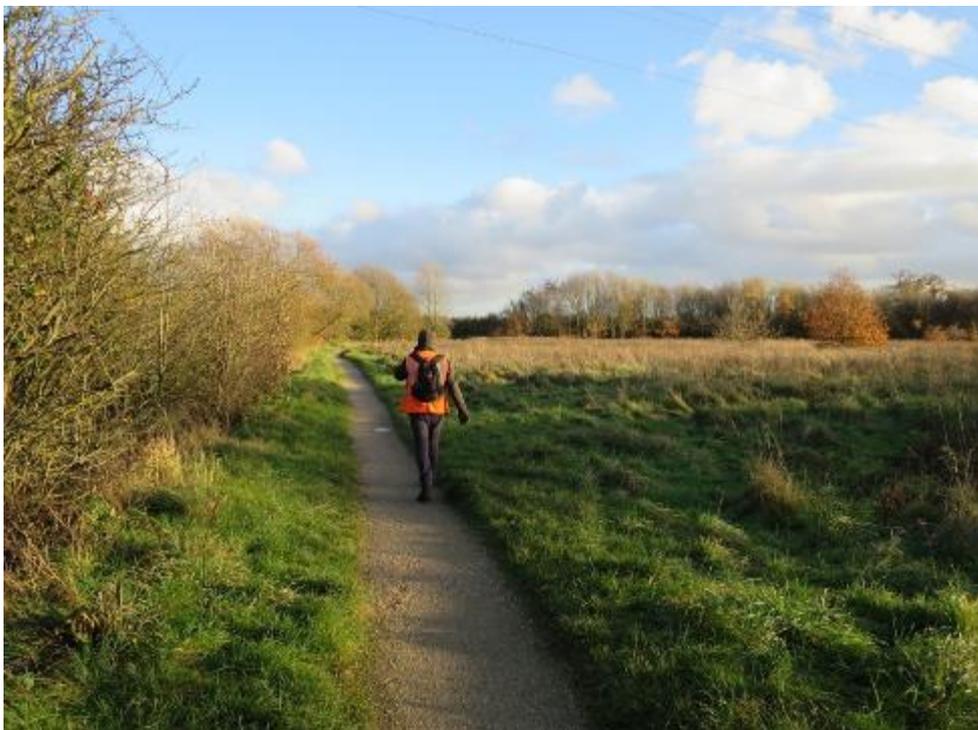
Figure 13: Further potential wetland scrape (view of floodplain) at SP 38347 80256 with associated river corridor shown in Fig. 14

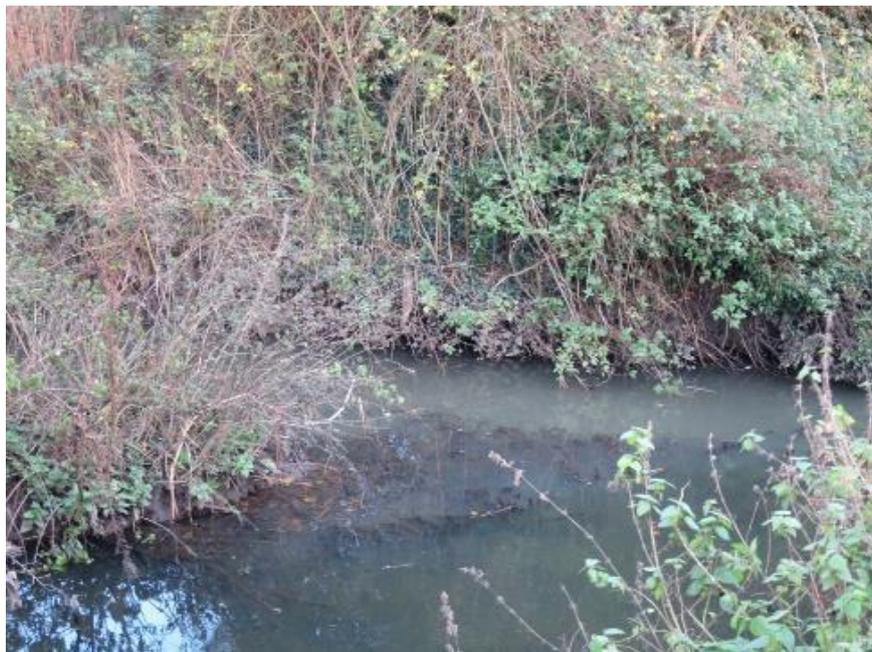
Figure 14: Confluence with the Withy Brook at SP 38474 80194 – note the milky colour of the Withy Brook water in the background before it becomes fully mixed with the water of the Sowe. This indicates elevated inputs of fine sediment (possibly from tilled soil on arable fields or hard-standing drainage from ongoing building development upstream) on the Withy Brook.

For the Sowe, it is possible that both wastewater and agricultural inputs (e.g. Fig. 14, potentially) are elevating phosphate levels in the river (as highlighted in the Water Framework Directive assessments described in the introduction to this report). In future it is likely that water companies will find cases where it is more cost-effective to fund solutions that tackle nutrient enrichment at the source (compared to attempting to strip nutrients once water arrives at a treatment works). A [pilot project by United Utilities](#) demonstrates the potential of this approach with phosphate. For all stakeholders in river water quality, it is important to understand that both fertilizer and livestock waste have high potential to increase nutrient levels in rivers.

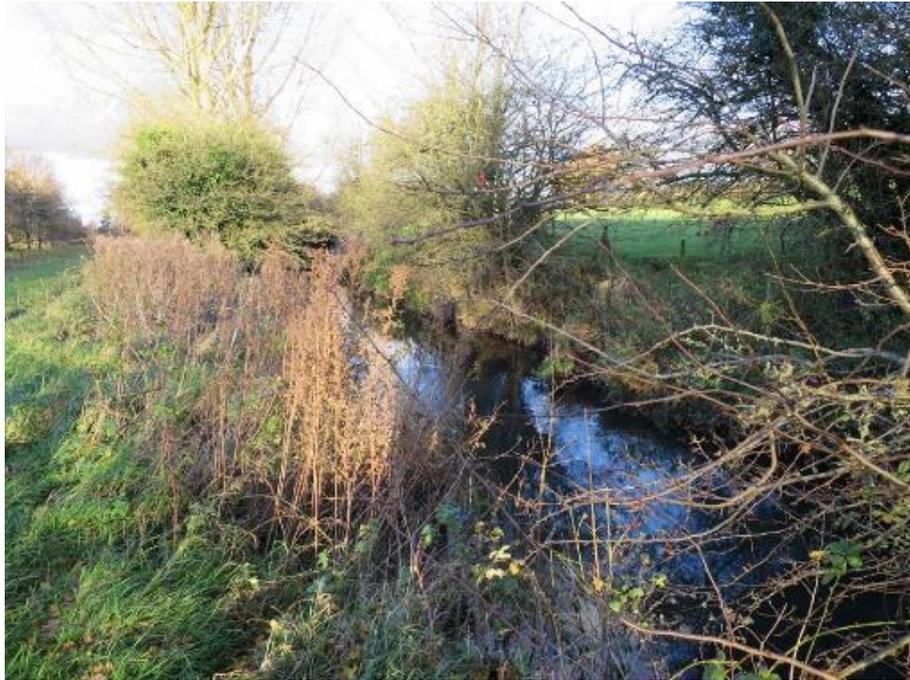
A typical example of the straightened sections of the River Sowe is given in Figure 19 (below). Straightened channels have a shorter path-length than meandering channels – which can have several impacts depending on the flow direction in relation to the shape of the landscape.

In the case of the River Sowe, it is notable that, for much of the visited reach, there is only a single line of trees along each bank of the river. To give the clearest guidance for this report, it is worth working through the considerations above for this specific reach.

Figure 19: Artificially straightened channel (and an associated, unnaturally uniform cross-sectional profile). Note the single line of trees along both banks.

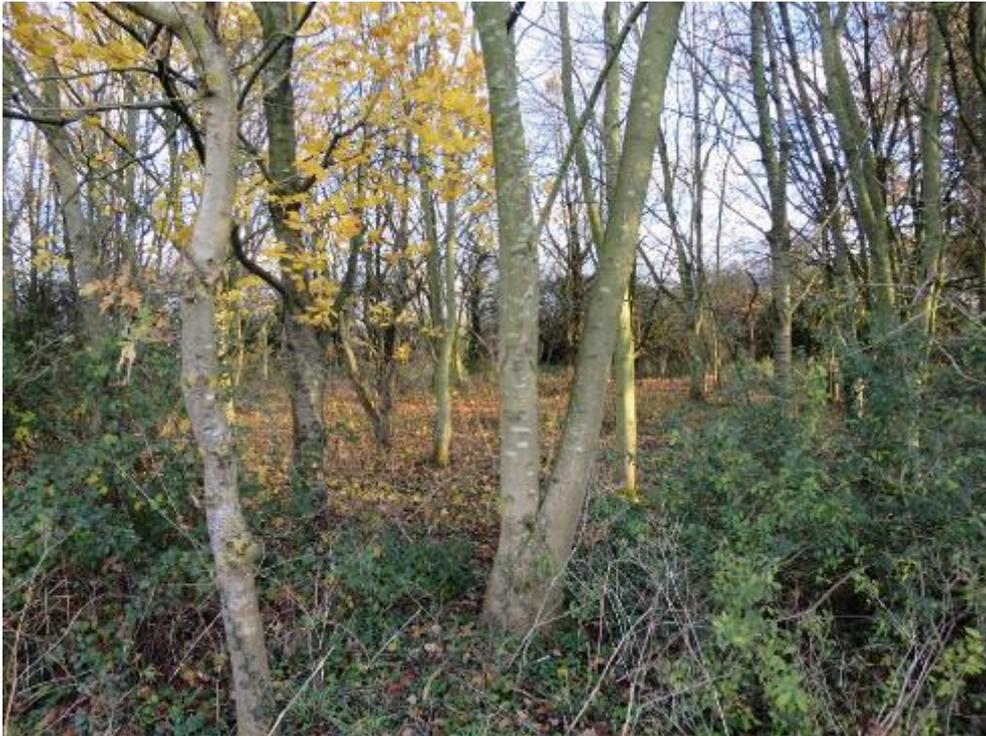
In contrast, a wider patch of woodland (e.g. Fig. 20) means that the river can't cut too far into the bank before encountering earth that is far more resistant to erosion. When the banks are less erodible than the riverbed, then the river must dig downwards instead of sideways – and this creates deeper pool habitat. Because that pool habitat is formed by the self-scouring action of the river, it is naturally swept clear of finer sediments that would otherwise deposit and cause a reduction in depth.

Figure 20: Broader strip of riparian woodland at SP 38424 80109 (N.B. feeding of birds in this location was noted to be supporting a large population of rats in this area - which is actually likely to have a negative impact on nesting birds).

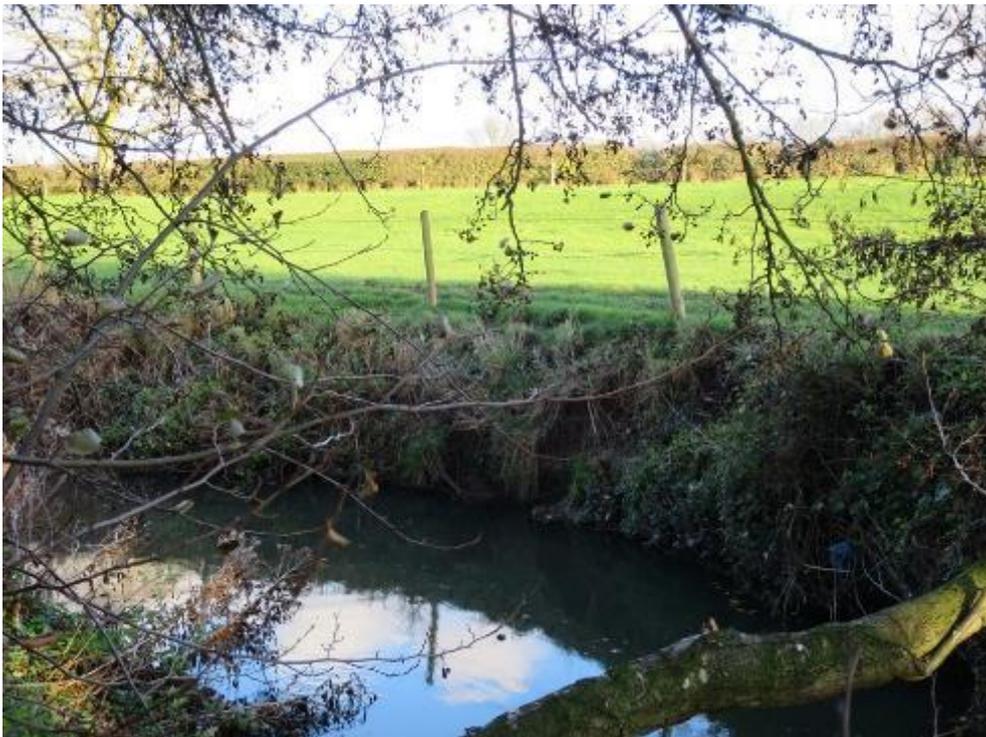
Figure 21: Shallow root horizons mean that fence-lines are vulnerable to collapse – but locking a straight channel in place has a negative influence on the river ecology.

The difficulty is in juggling the practicalities of various improvement opportunities against current land-use preferences and rights. Suggested options are discussed in section 3 “Recommendations”.

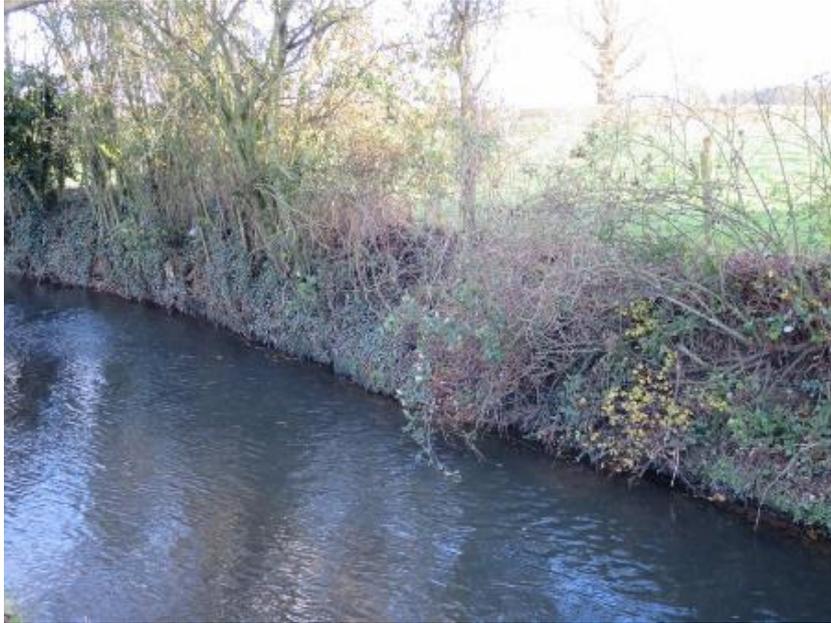
Although there are some limited examples of in-channel cover derived from trailing vegetation (e.g. Fig. 22), there is a general lack of this type of habitat,

Figure 22: Limited trailing vegetation cover, straightened channel and single-line of deeper-rooting species all acting to constrain the ecological potential of the Sowe. However, even though very narrow, the effectiveness of those deeper-rooting species in protecting the fence-line behind is notable. This may be viewed positively if you want to protect the fence, but also constrains the recovery of a more meandering channel.

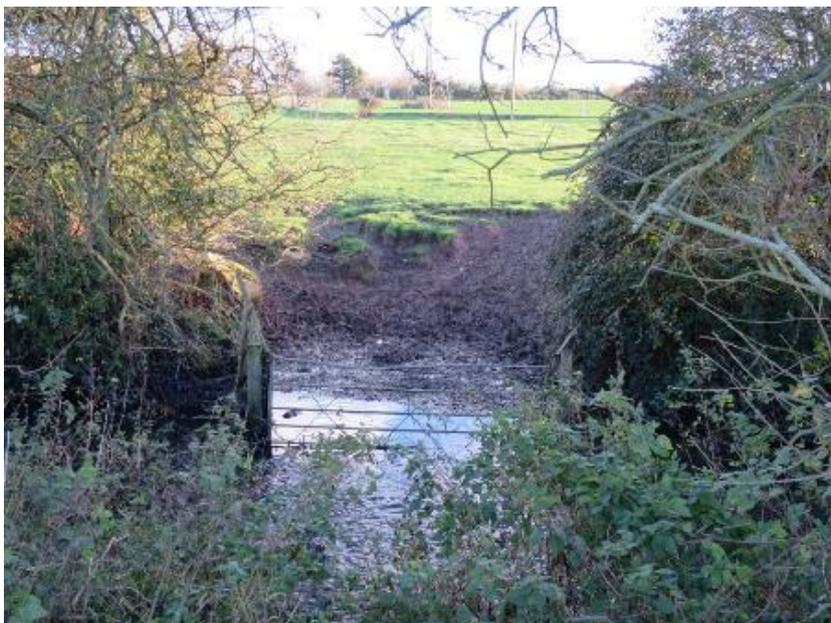
There is also a valuable separation of the channel from livestock – in part achieved by the inclusion of a fenced-off “cattle-drink” (Fig. 23) at SP38247 79582, although this method of stock watering does create increased sediment and nutrient issues locally.

Figure 23: Livestock drinking area - separation of animals from the watercourse and associated vegetation is beneficial to the river corridor ecology, but further reduction in sediment and nutrient inputs may also be possible to achieve through offline watering (pasture pumps or solar pumps, or even mains water, which delivers additional livestock health benefits).

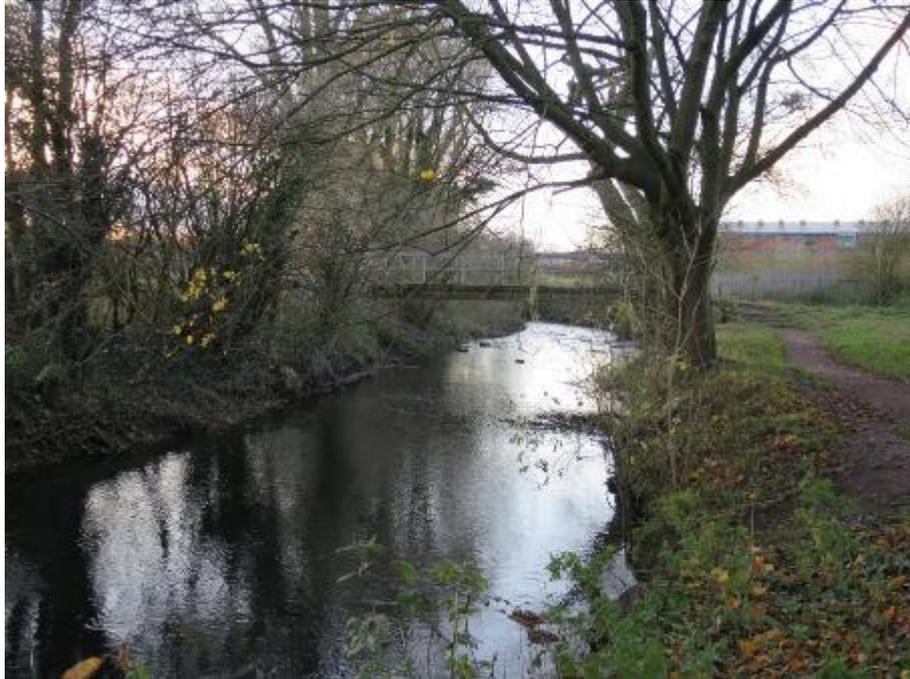
Downstream of the B4082/Clifford Bridge Road there are some shallower and wider sections (Fig. 24). Heavy visitor footfall and shading have contributed to hot-spotted areas of denuded banks (Fig. 25).

Figure 24: Footbridge over a wider, shallower section of the Sowe downstream of the B4082

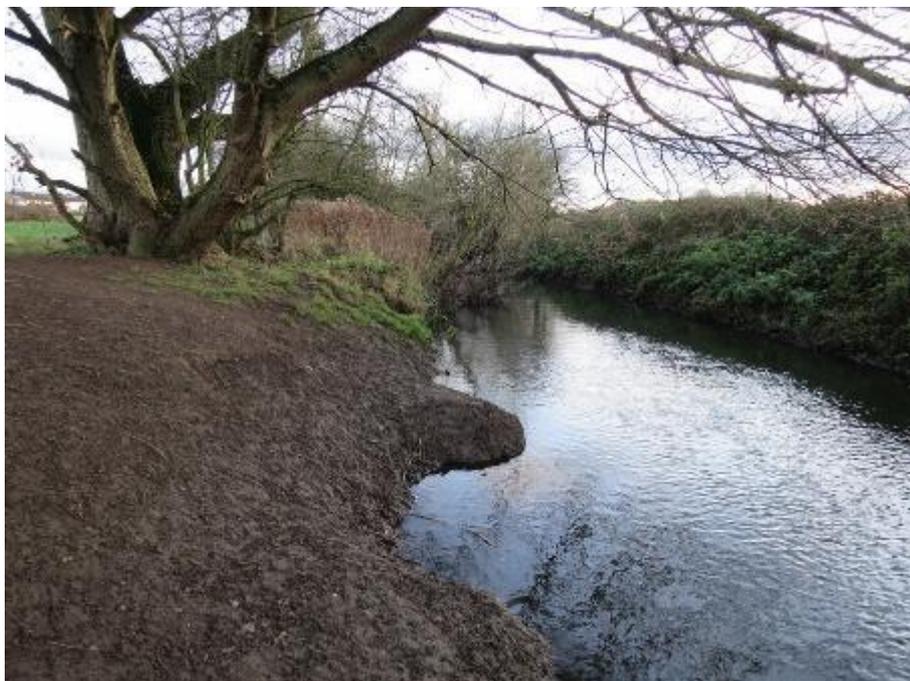
Figure 25: Heavy footfall and probable dog access to the channel has killed the vegetation to expose bare earth. While being an obvious point of low biodiversity, this type of damage seems to be quite limited in extent.

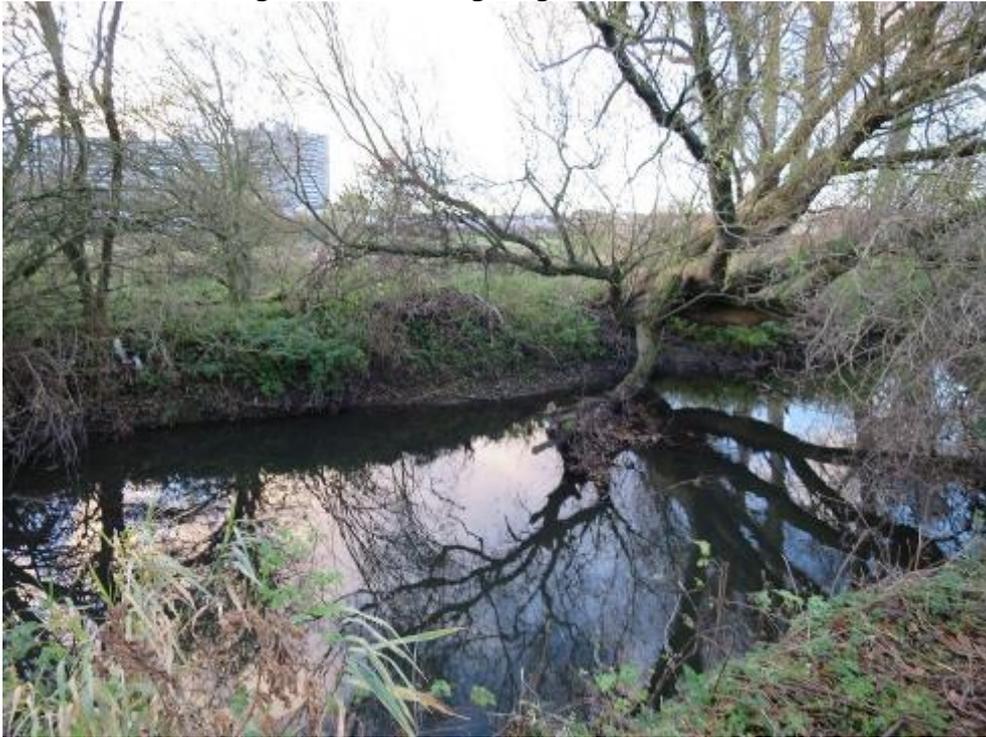
This section of the River Sowe also had some of the better examples of natural cover habitat seen during the visit – e.g. Figs. 26 and 27.

Figure 26: Great overhanging and trailing cover habitat - retaining valuable nutrients in the form of leaf litter and coarse woody material.

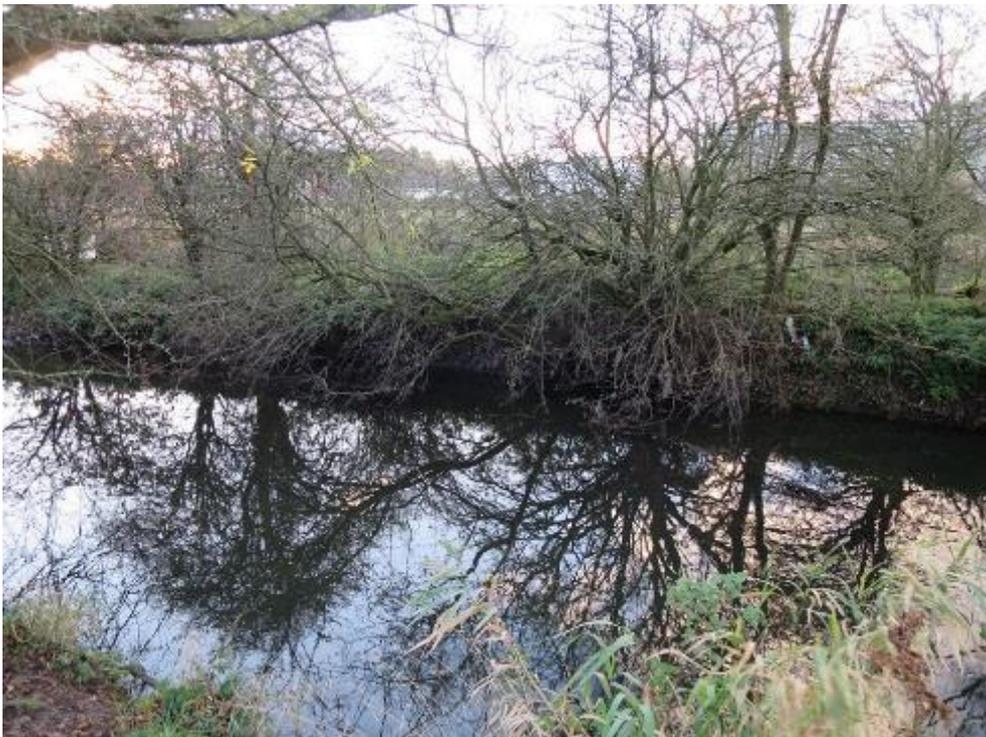
Figure 27: More examples of essential overhanging and trailing cover habitat.

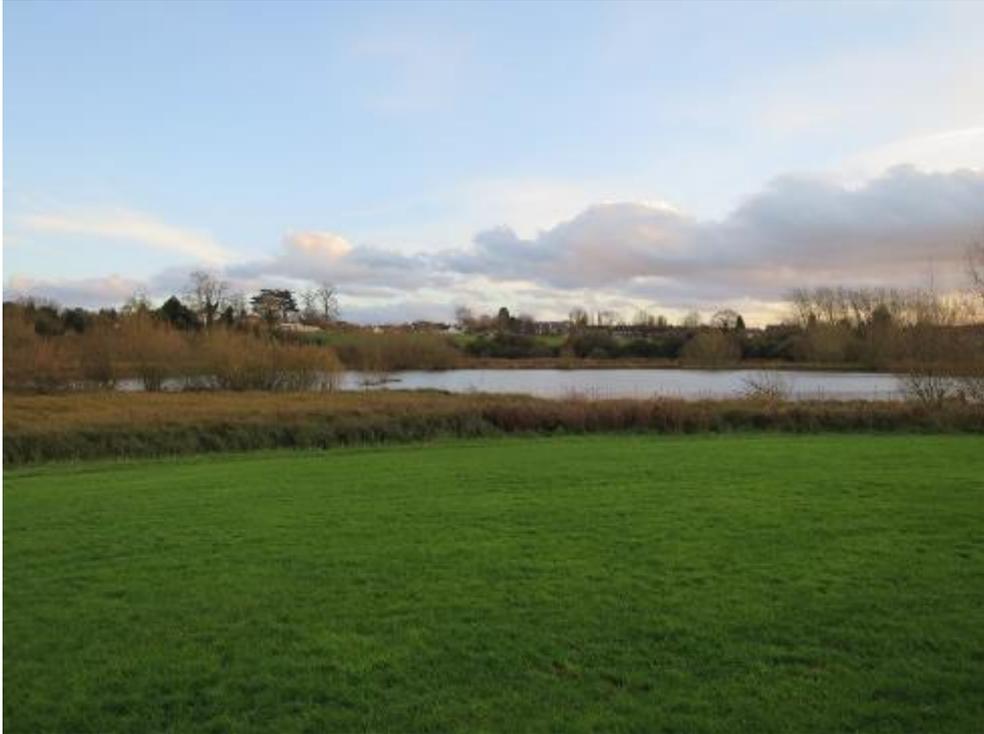
Not far downstream from this section, the impoundment caused by “Stoke Floods” lake is evident. The impounded section of river is associated with some surface scum that is likely to indicate a reduction in dissolved oxygen levels in this reach.

Figure 28: Stoke Floods - the downstream limit of this visit and a home for waterfowl

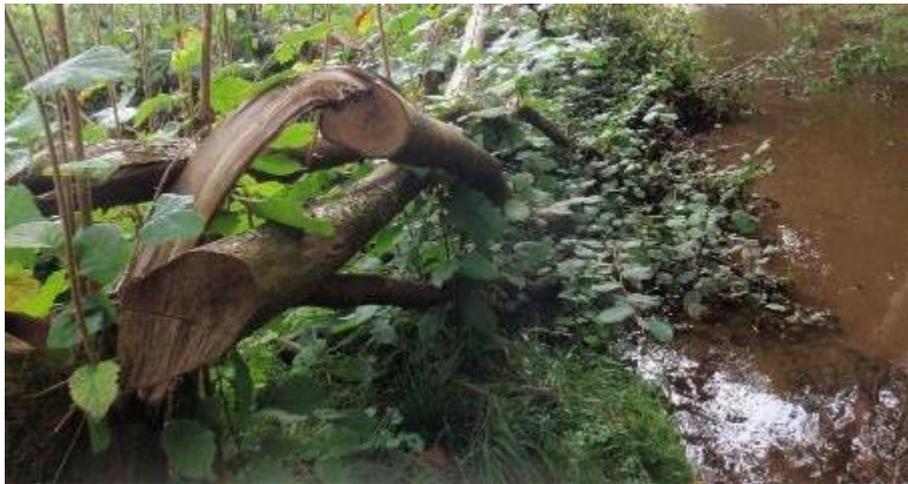
Figure 29: Hinged sapling growth (in this case hazel) used to create cover habitat in stream margins.

- Explore opportunities to “hinge” or “lay” (in the manner of hedge-laying) scattered patches of sapling-growth into the channel (e.g. Fig. 29) to promote some bed redistribution during high-flow conditions

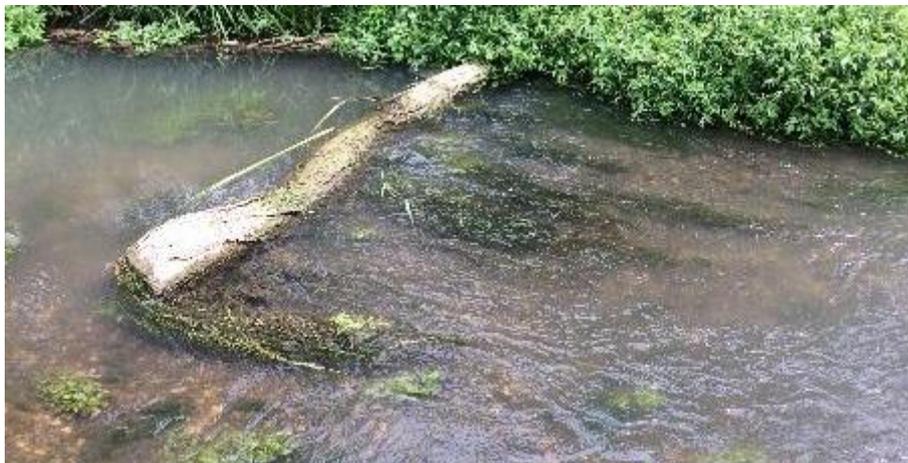
Figure 30: Securely pinned/staked woody material producing localised bed scour during high flows. Using this technique with material arising from tree management would create better habitat within un-impounded sections of the Sowe.

- Use materials arising from those routine tree-management activities to securely fix limbs, stems and branches from trees to encourage localised bed and (where safe to do so) bank scour (e.g. Fig. 30).
