Habitat Advisory visit to the River  
Robe, Co. Mayo, Eire.  
Undertaken on behalf of the River  
Robe Angling Club by Vaughan Lewis,  
Windrush AEC Ltd  
May 2013

## 1.0 Introduction

## 2.0 Habitat assessment

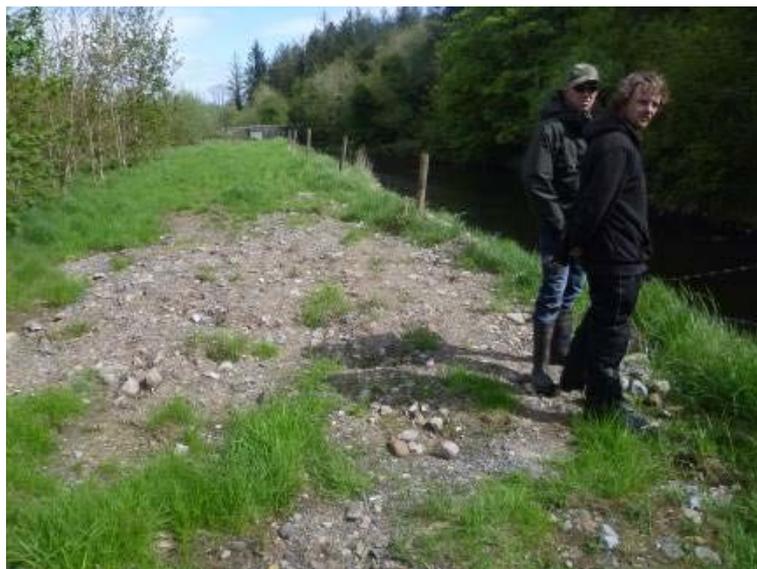
Upstream of the bridge, the channel was moderately shaded by riparian trees, but there was a dearth of instream cover, particularly Large Woody Debris (LWD). Recent clearance carried out by the Office of Public Works (OPW) had removed significant amounts of fallen timber from the channel, reducing the availability of cover. Some pollarding and coppicing of riparian trees was also undertaken, along with some localised removal of gravel from the channel, potentially impacting on the availability of spawning and juvenile habitat for trout. The removal of gravel had exposed the bank adjacent to a small weir and was causing some local erosion. Overall, the works had resulted in the creation of a rather featureless section of river (Figure 1)

**Fig 1: RRAC members standing on pile of gravel recently dredged from the river**

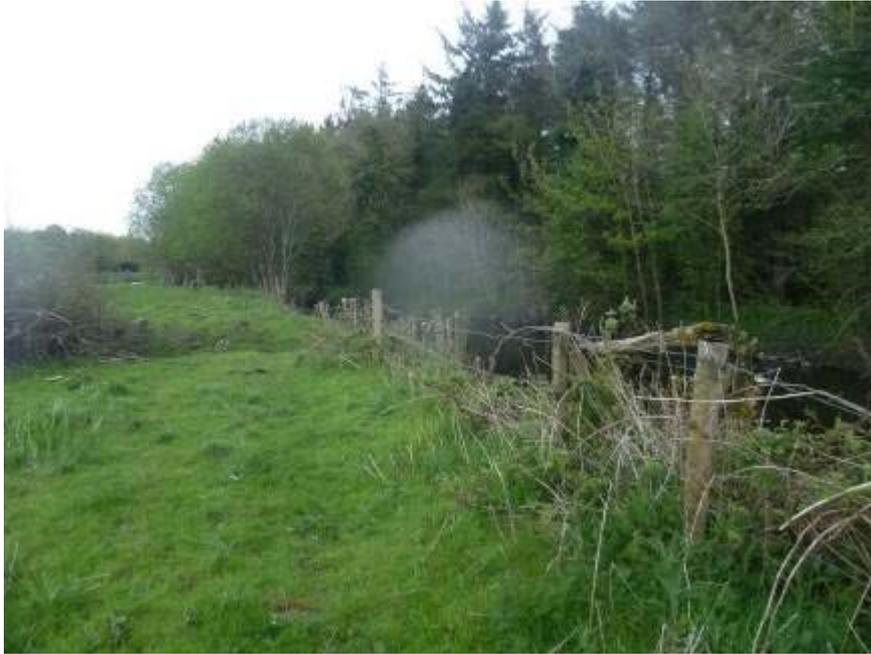
**Fig. 2 Recently coppiced trees with large pile of woody debris visible to the left**

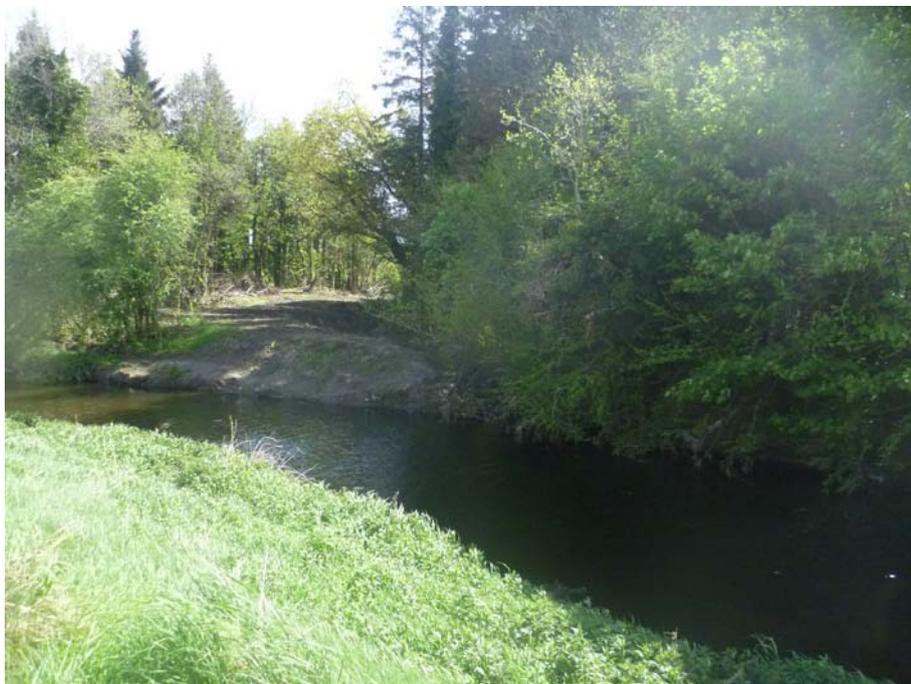
This section of the river was reasonably well-fenced with no significant erosion due to cattle poaching. There was also clear evidence of run-off into the river from a forestry area via a recently dredged tributary ditch, with a brown discharge noted on the day of the advisory visit. The ditch was apparently also very spatey with high volumes of water entering the river during periods of high rainfall (Figure 3).

**Fig.3 LB ditch recently cleaned and showing evidence of dirty discharge**

- The run-off from the forestry ditch is likely to be carrying significant amounts of sediment into the main river. Ideally, a review of the local drain network should be made by OPW with a view to attenuating flood flows and the associated sediment loading

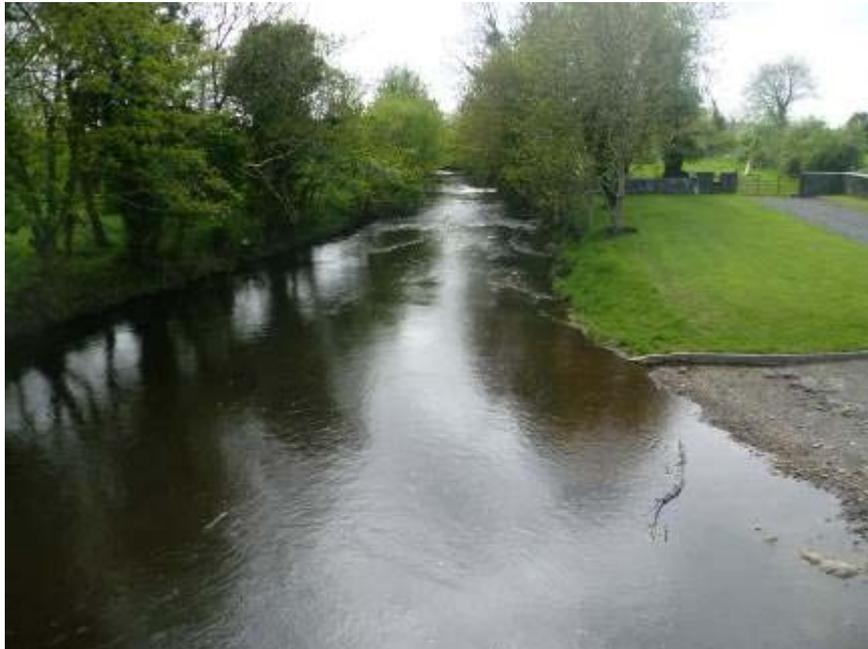
Downstream of Crossboyne bridge , a number of small weirs had been constructed, with associated sections of gravel riffle with a moderate gradient. It is likely that these provided some main stem spawning areas for brown trout.

**Fig. 4 River downstream of Crossboyne Bridge showing series of small weirs**

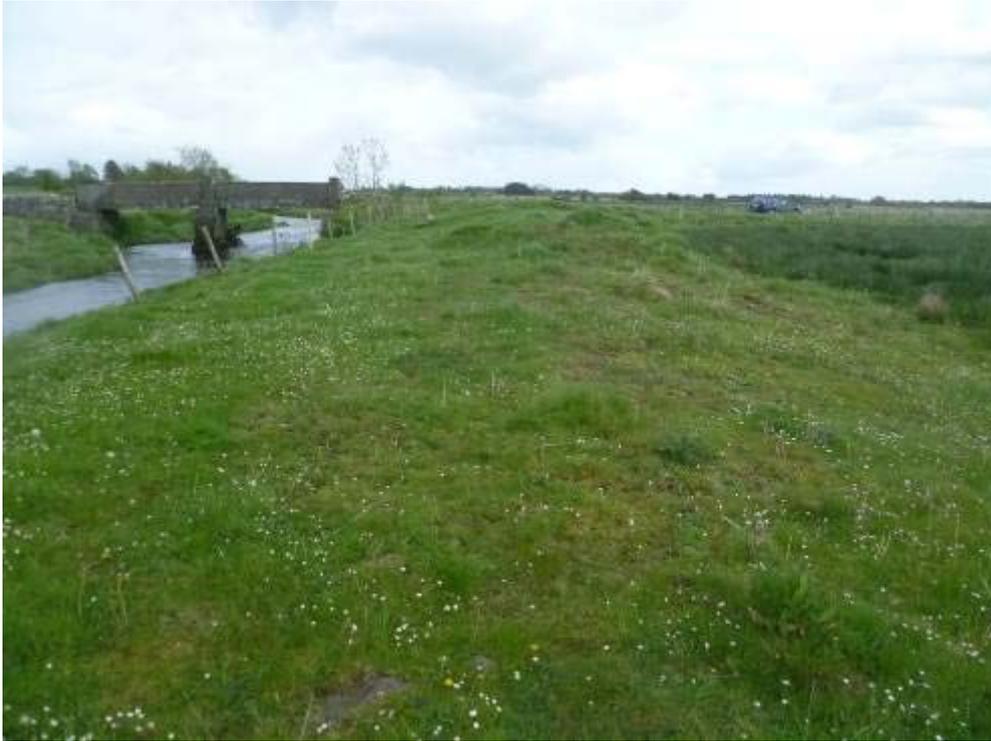
At the Coffin Bridge, approximately 3km downstream of Crossboyne, the river was a mixture of riffles and shallow glides with a reasonable gradient, and deeper more featureless sections of river. The banks were temporarily fenced using posts and electric wire. Unfortunately, the fencing was located very close to the bank top leaving a narrow buffer strip and limited coarse vegetation which is valuable for cover and limiting erosion (Figure 4). As a result there were also some very significant local erosion issues, particularly on the outside of bends.

The past dredging of the river had left a very extensive bund of material along the river's banks. In places, this was in excess of 1 m high with the bulk of the bund comprised of stone and gravel. With care, this could be re-used and introduced to the river to increase the availability of shallow riffles/rock ramps that provide ideal habitat for juvenile and spawning trout.

**Fig. 4 Temporary fencing close to the bank top. Note also the raised bank of dredged spoil on the LB**

- Fencing should be erected to exclude stock from the river banks. The maximum width possible (ideally in excess of 5m) should be isolated from the cattle, forming an un-grazed buffer strip of coarse vegetation that will reduce run-off of sediment from surrounding land, and allow the growth of fringing vegetation, valuable for the protection of juvenile fish. Where fencing is presently located very close to the bank top, it should be moved back to create a wider buffer strip, helping to reduce bank erosion

- Similarly, there was a very extensive raised bund on the LB downstream of Coffin Bridge. This was formed from material previously dredged from the river. Subject to consent from OPW/IFI, it could potentially be excavated and re-introduced to the river to create series of rock ramps/riffles for spawning and juvenile trout habitat.

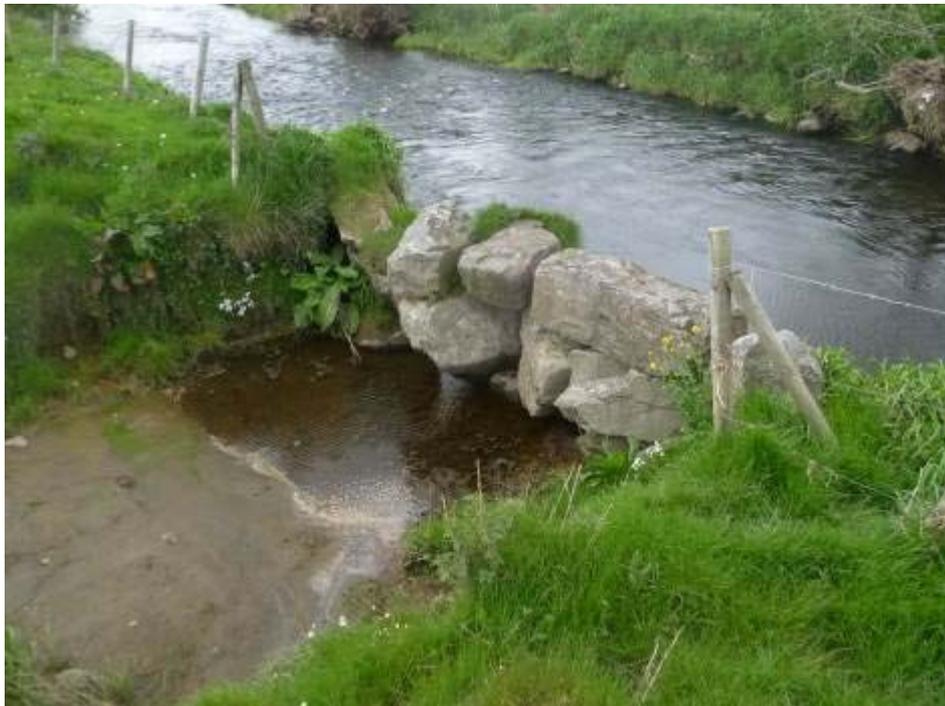
There were some well-constructed cattle drinks of un-usual and very practical design. There was a limited number of riparian trees, leaving the channel rather unshaded. There was also a lack of LWD in the channel.

**Fig. 6. Innovative and well-designed cattle drink**

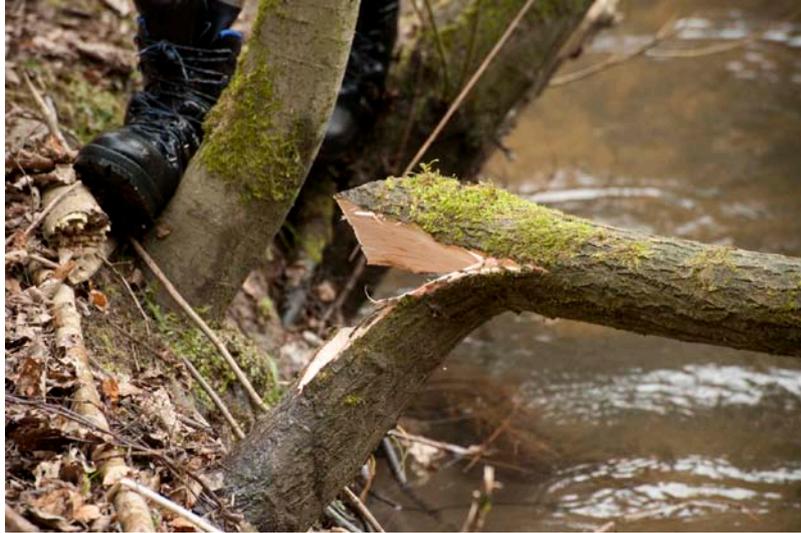
**Hinged timber ....**

- Large Woody Debris introduced to the channel is an excellent way of not only providing additional cover, but also of increasing bed scour, creating deeper pools and helping to sort the substrate. This is important as it will create short sections of silt free gravel at the tail of pools that is ideal for trout and salmon spawning. Ideally, LWD can be introduced by the partial cutting and hinging of bankside trees into the water. This has the advantage of maintaining a

secure fixing to the bank and also keeping the hinged trunk alive. The LWD can be further secured using either wooden stakes driven into the bed and wired to the trunk, or by drilling the trunk and driving rebar through it into the riverbed (beware hidden utility service cables and pipes)

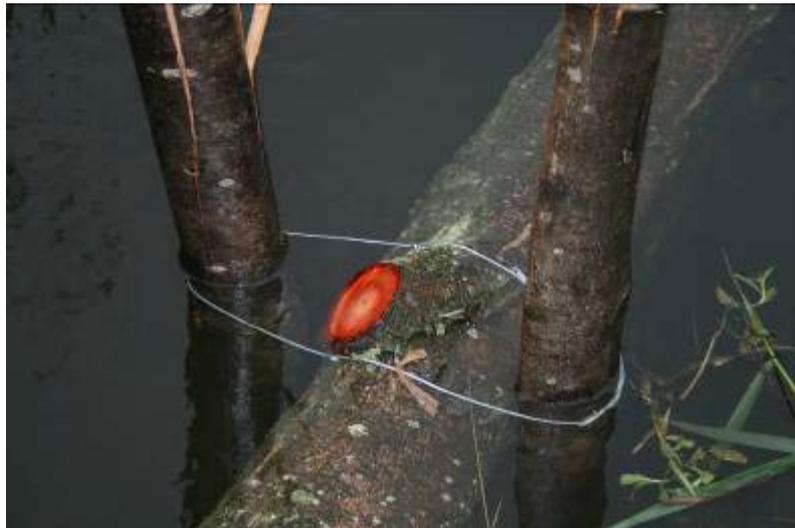
**.... And additional fixing using stakes and wire**

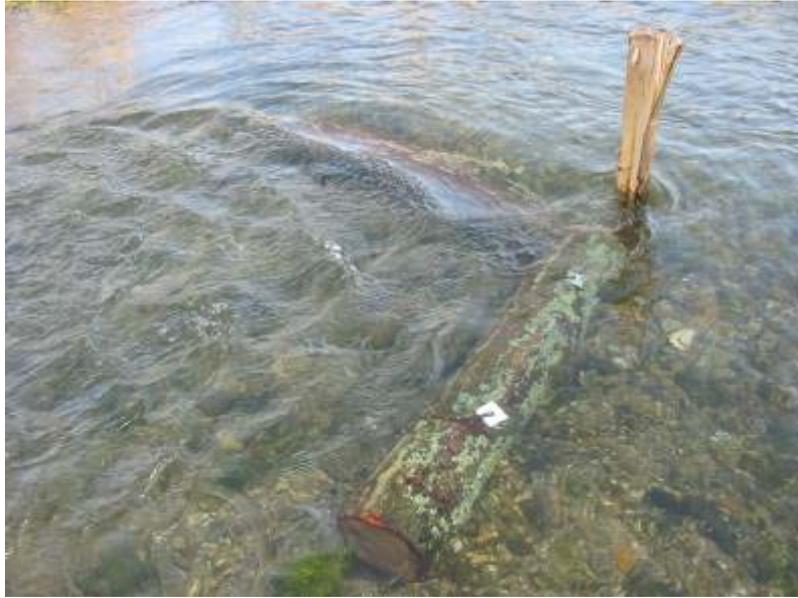
**Paired LWD limbs used to create a 'v' shaped deflector. Note rebar and steel washer fixing**

- Simple mid-stream deflectors can also be constructed using paired upstream facing timber limbs fixed in places with stakes or rebar. Arranged in this pattern, the LWD concentrates flow into the centre of the channel, scouring a small pool and downstream spawning riffle.

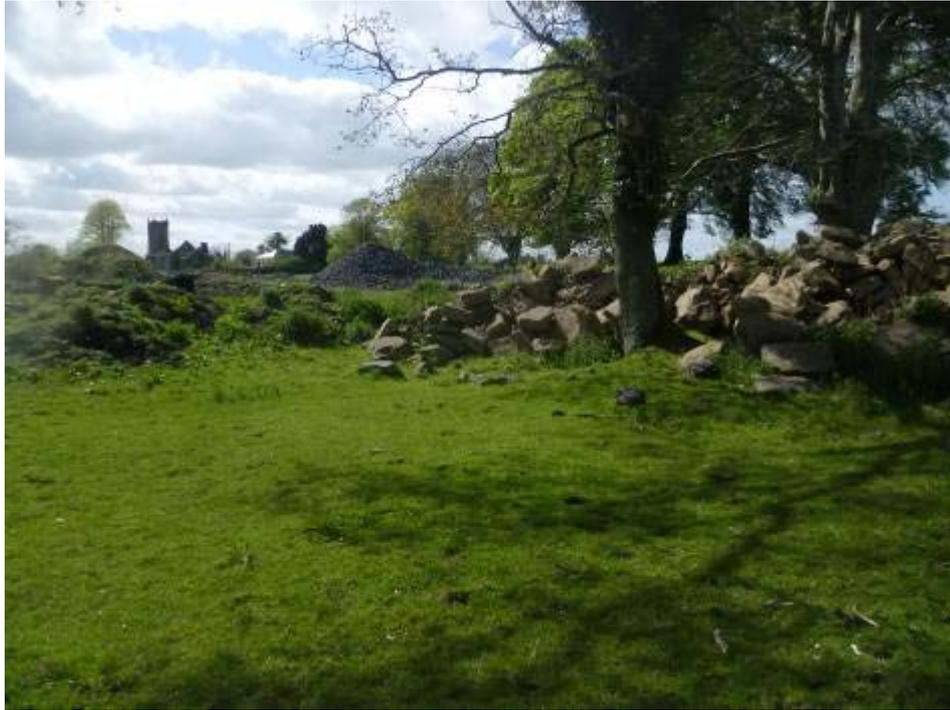
**Stone/gravel piles on RB upstream of Crossboyne Bridge**

- There was a large amount of stone and gravel present on the RB immediately upstream of Crossboyne Bridge. It is understood that this might be available for introduction into the river subject to the necessary consent of IFI/OPW. If this is the case, it could be used to construct riffles/rubble mats or for the construction of stone deflectors (see below). The gravel and stone recently removed from the river could also be re-introduced to the river to re-create some of the riffle areas lost during the dredging.

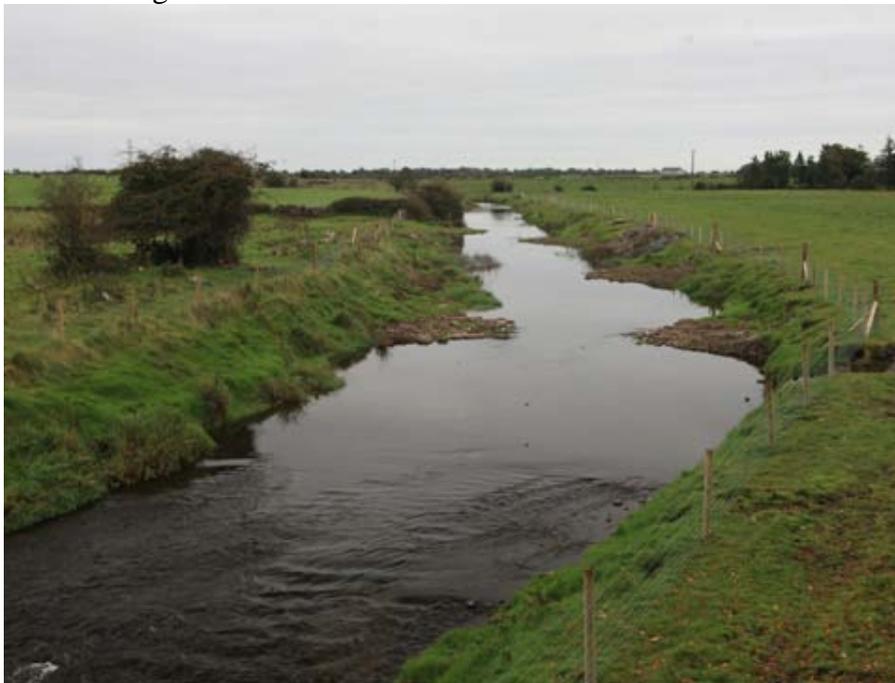
**Alternating and paired deflectors installed IFI with downstream rock ramp**

- Increased amounts of cover and bed variation can also be provided by the use of stone deflectors. Good examples have already been installed by IFI. Similar designs could be used elsewhere.

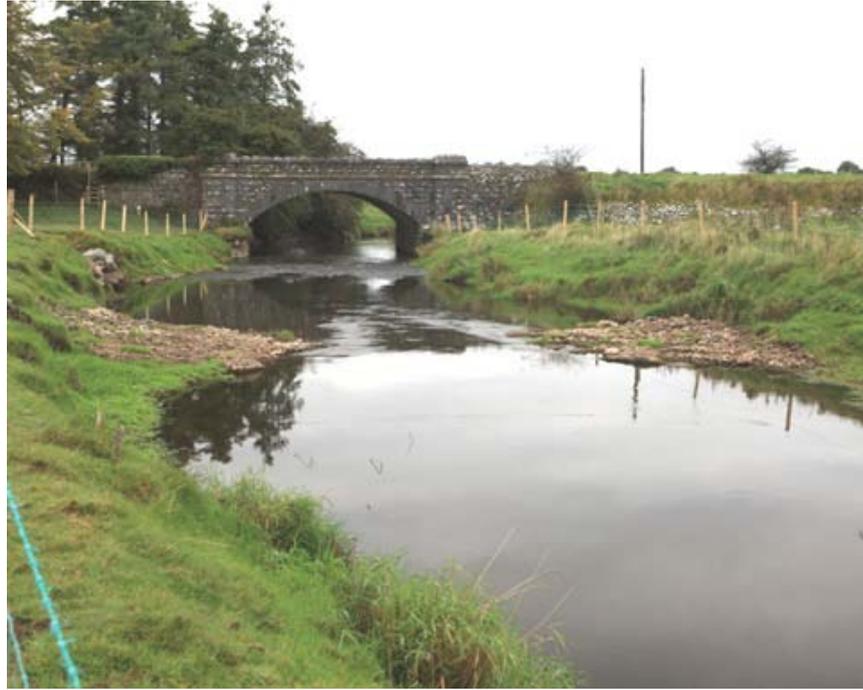
**Paired stone deflectors and rock ramp installed by IFI**

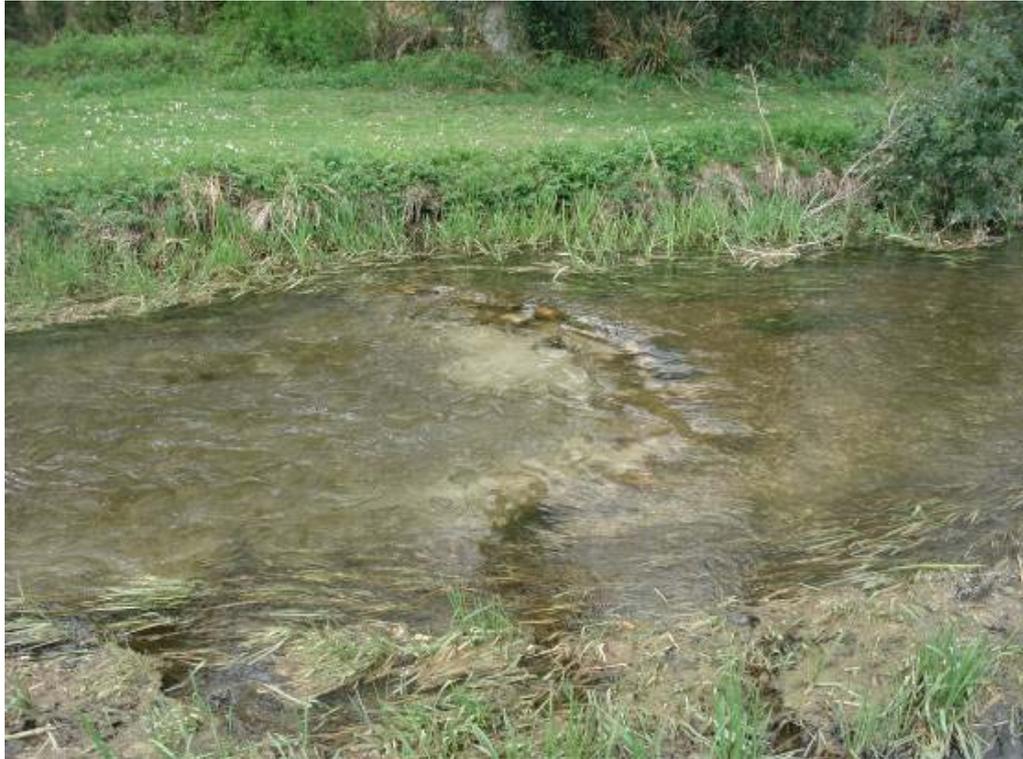
**A 'D' shaped deflector in a small limestone stream**

- Alternatively, a series of large boulders can be arranged into a rough upstream facing 'D' shape in the centre of the channel where there is some gravel present. (see photo below). The boulders do not need to span the full width of the channel and act by increasing water velocity locally, creating scour and cleaning fine sediment away from potential spawning gravel.
- To protect fish stocks from over-exploitation, it is important that a general presumption in favour of catch and release of trout is adopted. Fish stocks in rivers such as the Robe can easily be damaged by even relatively low levels of removal by anglers.
- The humane control of mink should be continued to protect both fish stocks and birds/small mammals in the river corridor.

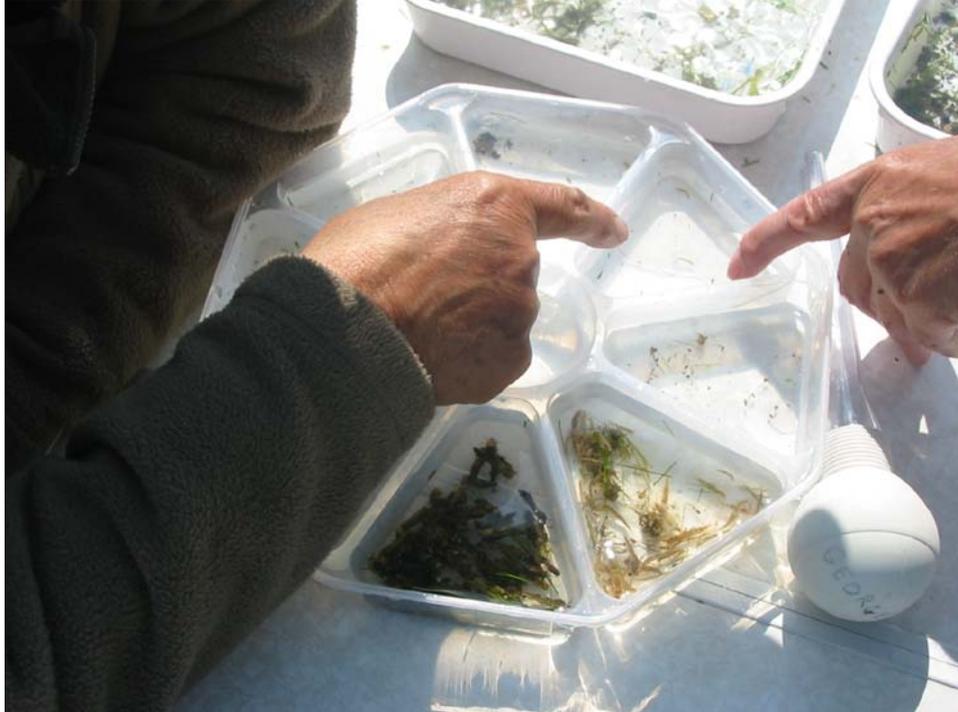
#### **Riverfly monitoring undertaken by anglers**

- It is important to develop a robust set of data regarding the invertebrate populations in the River Robe and hence its water quality. A system known as Small Stream Risk Score (SSRS) is used in Ireland to monitor water quality of rivers by monitoring macroinvertebrates. A training manual for SSRS can be found at [http://www.westernrbd.ie/PDF/SSRS-Training-manual\\_11\\_01\\_06.pdf](http://www.westernrbd.ie/PDF/SSRS-Training-manual_11_01_06.pdf). A perhaps simpler and more angler friendly alternative for members of the fishing club who are interested in the water quality and fly life of the river, would be to contact the Riverfly Partnership <http://www.riverflies.org/> who are able to provide information on monitoring

invertebrate populations in rivers. If there are one or two enthusiastic volunteers in the co-operative, it would be worth contacting the partnership for further advice and information. It is possible that the Riverfly partnership may be able to assist co-operative members to become familiar with the requirements of SSRS.
