**Sweatfords Water, Rockbourne Trout Fishery,
Rockbourne, Hampshire**

An Advisory Visit report by the Wild Trout Trust, August 2014

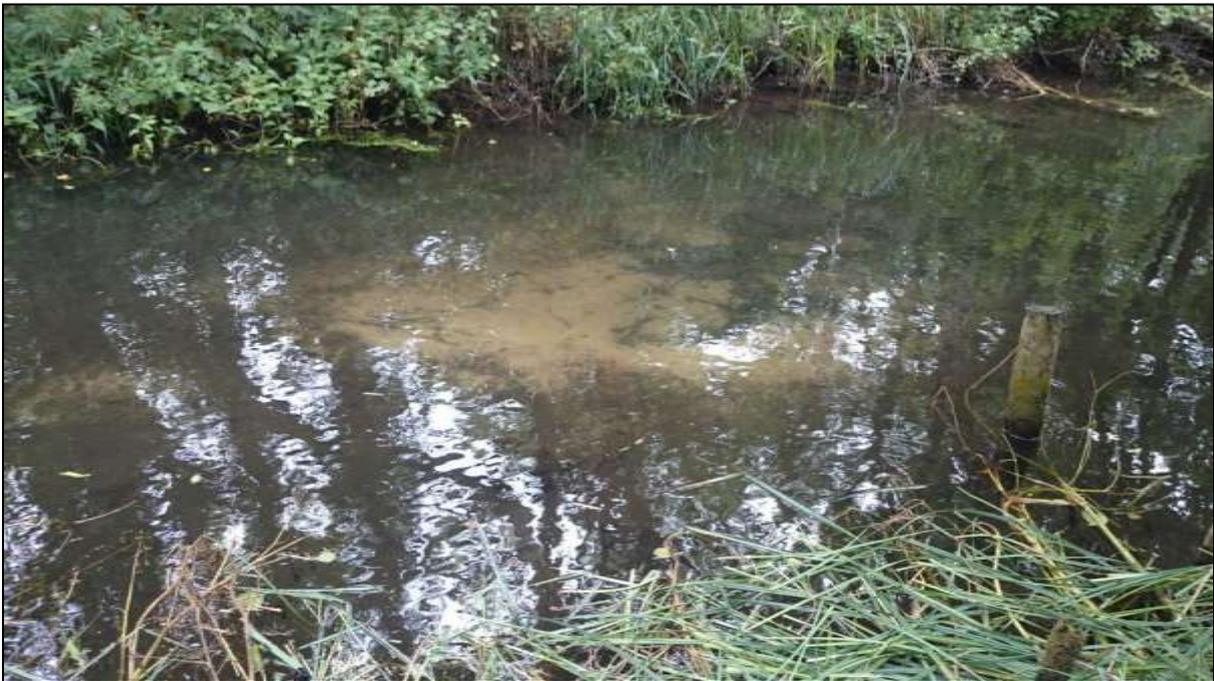
physical habitat. Sedimentation is excessive and much of the bed is smothered by a thick layer of fine, sandy silt. The accumulation of fine sediment is a symptom of the natural flow of the river being impeded by a weir downstream. The slowing of the river allows fine particles to drop out of suspension and settle. Where this happens uniformly across the bed, habitat diversity is reduced as the sediment evens out depth conditions (Figure 2).

Figure 2: A thick deposit of fine sandy sediment smothers the bed

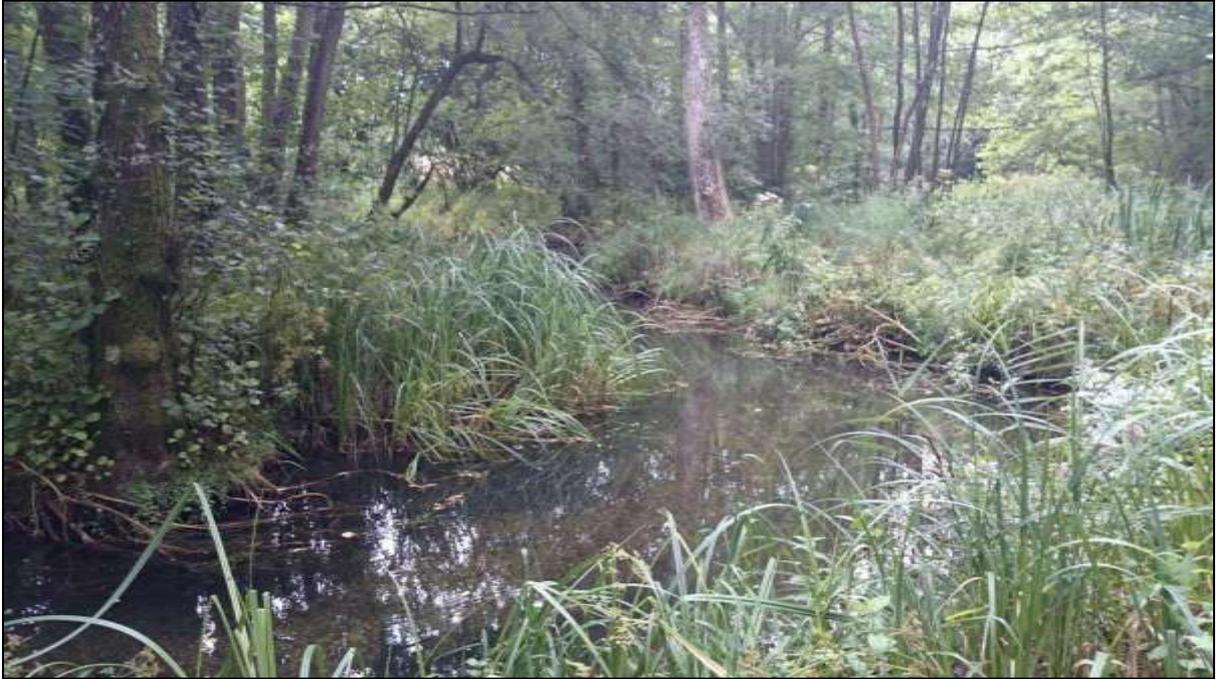
Despite the sluggish flow some sections of the bed in the impounded reach were relatively clear. This may be in part due to prolonged periods of scouring flow over the extremely wet winter but the main factor effecting scour is the presence of natural features such as tree roots extending out into the channel that pinch the channel and deflect flow (Figure 3).

Figure 3: Tree roots extending into the channel help to scour the bed clear of fine sediment

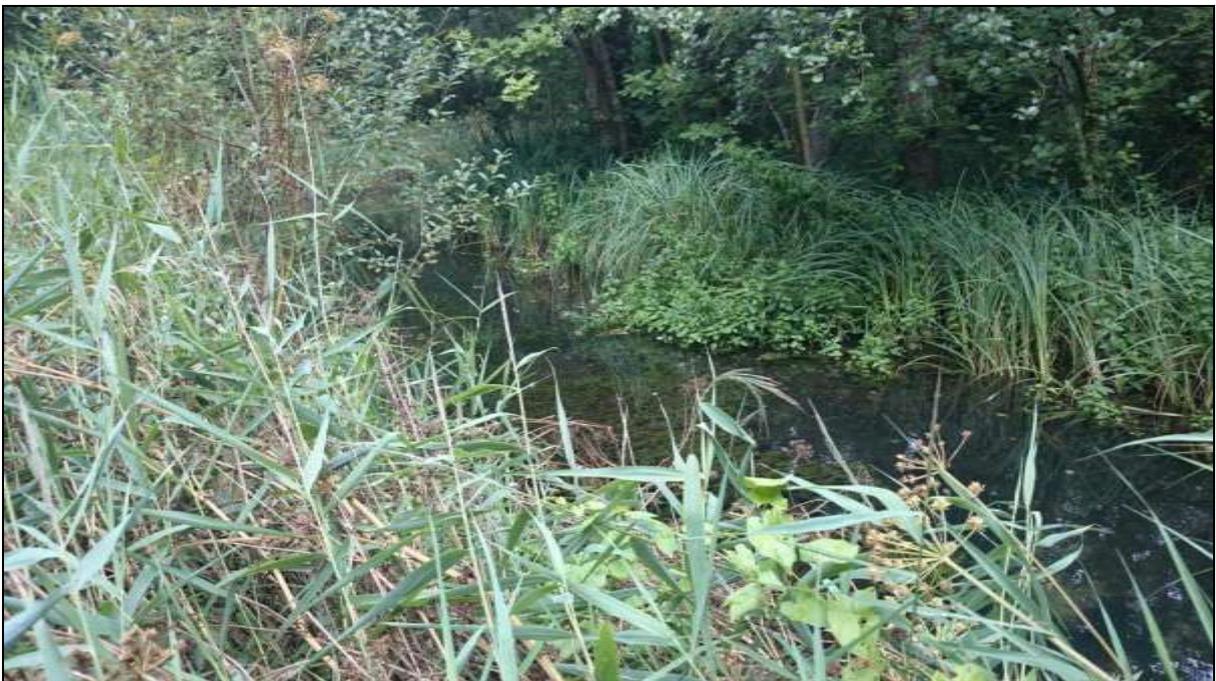
Although dense tree cover casts uniform shade over the river, marginal plants seem to be thriving. In the river, aquatic plants are present but their diversity and proliferation is impaired by a lack of direct sunlight (Figure 4) and sluggish flow. Water parsnip (*Berula erecta*) was observed in several places but other prominent chalk stream plants such as water crowfoot (*Ranunculus* spp.) and starwort (*Callitriche* spp.) were absent.

Figure 4: Heavy shade and sluggish flow limits submerged aquatic plants to mostly lesser water parsnip

Tree works to introduce more direct sunlight into the river would benefit in-stream primary production as well as giving rise to woody material that could be used to create a variety of habitat features.

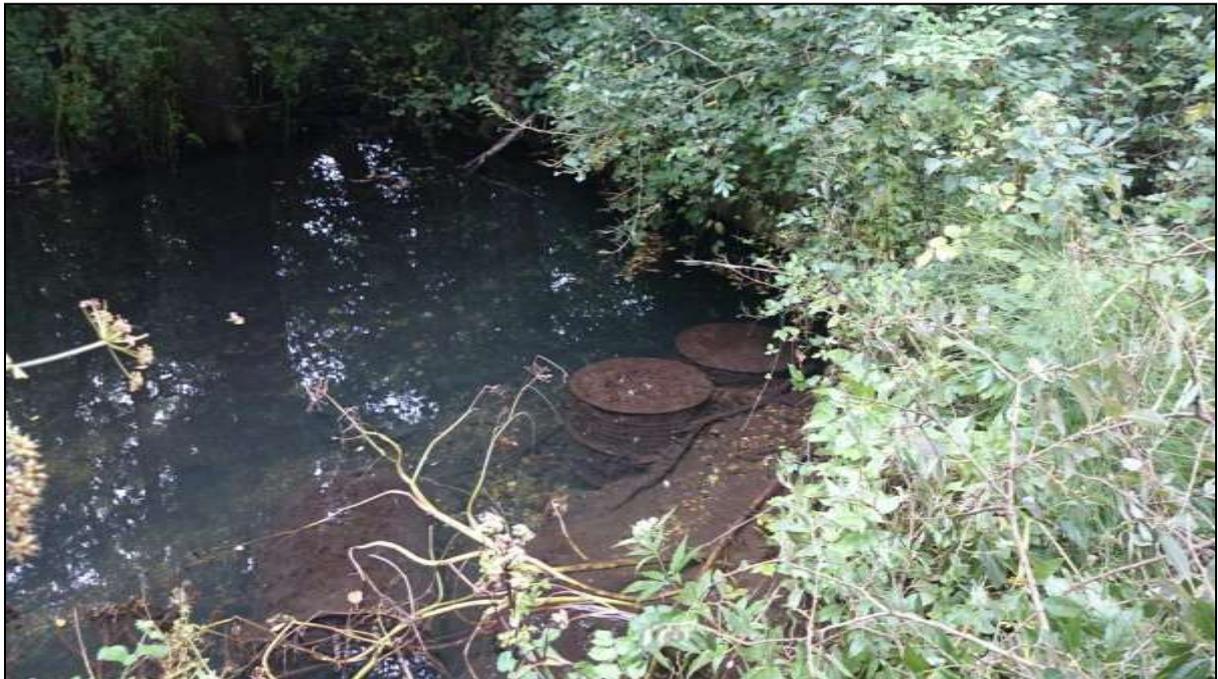
At SU 13177 16149, the river flows under a low bridge. The footings of the bridge have been protected by a make-shift revetment consisting of submerged steel barrels back-filled with gravel (Figure 5). Whilst the revetment is not

necessarily damaging to the river, it has very little ecological value and aesthetically detracts from the natural beauty of the fishery.

Figure 5: A revetment of submerged steel barrels has little habitat value and detracts from the river's natural beauty

3. Replace the barrel revetment at SU 13177 16149 (Figure 5) with a more natural and aesthetically appropriate alternative such as stacked logs or brushwood faggot bundles.
4. Introduce a greater diversity of light conditions by implementing a 5-10 year rotation of tree works. Natural England recommends a roughly 70:30 ratio of direct sunlight to dappled shade for chalkstreams. This ratio

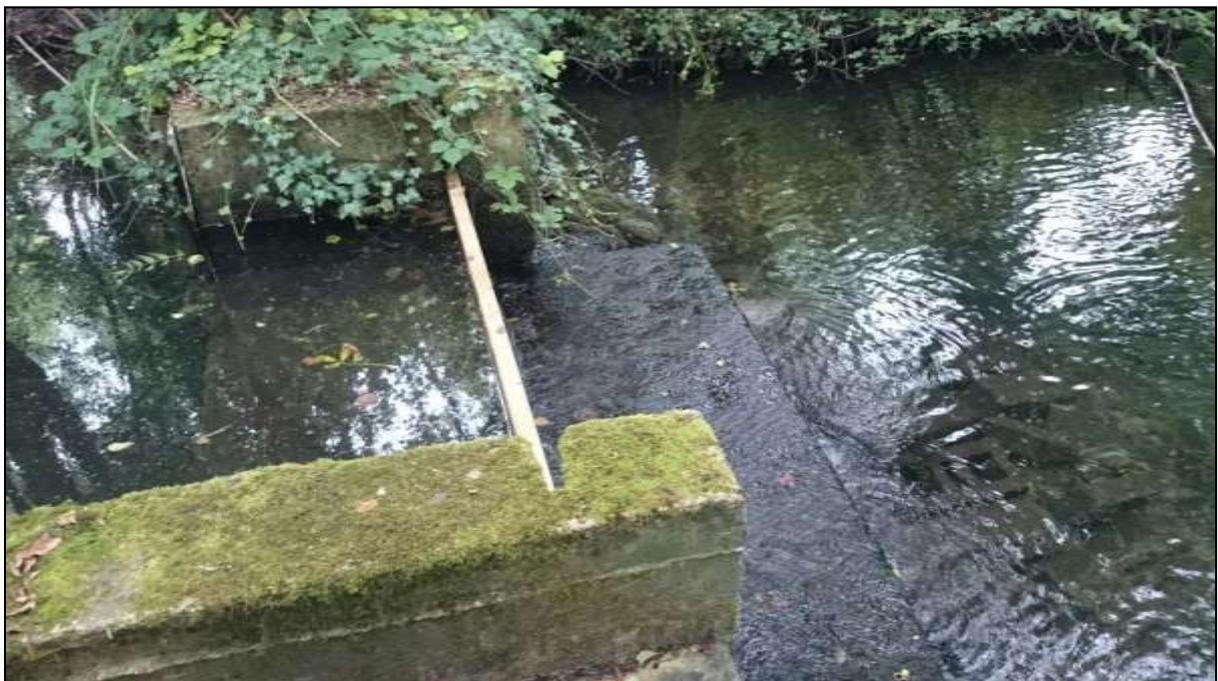
At SU 13188 16103, the river is impounded by a stoplog weir to hold up a head of water for the fishery stew ponds (Figure 6). The structure is impacting habitat quality throughout the whole of the reach upstream and is a barrier to fish passage.

Figure 6: The stoplog weir at SU 13188 16103 is a barrier to fish passage

In terms of natural river function and habitat quality and connectivity, the ideal scenario for the river would be for the structure to be completely removed. However, as the structure is vital to the present functioning of the stillwater fishery, this option is not feasible in the short-medium term. However, fish passage over the structure could be improved by the installation of a low-cost easement.

1. Trial lifting out of the stoplog at the downstream extent of the fishery and providing no detrimental effects, such as excessive erosion or a drop in pond water level are observed, permanent removal of the structure.
2. Improve fish passage over the weir upstream of the stew ponds by fixing timber baulks to the weir sill and cutting a notch in the stoplog (Figure 14). It may also be worthwhile installing a pre barrage immediately downstream of the weir to help spread the head loss over a greater distance.

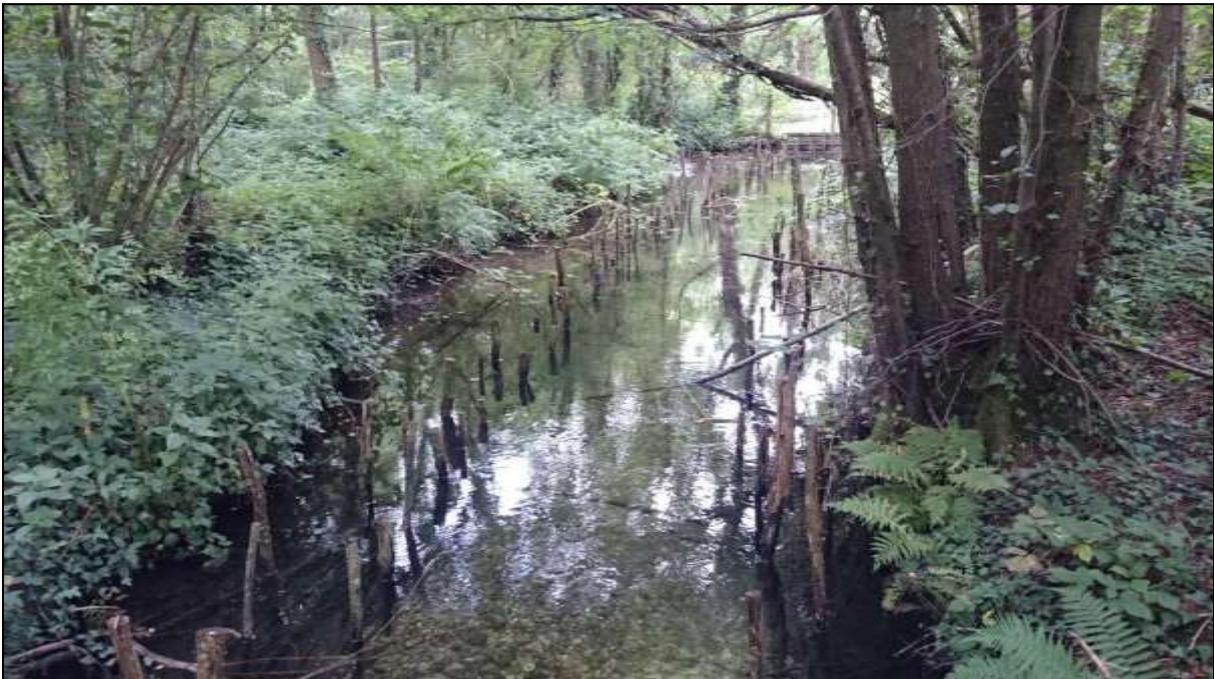
Above the impoundment the channel splits and a portion of flow is diverted to the stew ponds. Some brushwood channel narrowing has been attempted but unfortunately the bankside tree cover has prevented sufficient light conditions on the river and marginal plants have failed to colonise (Figure 7). More light needs to be let into the channel and further material may need to be installed to replace the decomposed brushwood.

Figure 7: Brushwood channel narrowing has failed to colonise under the heavy shade

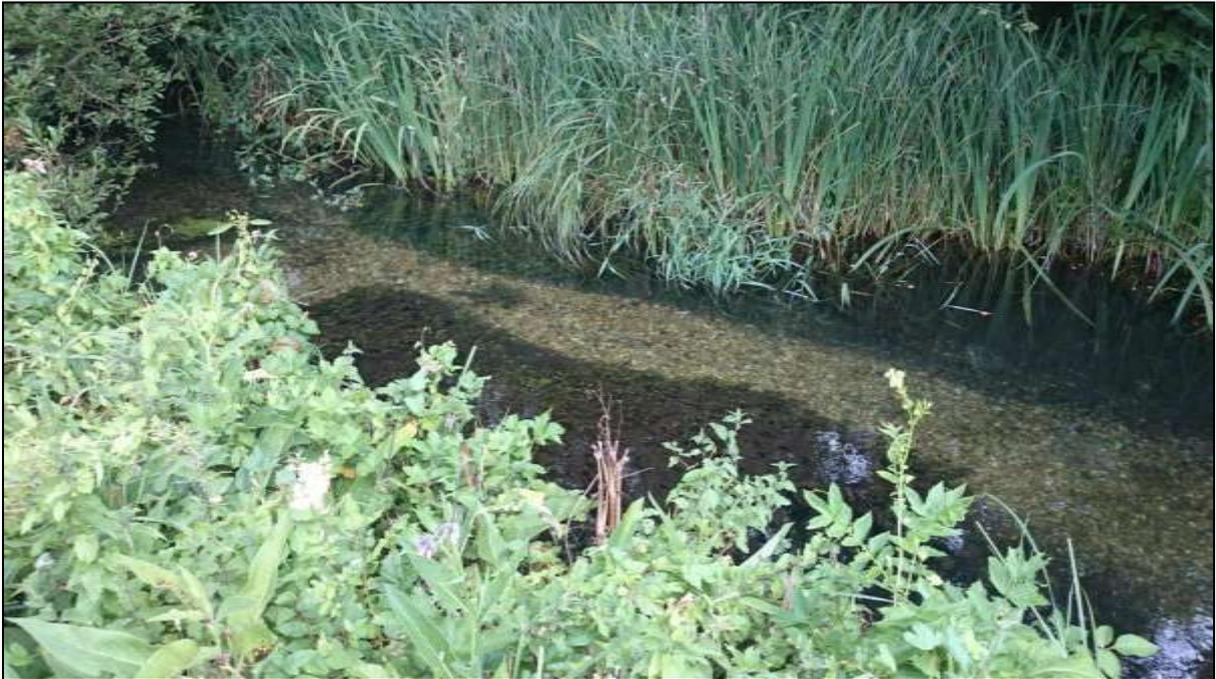
habitat for a range of invertebrates, birds and small mammals (Figure 8). However, in some places marginal plants have encroached across the channel (probably during a period of lower flow) and will require some maintenance in order to sustain a free-flowing channel (Figure 9). Crowns of water crowfoot were present but sparse and lesser water parsnip remained the dominant aquatic plant.

Figure 8: Downstream of the stew ponds, the river is shallower and fine sediment is confined to the river margins

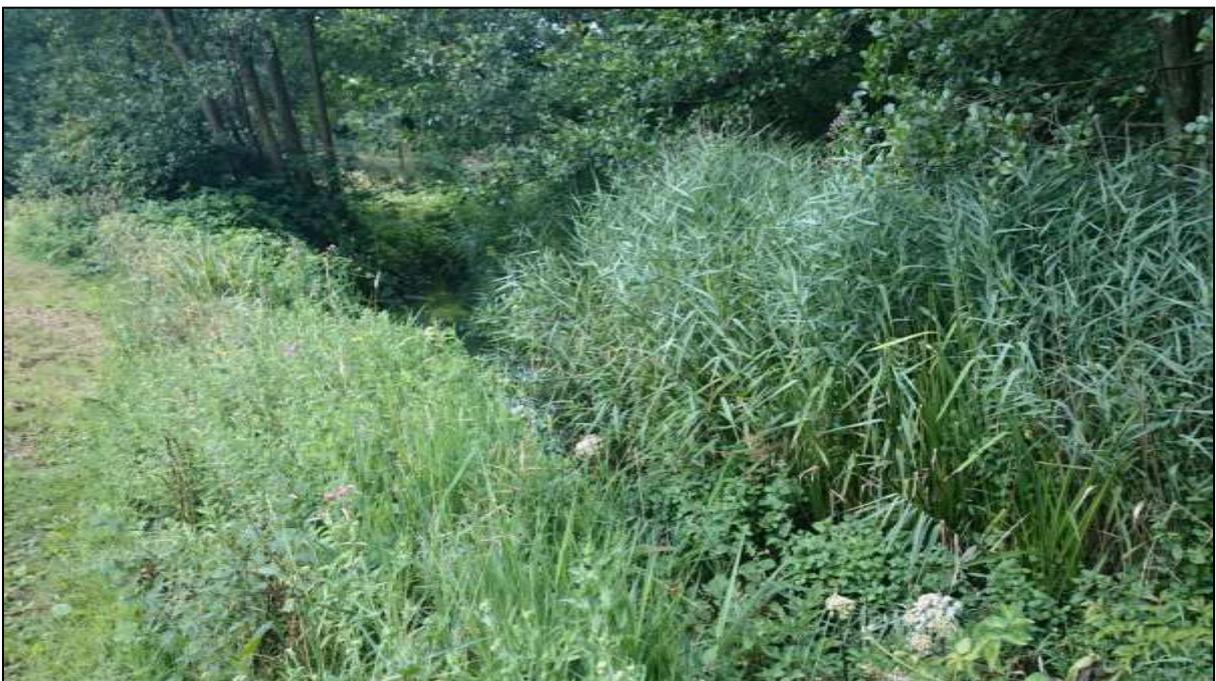
Figure 9: Marginal plants in some places have encroached across the channel and some light maintenance might be required.

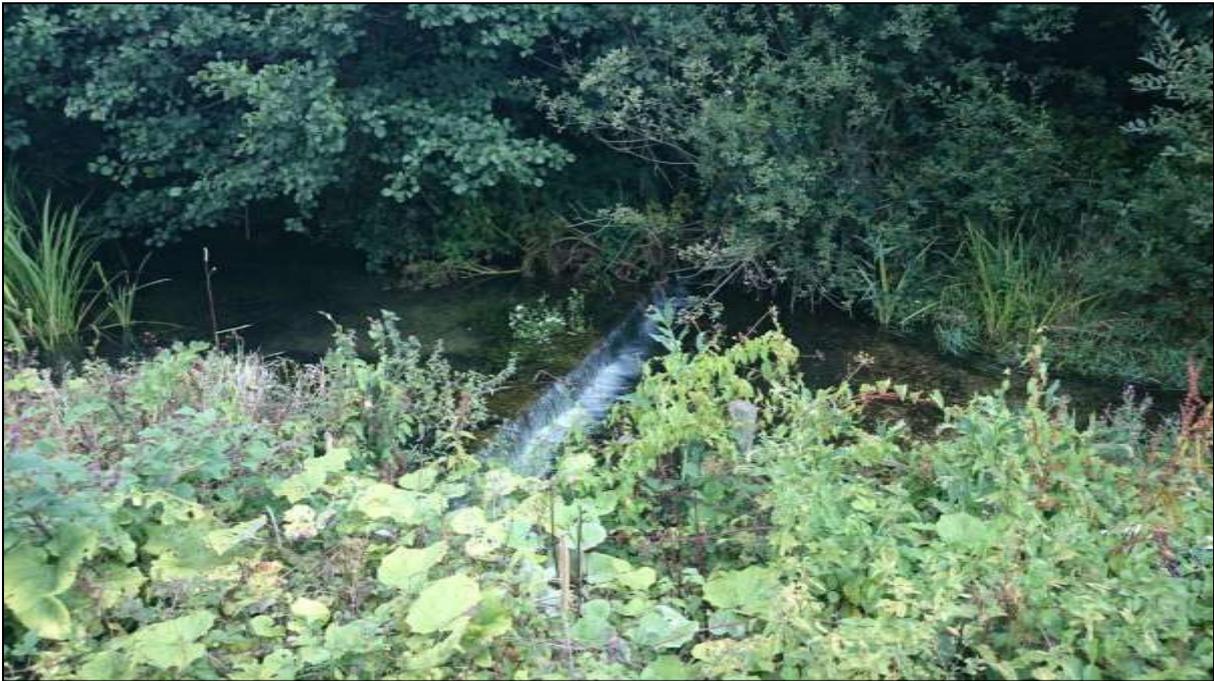
At SU 13287 15961, a small weir diverts flow into one of the nearby ponds. Although interrupting sediment transport, the weir has a minimal impounding effect and is probably passable for trout under most flow conditions.

Figure 10: The small weir at SU 13287 15961 interrupts natural morphology but is not a barrier to trout migration

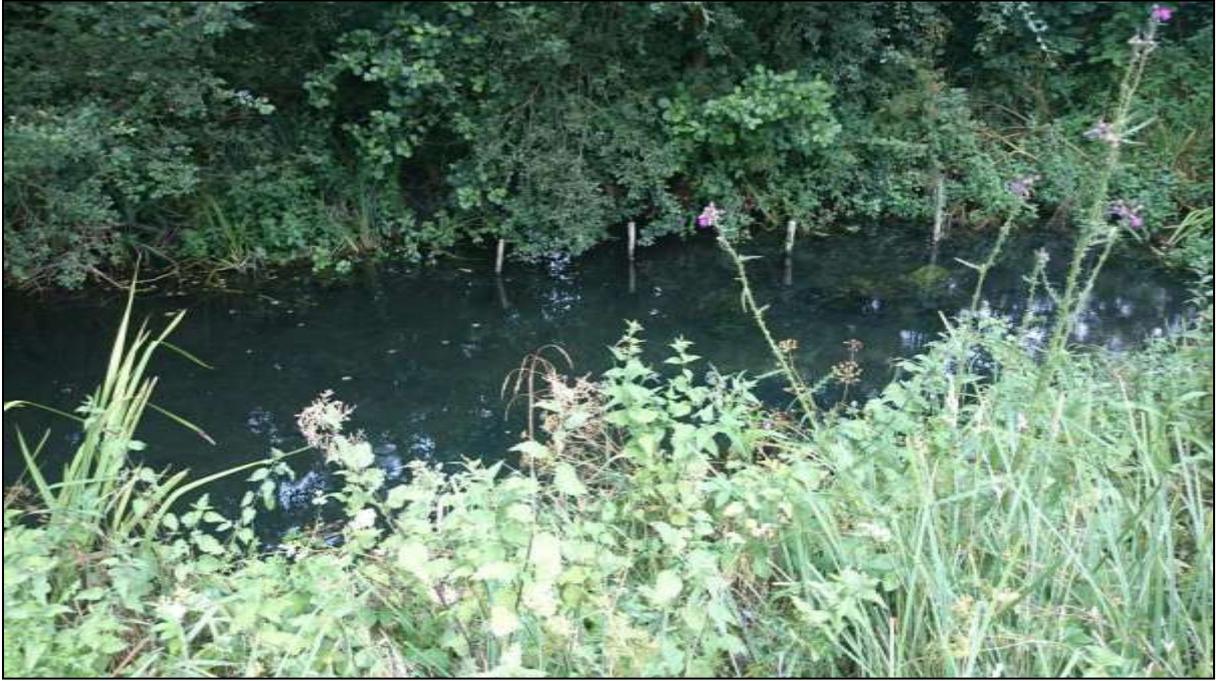
Downstream of the weir the natural sinuosity of the river helps to maintain a relatively good level of physical diversity. However, through some deeper and wider sections of the stream, where flows are slower, sedimentation is a problem and the introduction of more in-channel flow deflection would be beneficial (Figure 11). Furthermore, despite the installation of some marginal brushwood (Figure 12), the dense tree cover continues to inhibit marginal plant growth.

Figure 11: Sedimentation is a problem in some of the deeper and wider sections of the river

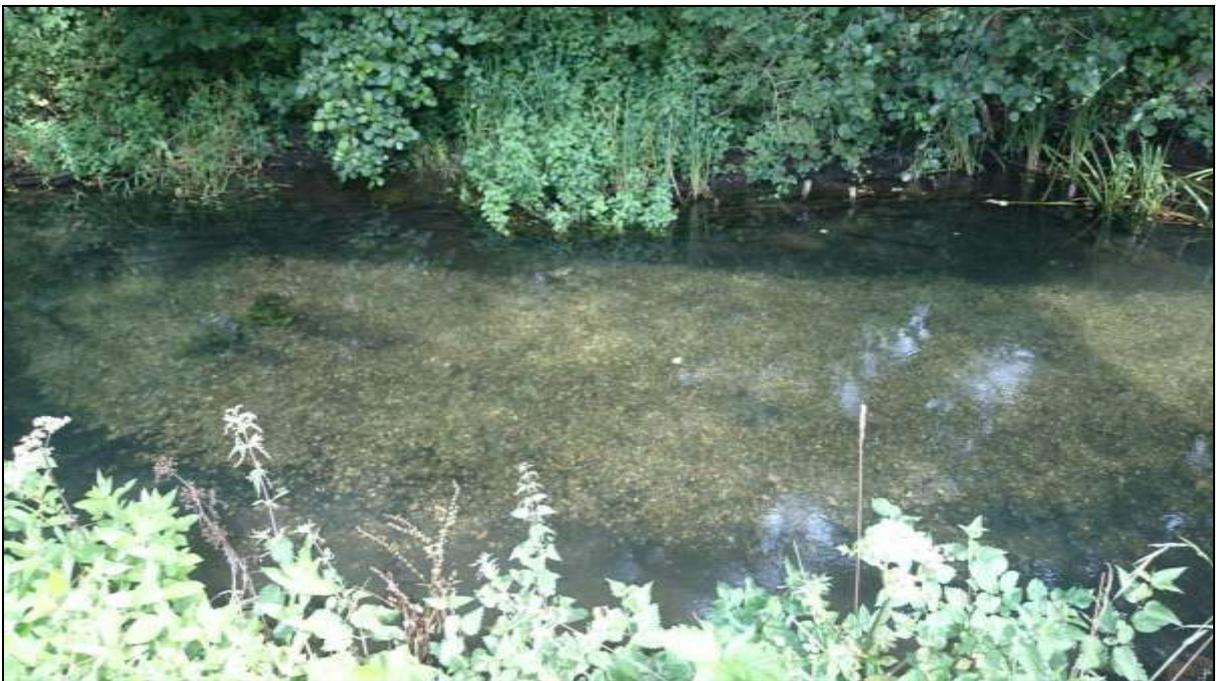
Figure 12: Heavy shade on the Left Bank has hindered colonisation of some of some brushwood habitat enhancements installed in the margin.

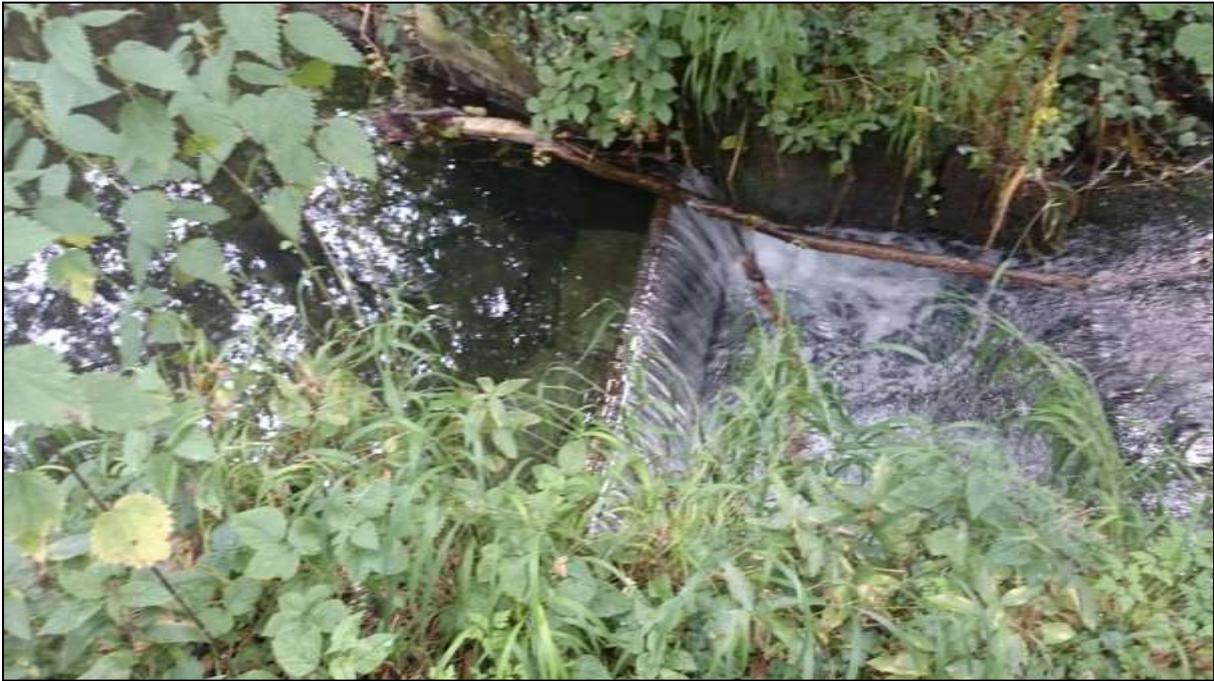
At the downstream extent of the reach visited, flow is impounded by a stoplog weir (Figure 13). The weir was impassable for trout under the flow conditions observed on the day of the visit and would be impassable under all but the highest flows. Downstream of the weir natural stream morphology resumes and habitat quality is good. Reconnecting the river through Rockbourne Trout Fishery with the resident trout population downstream would significantly improve trout recruitment, especially if undertaken in conjunction with habitat improvements. The purpose of this structure was unclear and it may be that it could be removed without impacting the operation of the stillwater fishery.

Figure 13: The stoplog at the downstream extent of the reach visited is a barrier to fish passage and does not appear to provide any useful function.

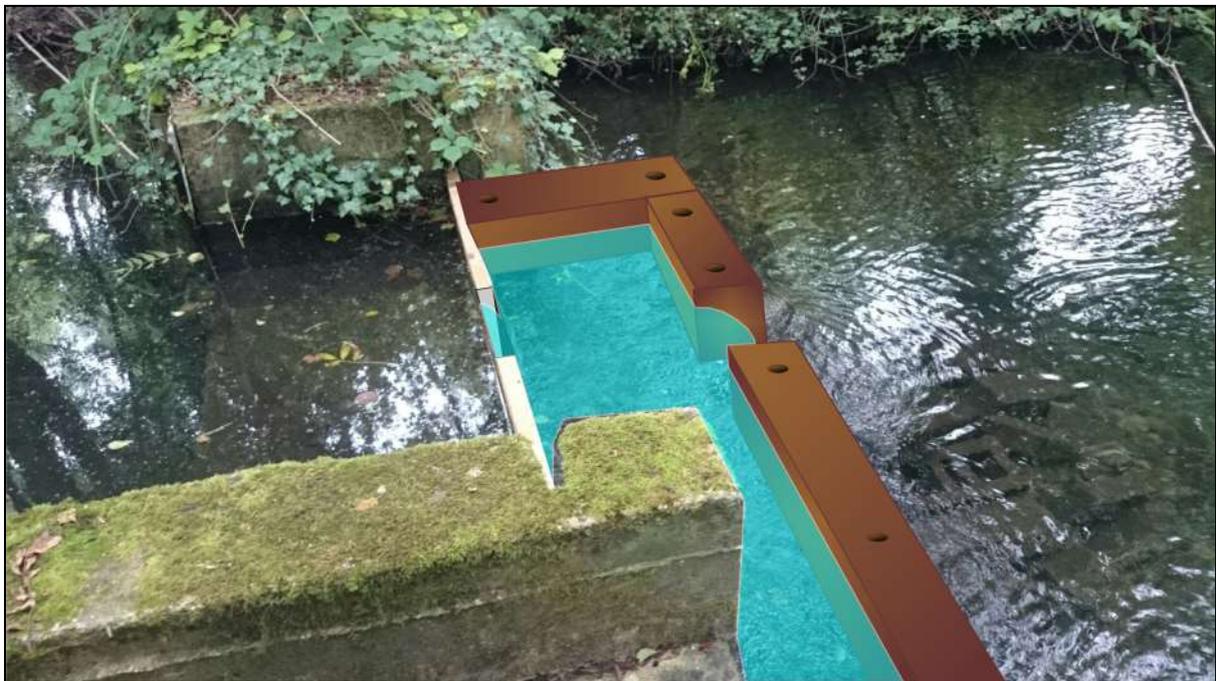
Figure 14: An illustration of how a notch and timber baulk fish passage easement could be installed on the weir

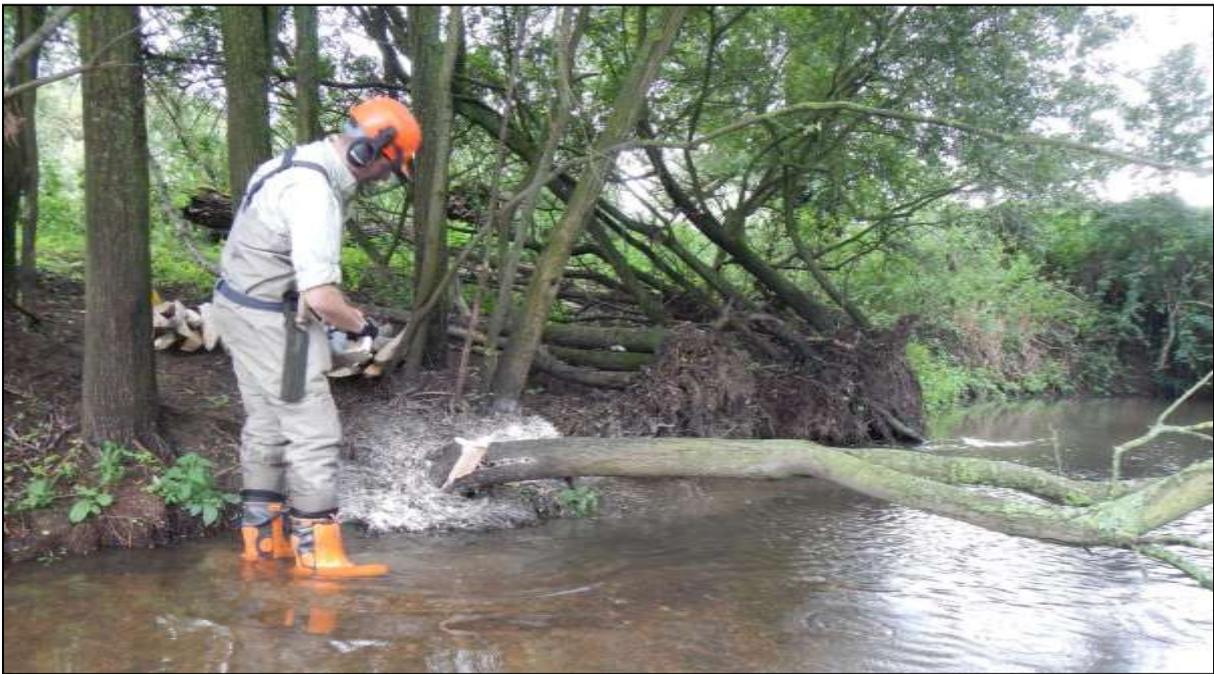
Figure 15: An example of 'hinging' a bankside tree downstream to provide cover habitat and flow deflection

5. Capitalise on the abundance of bankside trees and introduce further flow diversity and cover habitat by hinging occasional bankside trees into the river downstream and fixing them to the river bed with fencing stakes (ideally untreated sweet chestnut) and galvanised wire.

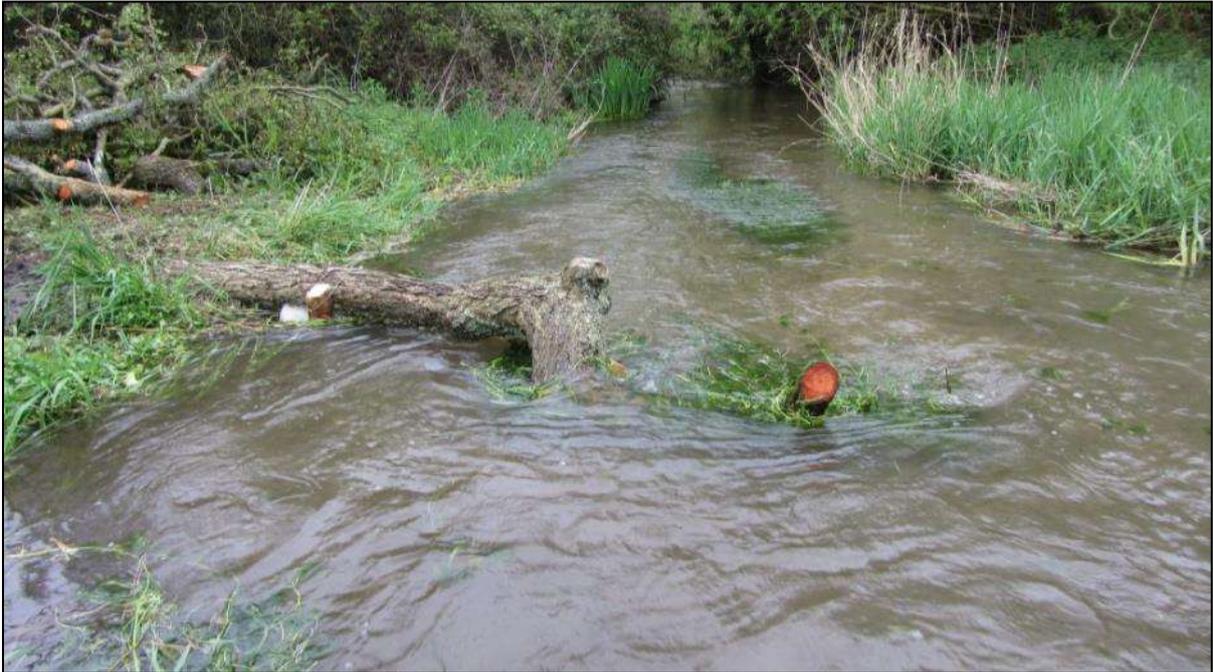
Figure 16: An example of a woody debris flow deflector installed to introduce some cover habitat and flow deflection.

6. Make use of trunks and thick limbs arising from tree works to create cover and refuge habitat features that also introduce a greater diversity of flow conditions. Focusing flows to scour the gravel bed will help sort the gravel and improve the quality of potential spawning habitat. Also make use of branches and other brushwood arising from the tree works to create some marginal brushwood shelves to trap fine sediment and provide a substrate for marginal plants. These should be positioned in direct sunlight in areas of natural deposition such as the inside of bends in the river.

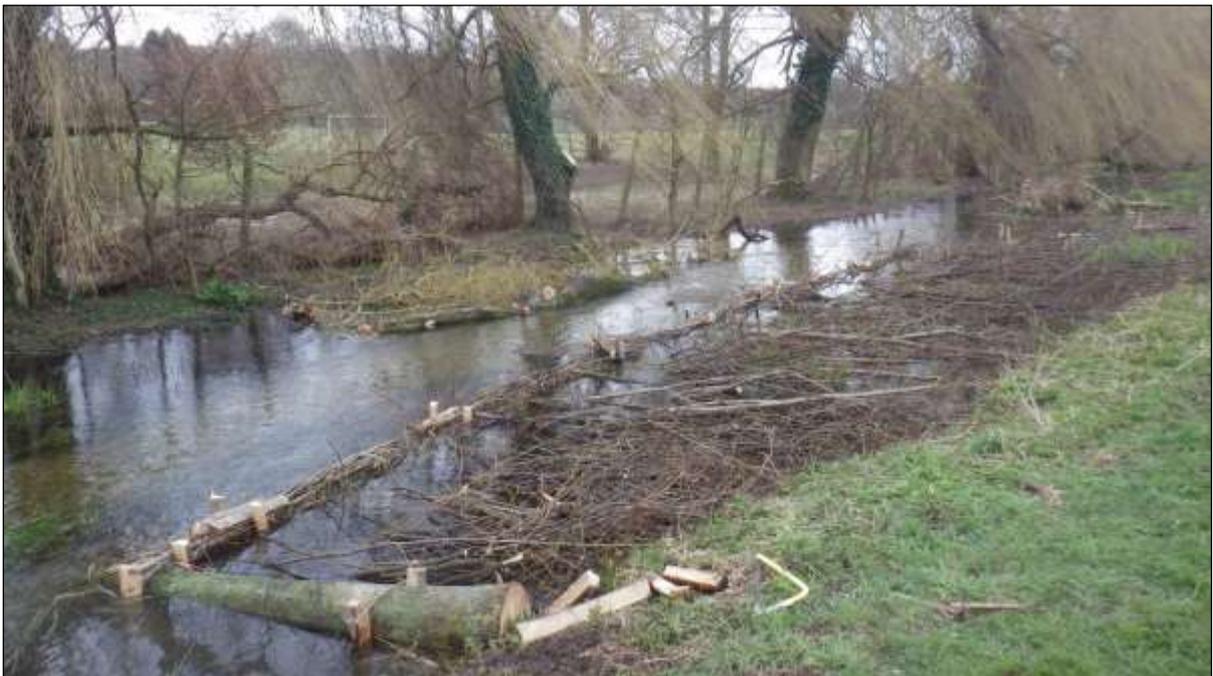
Figure 17: An example of a brushwood shelf installed in on the River Gade. This structure was left to be naturally colonised by emergent plant species.

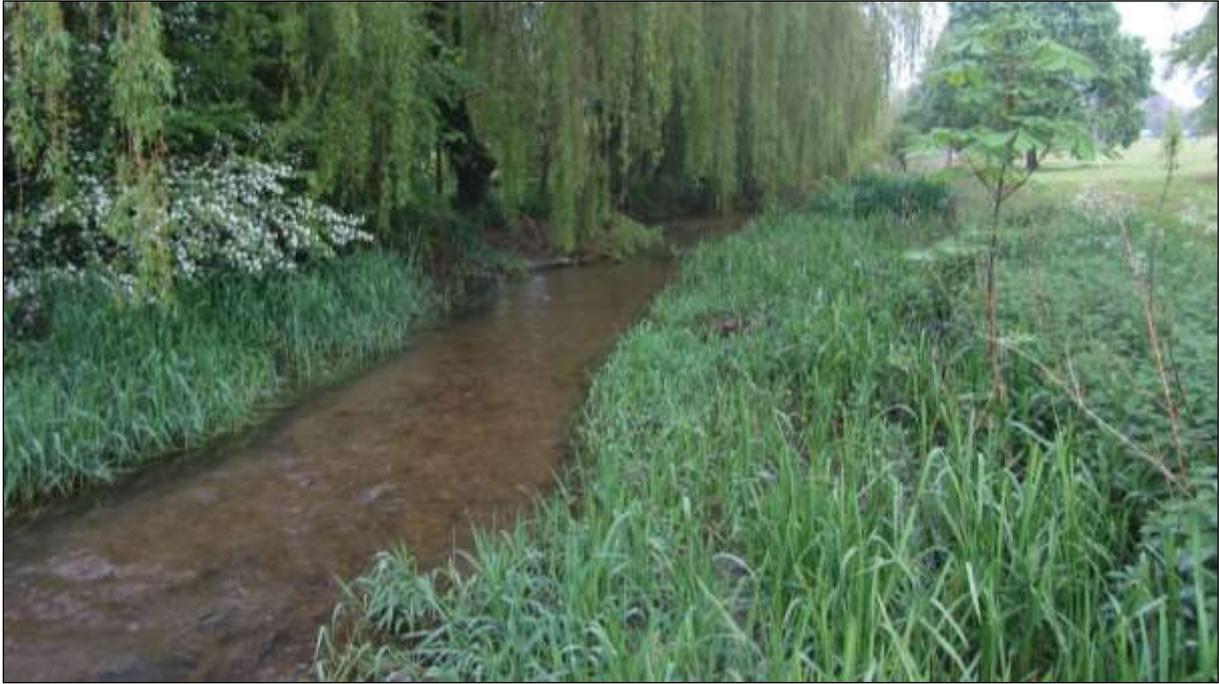
Figure 18: One year later. The structure has been naturally colonised by reed sweet-grass (*Glyceria maxima*).
