**River Rother – Hog Moor, Sheet.**

An advisory visit carried out by the Wild Trout Trust – July 2012

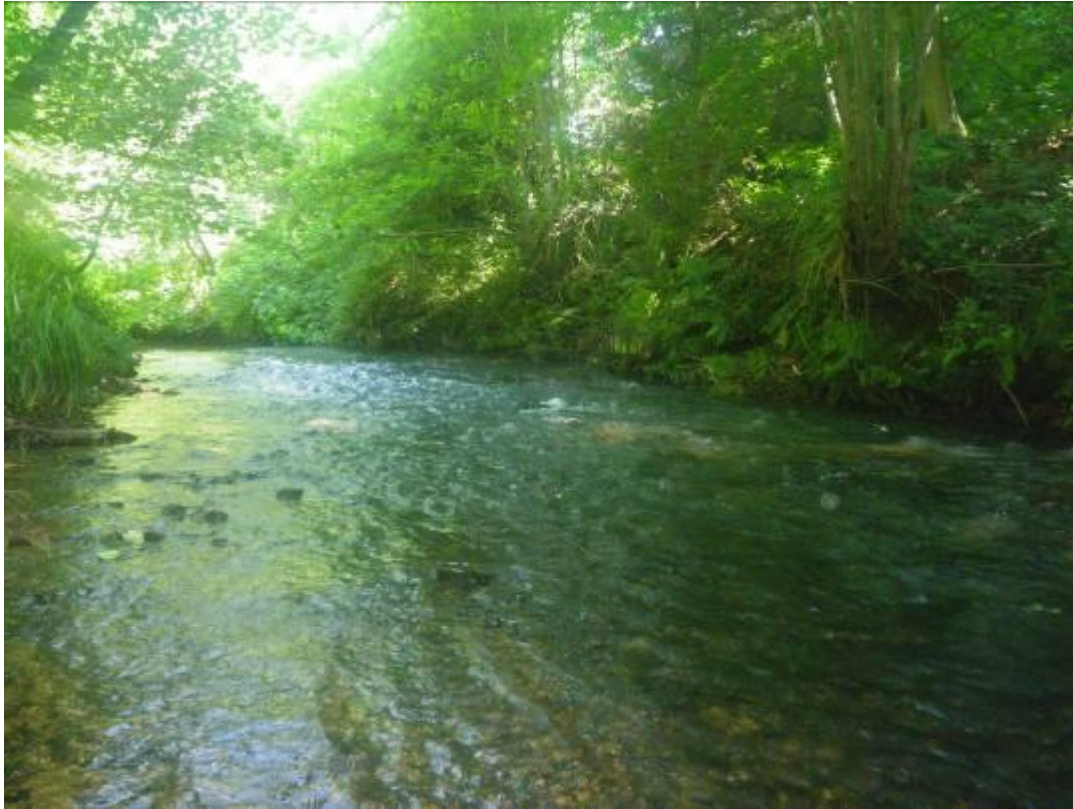
A wide shallow riffle on near the upper half of the beat. A superb spawning and nursery site for brown trout

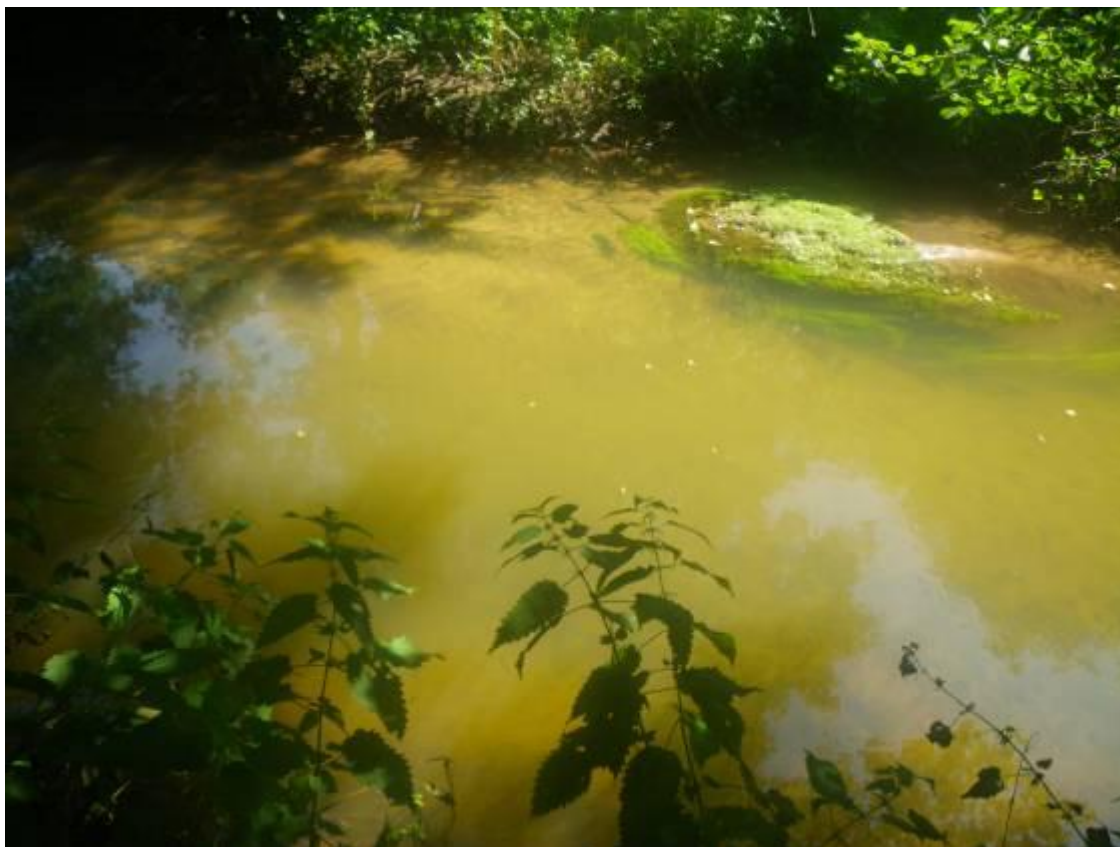
The lower half of the beat is impacted by the impounding effect of the weir at Sheet Mill, which is located just downstream of the bottom boundary. This structure has the effect of backing up the flow and slowing the water velocities. This has resulted in significant sand deposition, particularly where the channel is wide, or on the inside of any bend.

Sand deposited on the bed of the impounded lower section. A poor habitat for trout but potentially valuable for other species. Note the shaft of light promoting some limited weed growth.

The Sheet Mill was not inspected as part of this walk-over survey but it is worth exploring if there are any options for lowering the height of this impoundment. If accomplished, this change could radically improve habitat quality on the lower section of the Hog Moor reach by allowing water to flow much faster, reducing the amount of sediment deposited and, in some areas, helping to scour away sediment and expose valuable river bed gravels.

Exploring opportunities to enhance the lower reach by reducing the height of the impoundment at Sheet Mill should be explored.

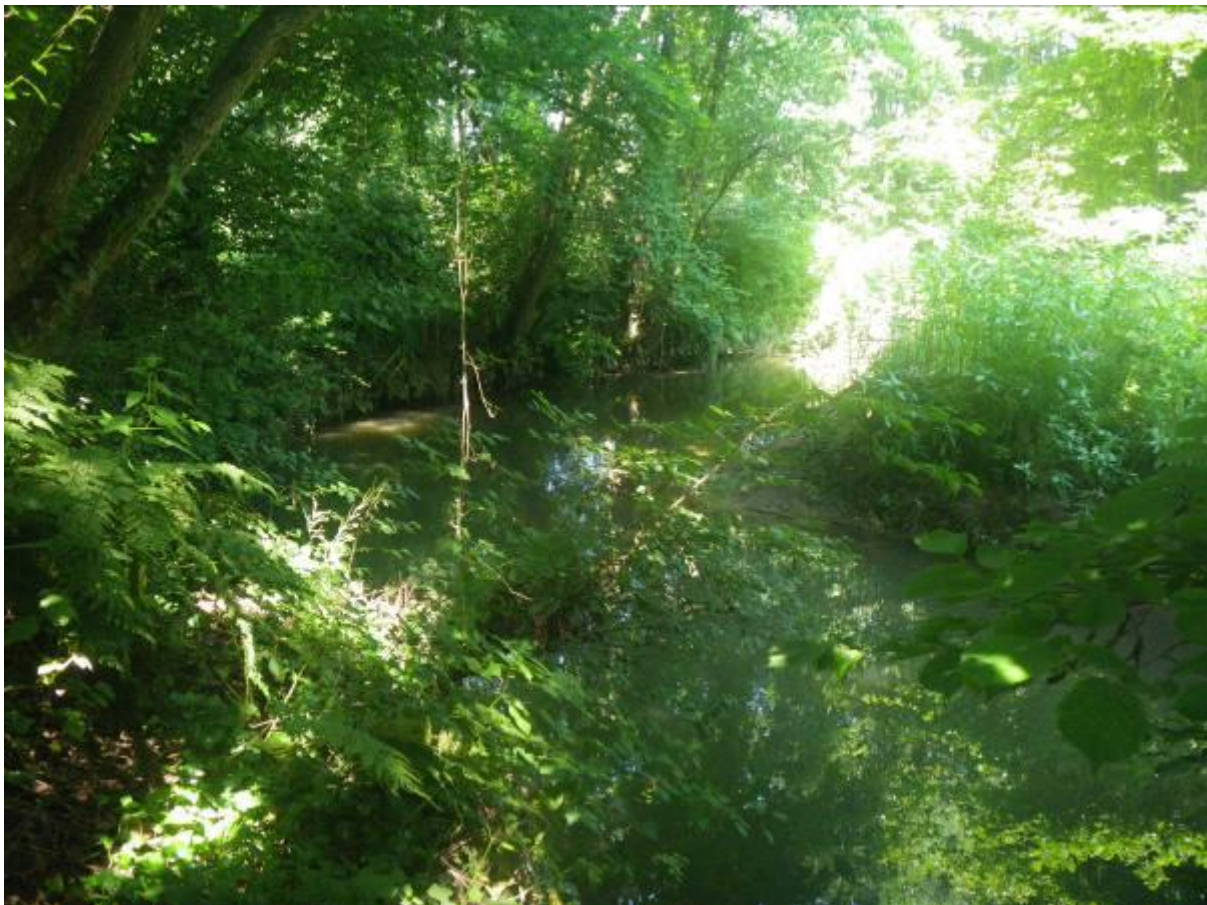
The Rother at Hog Moor is slightly over shaded and some tree work to open areas of dappled light would be beneficial to the river as a whole. Alder trees when coppiced survive well and will re-grow as a multi stemmed tree. Coppicing out the occasional clump of mature trees creates a varied structure to the tree canopy and avoids issues associated with large numbers of mature trees collapsing at the same time following severe weather. When choosing any trees to coppice, it is advisable to concentrate on thinning trees casting more shade from the southern bank.

Heavily shaded channel would benefit from some tree work.

When carrying out tree work, bear in mind that rotational coppicing over a 5 or 7 year period is the best approach. Large-scale works in one year will promote rapid re-growth and create a management problem a few years down the line. Small scale and selective tree work to allow light to fall onto shallow glides and riffles will promote the growth of in-channel plants. Leaving the shade over deep pools will allow trout to feel secure and keep water cool in hot summers.

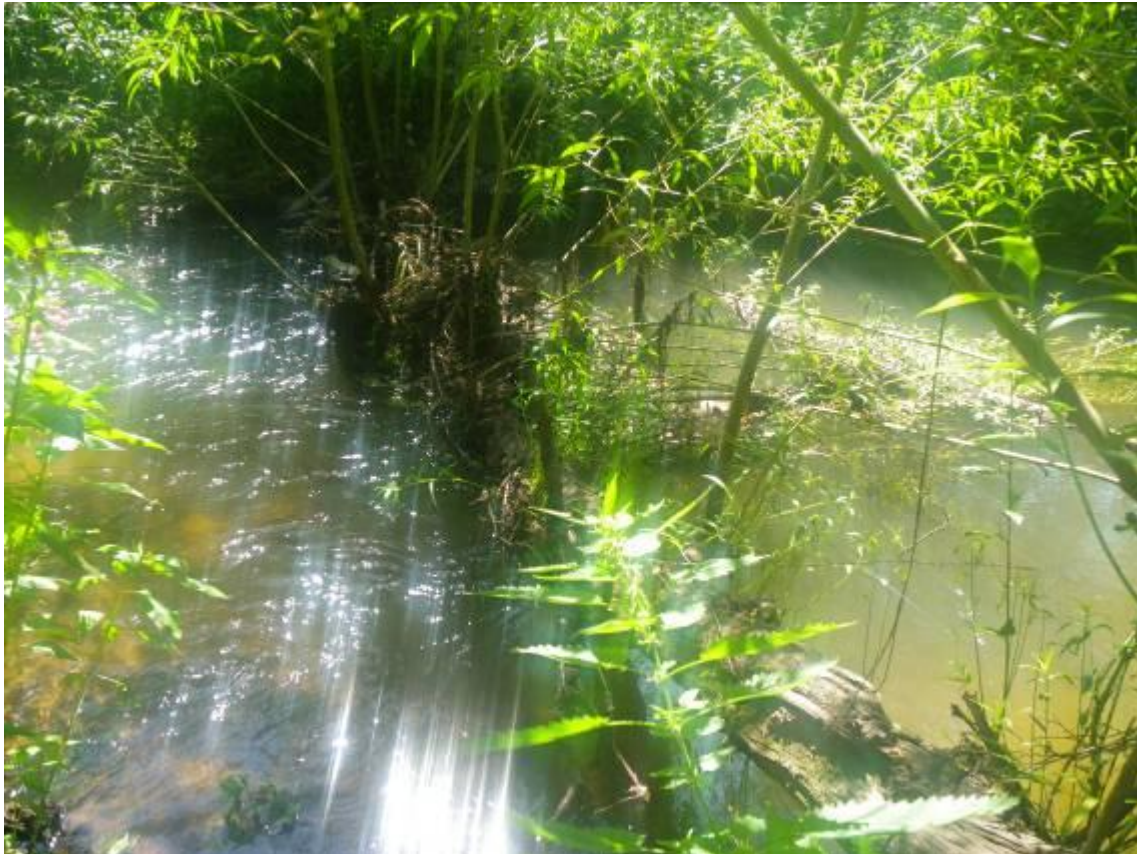
A fallen willow promoting river bed scour. Retaining the root wad and removing the outer half of the fallen tree will retain the valuable flow deflector and associated cover but will provide fishable access for the angler.

The retention of woody material within the channel is therefore essential and must be balanced with any need for maintaining access for angling. Fortunately, the Rother at Hog Moor is blessed with lots of in-channel woody material. If the woody material is situated in an area where it renders fishing impossible then it can simply be moved and secured so that there is room to cast a fly but essentially still be retained nearby as a bolt hole for the fish.

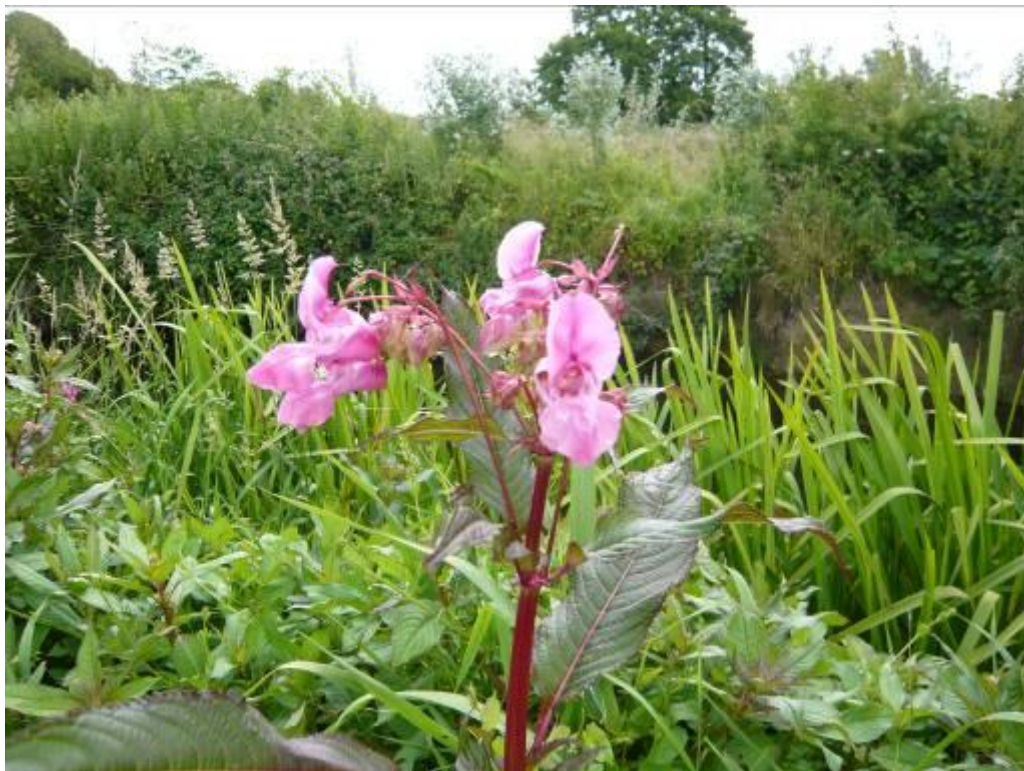
The non-native plant Himalayan balsam *Impatiens glandulifera* was present throughout this reach at moderate levels. This non-native plant is undesirable because its suppression of other ground vegetation, coupled with its winter die back, combine to leave extensive areas of bare bank, contributing to excessive erosion. The control of Himalayan balsam can be achieved by physical or chemical means:

Himalayan balsam flower. Easy to hand pull prior to setting seed pods.

The main method of control, and usually the most appropriate, is pulling plants by the root before they flower and set seed (usually in June or July). Working parties are the best means of doing this.

Himalayan balsam can be controlled with a weedkiller based on glyphosate, such as Roundup. Glyphosate is a non-selective, systemic weedkiller that is applied to the foliage. It is rendered inactive on contact with the soil or water, so there is no risk of damage to the roots of nearby plants or plants in the water, but care must be taken that the spray doesn't drift onto their foliage. Glyphosate is most effective when weed growth is vigorous. This usually occurs at flowering stage but before die-back begins; with most weeds, this is not earlier than mid-summer.

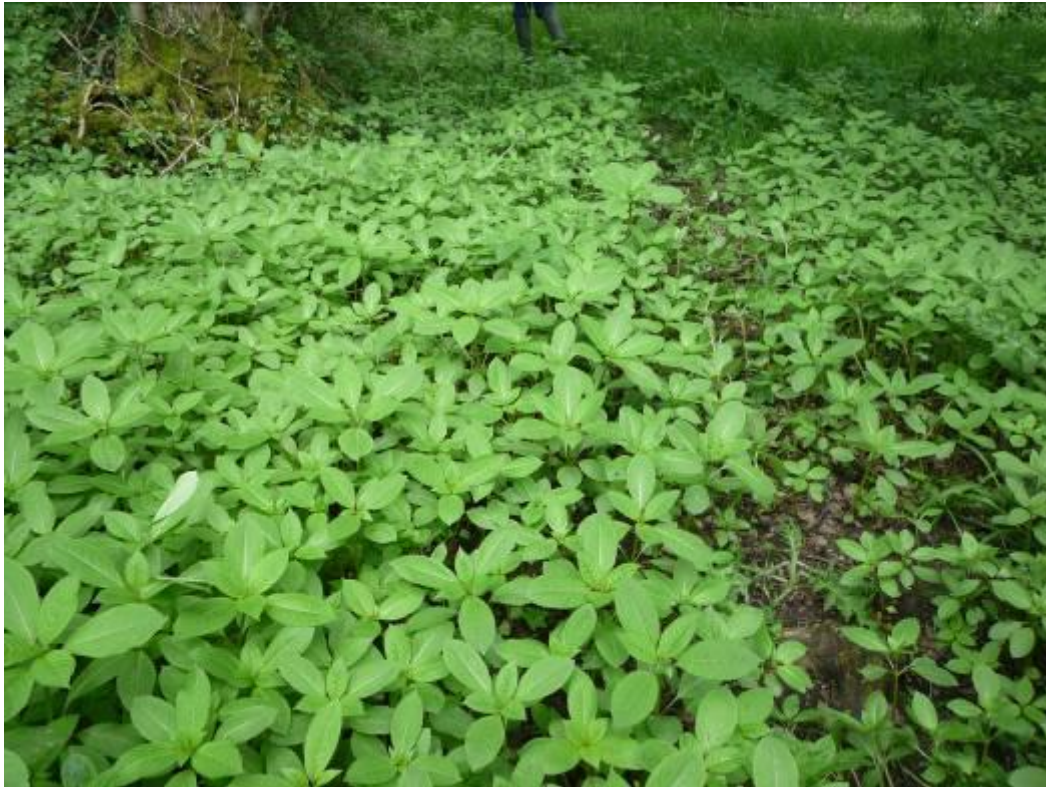
Himalayan balsam can rapidly shade out other native plants leaving banks vulnerable to winter erosion.
