River Rother – Fair Oak Estate – Habin to Trotton

Advisory Visit April 2018

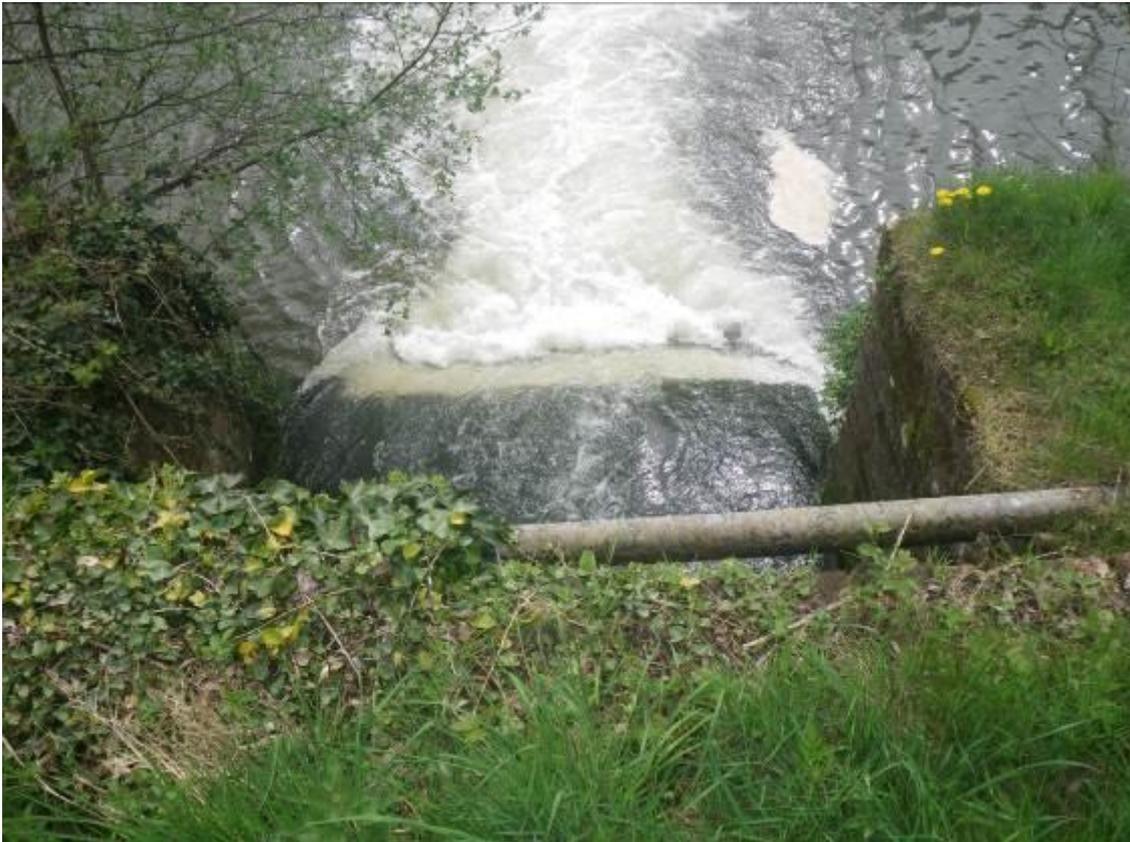
Unsurprisingly, this reach of the Western Rother is heavily impacted by the old milling impoundment located at Trotton Mill (photo 1), which forms the bottom boundary of the fishery. The river looks to have been re-aligned and perched, presumably to gain a greater head for milling, the legacy of which is clearly visible with old milling stones set into the floor of wing wall of the impoundment (photo 2).

Photo 1 Impoundment at Trotton Mill. Problematic for fish migration

The impoundment at Trotton Mill is responsible for adversely impacting on habitat quality on the lower 0.5km section of channel. It will also be restricting access for both brown and migratory sea trout in any low-flow autumn. The historic nature of the structure is problematic but all structures fail eventually and a dialogue with the owners should be opened in case there is ever an opportunity for modifications that could see an improvement for both sediment transport and the free migration of fish.

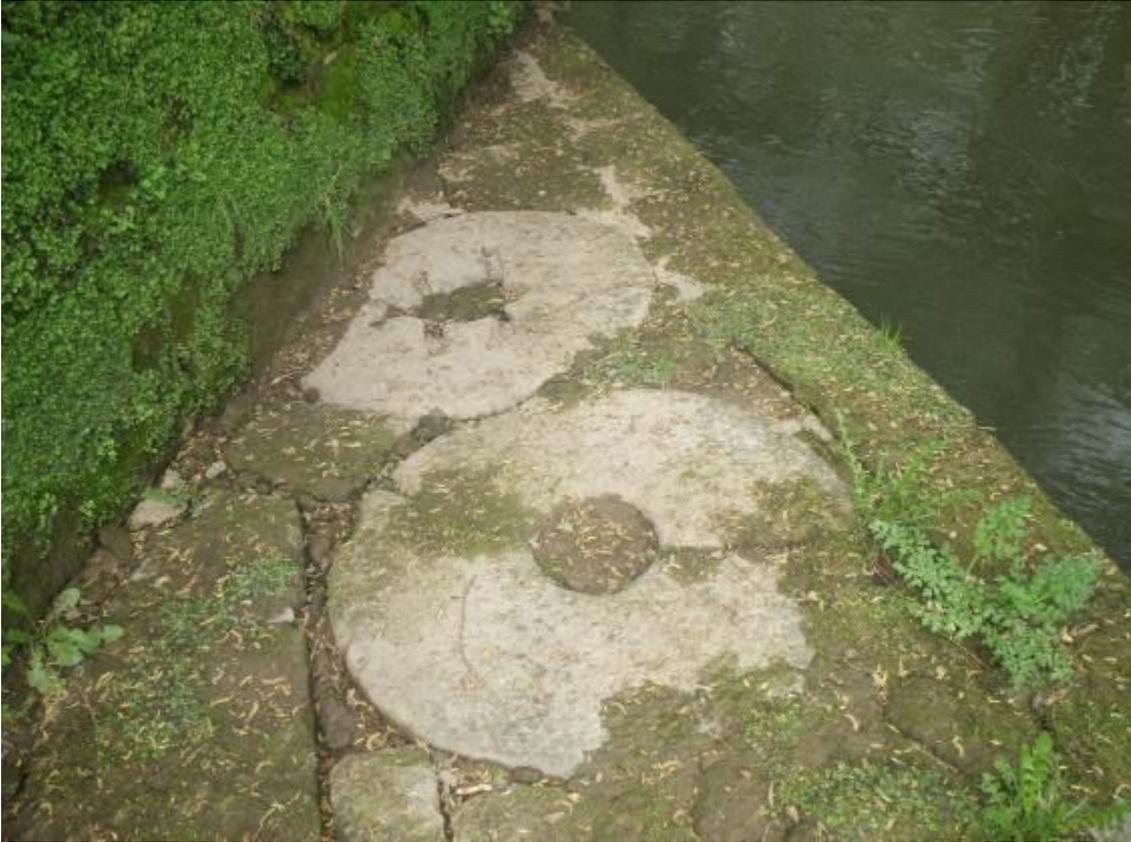
Photo 2. Old mill stones used as part of the weir structure.

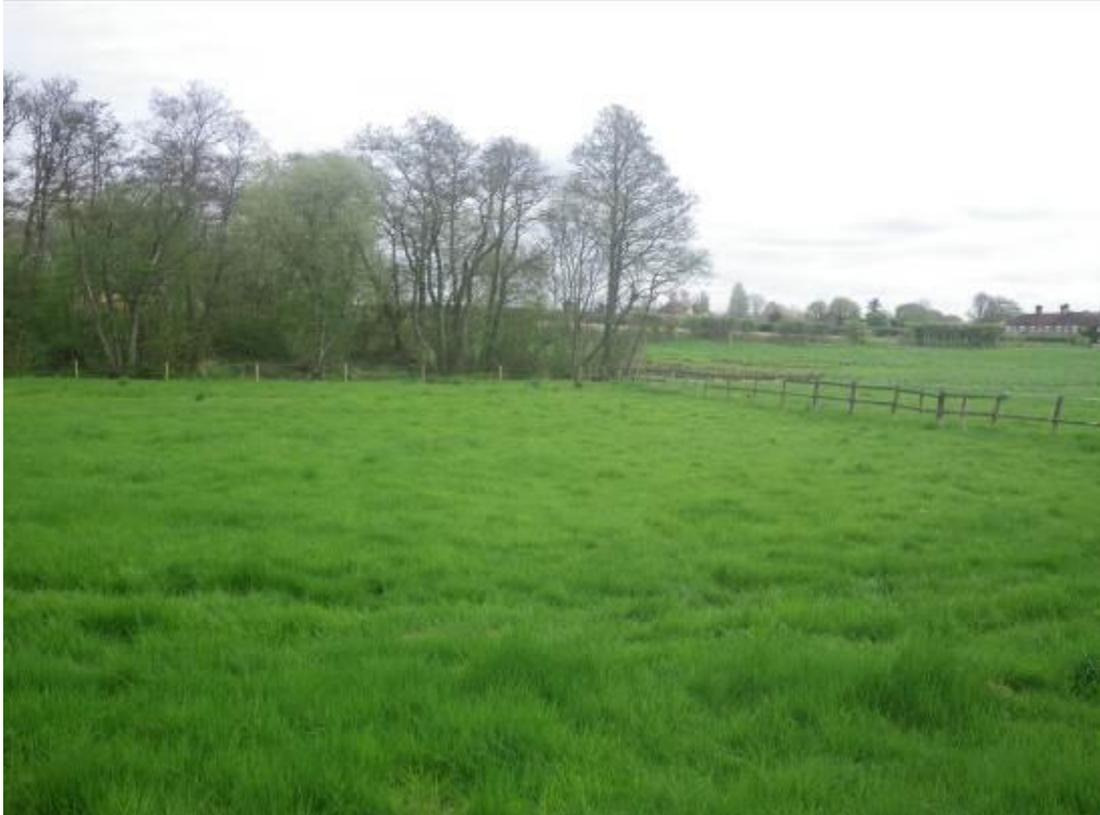
What looks to be the old original river channel can be seen running in the valley floor a short distance to the north (photo 3), although this channel also looks to have been heavily modified.

Photo 3. Tree lined ditch line to the north of Trotton Mill may have been on the original course of the river prior to the mill construction.

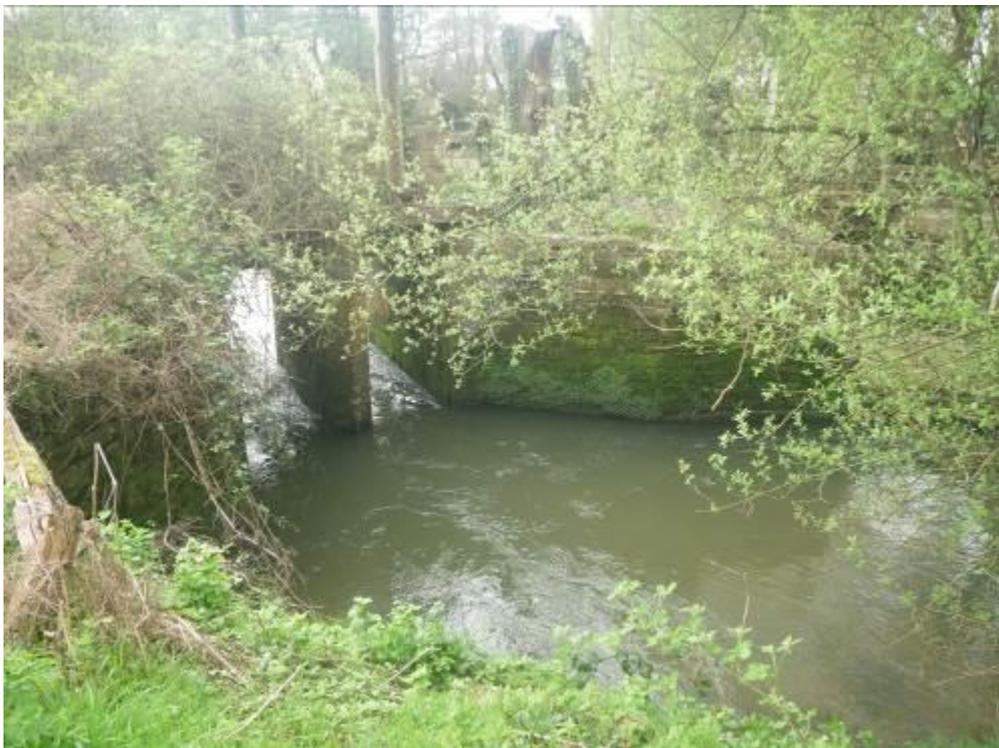
The milling structure is currently being managed with upstream water levels being run as low as possible, with all of the hatches fully drawn and stop logs removed (photo 4). Never the less, the structure still has an estimated head loss of approximately 600mm, which under the majority of flow conditions would mean that it acts as a block to any upstream fish migration. Even in spate conditions, when the head loss is drastically reduced, the high water velocities generated via the narrow hatch arches would be a challenge for all but the largest, most powerful swimming salmonids.

Photo 4. All the hatches are fully drawn, which helps to reduce the impounding effect on the reach upstream.

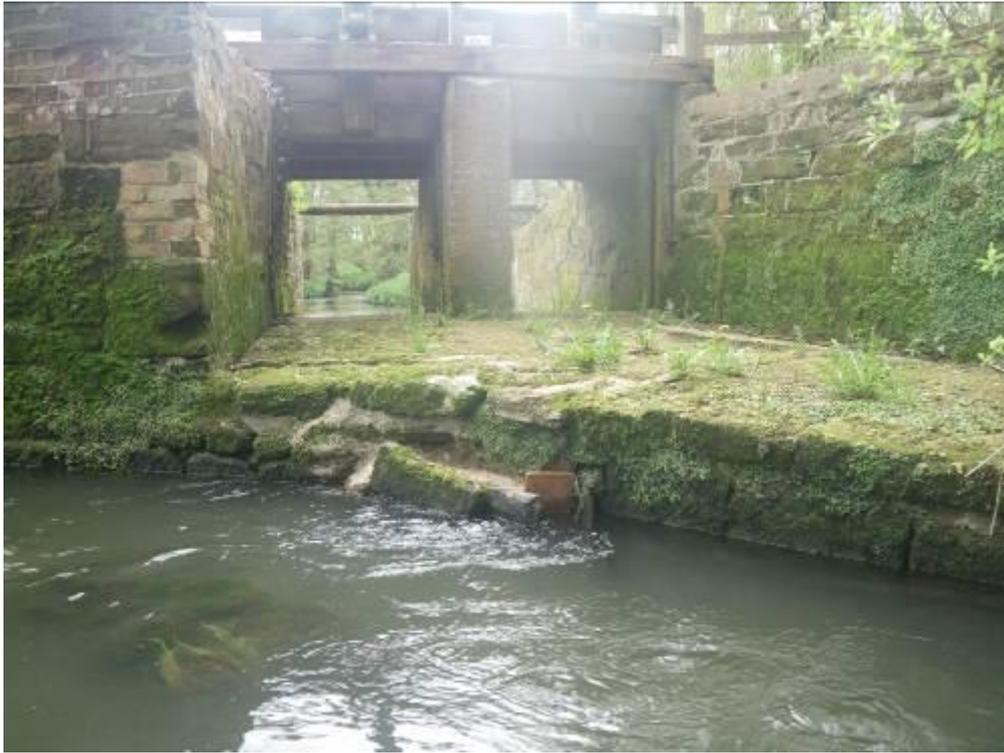
Photo 5. Additional capacity is available via two hatches adjacent to the RB

There is a secondary set of hatches adjacent to the RB (photo 5) with a higher invert than the main hatches and it might be possible to construct a technical fish pass within one of these chambers. The best outcome for the river would be to remove the impoundment completely. It is worth having a conversation with the mill owner to explore options, even if the prospects of complete removal of an historic milling impoundment seem very remote. Fish passage could be improved here with the Mill owners consent and could be the subject of a project proposal where technical and funding options explored in detail.

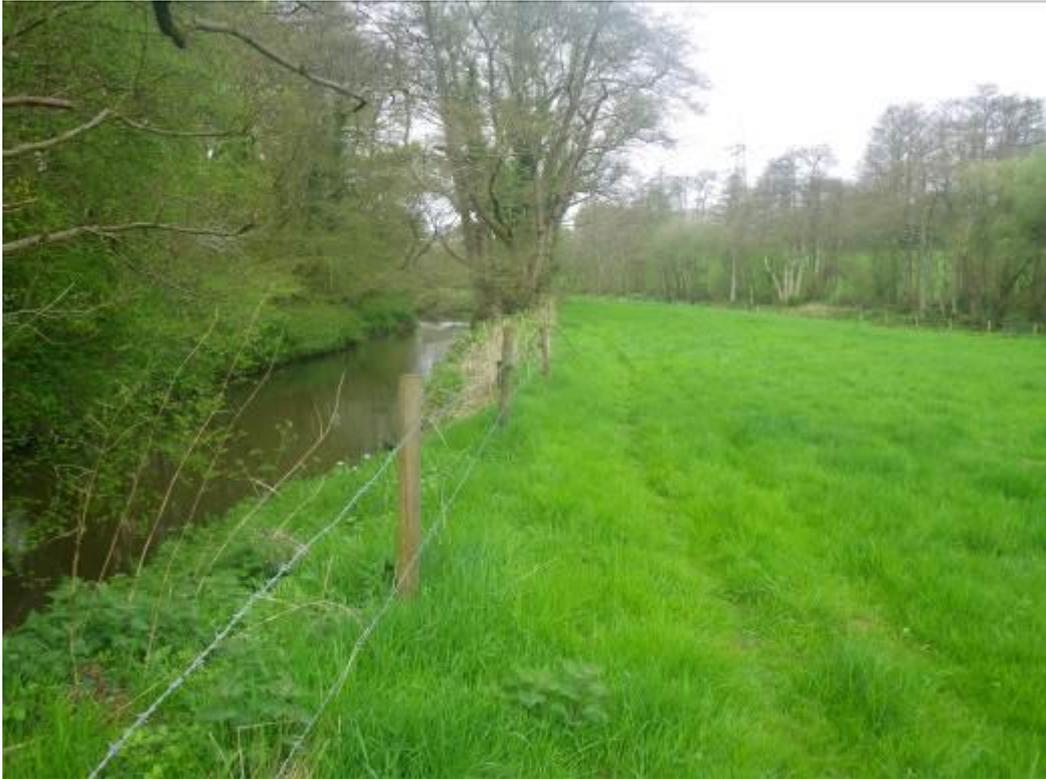
Habitat quality in this lower reach of the Fair Oak beat is considered to be poor. The 500m of channel above the mill is dominated by shallow uniform glide habitat flowing over a mainly sand-covered bed and lined by soft, friable river banks (photo 6). The only significant in-channel cover for trout is provided by the occasional root systems of river-side trees, such as Alder (*Alnus glutinosa*) and goat willows (*Salix caprea*) and occasional ash trees (*Fraxinus excelsior*), primarily located on the RB. Stock fencing has been installed adjacent to the LB but with a very narrow buffer zone between the fence and the soft bank tops. This lower section of LB is vulnerable to erosion and possibly block failure due to the comparative lack of bank-top trees and associated root systems.

Photo 6. Section immediately upstream of the mill is dominated by shallow glide habitat over a mainly sandy river bed. Habitat quality in this reach is considered to be poor for most fish species.

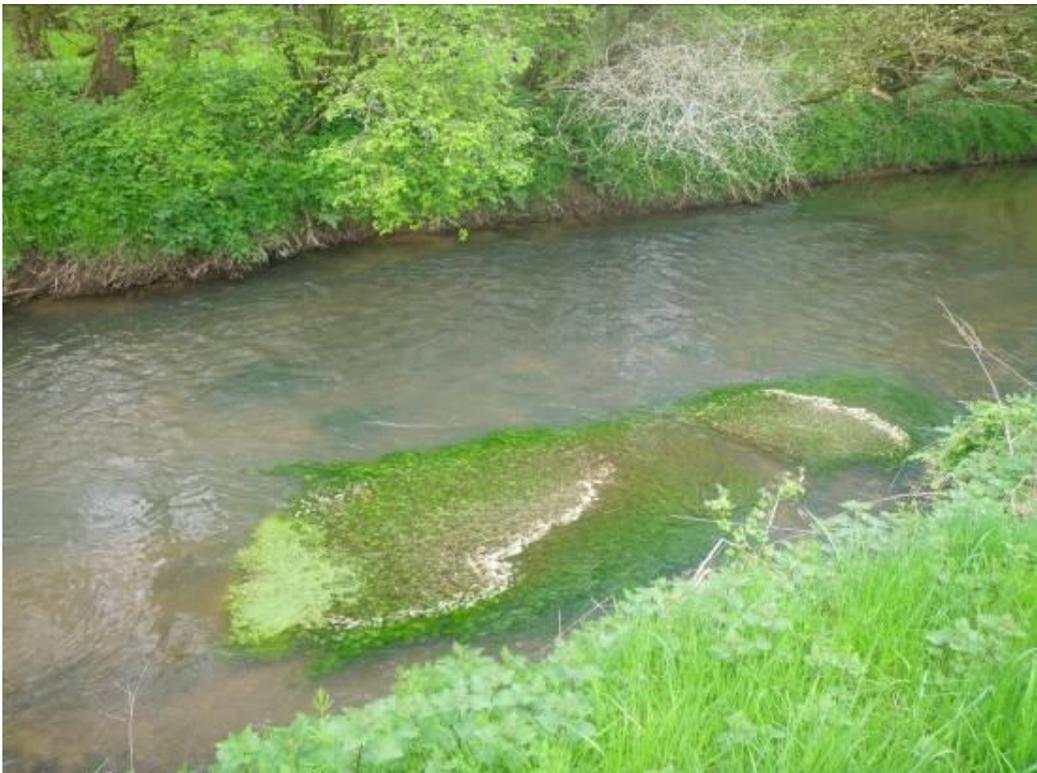
Two habitat features are worthy of mention in this bottom reach. There is a short section of shallow run, with what looks to be a hard, gravel lined bed, colonised by watercrowfoot (*Ranunculus* spp.) growth (photo 7). This provides a short but valuable habitat for invertebrates and presents possible fish spawning opportunities, however the lack of any significant, well covered nursery habitat in the vicinity compromises its value to the fishery.

Photo 7. A short section of shallow riffle habitat supporting luxuriant crowfoot growth.

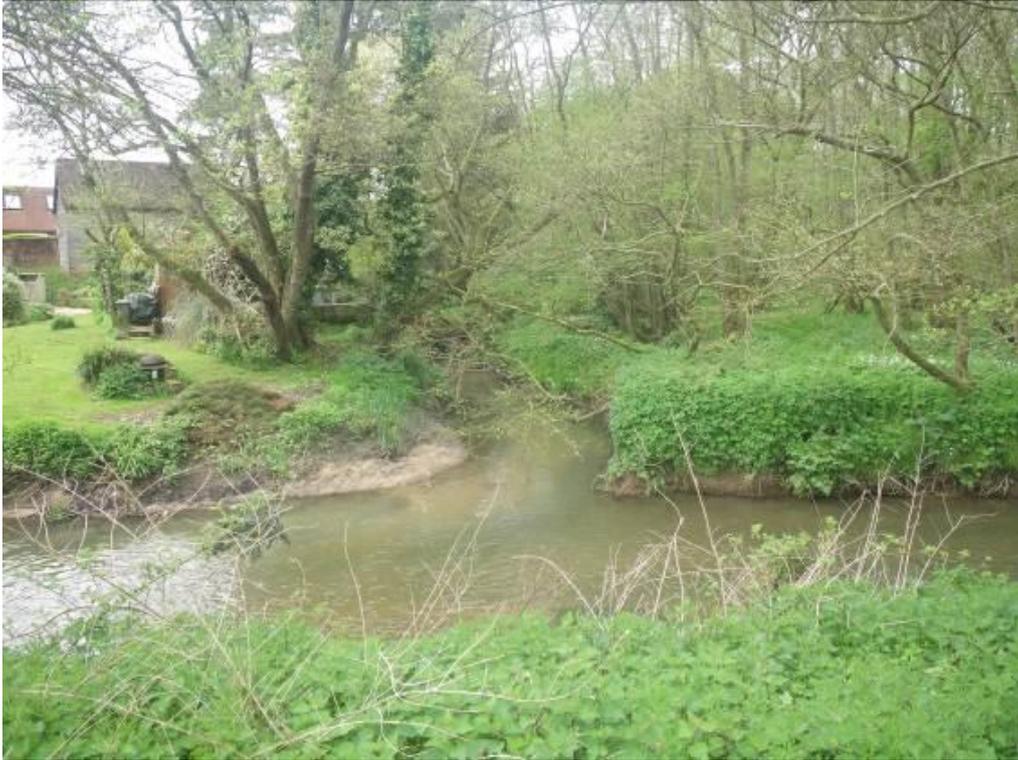
Photo 8. Small chalk stream entering from the south a short distance above the mill.

The tributary itself is a small chalk stream and will be contributing a valuable biomass of both invertebrates and juvenile fish to the main river. Unfortunately its value to the Fair Oak fishery is somewhat limited, discharging as it does at the very bottom of the reach.

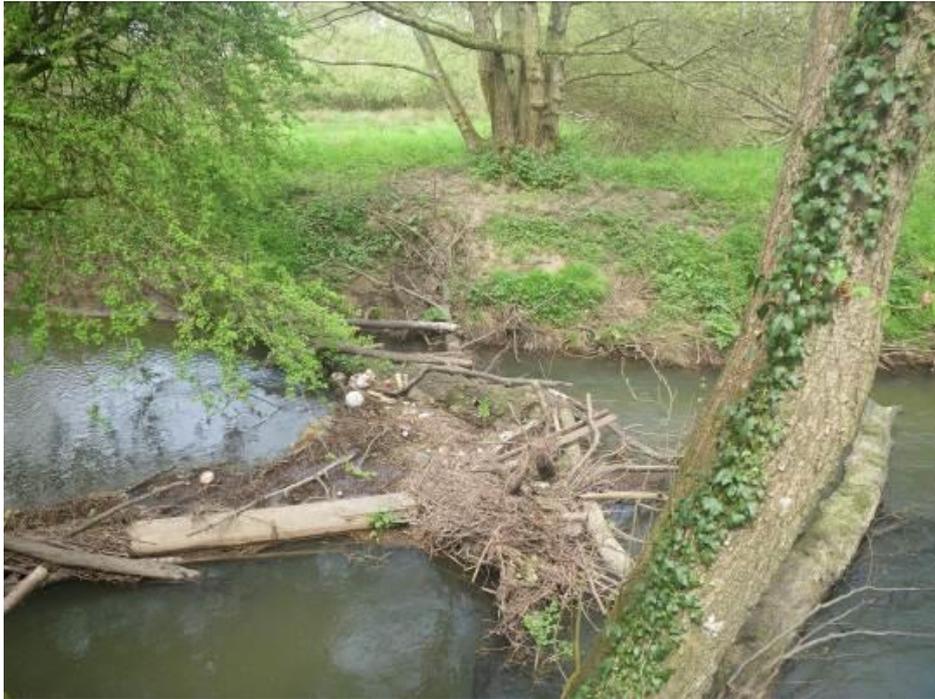
Photo 9. Full channel width debris dams will trap detritus and should be regularly monitored to ensure that a differential head in water levels does not form.

Full channel width debris dams (photo 9) can sometimes be a problem and a watching brief should be kept to ensure that any dam does not get completely occluded with fine material, resulting in a weir forming. All the while the debris dam has some under-shot flow, then it is unlikely that sediment transport is going to be significantly interrupted and free access for migrating fish can also be maintained. As seen from the photograph, full width debris dams can fulfil a useful role in trapping discarded plastics, however these debris dams require regular maintenance to avoid an unsightly build-up of waste material developing. If significant quantities of plastic litter are confirmed to be washing downstream from urban areas or public crossing points like bridges, consideration could be given to installing floating booms to intercept this litter at points which are easier and more accessible for clearance and removal of rubbish.

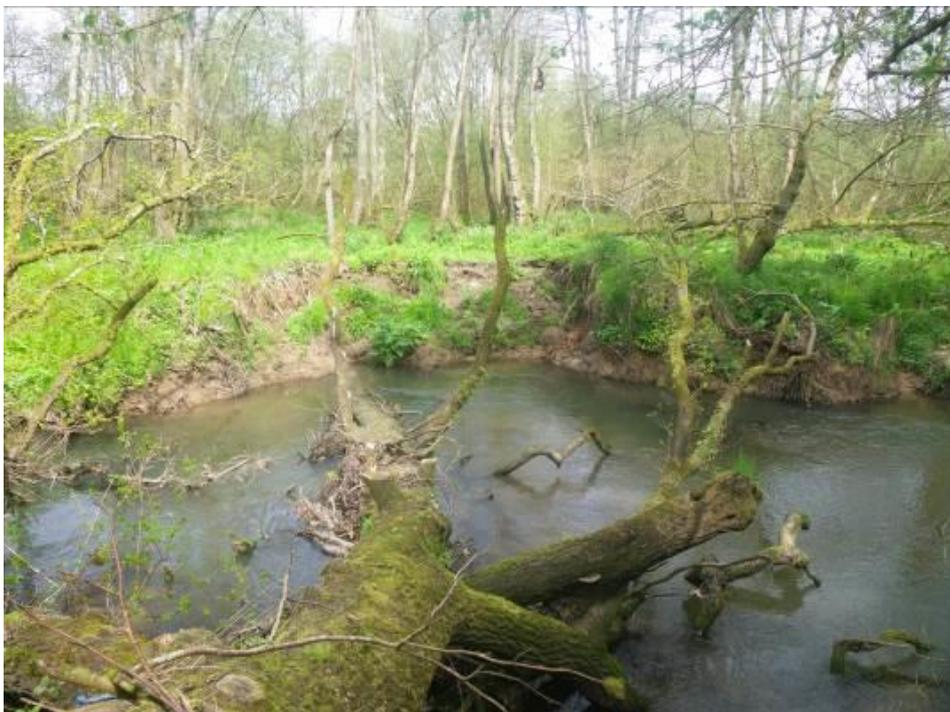
A key concern to many riparian owners on the Rother is bank erosion (photo 10). As previously stated, the banks are extremely soft and friable and when woody material falls into the channel it can locally exacerbate bank erosion. Equally, fallen woody material can help to protect vulnerable banks when it is packed into the toe of the bank and consists of a tight matrix of brushwood. This very much depends on the orientation of any fallen trees to the flow and whether or not the given tree helps to slow down flows adjacent to the toe of the bank, or conversely force elevated flows against undefended margins, where bank erosion is most likely to occur.

Photo 10. A large fallen tree promoting lateral bank scour

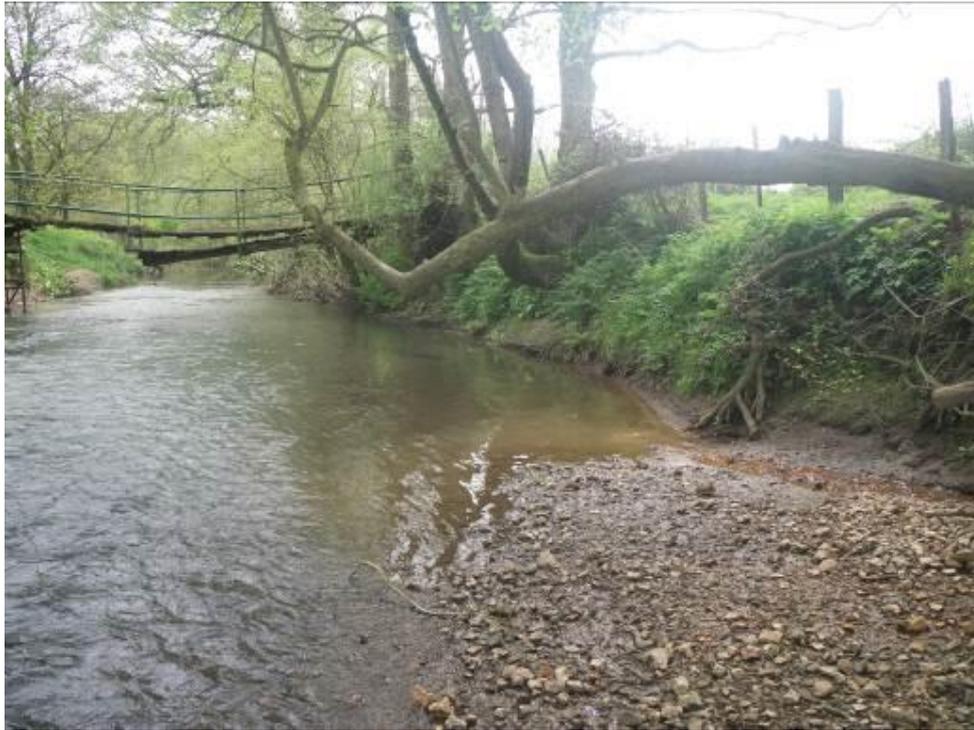
A notable exception to concerns over bank erosion is where there are obvious seams of eroded gravels, either derived from flints, or small local outcrops of eroded sand or iron stone. When these areas are identified, actively encouraging bank erosion via strategically securing large tree trunk sections into the channel to free-up fresh gravels is a good option for promoting improved gravel spawning habitat. These eroded bank and bed gravels normally settle into valuable ramps in the form of gravel bars, or occasionally full channel-width riffles (photo 11). These areas are of critical importance for many species of spawning fish, including trout and are also favoured areas for many specialised aquatic invertebrates.

Photo 11. A rare and valuable Rother gravel bar probably freed up as a direct result of fallen woody material promoting bed and bank scour

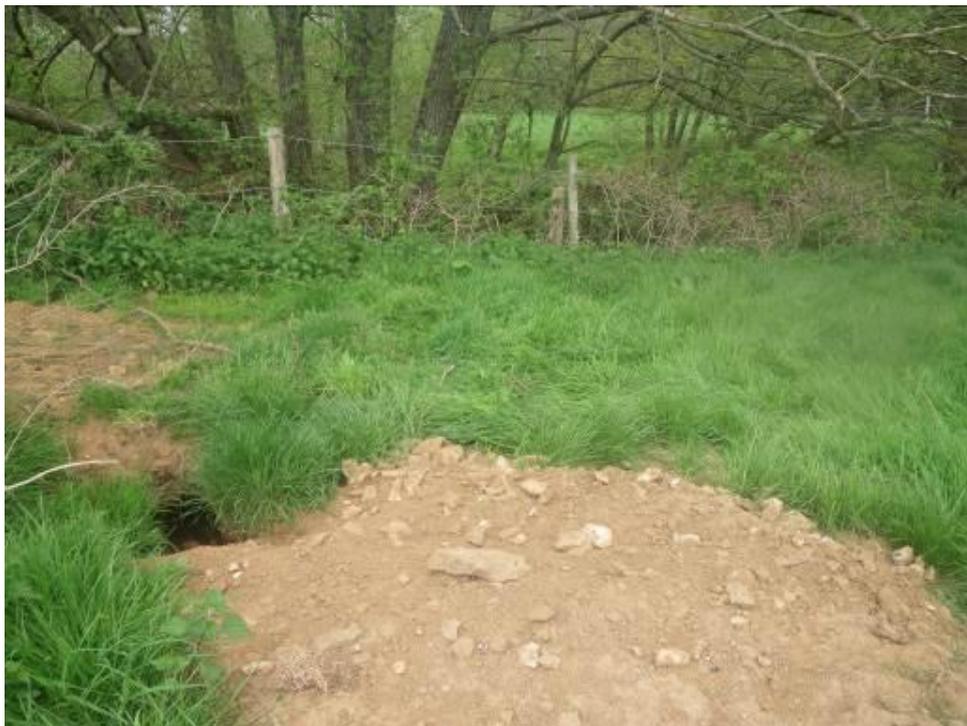
The presence of significant quantities of gravel were evident from the diggings of a badger very near to the top of the RB (photo 12). It could be assumed that the

gravel seam here extends to the toe of the bank and light bank erosion here should be viewed as beneficial.

Photo 12. A bank top badger set reveals a seam of gravels.

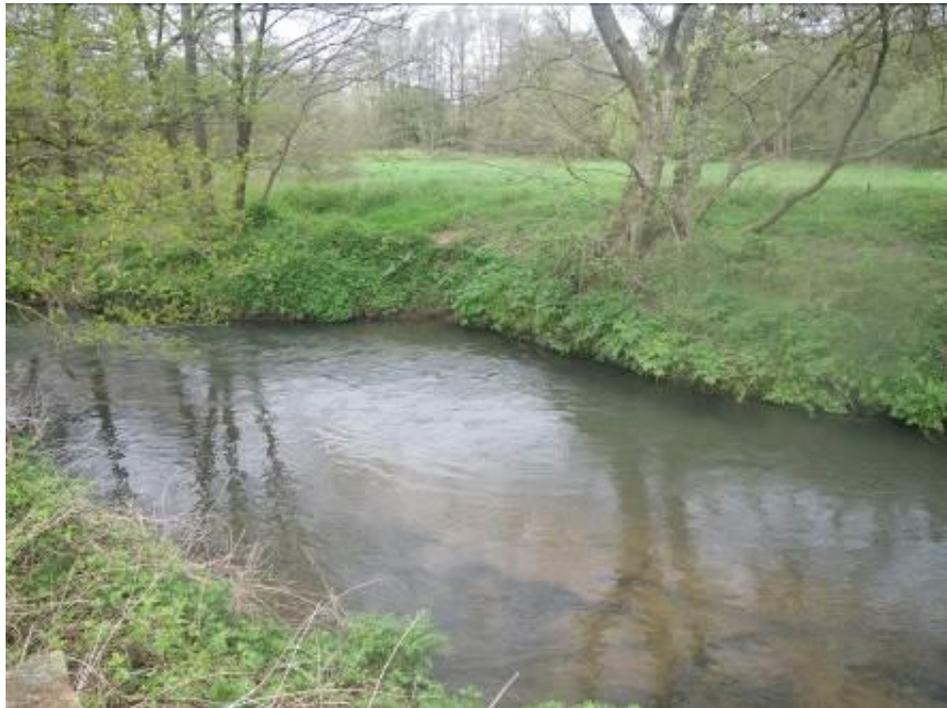
Habitat quality in the reach running approximately from where the high voltage pylons cross the river, right up to Habin Bridge was generally considered to be very good. Here the river has an active morphology with varied channel depths, substrate diversity and meandering planform. Photo 13 depicts a typically

Photo 13. A typically attractive run in the middle reaches. Note the “river friendly” land use on the valley floor adjacent to the LB.

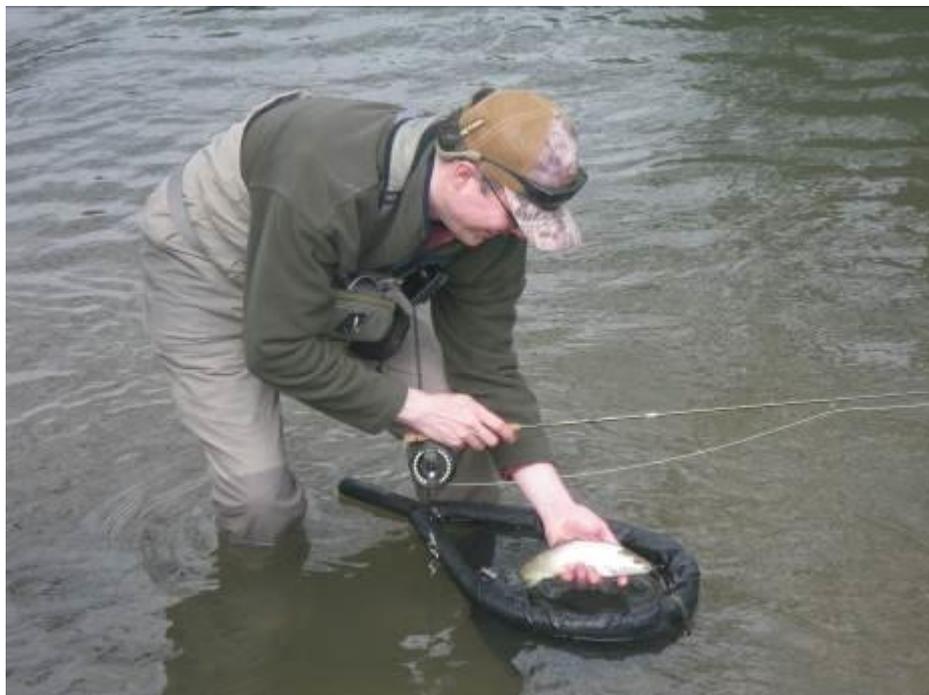
Photo 14. Wild Rother brown trout captured from the run in photo 13 confirming the potential of this section of the river for holding adult brown trout,

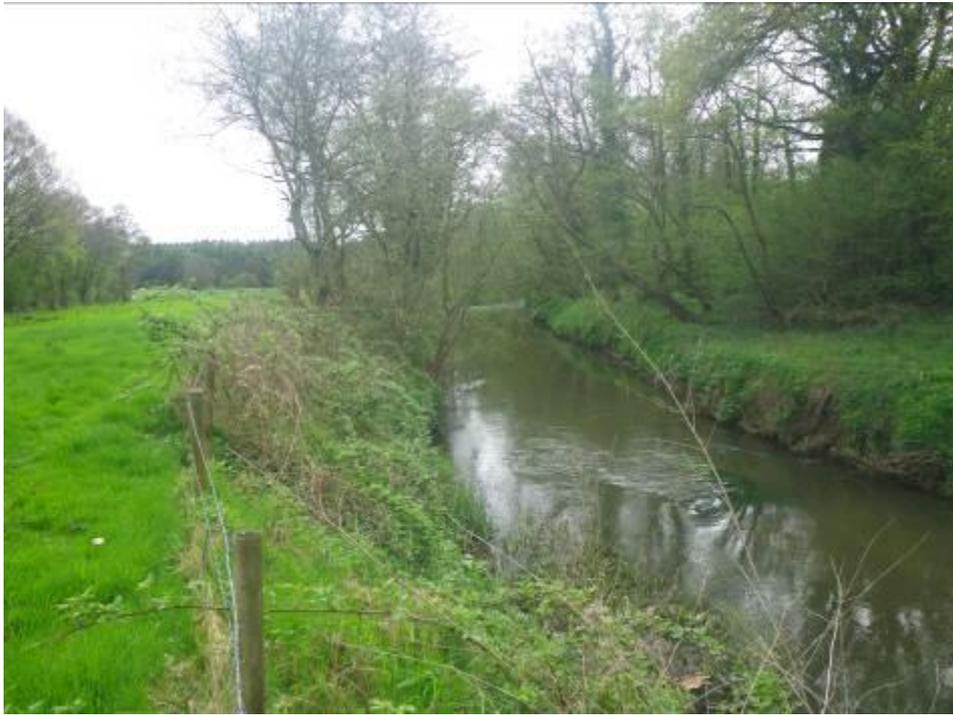
Unlike many sections of the Rother below Petersfield, the land use in the valley floor was mainly permanent pasture (photo 15) with occasional blocks of broad-

Photo 15. Typical riparian scene at Fair Oak with permanent pasture fenced from the river and blocks of deciduous woodland.

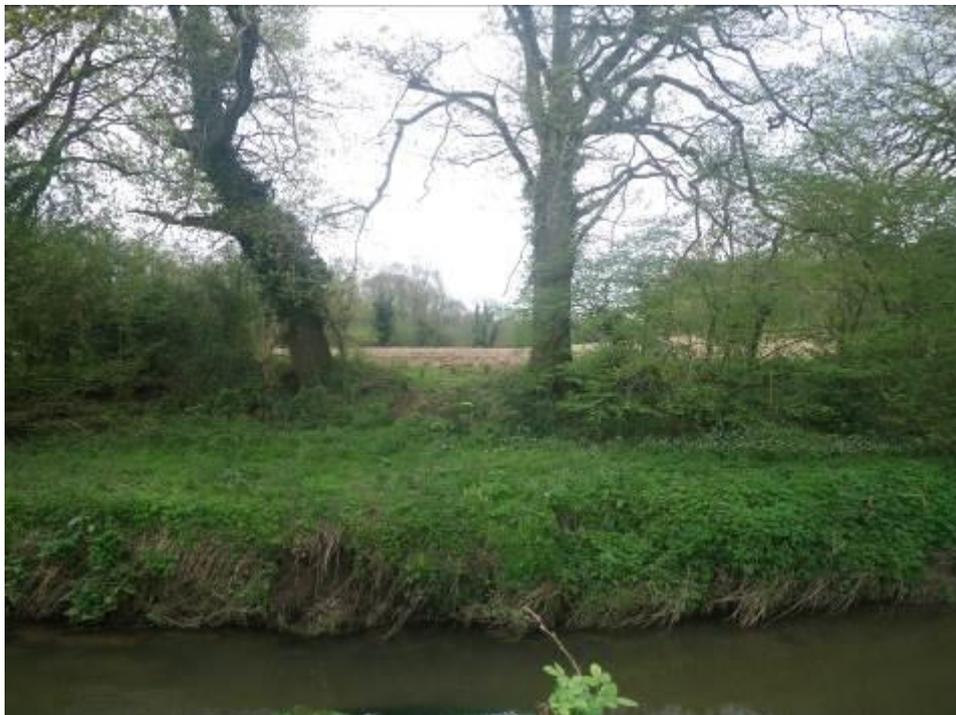
leafed woodland, wet meadow and amenity fields for horse eventing. There was the occasional glimpse of arable fields (photo 16) but usually behind substantial wooded buffer zones, with no obvious signs of sediment pathways.

Photo 16. A freshly ploughed arable field behind the tree line but no obvious sediment pathways. Arable fields, particularly on sloping valley sides are source of nutrient rich sediment on many sections of the River Rother.

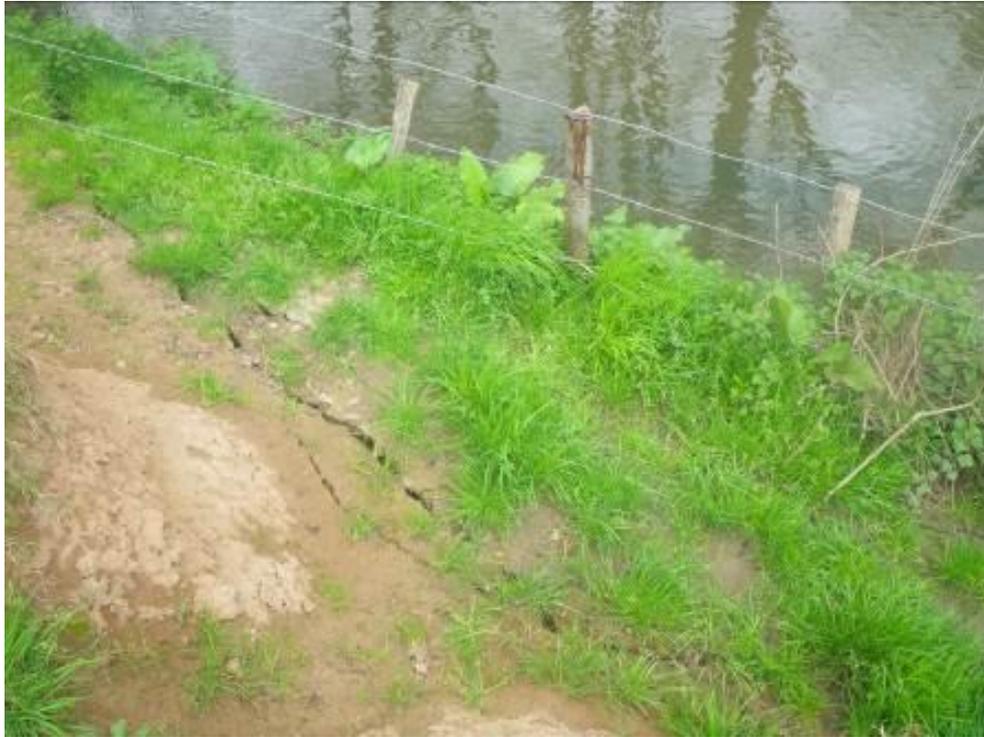
In several locations the lack of a wide buffer strip, coupled with grazing pressures and a lack of well-developed root systems on the top of the bank are threatening to cause block failure of the bank (photo 17). This is not an uncommon sight on the Rother and often results in lines of hanging fence posts above the river.

Photo 17. An example of immanent bank failure (block failure) where the buffer zone is far too narrow, coupled with a lack of binding root systems that usually results in slumping.

In areas where the soft banks have failed and collapsed it is recommended to plant up the toe of the bank to add stability. This will help to create a marginal habitat and also a safe, low vantage point for angling for those that find wading difficult. Sometimes these "slumped" margins naturally vegetate, but on the Rother, where the banks can be pure sand, plants either need to have their roots

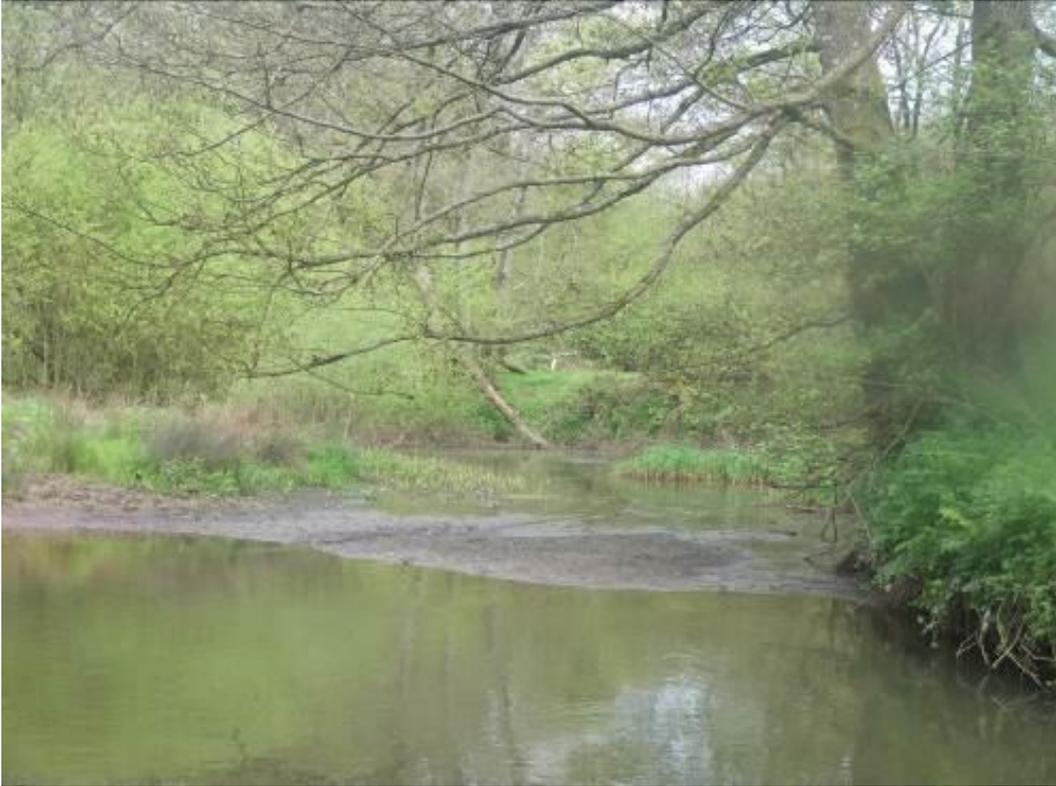
At one particular location there was evidence of an old oxbow (photo 18) adjacent to the LB which is now gradually reverting from open water to dry land. When still connected to the river, these relict channels often provide superb habitat, particularly for coarse fish species. Creating backwater habitat on rivers like the Rother, where the channel is deeply incised, is extremely difficult and periodically digging out sediment from natural features such as this is one method of providing high quality summer habitat for coarse fish fry, as well as a spate flow refuge area for all life stages.

Photo 18. An old oxbow backwater now separated from the river channel. Potentially this could be periodically dug out to create a high quality coarse fish habitat. A project like this could potentially attract Rivers Trust or EA funding.

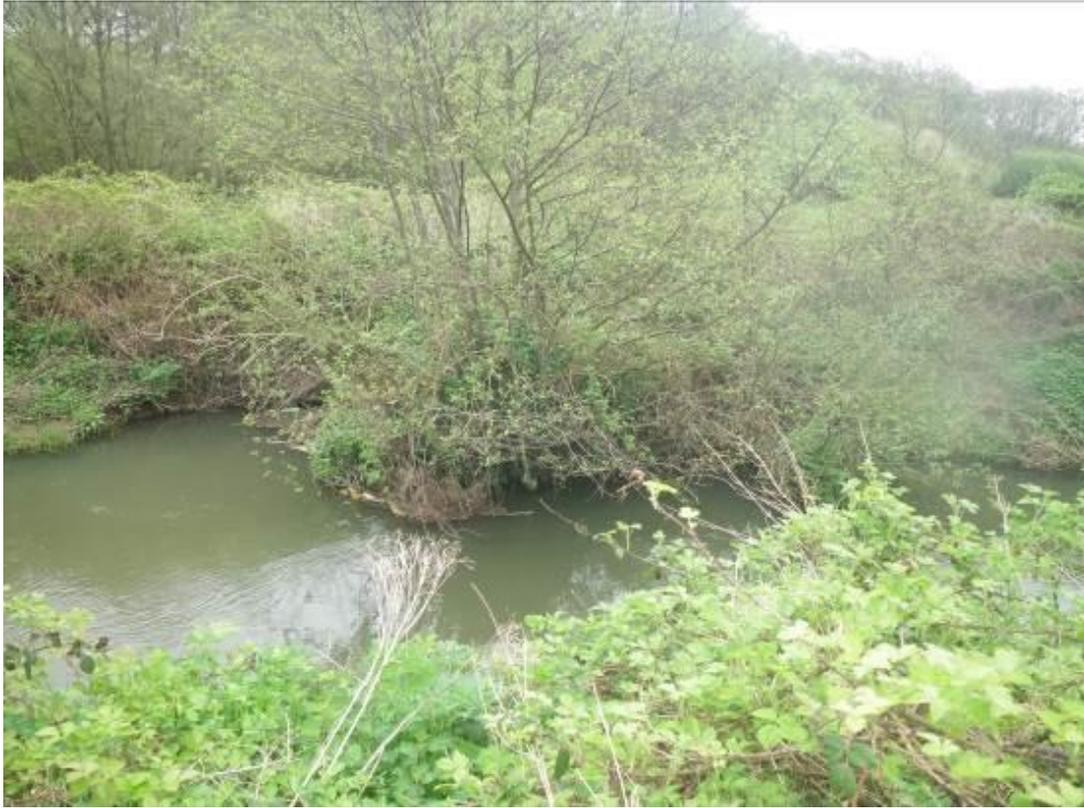
Photo 19. Trees that provide low scrubby cover are considered to be particularly valuable.

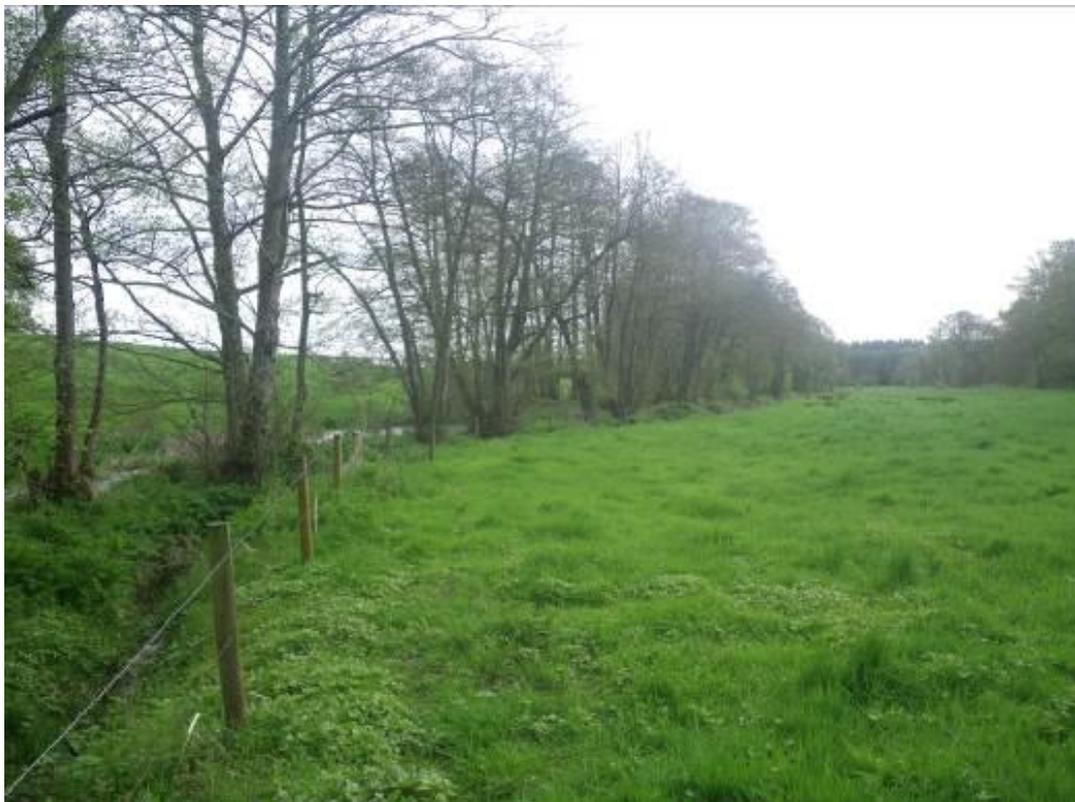
Alder trees (photo 20) were by far the most dominant bank top species at Fair Oak and these provide excellent bank protection and fish cover via well-developed root systems, which often form a tangled mat of sub surface cover. There is concern in the Rother Valley over phytophthora, a fungal disease which attacks many tree species but which is particularly damaging for alders, with the majority of specimens in the lower valley adversely impacted. When long stands of alder all become mature at the same time it is a good idea to create some diversity in the canopy by selectively coppicing the odd stand here and there. This not only promotes slightly bushy, low-level cover, via multi-stooped re-growth but also preserves the life of the tree and retains the valuable root systems. It is not uncommon for mature unmanaged alders to topple one after another once a single tree is lost, potentially creating a huge work load and a reduction in valuable in-channel cover once complex root systems are lost. Successional planting with a range of low bushy species to potentially compensate for future losses is recommended.

Photo 20. A long line of “leggy” alder trees adjacent to the RB. Occasional coppicing and planting with alternative low level species is recommended.

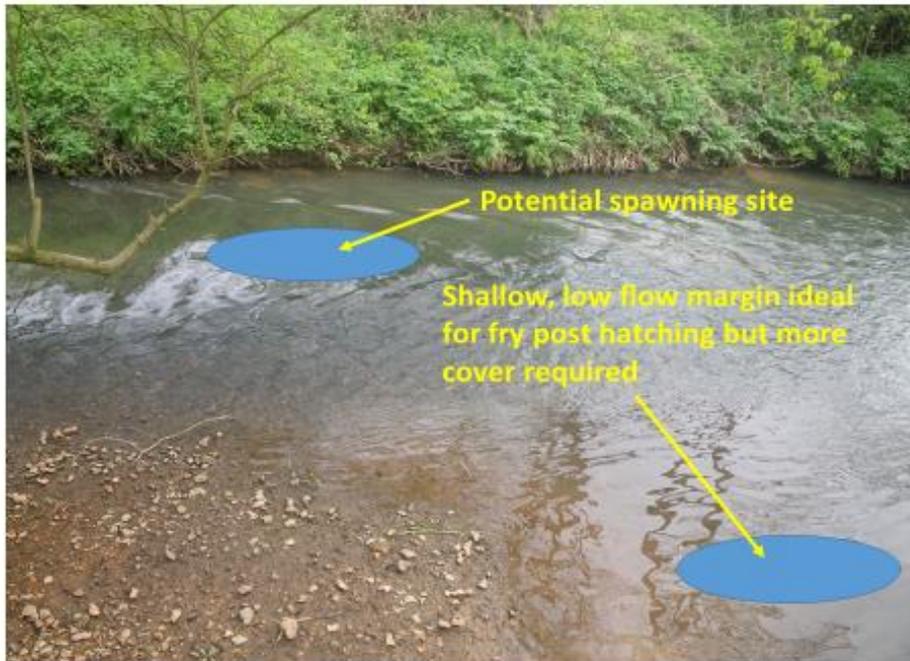
Potential spawning sites were located adjacent to areas of eroded gravels, forming shallow glides and broken riffles. Where margins were devoid of cover, improved fry survival can be encouraged with the addition of loose brushwood secured into the margins to provide essential cover for newly hatched trout fry.

Photo 21. A site that may well attract spawning activity. Improved fry survival can be achieved with the addition of improved winter cover over shallow, low flow margins.
Photo

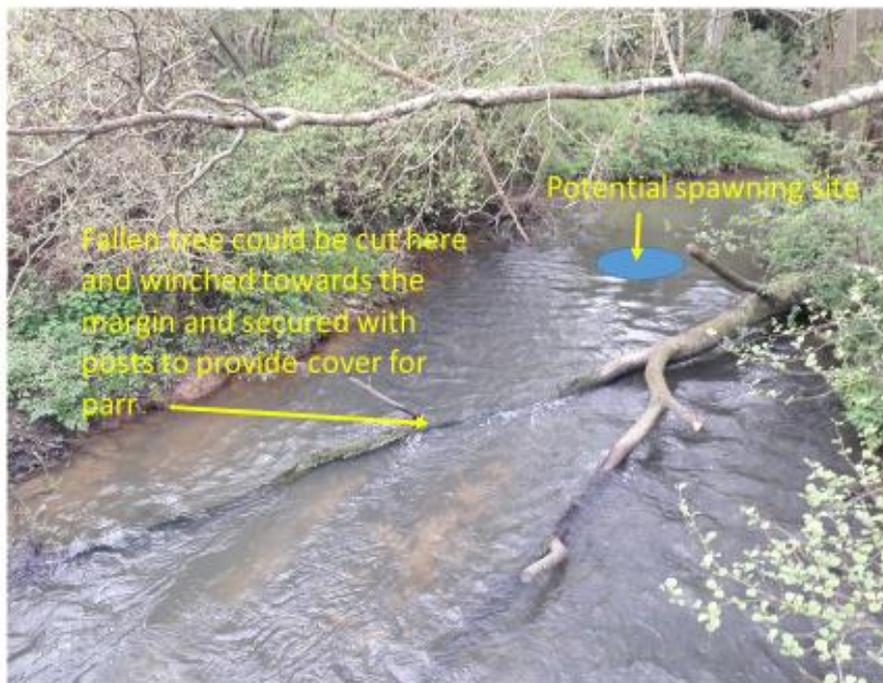
Photo 22. Shallow riffles provide ideal parr habitat when coupled with adequate cover. The fallen trees can be trimmed, moved and secured to create secure lies in the margin.

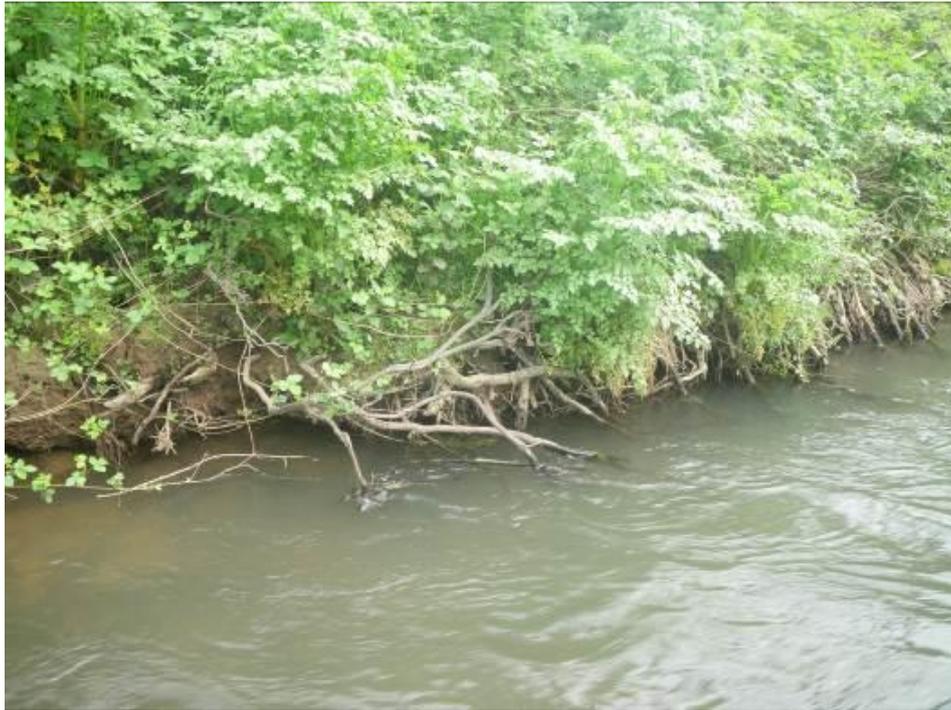
Photo 23. A good example of a well defended margin providing good opportunities for fish.

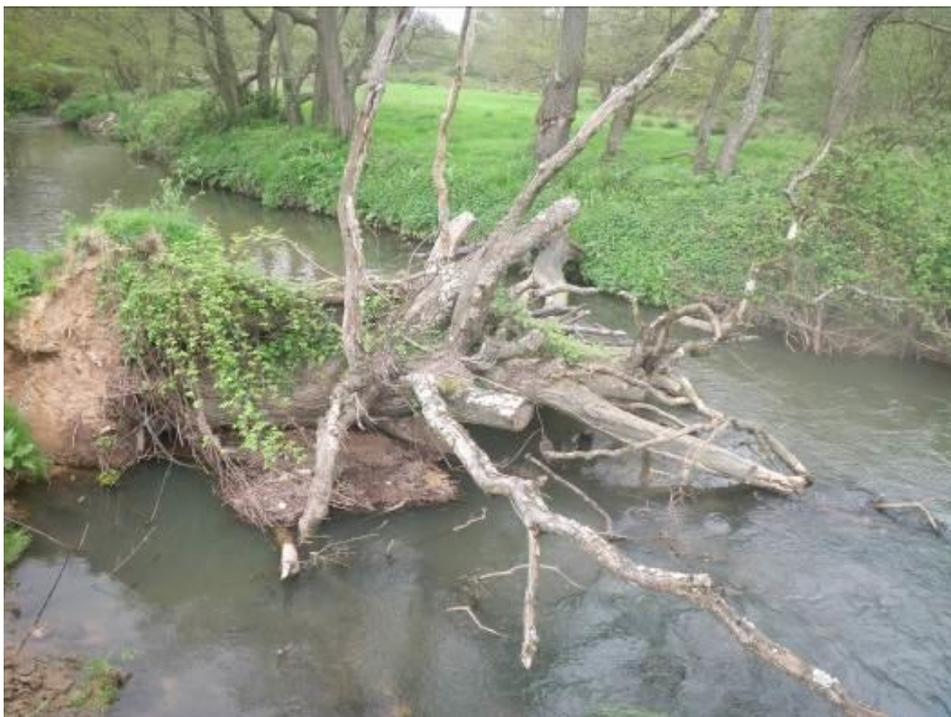
Photo 24. Large scale fallen trunks and root wads can often scour high quality pool habitat and throw up ramps of gravel providing potential spawning sites. The message here is to leave as much of this type of material in the channel as possible.

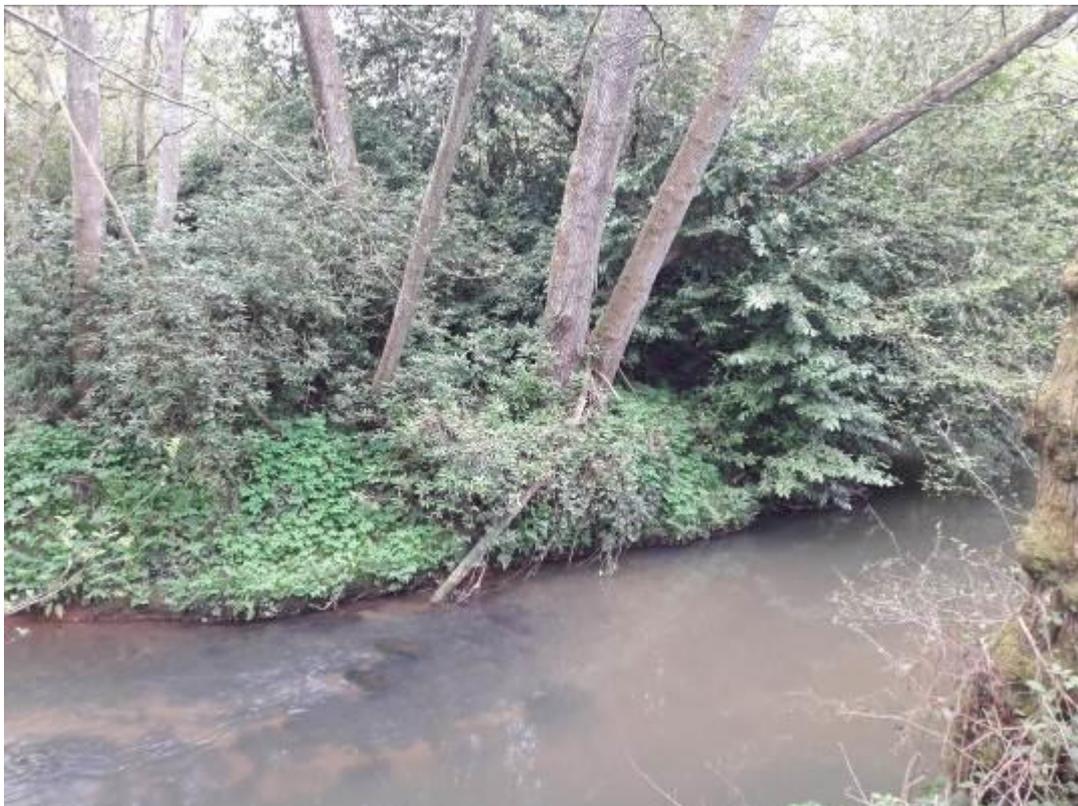
Another Victorian gardeners' legacy can also be seen at Fair Oak Estate in the form of extensive laurel or rhododendron bushes. These are considered to be inappropriate riverside plants due to the heavy shading and toxic nature of the leaves.

Photo 25. What appears to be either laurel or rhododendron bushes overhanging the river margins. Both of these plants are known to have toxic leaves and are not considered to be appropriate river-side shrubs.
